# Building and Timber Pest Inspection Report

Inspection Date: Tue, 7 Apr 2026

Property Address: 11 Chivell St, Corowa NSW 2646, Australia

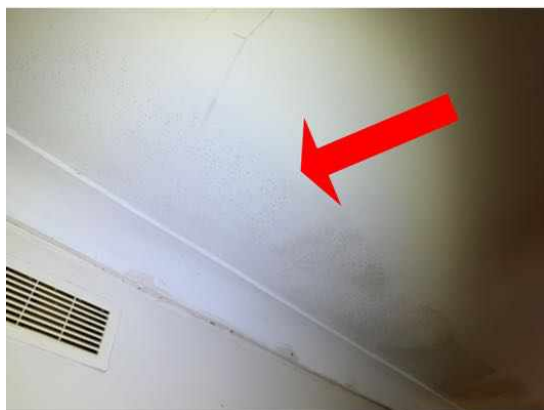
Finding: Mould - Present  
 Information: Mould growth was identified at, but not limited to, the ceiling of the rear bedroom. Causes of this defect may include previous leaking and/or insufficient air ventilation & light penetration to the area.

The client is advised to ensure that the general environment has sufficient airflow and light penetration to aid in the prevention of mould formation and development. Recommend engaging a mould remediation specialist to remove and treat the mould growth in the short term.

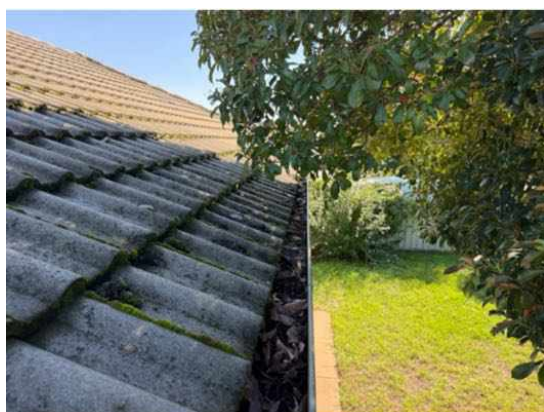
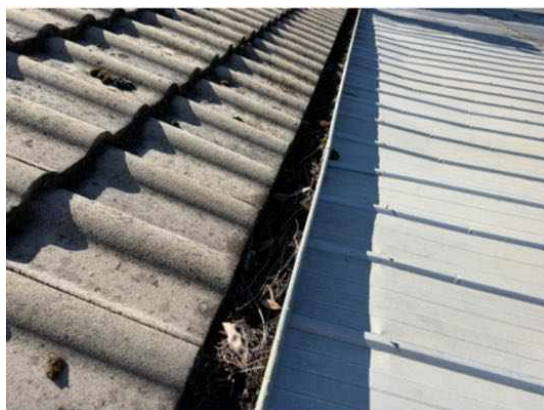
### Finding 3.03

Building: Main Building  
 Location: Gutters  
 Finding: Gutters - Debris & Water pooling  
 Information: Water pooling and debris were noted in sections of the guttering at the time of inspection, likely due to sagging or blockages. Water pooling can lead to deterioration of the roof plumbing over time, if neglected.

A licensed roof plumber should be engaged in the short term, to provide further advice & maintenance works to ensure adequate roof drainage is achieved. All debris should be cleared promptly to ensure proper drainage and prevent overflows.

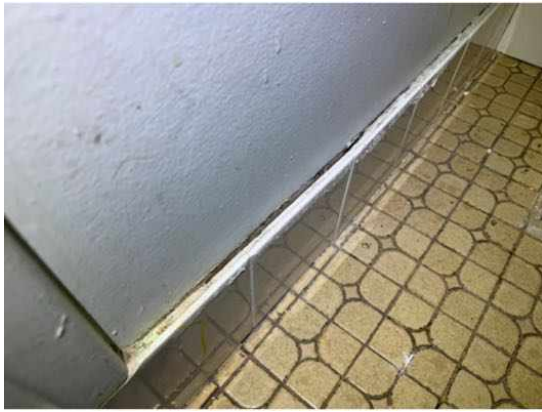
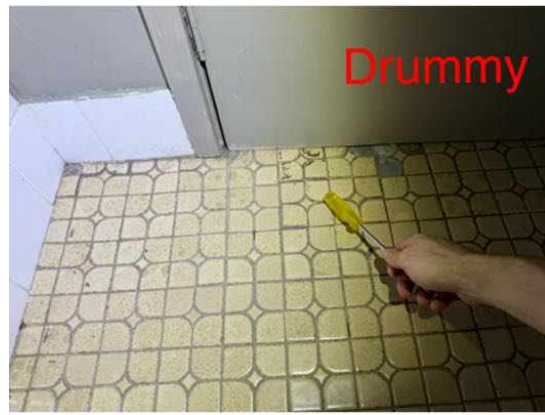
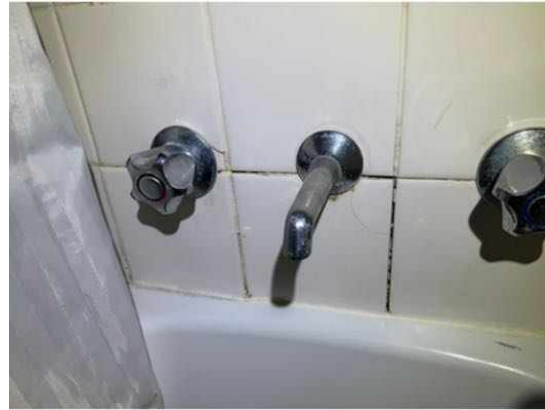
### Finding 3.04

Building:	Main Building
Location:	Tiled Areas
Finding:	Sealant / grouting - deteriorated or missing & Cracked & Drummy Tiles
Information:	It appears that the sealant and grout has deteriorated in some tiled areas, a common defect in buildings of a similar age. Areas of cracked & drummy/loose tiles were also noted, which can allow for moisture ingress behind the tiles, if neglected.

Sealant and grouting in areas that come into regular contact with water should be maintained for the long term care of your property.

Recommend engaging a licensed tiling contractor promptly, to provide maintenance works where necessary.

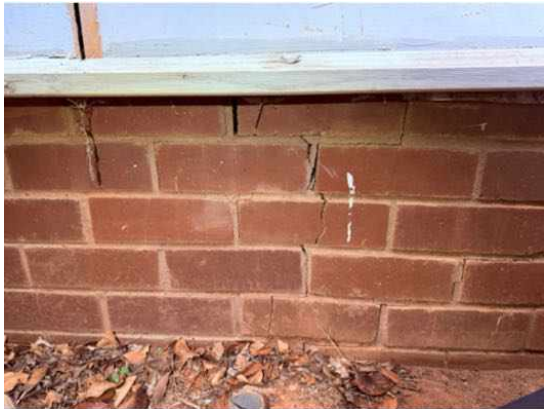
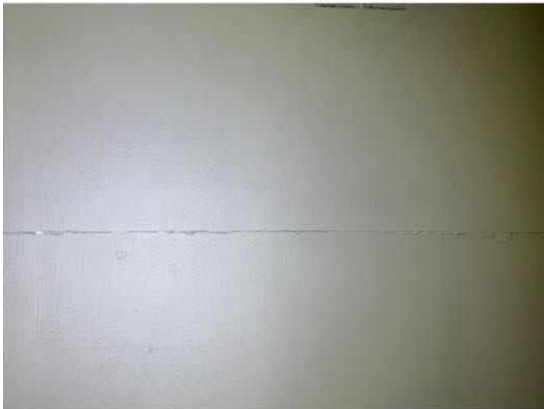
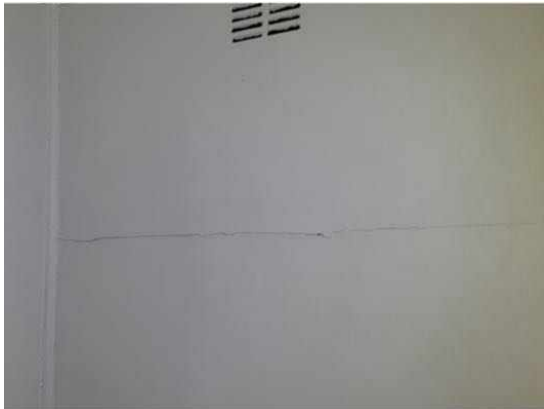
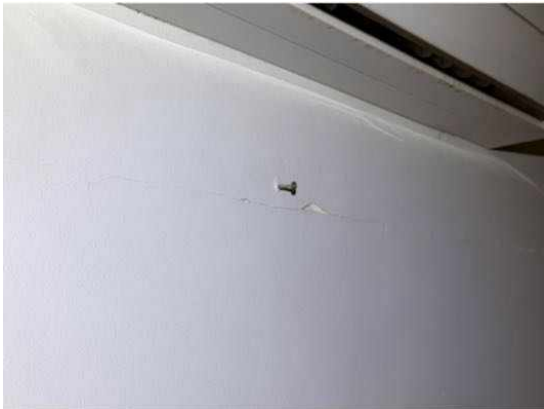
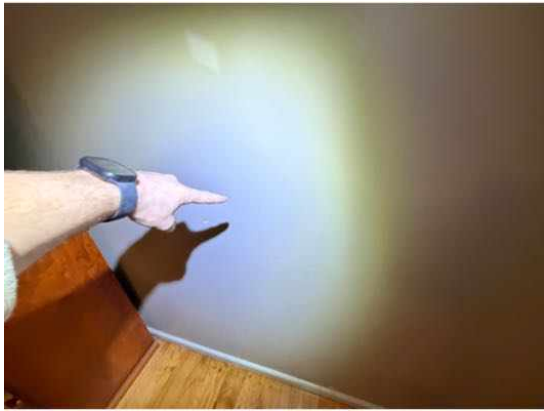
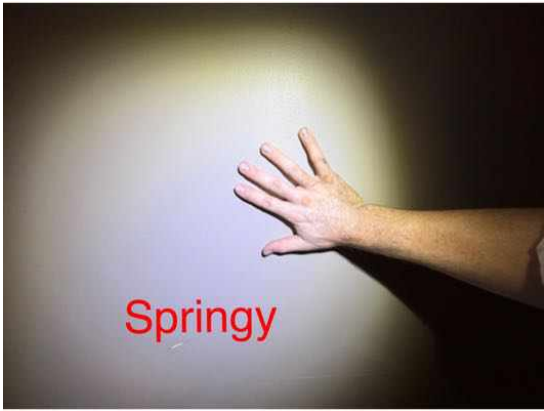
### Finding 3.05

Building:	Main Building
Location:	Wall linings, Brickwork
Finding:	Cracking - External & Internal & Loose Plaster
Information:	Cracking was identified to some areas of the brickwork and internal wall linings. Cracking has a variety of possible causes, however, the most common is general movement of adjacent footings and/or expansion / contraction of building materials. Some areas of loose/drummy plaster was also noted.

The client should monitor the cracking. Should the cracking lengthen, widen or become more numerous, the client should consult with a structural engineer promptly to provide further advice.

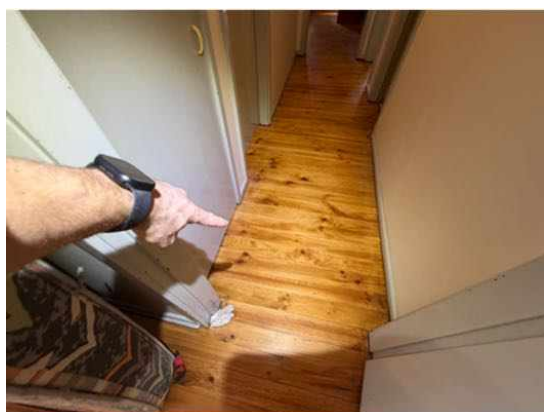
**Finding 3.06**

Building: Main Building  
Location: All Areas  
Finding: Flooring - Uneven  
Information: Some areas, of the flooring throughout the building appear to be slightly uneven. It is advised that the client monitor the flooring to identify any further movement. Where flooring remains relatively unchanged for an extended period of time, it is likely that this defect has been caused by expected movement of the foundations of the property.

However, where further movement and unevenness occurs, a structural engineer

should be engaged promptly for further evaluation.

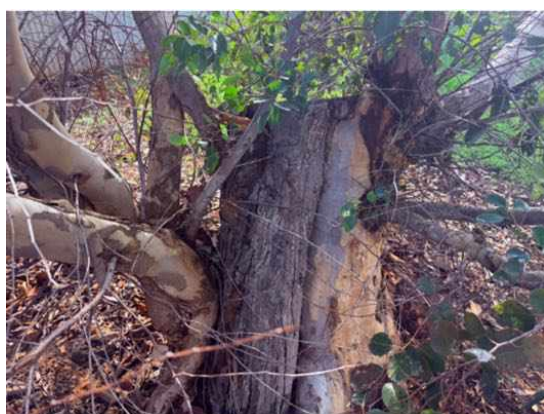
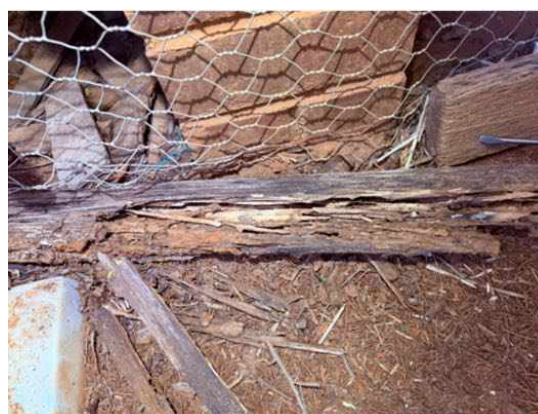
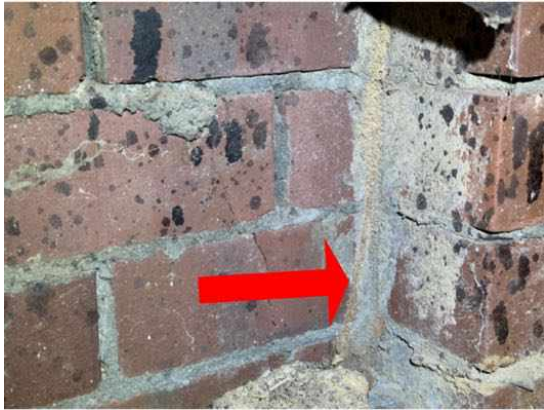
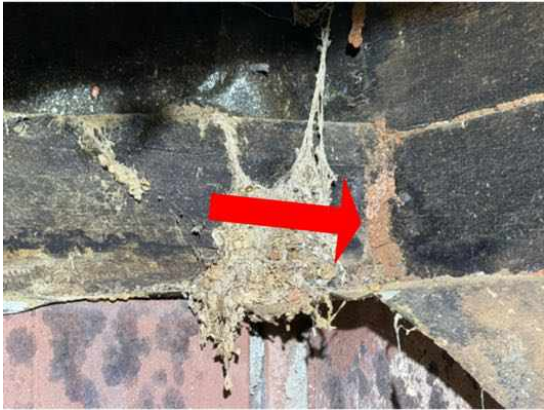
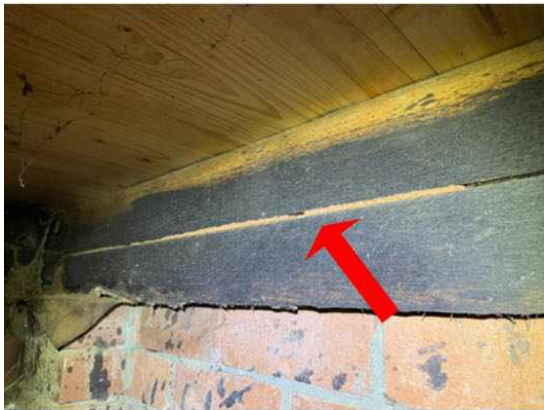
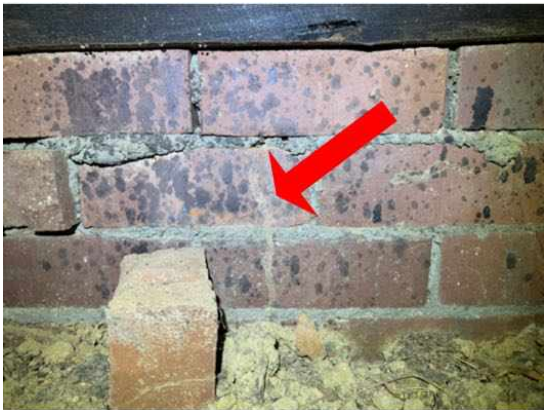
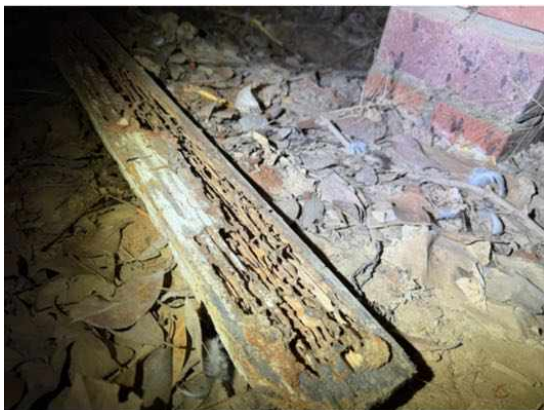
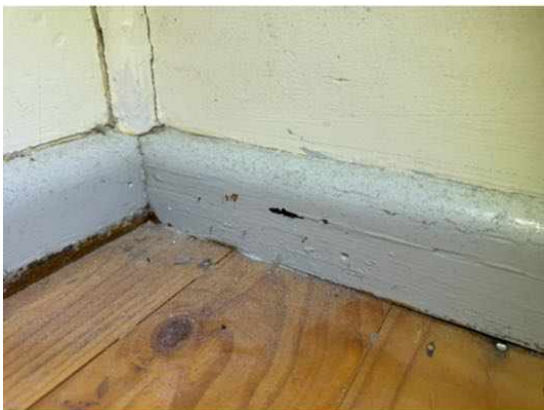
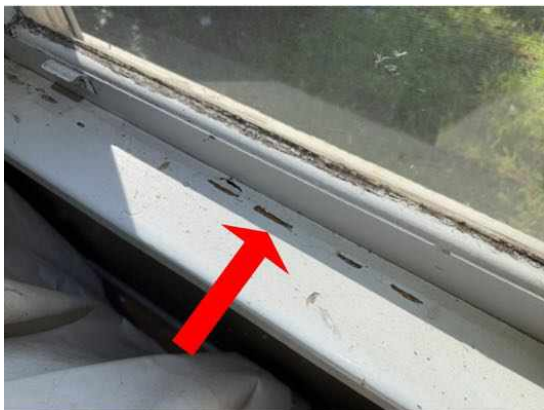
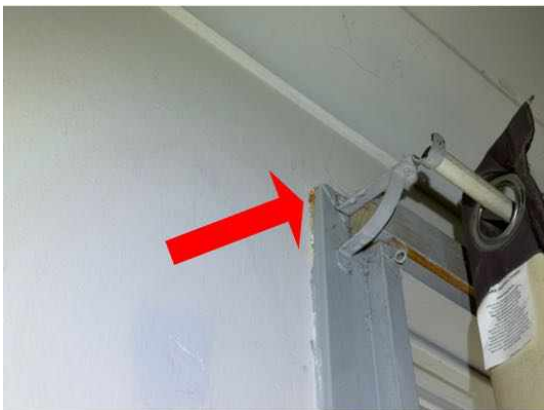
Building:	Main Building
Location:	Subfloor, Bedrooms
Finding:	Evidence of termite workings & damage
Information:	Although no live termite activity was identified at the time of inspection, termite damage & workings were identified at, but not limited to, areas throughout the subfloor, rear tree stump and front and rear bedrooms (window frames & skirting)

Although no live termite activity was identified at the time of inspection, termite workings & damage were identified to areas of the subfloor, and front & rear bedroom. It appears areas of audible droppings in the wall cavities were present, at but not limited to the front & rear bedroom walls. This may be an indicator of potential termite damage in the wall cavity. Recommend engaging a licensed tradesperson to conduct a more invasive inspection to identify extent of the damage & provide remedial works where necessary.

The client should engage a licensed pest controller promptly, to provide further advice regarding installation of a termite treatment.

6 monthly ongoing termite inspections, conducted by a qualified termite inspector, are also recommended

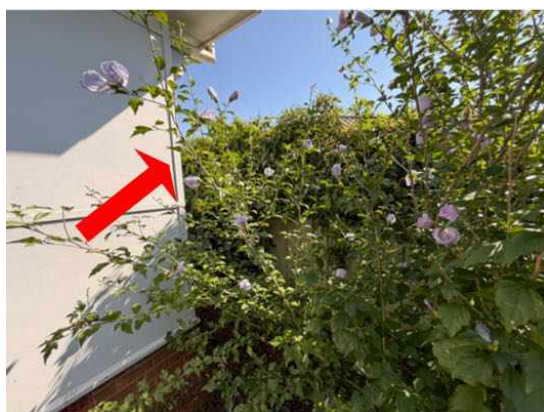
### Finding 6.01

Building:	Main Building
Location:	Switchboard
Finding:	Termite Management System - no evidence of a chemical installation
Information:	The application of a termite barrier is strongly recommended. The switchboard was unable to be accessed at the time of inspection due to a beehive nearby. Generally, a durable notice is placed in the meter box to indicate current termite barriers.

Such barriers are highly effective in preventing termite attack on the building and therefore should be installed.

Recommend seeking further advice from a licensed pest controller.

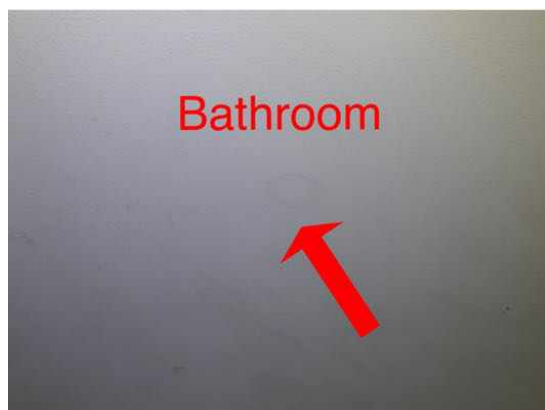
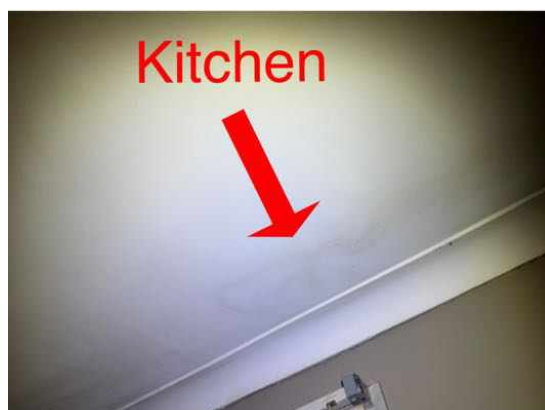
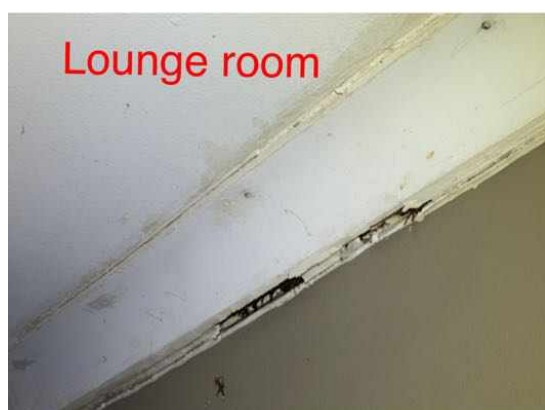
Building: Main Building  
 Location: Bathroom, Lounge Room & Kitchen Ceilings  
 Finding: Ceiling Leaks  
 Information: High moisture was identified at, but not limited to the ceilings of the bathroom & kitchen. It appears water staining was also present to the lounge room ceiling however no high moisture was identified in this area, at the time of inspection. Potential causes of leaking include damaged plumbing fittings and fixtures, or deterioration of the roof exterior.

High moisture was identified at, but not limited to the ceilings of the bathroom & kitchen and water staining was present to the lounge room ceiling. Recommend engaging a licensed roof plumber or roofing contractor promptly to identify the cause & provide remedial works.

This creates an environment conducive to termite activity. Recommend engaging a licensed roof plumber or roofing contractor promptly to identify the cause & provide remedial works.

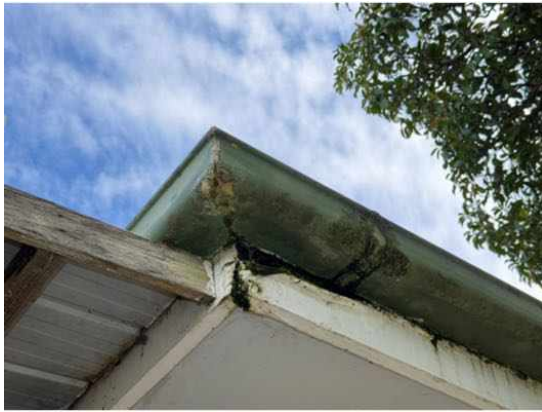
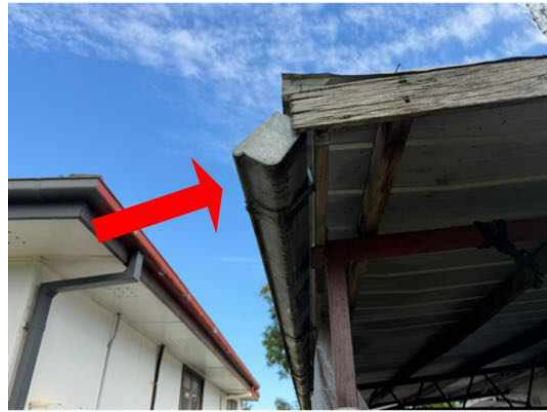
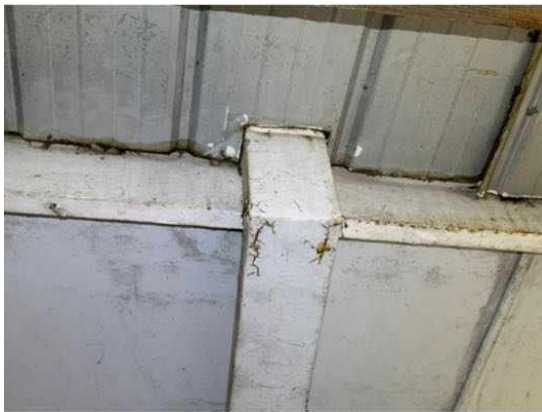
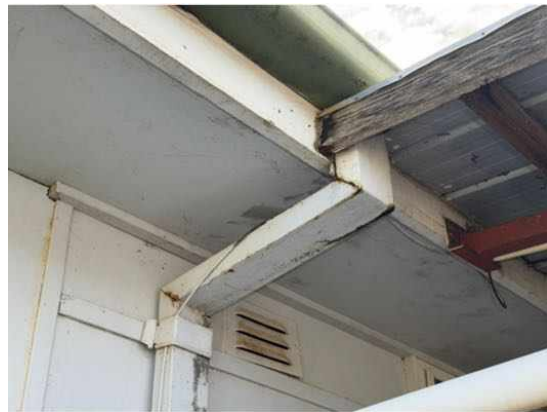
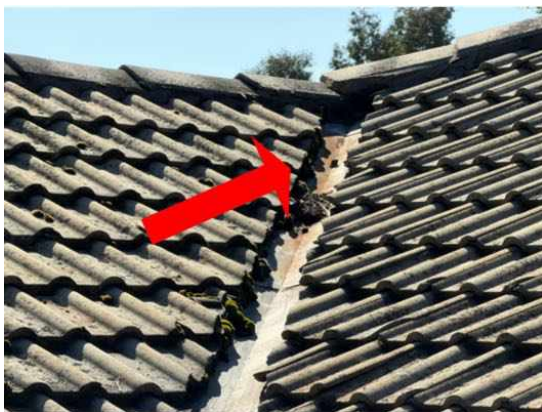
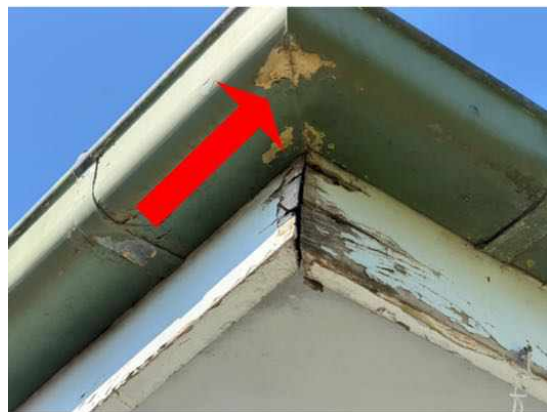
### Finding 6.04

Building:	Main Building
Location:	Gutters, Down-pipes
Finding:	Roof Plumbing - Rust & Leaking
Information:	It appears that areas of the roof plumbing (gutters & down-pipes) were leaking & had areas of rust. Rusted & leaking roof plumbing could eventually develop holes overtime that can affect other building elements, and create water pooling in the area, creating an environment conducive to termite activity, if neglected.

Recommend consulting with a licensed roof plumber in the short term, to provide further advice & remedial works where necessary.

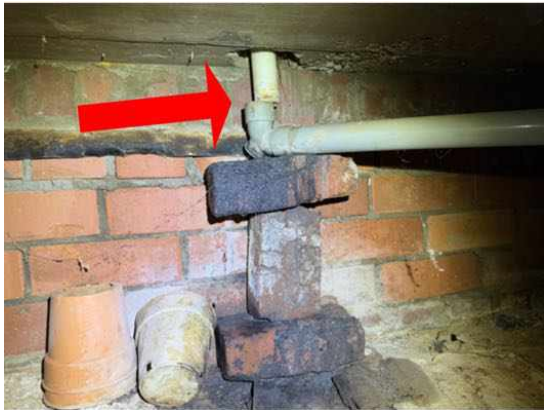
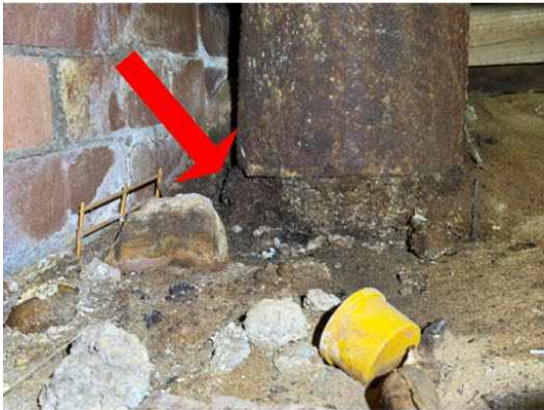
### Finding 6.05

Building:	Main Building
Location:	Subfloor
Finding:	Plumbing - Leaking
Information:	It appears that the plumbing beneath the bathroom/laundry area in the subfloor was leaking at the time of inspection. It appears that the pipework is disconnected and the adjacent pipework has also deteriorated and rusted.

This has created a moist environment in the area, creating an environment conducive to termite activity and water damage to surrounding materials, if neglected. Recommend engaging a licensed plumber promptly, to provide remedial works where

necessary.

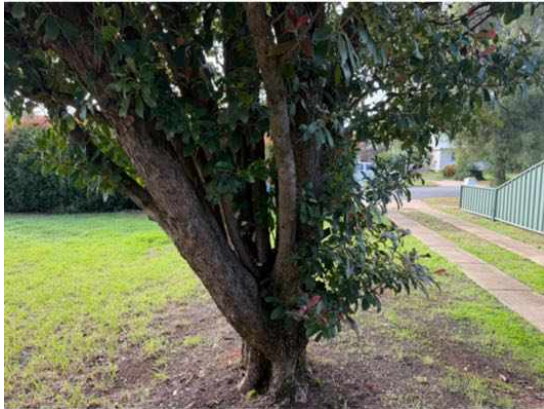
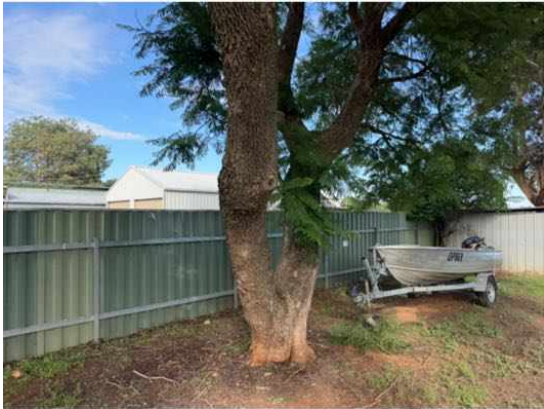
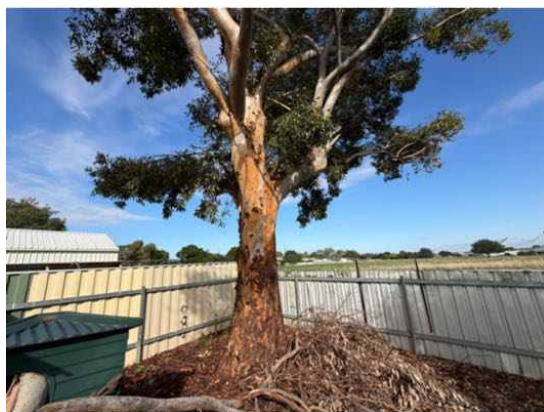
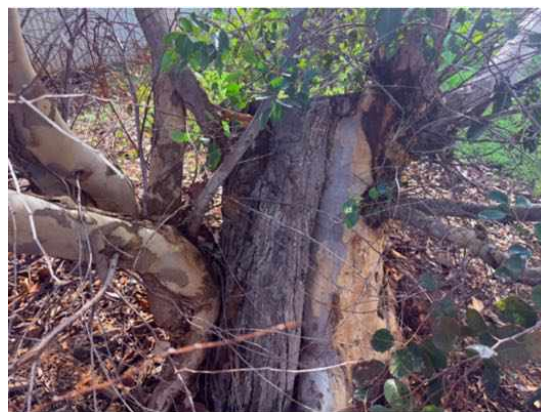
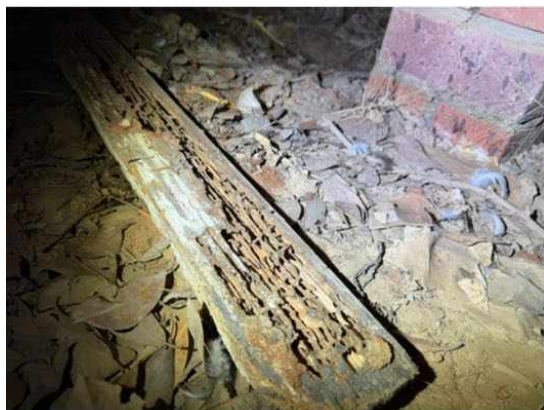
**Finding 6.06**

Building: Main Building  
 Location: All External Areas, Subfloor  
 Finding: Timber in direct ground contact & trees - conducive to termites  
 Information: Where timber materials are in direct contact with the ground and consequently moisture, they become conducive to termite activity. The tree stumps, timber debris in the subfloor, landscaping timbers, and trees surrounding the building create an environment conducive to termite infestation.

Where feasible, any timbers in direct contact with the ground should be removed and any trees in close proximity to the building should be removed or test drilled (inspected) at least annually to reduce the risk of termite infestation & detect any early signs of termite activity.

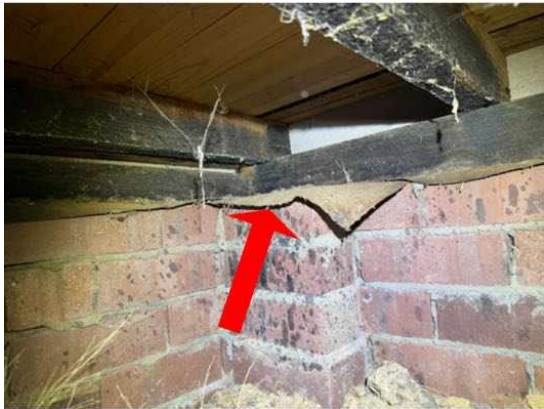
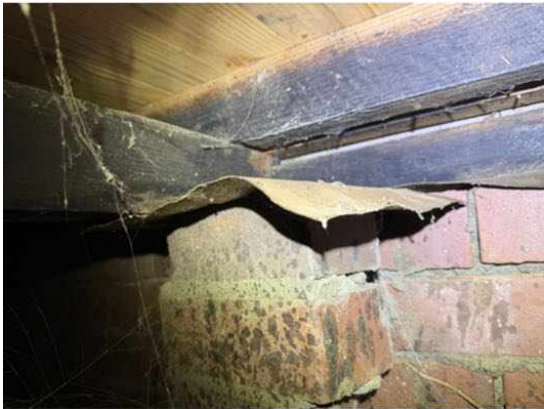
### Finding 6.07

Building:	Main Building
Location:	Subfloor
Finding:	Ant caps - Inadequate
Information:	It was found that several ant caps that have been installed are inadequate. Ant caps are designed to easily identify termite or pest ingress from stumps to the adjoining bearers.

Where ant caps are inadequate, this poses as an obstruction to the inspection and frequent monitoring of these areas should be carried out in order to identify any early signs of termite workings. Recommend engaging a licensed carpenter to install adequate ant caps to the subfloor.

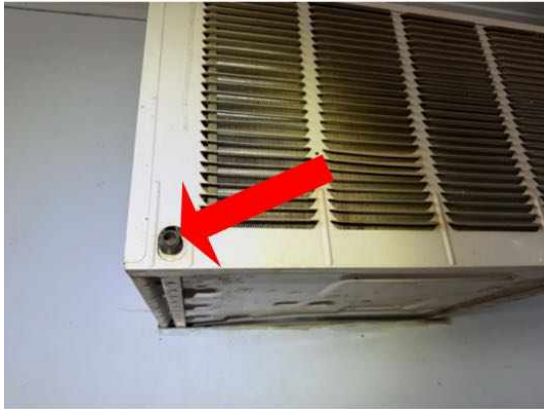
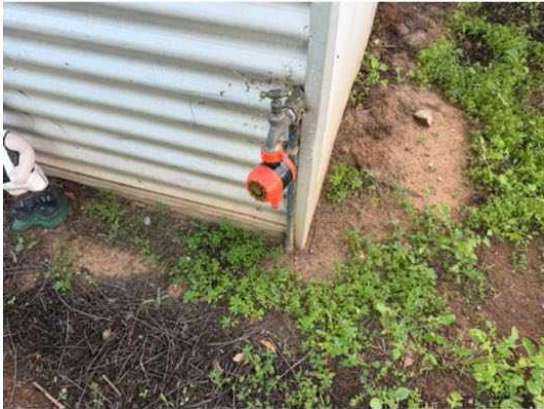
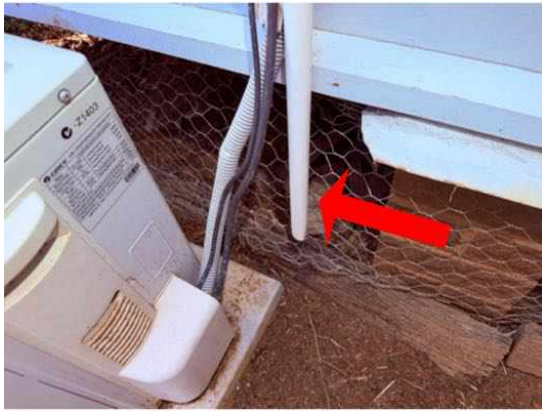
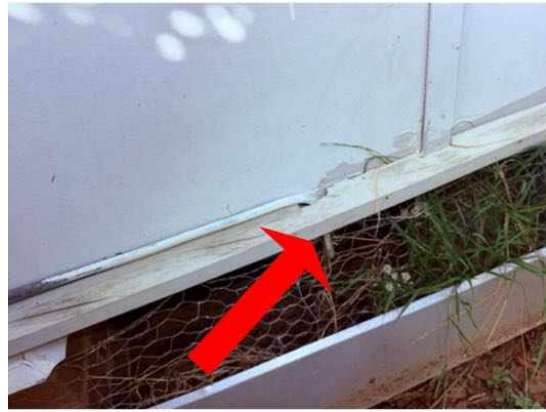
**Finding 6.08**

Building: Main Building  
Location: All external areas  
Finding: Potential Water pooling - against property  
Information: It appears that there are potential areas around the perimeter of the property that could be susceptible to water pooling. Where insufficient drainage of taps, hot water system & aircon overflows, and garden beds against the house are present, water pooling is likely to occur, and can create areas conducive to timber pests and potential damage to the subfloor structure overtime, if neglected.

Recommend consulting with a licensed plumber in the short term to further assess and provide remedial advice.

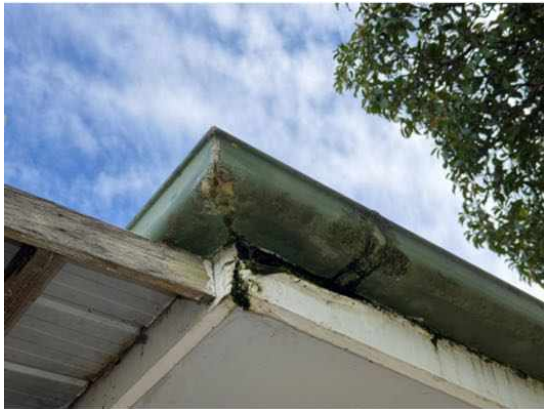
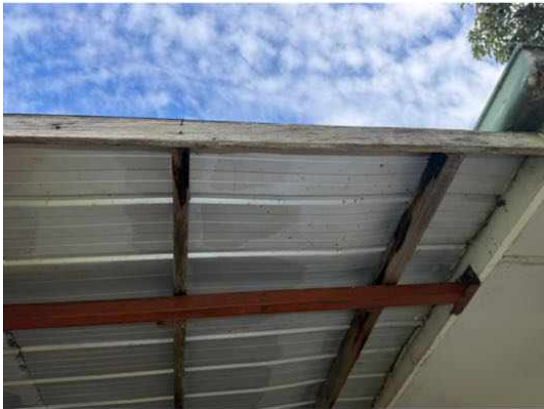
### Finding 7.01

Building:	Main Building
Location:	Fascias, window frames, carport framing
Finding:	Fungal decay & weathering
Information:	Areas of fungal decay (wood rot) were identified at but not limited to the fascias, window frames & carport framing. It appears that a rail of the front balustrade has also become loose & dropped.

For areas of fungal decay, the client can engage a licensed carpenter at their discretion to replace affected materials. For areas of general weathering, it is advised the client engage a licensed painter to apply protective sealant or coating to areas of weathered external timbers.

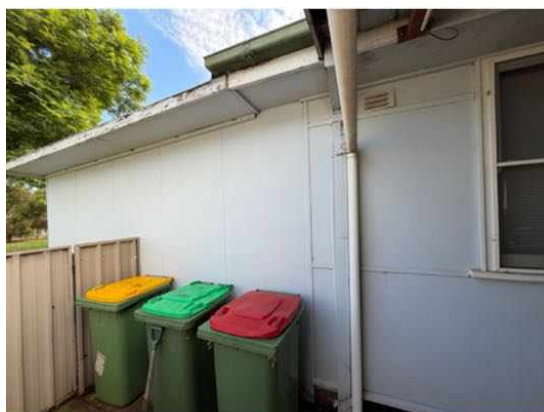
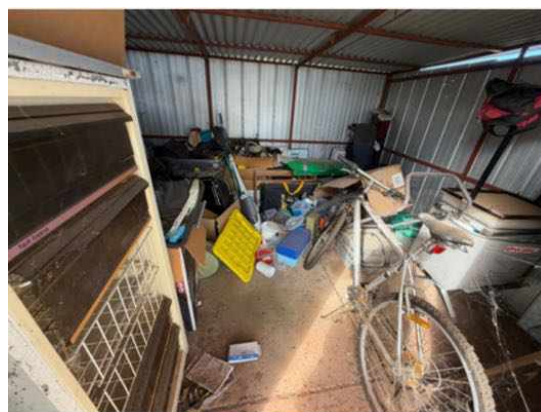
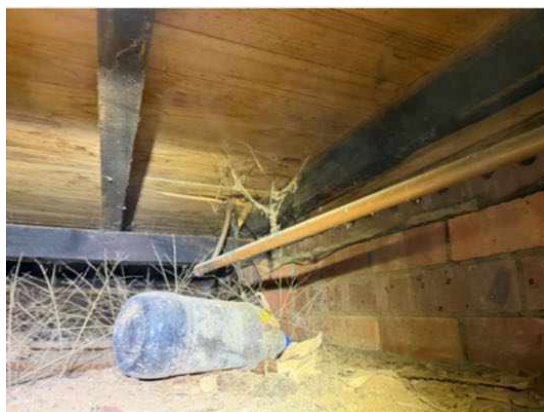
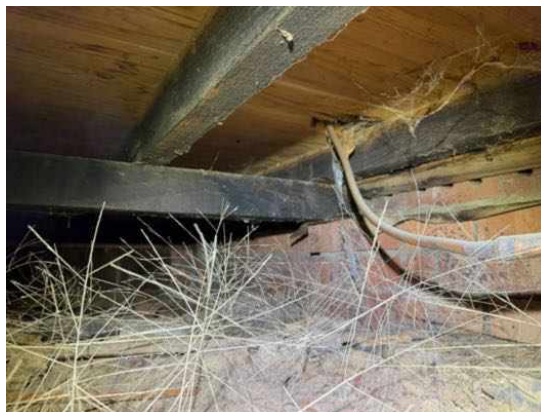
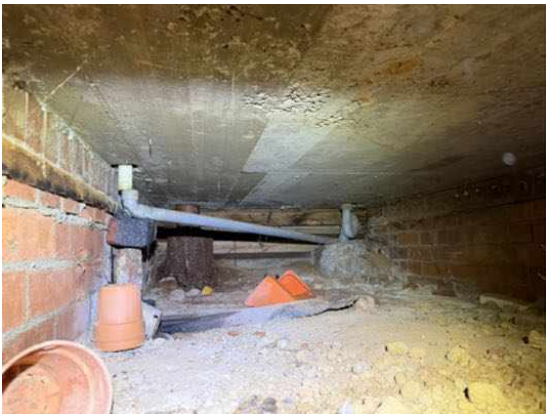
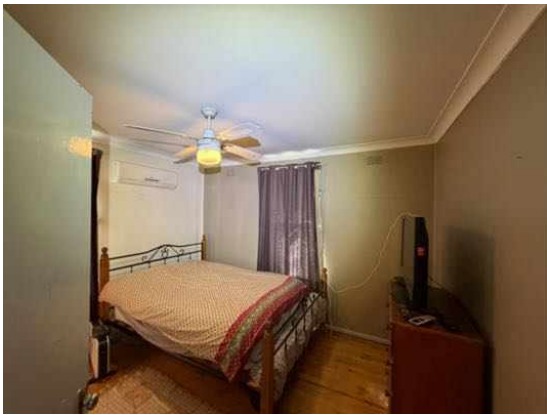
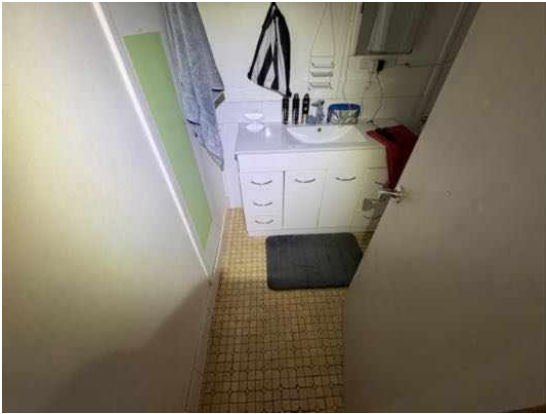
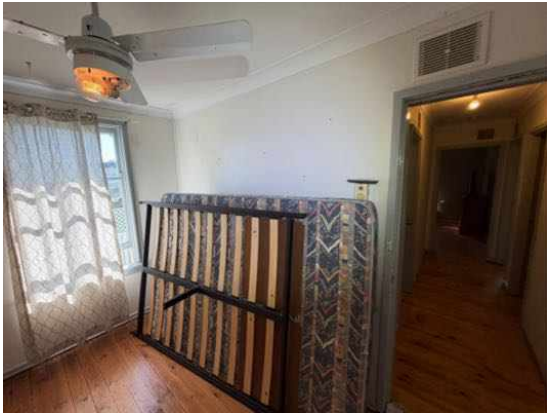
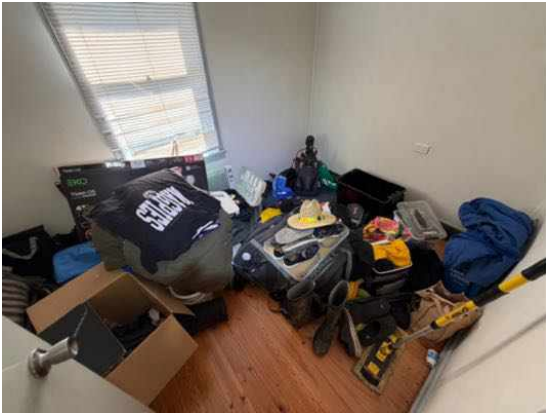
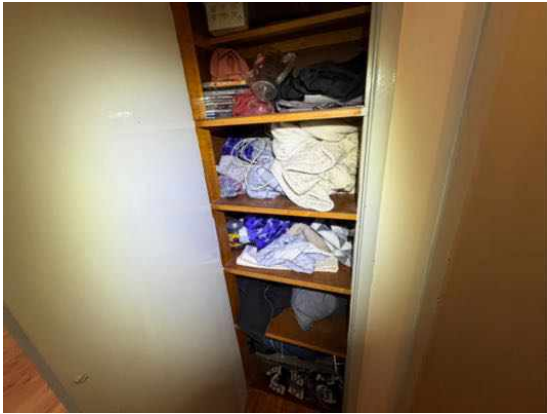
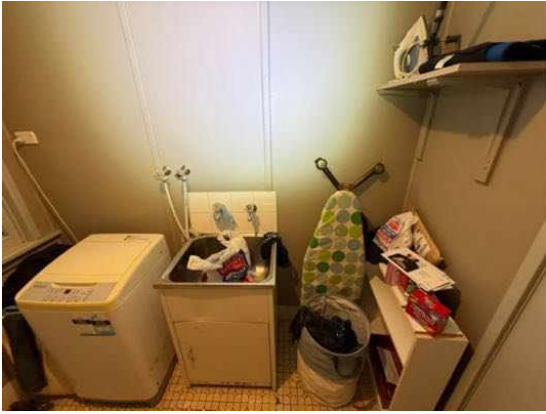
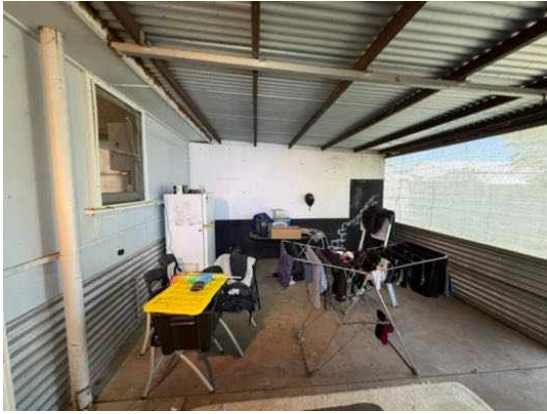
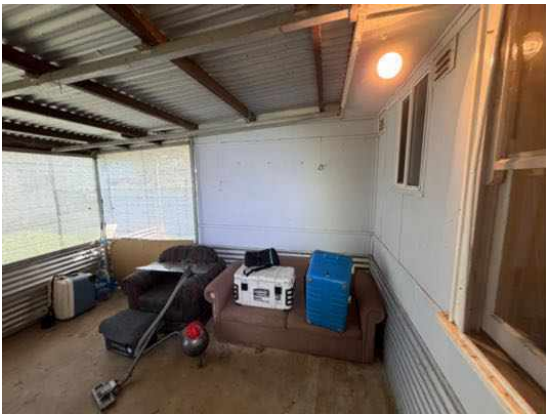
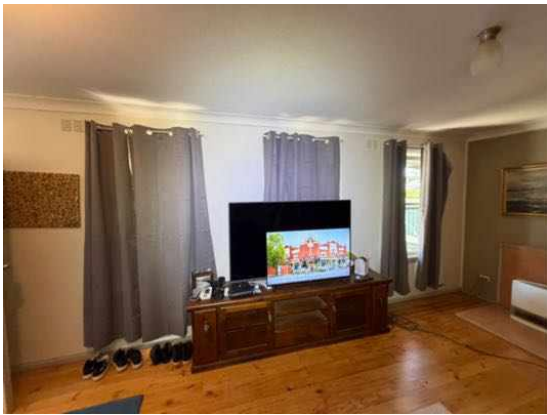
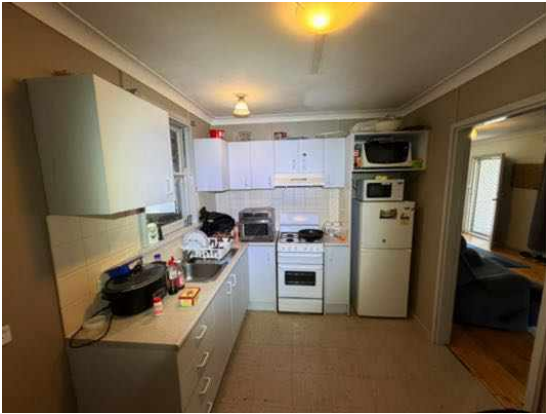
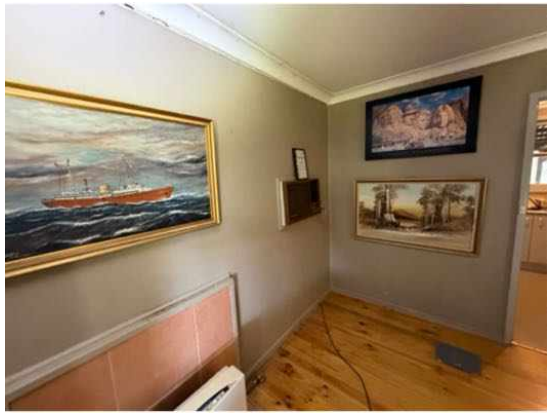
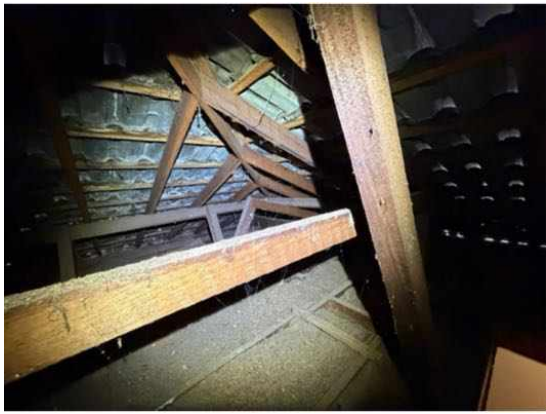
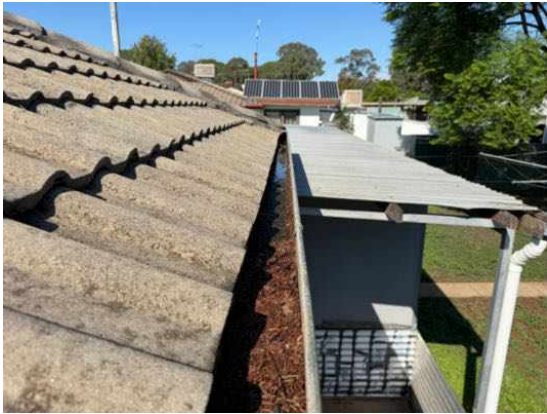
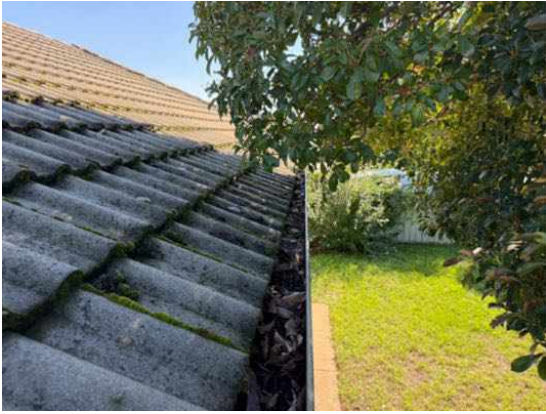
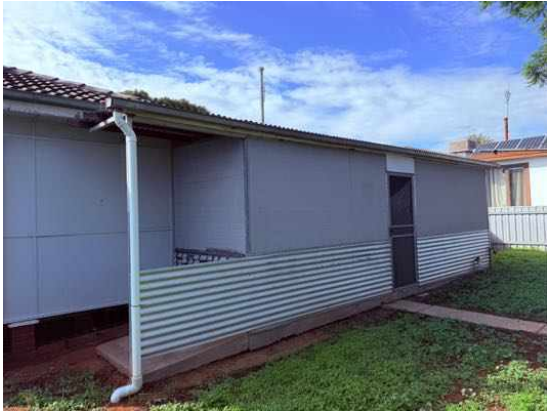
Building: Main Building  
Location: All Areas  
Finding: Additional Photos - Obstructions and Limitations  
Information: These photographs are an indication of the obstructions and limitations which impeded full inspection of the property at the time of inspection. These obstructions can hide an array of defects and should be removed to allow full inspection to be carried out. A re-inspection is recommended once the areas are made accessible.

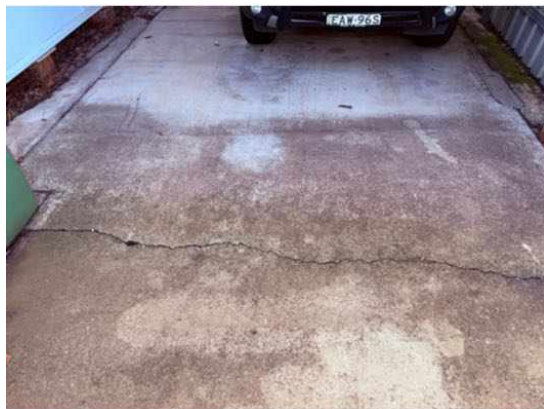
Building: Main Building  
 Location: Driveway  
 Finding: Cracking - Driveway  
 Information: It was noted there is cracking in areas of the driveway. Cracks in driveways are a common occurrence in houses of a similar age. Recommend that the client monitor the cracking. A concrete specialist can be engaged at clients discretion, to provide further advice, should cracks widen, lengthen, or become more numerous.

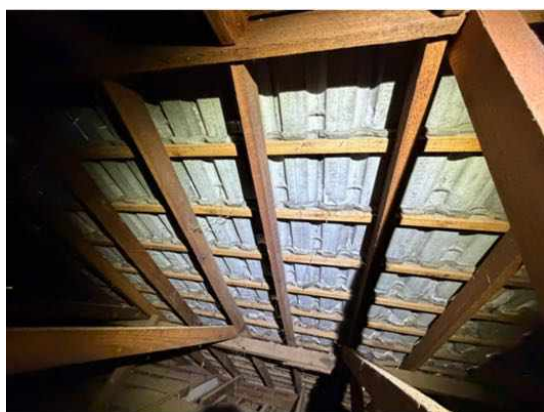
Building: Main Building  
 Location: Roof Void  
 Finding: Sarking - Not Present  
 Information: It is noted for your information that sarking has not been installed on the roof. Sarking is a laminated aluminium foil applied to the interior of the roof covering, assists in insulating the property and acting as a vapour-barrier to the roof void.

The client can consult with a licensed roofing contractor at their discretion, to provide further advice.
