Building and Timber Pest Inspection Report

Inspection Date: Wed, 21 Jan 2026

Property Address: 151 Kiara Rd, Miranda NSW 2228,
Australia

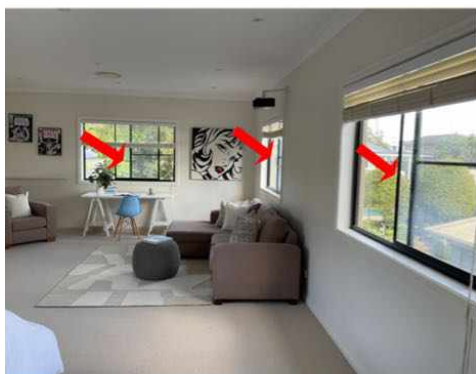
Building:	Building 1
Location:	Upstairs windows
Finding:	Window opening restrictors missing.
Information:	The Building Code of Australia rules require all openable windows (where the internal floor is more than 2m above the ground outside) in residential rooms to be fitted with a suitable screen or restrictor. Windows located 1.7m above the floor level do not require protection.

Window restrictors are required where people who are vulnerable to the risk of falling have access to windows. This means all windows above ground level which do not have another fall prevention safety measure in place, such as a balcony or balustrade should have a restrictor.

These need to be added urgently for the safety of all persons.

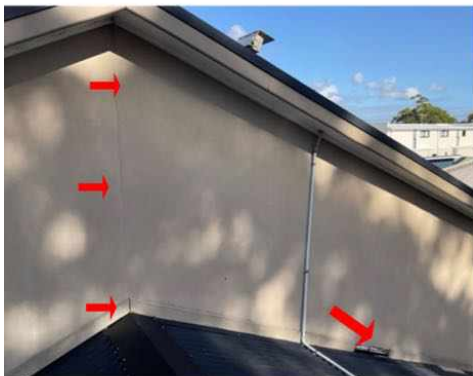
Finding 2.01

Building:	Building 1
Location:	Upper wall areas
Finding:	Cladding and Render (external) - loose and cracking
Information:	The wall cladding appears to be Hebel. Hebel needs meticulous sealing and waterproofing which has not occurred on this property.

It has been observed that numerous areas of loose cladding and cracked rendered surfaces has occurred. The degree of damage on the upper roof walls is severe and a

major defect as this can allow water ingress into the property to further damage internal areas. Some areas are falling off. The lower wall areas are described as minor defects due to most cracks being approximately 1-2 mm in width. Some are at expansion joints which show minor movement.

The upper roof damage required urgent repair/replacement and quotes for this should be sought. Due to the large number of cracks to the lower walls, it is suggested to get quotes to replace all cladding at one time.

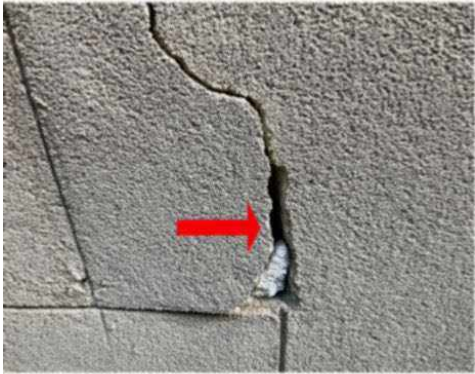
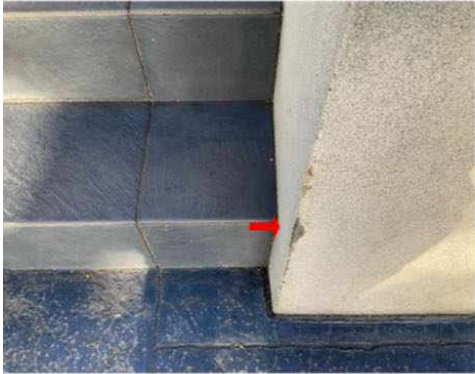
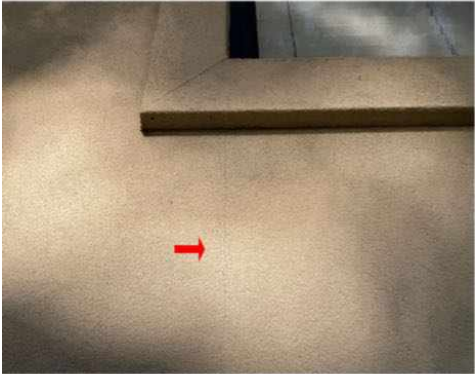
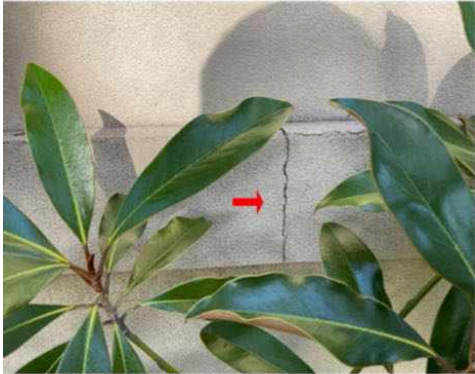
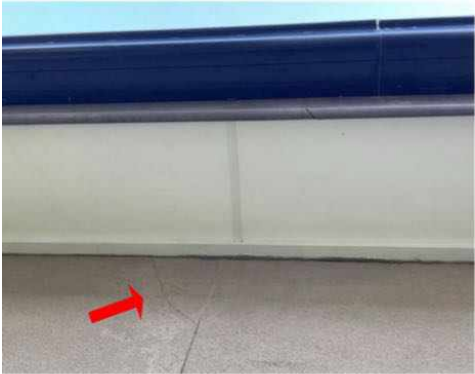
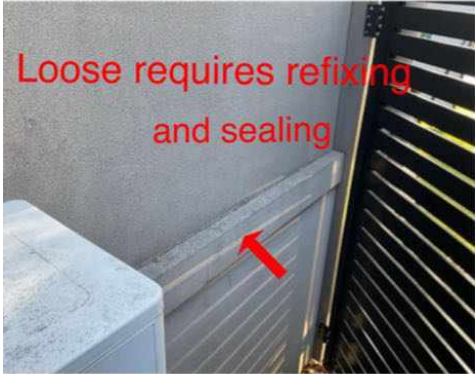
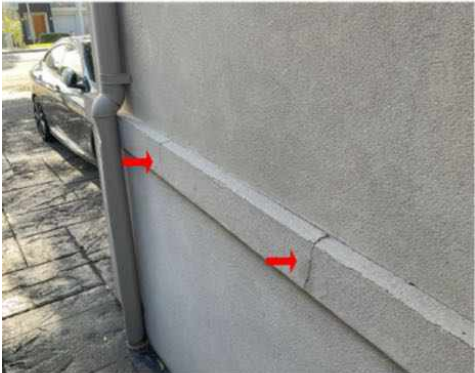
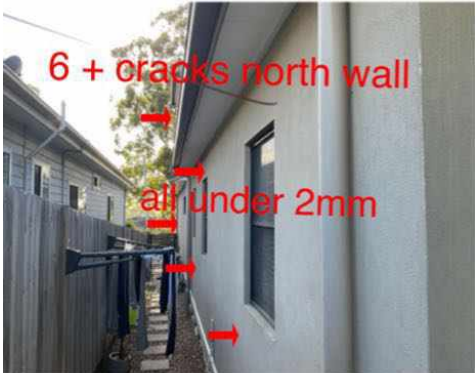
Finding 3.01

Building: Building 1
Location: Wall areas
Finding: Cladding and render (external) cracking and cladding damage on rear left (continued)
Information: See pictures of lower wall cracking which are all considered minor except photos 1 & 2.

All these require repair to keep the property watertight.

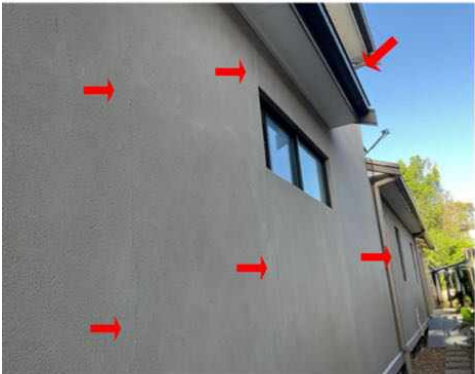
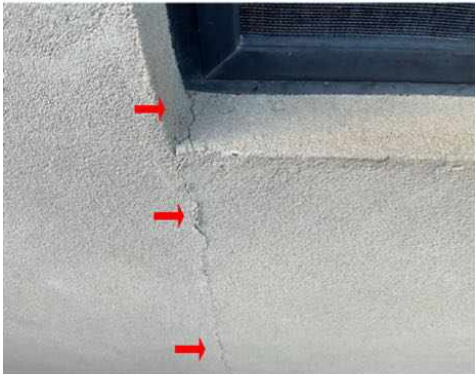
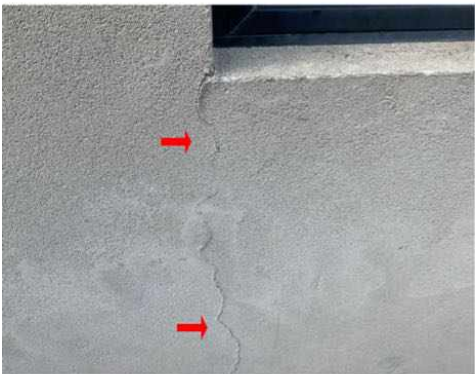
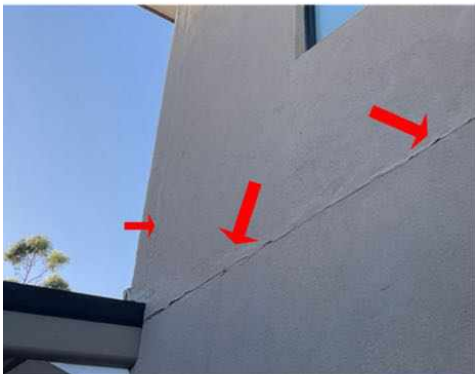
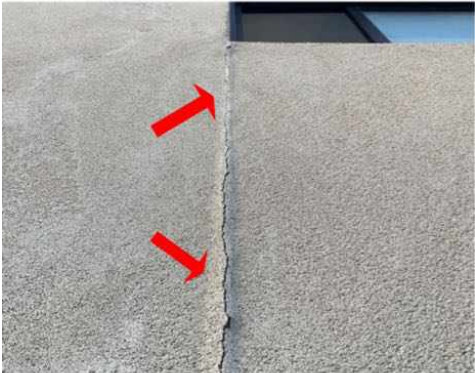
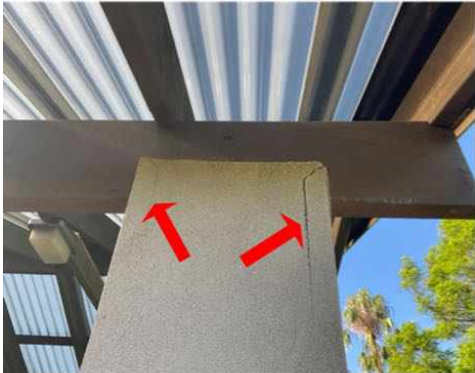
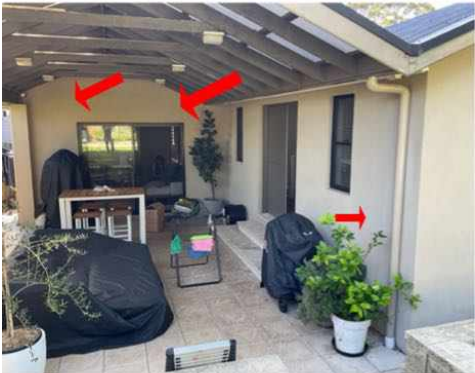
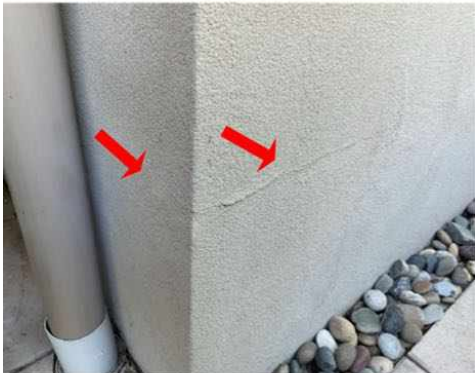
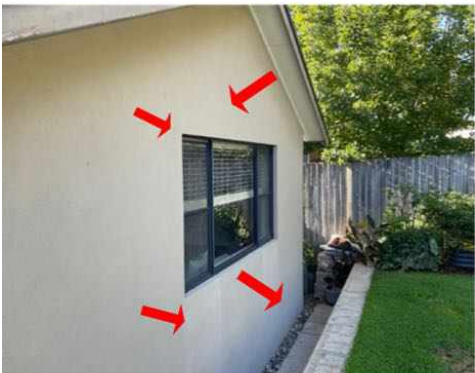
Finding 3.02

Building: Building 1
Location: Wall areas
Finding: Cladding and render (external) cracking in north wall and posts
Information: See pictures of the minor lower wall and rear post cladding and render cracking.

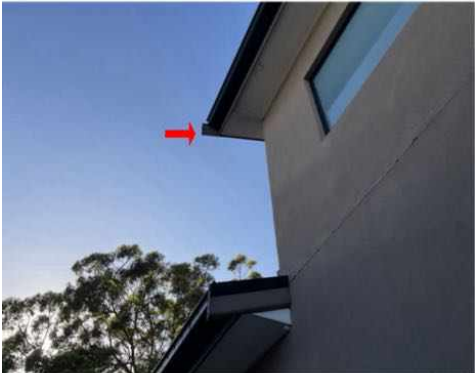
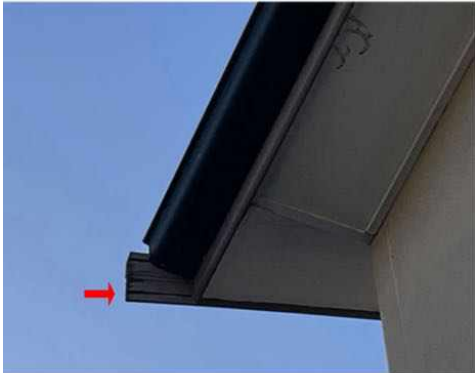
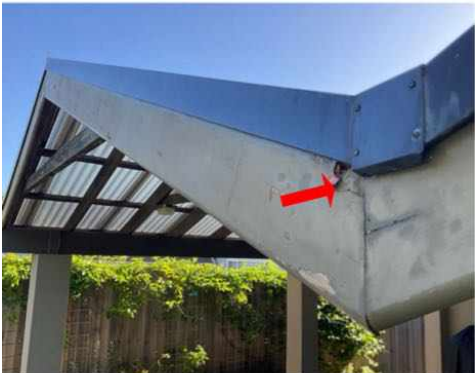
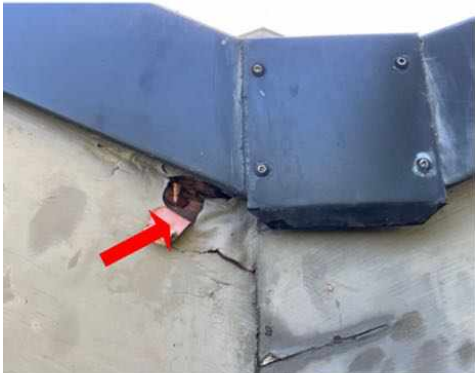
Finding: Wood rot

Information: The building shows evidence of a few small areas of wood rot. Wood rot, also known as Fungal Decay, occurs when timbers and other cellulose building materials are exposed to damp conditions on an ongoing basis. This could be the result of exposure to weathering over a prolonged period of time, or the attraction of excessive moisture from other abutting building materials.

Early intervention and regular maintenance, particularly of exterior timbers, will prolong the useful life of these building elements. Prior to any works being performed, the cause of the moisture that has created the visible wood rot should be identified and addressed in a suitable manner. Replacement of affected timbers may then be a necessary step in protecting surrounding building elements from such deterioration.

A qualified carpenter or registered builder may also be required to replace affected building materials.

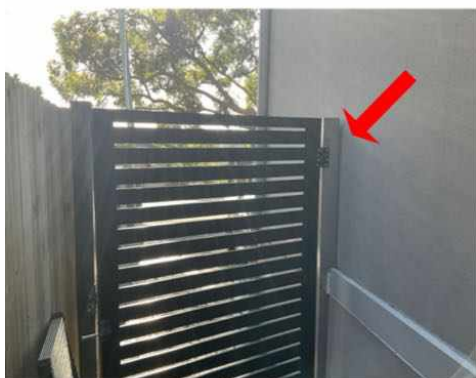
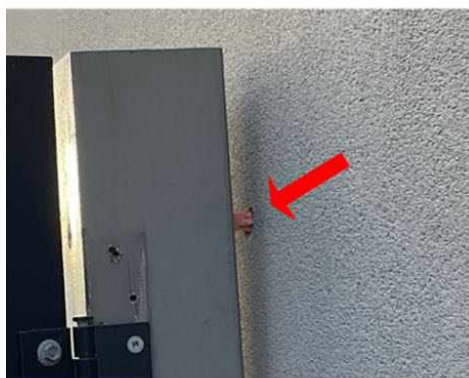
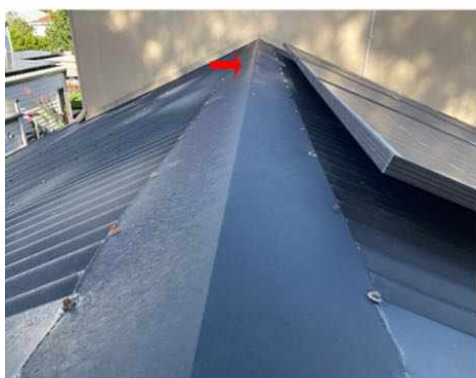
Finding 3.05

Building: Building 1
Location: Pictured small areas
Finding: Additional fixings required
Information: Evidence of insufficient fixings were evident on the right gate and front roof that need additional fixings to ensure their longevity. It is also recommended to replace all rusted roofing screws.

A carpenter or handy person would be able to add additional fixings to these areas.

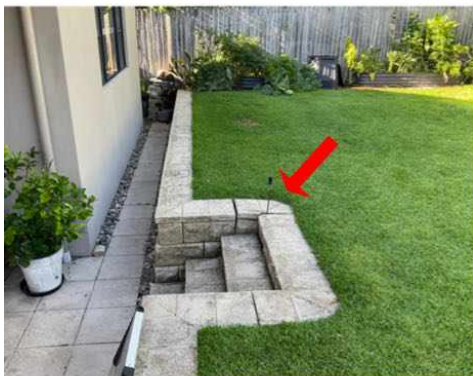
Building:	Building 1
Location:	Pictured areas
Finding:	Subsidence - monitor annually
Information:	It appears that a small area of the rear yard stairs has been affected by movement, often referred to as sinking or subsidence. General subsidence is usually initiated by changes in soil moisture content. The most critical factor is identifying the specific causes, and identifying if this is a recurring or ongoing problem, or one that has been resolved by previous works in the past.

At this point it is recommended to contain storm water flows in high rain events. A landscaping contractor can repair this area when convenient.

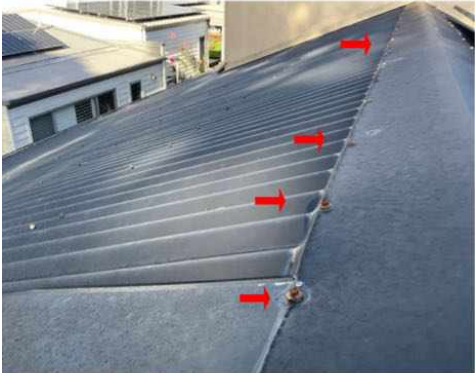
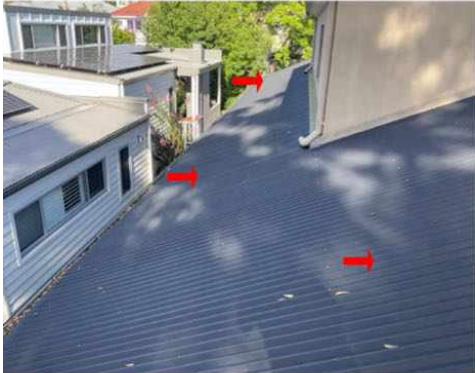
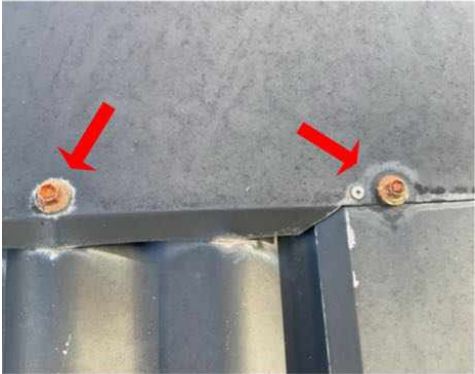
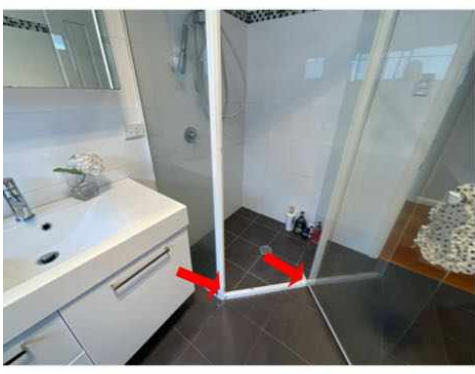
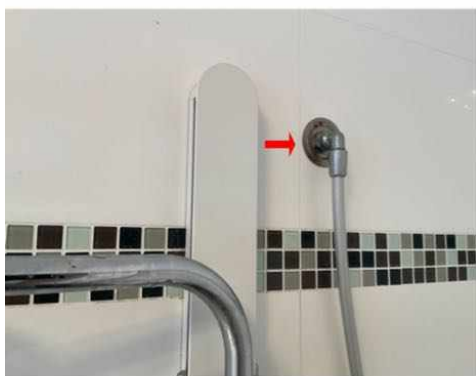
Finding 3.08

Building:	Building 1
Location:	Roof screws and bathroom areas
Finding:	Areas rusted or corroded
Information:	These roof and bathroom areas shows evidence of rusting and corrosion, which is likely to have developed as a result of excessive exposure to moisture and or inadequate coatings.

As surface rust provides no protection to the underlying iron, the deteriorating condition is likely to worsen if not addressed in the short-term future.

Where possible, the use of galvanized (treated) metals or aluminium coated metals aid in rust prevention, as does regular general maintenance. Rust formation can be controlled with coatings, such as paint, that isolate the iron from the environment.

Rusting and corrosion should be managed by ideally removing or limiting the affected surface from exposure to moisture. A skilled handy person should be appointed immediately to replace the roof screws that have been severely affected by rust or water damage.

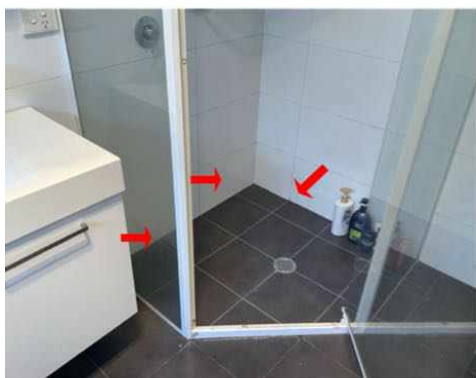
Finding 3.09

Building:	Building 1
Location:	Kitchen and bathroom
Finding:	Sealant and grouting - Missing or damaged
Information:	It was noted on inspection that sealant or grout is degraded to these pictured areas.

Different materials and floor areas move at different rates, generally causing cracking to grout or sealant at this point. A flexible sealant is required to allow for expected expansion and contraction, while keeping the joint water tight and protective of all associated building materials.

Flexible and mould resistant materials should be applied to affected areas to prevent any subsequent water damage that is likely to occur. Regular maintenance and replacement of damage or missing or damaged sealant and grout is highly recommended to the wet areas, as this is a regular wear and tear defect. Sealant and grouting in areas that come into regular contact with water should be maintained for the long term care of your property.

A sealant specialist or tiling contractor should be appointed to complete these works as soon as possible

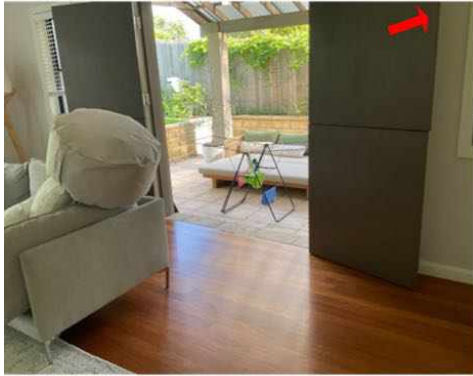
Building: Building 1
 Location: Two rear doors
 Finding: Building element - Damaged
 Information: Evidence of minor damage was identified to two door locks. They both need adjustment and one would no lock.

A carpenter would be trade responsible for rectification.

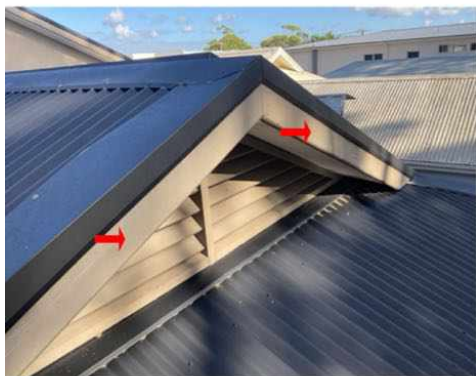
Building:	Building 1
Location:	Roof Exterior
Finding:	External painting deteriorated
Information:	Some of the small areas of external paintwork has been neglected and require attention to prepare and re-paint.

Whilst incomplete or missing paint finish is generally an appearance defect, it can also lead to the development of secondary building defects over time. Incomplete areas of paint finish expose the area to moisture, potentially accelerating the deterioration of underlying building materials.

Degraded paint finishes should be sanded back, filled, leveled and painted, as applicable. Where inadequate or missing paint protection has led to the deterioration of the associated building element, repair and/or replacement of this building element may be required.

A painting contractor should be appointed as soon as possible to perform necessary works to aid the appearance of the affected area and to ensure the area is protected against further deterioration. Alternatively, the homeowner following manufacturer instructions may perform these works.

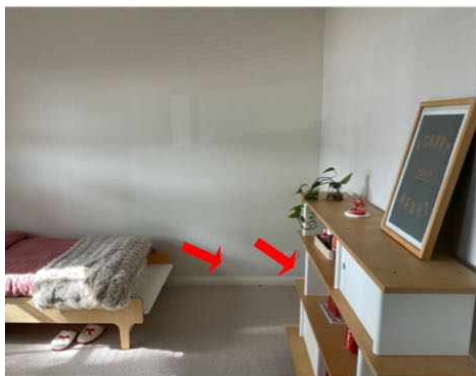
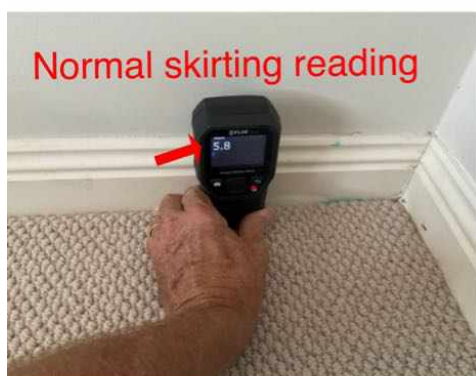
Building: Building 1
 Location: Bedroom - front
 Finding: Building element - Swollen
 Information: Swollen skirting generally indicate that the building materials have been affected by excessive moisture over a prolonged period of time, and have swollen as a result.

No reason was found for this damage and no significant moisture was found. It is thought to be old damage. Repair and/or replacement of the swollen skirting can be undertaken by a qualified carpenter.

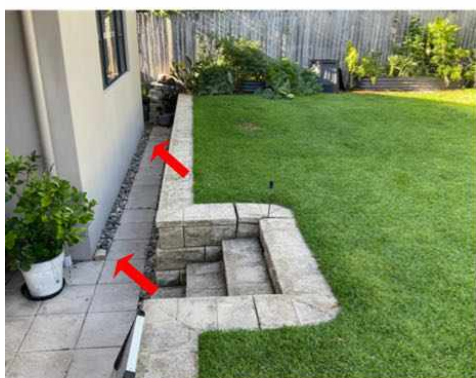
If the slab edge is not properly exposed there is a high risk of termite attack. Sometimes, in order to determine the type of slab, a suitably qualified person such as an architect or builder may be required to consult the construction plans.

Where the slab edge cannot be properly inspected, it is highly recommended that termite or timber pest inspections be carried out every 6-12 months to aid protection of the property against infestation.

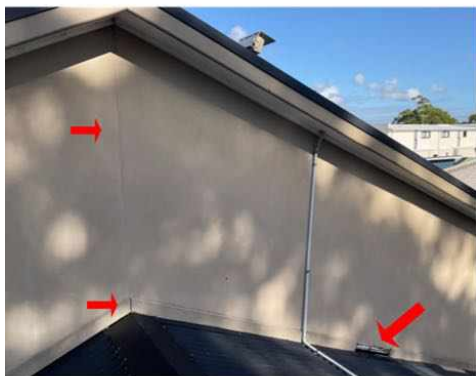
Finding 6.04

Building:	Building 1
Location:	Many wall areas
Finding:	Sealant (external) - missing and attractive to termites
Information:	It was noted on inspection that areas of external sealant was missing to small areas of the external walls. A flexible sealant or flashing is required to protect the associated building materials from rainwater ingress. Any moisture ingress into the property is very attractive to termites. Flexible sealants or flashing should be applied to these affected areas to prevent termite activity.

A sealant specialist or skilled handy person should be appointed to complete these works as soon as possible.

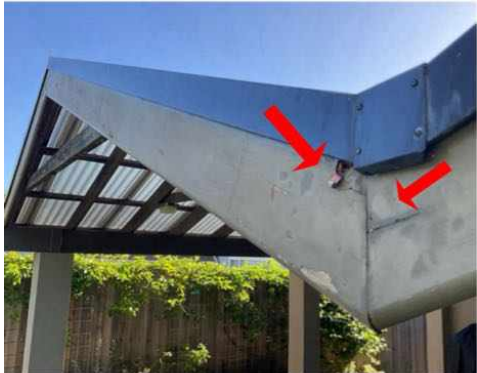
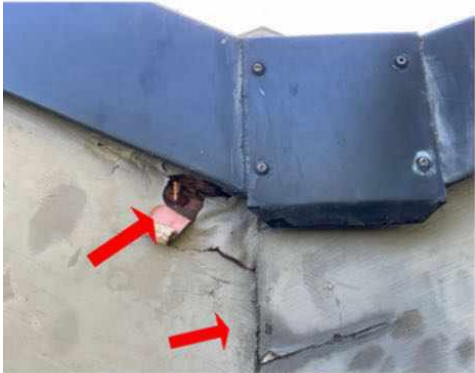
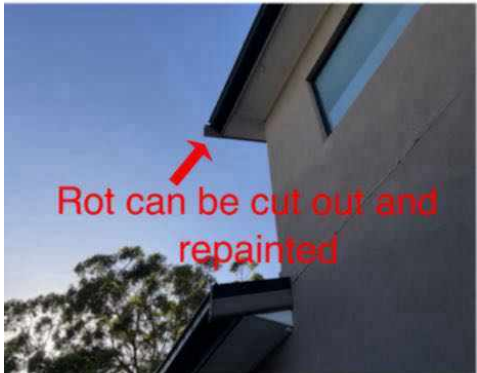
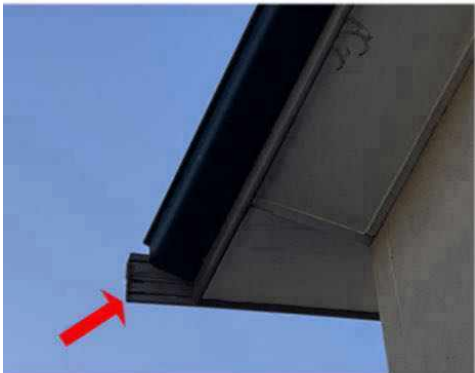
Building:	Building 1
Location:	Verandah
Finding:	Fungal decay - present (localised)
Information:	Fungal decay also known as wood decay or wood rot generally refers to the deterioration of timber elements when in contact with excessive levels of moisture for a prolonged period of time.

The development of fungal decay is accelerated by temperatures from 5degreeC to 40degreeC as well as the presence of oxygen. Generally fungal decay develops on timber elements that are in use in an external environment which are exposed to rain penetration.

In this case, the affected two timber areas are in a decaying state and will need replacement by a carpenter or licensed builder.
