Building and Timber Pest Inspection Report

Inspection Date: Tue, 7 Apr 2026

Property Address: 32 Renita St, Slacks Creek QLD 4127, Australia

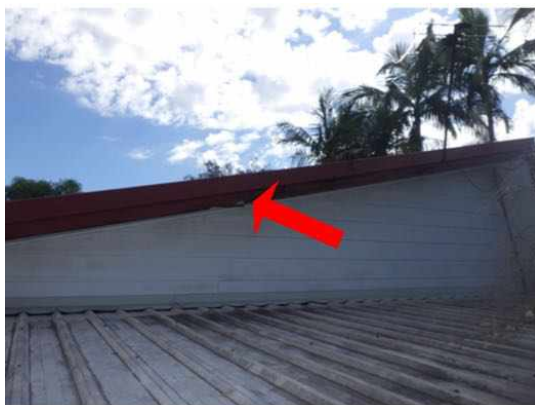
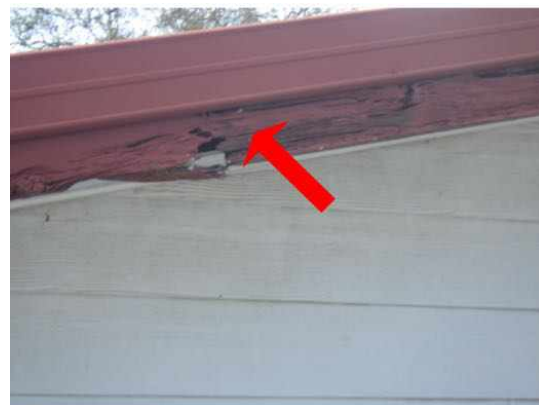
Building: Main Building
Location: Eaves > Existing
Finding: Fascias - Wood rot
Information: At the time of inspection wood rot was found to be affecting fascias and barges, evidenced by the presence of mould on the surface in some areas (as per example photos). Wood rot, also known as Fungal Decay, occurs when timbers and other cellulose building materials are exposed to damp conditions on an ongoing basis.

Frequent exposure to rain and other weather conditions make fascias and barges susceptible to accelerated deterioration.

Early intervention and regular maintenance will prolong the useful life of these building elements. Prior to any works being performed, the cause of the moisture that has created the visible wood rot should be identified and addressed in a suitable manner.

A qualified carpenter or registered builder will be required to replace affected fascia's.

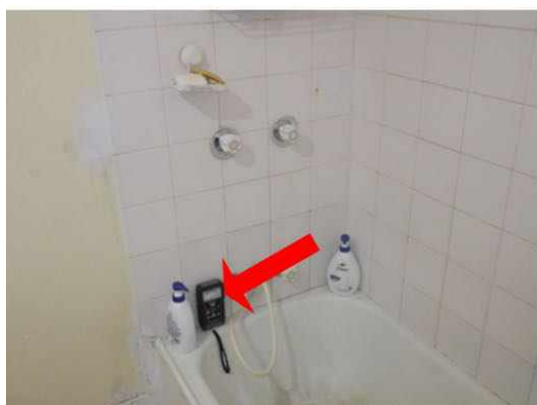
Finding 2.02

Building: Main Building
Location: Bathroom > Rear Right
Finding: Shower - Leaking
Information:

The bathroom shower area registered elevated moisture level readings to the wall areas of the shower cubicle at the time of inspection, with the elevated moisture level readings transferring to the opposite side of the walls which would indicate the shower is leaking.

It is suspected that the leaking has occurred as a result of general ageing of the building elements and deterioration of sealants and grout.

Leaking from the shower area, where left unattended, is likely to lead to water damage to adjoining flooring and walls. Such damage can lead to water damage and necessitate extensive remedial works being required. Active water leaks may also create an environment that is susceptible to the formation and development of mould and /or timber termite activity.

Appointment of a licensed builder or shower area specialist will be required to repair or replace the shower area. Such works should be performed as soon as possible to ensure that no further damage occurs.

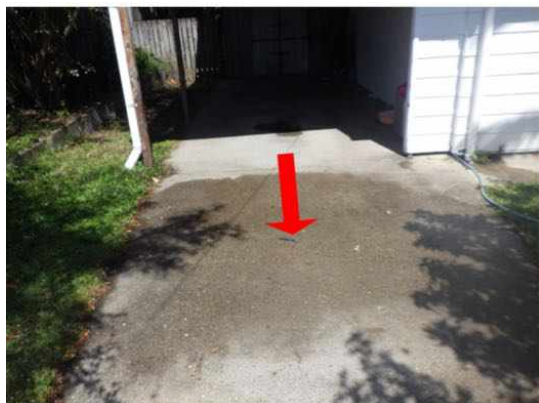
Building: Main Building
Location: Driveway > Ground Level
Finding: Cracking in concrete slab - Category 1
Information: Cracking coded as Category 1 was identified in the driveway and/or footpaths concrete slab. A Category 1 crack is described as a fine but noticeable crack, with the slab at an otherwise reasonable level.

To be considered Category 1, the approximate width of the crack is less than 1.0mm, or a less than 10mm change in offset when a 3m straight edge is placed over the defect.

Category 1 cracks should be monitored for a period of 12 months. At the end of the monitoring period, identified cracks that are rated greater than Category 2 are considered defects, and require rectification.

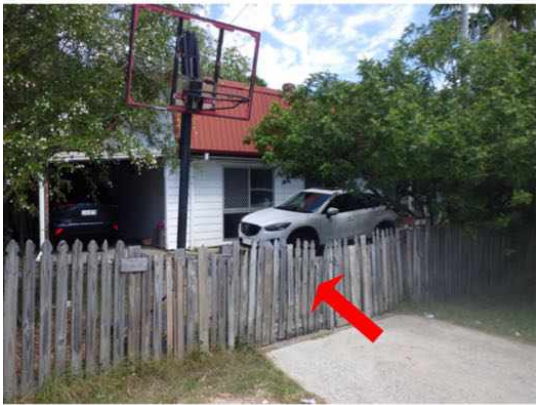
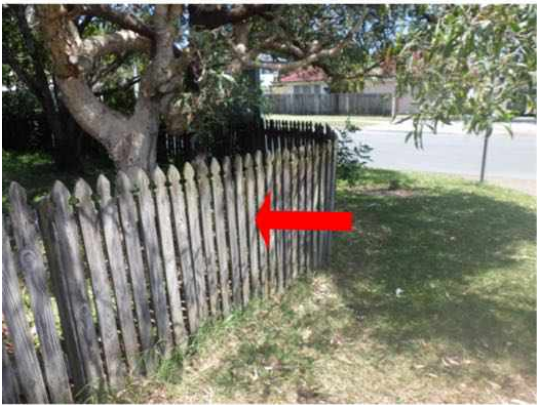
Finding 3.02

Finding: Fencing - Deteriorated

Information: It was noted at the time of inspection that sections of the fencing throughout the property have deteriorated (as per example photos). Typically fencing deteriorates due to age and or wear, rot and or rust which is generally expected for a structure of this age, due to prolonged exposure to weather conditions. Sometimes inadequate installation or maintenance can be to blame.

If left unattended, it is likely that further damage will occur. It is suspected that repair of several elements of the fencing may be required however replacement may be a consideration of the client also.

A licensed fencing contractor should be appointed to provide further advice and perform rectification works as necessary.

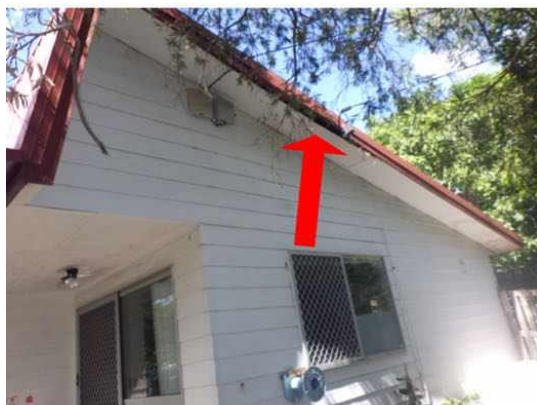
Finding 3.03

Building: Main Building
 Location: Eaves > Centre Right
 Finding: Eaves - Sagging
 Information: At the time of inspection the eaves to the right side of the property were found to have sagged. The damage may have been sustained as a result of a number of possible causes, including poor roof drainage, substandard workmanship at the time of construction or minor impact damage.

Where eaves show moderate damage, remedial works may be required.

NOTE - The eaves linings may be of an asbestos containing material.

A qualified carpenter or general handyman could be engaged to undertake repair work.

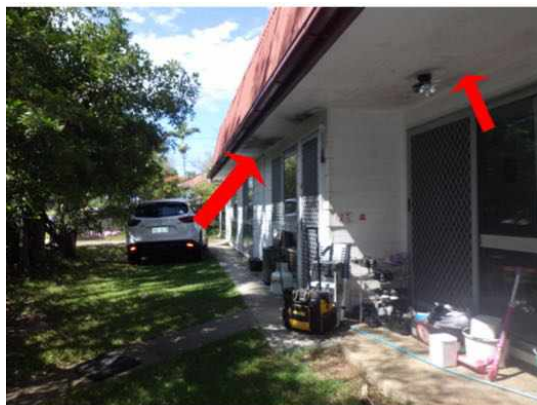
Finding 3.04

Building: Main Building
 Location: Eaves > Centre,Front
 Finding: Mould - Present in eaves.
 Information: The eaves linings to the front of the property show signs of excessive mould and mildew at the time of inspection. This defect can at times be caused by blocked or overflowing gutters in the areas associated.

Where evidence of mould growth was noted, there may be environmental, biological or health issues associated.

Generally, the client is advised to ensure that the general environment is free of moisture and humidity to aid in the prevention of mould formation and development. Any mould found during the inspection should be cleaned immediately by a cleaning contractor or the homeowner as applicable.

Please note that severely affected building elements may require replacement by a registered builder or qualified carpenter.

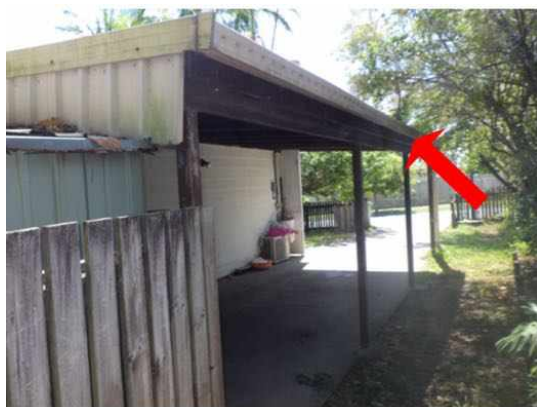
Finding 3.05

Building:	Main Building
Location:	Roof Exterior > Centre Left
Finding:	Gutter - Rusted
Information:	Upon inspection of the exterior guttering, evidence of significant rust and deterioration to the left side carport section was identified.

Metal gutters generally comprise of sections of guttering, which join and overlap. These intersections are particularly prone to lift at the edge and consequently rust at these points.

A roofing contractor could be appointed to assess the damage to the roof guttering and to perform remedial works as necessary.

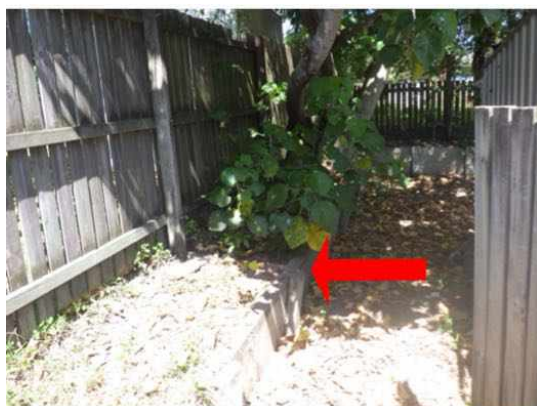
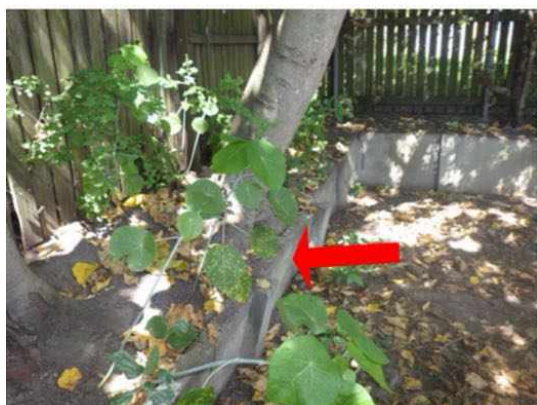
Finding 3.06

Building:	Main Building
Location:	Yard - Side > Ground Level
Finding:	Retaining wall
Information:	The concrete retaining wall to the left side of the property showed signs of movement at the time of inspection. Generally, deteriorated retaining walls are caused by poor material use or continuous exposure to weather conditions. However, deteriorated or

movement to retaining walls may also be a result of vegetation growth.

A landscaper or retaining wall installer could be appointed to repair or replace the wall, at the discretion of the client.

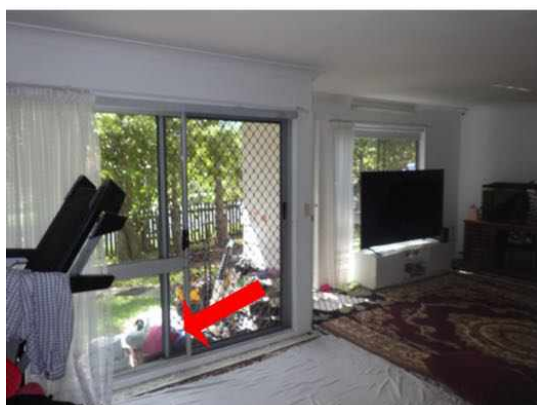
Building: Main Building
 Location: Dining Room > Front
 Finding: Door - Stiff to slide
 Information: The aluminium sliding door to the dining room area was stiff to operate at the time of the inspection. Doors provide ventilation to the adjoining area and should be at a fully operational level to ensure user comfort. Restricted function of the door may also pose as a potential safety hazard if required for emergency egress from the building.

Generally, factors such as general age of the building element and a lack of maintenance are the usual causes for this type of defect.

An aluminium sliding door service agent will be required to repair the affected door.

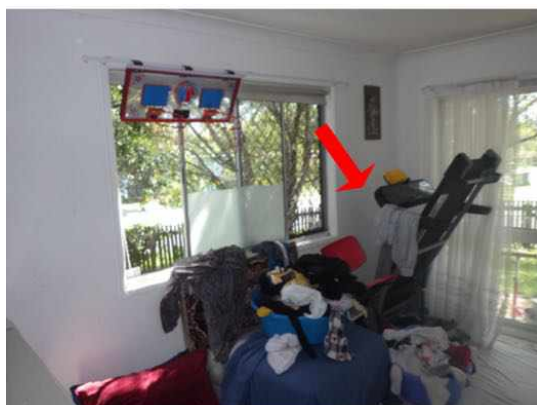
Location: Dining Room > Centre Right
 Finding: Cracking - Wall
 Information: There is cracking to an area of the wall lining in the dining room area.

The cracking appears minor in nature and is generally only ever an appearance defect. While such cracking may be noticeable in some cases, it is quite common and does not indicate any structural damage.

Cracking of this nature can generally be repaired with minor sanding, filling and/or repainting. Such works should be performed by a qualified painter or a general handyman.

Monitoring of all cracking should be conducted frequently. Always contact a building inspector should cracks widen, lengthen, or become more numerous.

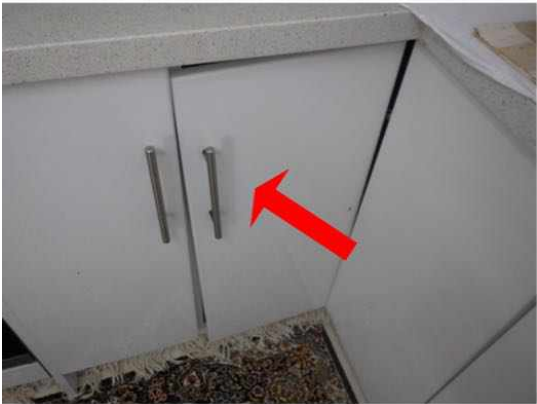
Building: Main Building
Location: Kitchen > Existing
Finding: Cabinetry - Deterioration
Information: At the time of inspection the kitchen cabinetry and appliances showed signs of deterioration. The level of damage appears consistent with exposure to moisture or general wear and tear.

A qualified cabinet maker or general handyman could be engaged to undertake repair works at the clients discretion.

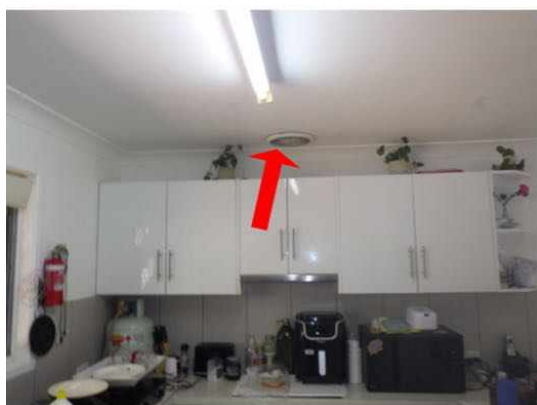
Finding 3.14

Building:	Main Building
Location:	Kitchen > Centre Right
Finding:	Cracking - Ceiling
Information:	There is cracking to an area of the kitchen ceiling.

The cracking appears minor in nature and is generally only ever an appearance defect. While such cracking may be noticeable in some cases, it is quite common and does not indicate any structural damage.

Cracking of this nature can generally be repaired with minor sanding, filling and/or repainting. Such works should be performed by a qualified painter or a general handyman.

Monitoring of all cracking should be conducted frequently. Always contact a building inspector should cracks widen, lengthen, or become more numerous.

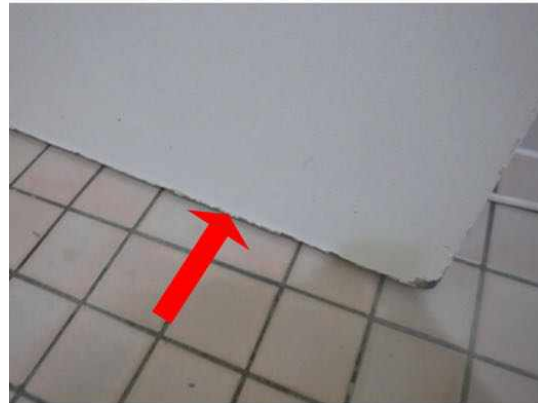
Finding 3.15

Building:	Main Building
Location:	Bathroom > Front
Finding:	Damaged Door
Information:	The door leading into the bathroom has suffered damage to the bottom edge.

Damage occurs generally when the building materials have aged and decayed, but in this instance the damage appears to be the result of exposure to moisture, possibly from the bottom and/or top edges of the door not being sealed with a suitable paint or sealant at the time of construction.

A qualified carpenter or general handyman could be appointed to repair/replace the door at the clients discretion.

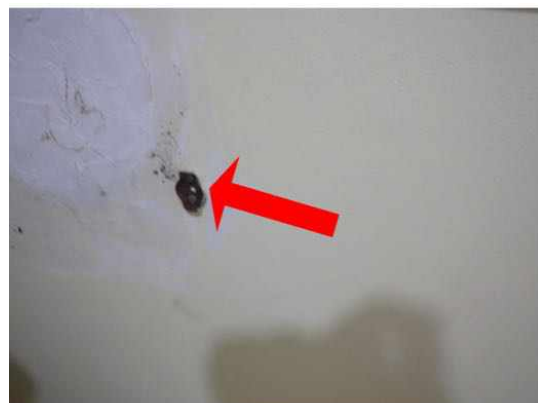
Finding 3.16

Building: Main Building
 Location: Bathroom > Centre Left
 Finding: Fitting or fixture - Missing
 Information: A fixture was missing from the bathroom wall at the time of inspection

A general handyman could be appointed to replace the missing fixture at discretion of the client.

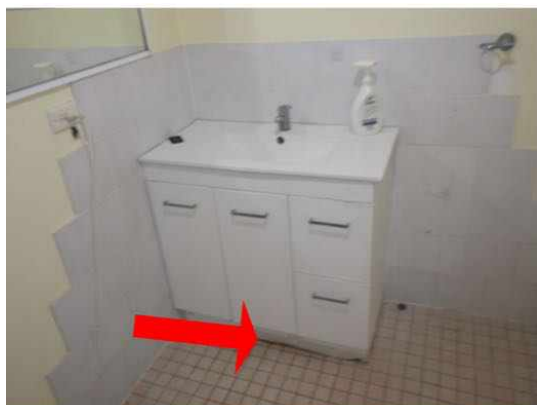
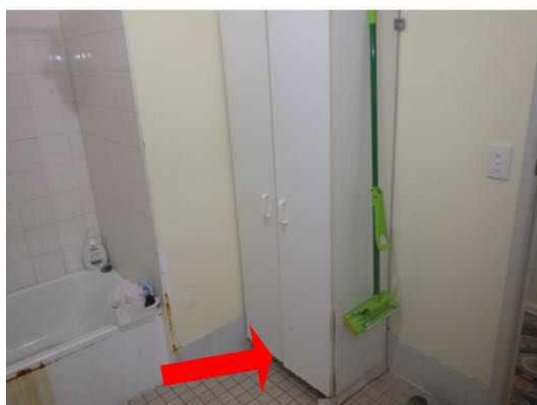
Finding 3.17

Location: Bathroom > Existing
 Finding: Cabinetry - Deterioration
 Information: At the time of inspection the bathroom cabinetry showed signs of deterioration. The level of damage appears consistent with exposure to moisture or general wear and tear.

A qualified cabinet maker or general handyman could be engaged to undertake repair works at the clients discretion.

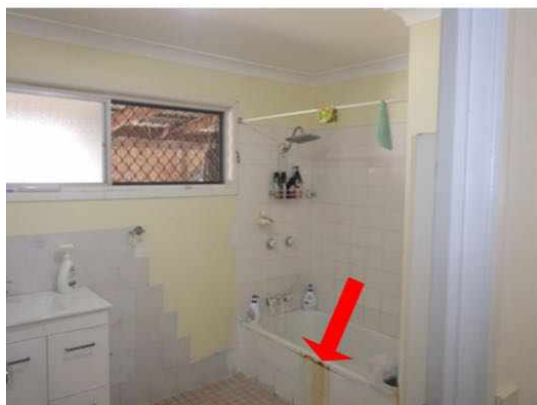
Finding 3.18

Building: Main Building
 Location: Bathroom > Centre Right
 Finding: Surface Rust
 Information: At the time of inspection the bath in the bathroom showed evidence of significant surface rust.

As surface rust provides no protection to the underlying iron, the deteriorating condition is likely to worsen if not addressed in the short-term future.

Rust formation can be controlled with coatings, such as paint, that isolate the iron from the environment.

Alternatively a qualified plumber could be engaged to replace the bath at the clients discretion.

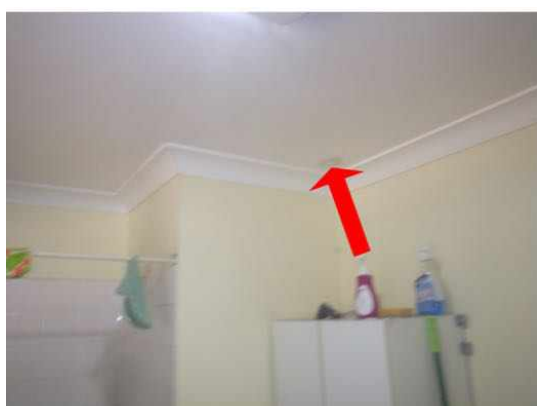
Finding 3.19

Building:	Main Building
Location:	Bathroom > Front Right
Finding:	Ceiling - Water stained
Information:	Water staining to ceiling linings in the bathroom area was evident at the time of inspection. Water staining indicates that surfaces have been exposed to excessive moisture over time. The minerals and other elements in the water lead to staining, which may graduate to corrosion and deterioration if left unmanaged.

While mostly an appearance defect, water staining can be indicative of more serious defects, which may be currently concealed by interior ceilings.

Where water staining is old and inactive, affected building materials may be repaired or replaced at client discretion.

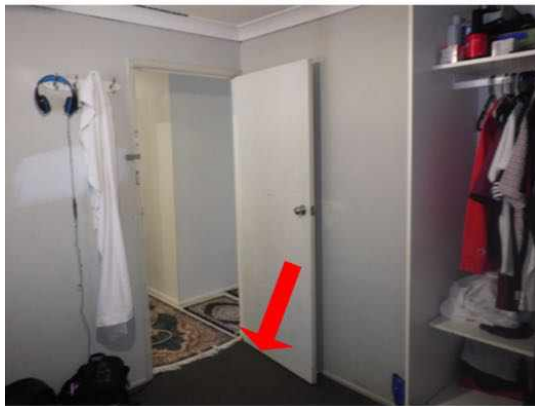
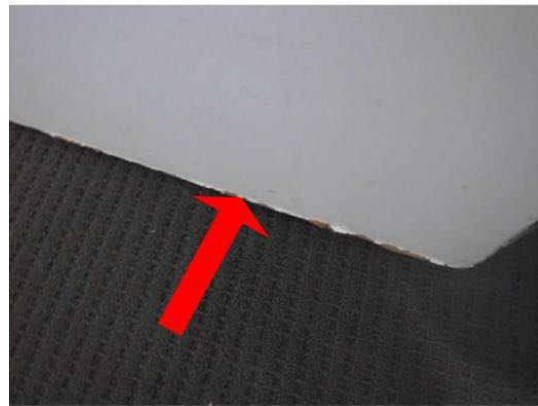
Finding 3.20

Building:	Main Building
Location:	Bedroom 3 > Front

A qualified carpenter or general handyman could be appointed to repair/replace the door at the clients discretion.

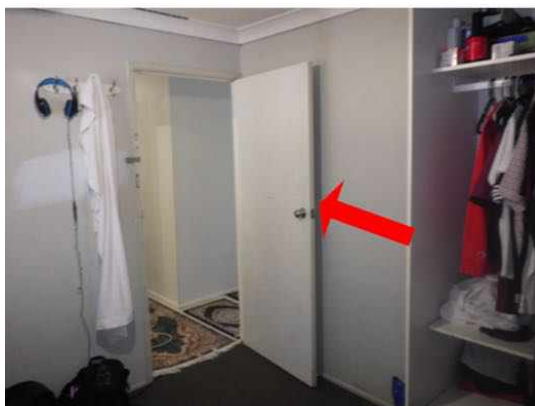
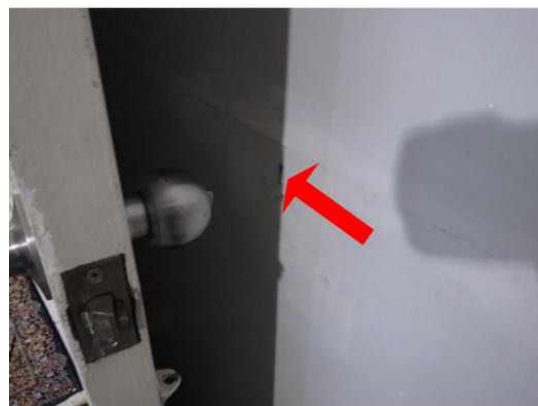
Finding 3.21

Building: Main Building
 Location: Bedroom 3 > Front Left
 Finding: Internal walls - Hole
 Information: A hole was identified in the bedroom 3 left hand side wall section. It is suspected the hole is caused from the door handle.

All excessive holes, gaps or cracks should be adequately filled by a suitable sealant to prevent any further damage. Such works may be conducted by a general handyperson or licensed painter.

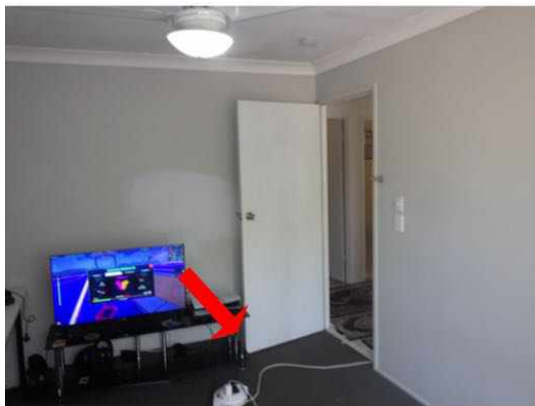
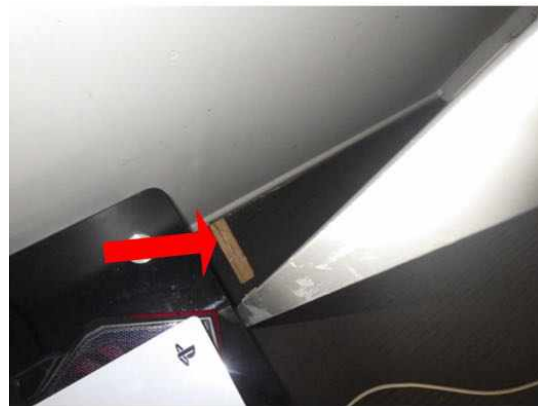
Finding 3.24

Building: Main Building
 Location: Bedroom 2 > Front
 Finding: Door stop - Missing
 Information: The bedroom 2 door stop is missing or is inadequate to stop the door handle from impacting the wall.

A general handyman may be appointed to perform these works at client discretion.

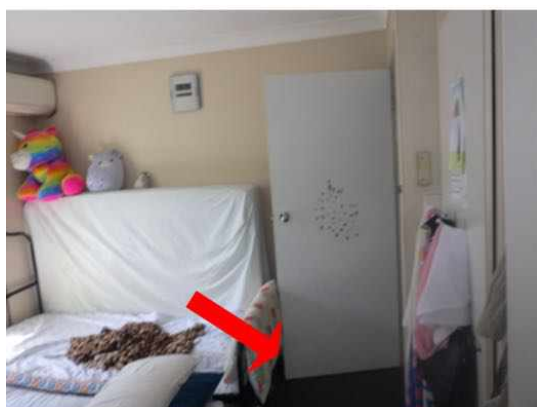
Finding 3.27

- Finding: Door stop - Missing
- Information: The bedroom 1 door stop is missing or is inadequate to stop the door handle from impacting the wall.
- Re-installation or replacement of the door stop is advised to prevent any subsequent damage to the wall linings or associated structures.
- A general handyman may be appointed to perform these works at client discretion.

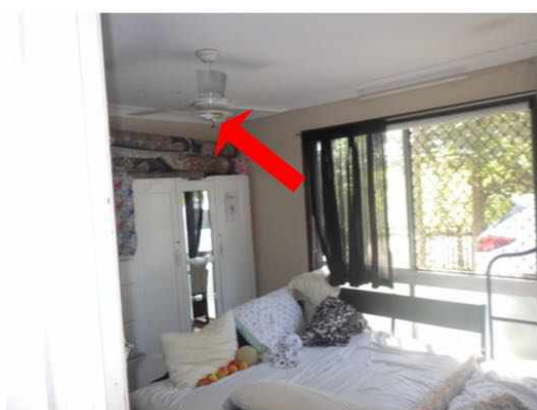
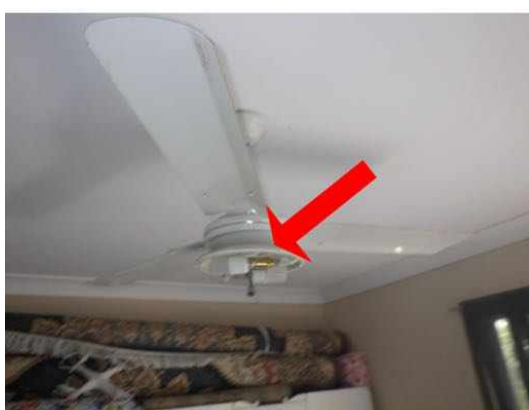
Finding 3.28

- Building: Main Building
- Location: Bedroom 1 > Centre
- Finding: Ceiling Fan
- Information: Although the light component to the bedroom 1 ceiling fan was operating it was missing the cover plate at the time of inspection.

A Licensed electrician could be appointed to repair/replace the ceiling fan.

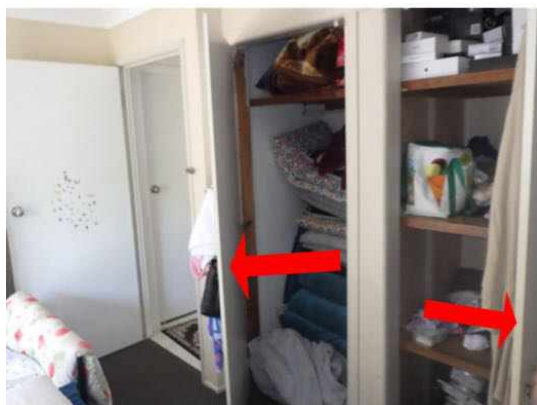
Finding 3.29

- Building: Main Building
- Location: Bedroom 1 > Centre Left

This is noted as a minor defect that you need to be aware of.

A licensed carpenter or general handyman could be engaged to ease the door at the clients discretion.

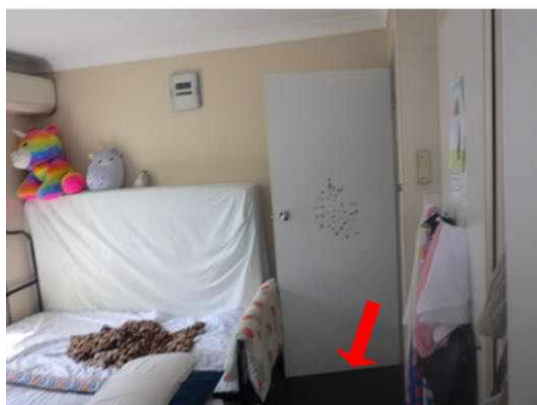
Finding 3.30

Building: Main Building
 Location: Bedroom 1 > Front
 Finding: Damaged Door
 Information: The door leading into bedroom 1 has suffered damage to the bottom edge.

A qualified carpenter or general handyman could be appointed to repair/replace the door at the clients discretion.

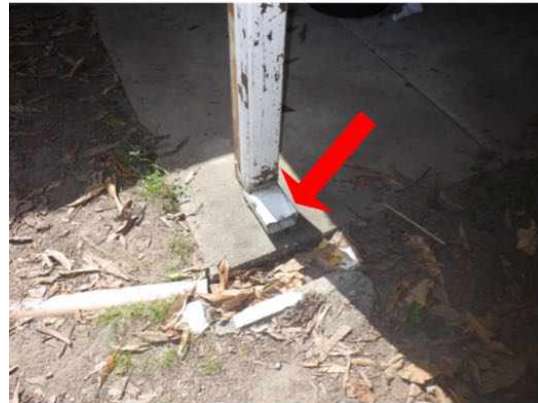
Finding 6.02

Building: Main Building
Location: Exterior walls - rear > Rear Right
Finding: Stormwater downpipe

It is recommended that a licensed plumber be appointed to further inspect and to extend the down pipes to the properties stormwater line as necessary.

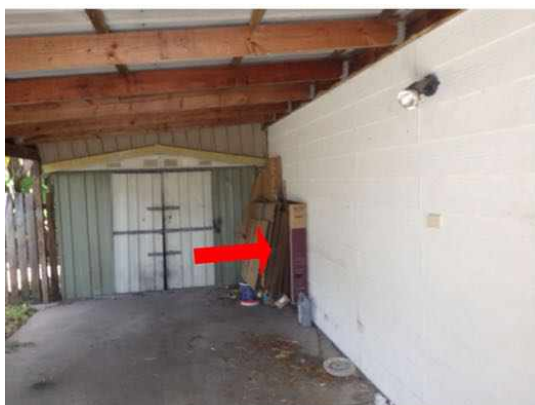
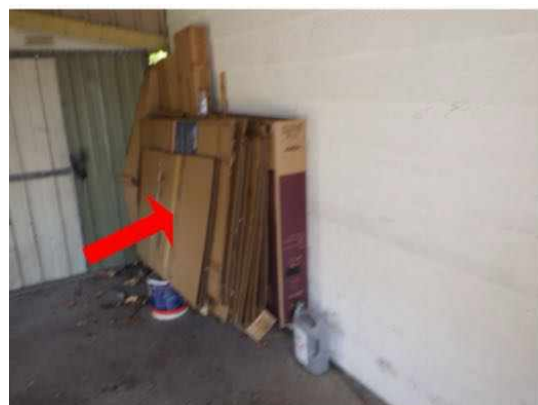
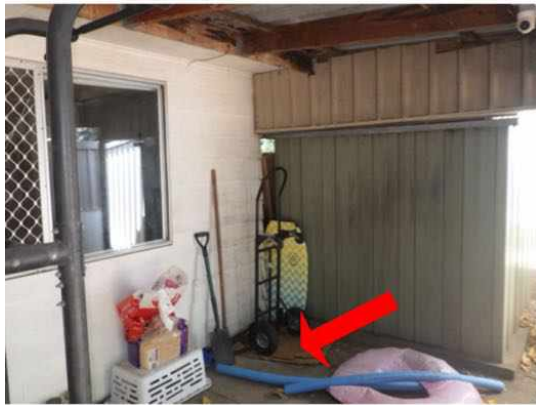
Finding 6.03

Building:	Main Building
Location:	Exterior walls > Existing
Finding:	Stored timbers - external area
Information:	At the time of inspection there was stored items and/or timbers against the exterior walls of the property.

It is highly recommended that any stored timbers and/or items be immediately removed from areas in which they may attract any termite / timber pest attack. Minimisation of risk / prevention of termite attack is far more adequate than dealing with the presence of termite activity.

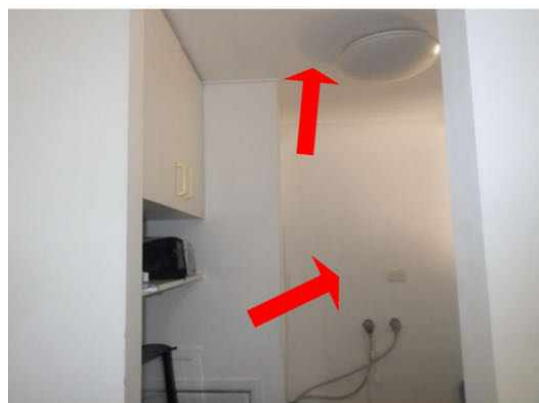
Building: Main Building
 Location: Internal Areas > Existing
 Finding: Asbestos - Suspected ACM Identified on Site
 Information: At the time of inspection it was suspected internal wall and ceiling linings may be of asbestos containing materials.

In the interim, the client is advised to act with caution, especially when considering any damage to building materials general wear and tear renovations extensions demolition and general maintenance activities due to the suspected presence of Asbestos.
