Building and Timber Pest Inspection Report

Inspection Date: Tue, 17 Mar 2026

Property Address: 23 Martindale Cres, Seymour VIC 3660,
Australia

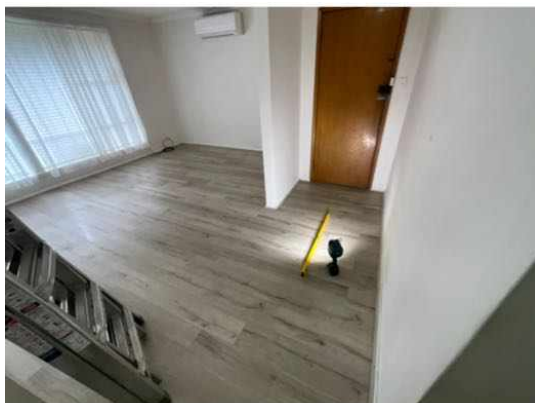
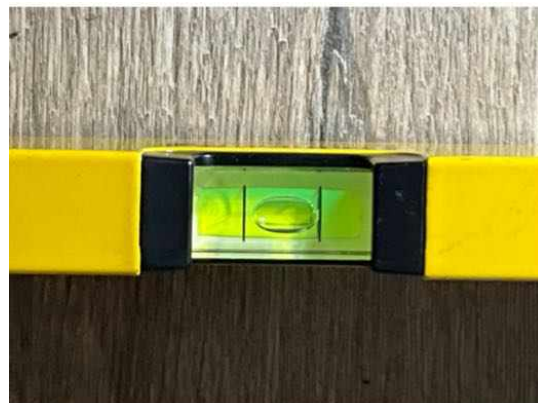
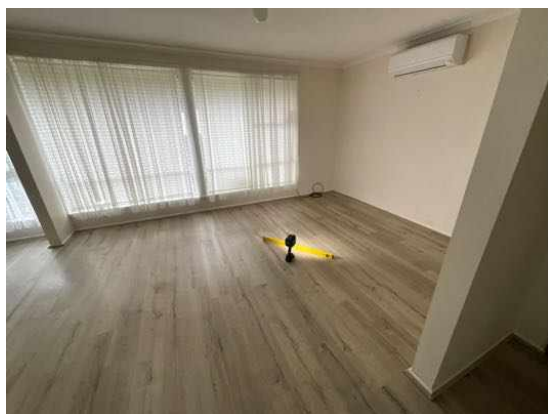
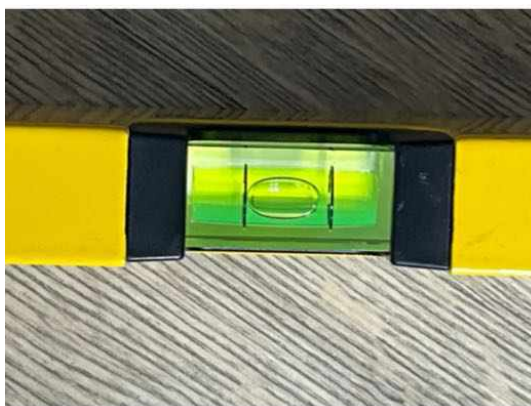
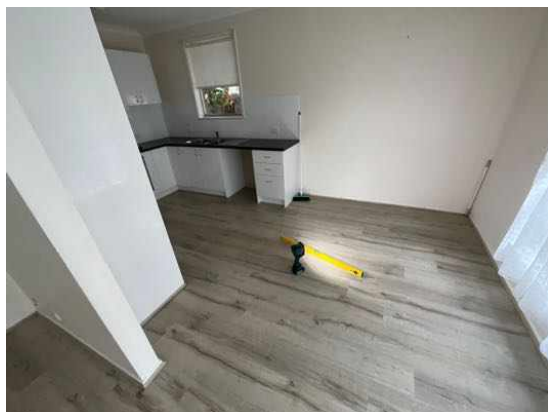
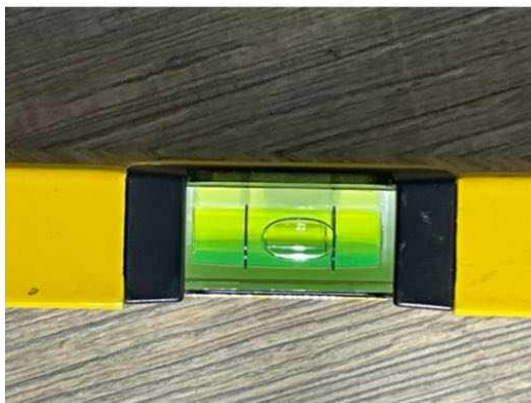
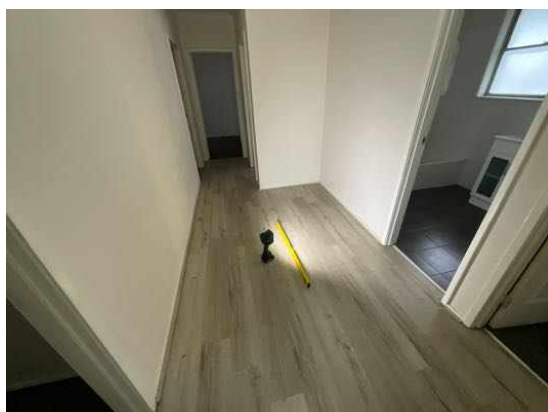
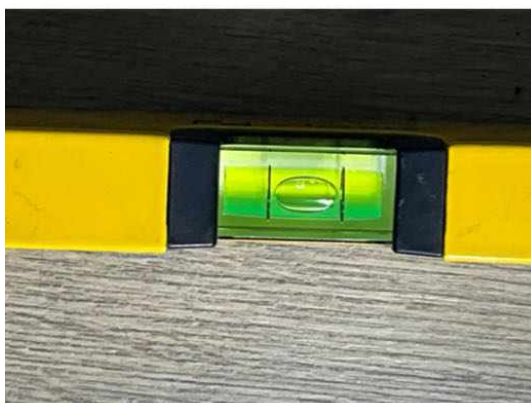
Finding 3.01

Building: Building 1
Location: All Internal Areas
Finding: Flooring - Uneven
Information: The internal flooring in this area is out of level and uneven. Uneven flooring is likely to indicate minor defects such as expected movement of the foundations of the property, but may also indicate subsidence of the associated subfloor stumps.

It is advised that the flooring be closely monitored to identify any further movement. Where flooring remains relatively unchanged for an extended period of time (i.e. several months), it is likely that this defect has been caused by expected movement of the foundations of the property.

However, where flooring is uneven further, potentially invasive inspection of the subfloor structures and stumps in this area is required. In this case, works to repair are likely to be required, and would be carried out by a registered builder specialising in re-stumping.

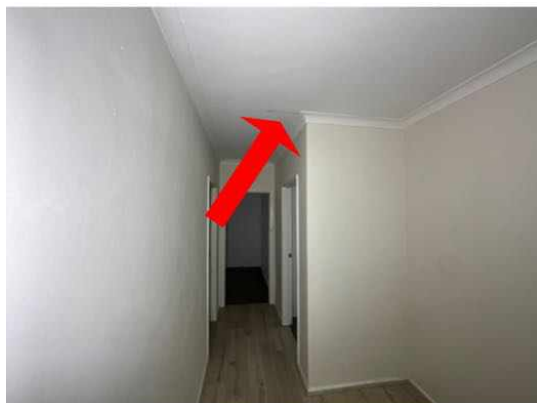
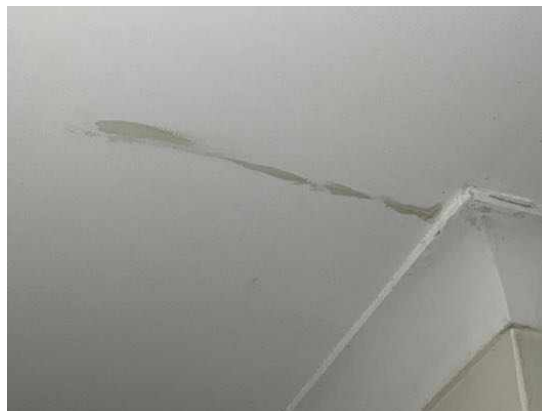
Finding 3.02

Building:	Building 1
Location:	Hall
Finding:	Ceiling - Water stained
Information:	Water staining to ceiling linings in this area was evident at the time of inspection. Water staining indicates that surfaces have been exposed to excessive moisture over time. The minerals and other elements in the water lead to staining, which may graduate to corrosion and deterioration if left unmanaged.

While mostly an appearance defect, water staining can be indicative of more serious defects, which may be currently concealed by interior ceilings.

Where water staining is active, a licensed plumber must be consulted to identify the cause of the staining and to provide advice on any reparation works that may be required. Replacement of any damaged structures is advised.

Conversely, where water staining is old and inactive, affected building materials may be repaired or replaced at client discretion.

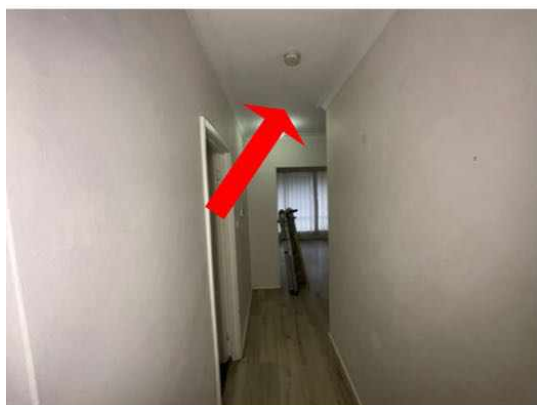
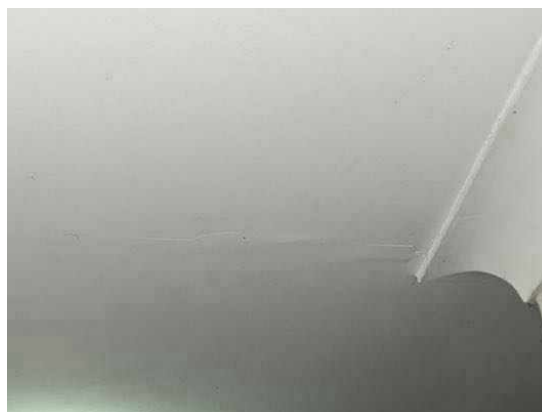
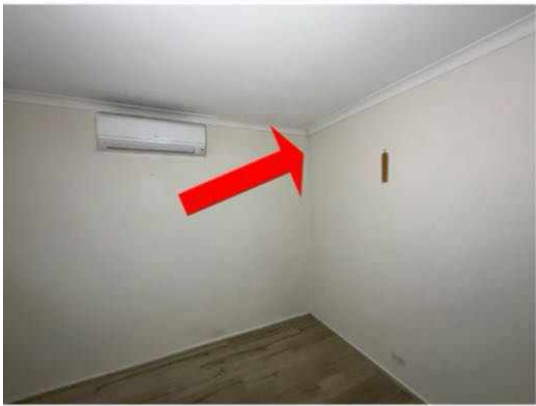
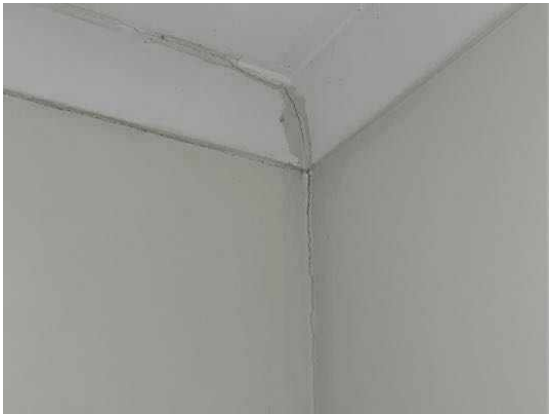
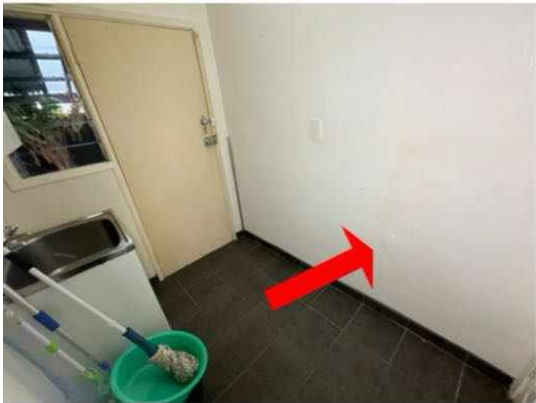
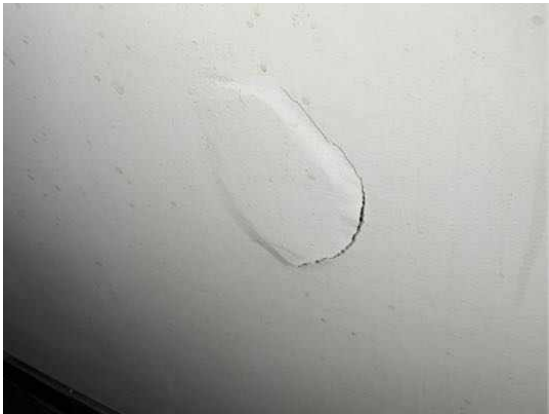
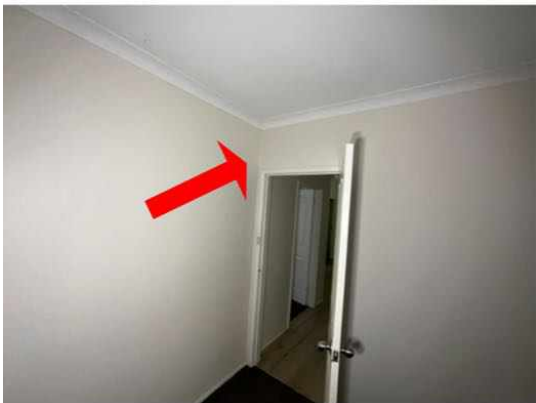
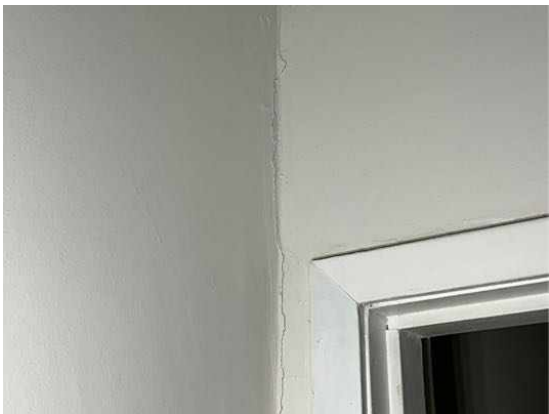
Finding 3.03

Building:	Building 1
Location:	Hall, living, laundry, bed 2
Finding:	Cracking - Damage Category 1 - Fine (up to 1mm)
Information:	Although fine cracks are quite noticeable, they are often only considered to be an appearance defect, and usually do not indicate any structural damage. Generally, the cause of a fine crack is indicative of a separation between building materials and finishes (e.g. paint, plaster, etc.) along joins.

Cracking of this nature can generally be repaired with minor sanding, filling and/or repainting. Such works should be performed by a qualified painter or a general handyman.

Monitoring of all cracking should be conducted frequently. Always contact a building inspector should cracks widen, lengthen, or become more numerous.

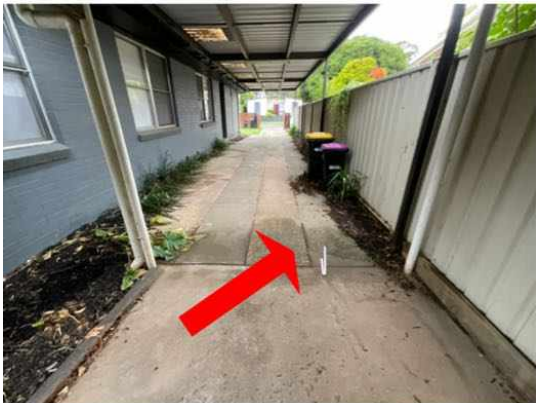
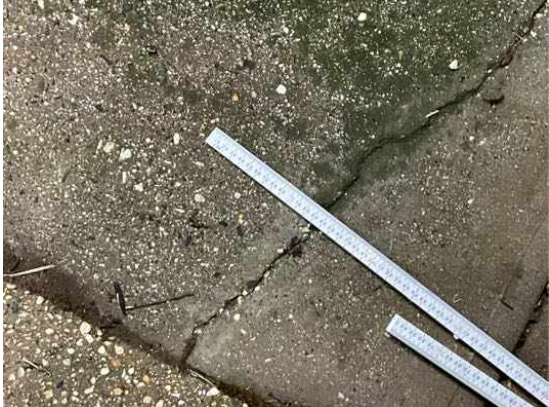
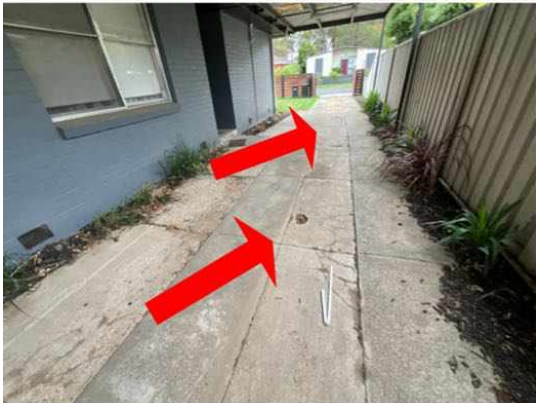
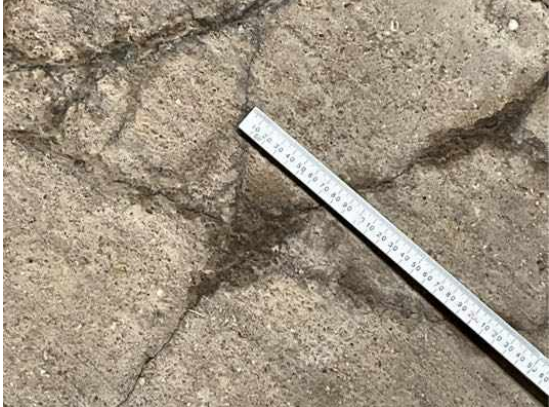
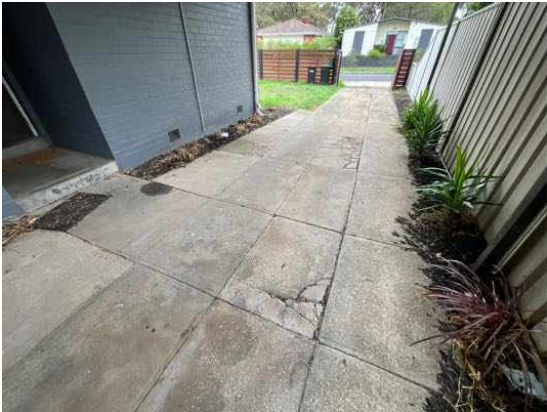
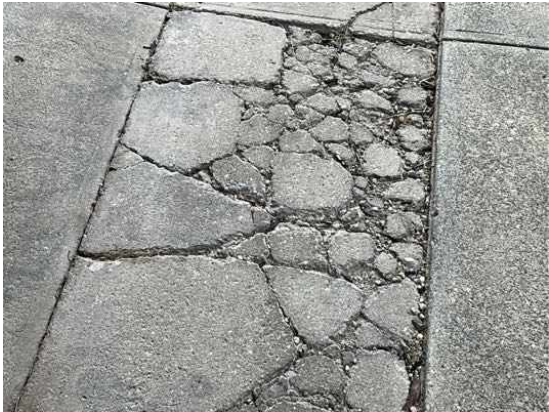
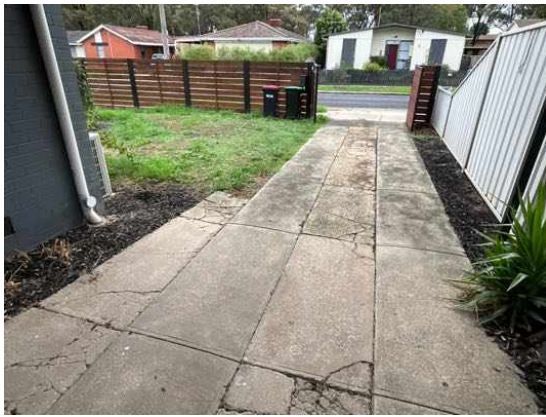
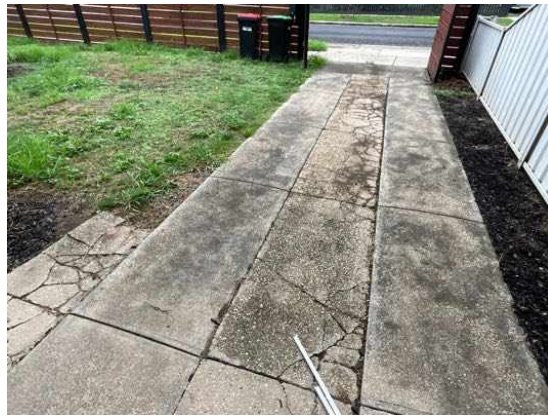
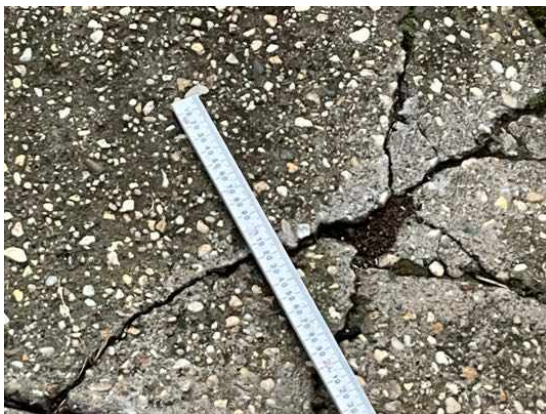
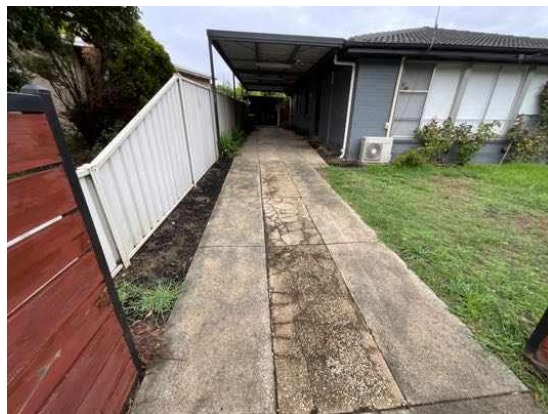
Finding 3.04

Building: Building 1
 Location: Driveway
 Finding: Cracking - External Concrete Paving Damage Category 3 - Wide Cracks (2mm - 4mm)
 Information: Wide cracks were identified in external concrete paving. Wide cracks are significant and are likely to lead to the development of safety hazards and secondary defects if left unmanaged.

General age and expected deterioration of the paved areas is a common cause of this type of cracking. However, expansion and contraction of the slab may also have occurred due to environmental factors. Such factors include variable moisture and

weather conditions, the presence of trees and their roots having a settling or lifting affect on the soil, or the effect of load bearing, e.g. heavy vehicles over a sustained period of time.

Cracking to this degree may also be due to poor original installation of the concrete. Factors such as poor compaction of the sub surface and/or inadequate reinforcing of the slab may create cracking and other secondary defects. Wide cracks may also have a more significant structural cause, such as subsidence of soils.

Where the crack is located adjacent to structural elements of the building, the advice of a Structural Engineer is advisable before undertaking repairs. Significant repair and likely replacement of the concrete paving is probable.

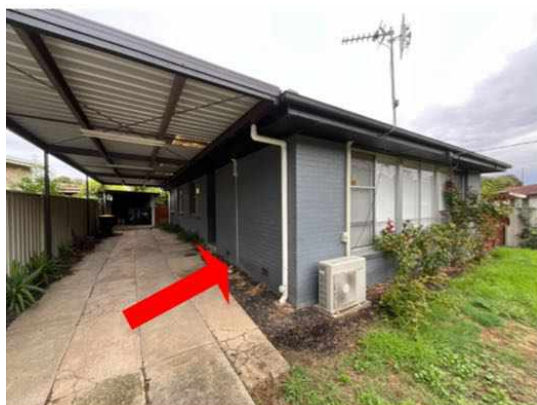
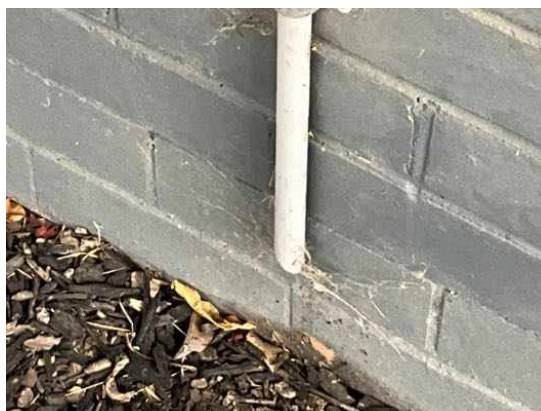
Finding 6.01

Building: Building 1
Location: Carport
Finding: Air conditioner - Disconnected overflow
Information: The Air Conditioner (A/C) overflow was found to be disconnected from storm water drainage and is creating excessive moisture in the surrounding area.

Such leaking creates an environment which is conducive to an array of defects, including water damage to associated building elements and the attraction of termite or timber pest infestation.

It is highly recommended that a licensed plumber be appointed to connect the A/C overflow in order to prevent such an environment from being created. These minor works should be carried out as soon as possible.

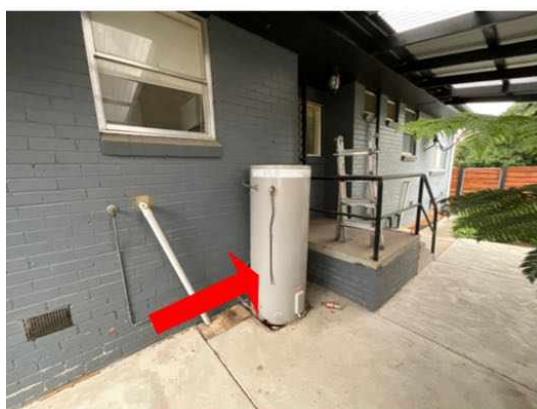
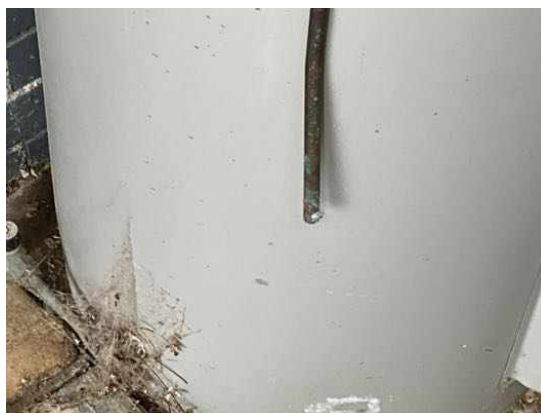
Finding 6.02

Building:	Building 1
Location:	Alfresco
Finding:	HWS Overflow - Not Connected
Information:	The Hot Water System (HWS) overflow was found to be disconnected from storm water drainage and is creating excessive moisture in the surrounding area.

These damp conditions can lead to secondary defects such as rot, rust or corrosion of associated building elements, the formation of fungal decay, or even the creation of potential slip hazards. When coupled with poor site drainage, pooling of water may also attract termite activity to this area.

It is highly recommended that a licensed plumber be appointed to connect the HWS overflow in order to prevent such an environment from being created. These minor works should be carried out as soon as possible.

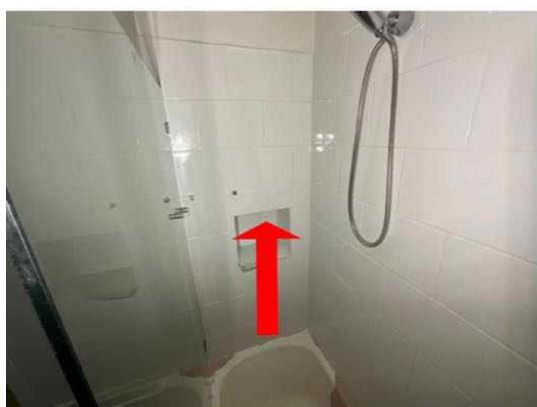
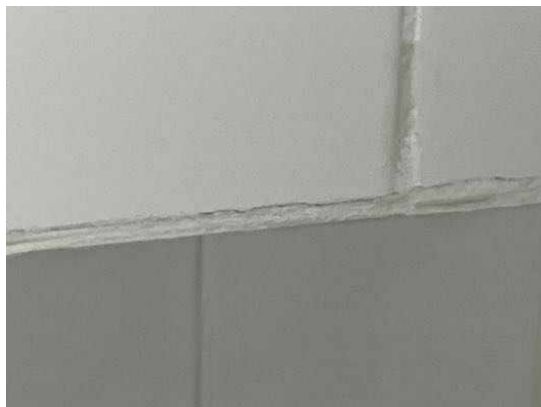
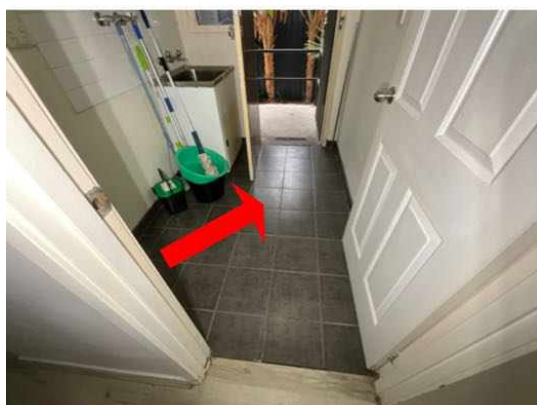
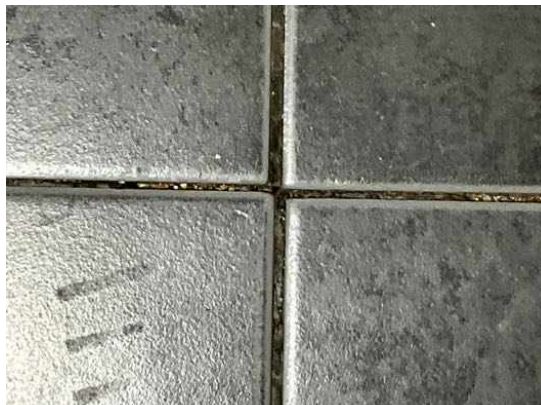
Finding 6.03

Building: Building 1
 Location: Bathroom, laundry
 Finding: Inadequate sealant or Grout
 Information: This area has a lack of effective Sealant or Grout. This is allowing the ingress of water to the structure inside the wall.

The presence of water encourages Termite attack, Mould and Fungal Decay.

A Tiler or General Handy person must be contacted as soon as possible to effect repairs and prevent further deterioration.

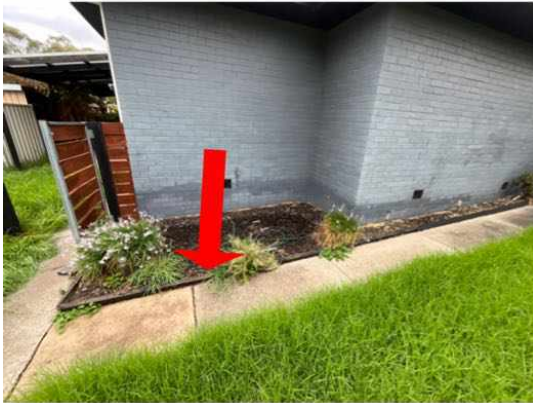
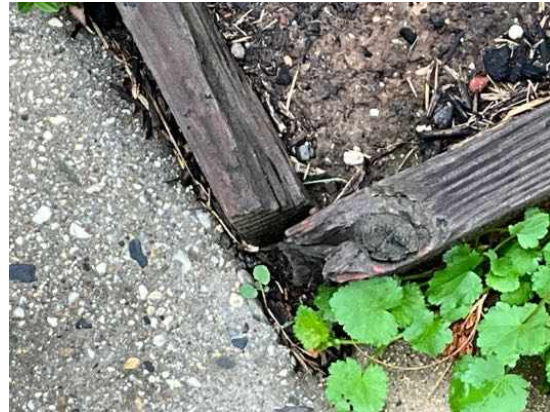
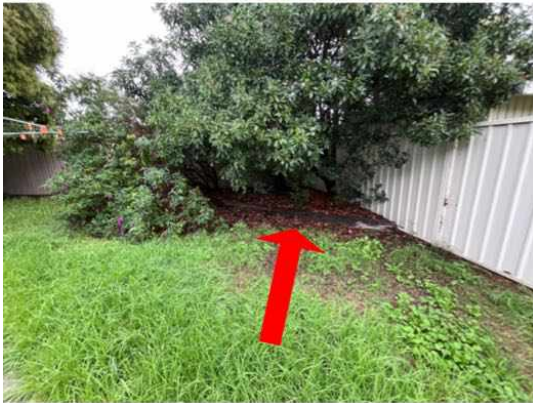
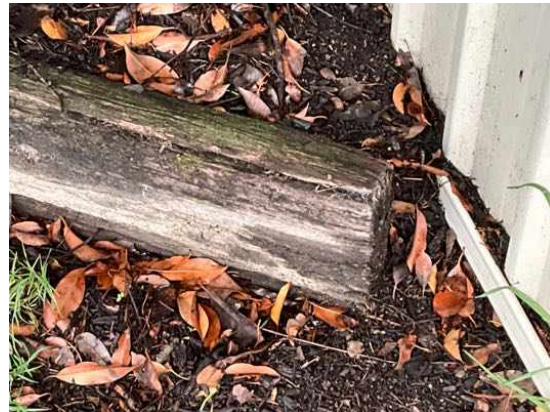
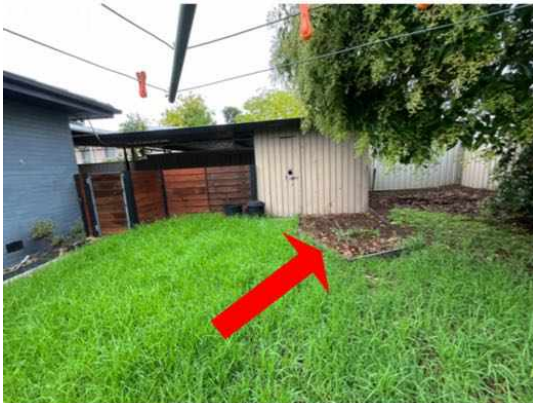
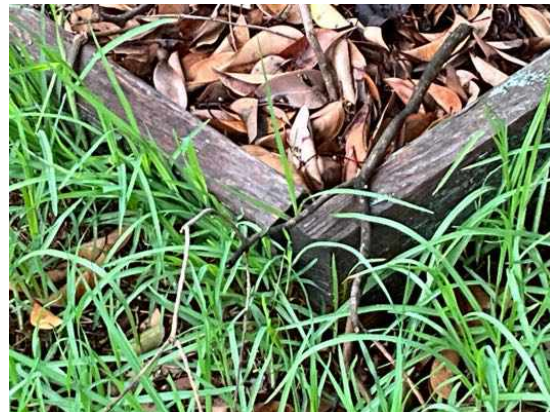
Finding 6.04

Building: Building 1
 Location: Yard - Back
 Finding: Untreated or non-durable timbers in a hazardous environment
 Information: To reduce the risk of timber pest attack it is essential that timber used in a hazardous environment (e.g. in direct contact with the ground or frequently exposed to damp conditions) is of sufficient durability and/or is adequately preservative treated.

Untreated timbers in direct contact with the ground are likely to develop severe wood rot and/or fungal decay if left unattended creating attraction for subterranean termites to infest the timbers from surrounding areas.

If untreated or non-durable timbers are found to be in a hazardous environment it is highly advised that replacement of these building elements be performed as soon as possible to aid the protection of the property against termite / timber pest attack.

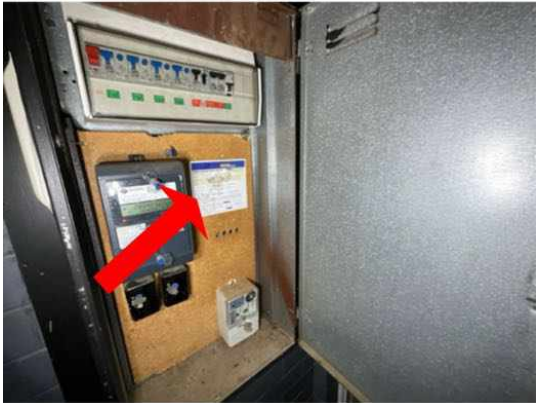
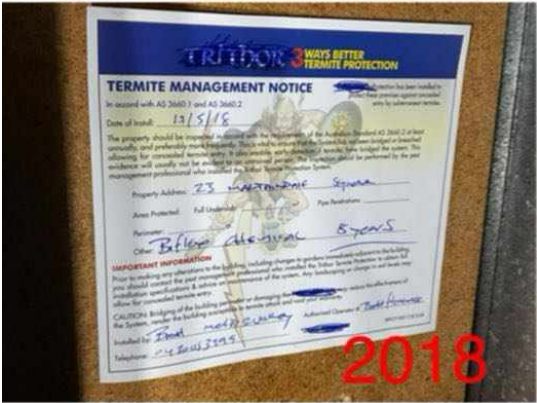
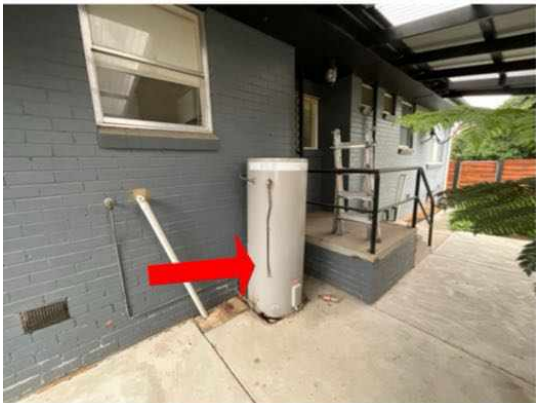
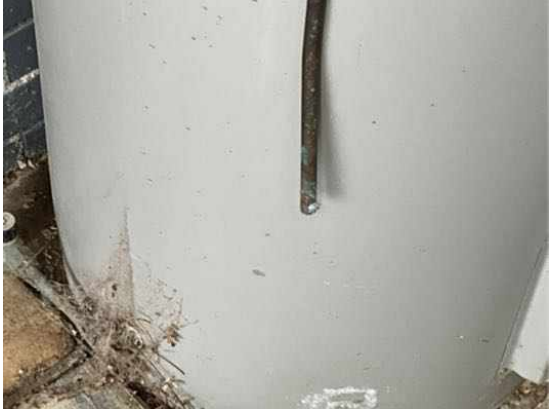
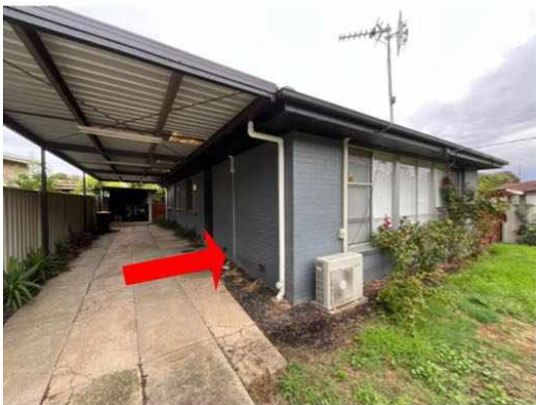
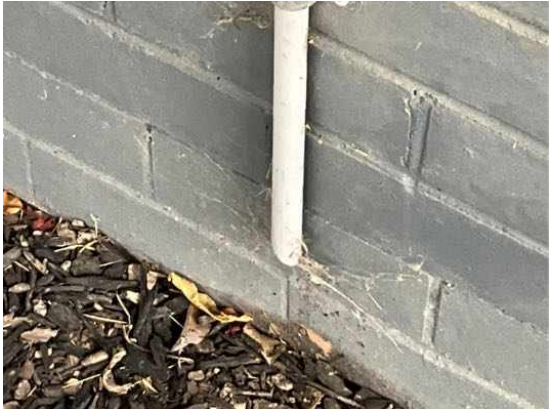
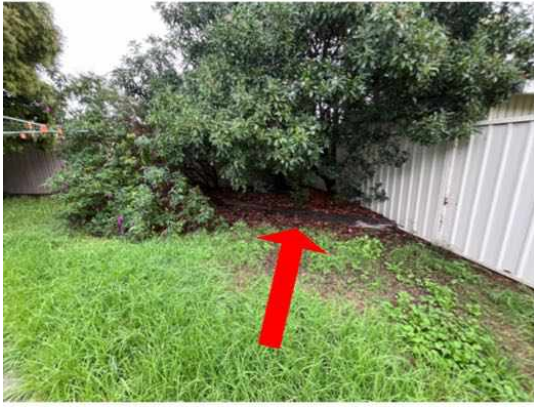
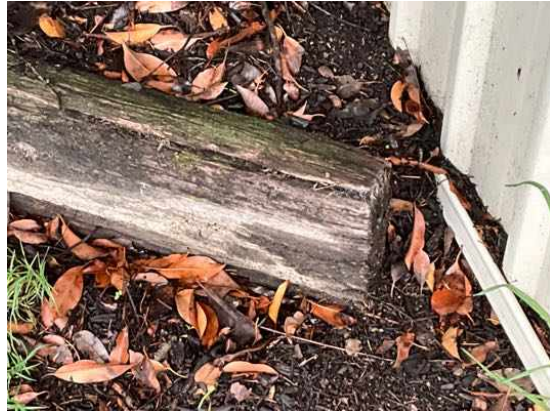
Finding 6.05

Building:	Building 1
Location:	All External Areas
Finding:	Termite Management System- evidence of a chemical installation
Information:	The application of a post-construction chemical termite barrier is highly recommended for all properties, particularly if live termite activity has been found on the site previously. Such barriers are highly effective in preventing termite attack on any timber

building elements throughout the property.

A durable notice has been placed in the switchboard unit to indicate current termite barriers. At the time of inspection, it appeared as though a termite management system has been installed. The recency of any treatment cannot be determined.

The client may consider gaining further advice from a pest controller as to the costs and procedures involved with this application. It is recommended that obtaining such advice be a short-term priority.

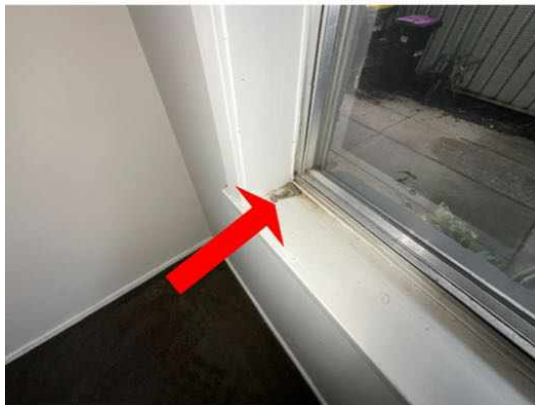
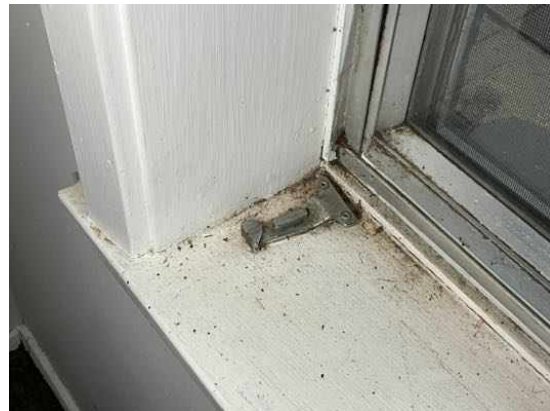
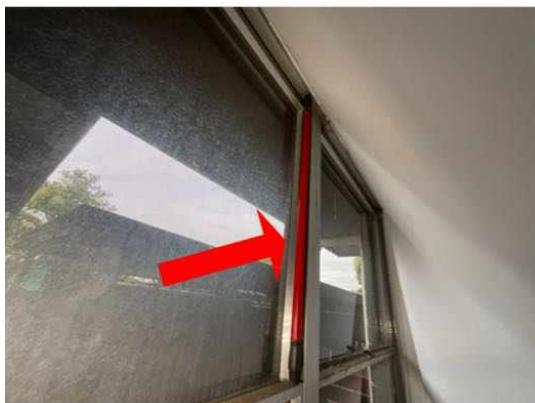
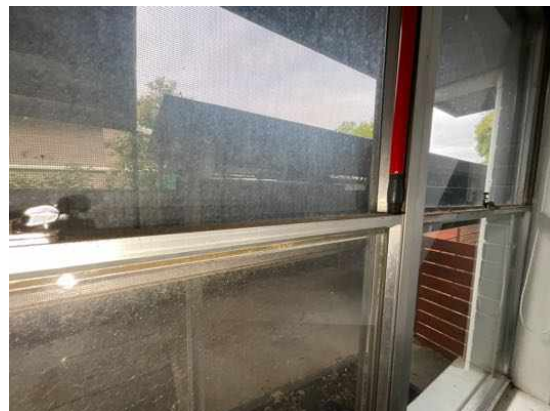
Building: Building 1
 Location: Bed 2
 Finding: Window handle- Poor operation
 Information: The window handle/ catch in this area was found to be faulty during the visual inspection. This is most probably because of a lack of maintenance or wear and tear over time.

A general Handy person or window specialist should be contacted to make needed repairs at the discretion of the owner and restore full function.

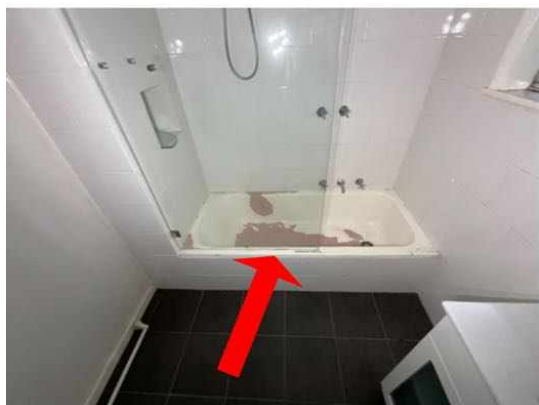
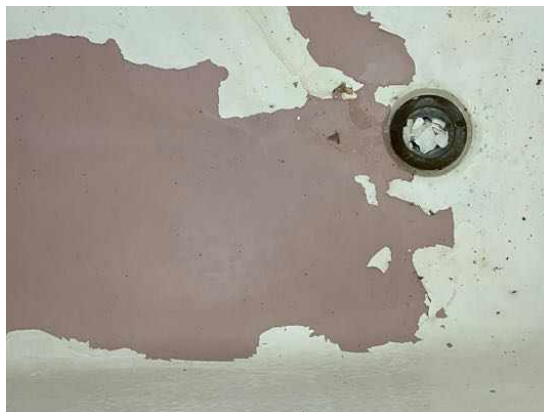
Building: Building 1
 Location: Bathroom
 Finding: Bath - paint Chipped
 Information: Chipping was evident to the bath paint at the time of inspection, which is suspected to have been caused by wear and tear over time. While the chipping appears to not

affect operation, any further impact damage/ use sustained by the bath may lead to additional cracking/ deterioration of the surface treatment.

Consultation with a bathroom specialist or handyman regarding bath repair or replacement is required at the discretion of the owner. Remedial works may be required to protect against any further deterioration.

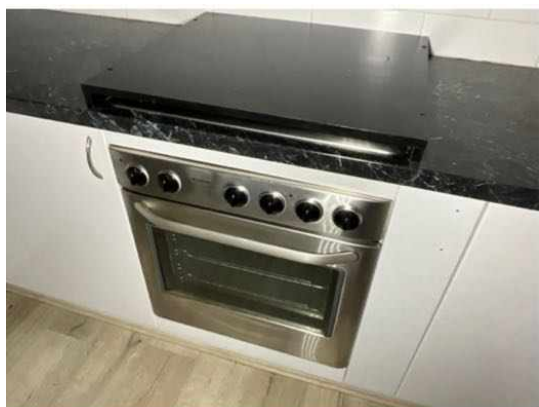
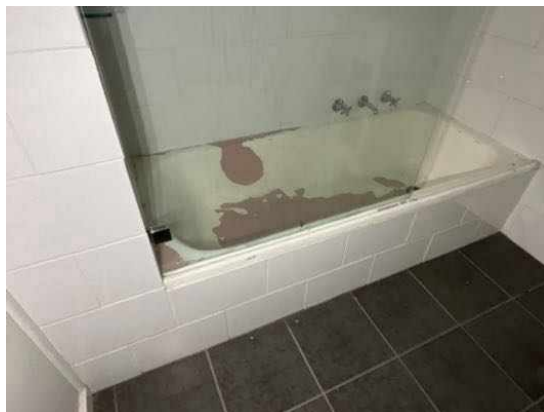
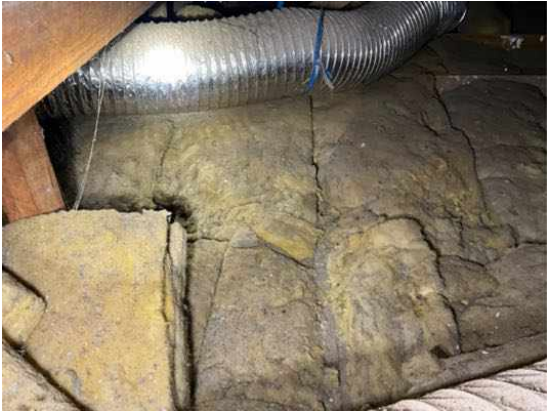
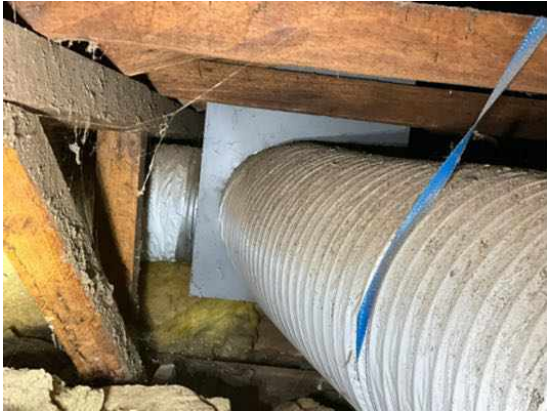
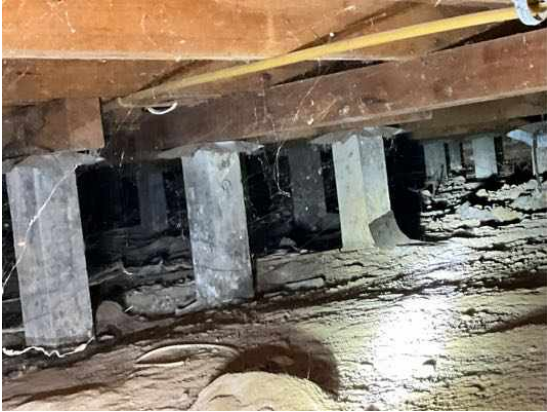
Building:	Building 1
Location:	All Areas
Finding:	Additional Photos - Obstructions and Limitations
Information:	These photographs are an indication of the obstructions and limitations which impeded full inspection of the property at the time of inspection. These obstructions can hide an array of defects and should be removed to allow full inspection to be carried out. A re-inspection is recommended once the areas are made accessible.
