Building and Timber Pest Inspection Report

Inspection Date: Wed, 11 Feb 2026

Property Address: 25 Byron Rd, Tahmoor NSW 2573, Australia

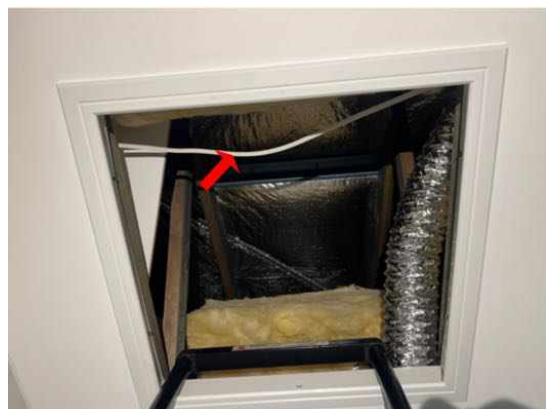
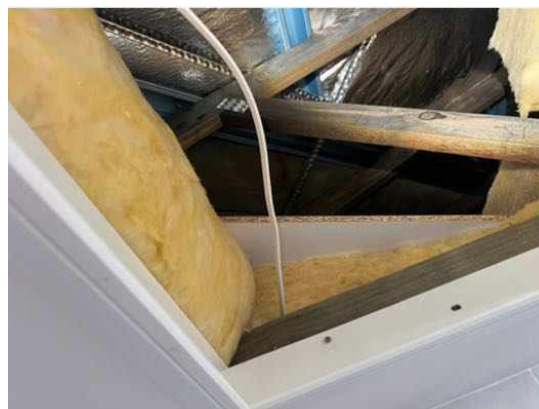
Building:	Main Building
Location:	Roof Void
Finding:	Electrical wires exposed - manhole access
Information:	Electrical wiring was observed running directly across the manhole access within the ceiling void. This installation may pose a safety hazard when accessing the roof space, as personal contact or accidental damage to the wiring may occur when using the manhole.

Best practice is for electrical wiring to be routed away from access points to minimise risk. The client should engage a licensed electrician to assess the installation and, if necessary, reposition or protect the wiring in accordance with current electrical standards and safety requirements.

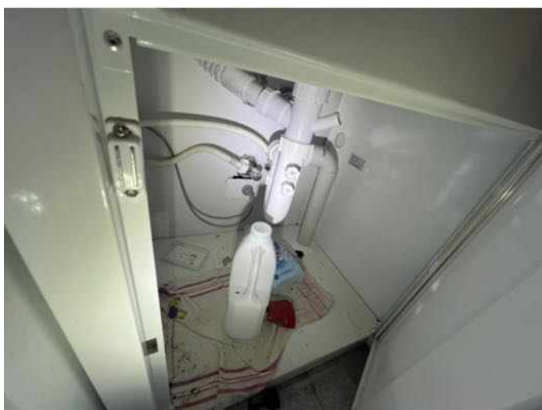
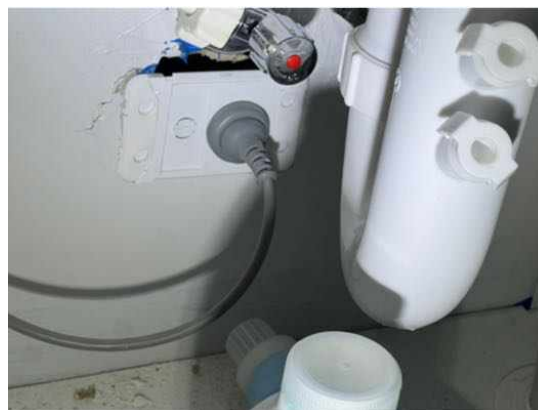
Finding 1.02

Building:	Main Building
Location:	Laundry
Finding:	Electrical - Suspected non compliance (GPO/splash risk)
Information:	A general-purpose outlet (GPO) was noted installed directly beneath the sink and adjacent to plumbing connections. While such arrangements are sometimes present in older installations, this setup may not meet current safety expectations, particularly with regard to moisture exposure and splash risk.

This installation may present a safety concern and should be assessed by a licensed electrician to confirm compliance with current standards and advise on any necessary rectification.

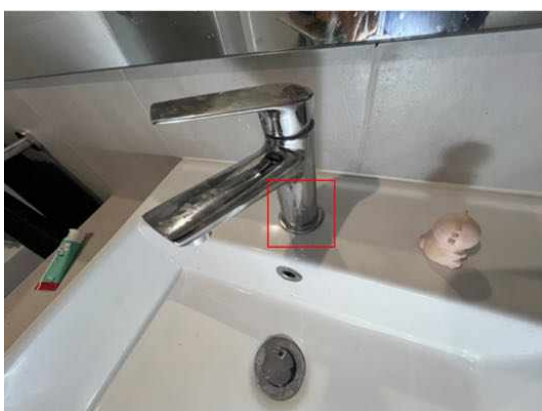
Building: Main Building
 Location: Bathroom
 Finding: Tap - Loose at connection
 Information: The tap was observed to be loose at its connection point at the time of inspection. This condition is commonly caused by poor installation, deterioration of sealant, or movement in the fixture over time.

The tap may lead to water leakage behind the wall/floor, potentially causing moisture damage and deterioration of associated building elements if left unmanaged.

It is recommended that a licensed plumber be engaged to assess and properly secure the tap to prevent further movement and potential water ingress.

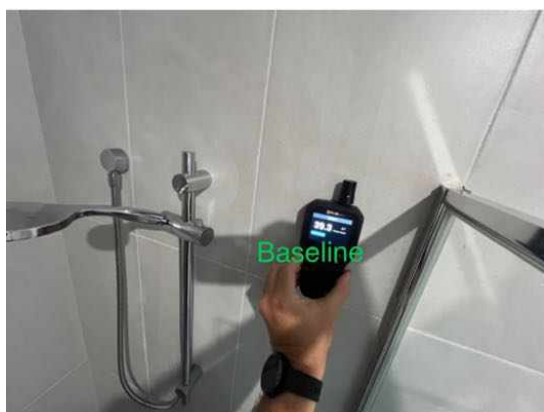
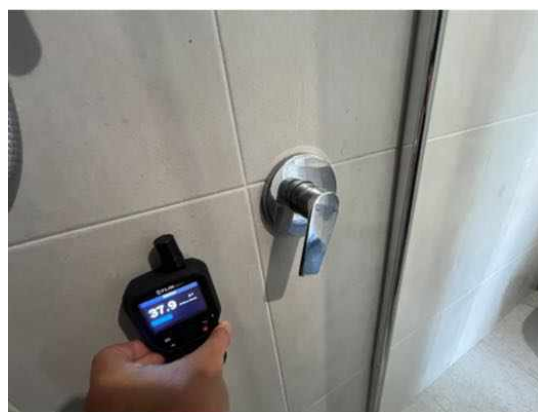
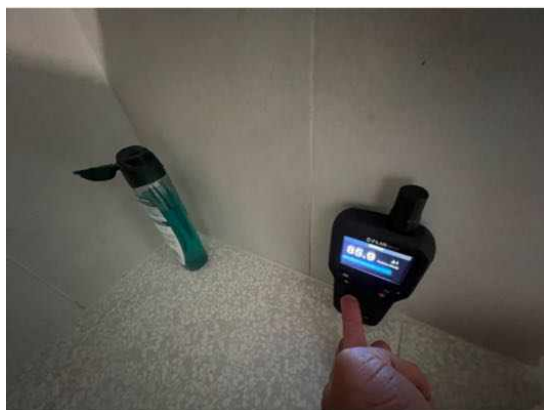
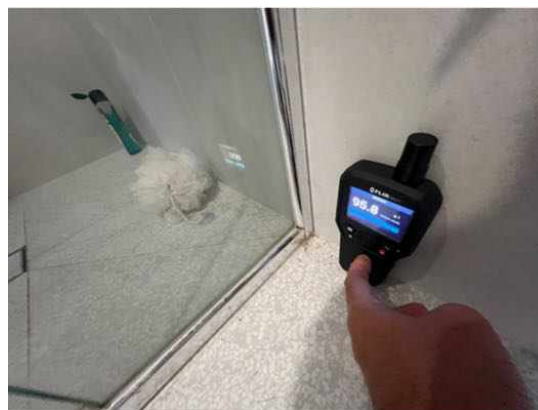
Finding 3.02

Building:	Main Building
Location:	Bathroom
Finding:	Moisture in Shower
Information:	Moisture is evident behind the tiles to the shower alcove. This defect is quite common, and is suspected to have been caused by moisture permeating through the grouting in this area. Leaking pipes within the adjoining wall is also a possible cause.

Damp (or structural damp) refers to the presence of unwanted moisture in the structure of a building, either as the result of intrusion from outside, or condensation from within the structure. In the shower area, internal water leaks or other sources of excessive moisture are generally the cause of damp. Always ensure that sealant and grout is in good condition to prevent any moisture issues occurring in the future.

Building:	Main Building
Location:	Bathroom
Finding:	Moisture in Shower (Photos shown in previous defect section)
Information:	Moisture is evident behind the tiles to the shower alcove. This defect is quite common, and is suspected to have been caused by moisture permeating through the grouting in this area. Leaking pipes within the adjoining wall is also a possible cause.

Consultation with a qualified plumber or bathroom specialist is advised to identify the cause of damp and to perform remedial works as required.

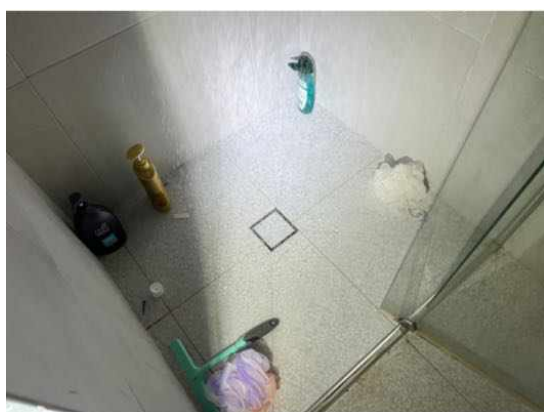
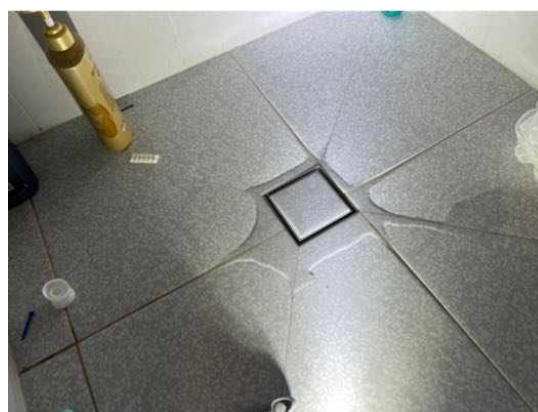
Finding 3.03

Building:	Main Building
Location:	Bathroom
Finding:	Shower base - Water pooling
Information:	Evidence of water pooling around the floor waste in the shower recess was noticed at the time of inspection. It is suspected that this excessive moisture is attributed to insufficient fall in the shower floor tiles.

This pooling is minor overall but is still considered unsatisfactory, as standard tiling practices would not permit this situation to occur. Pooling water around floor wastes can create a slip hazard in extreme cases and create conditions that are conducive to mould growth over time. Where left unmanaged, the degradation of sealant and grouting is also likely to occur, possibly necessitating further repair works.

Remedial works may involve some sections of tiling and flooring repair and replacement. A tiling contractor or bathroom specialist should be appointed to provide further advice on reparation options and to perform works as necessary.

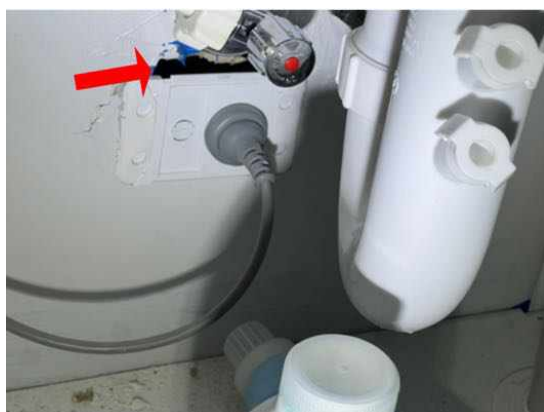
Finding 3.04

Building:	Main Building
Location:	Laundry

Finding: Plasterboard - Damaged
 Information: Breakage occurs generally when the building materials have either aged and decayed, or as a result of damage (accidental or deliberate).

Repair and/or replacement of broken elements is advised to ensure that additional secondary defects do not arise as a consequence. Such works are necessary, as all building elements play a key role in the operation and function of the overall structure and its performance.

A plasterer or general handy person should be appointed to repair or replace the affected building element prior to any subsequent damage being caused followed by a painter.

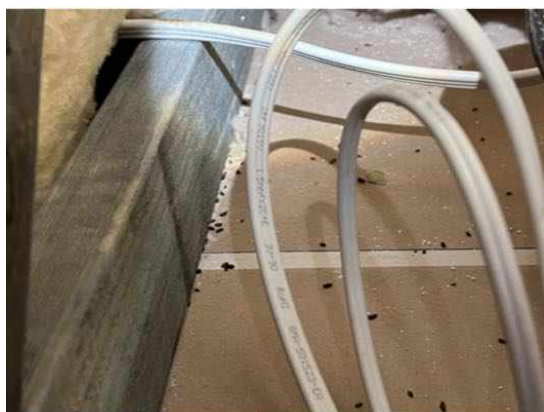
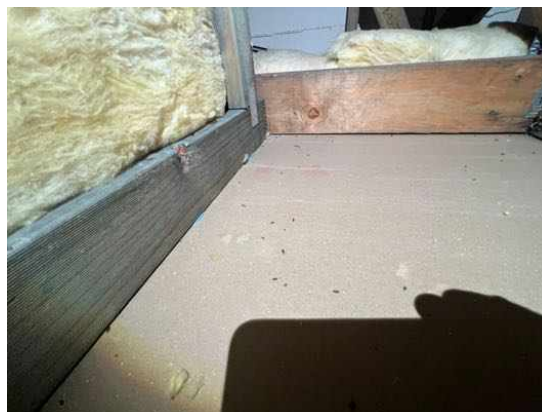
Finding 3.05

Building: Main Building
 Location: Roof Void
 Finding: Evidence of Vermin
 Information: Evidence of pests or rodents faeces in the roof space at time of inspection. Rodents can cause issues ranging from smells and stains through to physical damage to wiring and other elements in the roof void. A licensed pest controller should be appointed to free the roof void of any pests and to install deterrents or seal access points to ensure that rodents can not enter the roof space as easily.

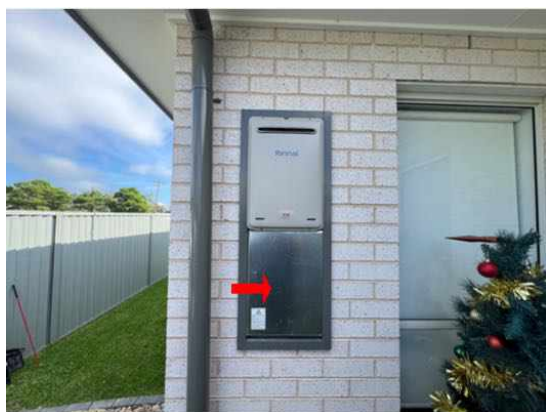
Finding 3.06

Building:	Main Building
Location:	Exterior walls - front
Finding:	Paint finish - Incomplete
Information:	The paint finish in this area was identified as being incomplete at the time of inspection.

Whilst incomplete or missing paint finish is generally an appearance defect, it can also lead to the development of secondary building defects over time. Incomplete areas of paint finish expose the area to moisture, potentially accelerating the deterioration of underlying building materials.

Incomplete paint finishes should be sanded back, filled, leveled and painted, as applicable. Where inadequate or missing paint protection has led to the deterioration of the associated building element, repair and/or replacement of this building element may be required.

A painting contractor should be appointed as soon as possible to perform necessary works to aid the appearance of the affected area and to ensure the area is protected against further deterioration. Alternatively, the homeowner following manufacturer instructions may perform these works.

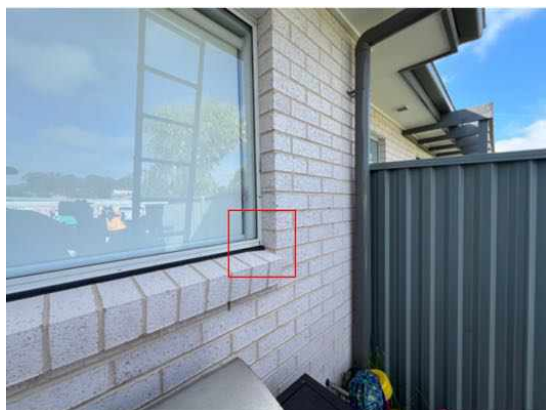
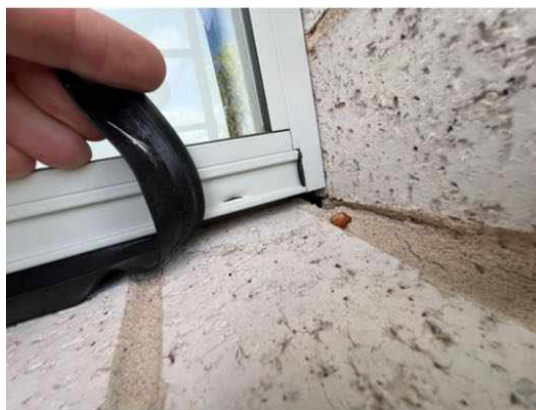
Finding 3.07

Building:	Main Building
Location:	Exterior walls - front
Finding:	Window seals - substandard
Information:	The window seals to the bottom of the windows were identified as having been installed to a substandard level of workmanship, with visible gaps present at the time of inspection. Poorly installed seals compromise the weather tightness of the window, increasing the potential for water ingress and subsequent deterioration of surrounding building elements.

If left unmanaged, these gaps may allow moisture penetration, leading to damage and compromising the overall performance of the window system.

It is recommended that a qualified carpenter or sealant specialist be appointed to assess and rectify the defective seals to ensure the windows are adequately protected against external weather conditions.

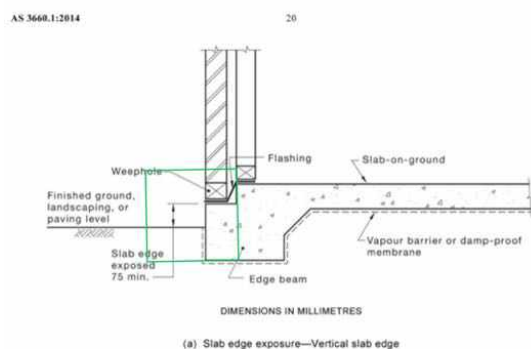
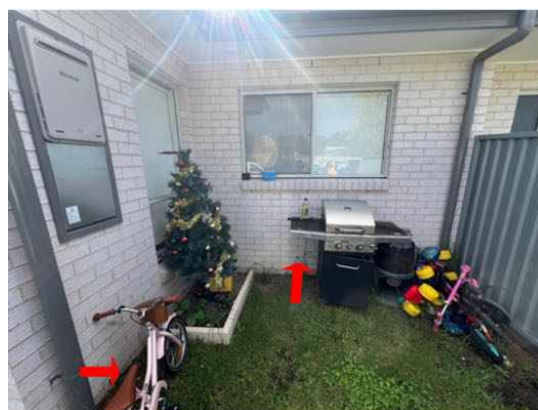
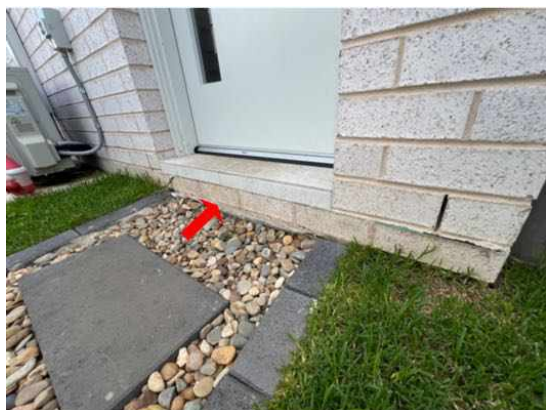
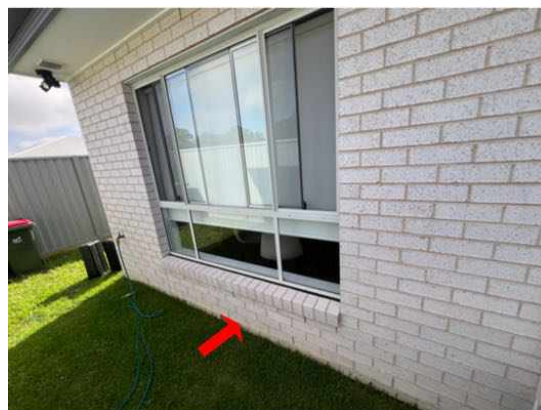
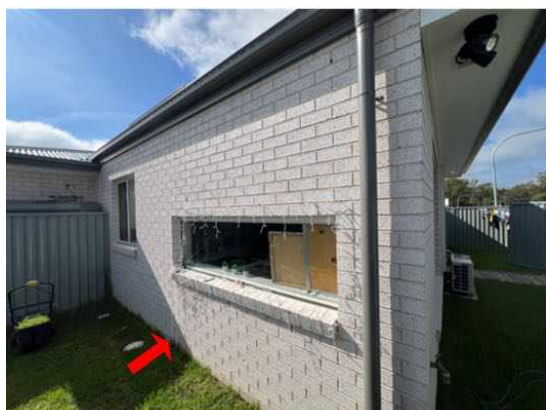
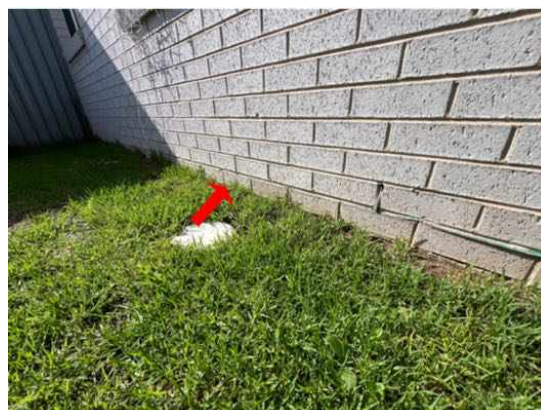
If the slab edge is not properly exposed there is a high risk of termite attack. Sometimes, in order to determine the type of slab, a suitably qualified person such as an architect or builder may be required to consult the construction plans.

Where the slab edge cannot be properly inspected, it is highly recommended that termite or timber pest inspections be carried out every 6-12 months to aid protection of the property against infestation.

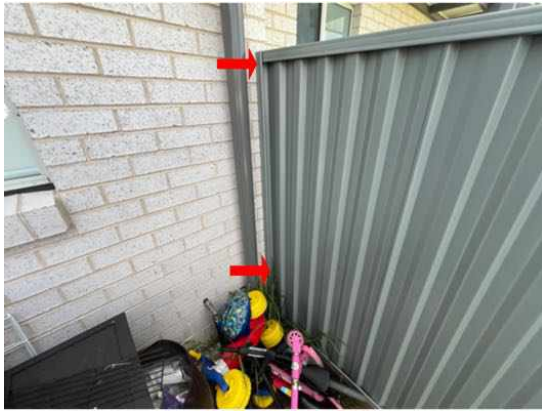
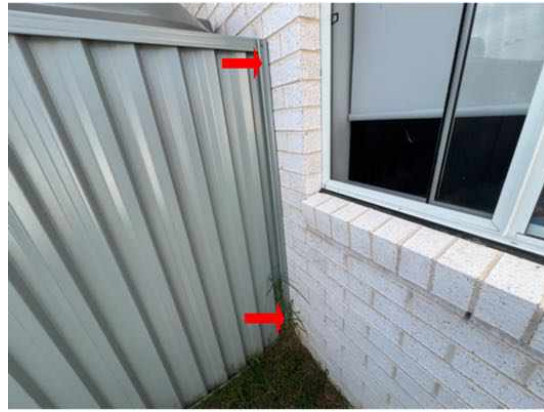
Finding 6.03

Building:	Main Building
Location:	All External Areas
Finding:	Bridging - Attachments to Buildings.
Information:	Bridging occurs when items against a building provide a concealed entry point for termites into the building or by passing around a termite management system.

Where any part of an attachment to a building is not isolated and is not provided with a clear gap of not less than 25mm from the building, bridging occurs. Attachments to buildings such as hot water services, downpipes, verandahs, decks, steps, fences, service conduits and the like provide the opportunity for concealed entry.

Building attachments of this nature need to be frequently inspected for termite activity by a qualified inspector

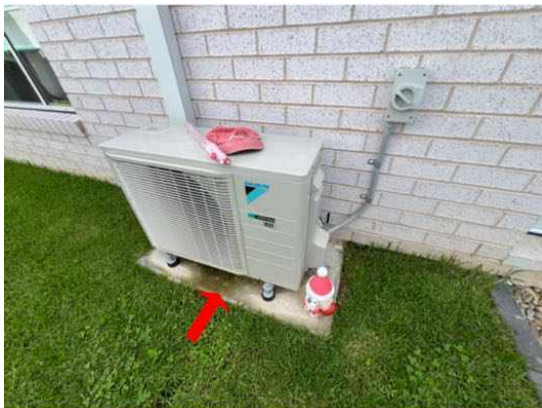
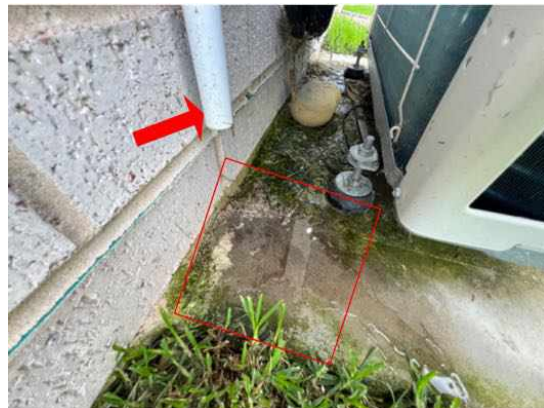
Finding 6.04

Building:	Main Building
Location:	Exterior walls - front
Finding:	Air conditioner - Disconnected overflow
Information:	The Air Conditioner (A/C) overflow was found to be disconnected from storm water drainage and is creating excessive moisture in the surrounding area.

Such leaking creates an environment which is conducive to an array of defects, including water damage to associated building elements and the attraction of termite or timber pest infestation.

It is highly recommended that a licensed plumber be appointed to connect the A/C overflow in order to prevent such an environment from being created. These minor works should be carried out as soon as possible.

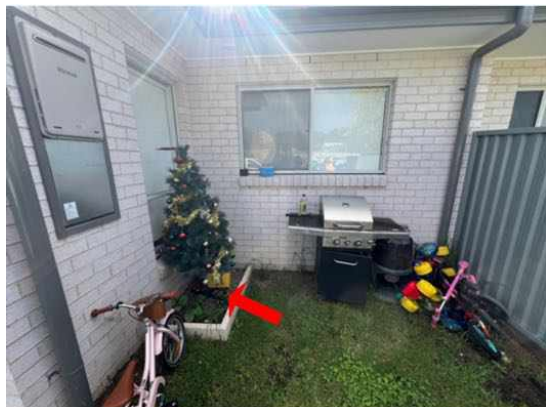
Finding 6.05

Building:	Main Building
Location:	All External Areas
Finding:	Garden Beds - Conditions Conducive to Termites
Information:	Garden beds were observed around the perimeter of the building, obstructing visual inspection of lower wall areas and providing potential concealed termite entry points.

Raised soil levels and retained moisture from watering can allow termites to access wall cavities or weep holes undetected, while timber edging materials may further encourage activity.

It is recommended that garden beds be reduced or cleared from the building perimeter, or that regular timber pest inspections be carried out in accordance with AS 4349.3 or AS 3660.2 to monitor risk.

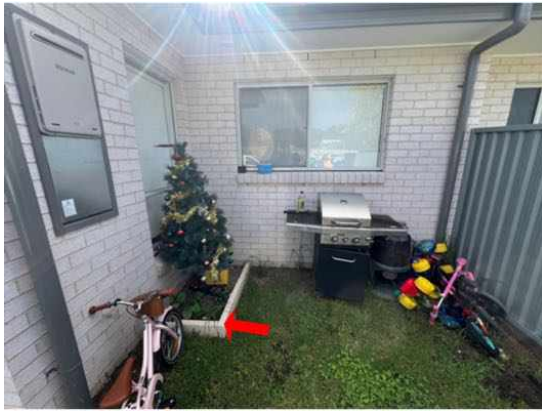
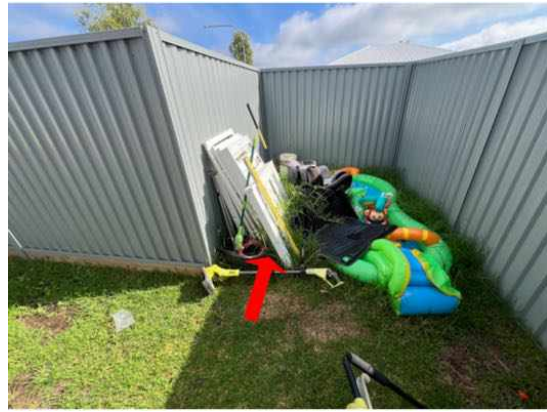
Finding 6.06

Building:	Yard
Location:	Yard
Finding:	Building materials in direct ground contact - conducive to termites
Information:	Where timber elements are in direct contact with the ground and consequently moisture or dampness they become conducive to termite activity. Whether timber is used as a building element part of a fencing structure or stored as an unused item they can provide an environment that is attractive to termite infestation.

When met with excessive moisture timber begins to decay and develop wood rot. Any timbers that are in direct contact with external grounds especially if left untreated or non-durable also provide ingress for subterranean termites into that particular element.

The removal of any such materials that may be conducive to termite activity should be removed as soon as possible to minimise the risk of termite attack.

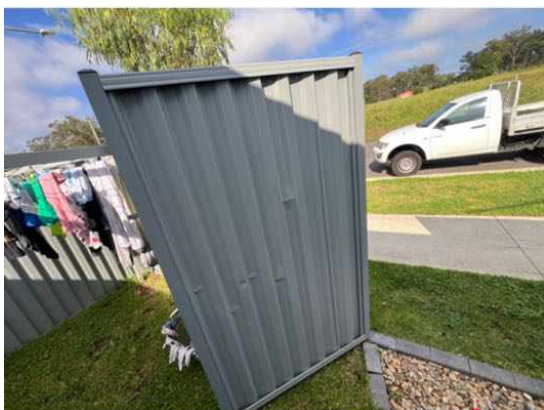
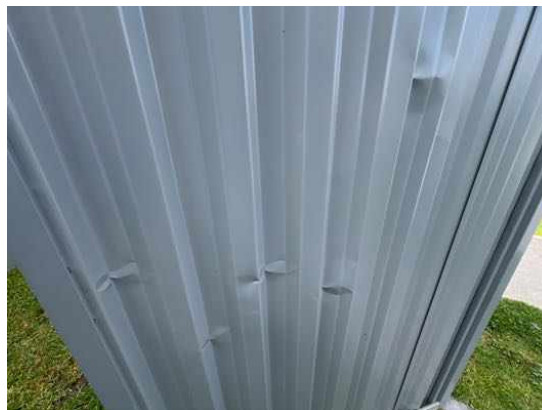
Building:	Yard
Location:	Yard - Front
Finding:	Colourbond Fencing - damage
Information:	Sections of the Colorbond fencing were identified as damaged at the time of inspection. Damage to fencing panels may occur due to impact, weathering, or improper installation, potentially affecting the structural integrity and appearance of the fence.

Where Colorbond panels are compromised, they may be more susceptible to corrosion and further deterioration over time.

It is recommended that a licensed fencing contractor be appointed to assess the extent of the damage and provide advice on remedial options to restore the fencing.

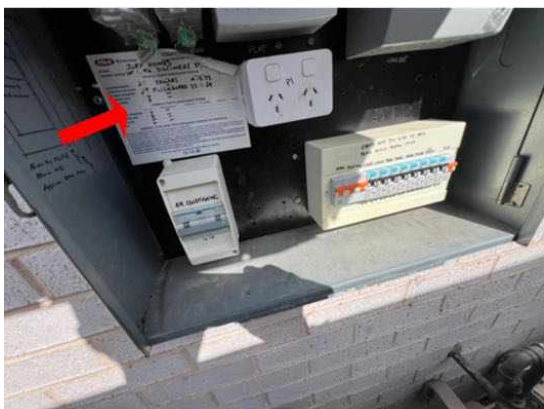
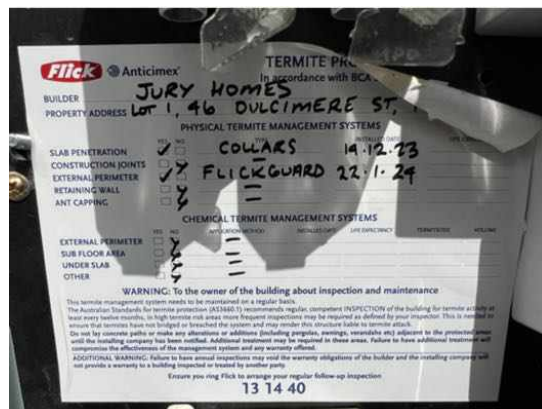
Where a Termite Management System has been identified you should refer to the type of barrier date of installation warranty conditions and any documentation provided by a builder or past owner. Consult the company who installed the barrier to confirm whether the system is still under warranty.

Most chemical termite management systems expire and require replenishment and all physical systems are primarily designed to prevent concealed entry.
