Building and Timber Pest Inspection Report VR

Inspection Date: Thu, 26 Feb 2026

Property Address: 40A Lamonerie St, Toongabbie NSW 2146,
Australia

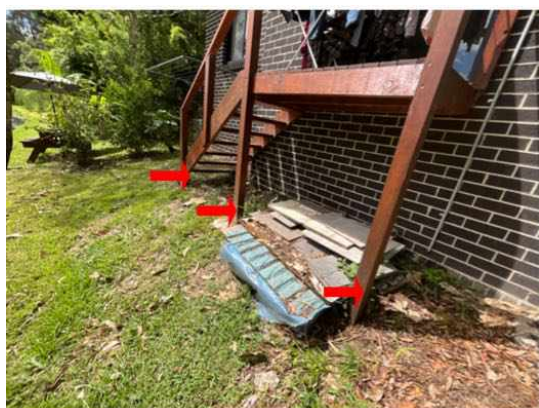
Building:	Main Building
Location:	Rear elevation
Finding:	Untreated or non-durable timbers in a hazardous environment

Information: To reduce the risk of timber pest attack it is essential that timber used in a hazardous environment (e.g. in direct contact with the ground or frequently exposed to damp conditions) is of sufficient durability and/or is adequately preservative treated.

Untreated timbers in direct contact with the ground are likely to develop severe wood rot and/or fungal decay if left unattended creating attraction for subterranean termites to infest the timbers from surrounding areas.

If untreated or non-durable timbers are found to be in a hazardous environment it is highly advised that replacement of these building elements be performed as soon as possible to aid the protection of the property against termite / timber pest attack.

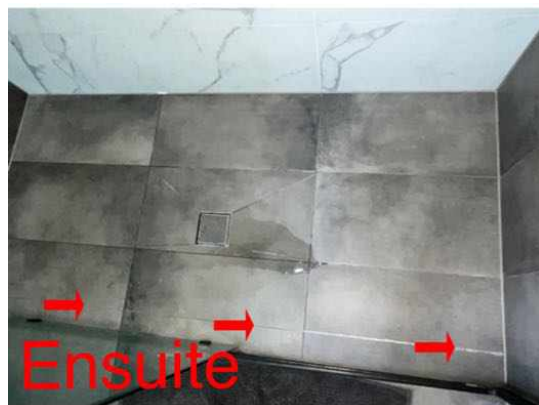
Finding 3.05

Building: Main Building
 Location: Multiple areas
 Finding: Sealant and grouting - Missing or damaged
 Information:

It was noted on inspection that sealant or grout is degraded to this area.

Different materials and floor areas move at different rates, generally causing cracking to grout or sealant at this point. A flexible sealant is required to allow for expected expansion and contraction, while keeping the joint water tight and protective of all associated building materials.

Flexible and mould resistant materials should be applied to affected areas to prevent any subsequent water damage that is likely to occur. Regular maintenance and replacement of damage or missing or damaged sealant and grout is highly recommended to the wet areas, as this is a regular wear and tear defect. Sealant and grouting in areas that come into regular contact with water should be maintained for the long term care of your property.

A sealant specialist should be appointed to complete these works as soon as possible.

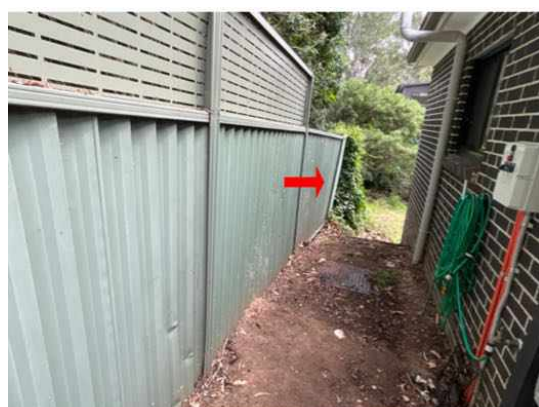
Building:	Main Building
Location:	Fencing
Finding:	Fencing - Deteriorated
Information:	It was noted at the time of inspection that sections of the fencing in this area has deteriorated. Typically fencing deteriorates due to age and or wear, rot and or rust which is generally expected for a structure of this age, due to prolonged exposure to weather conditions. Sometimes inadequate installation or maintenance can be to blame.

If left unattended, it is likely that further damage will occur. It is suspected that repair of several elements of the fencing may be required however replacement may be a consideration of the client also.

A licensed fencing contractor should be appointed to provide further advice and perform rectification works as necessary.

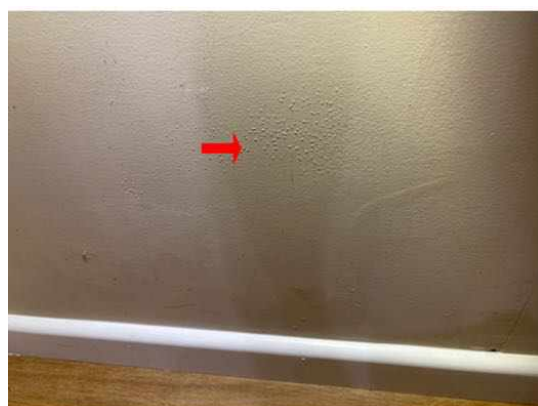
Building:	Main Building
Location:	Studio kitchen
Finding:	Evidence of excessive moisture was present at the time of inspection
Information:	Excessive moisture can attract termites and produce conditions that promote termite attack, fungal growth and wood decay. Excessive moisture is generally caused by deteriorated, inadequate or missing roof drainage, leaking plumbing pipes or fixtures, poorly plumbed HWS overflows or condenser units and poor site drainage. It is highly recommended that all plumbing and drainage fixtures and fittings be maintained regularly in order to prevent excessive moisture being present in the external / internal property.

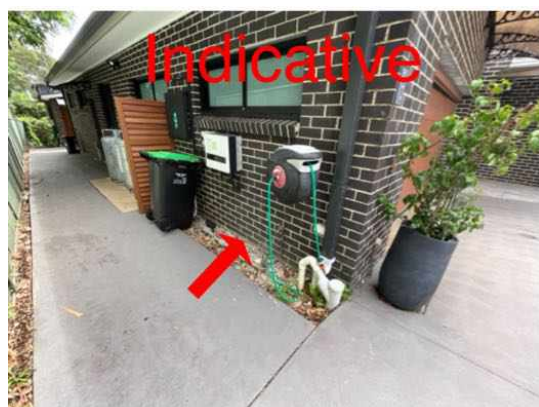
Building:	Main Building
Location:	Perimeter
Finding:	Slab Edge - Exposure
Information:	Slab Edge Exposure: Where external concrete slab edges are not exposed there is a high risk of concealed termite entry. In some buildings built since July 1995 the edge of the slab forms part of the termite shield system. In these buildings an inspection zone of at least 75mm should be maintained to permit detection of termite entry. The concrete edge should not be concealed by render, tiles, cladding, flashings, adjoining structures, paving, soil, turf or landscaping etc. Where this is the case you should arrange to have the slab edge exposed for inspection. Concealed termite entry may already be taking place but could not be detected at the time of the inspection. This may have resulted in concealed timber damage. Does the slab edge inspection zone fully comply?

Not able to comment. A very high proportion of termite attacks are over the edge of both Infill and other concrete slabs types. Covering the edge of a concrete slab makes concealed termite entry easy. Infill slab type construction has an even higher risk of concealed termite ingress as the slab edge is concealed due to the construction design and cannot be exposed. The type of slab may only be determined by assessment of the construction plans by a qualified person e.g. Builder, Architect. Construction Plans may be obtainable by your local Council or Builder. Termite activity and or damage may be present in concealed timbers of the building. We strongly recommend frequent regular inspections in accordance with AS 3660.2. Where the slab edge is not fully exposed or the slab is an infill slab or the slab type cannot be determined then we strongly recommend inspections every 3 to 6 months in accordance with AS 3660.2 or AS 4349.3.

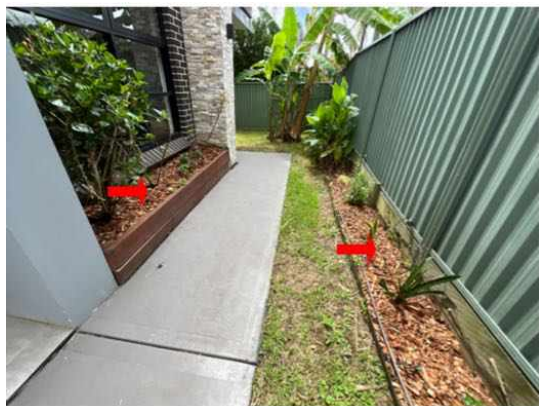
Finding 6.12

Building:	Main Building
Location:	Garden beds
Finding:	Garden Beds
Information:	Garden beds were found to be evident in the garden area. These garden beds can include untreated timber, and with a combination of moisture from watering hosing can make conditions conducive to termite activity and termite ingress.

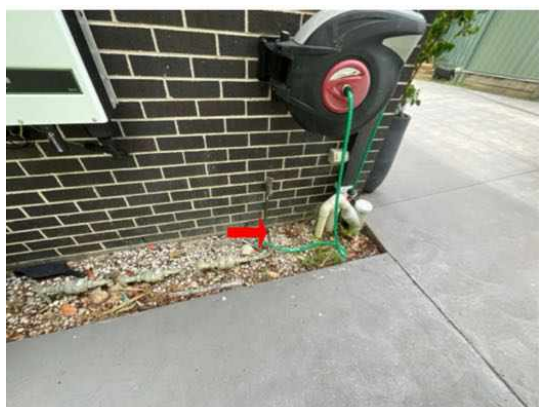
Finding 6.13

Building:	Main Building
Location:	External tap
Finding:	Tap - No drain
Information:	The external tap in this area was noted to have no drain at the time of inspection.

This keeps the surrounding surfaces damp while using the tap, which becomes conducive to termite activity.

A licensed plumber must be appointed to ensure an appropriate drain is installed.

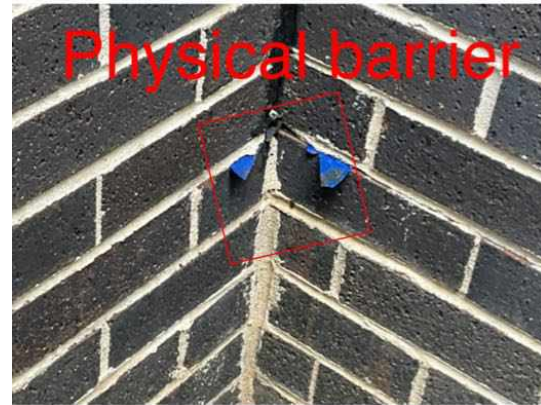
Where a Termite Management System has been identified you should refer to the type of barrier date of installation warranty conditions and any documentation provided by a builder or past owner. Consult the company who installed the barrier to confirm whether the system is still under warranty.

Most chemical termite management systems expire and require replenishment and all physical systems are primarily designed to prevent concealed entry.
