# Building and Timber Pest Inspection Report

Inspection Date: Thu, 12 Mar 2026

Property Address: 35 Union St, Maclean NSW 2463, Australia

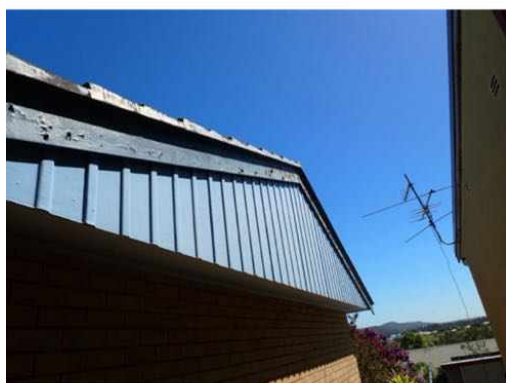
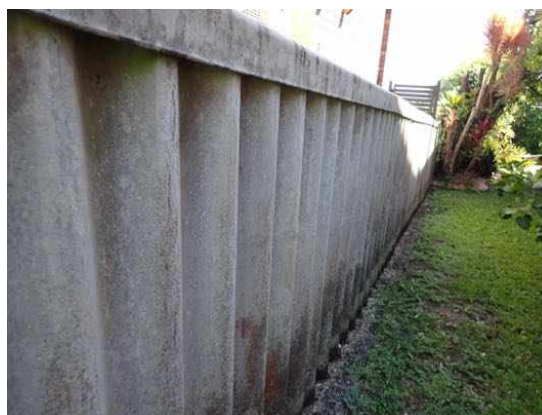
#### Finding 1.01

Building:	Main Building
Location:	Roof gable ends and fence
Finding:	Roof Gable End Cladding and Fence Suspected to Contain Asbestos
Information:	The cladding material to the roof gable ends and sections of the fencing are suspected to contain asbestos. Materials of this type were commonly used in older buildings and fencing products and may pose a health risk if damaged, disturbed, or deteriorating. If works are required to these areas, the materials should be treated as asbestos-containing until confirmed otherwise. Further assessment and any required removal or disturbance of the material should be carried out by a licensed asbestos contractor in accordance with relevant safety regulations.

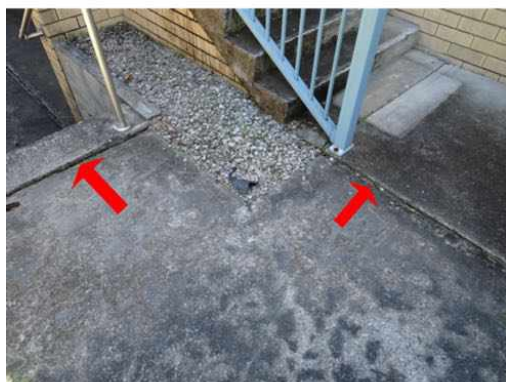
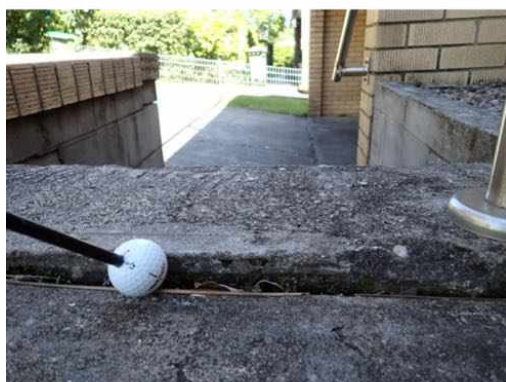
#### Finding 1.02

Building:	Main Building
Location:	Path at front of building
Finding:	Steps in Concrete Path at Front of Building
Information:	Steps were identified in the concrete path at the front of the building. Variations in the level of concrete paths can occur due to minor ground movement, settlement of the supporting ground, or ageing of the concrete over time and this is a common defect in external concrete paths. The uneven surface presents a trip hazard. Preventative measures include monitoring the area for any further movement. Repairs, if considered necessary, should be carried out by a suitably qualified concreter or suitably qualified handyman.

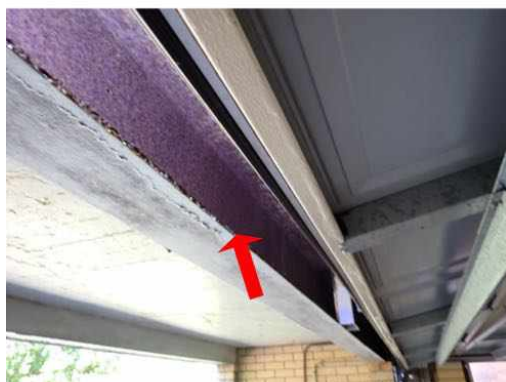
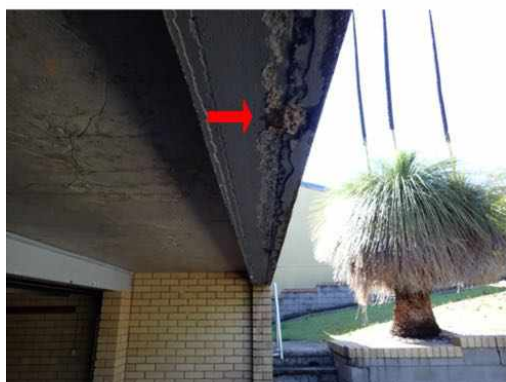
### Finding 2.01

Building:	Main Building
Location:	Garage
Finding:	Surface Rust Identified to Steel Beams at Garage Door and Front Porch
Information:	Surface rust was identified to the steel beam above the garage door and to the steel beam encased in concrete at the front of the front porch. Surface corrosion to exposed steel elements is commonly caused by moisture exposure and deterioration of protective coatings over time. If left unaddressed, the rust may continue to develop and lead to further deterioration of the steel. Preventative measures include removing the rust, treating the affected areas, and applying a suitable protective coating to help prevent further corrosion. Rectification works should be carried out by a suitably qualified handyman or relevant contractor.

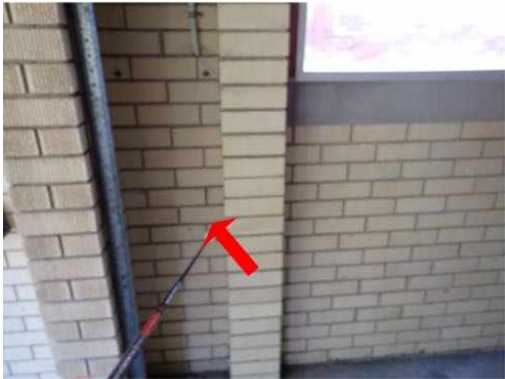
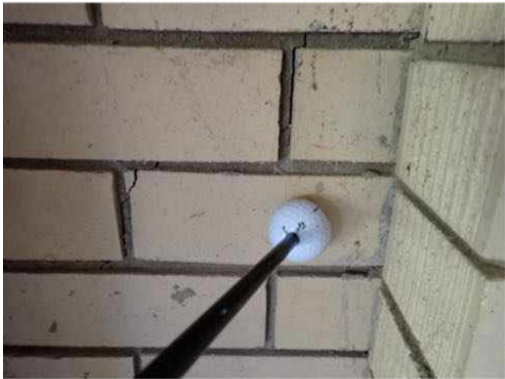
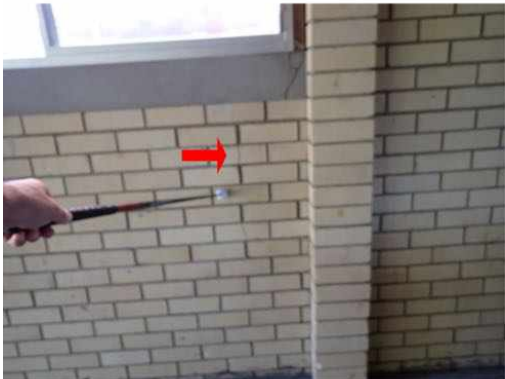
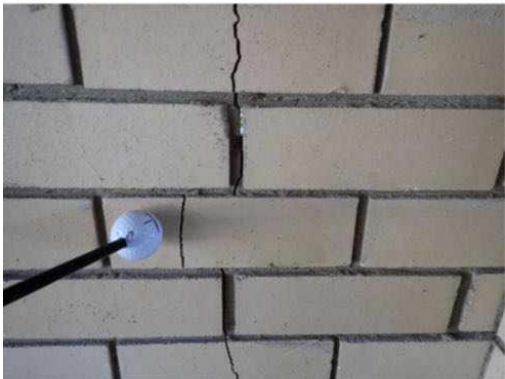
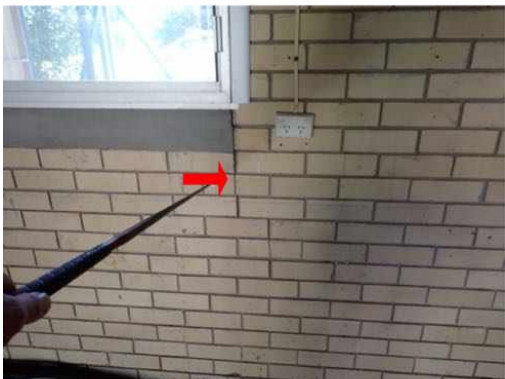
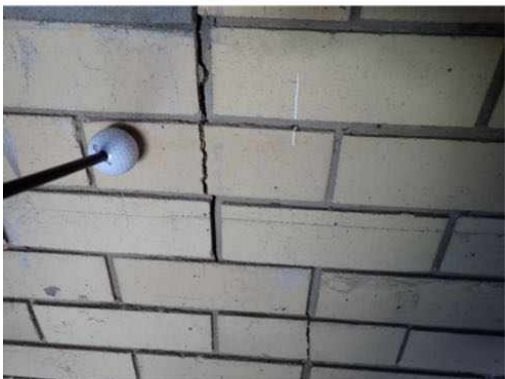
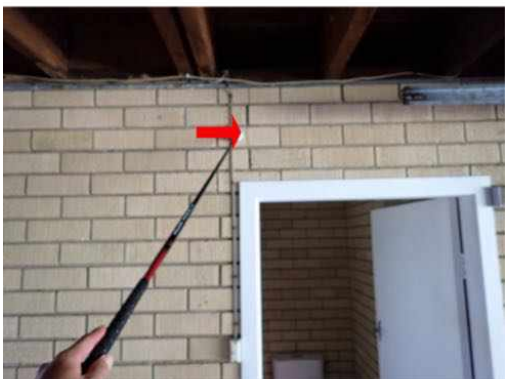
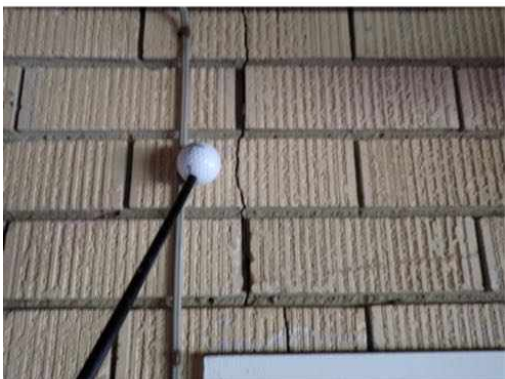
## Finding 2.02

Building:	Main Building
Location:	Garage
Finding:	Minor Cracks Identified in Garage Brickwork
Information:	<p>Minor cracking was identified in the internal brickwork to the garage. Cracking of this nature can occur due to normal building movement, minor settlement, or ageing of mortar joints and is commonly observed in brickwork. If the cracks worsen over time, further assessment may be required to determine if structural movement is occurring. Preventative measures include maintaining mortar joints and monitoring the cracks for any signs of further movement. If significant movement is observed, consultation with a structural engineer is recommended. Repairs, if considered necessary, should be carried out by a suitably qualified bricklayer or suitably qualified handyman.</p>

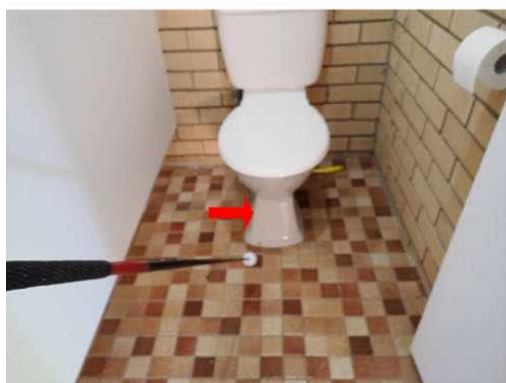
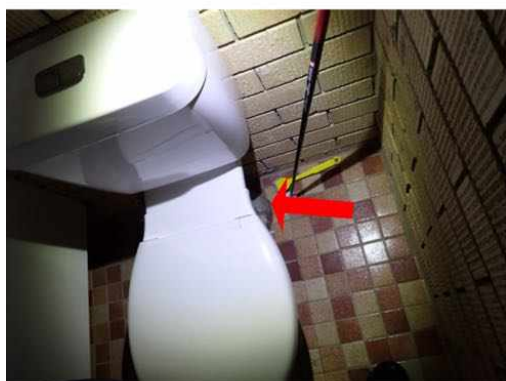
Finding 2.03

Building:	Main Building
Location:	Toilet (WC)
Finding:	Cracked Toilet Suite and Minor Leak at Sewer Connection
Information:	A crack was identified in the toilet suite, and a minor leak was observed where the toilet suite connects to the sewer plumbing. Cracks in toilet suites can allow water leakage and may worsen over time. If left unaddressed, continued leakage may cause water damage to surrounding materials and create unsanitary conditions. Preventative measures include ensuring plumbing fixtures remain in good condition and watertight. Repair or replacement of the toilet suite and sealing of the connection should be carried out by a licensed plumber.

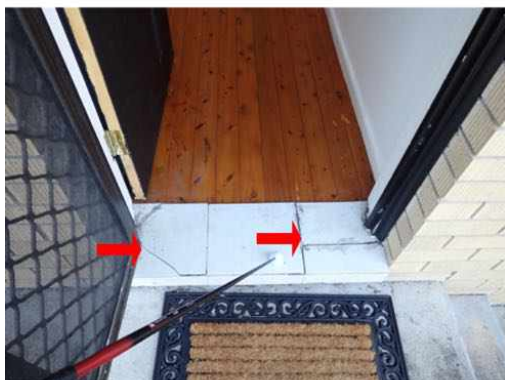
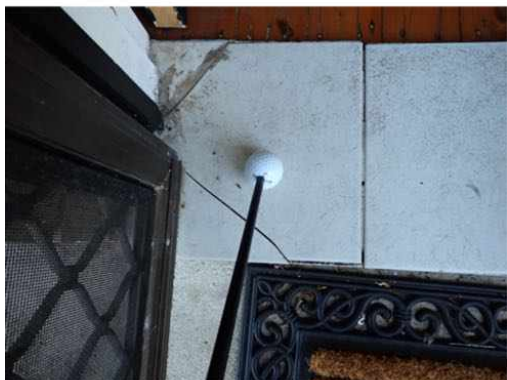
Finding: Cracked Sill Tiles to Front Door

Information: Cracked tiles were identified to the sill at the front door. Tile cracking can occur due to minor movement of the building structure, poor installation, impact, or age-related wear to the tiled surface and underlying substrate. If left unaddressed, the cracks may worsen and allow moisture to penetrate to the underlying materials. Preventative measures include maintaining the tiled surfaces and ensuring the underlying substrate remains stable. Repairs or replacement of the affected tiles should be carried out by a qualified tiler or suitably qualified handyman.

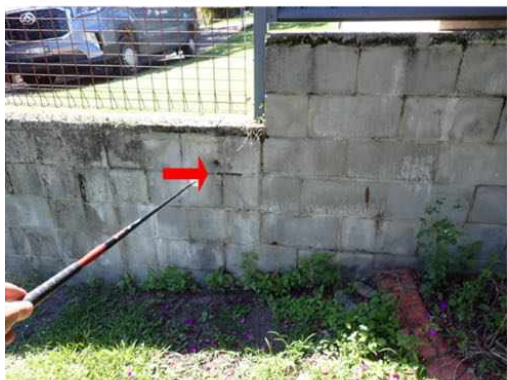
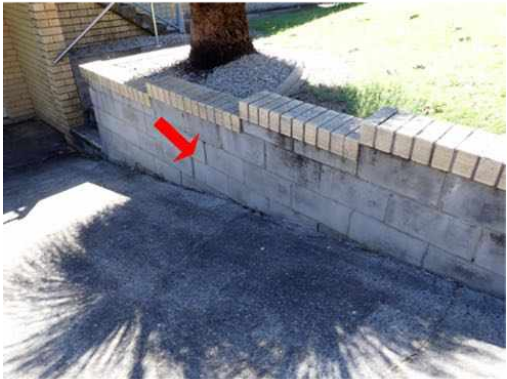
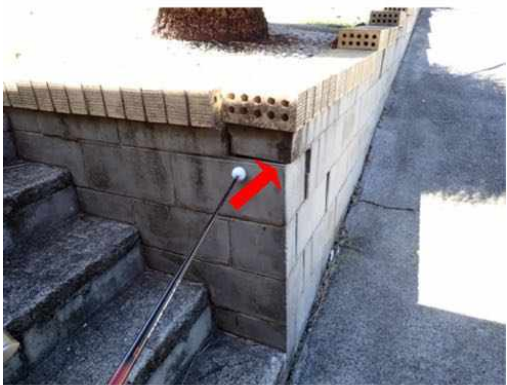
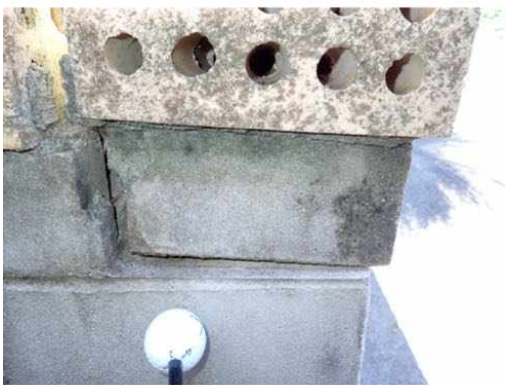
### Finding 2.06

Building:	Yard
Location:	Block work retaining walls
Finding:	Major and Minor Cracks Identified to Blockwork Retaining Walls
Information:	Major and minor cracks were identified in the blockwork retaining walls. Cracking of this nature can occur due to ground movement, soil pressure behind the wall, or settlement over time. If left unaddressed, the cracking may worsen and could affect the structural performance of the retaining walls. Preventative measures include monitoring the cracks for any signs of further movement or deterioration. Further assessment by a structural engineer is recommended to determine the extent of the issue and any required remedial works. Repairs should be carried out by a suitably qualified contractor in accordance with the engineer's recommendations.

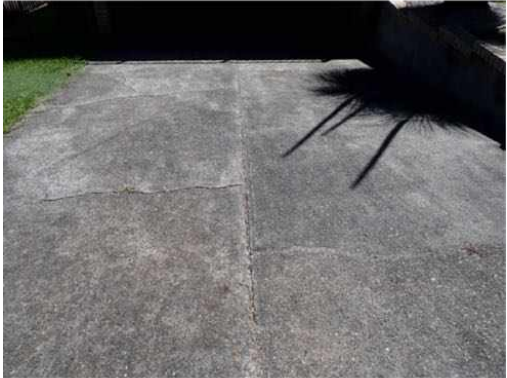
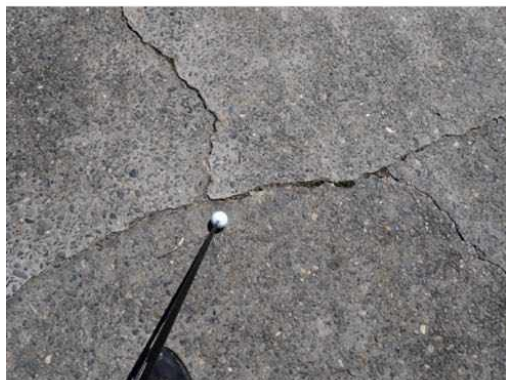
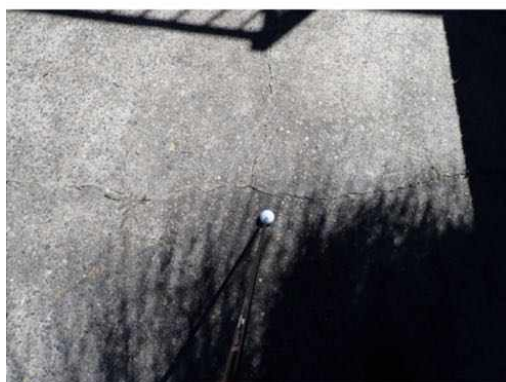
**Finding 2.07**

Building: Yard  
Location: Driveway  
Finding: Major and Minor Cracks Identified to Concrete Driveway  
Information: Major and minor cracks were identified in the concrete driveway. Cracking of this nature can occur due to ground movement, settlement of the supporting ground, or deterioration of the concrete over time. If left unaddressed, the cracks may gradually worsen and lead to further deterioration of the driveway surface. Preventative measures include monitoring the cracks for any signs of further movement. Repairs should be carried out by a suitably qualified concreter or suitably qualified handyman.

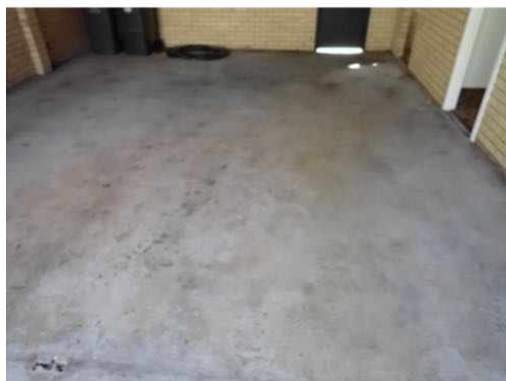
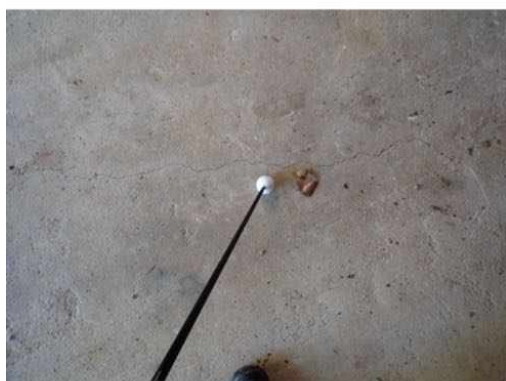
Building: Main Building  
Location: Garage  
Finding: Minor Cracks Identified in Garage Concrete Slab  
Information: Minor cracks were identified in the garage concrete slab. Cracking of this nature can occur in concrete due to natural shrinkage during curing, minor ground movement, or normal settlement of the supporting ground and is commonly observed in concrete slabs. Preventative measures include maintaining stable ground conditions and

monitoring the cracks for any signs of further movement or widening. If significant movement is observed, consultation with a structural engineer may be required. Repairs, if considered necessary, should be carried out by a suitably qualified concreter or suitably qualified handyman.

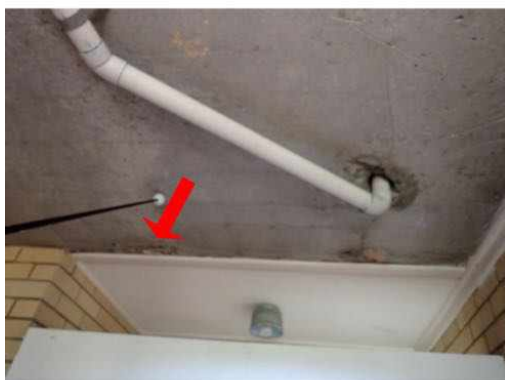
### Finding 3.02

Building:	Main Building
Location:	Laundry
Finding:	Minor Concrete Spalling Identified to Laundry Ceiling
Information:	Minor concrete spalling was identified to the laundry ceiling. Spalling occurs when small sections of concrete surface break away, often due to moisture exposure, corrosion of embedded reinforcement, or general ageing of the material. If left unaddressed, the affected area may continue to deteriorate over time. Preventative measures include identifying and addressing any sources of moisture and maintaining the surrounding structure. Repairs, if considered necessary, should be carried out by a suitably qualified concreter or suitably qualified handyman.

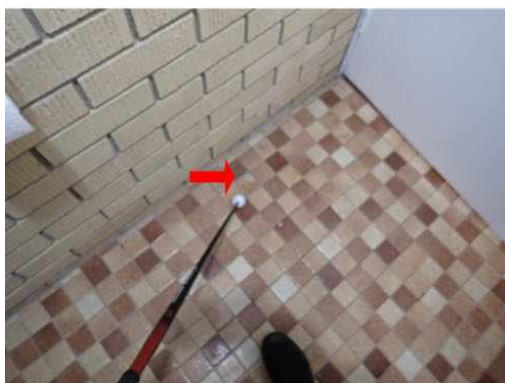
### Finding 3.03

Building:	Main Building
Location:	Toilet (WC)
Finding:	Damaged Tile to Toilet Area
Information:	A damaged tile was identified in the toilet area. Damage to tiles can occur from impact, general wear, or movement of the underlying substrate. If left unaddressed, the damage may worsen and allow moisture to penetrate through the tile surface and affect the underlying materials. Preventative measures include maintaining tiled surfaces and ensuring damaged tiles are repaired promptly. Repair or replacement of the affected tile should be carried out by a qualified tiler or suitably qualified handyman.

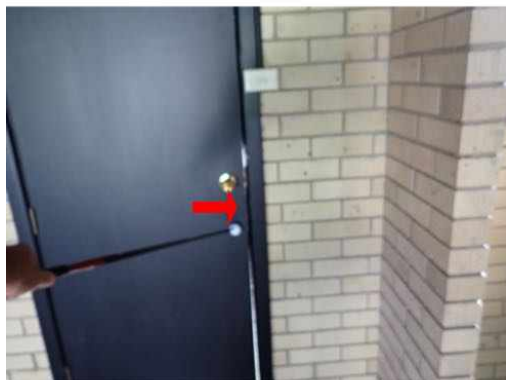
### Finding 3.04

Building:	Main Building
Location:	Garage
Finding:	Garage Entry Door Catching on Door Jamb
Information:	The garage entry door was observed catching on the door jamb during normal operation. This condition can occur due to minor building movement, door misalignment, swelling of the door, or wear to the door hardware. If left unaddressed, the issue may worsen and lead to damage to the door, door frame, or associated hardware. Preventative measures include maintaining door hardware and ensuring the

door and frame remain properly aligned. Adjustment, repair, or trimming of the door should be carried out by a qualified carpenter or suitably qualified handyman.

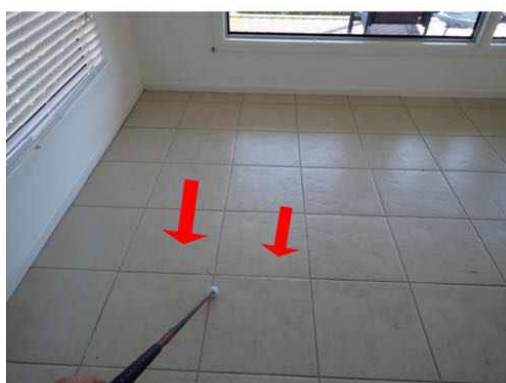
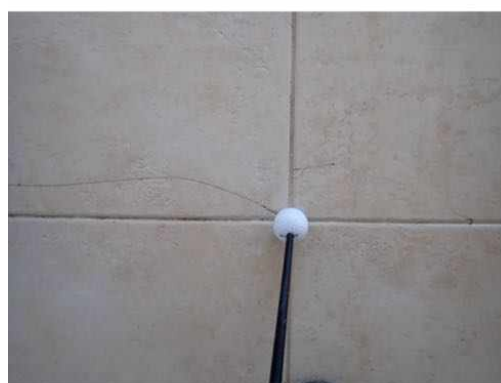
### Finding 3.05

Building:	Main Building
Location:	Living room
Finding:	Cracked Tiles to Living Room
Information:	Cracked tiles were identified to the living room floor. Tile cracking can occur due to minor movement of the building structure, poor installation, impact, or age-related wear to the tiled surface and underlying substrate. If left unaddressed, the cracks may worsen and allow further deterioration of the tiles and underlying materials. Preventative measures include maintaining the tiled surfaces and ensuring the underlying substrate remains stable. Repairs or replacement of the affected tiles should be carried out by a qualified tiler or suitably qualified handyman.

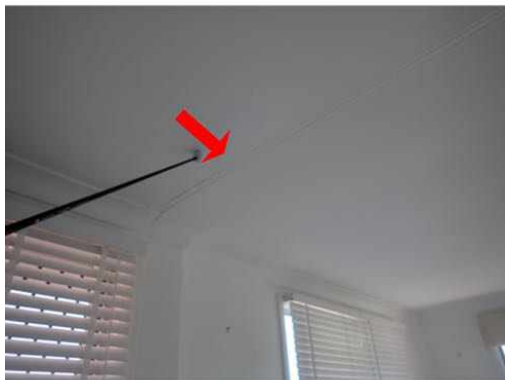
### Finding 3.06

Building:	Main Building
Location:	Living room
Finding:	Minor Cracks in Living Room Ceiling Plaster
Information:	Minor cracks were identified in the ceiling plaster within the living room. Cracking of this nature can occur due to normal building movement, settlement, or ageing of the

plaster materials and is commonly observed in plaster surfaces over time. If left unaddressed, the cracks may gradually widen and affect the cosmetic appearance of the ceiling. Preventative measures include maintaining stable building conditions and monitoring the cracks for any signs of further movement. Repairs, if considered necessary, should be carried out by a qualified plasterer or suitably qualified handyman.

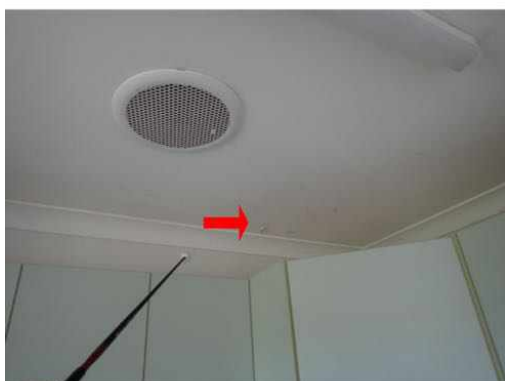
### Finding 3.07

Building: Main Building  
Location: Kitchen  
Finding: Deteriorated Paintwork to Kitchen Ceiling  
Information: Deteriorated paintwork was identified to the kitchen ceiling. Paint deterioration can occur due to age, moisture exposure, steam from cooking activities, or general wear over time. If left unaddressed, the condition may continue to deteriorate and affect the overall finish of the ceiling surface. Preventative measures include maintaining adequate ventilation within the kitchen area and ensuring ceiling surfaces are properly sealed and maintained. Repainting of the affected area should be carried out by a qualified painter or suitably qualified handyman.

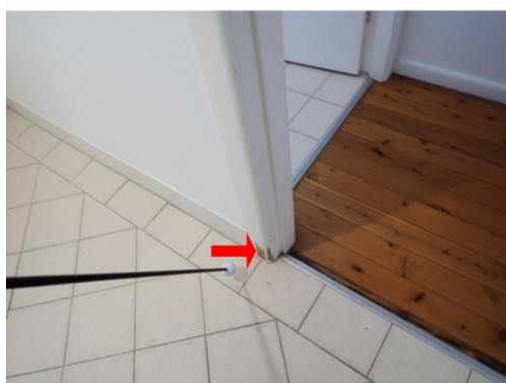
### Finding 3.08

Building: Main Building

Location:	Bathroom
Finding:	Impact-Related Damage to Bathroom Architrave
Information:	Impact-related damage was identified to the bathroom door architrave. Damage of this nature can occur from accidental impact or general wear over time. If left unaddressed, the damage may worsen and affect the condition and appearance of the timber trim. Repair or replacement of the affected architrave should be carried out by a qualified carpenter or suitably qualified handyman.

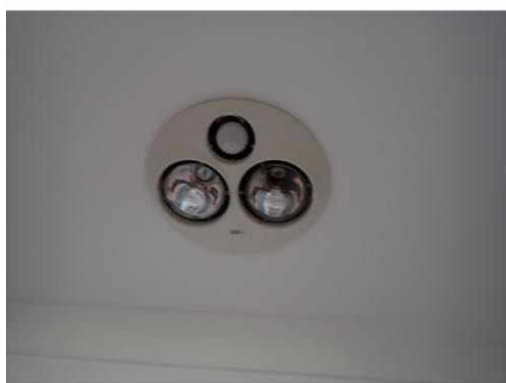
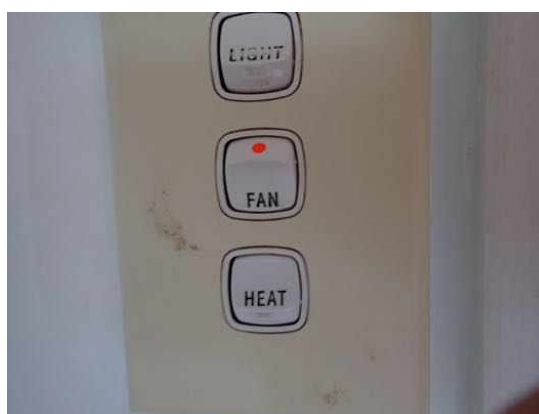
### Finding 3.09

Building:	Main Building
Location:	Bathroom
Finding:	Bathroom Exhaust Fan Not Operating
Information:	The bathroom exhaust fan was not operating at the time of inspection. Non-operational exhaust fans can lead to poor ventilation and increased moisture levels within the bathroom, which may contribute to deterioration of surrounding building materials and finishes. Preventative measures include ensuring bathroom ventilation systems are properly maintained and operational. Inspection and repair or replacement of the exhaust fan should be carried out by a licensed electrician.

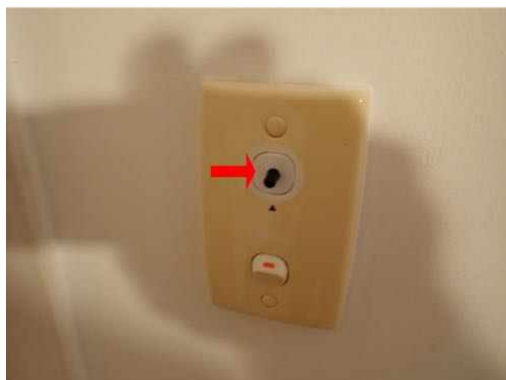
### Finding 3.10

Building:	Main Building
-----------	---------------

Location:	Bedroom
Finding:	Broken Bedroom Ceiling Fan Control Knob
Information:	The control knob to the bedroom ceiling fan was found to be broken at the time of inspection. Damaged control components can affect the normal operation of the fan and may lead to further wear of the internal mechanism if used in this condition. Preventative measures include maintaining fan controls and associated hardware in good working order. Repair or replacement of the control knob or fan unit should be carried out by a licensed electrician.

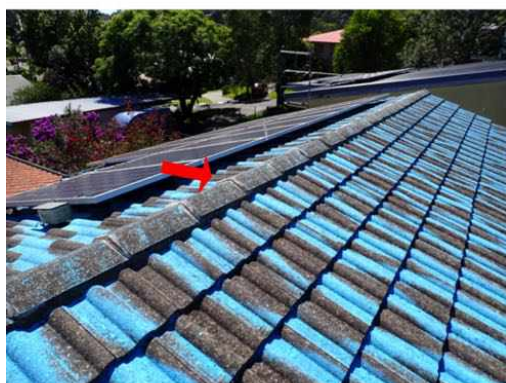
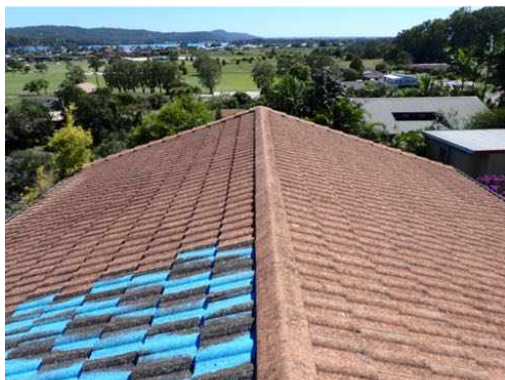
### Finding 3.11

Building:	Main Building
Location:	Roof exterior
Finding:	Roof Tiles in Fair Condition
Information:	The roof tiles were found to be in fair condition overall, with minor age-related cracking to the ridge capping pointing and general weathering of the tiles observed. These conditions are common with tiled roofs over time due to prolonged exposure to the elements. Preventative measures include routine roof inspections and maintenance to ensure tiles and ridge capping remain in serviceable condition. Repairs, if considered necessary, should be carried out by a licensed roofing contractor.

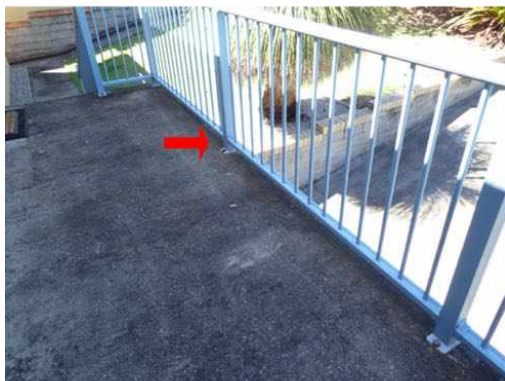
### Finding 3.12

Building:	Main Building
Location:	Front porch handrail
Finding:	Front Porch Handrail Post Fixings Rusted
Information:	Rust was identified to the fixings at the base of the front porch handrail posts. Corrosion of metal fixings can occur over time due to weather exposure and deterioration of protective coatings. If left unaddressed, the rust may continue to develop and affect the integrity of the fixings. Preventative measures include maintaining protective coatings and ensuring external metal fixings are regularly inspected and maintained. Repair or replacement of the affected fixings should be carried out by a suitably qualified handyman or relevant contractor.

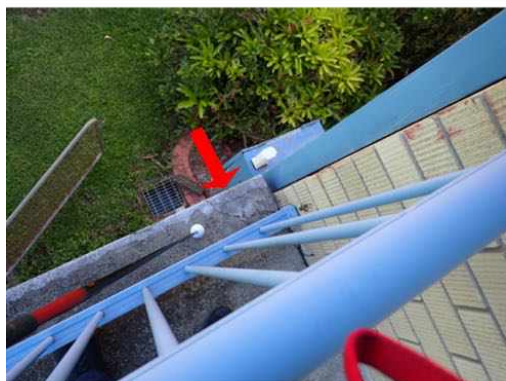
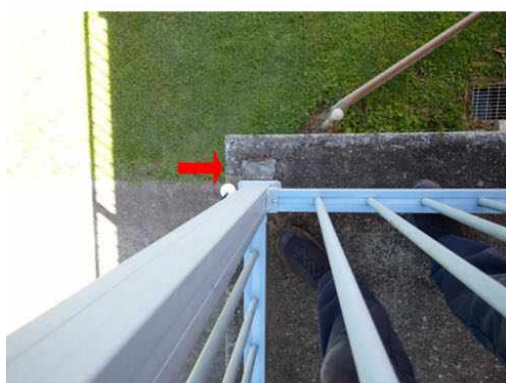
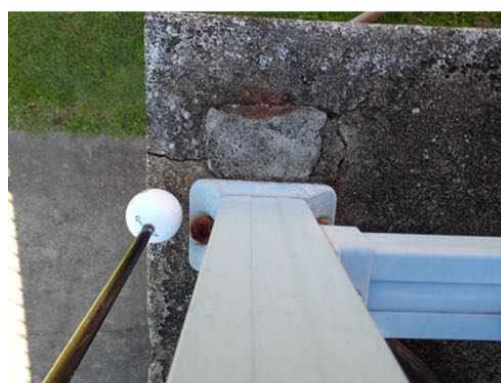
### Finding 3.13

Building:	Main Building
Location:	Front porch
Finding:	Minor Cracks Identified to Front Porch Suspended Concrete Slab at Left-Hand Cornes
Information:	Minor cracks were identified to the suspended concrete slab of the front porch at the left-hand corners. Cracking of this nature can occur due to normal building movement, minor settlement, or shrinkage of the concrete over time and is commonly observed in concrete structures. If left unaddressed, the cracks may allow moisture penetration and gradual deterioration of the concrete surface. Preventative measures include

monitoring the cracks for any signs of further movement. Repairs, if considered necessary, should be carried out by a suitably qualified concreter or suitably qualified handyman, and consultation with a structural engineer may be considered if the cracks worsen over time.

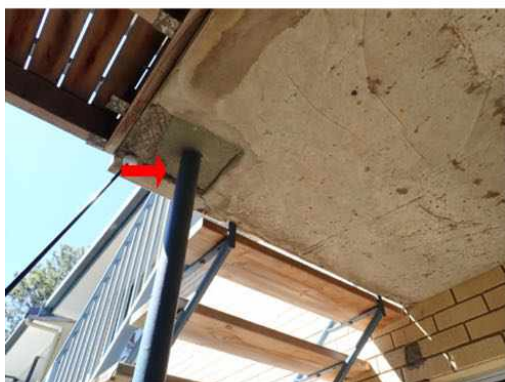
### Finding 3.14

Building:	Main Building
Location:	Rear of building
Finding:	Surface Rust Identified to Top Plates of Deck Support Steel Posts
Information:	Surface rust was identified to the top plates of the steel posts supporting the deck above. Corrosion of exposed steel elements can occur over time due to weather exposure and deterioration of protective coatings. If left unaddressed, the rust may continue to develop and lead to further deterioration of the steel components. Preventative measures include removing surface rust and applying a suitable protective coating to help prevent further corrosion. Rectification works should be carried out by a suitably qualified handyman or relevant contractor.

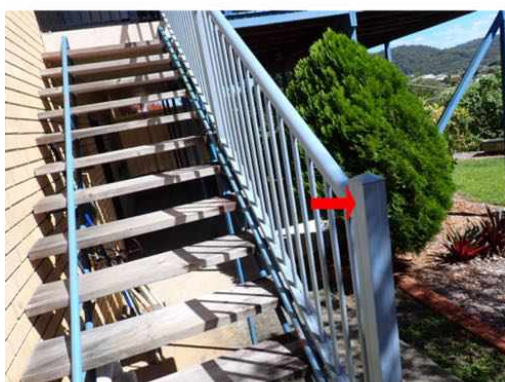
### Finding 3.15

Building:	Main Building
Location:	Rear of building
Finding:	Loose Handrail Post to Rear Staircase
Information:	The handrail post to the rear staircase was found to be loose at the time of inspection. Loose handrail posts can occur due to deterioration of fixings, or general wear over time. If left unaddressed, the condition may worsen and affect the stability of the handrail. Preventative measures include maintaining fixings and ensuring handrail components remain securely fastened. Re-fixing or repair of the handrail post should be carried out by a qualified carpenter or suitably qualified handyman.

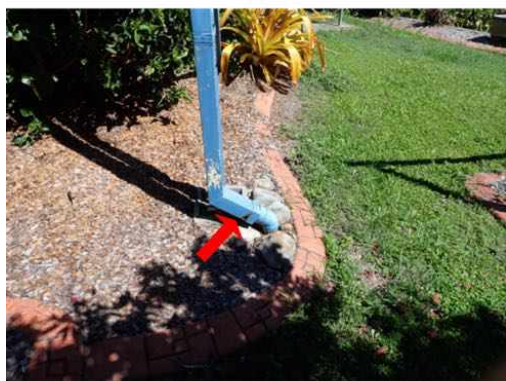
### Finding 3.16

Building:	Main Building
Location:	Rear yard
Finding:	Rust Identified to Bottom of Rear Deck Downpipe
Information:	Rust was identified to the bottom section of the rear deck downpipe. Corrosion of metal downpipes can occur over time due to prolonged exposure to moisture and weather conditions. If left unaddressed, the rust may worsen and lead to deterioration of the downpipe and potential water discharge issues. Preventative measures include maintaining protective coatings and ensuring downpipes are regularly inspected and maintained. Repair or replacement of the affected section should be carried out by a

licensed plumber or suitably qualified contractor.

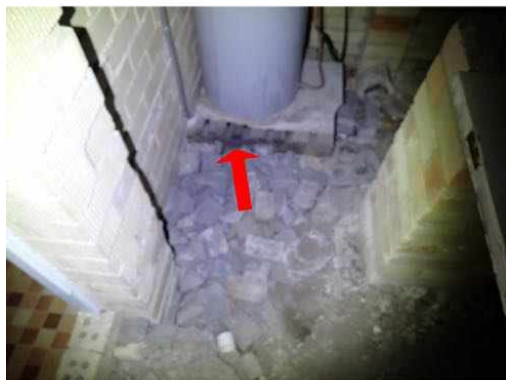
### Finding 6.01

Building:	Main Building
Location:	Subfloor
Finding:	Timber Pellet Used as Base for Hot Water Unit in Subfloor – Conducive to Termite Attack
Information:	A timber pellet was identified being used as a base for the hot water unit within the subfloor area. Timber materials in subfloor areas, particularly when in contact with or close to the ground, are considered conditions conducive to termite attack and timber decay. If left in place, the timber may attract termite activity and increase the risk of timber pest infestation within the structure. Preventative measures include removing timber materials from the subfloor area and replacing them with suitable non-timber supports. Rectification should be carried out by a suitably qualified handyman or relevant contractor.

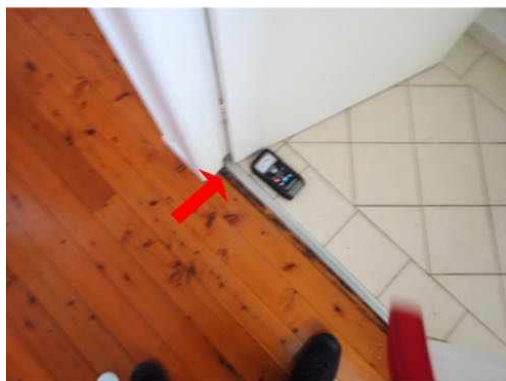
### Finding 7.01

Building:	Main Building
Location:	Bathroom
Finding:	Minor Wood Rot Identified to Flooring at Bathroom Door Entry
Information:	Minor wood rot was identified to the flooring at the door entry to the bathroom. No elevated moisture readings were identified in this area at the time of inspection. Wood rot of this nature is typically associated with past moisture exposure or long-term wear to the flooring materials. If left unaddressed, the affected timber may continue to deteriorate over time. Repairs or replacement of the affected flooring section should be carried out by a qualified carpenter or suitably qualified handyman.

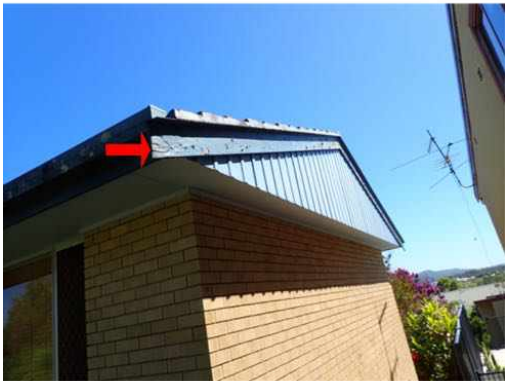
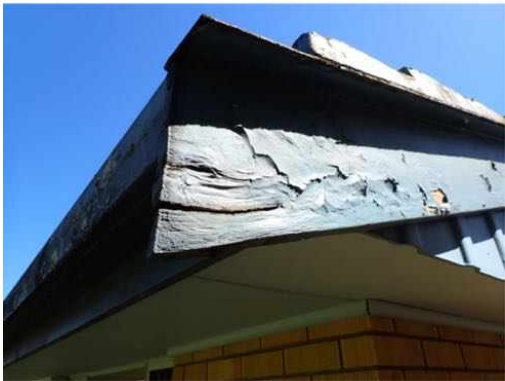
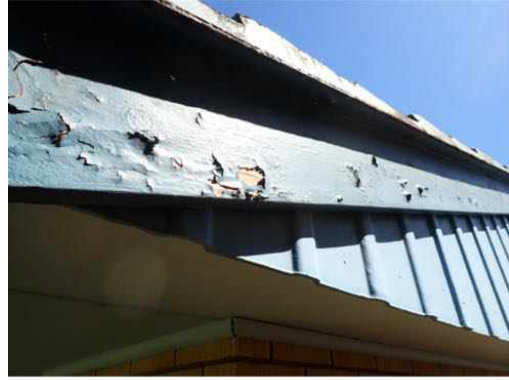
**Finding 7.02**

Building: Main Building  
Location: Fascia boards  
Finding: Minor wood Rot Identified to Ends of Fascia Boards and Flaking Paint  
Information: Minor wood rot was identified to the ends of the fascia boards along with areas of flaking and deteriorated paint. Deterioration of this nature is commonly associated with prolonged weather exposure and breakdown of protective paint coatings over time. If left unaddressed, the timber may continue to deteriorate and allow moisture penetration to surrounding building materials. Preventative measures include maintaining protective paint coatings and ensuring exposed timber elements are regularly inspected and maintained. Repairs or replacement of the affected sections and repainting should be carried out by a qualified carpenter or suitably qualified handyman.

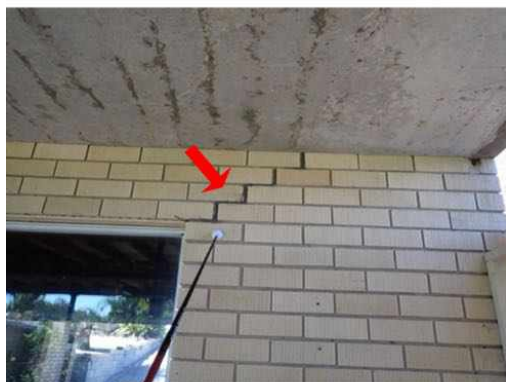
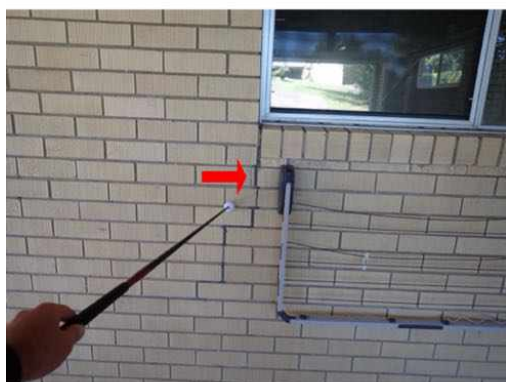
Building: Main Building  
Location: Garage  
Finding: Repaired Concrete Cracks Identified at Rear of Garage Wall  
Information: Previously repaired concrete cracks were identified at the rear of the garage wall. The real estate agent advised that a structural engineer's report has been obtained in relation to these cracks. Cracking of this nature can occur due to building movement, ground movement, or settlement. It is recommended that the structural engineer's report be obtained and reviewed to better understand the cause of the cracking and any recommended remedial works. Any further repairs, if required, should be carried out by a suitably qualified contractor in accordance with the engineer's recommendations.

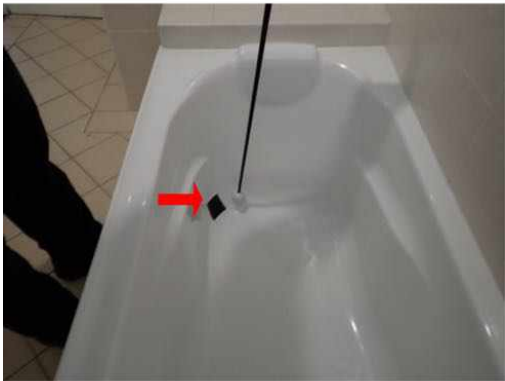
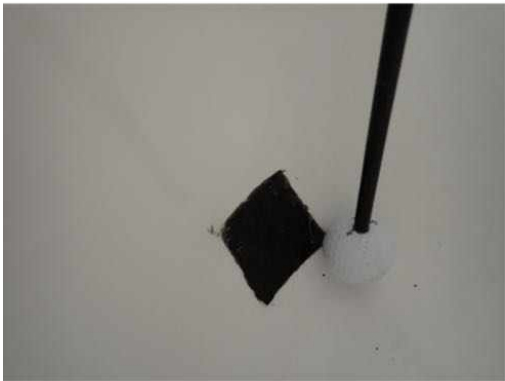
Building: Main Building  
Location: Bathroom

**Finding:** Duct Tape Applied to Bath Surface – Possible Concealed Damage  
**Information:** Duct tape was observed applied to the bath surface, possibly covering damage to the bath. The presence of tape suggests a temporary repair or an attempt to conceal cracking, holes, or deterioration to the bath surface. If damage is present and left unaddressed, water leakage or further deterioration of the bath may occur. Further inspection is recommended once the tape is removed to determine the condition of the bath. Repair or replacement of the bath, if required, should be carried out by a licensed plumber or suitably qualified contractor.

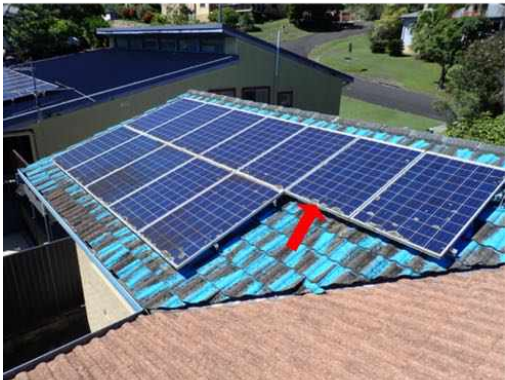
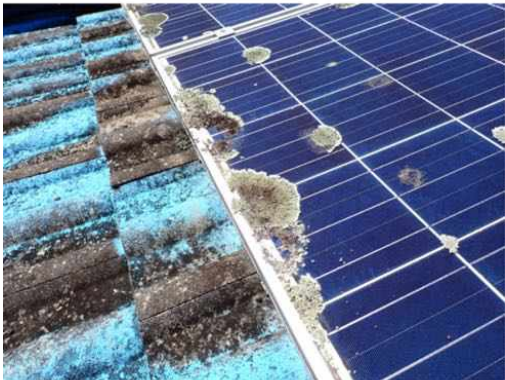
**Building:** Main Building  
**Location:** Roof exterior  
**Finding:** Lichen Identified on Solar Panels  
**Information:** Lichen growth was identified on the surface of the solar panels. Organic growth of this nature can occur over time due to exposure to moisture and environmental conditions. If left unaddressed, the buildup may reduce the efficiency of the panels by limiting sunlight exposure. Preventative measures include periodic cleaning and maintenance of the solar panels. Cleaning of the panels should be carried out by a suitably qualified contractor experienced in solar panel maintenance.

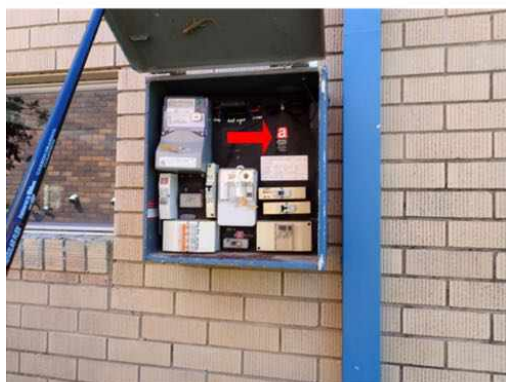
**Building:** Main Building

Location:	Left hand side of building
Finding:	Asbestos Warning Sign Identified Within Electrical Meter Box
Information:	An asbestos warning sign was identified within the electrical meter box. The presence of this sign indicates that asbestos-containing materials may be present within the building. Materials suspected to contain asbestos should not be disturbed as they may pose a health risk if fibres become airborne. If works are required in areas where asbestos-containing materials may be present, the materials should be treated as asbestos-containing until confirmed otherwise. Further assessment and any required removal should be carried out by a licensed asbestos contractor in accordance with relevant safety regulations.

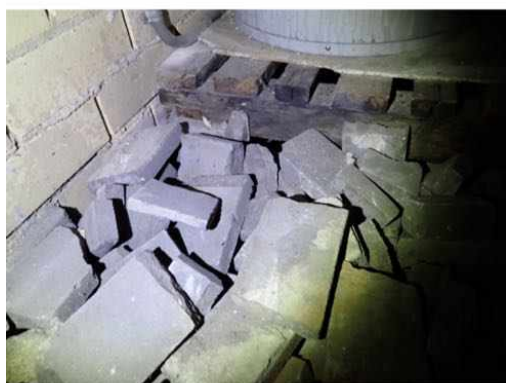
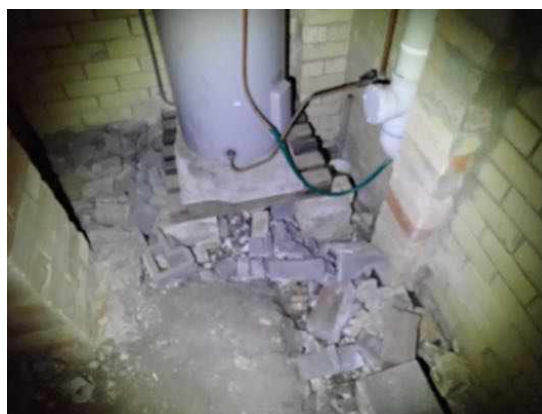
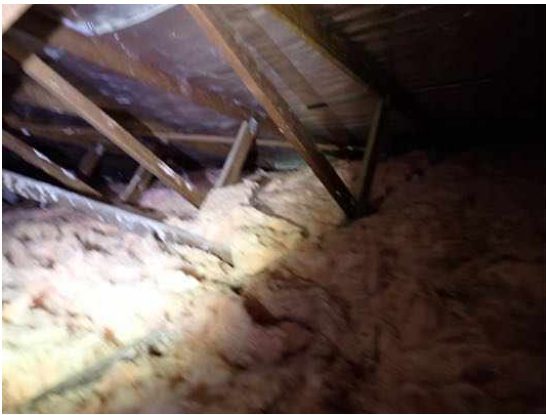
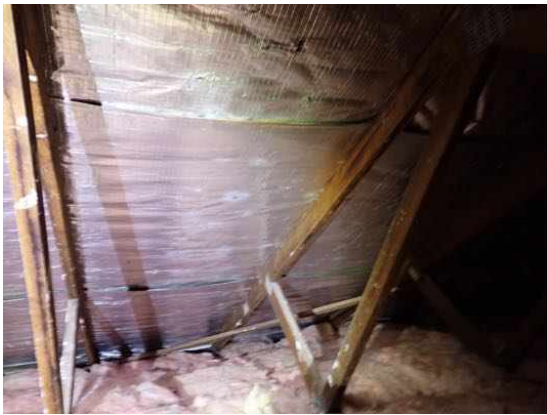
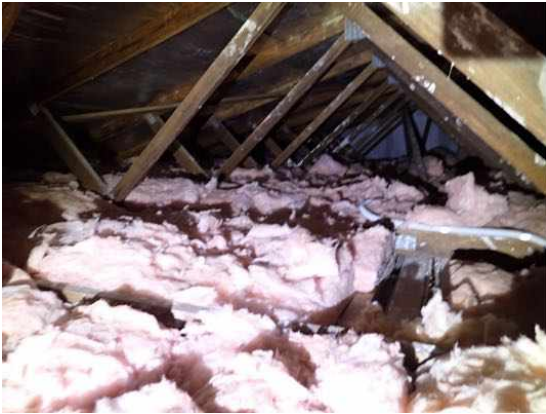
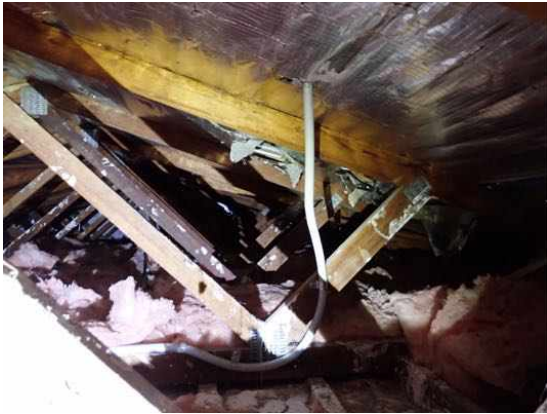
Building:	Main Building
Location:	All Areas
Finding:	Additional Photos - Obstructions and Limitations
Information:	These photographs are an indication of the obstructions and limitations which impeded full inspection of the area at the time of inspection. These obstructions can hide an array of defects and should be removed to allow full inspection to be carried out. A re-inspection is recommended once the areas are made accessible.
