Building and Timber Pest Inspection Report

Inspection Date: Fri, 6 Feb 2026

Property Address: 806/187 Kent Street, Sydney NSW 2000

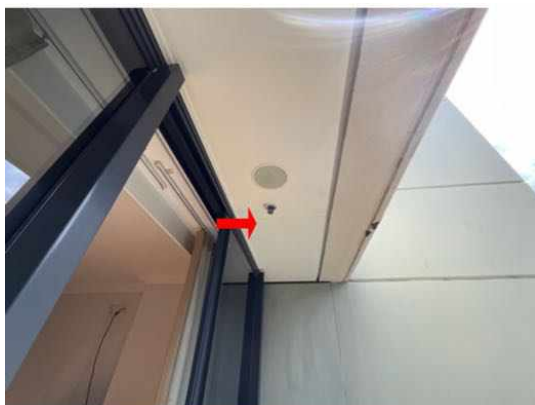
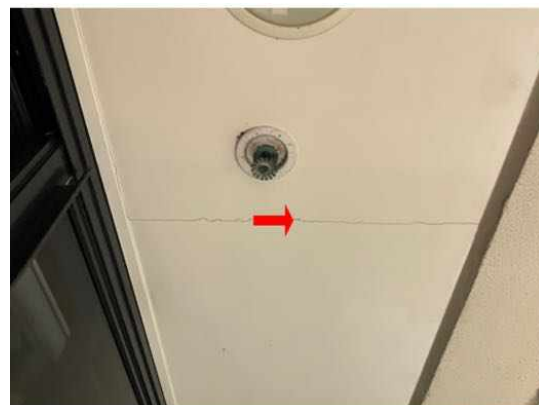
Finding 3.01

Building: Main Building
 Location: Balcony
 Finding: Cracking - Damage Category 1 - Fine (up to 1mm)
 Information: Although fine cracks are quite noticeable, they are often only considered to be an appearance defect, and usually do not indicate any structural damage. Generally, the cause of a fine crack is indicative of a separation between building materials and finishes (e.g. paint, plaster, etc.) along joins.

Cracking of this nature can generally be repaired with minor sanding, filling and/or repainting. Such works should be performed by a qualified painter or a general handyman.

Monitoring of all cracking should be conducted frequently. Always contact a building inspector should cracks widen, lengthen, or become more numerous.

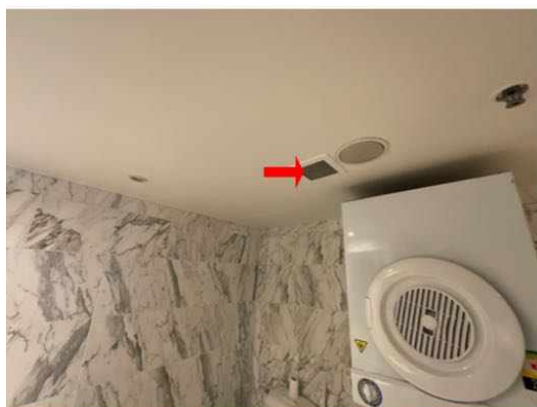
Finding 3.02

Building: Main Building
 Location: Bathroom
 Finding: Exhaust fan - Not operating

Information: The exhaust fan in this area appears to be damaged or blocked and is not operating as intended. If left unmanaged, a lack of general maintenance is likely to lead to the development of more significant defects, such as water damage to surrounding building materials from inadequate ventilation. If left unattended for a prolonged period of time, poor ventilation in this area may also be conducive to the development of mould.

Where no secondary damage has developed, the Homeowner may undertake minor cleaning of the area and consider replacement of the exhaust fan. Alternatively, consultation with a Licensed Electrician is required to check for any secondary or concealed damage and consider repair or replacement.

Please be advised that a cabinet maker or qualified carpenter may also be required if water damage has occurred and that an additional specialist mould inspection may be required if severe mould has resulted.
