Building Inspection Report

Inspection Date: Thu, 5 Feb 2026

Property Address: 3/111 Pashen St, Morningside QLD 4170,
Australia

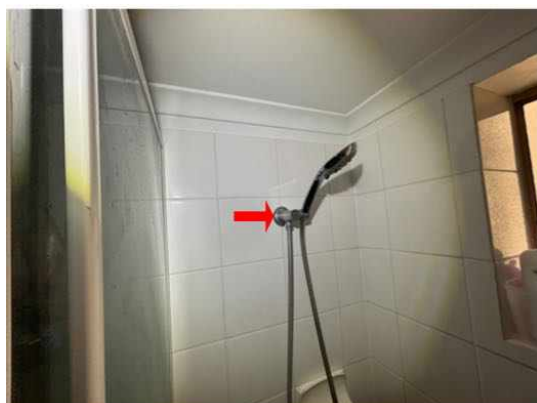
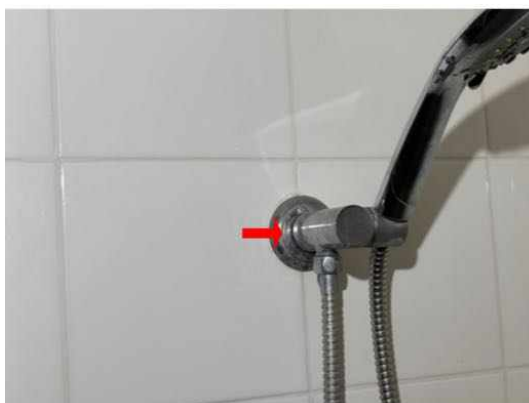
Defects 3.01

Building: Main Building
 Location: Bathroom
 Finding: Bathroom - shower outlet not secure
 Information: At the time of the inspection, it was noted that the shower outlet in the family bathroom was not secure. The outlet can be moved by hand. If left unaddressed, deterioration of the plumbing pipes in the wall cavity may occur. Sealant should be applied to the wall penetration to secure the outlet and prevent moisture from entering the wall cavity.

A building maintenance professional could be engaged to carry out this minor repair. This should be done as a short term priority.

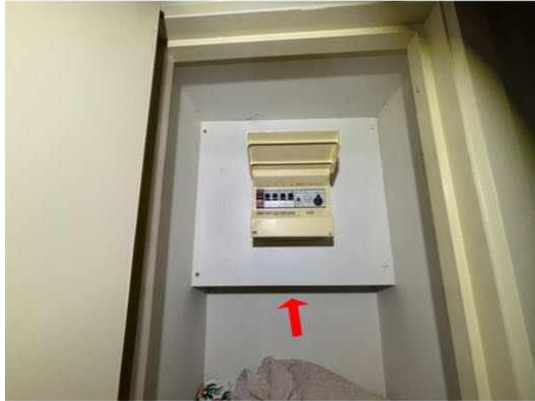
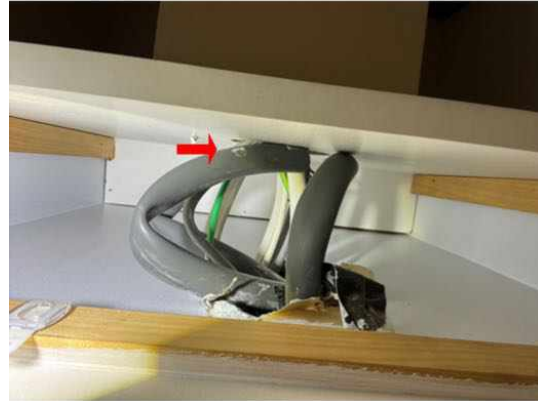
Defects 3.02

Building: Main Building
 Location: Hall cupboard
 Finding: Hallway cupboard - potential access to rear of electrical switchboard
 Information: At the time of the inspection, it was noted that there was no base to the bottom of the boxing for the electrical switchboard. The electrical cables into the rear of the switchboard can be accessed from the bottom of the timber boxing. A solid timber

base should be attached to the bottom of the boxing to eliminate this as a potential safety hazard.

A building maintenance professional or licensed carpenter should be engaged to carry out this work. This should be done as a short term priority.

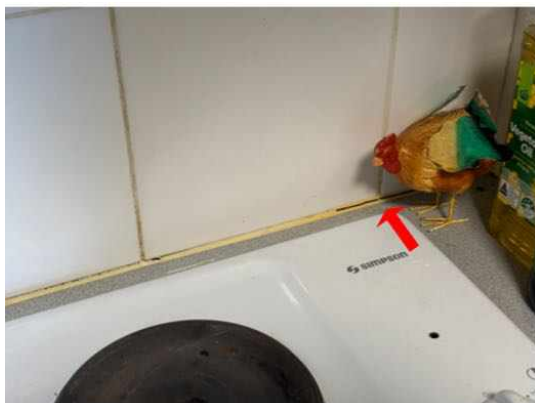
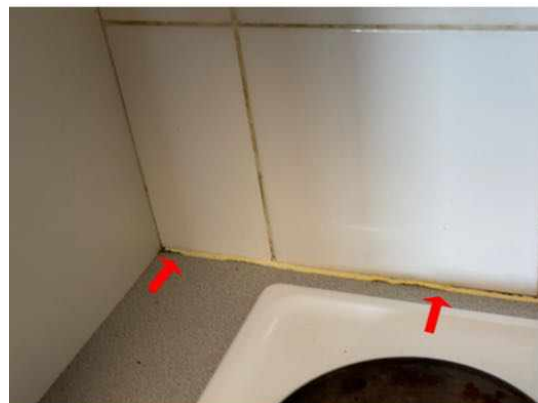
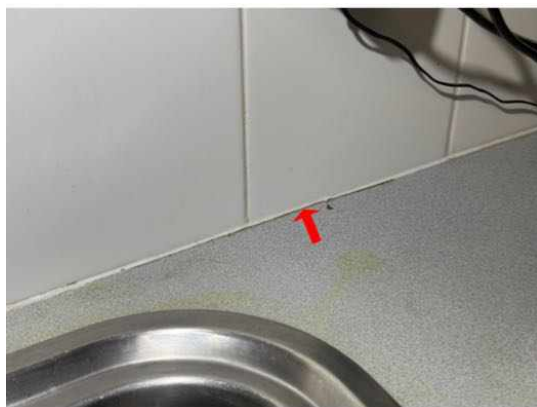
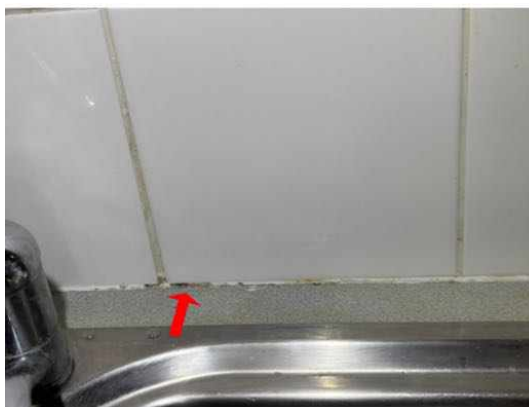
Defects 3.03

Finding: Kitchen - sealant deteriorating

Information: At the time of the inspection it was noticed that the sealant in the kitchen near the cooktop and sink was deteriorating.

Sealant is used in tiled areas to prevent moisture from entering the wall cavity, or getting behind cabinetry and causing damage to the building elements. A moist environment in the wall cavity may also be a conducive condition for termite activity.

If it is not addressed, damage to building elements will occur and would require invasive works to rectify any damage.

A building maintenance professional or sealant applicator should be appointed to replace all sealant as a matter of urgency.

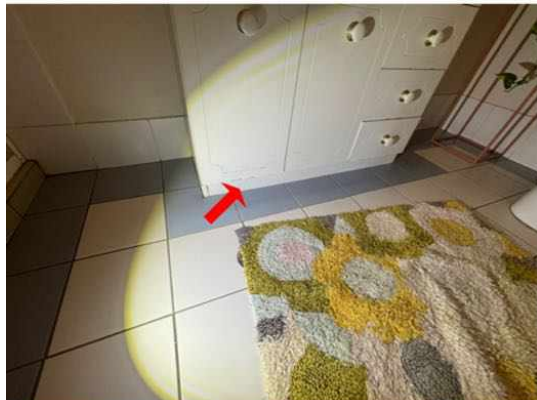
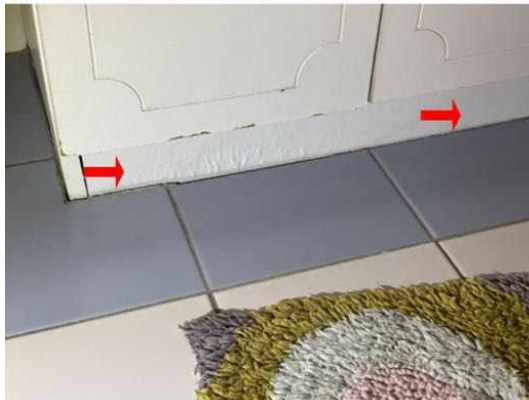
Defects 3.04

Building:	Main Building
Location:	Ensuite
Finding:	Ensuite - moisture damage to vanity base
Information:	At the time of the inspection, it was noted that there was evidence of moisture damage to the base of the vanity in the ensuite. This may due to the type of materials used, which may be more susceptible to moisture damage.

A building maintenance professional could be engaged to replace the affected materials. This can be done at the clients discretion.

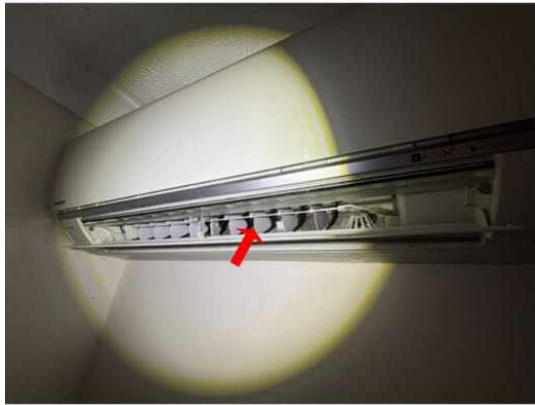
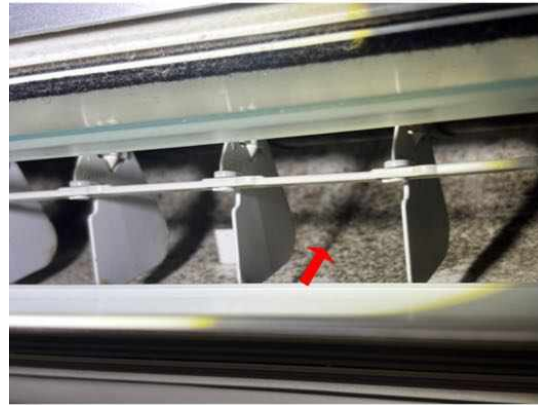
Defects 3.05

Building:	Main Building
Location:	Lounge
Finding:	Mould in air conditioning unit
Information:	At the time of the inspection, it was noted that there is mould to the wall mounted air conditioning unit in the lounge. Lack of maintenance may be a contributing factor.

The air conditioner should not be used until it is cleaned.

A specialist air conditioning cleaning company should be engaged to carry out a full

clean to the unit in the dwelling. This should be done as a matter of urgency.

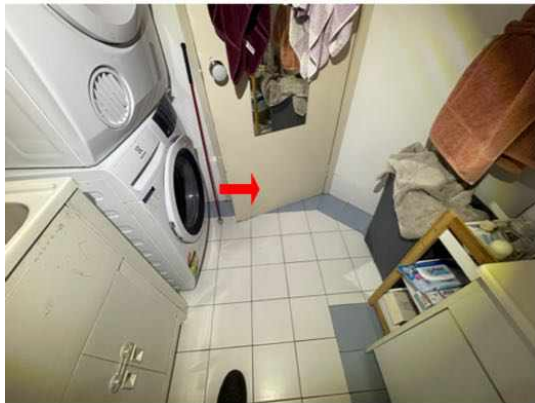
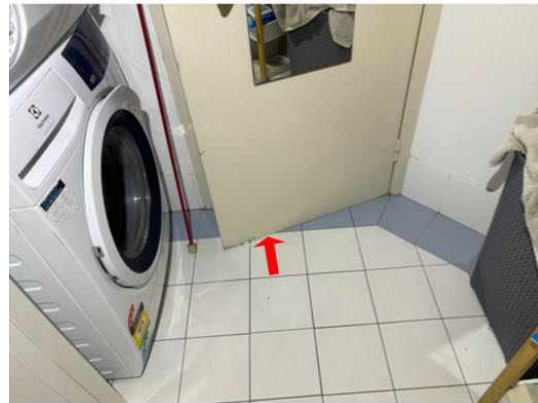
Defects 3.06

Finding: Bathroom - door binding on the floor

Information: At the time of the inspection, it was noted that the door to the family bathroom was binding on the tiled floor during normal operation. Continued use may cause premature wear to the tiles in that area. A small amount needs to be trimmed off the bottom of the door to clear the tiles.

A building maintenance professional or licensed carpenter could be engaged to carry out these works. This can be done at the clients discretion.

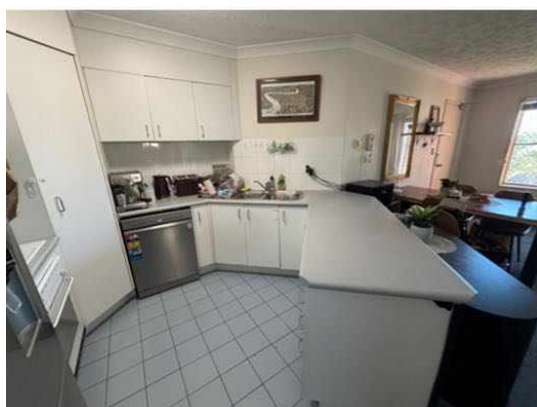
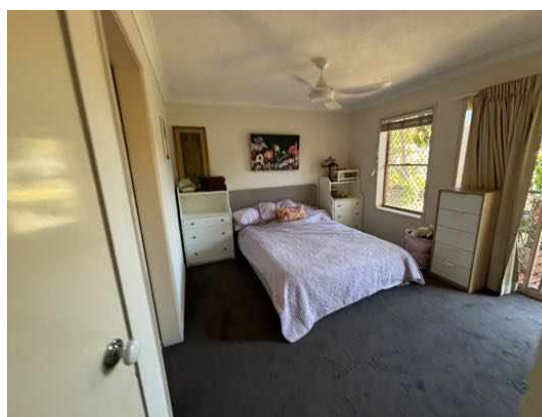
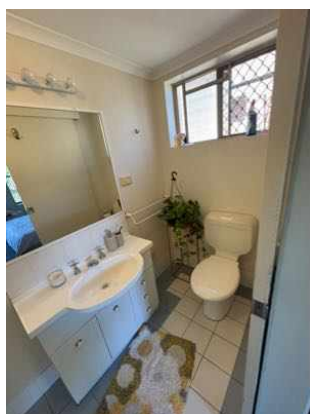
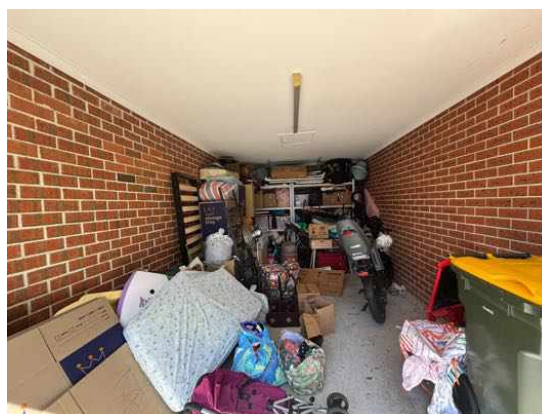
Noted Item

Building: Main Building
Location: All Internal Areas
Finding: Obstructions and Limitations - Internal areas
Information: These photographs are an indication of the obstructions and limitations which impeded full inspection of the property of the internal areas at the time of inspection. These obstructions can hide an array of defects and should be removed to allow full inspection to be carried out. A re-inspection is recommended once the areas are made accessible.
