# Building and Timber Pest Inspection Report

Inspection Date: Tue, 24 Feb 2026

Property Address: 19A Henderson Rd, Bexley NSW 2207,  
Australia

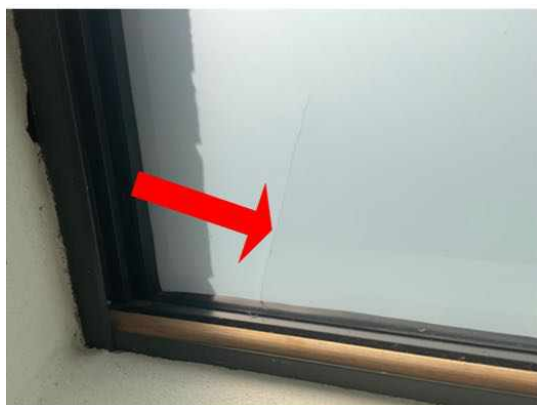
Building:	Main Building
Location:	Laundry
Finding:	Window - Cracked
Information:	Cracks were identified in the window in this area. Cracking in windows is generally the result of impact damage, and is likely to develop further when left unmanaged.

The likelihood of this windowpane further cracking and shattering is increased exponentially, providing a safety hazard in the area. The cracked window also impairs the weather tightness of the building, creating potential for minor water leaks.

A qualified glazier is required to repair the window as soon as possible. Depending on the extent of the cracking, replacement of the window may be required. Please be advised that any persons coming into contact with the cracked window should do so with due caution to avoid any personal injury that may ensue.

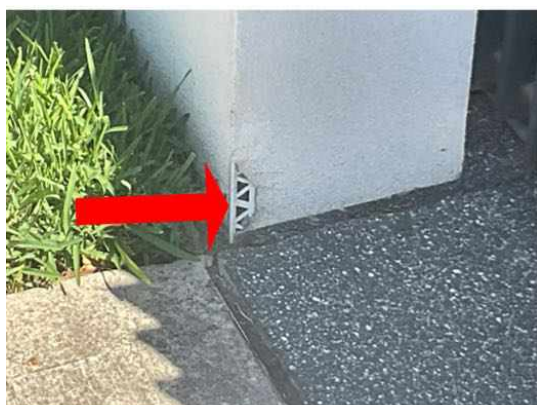
### Finding 3.02

Building:	Main Building
Location:	All External Areas
Finding:	Rendered or hard plastered surfaces - damaged
Information:	It is observed that the rendered and / or hard plastered surfaces are damaged as weather or other impacts. A qualified tradesperson should be nominated to rectify the defect for stopping the further damages

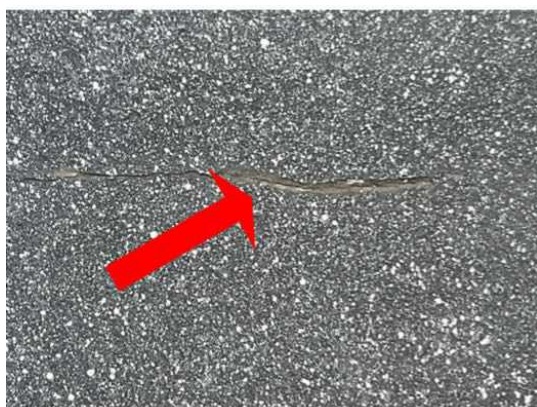
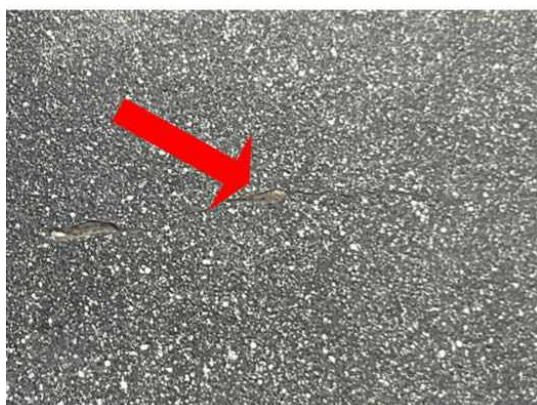
### Finding 3.04

Building:	Main Building
Location:	All External Areas
Finding:	Cracking - External Concrete Paving Damage Category 1 - Fine (less than 2mm)
Information:	Fine cracks were identified in external concrete paving. Although fine cracks are quite noticeable, they are often only considered to be an appearance defect, and usually do not indicate any structural damage. To be considered a Category 1 or fine crack, the crack is found to be less than 2mm in width.

Generally the cause of a hairline crack in existing concrete paving such as driveways and pathways is indicative of the expansion and contraction of the concrete. Such causes are generally due to environmental factors, such as moisture levels, weather conditions, root systems of nearby trees or the soil types on which they are laid.

Fine cracks may also be due to poor original installation of the concrete. Factors such as poor compaction of the sub surface and/or inadequate reinforcing of the slab may create cracking and other secondary defects.

Monitoring of all cracking should be conducted frequently. Always contact a building

inspector should cracks widen, lengthen, or become more numerous.

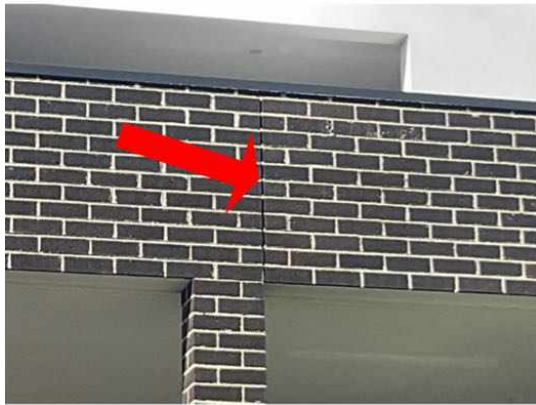
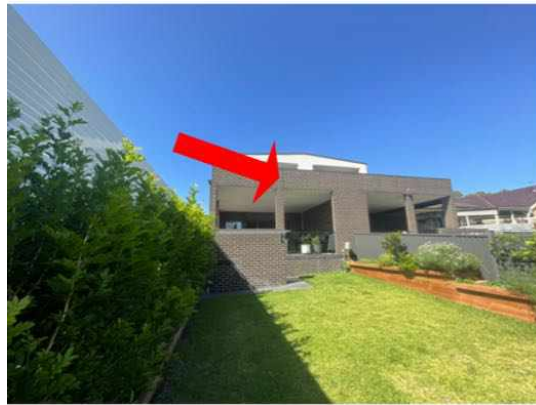
### Finding 3.05

Building:	Main Building
Location:	All External Areas
Finding:	Articulation joints - Inadequate
Information:	The articulation or control joints throughout the exterior brickwork were deemed as insufficient at the time of inspection. Mortar, a non-compressive material, is still evident in some of the joints, not allowing the joints to do their job and allow the brick walls to expand and contract as required during different weather conditions.

Articulation joints must be cleaned of all non-compressive material and then sealed with an appropriate flexible sealant. Failure to perform these necessary works is likely to lead to excessive moisture ingress into these joints, or cracking to the brick walls during extreme weather conditions, which may carry major implications for associated building elements if left unmanaged.

These preventative works are important in ensuring the structural integrity of the associated brickwork. Appointment of a qualified builder or bricklayer is advised to perform remedial works as necessary.

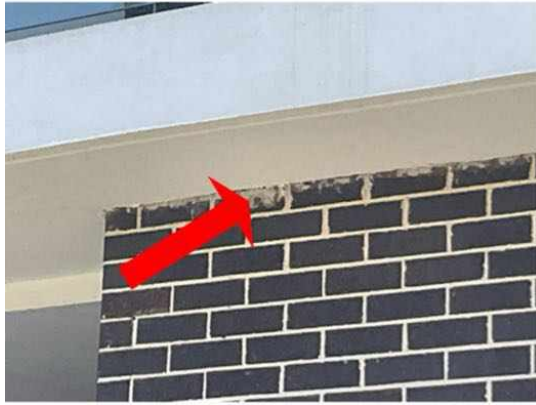
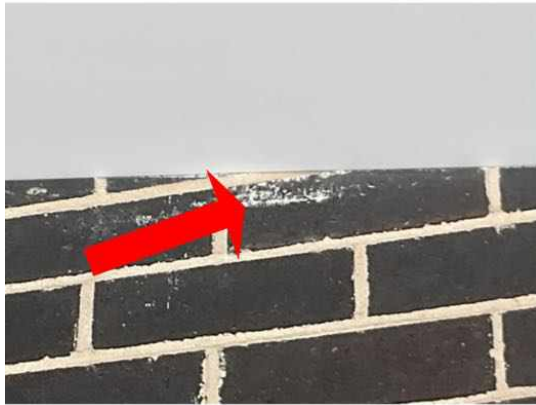
Building: Main Building  
Location: Exterior walls - front  
Finding: Surface - Requires cleaning  
Information: Regular cleaning and maintenance improves the longevity of all building elements. A build up of dirt and debris can reduce the useful life of building materials and may result in earlier replacement of items being required.

Excessive dirt is also likely to lead to secondary hazards, including potential health hazards, as the building elements begin to harbour bacteria and/or mould.

Remedial cleaning is recommended in order to improve the appearance of this area as well as to counteract the development of bacteria. Such works can be performed by a cleaning contractor and should be completed at the discretion of the client.

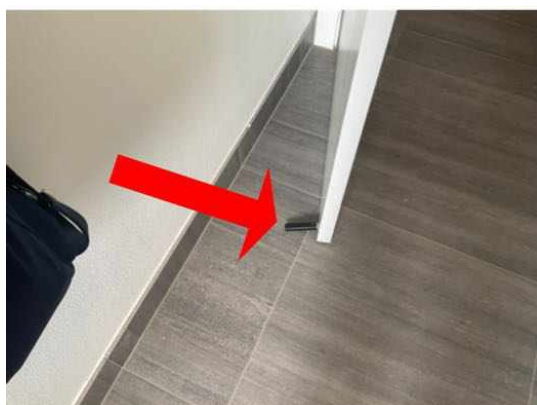
Building:	Main Building
Location:	Laundry
Finding:	Door stop - Missing
Information:	The door stop is missing or is inadequate to stop the door handle from damaging the wall. Although some building elements may seem irrelevant or unnecessary, all building elements play a key role in the operation and function of the overall structure and its performance.

Re-installation or replacement of the door stop is advised as soon as possible to prevent any subsequent damage to the door or associated structures. A general handyman may be appointed to perform these works at client discretion.

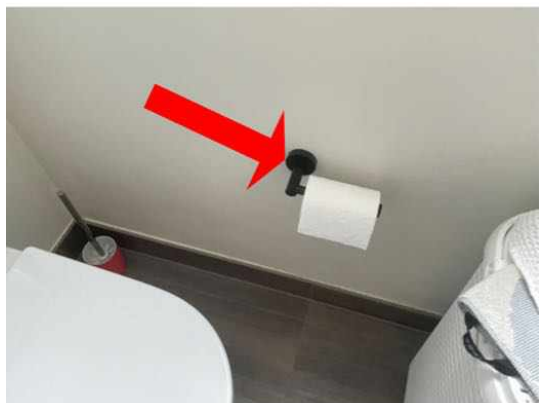
### Finding 3.10

Building:	Main Building
Location:	Laundry
Finding:	Toilet roll holder - Loose
Information:	The toilet roll holder was found to be loose at the time of inspection. While not a major operational defect, function can deteriorate if the problem is left unmanaged.

It is advised that the homeowner performs remedial works to re-attach the toilet roll

holder to its original fixing. A general handyperson may be required to perform these works.

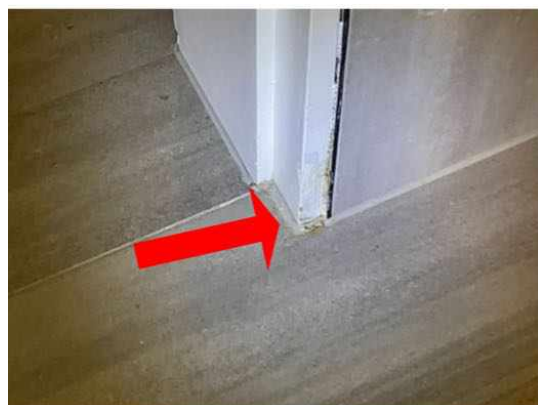
Finding 3.12

Building:	Main Building
Location:	Bathroom
Finding:	Bathroom - Damp
Information:	<p>Damp is evident to the lower 300mm of wall to the bathroom alcove. This defect is quite common, and is suspected to have been caused by moisture permeating through the grouting in this area, which shows evidence of deterioration. Leaking pipes within the adjoining wall is also a possible cause. Damp (or structural damp) refers to the presence of unwanted moisture in the structure of a building, either as the result of intrusion from outside, or condensation from within the structure. In the bathroom area, internal water leaks or other sources of excessive moisture are generally the cause of damp. Unmanaged damp in the bathroom recess is likely to facilitate the formation and development of mould and fungi growth, decaying associated building materials and compromising their structural integrity. It is important to address damp conditions, as the World Health Organisation notes that excess moisture leads - on almost all indoor materials - to growth of microbes such as moulds, fungi and bacteria, which subsequently emit spores and other matter into the indoor air. Exposure to these contaminants is associated with a wide range of respiratory and other health-related problems. Consultation with a qualified plumber or bathroom specialist is advised immediately to identify the cause of damp and to perform remedial works as required. Where excessive mould growth is present, further inspection by a specialist environmental health inspector should also be considered. Always ensure that sealant and grout is in good condition to prevent any moisture issues occurring in the future.</p>

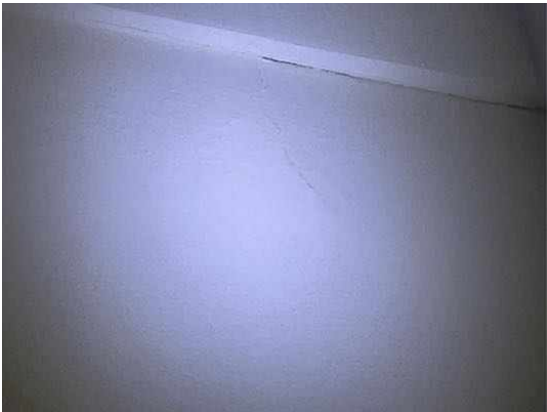
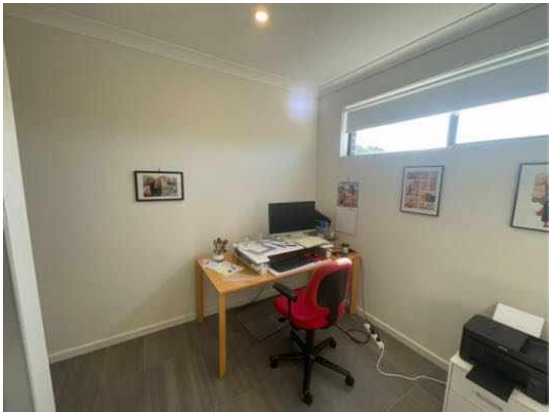
### Finding 3.13

Building:	Main Building
Location:	All Internal Areas
Finding:	Plasterboard - cracking
Information:	<p>It was identified that there are crack/s in the plasterboard hard plaster and / or other plaster elements affecting the walls ceilings and or bulkheads that is greater than 1mm in width which can be seen from a normal viewing position.</p>

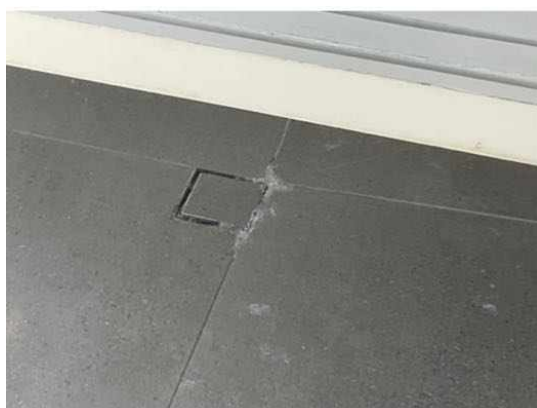
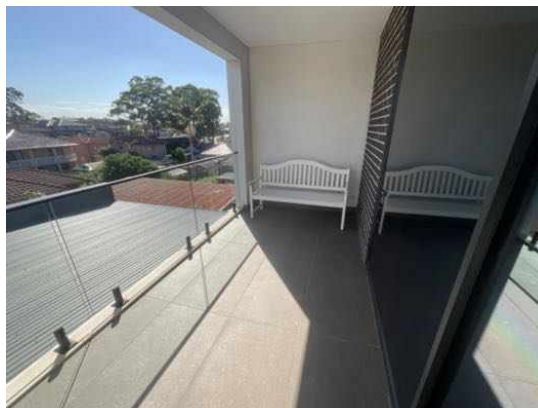
### Finding 3.14

Building:	Main Building
Location:	Balcony
Finding:	Balcony waterproofing / glue - defective
Information:	It appears that the waterproofing system or glue adhesive for the balcony has been installed in a manner which is not consistent with the manufacturer's installation instructions. Irrespective of whether or not it has failed substandard installation is considered a defect with reference to Standards and Tolerances.

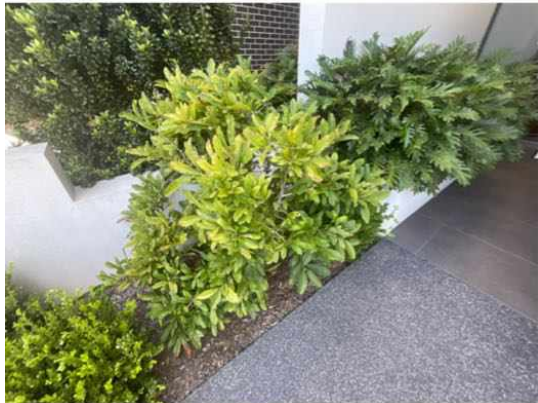
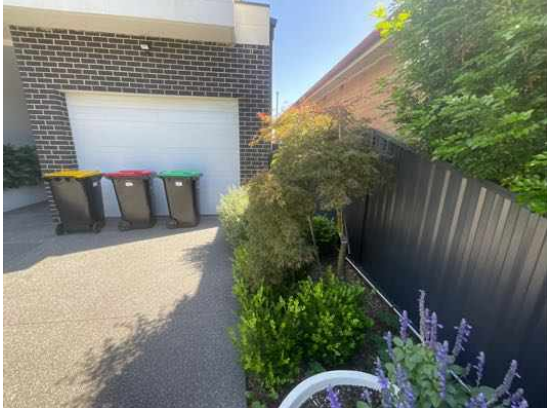
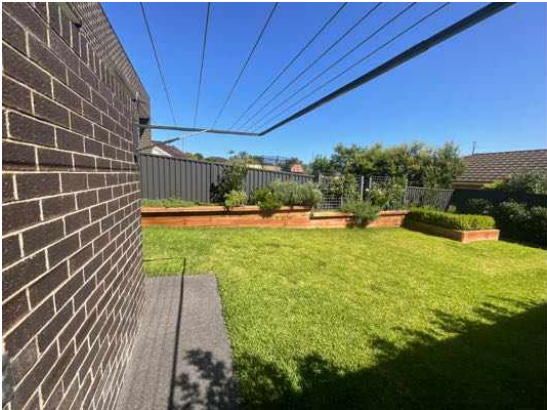
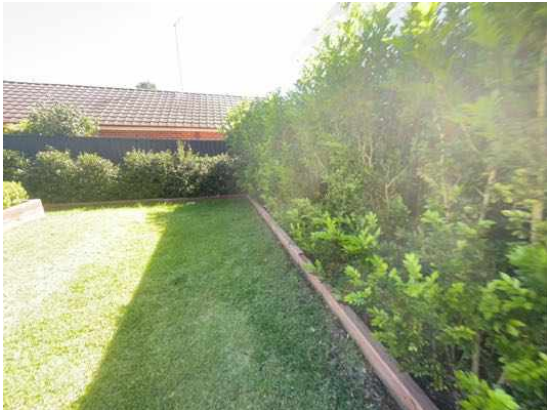
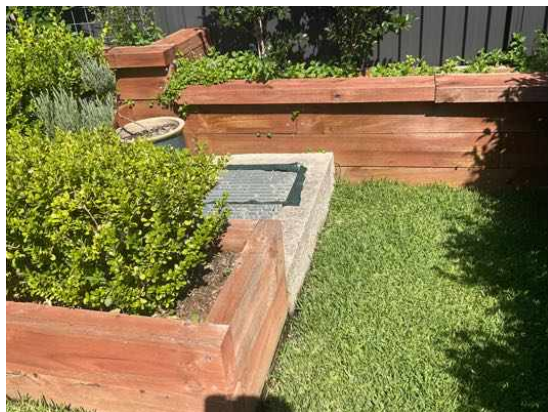
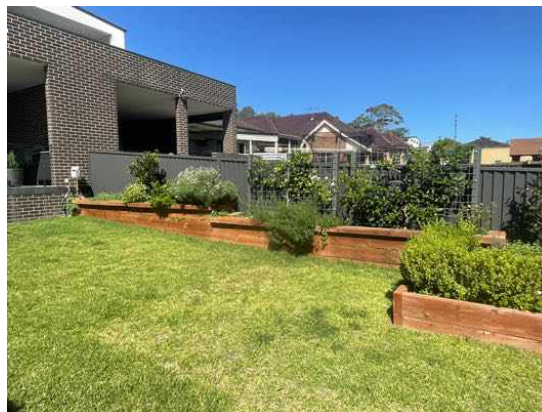
#### Finding 6.01

Building: Main Building  
Location: All Areas  
Finding: Garden Beds - Conditions Conducive to Termites  
Information: Garden beds were found to be evident in the garden area. These garden beds can include untreated timber, and with a combination of moisture from watering hosing can make conditions conducive to termite activity and termite ingress.

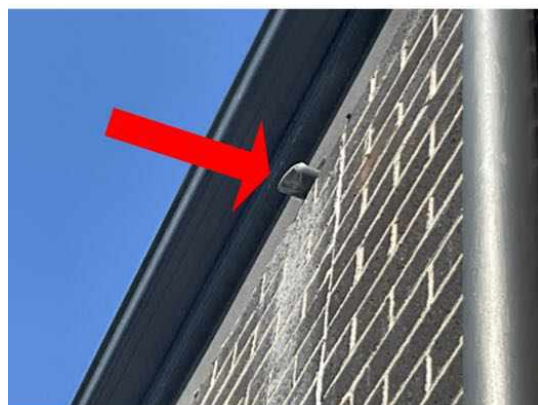
### Finding 6.02

Building:	Main Building
Location:	All Areas
Finding:	Overflow - Not plumbed for drainage
Information:	The overflow is not plumbed or connected to suitable drainage, which has resulted in the surrounding area becoming excessively damp. These damp conditions can lead to secondary defects such as rot, rust or corrosion of associated building elements, the formation of fungal decay, or even the creation of potential slip hazards. When coupled with poor site drainage, pooling of water may also attract termite activity to this area. It is highly recommended that a qualified plumber be appointed to install adequate drainage to the overflow. These works will ensure that the area remains dry and free of any secondary defects.

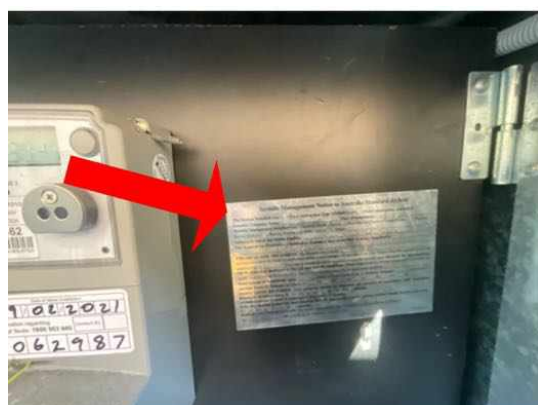
Building: Main Building  
 Location: All Areas  
 Finding: Evidence of a chemical treated zone barrier was identified  
 Information: During inspection of the property, it was noted that works to install a chemical treated zone barrier had previously been completed. A chemical treated zone barrier is likely to ensure effective protection against termites.

However, we strongly recommend annual inspections of the barrier and surrounding areas as there are several factors that can lead to deterioration of the barrier and decrease its effectiveness.
