Building Inspection Report

Inspection Date: Fri, 27 Feb 2026

Property Address: 8 Madeira Dr, Clyde North VIC 3978,
Australia

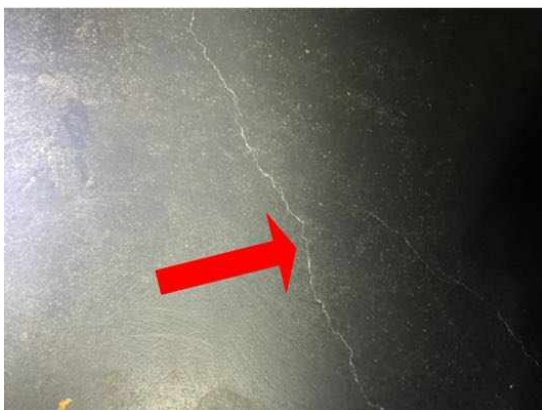
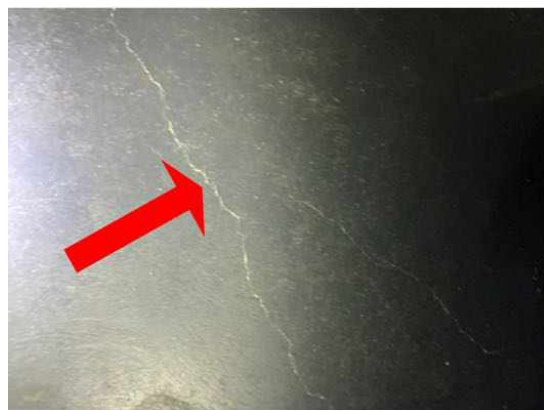
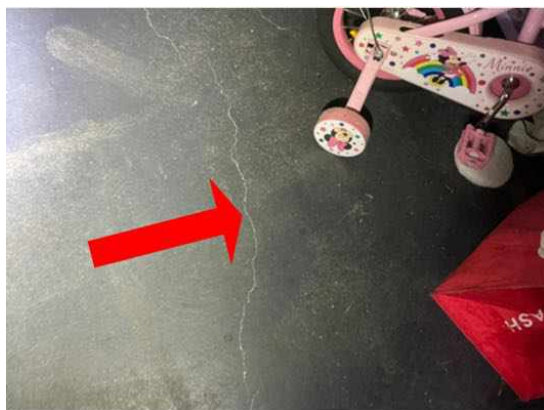
Defects 3.01

Finding: Noticeable cracks in concrete slab of the the garage floor

Information: During the inspection, multiple noticeable cracks were identified in the concrete slab of the garage floor. These cracks vary in size and location, which may indicate underlying movement or stress within the slab. While they do not currently appear to significantly impact the structural integrity, their presence suggests potential early-stage deterioration.

It is recommended that the cracks be monitored closely over the next 12 months. If any of the cracks widen or worsen during this period, it is critical to engage a structural engineer immediately to assess the situation and recommend appropriate rectification measures to prevent further damage and ensure the long-term stability of the structure.

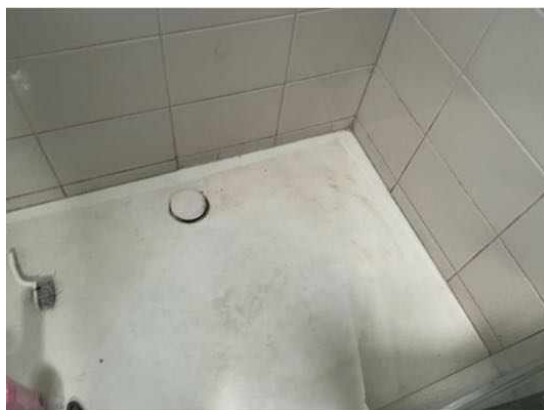
Defects 3.02

Building:	Main Building
Location:	Ensuite - Master
Finding:	Shower - Damp
Information:	Damp is evident to the lower 300mm of wall to the shower alcove. This defect is quite common, and is suspected to have been caused by moisture permeating through the grouting in this area, which shows evidence of deterioration. Leaking pipes within the adjoining wall is also a possible cause.

Damp (or structural damp) refers to the presence of unwanted moisture in the structure of a building, either as the result of intrusion from outside, or condensation from within the structure. In the shower area, internal water leaks or other sources of excessive moisture are generally the cause of damp.

Unmanaged damp in the shower recess is likely to facilitate the formation and development of mould and fungi growth, decaying associated building materials and compromising their structural integrity. It is important to address damp conditions, as the World Health Organisation notes that excess moisture leads - on almost all indoor materials - to growth of microbes such as moulds, fungi and bacteria, which subsequently emit spores and other matter into the indoor air. Exposure to these contaminants is associated with a wide range of respiratory and other health-related problems.

Consultation with a qualified plumber or bathroom specialist is advised immediately to identify the cause of damp and to perform remedial works as required. Where excessive mould growth is present, further inspection by a specialist environmental health inspector should also be considered.

Always ensure that sealant and grout is in good condition to prevent any moisture issues occurring in the future.

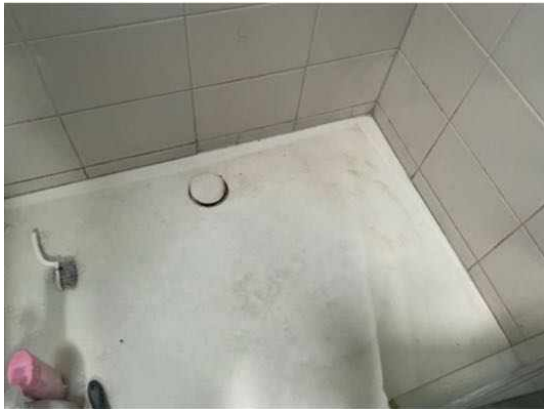
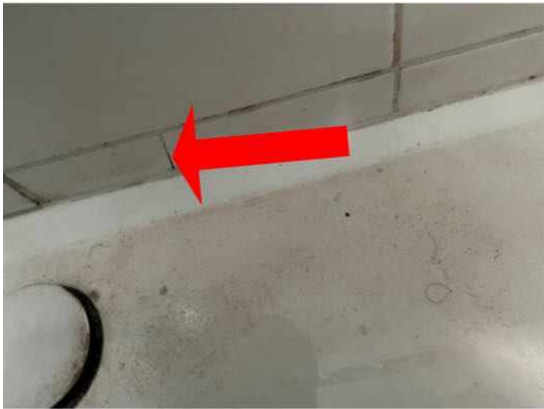
Defects 3.03

Building: Main Building
 Location: Ensuite - Master
 Finding: Sealant and grouting - Deteriorated
 Information:

It was noted at the time of inspection that sealant and/or grout is degraded to the tiled shower alcove and other areas of the bathroom. Different materials and floor areas move at different rates, generally causing cracking to grout or sealant at junctions and perimeters. A flexible sealant is required at movement joints to allow for expected expansion and contraction while maintaining a watertight seal and protecting associated building materials.

There appears to be excessive mould present to sections of the sealant and grout, which will likely require complete removal and replacement. In addition, a number of cracked tiles were observed within the shower area. It appears these cracked tiles have been filled or patched with grout rather than being properly replaced. Grouting over cracked tiles is not considered an appropriate repair method, as it does not restore the structural integrity or waterproof performance of the tiled surface. These cracked tiles should be removed and replaced without delay to prevent potential water ingress and further deterioration of the substrate or waterproof membrane.

Flexible, mould-resistant sealant materials should be applied to all affected movement joints following proper preparation of the surfaces. All deteriorated grout should be removed and replaced as required. Regular inspection, maintenance and timely replacement of damaged or missing sealant and grout is strongly recommended in wet areas, as this is considered a common wear-and-tear item. A qualified tiling contractor or sealant specialist should be engaged to undertake these rectification works as soon as practicable to minimise the risk of water damage.

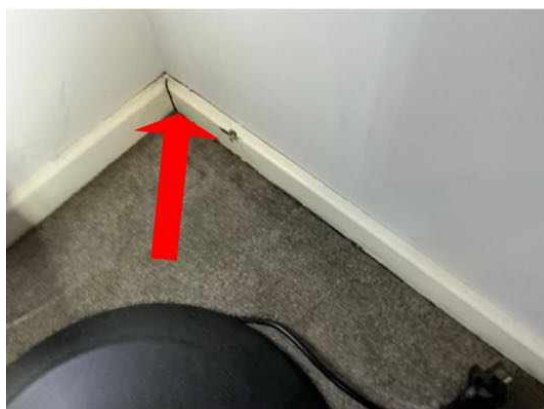
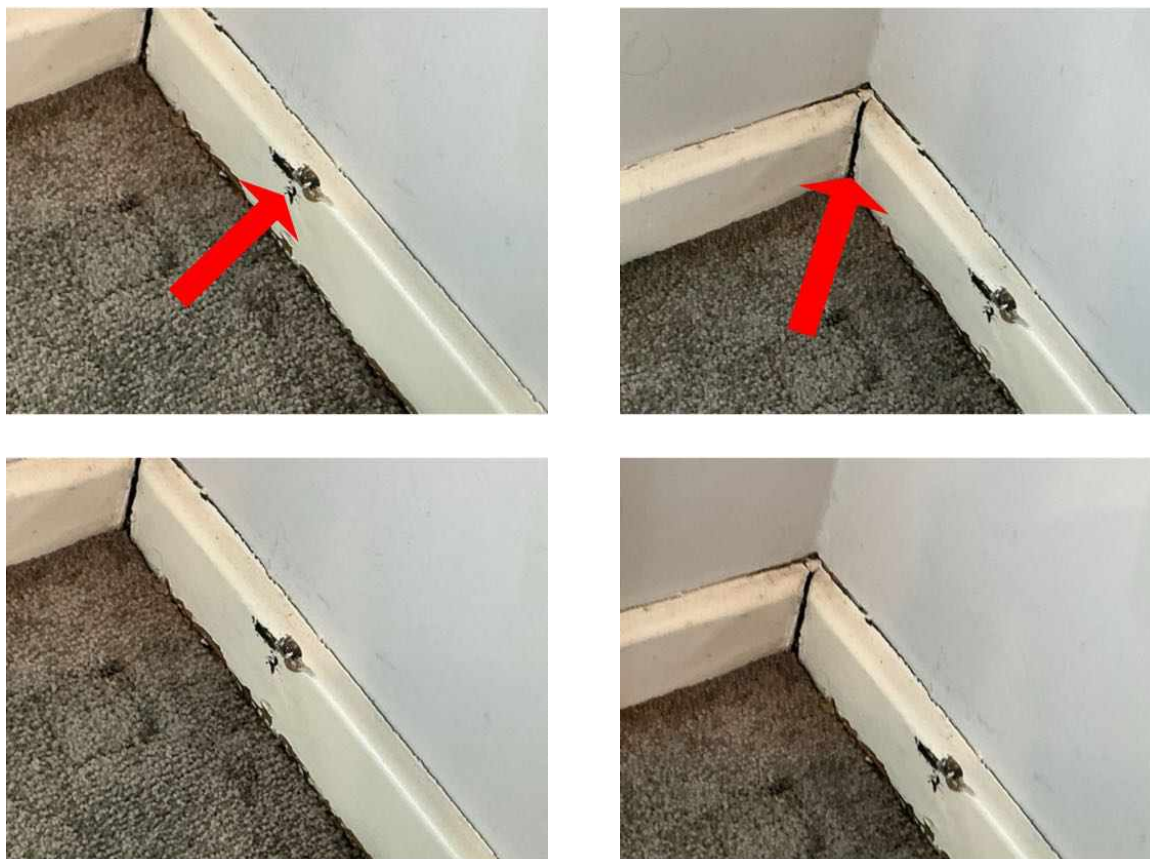
Defects 3.04

Building: Main Building
Location: Bedroom - Master
Finding: Possible Moisture Damage and Concealed Mould – Master Bedroom Wall Adjacent to Ensuite Shower

At the time of inspection, the lower section of the wall and skirting board within the master bedroom, directly adjacent to and behind the ensuite shower, exhibited staining and visual irregularities consistent with possible past moisture ingress. The base of the skirting board showed markings suggestive of potential mould growth. It appears that water may have previously penetrated from the adjoining shower area into the wall assembly. Non-invasive moisture testing conducted at the time of inspection did not record elevated moisture levels; however, this does not exclude the possibility of prior moisture exposure that has since dried.

As this was a visual, non-invasive inspection, no destructive testing or removal of finishes was undertaken. Concealed areas such as behind the skirting boards, within the wall cavity, behind plasterboard linings, insulation, or beneath the adjacent carpeted flooring could not be accessed. Accordingly, the presence of concealed mould growth, timber decay, or deterioration of the waterproofing membrane cannot be confirmed or ruled out. Visual indicators suggest that further investigation is warranted.

It is strongly recommended that a registered builder conduct an invasive inspection of the affected wall section, including removal of the skirting board and selective opening of the wall lining to inspect framing, insulation, and waterproofing integrity. If mould is identified, remediation should be undertaken by a qualified mould remediation specialist. Prompt investigation and rectification are advised to prevent potential ongoing structural deterioration or internal environmental issues.

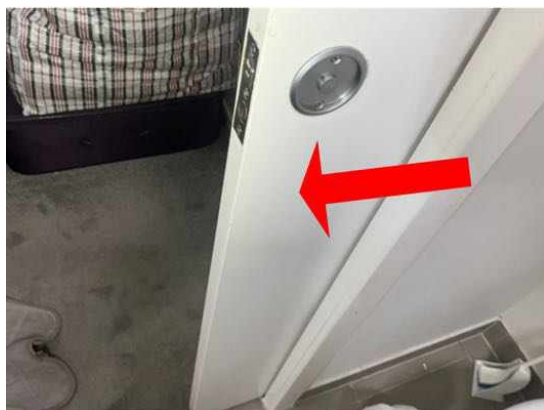
Defects 3.05

Building: Main Building
 Location: Bedroom - Master
 Finding: Sliding Door – Master Bedroom to Ensuite Not Operating Fully
 Information:

At the time of inspection, the sliding door separating the master bedroom and master ensuite was observed to be restricted in operation and did not open fully. The door travelled only approximately halfway along its track before stopping. This condition may be due to track misalignment, obstruction, hardware wear, roller failure, or frame distortion.

Restricted operation may result in inconvenience, reduced functionality of the room layout, and potential ongoing wear to door hardware if force is applied during use. Continued use in its current condition may lead to further deterioration of the track, rollers, or door frame components.

It is recommended that a qualified carpenter undertake adjustment, repair, or replacement of the sliding door hardware and track components as required to restore full and proper operation. Rectification should be carried out in a timely manner to prevent further damage to associated components.

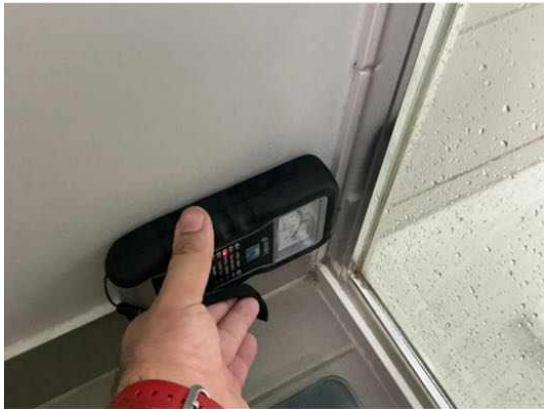
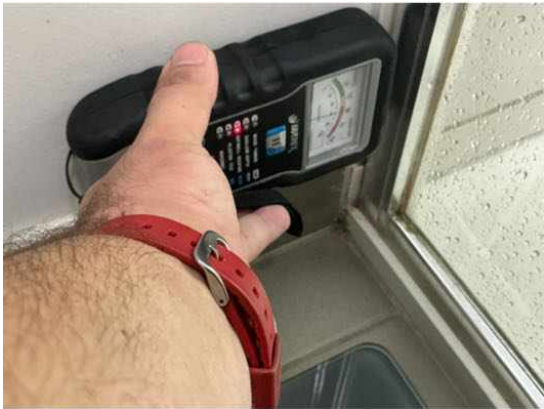
Defects 3.06

Building: Main Building
Location: Ensuite - Master
Finding: Elevated Moisture Readings – Wall Adjacent to Ensuite Shower
Information:

At the time of inspection, the plasterboard wall adjacent to the ensuite shower recorded elevated moisture readings when tested with a calibrated non-invasive moisture meter. The readings were higher than surrounding wall areas, indicating the possible presence of moisture within the wall cavity. No destructive testing was undertaken as this was a visual, non-invasive inspection only.

Elevated moisture levels to internal wall linings are commonly associated with shower waterproofing failure, leaking plumbing fittings, failed sealant, or concealed pipework defects. If moisture ingress is ongoing, this may result in deterioration of plasterboard, timber framing, insulation, and potential mould growth within concealed areas. Prolonged moisture exposure may also compromise the integrity of the waterproofing system.

It is strongly recommended that a licensed plumber undertake further investigation to determine the source of moisture. This may require invasive inspection, including removal of wall linings or access panels as necessary, to confirm whether active leakage is present. Any identified defects should be rectified without delay to prevent further damage to associated building elements.

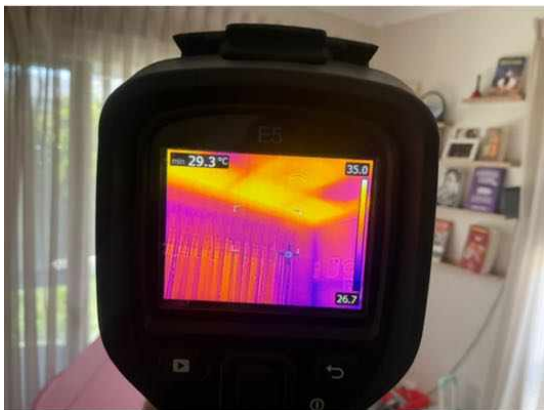
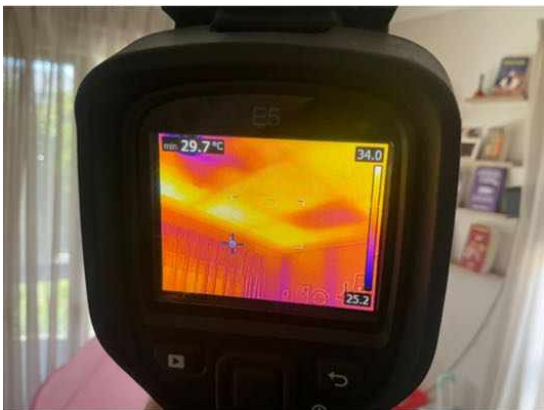
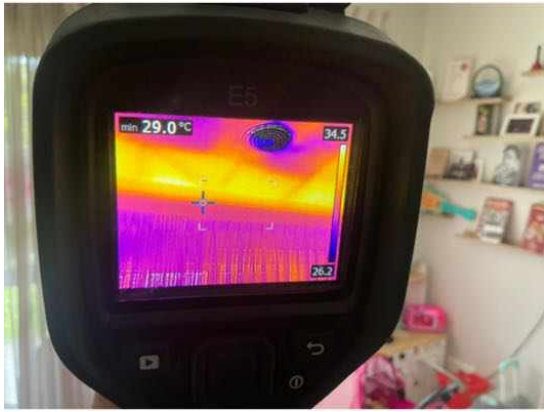
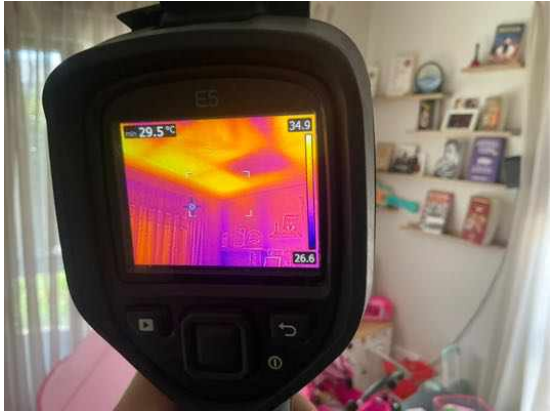
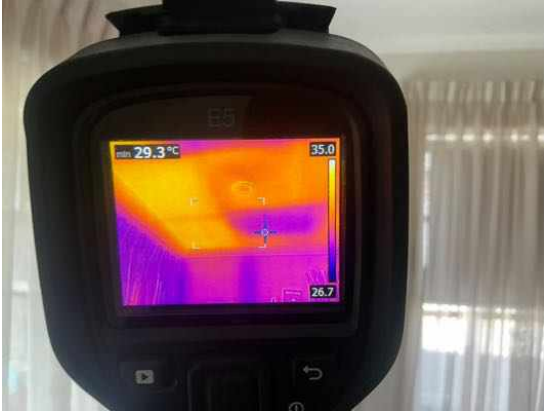
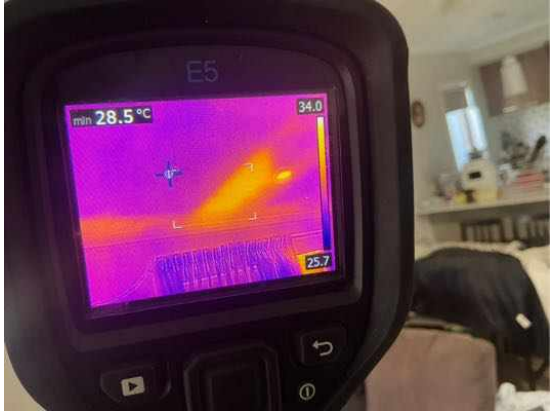
Defects 3.07

Building: Main Building
 Location: All Internal Areas
 Finding: Inconsistent Thermal Performance to Ceiling Areas – Suspected Insulation Deficiencies
 Information: Thermal imaging conducted to internal ceiling areas at the time of inspection identified inconsistent heat patterns, which are indicative of variations in thermal performance across the roof space. These patterns are commonly associated with areas of missing, displaced, or insufficient insulation above the ceiling linings.

Inadequate or uneven insulation coverage can reduce the energy efficiency of the dwelling, contribute to heat loss in cooler periods and heat gain in warmer conditions, and may result in reduced occupant comfort and increased heating and cooling costs. Due to the non-invasive nature of the inspection, the exact extent and condition of insulation could not be confirmed visually in all affected areas.

It is recommended that a qualified insulation contractor inspect the roof space, assess insulation coverage and condition, and top up or reinstate insulation where required to achieve consistent thermal performance throughout the property.

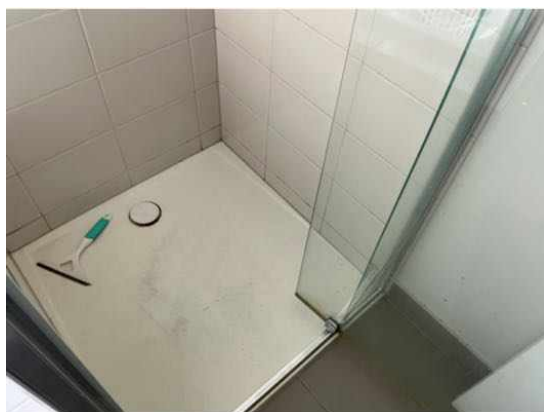
Defects 3.08

Information: Damp is evident to the lower 300mm of wall to the shower alcove. This defect is quite common, and is suspected to have been caused by moisture permeating through the grouting in this area, which shows evidence of deterioration. Leaking pipes within the adjoining wall is also a possible cause.

Damp (or structural damp) refers to the presence of unwanted moisture in the structure of a building, either as the result of intrusion from outside, or condensation from within the structure. In the shower area, internal water leaks or other sources of

excessive moisture are generally the cause of damp.

Unmanaged damp in the shower recess is likely to facilitate the formation and development of mould and fungi growth, decaying associated building materials and compromising their structural integrity. It is important to address damp conditions, as the World Health Organisation notes that excess moisture leads - on almost all indoor materials - to growth of microbes such as moulds, fungi and bacteria, which subsequently emit spores and other matter into the indoor air. Exposure to these contaminants is associated with a wide range of respiratory and other health-related problems.

Consultation with a qualified plumber or bathroom specialist is advised immediately to identify the cause of damp and to perform remedial works as required. Where excessive mould growth is present, further inspection by a specialist environmental health inspector should also be considered.

Always ensure that sealant and grout is in good condition to prevent any moisture issues occurring in the future.

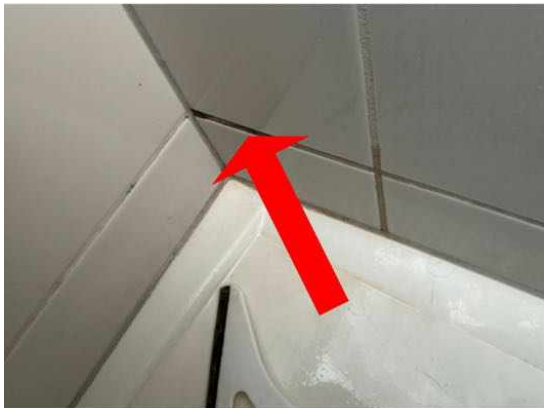
Defects 3.09

Building:	Main Building
Location:	Bathroom 2
Finding:	Sealant and grouting - Deteriorated
Information:	It was noted on inspection that sealant or grout is degraded to the tiled shower alcove and or other areas of the bathroom.

Different materials and floor areas move at different rates, generally causing cracking to grout or sealant at this point. A flexible sealant is required to allow for expected expansion and contraction, while keeping the joint water tight and protective of all associated building materials.

There appears to be minor mould to the sealant and grout which will likely require scraping out and replacement.

Flexible and mould resistant materials should be applied to affected areas to prevent any subsequent water damage that is likely to occur. Regular maintenance and replacement of damage or missing or damaged sealant and grout is highly recommended to the wet areas, as this is a regular wear and tear defect. Sealant and grouting in areas that come into regular contact with water should be maintained for the long term care of your property.

A sealant specialist or tiling contractor should be appointed to complete these works as soon as possible

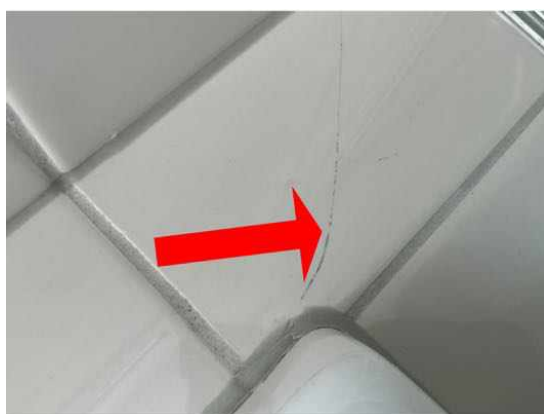
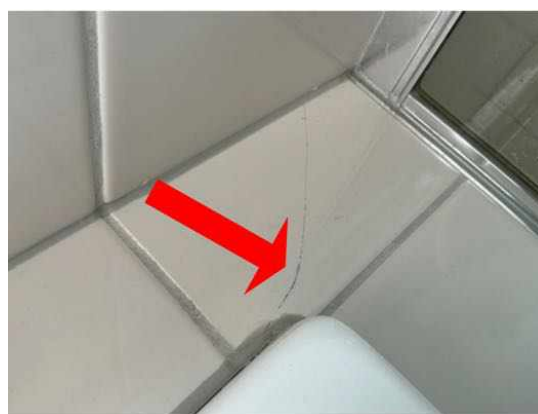
Defects 3.10

Building: Main Building
 Location: Bathroom 2
 Finding: Cracked Tile – Second Bathroom (Bathtub Area)
 Information:

At the time of inspection, one tile adjacent to the bathtub in the second bathroom was observed to be cracked. The crack extends through the tile surface and is considered a defect.

Cracked tiles in wet areas may allow moisture to penetrate behind the tiled surface, which can contribute to deterioration of underlying materials over time if not addressed.

It is recommended that a qualified tiler remove and replace the cracked tile to maintain the integrity and durability of the bathroom finishes. Rectification should be undertaken in a timely manner.

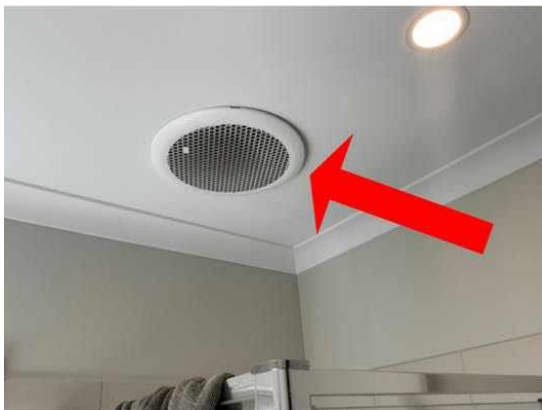
Defects 3.11

Building: Main Building
 Location: Bathroom 2
 Finding: Noisy Exhaust Fan in bathroom 2
 Information: The exhaust fan in the 2nd bathroom is producing excessive noise during operation, which indicates a potential issue with its motor, fan blades, or overall mechanism. The unusual noise disrupts the intended function of the fan and may suggest that it is either clogged, in need of maintenance, or nearing the end of its operational lifespan.

This issue may reduce the efficiency of the exhaust fan, leading to inadequate ventilation in the en-suite, which could contribute to moisture buildup and potential issues such as mold or mildew growth. A noisy fan is also generally less effective at expelling humid air, which could affect the overall air quality and comfort of the space.

It is recommended that a qualified technician inspect and service the exhaust fan to determine the cause of the noise. If necessary, the fan should be repaired or replaced to restore proper ventilation and ensure the en-suite remains well-ventilated and free of excess moisture.

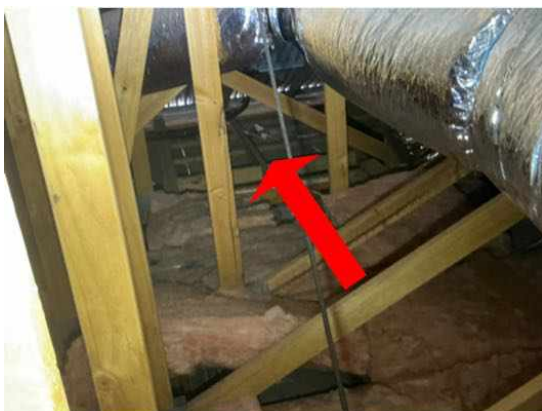
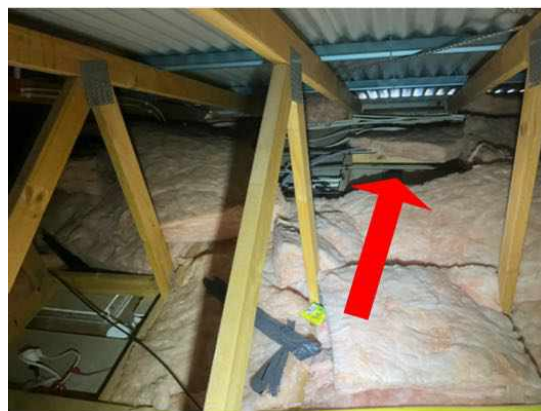
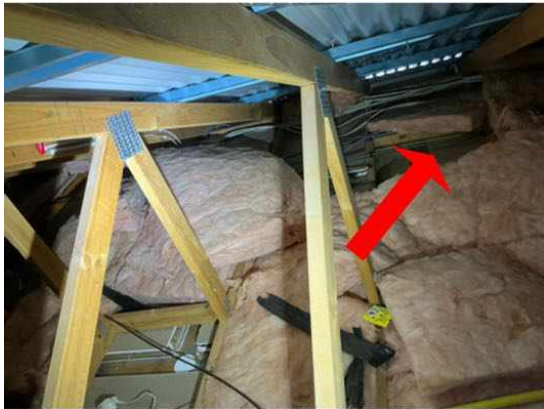
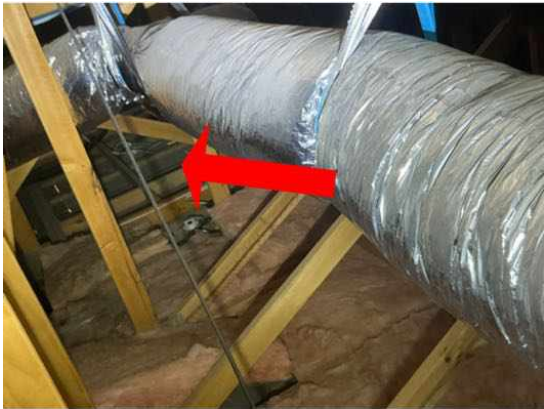
Defects 3.12

Building: Main Building
 Location: Roof Void
 Finding: Missing Ceiling Insulation – Roof Void
 Information:

At the time of inspection of the roof void, multiple large sections were observed where ceiling insulation batts were missing entirely. Insulation coverage was incomplete and inconsistent across the ceiling area.

Missing insulation reduces the thermal performance of the dwelling and may result in increased heat loss during winter and heat gain during summer. This can lead to reduced energy efficiency, higher heating and cooling costs, and diminished occupant comfort.

It is recommended that a qualified insulation installer supply and install compliant ceiling insulation batts to all areas where insulation is currently absent, ensuring even and continuous coverage in accordance with current NCC energy efficiency requirements. Rectification should be undertaken to restore the thermal performance of the dwelling.

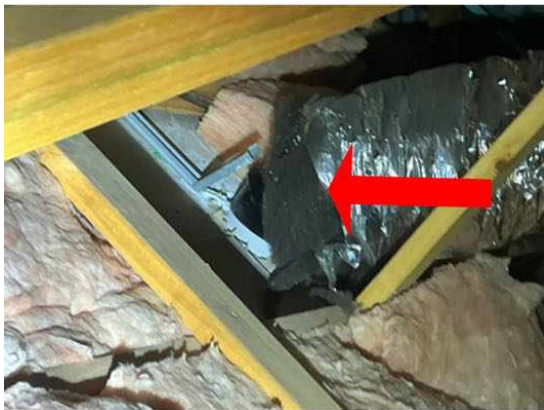
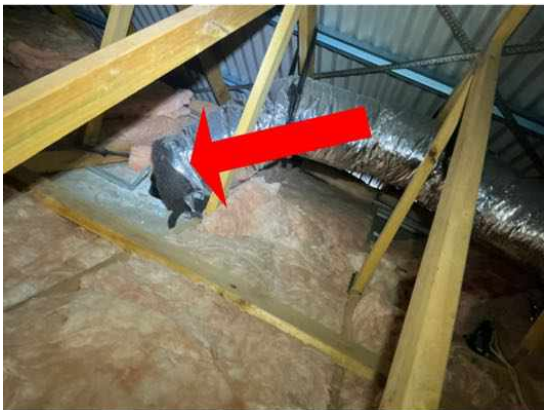
Defects 3.13

Building: Main Building
Location: Roof Void
Finding: Internal Duct Liner Insulation Dislodged – Roof Void
Information:

At the time of inspection, the internal insulation lining within the flexible ductwork in the roof void was observed to be detached and sagging inside the duct. The inner liner appears to have separated from its intended position and is partially obstructing the duct cavity.

Dislodged internal duct insulation may restrict airflow, reduce the efficiency of the heating and cooling system, and place additional strain on the mechanical components. Over time, this condition may contribute to uneven air distribution and reduced overall system performance.

It is recommended that a qualified HVAC technician inspect the affected ductwork and repair or replace the damaged duct section as required. Prompt rectification is advised to restore proper airflow and maintain system efficiency.

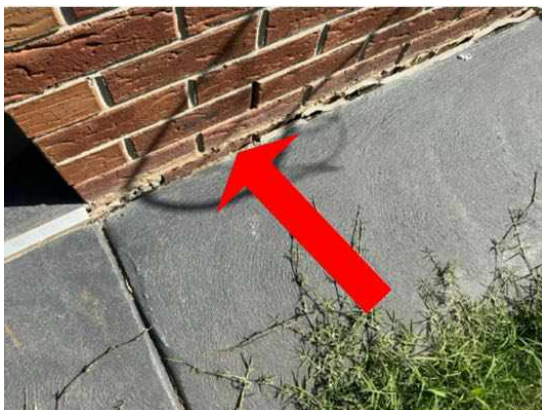
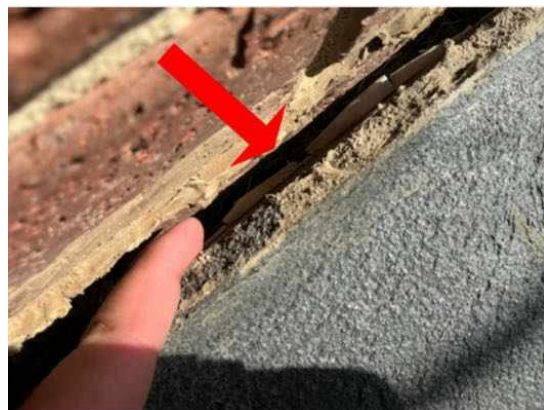
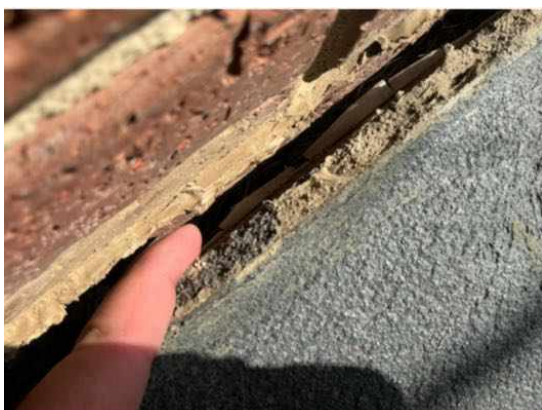
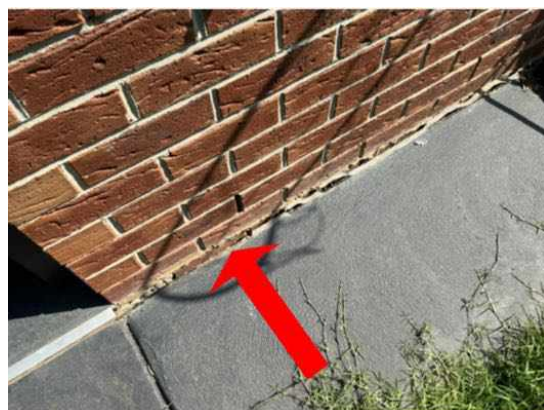
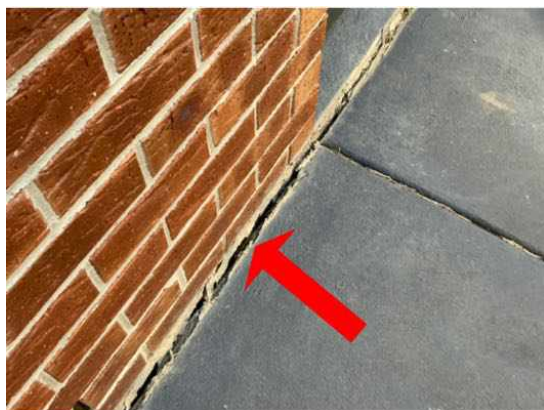
Defects 3.14

Information: At the time of inspection, noticeable gaps were observed between the external concrete path and the adjacent brickwork around sections of the dwelling perimeter. The separation appears greater than typically expected minor shrinkage movement and is consistent with differential ground movement over time. Detached downpipes were also noted in nearby areas, which further supports the likelihood of soil movement affecting external elements.

Separation between hard paving and the dwelling may indicate reactive soil movement, settlement, or moisture-related ground changes. Continued movement may place additional stress on footings, external walls, and connected services. If progressive, this condition could contribute to cracking of masonry, misalignment of drainage components, and other structural concerns.

It is recommended that the client monitor the affected areas for further movement or widening of gaps. If ongoing or progressive movement is observed, a qualified geotechnical engineer should be engaged to undertake further assessment of site conditions and provide recommendations. Early investigation is advised to mitigate the risk of more significant structural impact.

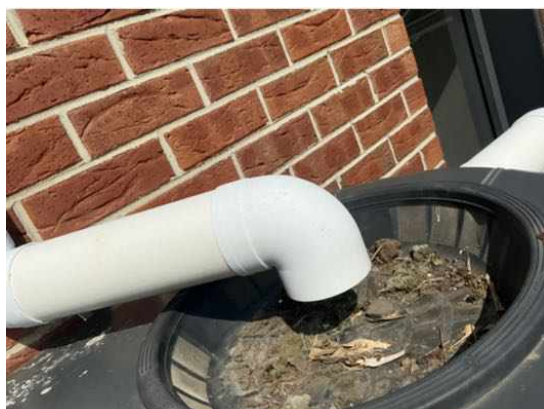
Defects 3.15

Building:	Main Building
Location:	Watertank
Finding:	Partially Blocked water tank inlet
Information:	The water tank inlet is currently partially blocked by an accumulation of grass, weeds, and rubbish. This obstruction hinders the proper flow of water into the tank, which can lead to reduced water capacity, contamination, and potential damage to the tank system. Immediate removal of the debris and regular maintenance are required to restore the water tank's functionality and prevent further issues.

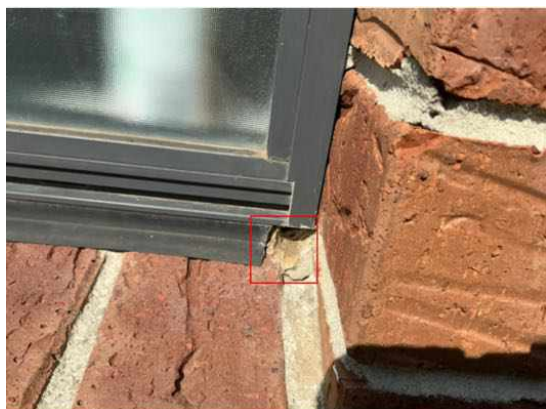
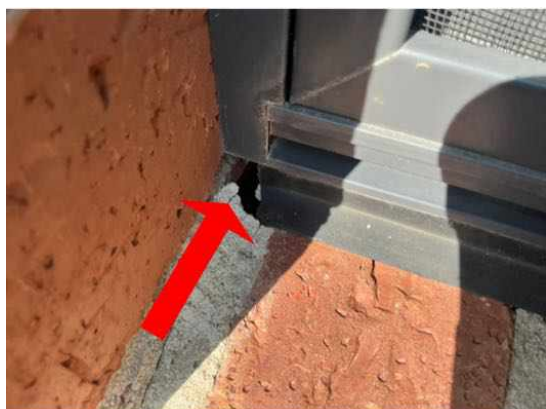
Defects 3.16

Building:	Main Building
Location:	All External Areas
Finding:	Gaps Around External Window Frames
Information:	Multiple gaps were identified between the external window frames and the adjoining brickwork across several elevations. These gaps appear to be the result of either poor or inconsistent sealant application during installation, or deterioration of the original sealant over time.

Unsealed or poorly sealed gaps can allow moisture ingress, wind-driven rain, draughts, and provide potential entry points for pests. Ongoing exposure to moisture

may also contribute to internal dampness and premature deterioration of surrounding building elements.

A qualified handyman or registered builder should apply a consistent, waterproof, flexible exterior-grade sealant around all affected windows to ensure adequate weatherproofing and protection against moisture and pest entry.

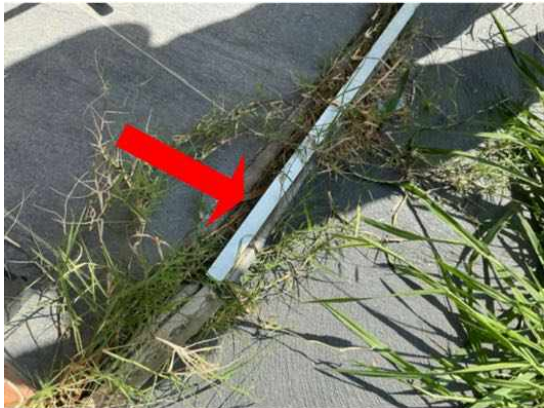
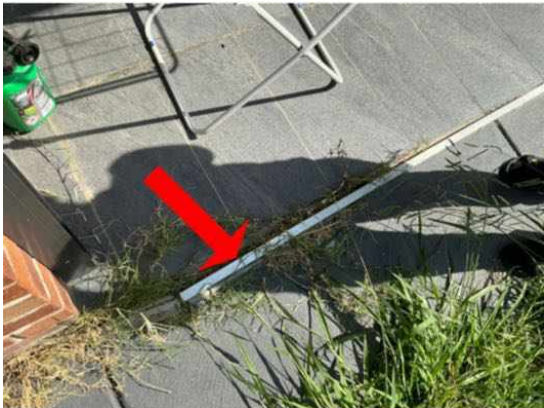
Defects 3.18

At the time of inspection, the tile edge trim at the alfresco area was observed to be detached from the adjoining tiles. The trim is no longer securely fixed and may be prone to further movement or displacement.

Loose or detached tile trim may present a minor trip or sharp edge hazard and can allow moisture to penetrate behind the tiled surface if left unrectified. Continued exposure to external conditions may result in further deterioration of the adhesive bond.

It is recommended that a qualified tiler resecure or replace the affected tile trim to ensure it is properly fixed and aligned. Rectification should be undertaken in a timely manner to maintain the integrity and safety of the tiled surface.

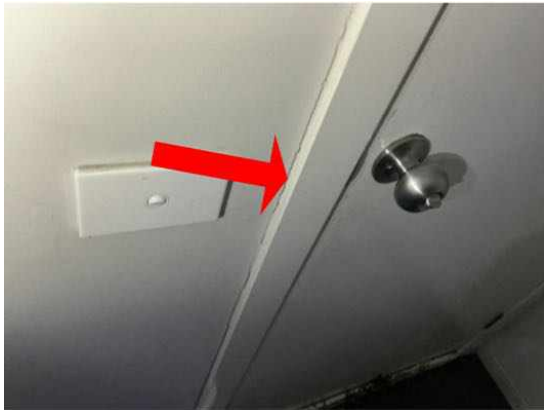
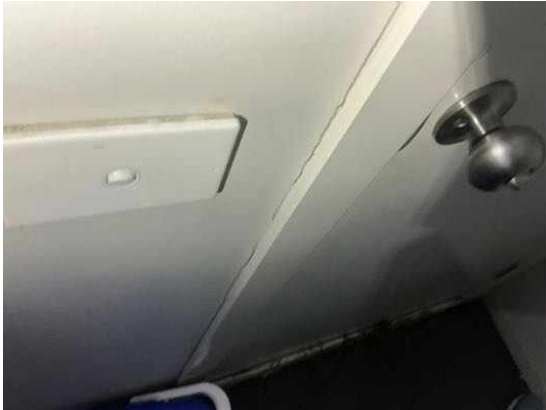
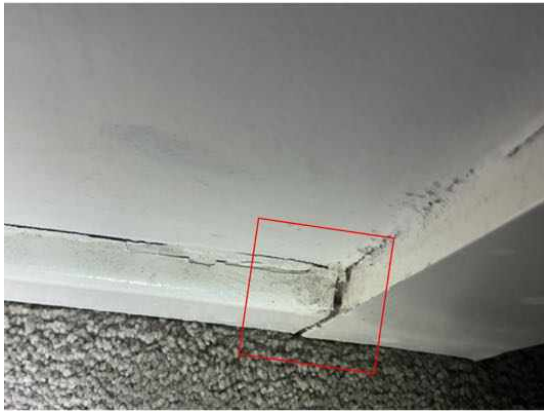
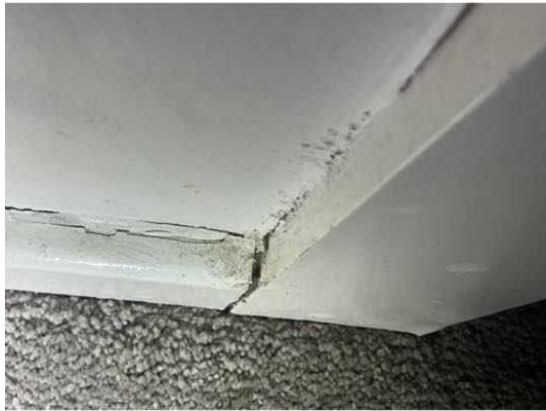
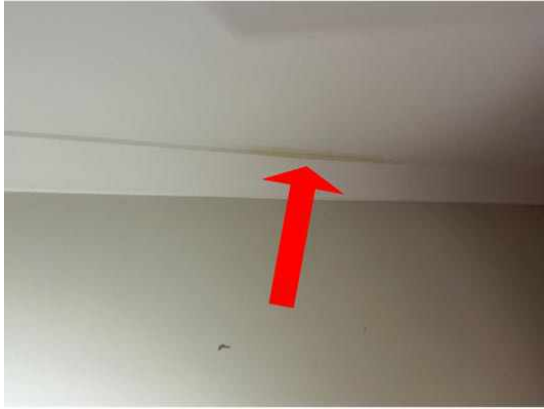
Defects 3.20

Building: Main Building
 Location: All Internal Areas
 Finding: Minor Cosmetic Cracking and General Wear and Tear – Internal Finishes
 Information:

At the time of inspection, multiple minor cosmetic defects were observed to internal finishes throughout the dwelling. These included small cracks and gaps around internal door frames consistent with minor settlement and building movement, localised wear and tear to the skirting board in the second bedroom, and sections of cornice within the living room that appear to have been previously filled with a patching compound of a differing colour. Such conditions are commonly associated with normal building settlement, shrinkage of materials, and general ageing, and in some

These defects are considered cosmetic in nature and do not currently indicate structural failure. However, they may affect the overall presentation and aesthetic finish of the dwelling if left unrectified.

Should the client wish to improve the visual presentation, a qualified plasterer and/or painter may be engaged to prepare surfaces, properly fill cracks and gaps, sand smooth, and repaint affected areas to achieve a uniform and professional finish. Rectification is considered discretionary and cosmetic.

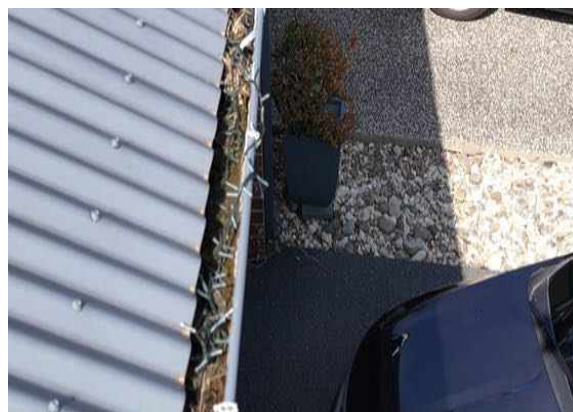
Defects 3.21

Building:	Main Building
Location:	Gutters
Finding:	Gutters - Partially Blocked
Information:	Sections of the external gutters were partially blocked with debris, soil and leaves. Roof plumbing structures, such as guttering and downpipes, should be free of all debris to prevent blockages. Blockages of the guttering and downpipes will lead to pooling and accumulated water overflows, which is likely to subsequently flood eaves and exterior walls.

Consult a Licensed Plumber for further specific advice on remedial works that may be required. In the interim, it is highly advised that blocked gutters be removed by the homeowner or a general handyperson as a matter of urgency.

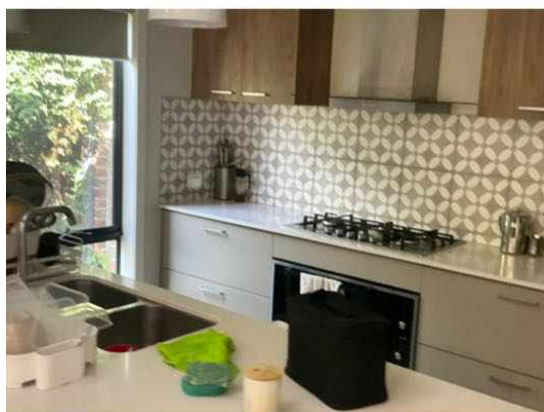
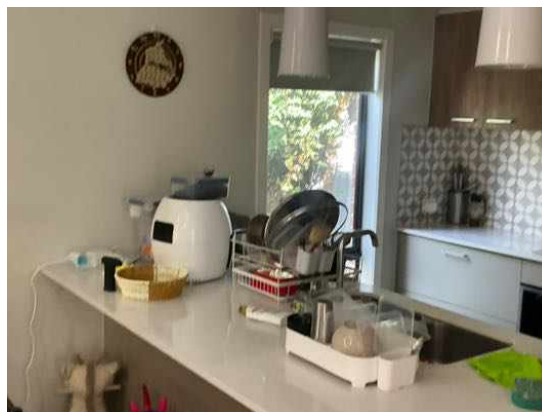
Noted Item

Building: Main Building
 Location: All Areas
 Finding: Obstructions and Limitations - Interior
 Information: These photographs are an indication of the obstructions and limitations which impeded the inspection of the internal areas of the property at the time of inspection. These obstructions can hide an array of defects and should be removed to allow full inspection to be carried out. A re-inspection is recommended once the areas are made accessible.

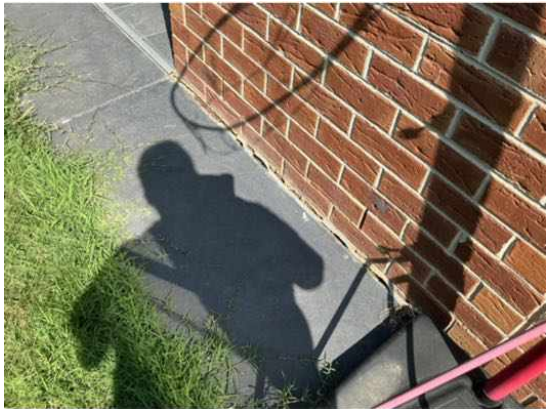
Noted Item

Building: Main Building
 Location: All External Areas
 Finding: Obstructions and Limitations - Exterior
 Information: These photographs are an indication of the obstructions and limitations which impeded the inspection of the external areas of the property at the time of inspection. These obstructions can hide an array of defects and should be removed to allow full inspection to be carried out. A re-inspection is recommended once the areas are made accessible.

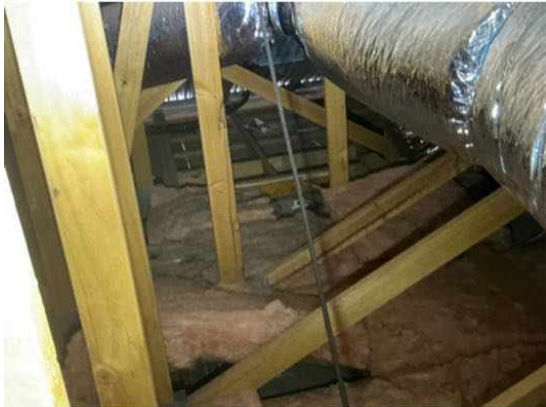
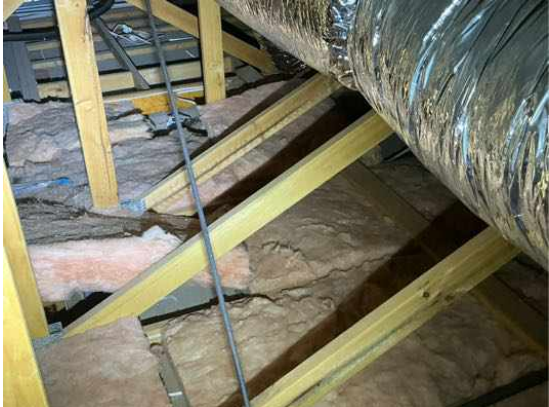
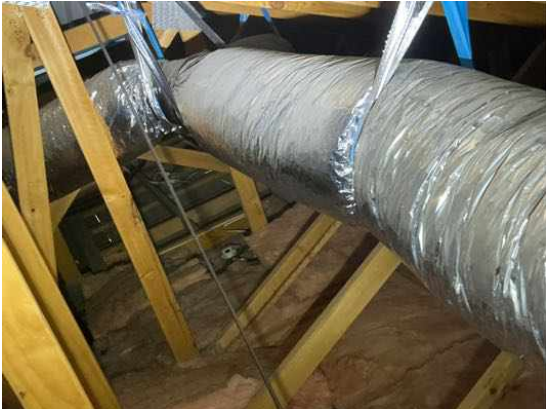
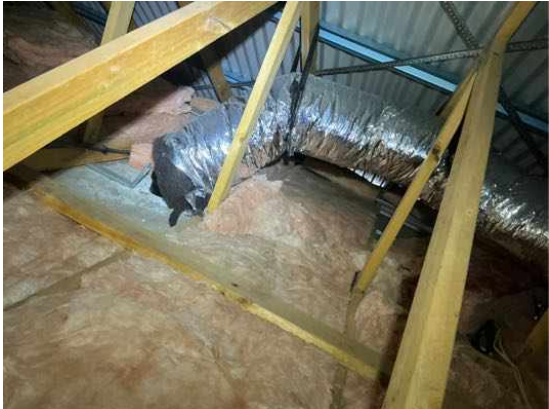
Noted Item

Building: Main Building
Location: Roof Void
Finding: Obstructions and Limitations - roof cavity
Information: These photographs are an indication of the obstructions and limitations which impeded the inspection of the roof cavity area of the property at the time of inspection. These obstructions can hide an array of defects and should be removed to allow full inspection to be carried out. A re-inspection is recommended once the areas are made accessible.
