Building and Timber Pest Inspection Report

Inspection Date: Tue, 24 Feb 2026

Property Address: 20 Pettitt St, Riverstone NSW 2765,
Australia

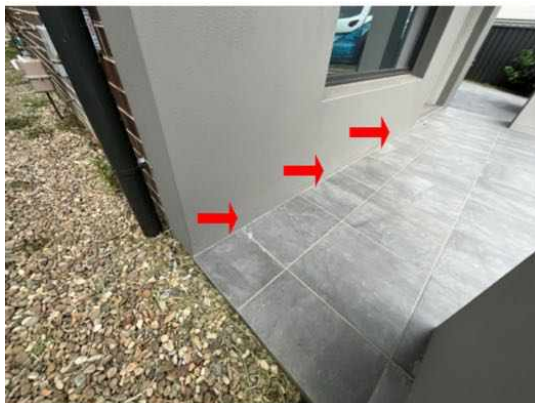
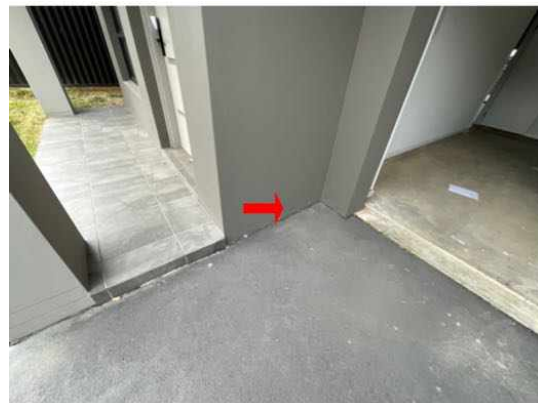
Finding 3.01

Building: Main Building
 Location: Porch
 Finding: Weepholes — inadequate
 Information: The weepholes to areas of the property are missing or inadequate.

Weepholes should be provided wherever it is necessary to drain moisture from or through masonry construction. Where flashings are incorporated in the masonry, weepholes shall be provided in the masonry course immediately above the flashing, at centres not exceeding 1200mm. The porch needs to be checked and repaired to comply with AS 3700-2011 Section 4.2.7.

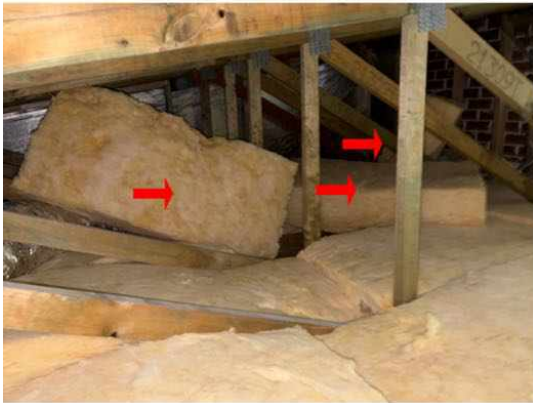
Finding 3.02

Building: Main Building
 Location: Roof Void
 Finding: Insulation - Moved
 Information:

Upon inspection of the roof void it was noted that some insulation is removed and or misplaced.

Insufficient insulation will result in a comparatively higher cost to heat and cool a property as there is a lack of Insulation (or uneven coverage of insulation) which works as a barrier to heat transfer. This helps to keep out unwanted heat in summer and preserves warmth inside your home in winter. It can also help soundproof your home from unwanted airborne noise transfer.

Installation of adequate insulation is required and should be conducted as soon as possible.

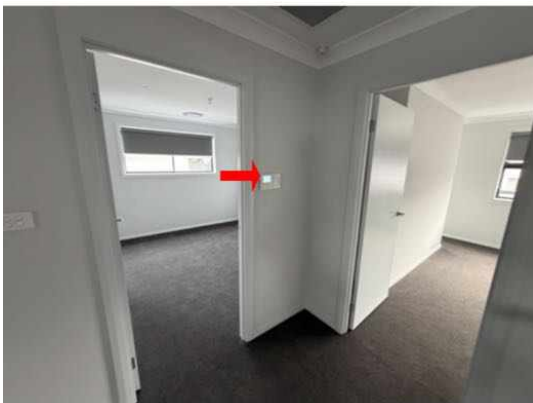
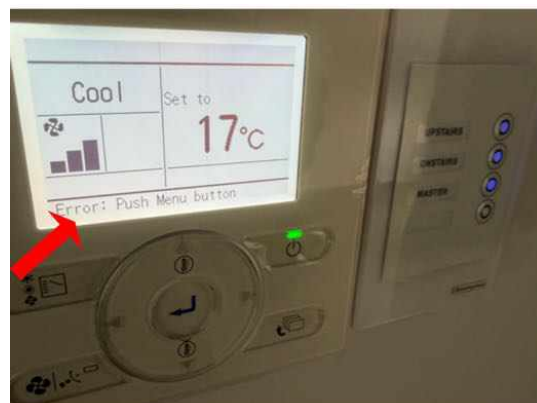
Finding 3.03

Building:	Main Building
Location:	Air conditioning unit
Finding:	Building element - Not operating
Information:	Non-operational items should be addressed to ensure that the full function of the building structure is available. Where some building elements are not operating as intended, it is possible that secondary building defects could arise due to their non-operation.

Repair and/or replacement of the faulty building element is recommended. It is highly recommended that the relevant tradesperson be engaged to perform any necessary works.

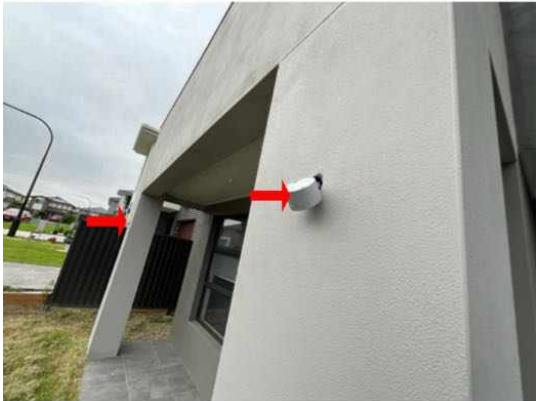
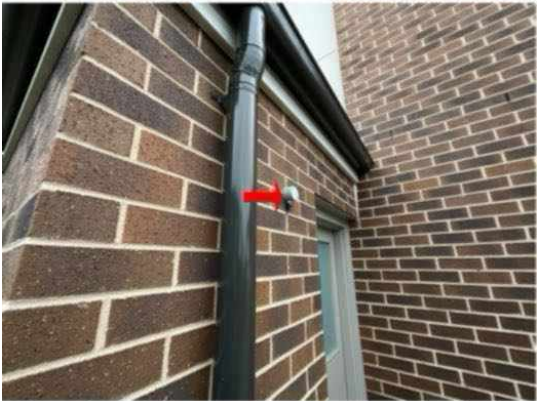
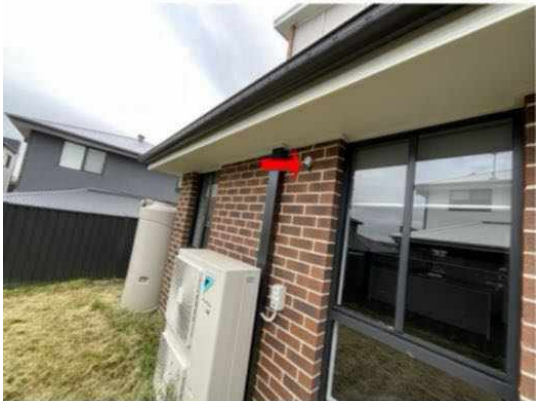
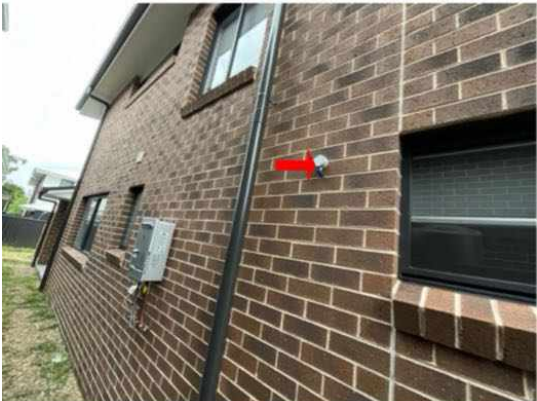
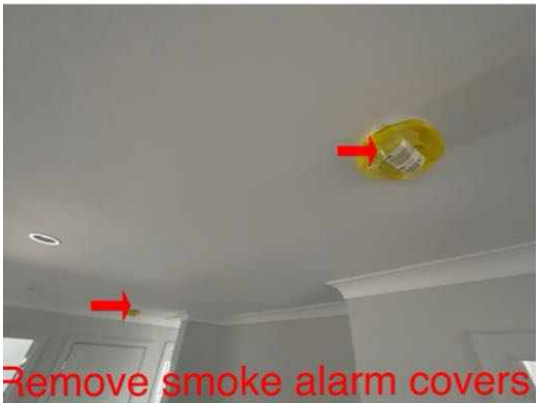
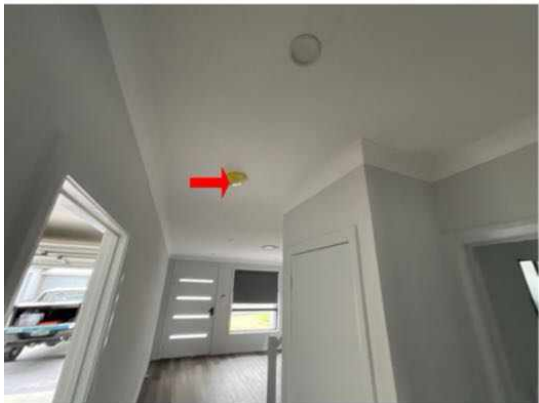
Finding 3.04

Building: Main Building
Location: Multiple areas
Finding: Incomplete or substandard works
Information: The works to this area appear to be incomplete or have been completed to a substandard level.

Works that have not been completed to a satisfactory level create potential for the development of building defects and may impede on the safety and integrity of the overall structure.

It is highly recommended that the relevant trades be appointed to complete these works and ensure the safety of the area and the longevity of all associated building elements.

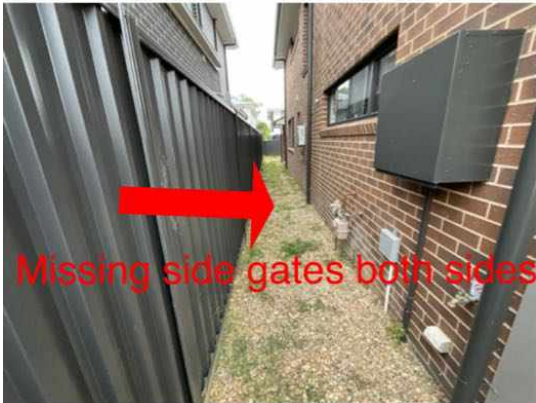
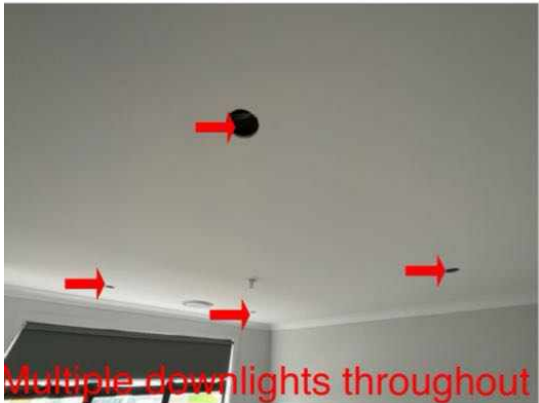
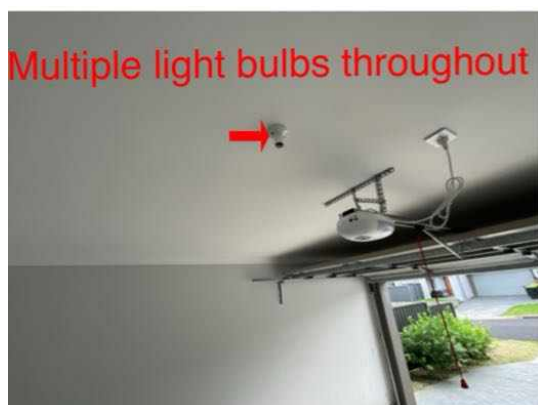
Finding 3.05

Building: Main Building
 Location: Multiple areas
 Finding: Building element - Missing
 Information: Although some building elements may seem irrelevant or unnecessary, all building elements play a key role in the operation and function of the overall structure and its performance.

Replacement of any missing building element should be conducted as soon as possible to ensure that no damage or functional issues occur to associated building materials.

The appropriate tradesperson should be appointed as soon as possible to replace the missing building element.

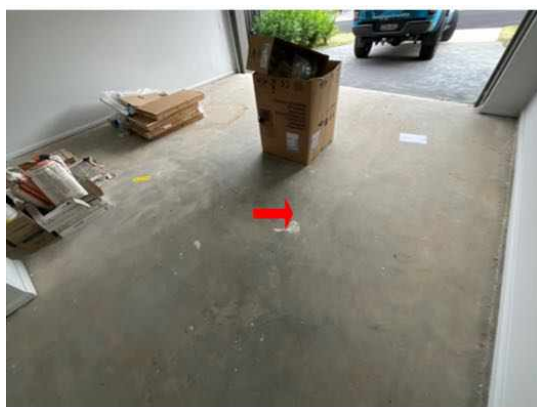
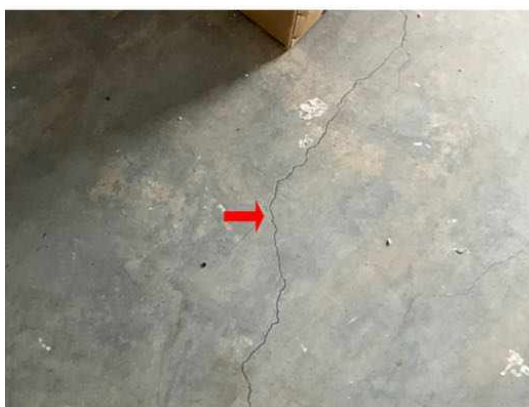
Finding 3.06

Building: Main Building
 Location: Garage
 Finding: Crack in concrete slab - Category 1
 Information: A crack coded as Category 1 was identified in the slab. A Category 1 crack is described as a fine but noticeable crack, with the slab at an otherwise reasonable level.

To be considered Category 1, the approximate width of the crack is less than 1.0mm, or a less than 10mm change in offset when a 3m straight edge is placed over the defect.

Category 1 cracks should be monitored for a period of 12 months. At the end of the monitoring period, identified cracks that are rated greater than Category 2 are considered defects, and require rectification.

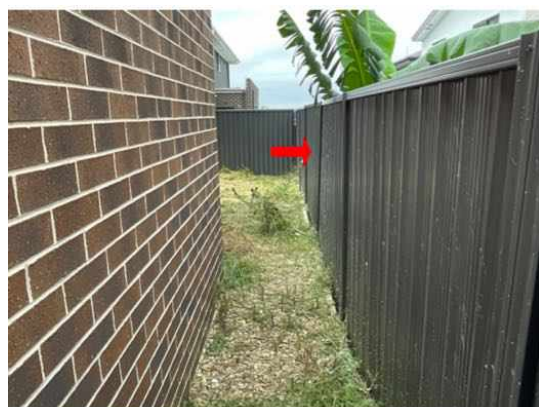
Finding 3.07

Building: Main Building
 Location: Fencing
 Finding: Fencing - Deteriorated
 Information: It was noted at the time of inspection that sections of the fencing in this area has

deteriorated. Typically fencing deteriorates due to age and or wear, rot and or rust which is generally expected for a structure of this age, due to prolonged exposure to weather conditions. Sometimes inadequate installation or maintenance can be to blame.

If left unattended, it is likely that further damage will occur. It is suspected that repair of several elements of the fencing may be required however replacement may be a consideration of the client also.

A licensed fencing contractor should be appointed to provide further advice and perform rectification works as necessary.

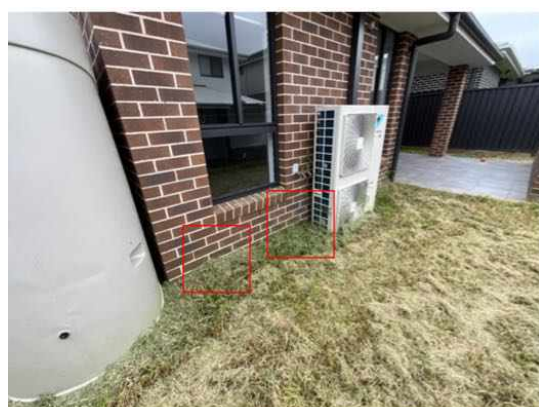
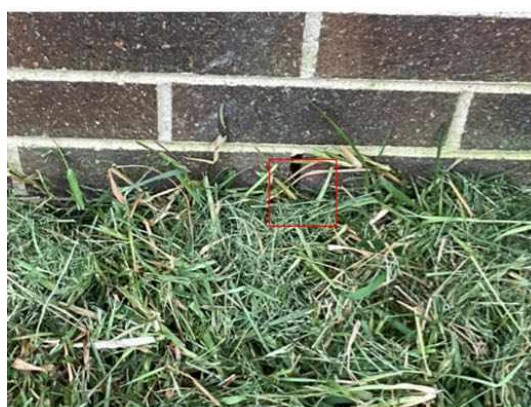
Finding 6.01

Building:	Main Building
Location:	Rear Elevation
Finding:	Bridging or breaching of termite barriers - weep holes
Information:	Bridging is the spanning of a termite barrier or inspection zone so that subterranean termites are provided with passage over or around that barrier.

Where weep holes are covered by external ground levels such as paving or garden beds concealed entry is available for termites from these grounds into the brickwork or external wall materials.

Additionally build-up of moisture is likely to occur if weep holes are covered further attracting termite activity to these areas.

It is highly recommended that weep holes are left exposed in all areas throughout the external property. Therefore if any termite activity leading into weep holes becomes easily detectable during frequent pest inspections.

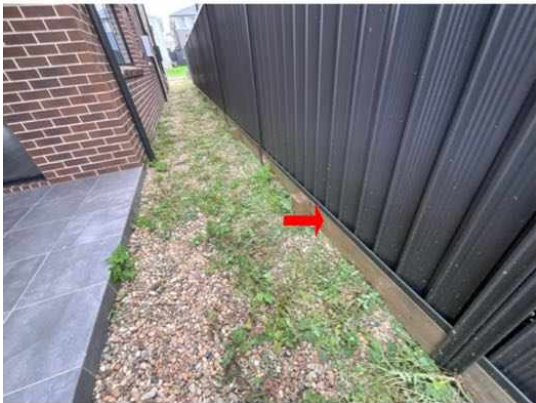
Finding 6.02

Building:	Main Building
Location:	Fencing & Landscaping
Finding:	Building materials in direct ground contact - conducive to termites
Information:	Where timber elements are in direct contact with the ground and consequently moisture or dampness they become conducive to termite activity. Whether timber is used as a building element part of a fencing structure or stored as an unused item they can provide an environment that is attractive to termite infestation.

When met with excessive moisture timber begins to decay and develop wood rot. Any timbers that are in direct contact with external grounds especially if left untreated or non-durable also provide ingress for subterranean termites into that particular element.

The removal of any such materials that may be conducive to termite activity should be removed as soon as possible to minimise the risk of termite attack.

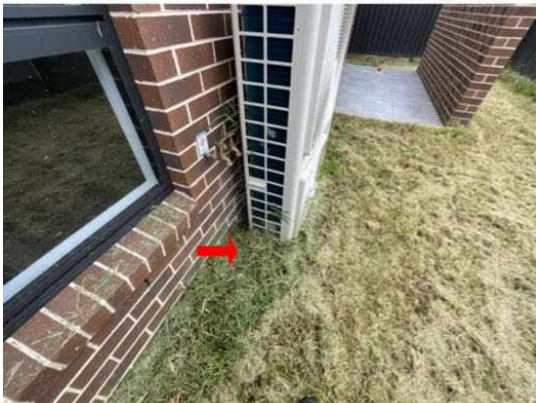
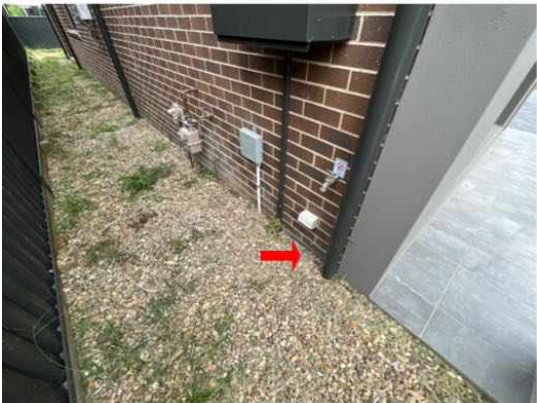
Finding 6.03

Building: Main Building
Location: External tap
Finding: Tap - No drain
Information: The external tap in this area was noted to have no drain at the time of inspection.

This keeps the surrounding surfaces damp while using the tap, which becomes conducive to termite activity.

A licensed plumber must be appointed to ensure an appropriate drain is installed.
