## Building Inspection Report

Inspection Date: Tue, 24 Mar 2026

Property Address: 62 Calibre Circuit, Clyde North VIC 3978,  
Australia

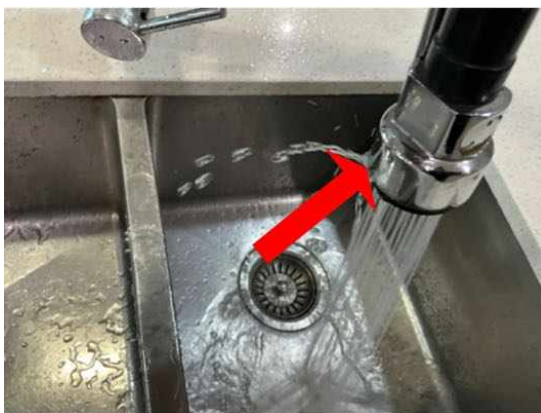
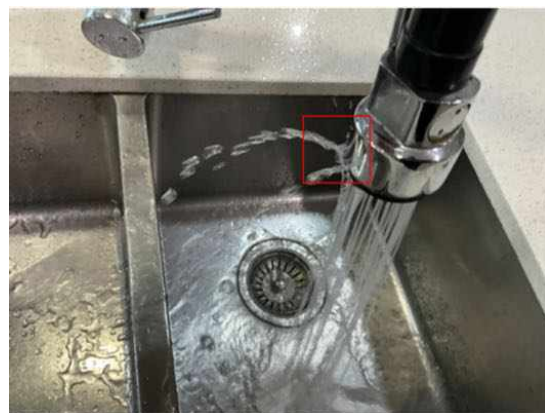
#### Defects 3.01

Building: Main Building  
Location: Kitchen  
Finding: Defective Kitchen Tap Mixer – Water Splashing from Mixer Head  
Information:

The kitchen tap mixer was observed to be operational; however, during use, water intermittently splashes out from the mixer head. This indicates a defect within the mixer outlet, potentially due to a worn aerator, internal component failure, or minor blockage affecting the water flow.

If left unaddressed, this condition may lead to inefficient water usage, ongoing inconvenience, and potential minor water damage to surrounding cabinetry or benchtop surfaces over time.

It is recommended that a licensed plumber inspect the kitchen tap mixer to identify the exact cause of the issue. The plumber should repair or replace the faulty components, including the mixer head or the entire tap assembly if required, to ensure proper and controlled water flow.

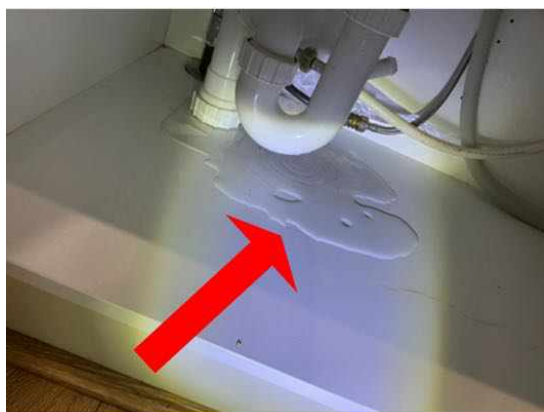
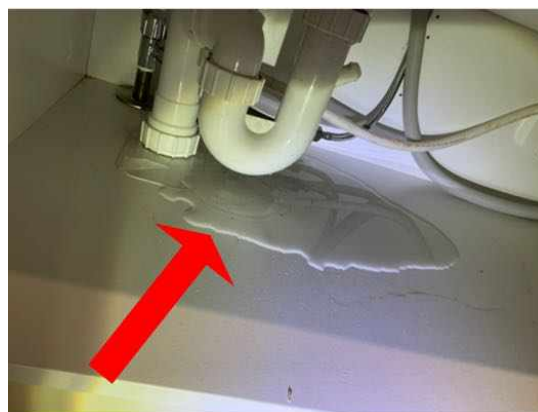
#### Defects 3.02

Building:	Main Building
Location:	Kitchen
Finding:	Kitchen plumbing pipes - Leaking
Information:	The plumbing pipes in the kitchen were found to be leaking at the time of inspection.

This is a common defect that is consistent with general ageing of the building element. However, it may be indicative of substandard plumbing workmanship if the tap is relatively new.

While this defect only seems minor, if left unmanaged, it is likely to result in the development of rust, water damage and/or extensive water usage.

It is advised that a handyman or licensed plumber be appointed to perform remedial works on the affected tap. Such works should be performed prior to the development of secondary defects to ensure adequate functionality of all associated building elements

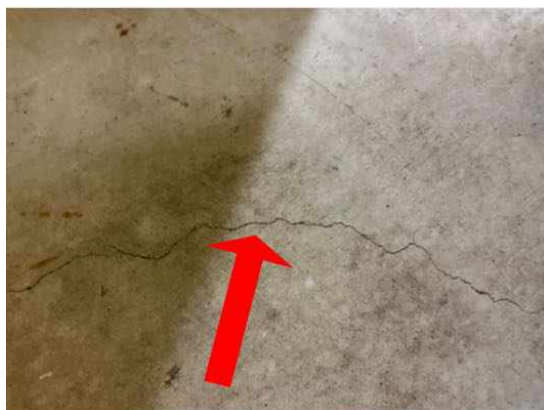
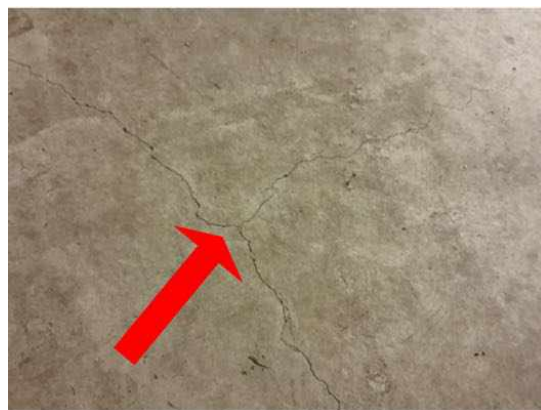
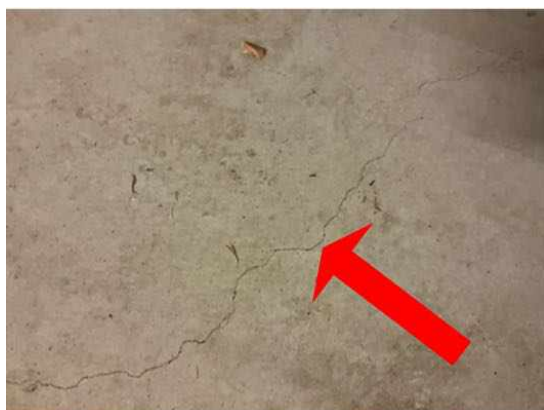
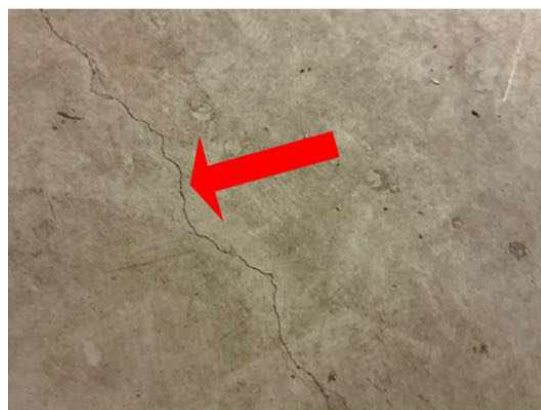
### Defects 3.03

Building:	Main Building
Location:	Garage
Finding:	Noticeable cracks in concrete slab of the the garage floor
Information:	During the inspection, multiple noticeable cracks were identified in the concrete slab of the garage floor. These cracks vary in size and location, which may indicate underlying movement or stress within the slab. While they do not currently appear to significantly impact the structural integrity, their presence suggests potential early-stage deterioration.

It is recommended that the cracks be monitored closely over the next 12 months. If any of the cracks widen or worsen during this period, it is critical to engage a structural engineer immediately to assess the situation and recommend appropriate rectification measures to prevent further damage and ensure the long-term stability of the structure.

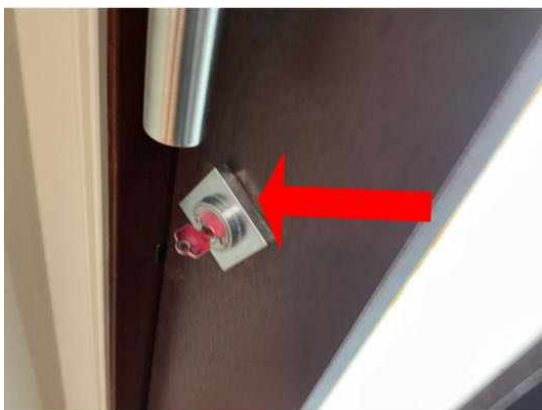
### Defects 3.04

Building: Main Building  
Location: Entry  
Finding: Loose Entry Door Lock Assembly – Not Securely Fixed  
Information:

The entry door lock assembly was observed to be loose and not securely fixed to the door. The escutcheon/cover plate surrounding the lock cylinder is unstable and moves when the key is operated, indicating that the fixing screws or internal components are not properly secured.

If left unaddressed, this condition may compromise the security of the property and may lead to further loosening or failure of the locking mechanism, potentially preventing proper locking of the entry door.

It is recommended that a qualified locksmith inspect the entry door lock assembly and securely fix or re-install the lock components. Replacement of the lock or associated hardware may be required if the existing unit is found to be defective or worn.

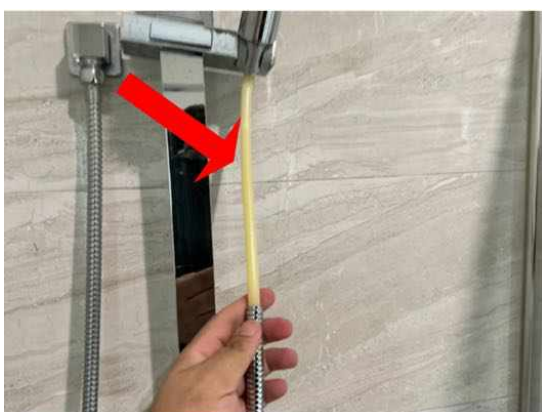
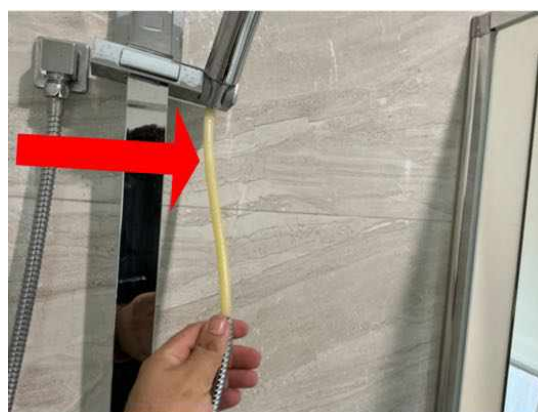
### Defects 3.05

Building: Main Building  
 Location: Ensuite  
 Finding: Shower Hose Inner Lining Deterioration – Potential Failure  
 Information:

The handheld shower hose was observed to have deterioration of the internal lining, with a yellow inner tube protruding from the outer flexible hose. This indicates that the hose has failed internally and the protective outer layer is no longer intact.

If left unaddressed, the hose may rupture during use, leading to uncontrolled water discharge, potential water damage to surrounding areas, and inconvenience to occupants.

It is recommended that a licensed plumber replace the shower hose with a new compliant unit to ensure safe and proper operation of the shower fixture.

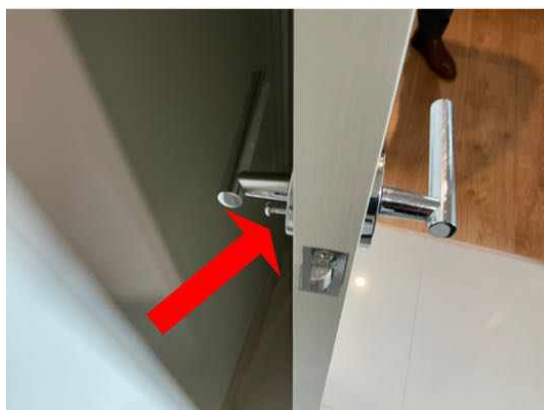
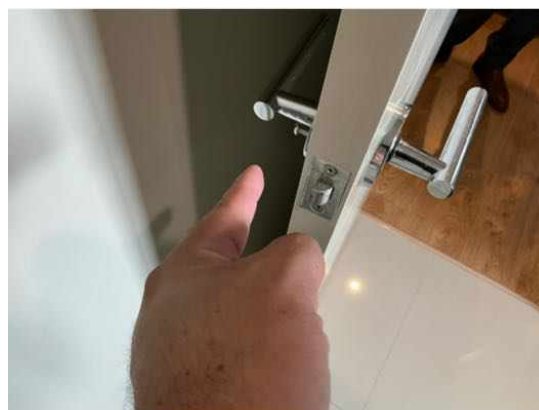
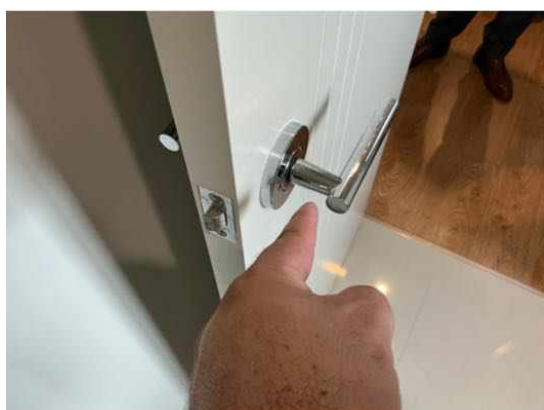
### Defects 3.06

Building: Main Building  
 Location: Ensuite  
 Finding: Ensuite Bathroom Door Lock Misalignment – Does Not Latch Properly  
 Information:

The ensuite bathroom door lock was observed to be misaligned and does not engage

If left unaddressed, the door may fail to latch or lock securely, leading to reduced privacy and potential ongoing wear to the lock and door components due to improper engagement.

It is recommended that a qualified carpenter or handyman realign the door, latch, and striker plate to ensure proper engagement and smooth operation of the locking mechanism.

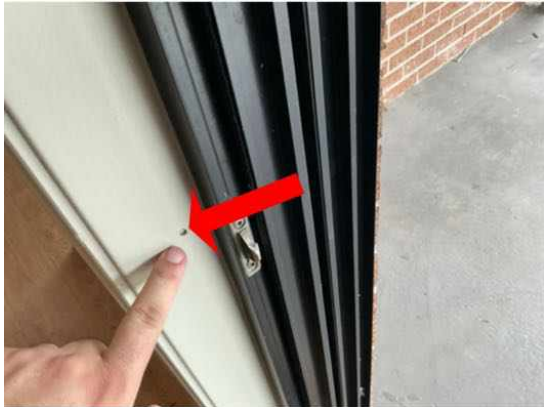
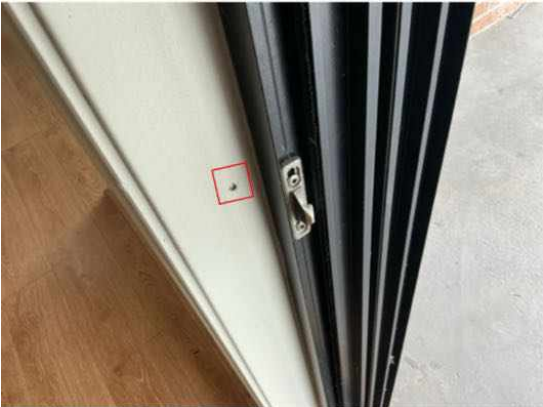
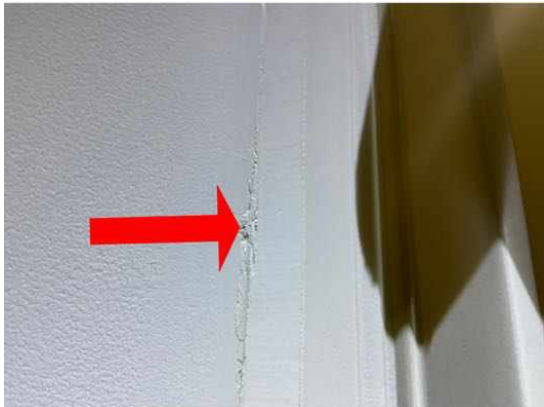
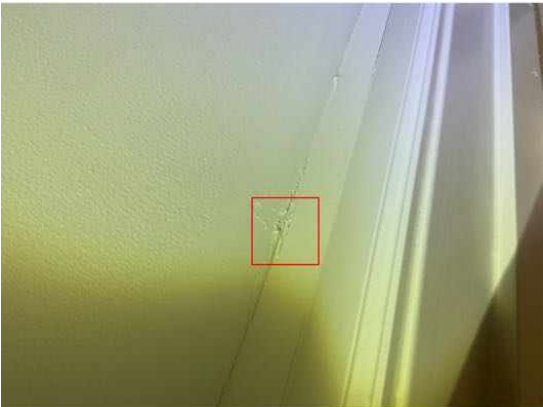
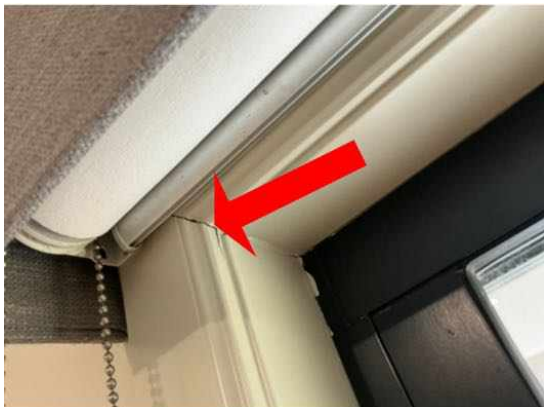
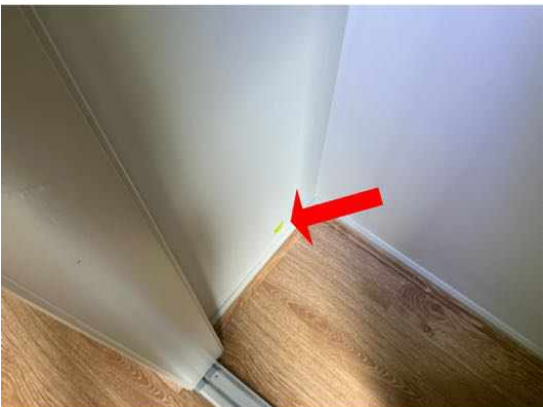
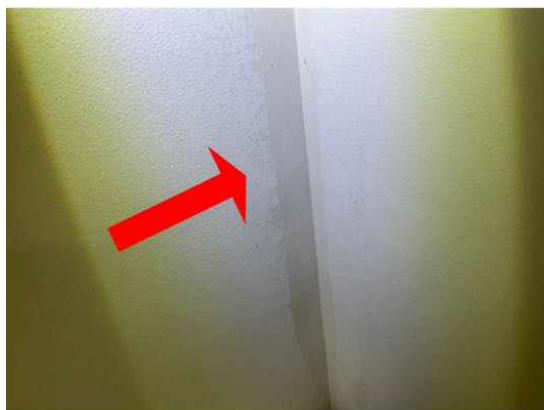
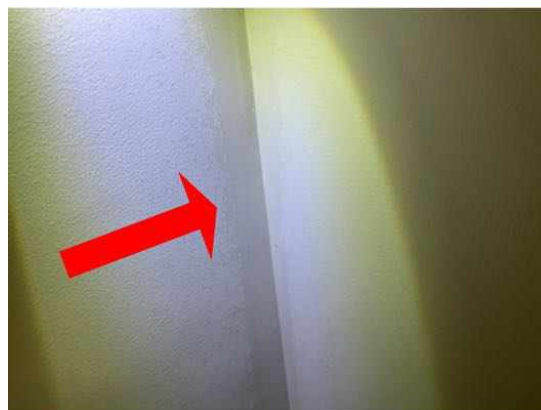
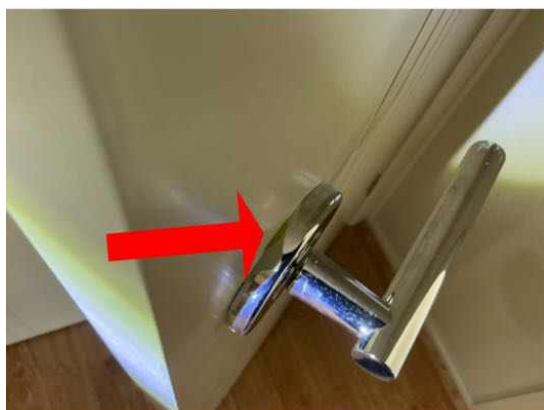
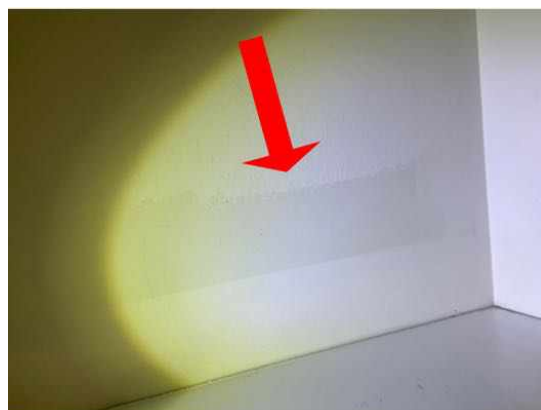
### Defects 3.07

Building: Main Building  
 Location: All Internal Areas  
 Finding: General Cosmetic Imperfections – Minor Wear and Finish Quality  
 Information:

performance of the building elements. They are typical of general wear and tear or finishing quality and do not constitute significant defects under the scope of this inspection.

Rectification of these items is at the client's discretion. Where desired, a qualified painter or handyman can carry out filling, sanding, and repainting works to improve the overall aesthetic finish.

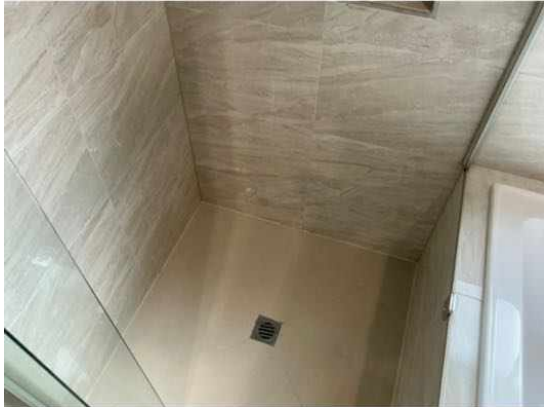
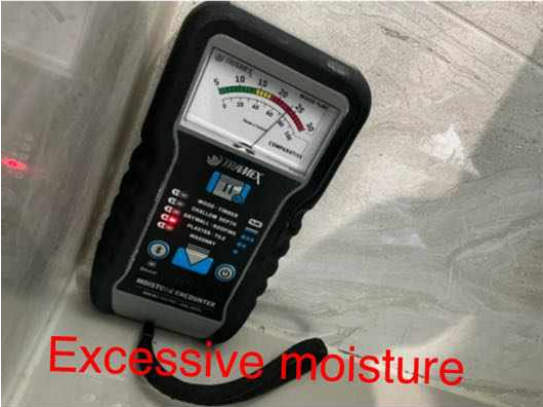
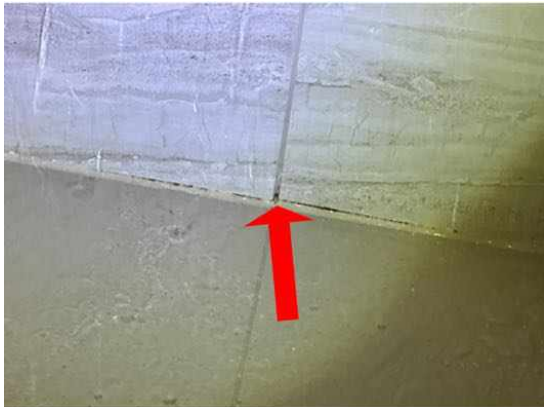
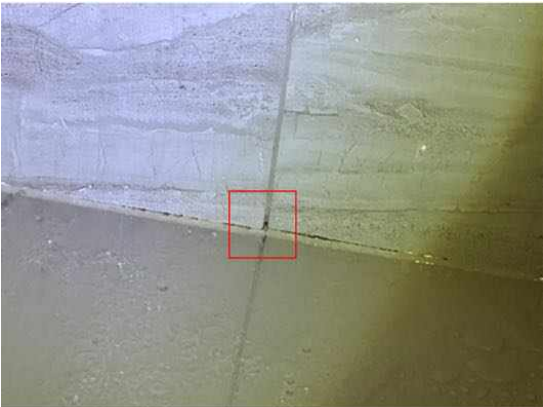
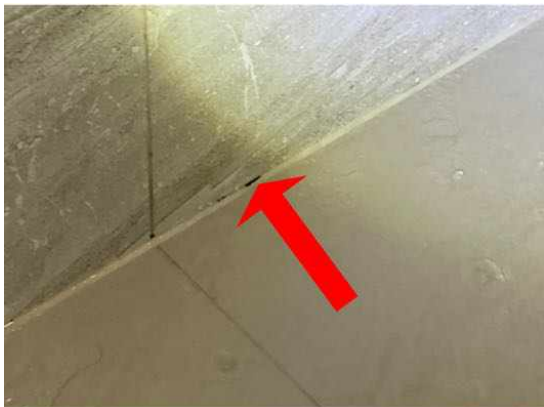
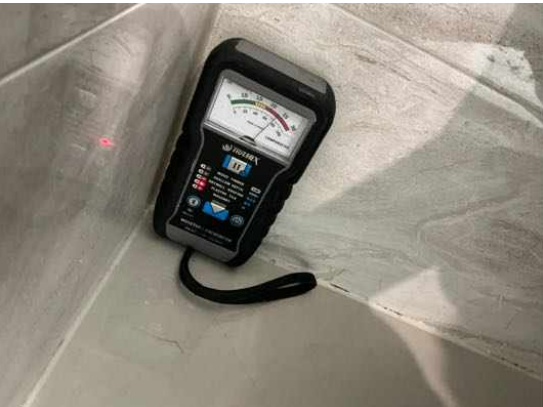
### Defects 3.08

Building:	Main Building
Location:	Bathroom 2
Finding:	Shower damp - Sealant and grout
Information:	Damp is evident to the lower 400mm of wall to the shower alcove. This defect is quite common, and is suspected to have been caused by moisture permeating or leaching through the grouting and sealant in this area, which shows evidence of deterioration. Leaking pipes within the wall is also a possible cause however this seems unlikely in this instance as there is no moisture build up around the taps or transferring to the other side of the wall. There appears to be no sealant around the tap spindles which may be a small contributing factor.

Damp (or structural damp) refers to the presence of unwanted moisture in the structure of a building, either as the result of intrusion from outside, or condensation from within the structure. In the shower area, internal water leaks, degraded materials or other sources of excessive moisture are generally the cause of damp.

Unmanaged damp in the shower recess is likely to facilitate the formation and development of mould and fungi growth, decaying associated building materials and compromising their structural integrity of associated elements. It is important to address damp conditions, as the World Health Organisation notes that excess moisture leads - on almost all indoor materials - to growth of microbes such as moulds, fungi and bacteria, which subsequently emit spores and other matter into the

indoor air. Exposure to these contaminants is associated with a wide range of respiratory and other health-related problems. Damp conditions also create a conducive environment for termite infestation.

Consultation with a bathroom sealant specialist is advised immediately to identify the cause of damp and to perform remedial works as required.

Always ensure that sealant and grout is in good condition to prevent any moisture issues occurring in the future.

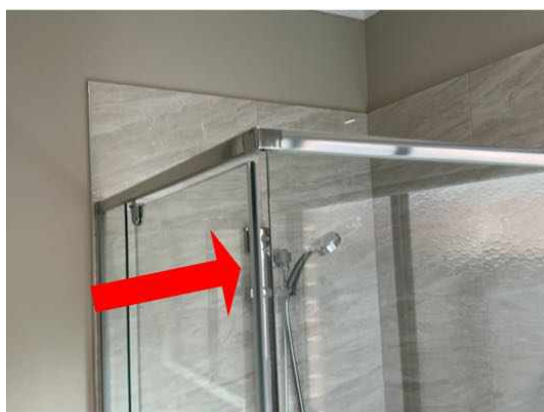
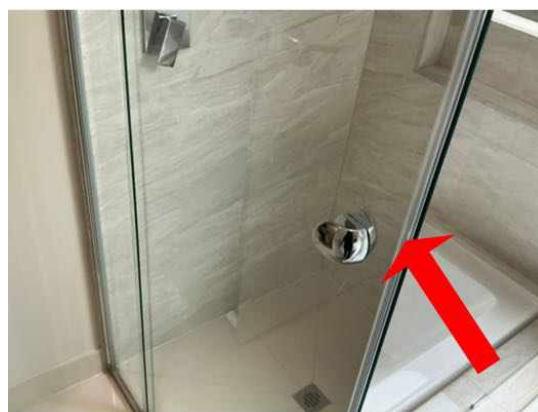
**Defects 3.09**

The shower screen door in the second bathroom was observed to close; however, it does not latch or secure in position due to the absence of a latching/catch mechanism.

If left unaddressed, the door may not remain properly closed during use, which can result in water escaping the shower enclosure and causing moisture damage to surrounding floor finishes and adjacent building elements.

It is recommended that a qualified shower screen installer or handyman supply and install an appropriate latch, magnetic strip, or catch mechanism, and adjust the door alignment as required to ensure the door closes and seals properly.

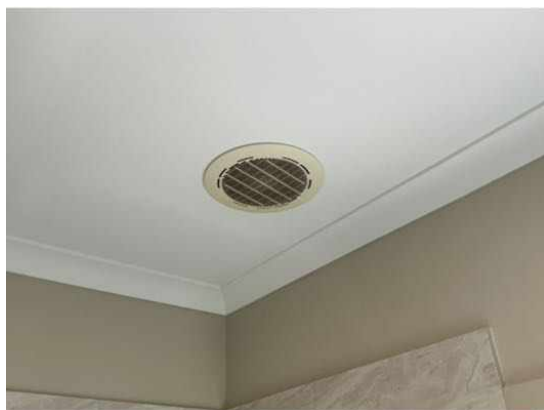
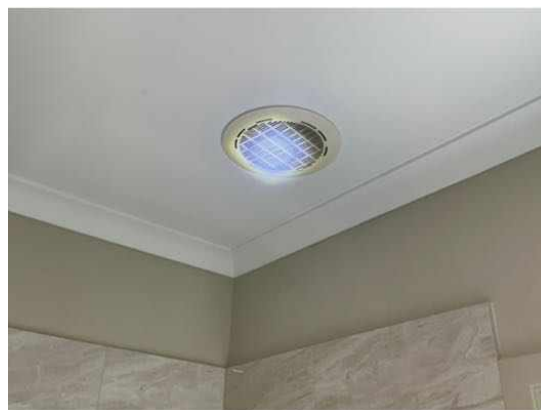
### Defects 3.10

Building: Main Building  
 Location: Bathroom 2  
 Finding: Non-Operational Exhaust Fan – Bathroom 2  
 Information:

If left unaddressed, the lack of mechanical ventilation may lead to the accumulation of moisture, increasing the risk of mould growth and deterioration of finishes within the bathroom.

It is recommended that a licensed electrician inspect the exhaust fan, verify power supply and connections, and repair or replace the unit as required to restore proper operation.

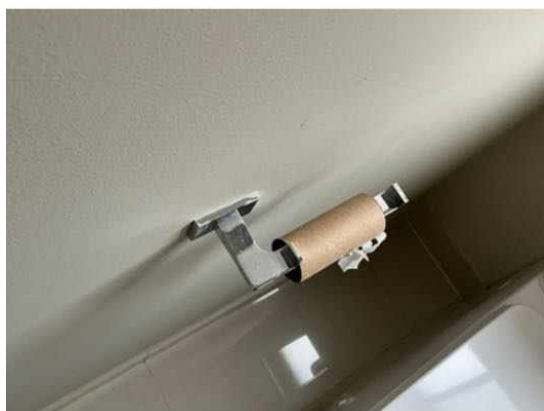
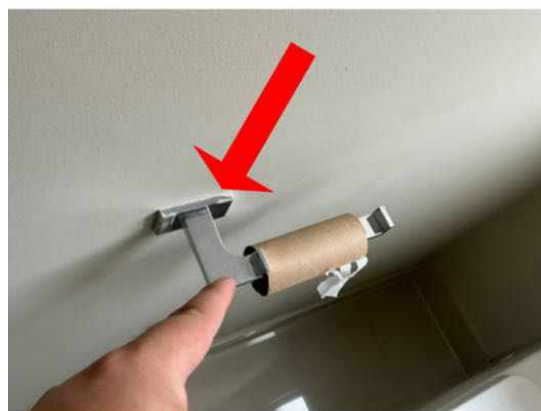
### Defects 3.11

Building:	Main Building
Location:	Toilet (WC)
Finding:	Toilet roll holder - Loose
Information:	The toilet roll holder was found to be loose at the time of inspection. While not a major operational defect, function can deteriorate if the problem is left unmanaged.

It is advised that the homeowner performs remedial works to re-attach the toilet roll holder to its original fixing. A general handyperson may be required to perform these works.

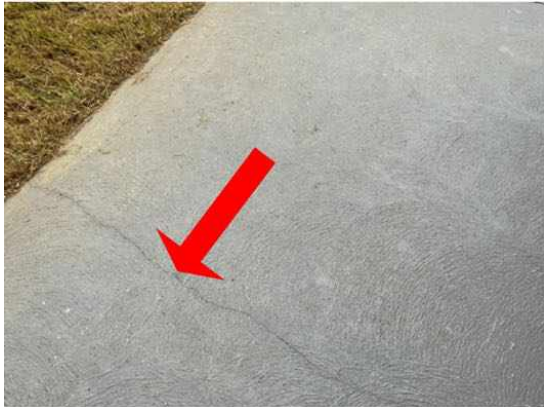
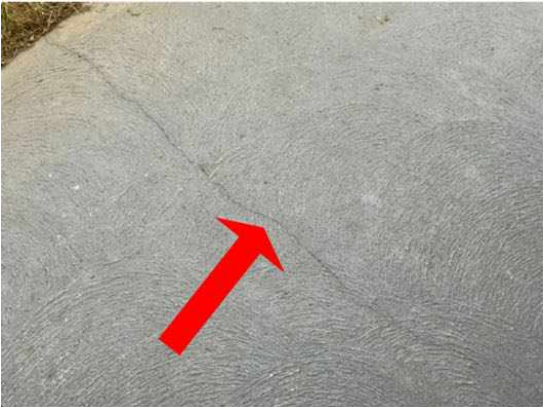
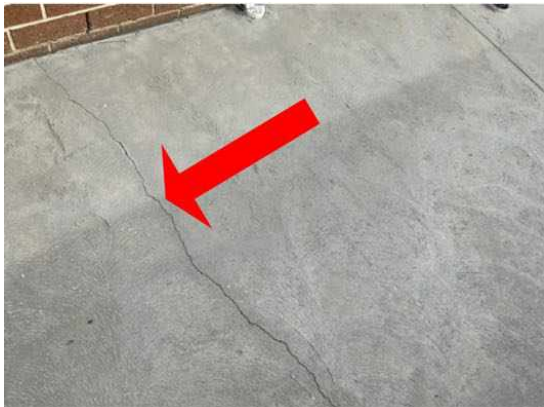
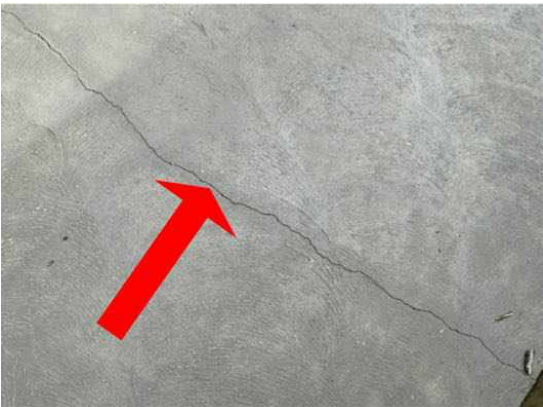
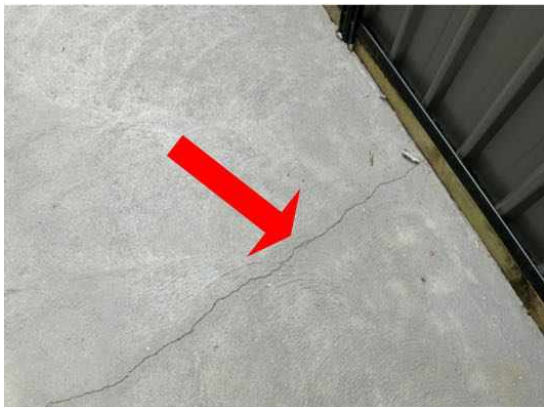
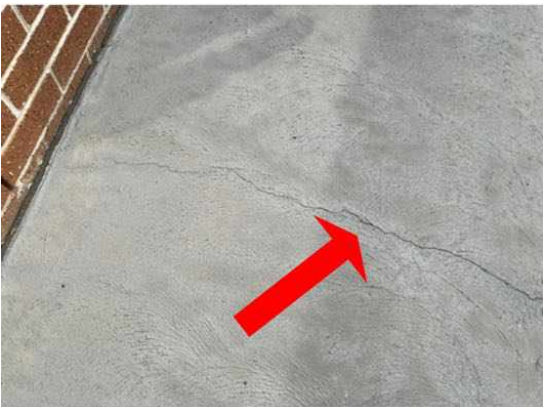
### Defects 3.12

Building:	Main Building
Location:	All External Areas
Finding:	Cracking - External Concrete Paving Damage Category 1 - Fine (less than 2mm)
Information:	Fine cracks were identified in external concrete paving. Although fine cracks are quite noticeable, they are often only considered to be an appearance defect, and usually do not indicate any structural damage. To be considered a Category 1 or fine crack, the crack is found to be less than 2mm in width.

Generally the cause of a hairline crack in existing concrete paving such as driveways

and pathways is indicative of the expansion and contraction of the concrete. Such causes are generally due to environmental factors, such as moisture levels, weather conditions, root systems of nearby trees or the soil types on which they are laid.

Fine cracks may also be due to poor original installation of the concrete. Factors such as poor compaction of the sub surface and/or inadequate reinforcing of the slab may create cracking and other secondary defects.

Monitoring of all cracking should be conducted frequently. Always contact a building inspector should cracks widen, lengthen, or become more numerous.

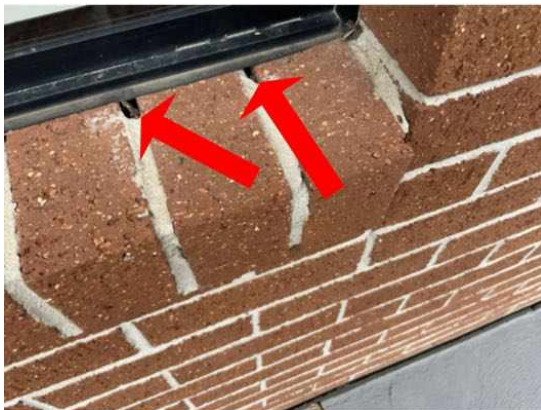
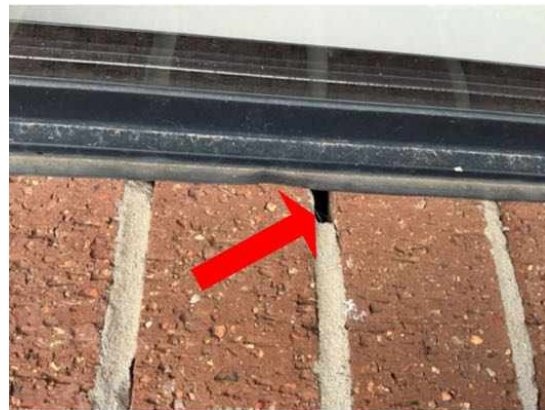
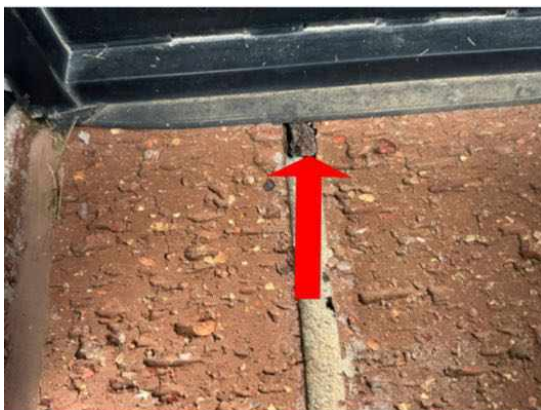
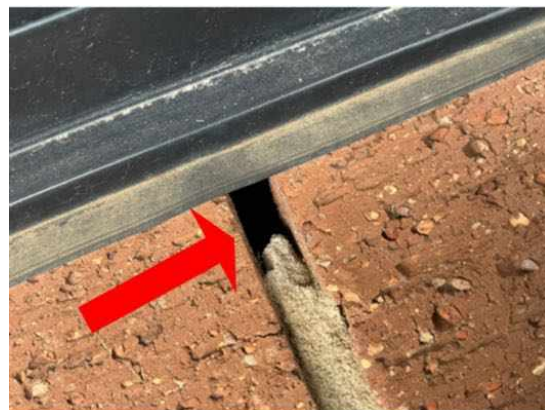
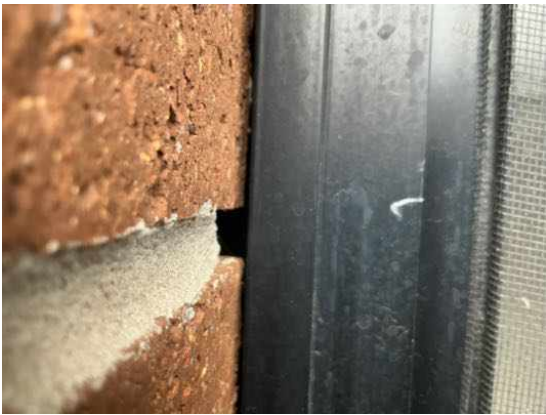
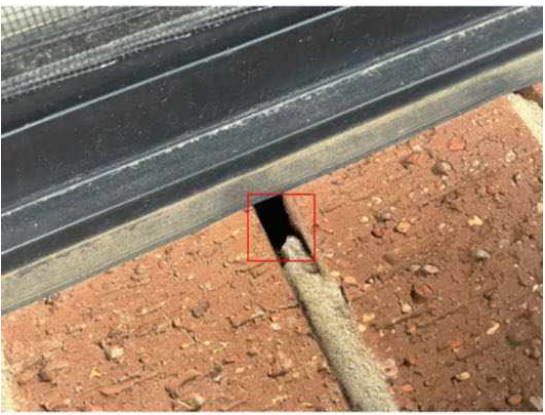
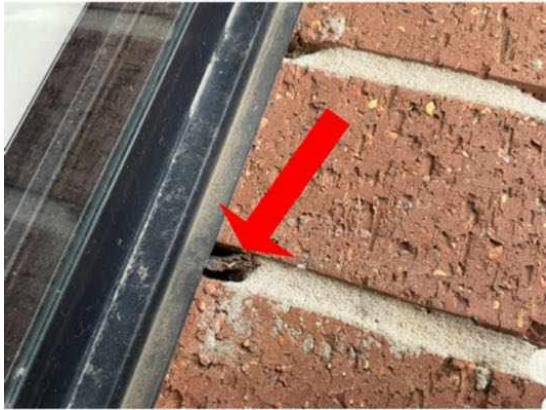
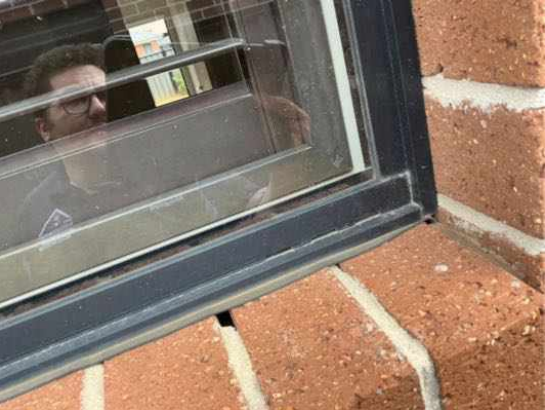
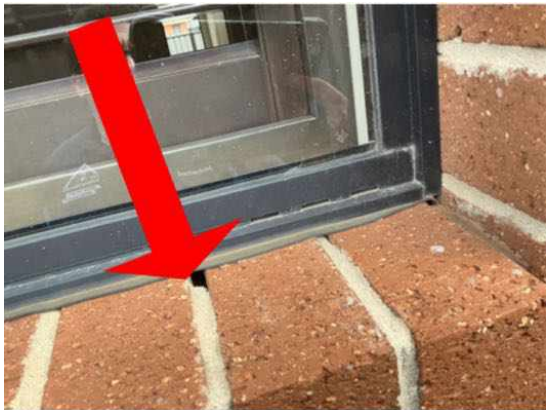
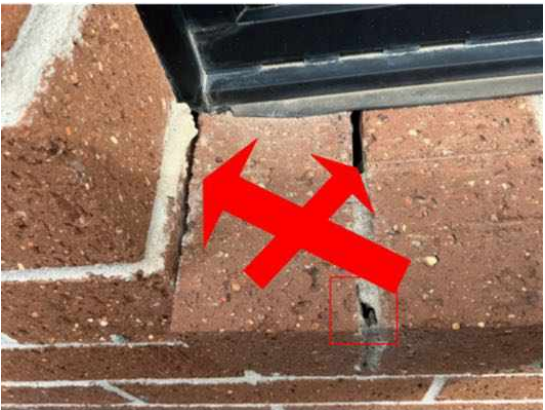
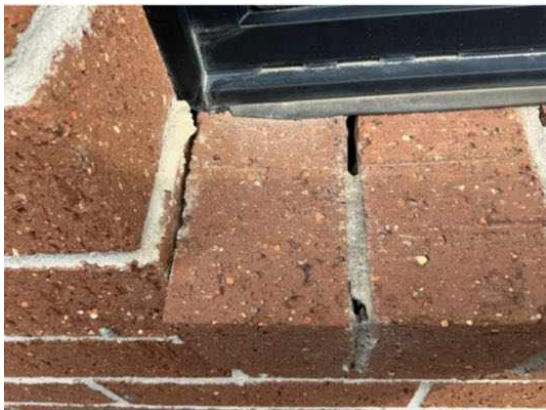
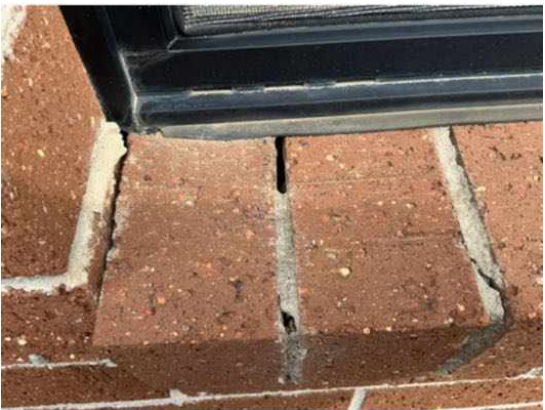
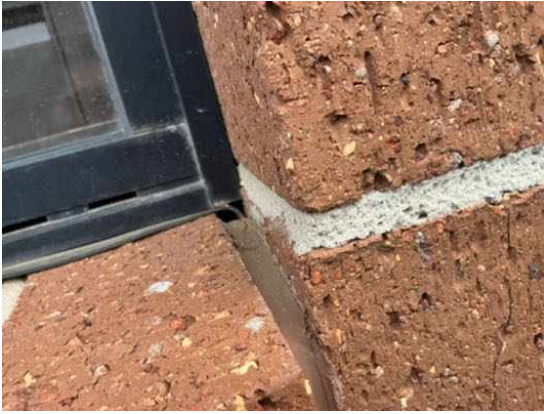
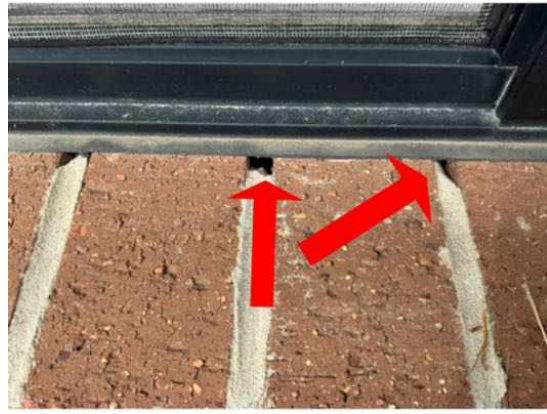
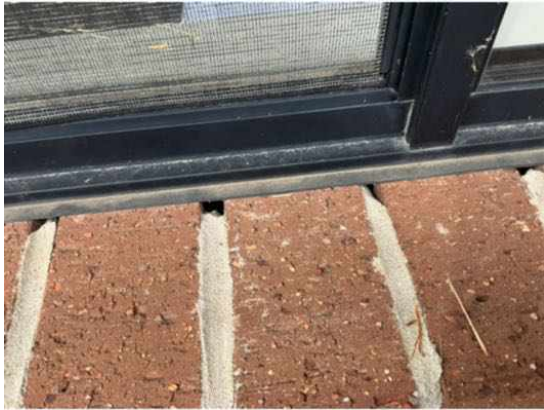
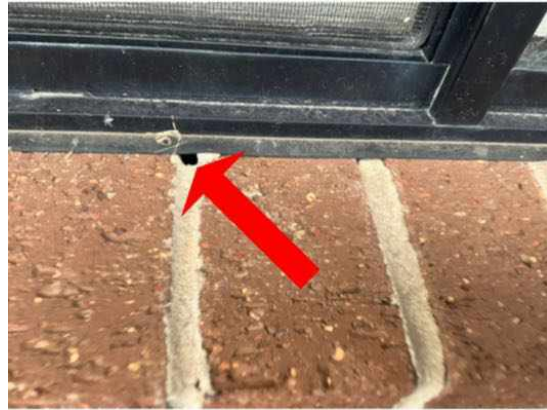
**Defects 3.13**

Building: Main Building  
Location: All External Areas  
Finding: Brickwork - Deteriorated mortar  
Information: Sections of the brickwork mortar around the external windows are missing with gaps visible around most of the windows. Mortar, or 'bedding', is the material which fills joins and intersections between bricks in masonry walls and structures. Sections of mortar in this brickwork were identified as having deteriorated, which is generally expected for a property of this age and condition.

Mortar may deteriorate as a result of age of building materials, minor movement of bricks, or frequent exposure to weathering. Mortar should be replaced to ensure that bricks remain in their intended location and to prevent gaps, which would allow water or moisture ingress and secondary damage as a result.

Mortar deterioration can be addressed by a bricklayer where areas of deterioration are localised and easily accessible. Alternatively, appointment of a registered builder is advised, to repoint large areas of decaying mortar. Where secondary structural defects have become evident, consultation with a structural engineer may be required.

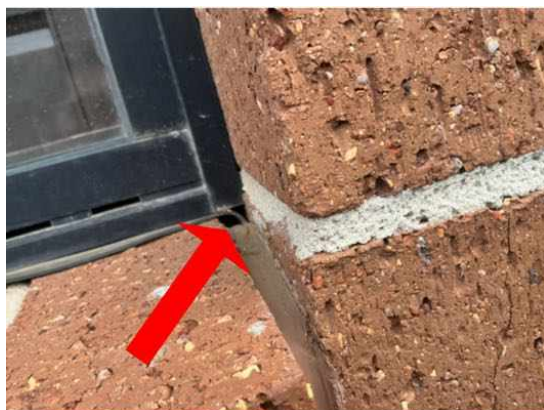
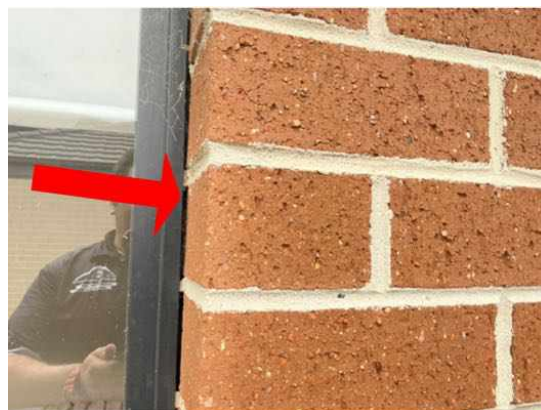
### Defects 3.14

Building:	Main Building
Location:	All External Areas
Finding:	Window seals - deteriorated
Information:	The window seals have deteriorated and are in a generally poor condition.

Where window seals have deteriorated, the window is no longer weather-tight; rain penetration and subsequent water damage is therefore likely to ensue. Insulation of the area against external weather conditions will also be compromised.

It is recommended that all deteriorated window seals be replaced by a general handyman or sealant expert to prevent any further damage and to restore the window to a fully functional level.

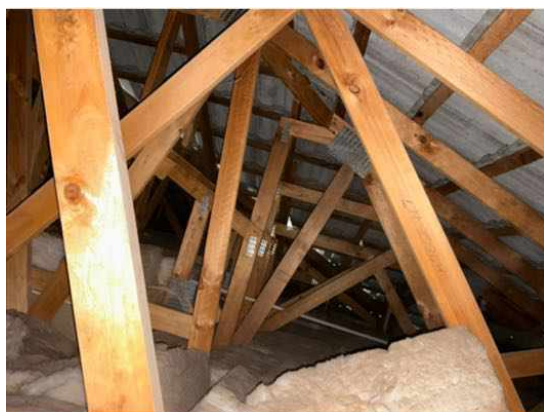
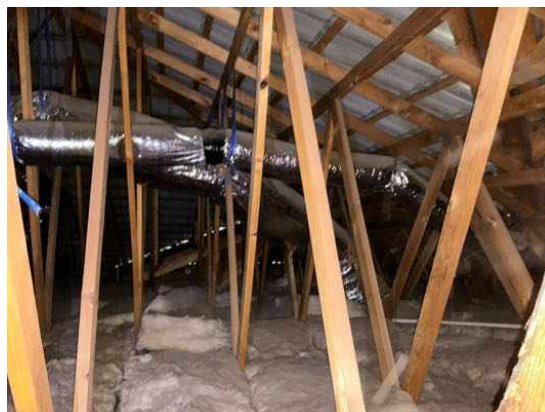
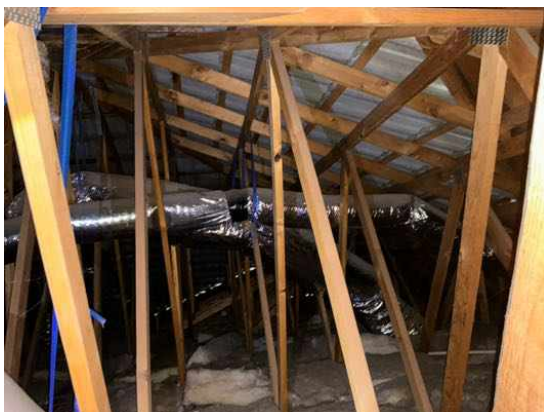
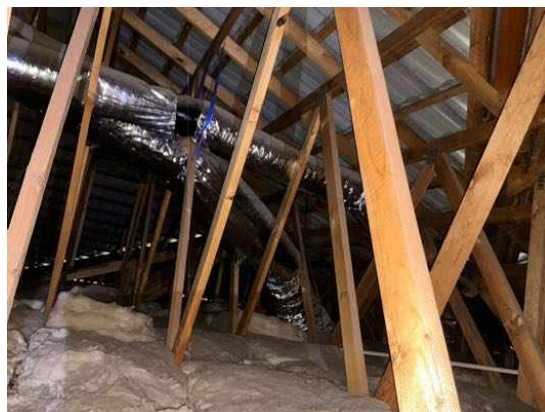
Building: Main Building  
Location: Roof Void  
Finding: Obstructions and Limitations - roof cavity  
Information: These photographs are an indication of the obstructions and limitations which impeded the inspection of the roof cavity area of the property at the time of inspection. These obstructions can hide an array of defects and should be removed to allow full inspection to be carried out. A re-inspection is recommended once the areas are made accessible.

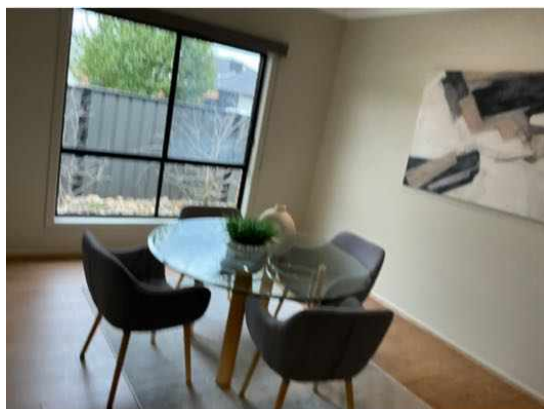
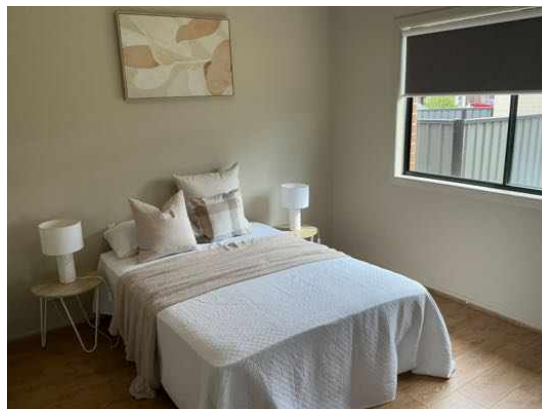
Building: Main Building  
Location: All Areas  
Finding: Obstructions and Limitations - Interior  
Information: These photographs are an indication of the obstructions and limitations which impeded the inspection of the internal areas of the property at the time of inspection.

These obstructions can hide an array of defects and should be removed to allow full inspection to be carried out. A re-inspection is recommended once the areas are made accessible.

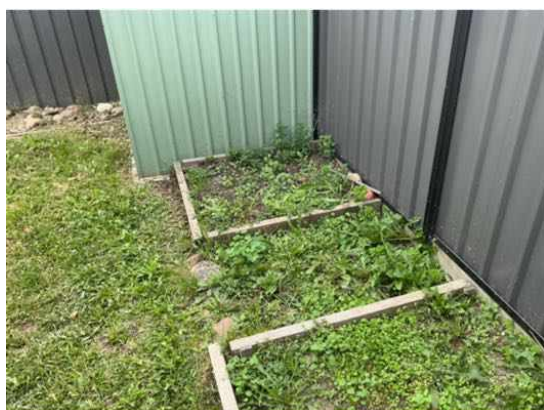
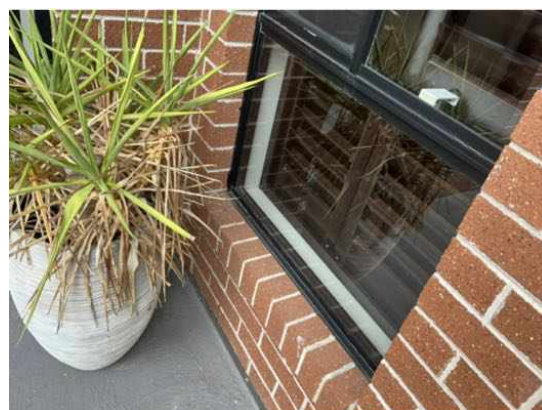
Building:	Main Building
Location:	All External Areas
Finding:	Obstructions and Limitations - Exterior
Information:	These photographs are an indication of the obstructions and limitations which impeded the inspection of the external areas of the property at the time of inspection. These obstructions can hide an array of defects and should be removed to allow full inspection to be carried out. A re-inspection is recommended once the areas are made accessible.

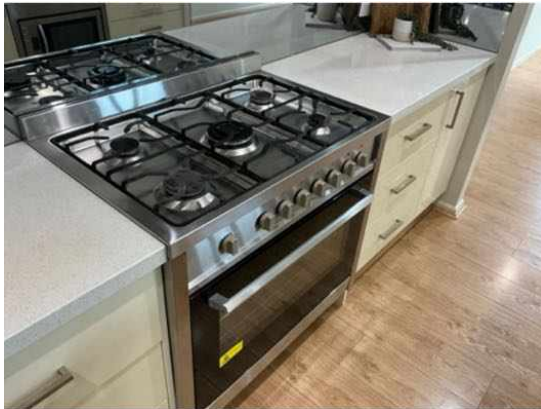
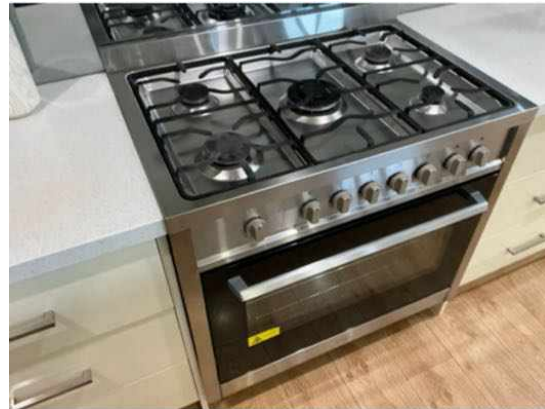
Building:	Main Building
Location:	Kitchen
Finding:	Gas Supply Not Connected – Gas Appliances Not Tested
Information:	At the time of inspection, the gas supply to the property was not connected from the main source. As a result, gas-fired appliances, including the oven, cooktop, and any

Due to the inability to test these appliances, their operational condition and safety could not be confirmed. Undetected faults, leaks, or non-compliant installations may be present and remain unidentified until the gas supply is reinstated.

It is recommended that once the gas supply is connected, all gas appliances and associated systems be inspected and tested by a licensed gas fitter to confirm their safe operation and compliance with relevant standards.
