Building and Timber Pest Inspection Report

Inspection Date: Tue, 24 Feb 2026

Property Address: 165 Quarry Rd, Ryde NSW 2112, Australia

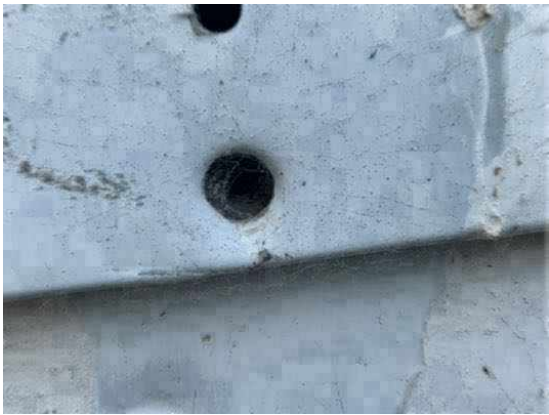
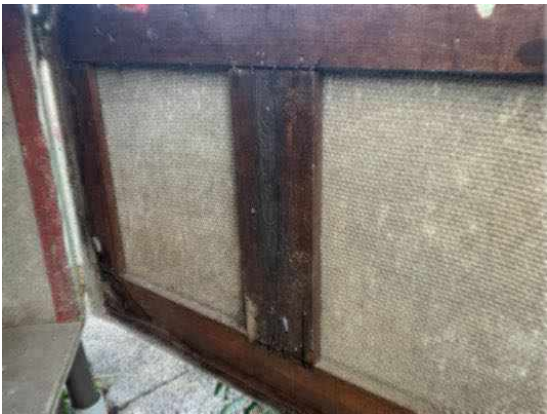
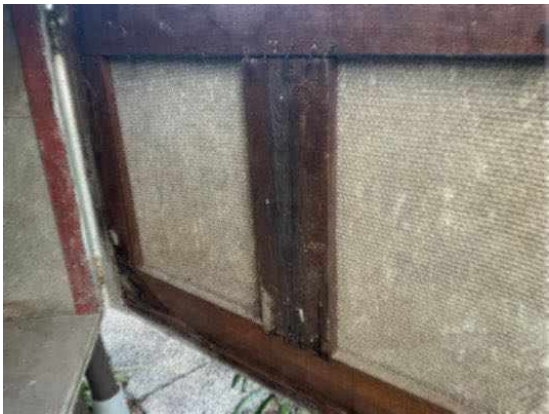
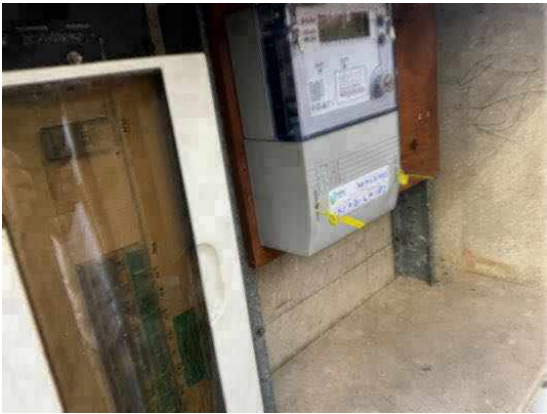
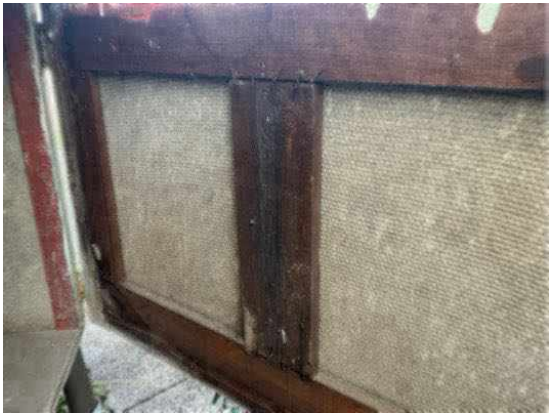
Building:	Main Building
Location:	All Areas
Finding:	Asbestos - Suspected ACM Identified on Site
Information:	Reporting on Asbestos is outside the Scope of this Report. This suspected defect is highlighted as a caution only. We suspect, based on our experience in the building industry, that there is a higher risk of the identified building element containing asbestos.

As Asbestos Reporting is outside the scope of this report, we advise that you consider a separate Asbestos Inspection and Condition Audit, which can include the taking of samples for definitive confirmation of the presence of Asbestos.

In the interim, the client is advised to act with caution, especially when considering any damage to building materials general wear and tear renovations extensions demolition and general maintenance activities due to the suspected presence of Asbestos.

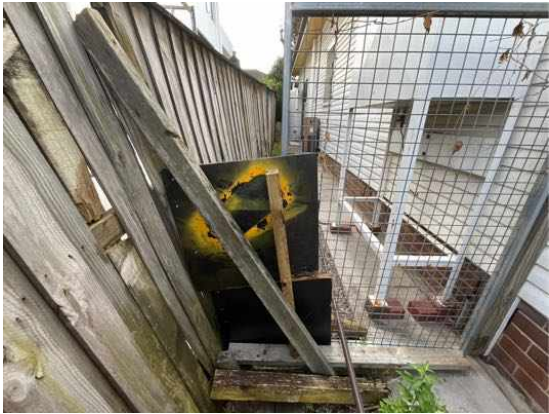
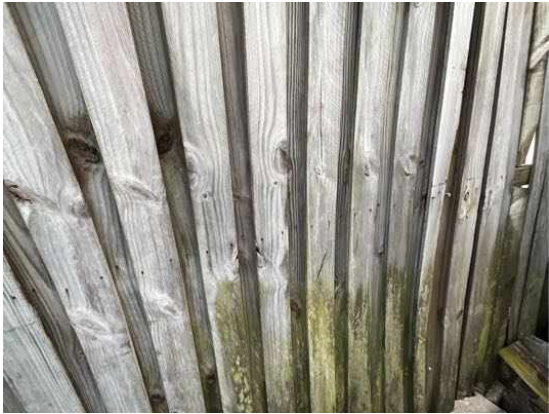
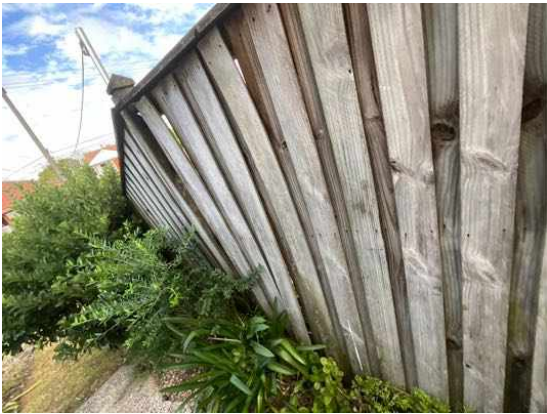
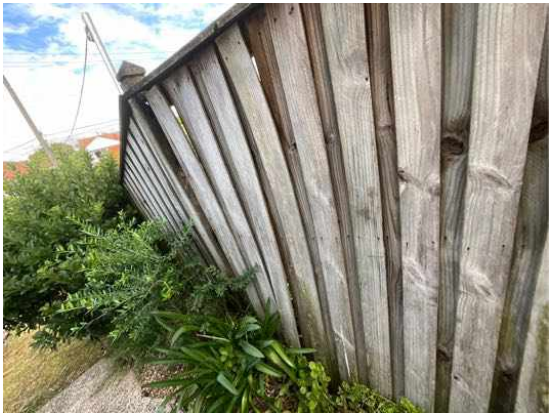
The fence along the property boundary has deteriorated significantly, showing signs of rot, rust, and structural weakness. Several sections are leaning or have become detached, compromising the integrity of the fence and its ability to perform its intended function.

The deteriorated fence poses multiple risks:

1. **Safety Hazard:** The unstable fence may collapse, posing a risk of injury to residents, visitors, and passersby.
2. **Security Concern:** The compromised fence may allow unauthorized access to the property, increasing the risk of theft, vandalism, or trespassing.
3. **Property Damage:** Falling sections of the fence could damage nearby structures, plants, or other property features.

- **Licensed Fencing Contractor:** A professional fencing contractor should be hired to assess the extent of the damage and either repair or replace the deteriorated sections.
- **Handyman Services:** For minor repairs, a qualified handyman could be engaged to reinforce or repair specific sections of the fence.
- **Landscaper (if the fence is part of a larger garden feature):** If the fence is integrated into the landscape design, a landscaper with experience in fencing could be involved in the repair or replacement process.

It's important to ensure that whoever is hired is experienced and qualified to ensure the fence is restored to a safe and functional condition, compliant with local regulations.

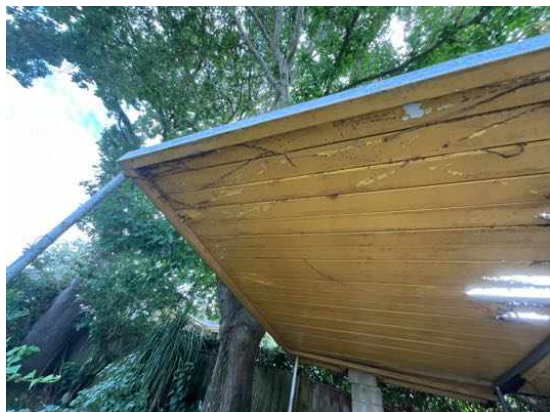
Finding 2.04

Building: Main Building
Location: Carport
Finding: carport shed - rusting
Information: The carport shed exhibits visible rusting on its structure, compromising its structural integrity and aesthetic appeal.”

Risk: Rust on the carport shed poses a risk of accelerated corrosion, potentially leading to weakened components and structural failure, which could result in safety hazards and reduced durability.

Resolution: Seek assistance from a qualified metalworker or a professional specializing in structural repairs. They can assess the extent of rust damage, perform necessary repairs, and apply protective coatings to prevent further deterioration. Regular maintenance is essential to prolong the lifespan of the carport shed.

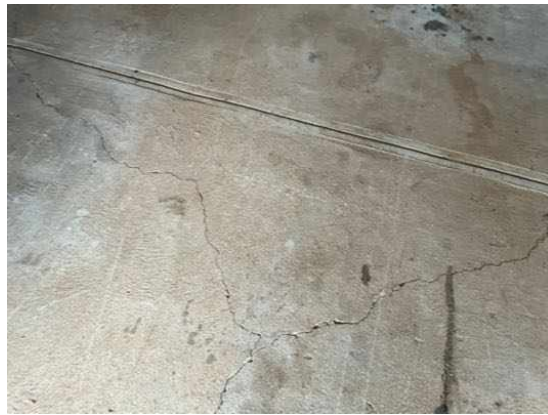
Finding 2.05

Building:	Main Building
Location:	All Areas
Finding:	Noticeable Cracking in Concrete Slab
Information:	Noticeable cracking has been observed in the concrete slab, failing to meet the required construction and quality standards.

- .
- Cracks are visible on the surface and may extend through the depth of the slab.
- Evidence of improper curing or inadequate reinforcement leading to cracking.

The presence of noticeable cracks in the concrete slab can result in:

- Compromised structural integrity of the slab, potentially leading to failure under load.
- Water ingress through cracks, causing corrosion of reinforcement and further weakening the structure.
- Potential trip hazards and aesthetic issues, reducing the overall value and safety of the property.
- Increased maintenance and repair costs due to ongoing deterioration.

- A structural engineer should be engaged to assess the extent of the cracking and recommend appropriate repair methods.
- A licensed contractor or concrete repair specialist should carry out the recommended repairs under the guidance of the structural engineer.

A detailed inspection should be conducted post-repair to confirm compliance with the required standards and to ensure that the structural integrity of the concrete slab has been restored.

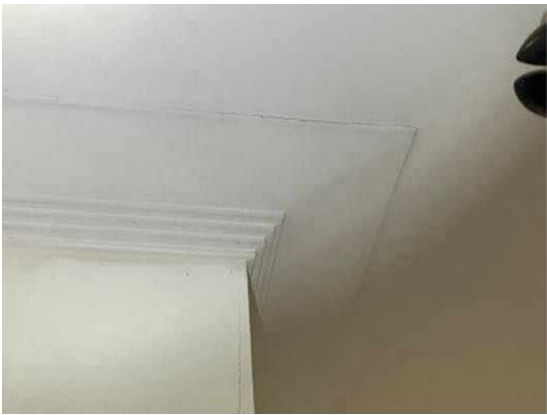
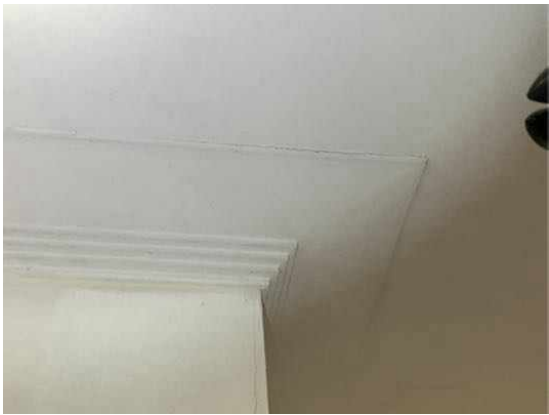
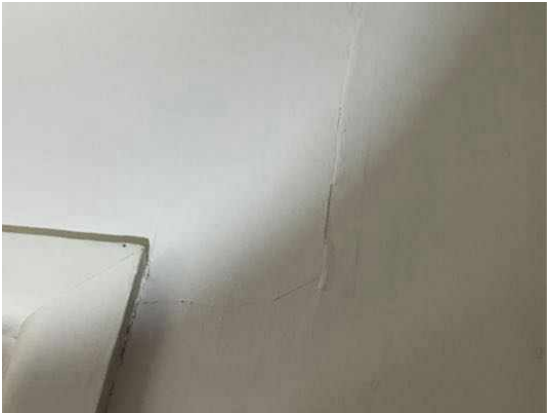
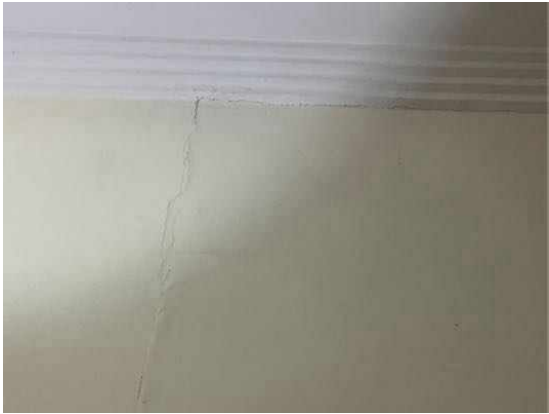
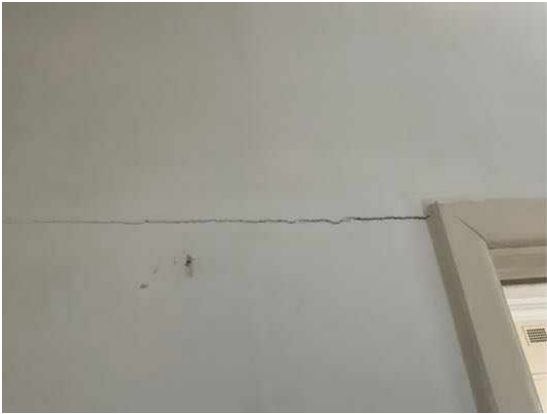
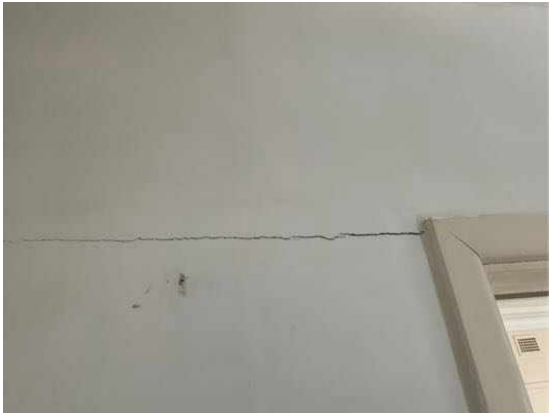
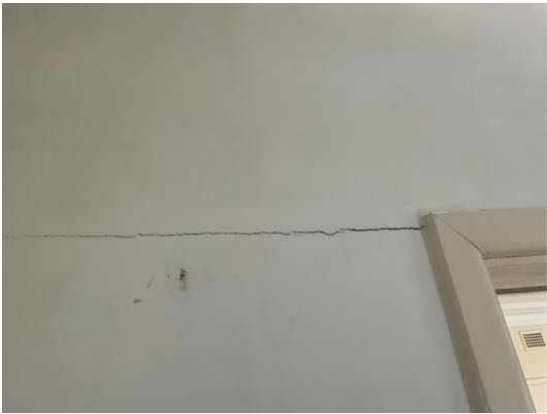
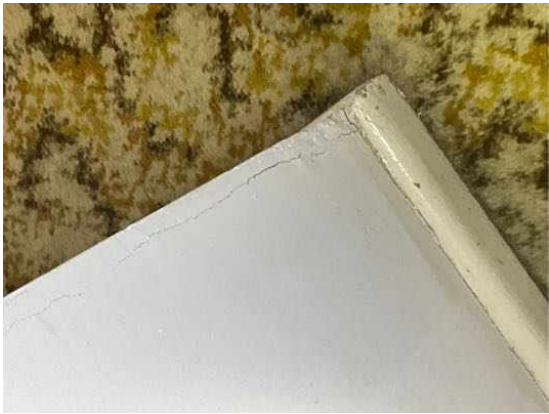
Finding 2.06

Building: Main Building
Location: All Areas
Finding: Gyprock - Crack (Fine) - walls and ceiling
Information: cracks have appeared in the gyprock of the ceiling and walls, suggesting potential issues with settling or structural movement.

These cracks in the gyprock pose a risk of further widening, compromising the aesthetic appeal of the space, and potentially indicating underlying structural problems.

A skilled plasterer or a contractor specializing in drywall repairs should assess the

extent of the cracks and address them promptly. Identifying and fixing the root cause of the issue, whether related to settling or structural concerns, is essential to prevent further damage and maintain the integrity of the ceiling.

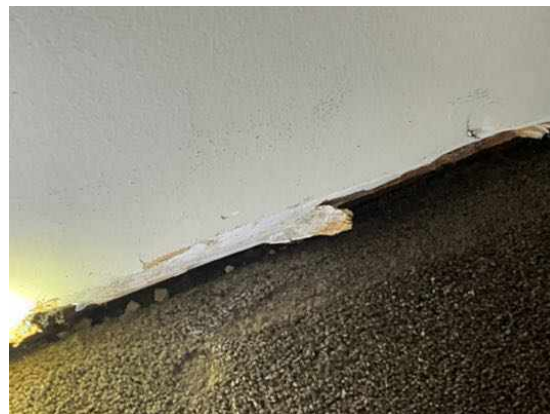
Finding 2.07

Building:	Main Building
Location:	Ensuite
Finding:	Suspected- Water damage
Information:	The area has sustained suspected water damage resulting in potential structural issues. This damage compromises both the aesthetic and functional aspects.

1 ****Plumber:**** If the water damage is due to plumbing issues, a plumber can fix leaks and ensure there are no further water-related problems.

2 ****General Contractor:**** If the damage is extensive and affects the surrounding area, a general contractor can coordinate the repair work, including any related structural or cosmetic repairs.

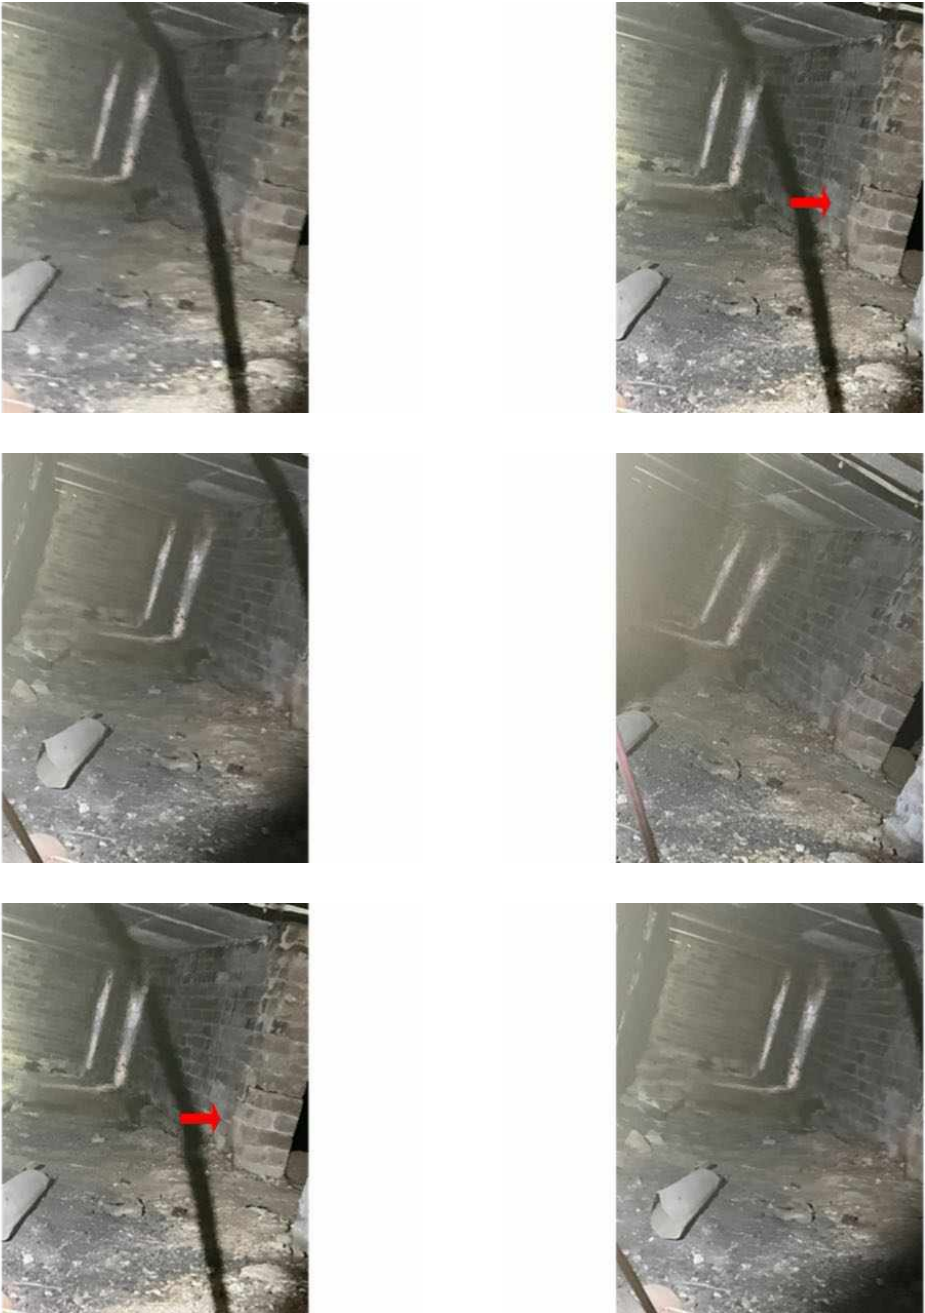
Building:	Main Building
Location:	Subfloor
Finding:	Subfloor Piers - Unstable or deteriorated
Information:	Piers to the subfloor structure are unstable, indicating that their structural integrity has been affected. The cause of this instability is likely to be movement by which piers deteriorate at a rapid rate.

The piers are suspected to be failing in their structural purpose, which is likely to lead to a range of major and minor defects. Further (potentially major) damage to the piers and structure may be imminent if left unattended.

Appointment of a Registered Builder specialising in re-stumping is required immediately to assess the condition of the stumps and provide advice on remedial works. This defect should not be left unmanaged.

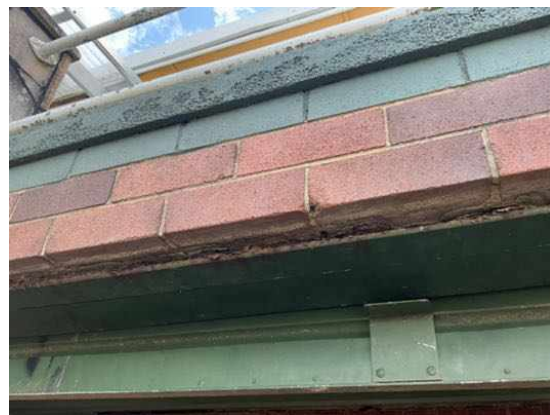
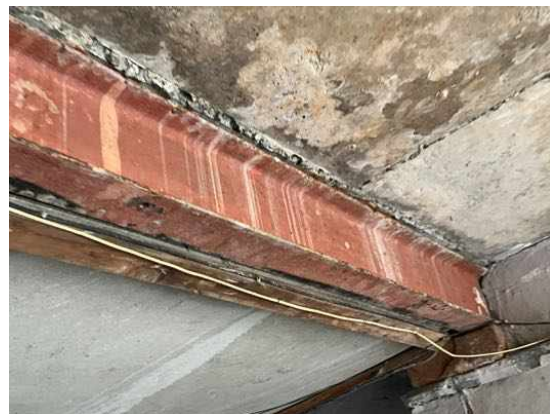
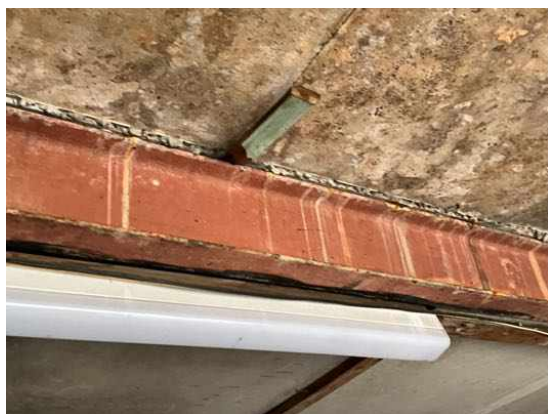
Finding 3.01

Building: Main Building
Location: All Areas
Finding: Building element - Rusted or corroded

Information: This building element shows evidence of rusting and corrosion, which is likely to have developed as a result of excessive exposure to moisture and or inadequate coatings.

As surface rust provides no protection to the underlying iron, the deteriorating condition is likely to worsen if not addressed in the short-term future.

Where possible, the use of galvanized (treated) metals or aluminium coated metals aid in rust prevention, as does regular general maintenance. Rust formation can be controlled with coatings, such as paint, that isolate the iron from the environment.

Rusting and corrosion should be managed by ideally removing or limiting the affected surface from exposure to moisture. A registered builder may be appointed to replace any building elements that have been severely affected by rust or water damage.

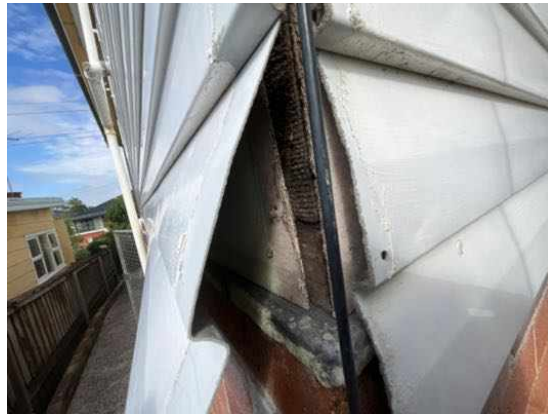
Finding 3.02

Building:	Main Building
Location:	All Areas
Finding:	Damaged Cladding
Information:	The cladding is damaged, displaying cracks, peeling, and disintegration, compromising its structural integrity and aesthetic appeal.

1. Structural instability: The damaged cladding can weaken the structure, leading to potential collapse or safety hazards.
2. Water ingress: Gaps in the cladding allow water to penetrate, leading to moisture damage, mold growth, and potential deterioration of the underlying structure.
3. Aesthetic degradation: Damaged cladding diminishes the visual appeal of the building, affecting its market value and reputation.

A qualified construction contractor specializing in cladding repair and replacement can fix the damaged cladding. Additionally, an architect or structural engineer may be required to assess the extent of the damage and recommend appropriate repair methods.

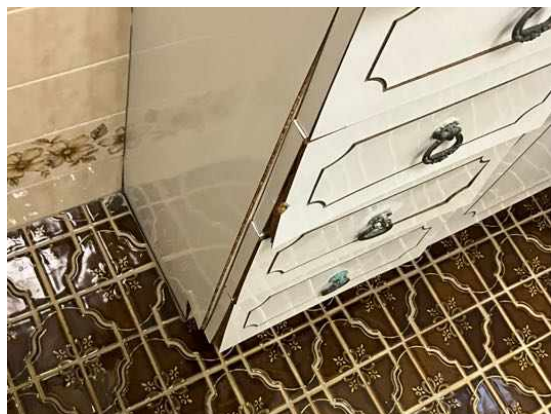
Building:	Main Building
Location:	Bathroom
Finding:	Water damage / Vanity
Information:	"The vanity in the shower area has sustained water damage, resulting in swelling and discoloration of the wood, as well as potential structural issues. This damage compromises both the aesthetic and functional aspects of the vanity."

1. **Carpenter or Woodworker:** They can assess and repair the damage to the vanity, potentially replacing any irreparable parts.
2. **Plumber:** If the water damage is due to plumbing issues, a plumber can fix leaks and ensure there are no further water-related problems.
3. **General Contractor:** If the damage is extensive and affects the surrounding area, a general contractor can coordinate the repair work, including both the vanity and any related structural or cosmetic repairs.

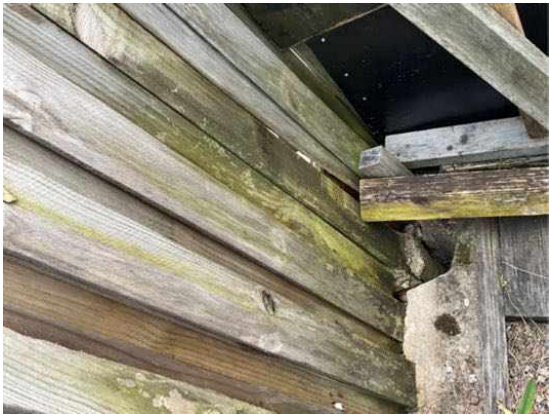
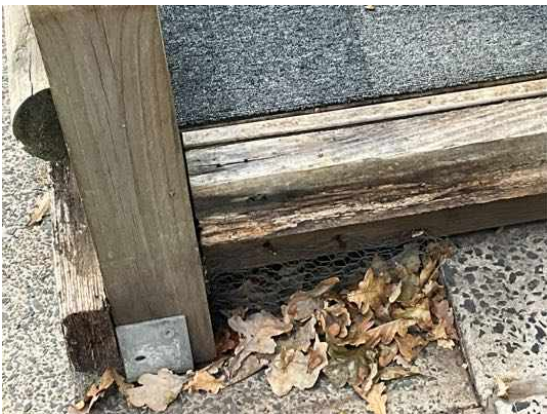
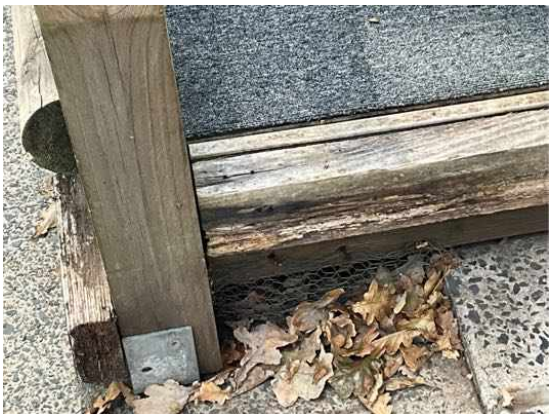
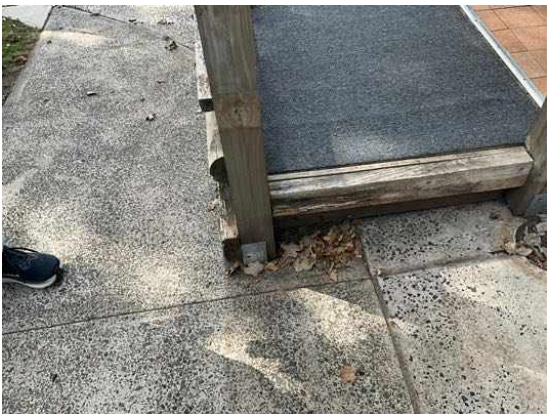
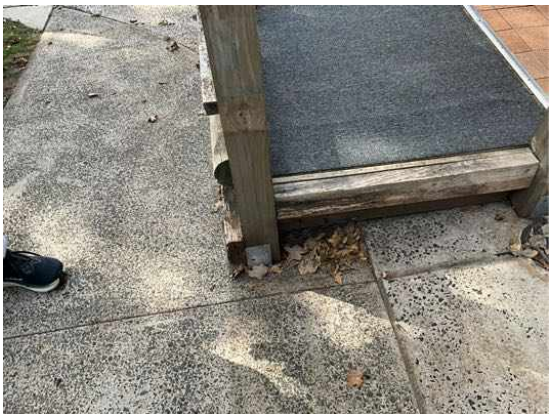
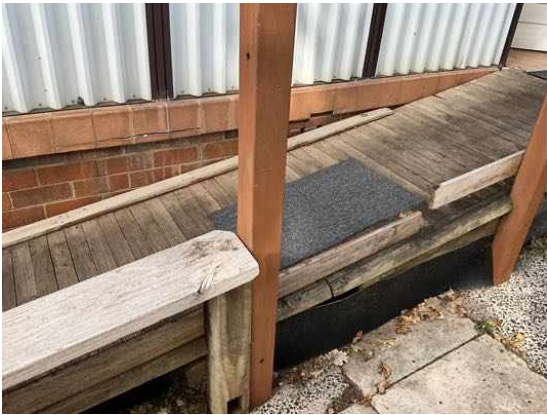
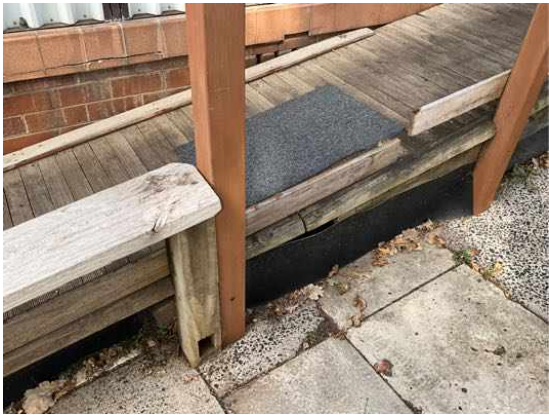
Finding 6.03

Building:	Main Building
Location:	All Areas
Finding:	Timber on ground / conducive conditions to termite damage
Information:	Timber on the ground is indeed conducive to termite damage. Termites are known to thrive in moist environments, and wood in contact with soil or moisture is more susceptible to infestation.

To prevent this, it's important to keep timber elevated and away from direct ground contact. Regular inspections and proper termite control measures are also essential to protect your wooden structures from termite damage.

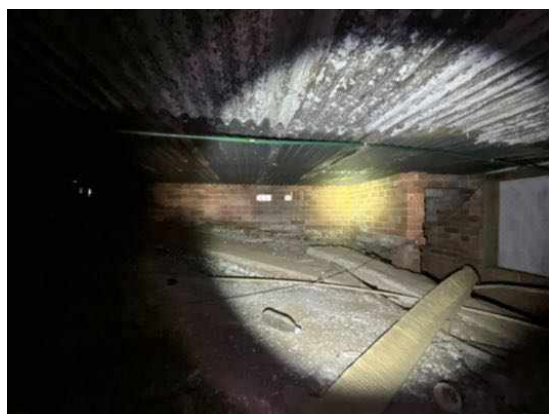
Finding 6.07

Building:	Main Building
Location:	Subfloor
Finding:	Subfloor - poor ventilation, inadequate site drainage, water stains
Information:	The subfloor lacks adequate ventilation, suffers from inadequate site drainage, exhibits water stains, creating conducive conditions for timber pests such as termites.

Risk: The combination of poor ventilation, inadequate drainage, water stains significantly increases the risk of timber pest infestations. Termites are attracted to moist environments and can thrive in subfloors with high humidity levels and water damage. The lack of proper ventilation and drainage exacerbates moisture retention, providing an ideal habitat for timber pests to establish colonies and cause extensive damage to the subfloor structure. Additionally, water stains indicate previous or ongoing moisture issues, which further attract timber pests and contribute to the deterioration of timber materials.

A licensed pest control professional specializing in timber pest management should be consulted to assess the extent of the infestation and develop a comprehensive treatment plan. They can implement strategies to eliminate existing timber pests, such as termites and prevent future infestations by addressing underlying moisture issues. Additionally, a qualified plumber or builder may be needed to improve subfloor ventilation, enhance site drainage, repair water-damaged areas. Regular inspections and maintenance are essential to ensure ongoing protection against timber pests and maintain the structural integrity of the subfloor.

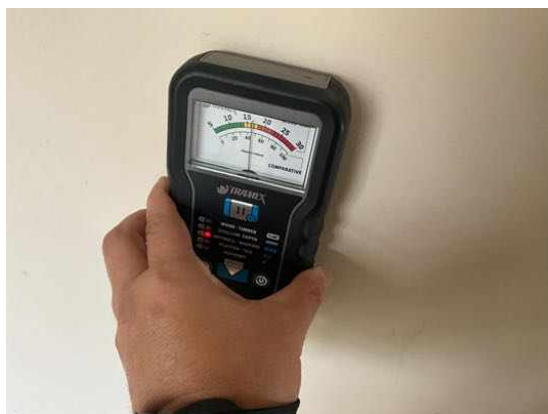
Finding 6.08

Building:	Main Building
Location:	All Areas
Finding:	Excessive moisture - Conducive to Timber pest
Information:	Excessive moisture can attract termites and produce conditions that promote fungal growth and wood decay.

Prior to any remedial works being performed a qualified plumber should be appointed to further inspect the property and to identify the cause of the excessive moisture. Works to remove affected building elements may then be necessary and should be performed by an appropriate tradesperson.
