Building and Timber Pest Inspection Report

Inspection Date: Mon, 2 Feb 2026

Property Address: 4 Soldiers Parade, Edmonson Park NSW
2174

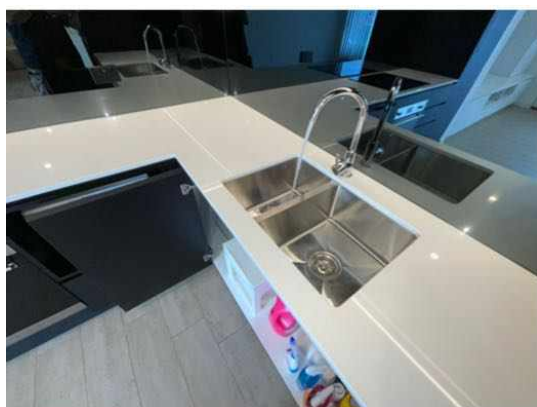
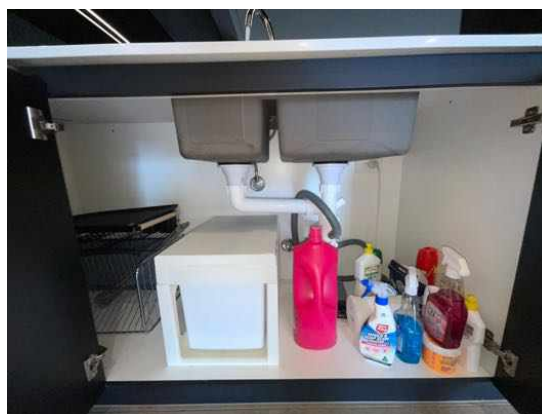
Building: Main Building
 Location: Kitchen
 Finding: Kitchen Sink – Overall Condition & Recommendations.
 Information: Observations:

- The kitchen sink tap(s) were water tested at the time of inspection, with no evidence of leaks or blockages observed in the visible plumbing or drainage.

- No significant water damage was observed to the cabinetry/unit

- Further monitoring and testing are recommended once the tap(s) are in constant use, to identify any drainage issues or signs of slow leaks not evident during the limited inspection.
- For long-term property care, it is advised that sealant and grouting in water-exposed areas be regularly inspected and maintained.

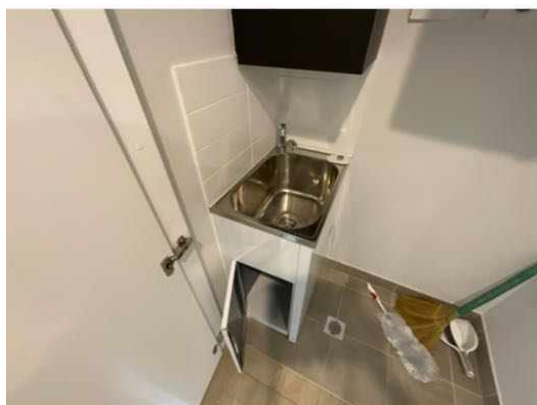
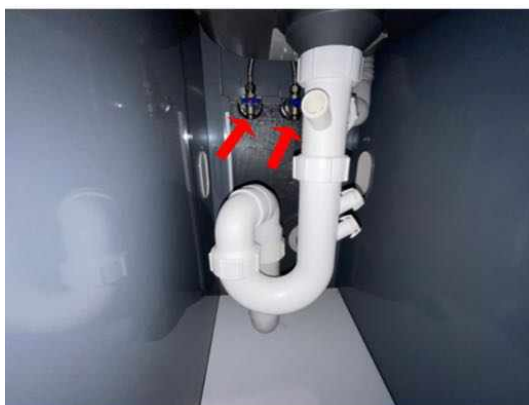
Building: Main Building
 Location: Laundry
 Finding: Tap/s - Not Operational (2 way tap connection).
 Information: Tap Not Operational – Laundry

- Tap(s) should be checked for proper operation once the washing machine is connected.
- If issues persist, a licensed plumber should be engaged to assess and repair as required.

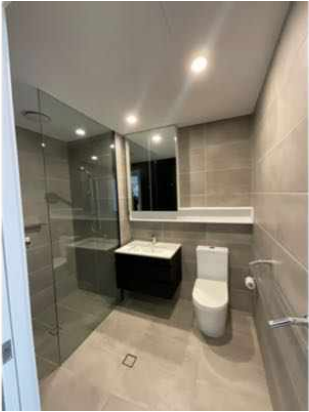
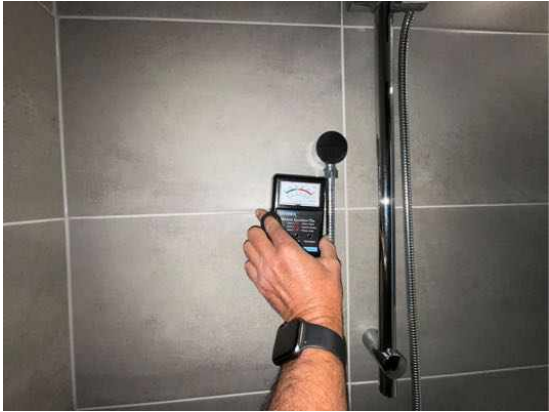
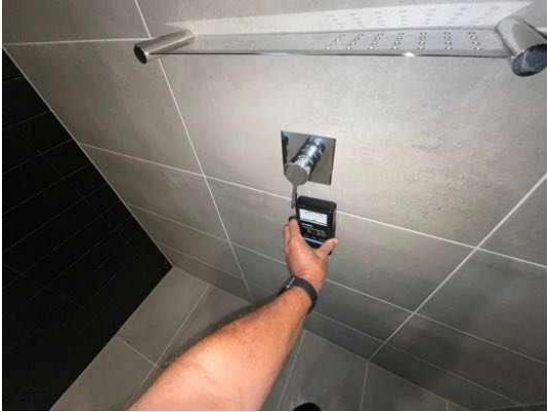
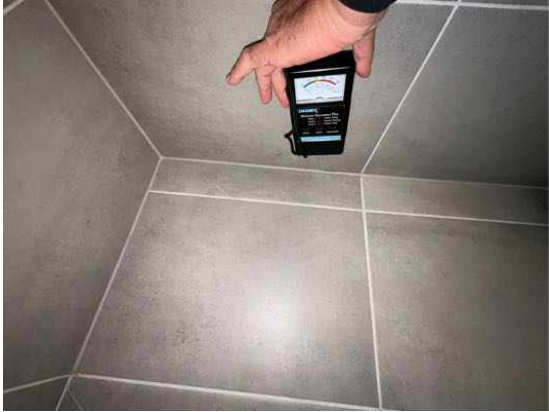
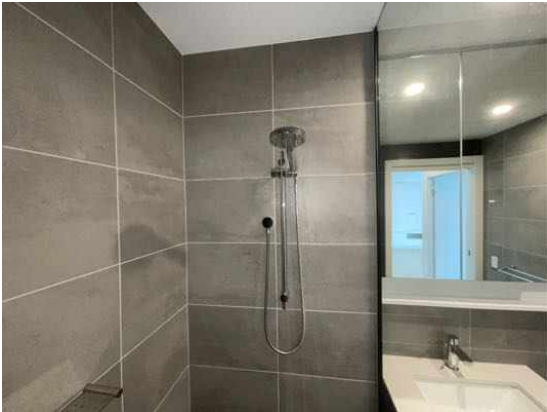
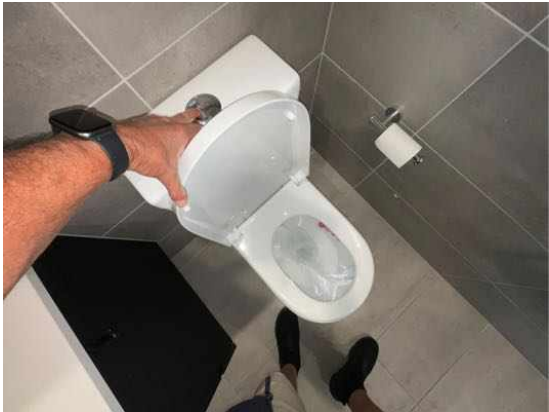
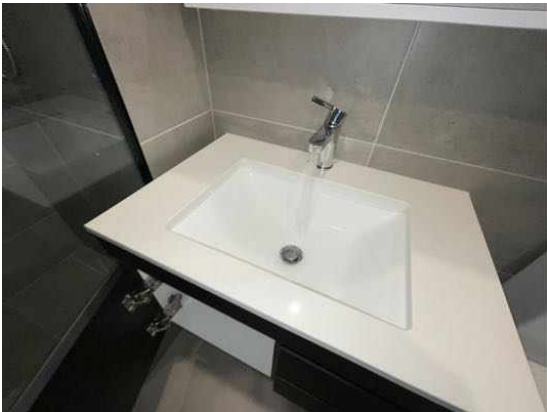
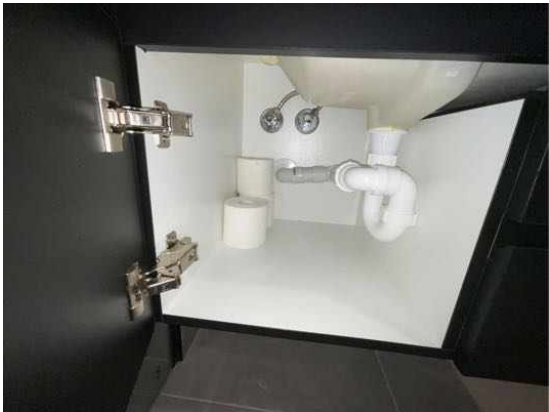
Building: Main Building
 Location: Bathroom
 Finding: Wet Areas - Bathroom(s) - Overall Condition & Recommendations.
 Information: Overall Condition & Recommendations

- Water appeared to flow freely towards the floor waste during testing of the shower taps. However, further monitoring is required after regular use to determine whether water pooling or retention occurs.
- Flood testing of the shower recess is recommended. This may reveal inadequacies in the waterproofing or shower screens, which could lead to water damage in surrounding areas.
- Floor waste was found to be clear and free of blockages at the time of inspection. Further monitoring is advised after consistent use to identify any drainage issues or buildup requiring cleaning.
- No elevated moisture readings were detected around the tap fittings or behind the shower walls (as viewed from adjacent rooms), suggesting no active plumbing leaks at the time of inspection.

- Sealing of grout and tiles is recommended to prevent moisture buildup and mould growth in damp areas such as showers.
- The condition of grout and sealant appeared to be good.
- The exhaust fan appeared to be operational, which supports moisture control in the bathroom.

- No leaks were observed during flushing. The toilet operated normally, and the toilet pan appeared to be securely fixed to the floor.

- Basin(s) were water tested and inspected, with no leaks or blockages identified in the plumbing or drainage system at the time of inspection.
- Further monitoring is recommended after the basin(s) are placed under regular use to confirm ongoing performance and cleanliness.
- No visible water damage was observed to the vanity cabinetry at the time of inspection.

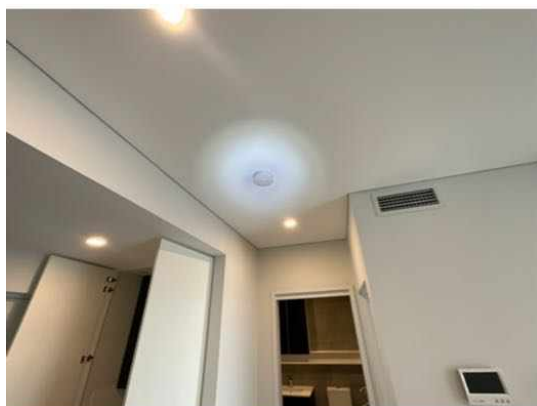
Building:	Main Building
Location:	All Areas
Finding:	Smoke Detectors / Alarms.
Information:	Reporting on the presence, type, location, or compliance of smoke detectors or alarms, including hard-wired smoke detection systems and their legislative requirements, is outside the scope of this inspection report.

To ensure compliance and safety, further inspection and/or advisory services from a qualified specialist are recommended. These services can confirm the sufficiency, type, location, and functionality of all smoke detection devices within the property.

- All smoke detectors be tested monthly by the homeowner.
- All systems comply with the requirements of AS 3786 and any applicable state-based legislation.
