Building and Timber Pest Inspection Report

Inspection Date: Thu, 15 Jan 2026

Property Address: 3/29 Pomona St, Pennant Hills NSW 2120, Australia

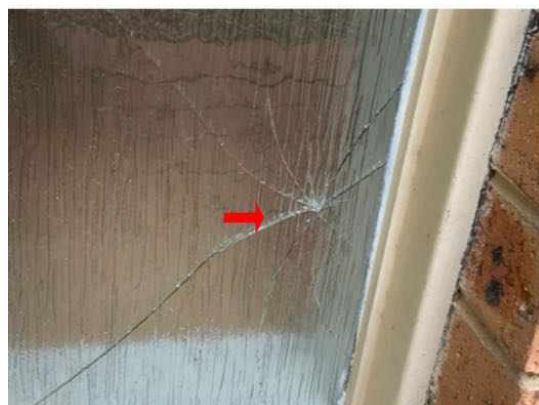
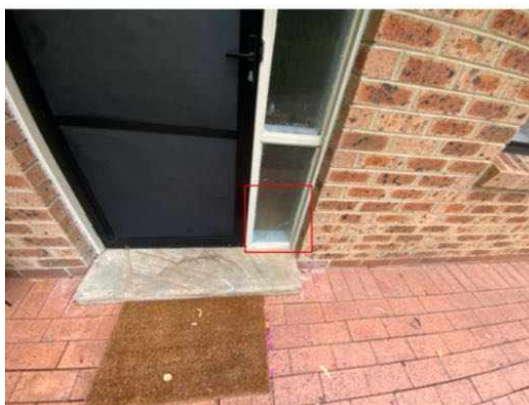
Building:	Main Building
Location:	Exterior walls - front
Finding:	Window - Cracked
Information:	Cracks were identified in the window in this area. Cracking in windows is generally the result of impact damage, and is likely to develop further when left unmanaged.

The likelihood of this windowpane further cracking and shattering is increased exponentially, providing a safety hazard in the area. The cracked window also impairs the weather tightness of the building, creating potential for minor water leaks.

A qualified glazier is required to repair the window as soon as possible. Depending on the extent of the cracking, replacement of the window may be required. Please be advised that any persons coming into contact with the cracked window should do so with due caution to avoid any personal injury that may ensue.

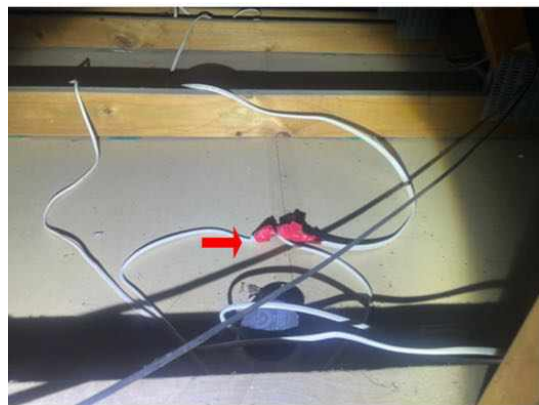
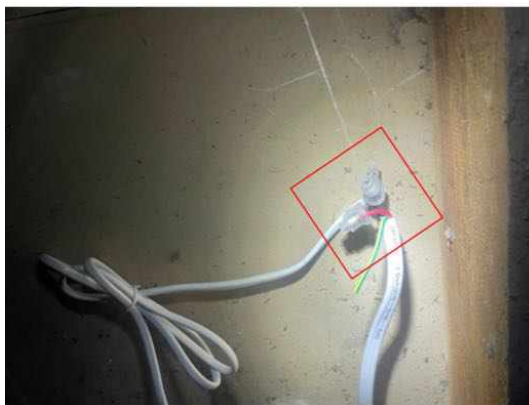
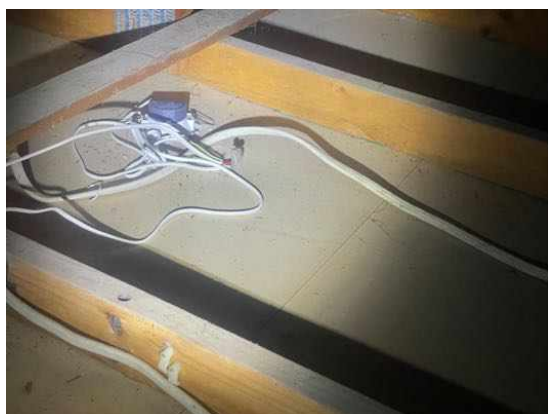
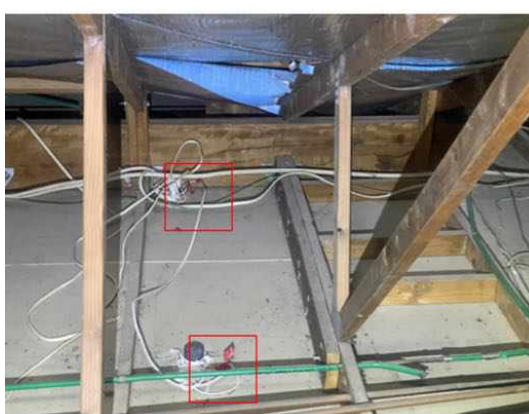
Finding 1.02

Building:	Main Building
Location:	Roof Void
Finding:	Electrical junction box - Missing
Information:	Several wiring joins in the roof space are not adequately protected by a junction box. Junction boxes provide a second insulation barrier to adequately seal off and protect the wires, increasing the safety of the immediate environment and ensuring that the wiring is not damaged.

The absence of junction boxes in the roof space poses as an electrical safety hazard, providing risk of electrocution. It appears as though wiring in this area has been completed to a substandard level of workmanship, evidenced by the lack of adequate

wiring protection.

Appointment of a licensed electrician is highly advised to provide additional information on the risks of unprotected wiring and to install junction boxes and any other elements as required. Such works should be carried out as a matter of urgency; until this time, any persons within the roof space should exercise a high level of caution.

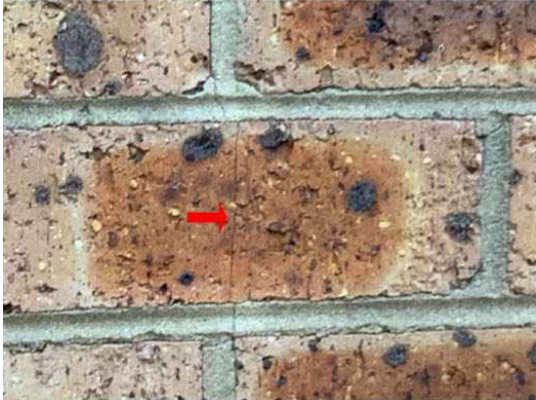
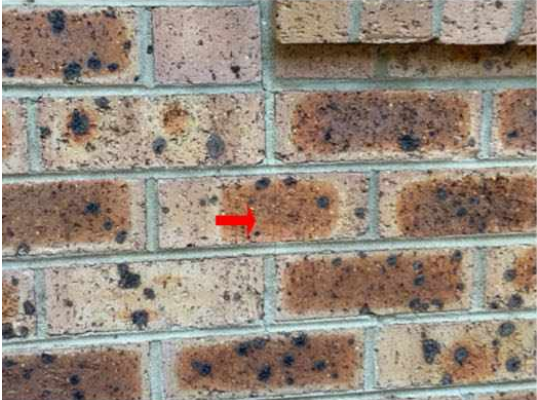
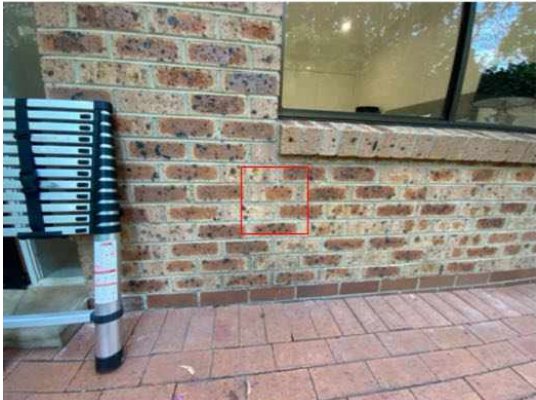
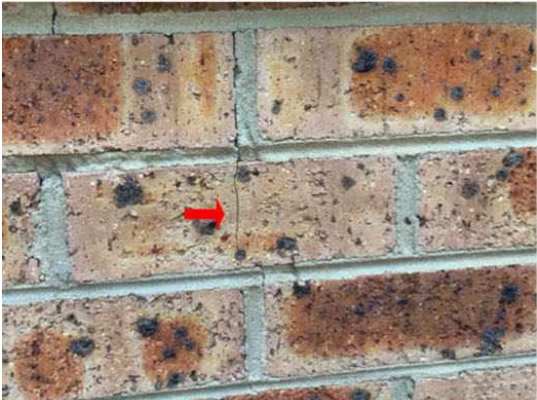
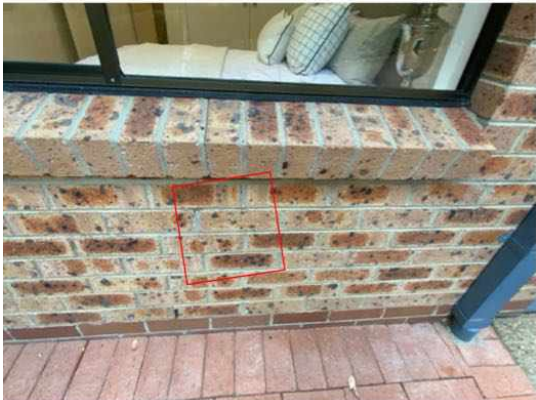
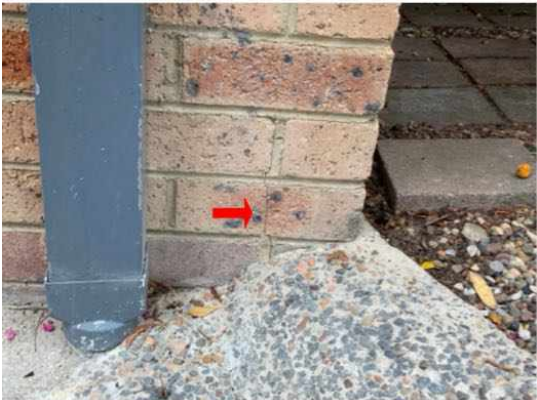
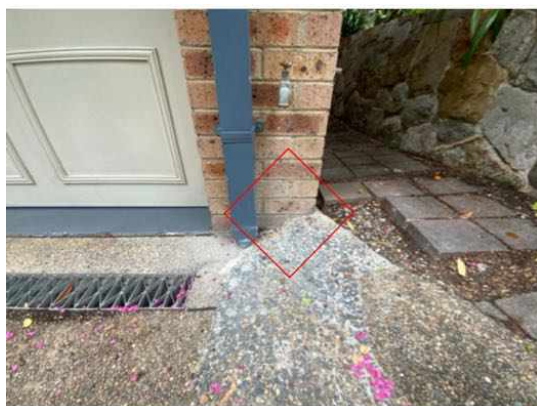
Building:	Main Building
Location:	Exterior walls - front
Finding:	Brickwork - Cracking noticeable
Information:	There were several cracks evident to external brickwork.

Noticeable cracks are a common occurrence in external brickwork and are a likely result of age expected building movement, general expansion, and/or contraction of

building materials in different weather conditions. Noticeable cracks in brickwork may develop if left unattended, with potential for necessitating major remedial works or replacement of the brickwork.

It is highly advised that a qualified bricklayer be appointed to provide necessary works to cracked brickwork to prevent any further damage. Such works should be conducted as soon as possible.

Always monitor these cracks and contact a building inspector should cracks widen, lengthen, or become more numerous.

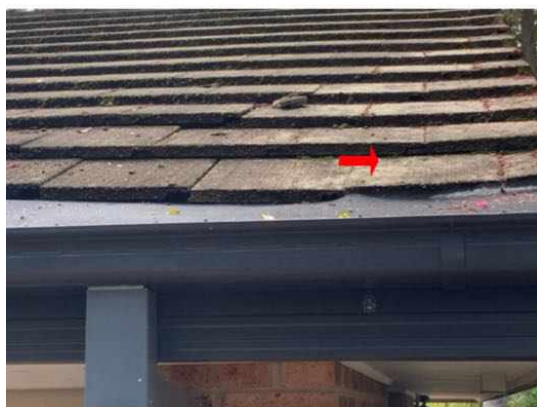
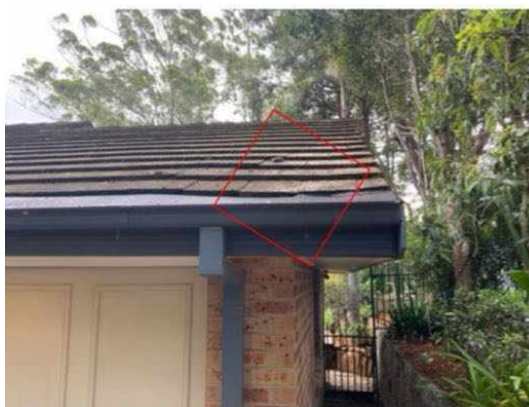
Finding 3.02

Building:	Main Building
Location:	Exterior walls - front
Finding:	Sagging roof - (tiles)
Information:	The roofing tiles were found to be sagging in sections at the time of inspection. This sagging is likely due to damaged roof battens under the tiles .

Sagging roof structures are likely to create strain on associated building elements, creating potential for secondary damage including the deterioration of roof coverings.

While it would appear that this defect has been present for a long period of time repair is recommended in the short term to ensure the longevity and structural integrity of the dwelling.

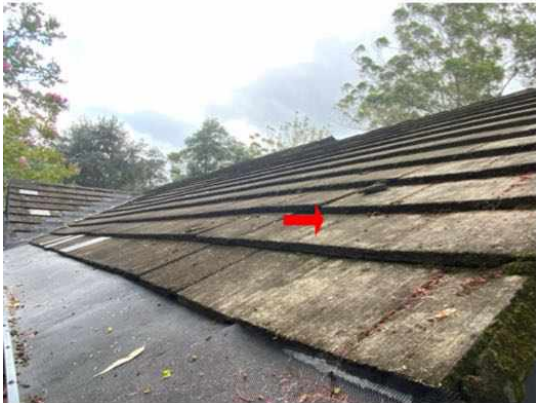
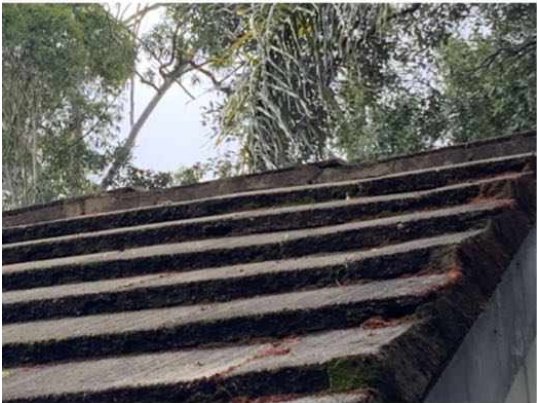
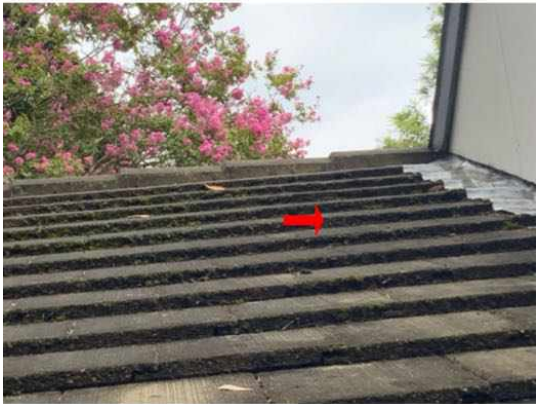
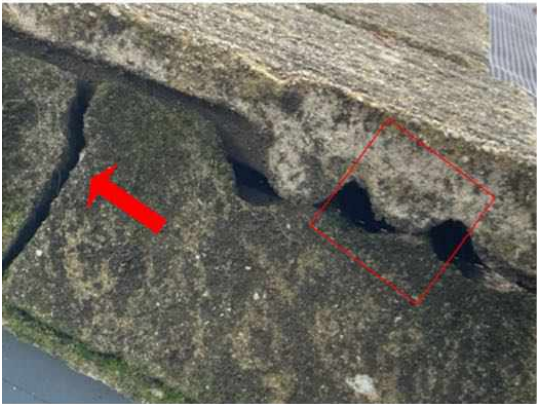
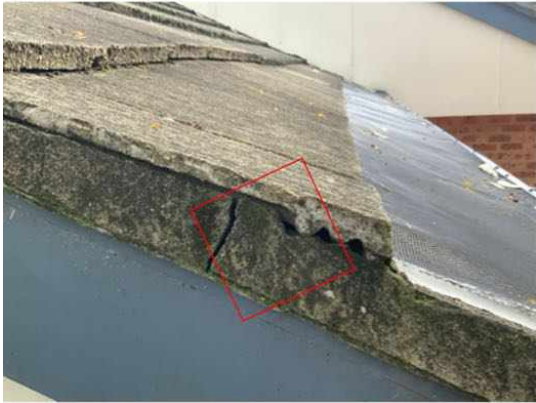
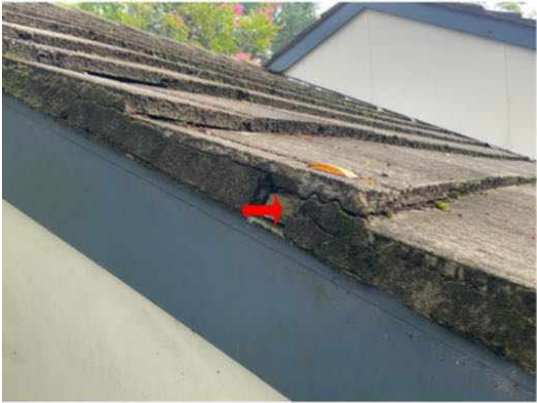
Finding 3.03

Building:	Main Building
Location:	Roof Exterior
Finding:	Roof tiles - Weathered
Information:	Upon inspection of the exterior roofing, the majority of roof tiles were considered to be in a fair condition. While weathering of the tiles is consistent with the age of the property, maintenance works are required.

Isolated areas of mortar have come loose in the valleys and minor cracking is also present. Re-pointing and re-sealing the may be considered as an interim solution by the client to help preserve and extend the life span of the tiles.

Where left unmanaged, deteriorating roof tiles are likely to lead to a number of secondary defects, including minor water leaks and weather exposure to internal roofing structures.

Consultation with a roofing contractor is highly advised to gain advice on cost of remedial works that may be required in the short to medium term. Remedial works are likely to increase the longevity of the exterior roofing structure.

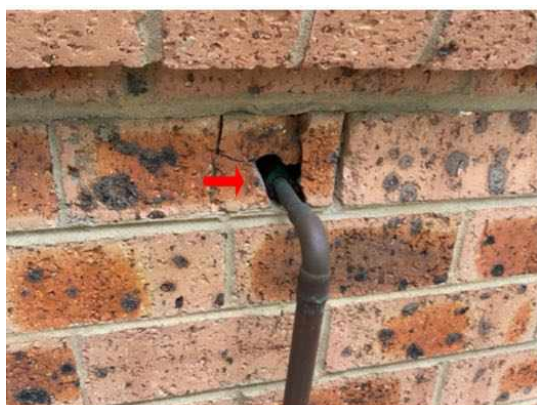
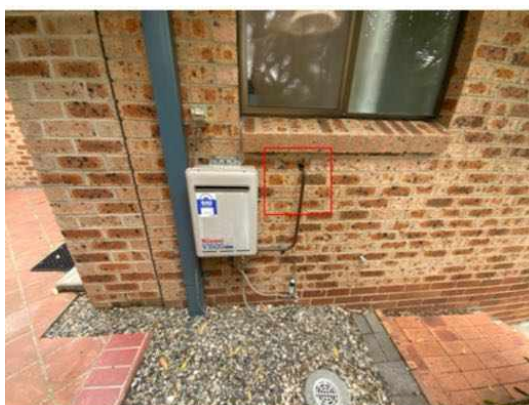
Finding 3.04

Building:	Main Building
Location:	Exterior walls - rear
Finding:	External walls - Holes
Information:	Significant holes were identified around pipe penetrations in this wall section. It is suspected that the installation of this pipework was completed to a substandard level of workmanship or is incomplete.

Gaps and holes around pipework makes the area susceptible to insect and vermin ingress, as well as allowing water penetration to the cavity wall. As such, associated building elements are likely to deteriorate at an accelerated rate, and major implications are expected if holes around the pipework are left unmanaged.

All excessive holes, gaps or cracks should be adequately filled by a suitable sealant or trimmings as soon as possible to prevent any further damage. Such works may be conducted by a general handyperson or licensed plumber.

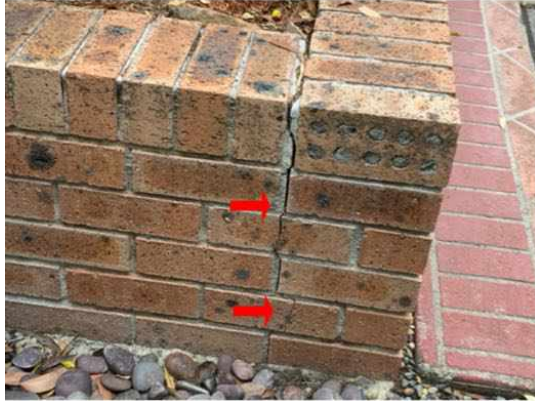
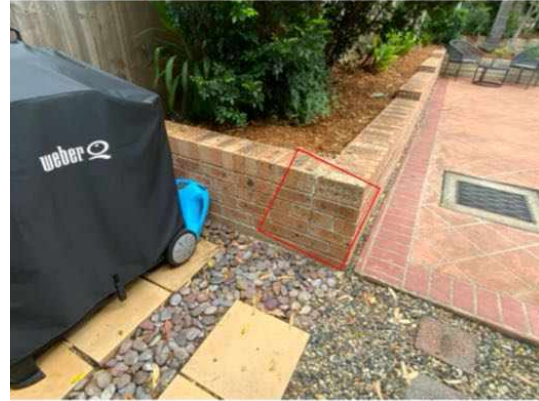
Finding 3.05

Building:	Main Building
Location:	Exterior walls - rear
Finding:	Subsidence Monitor
Information:	It appears that the retaining wall structure has been affected by movement of the foundations, often referred to as sinking or subsidence. A degree of movement is expected in subfloors over time, especially as environmental conditions change and buildings settle after construction.

The apparent subsidence is evidenced by some gaps and cracks to brickwork.

General subsidence is usually initiated by changes in soil moisture content. The most critical factor is identifying the specific causes, and identifying if this is a recurring or ongoing problem, or one that has been resolved by previous works in the past.

Subsidence can have complex and varying causes, which will influence the required remedial works. If movement continues It is advised to consult a builder.

The Builder would then generally carry out works .

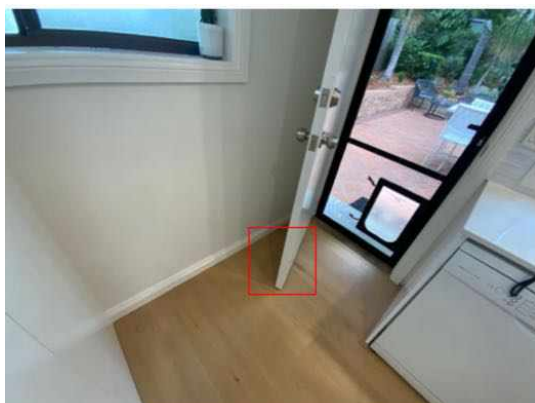
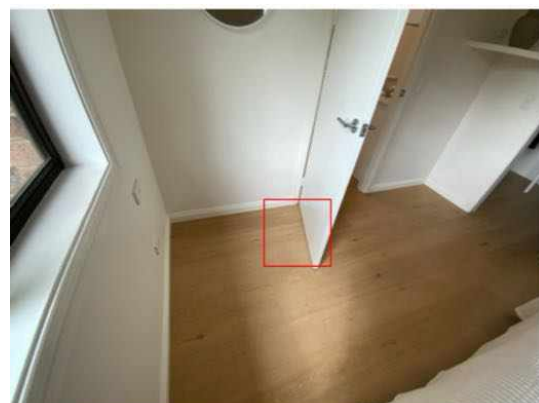
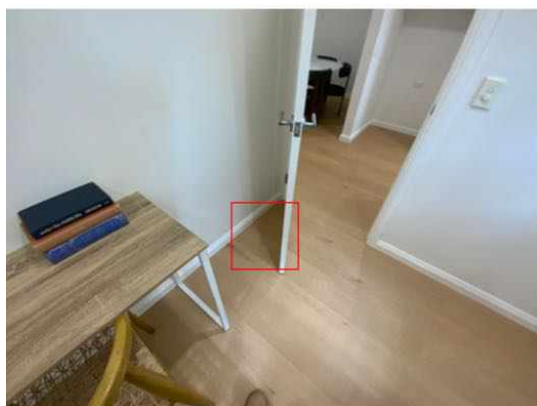
Finding 3.06

Building:	Main Building
Location:	All Internal Areas
Finding:	Door stop - Missing
Information:	The door stop is missing or is inadequate to stop the door handle from damaging the wall. Although some building elements may seem irrelevant or unnecessary, all building elements play a key role in the operation and function of the overall structure and its performance.

Re-installation or replacement of the door stop is advised as soon as possible to prevent any subsequent damage to the door or associated structures. A general handyman may be appointed to perform these works at client discretion.

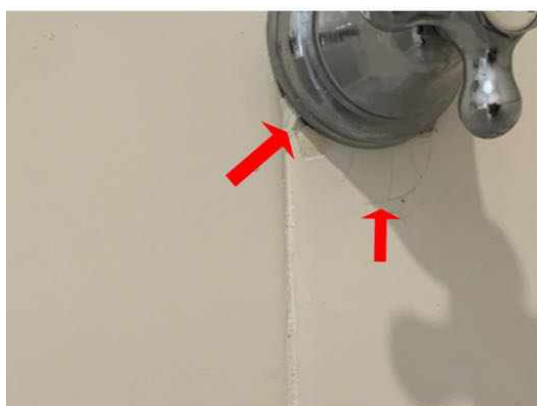
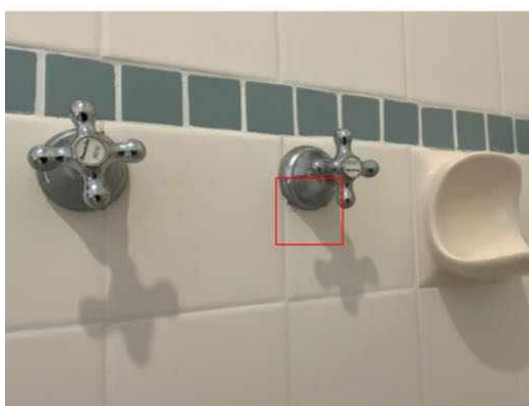
Finding 3.07

Building:	Main Building
Location:	Ensuite - Master
Finding:	Tiles - Cracked or damaged
Information:	Cracking was evident to the tiling in this area at the time of inspection. While the cracking appears to be minor, this area is frequently exposed to water, allowing potential for water penetration into adjoining sections of walls or flooring.

If left unmanaged, water penetration to these areas may lead to subsequent water damage, which is likely necessitate repair work to affected building elements.

A tiling contractor should be appointed to ensure that no further water damage occurs. The re-application of silicone and grouting throughout remaining tile work is also advised, to further protect the area against water penetration.

Where water penetration has led to water damage, appointment of a relevant tradesperson may be required to repair damaged building elements.

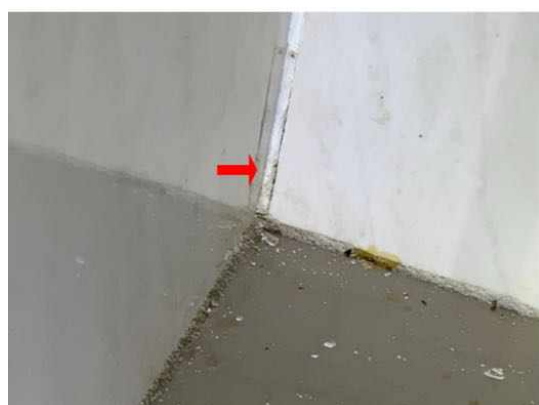
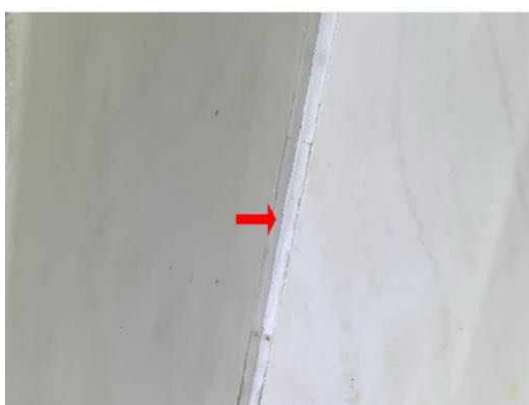
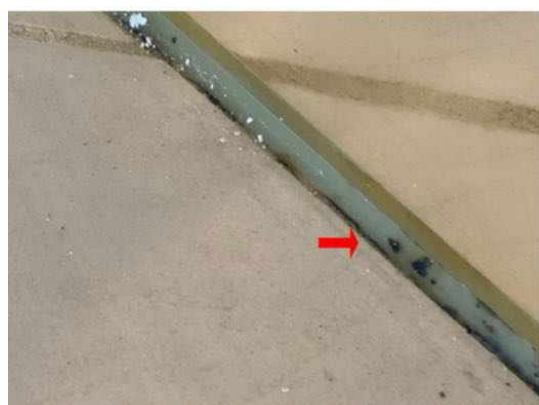
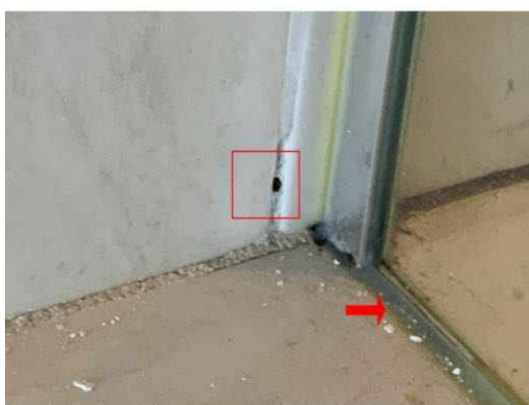
Finding 3.08

Building:	Main Building
Location:	Bathroom
Finding:	Sealant and grouting - Missing or damaged

Information: It was noted on inspection that sealant or grout is degraded to the tiled shower alcove and or other areas of the bathroom.

Different materials and floor areas move at different rates, generally causing cracking to grout or sealant at this point. A flexible sealant is required to allow for expected expansion and contraction, while keeping the joint water tight and protective of all associated building materials.

There appears to be excessive mould to the sealant and grout which will likely require scraping out and replacement.

Flexible and mould resistant materials should be applied to affected areas to prevent any subsequent water damage that is likely to occur. Regular maintenance and replacement of damage or missing or damaged sealant and grout is highly recommended to the wet areas, as this is a regular wear and tear defect. Sealant and grouting in areas that come into regular contact with water should be maintained for the long term care of your property.

A sealant specialist or tiling contractor should be appointed to complete these works as soon as possible

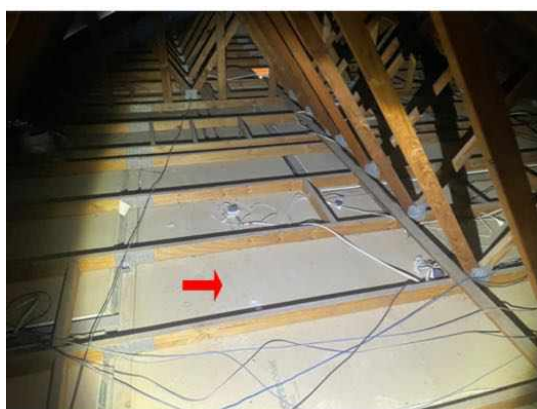
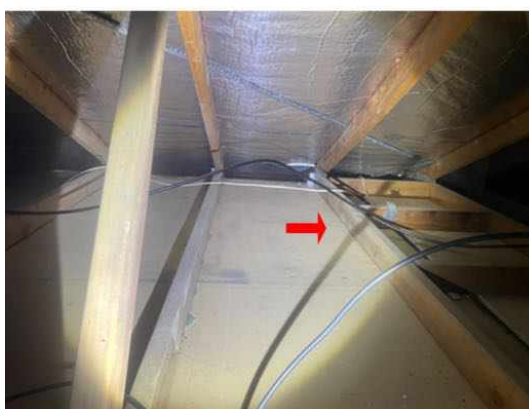
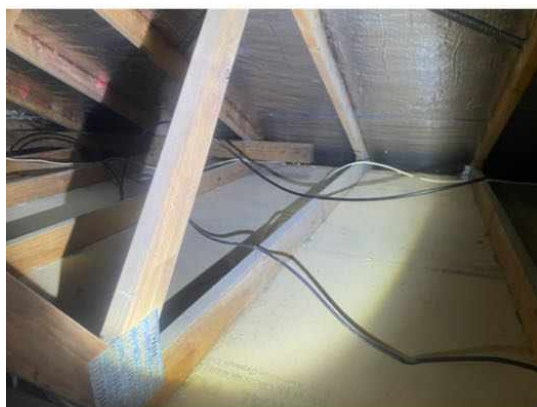
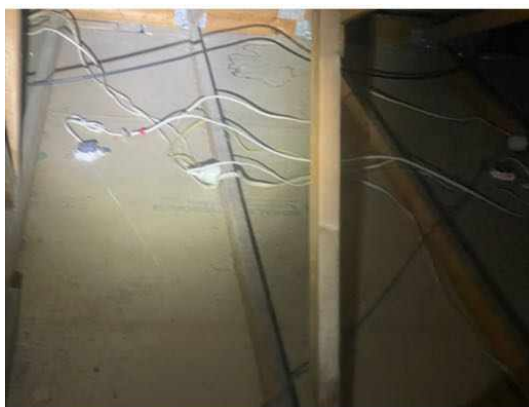
Finding 3.09

Building: Main Building

Location: Roof Void
Finding: Insulation - missing (AS4859)
Information: Upon inspection of the roof void it was noted that no ceiling insulation has been installed.

Insufficient insulation will result in a comparatively higher cost to heat and cool a property as there is a lack of Insulation (or uneven coverage of insulation) which works as a barrier to heat transfer. This helps to keep out unwanted heat in summer and preserves warmth inside your home in winter. It can also help soundproof your home from unwanted airborne noise transfer.

Installation of adequate insulation is required according to Australian Standards and should be conducted as soon as possible.

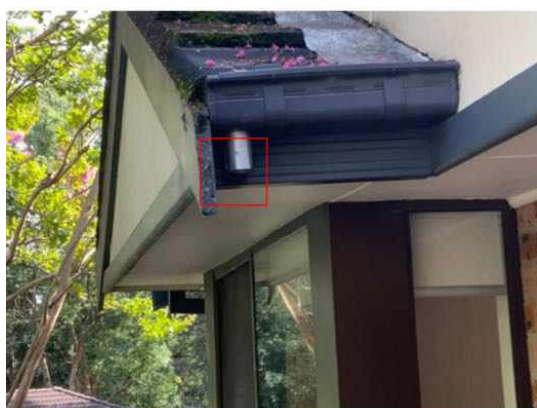
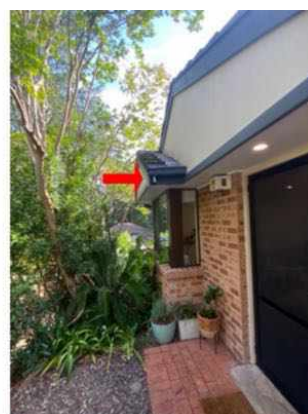
Building:	Main Building
Location:	Exterior walls - front
Finding:	Roof plumbing - Missing
Information:	Some sections of the roof are not adequately drained via gutters and downpipes. Gutters and downpipes that are not installed adequately are likely to result in excessively damp conditions against the exterior surfaces and around the base perimeter of the building.

Excessive moisture creates an environment which accelerates the deterioration of building elements in the area, as well as being conducive to termite and pest infestation. Such an environment is likely to necessitate repair and/or replacement of building elements, which are prone to sustaining wood rot, rust or corrosion.

A roofing plumber should be appointed as soon as possible to install relevant roof plumbing materials. Depending on the extent of the damage, repair and/or replacement of damaged building elements may be required.

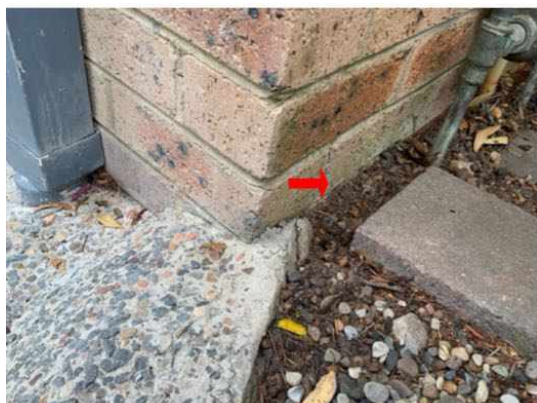
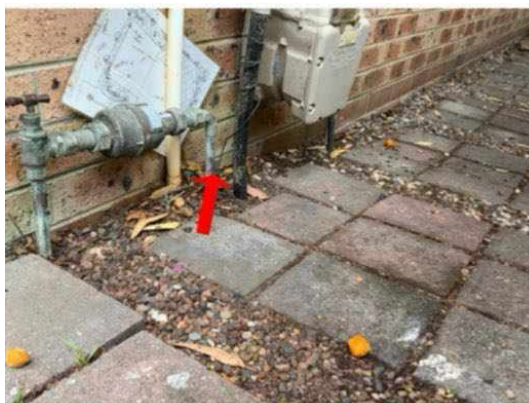
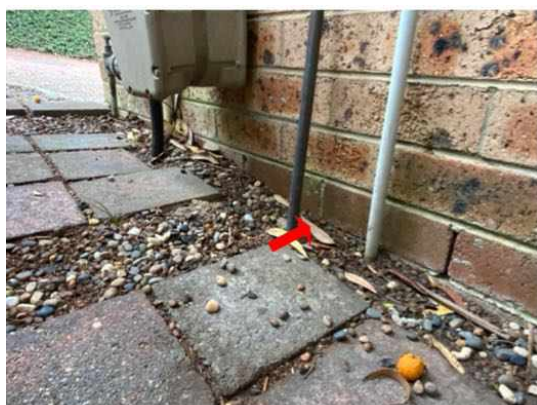
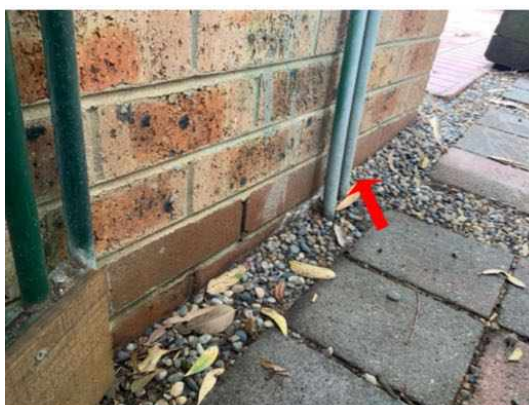
Finding 6.02

Building:	Main Building
Location:	Exterior walls - right side
Finding:	Bridging or breaching of termite barriers - damp course level
Information:	Bridging is the spanning of a termite barrier or inspection zone so that subterranean termites are provided with passage over or around that barrier.

Damp proof course (DPC) is a barrier of impervious material built into a wall or pier to prevent moisture from moving to any part of the building. Where external ground levels

are built up over this barrier ingress is provided for moisture from the exterior grounds into the base brickwork or other building material and allowed to rise.

Such conditions attract termites into these damp areas which is likely to lead to infestation if left untreated.

While retrospective fitting of DPC is considered to be impractical works are required in order to prevent the extraction of moisture from the external environment into exterior brickwork or wall materials. Landscaping or re-paving of external grounds may be considered by the client. Regular annual inspections are strongly advised.

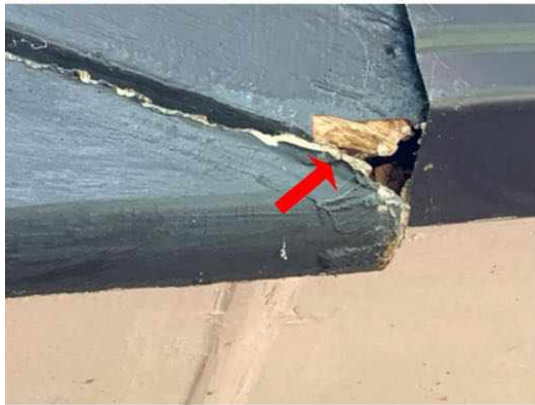
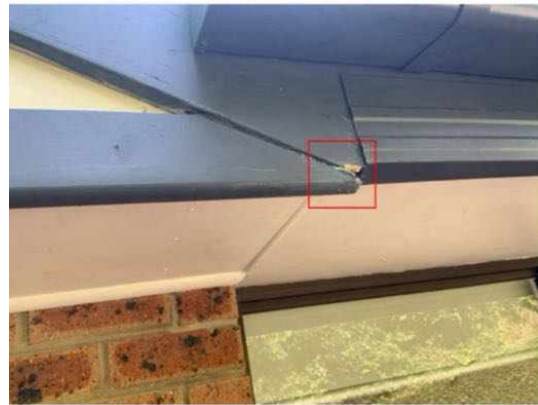
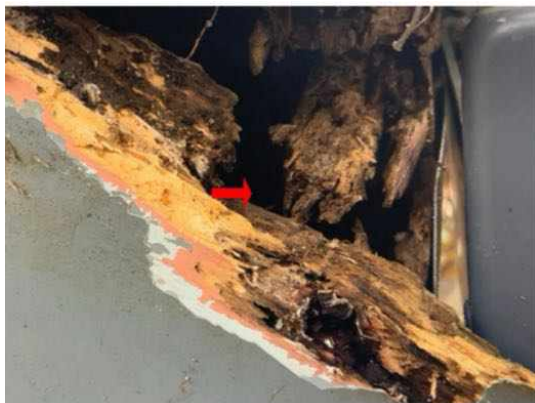
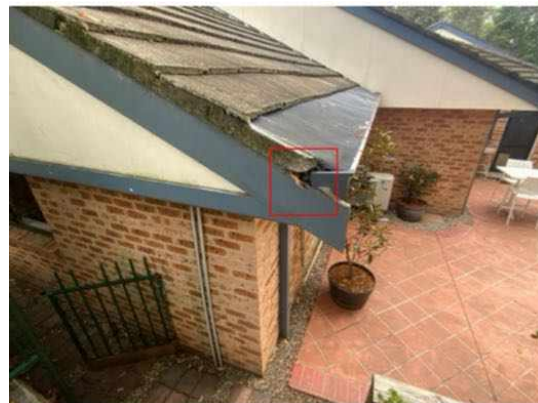
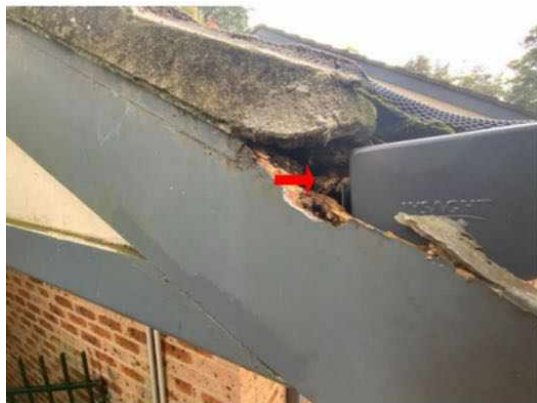
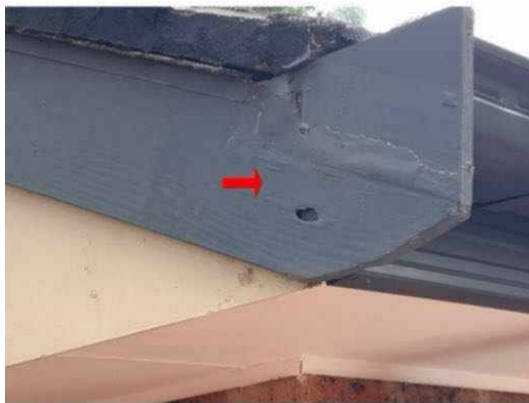
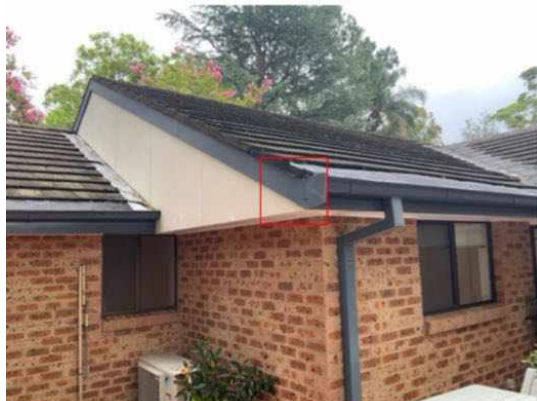
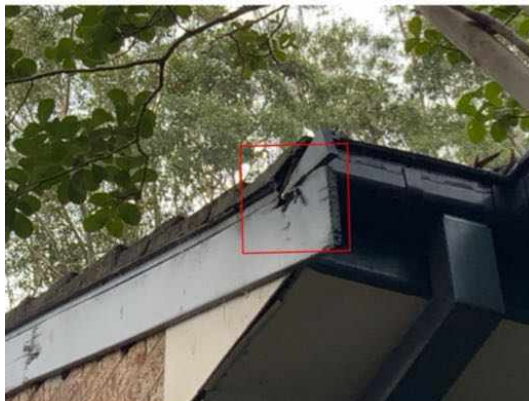
Finding 7.01

Building:	Main Building
Location:	All External Areas
Finding:	Fascias - Wood rot
Information:	Wood rot was found to be affecting fascias and barges in this area, evidenced by the presence of mould on the surface in some areas. Wood rot, also known as Fungal Decay, occurs when timbers and other cellulose building materials are exposed to damp conditions on an ongoing basis.

It is likely that this wood rot has developed as a result of faults in the roof plumbing, creating excessive moisture in this areas. Frequent exposure to rain and other weather conditions also make fascias and bargeboards susceptible to accelerated deterioration.

Early intervention and regular maintenance will prolong the useful life of these building elements. Prior to any works being performed, the cause of the moisture that has created the visible wood rot should be identified and addressed in a suitable manner.

It is advised that a roof plumber be appointed to inspect all roof plumbing and subsequently identify the cause of the wood rot. Replacement of affected fascias and bargeboards may then be a necessary step in protecting surrounding building elements from such deterioration.

A qualified plumber may be appointed to assess the cause of excessive moisture and to provide advice on any remedial works as required. A qualified carpenter or registered builder may also be required to replace affected building materials.

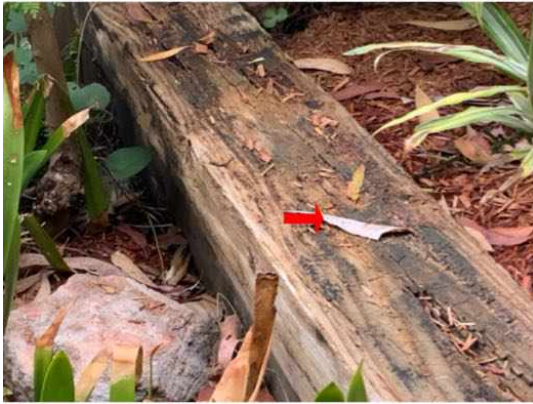
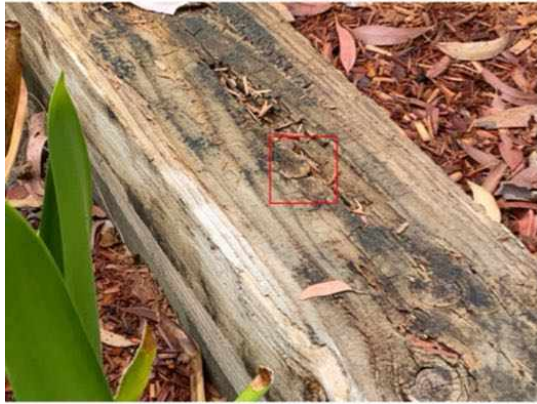
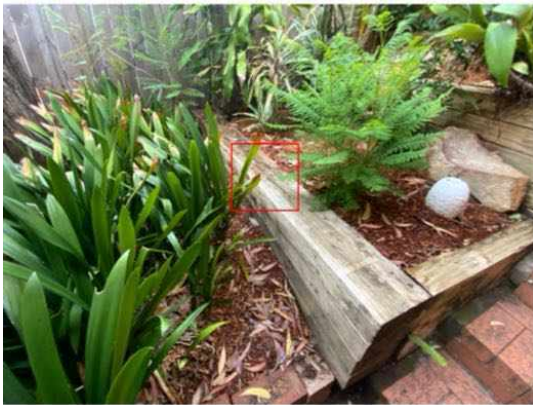
Finding 7.02

Building:	Main Building
Location:	Exterior walls - rear
Finding:	Wood rot /identified in landscaping
Information:	Upon inspection of the property site sections of the landscape timbers have deteriorated with wood rot evident.

This appears to be due to general ageing and deterioration of the structure which is to be expected of its age.

This could be the result of exposure to weathering in the long term or the pooling of water or absorbed moisture from other abutting building materials. Wood rot is often associated with general damp problems and if left unmanaged damp conditions can lead to further decay of timbers.

Where timber elements are in direct contact with the ground and consequently moisture or dampness they become conducive to termite activity. Whether timber is used as a building element part of a fencing structure, landscaping or stored as an unused item they can provide an environment that is attractive to termite infestation.

It is highly recommended that all susceptible timbers be removed and replaced with non-susceptible timber.

A landscaping contractor or handyman may be appointed to perform these works.

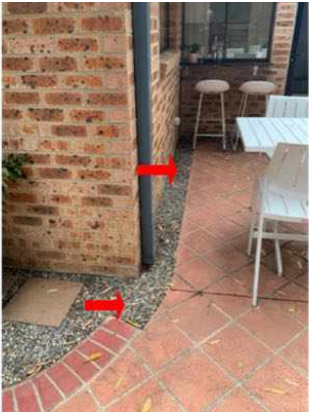
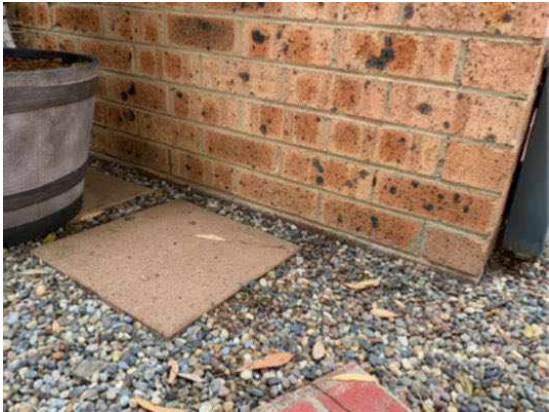
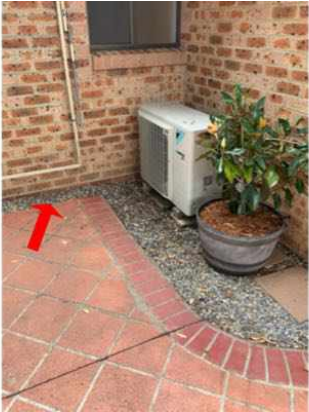
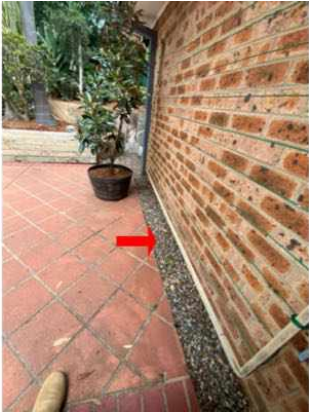
Noted Item

Building: Main Building
Location: Exterior walls - rear
Finding: Evidence of termite treatment
Information: At the time of inspection it was noted that section of the concrete stencil along the wall has been cut in a way to conceal the treatment that it has been done .

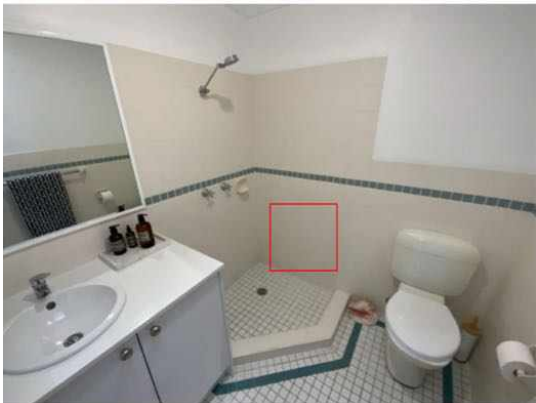
Noted Item

Building: Main Building
Location: Ensuite - Master
Finding: Shower screen missing
Information: Shower screen missing
