Building and Timber Pest Inspection Report

Inspection Date: Mon, 16 Feb 2026

Property Address: 22 Meaklim St, Shepparton VIC 3630,
Australia

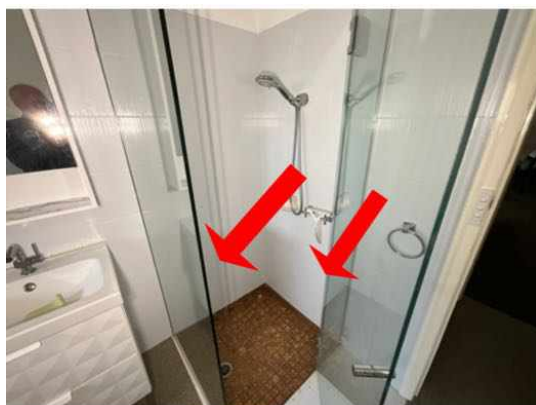
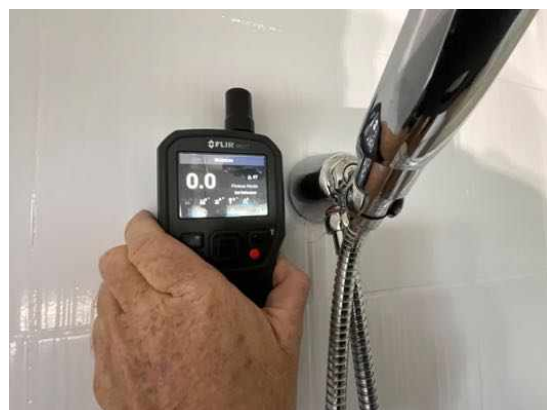
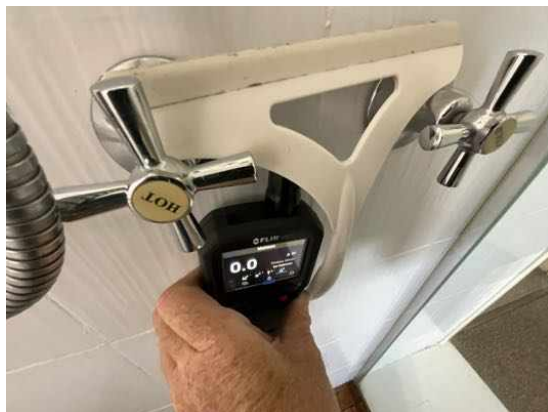
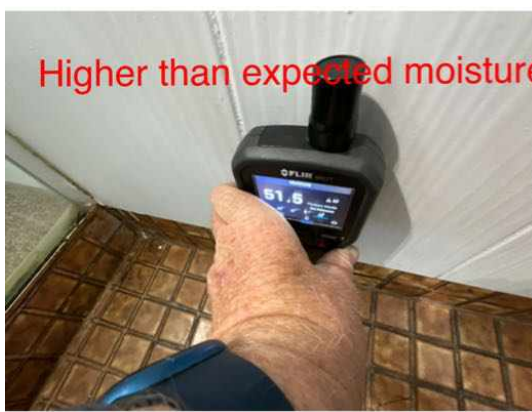
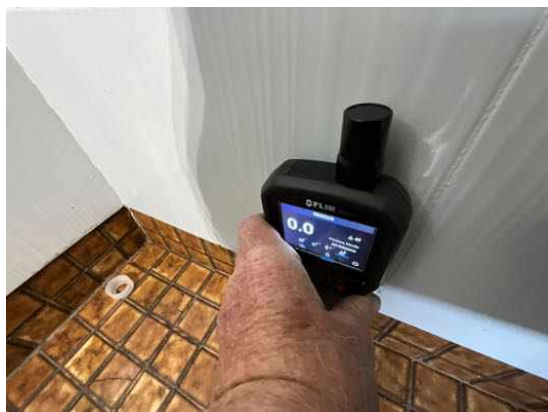
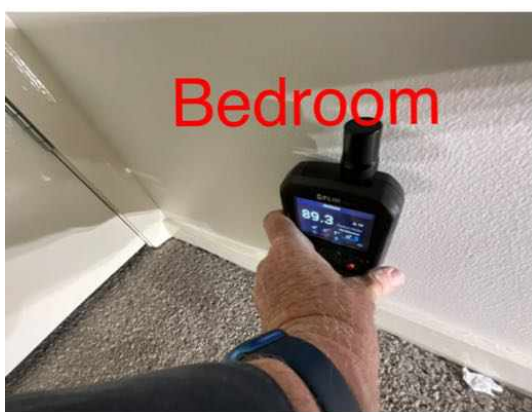
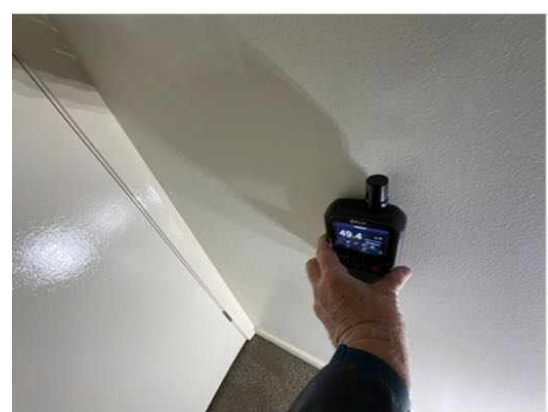
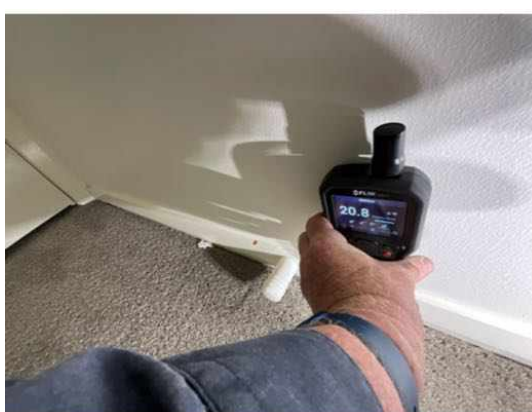
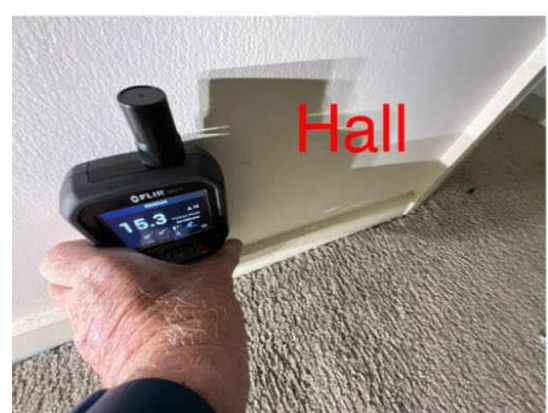
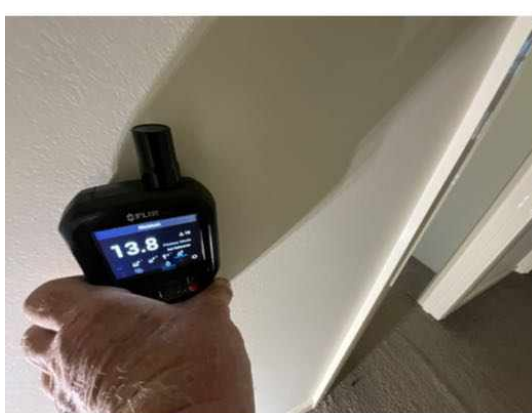
Finding 2.01

Building: Building 1
Location: Bathroom
Finding: Shower Damp- Major
Information: Damp is evident to the lower 300mm of wall to the Shower Alcove. This is suspected to have been caused by moisture permeating through the grouting in this area, which shows evidence of deterioration.

High levels of moisture were observed on the outside of the shower walls in the opposite wall.

Damp (or structural damp) refers to the presence of unwanted moisture in the structure of the building, either as a result of intrusion from outside, or condensation from within the structure. In the Shower area, internal water leaks or other sources of excessive moisture are generally the cause of damp.

A major defect is noted. The shower wall in the bathroom shows relatively high moisture. This will potentially continue to damage the wall if not restored. This situation may have occurred because of deterioration of the water proof membrane behind the tiles. This represents a major building defect. A plumber should be contacted to perform a pressure test and ensure no active leak is present.

Consultation with a qualified Plumber or Bathroom Specialist is advised immediately to identify the cause of damp and to perform remedial works as required.

Always ensure that sealant and grout is in good condition to prevent any moisture issues occurring in the future.

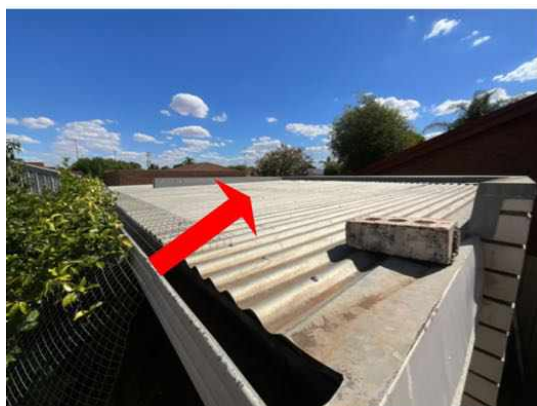
Finding 3.01

Building:	Building 1
Location:	Shed
Finding:	Roof sheets - Loose
Information:	Upon inspection of the exterior roof covering, it was noted that numerous roof sheets have become loose from their original fixings. It is suspected that this defect has developed as a result of a lack of adequate maintenance, but may also have been caused by inappropriate fixings being used in the construction process.

Loose roof sheeting detracts from the weather tightness of the roof covering, making the internal roofing structure susceptible to water penetration and subsequent damage. If left unaddressed, it is likely that secondary damage to associated building elements will develop, potentially necessitating remedial works to these structures.

A roofing restoration contractor should be appointed to advise on rectification options and on the cost of repair. It is advised that remedial works be performed as soon as possible to prevent any further damage.

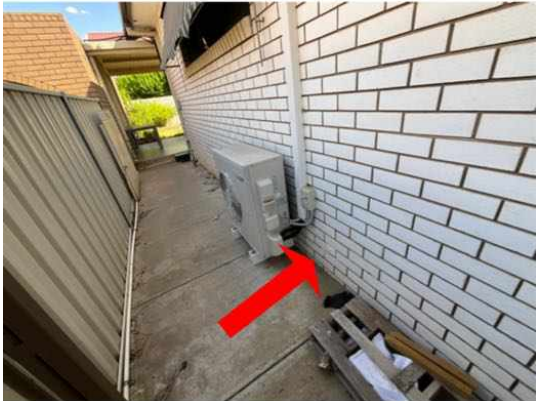
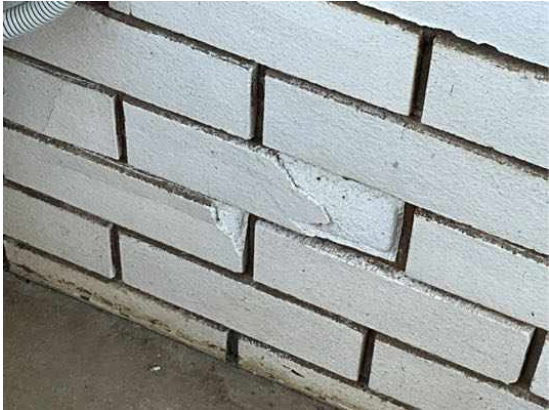
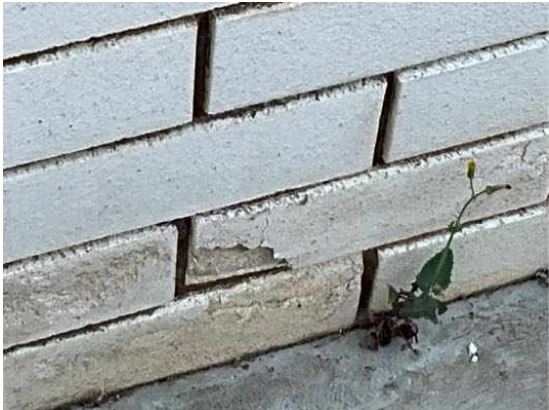
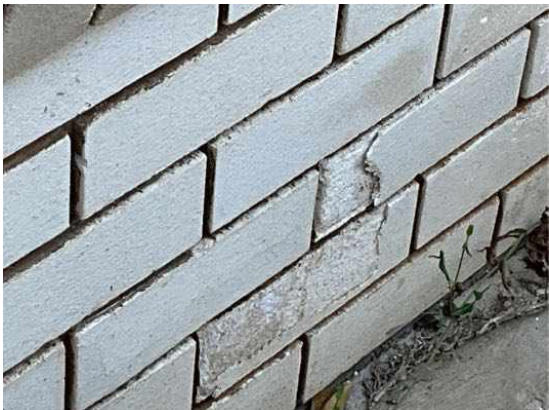
Finding 3.02

Building:	Building 1
Location:	Yard - Side
Finding:	Brickwork - Deterioration
Information:	Deterioration was evident to sections of the brickwork in this area at the time of inspection. Commonly referred to as brick corrosion or erosion, the bricks are aged and likely to have been affected by a variety of factors, including weather exposure, damage, salt-based deterioration, and more.

Overtime, these factors can affect the bricks, causing them to become brittle and appear corroded or eroded. The mortar in the brickwork may also become powdery, further detracting from the structural integrity of the brickwork. If left unmanaged,

potential implications include further deterioration of the building materials, the development of secondary defects, and potential development of structural instability of the wall.

A bricklayer should be contacted for any advice on remedial works.

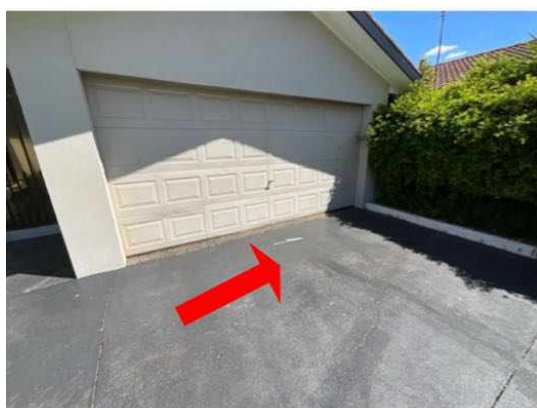
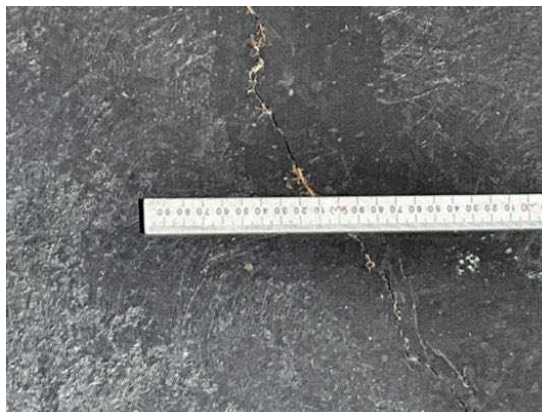
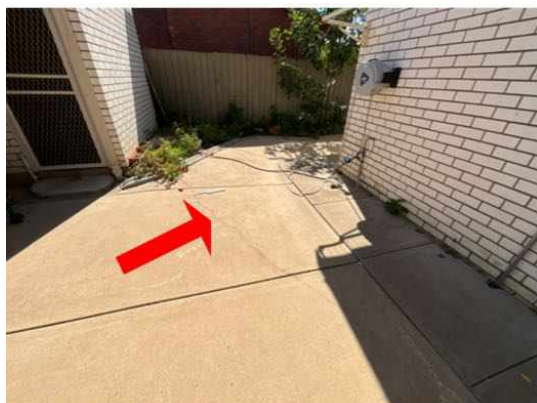
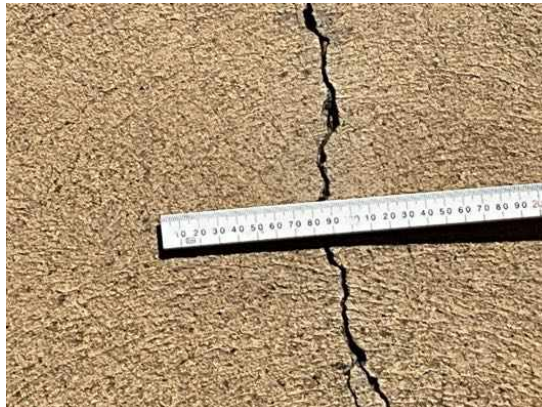
Finding 3.03

Building:	Building 1
Location:	Driveway, yard- back
Finding:	Cracking - External Concrete Paving Damage Category 1 - Fine (less than 2mm)
Information:	Fine cracks were identified in external concrete paving. Although fine cracks are quite

noticeable, they are often only considered to be an appearance defect, and usually do not indicate any structural damage. To be considered a Category 1 or fine crack, the crack is found to be less than 2mm in width.

Generally the cause of a hairline crack in existing concrete paving such as driveways and pathways is indicative of the expansion and contraction of the concrete. Such causes are generally due to environmental factors, such as moisture levels, weather conditions, root systems of nearby trees or the soil types on which they are laid.

Fine cracks may also be due to poor original installation of the concrete. Factors such as poor compaction of the sub surface and/or inadequate reinforcing of the slab may create cracking and other secondary defects.

Monitoring of all cracking should be conducted frequently. Always contact a building inspector should cracks widen, lengthen, or become more numerous.

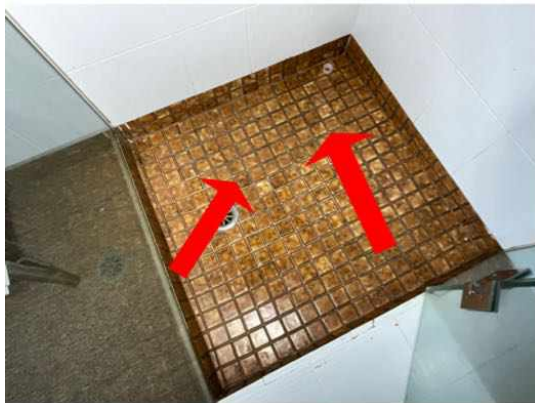
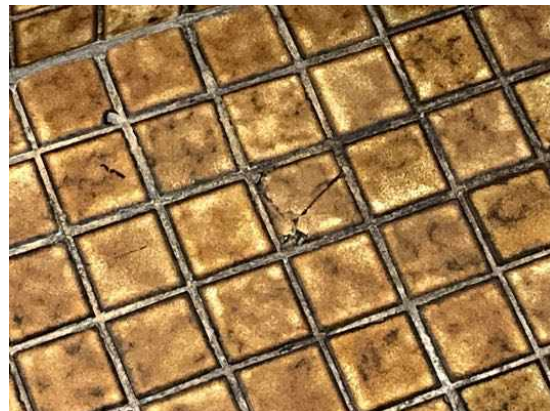
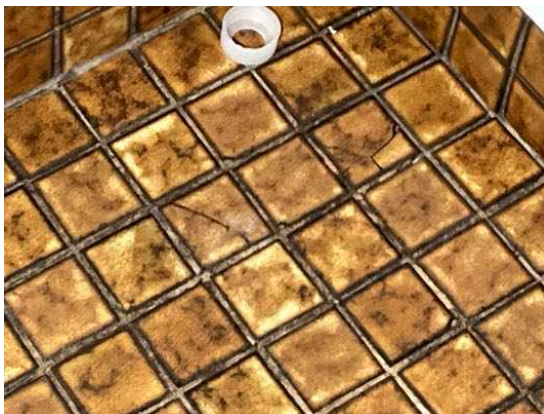
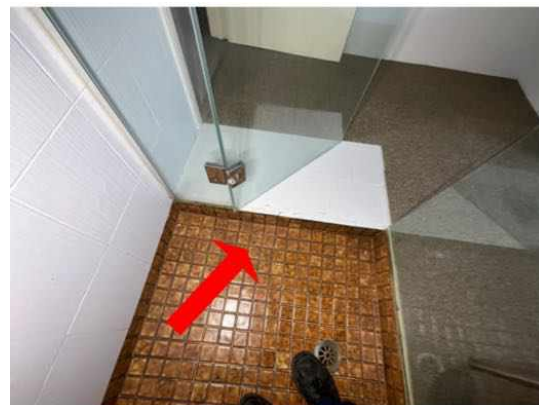
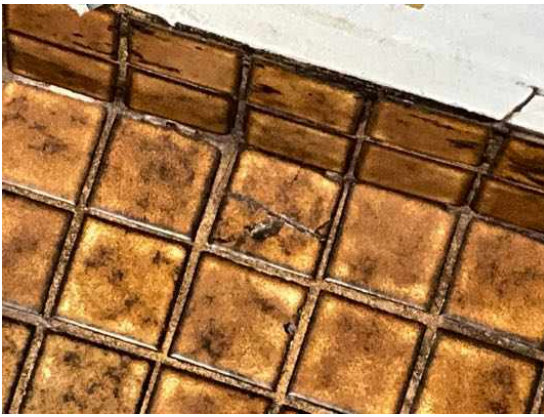
Finding: Cracked floor tiles

Information: Cracking in the floor tiles was evident in this area at the time of inspection. It is suspected that this cracking has occurred as a result of minor settlement or impact damage.

Cracked tiles throughout the household detract from the overall appearance of the affected areas however it is unlikely to create or lead to any secondary defects.

While not considered a matter of urgency, replacement of cracked floor tiles is recommended at the clients discretion. A tiling contractor may be appointed to perform these works. Where cracks become more numerous, contact a licensed building inspector for further investigation.

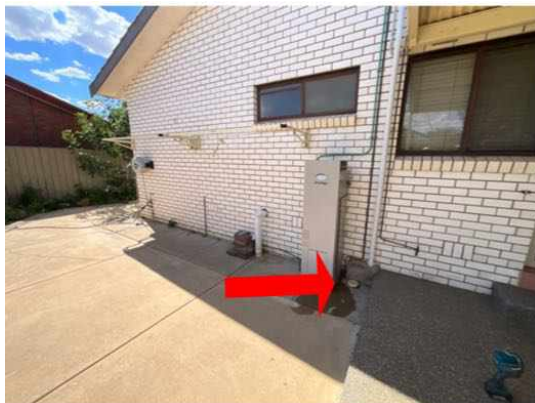
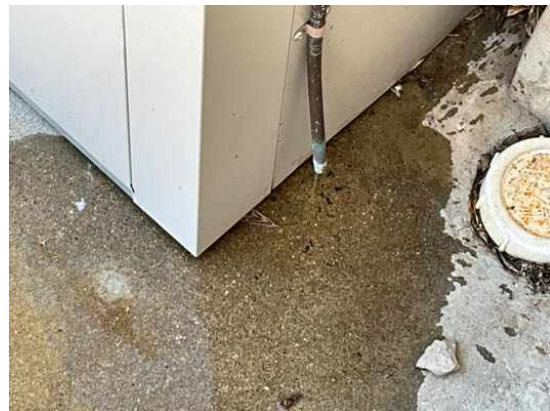
Finding 6.02

Building:	Building 1
Location:	Yard - Back
Finding:	HWS Overflow - Not Connected
Information:	The Hot Water System (HWS) overflow was found to be disconnected from storm water drainage and is creating excessive moisture in the surrounding area.

These damp conditions can lead to secondary defects such as rot, rust or corrosion of associated building elements, the formation of fungal decay, or even the creation of potential slip hazards. When coupled with poor site drainage, pooling of water may also attract termite activity to this area.

It is highly recommended that a licensed plumber be appointed to connect the HWS overflow in order to prevent such an environment from being created. These minor works should be carried out as soon as possible.

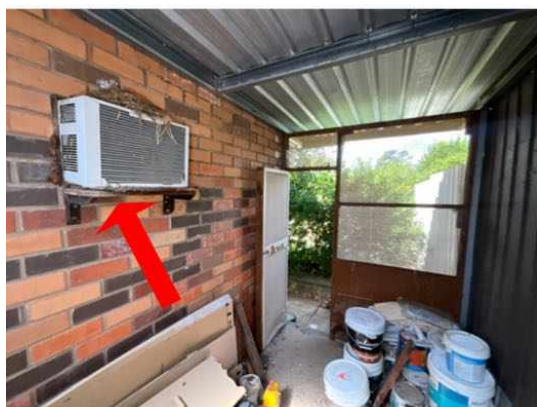
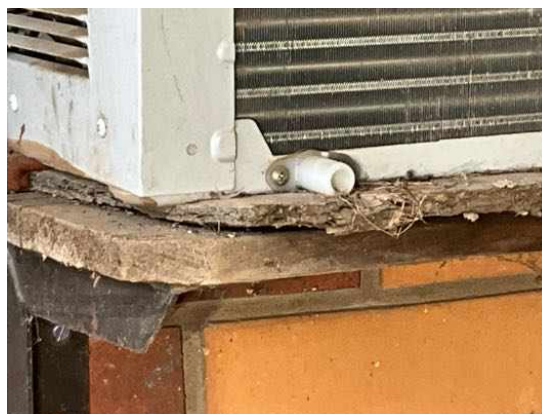
Finding 6.03

Building:	Building 1
Location:	Shed
Finding:	Air conditioner - Disconnected overflow
Information:	The Air Conditioner (A/C) overflow was found to be disconnected from storm water

drainage and is creating excessive moisture in the surrounding area.

Such leaking creates an environment which is conducive to an array of defects, including water damage to associated building elements and the attraction of termite or timber pest infestation.

It is highly recommended that a licensed plumber be appointed to connect the A/C overflow in order to prevent such an environment from being created. These minor works should be carried out as soon as possible.

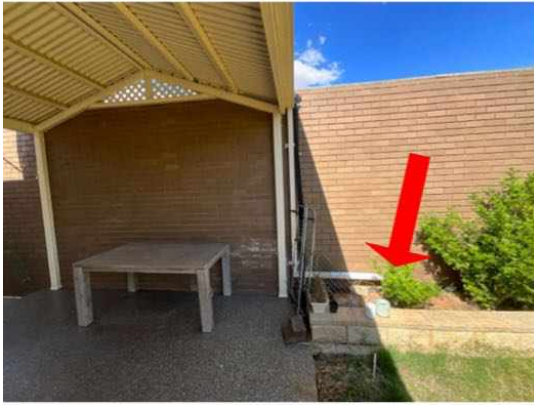
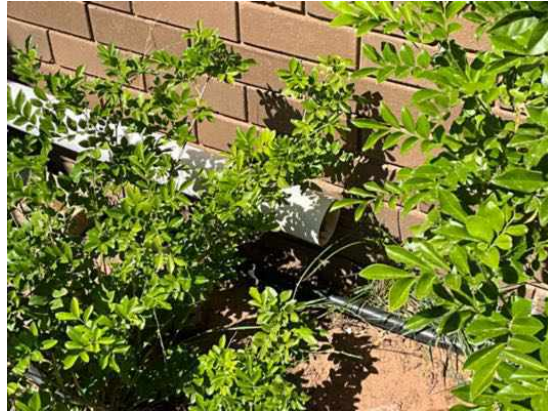
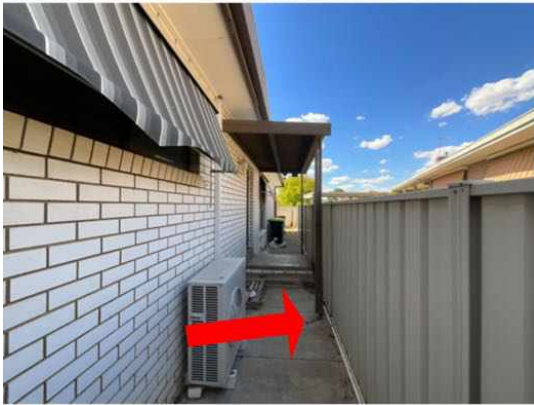
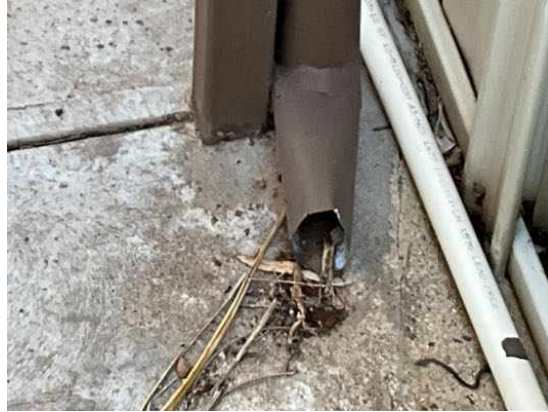
Finding 6.04

Building:	Building 1
Location:	Yard - Back, side
Finding:	Stormwater drain - Not connected
Information:	The roof plumbing is not adequately connected to stormwater drainage on the site. This disconnection negatively impacts the functional capacity of the roof plumbing.

Where roof plumbing doesn't drain adequately, the area at the base perimeter can become excessively damp, potentially creating an environment that is susceptible to rust and corrosion of surrounding building elements, as well as attracting termites and other pests.

It is highly recommended that a plumber be appointed to further inspect the area and to install adequate drainage equipment where necessary.

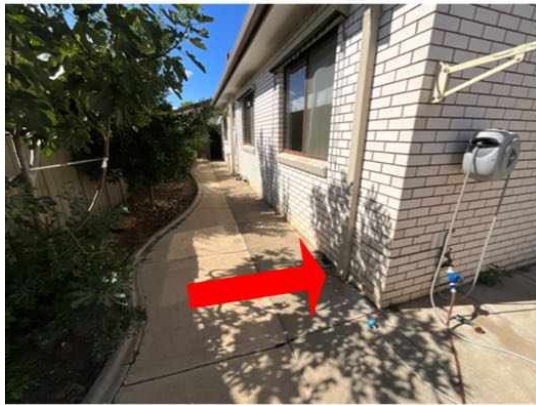
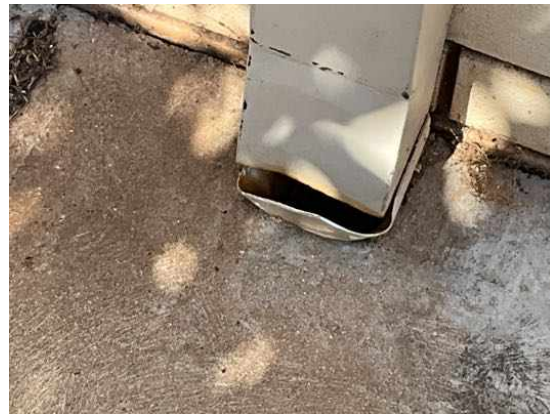
Finding 6.05

Building:	Building 1
Location:	Yard - Side
Finding:	Downpipe/ Stormwater pipe Damaged
Information:	The Stormwater element was found to be damaged at the time of inspection.

Downpipes ensure excess water is directed away from the structure to prevent damage. This damage includes Fungal timber decay, Termite attack and sinking of the stumps that support the floor. All of this type of damage may lead to costly repairs.

A Plumber should be contacted to make repairs as soon as possible to prevent deterioration of the Structure.

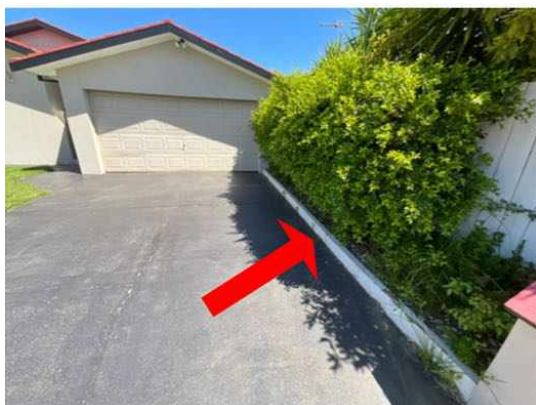
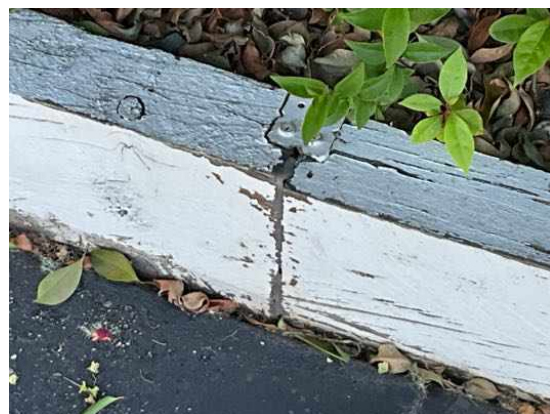
Finding 6.06

Building:	Building 1
Location:	Driveway
Finding:	Untreated or non-durable timbers in a hazardous environment
Information:	To reduce the risk of timber pest attack it is essential that timber used in a hazardous environment (e.g. in direct contact with the ground or frequently exposed to damp conditions) is of sufficient durability and/or is adequately preservative treated.

Untreated timbers in direct contact with the ground are likely to develop severe wood rot and/or fungal decay if left unattended creating attraction for subterranean termites to infest the timbers from surrounding areas.

If untreated or non-durable timbers are found to be in a hazardous environment it is highly advised that replacement of these building elements be performed as soon as possible to aid the protection of the property against termite / timber pest attack.

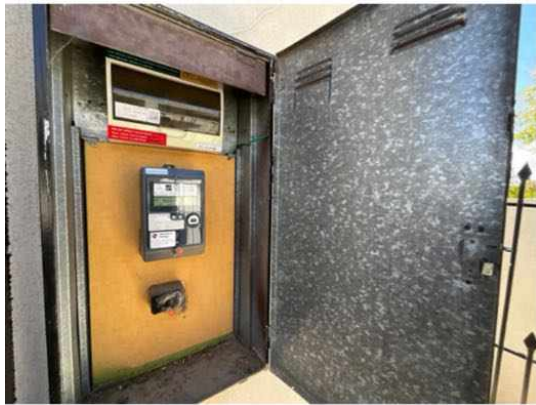
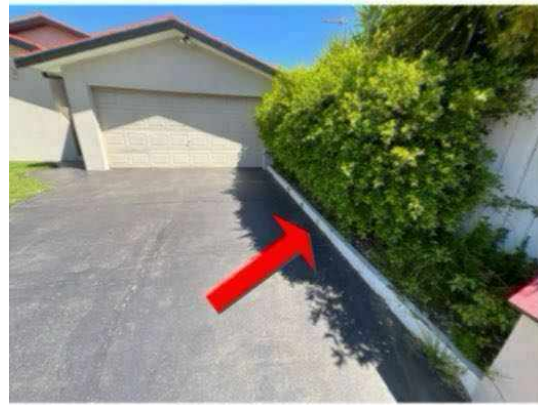
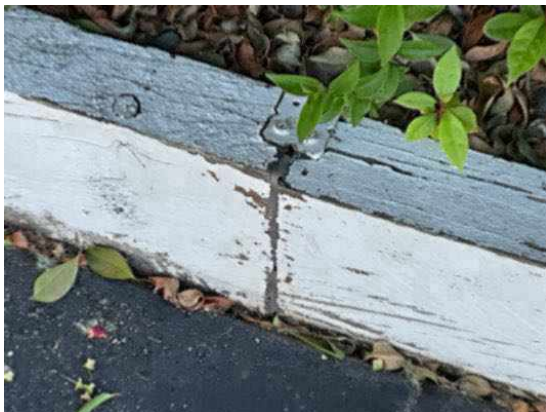
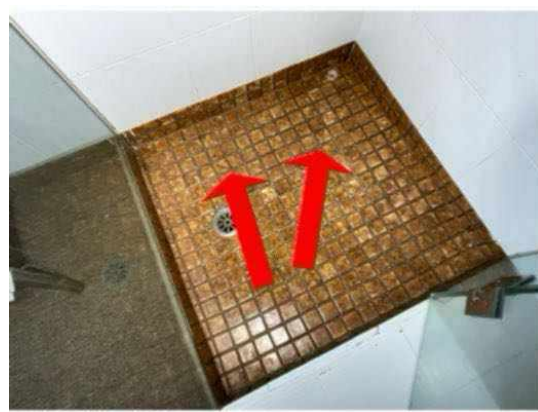
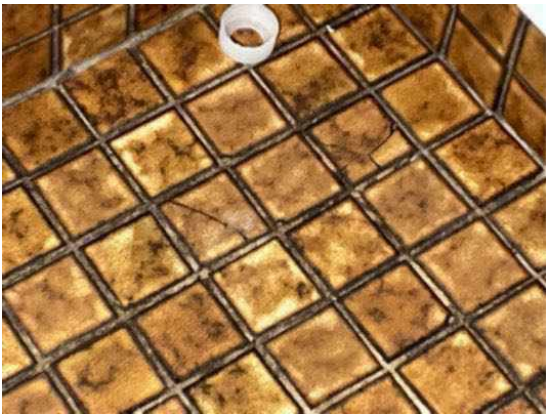
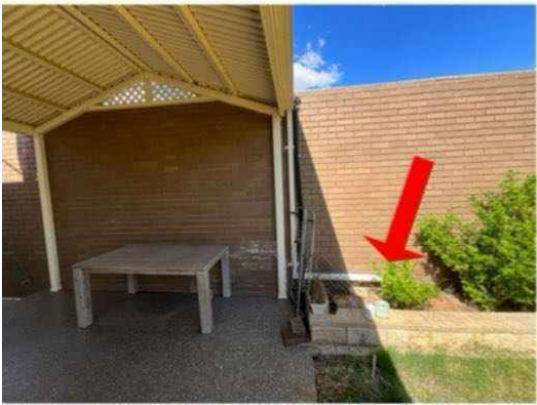
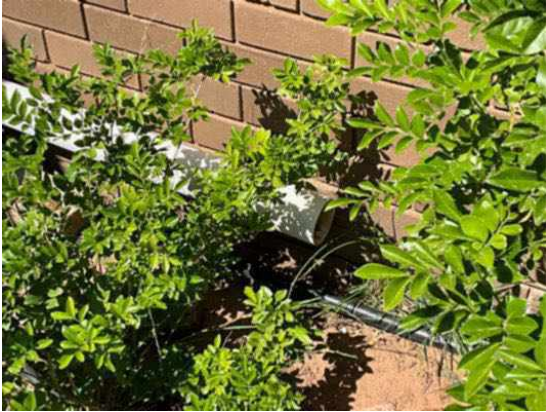
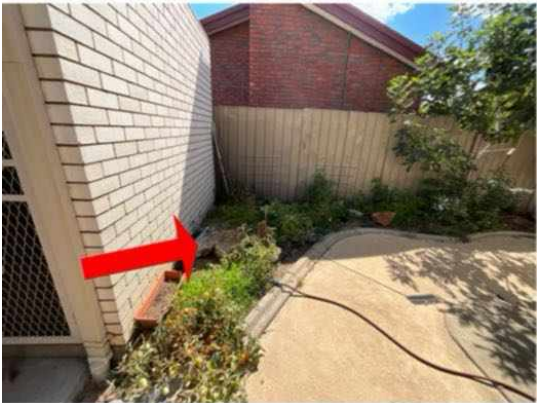
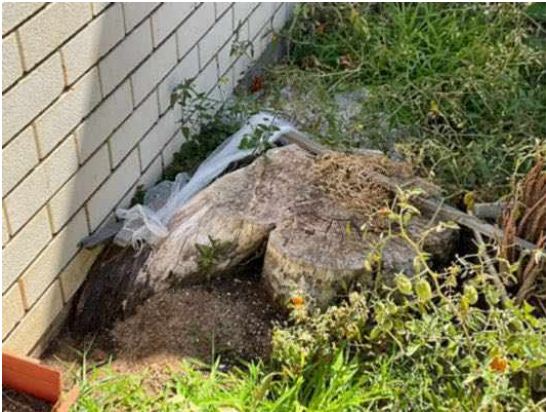
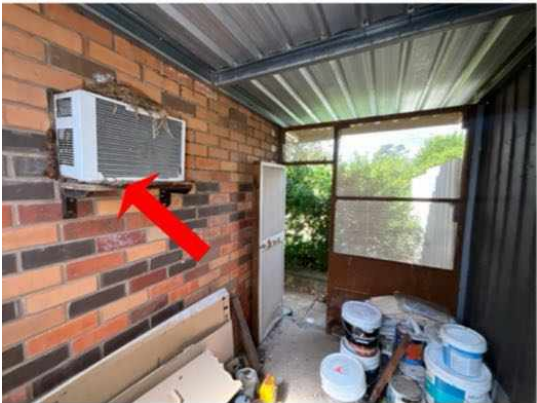
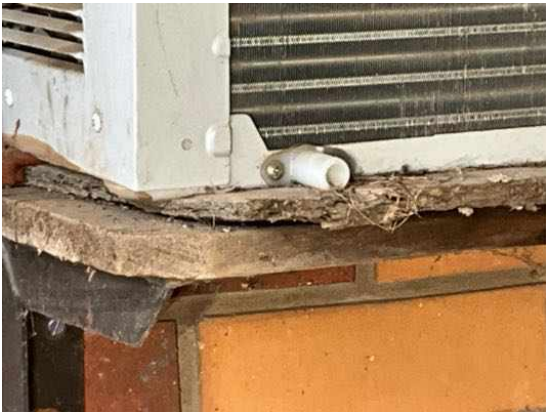
Location: All External Areas
Finding: Termite Management System - no evidence of a chemical installation
Information: The application of a post-construction chemical termite barrier is highly recommended for all properties, particularly if live termite activity has been found on the site previously. Such barriers are highly effective in preventing termite attack on any timber building elements throughout the property.

A durable notice should be placed in the switchboard unit to indicate current termite barriers. At the time of inspection, it appeared as though no termite management system has been installed, with no evidence to suggest preventative works taking place.

There is no evidence of previous Termite Management services. The property has factors that are Conducive to Termite attack. A Licensed Pest controller should be contacted soon to advise on a Termite Management Plan and avoid potentially costly repairs.

The client may consider gaining further advice from a pest controller as to the costs and procedures involved with this application. It is recommended that obtaining such advice be a short-term priority.

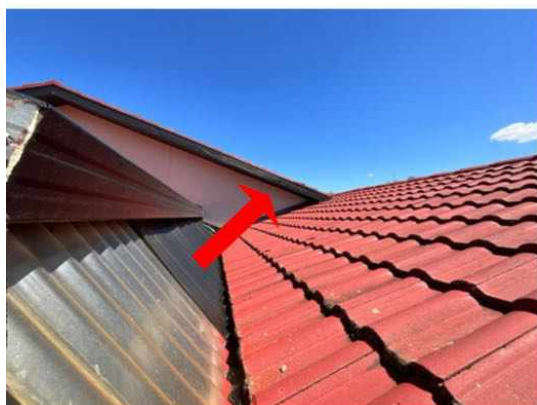
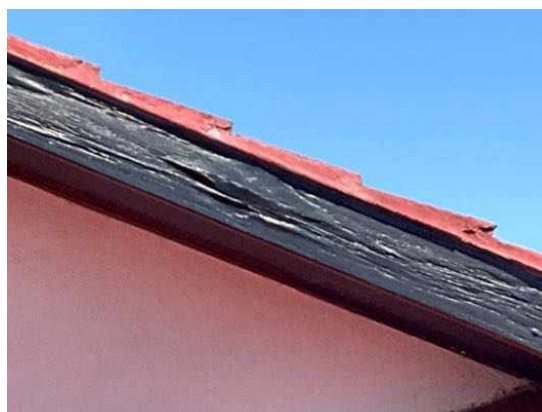
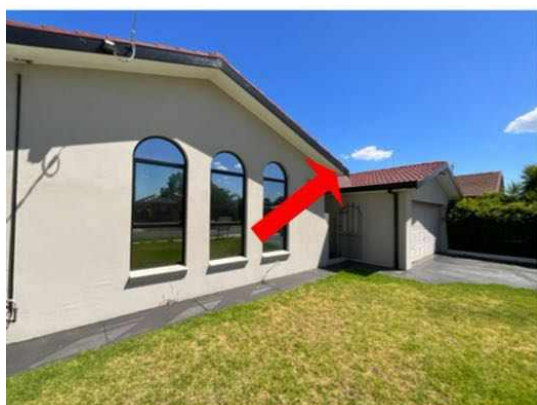
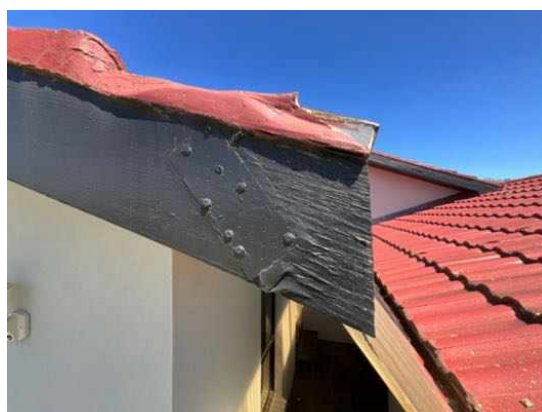
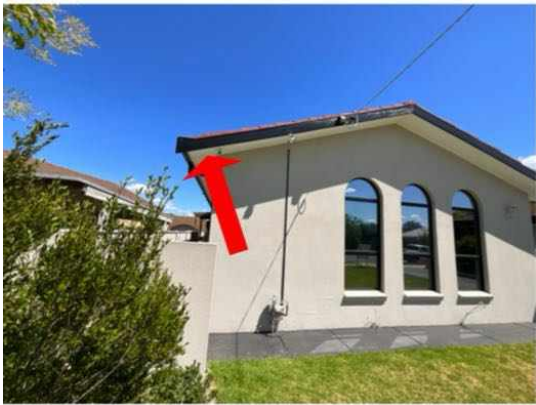
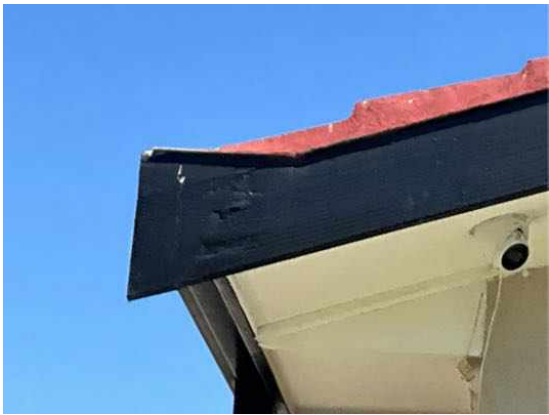
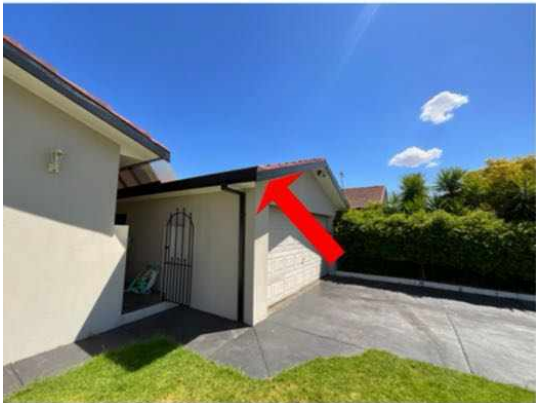
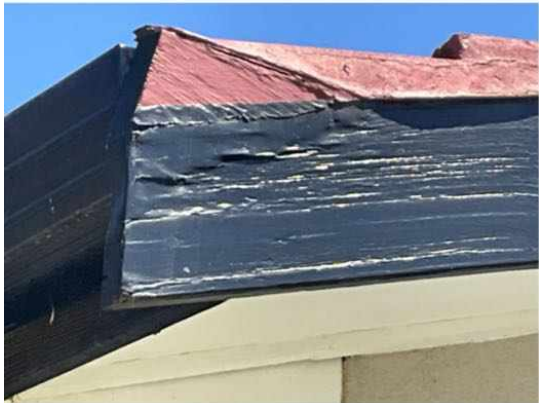
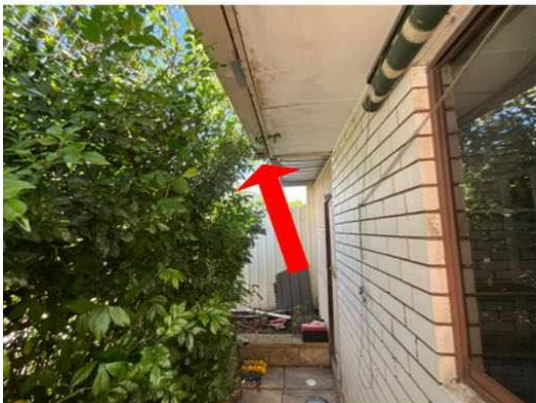
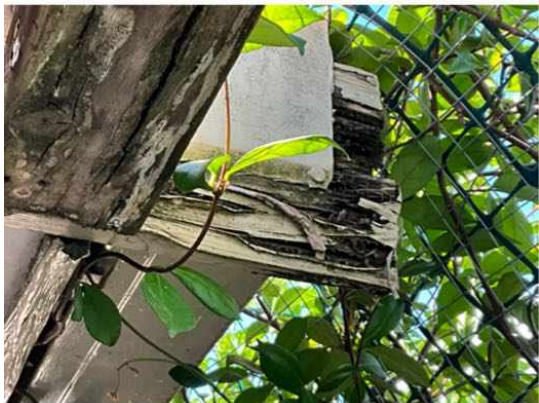
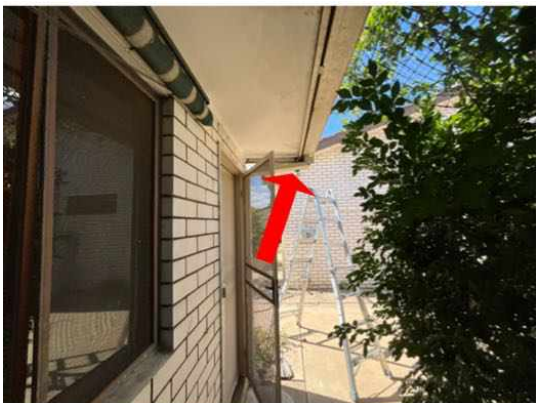
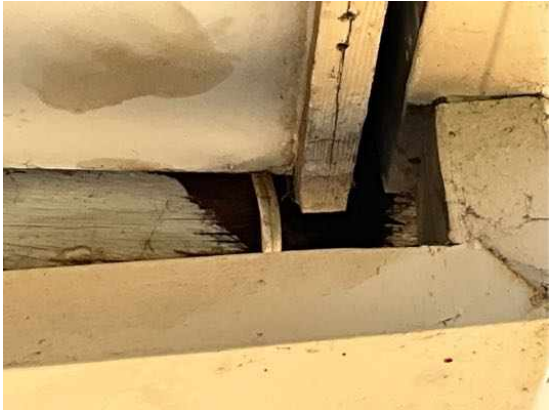
Finding 7.01

Building:	Building 1
Location:	Eaves
Finding:	Fungal decay - present (localised)
Information:	Fungal decay also known as wood decay or wood rot generally refers to the deterioration of timber elements when in contact with excessive levels of moisture for a prolonged period of time.

The development of fungal decay is accelerated by temperatures in the range of 5degreeC to 40degreeC as well as the presence of oxygen. Generally fungal decay develops on timber elements that are in use in an external environment which are exposed to rain penetration.

In this case although the affected timber element is in a decaying state the extent of any visible damage appears to be localised to a specific area and is yet to spread to other parts of the building element or affect adjoining structures. The fungal decay is therefore likely to be of a relatively superficial nature with minimal impact on the structural integrity or tensile strength of the timber element.

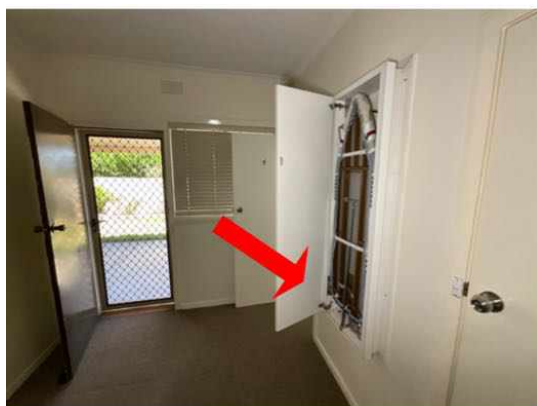
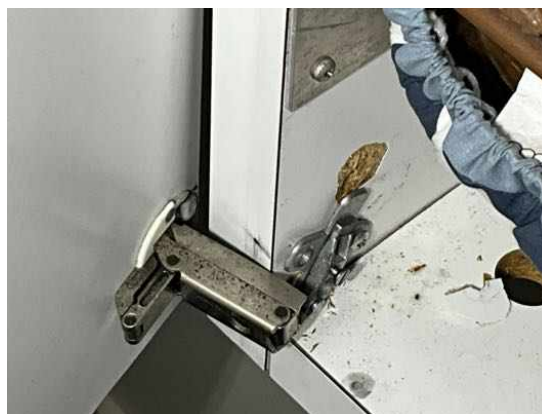
Building: Building 1
 Location: Laundry
 Finding: Cabinetry - Misaligned
 Information: The Cabinetry element at the time of inspection was found to be misaligned. The Cabinetwork was not returning all the way when closed. This is not a structural problem. The operation of sliding/ hinged mechanisms can be maintained by periodic adjustments to avoid increased damage as required.

It is recommended that a Handy Person or Cabinet maker be contacted to adjust the cabinetry and prevent any potential deterioration. This can be done at the discretion of the owner.

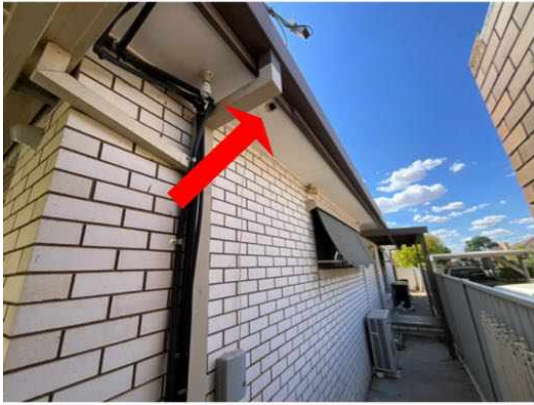
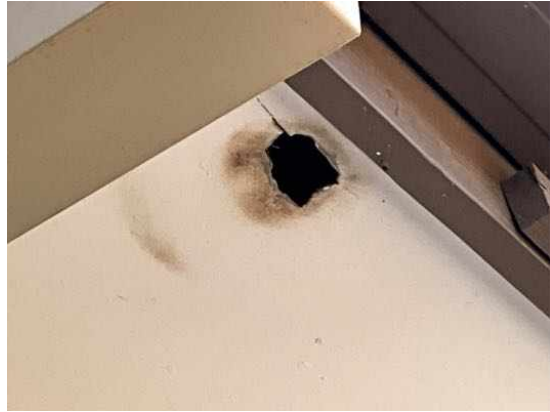
Building: Building 1
 Location: Eaves
 Finding: Damage
 Information: There is a small hole in the eaves. This could allow the ingress of pests.

A handyman should be contacted, at the discretion of the client, to repair the area and prevent potential further deterioration.

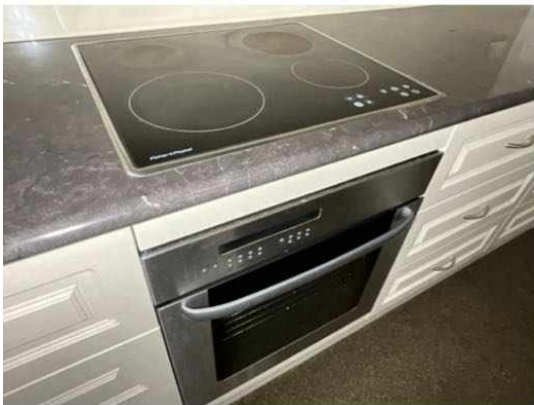
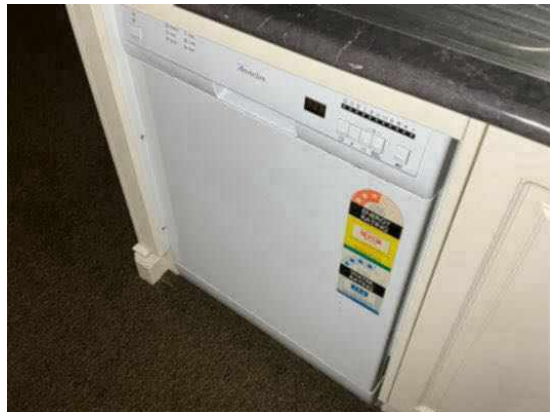
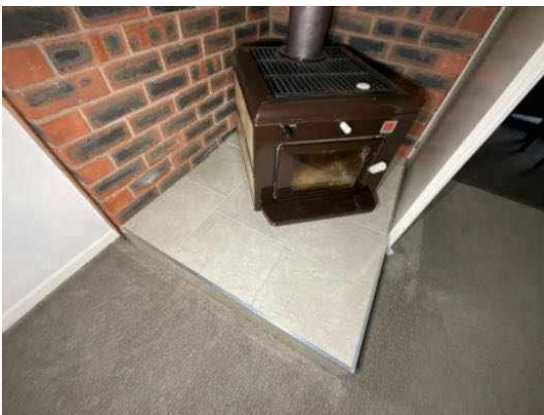
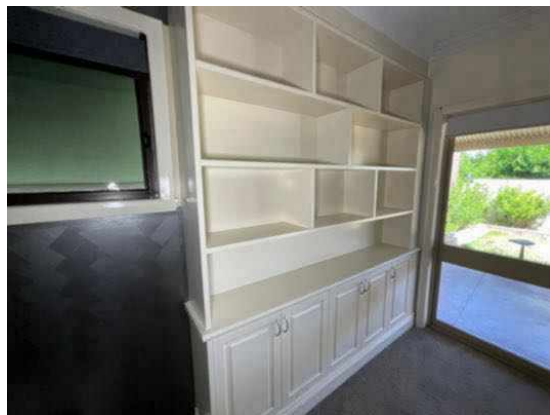
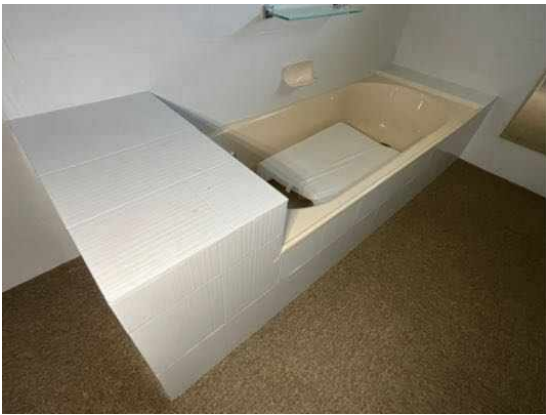
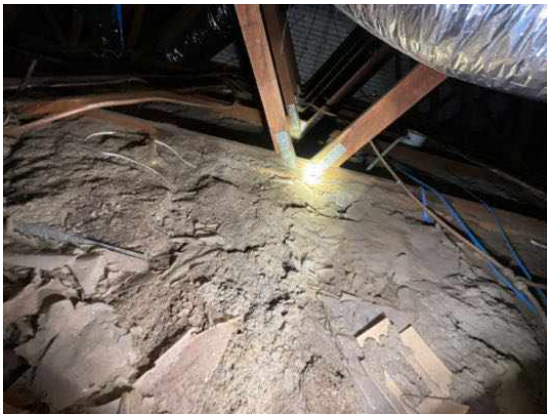
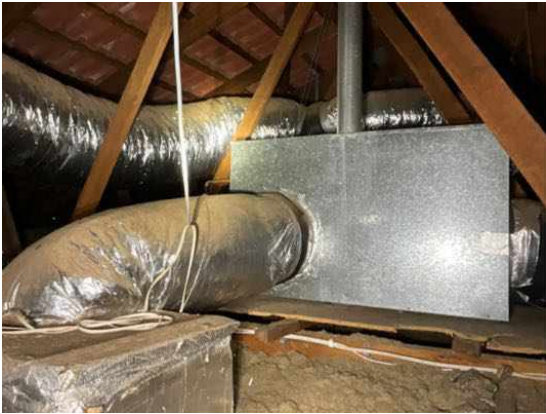
Building: Building 1
Location: All Areas
Finding: Additional Photos - Obstructions and Limitations
Information: These photographs are an indication of the obstructions and limitations which impeded full inspection of the property at the time of inspection. These obstructions can hide an array of defects and should be removed to allow full inspection to be carried out. A re-inspection is recommended once the areas are made accessible.
