Building and Timber Pest Inspection Report

Inspection Date: Fri, 20 Mar 2026

Property Address: 91 Fairway Dr, Sanctuary Point NSW 2540, Australia

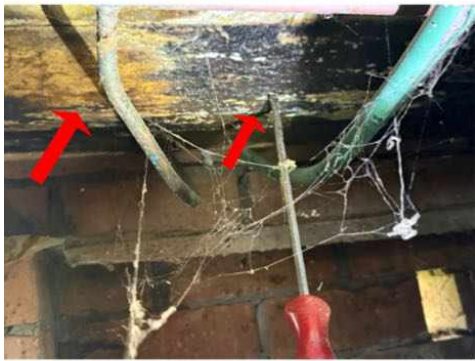
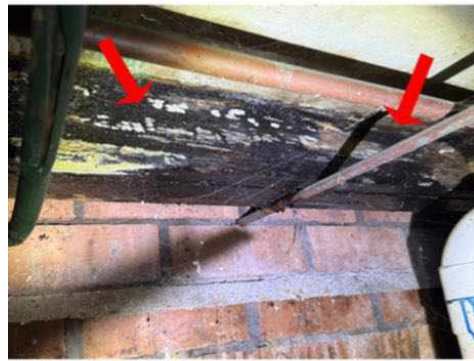
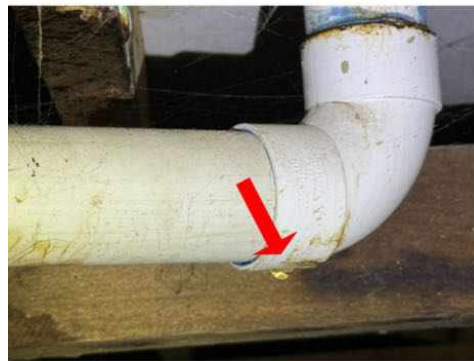
Building: Building 1
Location: Bathroom
Finding: Bathroom areas Leaking
Information: Leaking was evident to at least 3 bathroom subfloor areas/ pipes at the time of inspection. It is suspected that the leaking has occurred as a result of a failed waterproofing membrane and substandard plumbing as the bathroom does not appear very old.

Leaking from the bathroom and shower base has lead to water damage to adjoining flooring. Such damage can necessitate extensive remedial works being required.

An invasive inspection may also find wood rotted wall frames in the bathroom perimeter walls. These active water leaks are also resulting in mould growth.

Appointment of a bathroom contractor and plumber is required to repair or replace these damaged areas. Such works should be performed as soon as possible to ensure that no further damage occurs. Quotes should be obtained before purchase as they will be substantial.

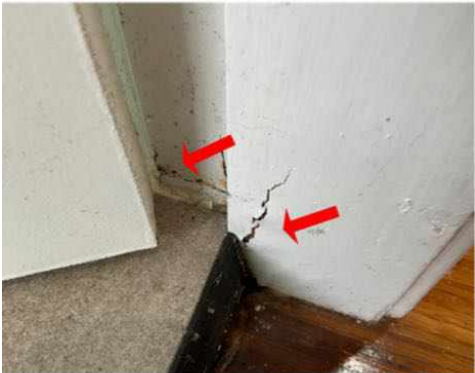
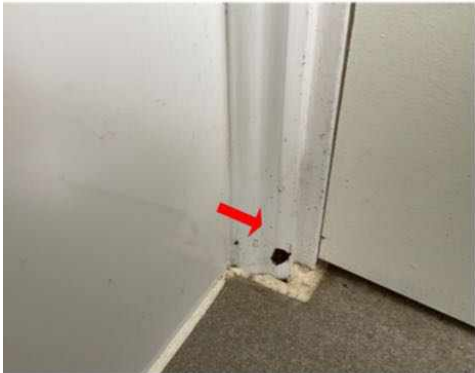
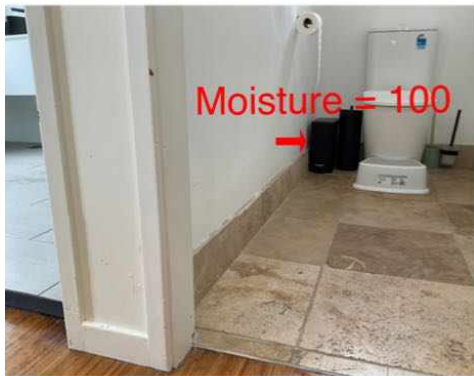
Finding 3.01

Building:	Building 1
Location:	Bathroom/ toilet wall
Finding:	Evidence of excessive moisture was present at the time of inspection
Information:	Excessive moisture was found in the bathroom door frame and toilet wall at the time of the inspection. A high reading of 93.1 was recorded in the right side bathroom door and 25 on the left side. The toilet rear left wall showed a maximum reading of 100. The adjacent laundry frame showed a zero reading for reference.

Excessive moisture can attract termites and produce conditions that promote termite attack, fungal growth and wood decay. Excessive moisture is generally caused by deteriorated, inadequate or missing, leaking plumbing pipes or fixtures, poorly plumbed HWS overflows or condenser units and poor site drainage. Damaged paint and minor mould is also evident in the door frame. A sealant specialist or licensed plumber can be consulted for advice.

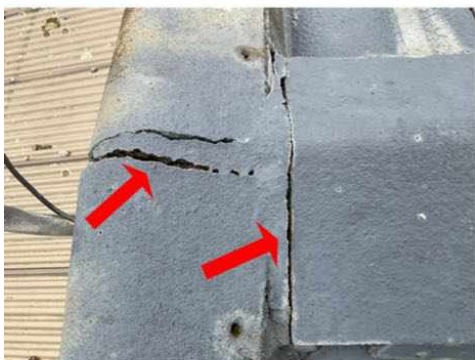
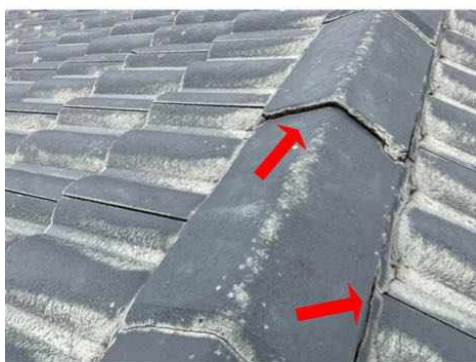
Finding 3.02

Building:	Building 1
Location:	Roof Exterior
Finding:	Roofing areas - Weathered
Information:	Upon inspection of the exterior roofing, the majority of the roof areas were considered to be in a fair condition. While weathering of these pictured areas is consistent with the age of the property, maintenance works are required.

Re-sealing and replacing gaps and damage must be undertaken immediately to help preserve and extend the life span of these roofing areas and protect the internal building. Where left unmanaged, deteriorating roofing materials are likely to lead to a number of secondary defects, including minor water leaks and weather exposure to internal roofing structures.

Consultation with a roofing contractor is highly advised to repair these areas immediately. Remedial works are likely to increase the longevity of the exterior roofing structure.

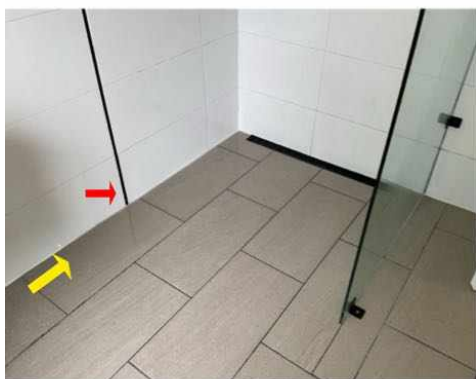
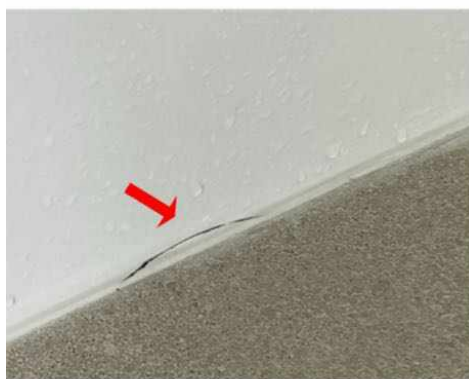
Building:	Building 1
Location:	Bathroom
Finding:	Tile cracked and door missing
Information:	One cracked tile was evident in the bathroom at the time of inspection. It is suspected that this cracking has occurred as a result of minor settlement.

Cracked tiles throughout the household detract from the overall appearance of the affected areas. In wet areas of kitchens and bathrooms, it can lead to water damage of adjoining walls and floors.

As there is no shower door, water left the shower alcove toward the vanity as indicated by the yellow arrow in the photo. This appears to be one of the many subfloor leaks from this area.

Replacement of cracked tiles is recommended. A tiling contractor may be appointed to perform these works. Where cracks become more numerous, contact a licensed building inspector for further investigation.

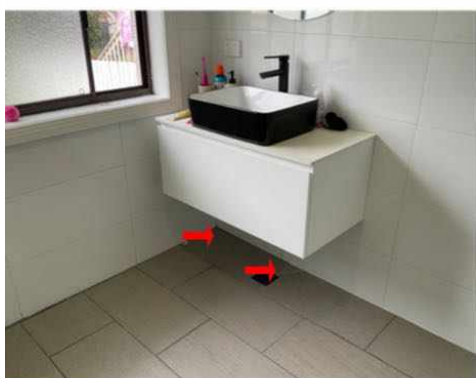
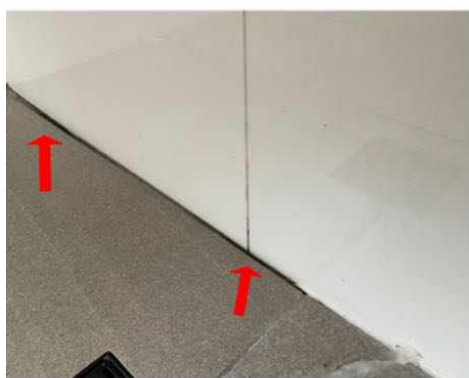
Finding 3.05

Building:	Building 1
Location:	Bathroom

Finding: Sealant and grouting - Missing or damaged
Information: It was noted on inspection that sealant or grout is degraded to these pictured wet areas.

Different materials and floor areas move at different rates, generally causing cracking to grout or sealant at this point. A flexible sealant is required to allow for expected expansion and contraction, while keeping the joint water tight and protective of all associated building materials.

Flexible and mould resistant materials should be applied to affected areas to prevent any subsequent water damage that is likely to occur. Regular maintenance and replacement of damage or missing or damaged sealant and grout is highly recommended to the wet areas, as this is a regular wear and tear defect. Sealant and grouting in areas that come into regular contact with water should be maintained for the long term care of your property.

A sealant specialist or tiling contractor should be appointed to complete these works as soon as possible

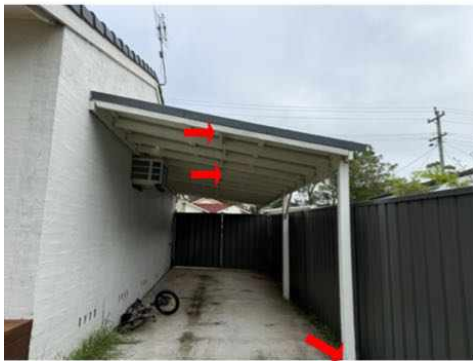
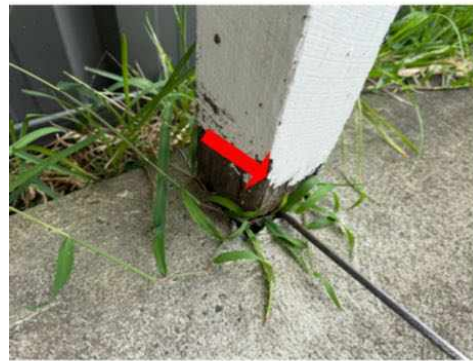
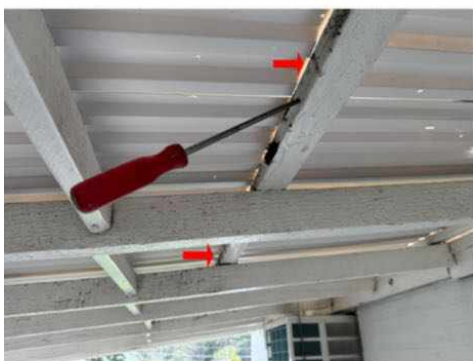
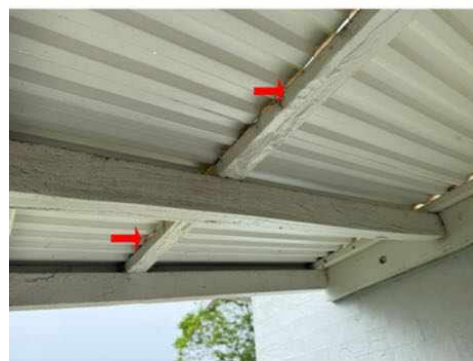
Finding 3.06

Building: Building 1
Location: Subfloor and carport areas

Finding: Wood rot

Information: The subfloor and carport shows evidence of wood rot. Wood rot, also known as Fungal Decay, occurs when timbers and other cellulose building materials are exposed to damp conditions on an ongoing basis. This could be the result of exposure to weathering over a prolonged period of time, or the attraction of excessive moisture from other abutting building materials.

Early intervention and regular maintenance, particularly of exterior timbers, will prolong the useful life of these building elements. Prior to any works being performed, the cause of the moisture that has created the visible wood rot should be identified and addressed in a suitable manner. Replacement of affected timbers may then be a necessary step in protecting surrounding building elements from such deterioration. Some carport posts need urgent paint protection or will need replacement in the near future.

A qualified carpenter or registered builder may also be required to replace affected building materials.

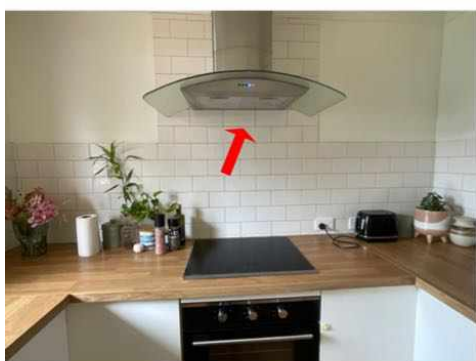
Without a functional fan, a build-up of grease and evaporative moisture is likely to accelerate deterioration of the range hood and associated flue. This potential build up may also create a minor fire hazard, particularly if left uncleaned.

A licensed electrician should be appointed to replace the fan on the range hood to restore it to a fully operational state.

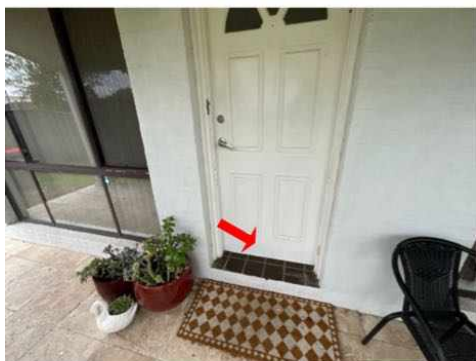
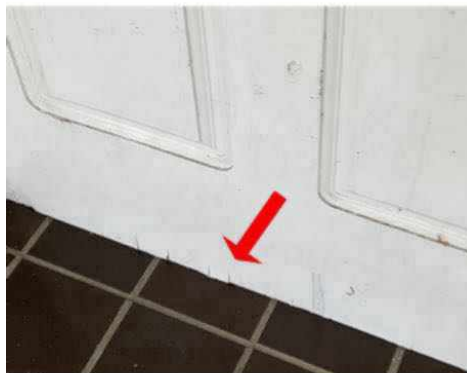
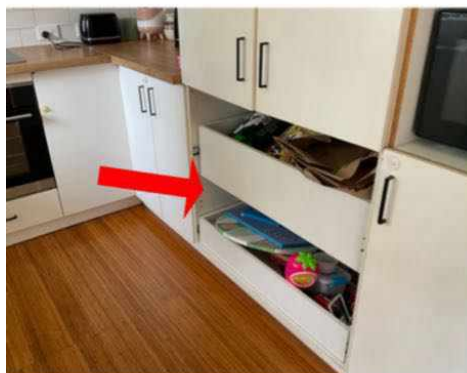
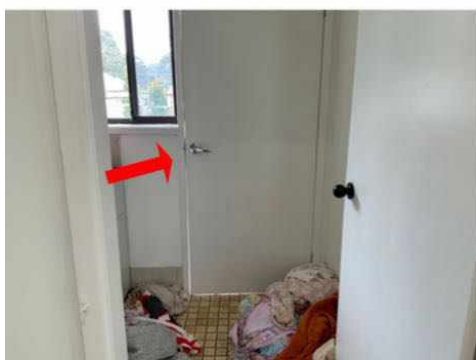
Finding 3.09

Building:	Building 1
Location:	Pictured external areas
Finding:	Building elements - Damaged
Information:	Evidence of minor missing or damaged areas was identified at the time of the inspection. These include -

1. The front door is starting to delaminate and may need replacement in the next few years.
2. One kitchen and one bathroom downlight do not work.
3. Some kitchen cupboard doors were missing.
4. The laundry door is binding on the frame and requires sanding. Two other door shows minor splitting.

A carpenter and electrician would be the trades responsible for rectification of these areas when convenient.

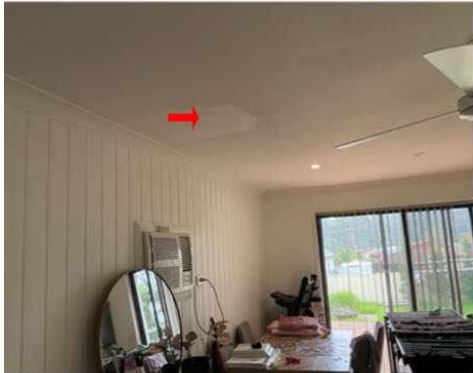
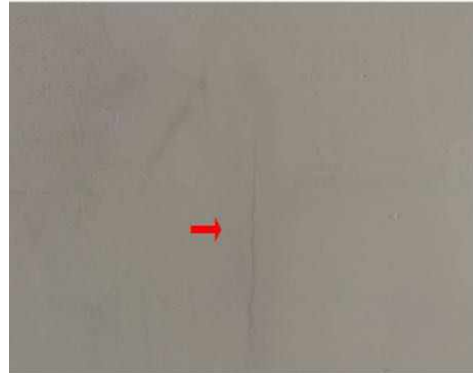
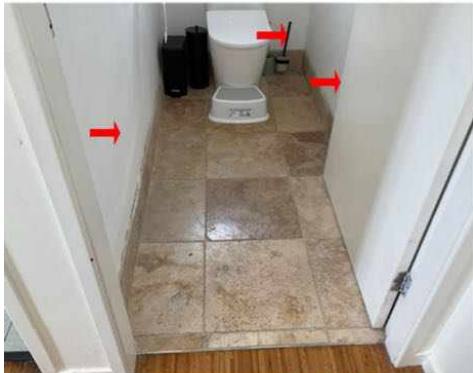
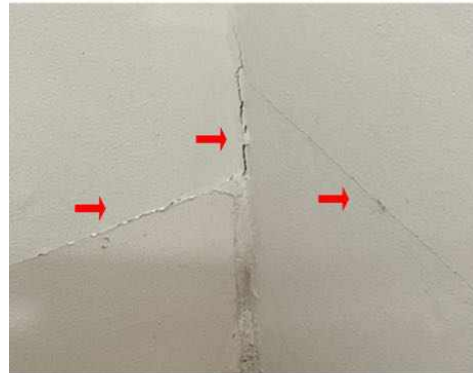
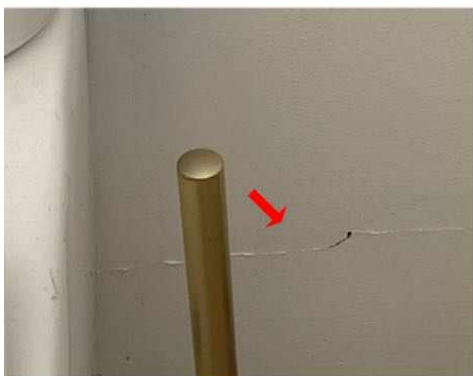
Finding 3.10

Building:	Building 1
Location:	Lounge Room & toilet
Finding:	Cracking - Damage Category 1 - Fine (up to 1mm)
Information:	Although fine cracks are quite noticeable, they are often only considered to be an appearance defect, and usually do not indicate any structural damage. Generally, the cause of a fine crack is indicative of a separation between building materials and finishes (e.g. paint, plaster, etc.) along joins.

Cracking of this nature can generally be repaired with minor sanding, filling and/or

repainting. Such works should be performed by a qualified painter or a general handyman.

Monitoring of all cracking should be conducted frequently. Always contact a building inspector should cracks widen, lengthen, or become more numerous.

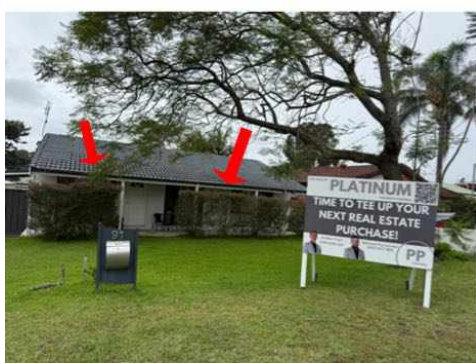
Finding 3.11

Building:	Building 1
Location:	Roof exterior
Finding:	Gutters - Full and blocked
Information:	The guttering on around the roof was found to be blocked at the time of the

Blocked gutters are likely to lead to high levels of moisture in the affected areas which can cause rust and decay of the gutters and downpipes and wood rot to adjoining timber areas. Blockages in gutters should therefore be removed immediately to ensure dry conditions are maintained.

It is highly advised that gutters be cleaned by the homeowner or a general handy person as a matter of urgency.

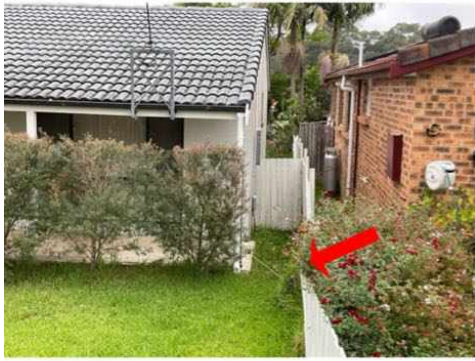
Finding 3.12

Building:	Building 1
Location:	Pictured right fence
Finding:	Fence damaged - leaning
Information:	Evidence of damage to the pictured fence was identified at the time of the inspection. The likely cause of this fence leaning is not enough concrete used in the post footings.

If left unmanaged this fence may deteriorate further. It is suggest a fencing contractor be engaged for rectification when convenient.

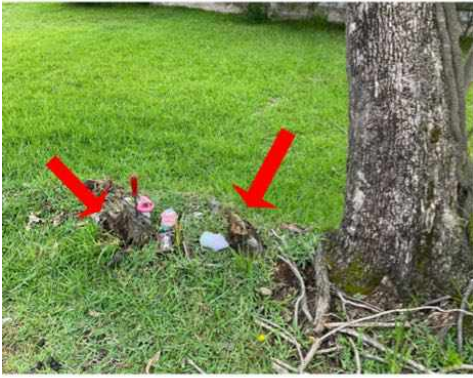
Finding 6.04

Building: Building 1
 Location: Front yard area
 Finding: Tree stumps - left in ground
 Information: Tree stumps left in ground provide opportunity for termite attack as they are likely to be subject to rot and decay providing an attractive food source. Treatment and/or Removal of the stump is highly recommended. A pest controller and tree removalist should be engaged to perform such works.

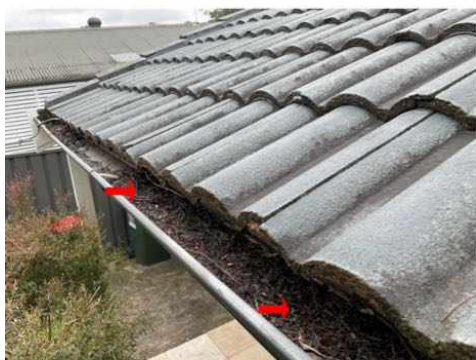
Information: The guttering on around the roof was found to be blocked at the time of the inspection. Roof plumbing structures, such as guttering and downpipes, should be free of all debris to prevent blockages. Blockages of the guttering and downpipes will lead to pooling and accumulated water overflows, which is likely to subsequently flood eaves and exterior walls.

Blocked gutters are likely to lead to high levels of moisture in the affected areas. Such moisture will not only cause rust and decay of the associated building materials, but can also provide conditions that are conducive to termite and timber pest activity. Blockages in gutters should therefore be removed immediately to ensure dry conditions are maintained.

It is highly advised that gutters be cleaned by the homeowner or a general handyman as a matter of urgency.

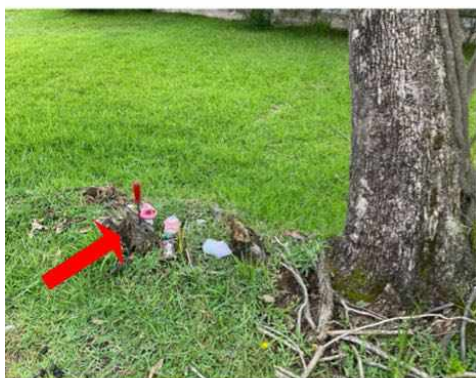
Building:	Building 1
Location:	Pictured yard area
Finding:	Evidence of wood borer activity identified
Information:	Wood borers small beetles that colonise in exposed timber elements are a common timber pest that are regularly mistaken for termites. Although wood borer activity is generally not detrimental to the affected timber they may lead to serious damage and necessitate replacement of certain building elements if left unattended.

The other commonly known borer the Anobium borer is more likely to attack floorboards and may cause severe structural damage to flooring areas.

As no live wood borer activity was identified treatment is not required at this time.

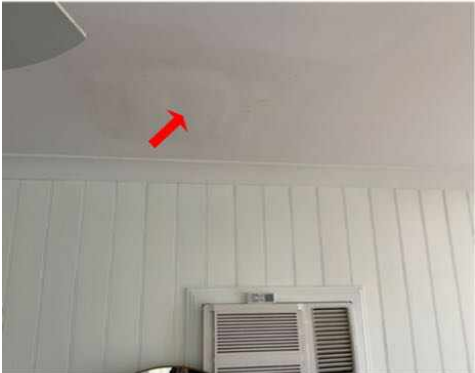
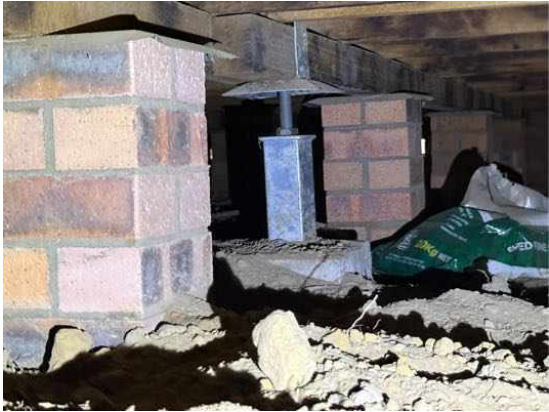
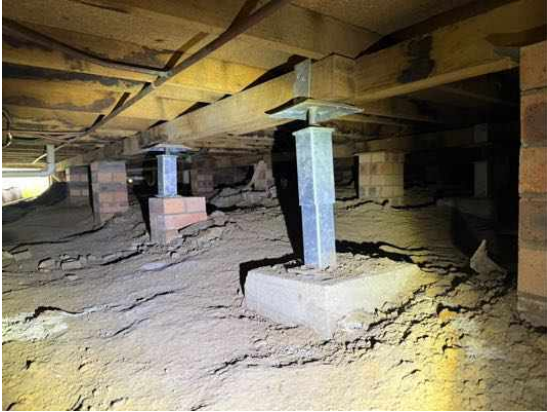
Building: Building 1
 Location: Pictured Areas
 Finding: Repairs evident
 Information:
