Building and Timber Pest Inspection Report

Inspection Date: Wed, 21 Jan 2026

Property Address: 14 Frances St, LIDCOMBE, NSW, 2141,
Australia

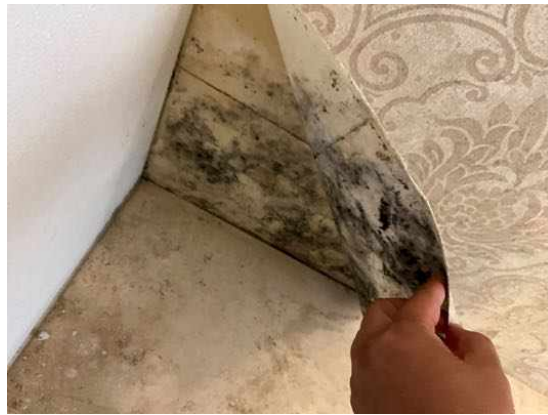
Building:	Main Building
Location:	Basement
Finding:	Mould - Present
Information:	Mold growth is present throughout the property, primarily due to inadequate ventilation. Poor airflow and moisture accumulation within the house have created ideal conditions for mold to thrive.

A licensed mold remediation specialist should be engaged to remove the mold and treat affected areas. In addition, a ventilation expert or builder should assess and improve the house's ventilation system, possibly installing exhaust fans, vents, or mechanical ventilation systems to ensure adequate airflow and prevent future mold growth.

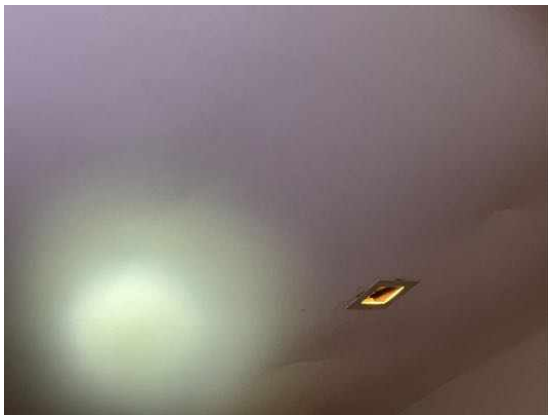
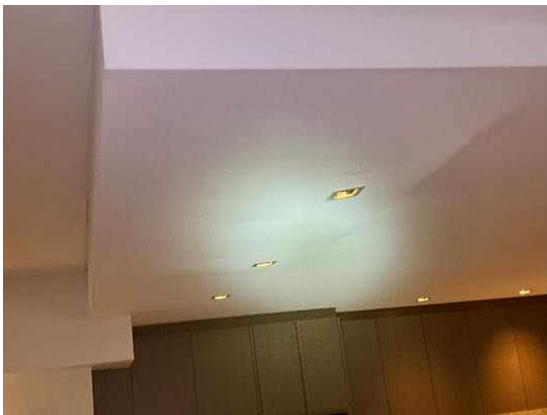
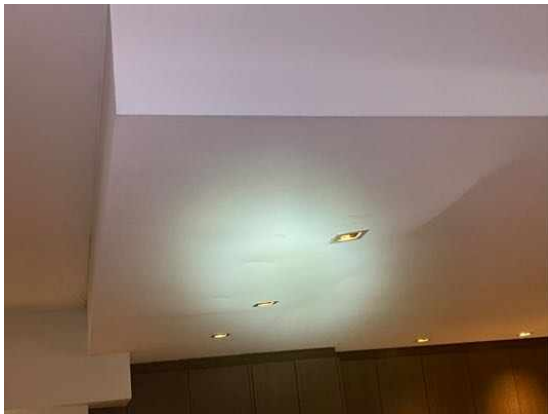
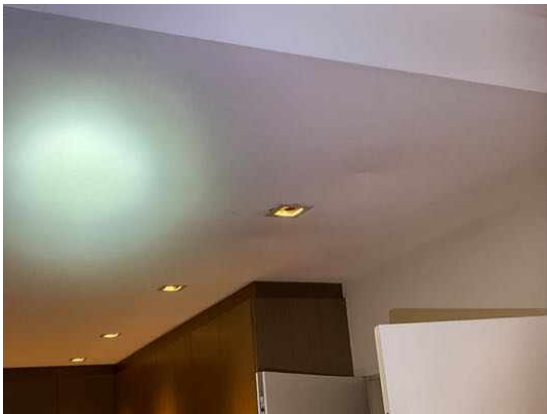
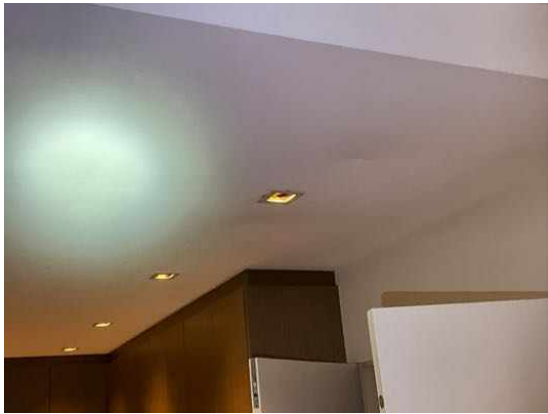
Finding 2.01

Risk: Sagging ceilings pose several risks, including potential collapse or detachment of ceiling materials, which can lead to property damage and serious injuries to occupants. Additionally, sagging ceilings may indicate underlying structural issues, such as water damage or compromised support beams, which could worsen over time if left unaddressed.

A qualified and licensed Builder or structural engineer should be consulted to assess the extent of the sagging and identify the underlying cause. Depending on the severity and cause, repairs may involve reinforcing support structures, addressing water damage, or replacing damaged ceiling materials to ensure safety and structural integrity.

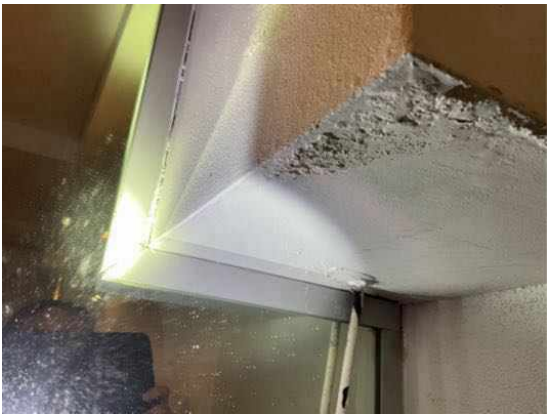
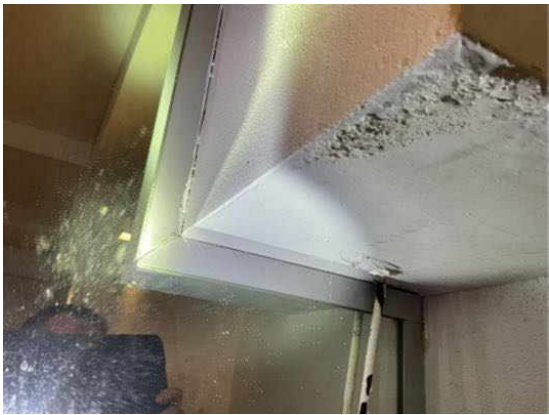
Building: Main Building
Location: Basement
Finding: Evidence of excessive moisture - Drywall

Information: Excessive moisture is present at the time of , indicating a potential water leakage issue within the wall.

The prolonged presence of moisture can lead to mold growth, deteriorate the structure, and create an environment conducive to health hazards. Additionally, it may compromise the adhesive holding the tiles, leading to their detachment.

A licensed plumber or a qualified contractor specializing in water damage remediation should investigate the source of the moisture, fix any leaks, and address the damage. Additionally, replacing affected tiles and ensuring proper waterproofing are crucial to preventing future issues.

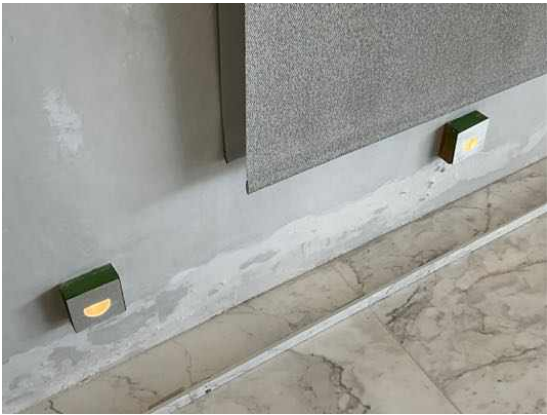
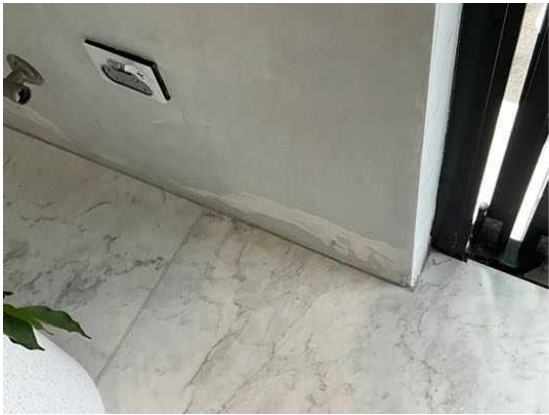
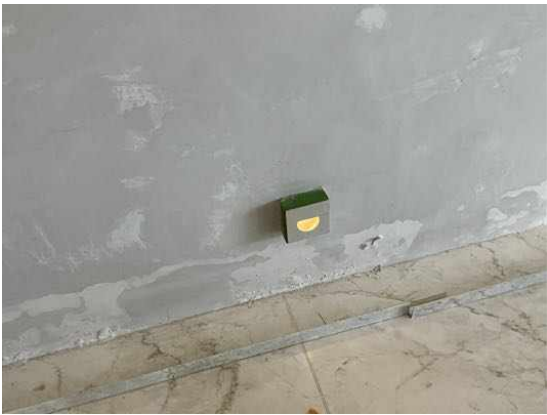
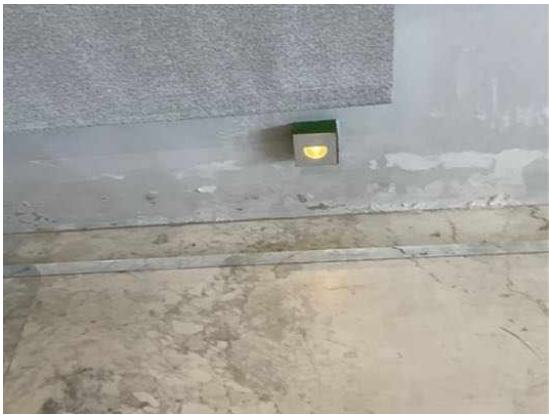
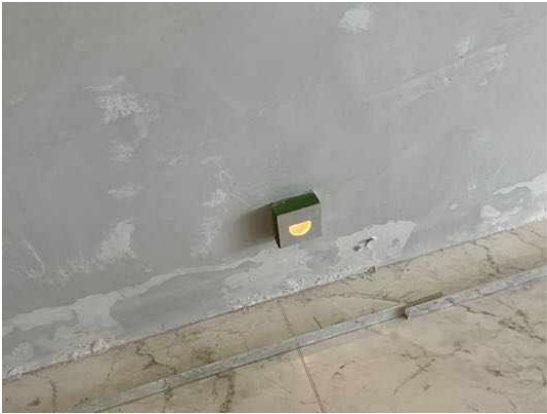
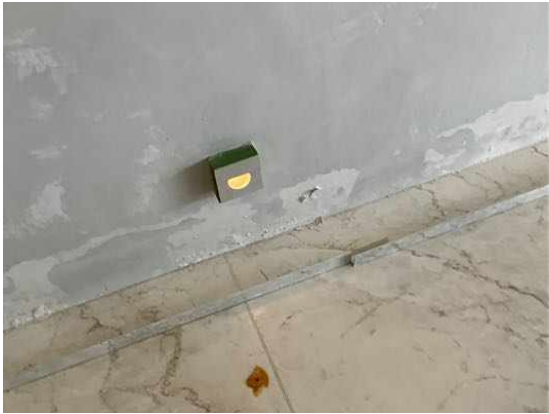
Finding 2.04

Building: Main Building
Location: All Areas
Finding: Flaky Paint
Information: Sections of the paint in this area was found to have deteriorated. Paint deteriorating is generally an indication of excessive moisture in the area that is currently hidden by the painted surface.

The presence of excessive moisture can have major implications on associated building elements if left unattended. While only seemingly minor at this stage, the damage cannot be determined due to the paint, obstructing any further inspection of the damage.

It is highly advised that the affected paint to be cleaned to allow a further, more invasive inspection by a licensed builder/painter. Failure to act on this defect may necessitate major works in the future.

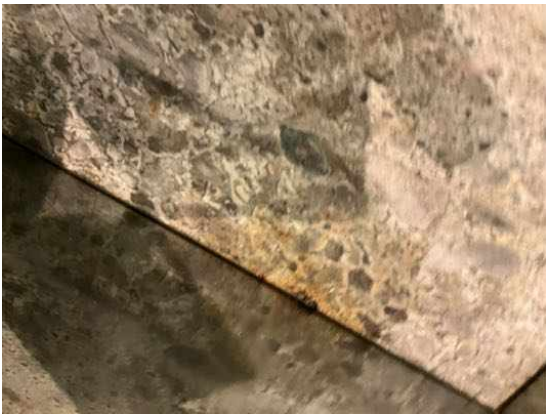
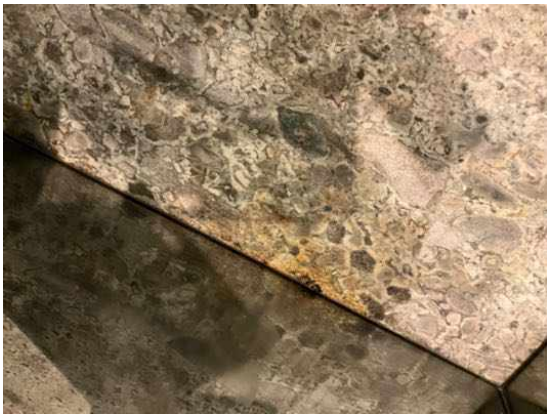
Finding 2.05

Building:	Main Building
Location:	Bathroom downstairs
Finding:	Evidence of excessive moisture was present at the time of inspection
Information:	Excessive moisture is present behind the bathroom tiles, indicating a potential water leakage issue within the wall.

The prolonged presence of moisture can lead to mold growth, deteriorate the structure, and create an environment conducive to health hazards. Additionally, it may compromise the adhesive holding the tiles, leading to their detachment.

A licensed plumber or a qualified contractor specializing in water damage remediation should investigate the source of the moisture, fix any leaks, and address the damage. Additionally, replacing affected tiles and ensuring proper waterproofing are crucial to preventing future issues.

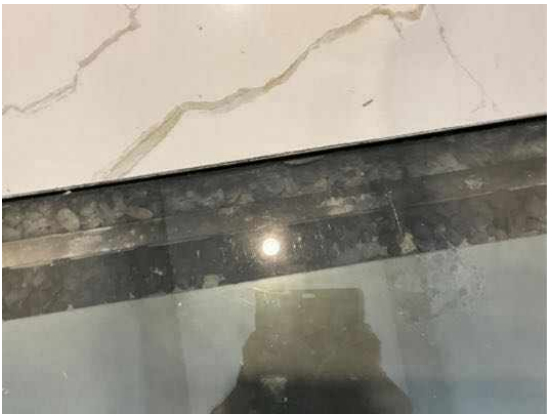
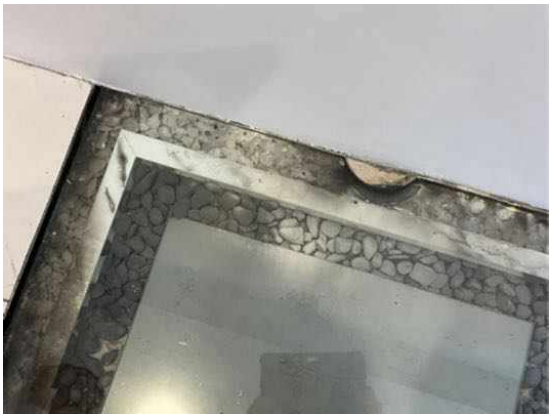
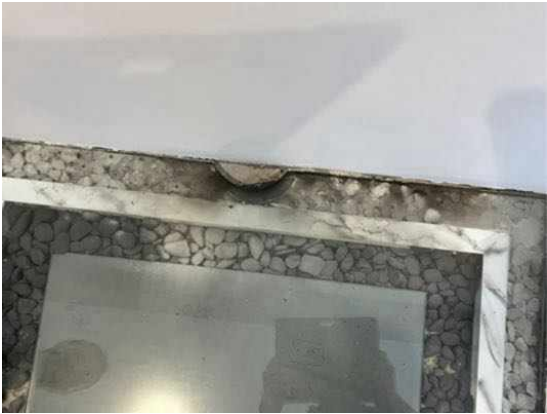
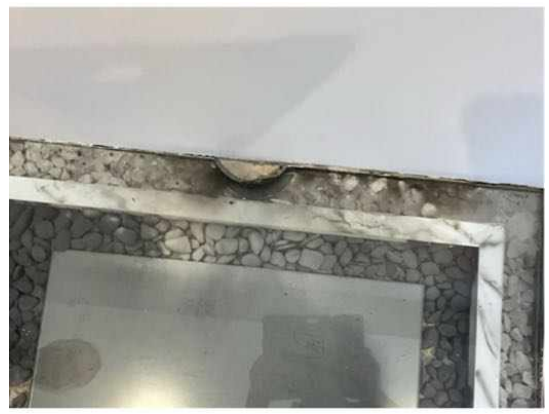
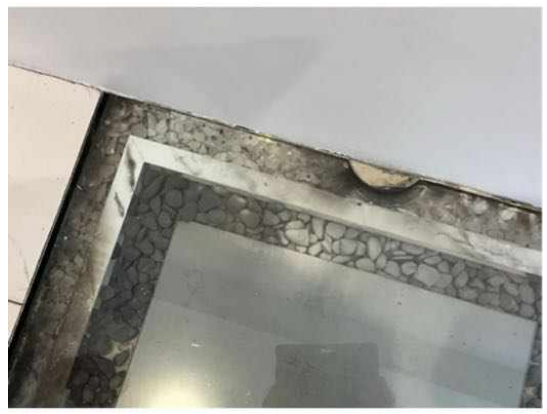
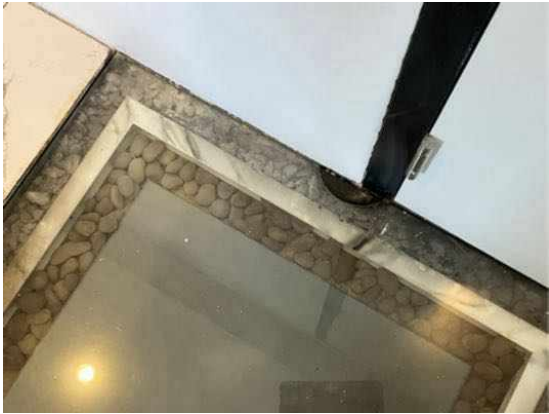
Finding 2.06

Building: Main Building
Location: Foyer upstairs
Finding: Fire Damage
Information: Evidence of fire-related damage, including heat staining and surface deterioration, was observed to finishes. The full extent of damage, including any impact to concealed elements or structural components, could not be determined within the scope of a visual, non-invasive inspection.

Recommendation: A detailed structural inspection by a suitably qualified structural engineer is recommended, along with further assessment and rectification by an appropriately qualified fire restoration or building contractor.

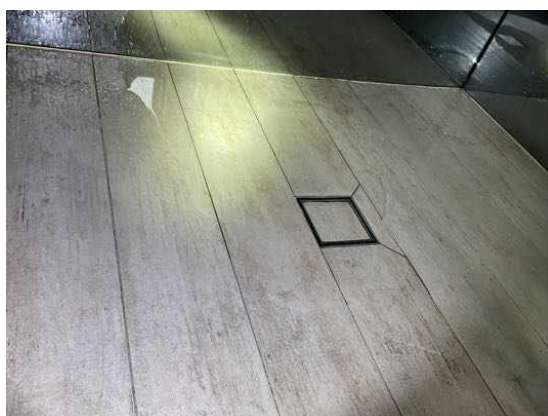
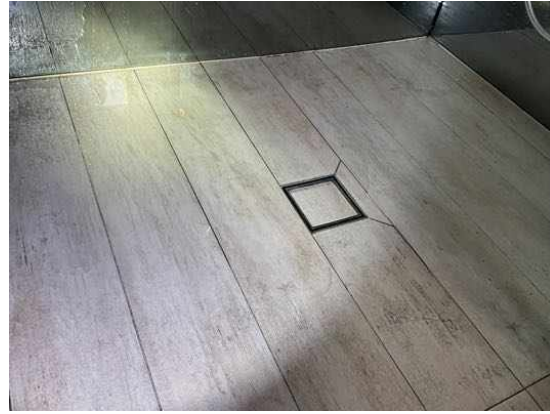
Finding 2.07

Building: Main Building
Location: Ensuite 2
Finding: Shower base - Water pooling
Information: Evidence of water pooling around the floor waste in the shower recess was noticed at the time of inspection. It is suspected that this excessive moisture is attributed to insufficient fall in the shower floor tiles.

This pooling is major and considered unsatisfactory, as standard tiling practices would not permit this situation to occur. Pooling water around floor wastes can create a slip hazard in extreme cases and create conditions that are conducive to mould growth over time. Where left unmanaged, the degradation of sealant and grouting is also likely to occur, possibly necessitating further repair works.

Remedial works may involve some sections of tiling and flooring repair and replacement. A tiling contractor or bathroom specialist should be appointed to provide further advice on reparation options and to perform works as necessary.

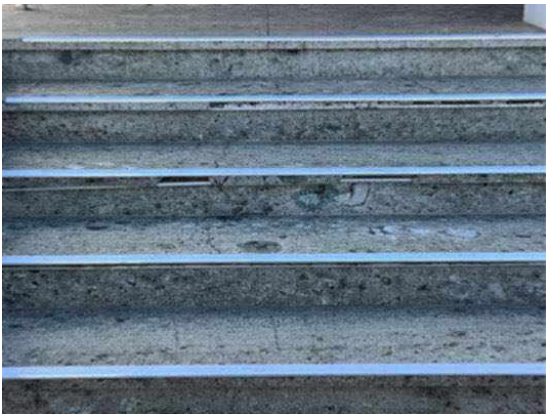
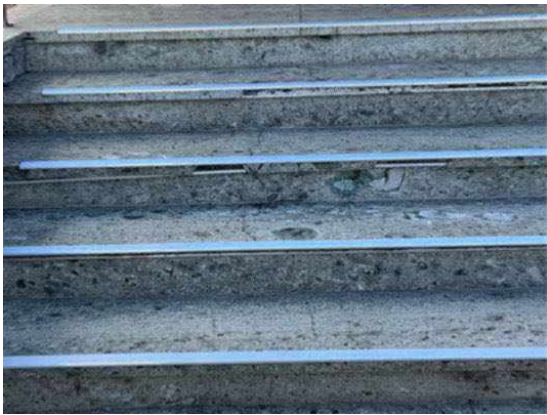
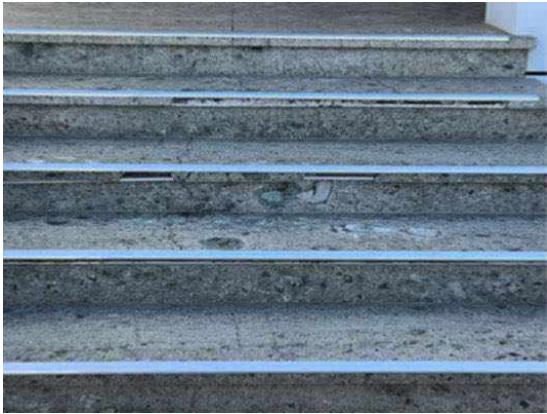
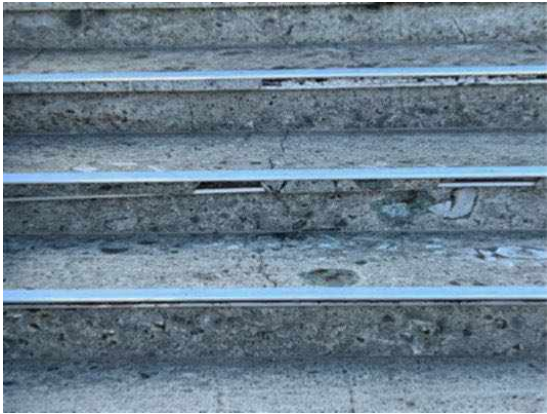
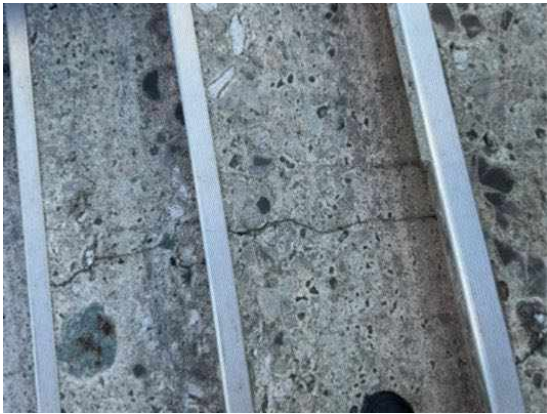
Building: Main Building
 Location: All Areas
 Finding: Tile Damaged
 Information: Tiles are visibly damaged, showing a chipped/broken section on the surface.

The damaged tile presents a trip hazard, may lead to cuts if stepped on barefoot, and can allow moisture ingress into the substrate, which may cause further deterioration or loosening of adjacent tiles. It also affects the overall appearance of the floor.

A licensed tiler should be engaged to remove the damaged tile and install a matching replacement. If spare tiles are unavailable, additional remedial work may be required to blend the repair with surrounding finishes.

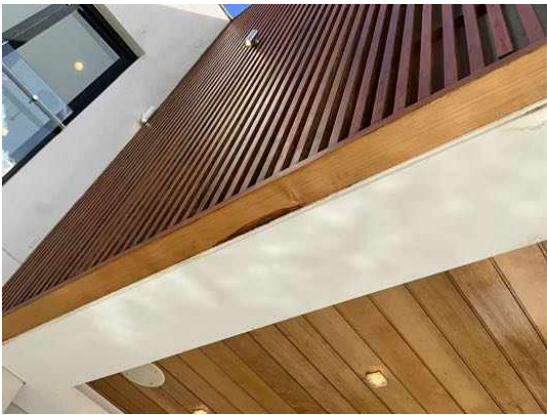
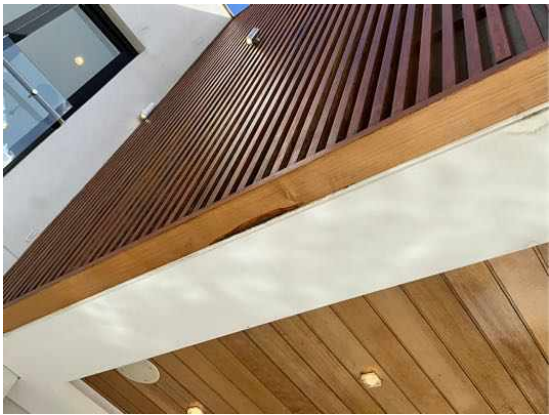
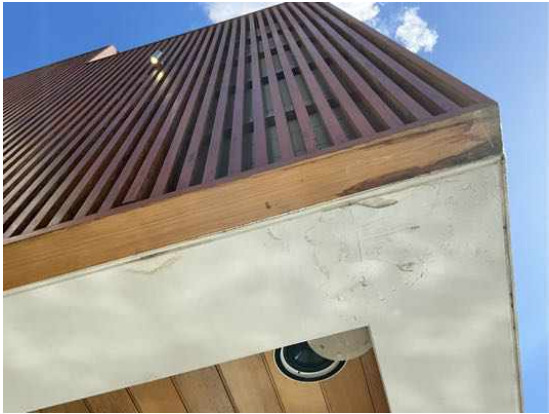
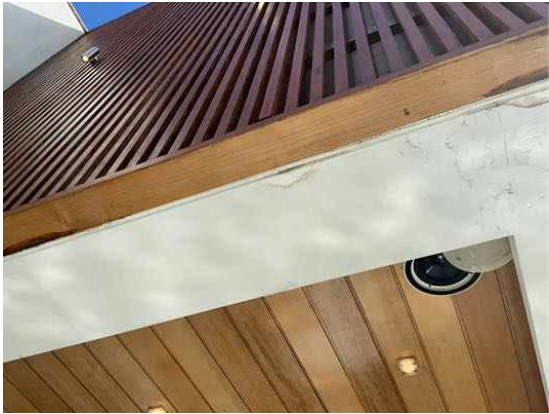
Building:	Main Building
Location:	All Areas
Finding:	Water staining
Information:	Water staining was evident in this area at the time of inspection. Water staining indicates that surfaces have been exposed to excessive moisture over time. The minerals and other elements in the water lead to staining, which may graduate to corrosion and deterioration if left unmanaged.

While mostly an appearance defect, water staining can be indicative of more serious defects, which may be currently concealed by other building elements.

Where water staining is active, a licensed plumber must be consulted to identify the cause of the staining and to provide advice on any reparation works that may be required. Replacement of any broken or damaged structures is advised.

Conversely, where water staining is old and inactive, affected building materials may be repaired or replaced at client discretion. A qualified carpenter or registered builder may be appointed to perform these works.

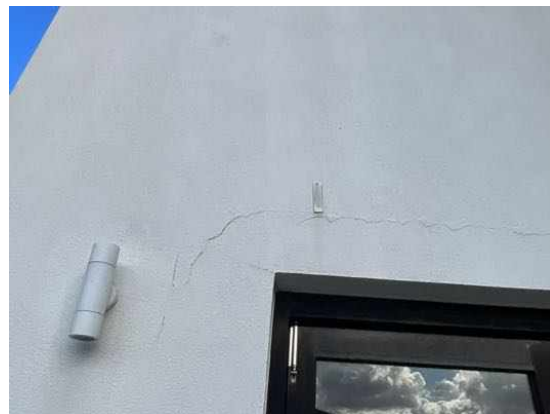
Finding 3.04

Building: Main Building
 Location: Rear Elevation
 Finding: Cracking - Damage Category 0 - Hairline (less than 1mm)
 Information: Hairline cracks are very minor in nature and generally are only ever an appearance defect. While such cracking may be noticeable in some cases, it is quite common and does not indicate any structural damage.

Cracking of this nature can generally be repaired with minor sanding, filling and/or repainting. Such works should be performed by a qualified painter or a general handyman.

Monitoring of all cracking should be conducted frequently. Always contact a building inspector should cracks widen, lengthen, or become more numerous.

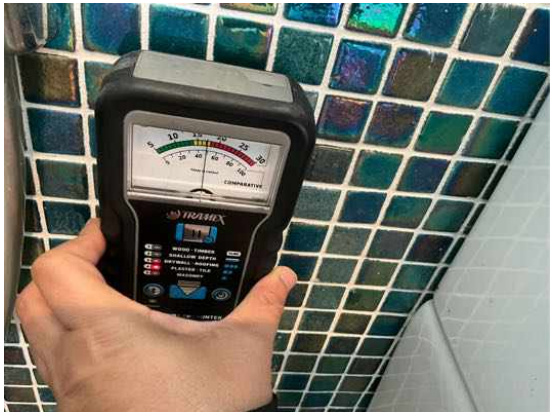
Building: Main Building
 Location: Entertainment area / Toilet
 Finding: Evidence of excessive moisture was present at the time of inspection
 Information: Excessive moisture is present behind the bathroom tiles, indicating a potential water leakage issue within the wall.

The prolonged presence of moisture can lead to mold growth, deteriorate the structure, and create an environment conducive to health hazards. Additionally, it may

compromise the adhesive holding the tiles, leading to their detachment.

A licensed plumber or a qualified contractor specializing in water damage remediation should investigate the source of the moisture, fix any leaks, and address the damage. Additionally, replacing affected tiles and ensuring proper waterproofing are crucial to preventing future issues.

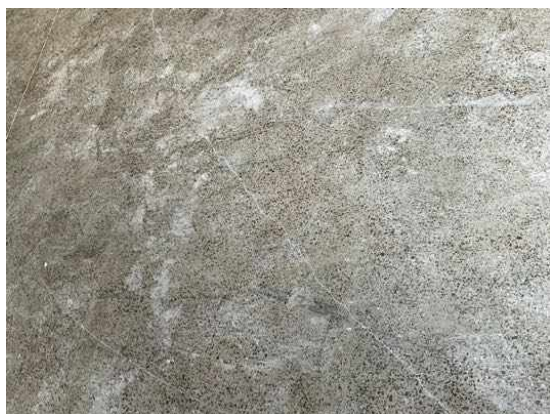
Finding 3.09

Finding: Crack in concrete slab - Category 0

Information: A crack coded as Category 0 was identified in the slab. A Category 0 crack is described as a hairline crack, representing insignificant movement of slab from level.

The approximate width of the crack to be considered Category 0 is 0.3mm, or change in offset of less than 8mm when a 3m straight edge is placed over the defect.

No rectification is required at this time. However, all cracking should be monitored over a 12 month period to identify any further damage in the area.

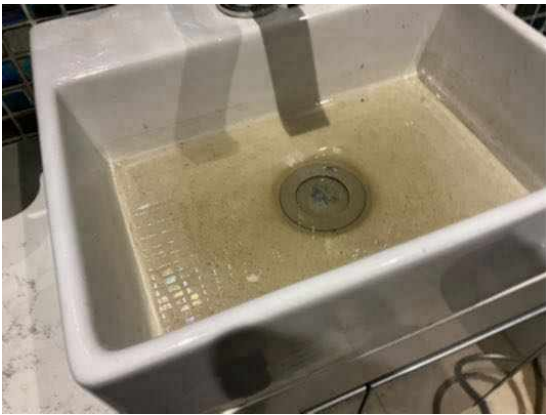
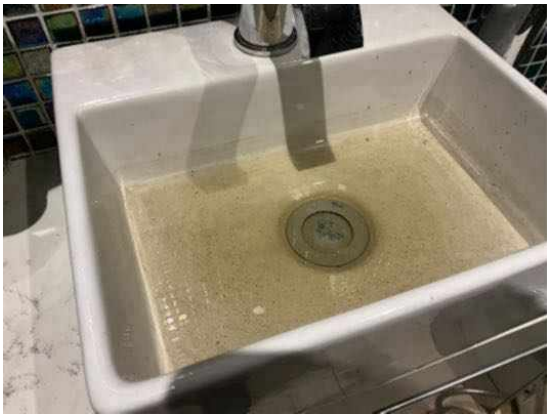
Finding 3.10

Information: The basin drain appeared to be blocked at the time of inspection. Blockages prevent building elements from operating as intended. If left unmanaged, a lack of general maintenance may lead to the development of more significant defects, such as water damage to surrounding building materials.

A licensed plumber should be appointed as soon as possible to perform any remedial works where required. Please be advised that a cabinet maker or qualified carpenter may be required if water damage is evident.

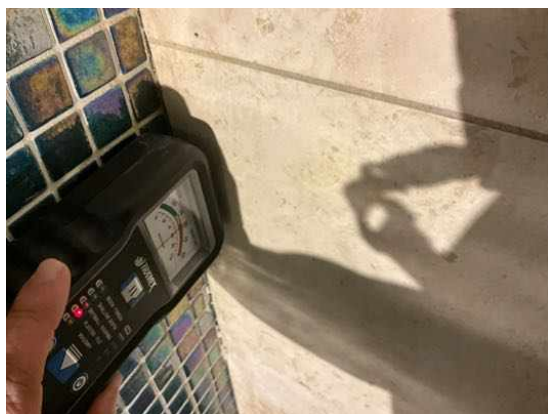
Finding 3.11

Building: Main Building
Location: Basement - Toilet
Finding: Evidence of excessive moisture was present at the time of inspection
Information: Excessive moisture is present behind the bathroom tiles, indicating a potential water leakage issue within the wall.

A licensed plumber or a qualified contractor specializing in water damage remediation should investigate the source of the moisture, fix any leaks, and address the damage. Additionally, replacing affected tiles and ensuring proper waterproofing are crucial to preventing future issues.

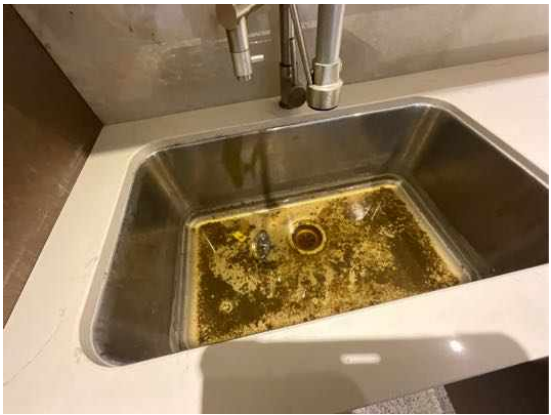
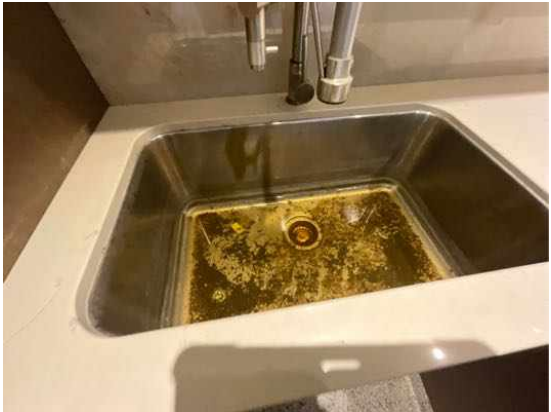
Finding 3.12

Building:	Main Building
Location:	Basement - Kitchen
Finding:	Basin - Blocked
Information:	The basin drain appeared to be blocked at the time of inspection. Blockages prevent building elements from operating as intended. If left unmanaged, a lack of general maintenance may lead to the development of more significant defects, such as water damage to surrounding building materials.

It is advised that the blockage be removed prior to any further inspection or remedial works. Additionally, check for any secondary or concealed damage and then attempt to address the cause of the blockage to prevent any water damage to associated structures.

A licensed plumber should be appointed as soon as possible to perform any remedial works where required. Please be advised that a cabinet maker or qualified carpenter may be required if water damage is evident.

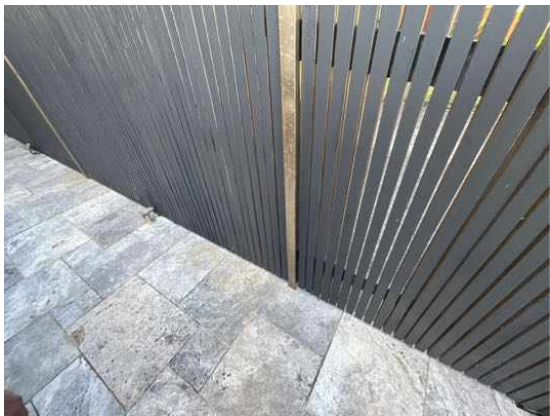
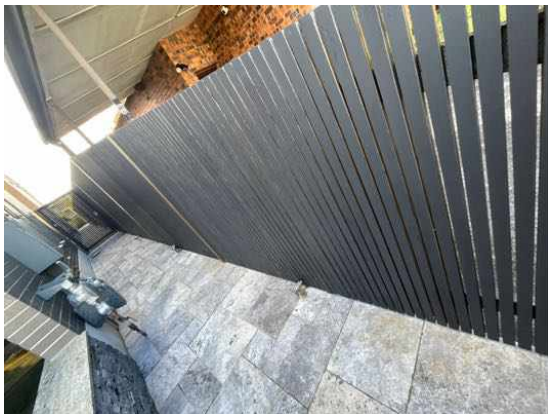
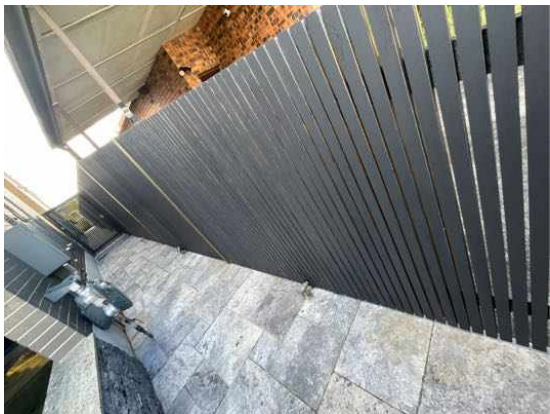
Building: Main Building
Location: All Areas
Finding: Timber on ground / conducive conditions to termite damage
Information: Timber on the ground is indeed conducive to termite damage. Termites are known to thrive in moist environments, and wood in contact with soil or moisture is more susceptible to infestation.

To prevent this, it's important to keep timber elevated and away from direct ground contact. Regular inspections and proper termite control measures are also essential to protect your wooden structures from termite damage.

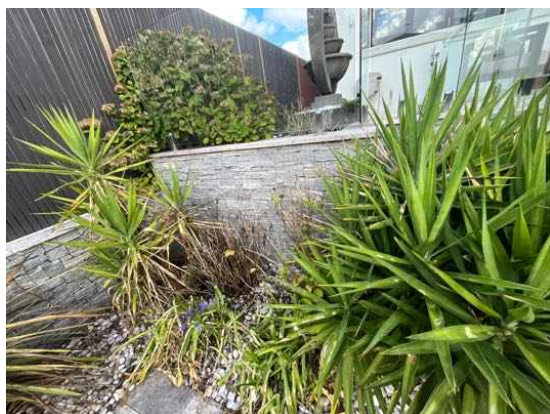
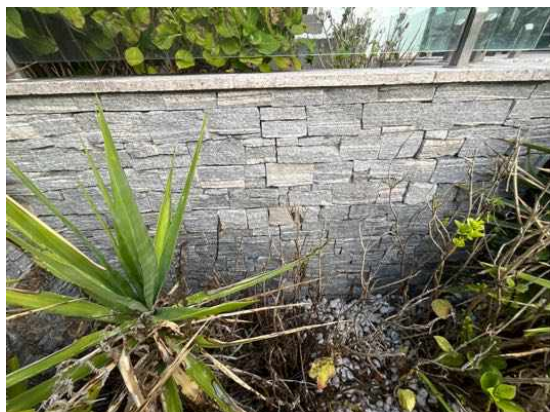
Finding 6.04

Building: Main Building
Location: All Areas
Finding: Dense vegetation around a property can increase the risk of termite infestation
Information: The presence of dense vegetation around a property can increase the risk of termite infestation, as it provides a conducive environment for them. To address this, consider maintaining a clear space between the vegetation and your home. If you suspect a termite issue, it's advisable to consult with a licensed pest control professional for inspection and treatment.

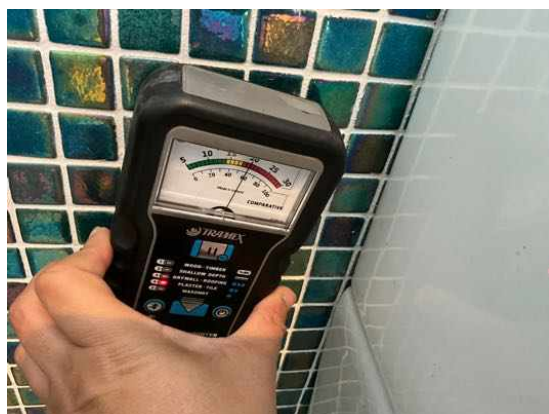
Finding 6.05

Building:	Main Building
Location:	Entertainment area / Toilet
Finding:	Excessive moisture - Conducive to Timber pest
Information:	Excessive moisture can attract termites and produce conditions that promote fungal growth and wood decay.

Prior to any remedial works being performed a qualified plumber should be appointed to further inspect the property and to identify the cause of the excessive moisture. Works to remove affected building elements may then be necessary and should be performed by an appropriate tradesperson.

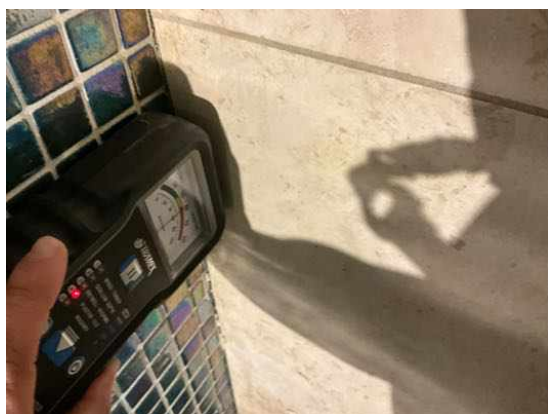
Finding 6.06

Building:	Main Building
Location:	Basement - Toilet
Finding:	Excessive moisture - Conducive to Timber pest
Information:	Excessive moisture can attract termites and produce conditions that promote fungal growth and wood decay.

Prior to any remedial works being performed a qualified plumber should be appointed to further inspect the property and to identify the cause of the excessive moisture. Works to remove affected building elements may then be necessary and should be performed by an appropriate tradesperson.

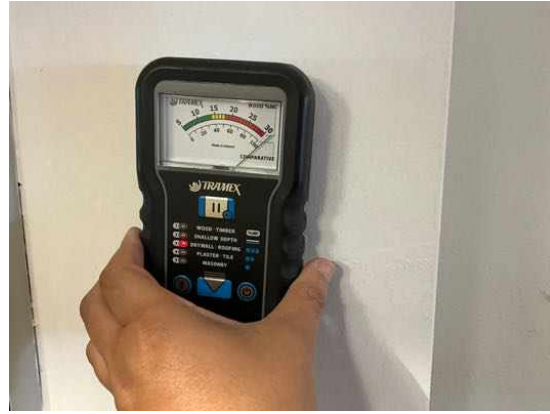
Finding 6.07

Building:	Main Building
Location:	Basement
Finding:	Excessive moisture - Conducive to Timber pest
Information:	Excessive moisture can attract termites and produce conditions that promote fungal growth and wood decay.

Prior to any remedial works being performed a qualified plumber should be appointed to further inspect the property and to identify the cause of the excessive moisture. Works to remove affected building elements may then be necessary and should be performed by an appropriate tradesperson.

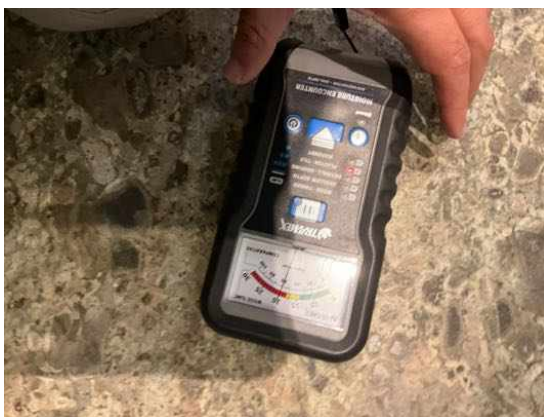
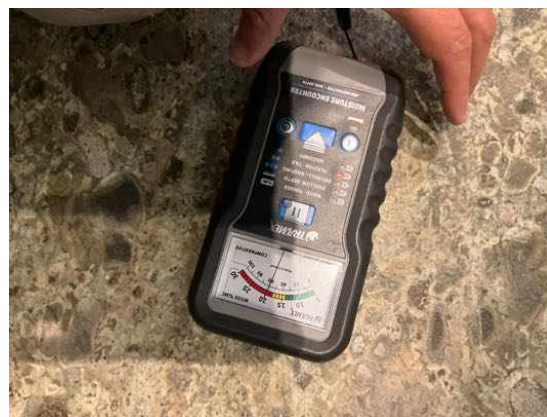
Finding 6.08

Building:	Main Building
Location:	Bathroom downstairs
Finding:	Excessive moisture - Conducive to Timber pest
Information:	Excessive moisture can attract termites and produce conditions that promote fungal growth and wood decay.

Prior to any remedial works being performed a qualified plumber should be appointed to further inspect the property and to identify the cause of the excessive moisture. Works to remove affected building elements may then be necessary and should be performed by an appropriate tradesperson.
