Building and Timber Pest Inspection Report

Inspection Date: Tue, 24 Mar 2026

Property Address: 213 Somerville Rd, Yarraville VIC 3013,
Australia

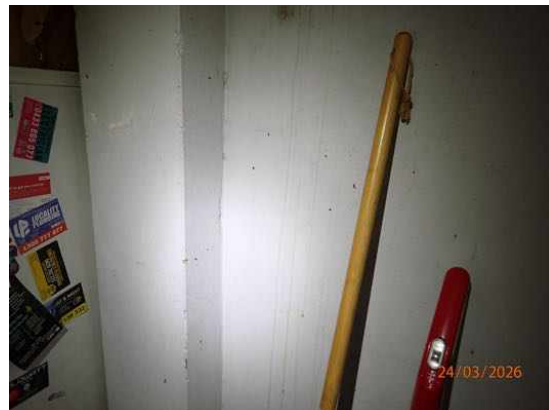
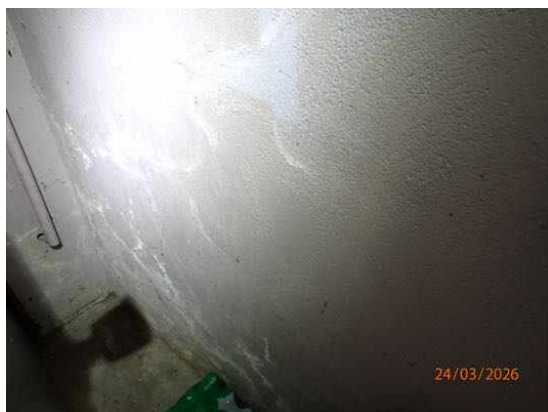
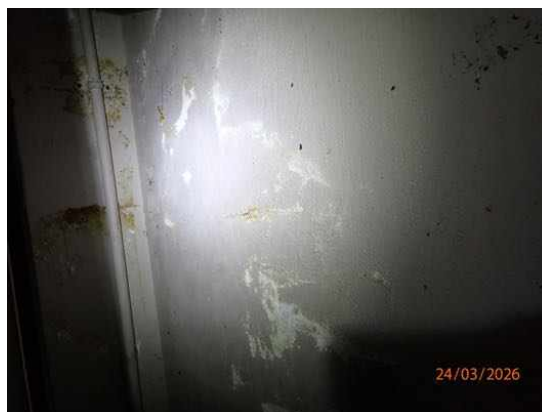
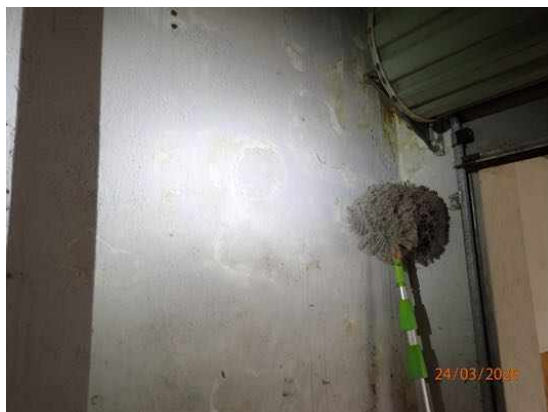
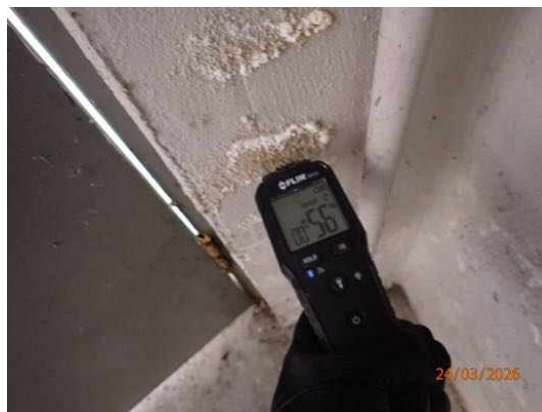
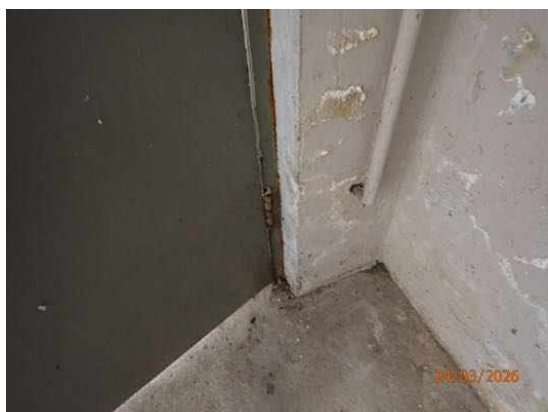
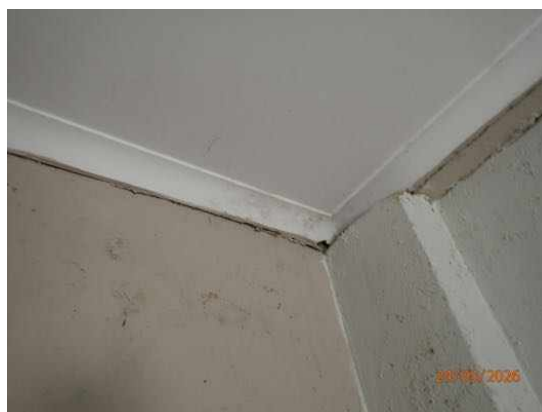
Finding 3.01

Building: Main Building
Location: Garage
Finding: Garage wall moisture:
Information: Water staining, efflorescence and high moisture readings were noted to sections of the garage wall/brickwork during inspection. This suggests moisture ingress, possibly due to overflowing gutters, inadequate stormwater disposal and/or defective gutter plumbing. This should be addressed promptly to prevent further moisture-related damage and deterioration to adjoining building elements. A licensed plumber should be engaged promptly to investigate and rectify the source, with a registered builder to repair any resultant damage. This is noted as a minor defect with major implications if not rectified immediately.

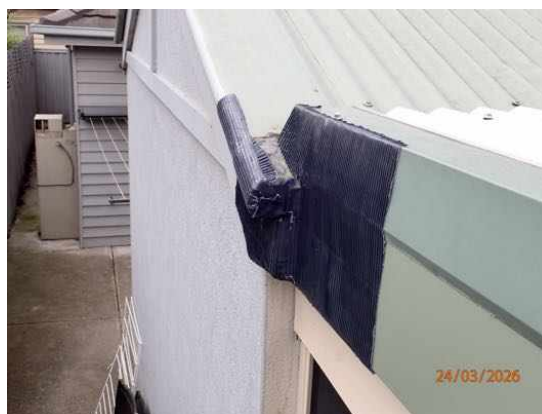
Finding 3.04

Building:	Main Building
Location:	Exterior walls - rear
Finding:	Pergola roof flashing: inadequate
Information:	The flashing to the rear pergola roof was noted inadequate, with a temporary self-adhesive flashing material applied. No active leakage was noted at the time of inspection; however, the current repair appears temporary only and may not provide long-term weatherproofing. A proper flashing repair is recommended. A licensed plumber should be engaged in the near term.

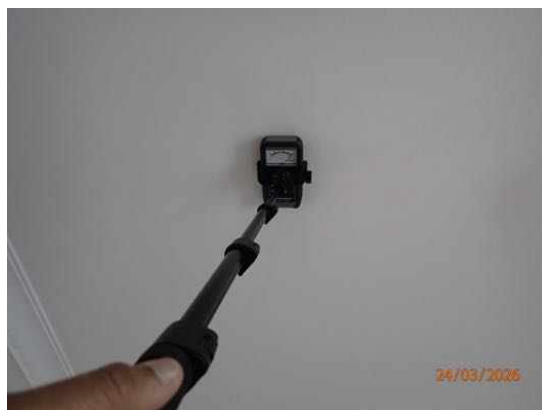
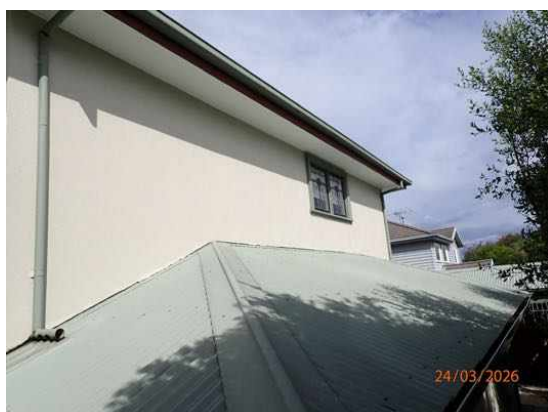
Finding 3.06

Building: Main Building
 Location: Bedroom - Master
 Finding: Master bedroom ceiling moisture staining:
 Information: Water staining and high moisture readings were noted to the ceiling of the master bedroom during inspection. The staining pattern did not appear consistent with a typical roof leak, and a concealed plumbing leak or other moisture source cannot be ruled out. This should be investigated promptly to prevent hidden damage and further deterioration. A licensed plumber should be engaged promptly, with a registered builder to repair any damaged finishes once the source is rectified.

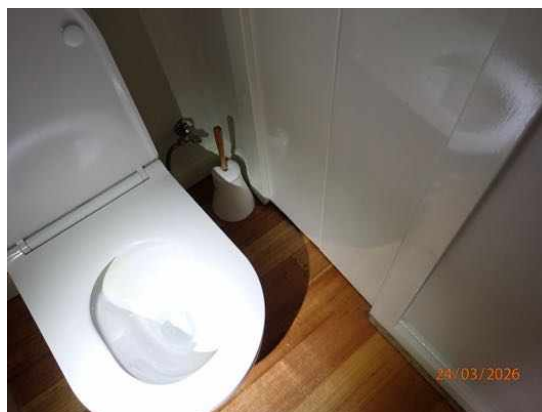
Finding 3.07

Building: Main Building
 Location: Toilet (WC)
 Finding: Swollen architrave:
 Information: The architrave to the storage room next to the toilet was noted swollen during inspection. No elevated moisture was detected at the time of inspection; however, the damage is likely due to past moisture exposure and/or wear over time. Repair or replacement is recommended to prevent further deterioration. A qualified carpenter should be engaged in the near term.

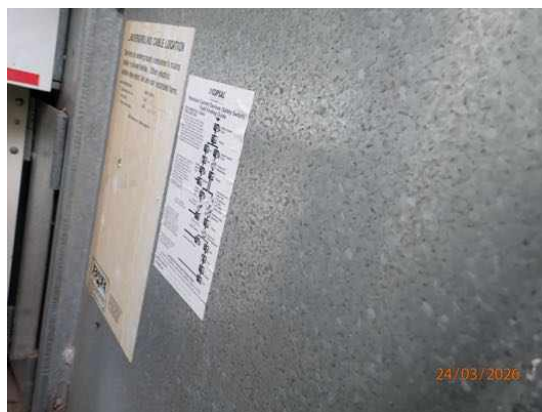
Building:	Main Building
Location:	Meter Box
Finding:	Termite Management System - no evidence of a chemical installation
Information:	The application of a post-construction chemical termite barrier is highly recommended for all properties, particularly if live termite activity has been found on the site previously. Such barriers are highly effective in preventing termite attack on any timber building elements throughout the property.

A durable notice should be placed in the switchboard unit to indicate current termite barriers. At the time of inspection, it appeared as though no termite management system has been installed, with no evidence to suggest preventative works taking place.

The client may consider gaining further advice from a pest controller as to the costs and procedures involved with this application. It is recommended that obtaining such advice be a short-term priority.

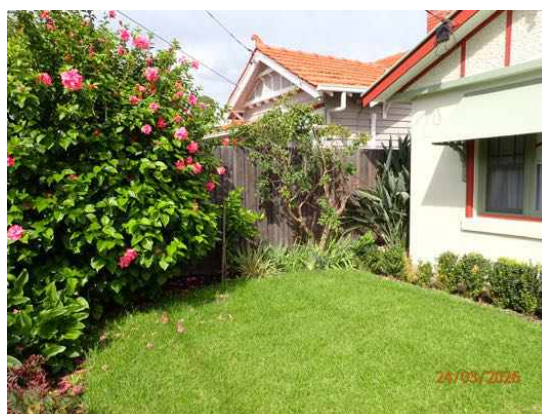
Finding 6.02

Building:	Main Building
Location:	All External Areas
Finding:	Garden Beds - Conditions Conducive to Termites
Information:	Garden beds were found to be evident abutting the external walls of the property. These garden beds can include untreated timber, and with a combination of moisture from watering hosing can make conditions conducive to termite activity and termite ingress.

It is recommended that the property owner be vigilant in reducing conducive conditions around the property where possible. If conducive conditions are present and not removable periodically inspections should be conducted by a licensed pest controller.

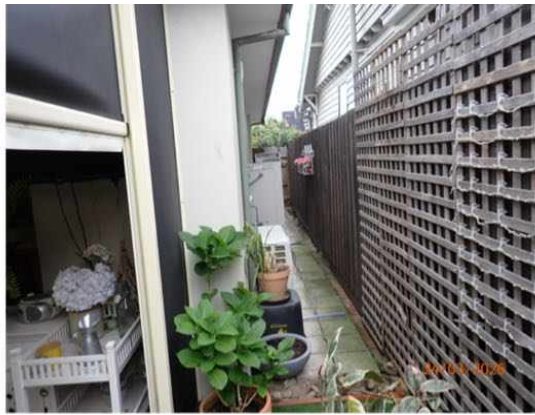
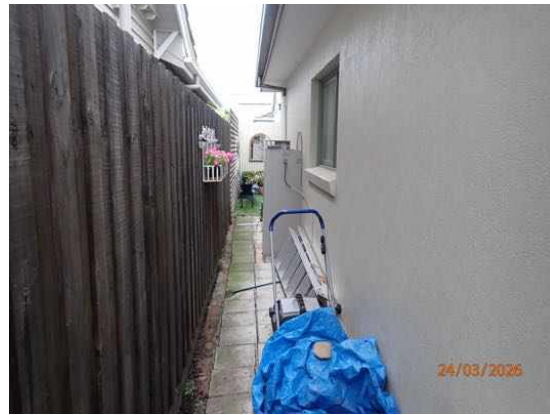
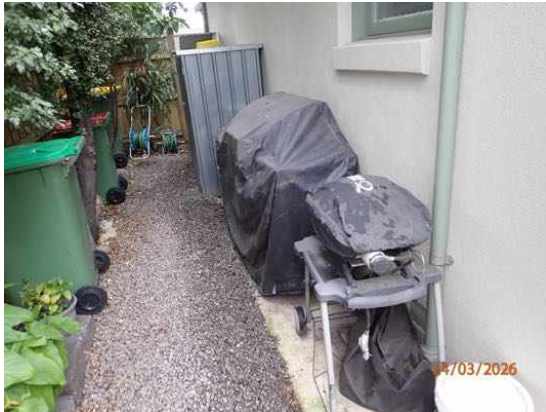
Building:	Main Building
Location:	All External Areas
Finding:	Stored Timbers and personal items
Information:	The storing of timbers and personal items in the subfloor space increases the risk of termite activity being present. As they are likely to come into contact with weather conditions or excessive moisture wood rot is likely to develop on timbers that are not treated.

It is highly recommended that any stored timbers and personal items be immediately removed from areas in which they may attract any termite / timber pest attack. Minimisation of risk / prevention of termite attack is far more adequate than dealing with the presence of termite activity.

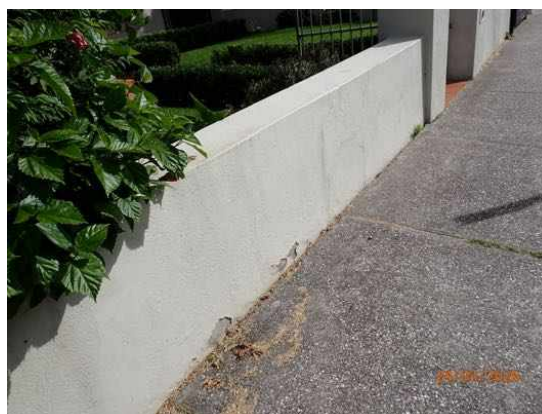
Building:	Main Building
Location:	Exterior walls - front
Finding:	Front fence:
Information:	Cracking and slight lean were noted to the front brick fence during inspection. This is likely due to age, weathering and/or minor movement over time. The fence should be monitored and repaired as required to prevent further deterioration. A registered builder or suitable handy person should be engaged in the near term.

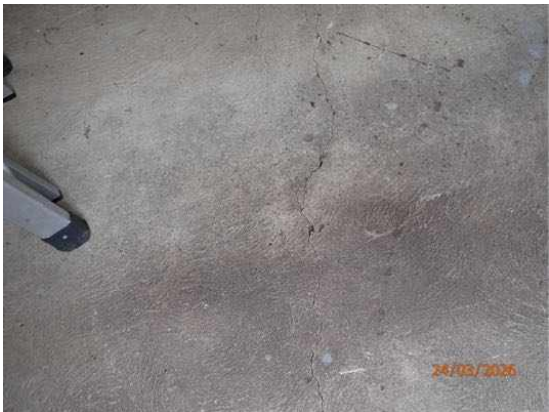
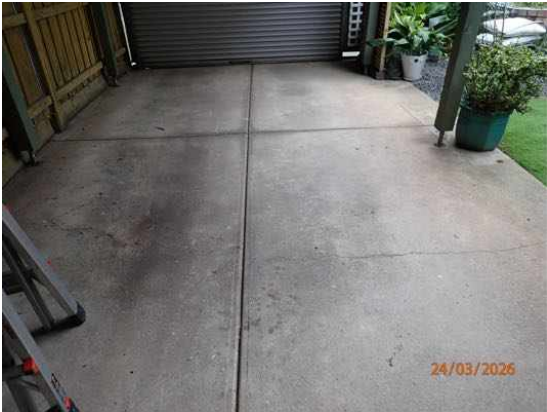
Building:	Main Building
Location:	Exterior walls - rear
Finding:	Driveway slab: Minor crack/s
Information:	Minor crack/s were noted to the concrete driveway slab during inspection. These are minor in nature and are commonly associated with age, shrinkage and/or minor ground movement. The affected areas should be monitored and repaired if cracking worsens. A registered builder or suitable concrete repair contractor should be engaged as required.

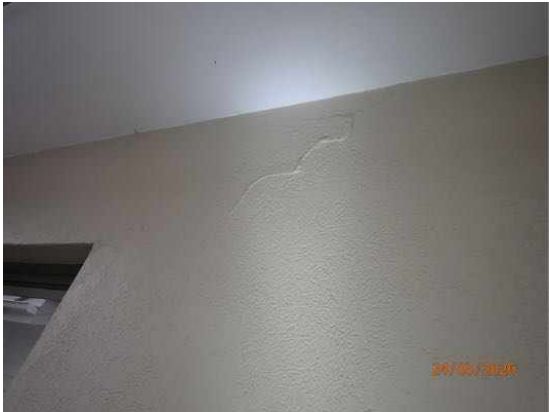
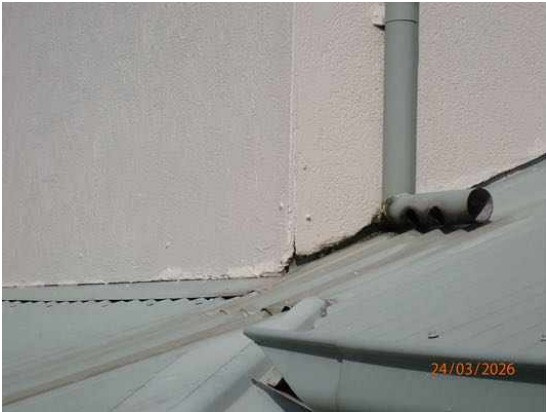
Building: Main Building
Location: All External Areas
Finding: External rendered wall cracking:
Information: Minor cracking was noted to the external rendered walls during inspection. Although some cracks were diagonal, they appear minor in nature at the time of inspection and may be associated with minor movement and/or render shrinkage. These areas should be monitored for any increase in width or further movement. A registered builder should be engaged for repairs, and a structural engineer should be consulted if cracking worsens.

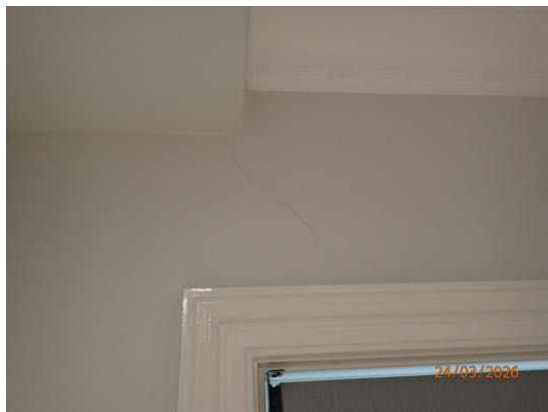
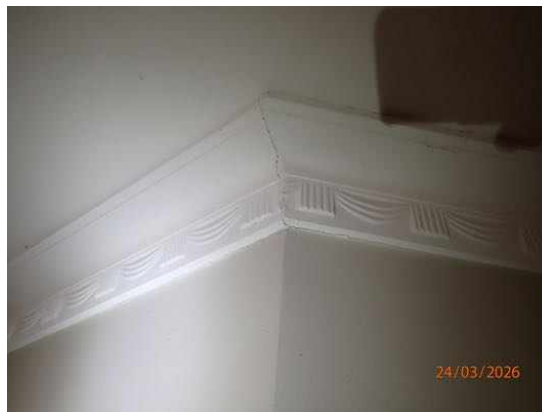
Building: Main Building
Location: All Internal Areas
Finding: Internal plaster cracking:
Information: Minor plaster cracking was noted to internal wall surfaces throughout the house during inspection. This is commonly associated with minor settlement, movement and/or normal age-related building movement. These areas should be monitored and repaired as required. A handy person or registered builder should be engaged if repairs are desired, and a structural engineer should be consulted if cracking worsens.

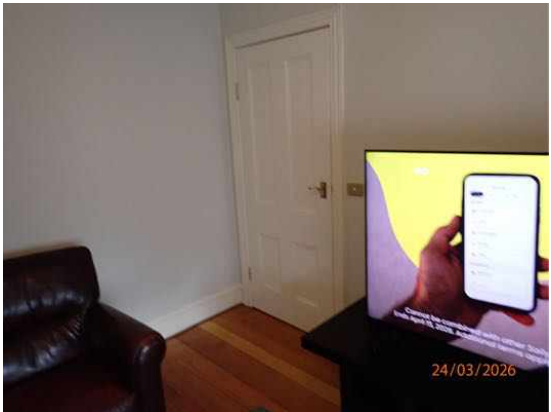
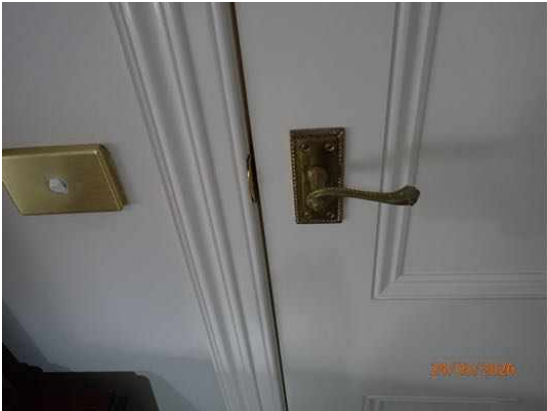
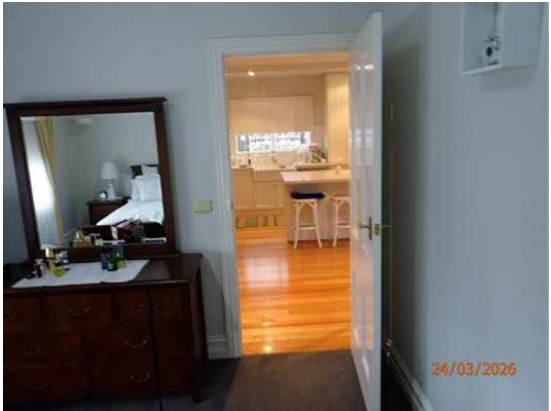
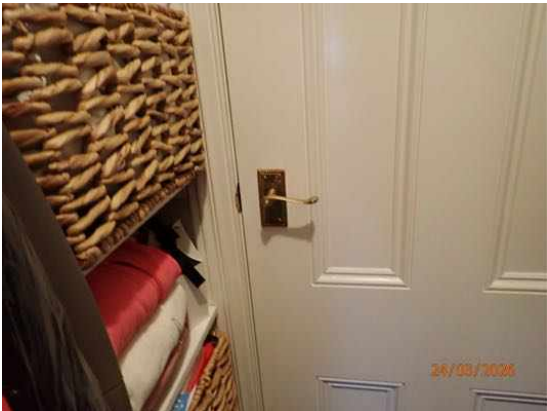
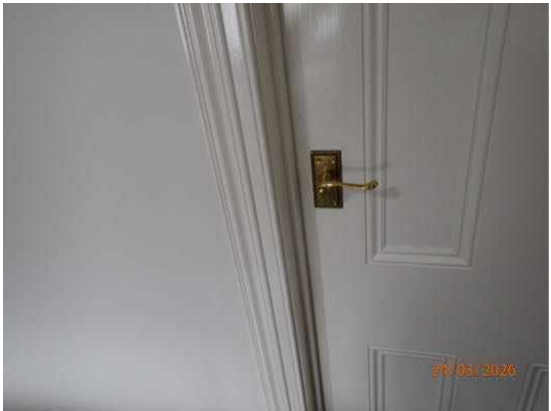
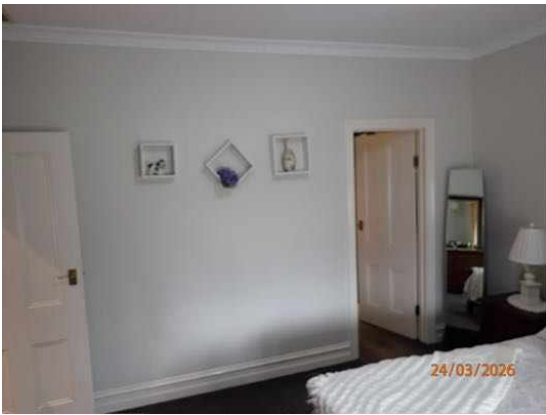
Building: Main Building
Location: All Internal Areas
Finding: Misaligned doors:
Information: Misalignment was noted to the striker plates/door latching to the master bedroom, bathroom, master wardrobe and living room doors during inspection. This is likely due to minor movement, wear and tear and/or poor adjustment of the door hardware. Adjustment and repair are recommended to ensure proper door operation. A qualified carpenter or suitable handy person should be engaged in the near term.

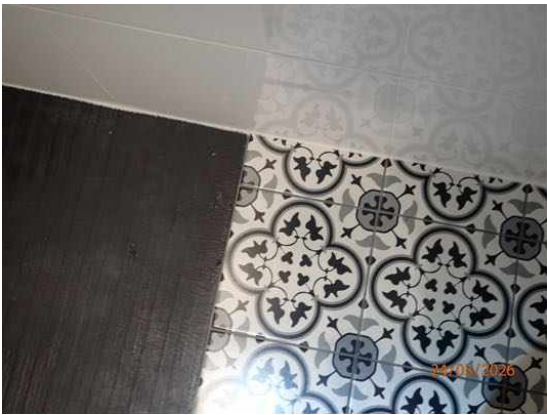
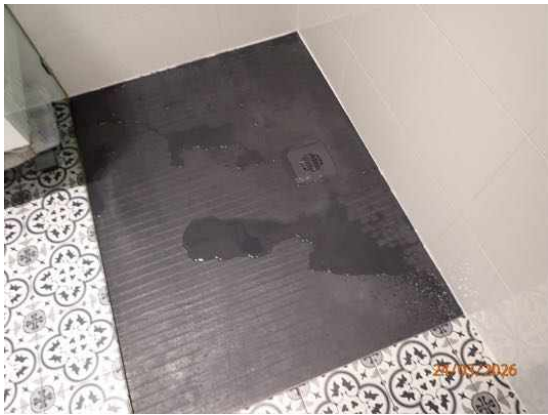
Building: Main Building
Location: Ensuite - Master
Finding: Water stop not visible in shower
Information: During the inspection in the bathrooms, the water stop to the shower area was not visible. Water stops are essential components of waterproofing systems designed to prevent water or moisture from escaping the wet area and causing damage to other materials and structural building elements.

The absence of visible water stops suggests potential issues with the waterproofing of the shower areas. Without proper waterproofing, water leakage can occur, leading to damage to surrounding materials and compromising the structural integrity of the building.

This observation is noted for your reference. Depending on the time the house was built, current regulations may not have been applicable. However, it is recommended to further investigate the waterproofing system of the shower areas to ensure they meet appropriate standards and to address any deficiencies promptly to prevent water damage issues in the future. If necessary, consulting a qualified building inspector or waterproofing specialist for an assessment and potential remediation is advised.

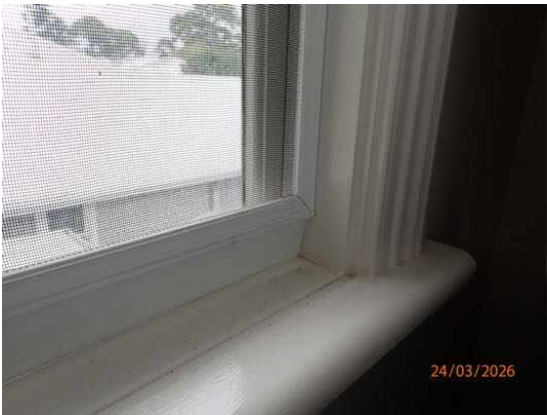
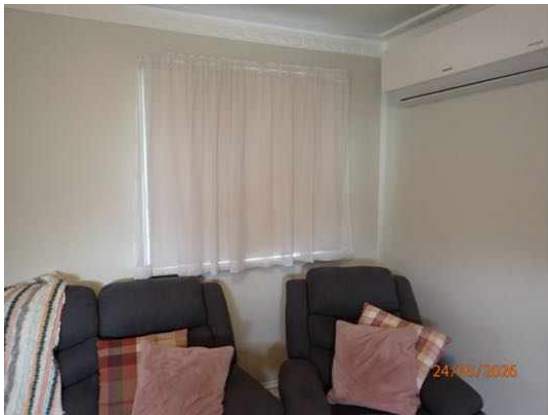
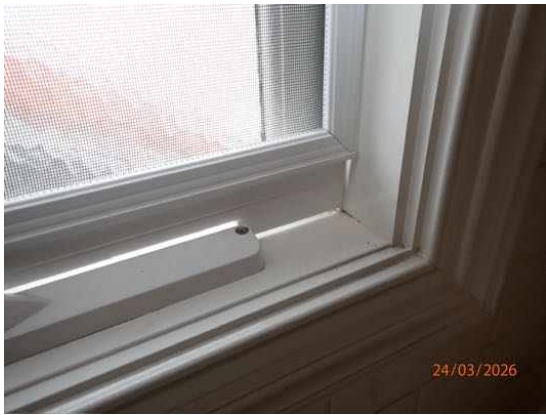
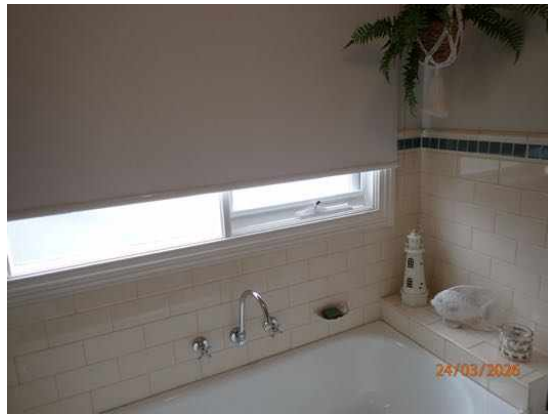
Building: Main Building
 Location: All areas
 Finding: Binding windows:
 Information: Windows in the laundry, rumpus and bathroom were noted binding during inspection. This may be due to minor movement, swelling of timber components, hardware wear and/or poor adjustment. Repair or adjustment is recommended to restore proper operation. A qualified carpenter should be engaged in the near term.

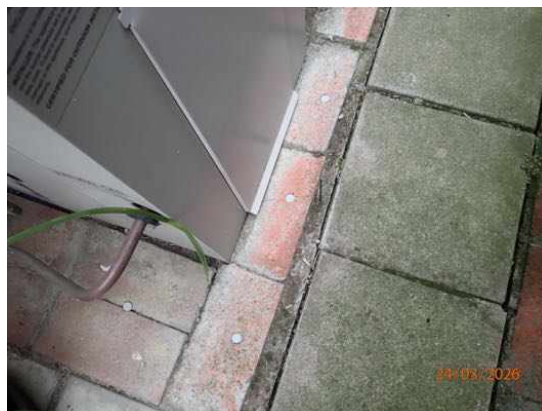
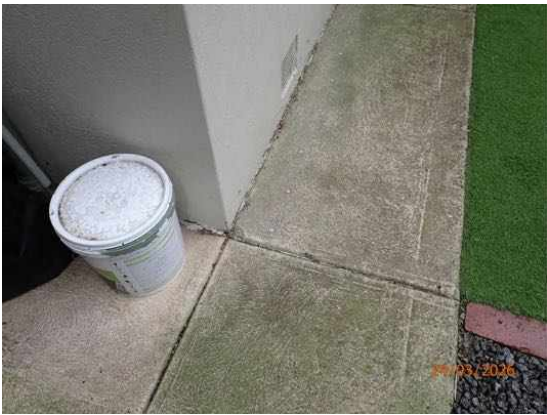
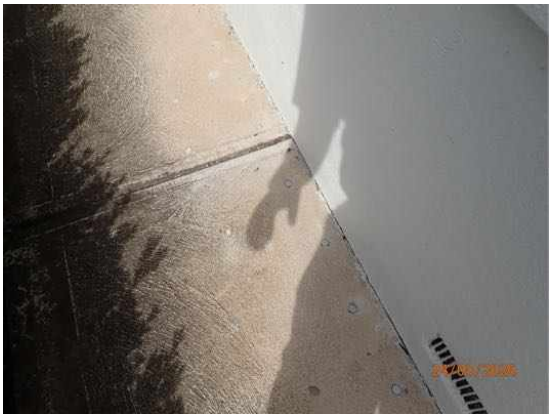
Building:	Main Building
Location:	All External Areas
Finding:	Evidence of a previous termite management system was identified
Information:	Drill marks with plastic plugs were noted in the external concrete at the front and left-hand side of the house, which may indicate a previous termite management treatment. No durable notice was observed during the inspection.

Where a termite management system is present, it is important to confirm the type of barrier installed, the date of installation, warranty conditions, and any supporting documentation from the builder or previous owner. The company that carried out the treatment should be contacted to confirm whether the system remains current or under warranty.
