# Building and Timber Pest Inspection Report

Inspection Date: Wed, 14 Jan 2026

Property Address: 22/6 Jacquinet Pl, Glenfield NSW 2167,  
Australia

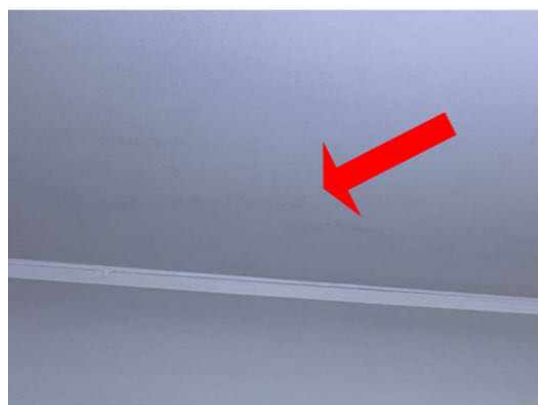
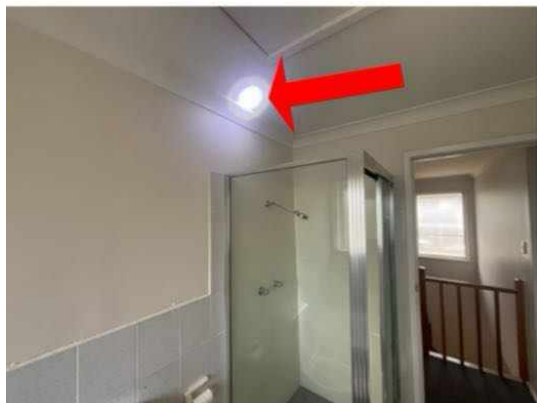
Building: Main Building  
Location: Bathroom  
Finding: Exterior roof - Leaking  
Information: Active roof leaks were evident at the time of inspection. Roof leaks can have a number of causes, including damage to roof coverings, deterioration of roof fixtures and fittings, or loosely associated materials (fascias etc.).

Where water leaks are active, rain penetration is likely to cause water damage to associated structures and building elements in this area, which can have a range of implications. If left unmanaged, the development of major structural damage to the roofing and associated structures may occur.

A roof plumber should be appointed as soon as possible to primarily identify the cause of the leak, and to provide subsequent repair works as necessary. Depending on the extent of the damage, replacement of sections of the roof covering and/or roofing structures may be required, and may be performed by a registered builder or qualified carpenter.

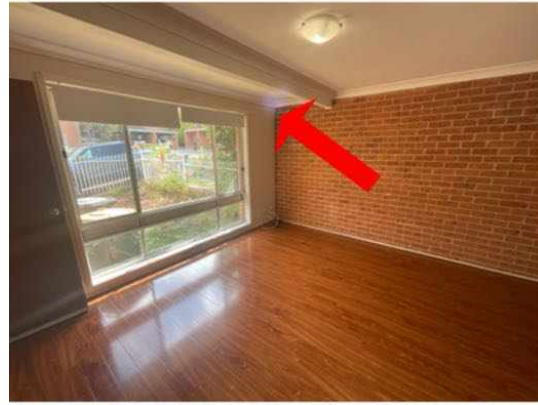
### Finding 2.02

Building:	Main Building
Location:	Living Room
Finding:	Ceiling - Water damaged
Information:	Water damage to the ceiling lining is generally an indication of excessive moisture being present in the roof void, usually via a leak to the roof covering.

Where water damage is evident to the ceiling, the primary requirement is to identify and rectify the source of the leak. A roofing plumber should be appointed as soon as possible to identify the leak and perform rectification works as necessary, ensuring the water damage is restricted.

Once the leak is repaired, consultation with relevant tradespeople, including plasterers and painters, is advised. Rectification works may include replacement of ceiling lining or minor repainting, depending on the extent of the damage.

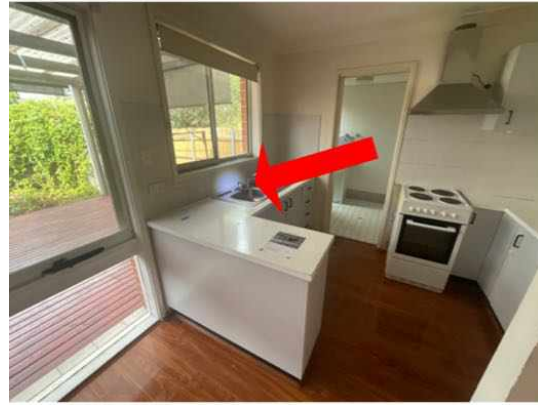
### Finding 2.03

Finding: Water leak - Internal

Information: A water leak was found in this area at the time of inspection. Internal water leaks can be detrimental to surrounding building elements; their potential causes include damage to plumbing fittings and fixtures, through to water damage and deterioration of associated building elements.

Rust, corrosion, decay and water damage are potential outcomes where a minor water leak is left unattended. More serious defects may also result, such as electrical hazards, or water damage to structural building elements.

In extreme cases, structural damage may develop due to a prolonged water leak. It is highly advised that internal water leaks be addressed by a licensed plumber as a matter of relative urgency.

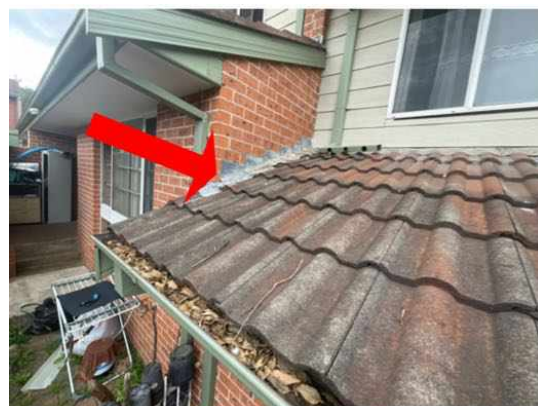
### Finding 2.04

Building:	Main Building
Location:	Roof Exterior
Finding:	Roof plumbing - Flashing inadequate
Information:	Some sections of the roof are missing or have inadequate roof flashings. Flashings are metal and other materials which are applied to seals and intersections between roof coverings and building elements. They are designed to aid in weatherproofing of roof joins.

Flashings that are not installed adequately or are missing are likely to result in water penetration to the interior of the property, as well as creating excessively damp conditions against the exterior surfaces and around the base perimeter of the building.

Premature ageing and secondary building defects are imminent where roof plumbing is missing or inadequately installed. Additionally, water pooling also creates an environment that is susceptible to termite and pest infestation.

A roofing plumber should be appointed as soon as possible to install relevant roof plumbing materials, ensuring that no further damage is sustained.

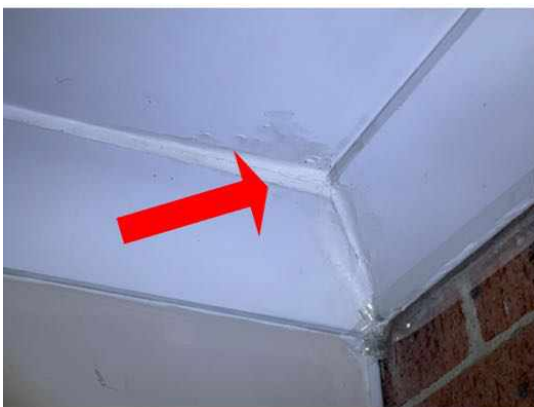
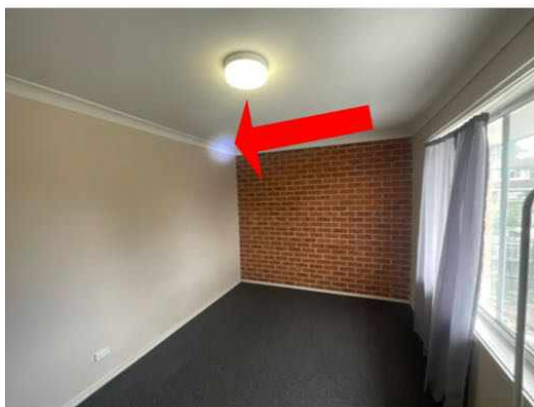
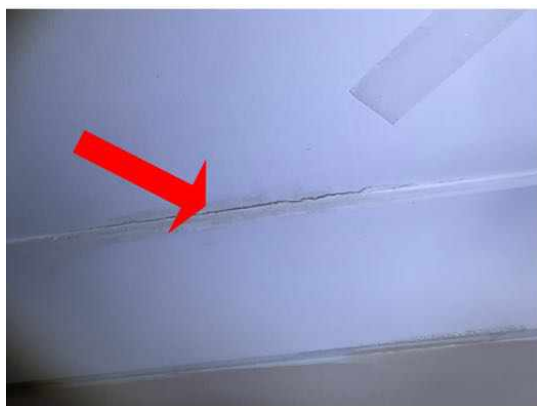
Building:	Main Building
Location:	All Internal Areas
Finding:	Cornices - Sagging
Information:	Sagging and uneven cornices generally indicate that the building materials have swollen, due to contact with water, or the movement of the ceiling joints or that fixings (e.g. nails or glue) have become loose and require reattachment. In some cases, sagging and uneven surfaces may also indicate that there are structural issues causing surfaces to warp, twist, or sag.

Where sagging appears to be major, appointment of a structural engineer is advised to further inspect the property. Otherwise, minor works such as re-gluing of wall/ceiling sheets may be required and should be performed by an aptly qualified plasterer or carpenter.

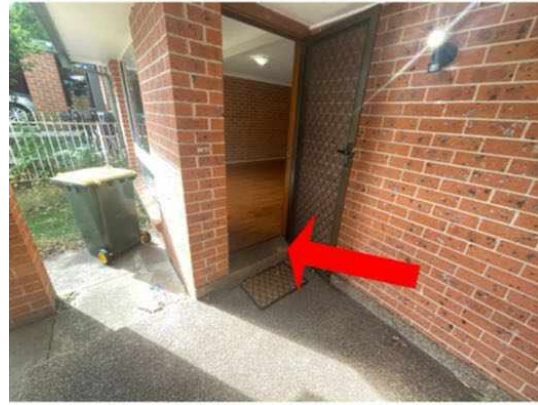
### Finding 3.02

Building:	Main Building
Location:	Entry
Finding:	Entry step - Cracked or damaged
Information:	Cracking was evident to the step in this area at the time of inspection. While the cracking appears to be minor, this area is frequently exposed to water, allowing potential for water penetration into adjoining sections of walls or flooring.

If left unmanaged, water penetration to these areas may lead to subsequent water damage, which is likely necessitate repair work to affected building elements.

A tiling contractor should be appointed to ensure that no further water damage occurs. The re-application of silicone and grouting throughout remaining tile work is also advised, to further protect the area against water penetration.

Where water penetration has led to water damage, appointment of a relevant tradesperson may be required to repair damaged building elements.

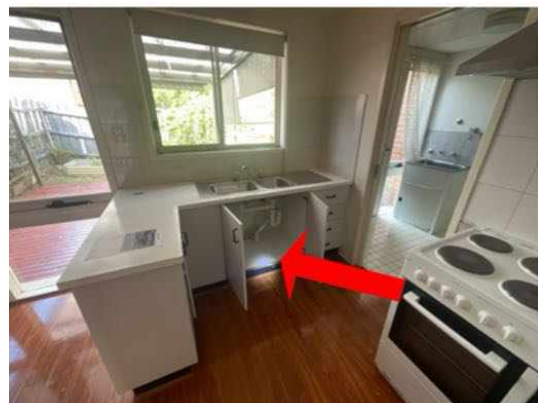
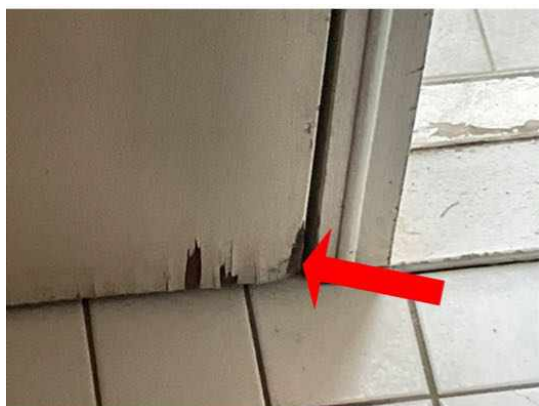
### Finding 3.03

Building:	Main Building
Location:	Kitchen / Laundry
Finding:	Delamination of timbers
Information:	Delamination is one means by which composite materials (e.g. layered timber composites) may fail over time. In laminated materials, repeated cyclic stresses may lead to the formation of mini-structures of separate layers, with significant loss of mechanical toughness. Water penetration or the presence of excessive moisture also generally contributes to delamination.

Where building materials have become delaminated, they lose their structural strength, and are likely to have a variety of appearance and serviceability defects as a result.

Delamination of timbers may be repaired where the area affected is minor and/or easily accessible, by gluing and screwing layers back together. However, this is an interim repair, and where delamination has occurred, the client should plan for the replacement of affected timbers sooner than would otherwise be expected.

All timber structures affected by delamination should be replaced as soon as possible to avoid any further damage. Repair and replacement estimates should be sought from a registered builder or qualified carpenter.

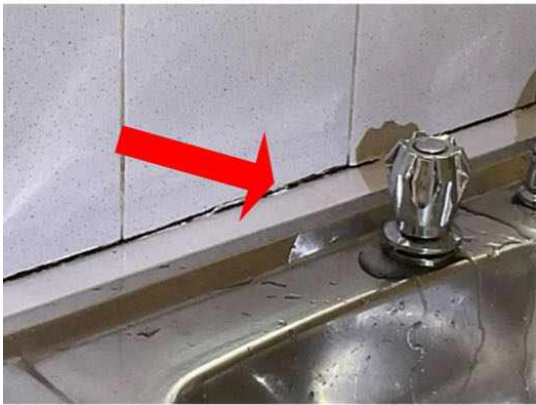
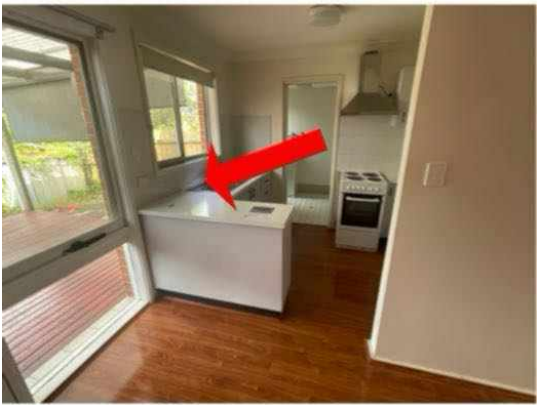
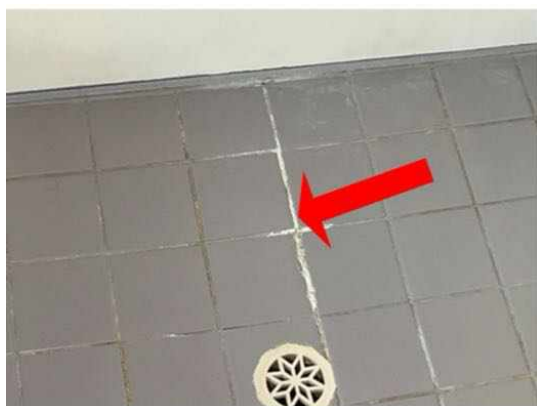
### Finding 3.04

Building:	Main Building
Location:	Kitchen / Laundry / Bathroom
Finding:	Sealant and grouting - Missing or damaged
Information:	It was noted on inspection that sealant or grout is degraded to the tiled shower alcove and or other areas of the bathroom.

Different materials and floor areas move at different rates, generally causing cracking to grout or sealant at this point. A flexible sealant is required to allow for expected expansion and contraction, while keeping the joint water tight and protective of all associated building materials.

There appears to be excessive mould to the sealant and grout which will likely require scraping out and replacement.

Flexible and mould resistant materials should be applied to affected areas to prevent any subsequent water damage that is likely to occur. Regular maintenance and replacement of damage or missing or damaged sealant and grout is highly recommended to the wet areas, as this is a regular wear and tear defect. Sealant and grouting in areas that come into regular contact with water should be maintained for the long term care of your property.

A sealant specialist or tiling contractor should be appointed to complete these works as soon as possible

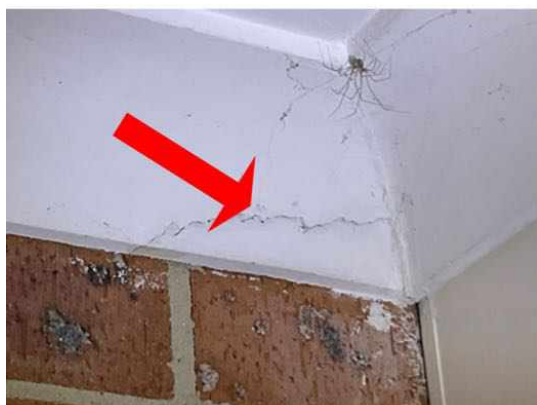
### Finding 3.05

Building:	Main Building
Location:	All Internal Areas
Finding:	Cracking - Damage Category 1 - Fine (up to 1mm)
Information:	Although fine cracks are quite noticeable, they are often only considered to be an appearance defect, and usually do not indicate any structural damage. Generally, the cause of a fine crack is indicative of a separation between building materials and finishes (e.g. paint, plaster, etc.) along joins.

Cracking of this nature can generally be repaired with minor sanding, filling and/or repainting. Such works should be performed by a qualified painter or a general handyman.

Monitoring of all cracking should be conducted frequently. Always contact a building inspector should cracks widen, lengthen, or become more numerous.

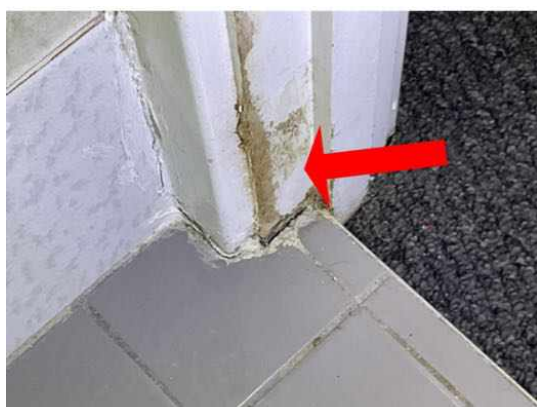
**Finding 3.06**

Building: Main Building  
 Location: Bathroom  
 Finding: Bathroom - Damp  
 Information: Damp is evident to the lower 300mm of wall to the bathroom alcove. This defect is quite common, and is suspected to have been caused by moisture permeating through the grouting in this area, which shows evidence of deterioration. Leaking

pipes within the adjoining wall is also a possible cause. Damp (or structural damp) refers to the presence of unwanted moisture in the structure of a building, either as the result of intrusion from outside, or condensation from within the structure. In the bathroom area, internal water leaks or other sources of excessive moisture are generally the cause of damp. Unmanaged damp in the bathroom recess is likely to facilitate the formation and development of mould and fungi growth, decaying associated building materials and compromising their structural integrity. It is important to address damp conditions, as the World Health Organisation notes that excess moisture leads - on almost all indoor materials - to growth of microbes such as moulds, fungi and bacteria, which subsequently emit spores and other matter into the indoor air. Exposure to these contaminants is associated with a wide range of respiratory and other health-related problems. Consultation with a qualified plumber or bathroom specialist is advised immediately to identify the cause of damp and to perform remedial works as required. Where excessive mould growth is present, further inspection by a specialist environmental health inspector should also be considered. Always ensure that sealant and grout is in good condition to prevent any moisture issues occurring in the future.

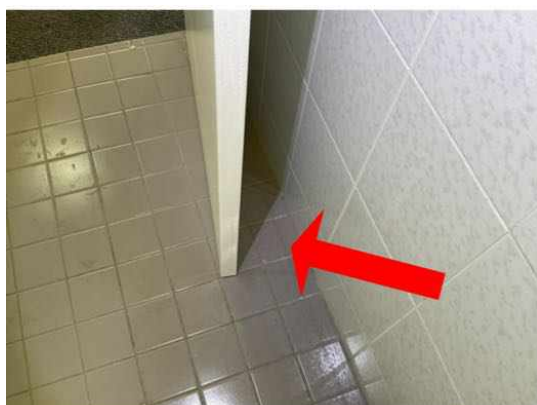
Building:	Main Building
Location:	Bathroom
Finding:	Door stop - Missing
Information:	The door stop is missing or is inadequate to stop the door handle from damaging the wall. Although some building elements may seem irrelevant or unnecessary, all building elements play a key role in the operation and function of the overall structure and its performance.

Re-installation or replacement of the door stop is advised as soon as possible to prevent any subsequent damage to the door or associated structures. A general handyman may be appointed to perform these works at client discretion.

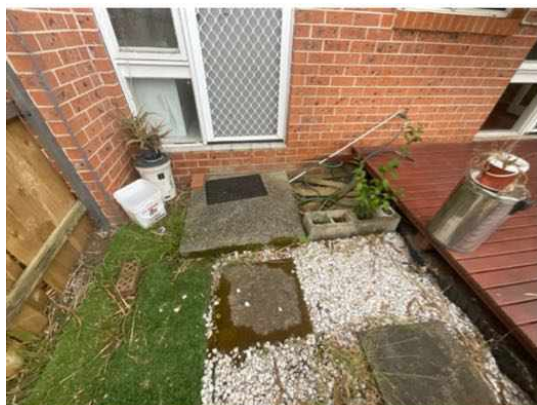
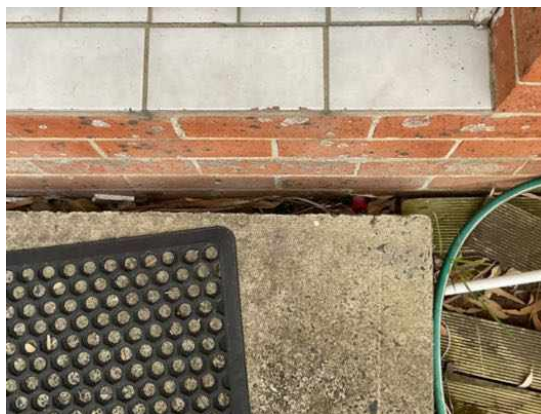
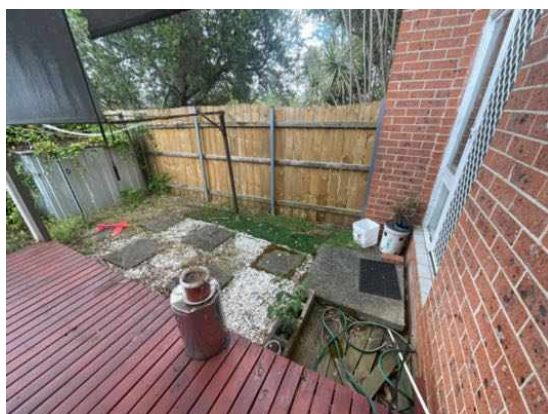
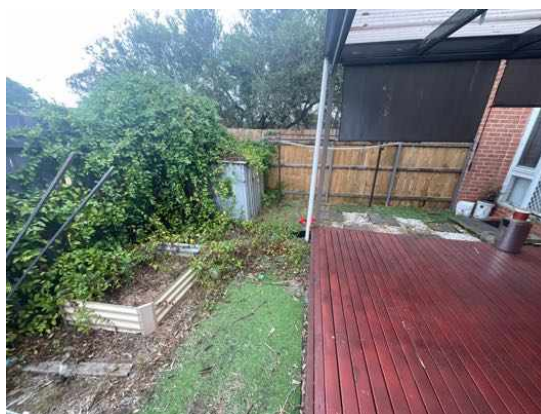
### Finding 3.09

Building:	Main Building
Location:	All Internal Areas
Finding:	Site drainage - Inadequate
Information:	The site drainage in this area was found to be inadequate at the time of inspection, creating potential for subsequent water damage to associated building elements.

ground levels should be sloped to drain water away from walls. Downpipes should not disgorge stormwater onto lower walls or plinths. Stormwater should be carried away by large, regularly cleaned drains. Ground levels may need to be lowered to expose a buried DPC.

Where site drainage is inadequate, installation of an Agricultural (Aggie) Drain may be required. A qualified plumber should be appointed to further inspect the property and perform any remedial works as necessary. Water damage and secondary defects are likely to occur if left unmanaged.

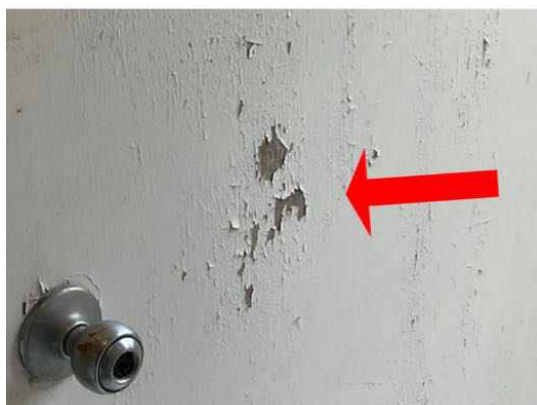
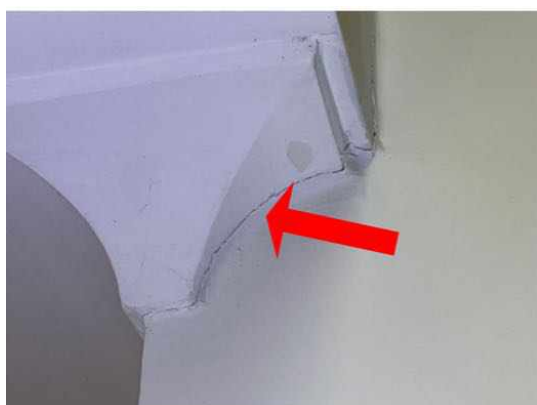
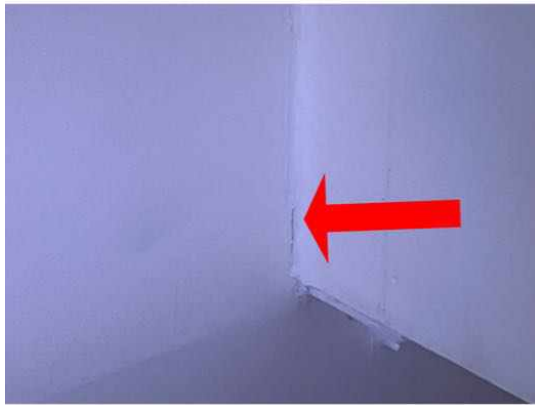
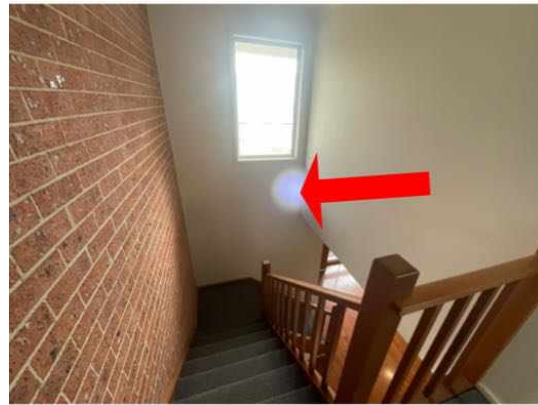
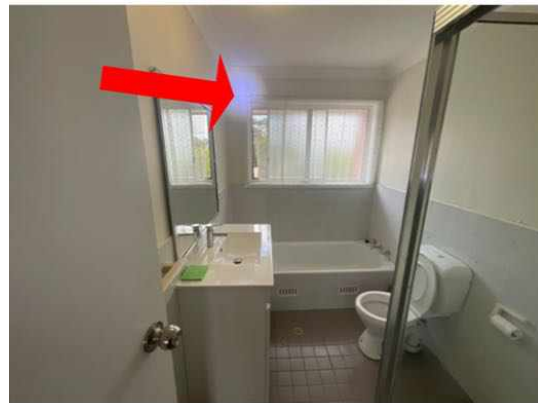
### Finding 3.14

Finding: Paint finish - Substandard, Wear and Tear  
Information: The paint finish in this area was found to have been completed to a substandard level or wear and tear as the normal deterioration of a property from ordinary, everyday use. Exposure to the elements, time, as well as day to day living can cause fair wear and tear.

If this applies, further areas of poor and incomplete finishes could develop over time. Furthermore, substandard, wear and tear paint finishes in areas exposed to moisture, e.g. external areas or wet areas, could lead to deterioration of underlying building materials.

Substandard, wear and tear paint finishes should be sanded back, filled, leveled and repainted, as applicable. Where inadequate paint protection has led to the deterioration of the associated building element, repair and/or replacement of this building element may be required.

A painting contractor should be appointed as soon as possible to perform necessary works to aid the appearance of the affected area and to ensure that the area is protected against further deterioration. Alternatively, the homeowner following manufacturer instructions may be able to provide this service.

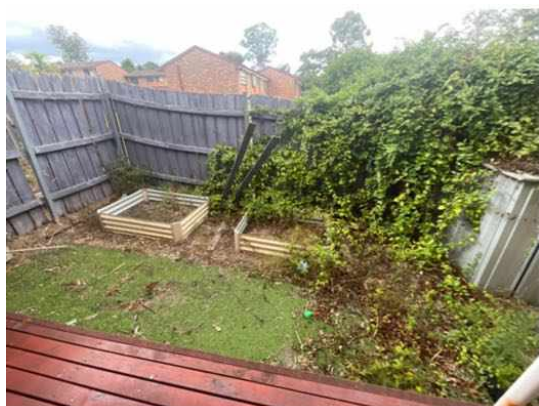
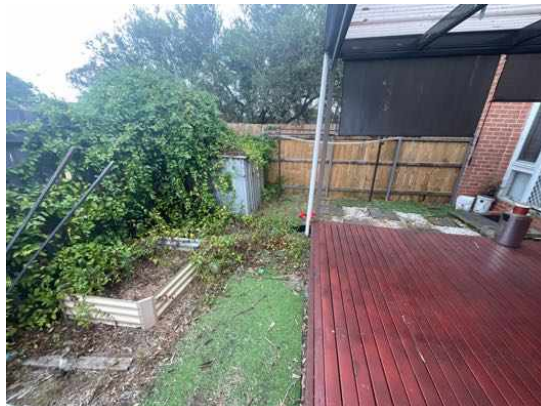
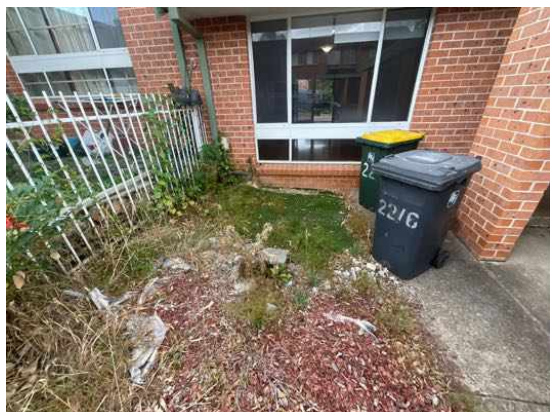
#### Finding 6.01

Building:	Main Building
Location:	All Areas
Finding:	Garden Beds - Conditions Conducive to Termites
Information:	Garden beds were found to be evident in the garden area. These garden beds can include untreated timber, and with a combination of moisture from watering hosing can make conditions conducive to termite activity and termite ingress.

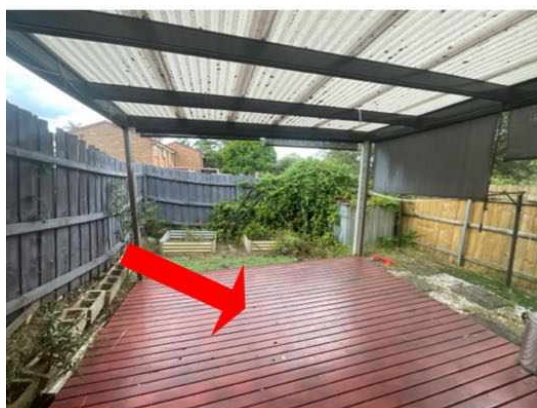
Building:	Main Building
Location:	All Areas
Finding:	Timber - exposed to weather
Information:	External timbers that are frequently exposed to harsh weather conditions require adequate protection in order to maintain their condition. Where timbers have not been painted or treated adequately, general deterioration is likely to occur at an accelerated rate.

If left unattended, replacement of these timbers is likely to be necessary in the short-term future. Adequate treatment of these timbers is required as soon as possible by a painting contractor or general handyman.

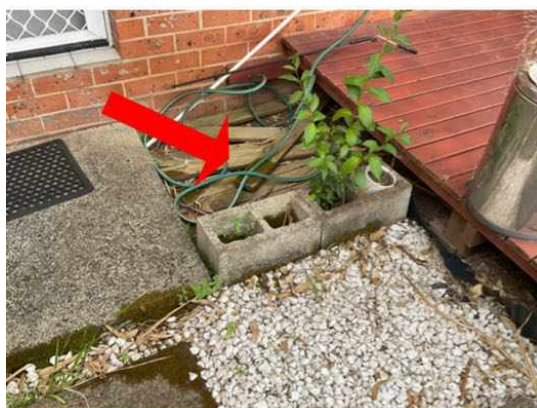
### Finding 6.05

Information: Any timbers in direct ground contact provide opportunity for concealed termite entry and are likely to be subject to premature rot and decay as the soil retains moisture or damp conditions against the timbers.

Remove untreated timber that is in direct contact with external grounds. Consider replacement with more durable materials i.e. treated timber or non timber elements. Frequent pest inspections are advised to readily identify any termite activity in these areas.

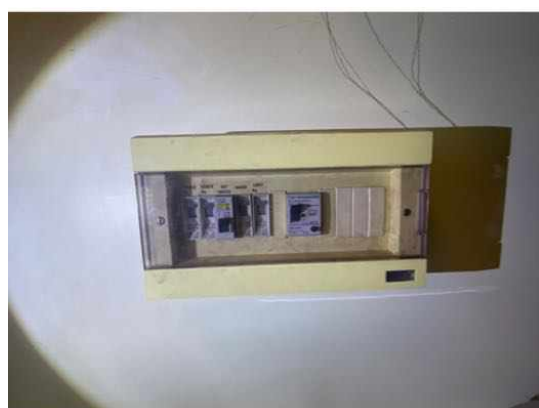
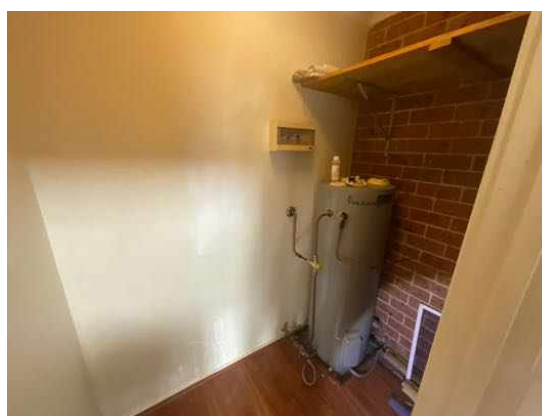
Building:	Main Building
Location:	All Areas
Finding:	Termite Management System - no evidence of a chemical installation
Information:	The application of a post-construction chemical termite barrier is highly recommended for all properties, particularly if live termite activity has been found on the site previously. Such barriers are highly effective in preventing termite attack on any timber building elements throughout the property.

A durable notice should be placed in the switchboard unit to indicate current termite barriers. At the time of inspection, it appeared as though no termite management system has been installed, with no evidence to suggest preventative works taking place.

The client may consider gaining further advice from a pest controller as to the costs and procedures involved with this application. It is recommended that obtaining such advice be a short-term priority.
