Building Inspection Report

Inspection Date: Thu, 15 Jan 2026

Property Address: 49 S Station Rd, Booval QLD 4304, Australia

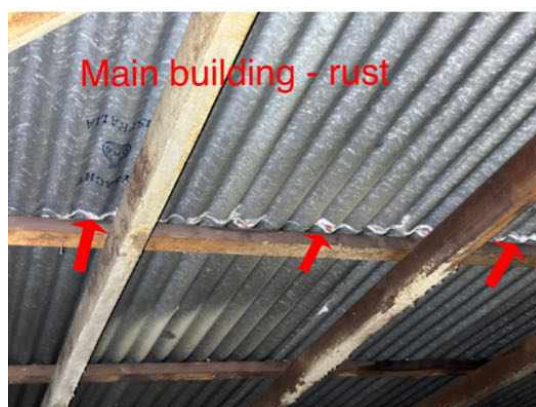
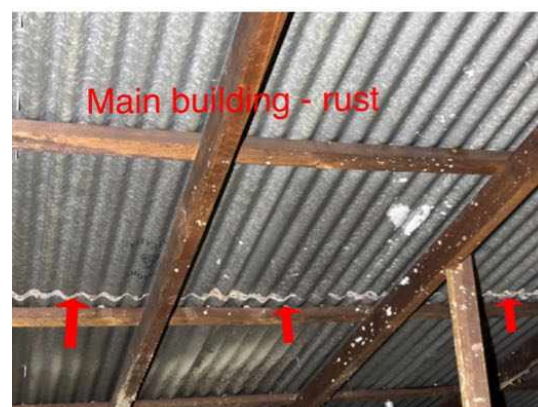
Defects 2.01

Building: Main Building
Location: Roof Exterior
Finding: Roof exterior - evidence of rust
Information: At the time of the inspection, it was noted that the metal roof coverings to all three buildings had evidence of various stages of rusting.

The main building has rusting to the joints in the roof sheets. Several holes can be seen from inside the roof cavity. The shed has rusting to the joints in the roof sheeting and several large holes can be seen from inside the shed. The bakery has surface rust to the metal roof covering.

The metal roof coverings to the three buildings need to be replaced to prevent undetected damage occurring to the buildings.

A roofing contractor should be engaged to replace the metal roof coverings to all three buildings. This should be done as a matter of urgency.

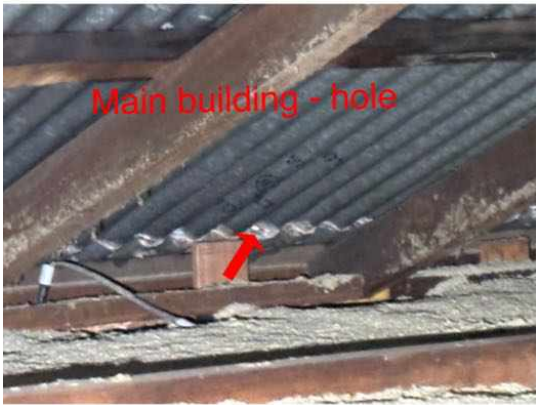
Main building - hole

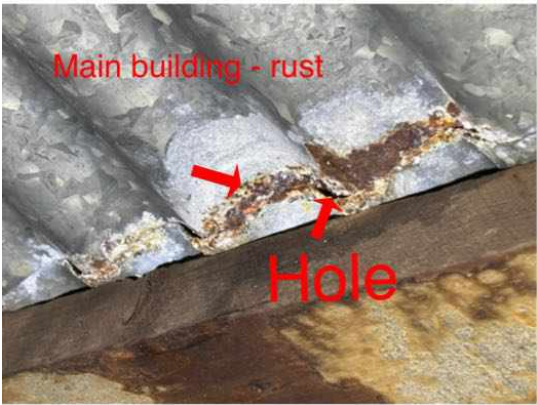
Main building - rust

Hole

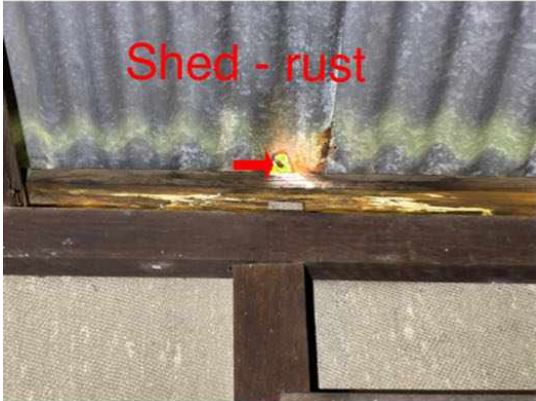
Shed - rust

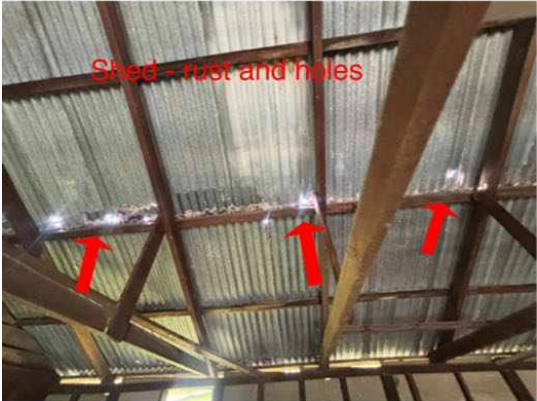
Shed - rust and holes

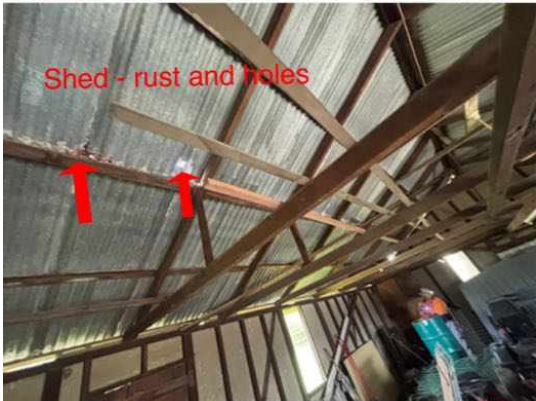
Shed - rust and holes

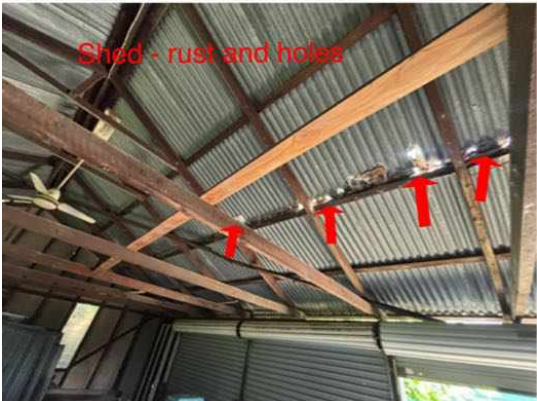
Shed - rust and holes

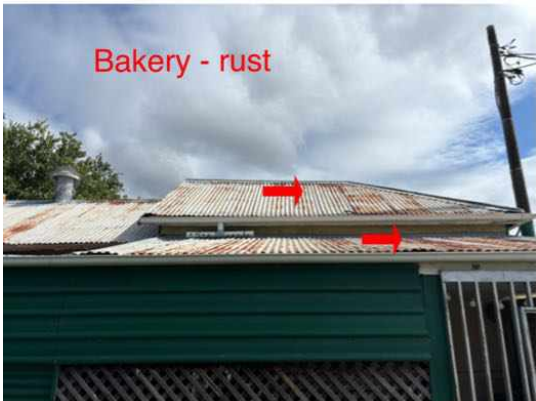
Bakery - rust

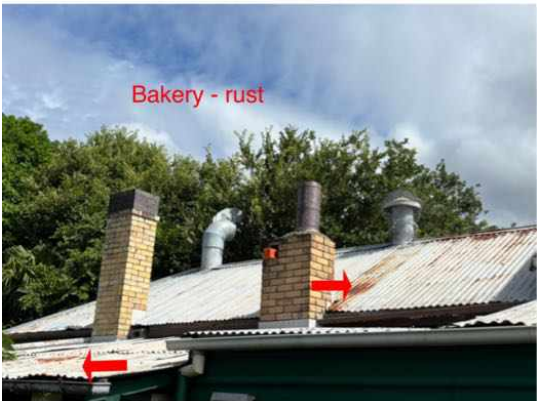
Bakery - rust

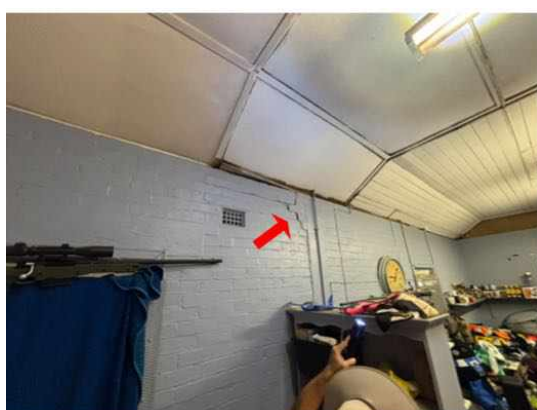
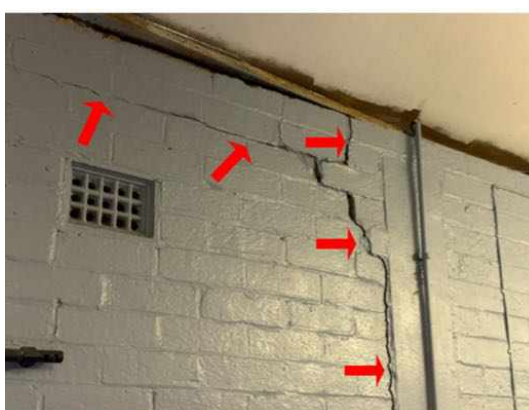
Defects 2.03

Building:	Out Building
Location:	All Internal Areas
Finding:	Brickwork - Step cracking
Information:	At the time of the inspection, it was noted that there was step cracking to the brickwork on the right hand side of the bakery. The client should monitor this area for

any change to the step cracking.

Step cracking, which is similar to other forms of cracking, has a variety of possible causes. However, the most common is the subsidence of adjacent footings.

Step cracking is a relatively common defect, and is most likely to occur adjacent to windows, doors and other openings. Mortar failure in the gaps between affected bricks indicates the stresses and tensions affecting the wall.

Where step cracking is extensive or severe, the client is advised to consult a structural engineer. Minor step cracking can be used as a warning sign to address factors causing stress to the wall, which can include the effect of surrounding trees, water leaks, soil erosion, or even the presence of reactive soils in the surrounding area.

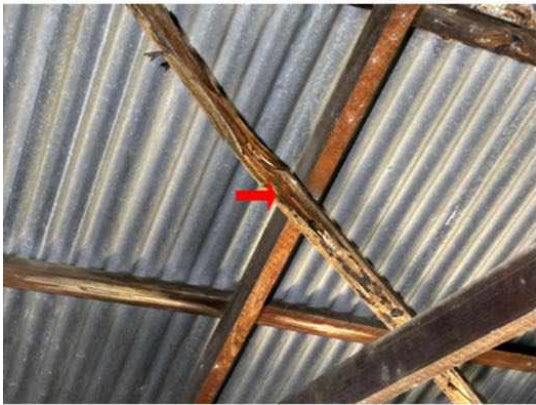
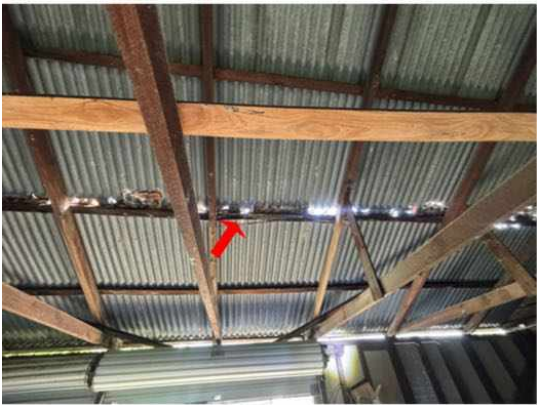
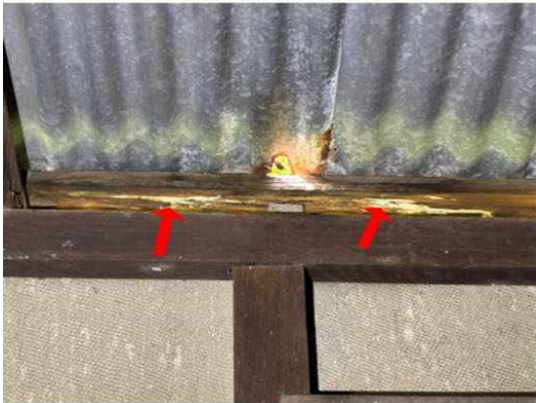
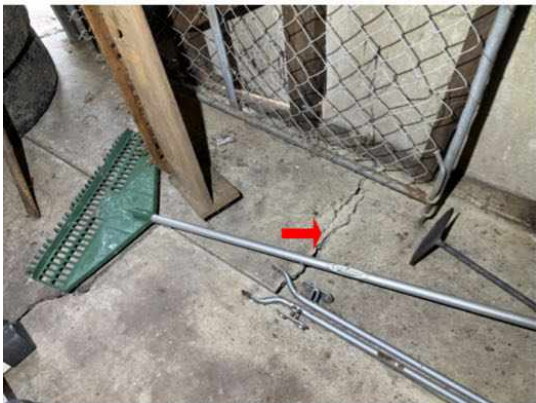
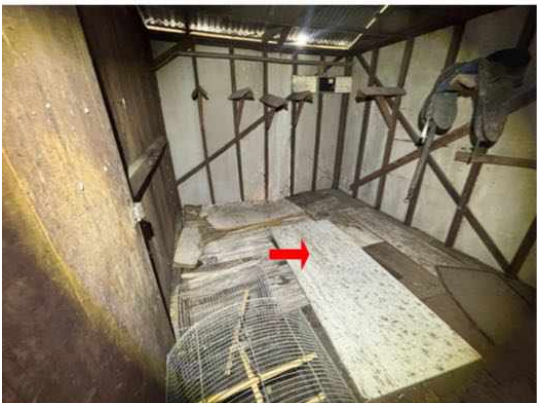
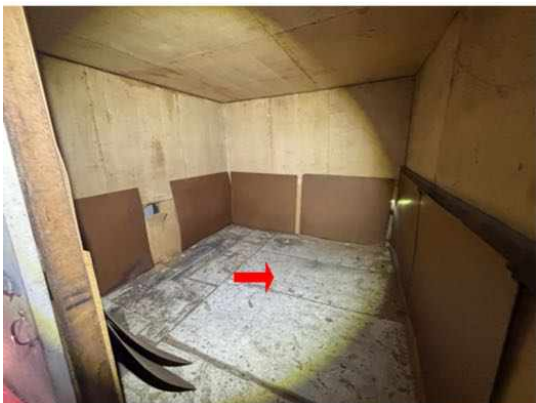
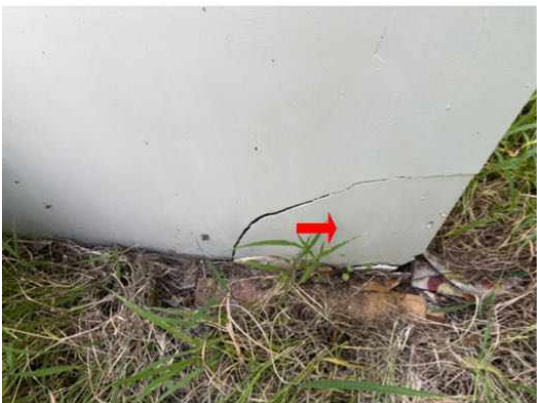
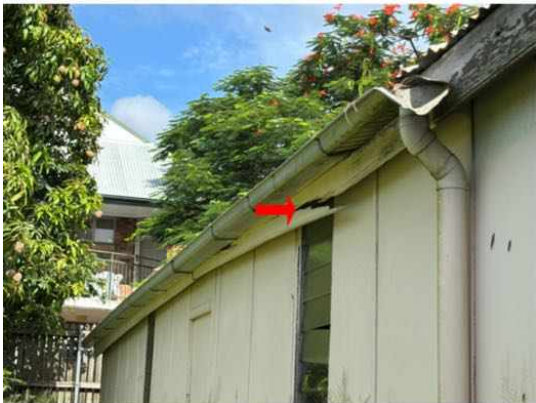
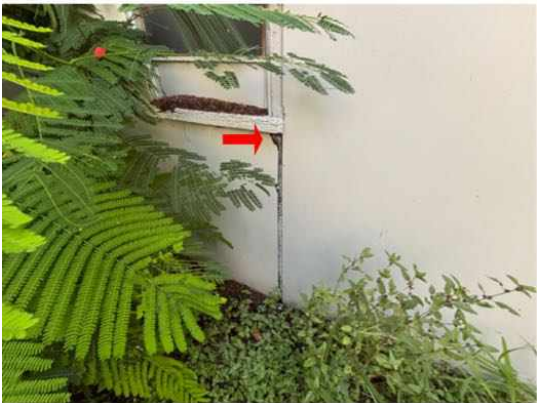
Defects 2.04

Building:	Out Building
Location:	Shed
Finding:	Shed - general deterioration
Information:	At the time of the inspection, it was noted that the shed in the backyard was deteriorating. Timber roof framing has been affected by wood rot. There are cracks in the concrete floor. The timber floor at the front of the shed is not safe to walk on. A section of timber fascia board is broken and sections of the external cladding is cracked. This external cladding may be an Asbestos Containing Material and should be treated as a such until it has been tested for Asbestos.

A licensed builder should be engaged to provide a solution for the above mentioned issues. This should be done as a short term priority.

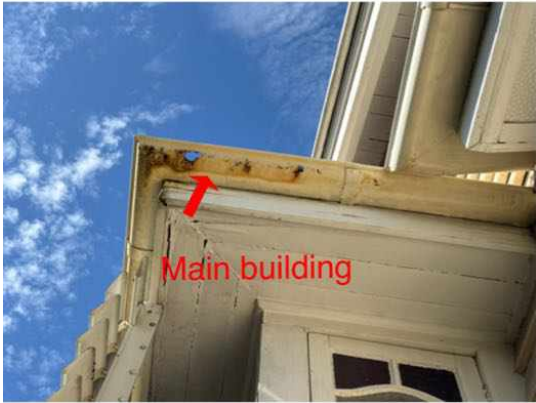
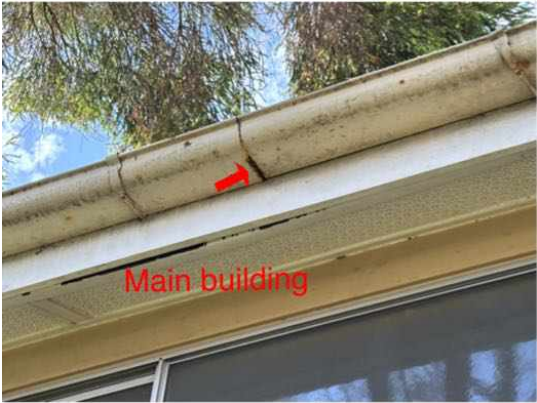
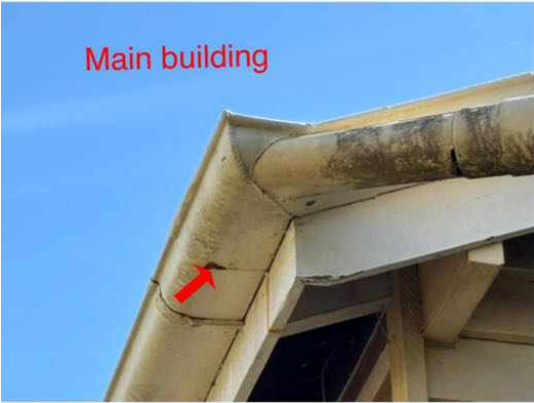
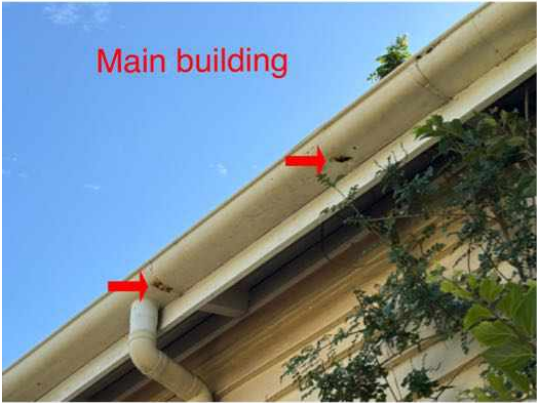
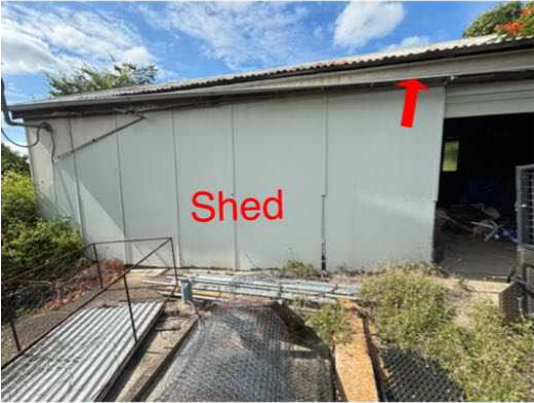
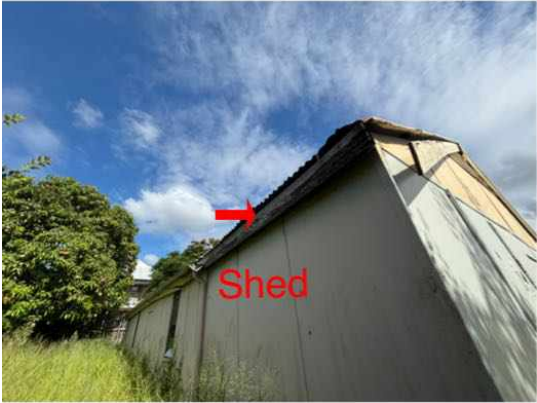
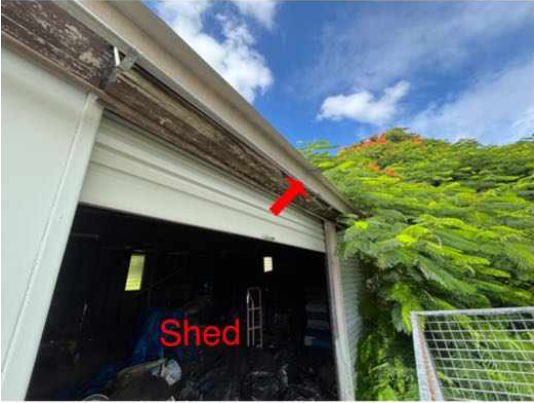
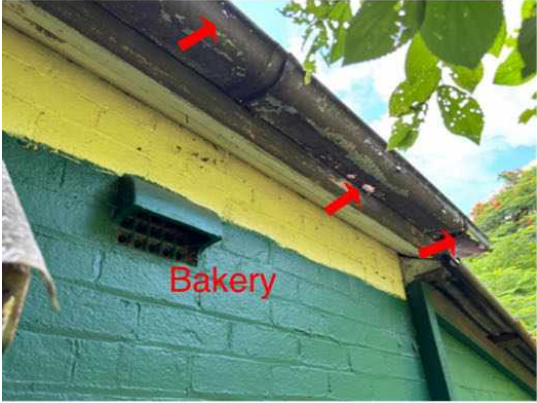
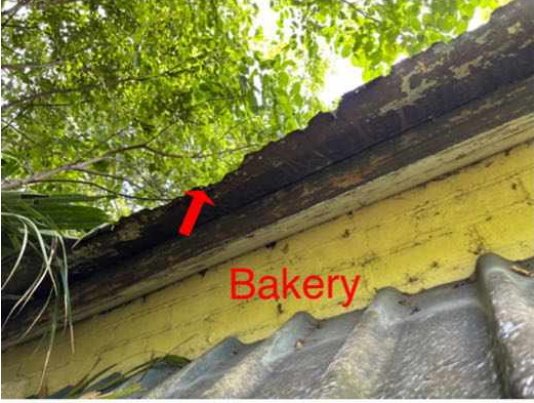
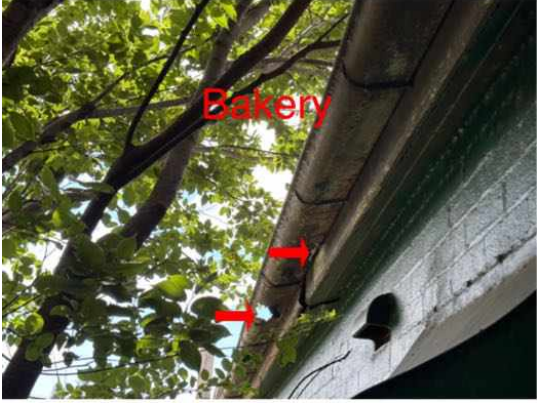
Defects 3.01

Building: Main Building
Location: All External Areas
Finding: Gutters - rusting
Information: At the time of the inspection, it was noted that the gutters to all three buildings were rusting and damaged in some instances and as such leaking in numerous areas. Gutters need to be in good working order to drain the roof properly.

If gutters are leaking , moisture may get to areas of the building that are meant to be keep dry. Damage to building elements may result of moisture ingress.

A licensed roof plumber should be appointed to inspect the gutters and advise on necessary rectification works. This should be done as a matter of urgency.

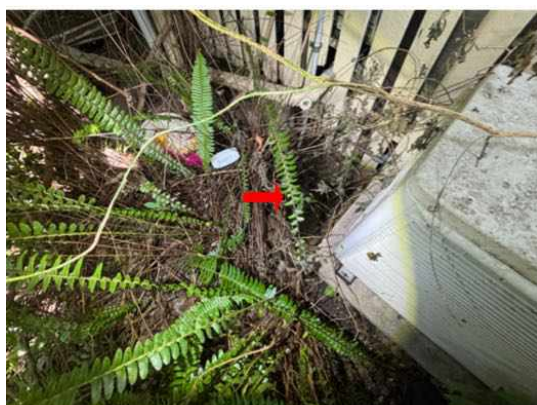
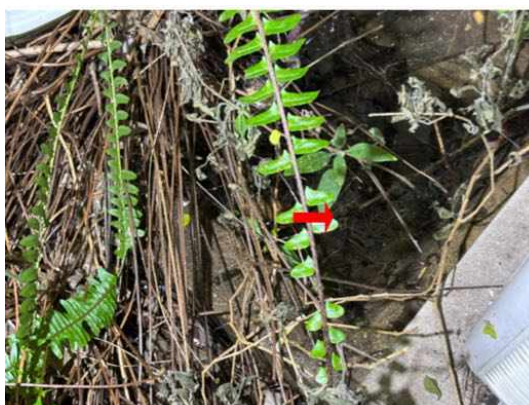
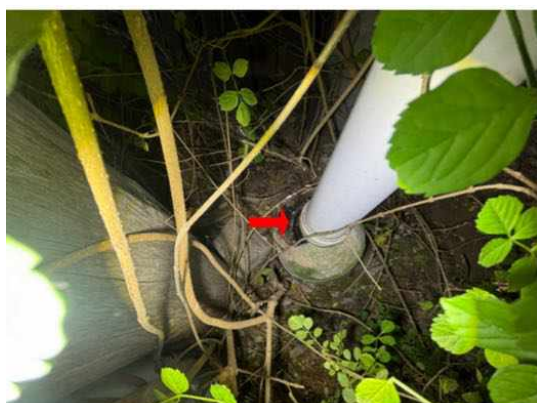
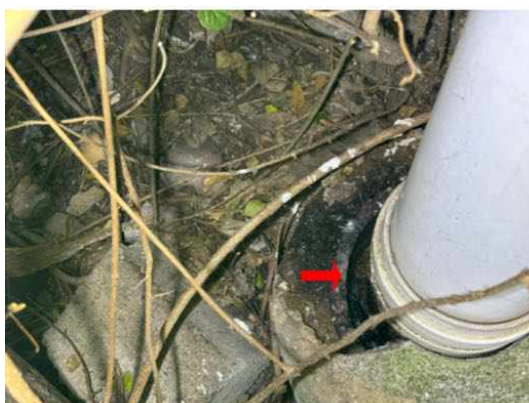
Defects 3.02

Building: Main Building
 Location: Left side yard
 Finding: Side yard - drain blocked
 Information: At the time of the inspection, it was noted that a drain on the left hand side of the main building appears to be blocked as it is full of water. This has been noted as a minor defect as the source of the blockage cannot be determined. Further investigation by a licensed plumber is required to determine the source of the blockage.

A licensed plumber should be engaged to investigate the source of the blockage. This should be done as a matter of urgency.

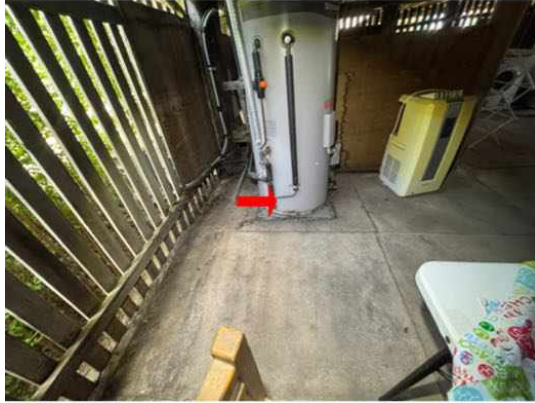
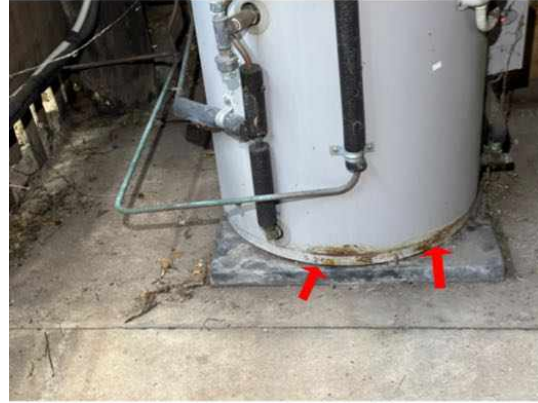
Defects 3.03

Building: Main Building
 Location: Subfloor
 Finding: Subfloor - hot water unit has signs of rusting
 Information: At the time of the inspection, it was noted that the hot water unit in the subfloor area had signs of rusting to a section of the base of the unit. Rusting may lead to the premature deterioration of the hot water unit which would necessitate replacement of the unit.

A licensed plumber could be engaged to assess the unit. This can be done at the clients discretion.

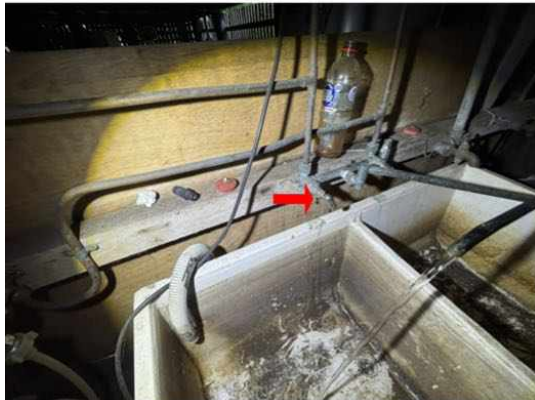
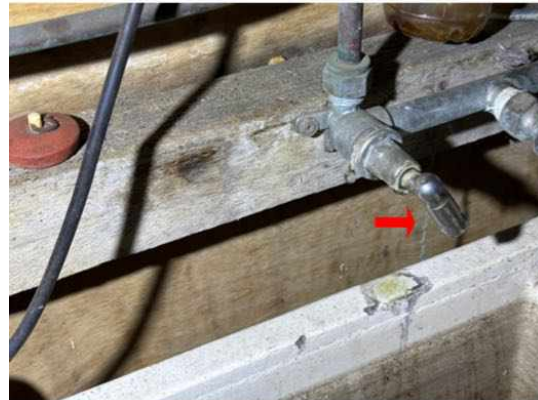
Defects 3.04

Finding: Subfloor - laundry tap leaking

Information: At the time of the inspection, it was noted that the left hand tap for the laundry tub was leaking when it was turned on. This may be due to general wear and tear of the seals in the tap.

A licensed plumber should be engaged to repair this leaking tap. This should be done as a short term priority.

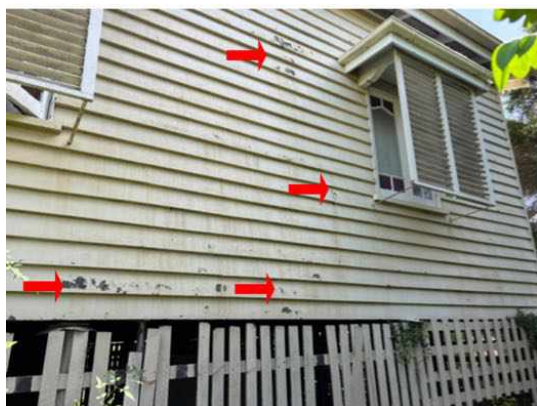
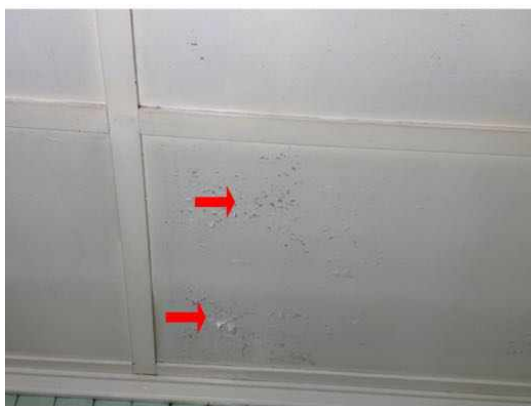
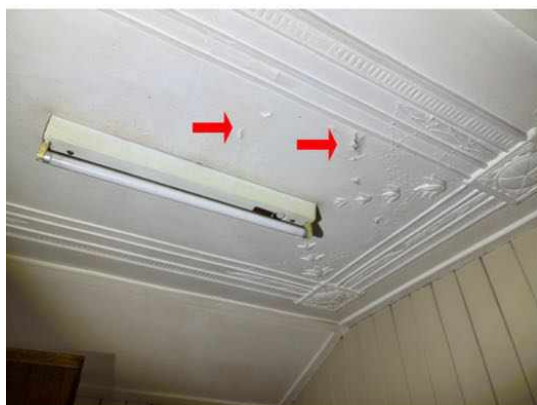
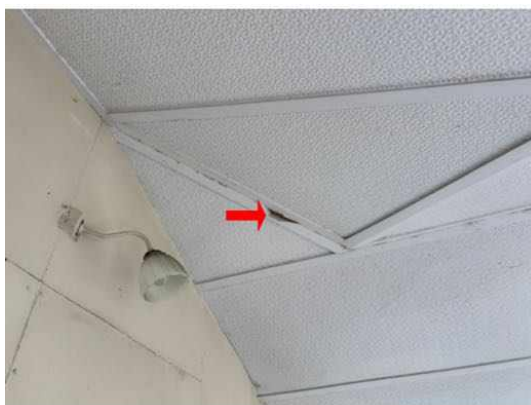
Defects 3.05

Finding: Paint peeling

Information: At the time of the inspection, it was noted that the paint was peeling in several areas of the dwelling. Evidence was found on the timber weatherboards, bedroom ceiling, entry ceiling and entry deck ceiling.

Peeling paint can be caused by moisture, poor preparation or age. There was no

evidence of moisture found.

A painter or building maintenance professional could be engaged to rectify this issue. This can be done at the clients discretion.

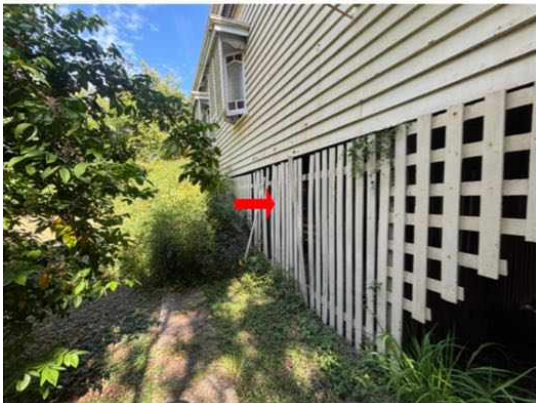
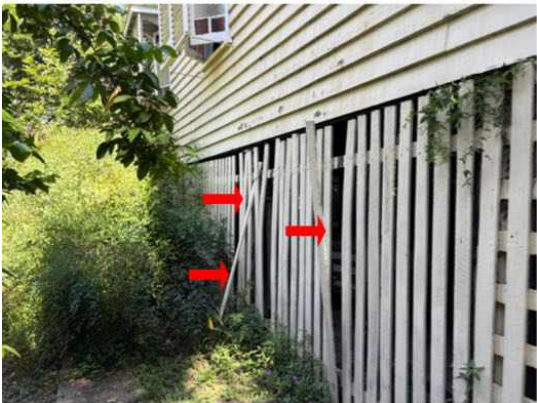
Defects 3.06

Building:	Main Building
Location:	Side yard
Finding:	Subfloor - timber battens loose
Information:	At the time of the inspection, it was noted that several timber subfloor battens were loose. This may be due the failing of the fasteners.

A building maintenance professional or licensed carpenter could be engaged to re-attach the loose battens. This can be done at the clients discretion.

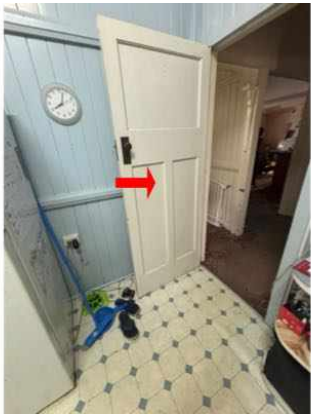
Defects 3.07

Building: Main Building
Location: All Internal Areas
Finding: Doors - Binding during normal operation
Information: At the time of the inspection, it was noted that doors in the dwelling were binding during normal operation. This appears to be general wear and tear.

The door to the kitchen is binding on the floor and a door to the sunroom is binding on the top of the door frame.

For minor causes, a qualified carpenter or building maintenance professional should be appointed to perform minor rectification works at client discretion.

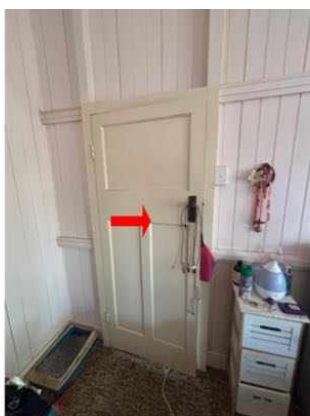
Defects 3.08

Building:	Main Building
Location:	Front bedroom
Finding:	Front bedroom - door handle not latching
Information:	At the time of the inspection, it was noted that the door to the front bedroom was not latching during normal operation. Whilst detracting from the functionality of this building element, this minor defect may also be a privacy issue. This appears to be from general wear and tear.

A qualified carpenter or building maintenance professional may be appointed to perform rectification works as necessary, at client discretion. If left unattended, further functional impairment is likely to occur.

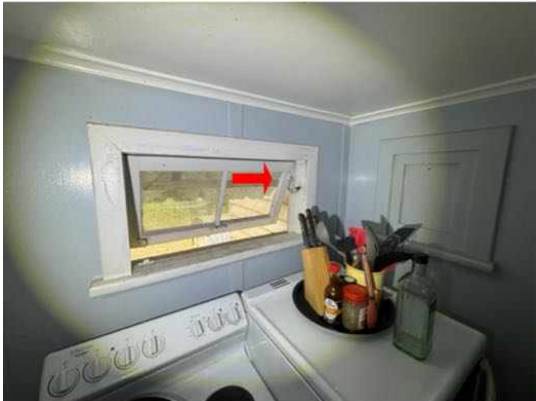
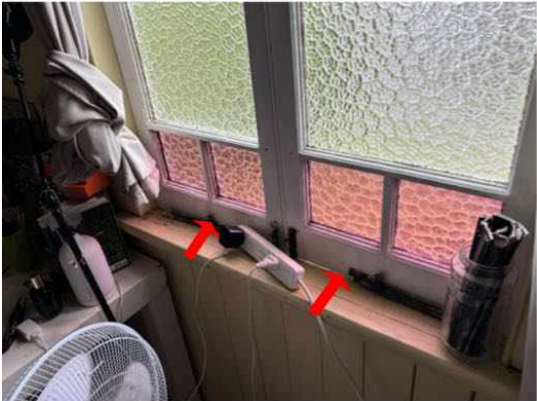
Defects 3.09

Building:	Main Building
Location:	All Internal Areas
Finding:	Windows binding
Information:	At the time of the inspection, it was noted that several windows throughout the dwelling were binding on the window frames during normal operation. This affects the functionality of the affected windows. This is a typical fault found in this style and age of building.

A building maintenance professional or licensed carpenter could be engaged to carry out the necessary repairs to restore full functionality to the affected windows.
