## Building and Timber Pest Inspection Report

Inspection Date: Tue, 10 Feb 2026

Property Address: 3/37 Gayview Dr, West Wodonga VIC 3690,  
Australia

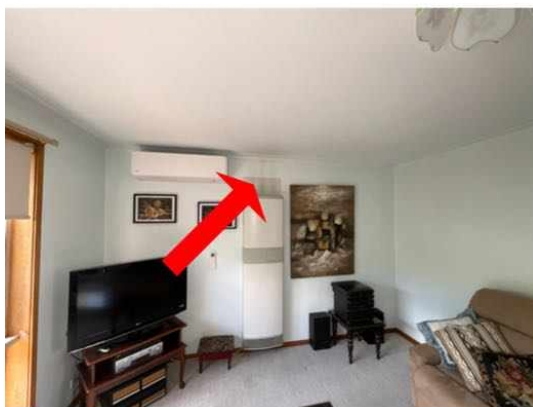
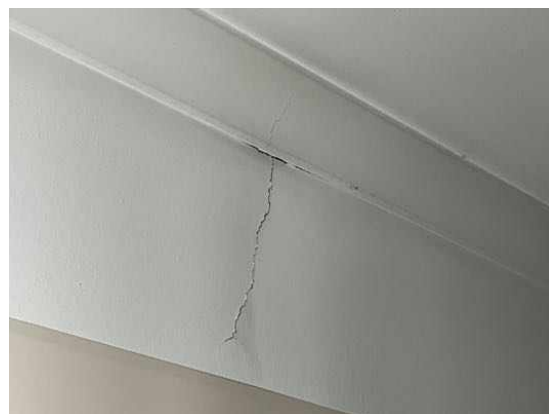
#### Finding 3.01

Building: Building 1  
 Location: Living Room  
 Finding: Cracking - Damage Category 1 - Fine (up to 1mm)  
 Information: Although fine cracks are quite noticeable, they are often only considered to be an appearance defect, and usually do not indicate any structural damage. Generally, the cause of a fine crack is indicative of a separation between building materials and finishes (e.g. paint, plaster, etc.) along joins.

Cracking of this nature can generally be repaired with minor sanding, filling and/or repainting. Such works should be performed by a qualified painter or a general handyman.

Monitoring of all cracking should be conducted frequently. Always contact a building inspector should cracks widen, lengthen, or become more numerous.

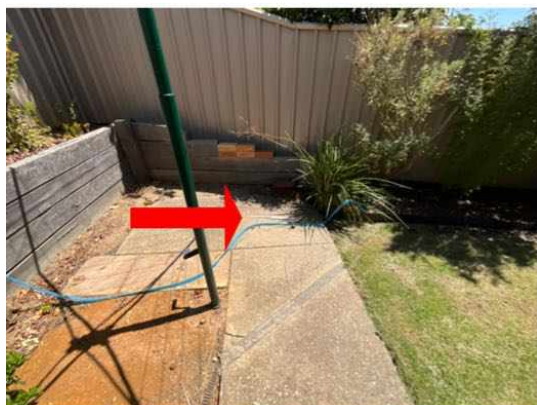
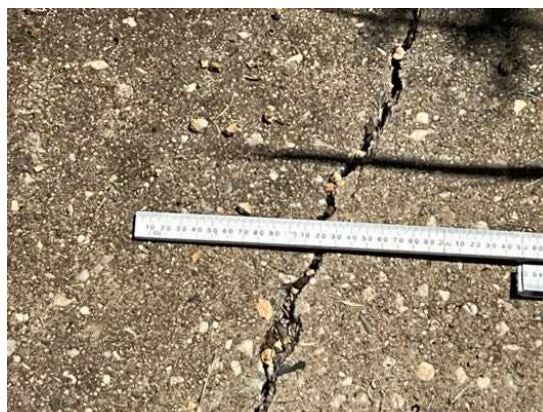
#### Finding 3.02

Building: Building 1  
 Location: Yard - Back  
 Finding: Cracking - External Concrete Paving Damage Category 3 - Wide Cracks (2mm - 4mm)

Information: Wide cracks were identified in external concrete paving. Wide cracks are significant and are likely to lead to the development of safety hazards and secondary defects if left unmanaged.

General age and expected deterioration of the paved areas is a common cause of this type of cracking. However, expansion and contraction of the slab may also have occurred due to environmental factors. Such factors include variable moisture and weather conditions, the presence of trees and their roots having a settling or lifting affect on the soil, or the effect of load bearing, e.g. heavy vehicles over a sustained period of time.

Cracking to this degree may also be due to poor original installation of the concrete. Factors such as poor compaction of the sub surface and/or inadequate reinforcing of the slab may create cracking and other secondary defects. Wide cracks may also have a more significant structural cause, such as subsidence of soils.

Where the crack is located adjacent to structural elements of the building, the advice of a Structural Engineer is advisable before undertaking repairs. Significant repair and likely replacement of the concrete paving is probable.

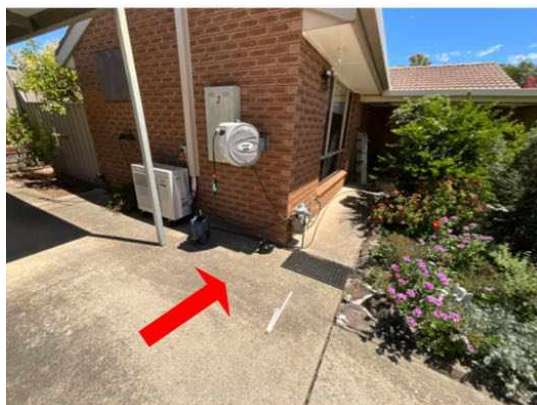
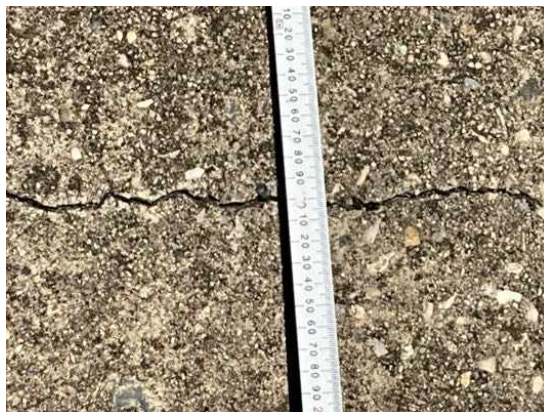
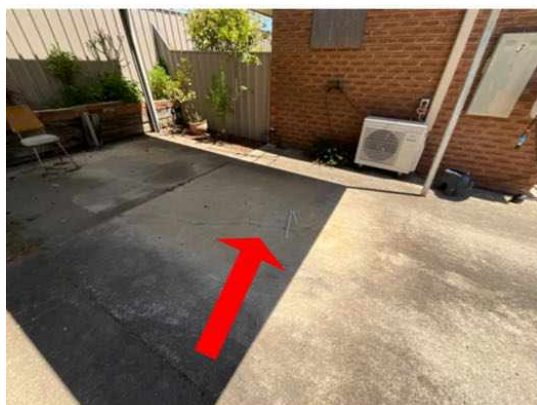
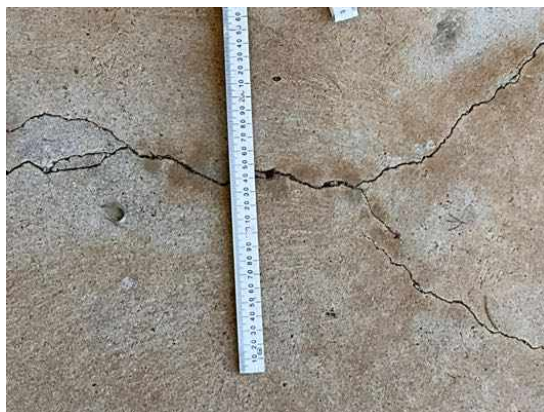
### Finding 3.03

Building: Building 1  
 Location: Carport  
 Finding: Cracking - External Concrete Paving Damage Category 1 - Fine (less than 2mm)  
 Information: Fine cracks were identified in external concrete paving. Although fine cracks are quite noticeable, they are often only considered to be an appearance defect, and usually do not indicate any structural damage. To be considered a Category 1 or fine crack, the crack is found to be less than 2mm in width.

Generally the cause of a hairline crack in existing concrete paving such as driveways and pathways is indicative of the expansion and contraction of the concrete. Such causes are generally due to environmental factors, such as moisture levels, weather conditions, root systems of nearby trees or the soil types on which they are laid.

Fine cracks may also be due to poor original installation of the concrete. Factors such as poor compaction of the sub surface and/or inadequate reinforcing of the slab may create cracking and other secondary defects.

Monitoring of all cracking should be conducted frequently. Always contact a building inspector should cracks widen, lengthen, or become more numerous.

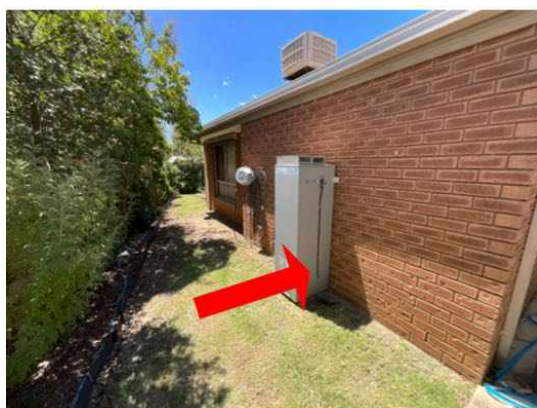
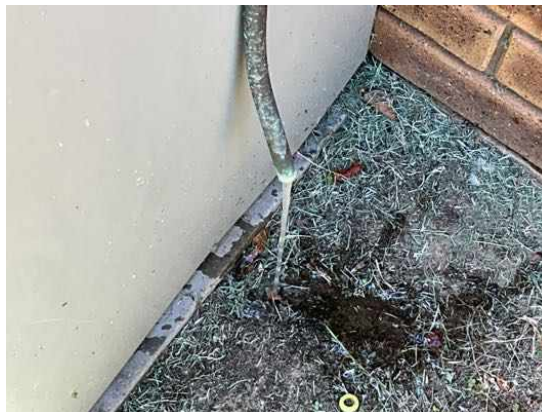
#### Finding 6.01

Building: Building 1  
 Location: Yard - Side  
 Finding: HWS Overflow - Not Connected

Information: The Hot Water System (HWS) overflow was found to be disconnected from storm water drainage and is creating excessive moisture in the surrounding area.

These damp conditions can lead to secondary defects such as rot, rust or corrosion of associated building elements, the formation of fungal decay, or even the creation of potential slip hazards. When coupled with poor site drainage, pooling of water may also attract termite activity to this area.

It is highly recommended that a licensed plumber be appointed to connect the HWS overflow in order to prevent such an environment from being created. These minor works should be carried out as soon as possible.

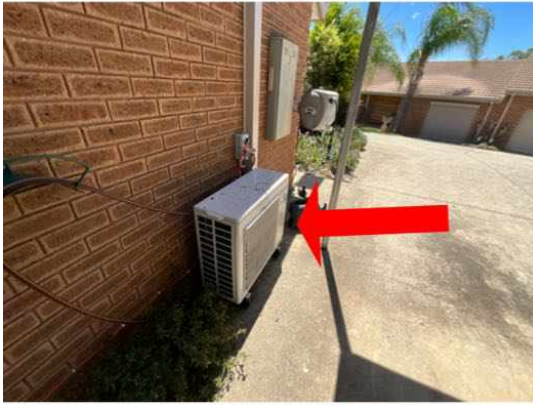
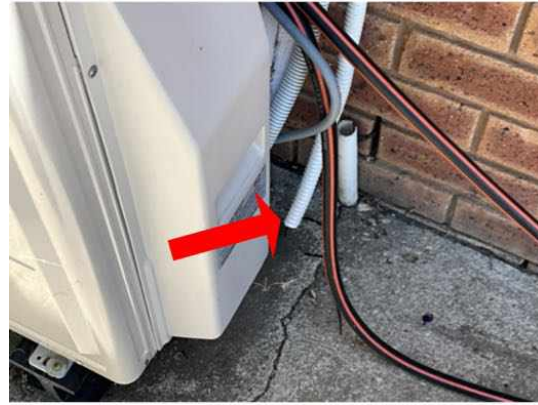
## Finding 6.02

Building: Building 1  
 Location: Carport  
 Finding: Air conditioner - Disconnected overflow  
 Information: The Air Conditioner (A/C) overflow was found to be disconnected from storm water drainage and is creating excessive moisture in the surrounding area.

Such leaking creates an environment which is conducive to an array of defects, including water damage to associated building elements and the attraction of termite or timber pest infestation.

It is highly recommended that a licensed plumber be appointed to connect the A/C overflow in order to prevent such an environment from being created. These minor works should be carried out as soon as possible.

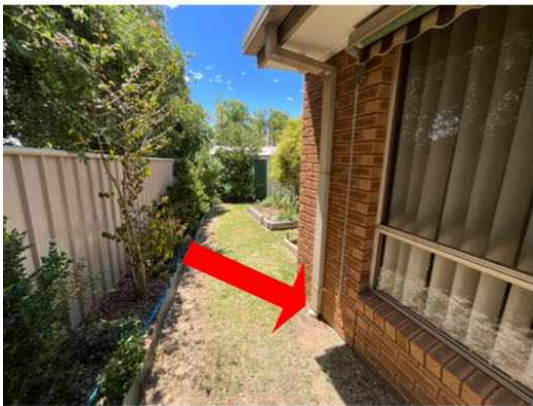
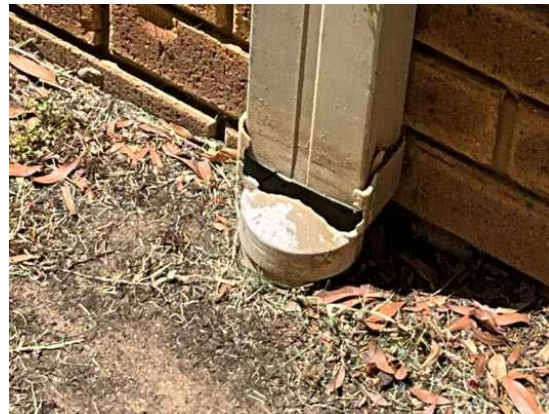
### Finding 6.03

Building:	Building 1
Location:	Yard - Side
Finding:	Downpipe- Damaged
Information:	The Downpipe was found to be damaged at the time of inspection. This damage has occurred because of impact from a foreign object.

Downpipes ensure excess water is directed away from the structure to prevent damage. This damage includes Fungal timber decay, Termite attack and sinking of the stumps that support the floor. All of this type of damage may lead to costly repairs.

A Plumber should be contacted to make repairs as soon as possible to prevent deterioration of the Structure.

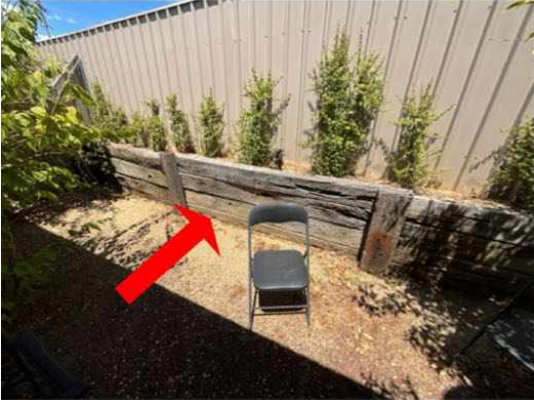
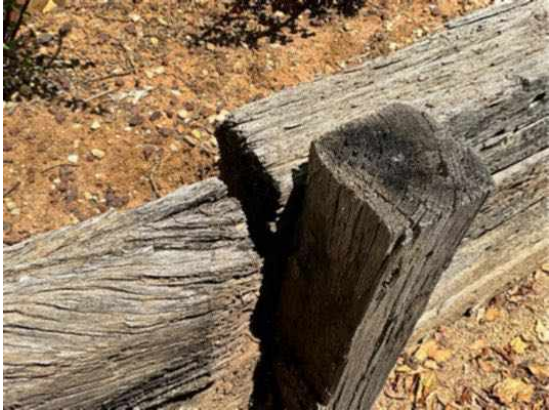
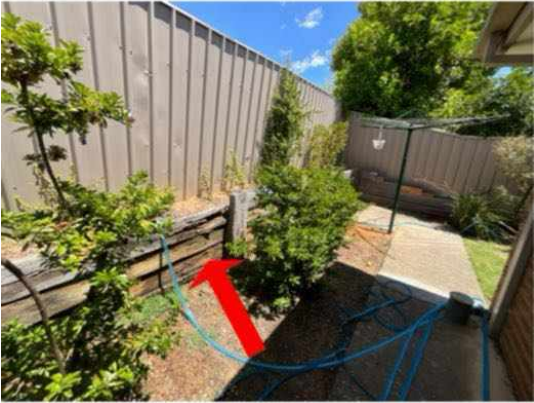
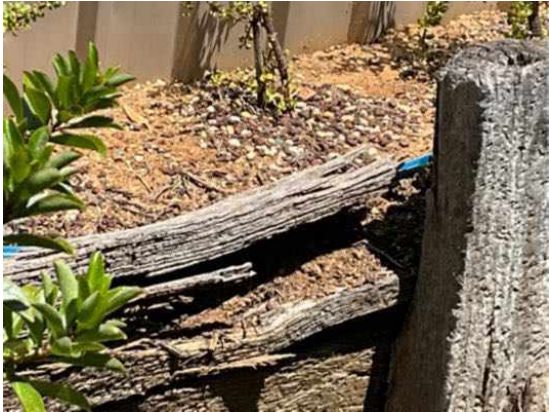
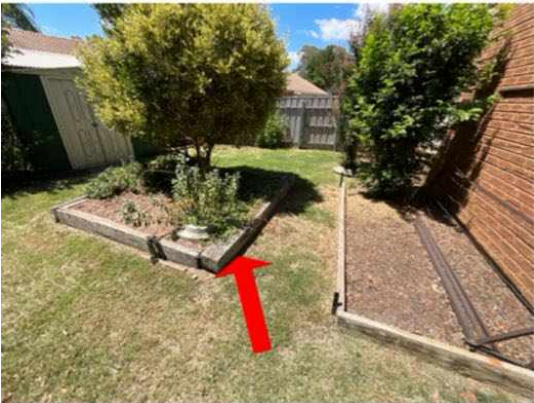
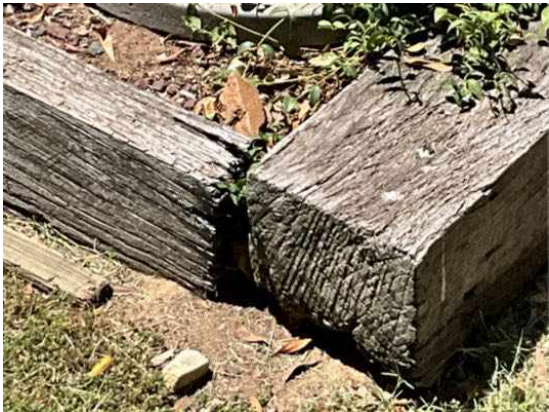
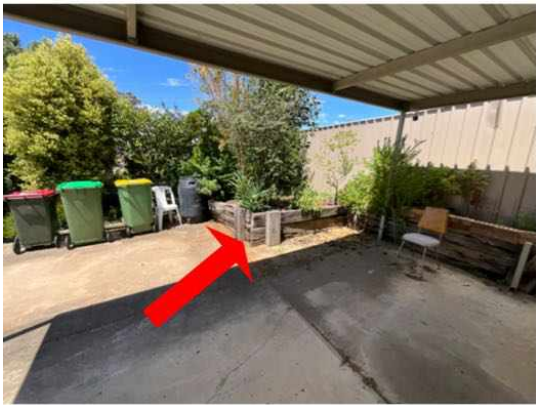
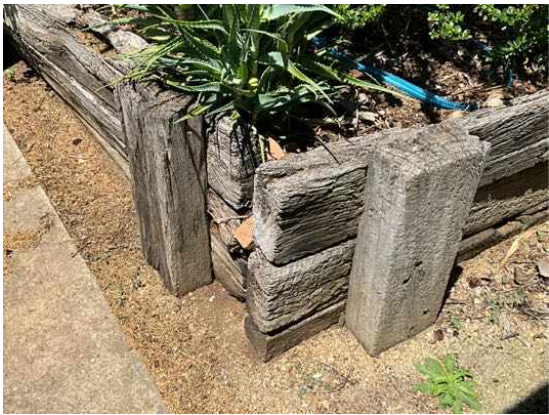
### Finding 6.04

Building:	Building 1
Location:	Yard - Back, front
Finding:	Untreated or non-durable timbers in a hazardous environment
Information:	To reduce the risk of timber pest attack it is essential that timber used in a hazardous environment (e.g. in direct contact with the ground or frequently exposed to damp conditions) is of sufficient durability and/or is adequately preservative treated.

Untreated timbers in direct contact with the ground are likely to develop severe wood rot and/or fungal decay if left unattended creating attraction for subterranean termites to infest the timbers from surrounding areas.

If untreated or non-durable timbers are found to be in a hazardous environment it is highly advised that replacement of these building elements be performed as soon as possible to aid the protection of the property against termite / timber pest attack.

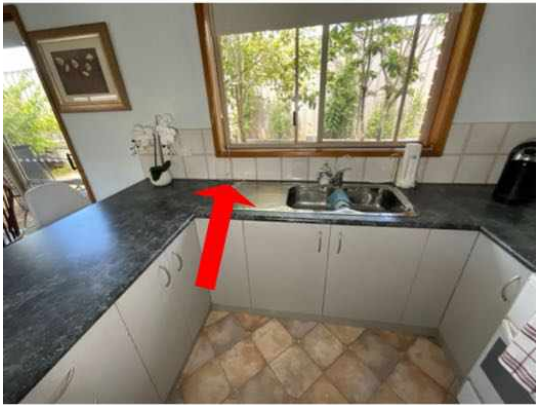
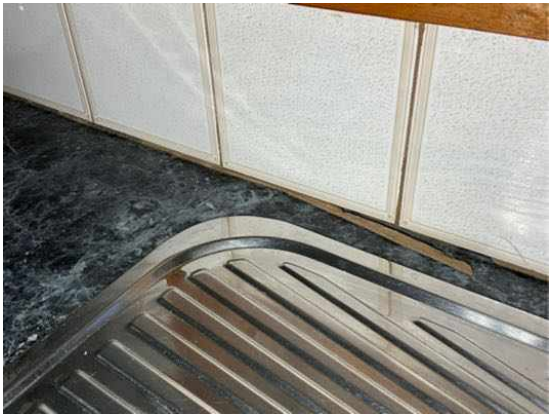
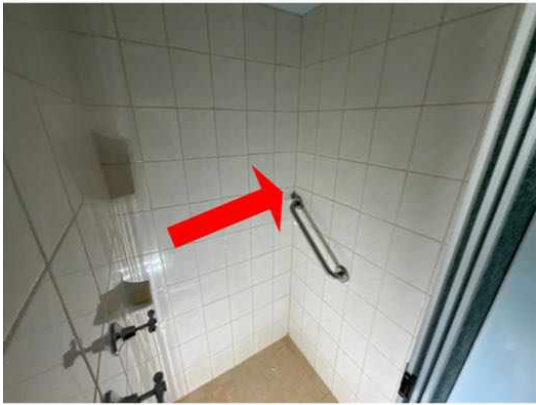
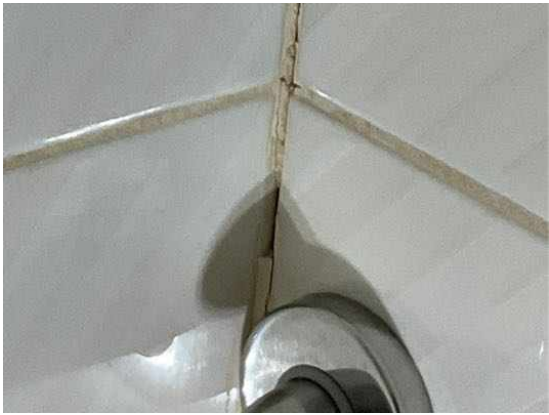
**Finding 6.05**

Building: Building 1  
 Location: Kitchen, bathroom  
 Finding: Inadequate sealant or Grout  
 Information: This area has a lack of effective Sealant or Grout. This is allowing the ingress of water to the structure inside the wall.

The presence of water encourages Termite attack, Mould and Fungal Decay.

A Tiler or General Handy person must be contacted as soon as possible to effect repairs and prevent further deterioration.

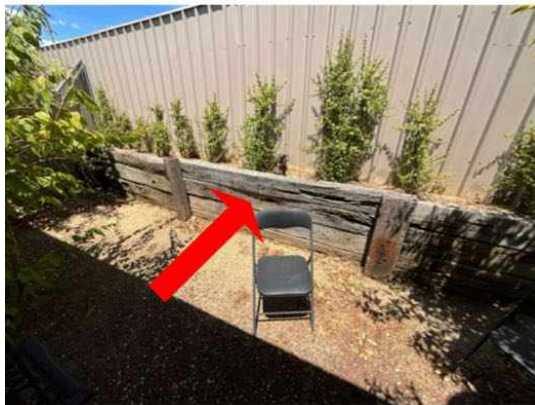
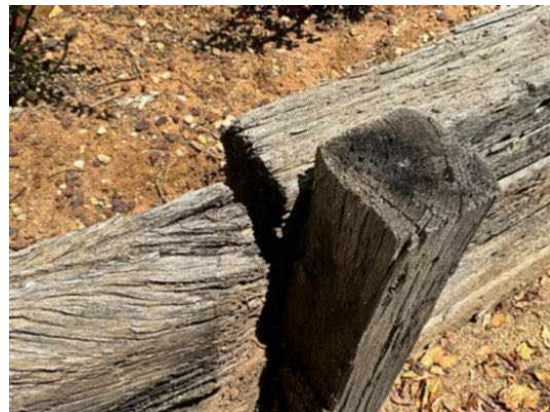
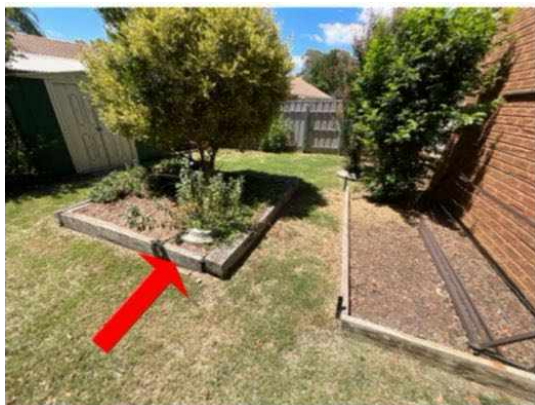
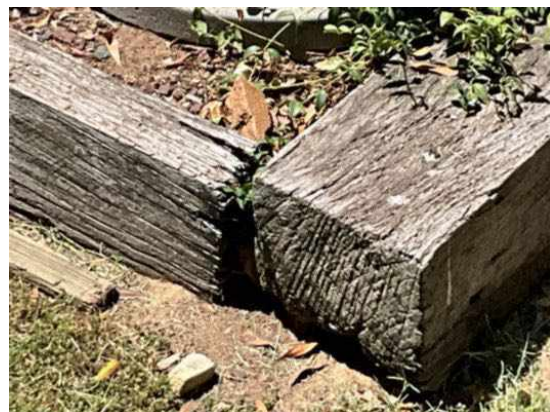
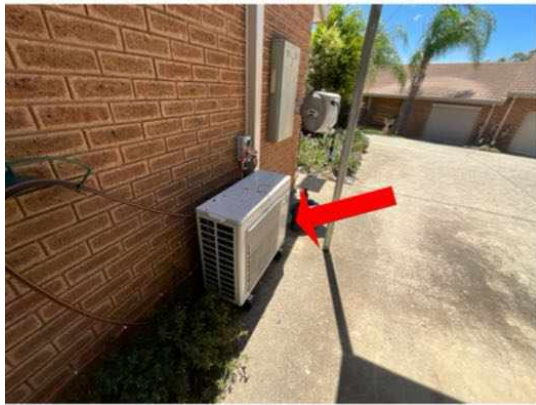
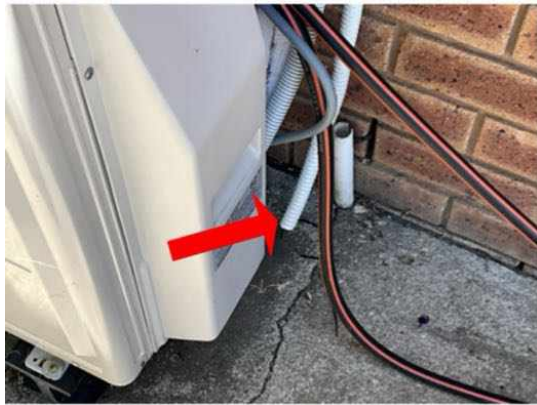
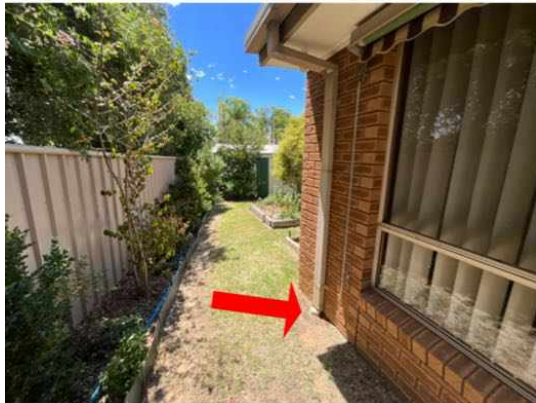
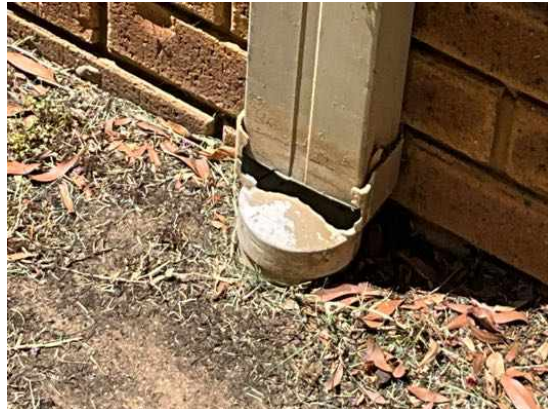
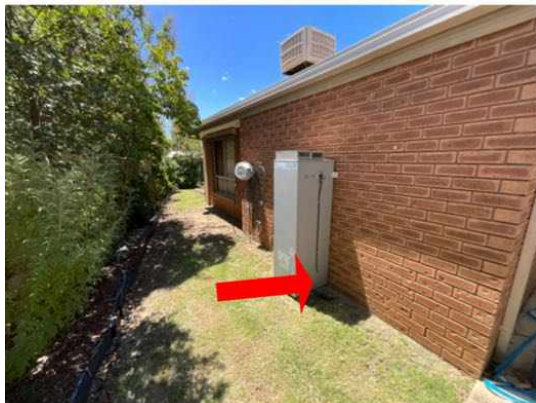
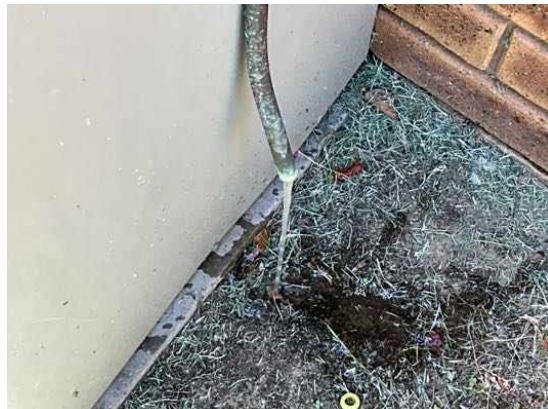
## Finding 6.06

Building:	Building 1
Location:	All External Areas
Finding:	Termite Management System - no evidence of a chemical installation
Information:	The application of a post-construction chemical termite barrier is highly recommended for all properties, particularly if live termite activity has been found on the site previously. Such barriers are highly effective in preventing termite attack on any timber building elements throughout the property.

A durable notice should be placed in the switchboard unit to indicate current termite barriers. At the time of inspection, it appeared as though no termite management system has been installed, with no evidence to suggest preventative works taking place.

The client may consider gaining further advice from a pest controller as to the costs and procedures involved with this application. It is recommended that obtaining such advice be a short-term priority.

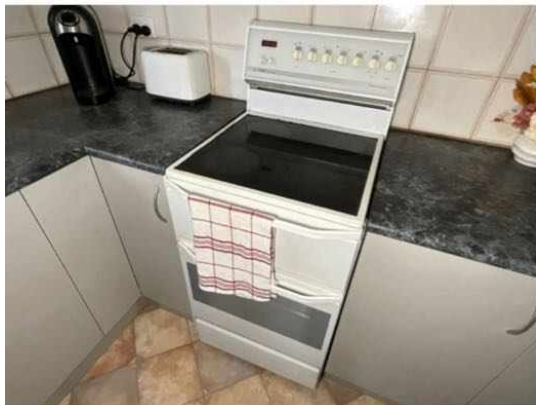
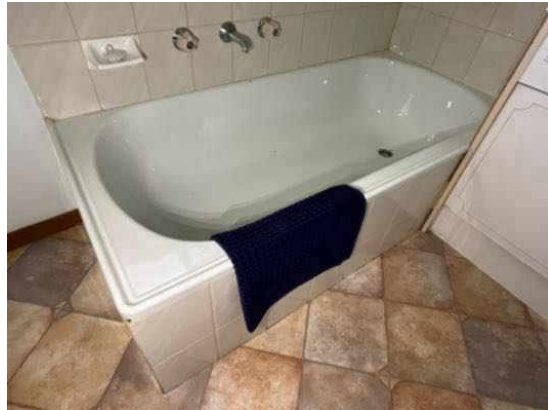
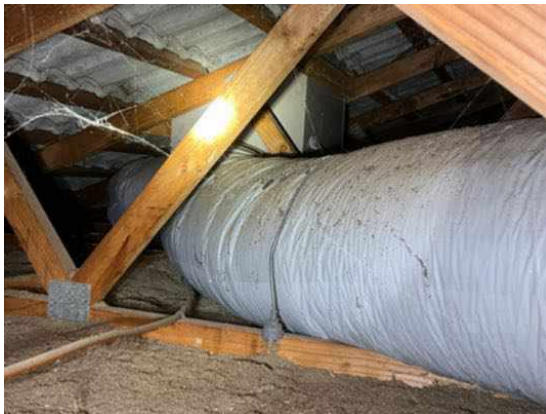
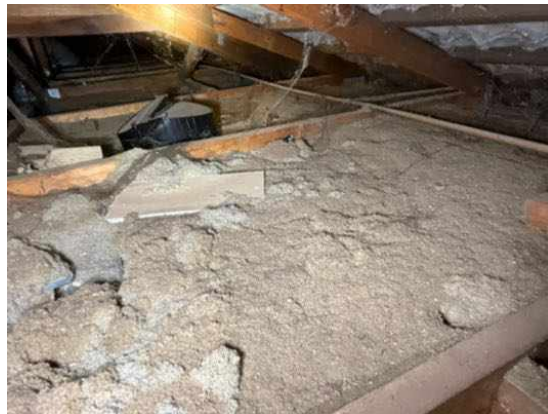
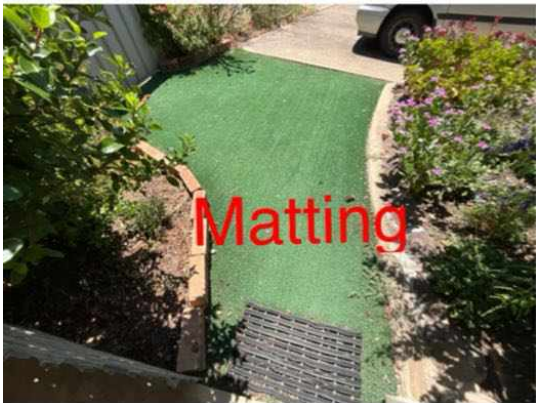
#### Noted Item

Building: Building 1  
Location: All Areas  
Finding: Additional Photos - Obstructions and Limitations  
Information: These photographs are an indication of the obstructions and limitations which impeded full inspection of the property at the time of inspection. These obstructions can hide an array of defects and should be removed to allow full inspection to be carried out. A re-inspection is recommended once the areas are made accessible.
