Building Inspection Report

Inspection Date: Fri, 20 Mar 2026

Property Address: Unit 505, 4 Broughton Street, Canterbury
NSW 2193

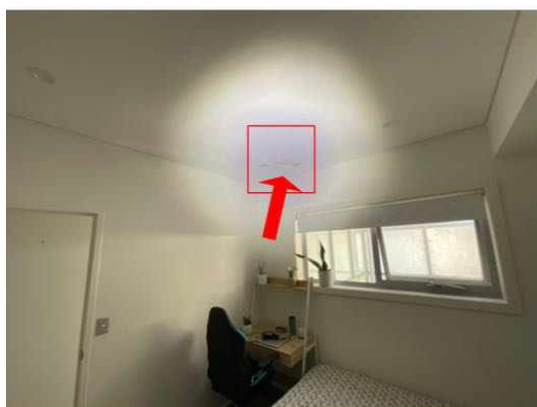
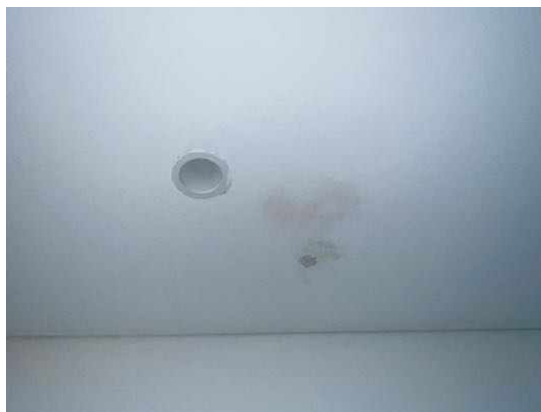
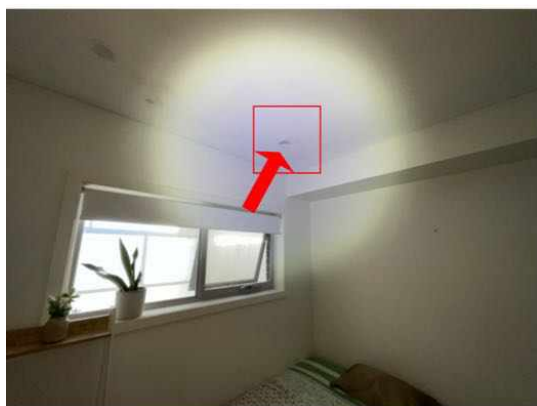
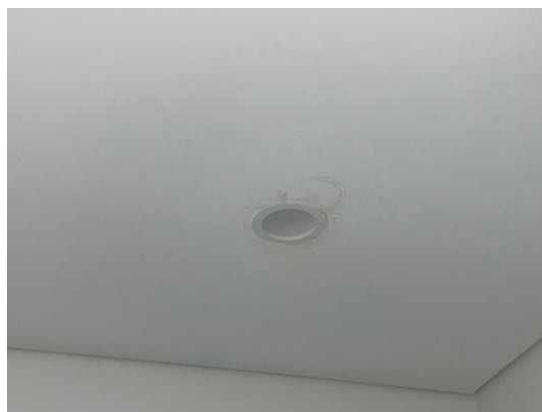
Defects 2.01

Building: Main Building
Location: Bedroom
Finding: Major Defect – Ceiling Water Staining / Suspected Moisture Ingress (Strata Property)
Information:

Water staining was noted to ceiling linings in the inspected area(s) at the time of inspection. The staining presented as discoloured and patchy areas consistent with moisture exposure. The extent and pattern of staining suggest possible ongoing or recurrent moisture ingress, commonly associated with roof leaks, defective flashings, or plumbing issues. This assessment was based on a visual inspection only, and no invasive testing or moisture readings were undertaken.

The presence of ceiling water staining may indicate a failure in the building envelope or internal plumbing systems. In a strata-managed property, this type of defect may involve common property (such as the roof structure, external elements, or shared services), which can fall under the responsibility of the owners corporation/strata management.

Due to the visual-only nature of this pre-purchase inspection, it was not possible to determine whether the staining is active or historical at the time of inspection. The defect has been classified as major due to the potential for ongoing deterioration if the source of moisture ingress remains unresolved.

It is recommended that the owners corporation/strata manager be formally notified as soon as possible, as the source of the leak may originate from common property or shared building elements.

A suitably qualified roofing contractor and/or licensed plumber (as applicable) should be engaged—either privately or via strata—to carry out a detailed investigation to identify the exact source of moisture ingress. Repairs should be undertaken to defective roof coverings, flashings, penetrations, or plumbing components as required.

Following rectification of the source, damaged ceiling linings and finishes within the lot should be repaired or replaced as necessary. Clarification should be sought from the strata manager regarding responsibility for both investigation and rectification works.

Further assessment, potentially including moisture testing and inspection during wet weather conditions, is recommended. Responsibility for repairs should be confirmed with the owners corporation, as this may vary depending on the location and source of the defect.

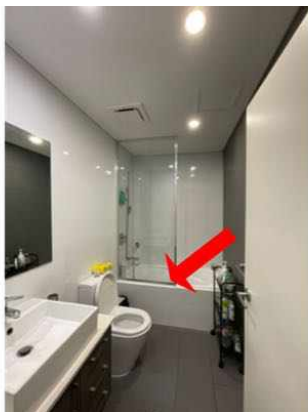
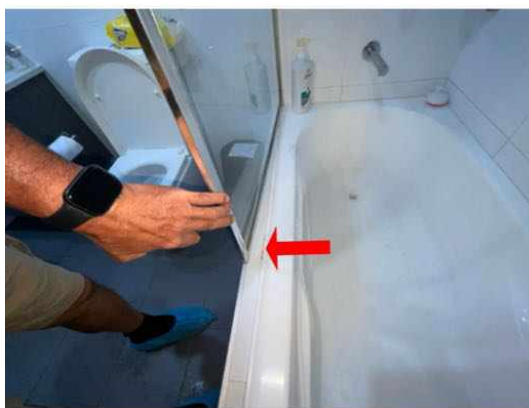
Defects 3.01

Building: Main Building
 Location: Bathroom
 Finding: Minor Defect – Shower Screen Fixing and Sealing
 Information:

At the time of inspection, the shower screen glass panel within the bathroom was observed to be loose and inadequately secured to the bathtub. The junction between the glass panel and the bathtub also appeared insufficiently sealed, with gaps evident in the existing sealant. This assessment was based on a visual inspection only, and no invasive testing was undertaken.

A loose and poorly sealed shower screen may allow water to escape the shower recess during normal use. Ongoing moisture egress can contribute to water damage in adjacent finishes and building elements, including deterioration of wall linings, flooring materials, and potential mould growth if left unaddressed. While considered a minor defect at the time of inspection, deterioration may accelerate if not maintained.

It is recommended that a suitable sealant (e.g. sanitary-grade silicone) be applied to properly seal the junction between the shower screen and bathtub, and that the glass panel be securely fixed in position. Works should be carried out by a suitably qualified tradesperson to ensure adequate waterproofing and stability of the installation. Ongoing monitoring and routine maintenance of sealant joints is advised.

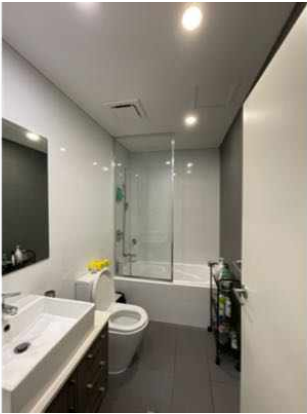
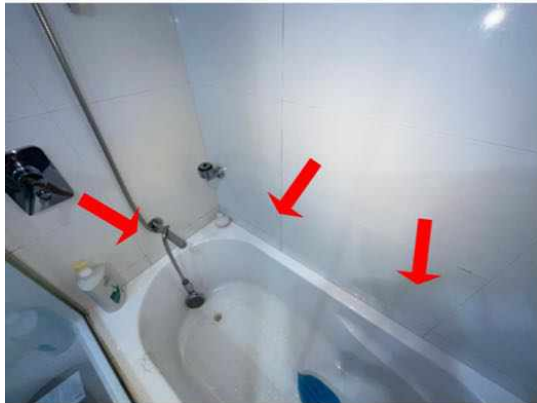
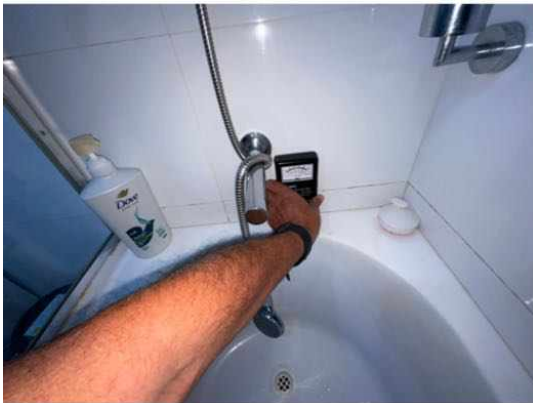
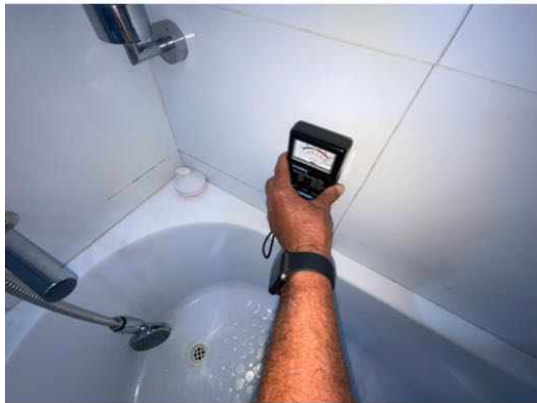
Defects 3.02

Building:	Main Building
Location:	Bathroom
Finding:	Shower Area – Moisture Readings & Damp Assessment
Information:	Moisture readings were detected in the lower shower walls. This is a common occurrence with certain types of tiles, particularly those with higher porosity, which tend to absorb more moisture than others.

Moisture detected is suspected to be due to moisture ingress around the spout penetrations, which may not be adequately sealed.

However, the possibility of leaking pipes or fittings within the adjoining wall cavity cannot be entirely ruled out at this stage.

- Engage a licensed plumber to investigate the source of moisture near the tap fittings and carry out any necessary repairs.
- Consider appointing a bathroom waterproofing specialist to assess and reseal the shower area if needed.

- Regularly check and maintain all sealant at junctions, grout lines, and around tap fittings to prevent future moisture ingress.

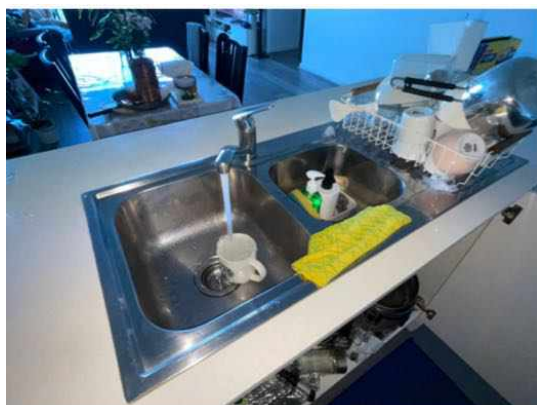
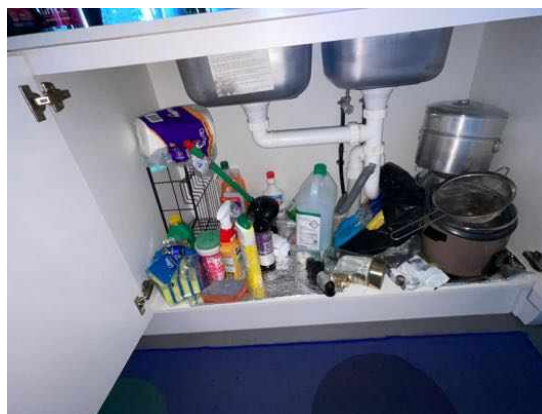
Building: Main Building
 Location: Kitchen
 Finding: Kitchen Sink – Overall Condition & Recommendations.
 Information: Observations:

- The kitchen sink tap(s) were water tested at the time of inspection, with no evidence of leaks or blockages observed in the visible plumbing or drainage.
- No significant water damage was observed to the cabinetry/unit;
- Stored items under the sink obstructed access, limiting a full inspection of the plumbing and internal cabinetry.

- Further monitoring and testing are recommended once the tap(s) are in constant use, to identify any drainage issues or signs of slow leaks not evident during the limited inspection.
- It is recommended that the stored items beneath the sink be removed to allow for a full re-inspection of the plumbing and cabinetry, ensuring no concealed defects are present.

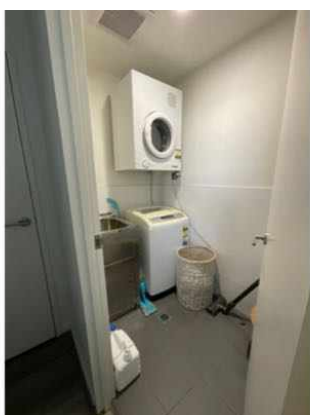
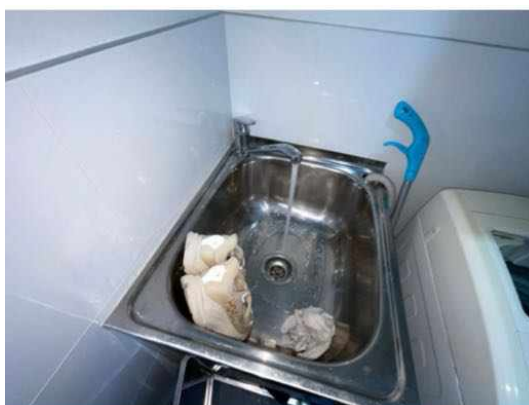
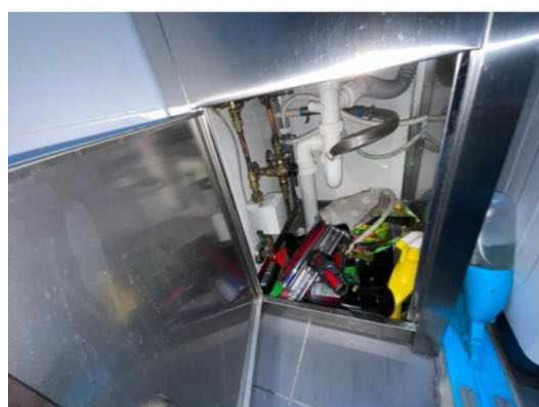
Building: Main Building
 Location: Laundry

- The taps to the laundry tub were water tested and inspected, with no evidence of plumbing or drainage leaks observed at the time of inspection.
- No visible signs of water damage, rust, or corrosion were noted to the cabinetry or surrounding unit during the inspection.

- Further monitoring or testing is recommended once the taps are placed into regular use, to ensure no leaks develop over time and that the drainage system continues to perform adequately.
- Sealant and grouting in wet areas should be maintained as part of the long-term care and upkeep of the property.

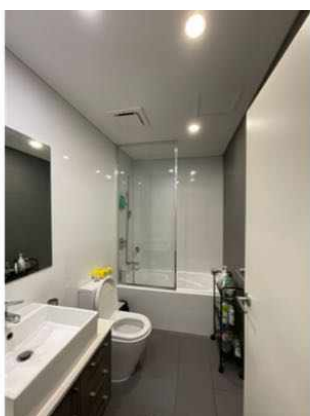
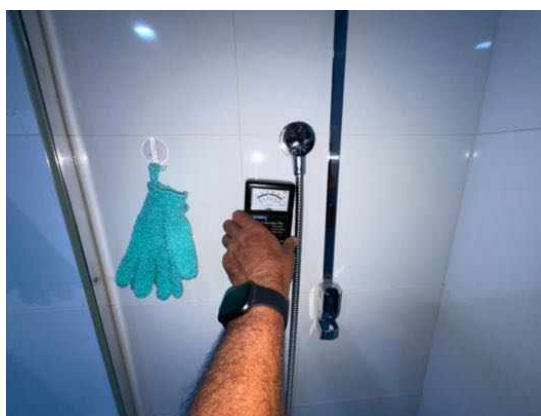
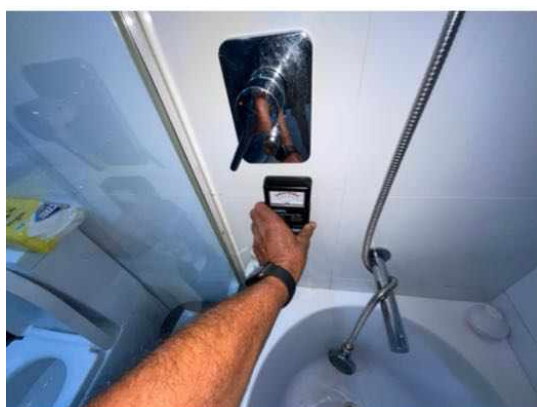
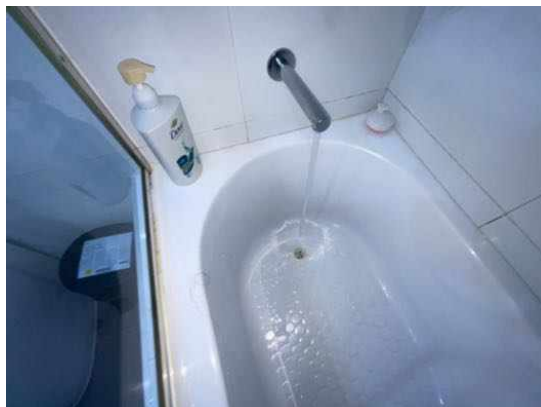
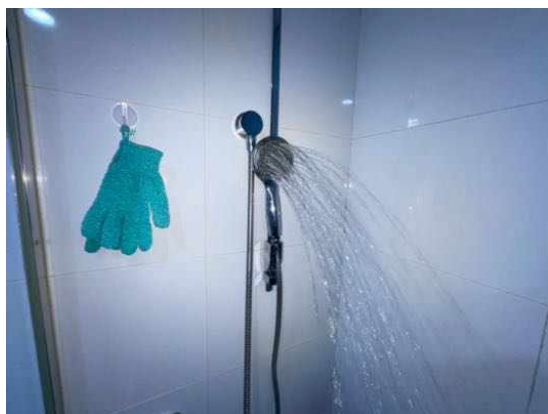
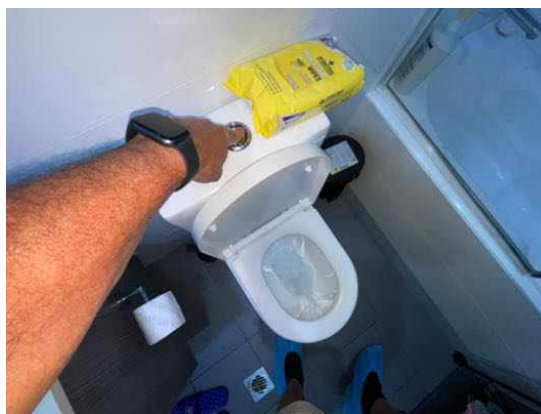
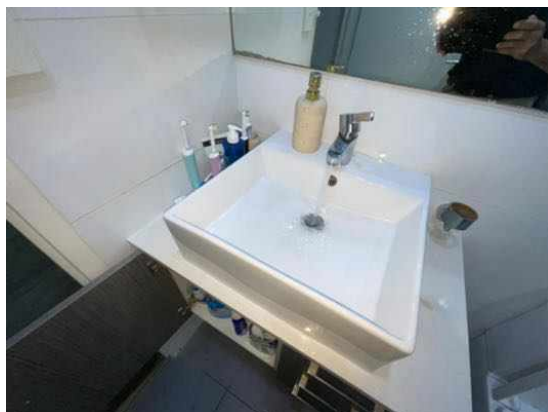
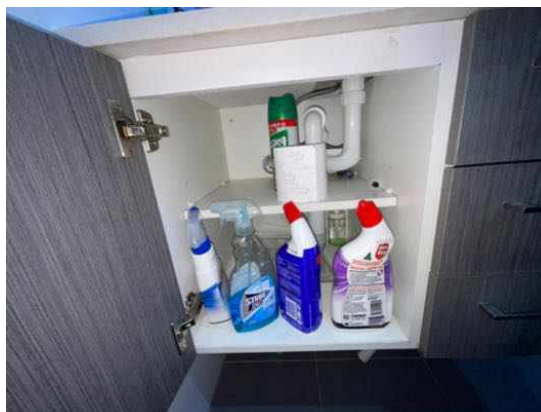
Finding: Wet Areas - Bathroom(s) - Overall Condition & Recommendations.
Information: Overall Condition & Recommendations

- Elevated moisture readings were found adjacent the spout fitting and lower shower walls, mould growth in the grouting suggesting some retained moisture in the shower walls, which is a common occurrence with certain tile types that naturally absorb more moisture. This (as documented in the report) should be further investigated.

- The condition of grout and sealant appeared to be below average, with some areas potentially requiring maintenance or replacement.
- Mould growth was noted in some areas of grout/sealant. Cleaning or, if necessary, replacing affected grout or sealant is recommended to maintain hygiene and waterproofing integrity.

- The exhaust fan appeared to be operational, which supports moisture control in the bathroom.
- The shower screen panel is loose requiring rectification.

- Further monitoring is recommended after the basin(s) are placed under regular use to confirm ongoing performance and cleanliness.
- Water damage was noted to the vanity unit, appearing minor.
- Stored items inside the vanity obstructed full visibility during the inspection. It is advised that the area be re-inspected once all obstructions are removed.

- Sealing of grout and tiles is recommended to prevent moisture buildup and mould growth in damp areas such as showers.
- Moisture readings Further investigation by a qualified plumber or waterproofing specialist is advised to confirm any underlying issues.

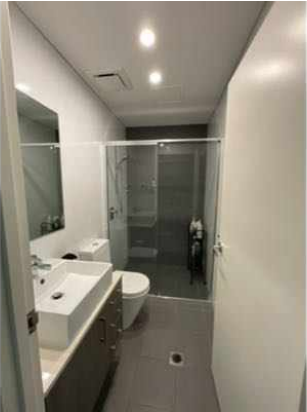
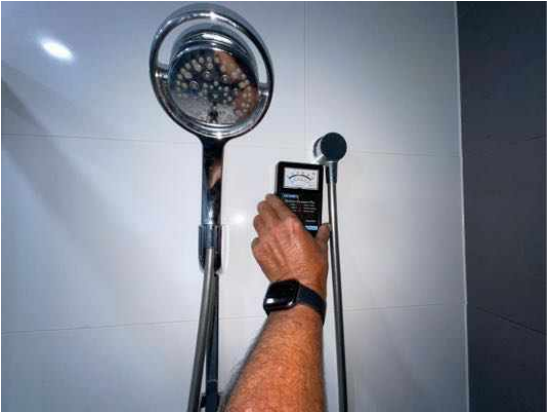
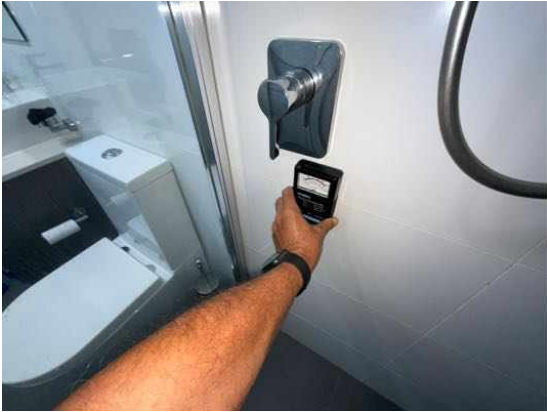
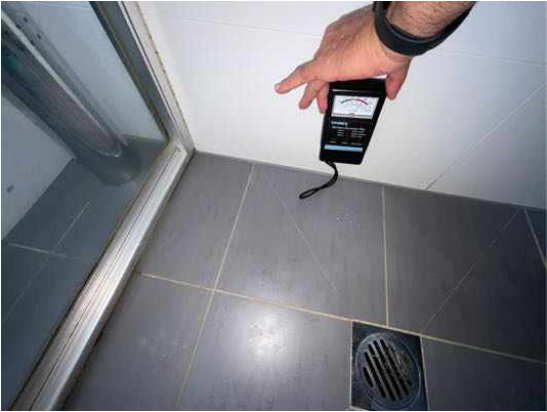
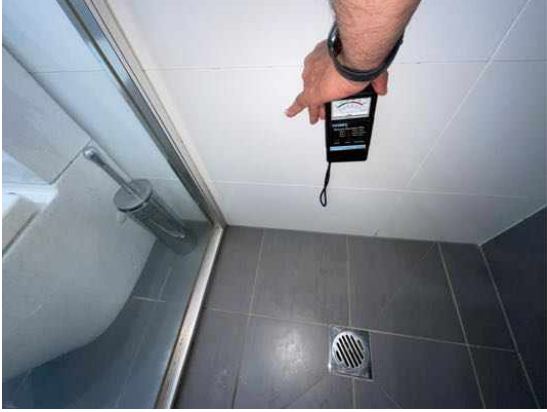
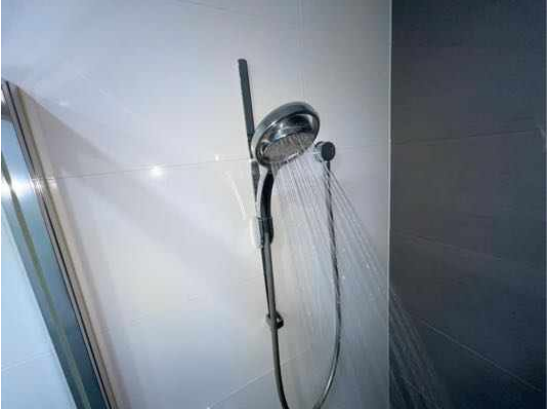
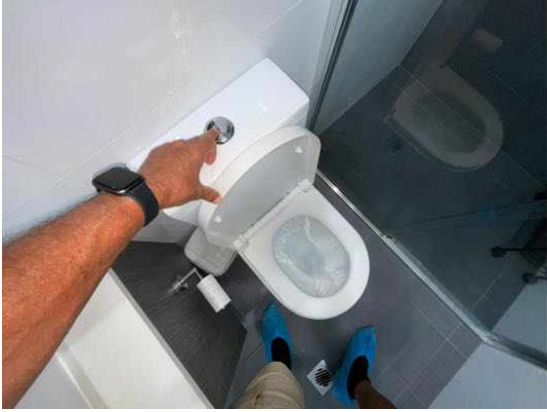
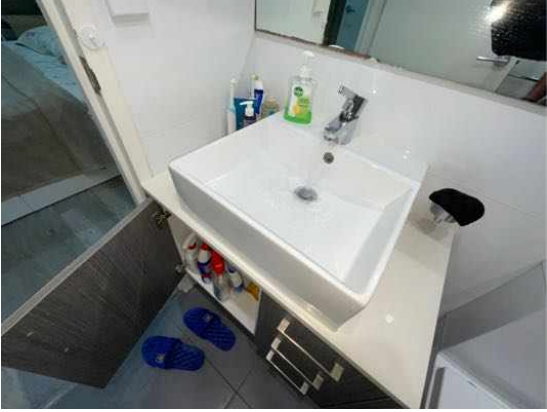
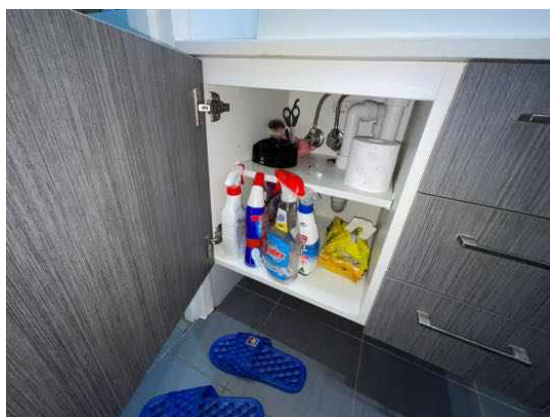
Building: Main Building
 Location: Ensuite
 Finding: Wet Areas - Bathroom(s) - Overall Condition & Recommendations.
 Information: Overall Condition & Recommendations

- Water appeared to flow freely towards the floor waste during testing of the shower taps. However, further monitoring is required after regular use to determine whether water pooling or retention occurs.
- Flood testing of the shower recess is recommended. This may reveal inadequacies in the waterproofing or shower screens, which could lead to water damage in surrounding areas.
- Floor waste was found to be clear and free of blockages at the time of inspection. Further monitoring is advised after consistent use to identify any drainage issues or buildup requiring cleaning.
- No elevated moisture readings were detected around the tap fittings or behind the shower walls (as viewed from adjacent rooms), suggesting no active plumbing leaks at

- Elevated moisture readings were found in the lower shower walls, which is a common occurrence with certain tile types that naturally absorb more moisture. This should be monitored over time.
- Sealing of grout and tiles is recommended to prevent moisture buildup and mould growth in damp areas such as showers.
- The condition of grout and sealant appeared to be serviceable,
- The exhaust fan appeared to be operational, which supports moisture control in the bathroom.
