Building and Timber Pest Inspection Report

Inspection Date: Thu, 9 Apr 2026

Property Address: 20 Royce Cres, Lavington NSW 2641,
Australia

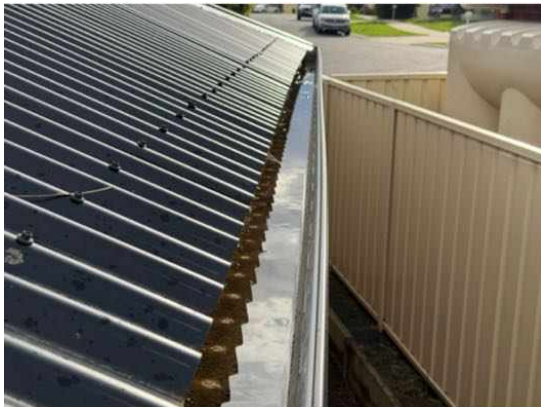
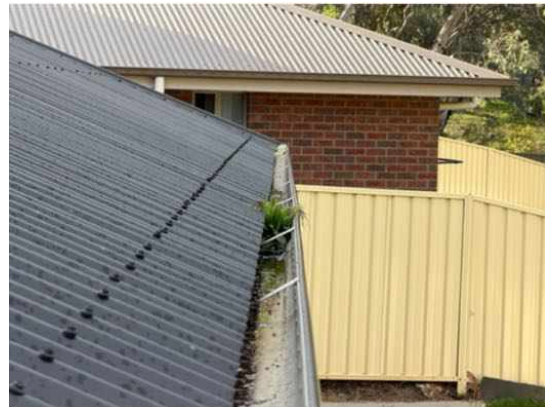
Finding 3.01

Building: Main Building
Location: Guttering
Finding: Gutters - Debris & Water pooling
Information: Some water pooling and debris were noted in sections of the gutters at the time of inspection. Recommend client to remove all debris from the gutters, to ensure proper roof drainage is achieved.

- Old water tank slab found to have moved and separated. Recommend consulting with a concrete specialist to provide further advice.
- Areas of water pooling & debris identified in gutters. Recommend client to remove all debris to ensure adequate roof drainage is achieved.

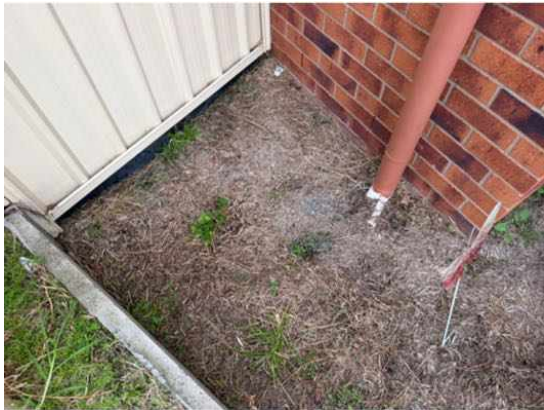
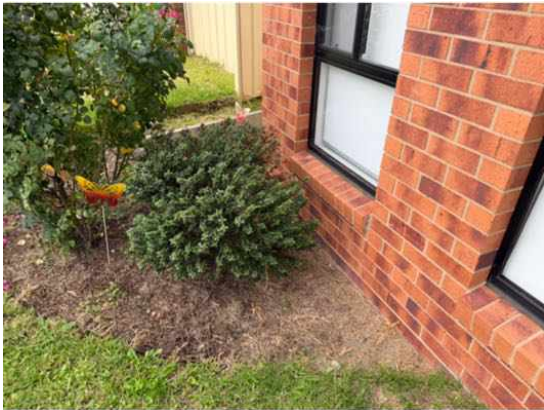
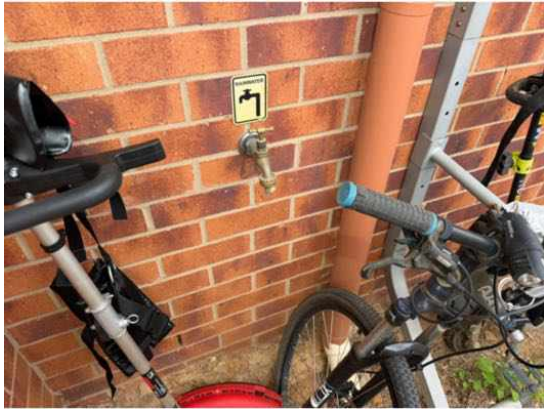
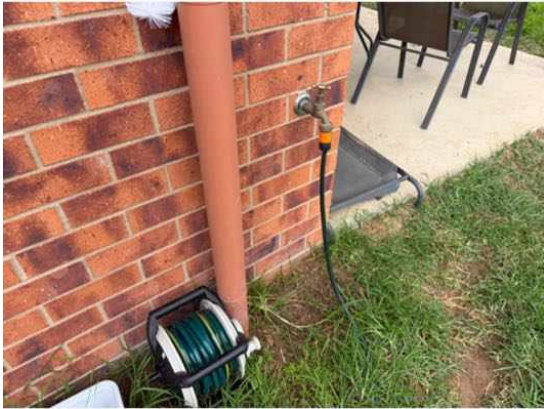
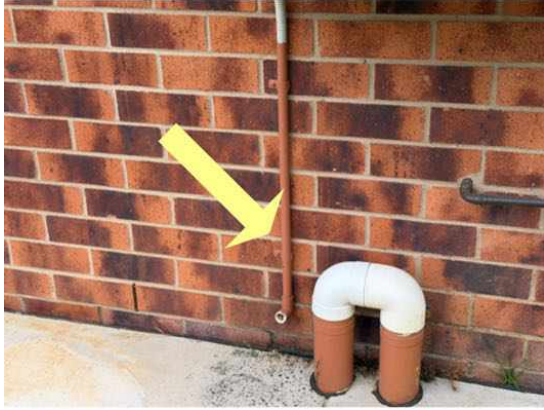
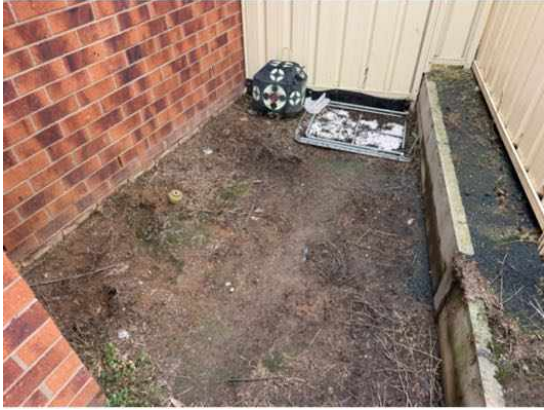
Finding 6.01

Building: Main Building
Location: All external areas
Finding: Potential Water pooling - against property
Information: Potential areas of water pooling & poor site drainage around the perimeter of the property were identified. Where insufficient drainage of taps & aircon overflows, and garden beds against the house are present, water pooling is likely to occur, and can create areas conducive to timber pests.

Recommend consulting with a licensed plumber and/or landscaping contractor to provide further advice.

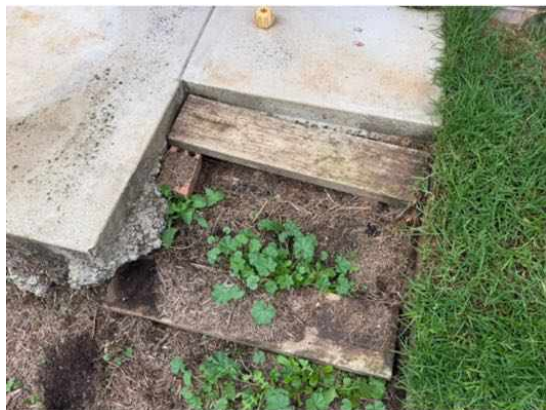
Finding 6.02

Building:	Main Building
Location:	All External Areas
Finding:	Timber in direct ground contact - conducive to termites
Information:	Where timber materials are in direct contact with the ground and consequently moisture, they become conducive to termite activity. The timber palings to the rear of the building create an environment conducive to termite activity. Recommend client to remove the timbers to avoid creating such an environment

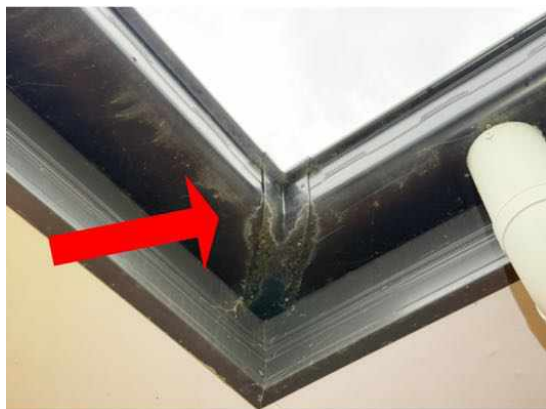
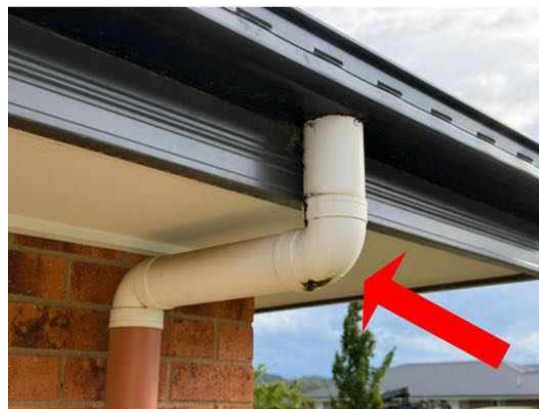
Finding 6.03

Building:	Main Building
Location:	Gutters, Down-pipe
Finding:	Roof Plumbing - Signs of Leaking
Information:	It appears that some areas of the corners of the gutters and front down-pipe showed signs of minor leaking / corrosion. This is a common finding in buildings of a similar age. Such leaking can create an environment conducive to termite activity, if neglected.

Recommend engaging a licensed roof plumber to provide maintenance works where necessary.

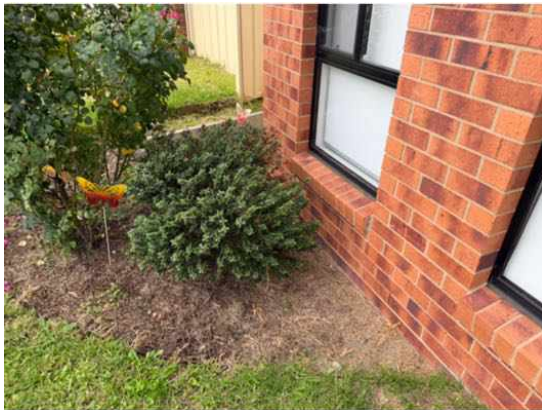
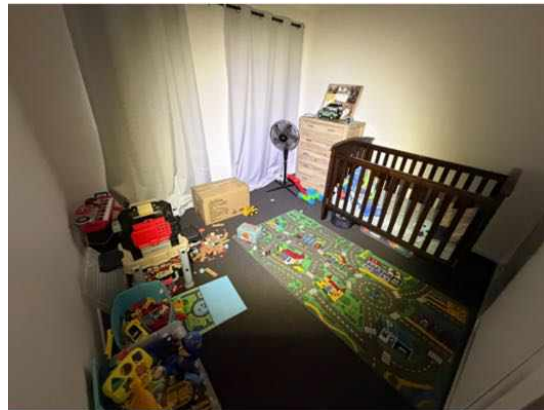
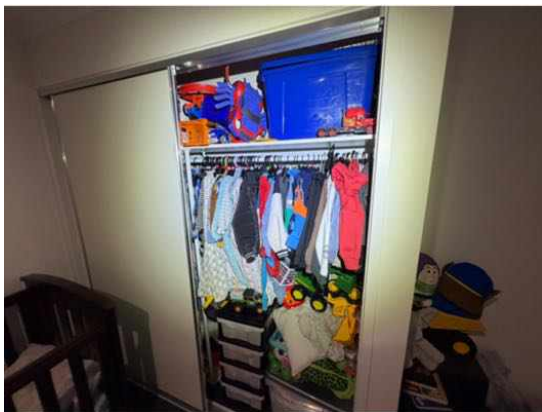
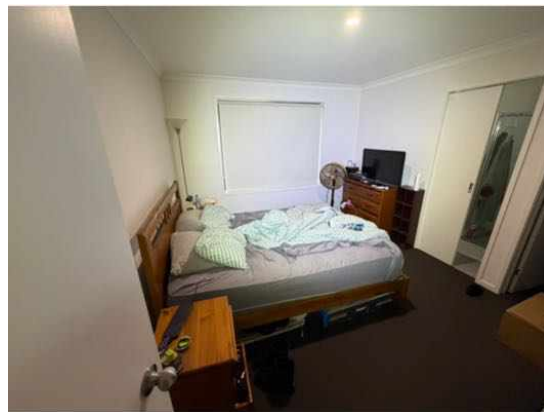
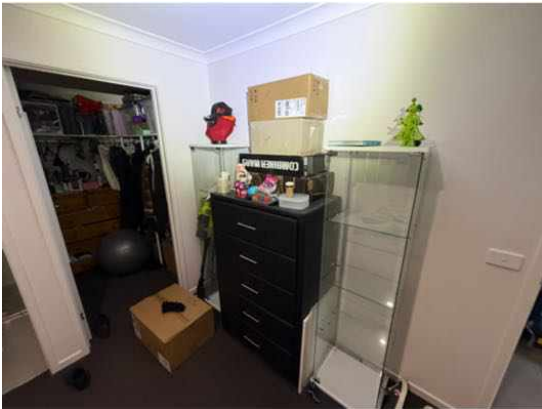
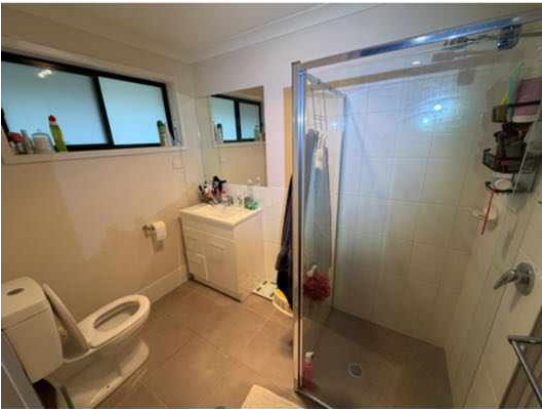
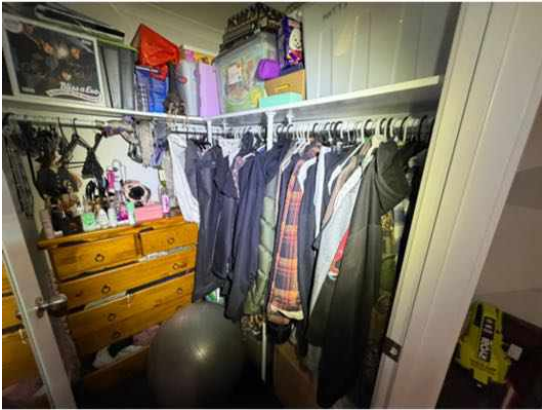
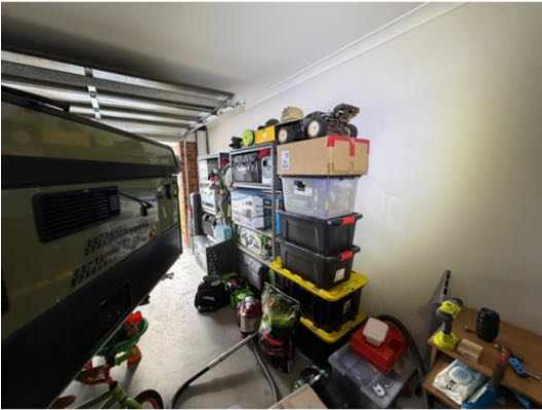
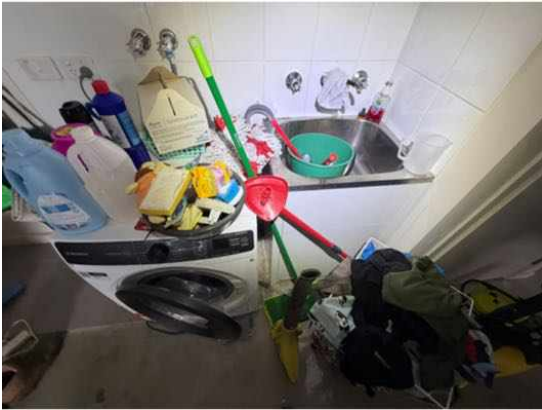
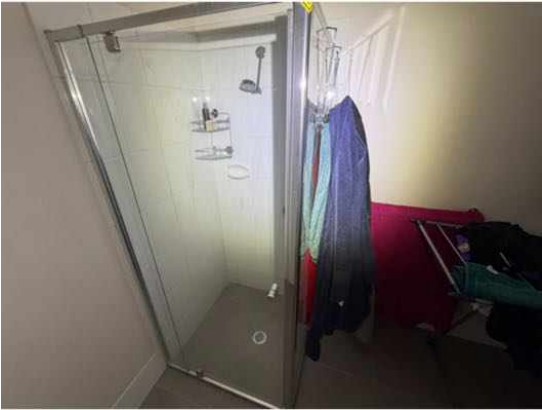
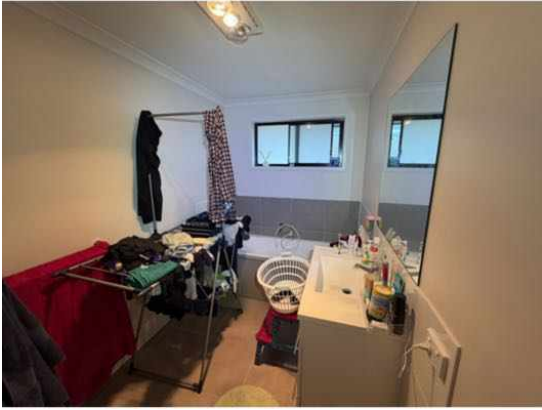
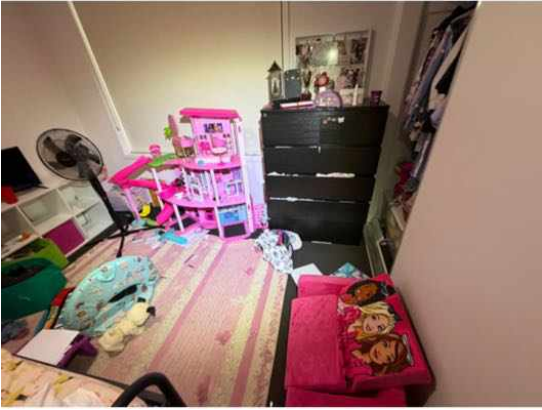
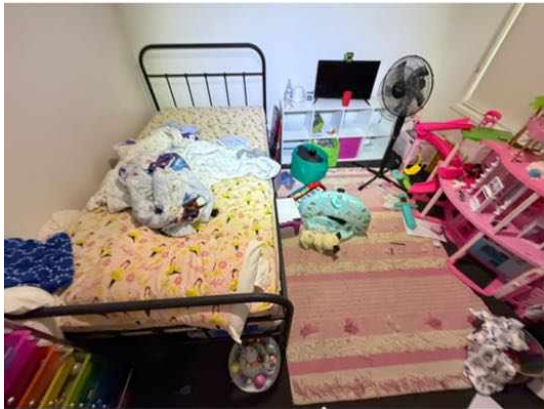
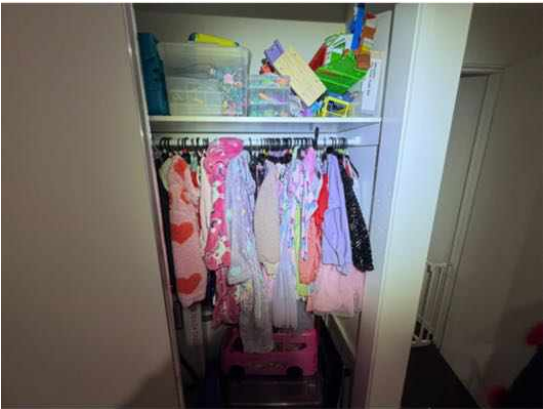
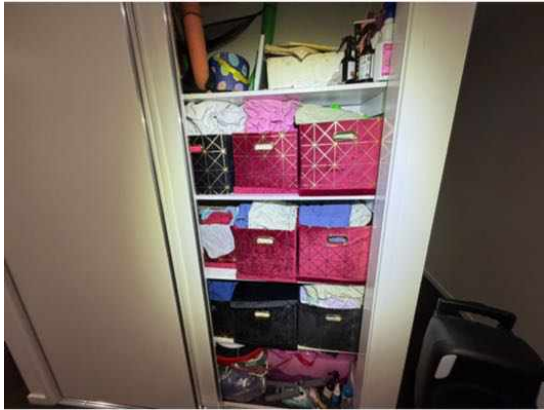
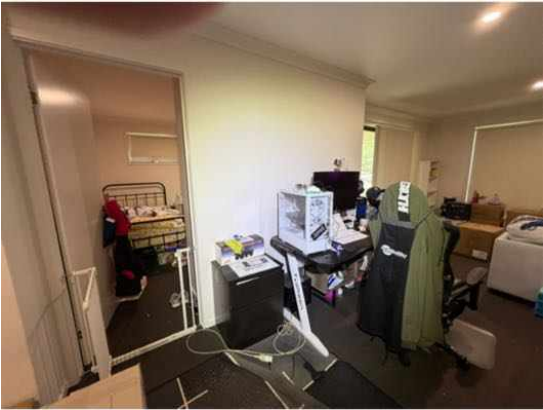
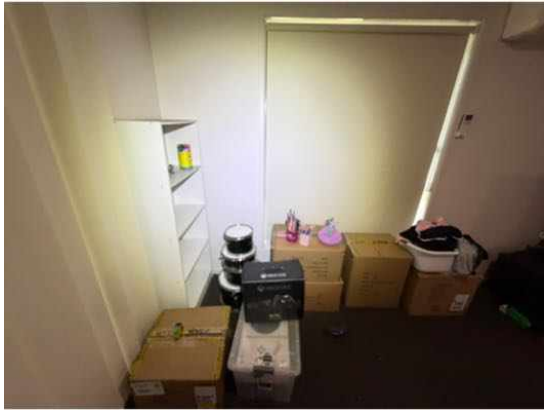
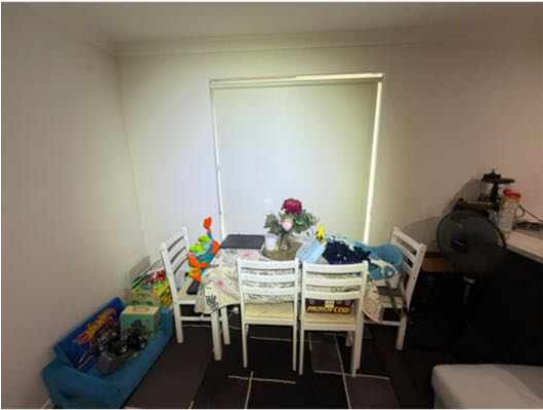
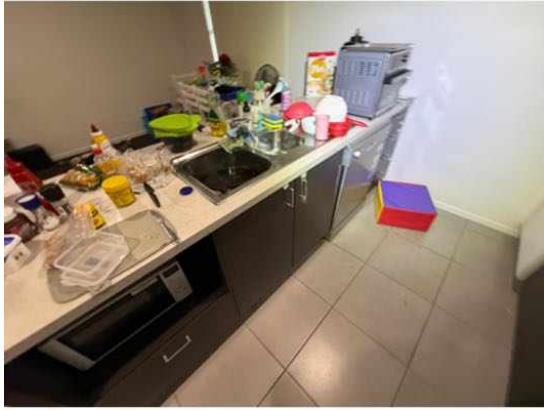
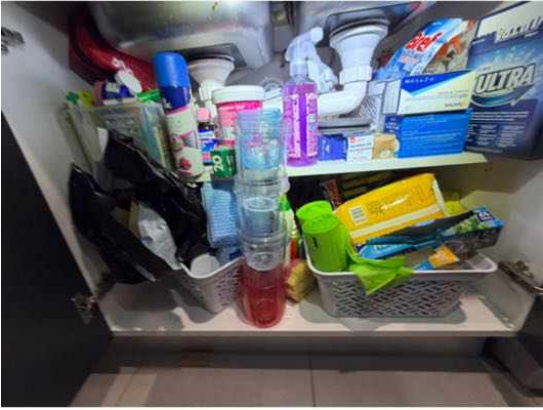
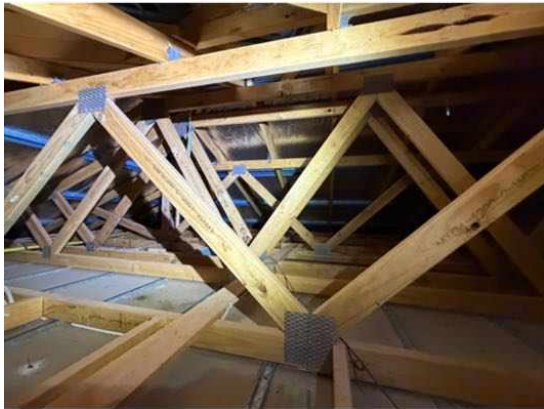
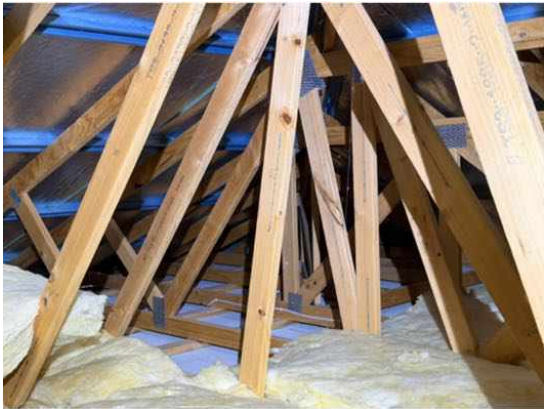
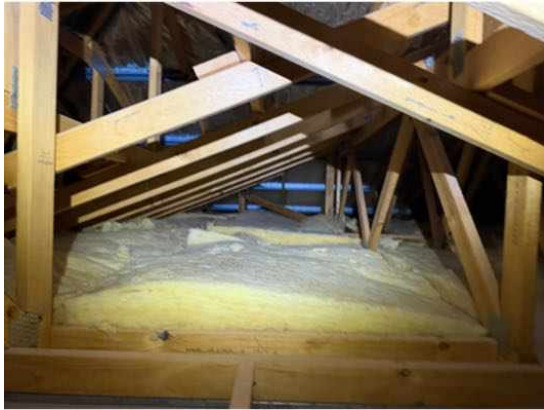
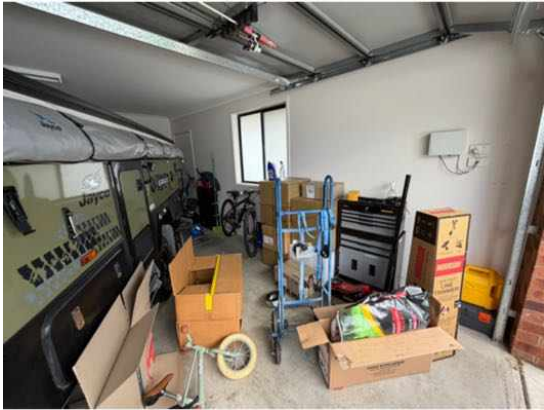
Finding: Additional Photos - Obstructions and Limitations

Information: These photographs are an indication of the obstructions and limitations which impeded full inspection of the property at the time of inspection. These obstructions can hide an array of defects and should be removed to allow full inspection to be carried out. A re-inspection is recommended once the areas are made accessible.

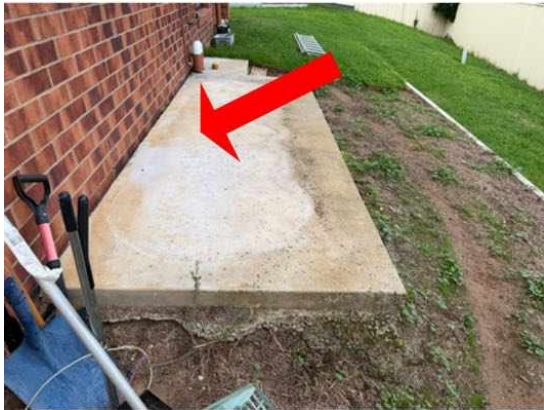
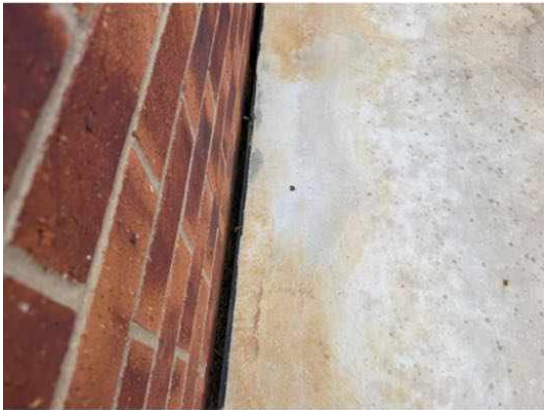
Building: Main Building
 Location: Old Water Tank Slab
 Finding: Old Water Tank Slab - Moved & Separated
 Information: It appears that the old water tank slab to the rear of the building has moved and separated from the building. Despite the slab being unused, the client can consult with a concrete specialist, at their discretion to provide further advice.

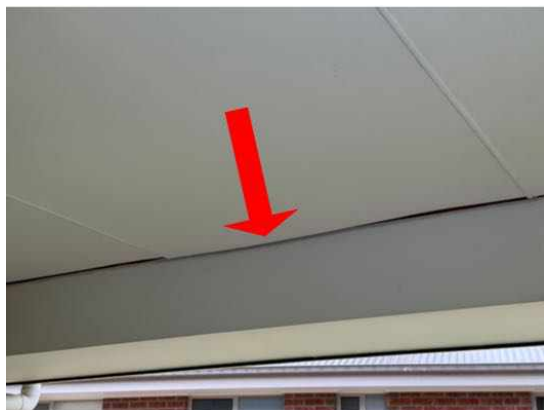
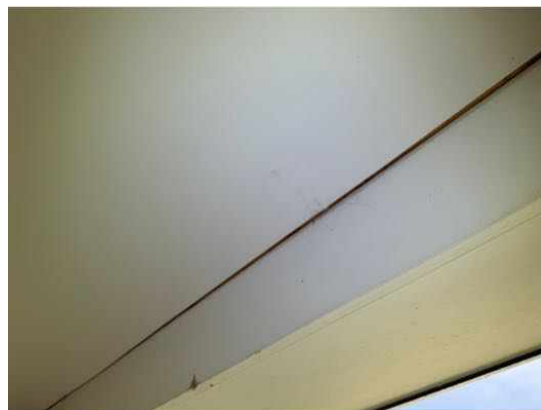
Location: Patio
 Finding: Trim Missing & Ceiling Minor Sag
 Information: It appears that some timber trims to the rear patio ceiling were missing, and some areas of sagging were noted to the patio ceiling sheets. Recommend engaging a licensed carpenter to provide minor maintenance works where necessary, at clients discretion.

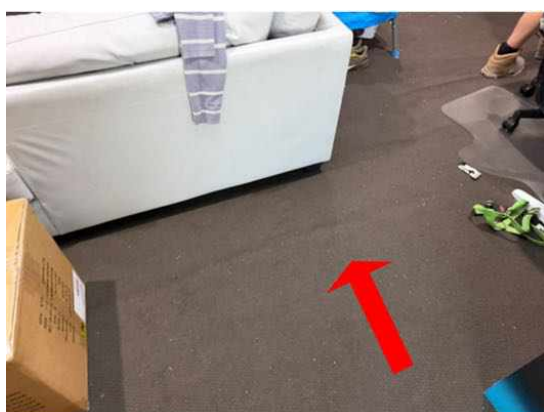
Building: Main Building
 Location: Internal Carpet
 Finding: Carpet - Loose
 Information: It appears that areas of the carpet was loose / weathered at the time of inspection. Although mostly a visual defect, the client can engage a flooring contractor at their discretion to provide remedial works where necessary.

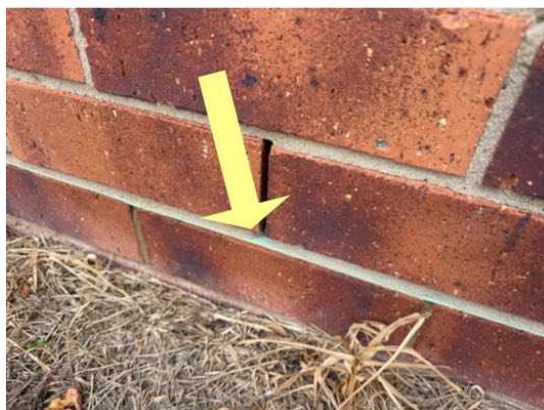
Building: Main Building
Location: Brickwork
Finding: Evidence of a previous termite management system
Information: Although no durable notice was identified in the switchboard, it appears that a physical termite barrier is in place. These barriers prevent concealed termite entry into the building and forces termites out into the open.

Recommend consulting with the pest control company that installed the system to provide further advice regarding the system and future management plan. Regular 12 monthly inspections should be conducted by a qualified termite inspector, to identify any timber-pest activity.
