Building and Timber Pest Inspection Report VR

Inspection Date: Thu, 26 Feb 2026

Property Address: 34 Allen St, Leichhardt NSW 2040, Australia

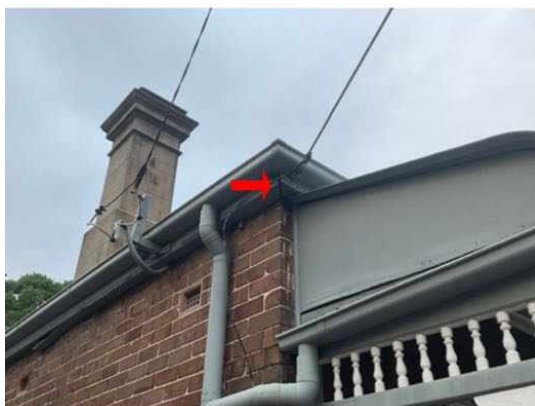
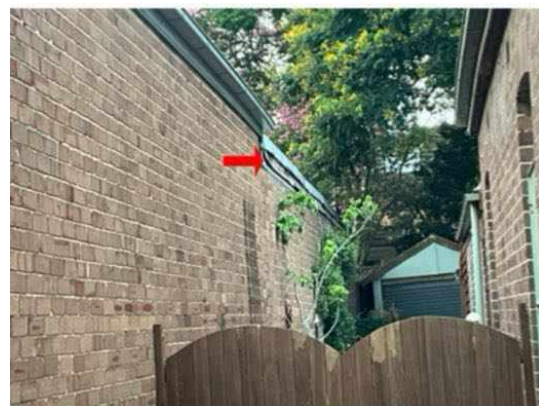
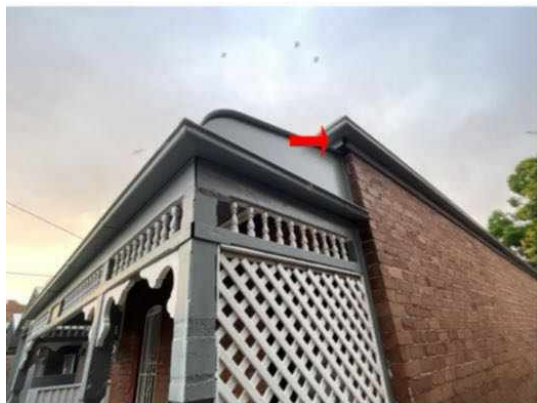
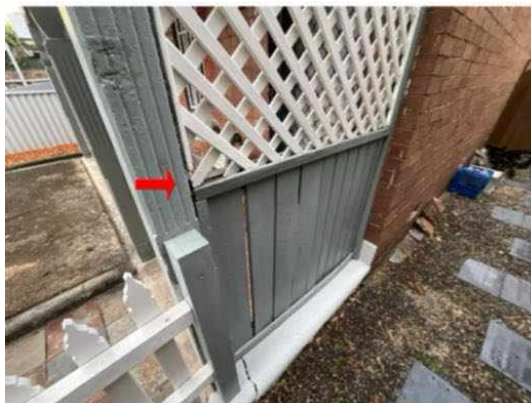
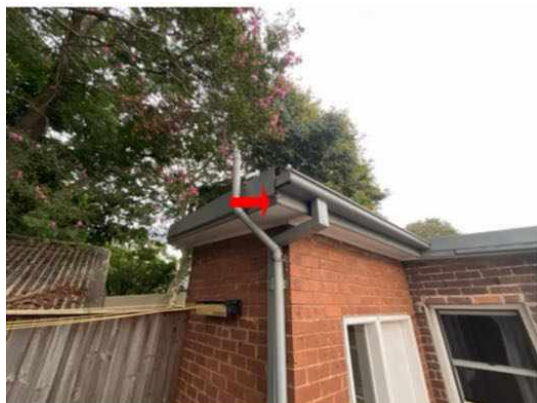
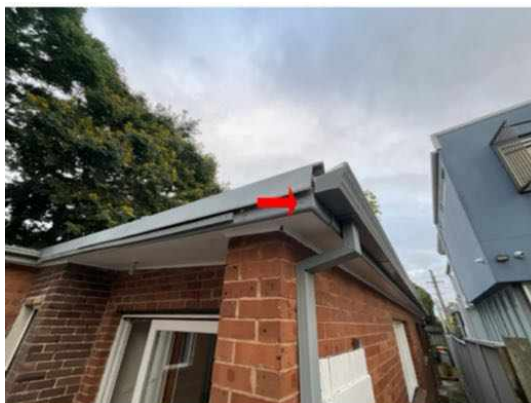
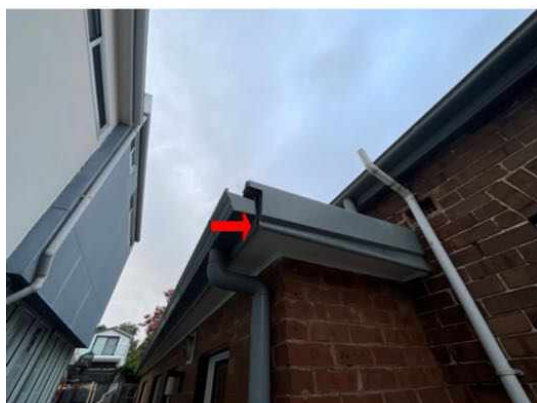
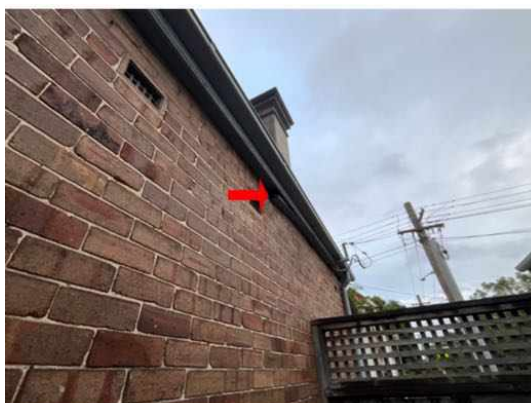
Building:	Main Building
Location:	External Areas
Finding:	Wood rot
Information:	This building element shows evidence of wood rot. Wood rot, also known as Fungal Decay, occurs when timbers and other cellulose building materials are exposed to damp conditions on an ongoing basis. This could be the result of exposure to weathering over a prolonged period of time, or the attraction of excessive moisture from other abutting building materials.

Early intervention and regular maintenance, particularly of exterior timbers, will prolong the useful life of these building elements. Prior to any works being performed, the cause of the moisture that has created the visible wood rot should be identified and addressed in a suitable manner. Replacement of affected timbers may then be a necessary step in protecting surrounding building elements from such deterioration.

A qualified carpenter or registered builder may also be required to replace affected building materials.

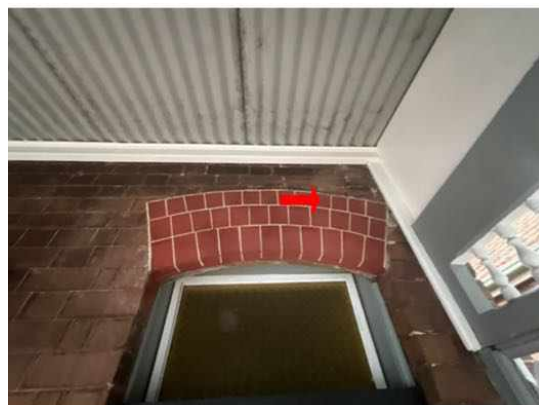
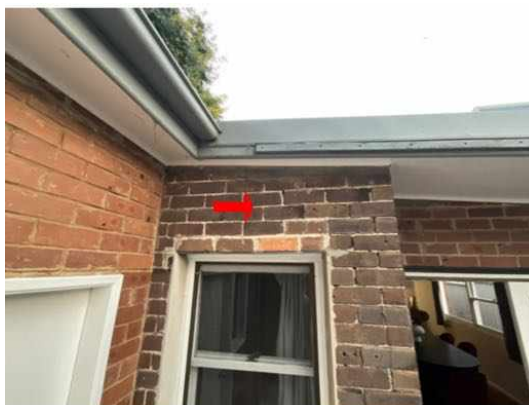
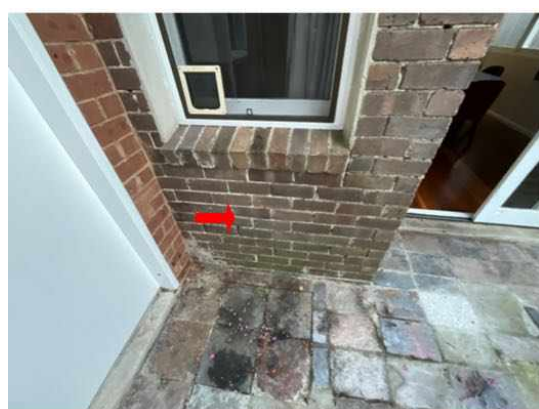
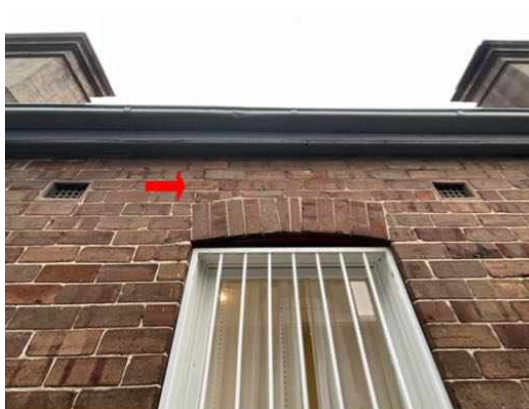
Finding 3.02

Building:	Main Building
Location:	Exterior walls
Finding:	Brickwork - Cracking noticeable
Information:	There were several cracks and or crack repairs evident to external brickwork.

Noticeable cracks are a common occurrence in external brickwork and are a likely result of age expected building movement, general expansion, and/or contraction of building materials in different weather conditions.

It is highly advised that a qualified bricklayer be appointed to provide necessary works to cracked brickwork to prevent any further damage.

Always monitor these cracks and contact a building inspector should cracks widen, lengthen, or become more numerous.

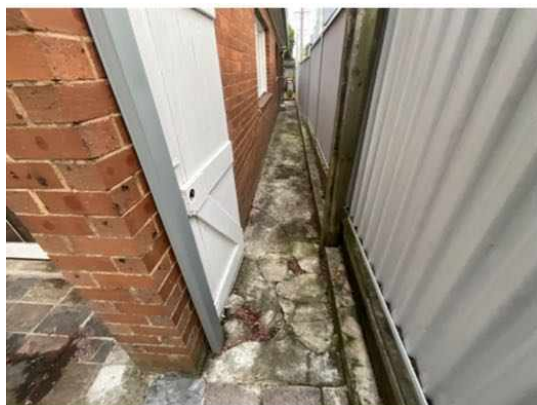
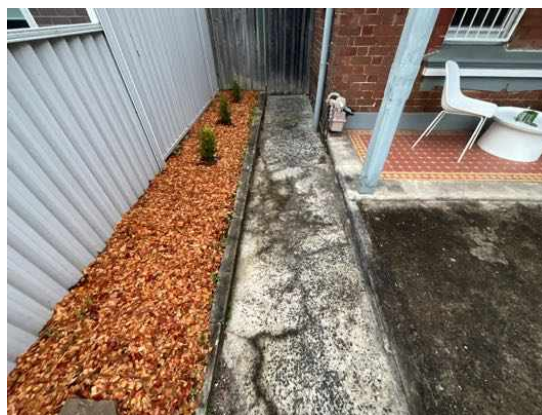
Finding 3.03

Building:	Yard
Location:	Pathway
Finding:	Cracking - External Concrete Paving Damage Category 1 - Fine (less than 2mm)
Information:	Fine cracks were identified in external concrete paving. Although fine cracks are quite noticeable, they are often only considered to be an appearance defect, and usually do not indicate any structural damage. To be considered a Category 1 or fine crack, the crack is found to be less than 2mm in width.

Generally the cause of a hairline crack in existing concrete paving such as driveways and pathways is indicative of the expansion and contraction of the concrete. Such causes are generally due to environmental factors, such as moisture levels, weather conditions, root systems of nearby trees or the soil types on which they are laid.

Fine cracks may also be due to poor original installation of the concrete. Factors such as poor compaction of the sub surface and/or inadequate reinforcing of the slab may create cracking and other secondary defects.

Monitoring of all cracking should be conducted frequently. Always contact a building

inspector should cracks widen, lengthen, or become more numerous.

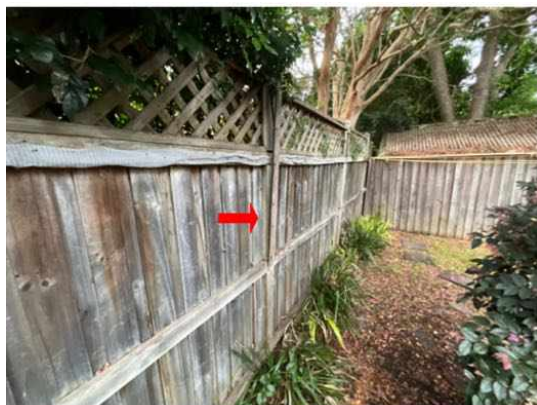
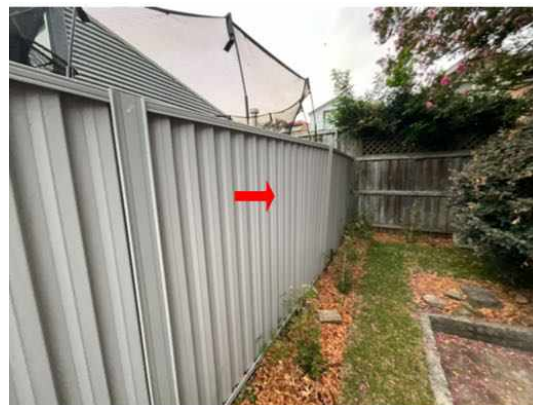
Finding 3.04

Building: Yard
 Location: Fencing
 Finding: Fencing - Leaning
 Information: It was noted at the time of inspection that sections of the fencing in this area are leaning.

A licensed fencing contractor should be appointed to provide further advice and perform rectification works as necessary.

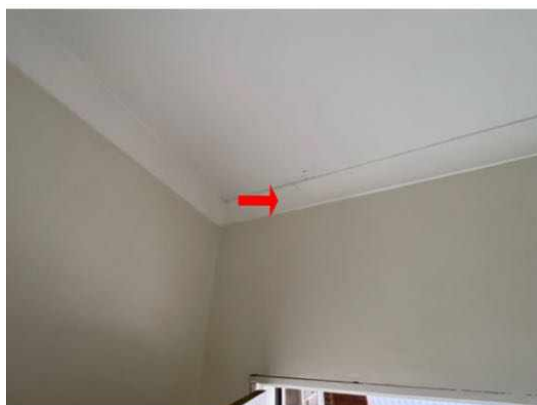
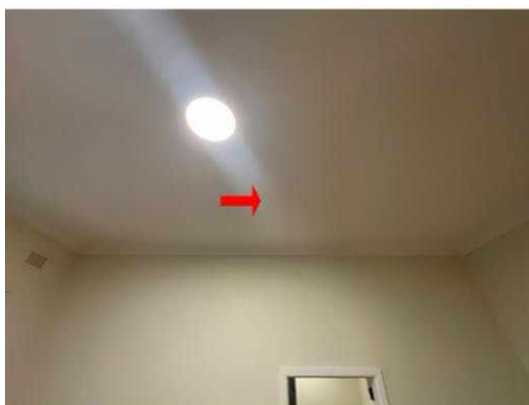
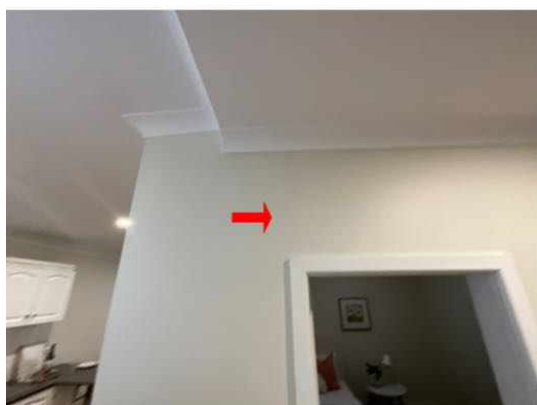
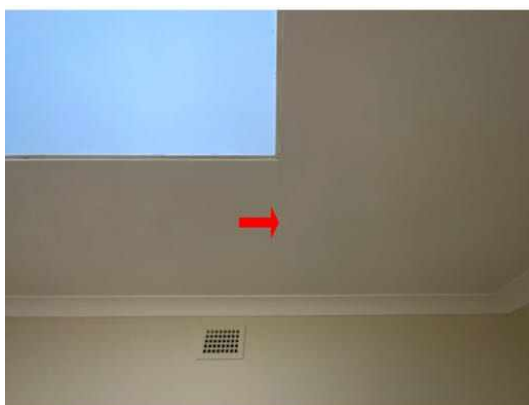
Finding 3.05

Building: Main Building
 Location: Internal Areas
 Finding: Cracking - Damage Category 1 - Fine (up to 1mm)
 Information: Although fine cracks are quite noticeable, they are often only considered to be an appearance defect, and usually do not indicate any structural damage. Generally, the cause of a fine crack is indicative of a separation between building materials and finishes (e.g. paint, plaster, etc.) along joins.

Cracking of this nature can generally be repaired with minor sanding, filling and/or repainting. Such works should be performed by a qualified painter or a general handyman.

Monitoring of all cracking should be conducted frequently. Always contact a building inspector should cracks widen, lengthen, or become more numerous.

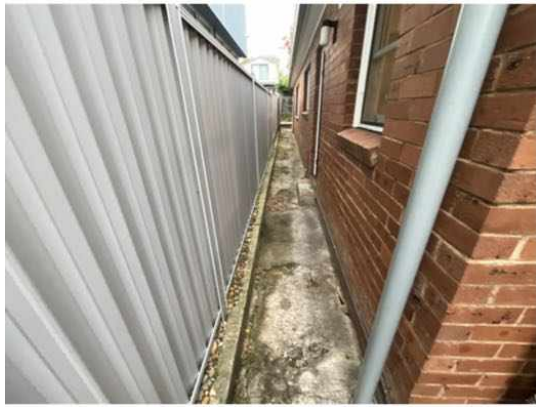
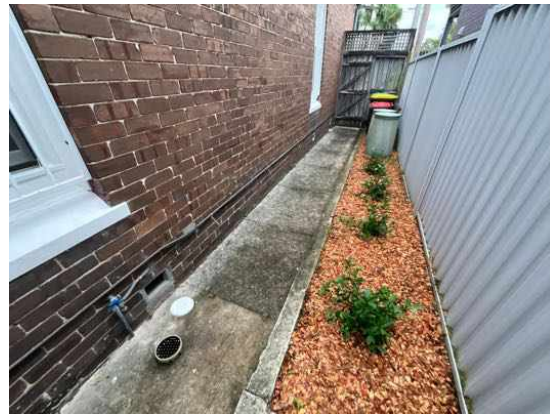
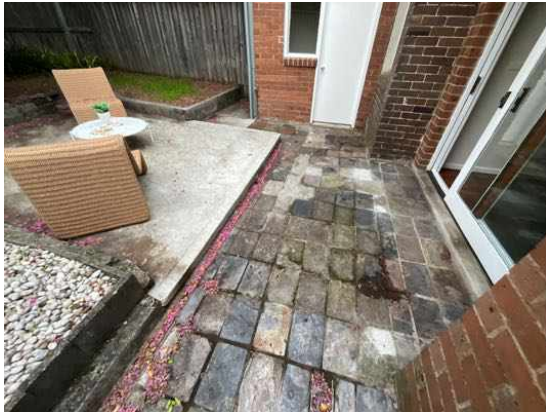
Finding 3.06

Building:	Yard
Location:	The Site
Finding:	Site drainage - Inadequate
Information:	The site drainage in this area was found to be inadequate at the time of inspection, creating potential for subsequent water damage to associated building elements.

It is important that water does not lie against the base of walls; surrounding paths and ground levels should be sloped to drain water away from walls.

Where site drainage is inadequate, installation of drains may be required. A qualified plumber should be appointed to further inspect the property and perform any remedial works as necessary. Water damage and secondary defects are likely to occur if left unmanaged.

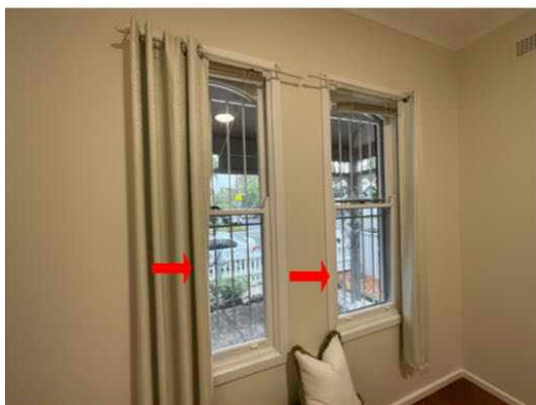
Finding 3.07

Finding: Glass - Cracked

Information: Cracks were identified in the glass in this area. Cracking in glass is generally the result of impact damage, and is likely to develop further when left unmanaged.

A qualified glazier is required to repair the glass.

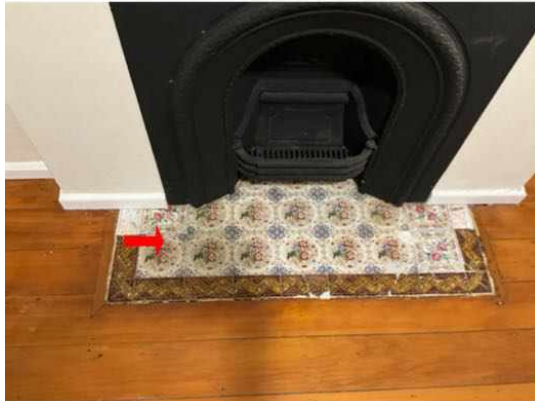
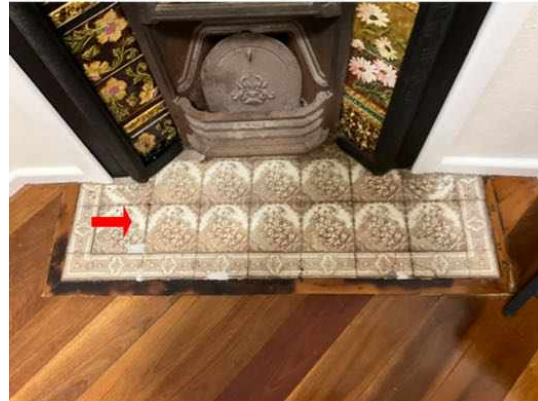
Finding 3.08

Building: Main Building
Location: Bedrooms
Finding: Tile - Cracked or damaged
Information: Cracking was evident to the tiling in this area at the time of inspection.

I recommend appointing a tiling contractor to see what necessary works are required to replace any damaged tiles.

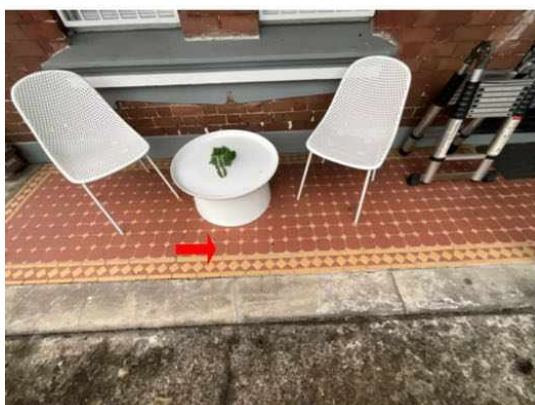
Finding 3.09

Building: Main Building
Location: Front Porch
Finding: Tile - Cracked or damaged
Information: Cracking was evident to the tiling in this area at the time of inspection.

I recommend appointing a tiling contractor to see what necessary works are required to replace any damaged tiles.

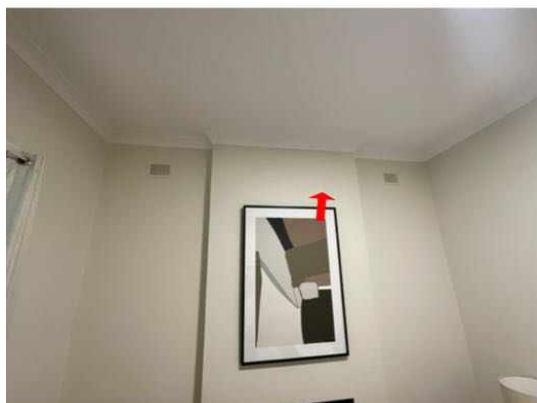
Finding 3.10

Building: Main Building
Location: Bedroom
Finding: Damp - Rain penetration

Common causes include faulty or missing flashing, lack of sealant and lateral damp.

The cause of the water leak should be addressed to prevent further damage. It is recommended that the water leak be resolved prior to any repairs of the damaged area, which may require localised replacement of building materials and refinishing.

I recommend appointing a builder to see what necessary works are required.

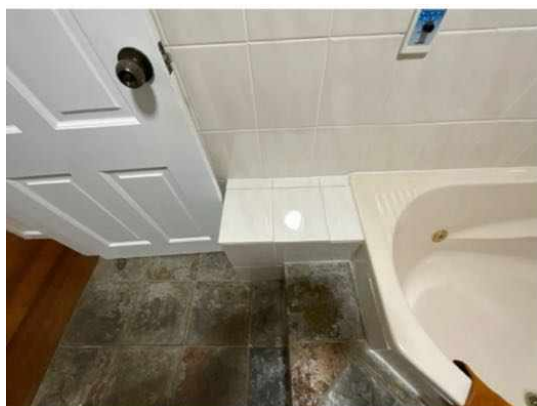
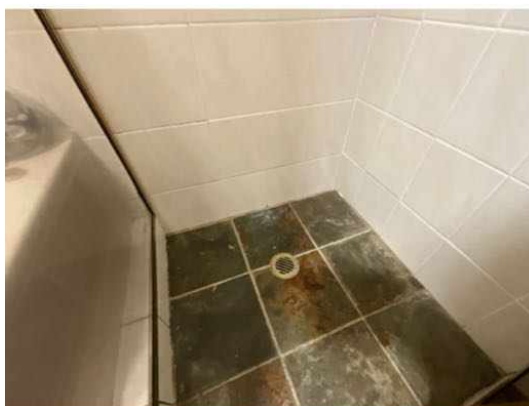
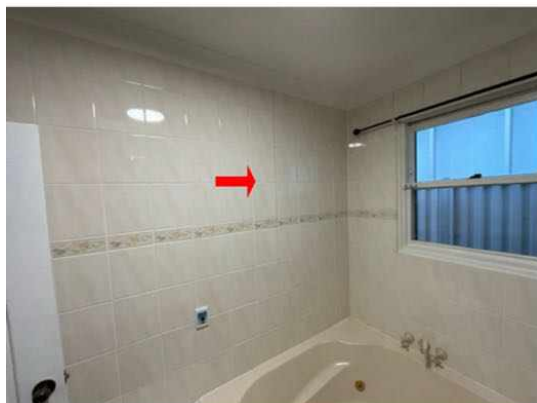
Finding 3.11

Finding: Cracked Bathroom Tiles – Possible Structural Movement

Information: Cracking was observed to tiles within the bathroom. One of the cracks appears consistent with movement in the underlying brickwork.

Tile cracking may compromise waterproofing within the wet area and may indicate structural or substrate movement. Continued movement could result in further cracking or moisture ingress.

A builder should assess the affected area to determine the extent of movement and carry out repairs as required. Damaged tiles and waterproofing should be rectified once the underlying cause has been addressed.

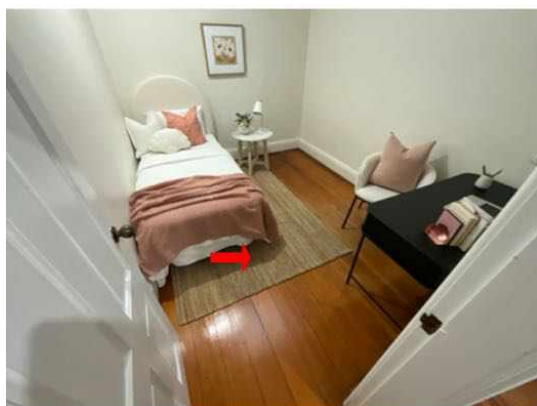
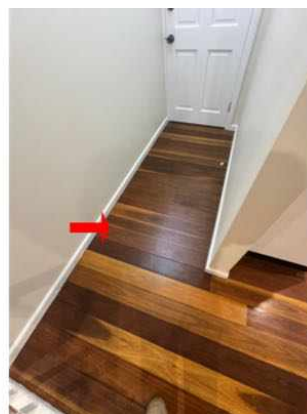
Finding 3.12

Building:	Main Building
Location:	Bedroom 3 & Hallway
Finding:	Floors - bouncy
Information:	The internal flooring in this area was identified as being bouncy at the time of inspection. A bouncy floor surface generally presents as a discernible change in level as they are walked across, in noisy or creaking flooring, or in consequent movement of surrounding furniture and fixtures.

Bouncy floors generally indicate that the floorboards or the subfloor structures are coming loose from the joists that they are installed on. Bouncy flooring may also be the result of gaps between flooring and joist structures, which require packing.

The client is advised to seek quotations for required repairs from a Registered Builder.

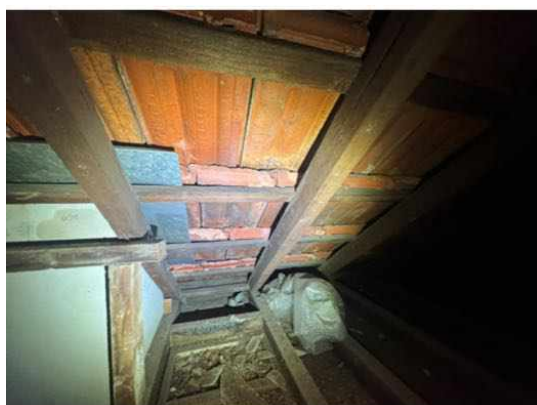
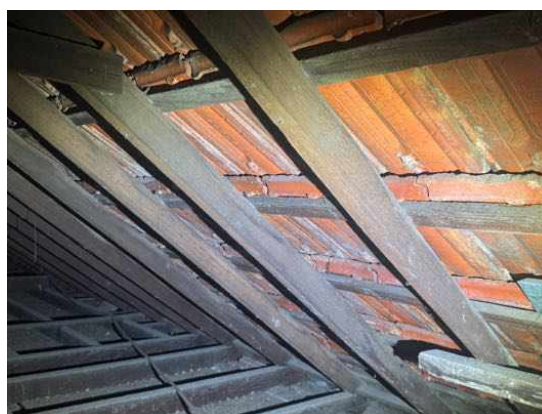
Finding 3.13

Building:	Main Building
Location:	Roof Void
Finding:	Roof Tiles - Weathered
Information:	Upon inspection of the interior roofing, sections of the tiles were beginning to deteriorate. While deteriorating of the tiles is consistent with the age of the property, replacement of the roof tiles may need to be carried out to prevent future defects to the property.

Where left unmanaged, deteriorating roof tiles may lead to a number of secondary defects, including minor water leaks and weather exposure to internal roofing structures.

Further consultation with a roofing contractor is height advised to gain advice of remedial works that may be required.

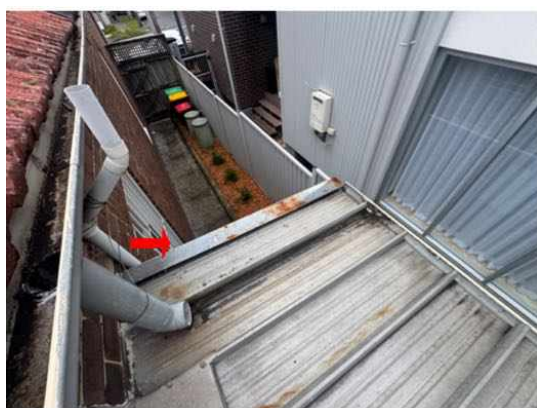
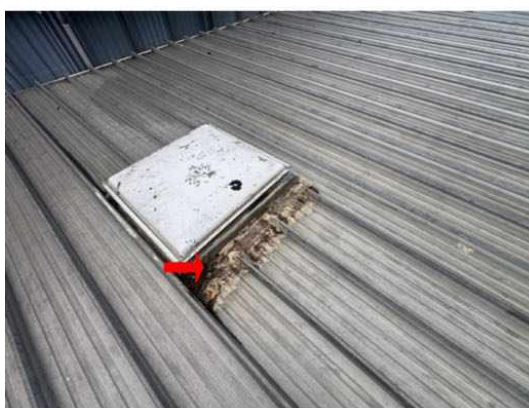
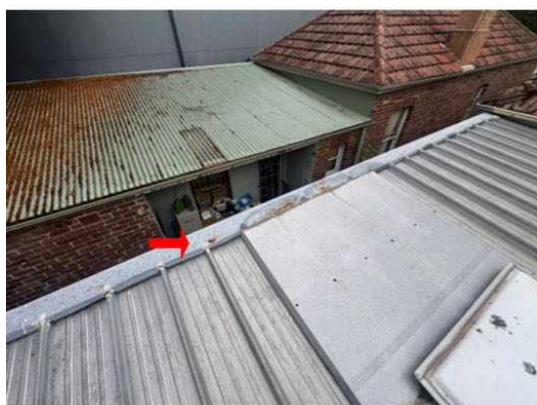
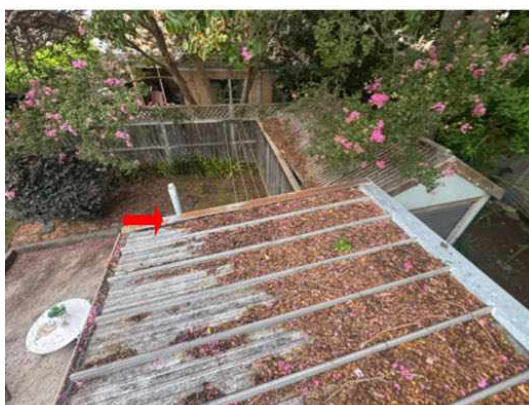
Finding 3.14

Building:	Main Building
Location:	Roof Exterior
Finding:	Roof sheets - Rusted
Information:	Metal roofs generally comprise numerous individual sheets, which join and overlap.

These intersections are particularly prone to lift at the edge and consequently rust at these points.

Upon inspection of the exterior roofing structure, evidence of rust to these sections was identified.

A roofing contractor should be appointed to assess the damage to the roofing sheets and to perform remedial works as necessary.

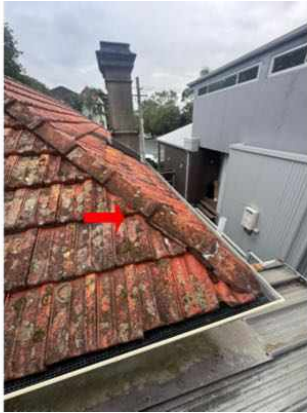
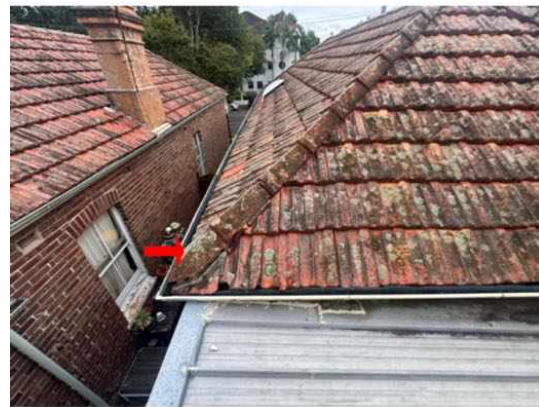
Finding 3.15

Building:	Main Building
Location:	Roof Exterior
Finding:	Mortar - Deterioration
Information:	Mortar, or 'bedding', is the material which fills joins and intersections between tiles and other building elements on the exterior roof covering, such as gable ends, hip capping and valleys. Upon inspection of the exterior roof, it was noted that sections of the mortar show varying levels of deterioration.

Mortar generally deteriorates as a result of frequent exposure to weather conditions over a prolonged period of time. Mortar that is deteriorating may allow water ingress into the roof void, putting associated building elements and roofing structures at risk of water damage. Deteriorated mortar also detracts from the functionality of roof tiles and other roofing elements, potentially decreasing weather tightness and roof drainage.

Mortar deterioration can be attended to by a handyperson where areas of deterioration are localised and easily accessible. Otherwise, consultation with a roofing contractor is advised where greater works are required.

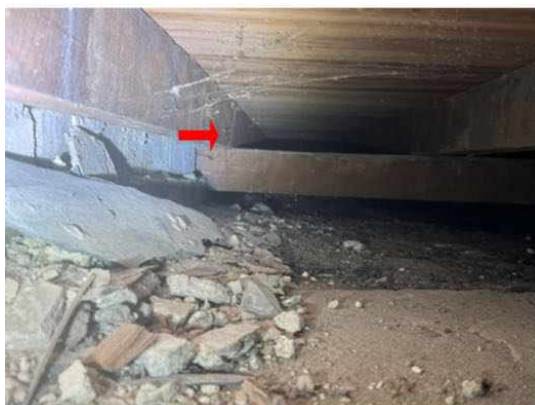
Building:	Main Building
Location:	Subfloor
Finding:	Termite - damage identified
Information:	Despite no live termite or timbered pest activity being indicated, termite damage was found to have affected this area.

A building contractor should be appointed to provide a further invasive inspection and to see what necessary works are required.

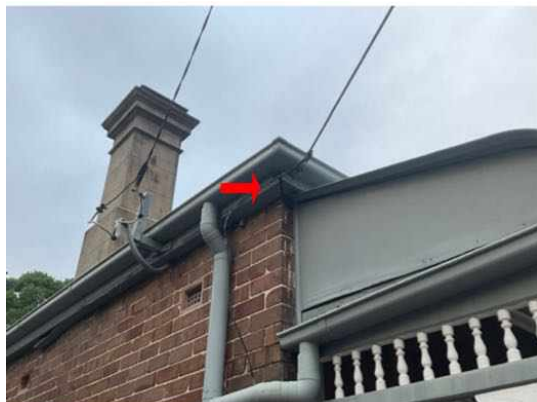
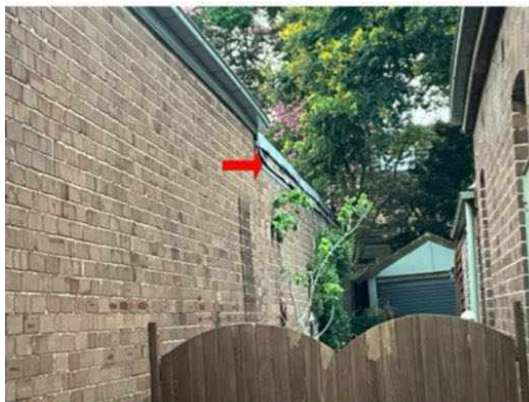
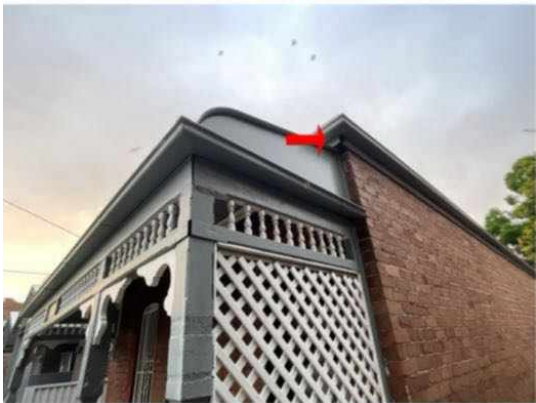
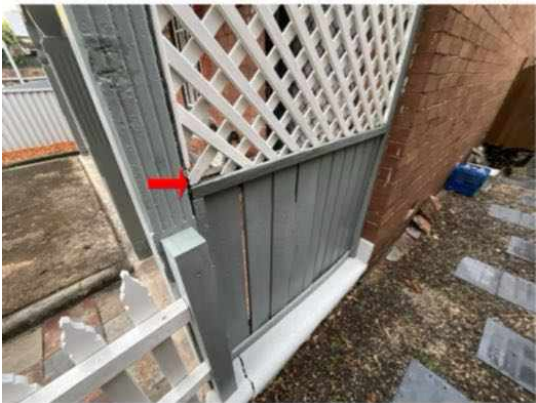
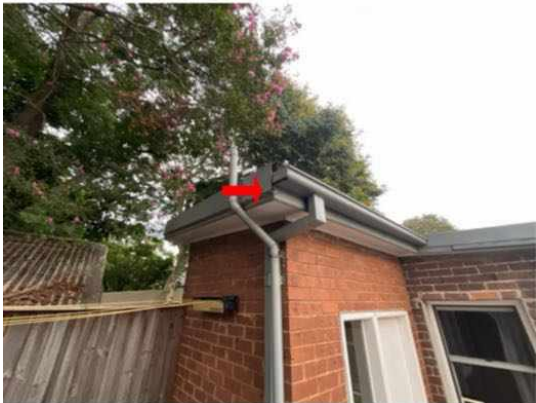
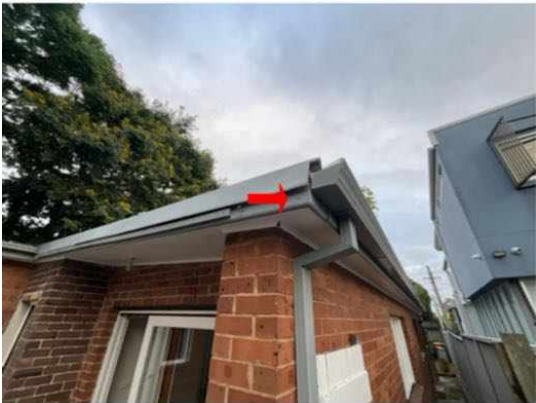
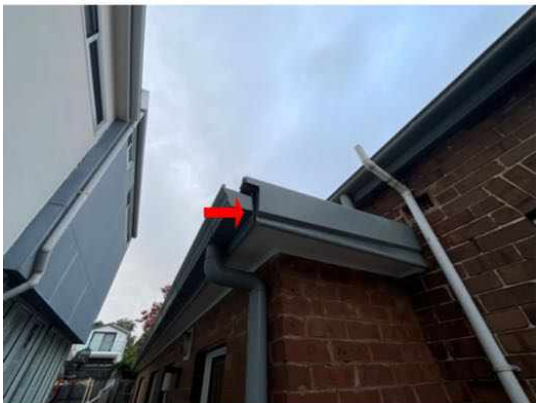
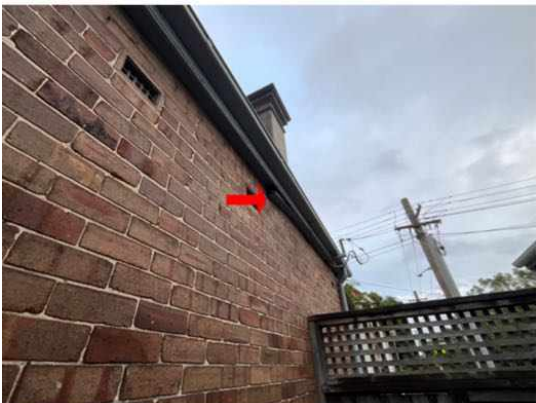
Building:	Main Building
Location:	External Areas
Finding:	Fungal decay - present (localised)
Information:	Fungal decay also known as wood decay or wood rot generally refers to the deterioration of timber elements when in contact with excessive levels of moisture for a prolonged period of time.

The development of fungal decay is accelerated by temperatures in the range of 5degreeC to 40degreeC as well as the presence of oxygen. Generally fungal decay develops on timber elements that are in use in an external environment which are exposed to rain penetration.

In this case although the affected timber element is in a decaying state the extent of any visible damage appears to be localised to a specific area and is yet to spread to other parts of the building element or affect adjoining structures. The fungal decay is therefore likely to be of a relatively superficial nature with minimal impact on the structural integrity or tensile strength of the timber element.

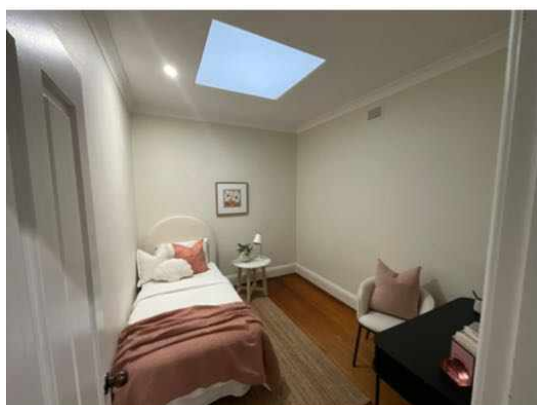
Building: Main Building
 Location: Bedroom 3
 Finding: Bedroom Without Window

Lack of a window may affect natural light, ventilation, and compliance with building code requirements for habitable rooms.

Further assessment is recommended to determine compliance with relevant building standards. Installation of a compliant window or approved alternative ventilation and light source may be required.

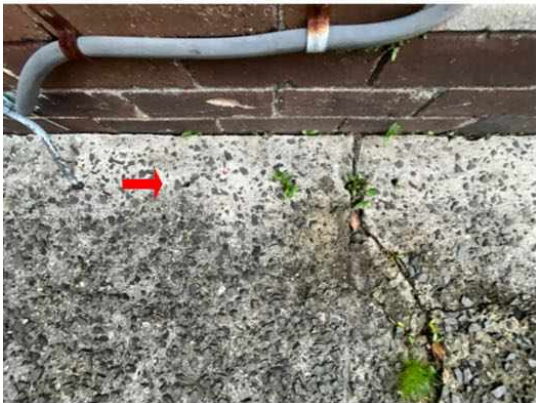
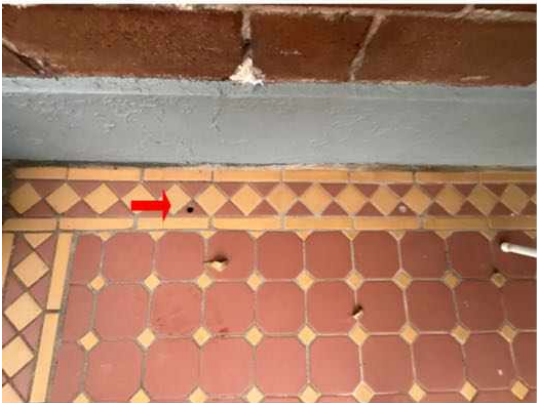
Where a Termite Management System has been identified you should refer to the type of barrier date of installation warranty conditions and any documentation provided by a builder or past owner. Consult the company who installed the barrier to confirm whether the system is still under warranty.

Most chemical termite management systems expire and require replenishment and all physical systems are primarily designed to prevent concealed entry.
