# Building and Timber Pest Inspection Report

Inspection Date: Tue, 27 Jan 2026

Property Address: 6 Flame Tree Ct, Palmwoods QLD 4555,  
Australia

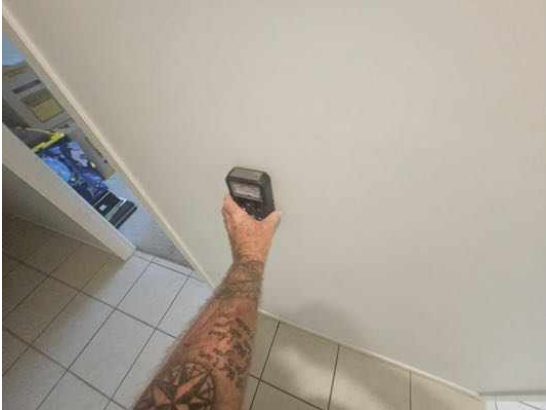
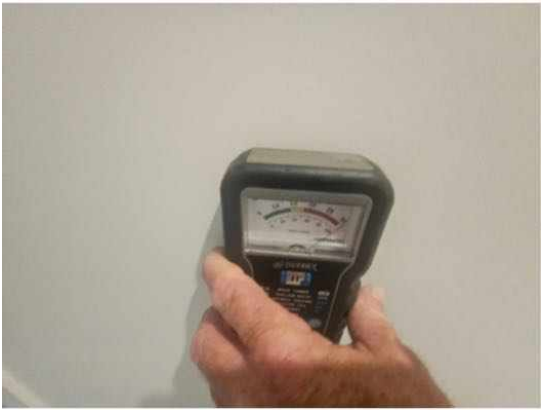
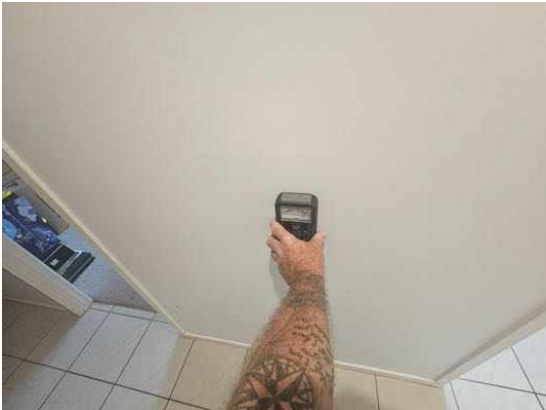
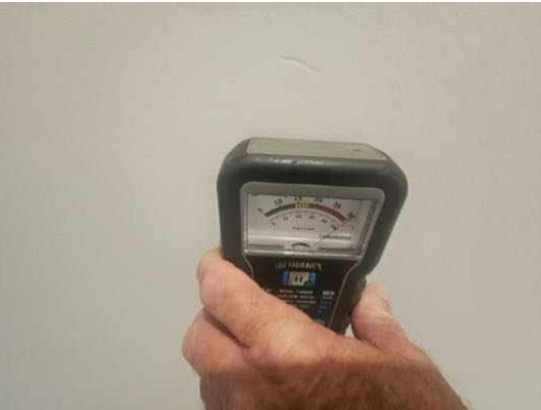
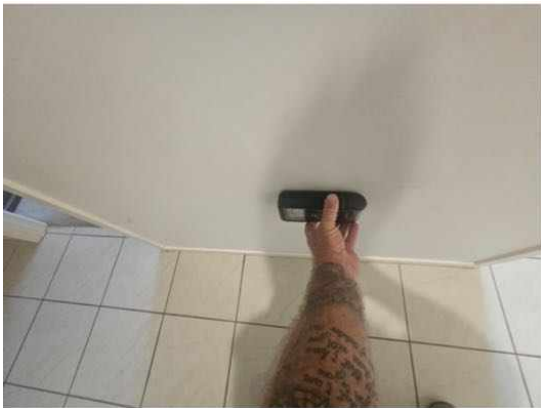
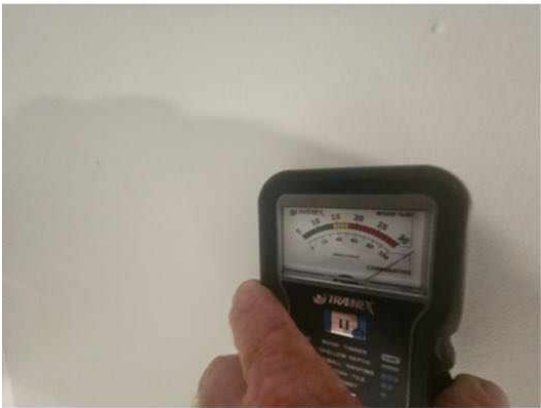
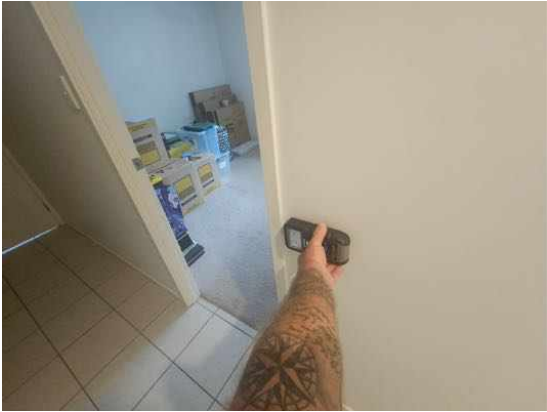
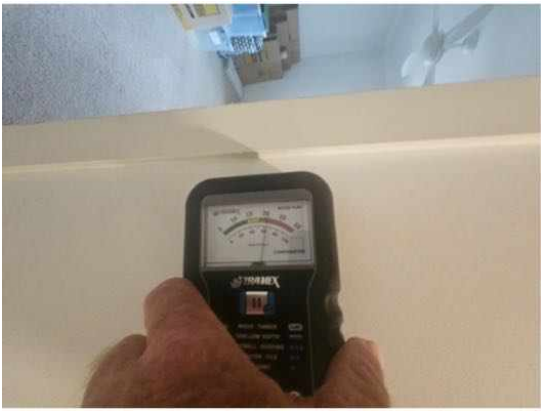
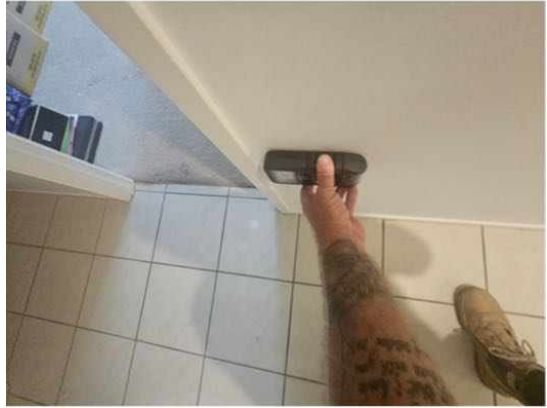
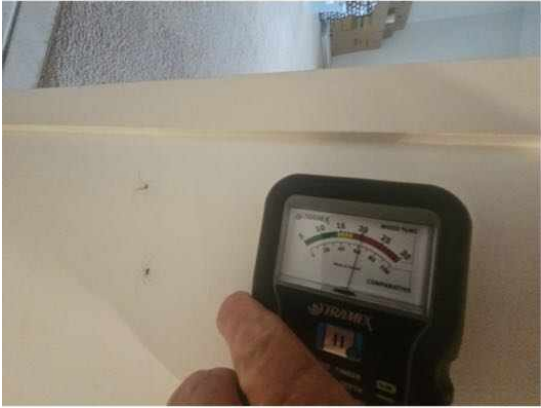
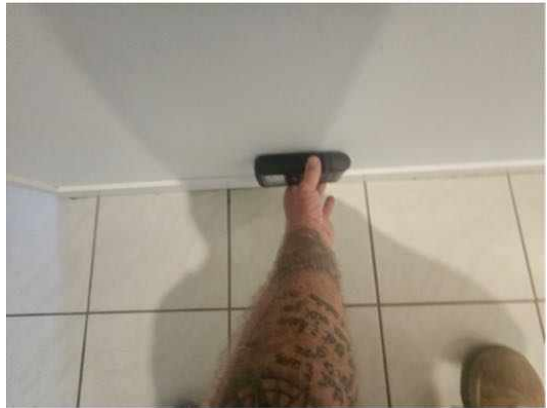
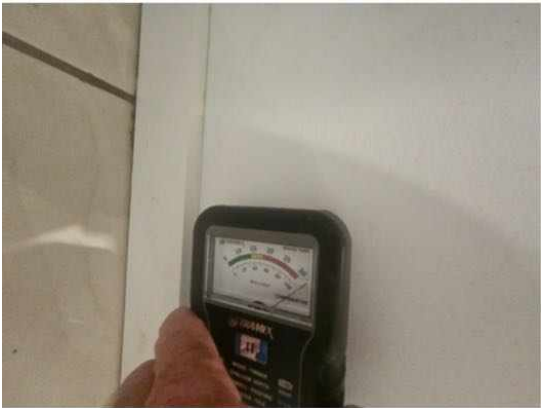
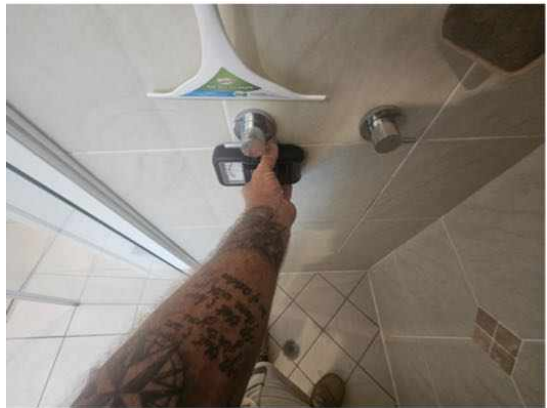
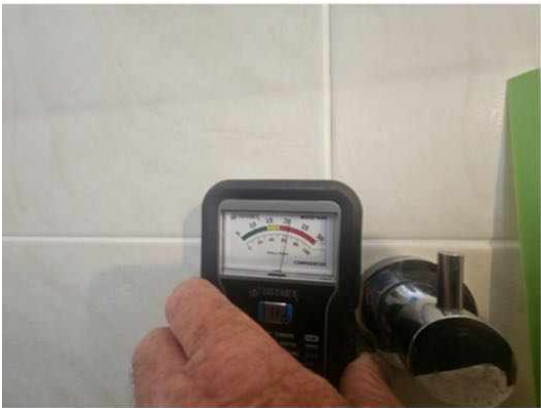
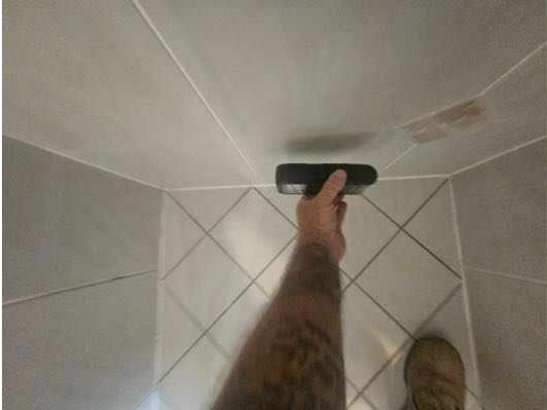
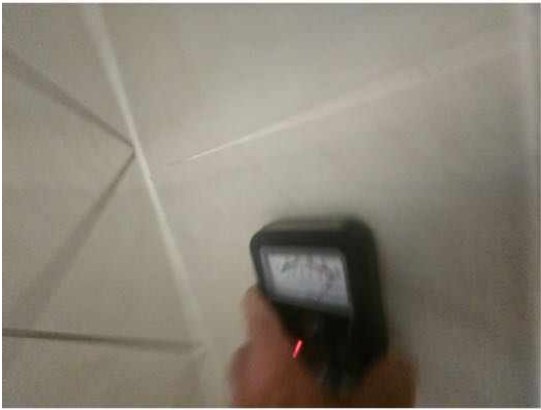
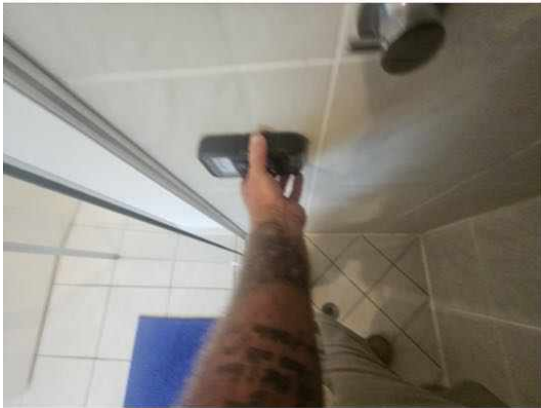
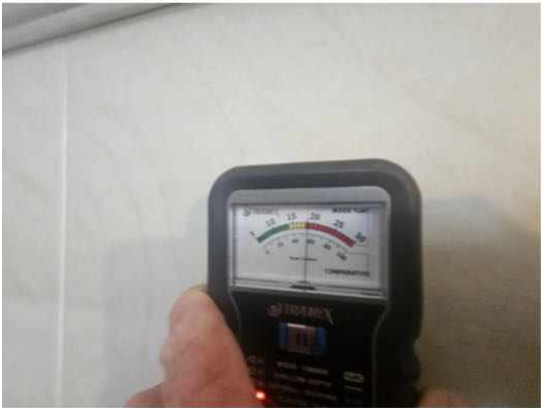
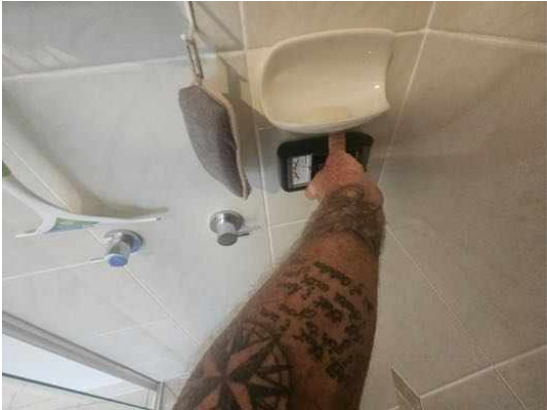
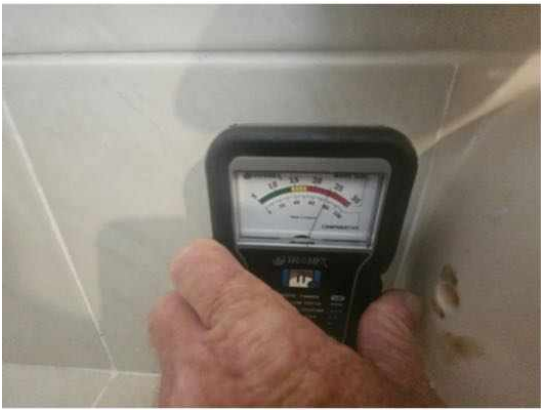
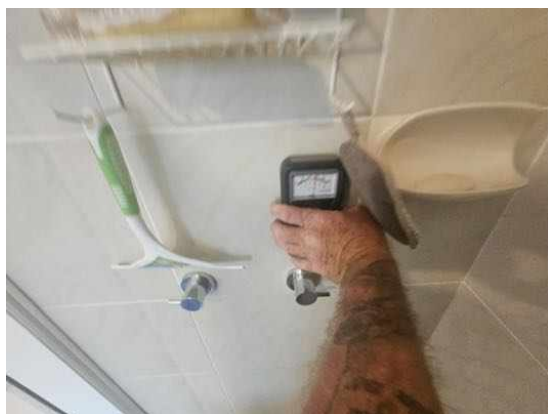
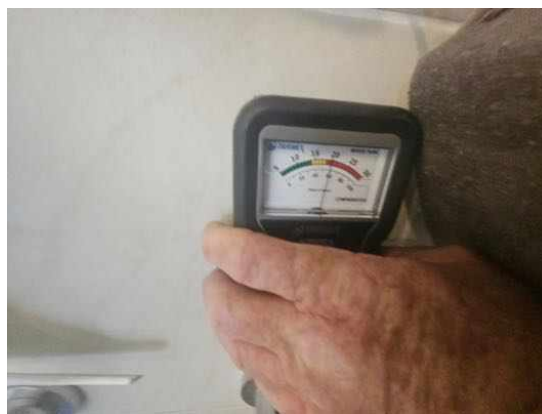
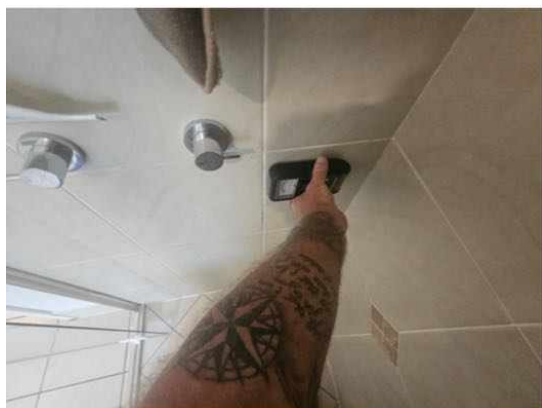
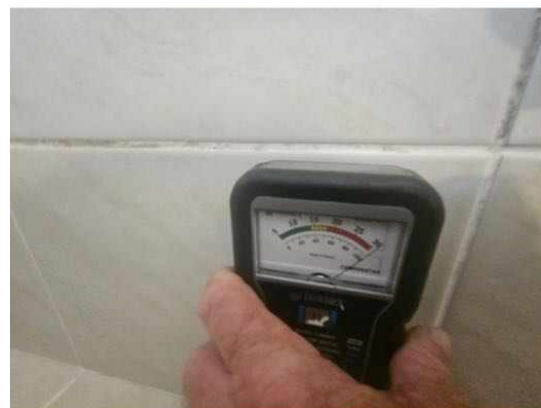
#### Finding 2.01

Building: Main Building  
 Location: Bathroom  
 Finding: Elevated moisture present at the time of inspection - bathroom  
 Information: Elevated moisture was noted in the lower tiled wall surfaces of the bathroom shower. The moisture readings were mostly contained in the wall housing the tapware. Moisture readings were recorded on the opposing side of the wall in the hallway.

The levels varied at differing points throughout the recess. This could possibly be due to deteriorated grout and silicone sealants and / or plumbing fittings and fixtures. The grouts and sealants can break down over time and become porous, allowing moisture to enter the wall sheet surface behind the tiles. It is believed that, given the pattern and location of the readings, the moisture ingress is related to the tapware, plumbing service or the wall penetrations.

Plumbing, and shower fittings and fixtures, can be areas of water penetration if not installed correctly and sealed completely. Whenever a fitting is screwed / fitted to the tiled shower walls, the holes and fittings should be sealed with an appropriate sealant to prevent water from entering the wall cavity. This is a common fault.

Elevated moisture can attract timber pests and vermin, and produce conditions that promote timber pest attack, fungal growth and wood decay.

Due to the unknown nature of the moisture in the wall cavity and any possible damage, this has been given a the rating of major defect.

It is recommended that the moisture levels in these areas be investigated further by a licensed plumber.

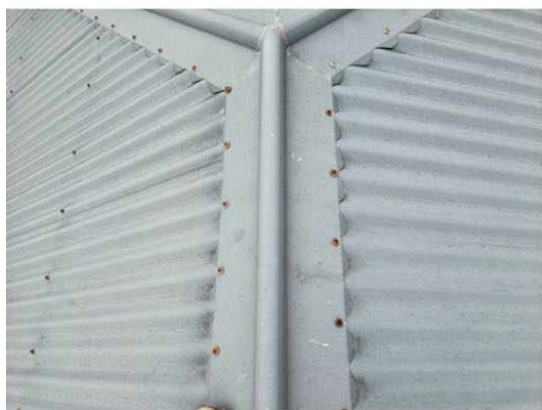
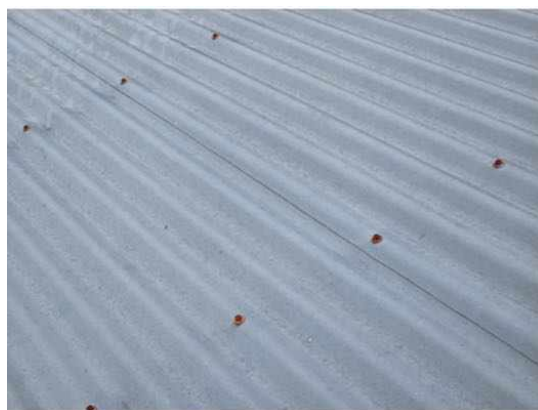
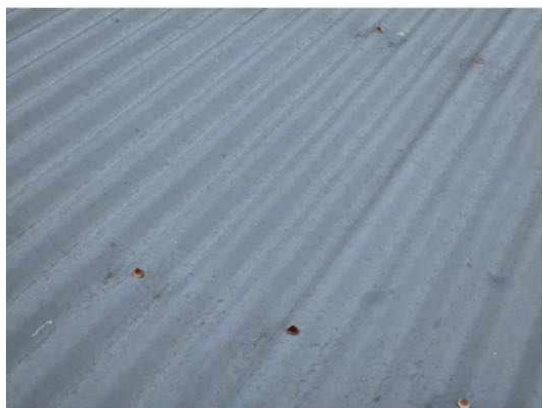
### Finding 3.01

Building:	Main Building
Location:	All External Areas
Finding:	Roof screws - rusting
Information:	It was noted during inspection, that throughout the roof surface the majority of roof screws are showing signs of rust at varying degrees ranging from minor to moderate.

This should be monitored over time, and should the condition worsen, consider replacement of the screws. As roof screws deteriorate they can have an effect on the adjoining roof materials.

A roofing plumber could be appointed at the clients discretion to replace the screws in question.

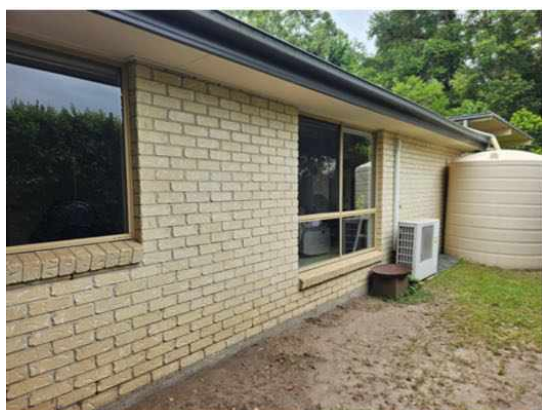
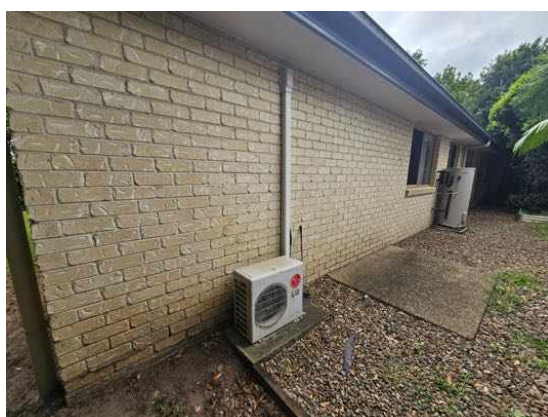
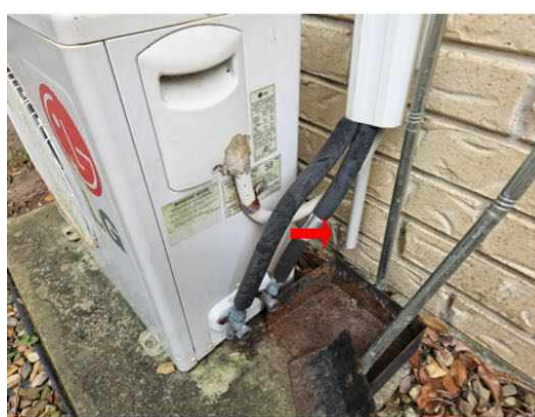
**Finding 6.01**

Building:	Main Building
Location:	As shown
Finding:	Air conditioner - Disconnected drain
Information:	The Air Conditioner (A/C) overflow was found to be disconnected from storm water drainage and could create excessive moisture in the surrounding area.

Such leaking creates an environment which is conducive to an array of defects, including water damage to associated building elements and the attraction of termite or timber pest infestation.

It is recommended that a licensed plumber be appointed to connect the A/C overflow to a drainage source in order to prevent such an environment from being created. An alternative is to extend the overflow further into the garden away from the building perimeter.

These minor works should be carried out in the short term.

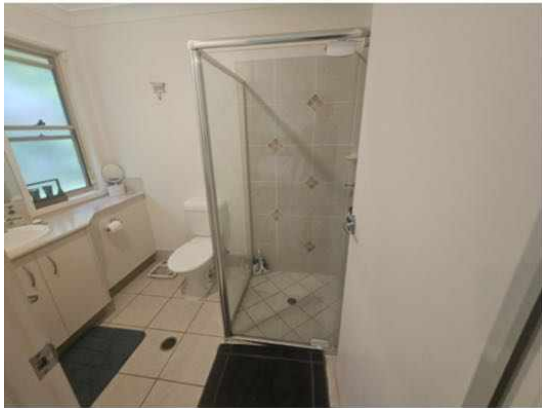
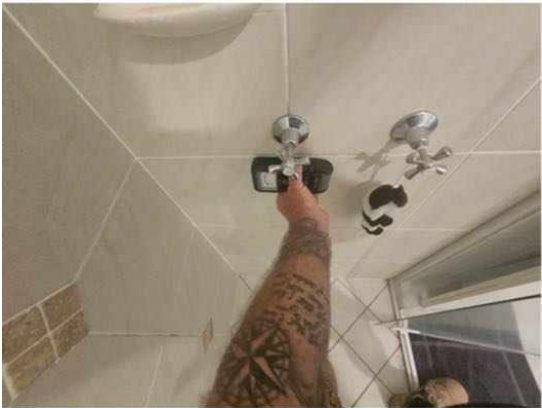
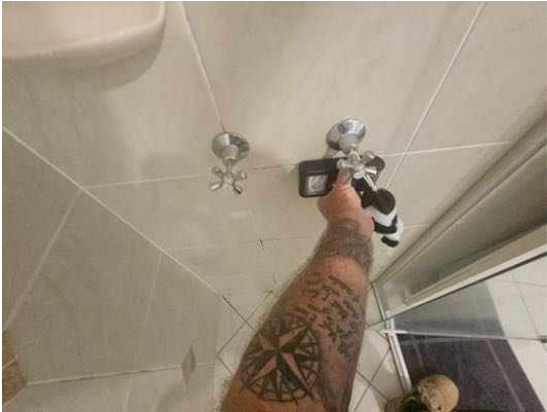
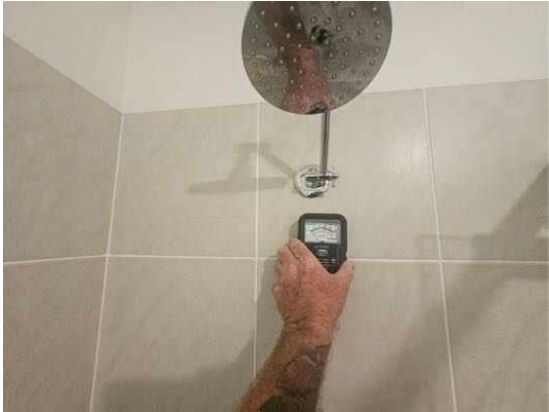
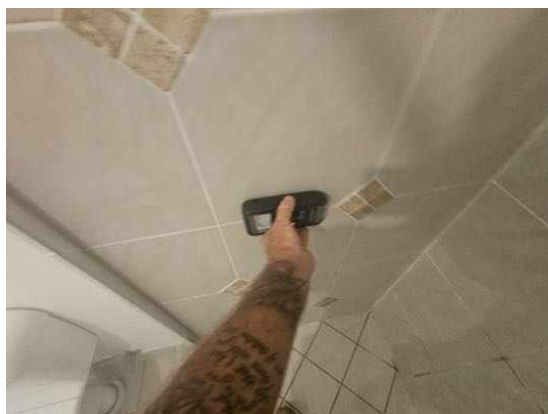
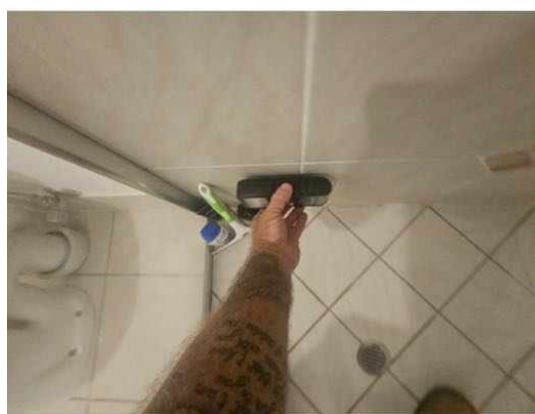
Building: Main Building  
Location: Ensuite - Master  
Finding: No moisture detected in ensuite  
Information: On the day of inspection the shower in the ensuite was measured for moisture using a "Tramex" moisture meter. During this inspection no moisture was detected in these areas and the tiled / sheeted surfaces appear to be in good order.

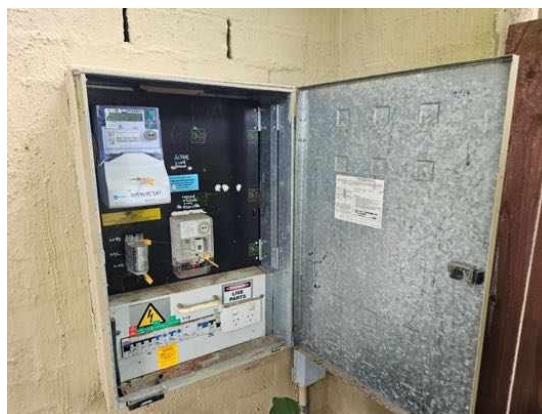
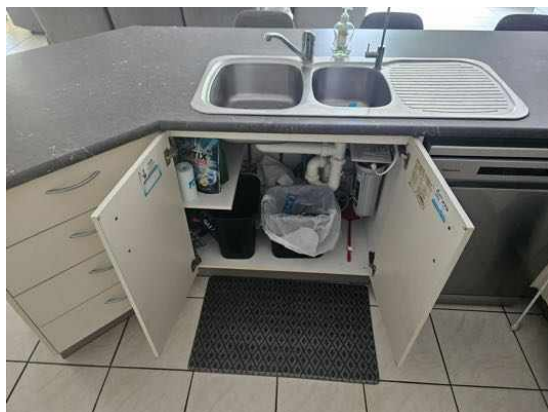
Building:	Main Building
Location:	Meter box, kitchen cupboard
Finding:	Durable pest inspection notice - not assessable
Information:	On the day of inspection it was noted that the durable timber pest inspection / treatment notice was missing, not visible or out of date. These notices / stickers are to verify the timber pest inspection dates, the inspector, the currency and type of timber pest system / barrier in place or being used in and around the property.

Annual, or more regular, inspections are crucial in maintaining and managing the properties timber pest risk profile. By not having regular inspections of the property raises the properties risk of undetected defects and damage. Without regular inspection at intervals of not greater than annually the buildings risk profile will be categorised as high. Properties with trees within 50m and with gardens close to the building are at greater risk and will have a high risk profile.

It is recommended that a licensed timber pest controller be contacted to assess the properties needs and provide costings for an annual inspection programme.

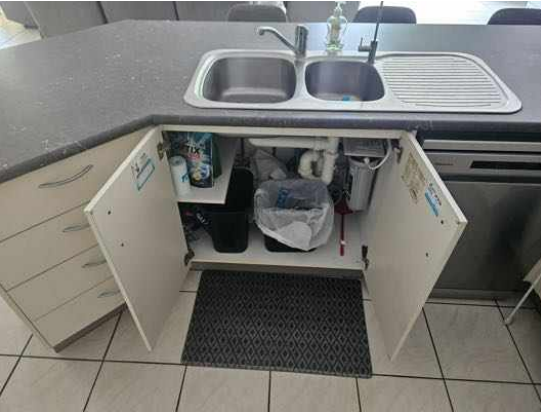
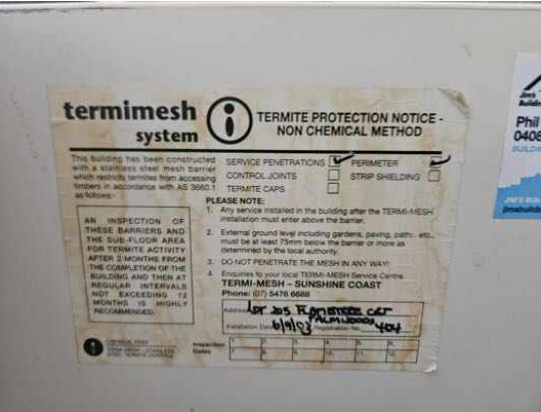
The building employs a "Termimesh" physical barrier system to the perimeter and slab penetrations. In order for a barrier system to be effective, the property must have regular inspections at intervals of not greater than 12 months. Depending on the risk profile attributed to the property, these inspections may be recommended at lesser time periods.
