Building and Timber Pest Inspection Report

Inspection Date: Mon, 23 Mar 2026

Property Address: 3 Lawson St, Woodridge QLD 4114,
Australia

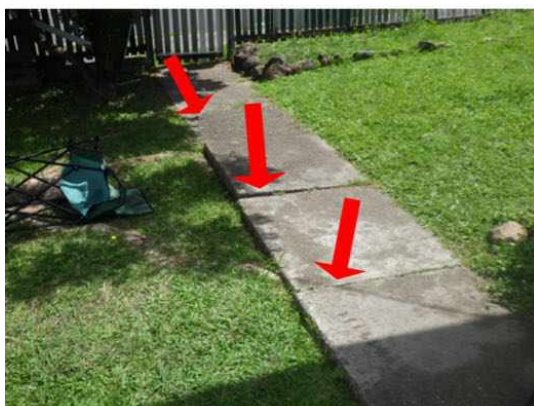
Building: Main Building
 Location: Yard - Front > Ground Level
 Finding: Paving - Uneven
 Information: Sections of the external paved footpath area at the front of the property are uneven, creating a potential trip hazard. It appears as though the area has been subject to rough installation, or that paving sections have lifted due to nearby vegetation growth.

Where paving creates a trip hazard, personal injury may ensue if due caution is not taken by all persons within this area.

Re-paving of the area is required as soon as possible to remedy this situation.

A licensed concreter or landscaper should be engaged to undertake rectification work.

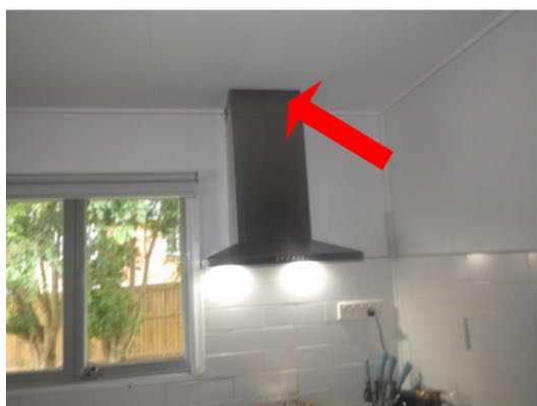
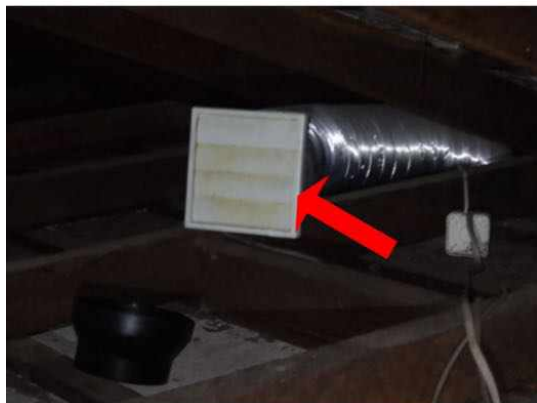
Building: Main Building
Location: Attic > Centre Right
Finding: Rangehood - Vented into roof space
Information: The kitchen range hood flue was found to lead directly into the roof space, rather than venting to the exterior of the building.

The positioning of this flue is likely to lead to a build-up of grease and grime in the surrounding area within the ceiling void, which can pose as a fire hazard in the roof void. The presence of insulation surrounding the flue adds to this fire safety risk.

Without re-direction to the exterior of the building, the Rangehood is not considered fully operational and is deemed a minor safety hazard. It is therefore preferable that the flue be re-directed to vent into the external environment. A licensed carpenter or plumber should be appointed as soon as possible to undertake any necessary works.

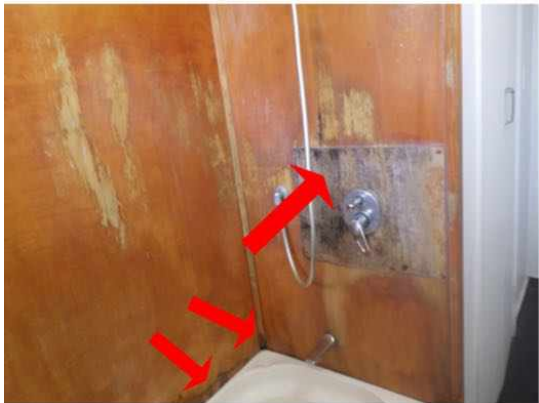
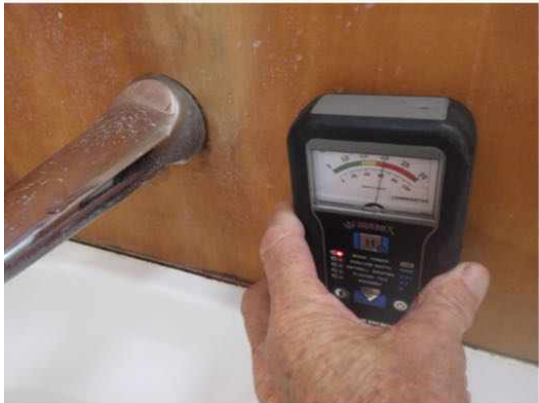
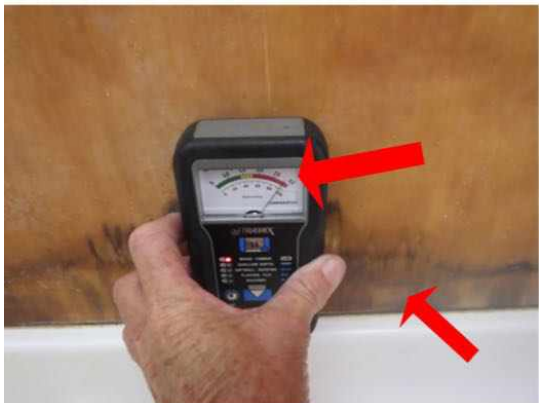
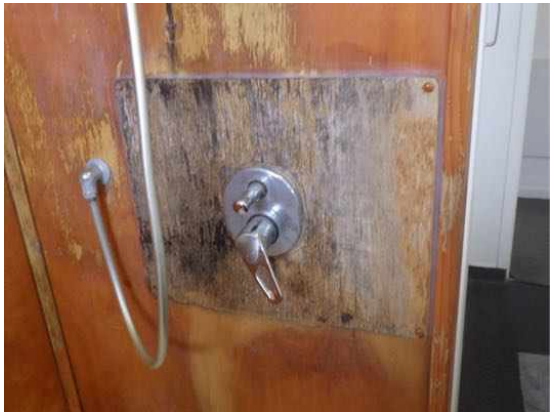
Finding 2.01

| Finding: | Shower - Leaking |
| Information: | The bathroom shower area registered elevated moisture level readings to wall areas of the shower cubicle at the time of inspection. |

It is suspected that the leaking has occurred as a result of general ageing and deterioration of wall linings. Additionally evidence of mould growth and previous repair work was noted.

Leaking from the shower area, where left unattended, is likely to lead to water damage to adjoining flooring and walls. Such damage can lead to water damage and necessitate extensive remedial works being required. Active water leaks may also create an environment that is susceptible to the formation and development of mould and /or timber termite activity.

Appointment of a licensed builder or shower area specialist will be required to repair or replace the shower area. Such works should be performed as soon as possible to ensure that no further damage occurs.

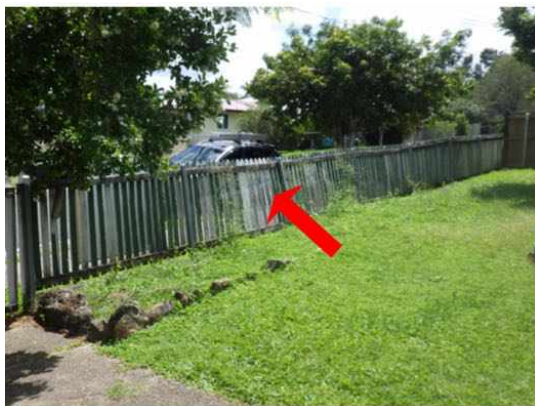
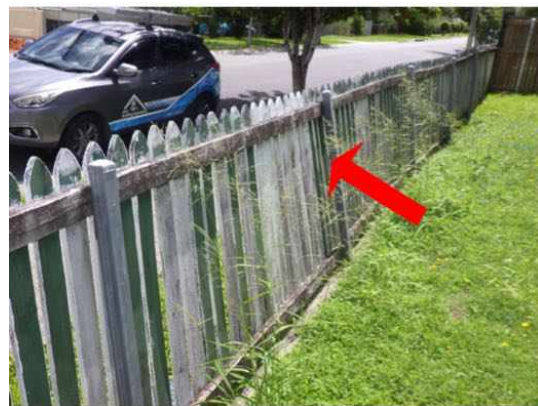
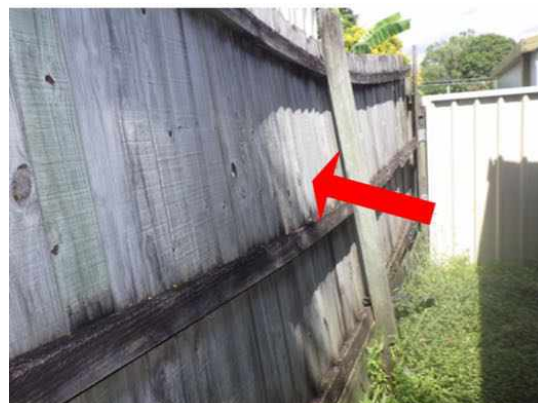
Finding 3.01

Building: Main Building
Location: Yard - Front & Back > Existing
Finding: Fencing - Deteriorated
Information: It was noted at the time of inspection that sections of the fencing to the front and rear of the property have deteriorated (as per example photos). Typically fencing deteriorates due to age and or wear, rot and or rust which is generally expected for a structure of this age, due to prolonged exposure to weather conditions. Sometimes inadequate installation or maintenance can be to blame.

If left unattended, it is likely that further damage will occur. It is suspected that repair of several elements of the fencing may be required however replacement may be a consideration of the client also.

A licensed fencing contractor should be appointed to provide further advice and perform rectification works as necessary.

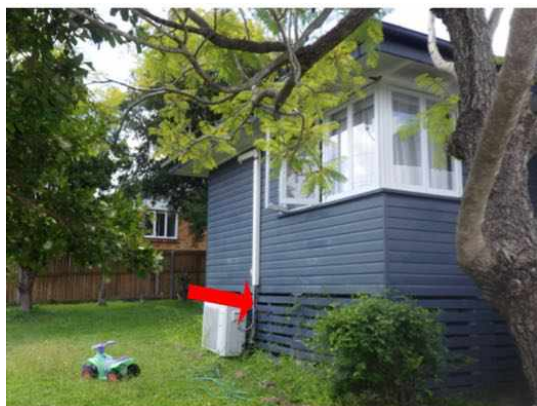
Finding 3.02

| Finding: | Pipework - Insulation deteriorated |
| Information: | <p>At the time of inspection sections of the air conditioning unit pipe work insulation showed evidence of damage and deterioration. It is suspected that this deterioration has developed as a result of excessive exposure to weather, including UV exposure in daylight. Deteriorated insulation reduces the effectiveness of the material in helping to maintain the desired temperature and work most efficiently.</p> <p>If left in an exposed position, it is likely that the deterioration will continue and worsen over time, potentially resulting in secondary building defects as well as a further loss in insulating properties.</p> <p>Some areas of replacement of pipe insulation is likely to be required. Further preventative measures to remove or protect the material from future exposure are also advisable. Consultation with a licensed air conditioning installer is advised to gain quotes for the repair and/or replacement of deteriorated insulation.</p> |

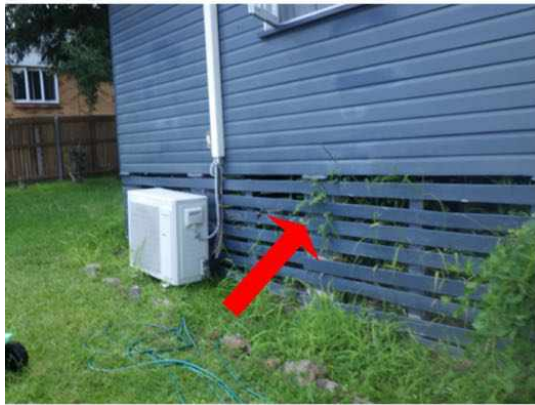
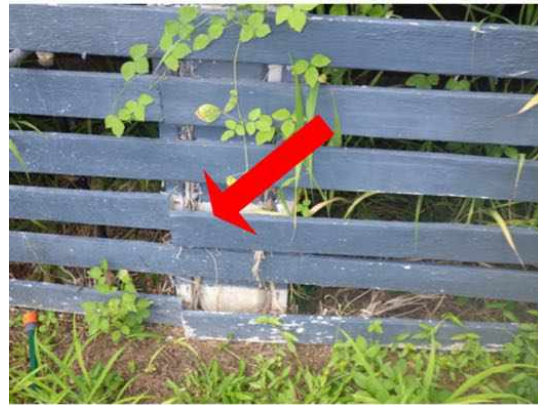
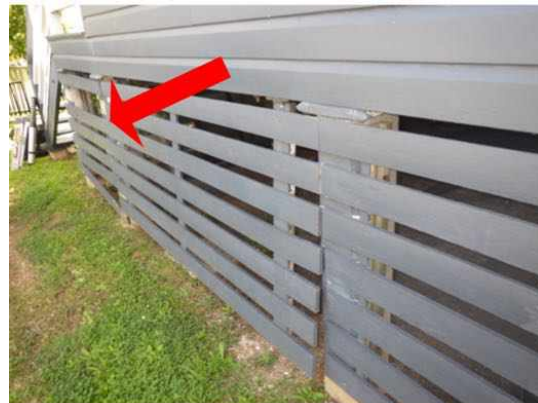
Finding 3.03

| Finding: | Wall Cladding /Screening |
| Information: | <p>It was noted at the time of inspection that sections of the exterior timber screening to the sub floor area of the property have deteriorated. Typically wall cladding and /or timber screening deteriorate due to prolonged exposure to weather conditions. Sometimes inadequate installation or maintenance can be to blame.</p> <p>If left unattended, it is likely that further damage will occur. It is suspected that repair of several elements of the timber screening may be required.</p> <p>A qualified carpenter should be engaged to undertake repair work as required.</p> |

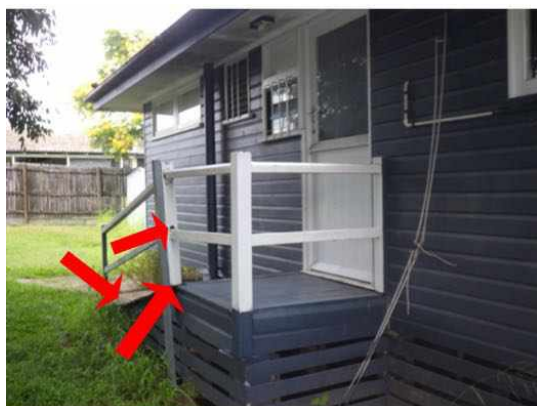
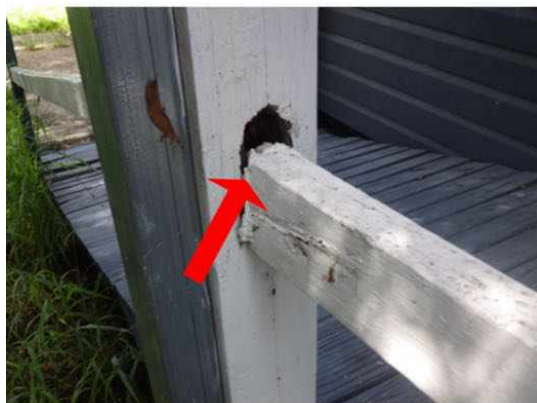
Finding 3.04

| Finding: | Decking - Deteriorated |
| Information: | It was noted at the time of inspection that sections of the timber balustrade, ramp and decking on the left side of the property have deteriorated. Typically timber decking deteriorates due to age and or wear, rot and or rust which is generally expected for a structure of this age, due to prolonged exposure to weather conditions. Sometimes inadequate installation or maintenance can be to blame. |

If left unattended, it is likely that further damage will occur. It is suspected that repair of several elements of the timber balustrade and decking may be required however replacement may be a consideration of the client also.

A licensed builder should be appointed to provide further advice and perform rectification works as necessary.

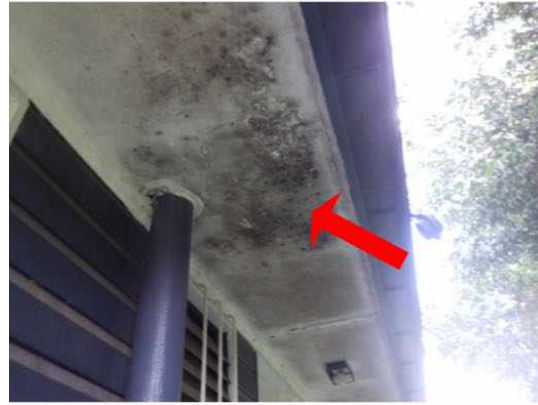
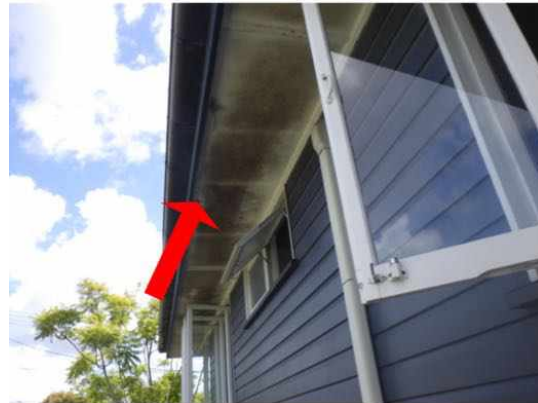
Finding 3.05

| Information: | The eaves linings to the exterior of the property show signs of excessive mould and mildew at the time of inspection (as per example photos). This defect can at times be caused by blocked or overflowing gutters in the areas associated. |

Where evidence of mould growth was noted, there may be environmental, biological or health issues associated with the report. A specialist inspection by a suitably qualified environmental health inspector may be warranted, where mould is extensive or where any queries regarding air quality spores or other related issues apply.

Generally, the client is advised to ensure that the general environment is free of moisture and humidity to aid in the prevention of mould formation and development. Any mould found during the inspection should be cleaned immediately by a cleaning contractor or the homeowner as applicable.

Please note that severely affected building elements may require replacement by a registered builder or qualified carpenter.

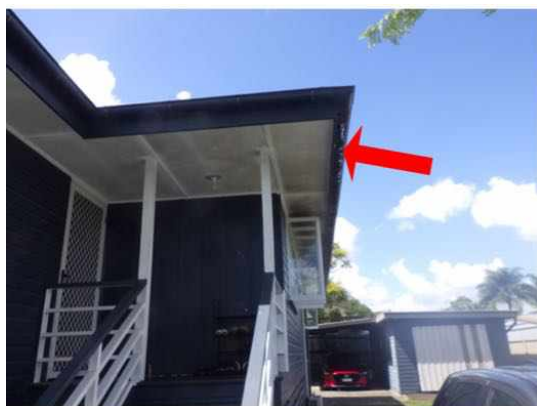
Finding 3.06

| Finding: | Gutter - Rusted |
| Information: | Upon inspection of the exterior guttering, evidence of significant rust to the right side section was identified. |

Metal gutters generally comprise of sections of guttering, which join and overlap. These intersections are particularly prone to lift at the edge and consequently rust at these points.

A roofing contractor could be appointed to assess the damage to the roof guttering in all areas and to perform remedial works as necessary.

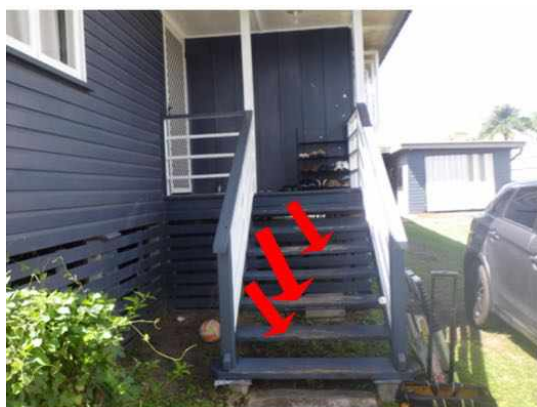
Finding 3.07

| Finding: | Decking - Deteriorated |
| Information: | It was noted at the time of inspection that sections of the timber stair treads at the front of the property have deteriorated. Typically timber treads deteriorate due to age and or wear, rot and or rust which is generally expected for a structure of this age, due to prolonged exposure to weather conditions. |

If left unattended, it is likely that further damage will occur. It is suspected that repair of several stair treads may be required however replacement may be a consideration of the client also.

A licensed carpenter or general handyman could be appointed to perform rectification works as necessary.

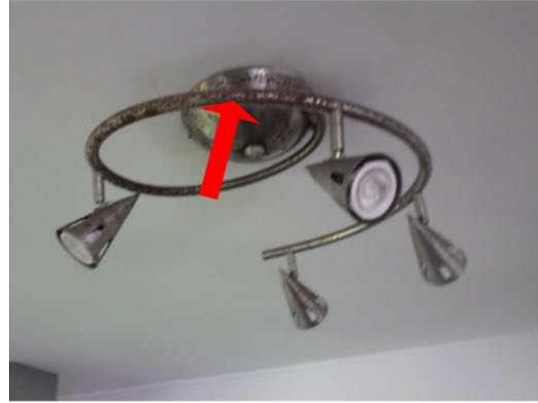
Finding 3.08

| Finding: | Light Fitting Rusty |

surface rust.

Excessive surface rust or corrosion of electrical fittings may compromise the operation and safety of the fitting.

A licensed electrician should be engaged to repair or replace the light fitting.

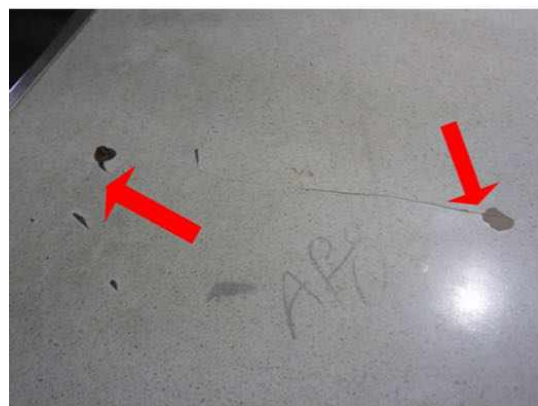
Finding 3.09

Building: Main Building
 Location: Kitchen > Centre Left
 Finding: Cabinetry - Deterioration
 Information: At the time of inspection the kitchen bench top showed signs of deterioration. The level of damage appears consistent with exposure to moisture or general wear and tear.

A qualified cabinet maker or general handyman could be engaged to undertake repair works at the clients discretion.

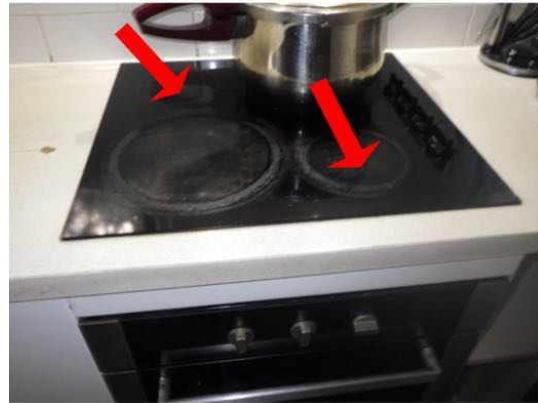
Finding 3.10

Building: Main Building
 Location: Kitchen > Rear Left

Finding: Cooktop
 Information: The cooktop in the kitchen area was found to be damaged or not fully operational at the time of inspection. Damage occurs generally when appliances have aged and decayed.

Repair and/or replacement of the damaged cooktop is advised. A Licensed electrician should be appointed to repair/replace the cooktop at the client's discretion.

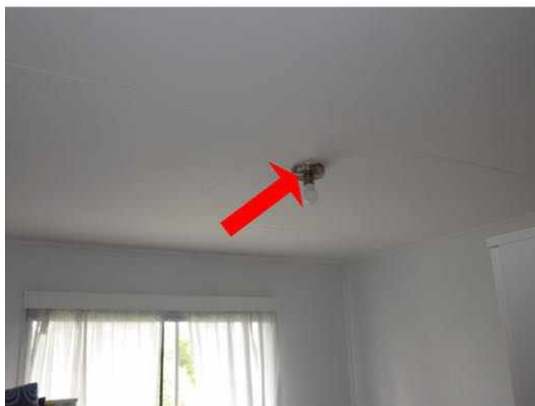
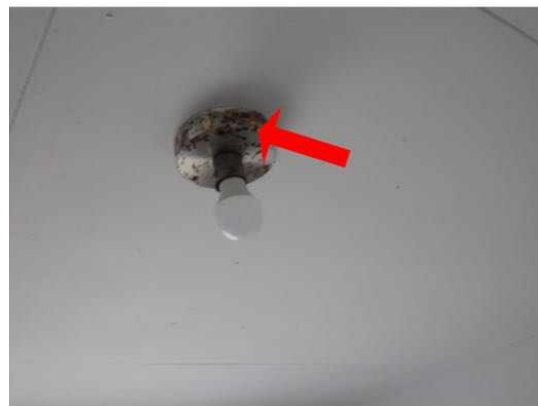
Finding 3.11

Building: Main Building
 Location: Bedroom 2 > Centre
 Finding: Light Fitting Rusty
 Information: At the time of inspection the light fitting in the bedroom 2 area showed signs of significant surface rust.

Excessive surface rust or corrosion of electrical fittings may compromise the operation and safety of the fitting.

A licensed electrician should be engaged to repair or replace the light fitting.

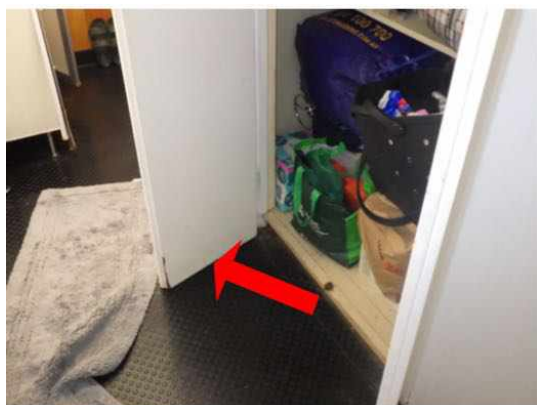
Finding 3.12

Building: Main Building
 Location: Bathroom > Centre Right
 Finding: Door Rubbing
 Information: It was noted that the bottom edge of the bathroom cupboard door is rubbing on the floor, making the door stiff to open and close at the time of inspection.

This is noted as a minor defect that you need to be aware of.

A licensed carpenter or general handyman could be engaged to ease the door at the clients discretion.

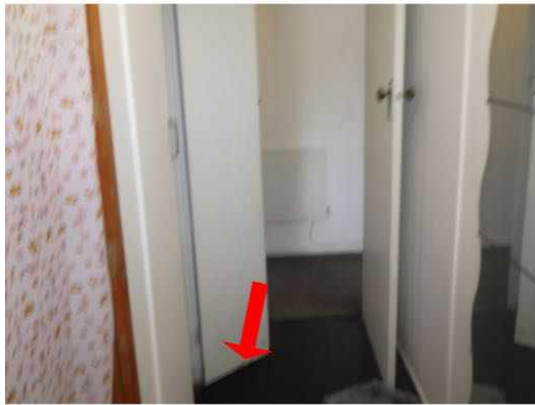
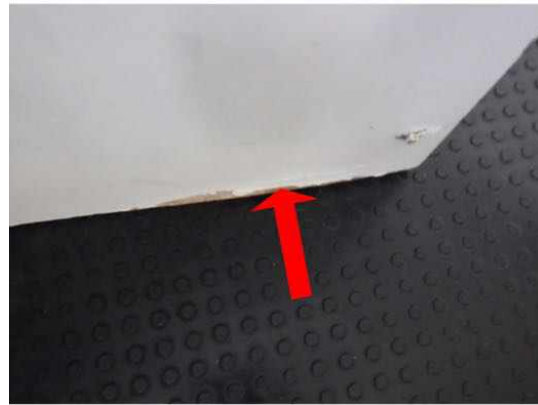
Finding 3.13

Building: Main Building
 Location: Bathroom > Centre Right
 Finding: Damaged Door
 Information: The right side cupboard door in the bathroom has suffered damage to the bottom edge.

Damage occurs generally when the building materials have aged and decayed, but in this instance the damage appears to be the result of exposure to moisture, possibly from the bottom and/or top edges of the door not being sealed with a suitable paint or sealant at the time of construction.

A qualified carpenter or general handyman could be appointed to repair/replace the door at the clients discretion.

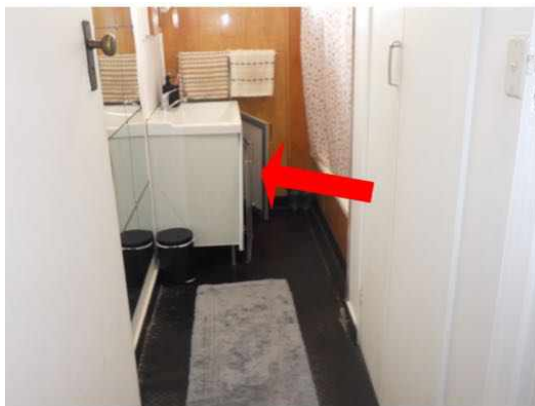
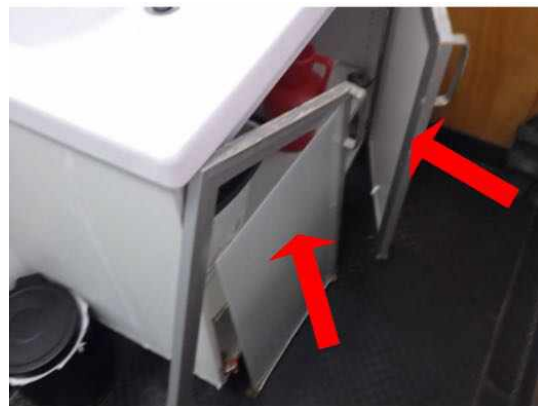
Finding 3.14

Building: Main Building
 Location: Bathroom > Rear Left
 Finding: Cabinetry - Deterioration
 Information: At the time of inspection the bathroom cabinetry showed signs of significant deterioration. The level of damage appears consistent with exposure to moisture or general wear and tear.

A qualified cabinet maker or general handyman could be engaged to undertake repair or replacement works at the clients discretion.

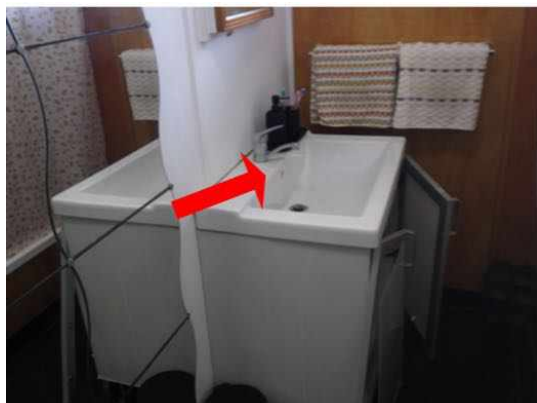
Finding 3.15

Building: Main Building
 Location: Bathroom > Rear Left
 Finding: Basin - spider web type cracking
 Information: Significant spider web type cracking was evident to the bathroom basin at the time of inspection. Any future impact sustained by the basin may lead to additional cracking.

The cracking may provide potential ingress for water and/or secondary water damage may occur to associated cabinetry if left unmanaged.

Consultation with a plumber regarding basin replacement will be required.

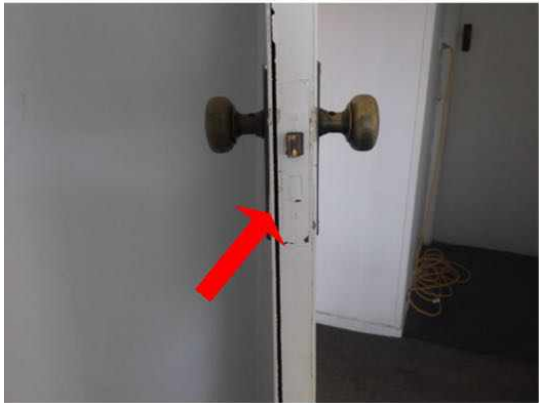
Building: Main Building
Location: Bedroom 1 > Front
Finding: Damaged Door
Information: The door leading into bedroom 1 has suffered damage to the front and back panels.

Damage occurs generally when the building materials have aged and decayed, but may be indicative of impact damage.

A qualified carpenter or general handyman could be appointed to replace the door at the clients discretion.

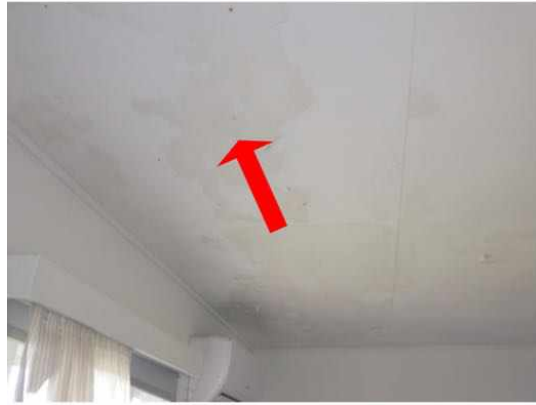
| Information: | Sections of paint to the bedroom 1 ceiling area was found to have bubbled and deteriorated. Paint bubbling or deterioration is generally an indication of excessive moisture in the area generally caused by moisture exposure or a lack of natural or mechanical ventilation. |

The presence of excessive moisture can have major implications on associated building elements if left unattended. While only seemingly minor at this stage, the damage cannot be fully determined.

It is advised that the affected ceiling area be further inspected by a licensed painter.

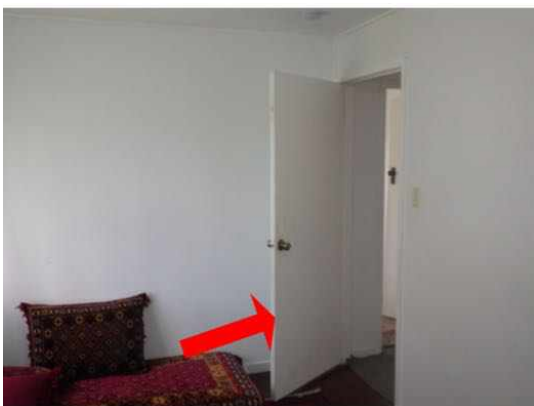
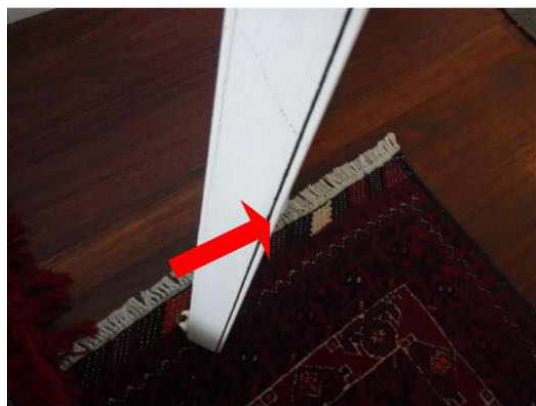
Finding 3.20

Building: Main Building
 Location: Bedroom 3 > Front
 Finding: Damaged Door
 Information: The door leading into bedroom 3 has suffered damage to the front and back panels.

Damage occurs generally when the building materials have aged and decayed, but may be indicative of impact damage.

A qualified carpenter or general handyman could be appointed to replace the door at the clients discretion.

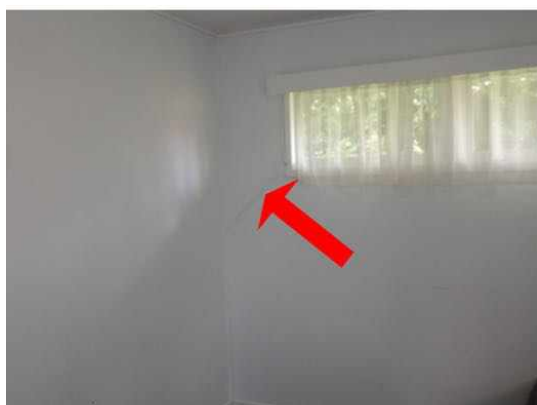
Finding 3.21

| Finding: | Cracking - Wall |
| Information: | There is cracking to an area of the wall lining in bedroom 3. |

The cracking appears minor in nature and is generally only ever an appearance defect. While such cracking may be noticeable in some cases, it is quite common and does not indicate any structural damage.

Cracking of this nature can generally be repaired with minor sanding, filling and/or repainting. Such works should be performed by a qualified painter or a general handyman.

Monitoring of all cracking should be conducted frequently. Always contact a building inspector should cracks widen, lengthen, or become more numerous.

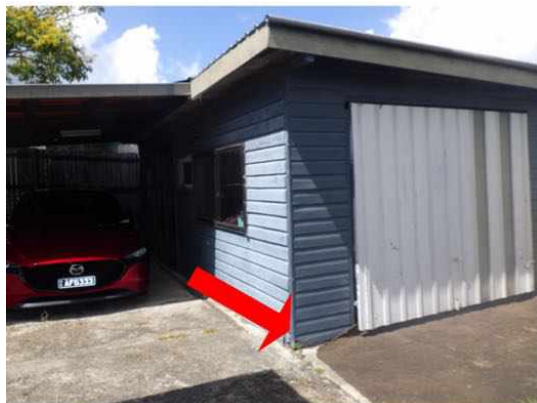
Finding 3.22

| Finding: | Wood rot - Corner Stop. |
| Information: | The timber corner stop to the shed exterior weatherboard cladding shows evidence of wood rot. Wood rot, also known as Fungal Decay, occurs when timbers and other cellulose building materials are exposed to damp conditions on an ongoing basis. This could be the result of exposure to weathering over a prolonged period of time, or the attraction of excessive moisture from other abutting building materials. Contributing factors also include poor air ventilation in the area. |

Wood rot is often associated with general damp problem, a Carpenter or handyman should be consulted regarding repair work.

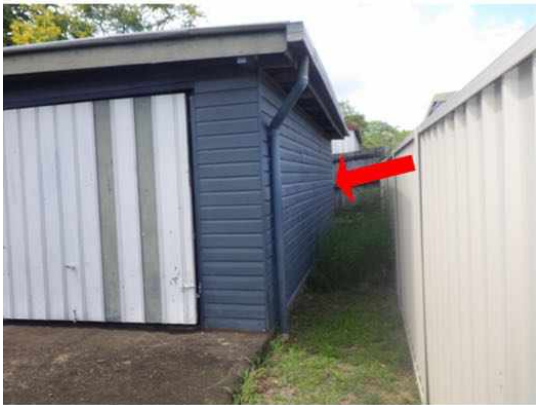
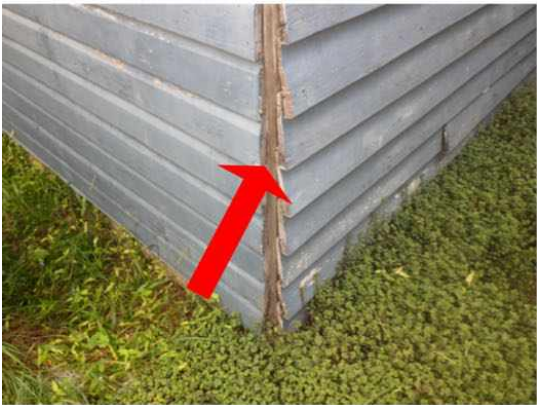
| Finding: | Timber Trim - Missing |
| Information: | At the time of inspection it was observed the timber corner stop on the rear right side of the shed was missing. |

A qualified carpenter or general handyman could be engaged to replace any missing timber corner stop.

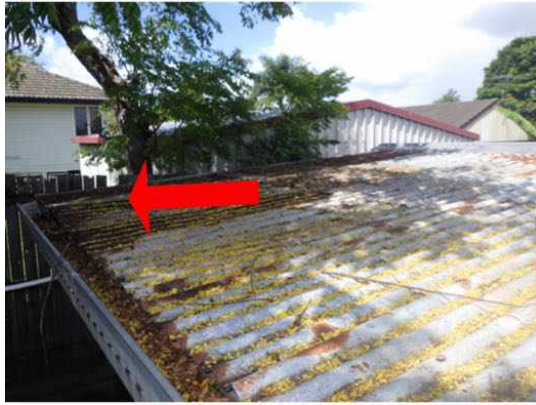
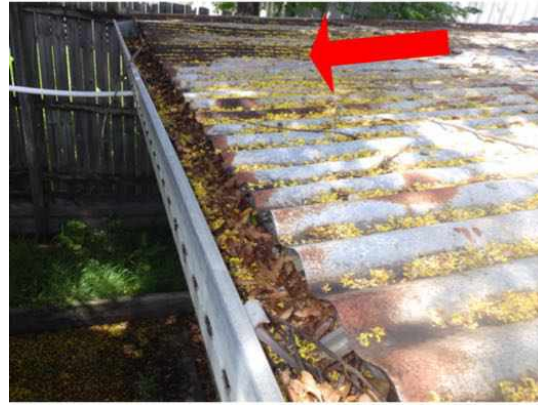
Finding 3.25

Building: Shed
Location: Roof Exterior > Rear Left
Finding: Roof sheets - Rusted
Information:

Upon inspection of the shed exterior roofing structure, evidence of rust to the carport area metal roof sheeting was identified. If left unmanaged, these degrading roof sheets can allow water ingress to the internal roofing structures, potentially leading to secondary damage of building elements. Accelerated deterioration of the roofing sheets and any associated building elements is also likely to occur.

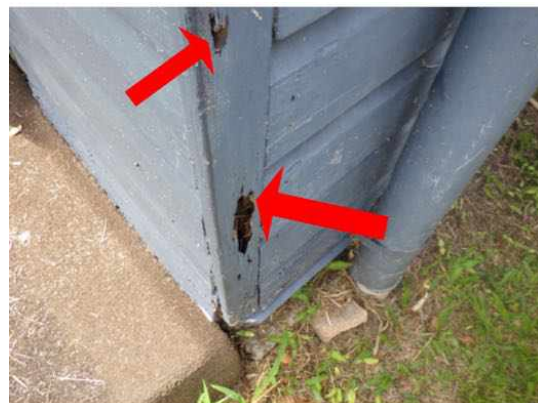
| Finding: | Evidence of termite damage |

A building contractor may be appointed to repair the timber wall cladding and provide a further invasive inspection if further damage is evident.

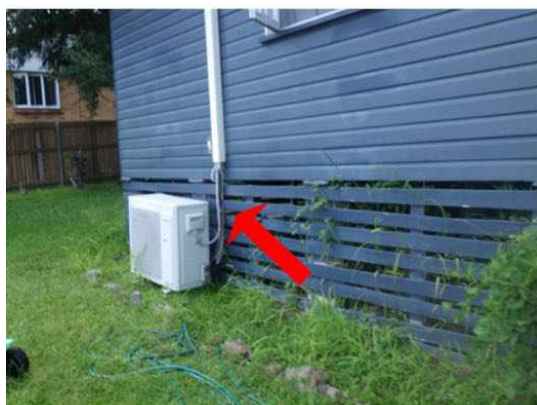
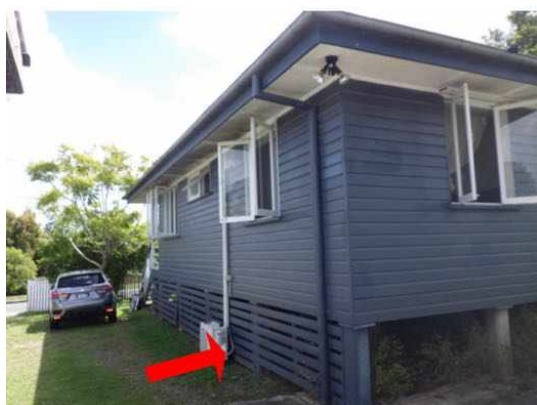
Finding 6.01

| Finding: | Overflows - Not plumbed for drainage |
| Information: | The air conditioning units overflow's are not plumbed or connected to suitable drainage, which can result in the surrounding areas becoming excessively damp. These damp conditions can lead to secondary defects such as rot, rust or corrosion of associated building elements, the formation of fungal decay, or even the creation of potential slip hazards. When coupled with poor site drainage, pooling of water may also attract termite activity to this area. It is highly recommended that a qualified plumber be appointed to install adequate drainage to the overflows. These works will ensure that the area remains dry and free of any secondary defects. |

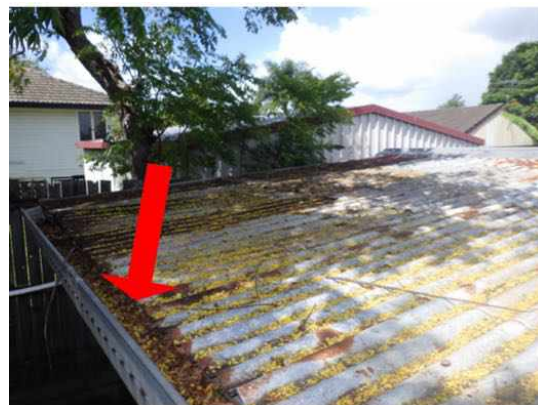
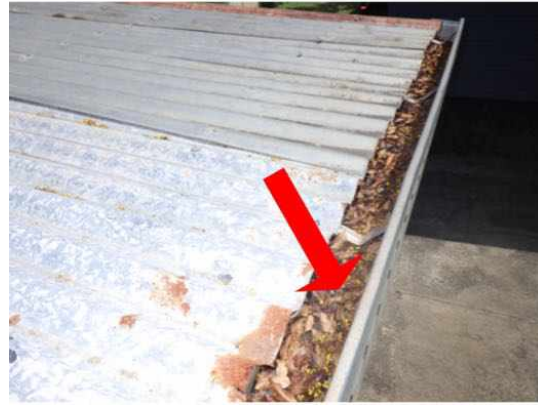
Blocked gutters are likely to lead to high levels of moisture in the affected areas. Such moisture will not only cause rust and decay of the associated building materials, but can also provide conditions that are conducive to termite and timber pest activity. Blockages in gutters should therefore be removed immediately to ensure dry conditions are maintained.

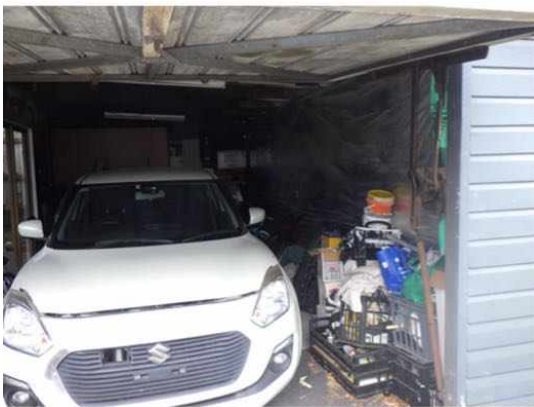
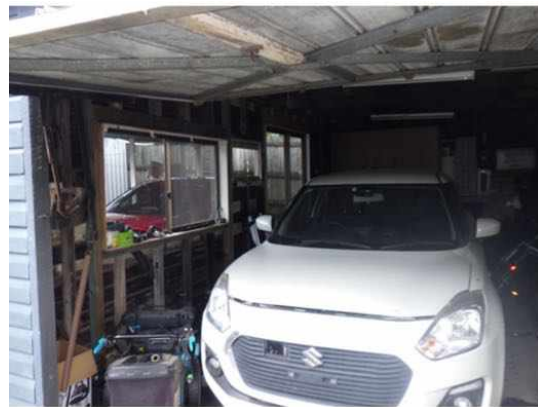
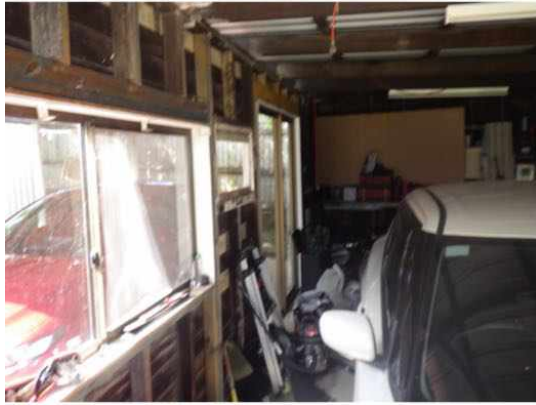
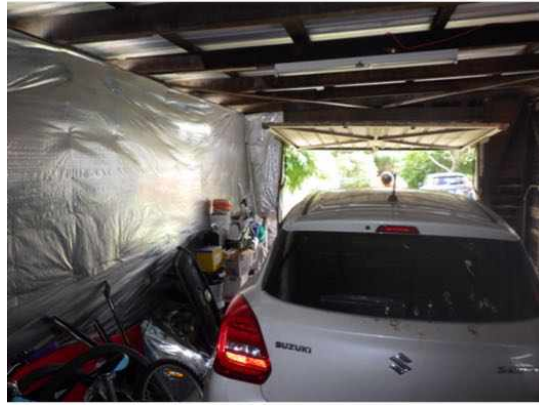
Finding 6.07

Building: Shed
 Location: Internal Areas > Existing
 Finding: Stored Items
 Information: At the time of inspection there was furniture, personal and stored items against internal walls in areas of the shed/garage area inspected.

It is highly recommended the items are removed to allow for complete inspection of the area.

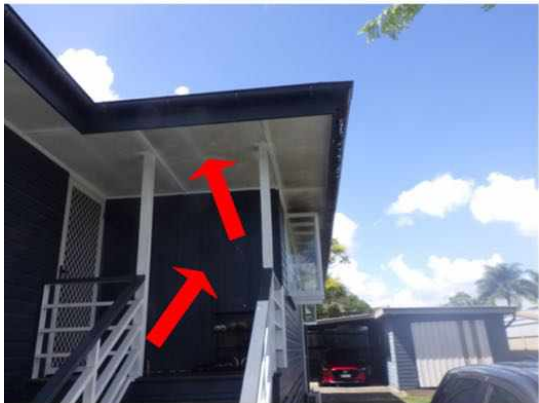
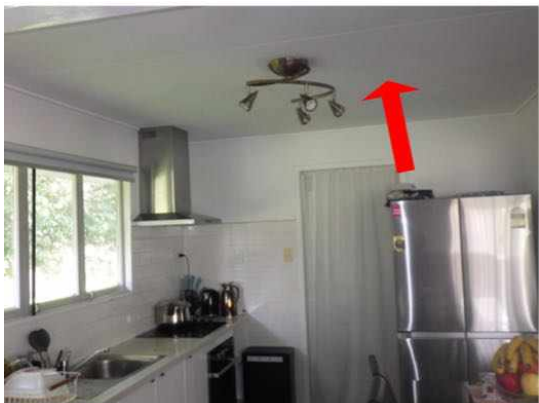
Building: Main Building
 Location: Internal Areas > Existing
 Finding: Asbestos - Suspected ACM Identified on Site
 Information: At the time of inspection it was suspected exterior eaves linings, internal ceiling linings and wet areas wall linings may be of asbestos containing materials.

In the interim, the client is advised to act with caution, especially when considering any damage to building materials general wear and tear renovations extensions demolition and general maintenance activities due to the suspected presence of Asbestos.
