Building Inspection Report

Inspection Date: Fri, 20 Mar 2026

Property Address: 32 Purnana Ave, St Georges SA 5064,
Australia

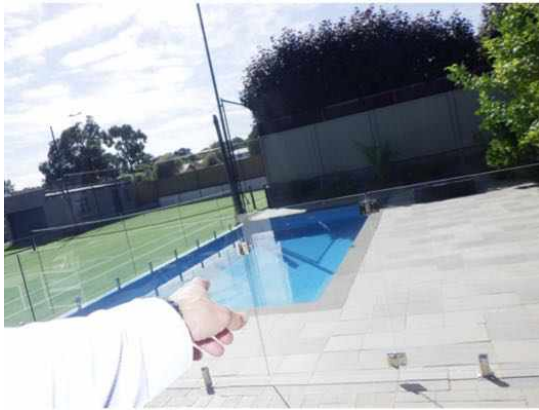
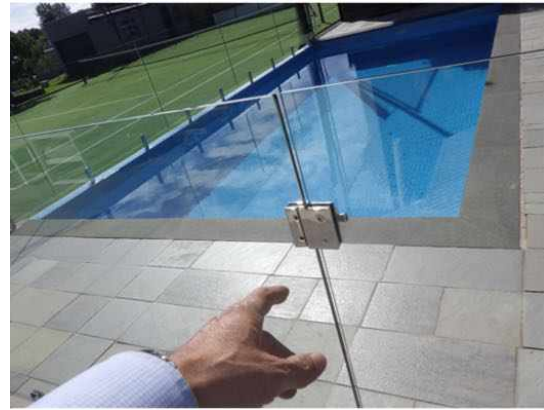
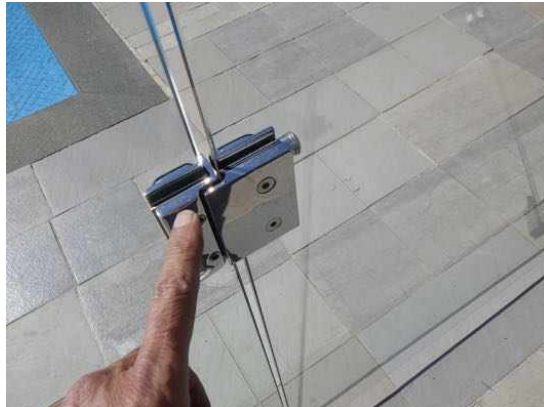
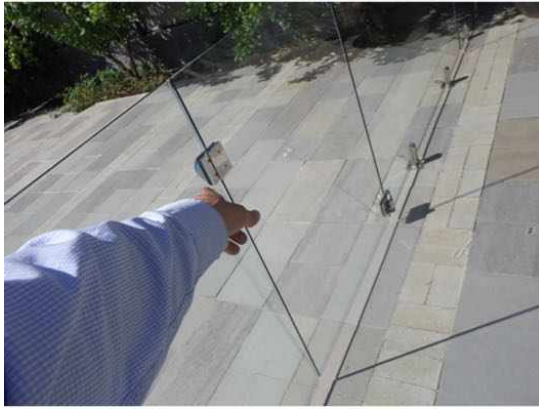
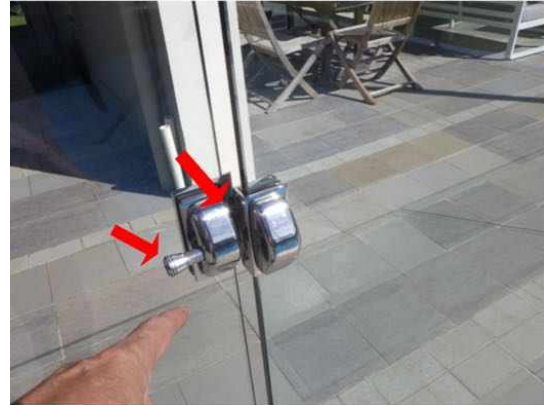
Defects 1.01

Building: Building 1
Location: All External Areas
Finding: Pool fencing - Do not to comply with Australian Standards- Inspection required
Information: It is suspected that areas of the pool fencing do not to comply with Australian Standards and do not appear to be safe. Assessment of the pool area is required.

Please note that this inspection does not cover pool fencing and other pool fittings and fixtures. It is highly advised that a specialist be appointed to inspect the pool and surrounding area and provide advice on rectification works that may be required.

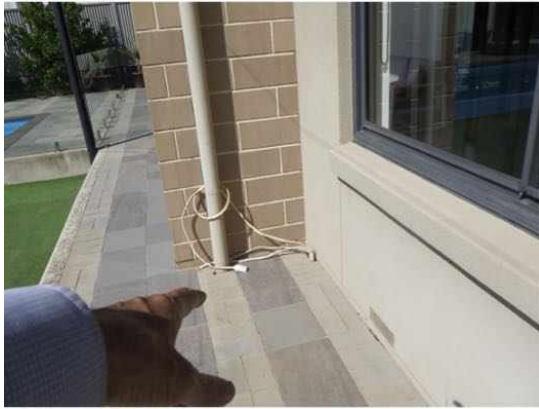
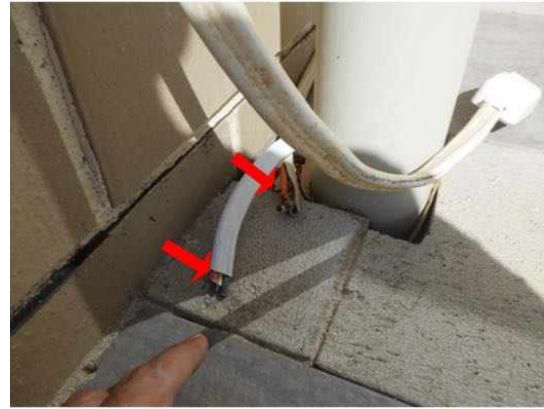
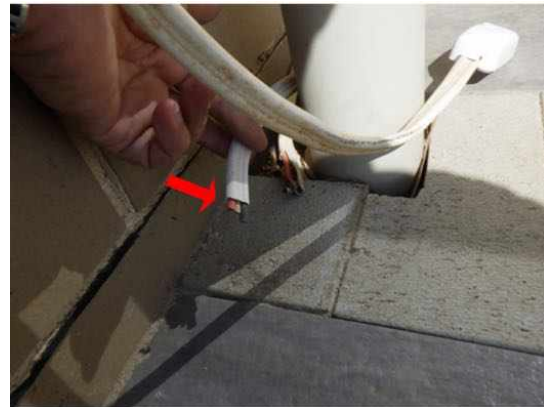
Defects 1.02

Building: Building 1
Location: All External Areas
Finding: External Area - Electrical wires exposed
Information: At the time of inspection it was noticed exposed electrical wiring was identified.

Exposed electrical wiring represents a potential safety hazard including for fire and personal contact.

Contact a licensed electrician urgently for further inspection investigation and rectification.

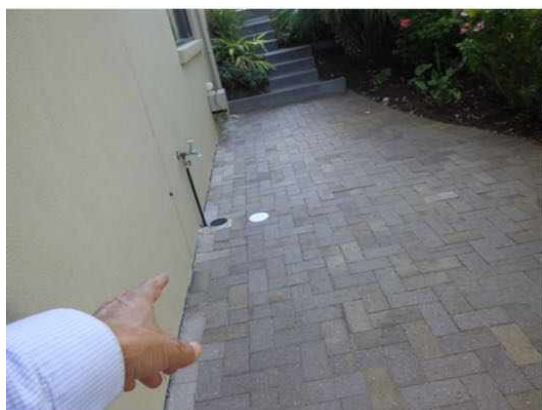
Defects 3.02

Building: Building 1
Location: All External Areas
Finding: Slab Edge - Exposure compromised
Information: At the time of inspection it was noticed that slab edge exposure has been compromised in few sections around the property.

At the time of inspection it was noticed that damp course member has been popping upwards from the external paving in few sections around property and result of that slab edge exposure has been compromised. It's advised to cut the extra popping upwards damp course.

An inspection zone of at least 75mm in relation to the exposed slab edge, between the bottom brick and the perimeter paving, is required. This inspection zone should be maintained in order to force termites into the open where they can be detected more readily during regular inspections. The slab edge should not be concealed by anything that may prevent inspection of the area, including render, landscaping, soil, turf, paving, concrete cladding or other structures.

If the slab edge is not properly exposed there is a high risk of termite attack. Sometimes, in order to determine the type of slab, a suitably qualified person such as an architect or builder may be required to consult the construction plans.

Where the slab edge cannot be properly inspected, it is highly recommended that termite or timber pest inspections be carried out every 6-12 months to aid protection of the property against infestation.

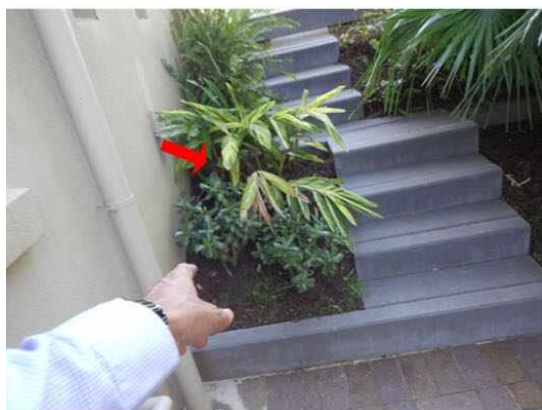
Defects 3.03

Building: Building 1
 Location: All External Areas
 Finding: Bridging - Vegetation
 Information: Where vegetation obstructs inspection of building elements, also known as bridging as it provides a bridging point for the access of termites, full inspection can not be achieved. Consequently moisture or dampness may be present and the areas becomes conducive to termite activity. Plants against or very close to buildings provide cover, shade and can provide an environment that is attractive to termite infestation.

The removal and replanting of species that do not provide "cover" or cutting back of existing vegetation will assist greatly in preventing Bridging from occurring.

The removal of any such materials that may be conducive to termite activity should be carried out as soon as possible and arrange re inspection to minimize the risk of termite attack.

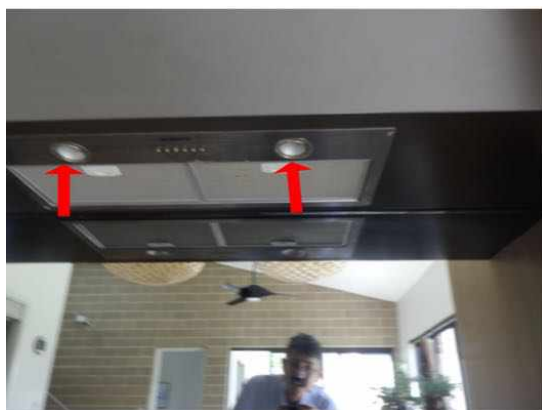
Defects 3.04

Building: Building 1
 Location: Kitchen
 Finding: Rangehood - Light not working
 Information: While the range hood appears to be working at a satisfactory level, the light to the appliance was not working at the time of inspection.

A licensed electrician should be appointed to replace the light on the range hood to restore it to a fully operational state.

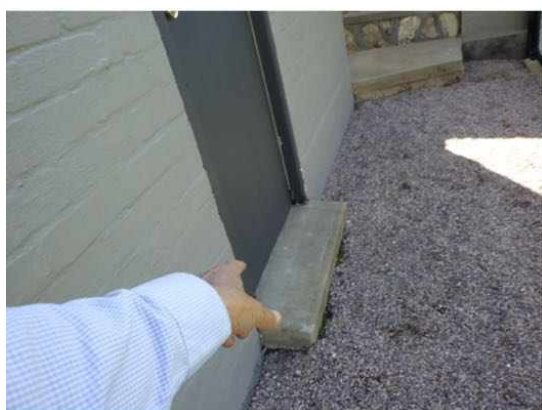
Defects 3.05

Building:	Building 1
Location:	All External Areas
Finding:	Building element - Damaged / Deteriorated
Information:	At the time of inspection it was noticed building elements were damaged / deteriorated in this external store room area.

Breakage occurs generally when the building materials have either aged and decayed, or as a result of damage (accidental or deliberate).

Repair and/or replacement of broken elements is advised to ensure that additional secondary defects do not arise as a consequence. Such works are necessary, as all building elements play a key role in the operation and function of the overall structure and its performance.

A relevant tradesperson should be appointed to repair or replace the affected building element prior to any subsequent damage being caused.

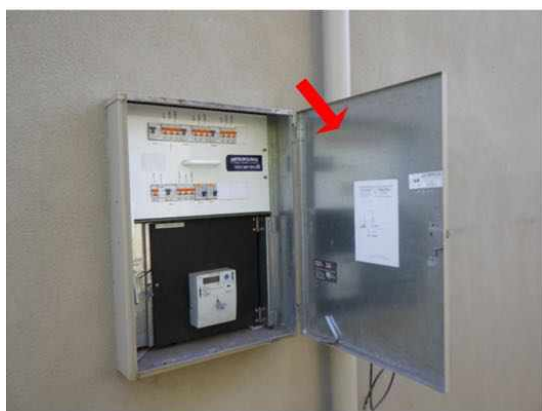
Building: Building 1
 Location: All External Areas >
 Finding: Termite Management System - No evidence of a chemical installation
 Information: The application of a post-construction chemical termite barrier is highly recommended for all properties, particularly if live termite activity has been found on the site previously. Such barriers are highly effective in preventing termite attack on any timber building elements throughout the property.

A durable notice should be placed in the switchboard unit to indicate current termite barriers. At the time of inspection, it appeared as though no termite management system has been installed, with no evidence to suggest preventative works taking place.

The client may consider gaining further advice from a pest controller as to the costs and procedures involved with this application. It is recommended that obtaining such advice be a short-term priority.

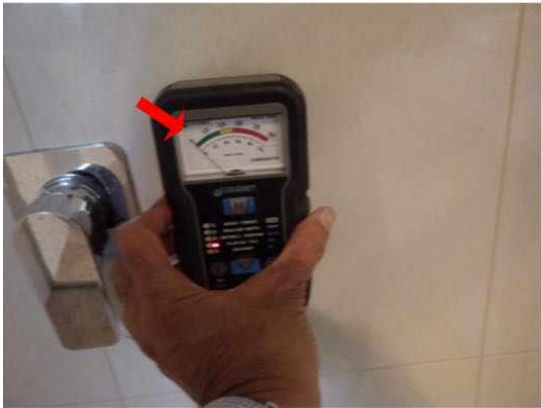
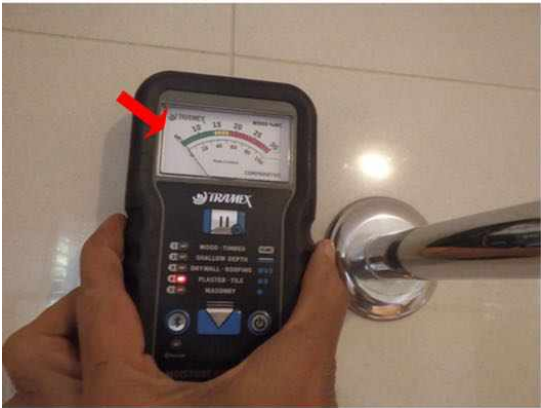
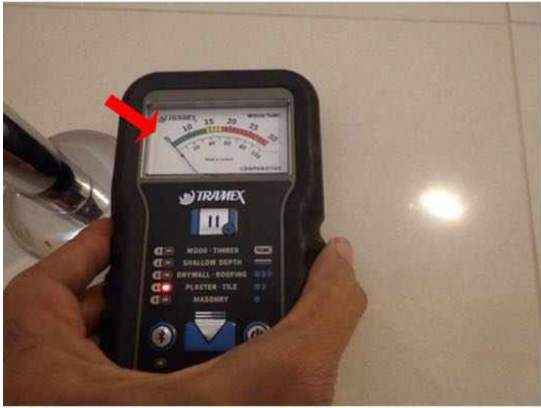
Building: Building 1
 Location: Ground floor - Bathroom-Ensuite
 Finding: Shower Alcove - No Damp
 Information: At the time of inspection it was noticed that damp is not evident to the shower alcove.

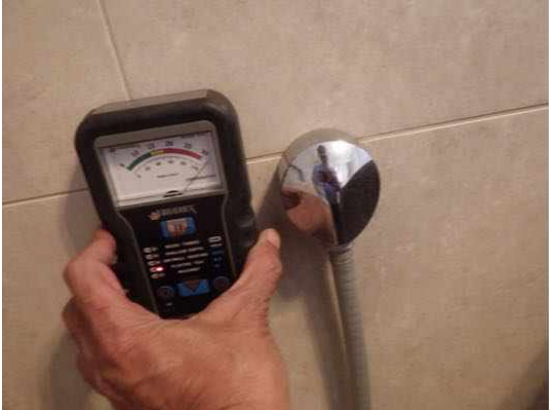
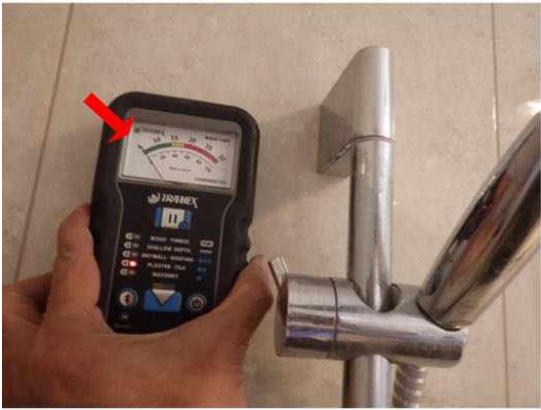
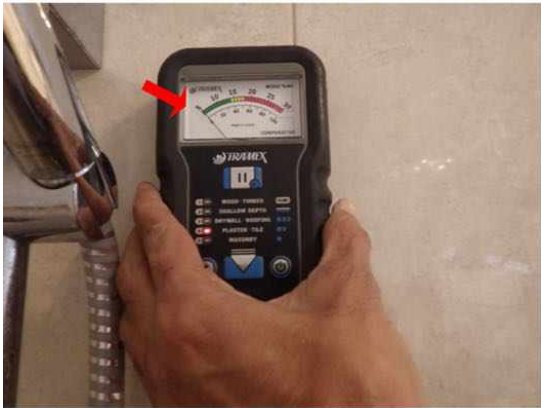
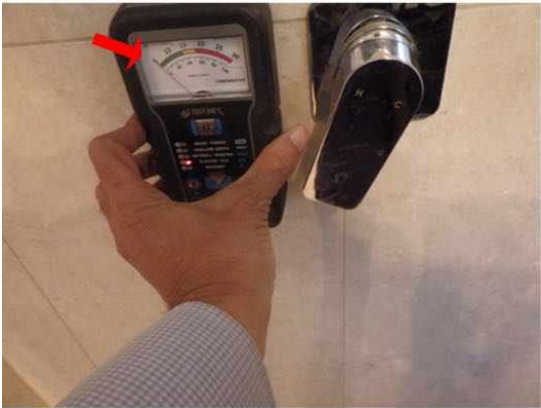
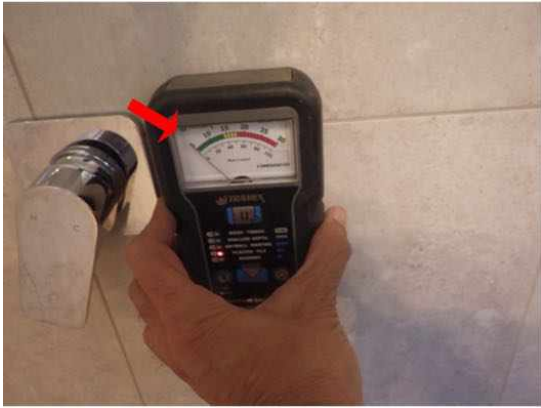
Building: Building 1
Location: Bathroom 3
Finding: Shower Alcove - No Damp
Information: At the time of inspection it was noticed that damp is not evident to the shower alcove.

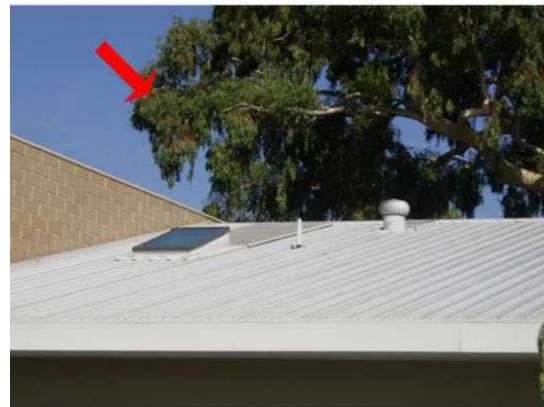
Building:	Building 1
Location:	All External Areas
Finding:	Trees - Overhanging and filling gutters
Information:	Overhanging trees often result in excessive amounts of leaf debris accumulating in gutters.

Gutters are a critical part of the building's management of storm water and rain. It is therefore important that they be kept clear to prevent secondary damage to associated building elements, including exterior and interior walls, ceiling linings and any adjoining building elements. Where gutters are blocked, pooling of rainwater is likely to occur, fast-tracking rust and corrosion of the roof plumbing elements.

It is highly advised that all overhanging tree branches be removed as soon as possible to prevent any further damage. Repair and/or replacement of sections of damaged guttering may also be required where the extent of the damage necessitates.

Such works should be performed by the homeowner; however, appointment of a landscape contractor or an arborist may be required. Consultation with a licensed roof plumber is required where guttering has been damaged.

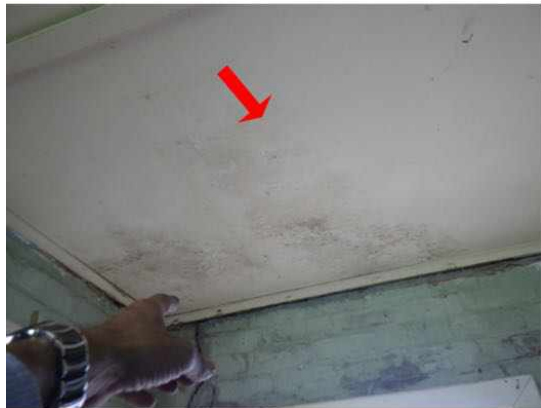
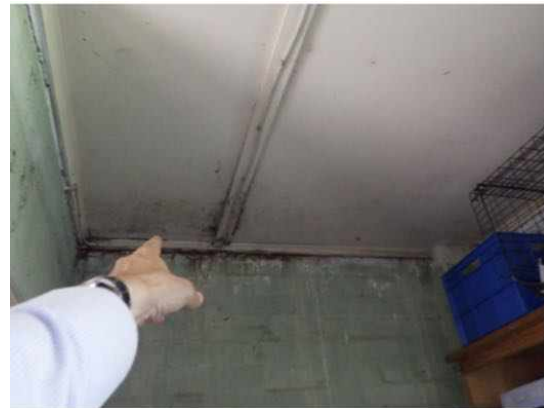
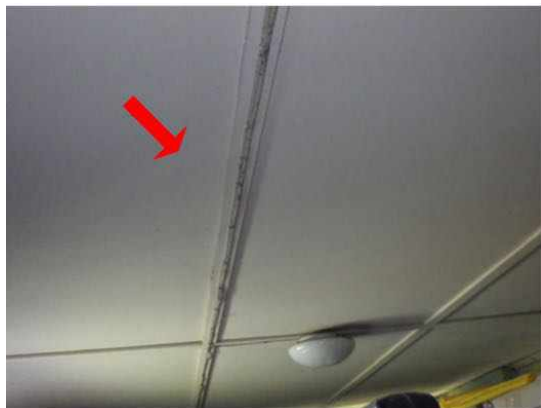
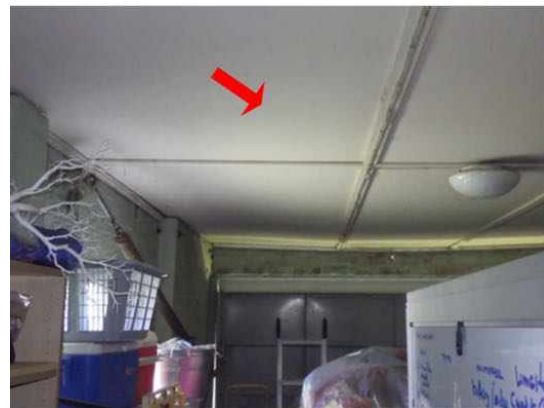
Location: Store Room
 Finding: Asbestos - Suspected ACM Identified on Site
 Information: Reporting on Asbestos is outside the Scope of this Report. This suspected defect is highlighted as a caution only. We suspect, based on our experience in the building industry, that there is a higher risk of the identified building element containing asbestos.

As Asbestos Reporting is outside the scope of this report, we advise that you consider a separate Asbestos Inspection and Condition Audit, which can include the taking of samples for definitive confirmation of the presence of Asbestos.

In the interim, the client is advised to act with caution, especially when considering any damage to building materials general wear and tear renovations extensions demolition and general maintenance activities due to the suspected presence of Asbestos.
