# Building and Timber Pest Inspection Report

Inspection Date: Tue, 24 Mar 2026

Property Address: 1/125 Appin St, Wangaratta VIC 3677,  
Australia

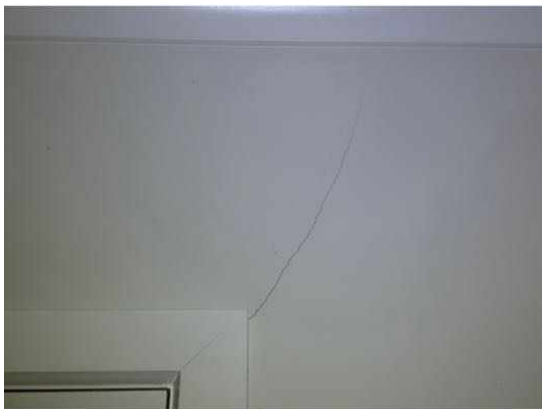
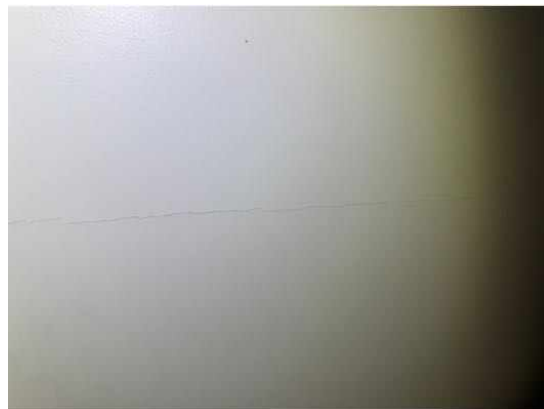
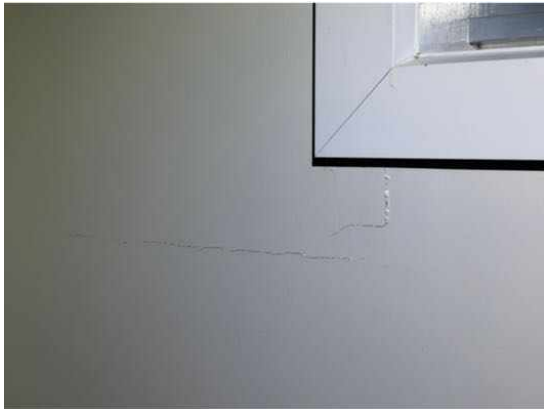
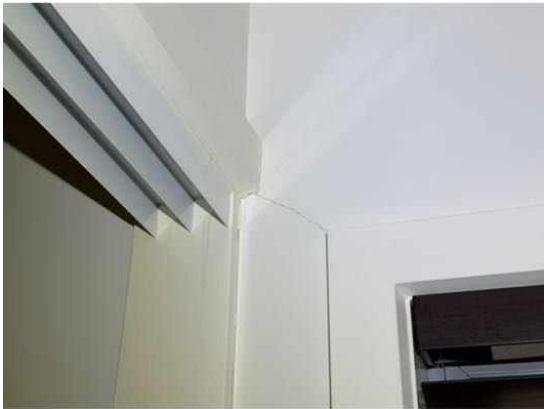
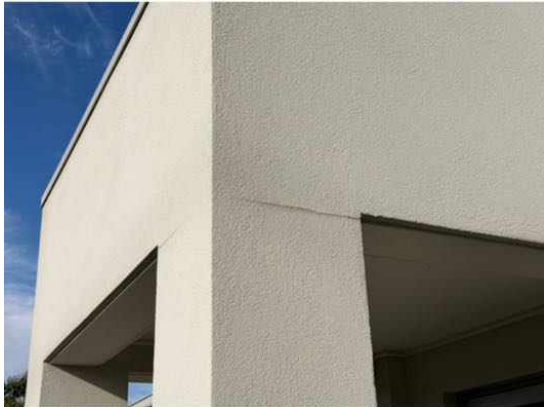
#### Finding 3.01

Building: Main Building  
Location: Internal Areas, Render  
Finding: Cracking - External & Internal  
Information: Cracking was identified to some areas of the render and internal wall linings at the time of inspection. The most common cause of cracking is “settling” of the building after construction and/or expansion / contraction of building materials. Cracking is a relatively common defect, and is most likely to occur adjacent to windows, doors and other openings.

The client should monitor the cracking. Should the cracking lengthen, widen or become more numerous, the client should consult with their building inspector promptly, to provide further advice.

All areas of internal and external cracking should be monitored. Should cracking lengthen, widen, or become more numerous, the client should engage their building inspector promptly, to provide further advice.

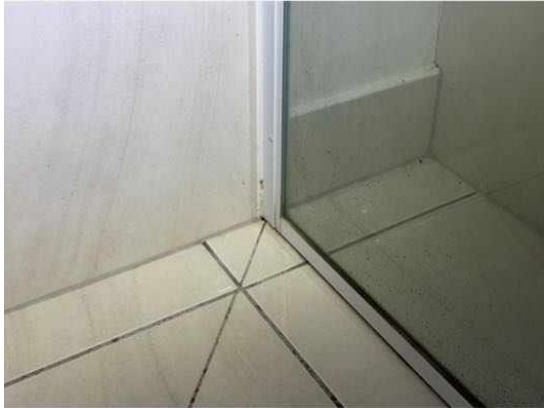
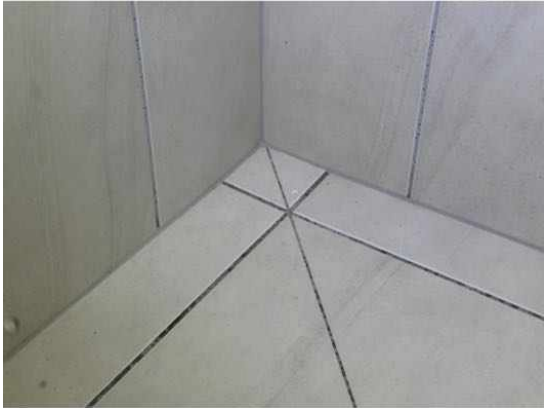
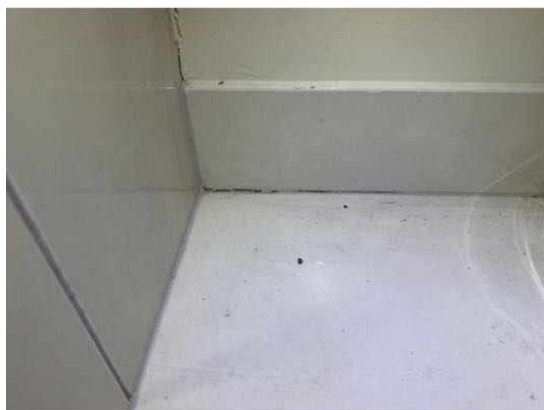
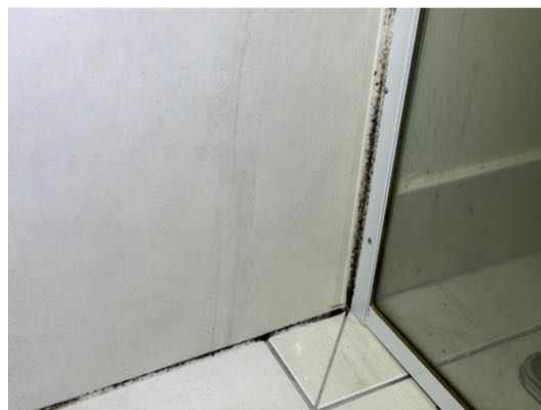
**Finding 3.02**

Building: Main Building  
 Location: Tiled Areas  
 Finding: Sealant and grouting - deteriorated / Weathered  
 Information: It appears that the sealant and grout is slightly deteriorated / weathered, in some tiled areas. Sealant and grouting in areas that come into regular contact with water should be maintained for the long term care of your property.

A sealant specialist or tiling contractor can be appointed, at clients discretion, to complete maintenance works where necessary.

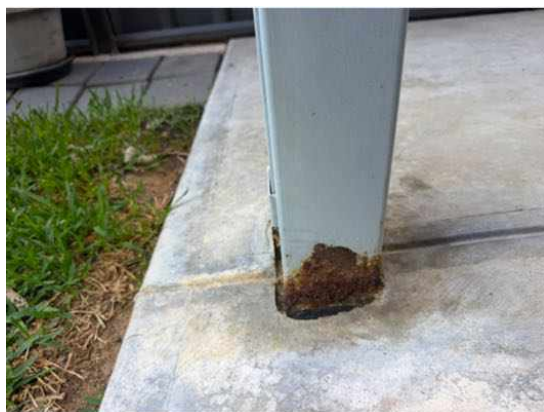
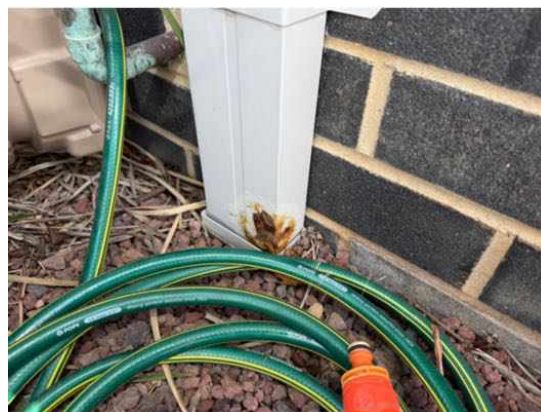
### Finding 3.03

Building:	Main Building
Location:	Rear Post, Down-pipe
Finding:	Down-pipe & Post - Rust / Corrosion
Information:	It appears that areas of rust / corrosion were present at, but not limited to the front down-pipe and rear post. Areas of rust/corrosion are a relatively common finding and could have several possible causes including water pooling in the area or ongoing exposure to weather conditions.

Recommend client to monitor these areas. Should the rust develop further, a licensed plumber and/or licensed carpenter should be engaged to provide further advice.

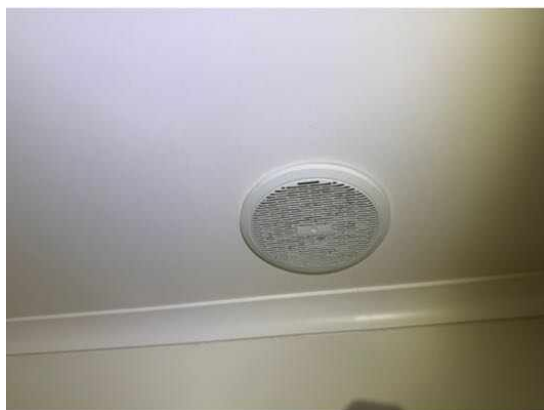
### Finding 3.04

Building:	Main Building
Location:	Ensuite
Finding:	Exhaust fan - Not operating
Information:	It appears that the ensuite exhaust fan was not operating at the time of inspection.

Recommend engaging a licensed electrician to repair / replace the exhaust fan, at the clients convenience.

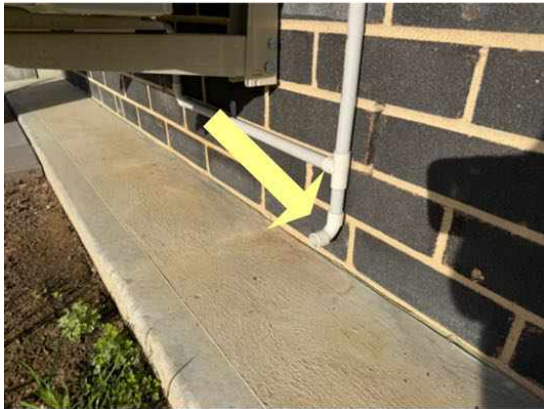
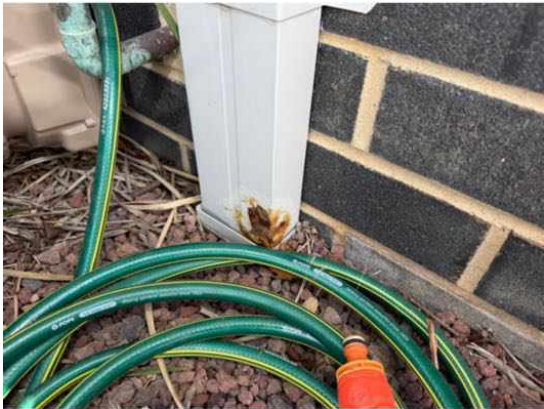
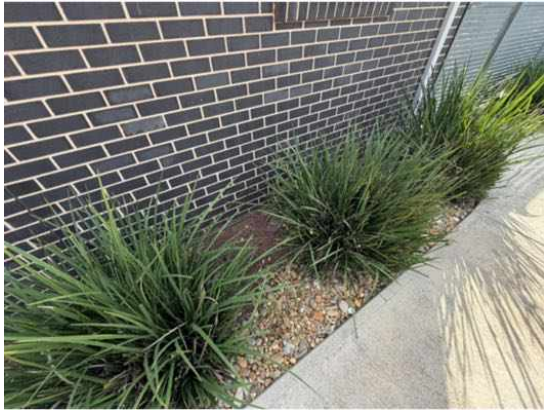
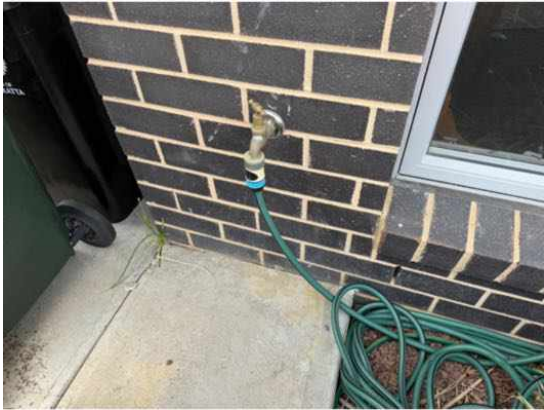
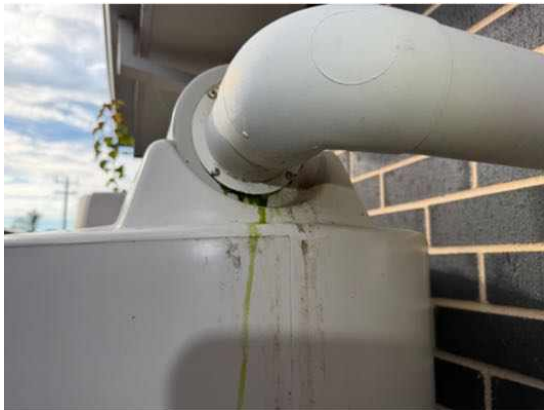
### Finding 6.01

Building: Main Building  
Location: All external areas  
Finding: Potential Water pooling - against property  
Information: Potential areas of water pooling around the perimeter of the property were identified. It appears the water tank overflow, showed signs of minor leaking.

Where insufficient drainage of taps, aircon overflows, and garden beds against the house are present, water pooling is likely to occur, and can create areas conducive to timber pests.

Recommend consulting with a licensed plumber and/or landscaping contractor to provide further advice & remedial works where necessary.

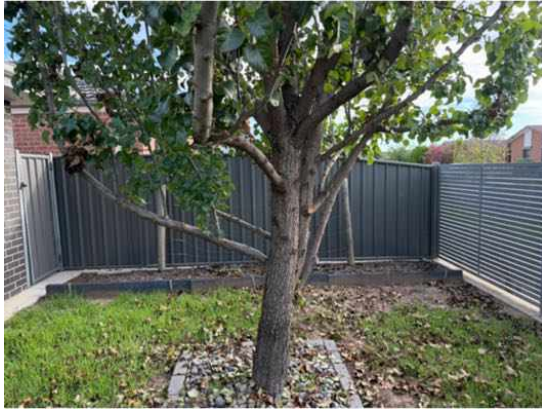
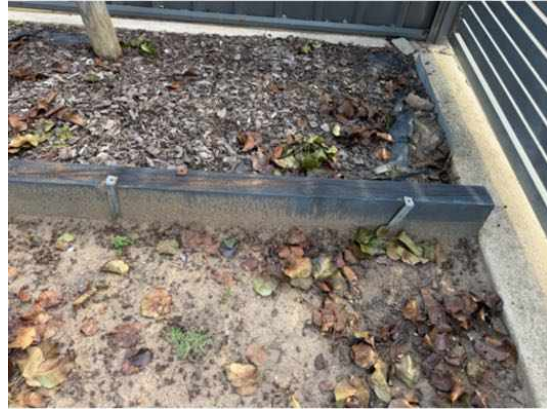
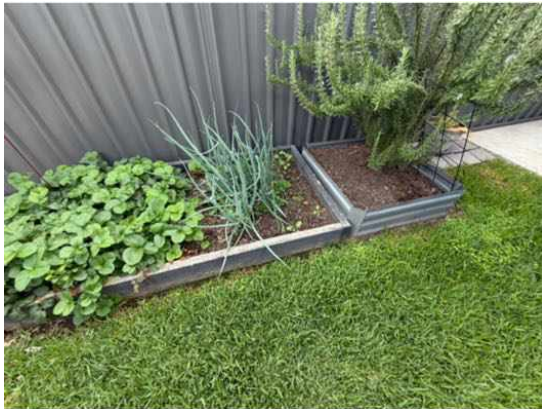
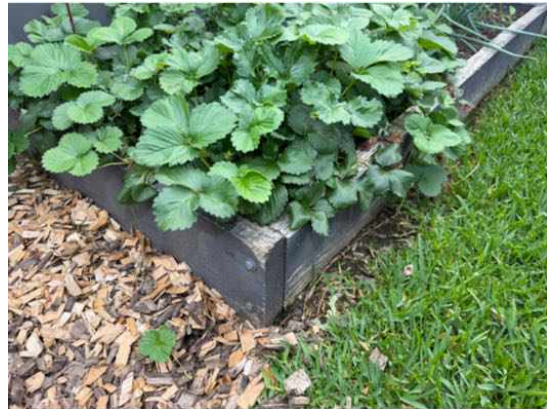
**Finding 6.02**

Building: Main Building  
 Location: All External Areas  
 Finding: Timber in direct ground contact & trees - conducive to termites  
 Information: Where timber materials are in direct contact with the ground and consequently moisture, they become conducive to termite activity. The landscaping timbers, and trees surrounding the building create an environment conducive to termite activity.

Where feasible, any timbers in direct contact with the ground should be removed and any trees in close proximity to the building should be removed or test drilled (inspected) at least annually to reduce the risk of termite infestation & detect any early signs of termite activity.

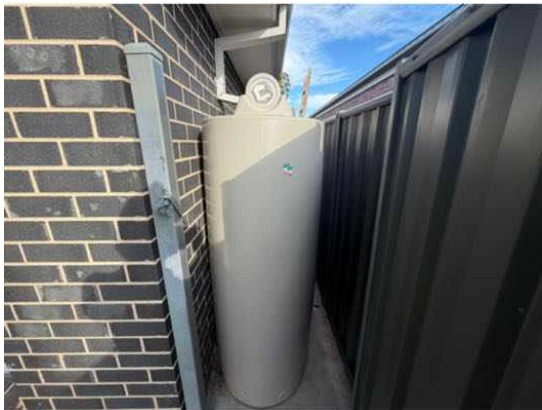
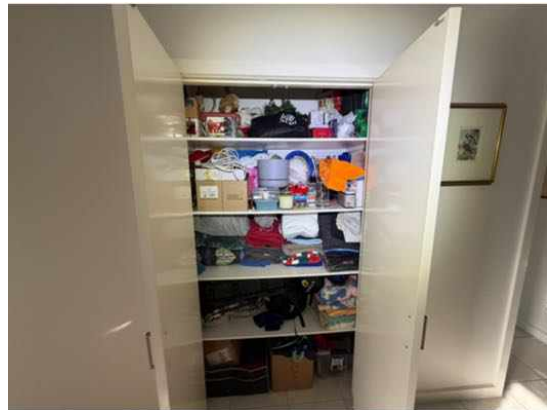
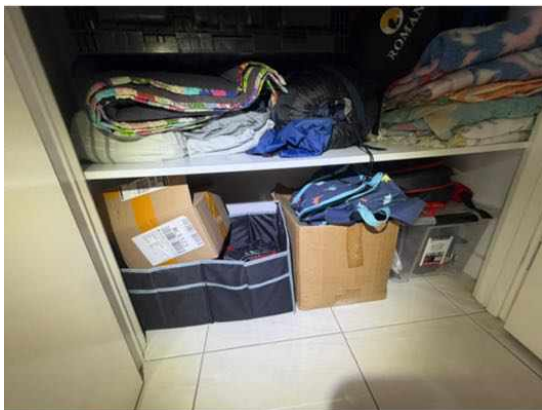
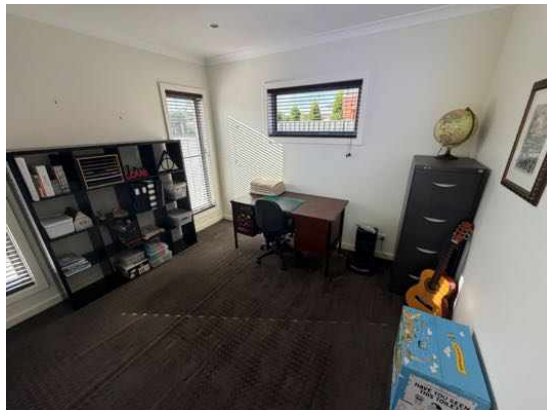
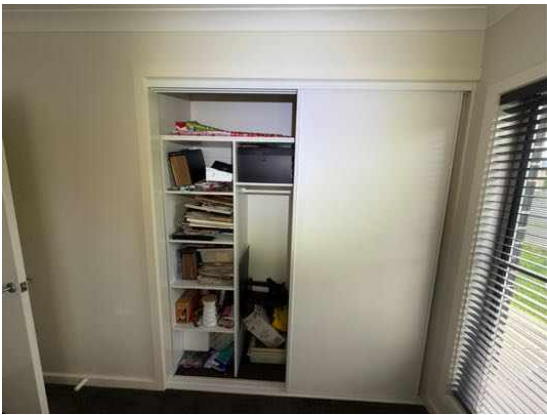
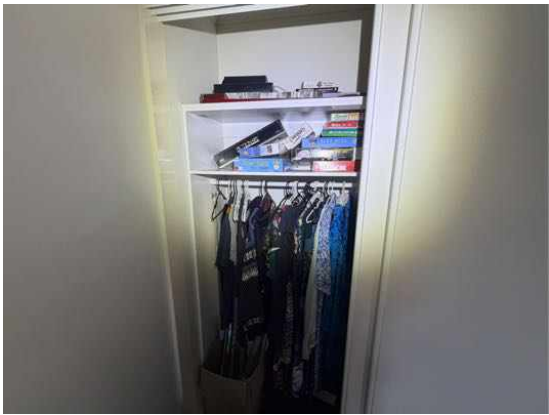
Finding: Additional Photos - Obstructions and Limitations

Information: These photographs are an indication of the obstructions and limitations which impeded full inspection of the property at the time of inspection. These obstructions can hide an array of defects and should be removed to allow full inspection to be carried out. A re-inspection is recommended once the areas are made accessible.

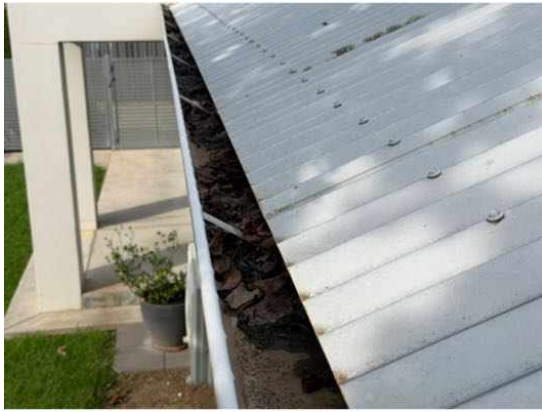
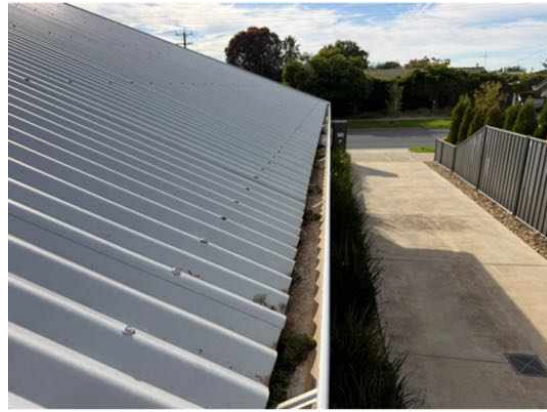
Building: Main Building  
 Location: Guttering  
 Finding: Debris in Gutters  
 Information: It appears that there is some debris in the gutters. Accumulation of debris can lead to blockages of the gutters overtime, if neglected.

Recommend engaging a general handyman to remove debris from the gutters to prevent further accumulation.

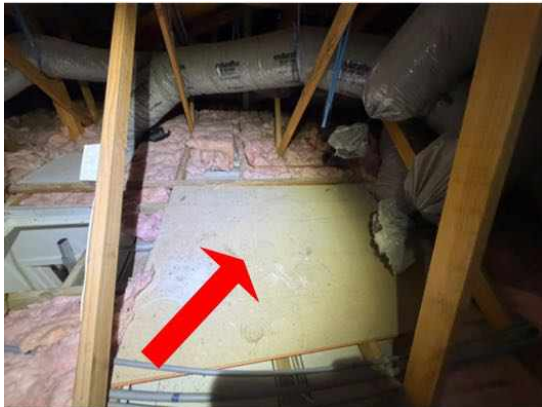
Building:	Main Building
Location:	Roof Void
Finding:	Ducted Gas Heater - Disconnected
Information:	It is noted for your information that the ducted gas heating appears to have been disconnected. The client can seek further advice from a HVAC specialist, at their discretion.

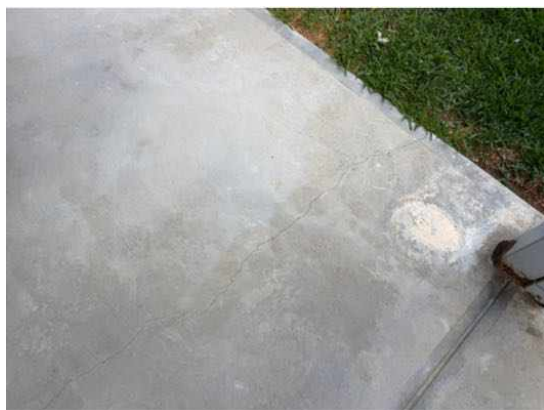
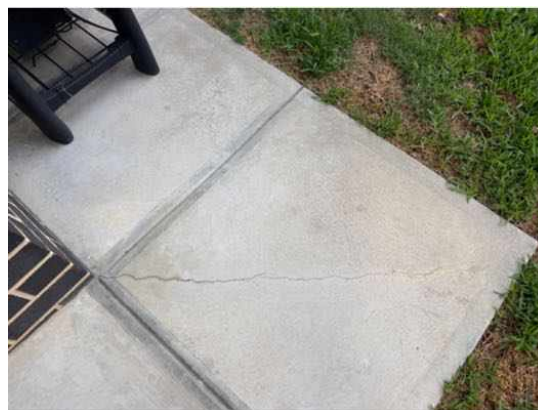
Building:	Main Building
Location:	Pavement
Finding:	Cracking - Pavement & Footpath
Information:	It was noted there is cracking in areas of the pavement. Cracks in the pavement are a common occurrence in houses of a similar age.

Recommend that the client monitor the cracking. A licensed concreter can be engaged at clients discretion, should cracks widen, lengthen, or become more numerous.

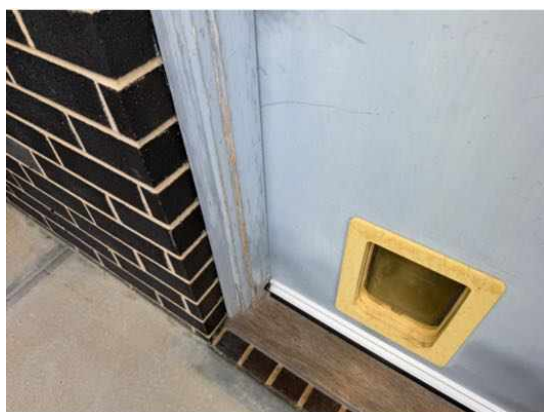
Building: Main Building  
 Location: Garage Door frame  
 Finding: External Timbers - General Weathering  
 Information: Some external timbers at, but not limited to the garage door frame had areas of general weathering, a common defect in buildings of a similar age.

Recommend engaging a licensed painting contractor at clients discretion, to provide maintenance works where necessary.

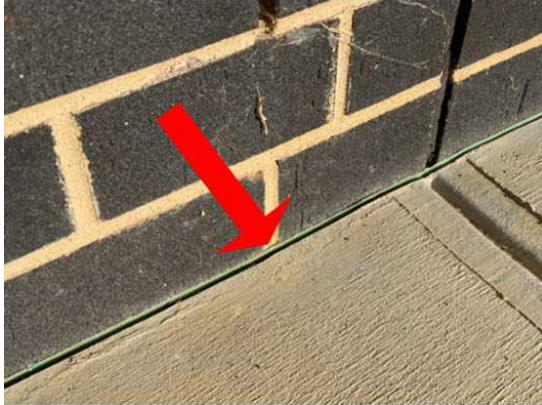
Building: Main Building  
 Location: Brickwork  
 Finding: Evidence of a previous termite management system (physical barrier)  
 Information: Although no durable notice was present in the meter box, it appears that a physical barrier is in place. This barrier prevents concealed termite entry into the building and forces termites out into the open. Regular 12 monthly inspections should be

conducted by a qualified termite inspector, to identify any early signs of timber-pest activity.

Recommend consulting with the pest control company that installed the barrier, to provide further advice regarding the system and future management plan.
