# Building and Timber Pest Inspection Report

Inspection Date: Thu, 29 Jan 2026

Property Address: 63 Tanbark Cct, Werrington Downs NSW  
2747

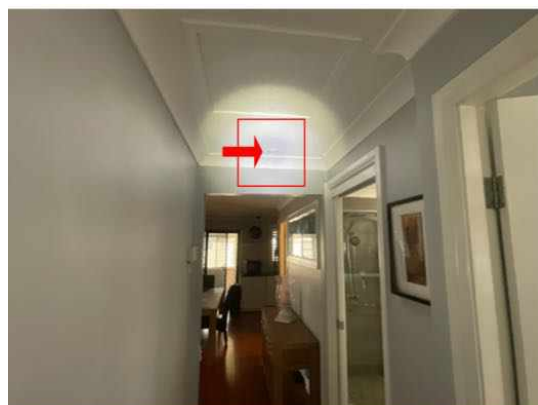
No smoke protectors were found in the house.

To ensure compliance and safety, further inspection and/or advisory services from a qualified specialist are recommended. These services can confirm the sufficiency, type, location, and functionality of all smoke detection devices within the property.

- All smoke detectors be tested monthly by the homeowner.
- All systems comply with the requirements of AS 3786 and any applicable state-based legislation.

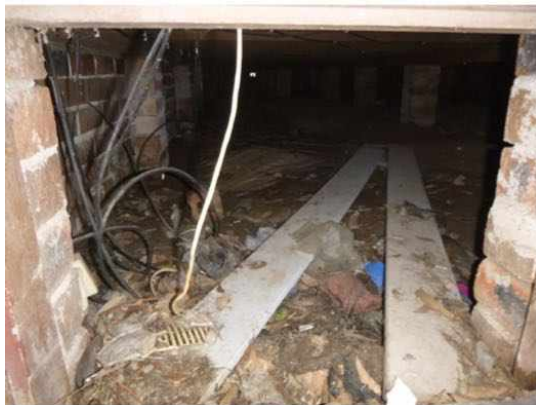
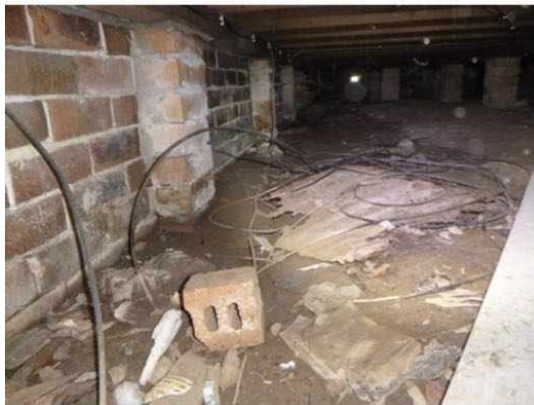
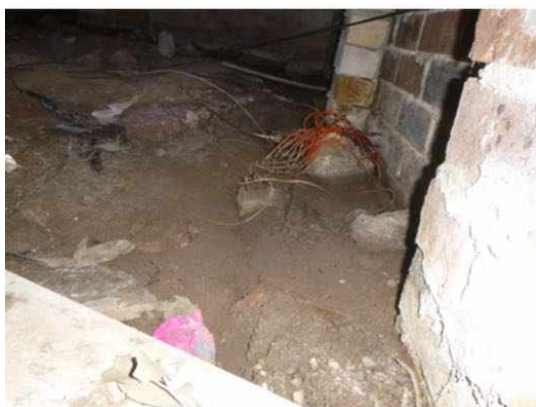
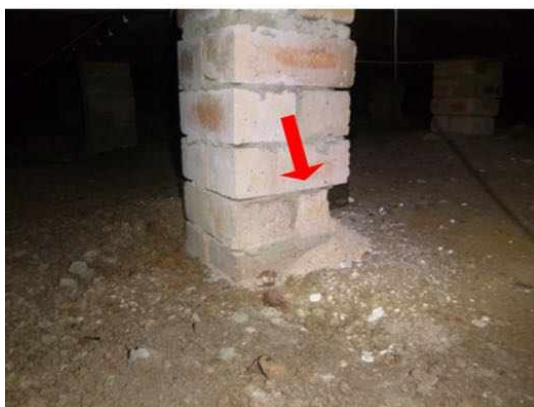
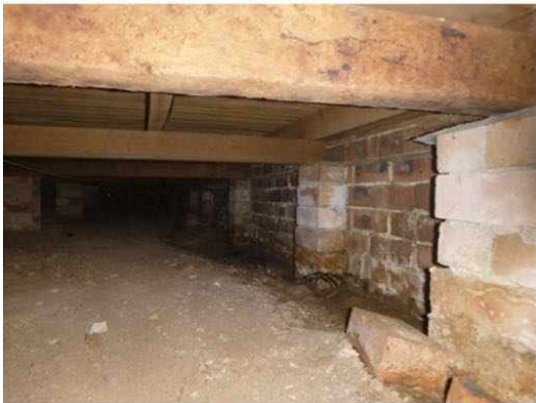
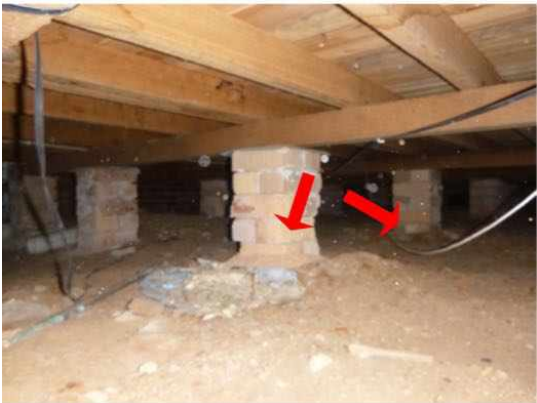
### Finding 2.01

| Finding: | Subfloor - Excessive Moisture identified. |

Evidence of excessive moisture was noted in isolated areas of the subfloor area. These findings indicate that moisture problems are ongoing and likely associated with substandard yard/subfloor drainage and ventilation.

Although the subfloor was mostly dry at the time of inspection, there was evidence of previous dampness and indicators of ongoing moisture-related issues.

- Compacted or cracked soil and minor fretting of some piers was noted, which typically suggests the area has been exposed to excessive moisture that has since dried.
- Such conditions are common in properties with sloping land, where poor site drainage leads to water entering and pooling in the subfloor.

- Redirect all surface water runoff away from the building to prevent further moisture ingress.
- Where subfloor drainage is inadequate, install an agricultural (Aggie) drain or equivalent drainage system.
- Consider the installation of fan-forced subfloor ventilation to improve airflow and assist in drying out excess moisture.
- Engage a qualified roof and drainage plumber experienced in site drainage to assess and rectify contributing issues.
- Consult a subfloor ventilation specialist to design and install an effective ventilation system suited to site conditions.

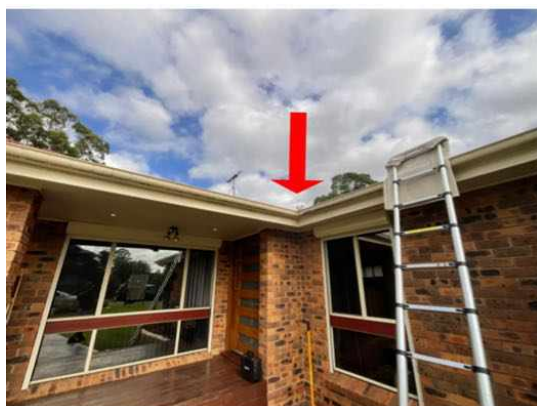
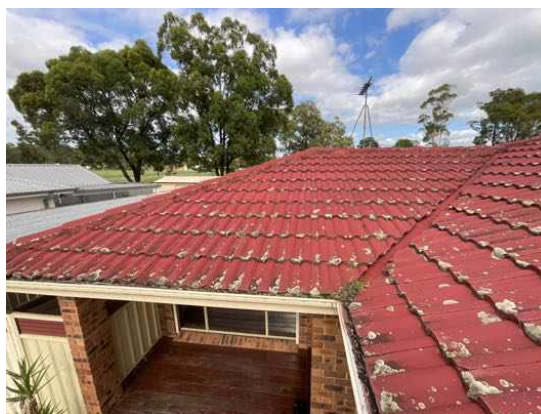
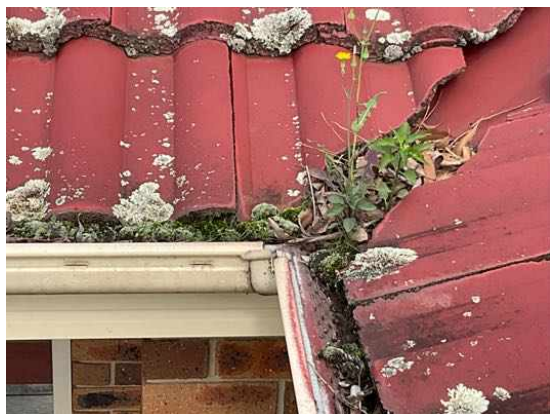
### Finding 3.01

| Finding: | Minor Defect – Blocked Guttering. |

During the inspection, the guttering was found to be blocked at this location. Debris accumulation was observed, restricting the effective flow of rainwater through the gutter system.

This defect is considered minor; however, timely maintenance is advised. Blocked gutters should be cleared to restore effective drainage and reduce the risk of moisture-related deterioration. Cleaning may be undertaken by the homeowner or a general handyperson in the short term. For further assessment or if ongoing drainage issues are identified, consultation with a licensed plumber is recommended to determine whether additional remedial works or system improvements are required.

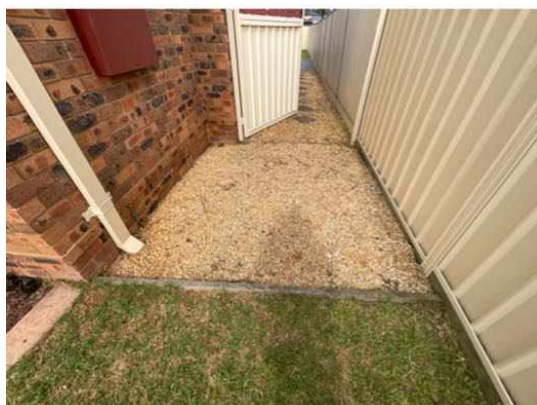
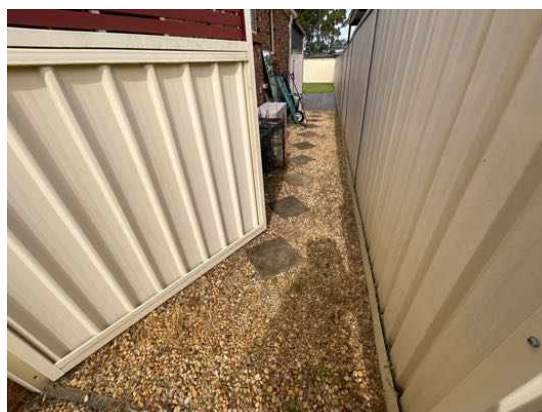
### Finding 3.02

| Finding: | Site/Yard drainage - Inadequate. |

At the time of inspection, site drainage in this area was found to be inadequate, allowing water to pool against the base of the external walls.

Site drainage in the inspected areas appears to be below average, with no surface drains observed at the time of inspection. Ground surfaces and paved areas adjacent to the building do not appear to be adequately graded to facilitate effective surface water runoff.

- A licensed plumber and/or landscaping contractor should be engaged to:
  - Evaluate the current site grading and surface runoff conditions
  - Install or upgrade surface water drainage (e.g. strip drains, spoon drains, grated channels) as required
  - Improve grading around the building to ensure water flows away from the structure

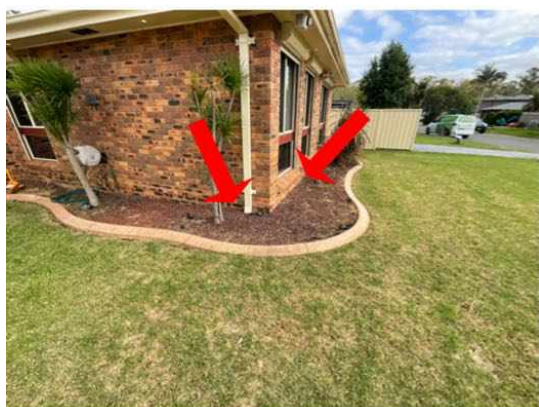
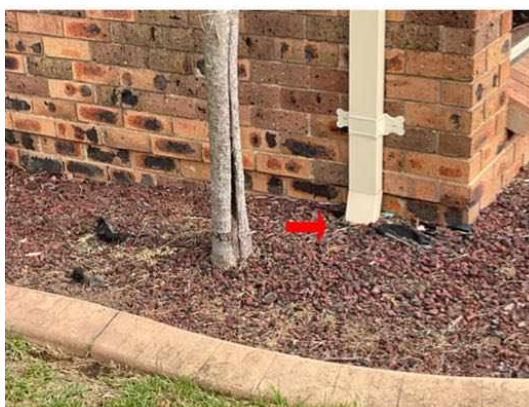
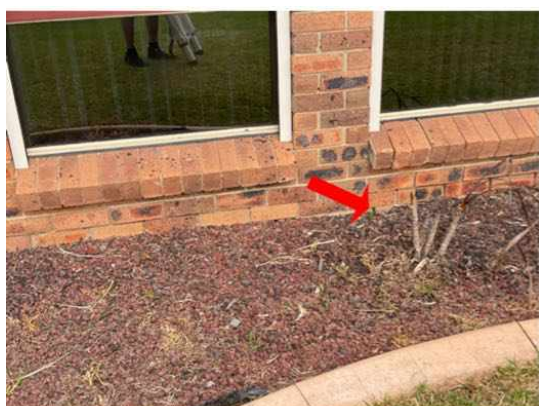
### Finding 3.04

| Information: | Subfloor Ventilation and Ground Levels – Moisture Risk |

Subfloor wall vents in the inspected locations were found to be positioned too low due to substandard external landscaping and ground levels. The external ground raised adjacent to the building perimeter, increasing the likelihood that rainwater can enter the subfloor via the vents during wet conditions.

Ongoing moisture ingress into the subfloor can result in persistently elevated moisture levels. If left unrectified, these conditions may promote fungal growth, timber decay, deterioration of mortar and brickwork, and cracking or subsidence of supporting piers. Elevated moisture levels also increase the susceptibility of the property to termite and other timber pest activity. Secondary water damage is likely to occur over time if the issue remains unmanaged.

Perimeter landscaping and ground levels should be rectified to expose and ensure adequate airflow through vents and fall away from the building. As a general guide, paved surfaces should fall away from the structure by a minimum of 25 mm over the first metre, and bare ground should fall away by approximately 50 mm over the first metre. This will assist in preventing moisture from pooling against the building and entering the subfloor.

Where site drainage is inadequate or rectification is complex, a qualified plumber and landscaping contractor should be engaged to further assess the site and undertake appropriate remedial works to achieve and maintain a dry subfloor environment.

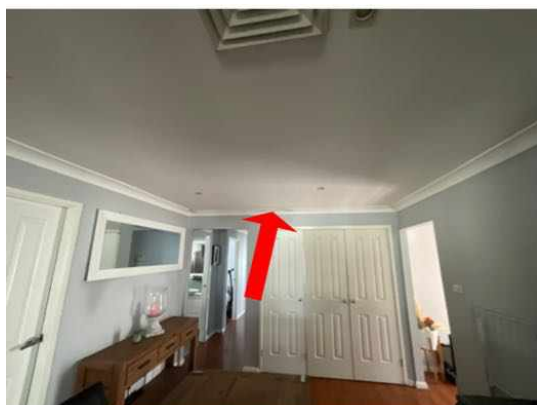
### Finding 3.05

Building: Main Building  
 Location: Dining Room  
 Finding: Ceiling - Water stained.  
 Information: Observation:

Water staining was noted to ceiling linings in the inspected area(s) at the time of the inspection. These stains present as discoloured or patchy areas and may suggest a history of moisture ingress, most commonly associated with roof leaks or plumbing issues.

- Where the staining is active or suspected to be active during wet weather, a qualified roofing specialist should be engaged to conduct a more detailed inspection. Their investigation should focus on identifying the exact source of moisture ingress and advising on necessary repairs to the roof coverings, flashings, penetrations, or associated components.
- Where the staining appears to be historical (i.e., dry and showing no recent progression), reparation of affected ceiling materials (such as repainting or patching) may be carried out at the client's discretion, subject to confirmation that the source of the leak has been effectively addressed.

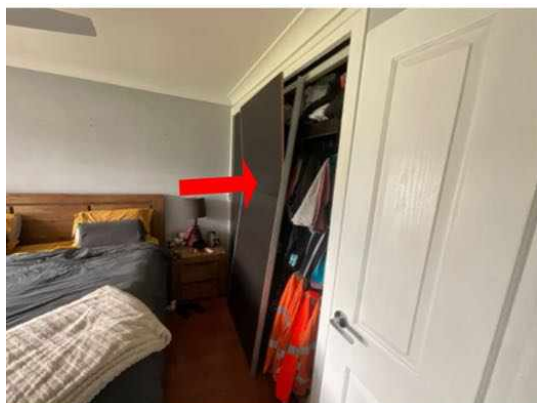
### Finding 3.06

Finding: Minor Defect – Internal Door

During the inspection, damage was identified to an internal door within the property. The door panel is cracked and snapped, with the damage consistent with impact. As a result of this damage, the door is unable to operate as intended.

While this defect is not structural and does not present an immediate safety risk to the dwelling, the door is currently non-functional. This affects usability, privacy, and general amenity of the affected room. The extent of damage suggests the door has lost its structural integrity.

Repairs are considered minor and non-urgent and may be attended to at the client's discretion. Due to the extent of cracking and snapping, repair is unlikely to be economical. It is recommended that a qualified carpenter or experienced handyperson be engaged to replace the damaged door to restore proper function and appearance.

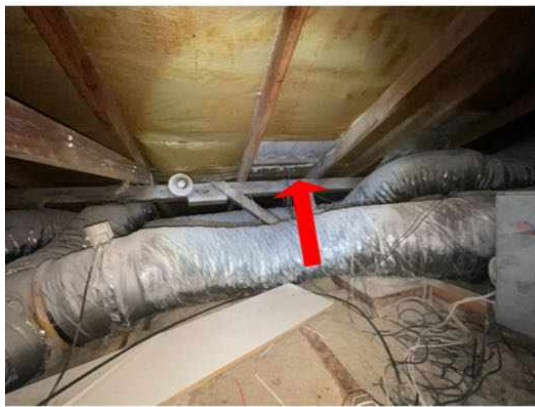
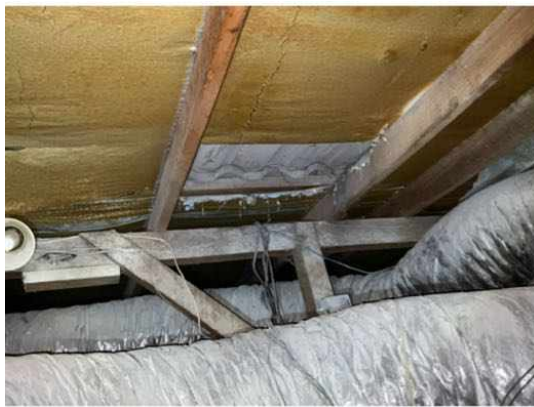
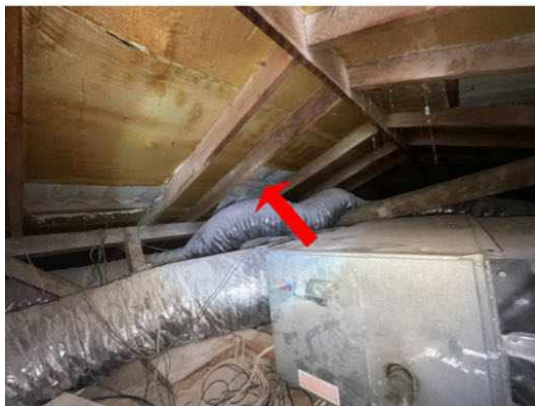
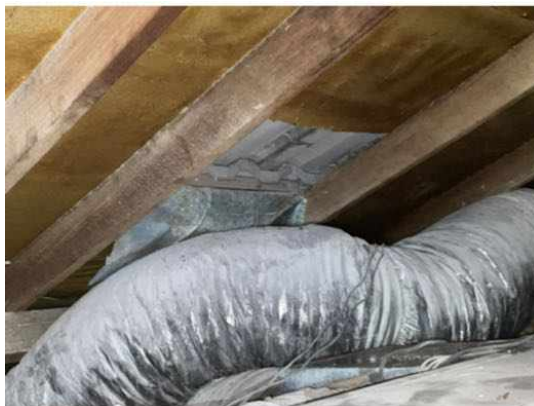
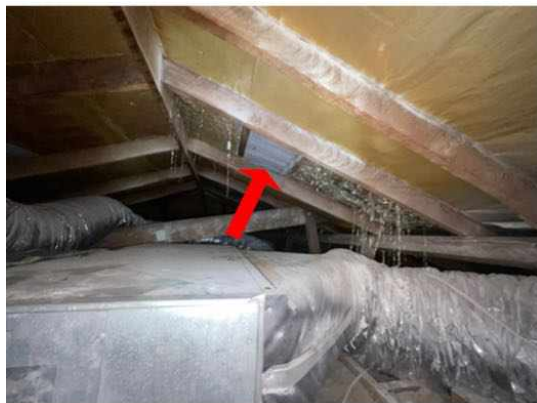
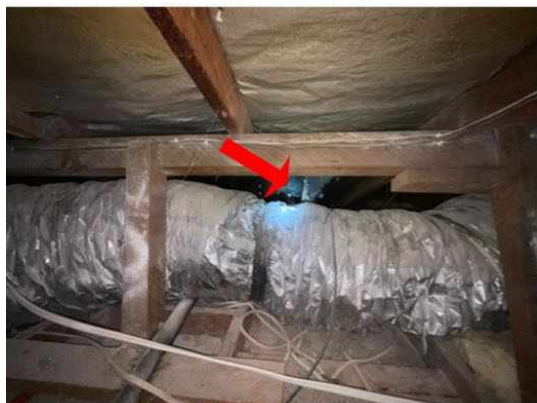
### Finding 3.07

Finding: Damaged Roof Sarking

Where sarking is damaged, its ability to insulate and prevent moisture ingress is compromised. This may reduce the property's energy efficiency and increase the risk of moisture penetration, particularly from condensation or leaking roof tiles.

Any holes or damaged sections of sarking should be repaired or replaced to restore full functionality. These works should be completed by a roofing contractor or other suitably qualified tradesperson.

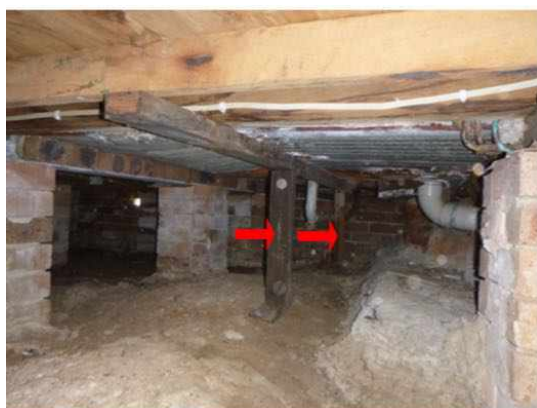
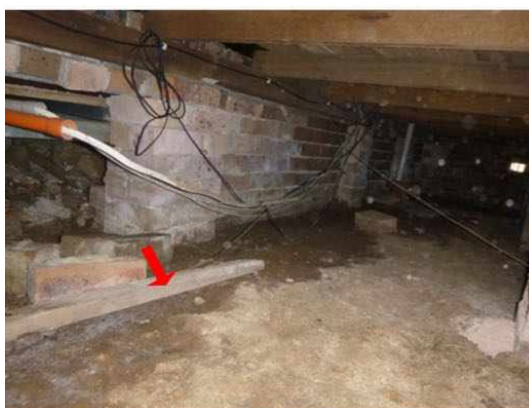
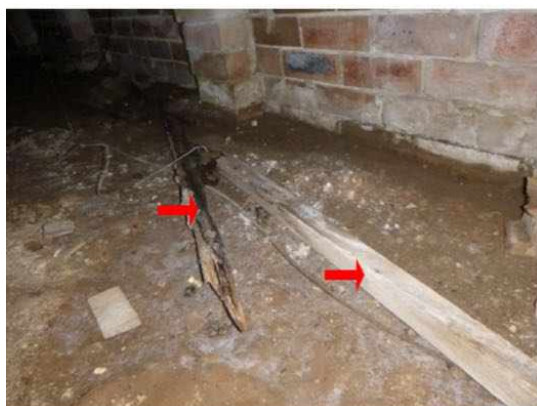
During the inspection, formwork timbers and timber props were observed within the subfloor area. These appear to have been left in place following the concrete construction phase, and are not part of the structural design.

It is strongly recommended that all residual formwork timber and loose timber debris be immediately removed from the subfloor and surrounding areas of the property.

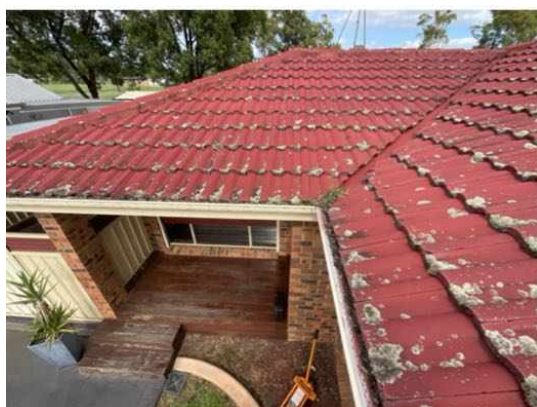
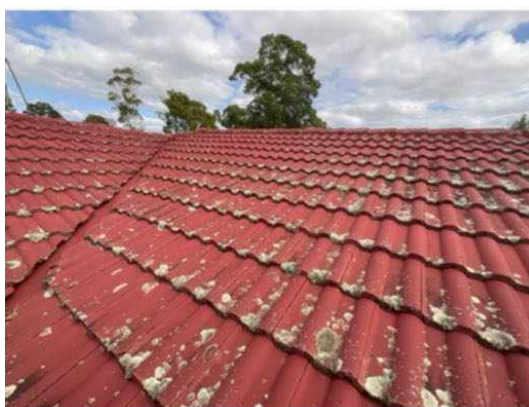
The tiled roof covering was generally sound at the time of inspection; however, evidence of staining to the dining room ceiling suggests possible current or previous water ingress. Further investigation by a licensed roofing contractor is recommended to identify the source and carry out any necessary repairs. Regular maintenance, including cleaning of valleys and gutters and periodic re-pointing of ridge tiles, is advised to maintain weatherproofing and prolong the roof's service life.

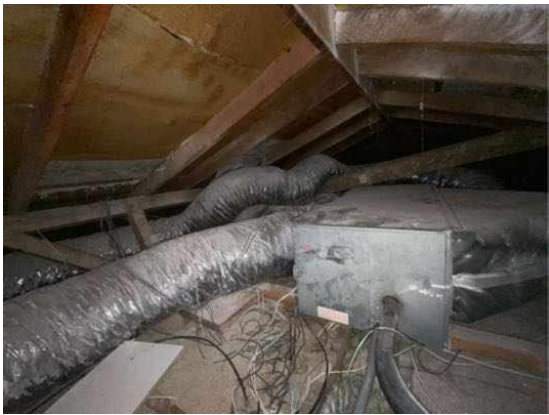
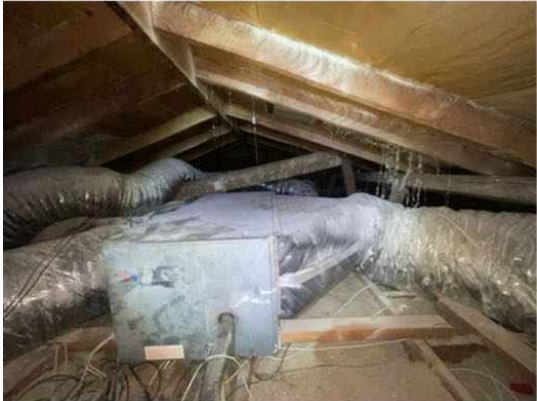
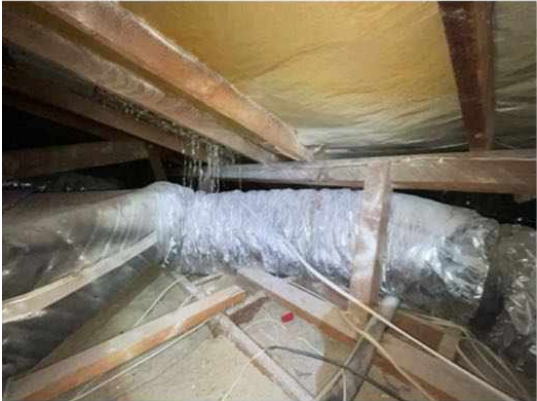
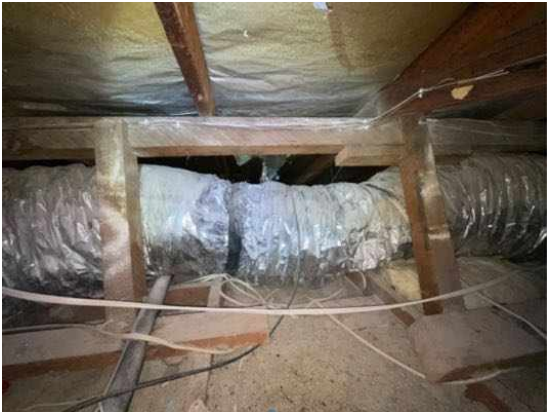
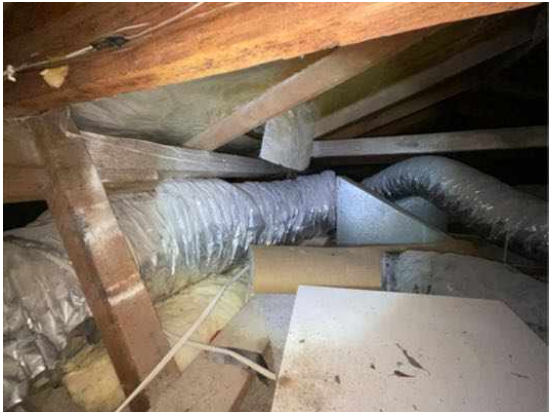
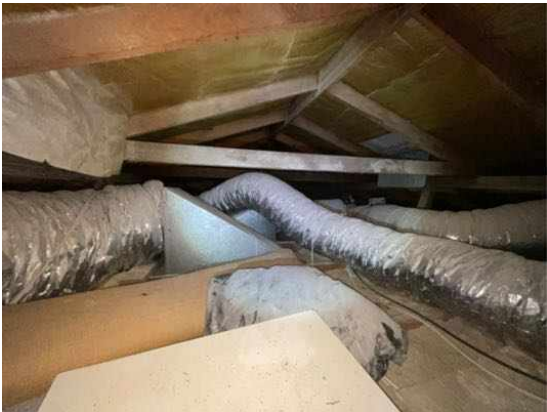
Building: Main Building  
 Location: Roof Void  
 Finding: Roof Void – Limited Accessibility..  
 Information: Observation:

Installation of an additional manhole is recommended to facilitate a re-inspection and enable a more thorough assessment of the roof void in the future. This will help ensure that all structural elements and concealed areas are properly evaluated.
