# Building and Timber Pest Inspection Report

Inspection Date: Wed, 18 Feb 2026

Property Address: 2 McKinnon Dr, Burnside QLD 4560,  
Australia

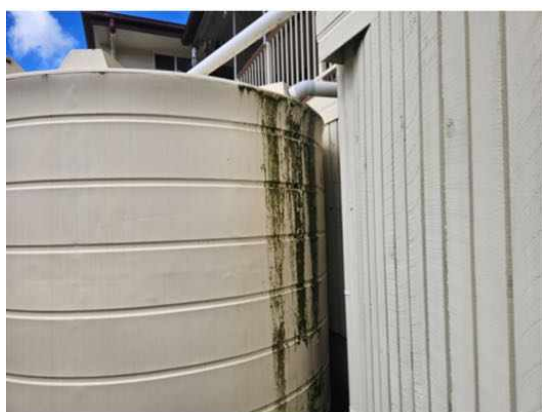
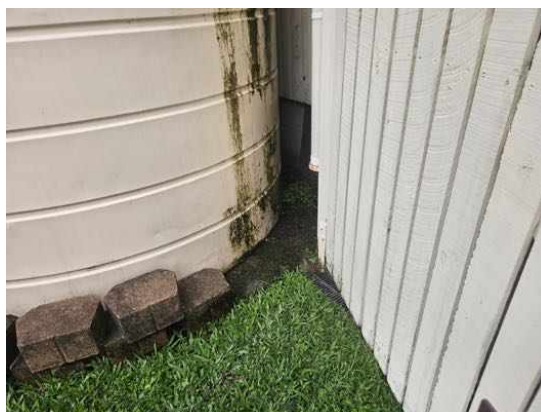
Building: Main Building  
 Location: Rear elevation  
 Finding: Water tank - leaking overflow  
 Information: During the inspection the outlet / overflow was noted as not being effectively connected to the tank. The overflow water is causing rust to form on the surface of the tank. This will likely reduce the tanks life span.

Sealing the overflow and treating the rust on the tanks surface will likely extend the water tanks effective working life.

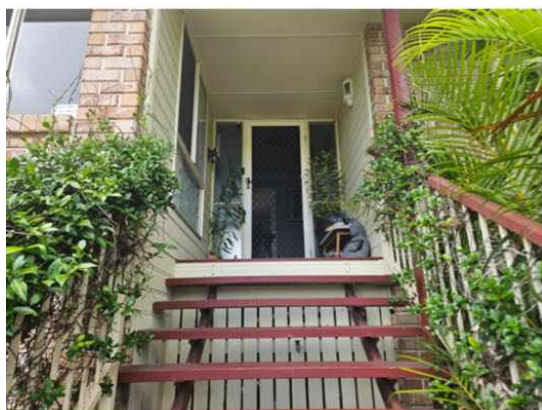
### Finding 3.02

Building: Main Building  
 Location: Front steps

Finding: Wood rot - steps  
 Information: The step tread on the steps to the front entry deck shown have evidence of developing wood rot in the tread shown.

Wood rot, also known as Fungal Decay, occurs when timbers and other cellulose building materials are exposed to damp conditions on an ongoing basis. This could be the result of exposure to weathering over a prolonged period of time, or the attraction of excessive moisture from other abutting building materials. Contributing factors also include poor air ventilation in the area.

Early intervention and regular maintenance, particularly of exterior timbers, will prolong the useful life of these building elements. Prior to any works being performed, the cause of the moisture that has created the visible wood rot should be identified and addressed in a suitable manner. Replacement of affected timbers may then be a necessary step in protecting surrounding building elements from such deterioration.

A licensed carpenter or handy person may be appointed to assess the cause of excessive moisture and to provide advice on any remedial works as required and replace any affected building materials.

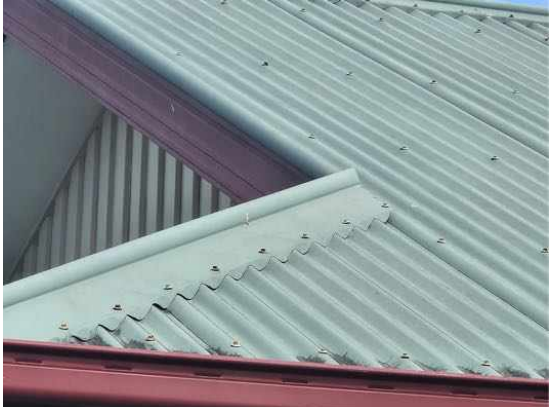
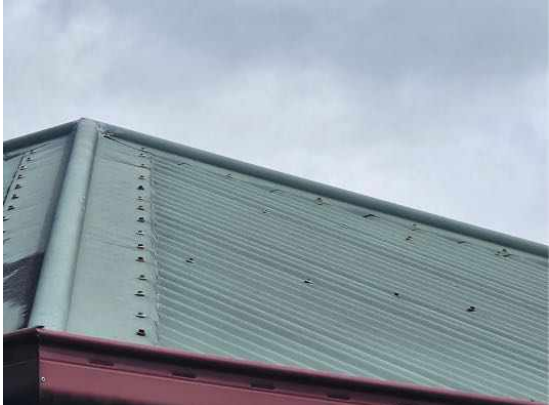
### Finding 3.03

Building: Main Building  
 Location: All External Areas  
 Finding: Roof screws - rusting  
 Information: It was noted during inspection, that throughout the roof surface the majority of roof screws are showing signs of rust to a minor degree.

This should be monitored over time, and should the condition worsen, consider replacement of the screws. As roof screws deteriorate they can have an effect on the adjoining roof materials.

A roofing plumber could be appointed at the clients discretion to replace the screws in question.

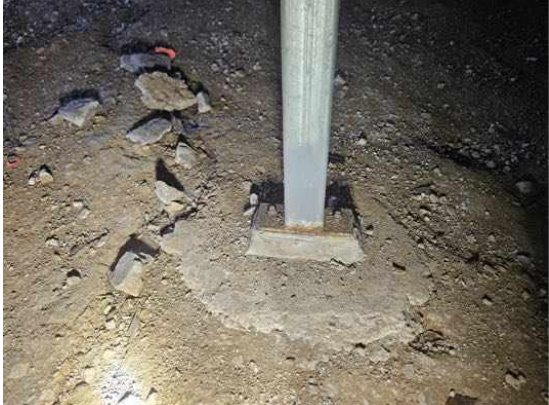
**Finding 3.04**

Building: Main Building  
Location: As shown  
Finding: Post base - rusting.  
Information: It was noted at the time of inspection that surface rust is developing at the base of the house subfloor posts. This should be treated and coated to prevent possible further deterioration.

A licensed painter or suitably qualified handy person could be engaged to carry out the required task.

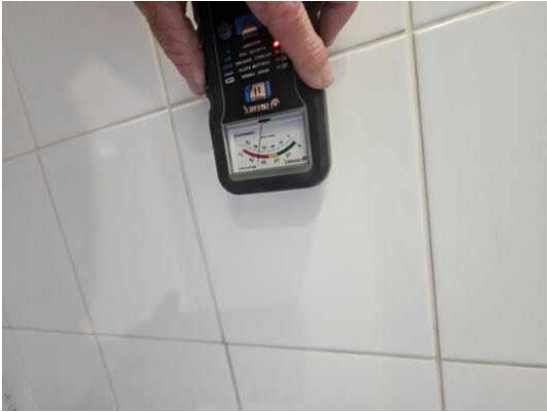
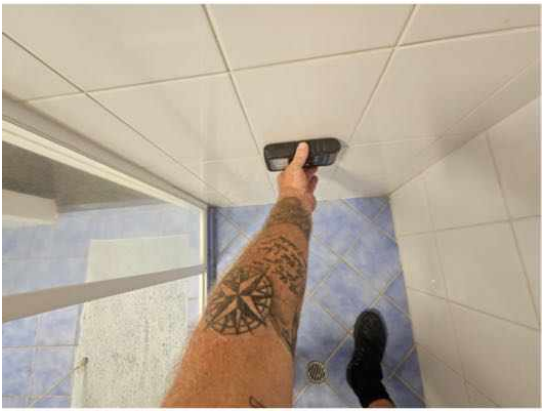
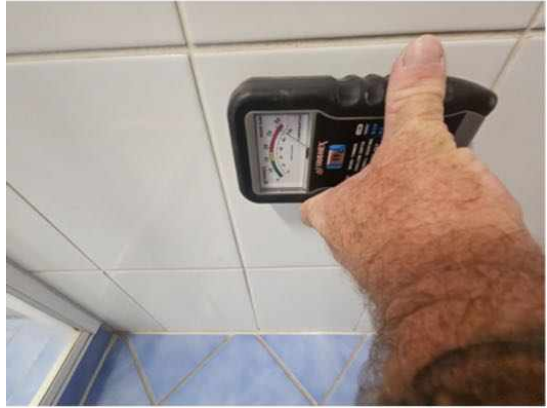
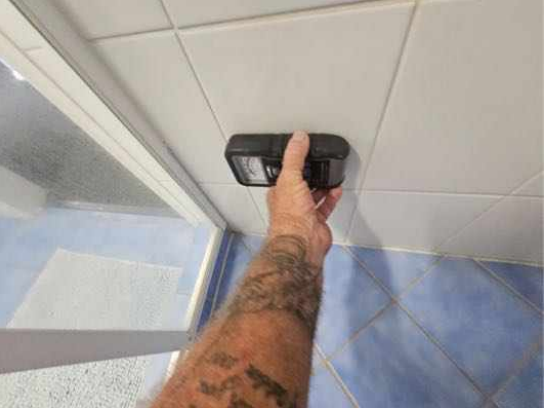
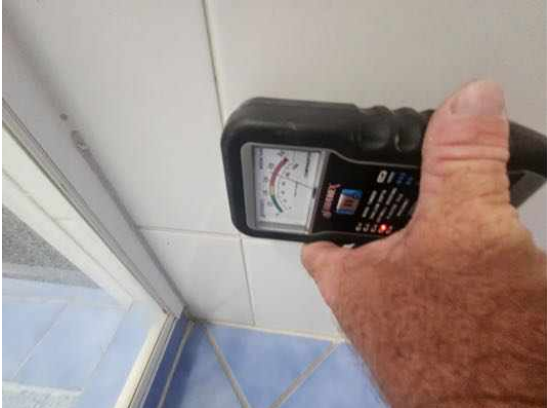
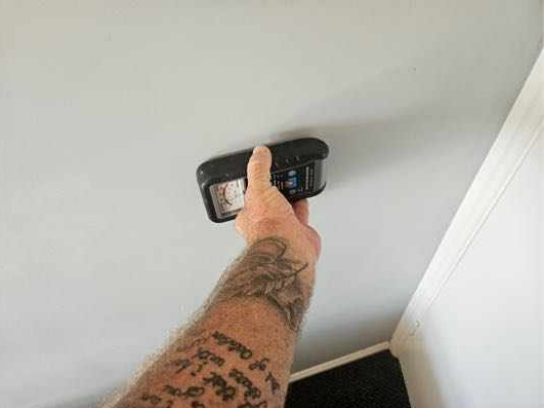
Building: Main Building  
Location: Ensuite - Master  
Finding: Elevated moisture present - ensuite shower  
Information: Elevated moisture was noted in the lower tiled wall surfaces of the ensuite shower.

The levels varied at differing points throughout the recess. This could possibly be due to deteriorated grout and silicone sealants and / or plumbing fittings and fixtures. The grouts and sealants can break down over time and become porous, allowing moisture to enter the wall sheet surface behind the tiles.

No moisture was detected the in the walls on the reverse side of the shower in the bedroom.

Elevated moisture can attract timber pests and vermin, and produce conditions that promote timber pest attack, fungal growth and wood decay.

It is recommended that the moisture levels in these areas be monitored over time and the grout and silicone be renewed to possibly eliminate any further moisture penetration.

A licensed tiler and / or sealant specialist could be engaged to renew these elements.

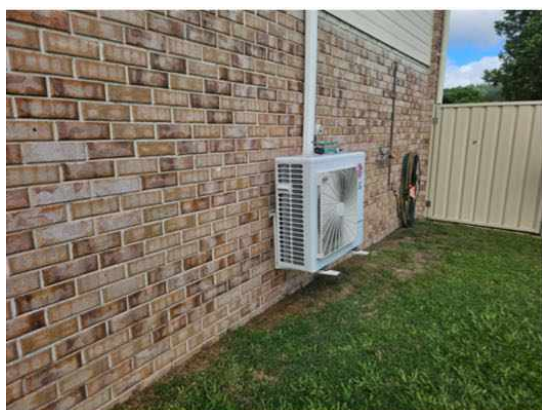
Building: Main Building  
Location: Left elevation  
Finding: Air conditioner - Disconnected drain  
Information: The Air Conditioner (A/C) overflow was found to be disconnected from storm water drainage and could create excessive moisture in the surrounding area.

Such leaking creates an environment which is conducive to an array of defects, including water damage to associated building elements and the attraction of termite or timber pest infestation.

It is recommended that a licensed plumber be appointed to connect the A/C overflow to a drainage source in order to prevent such an environment from being created. An alternative is to extend the overflow further into the garden away from the building perimeter.

These minor works should be carried out in the short term.

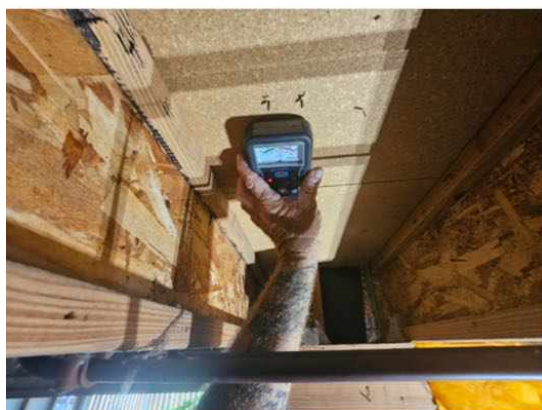
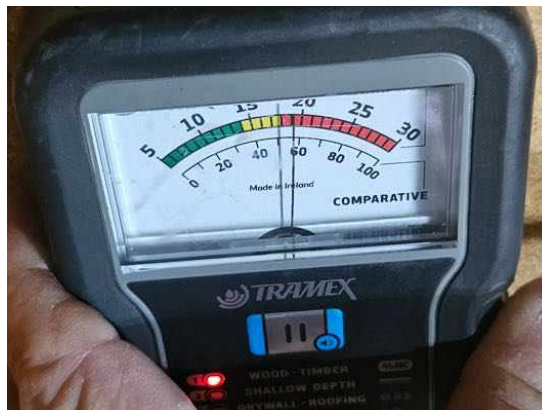
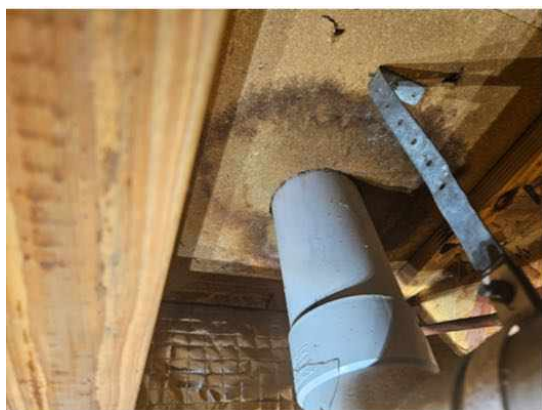
Building:	Main Building
Location:	Toilet, laundry
Finding:	Floor sheets - Water stained, moisture present
Information:	Water staining and elevated moisture levels to underside of the floor sheets of the toilet, and to a lesser degree beneath the laundry, was evident at the time of inspection. Water staining indicates that surfaces have been exposed to moisture over

time, possibly from a leak in the toilet waste pipe. The stains did read as high in moisture on the day of inspection, and when compared to other areas of the floor, the relative difference is high. The plumbing service / fixtures in this area should be assessed.

Minor staining and elevated readings were noted beneath the laundry also and will require assessment of the drains.

While mostly an appearance defect at this time, if left unattended, the water staining / damage can become a more serious defect, which may lead to the breakdown of the flooring substrate.

Where water staining is active, a licensed plumber must be consulted to identify the cause of the staining and to provide advice on any reparation works that may be required. Replacement of any damaged structures is advised.

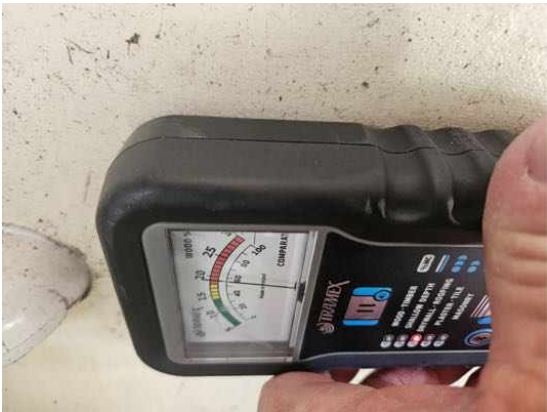
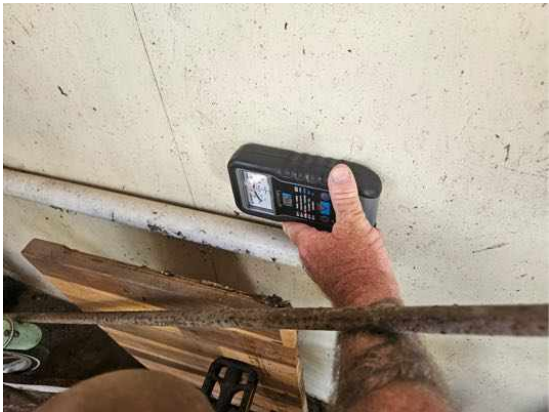
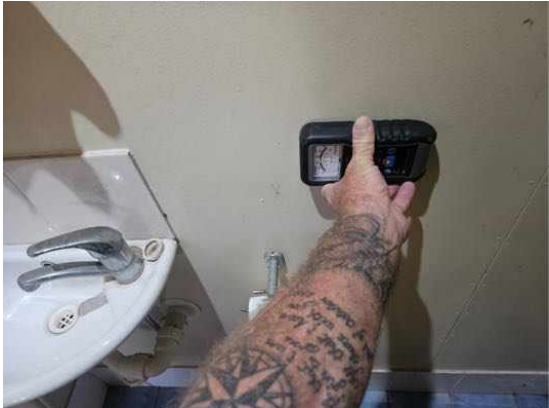
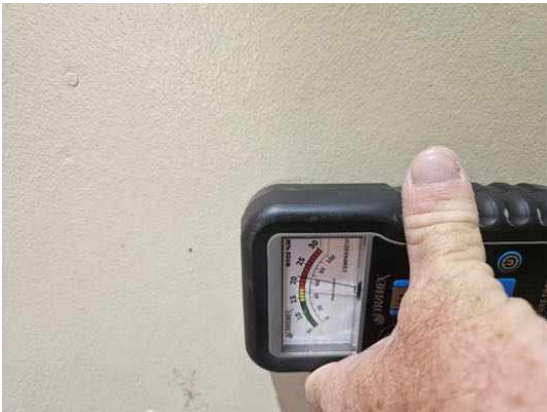
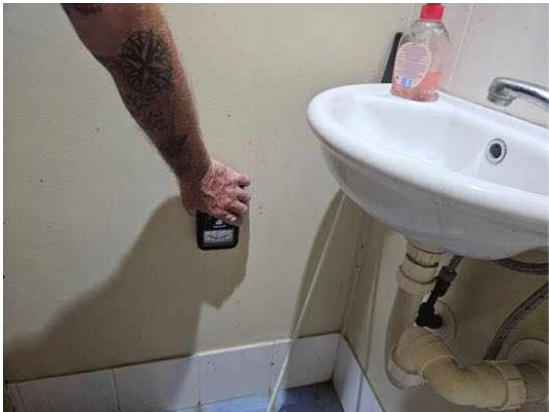
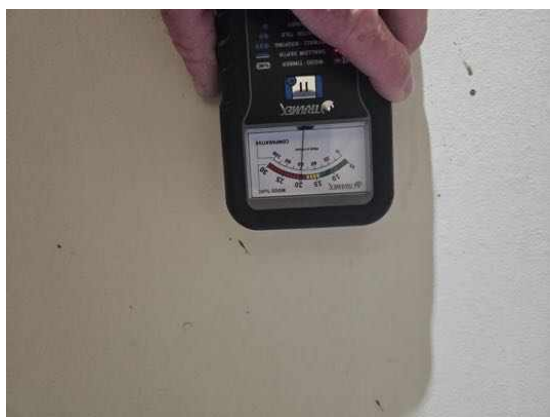
### Finding 6.04

Building: Main Building  
 Location: Ground floor toilet  
 Finding: Elevated moisture noted - toilet  
 Information: During the inspection it was noted that the rear walls of the toilet suite in the garage space under the house had higher than normal moisture readings throughout the walls. It appears that there is weather exposure in this position and with the visible water marks on the floor, has constant exposure to standing water.

Noting the wood rot in the joinery at ground level, it would be prudent to investigate the condition of the wall frames for water affected damage. It has an elevated timber pest risk profile.

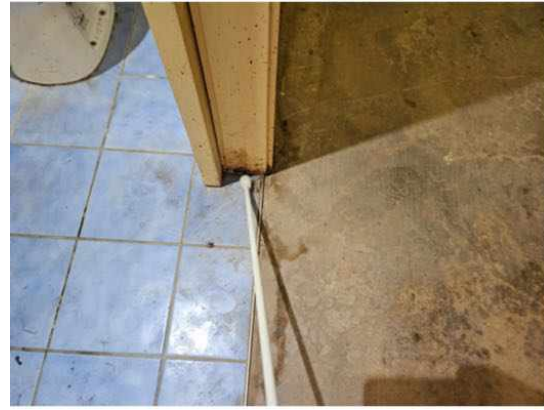
### Finding 6.05

Building: Main Building  
 Location: Ground floor toilet  
 Finding: Wood rot / fungal decay

Information: The timber joinery of the ground floor toilet shows evidence of wood rot in the end sections of the timber. This is most probably due to continued exposure to water in the underside area of the house. Due to the elevated moisture levels in the walls of the toilet, it is most likely that this moisture effect on the timbers is affecting the framing and this should be checked.

Wood rot, also known as Fungal Decay, occurs when timbers and other cellulose building materials are exposed to damp conditions on an ongoing basis. This could be the result of exposure to weathering over a prolonged period of time, or the attraction of excessive moisture from other abutting building materials.

Early intervention and regular maintenance, particularly of exterior timbers, will prolong the useful life of these building elements. Prior to any works being performed, the cause of the moisture that has created the visible wood rot should be identified and addressed in a suitable manner. Replacement of affected timbers may then be a necessary step in protecting surrounding building elements from such deterioration.

A licensed carpenter or licensed builder should be consulted to advise on a solution for the affected building materials.

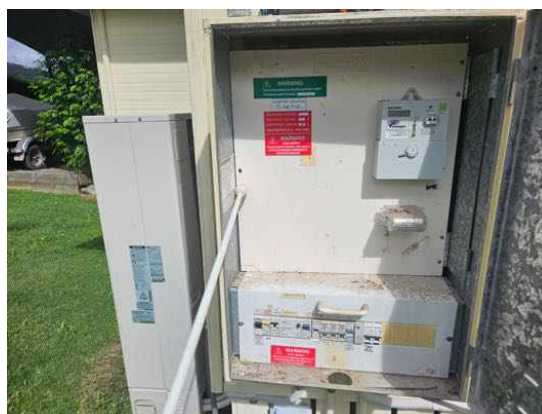
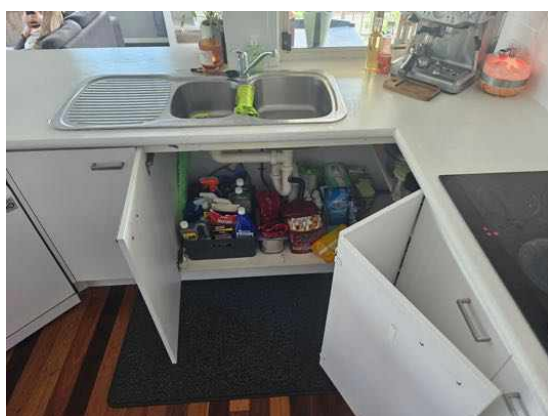
Building:	Main Building
Location:	Meter box, kitchen cupboard
Finding:	Durable pest inspection notice - not assessable
Information:	On the day of inspection it was noted that the durable timber pest inspection / treatment notice was missing, not visible or out of date. These notices / stickers are to verify the timber pest inspection dates, the inspector, the currency and type of timber pest system / barrier in place or being used in and around the property.

Annual, or more regular, inspections are crucial in maintaining and managing the properties timber pest risk profile. By not having regular inspections of the property raises the properties risk of undetected defects and damage. Without regular inspection at intervals of not greater than annually the buildings risk profile will categorised as high. Properties with trees within 50m and with gardens close to the building are at greater risk and will have a high risk profile.

It is recommend that a licensed timber pest controller be contacted to assess the properties needs and provide costings for an annual inspection programme.
