Building and Timber Pest Inspection Report

Inspection Date: Fri, 20 Feb 2026

Property Address: 47A Goldmark Cres, Cranebrook NSW 2749,
Australia

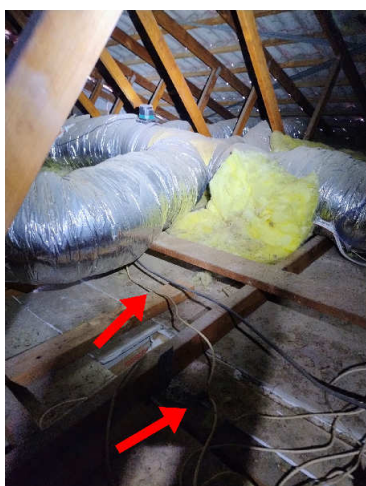
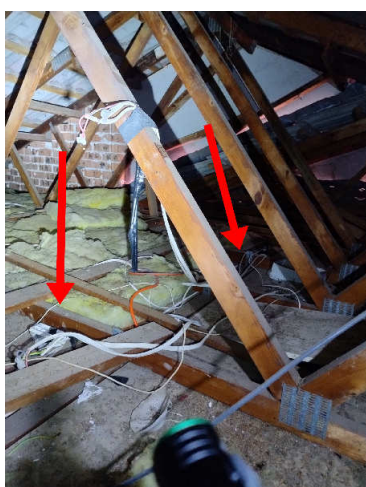
Not fixed electrical wiring at the entrance of this roof space represents a potential safety hazard to personal contact.

Contact a licensed electrician urgently for further inspection investigation and rectification.

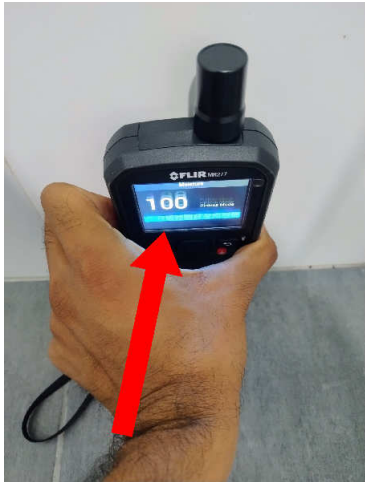
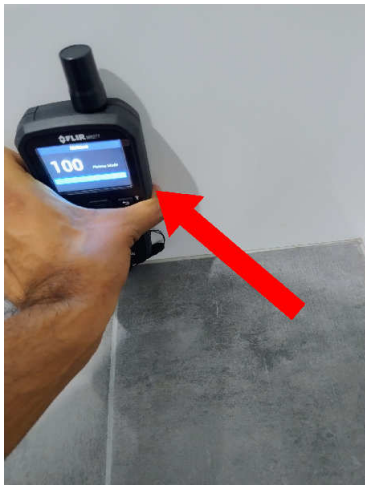
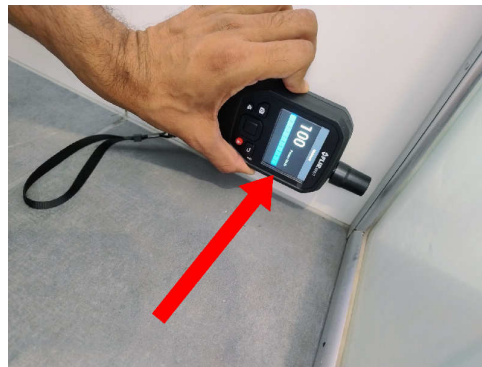
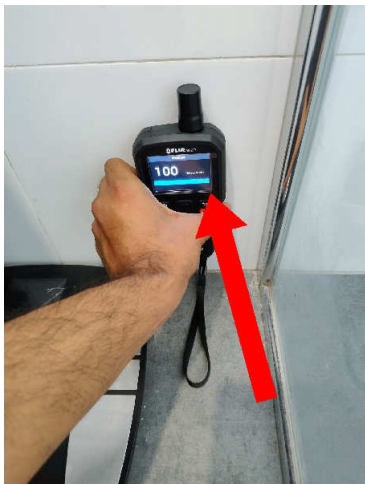
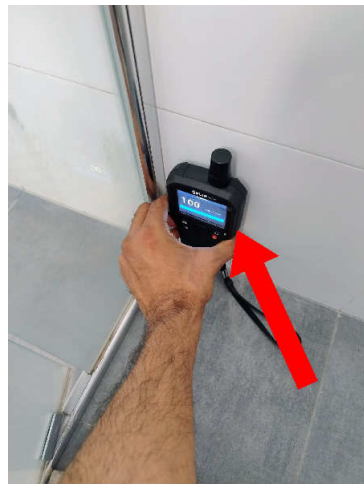
Finding: Evidence of Excessive moisture - identified in both bathroom

Information: Evidence of excessive moisture recorded by moisture meter in both Bathroom and shower area walls at the time of inspection. Excessive moisture can attract termites and produce conditions that promote fungal growth and wood decay.

Excessive moisture is generally caused by deteriorated, inadequate or missing roof drainage, leaking plumbing pipes or fixtures, poorly plumbed HWS overflows or condenser units and poor site drainage.

Prior to any remedial works being performed a qualified plumber should be appointed to further inspect the property and to identify the cause of the excessive moisture. Works to remove affected building elements may then be necessary and should be performed by an appropriate tradesperson as soon as possible.

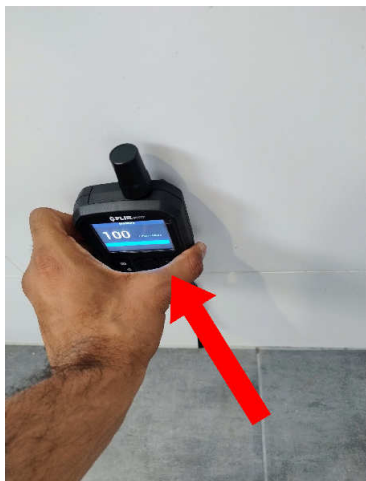
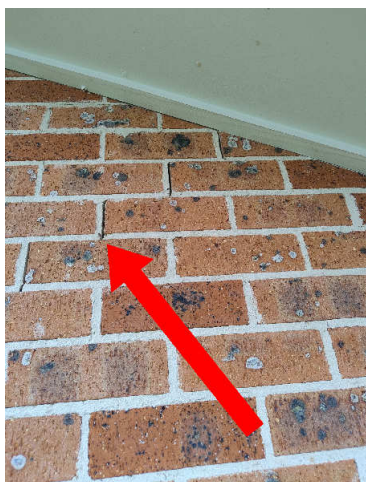
Finding 3.02

Finding: Brickwork - Cracking [Fine] - external wall

Information: Several cracks were observed in the side wall under patio and the exterior rear walls rear elevation.

Generally, the cause of a fine crack is indicative of a separation between brickwork and mortar throughout the structure, but single bricks may also show cracks of this nature.

Cracking of this nature can generally be repaired with minor filling and should be conducted by a qualified bricklayer.

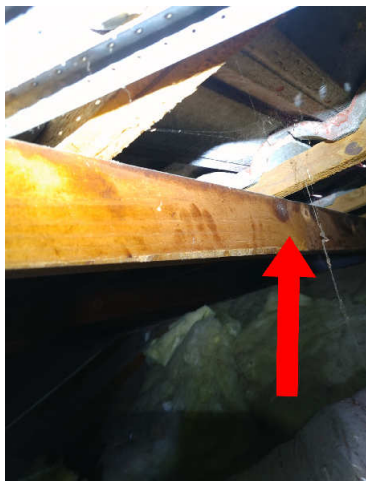
Finding: Stained timber

Information: At the time of the inspection, water staining was observed in Roof void areas. The staining was visually evident, with discoloration and marks present on the surface.

This suggests that the staining is likely a result of a previous water intrusion event that has since dried. It is recommended that the cause of the water staining be further investigated by means of an invasive inspection, to ensure that there are no underlying issues that could lead to a MAJOR defect and future moisture problems.

The vendor or the real estate agent might be able to provide further information on the cause of the staining and potential rectification at the time. Otherwise, a roofing contractor is recommended to investigate the roof flashings for any areas of water ingress as soon as possible.

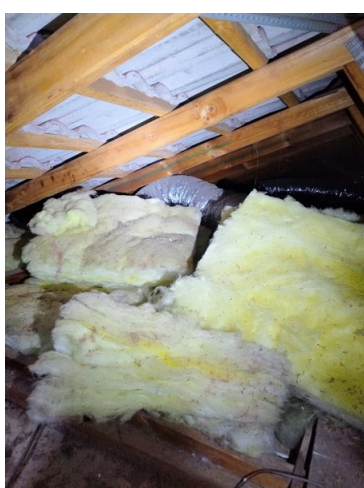
Finding 3.05

Finding: Structural Timber framing connection loose

Information: At the time of the inspection timber member connection was found loose between garage and kitchen roof void area.

Roof timber connection plays an important role in the structural integrity of roof. If not attended can lead to major defect or safety issue.

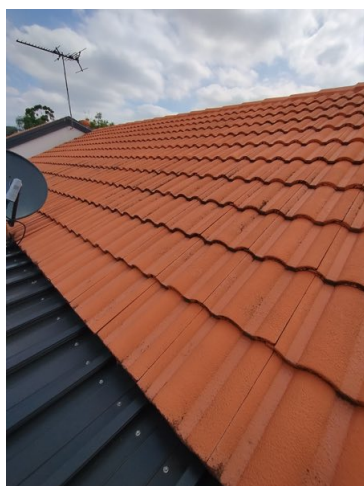
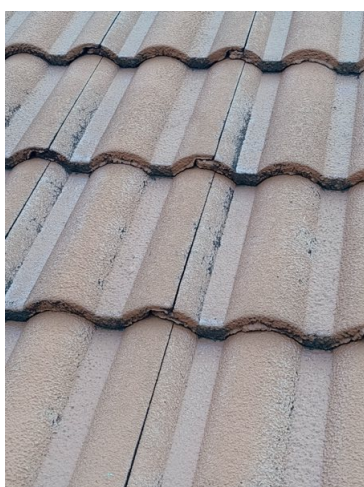
Finding 3.07

Information: Upon inspection of the exterior roofing, the majority of roof tiles were considered to be in a fair condition. While weathering of the tiles is consistent with the age of the property, maintenance works are required.

Isolated areas of mortar have come loose in the valleys and minor cracking is also present. Re-pointing and re-sealing the may be considered as an interim solution by the client to help preserve and extend the life span of the tiles.

Where left unmanaged, deteriorating roof tiles are likely to lead to a number of secondary defects, including minor water leaks and weather exposure to internal roofing structures.

Consultation with a roofing contractor is highly advised to gain advice on cost of remedial works that may be required in the short to medium term. Remedial works are likely to increase the longevity of the exterior roofing structure.

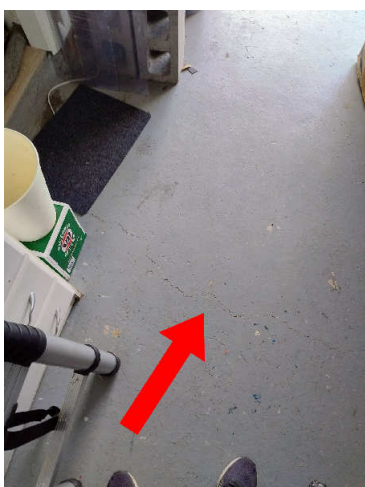
Finding 3.08

Finding: Crack in concrete slab - Category 1

Information: Cracks was observed in the garage slab at the time of inspection. A crack coded as Category 1 was identified in the slab. A Category 1 crack is described as a fine but noticeable crack, with the slab at an otherwise reasonable level.

To be considered Category 1, the approximate width of the crack is less than 1.0mm, or a less than 10mm change in offset when a 3m straight edge is placed over the defect.

Category 1 cracks should be monitored for a period of 12 months. At the end of the monitoring period, identified cracks that are rated greater than Category 2 are considered defects, and require rectification.

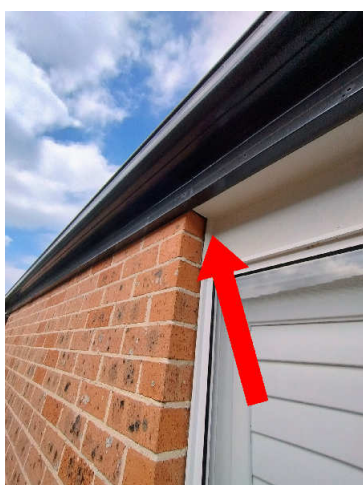
Finding 3.09

Any gaps to the exterior walls of the building that are larger than 3mm are deemed a defect and require filling, beading or replacement of brickwork to close or cover the gaps. Such gaps create potential for pest ingress, excessive moisture and structural issues, and should therefore be minimised prior to the development of secondary defects.

Such works should be carried out by the builder on site to prevent secondary defects and to comply with Australian Standards.

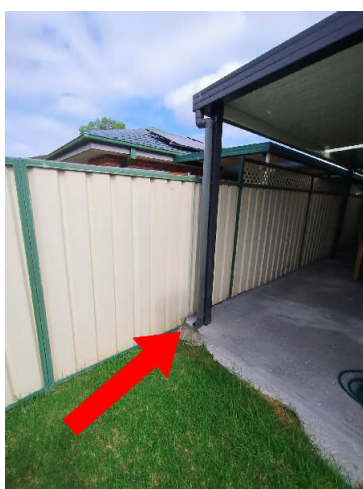
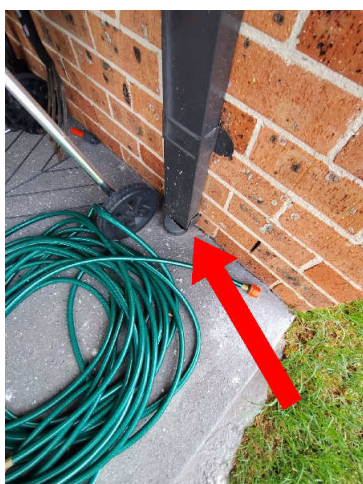
Finding 3.10

Stormwater drain was observed to be not connected to the drain at the time of inspection.

Where roof plumbing doesn't drain adequately, the area at the base perimeter can become excessively damp, potentially creating an environment that is susceptible to rust and corrosion of surrounding building elements, as well as attracting termites and other pests.

It is highly recommended that a plumber be appointed to further inspect the area and to install adequate drainage equipment where necessary.

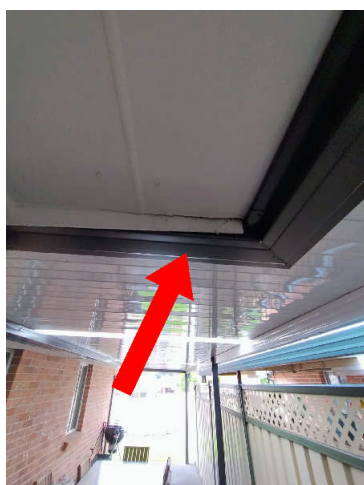
Finding 3.11

Finding: Cracking - Damage Category 2 - Noticeable (up to 5mm)

Information: Cracks were observed in the ceiling of exterior roof at the time of inspection. Noticeable cracks are a common occurrence as a result of many primary defects. Such causes may include age, general wear and tear, expected building movement, general expansion/contraction of building materials in different weather conditions, and/or minor failings in the installation or application of building materials.

Noticeable cracks may result in minor sticking or jamming of associated doors and windows, which require easement. However, noticeable cracks are easily filled and repaired. A plasterer can be consulted to install an expansion joint at this point to allow for this movement during different weather conditions.

Relevant tradespeople, such as carpenters, painters and plasterers, should be appointed to perform remedial works, as deemed necessary.

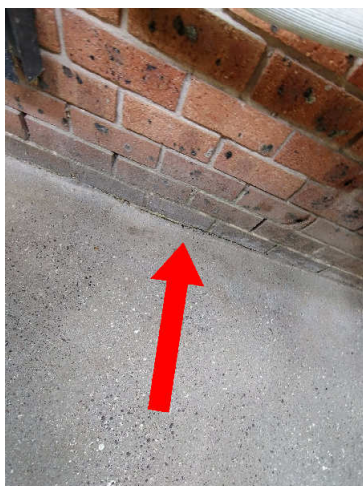
Finding 3.12

Efflorescence appears to be affecting the brickwork, in right side wall area. Below air condition unit at the time of inspection.

It is typically seen as white salt deposits on the surfaces of concrete pavement or mortar between bricks or tiles. While detracting from the overall appearance of the affected area, efflorescence is not likely to develop into secondary damage if left unmanaged.

Generally, soluble salt deposits can be removed by dry brushing with a stiff-bristled brush. Repeated dry brushing is an ideal treatment for eliminating this forming of efflorescence. A cleaning contractor or general handyperson may be appointed to perform these works at the discretion of the client.

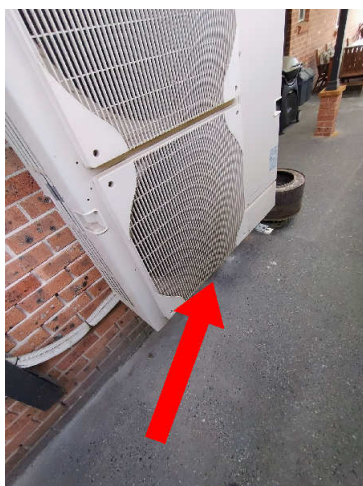
Finding: Air conditioner unit - Not connected overflow

Information: The Air Conditioner (A/C) overflow was found to be not connected to storm water drainage and is creating excessive moisture in the surrounding area.

Such leaking creates an environment which is conducive to an array of defects, including water damage to associated building elements and the attraction of termite or timber pest infestation.

It is highly recommended that a licensed plumber be appointed to connect the A/C overflow in order to prevent such an environment from being created. These minor works should be carried out as soon as possible.

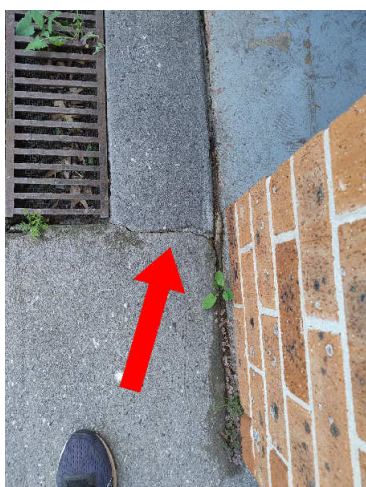
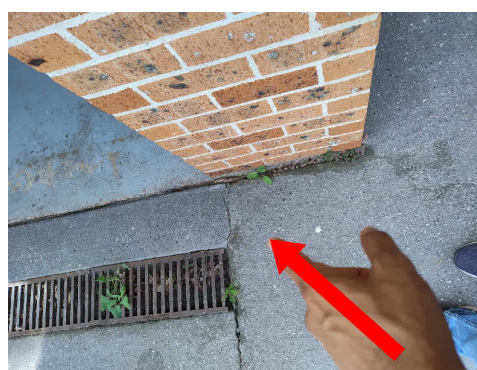
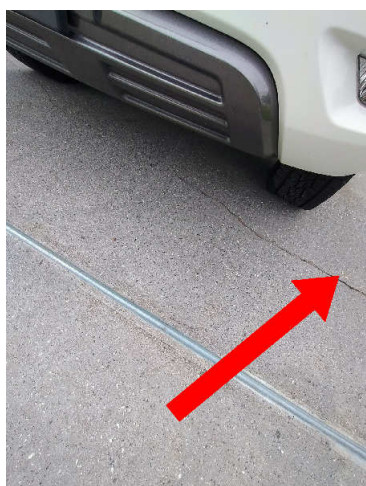
Finding 3.15

Finding: Crack in concrete slab - Category 2

To be considered Category 2, the approximate width of the crack is less than 2.0mm, or a change in offset of less than 15mm when a 3m straight edge is placed over the defect.

Category 2 cracks to slabs should be monitored for a period of 12 months. At the end of the monitoring period, cracks rated greater than Category 2 are considered defects that require rectification.

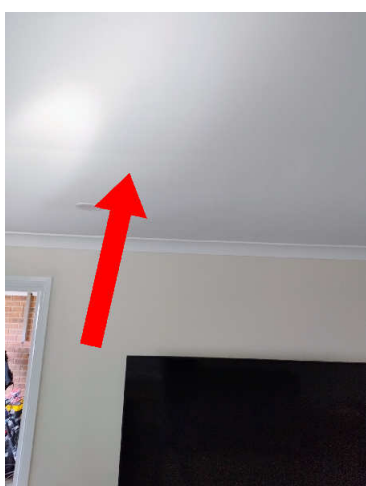
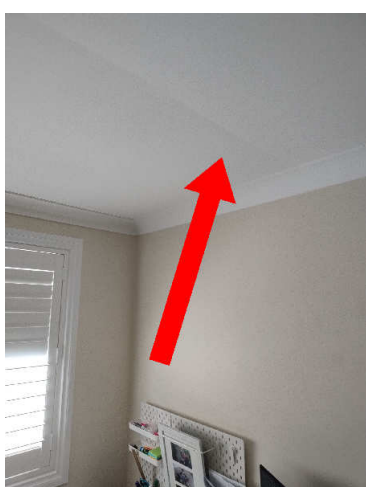
Building:	Main Building
Location:	Lounge Room + Bedroom
Finding:	Ceiling - Sagging

In some cases, sagging ceiling linings may also indicate that there are structural issues, causing surfaces to warp, twist or sag. Where sagging appears to be major, appointment of a structural engineer is advised to further inspect the property and identify the source and rectification works required.

The appropriate action should be taken by the client as soon as possible to ensure that any potential further damage is limited.

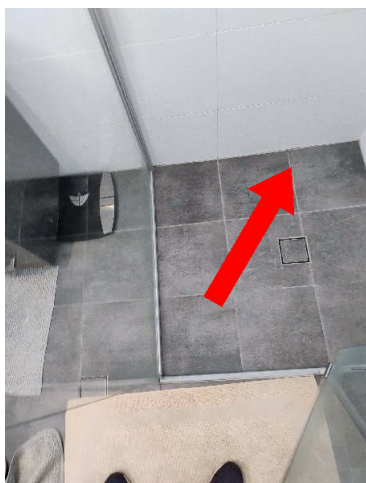
Finding 3.18

Information: It was noted on inspection that sealant or grout is degraded to the tiled shower alcove and or other areas of the bathroom in bathroom.

This can lead to water ingress into the shower base and creates conducive condition to termite activity. If left unmanaged can cause further deterioration to building elements.

Qualified trade person or plumber must be appointed for rectification on priority.

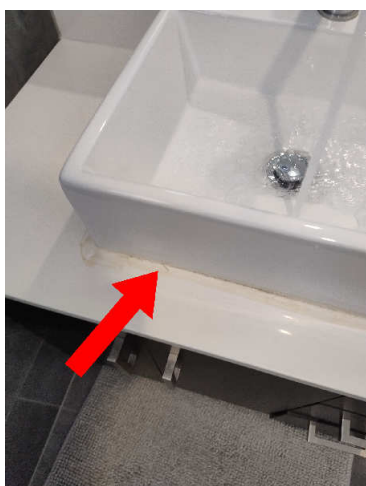
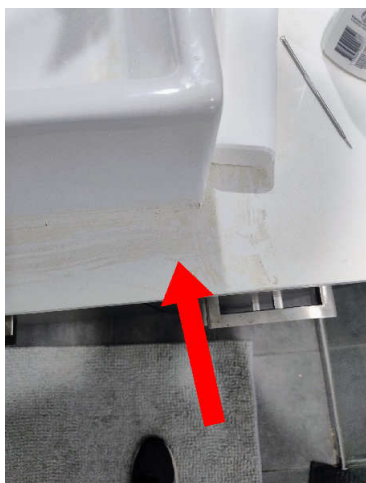
Finding 3.19

Finding: Bench top joint sealant - defective or unprofessional workmanship

Information: It is observed that the joint sealant material of the bench top is defective because it is not sealed and or not flush filled with a suitable flexible sealant of matching colour.

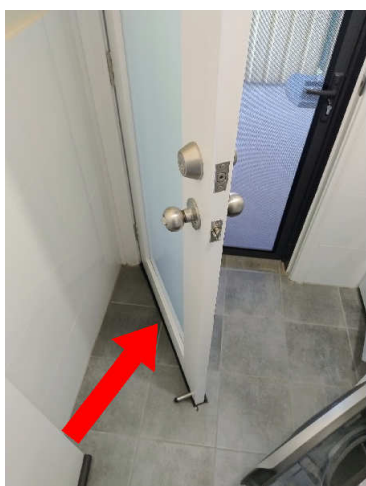
Building: Main Building
Location: Laundry
Finding: Door - Binding/jamming

Where door binding/jamming appears to indicate major structural issues, a registered builder specialising in re-stumping should be appointed to provide an estimate on the cost of rectification.

For minor causes, a qualified carpenter or general handyman should be appointed to perform minor rectification works at client discretion.

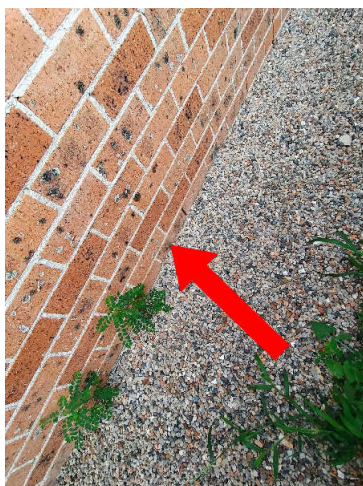
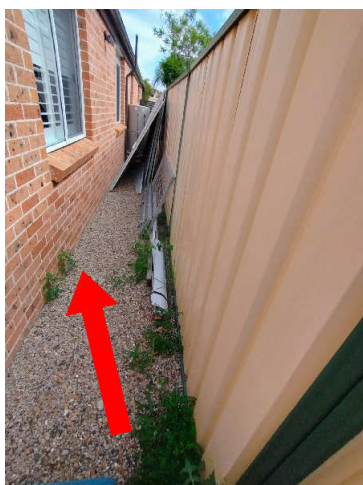
Finding 6.02

Building: Main Building
 Location: All External Areas
 Finding: Slab Edge - Exposure not fully available

Where the slab edge cannot be properly inspected, it is highly recommended that termite or timber pest inspections be carried out every 6-12 months to aid protection of the property against infestation.

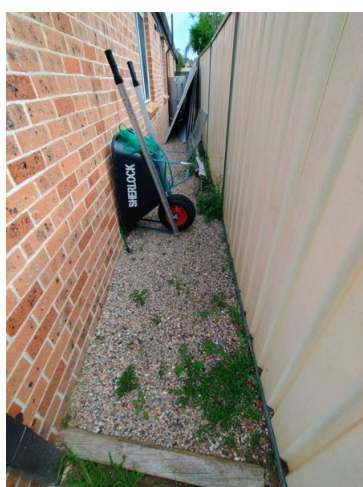
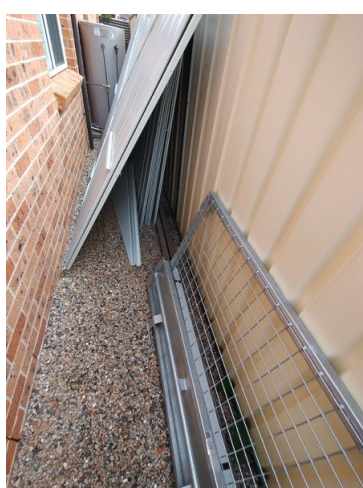
Finding 6.08

Building: Main Building
Location: Exterior walls - left side
Finding: Site drainage - Inadequate

Where site drainage is inadequate, installation of an Agricultural (Aggie) Drain may be required. A qualified plumber should be appointed to further inspect the property and perform any remedial works as necessary. Water damage and secondary defects are likely to occur if left unmanaged.
