Building and Timber Pest Inspection Report

Inspection Date: Mon, 12 Jan 2026

Property Address: 5/84 The Promenade, Springfield Lakes
QLD 4300, Australia

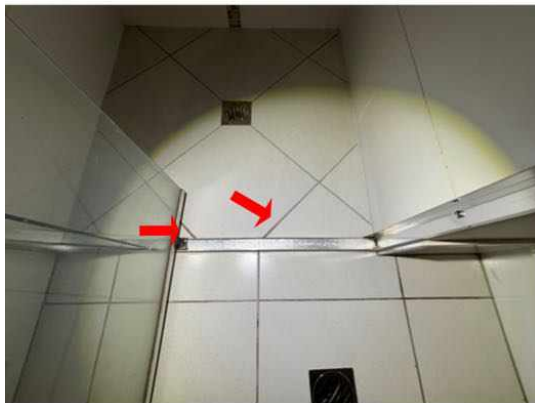
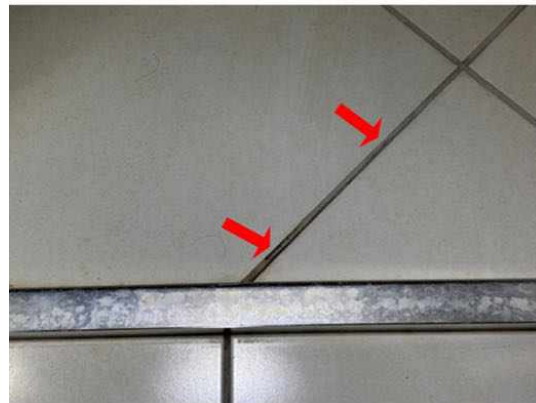
Finding 3.01

Building: Main Building
 Location: Ensuite
 Finding: Ensuite - grout deterioration
 Information: At the time of the inspection, it was noted that a section of grout on the ensuite shower floor had some minor cracking to it. This may be due to general wear and tear.

A building maintenance professional or bathroom specialist could be engaged to redo the affected grout. This can be done at the clients discretion.

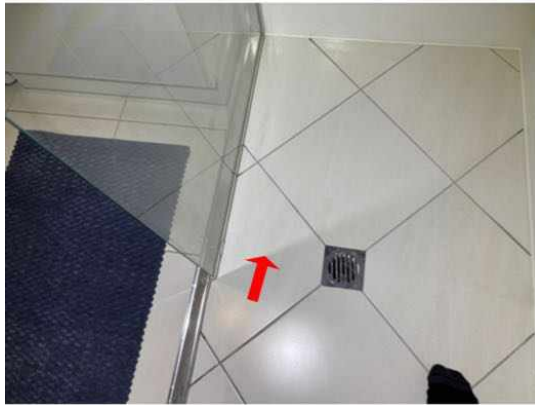
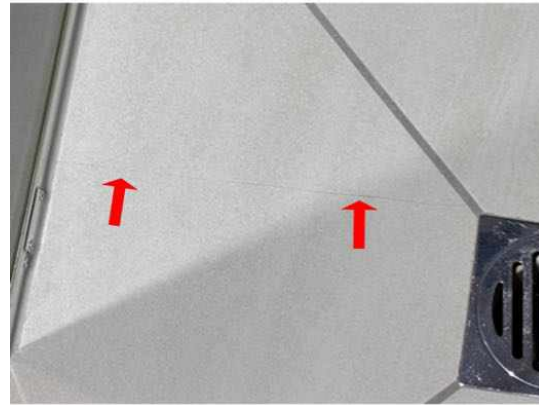
Finding 3.02

Building: Main Building
 Location: Family bathroom
 Finding: Family bathroom - cracked tile
 Information: At the time of the inspection it was noted that a tile on the family bathroom shower floor had a hairline crack to it. The affected tile does not need to be replaced. Sealing of the shower floor is recommended to ensure longevity of the bathroom.

A bathroom specialist should be engaged to seal the shower floor. This can be done

at the clients discretion.

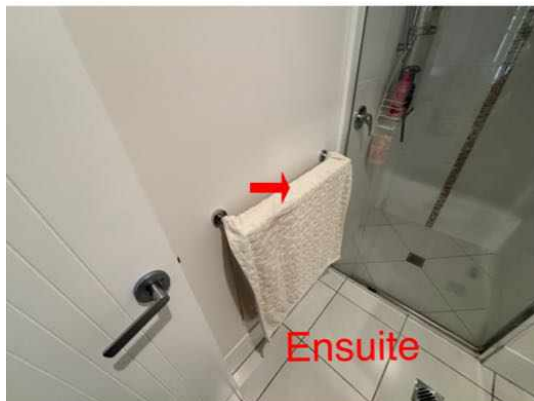
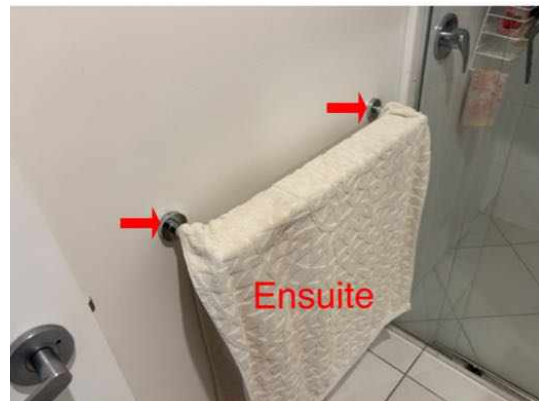
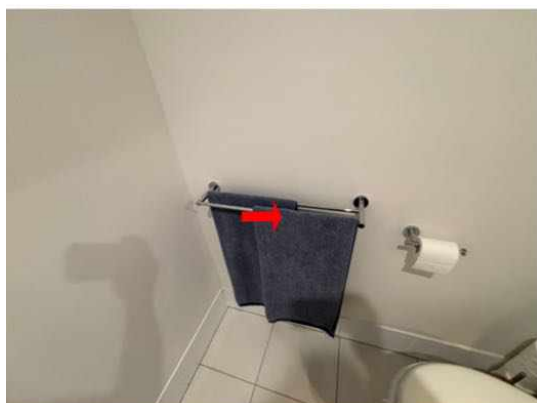
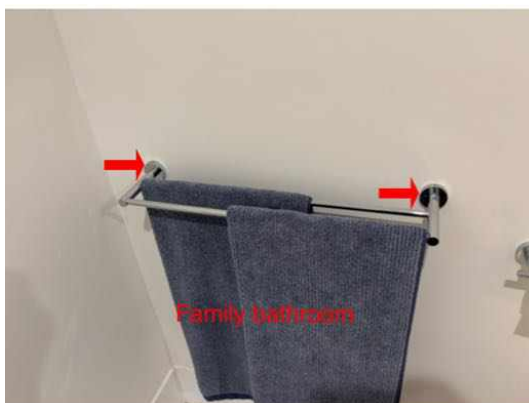
Finding 3.03

Building: Main Building
 Location: Ensuite and family bathroom
 Finding: Ensuite and family bathroom
 Information: At the time of the inspection, it was noted that the towel rails in the ensuite and family bathroom were loose. This appears to be from general wear and tear. If not addressed, the towel rails may come away from the wall.

This may require simple adjustment of the fasteners attaching the towel rails. A building maintenance professional could be engaged to carry out this minor repair. This can be done at the clients discretion.

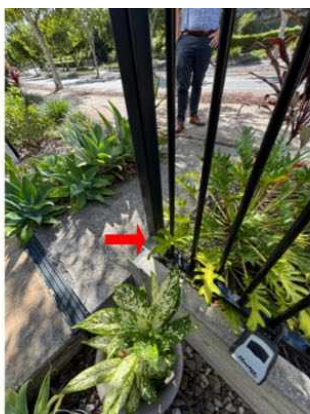
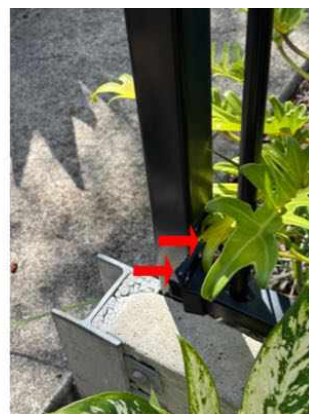
Finding 3.04

Building:	Main Building
Location:	Front elevation
Finding:	Front yard - screws missing from fence
Information:	At the time of the inspection, it was noted that screws were missing from the bottom rail of the metal fence at the front of the dwelling.

A building maintenance professional could be engaged to install two screws to secure the fence panel to the post. This can be done at the clients discretion.

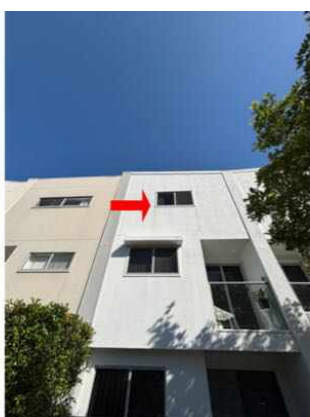
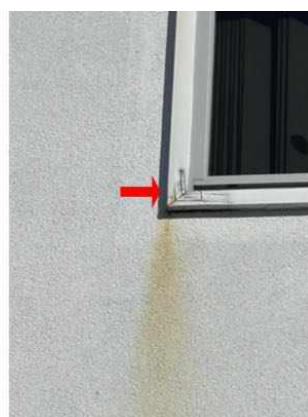
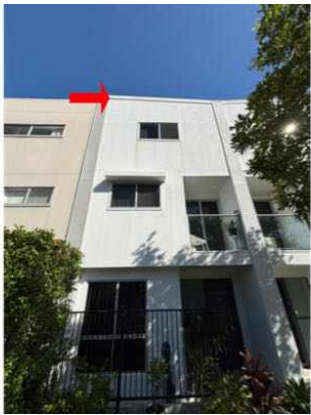
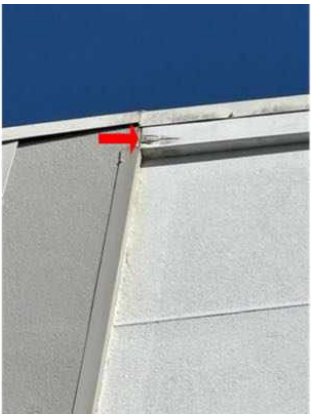
Finding 7.01

Building:	Main Building
Location:	Front elevation
Finding:	Wood rot
Information:	At the time of the inspection, it was noted that there was evidence of wood rot to timber mouldings on the front of the dwelling. This may be due to the age of the timber building elements and general weathering. The client should inform the body corporate of these findings in order for this to be addressed as part of the maintenance plan for the complex.

This building element shows evidence of wood rot. Wood rot, also known as Fungal Decay, occurs when timbers and other cellulose building materials are exposed to damp conditions on an ongoing basis.

Wood rot is often associated with general damp problems and is evidenced by a 'musty' smell or mould and mildew occurring on surfaces. If left unmanaged, damp conditions can lead to further health problems and the decay of timbers will continue.

Early intervention and regular maintenance, particularly of exterior timbers, will prolong the useful life of these building elements. Prior to any works being performed, the cause of the moisture that has created the visible wood rot should be identified and addressed in a suitable manner. Replacement of affected timbers may then be a necessary step in protecting surrounding building elements from such deterioration.

A qualified carpenter or registered builder may also be required to replace affected building materials.

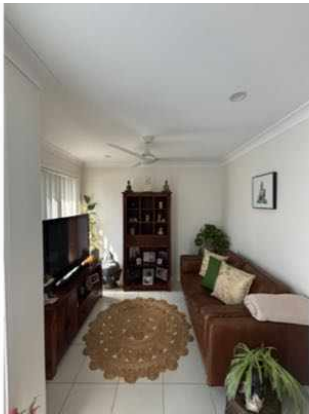
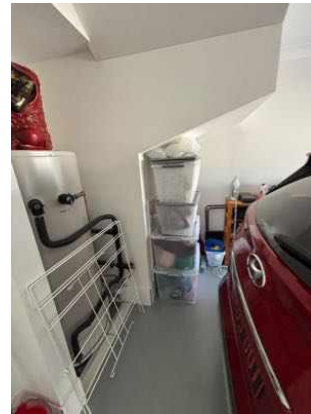
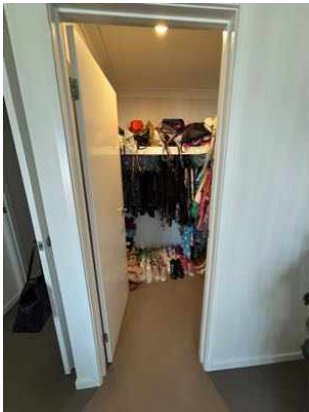
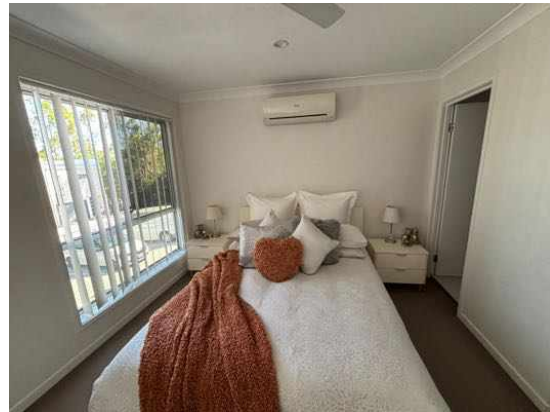
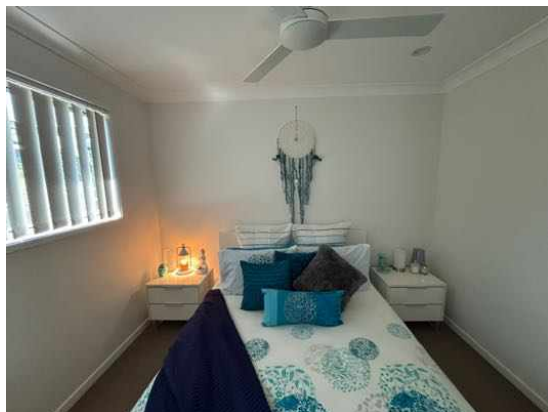
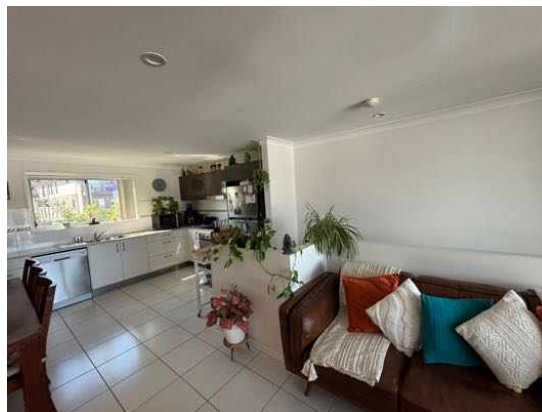
Noted Item

Building: Main Building
Location: All Internal Areas
Finding: Obstructions and Limitations - Internal areas
Information: These photographs are an indication of the obstructions and limitations which impeded full inspection of the property of the internal areas at the time of inspection. These obstructions can hide an array of defects and should be removed to allow full inspection to be carried out. A re-inspection is recommended once the areas are made accessible.

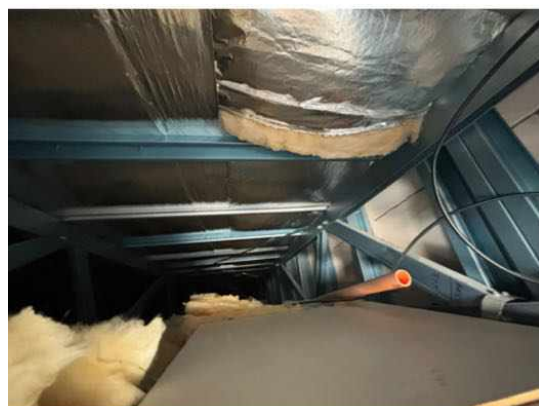
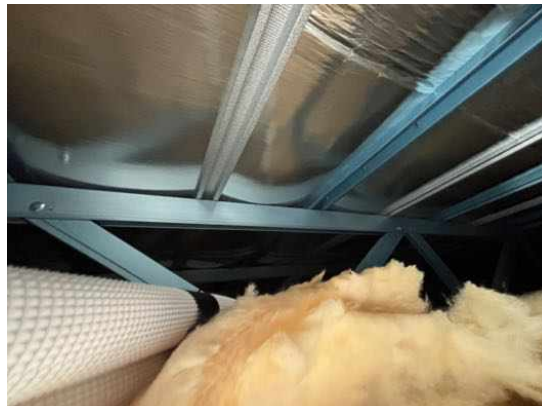
Noted Item

Building: Main Building
 Location: Roof Void
 Finding: Obstructions and Limitations - Roof cavity
 Information: These photographs are an indication of the obstructions and limitations which impeded full inspection of the property of the roof cavity

at the time of inspection. These obstructions can hide an array of defects and should be removed to allow full inspection to be carried out. A re-inspection is recommended once the areas are made accessible.

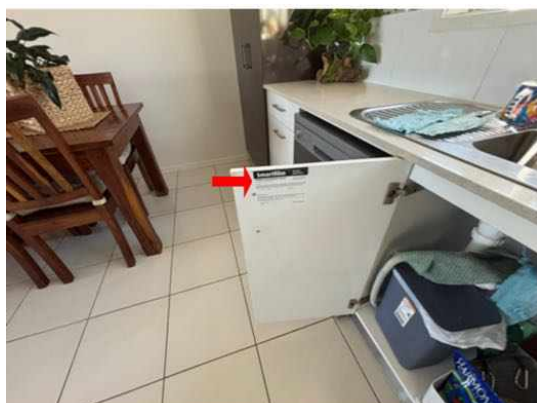
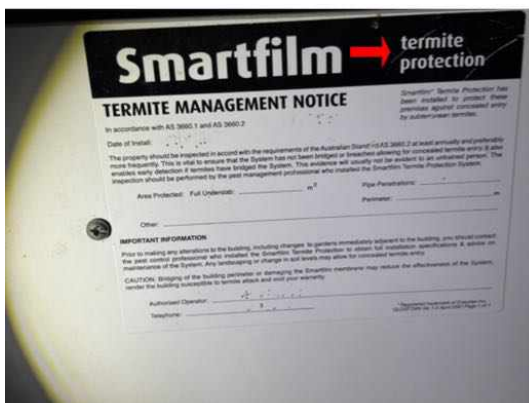
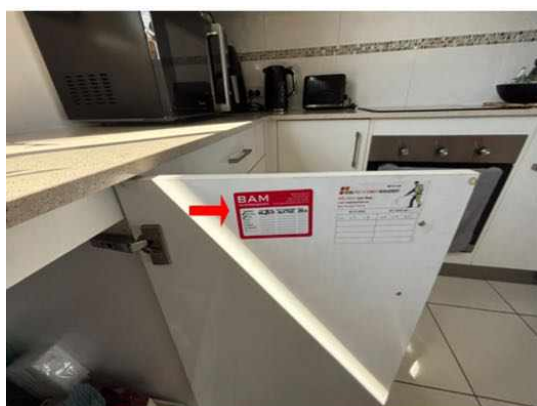
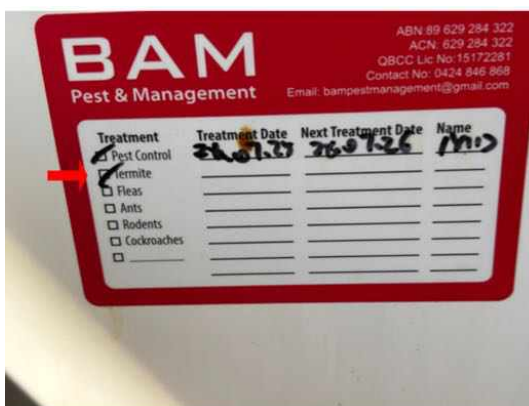
Noted Item

Building: Main Building
 Location: All External Areas
 Finding: Evidence of a physical termite management system was identified.
 Information: At the time of the inspection, evidence of a physical termite management system was found by way of a durable notice in the kitchen sink cabinet.

A physical termite barrier was installed to the slab penetrations and perimeter during construction. The durable notice appears to be dated the 17/08/2017. The durable notice is worn and as a result the date and full details of the physical termite barrier is difficult to determine. The last recorded annual termite inspection, was carried out on the 26/07/2025.

The client may wish to enquire of the body corporate as to the nature of the termite management plan for the complex and the individual units. It is important that annual termite inspections are carried out, which should be the responsibility of the body corporate.

A termite and timber pest technician should be engaged to carry out annual termite inspections as per AS 3660 in order to further protect the dwelling. Annual termite inspections must be carried out in partnership with any termite treatment system, physical or chemical, as no termite treatment system can be expected to be 100% effective.
