# Building and Timber Pest Inspection Report

Inspection Date: Fri, 20 Feb 2026

Property Address: 25 Munmorah Ave, Charmhaven NSW 2263,  
Australia

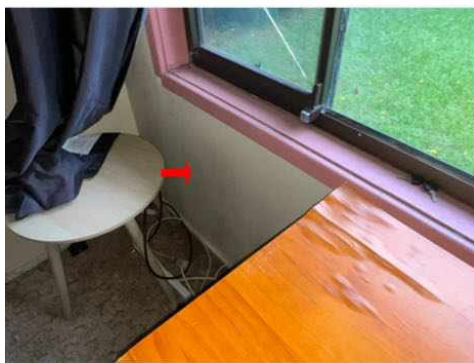
Building: Main Building  
Location: Bedroom > Front, Centre  
Finding: Mould - Present  
Information: Mould appeared was evident to the front centre bedroom wall at the time of the inspection. Where evidence of mould growth was noted, there may be environmental, biological or health issues associated with the report. A specialist inspection by a suitably qualified environmental health inspector is warranted, where mould is extensive or where any queries regarding air quality spores or other related issues apply.

Generally, the client is advised to ensure that the general environment is free of moisture and humidity to aid in the prevention of mould formation and development. Any mould found during the inspection should be cleaned immediately by a cleaning contractor or the homeowner as applicable.

Please note that severely affected building elements may require replacement by a builder or qualified carpenter.

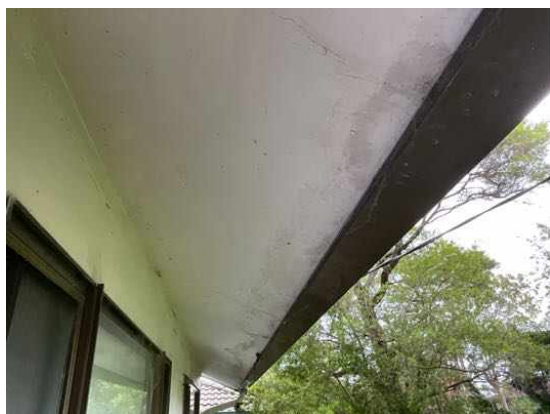
Building:	Main Building
Location:	Eaves > Front
Finding:	Mould - Present
Information:	Mould was present to the eaves at the front of the property at the time of the inspection. Where evidence of mould growth was noted, there may be environmental, biological or health issues associated with the report. A specialist inspection by a suitably qualified environmental health inspector is warranted, where mould is extensive or where any queries regarding air quality spores or other related issues apply.

Generally, the client is advised to ensure that the general environment is free of moisture and humidity to aid in the prevention of mould formation and development. Any mould found during the inspection should be cleaned immediately by a cleaning contractor or the homeowner as applicable.

Please note that severely affected building elements may require replacement by a builder or qualified carpenter.

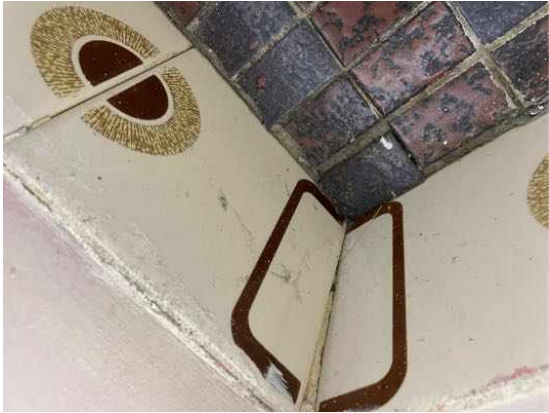
Building:	Main Building
Location:	Toilet (WC) > Rear
Finding:	Tiles and Sealant - Drummy
Information:	Tiles within the toilet area sounded drummy when tapped, and sealant was missing at skirting tile junctions.

Drummy tiles may indicate loss of adhesion and may become loose or crack over time. Missing sealant increases the risk of moisture ingress into wall and floor junctions.

A qualified tiler should assess and re-fix affected tiles and reinstate sealant. Repairs

should be undertaken in the short to medium term.

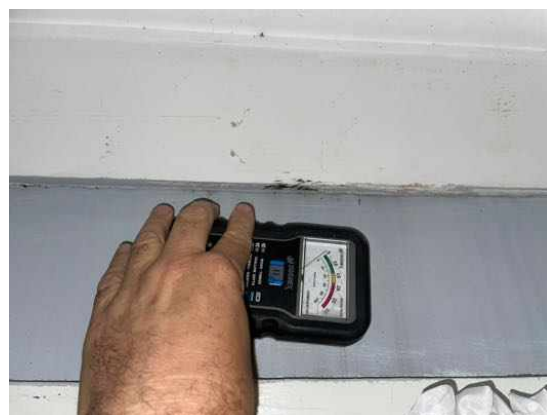
Building:	Main Building
Location:	Living Room, Dining Room > Front,Rear Left
Finding:	Walls - Water stained
Information:	Water staining to sections of the walls to the living and dining room and the rear right bedroom, this was evident to the top of the walls coming from behind the cornice. Water staining indicates that surfaces have been exposed to excessive moisture over time. The minerals and other elements in the water lead to staining, which may graduate to corrosion and deterioration if left unmanaged. No elevated moisture levels were evident on the moisture meter at the time of the inspection.

While mostly an appearance defect, water staining can be indicative of more serious defects, which may be currently concealed by wall linings.

Where water staining is active, a roof plumber must be consulted to identify the cause of the staining and to provide advice on any reparation works that may be required. Replacement of any broken or damaged structures is advised.

Conversely, where water staining is old and inactive, affected building materials may be repaired or replaced at client discretion.

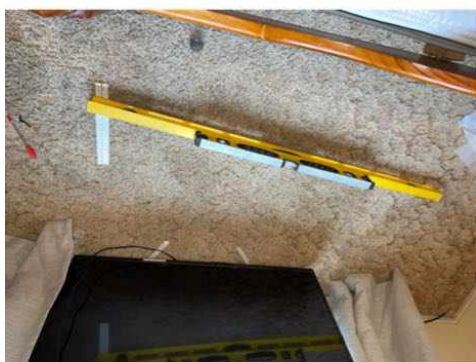
Building:	Main Building
Location:	All Internal Areas > All Areas
Finding:	Flooring - Uneven
Information:	The internal flooring throughout the building is out of level and uneven between 5mm-15mm. Also several rooms appeared to have a significant bow in the floor, this was apparent in the living space, the kitchen and the bathroom. Uneven flooring is likely to indicate minor defects such as expected movement of the foundations of the property, but may also indicate subsidence of the associated subfloor stumps.

It is advised that the flooring be closely monitored to identify any further movement. Where flooring remains relatively unchanged for an extended period of time (i.e. several months), it is likely that this defect has been caused by expected movement of the foundations of the property.

However, where flooring is uneven further, potentially invasive inspection of the subfloor structures and stumps in this area is required. In this case, works to repair are likely to be required, and would be carried out by a builder specialising in re-stumping.

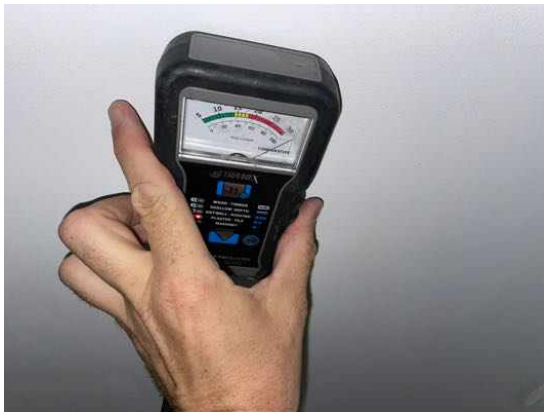
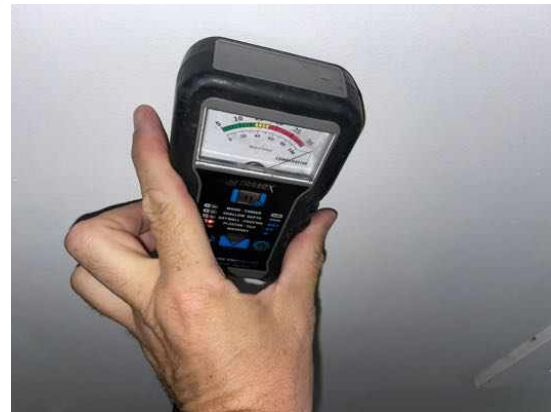
Building:	Main Building
Location:	Kitchen > Rear, Centre
Finding:	Water leak - Active
Information:	Elevated moisture readings were detected to the kitchen ceiling, and a broken roof tile was observed above this area.

Ongoing water ingress can cause deterioration of ceiling linings, insulation, and roof framing timbers, and may contribute to mould growth if not addressed promptly.

A licensed roofer should replace the broken tile immediately to prevent further water ingress. Damaged ceiling materials should be repaired by a plasterer once the leak source is confirmed rectified. This should be repaired immediately.

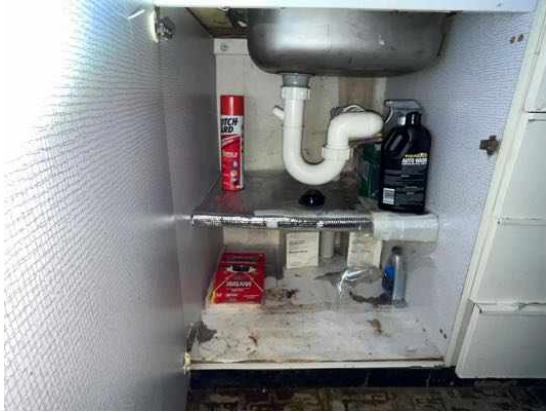
Building:	Main Building
Location:	Kitchen > Rear, Centre
Finding:	Kitchen Joinery - Defects
Information:	The kitchen joinery shows water damage to lower cupboard doors and kickboards, deteriorated sealant, and general wear and tear.

Ongoing moisture exposure may continue to degrade cabinetry and may indicate past or present plumbing leaks.

It is recommended that plumbing connections be checked for leaks and that damaged joinery components be repaired or replaced as required.

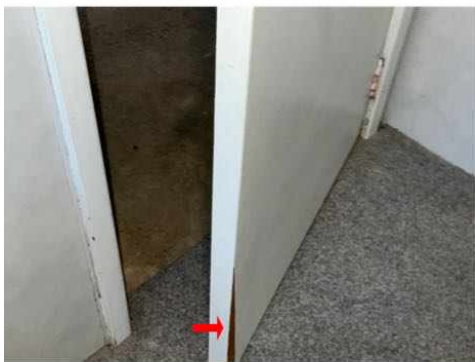
Delaminating door skins may worsen over time, particularly in high-moisture areas.

It is recommended that damaged doors be repaired or replaced.

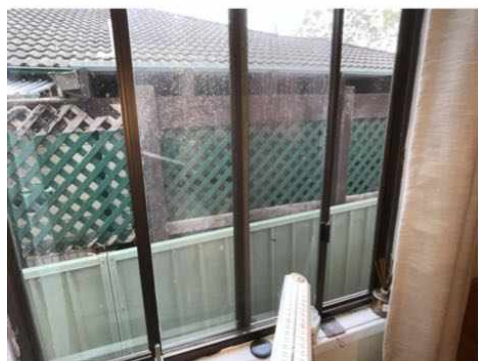
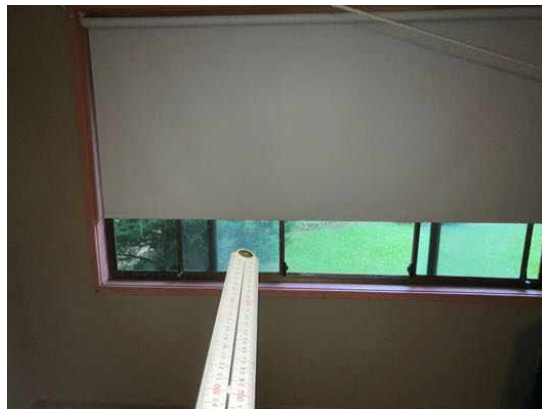
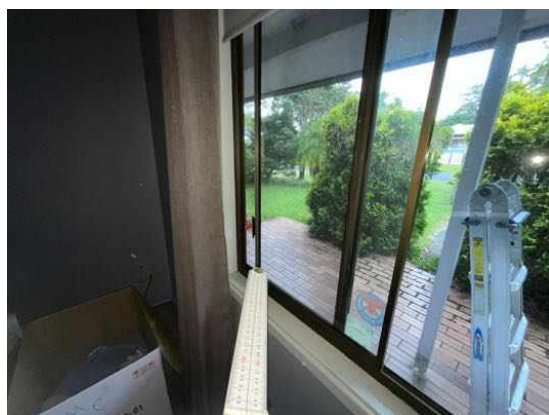
Building:	Main Building
Location:	All Internal Areas > All Areas
Finding:	Window - Stiff to slide
Information:	The majority of the windows throughout was jammed and difficult to operate at the time of the inspection. Windows provide ventilation to the adjoining area and should be at a fully operational level to ensure user comfort. Restricted function of the window may also pose as a potential safety hazard if required for emergency egress from the building.

Generally, factors such as general age of the building element and a lack of maintenance are the usual causes for this type of defect.

Replacement of window hardware or frame may be required, as well as minor repairs and cleaning. A builder or general handy person will be required to repair the window.

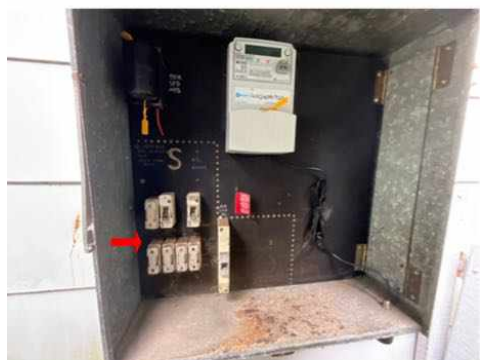
Building:	Main Building
Location:	Meter Box > Front Right
Finding:	Electrical switchboard - Old ceramic fuses
Information:	The electrical switchboard while appearing to have adequate safety switches installed has old ceramic fuses in place.

While this on its own on is not considered a defect it is noted for the clients consideration that a switchboard upgrade may be required in the short to mid term to improve the functionality of the electrical system. A licensed electrician could be appointed to provide quotation for the works at the client's discretion which may in turn expose other required works to bring the system up to a compliant state.

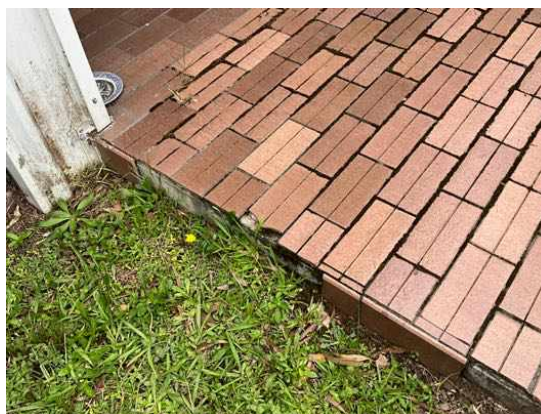
Building:	Main Building
Location:	Porch > Front
Finding:	Porch Tiling - Defects
Information:	The tiling to the front porch area shows multiple cracked tiles, isolated missing tiles, and significant moss growth within mortar joints/grout lines. Some tiles appear uneven and there are open joints where grout has deteriorated or is missing.

Cracked and missing tiles may allow water penetration beneath the tiled surface, potentially leading to further tile lifting, substrate deterioration, or concrete spalling over time. Moss growth indicates ongoing moisture retention, which can accelerate surface degradation and create a slip hazard, particularly in wet conditions.

A qualified tiler or builder should assess the tiled area, remove and replace cracked or missing tiles, re-grout affected joints, and clean/treat the surface to remove moss. Rectification should be undertaken in the short term to prevent further deterioration and reduce safety risks.
