# Building and Timber Pest Inspection Report

Inspection Date: Sun, 22 Feb 2026

Property Address: 31 Calder St, Schofields NSW 2762,  
Australia

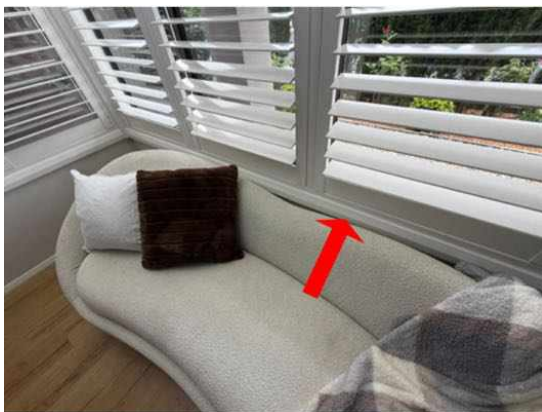
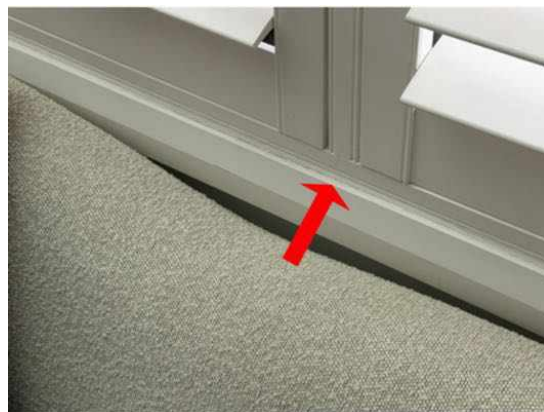
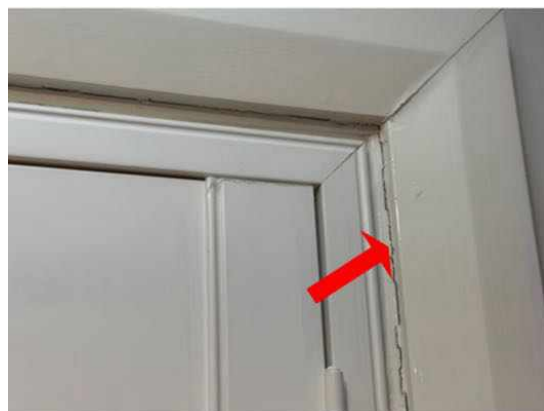
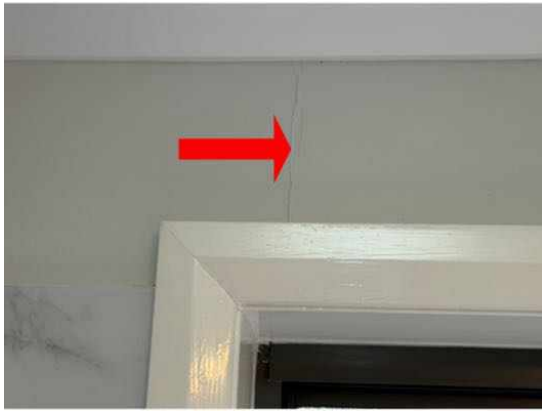
Finding: Cracking - Damage Category 1 - Fine (up to 1mm)

Information: Although fine cracks are quite noticeable, they are often only considered to be an appearance defect, and usually do not indicate any structural damage. Generally, the cause of a fine crack is indicative of a separation between building materials and finishes (e.g. paint, plaster, etc.) along joins.

Cracking of this nature can generally be repaired with minor sanding, filling and/or repainting. Such works should be performed by a qualified painter or a general handyman.

Monitoring of all cracking should be conducted frequently. Always contact a building inspector should cracks widen, lengthen, or become more numerous.

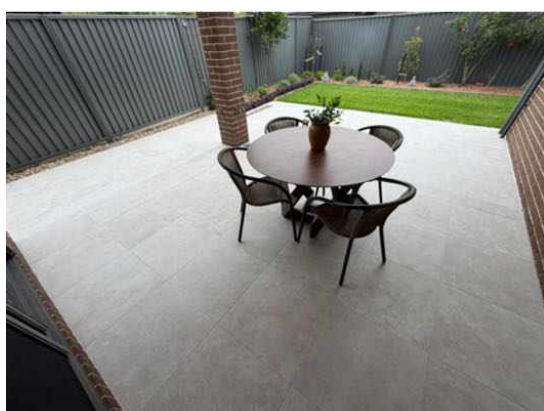
Building: Main Building  
 Location: Rear Patio  
 Finding: Tiles - Drummy  
 Information: Drummy tiled areas were identified in this area at the time of inspection. The term 'drummy' refers to tiles that have become detached from their fixing, despite otherwise being in relatively good condition. Such defects are generally caused by physical or moisture damage to the area. Drummy tiled areas may also be a direct result of poor workmanship during the construction process.

Tiled areas may swell and shrink with changes in air humidity if the area has sustained moisture damage. Any exposure to moisture is capable of causing tiled areas to become drummy and/or cracked over a prolonged period of time. Drummy tiled areas generally require removal and replacement of affected tiles, with adequate sealant and grouting.

It is advised that a tiling contractor be appointed to perform remedial works as necessary as soon as possible to ensure that no further damage is sustained in the affected area.

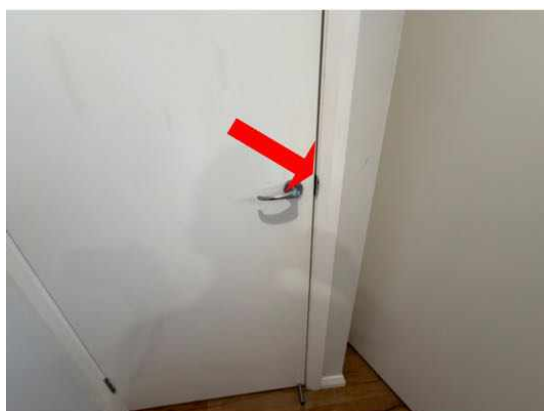
### Finding 3.04

This is a common defect and whether being due to substandard installation or general deterioration of the door hardware.

Readjustment of the striker plate is recommended at client discretion. Works such as these can be completed by a general handyman or qualified carpenter.

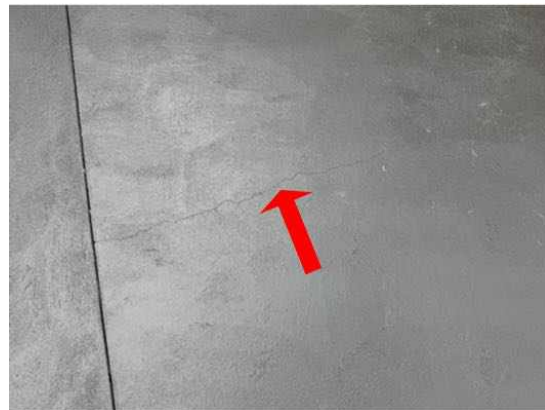
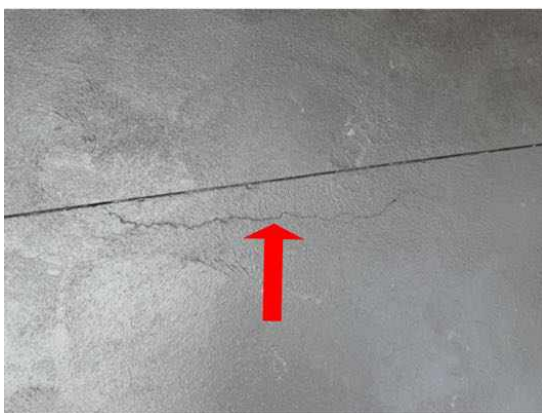
Building: Main Building  
Location: Driveway  
Finding: Cracking - External Concrete Paving Damage Category 0 - Hairline (less than 1mm)  
Information: Hairline cracks were identified in external concrete paving. Hairline cracks are very minor in nature and generally are only ever an appearance defect. To be classified as a Category 0 or hairline crack, the crack width would be less than 0.3mm. While such cracking may be noticeable in some cases, it is common and does not indicate any structural damage.

Generally the cause of a hairline crack in existing concrete paving such as driveways and pathways is indicative of the expansion and contraction of the concrete. Such causes are generally due to environmental factors, such as moisture levels, weather conditions, root systems of nearby trees or the soil types on which they are laid.

Hairline cracks may also be due to poor original installation of the concrete. Factors such as poor compaction of the sub surface and/or inadequate reinforcing of the slab may create cracking and other secondary defects.

Monitoring of all cracking should be conducted frequently. Always contact a building inspector should cracks widen, lengthen, or become more numerous.

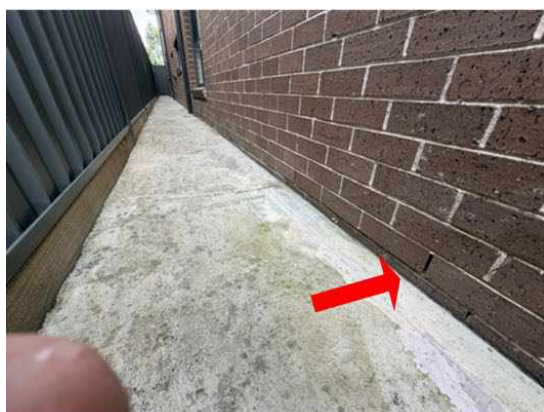
If the slab edge is not properly exposed there is a high risk of termite attack. Sometimes, in order to determine the type of slab, a suitably qualified person such as an architect or builder may be required to consult the construction plans.

Where the slab edge cannot be properly inspected, it is highly recommended that termite or timber pest inspections be carried out every 6-12 months to aid protection of the property against infestation.

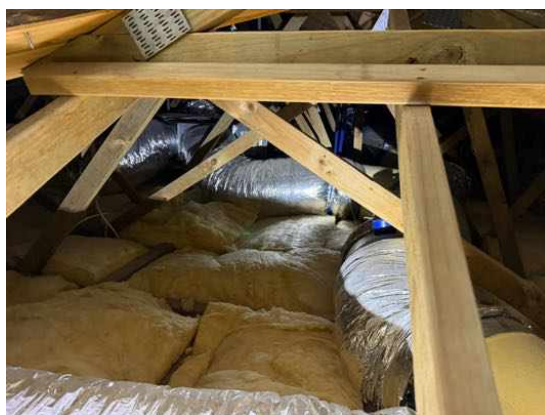
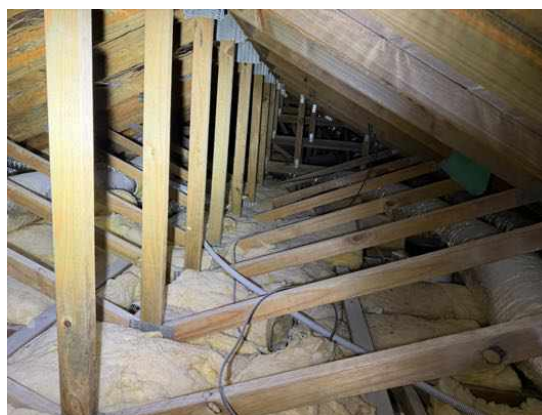
Building:	Main Building
Location:	Roof Void
Finding:	Obstructions and Limitations-Roof Void
Information:	These photographs are an indication of the obstructions and limitations that impeded the full inspection of the roof cavity at the time of inspection. Note that the insulation covered nearly all the ceiling joists, which are a major structural element of the ceiling; the inspection was also limited to areas with an allowable crawl space of 600mm x 600mm, in particular towards the external walls where the roof line diminishes, it was not accessible. These obstructions and limitations can hide an array of defects and should be removed to allow a full inspection to be carried out. A re-inspection is recommended once areas are made accessible.

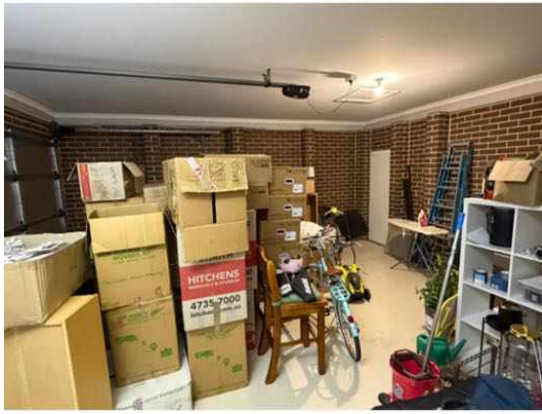
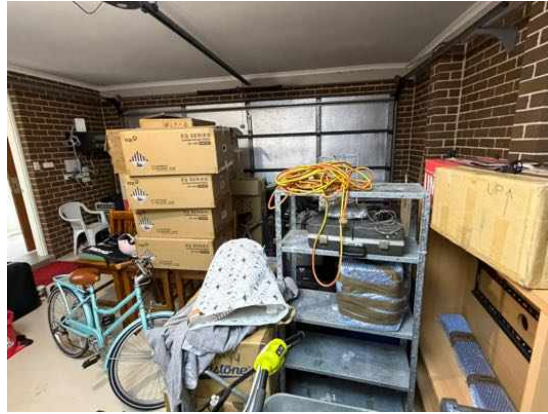
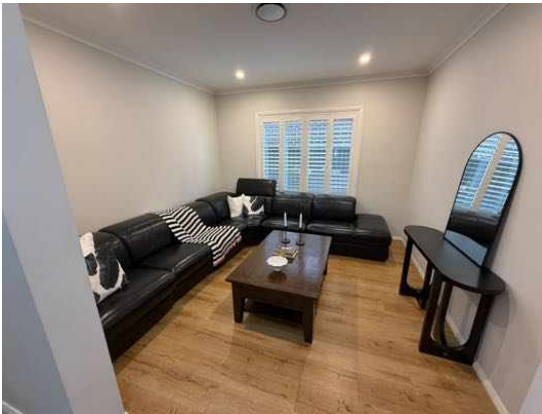
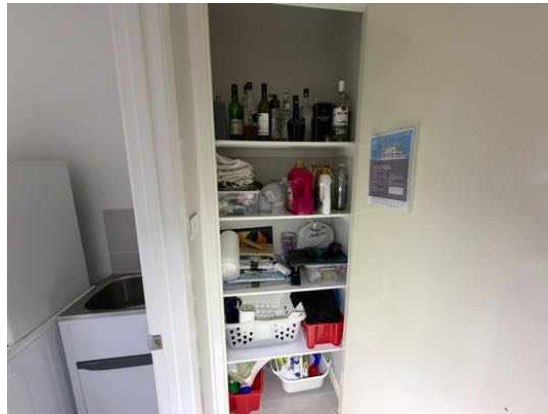
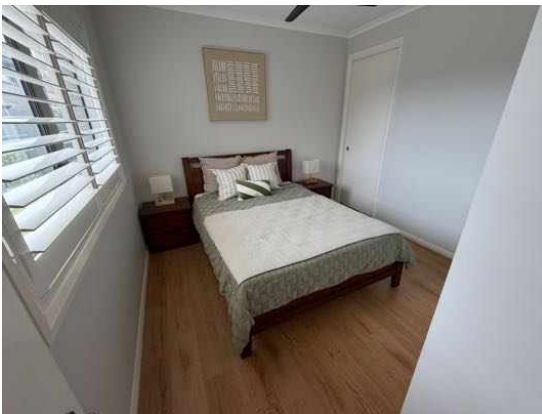
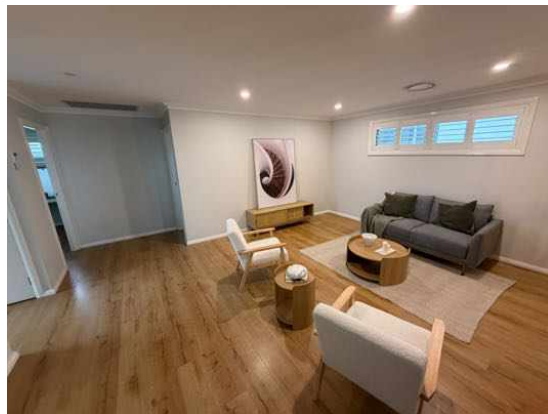
Building:	Main Building
Location:	Internal Areas
Finding:	Obstructions and Limitations-Internal areas
Information:	These photographs are an indication of the obstructions and limitations which impeded full inspection of the internal areas at the time of inspection. These obstructions can hide an array of defects and should be removed to allow a full inspection to be carried out. A re-inspection is recommended once the areas are made accessible.

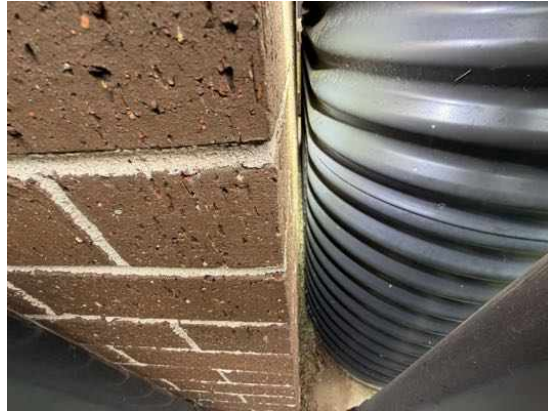
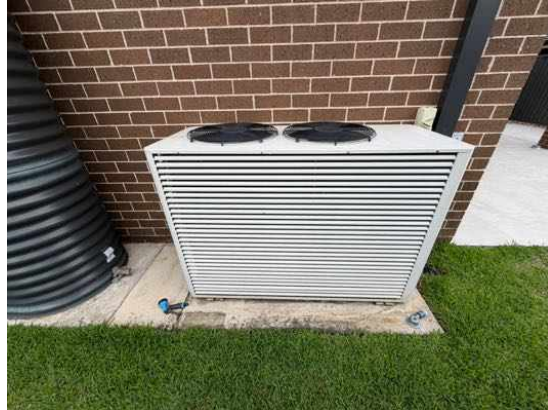
Building: Main Building  
 Location: External Areas/Sub-Floor  
 Finding: Obstructions and Limitations-External Areas/Sub-Floor  
 Information: These photographs are an indication of the obstructions and limitations which impeded full inspection of the external areas at the time of inspection. These obstructions can hide an array of defects and should be removed to allow full inspection to be carried out. A re-inspection is recommended once the areas are made accessible.

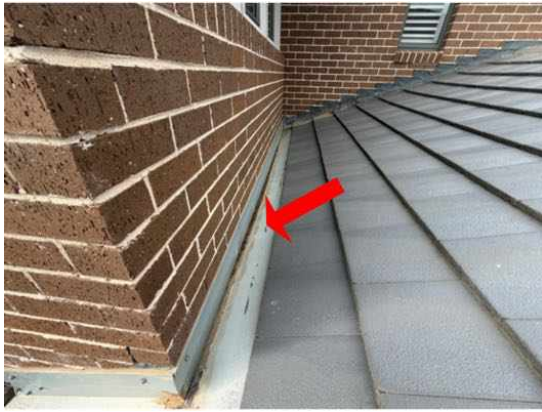
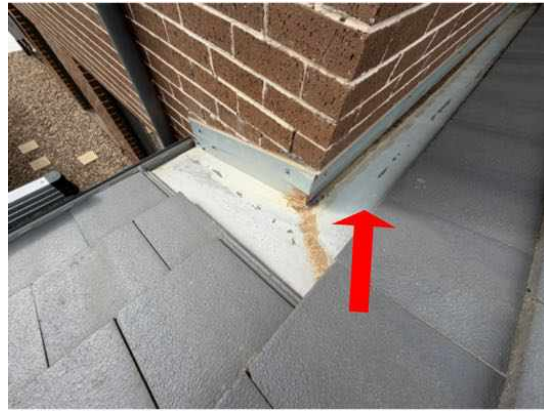
Building:	Main Building
Location:	Box Gutter
Finding:	FYI Box Gutter-Above Garage
Information:	The box gutter located above the garage roof appeared to be in generally good condition at the time of inspection, with no obvious signs of active leakage noted.

Box gutters are known to be susceptible to blockage from debris accumulation and may be prone to overflow or leaking if not regularly maintained. Poor maintenance can result in water ponding and potential moisture ingress into surrounding building elements.

It is recommended that the gutter be kept clean and free of leaves, dirt, and other debris, and that the area be periodically monitored for any signs of blockage, deterioration, or leakage.

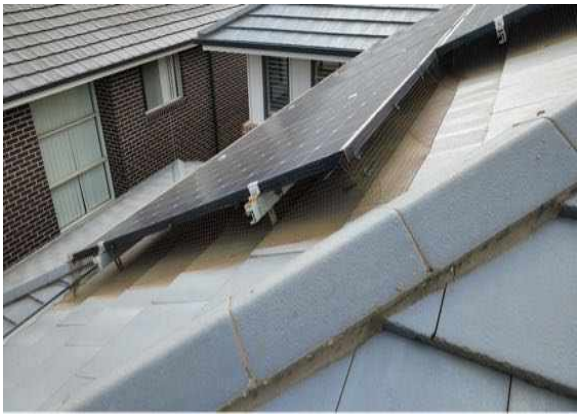
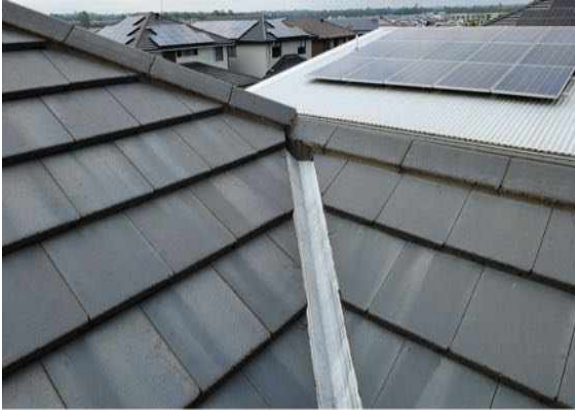
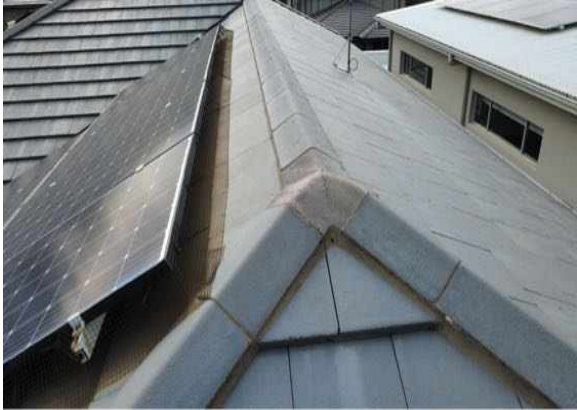
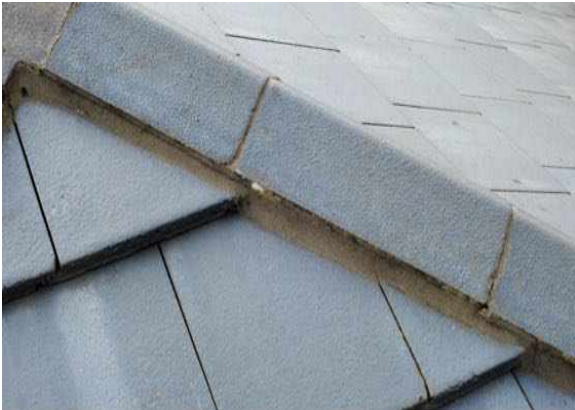
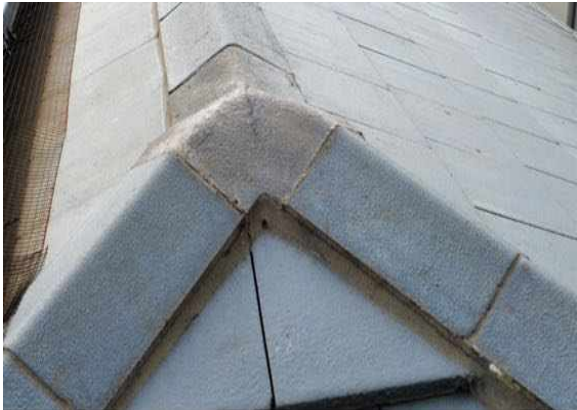
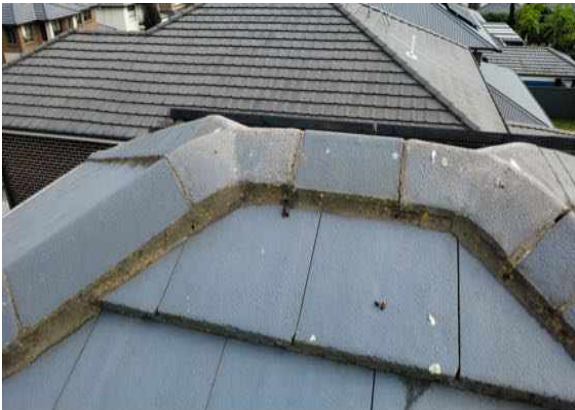
Building:	Main Building
Location:	Roof Exterior
Finding:	Roof tiles - Weathered
Information:	Upon inspection of the exterior roofing, the majority of roof tiles were considered to be in a fair condition. While weathering of the tiles is consistent with the age of the property, maintenance works are required.

Consultation with a roofing contractor is highly advised to gain advice on cost of remedial works that may be required in the short to medium term. Remedial works are likely to increase the longevity of the exterior roofing structure.

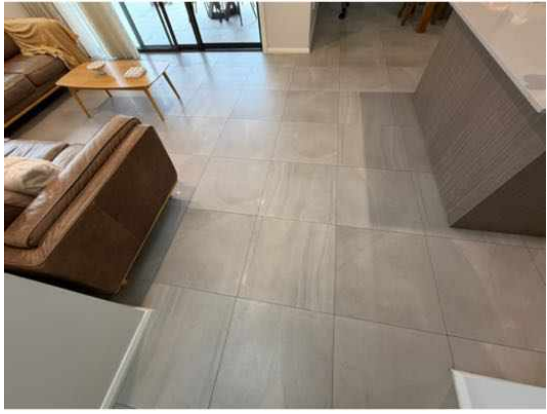
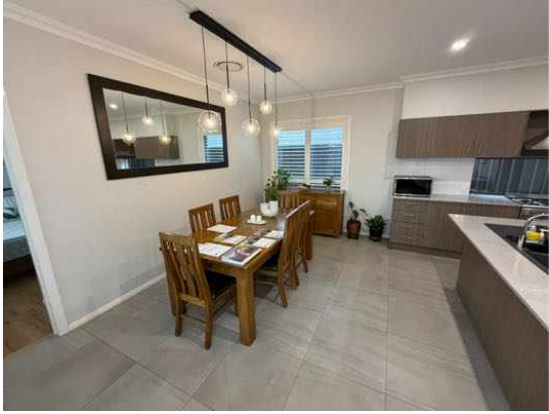
Building: Main Building  
Location: All Internal tiling  
Finding: FYI-Internal Tiling  
Information: All internal floor tiling was in good condition with no obvious cracking or drummy tiling identified.
