# Building and Timber Pest Inspection Report

Inspection Date: Thu, 6 Nov 2025

Property Address: Wondara, 233 Logans Rd, Carabost NSW  
2650, Australia

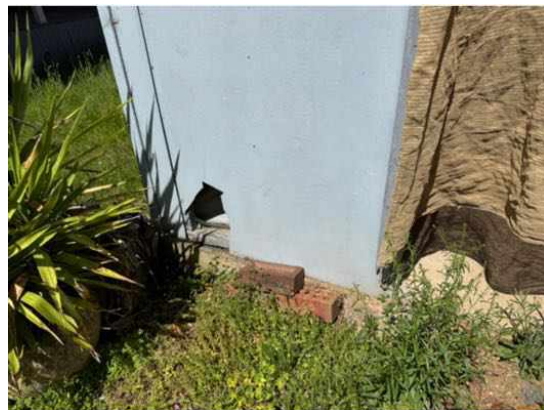
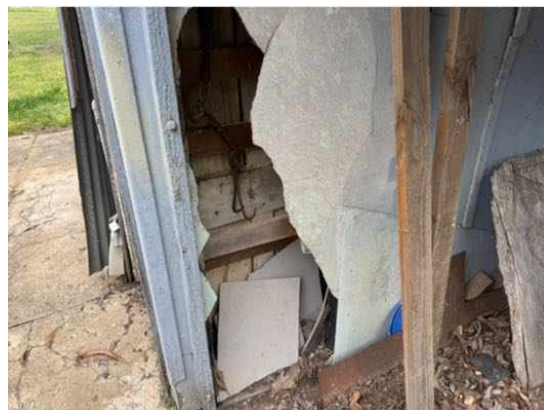
Building:	Main Building
Location:	Internal Walls, Shed Cladding
Finding:	Asbestos - Damaged Suspected ACM
Information:	This suspected defect is highlighted as a caution only as reporting on asbestos is outside the scope of this report. Several areas of damaged suspected ACM were identified throughout the building and shed.

It is advised that the client consider a separate Asbestos Inspection and Condition Audit, which can include the taking of samples for definitive confirmation of the presence of Asbestos, carried out by a licensed Asbestos Inspector.

In the interim, no works should be conducted to these areas without further specialist advice, and the area should be avoided to avoid potential safety hazards.

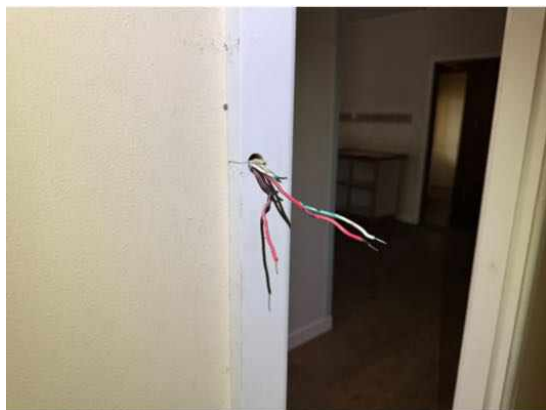
#### Finding 1.02

Location:	Front Bedroom
Finding:	Electrical wires exposed
Information:	Exposed electrical wiring was identified at but not limited to the front bedroom door frame. Exposed electrical wiring represents a potential safety hazard including fire and personal contact risks.

The client should contact a licensed electrician promptly for further inspection of electrical wiring and to provide remedial works where necessary. In the interim, the client should avoid the area to avoid safety hazards.

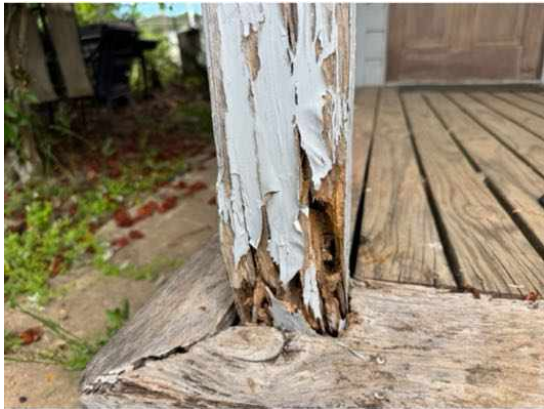
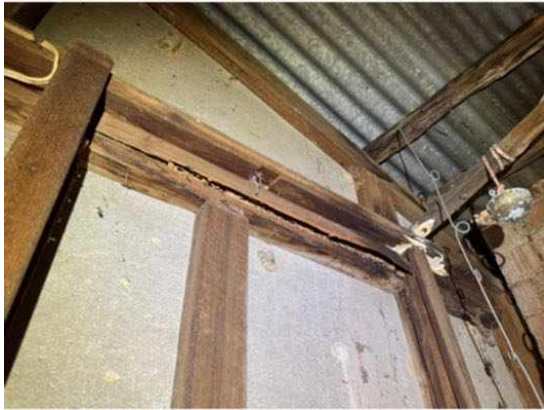
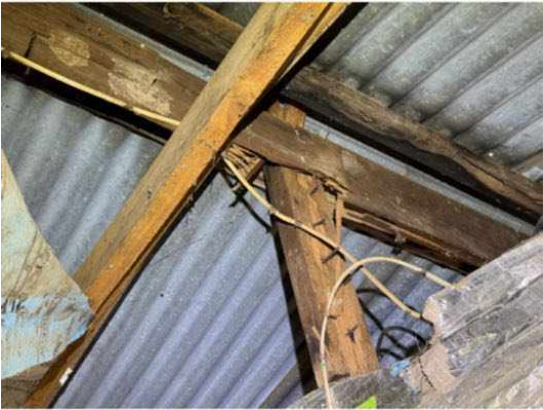
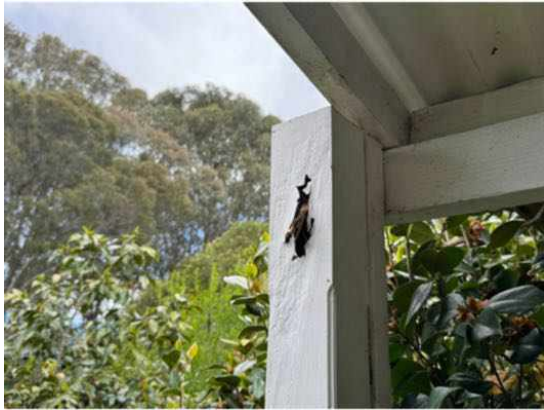
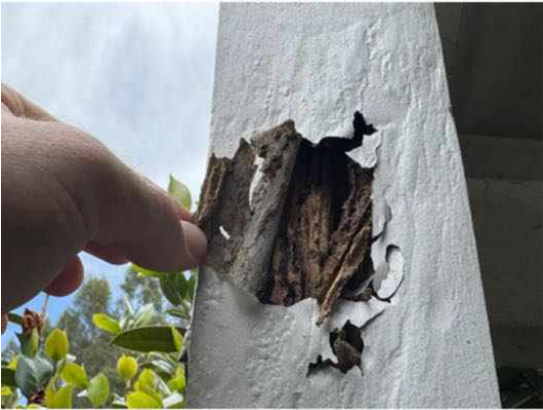
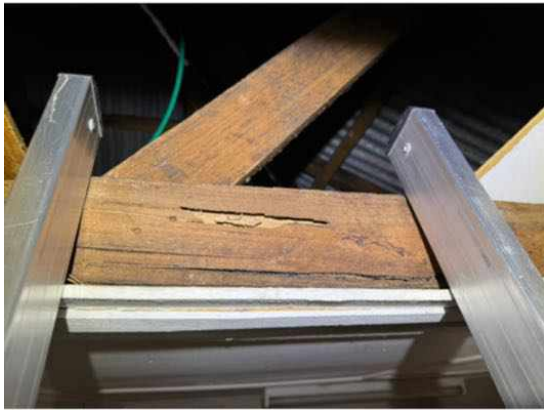
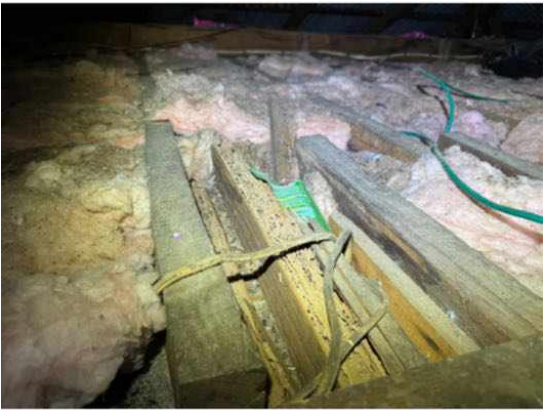
### Finding 2.01

Building:	Main Building
Location:	Roof framing & beams, Shed framing and beams, verandah posts
Finding:	Structural Members - Termite Damage & Fungal Decay
Information:	It appears several structural members have been affected by termite damage and fungal decay, including but not limited to areas of the roof framing, verandah posts, a subfloor bearer and the shed framing.

This inhibits the structural integrity of the building. Recommend consulting with a registered builder and structural engineer promptly to provide further advice & remedial works to avoid further deterioration of the building. It is also advised that the client engage a licensed tradesperson to conduct a more invasive inspection to identify the extent of the termite damage and rectify accordingly. A more invasive inspection may reveal secondary building defects.

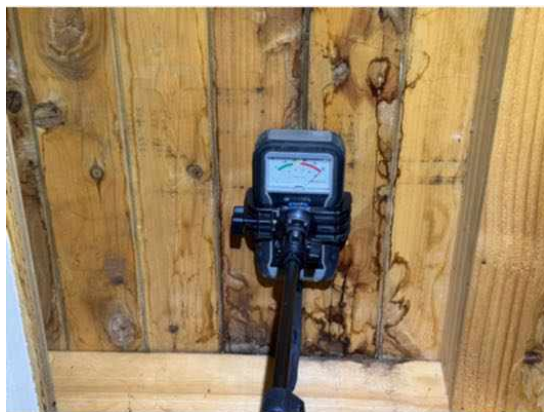
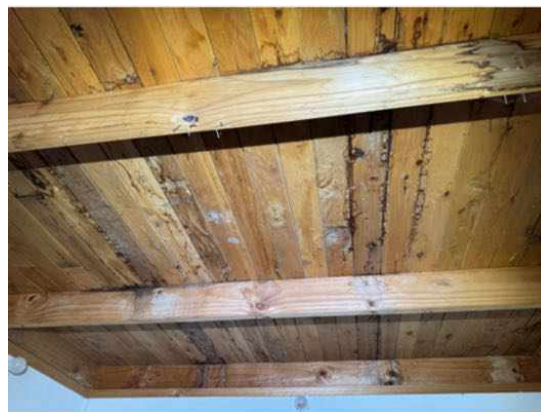
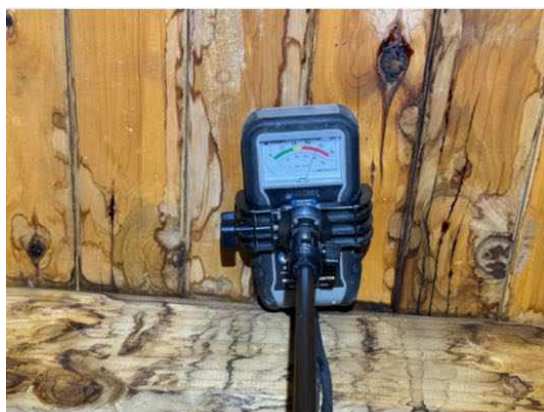
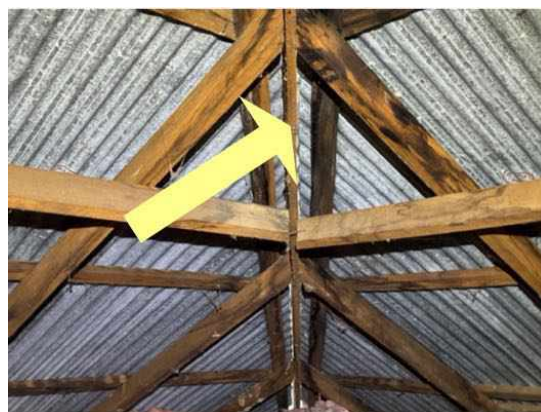
**Finding 2.02**

Building: Main Building  
 Location: Eaves, Internal Timber Ceilings, Roof Framing  
 Finding: Ceiling & Roof Leaks Present  
 Information: High moisture and areas of leaking were identified to several areas of the timber ceiling, roof framing and eaves. Potential causes of leaking include damaged plumbing fittings and fixtures, or deterioration of the roof plumbing.

This creates an environment conducive to termite activity & water damage to surrounding building materials. Recommend engaging a licensed roof plumber or roofing contractor promptly to provide remedial works.

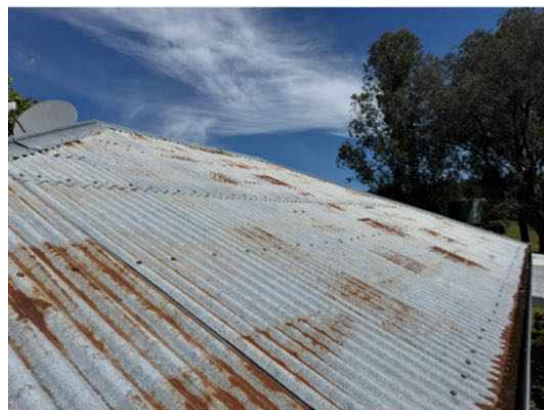
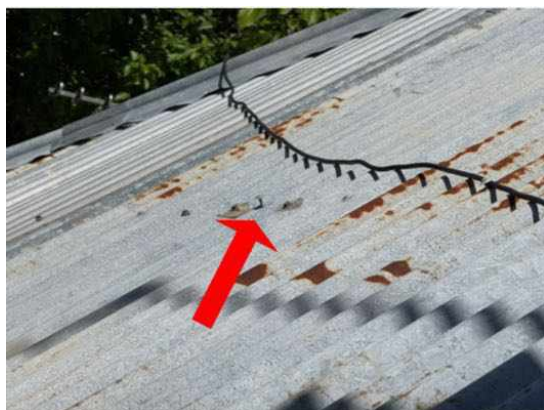
### Finding 3.02

Building:	Main Building
Location:	Roof Exterior
Finding:	Roof Exterior - Weathered, Rust & Loose
Information:	The roof exterior was found to be in a weathered condition at the time of inspection evidenced by loose screws and roof sheeting, and areas of rust.

Where left unmanaged, deteriorating and damaged roof sheeting and plumbing is likely to lead to secondary defects, including water leaks.

It is advised that the client consult with a licensed roofing contractor at their earliest convenience, to provide further advice on remedial works that are required and to ensure all roof sheeting is secure.

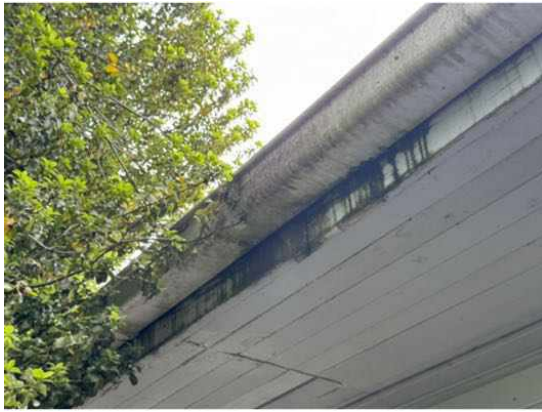
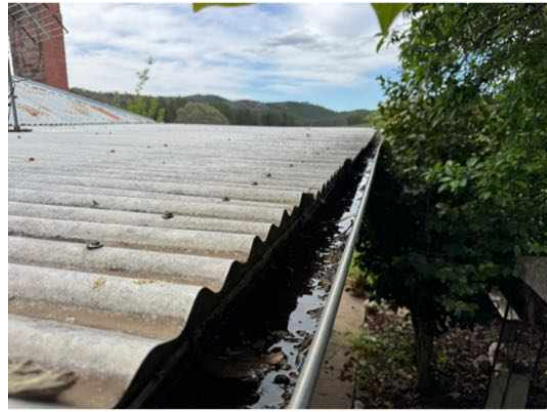
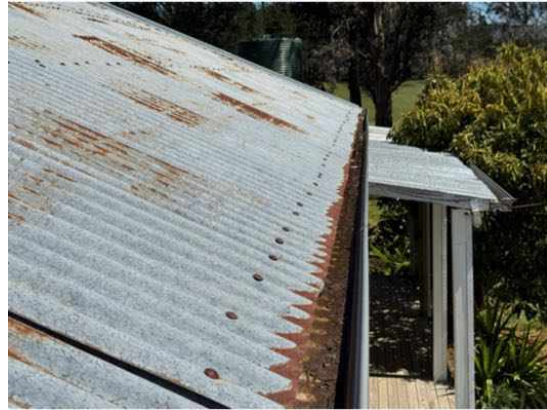
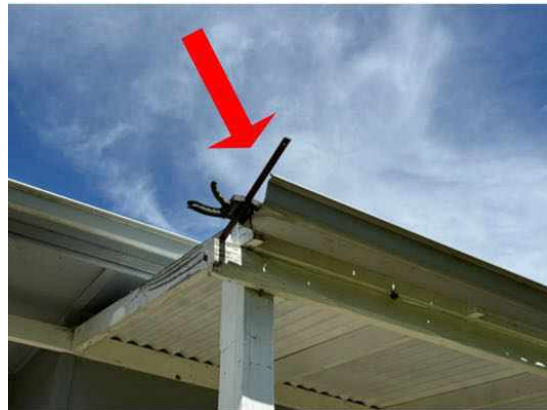
### Finding 3.03

Building:	Main Building
Location:	Guttering >
Finding:	Gutters - Debris, Water Pooling, Rust, Not Connected
Information:	Areas of water pooling, debris and rust were identified throughout the guttering. The gutter to the front elevation was also found to be disconnected from drainage, creating an environment conducive to termites. Water pooling & rust of the gutters is likely to lead to deterioration and overflows of the roof plumbing if neglected.

Recommend engaging a licensed roof plumber in the short term, to provide further advice to ensure adequate roof drainage is achieved. All debris should be removed from the gutters promptly to avoid overflows.

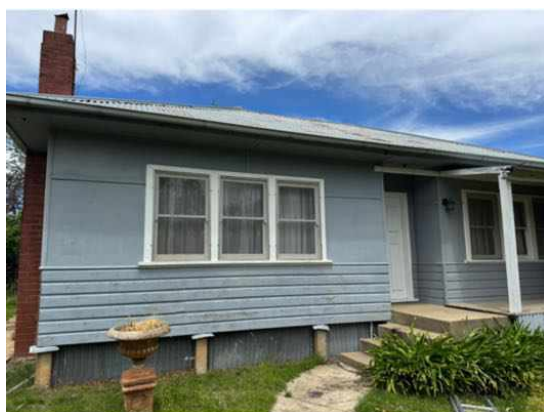
Building:	Main Building
Location:	No Treatment
Finding:	Termite Management System - no evidence of a chemical installation
Information:	The application of a termite barrier is recommended, as it appears no termite management system has been installed, with no evidence or durable notice to suggest works taking place.

Such barriers are highly effective in preventing termite attack on the building and therefore should be installed.

Recommend seeking further advice from a licensed pest controller promptly.

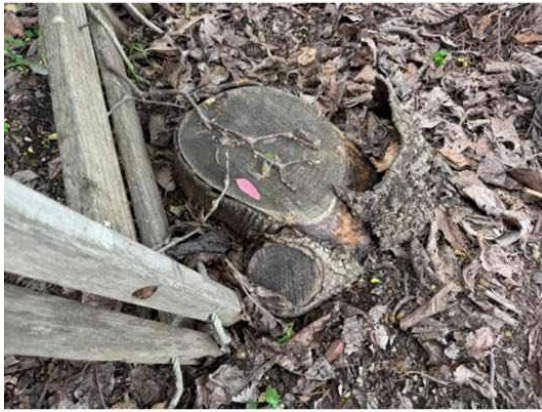
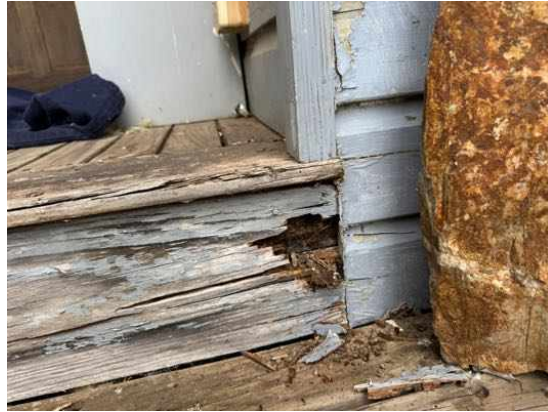
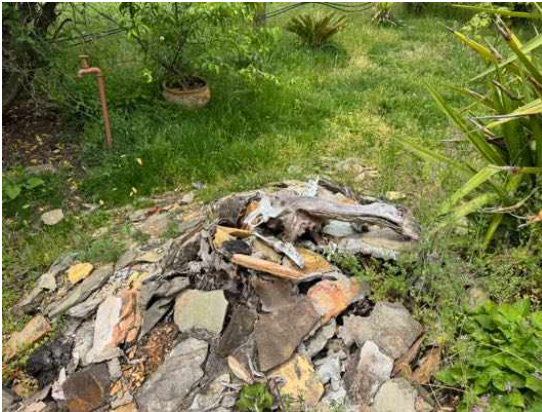
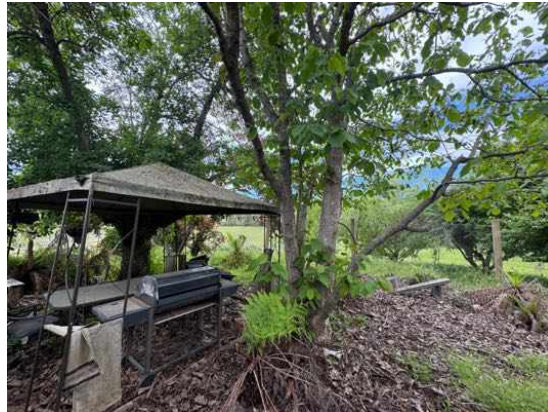
### Finding 6.02

Building:	Main Building
Location:	All External Areas
Finding:	Timber in direct ground contact & trees - conducive to termites
Information:	Where timber materials are in direct contact with the ground and consequently moisture, they become conducive to termite activity. The landscaping timbers, trees & stumps surrounding the building create an environment conducive to termite infestation.

Where feasible, any timbers in direct contact with the ground, or trees in close proximity to the building should be removed, to reduce the risk of termite infestation.

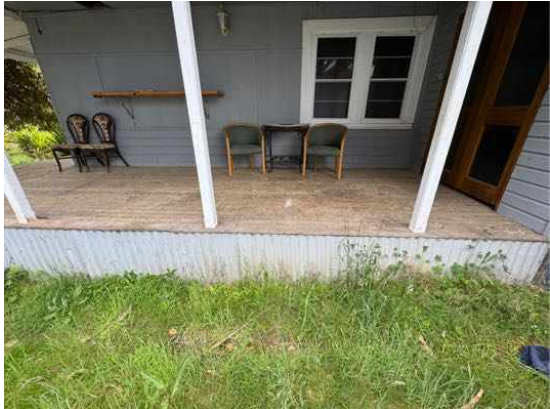
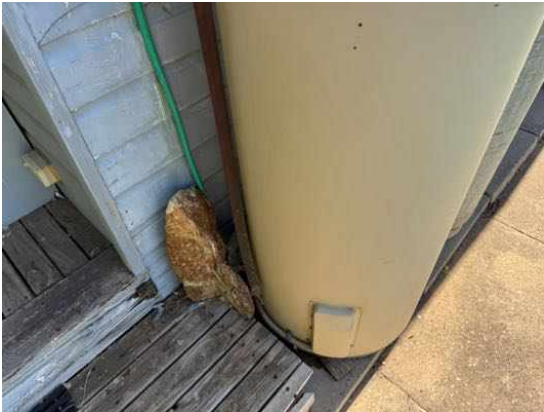
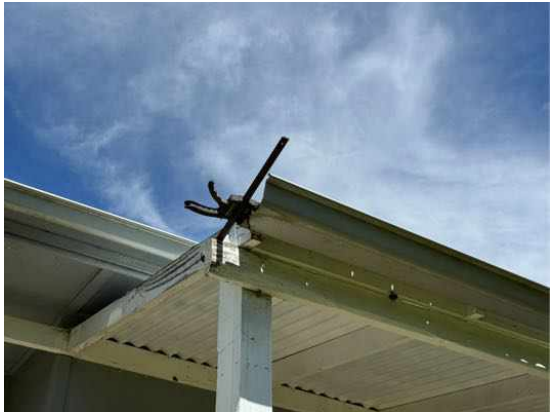
### Finding 6.03

Building:	Main Building
Location:	All external areas, Gutters, HWS
Finding:	Potential Water pooling - against property
Information:	It appears that there are potential areas around the perimeter of the property that could be susceptible to water pooling.

Where insufficient drainage of taps, roof plumbing, hot water system & aircon overflows, and garden beds against the house are present, water pooling is likely to occur, and can create areas conducive to timber pests and potential damage to the subfloor structure overtime, if neglected.

Recommend consulting with a licensed plumber in the short term to further assess and provide remedial advice.

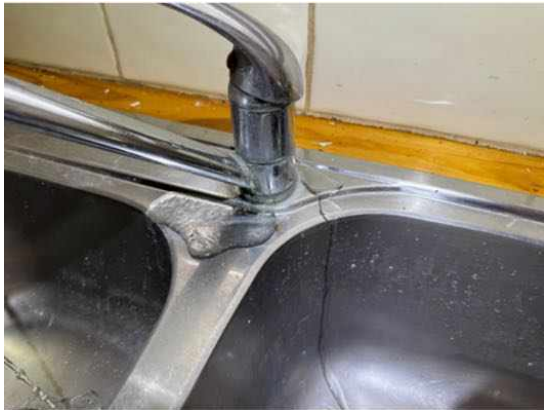
**Finding 6.04**

Building: Main Building  
Location: Kitchen Tap  
Finding: Tap - Leaking  
Information: It appears that the kitchen tap was leaking at the time of inspection. This is a relatively common defect that is consistent with general ageing of the building element.

Areas of leaking create an environment conducive to termite activity & water damage to surrounding materials. Recommend engaging a licensed plumber in the short term, to provide minor remedial works.

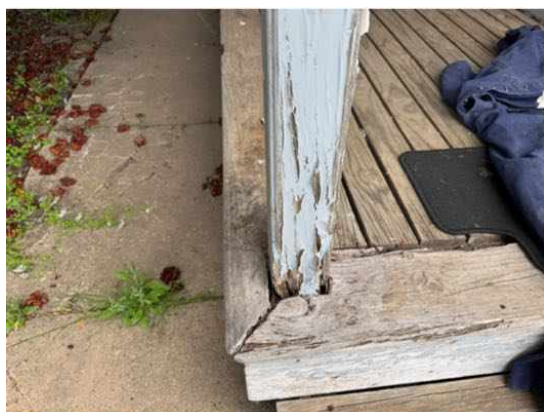
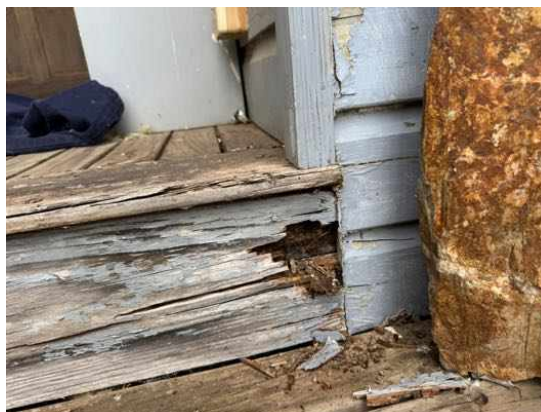
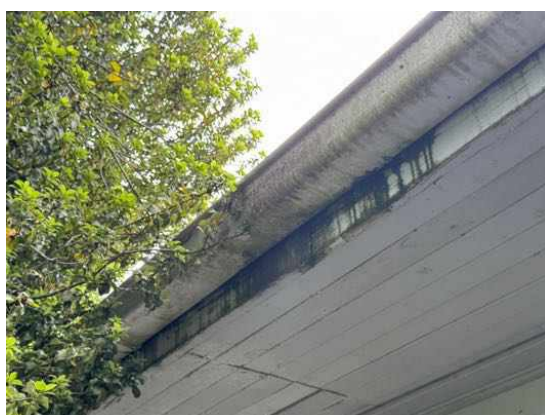
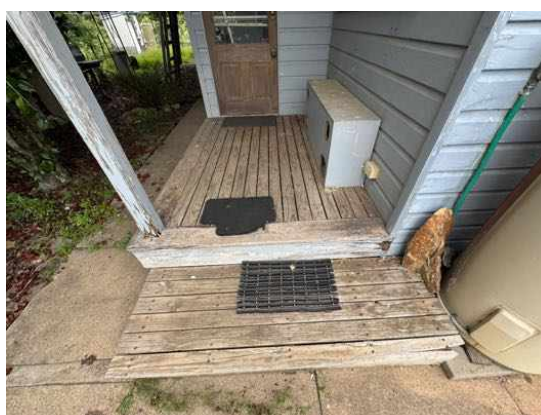
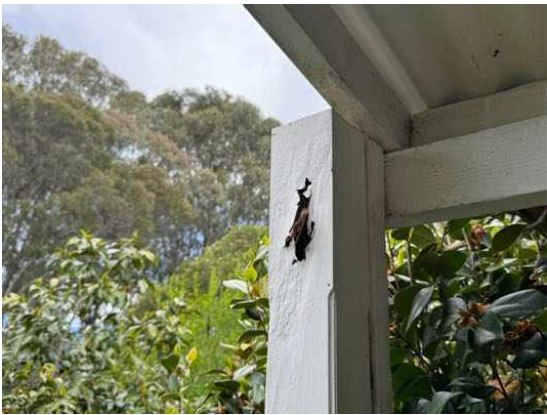
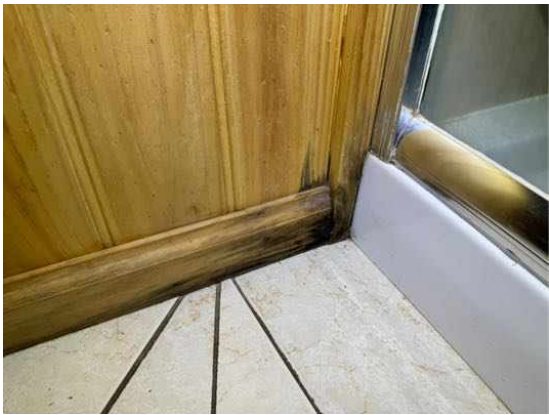
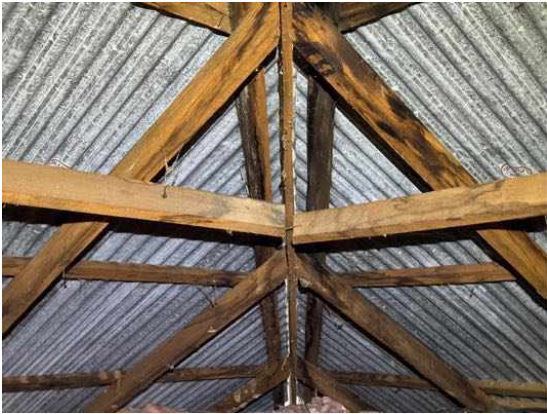
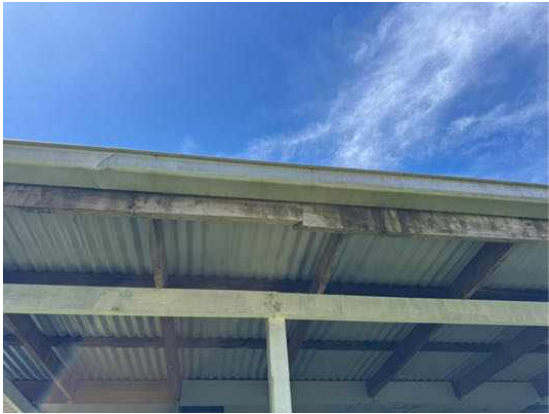
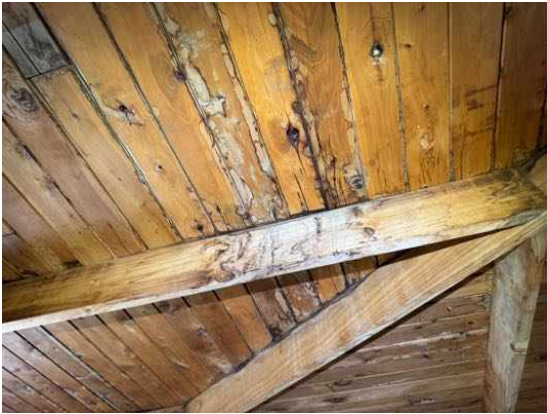
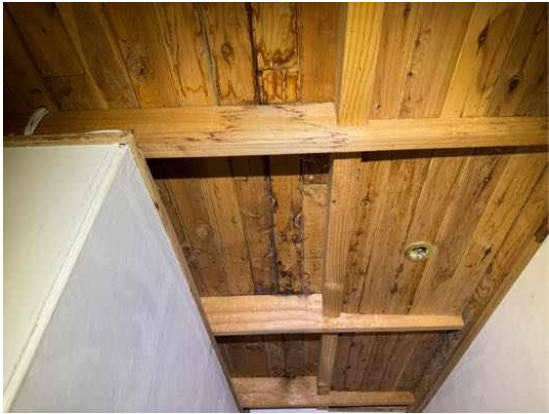
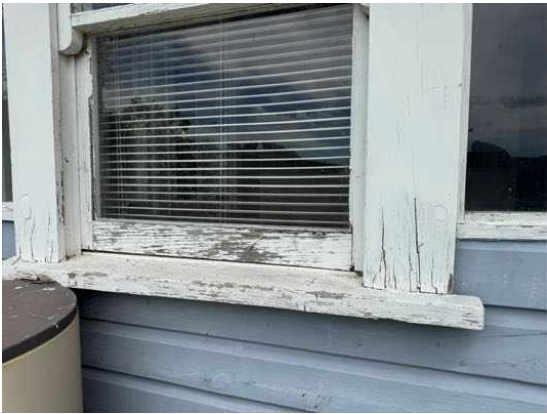
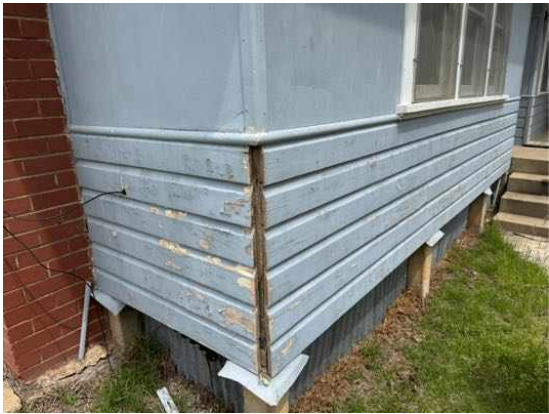
### Finding 7.01

Building:	Main Building
Location:	Decking, weatherboards, window frames, fascia's, bathroom skirting, external timbers, posts, roof framing, timber ceiling
Finding:	Fungal decay & weathering
Information:	Areas of fungal decay (wood rot) & weathering were identified at but not limited the decking, verandah posts, window frames, fascia's, roof framing, and external timbers.

For areas where structural timbers are affected by wood rot (verandah posts) a registered builder should be engaged promptly to replace affected materials where necessary.

For areas where fungal decay is superficial, the client can engage a licensed carpenter at their discretion to replace affected materials.

For areas of general weathering, it is advised the client engage a licensed painter to apply protective sealant or coating to areas of weathered external timbers.

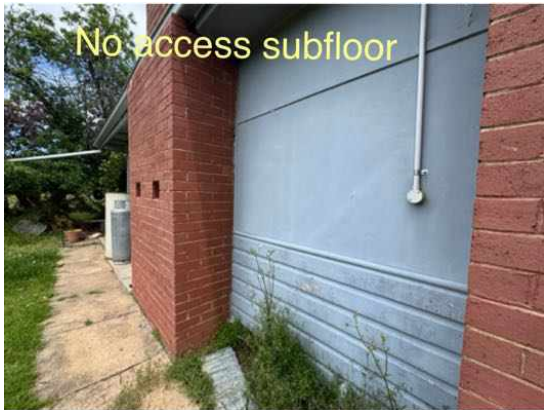
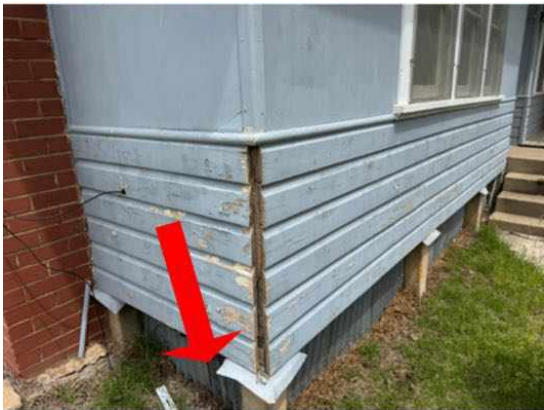
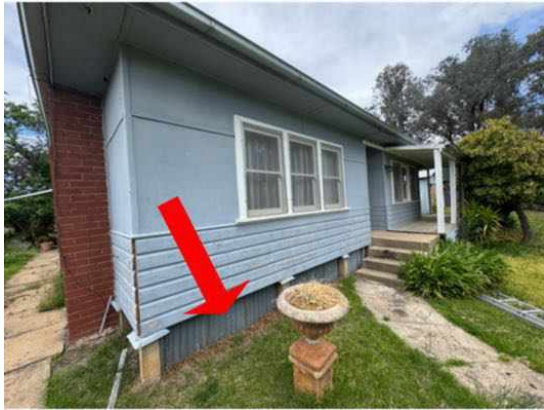
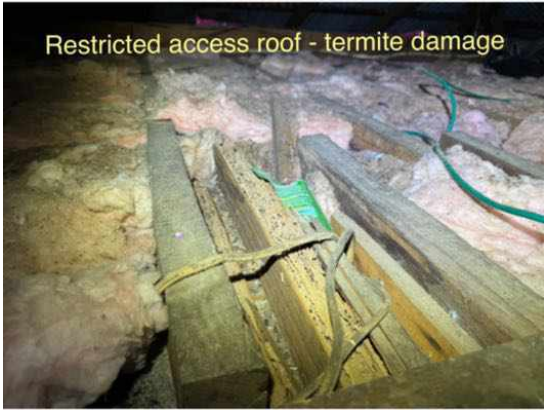
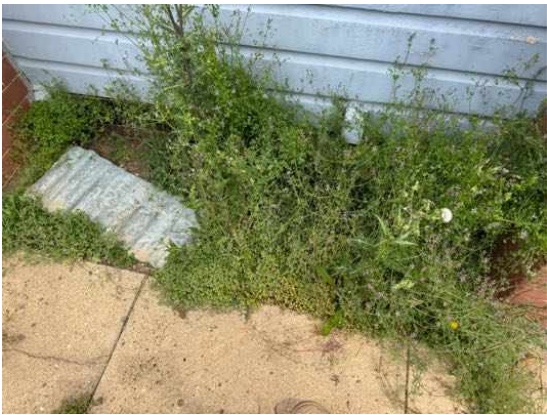
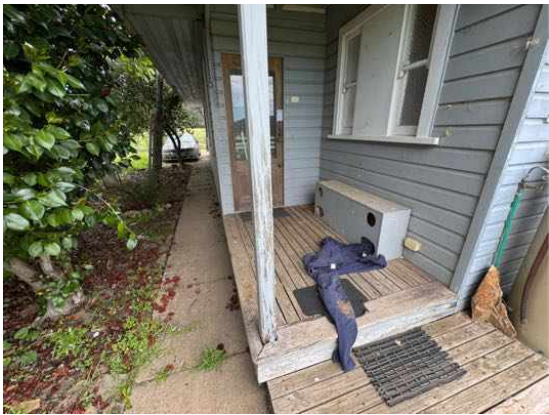
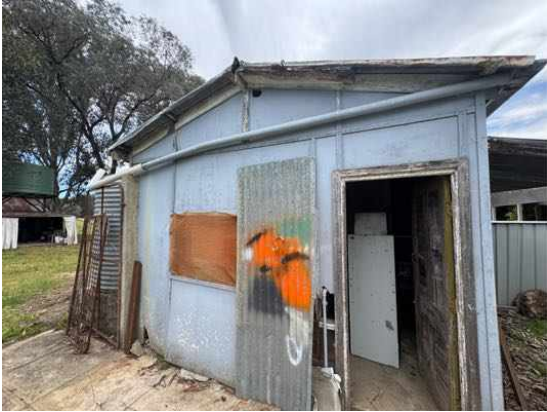
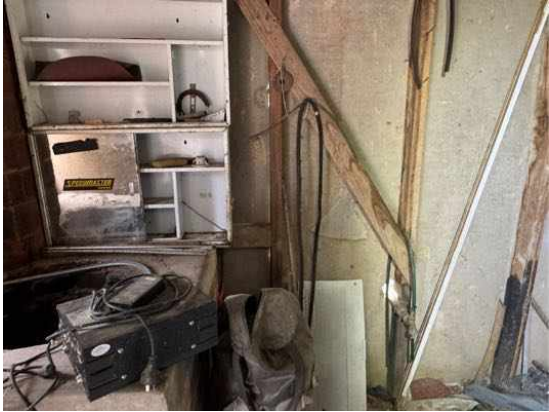
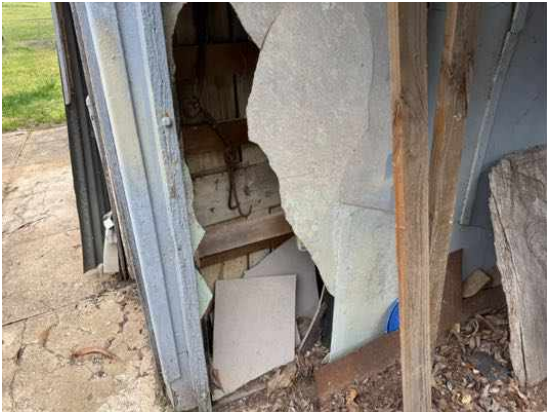
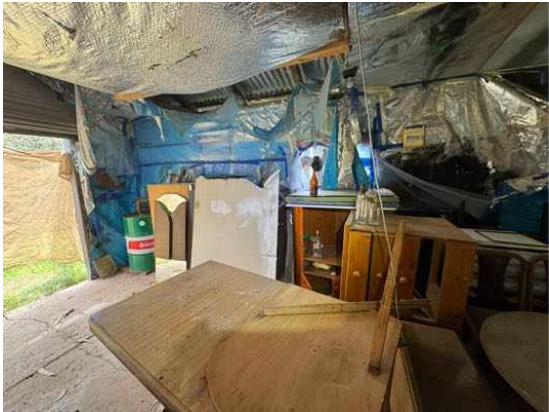
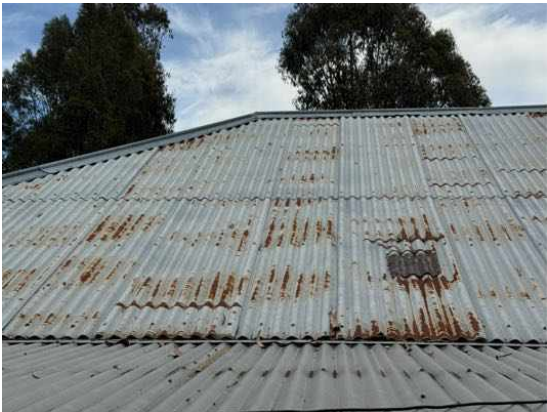
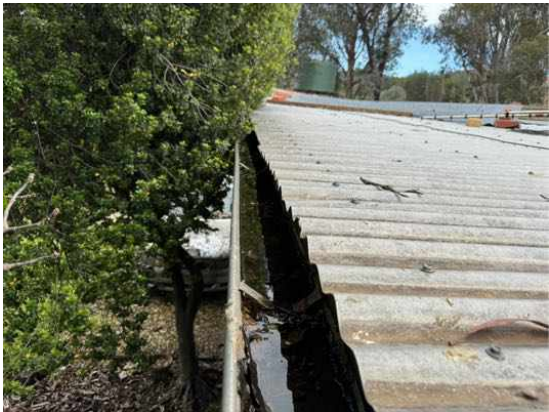
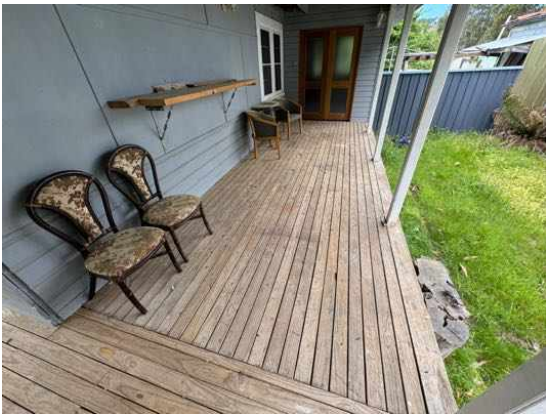
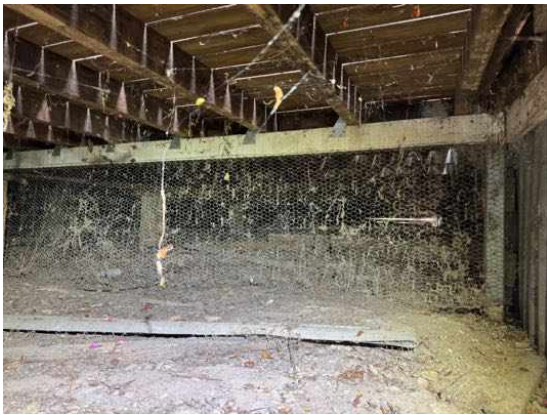
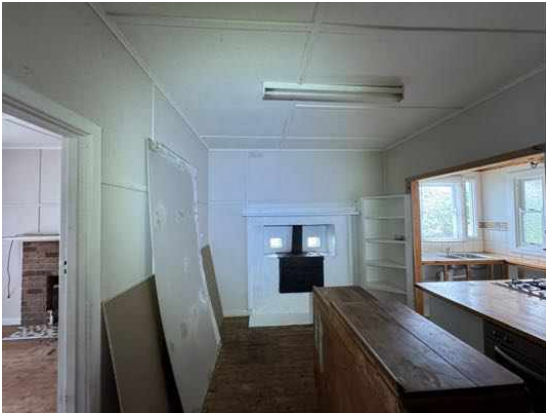
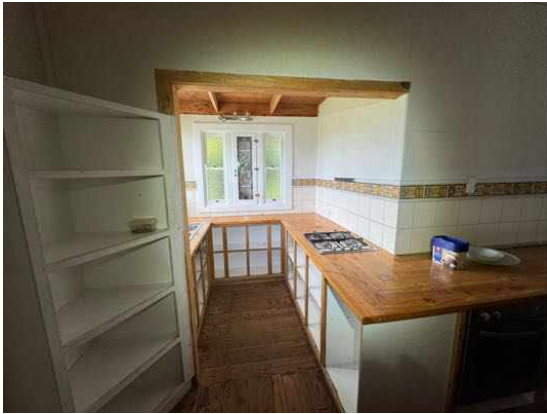
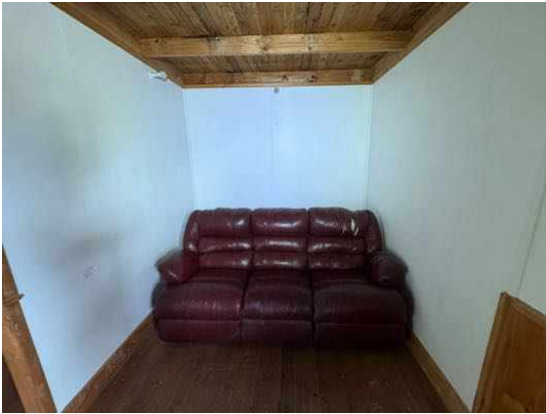
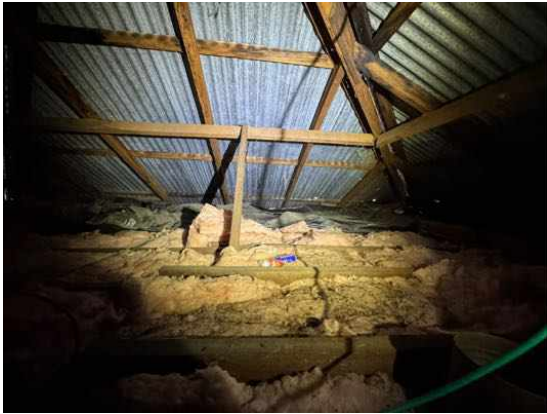
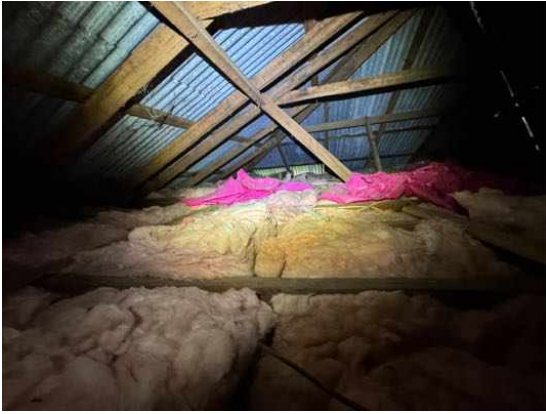
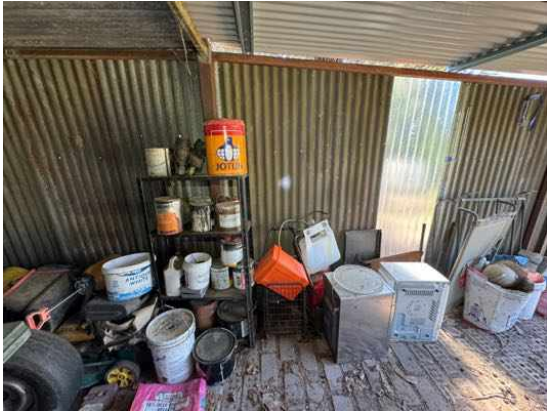
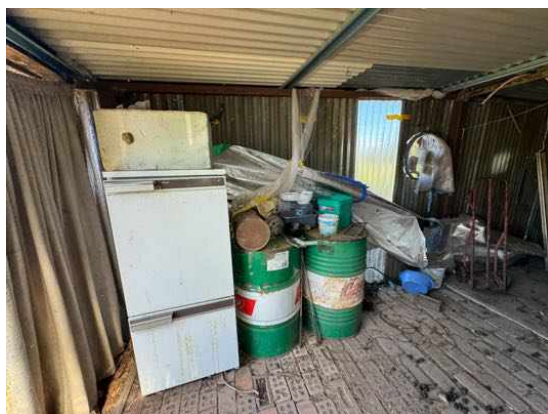
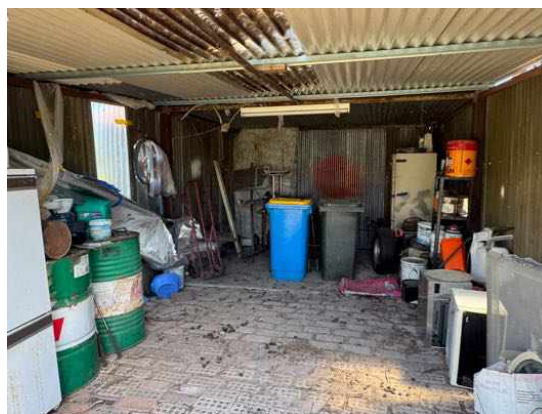
Building: Main Building  
Location: All Areas  
Finding: Additional Photos - Obstructions and Limitations  
Information: These photographs are an indication of the obstructions and limitations which impeded full inspection of the property at the time of inspection. These obstructions can hide an array of defects and should be removed to allow full inspection to be carried out. A re-inspection is recommended once the areas are made accessible.

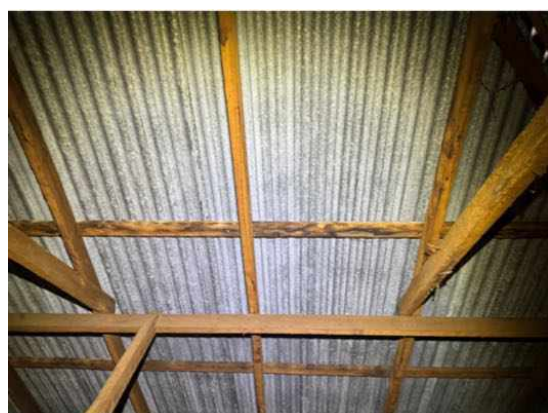
Building: Main Building  
 Location: Roof Void  
 Finding: Sarking - Not Present  
 Information: It is noted for your information that sarking has not been installed on the roof. Sarking is a laminated aluminium foil applied to the interior of the roof covering, assists in insulating the property and acting as a vapour-barrier to the roof void.

The client can consult with a licensed roofing contractor at their discretion, to provide further advice.

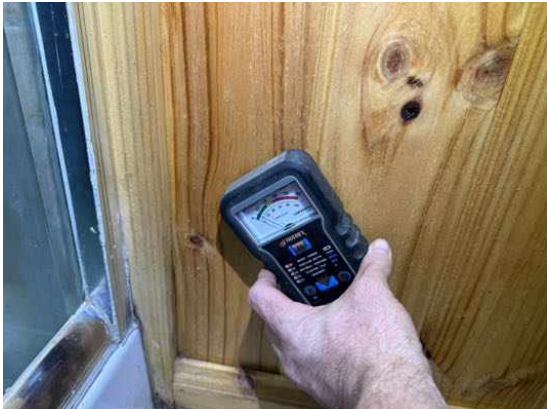
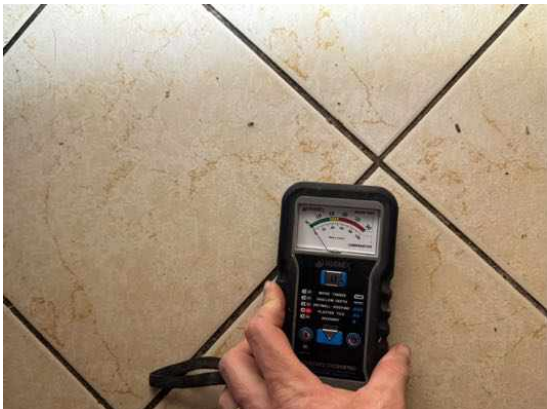
Building: Main Building  
 Location: All Areas  
 Finding: FYI Moisture Readings  
 Information: These photos are the moisture readings taken near plumbing fixtures and fittings, for your information.

No excessive moisture was evident in these areas at the time of inspection.
