Building and Timber Pest Inspection Report

Inspection Date: Thu, 26 Mar 2026

Property Address: 126 Vantage Blvd, Craigieburn VIC 3064,
Australia

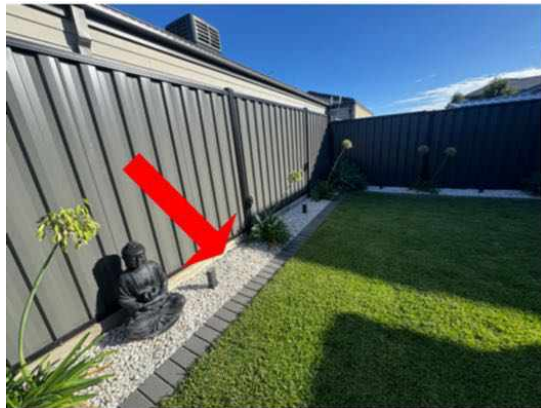
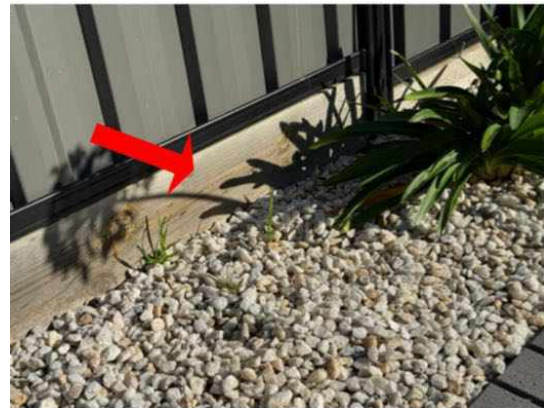
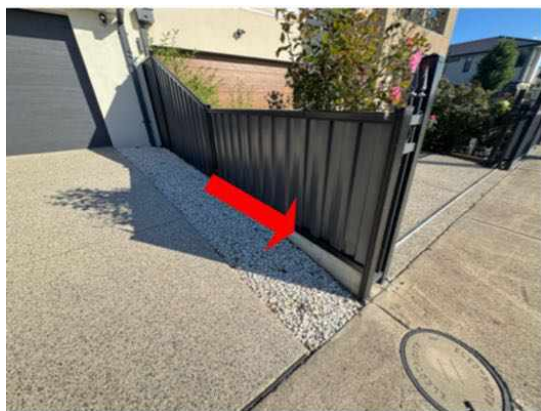
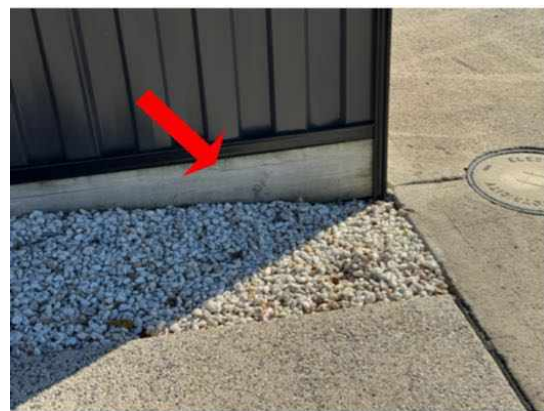
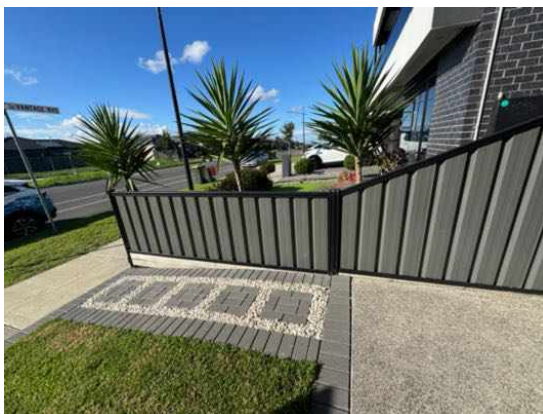
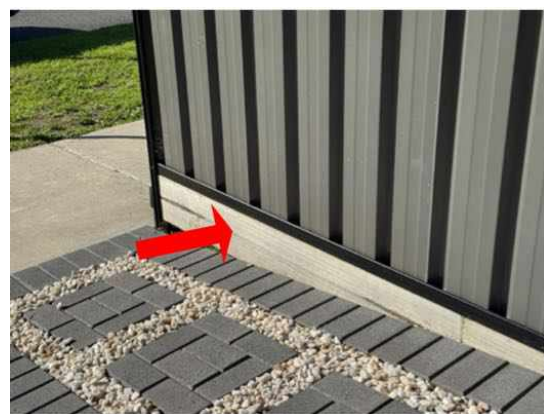
Finding 6.01

Building:	Main Building
Location:	Yard > All Areas
Finding:	Building materials in direct ground contact - conducive to termites
Information:	Where timber elements are in direct contact with the ground and consequently moisture or dampness they become conducive to termite activity. Whether timber is used as a building element part of a fencing structure or stored as an unused item they can provide an environment that is attractive to termite infestation.

When met with excessive moisture timber begins to decay and develop wood rot. Any timbers that are in direct contact with external grounds especially if left untreated or non-durable also provide ingress for subterranean termites into that particular element. Consider replacement with more durable materials i.e. treated timber or non timber elements.

The removal of any such materials that may be conducive to termite activity should be removed as soon as possible to minimise the risk of termite attack. Where it is not possible frequent inspections of these areas shall be undertaken to provide early detection of infestation

It is highly recommended that termite or timber pest inspections be carried out every 6-12 months to aid protection of the property against infestation.

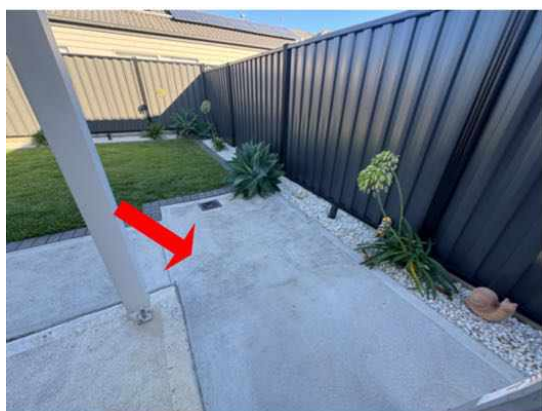
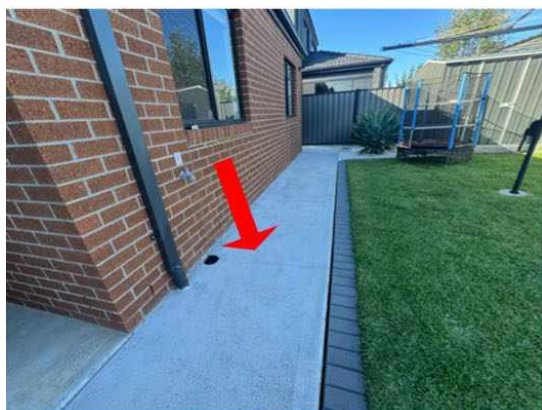
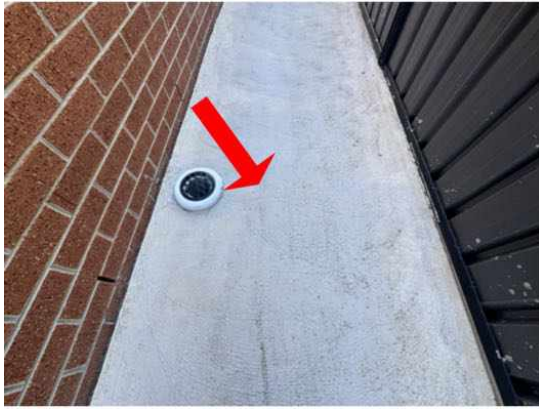
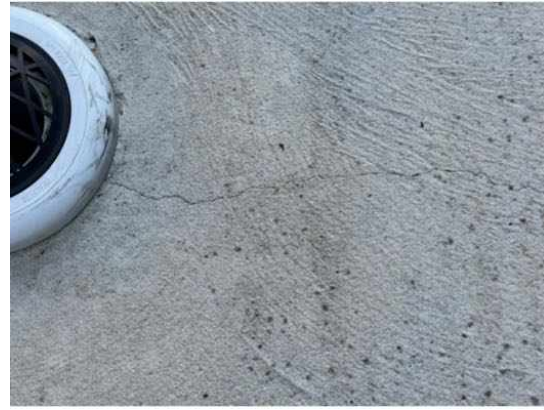
Building: Main Building
Location: Footpath
Finding: Cracking - External Concrete Paving Damage Category 0 - Hairline (less than 1mm)
Information: Hairline cracks were identified in external concrete paving. Hairline cracks are very minor in nature and generally are only ever an appearance defect. To be classified as a Category 0 or hairline crack, the crack width would be less than 0.3mm. While such cracking may be noticeable in some cases, it is common and does not indicate any structural damage.

Generally the cause of a hairline crack in existing concrete paving such as driveways and pathways is indicative of the expansion and contraction of the concrete. Such causes are generally due to environmental factors, such as moisture levels, weather conditions or the soil types on which they are laid.

Monitoring of all cracking should be conducted frequently. Always contact a building inspector should cracks widen, lengthen, or become more numerous.

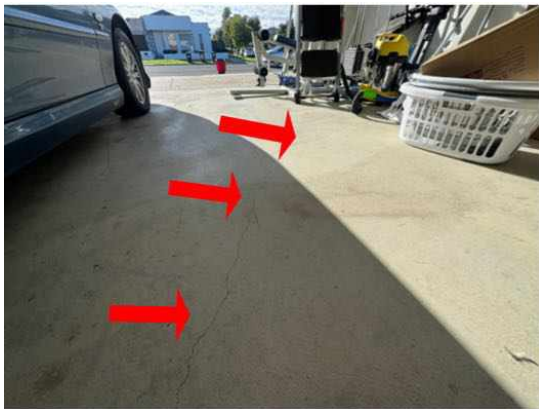
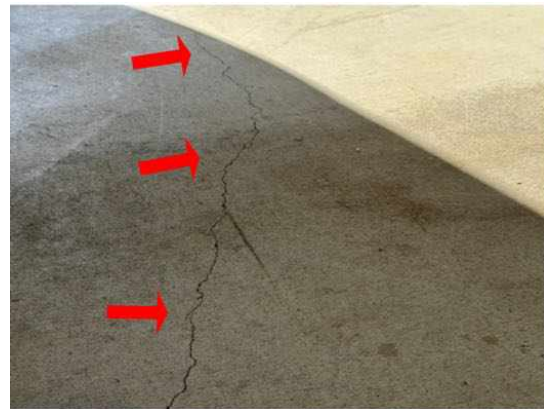
Building:	Main Building
Location:	Garage
Finding:	Cracking - Concrete Category 0 - Hairline (less than 1mm)
Information:	Hairline cracks were identified in the concrete slab. Hairline cracks are very minor in nature and generally are only ever an appearance defect. To be classified as a Category 0 or hairline crack, the crack width would be less than 0.3mm. While such cracking may be noticeable in some cases, it is common and does not indicate any structural damage.

Monitoring of all cracking should be conducted frequently. Always contact a building inspector should cracks widen, lengthen, or become more numerous.

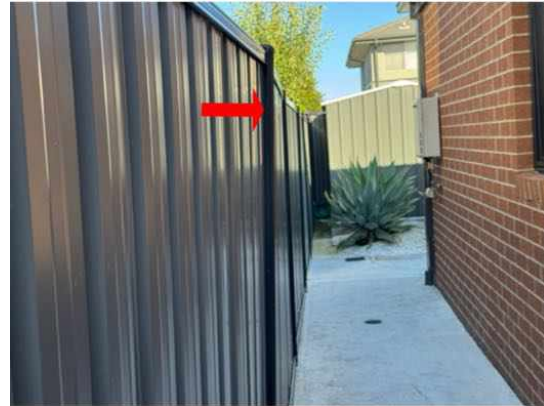
Building:	Main Building
Location:	Fencing
Finding:	Fencing - Deteriorated
Information:	It was noted at the time of inspection that the fencing to this area has moved . Typically fencing deteriorates due to age and or wear, rot and or rust which is generally expected for a structure of this age, due to prolonged exposure to weather conditions. Sometimes inadequate installation or maintenance can be to blame.

If left unattended, it is likely that further damage may occur. It is suspected that repair of the fencing may be required in the medium term.

A licensed fencing contractor should be appointed to provide further advice and perform rectification works as necessary at the clients discretion.

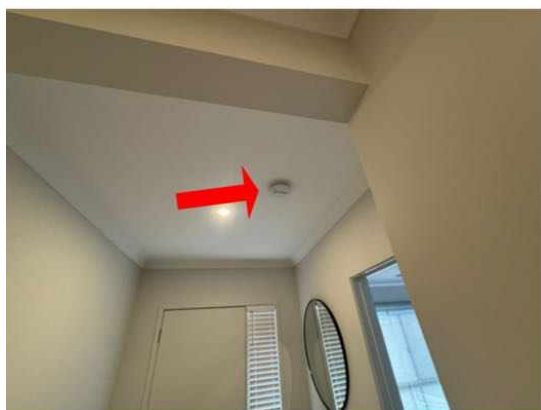
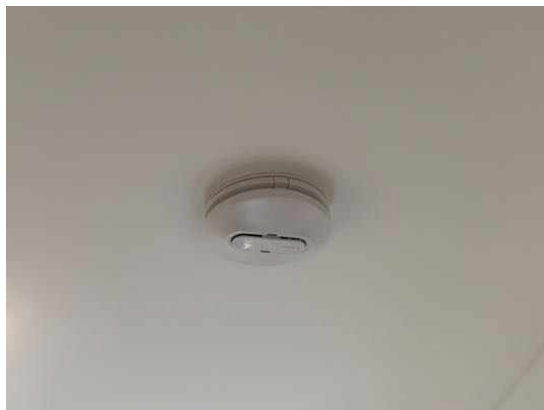
Building: Main Building
 Location: All Areas
 Finding: Smoke Detectors and Alarms
 Information: Reporting on Smoke Detectors or Alarms, including hard wired smoke detection systems and their legislative requirements, is outside the Scope of this Report.

Always ensure sufficient working and suitable smoke detectors are installed prior to occupying any building. Additionally, it is advised that all smoke detectors be tested by the homeowner on a monthly basis.

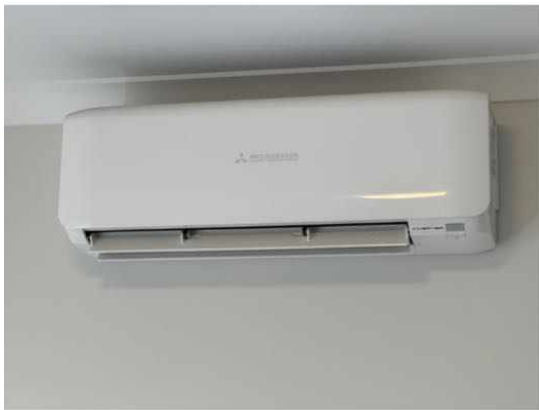
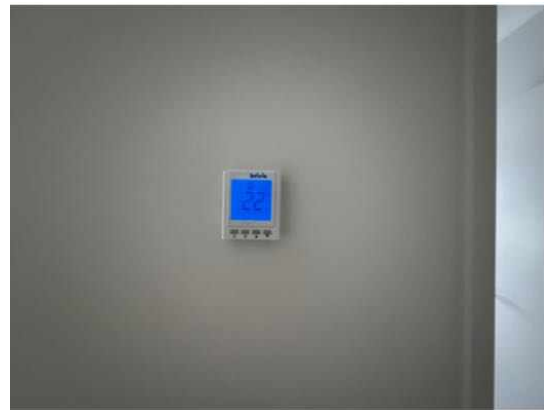
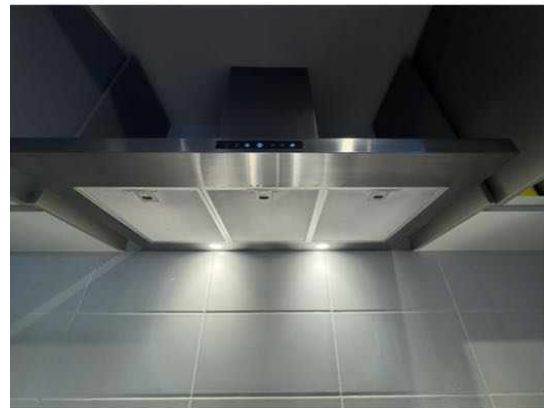
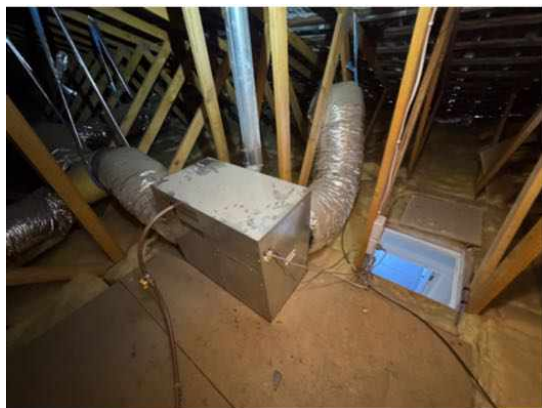
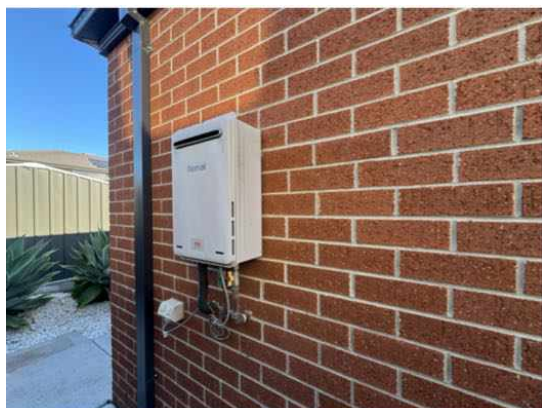
Building: Main Building
 Location: All Areas >
 Finding: Plumbing and Electrical

Information: All gas and electrical appliances need to be serviced and maintained in good order. I can not guarantee that all appliances are working to full capacity and always recommend that heating/cooling equipment be serviced regularly.

Plumbing and electrical inspections are outside the scope of the building inspection and must be conducted by Licensed and registered tradespersons. It is recommended that the client arrange to have the gas and electrical appliances checked by licensed and registered tradespersons to ensure they work safely and efficiently.

We recommend all other installations be checked also. While we note and comment on visually apparent defects that present during the building inspection, legislation requires the checking and documenting of compliance for plumbing and electrical requirements to be done by licensed plumbers and electricians to ensure they are functioning correctly.

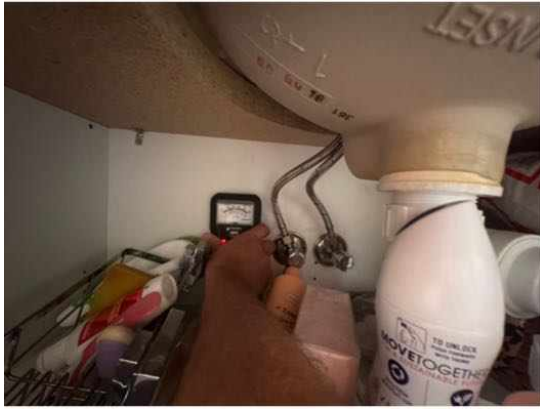
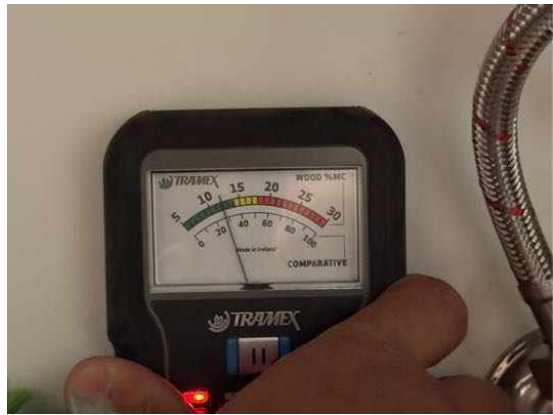
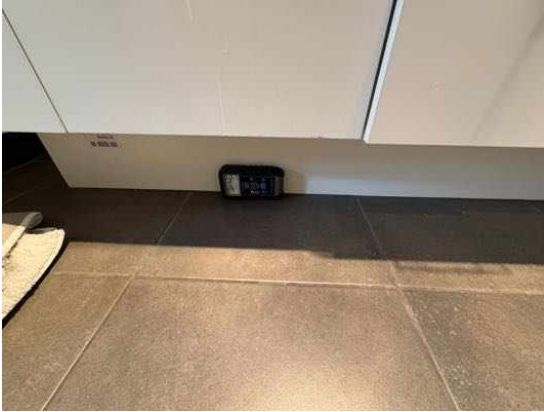
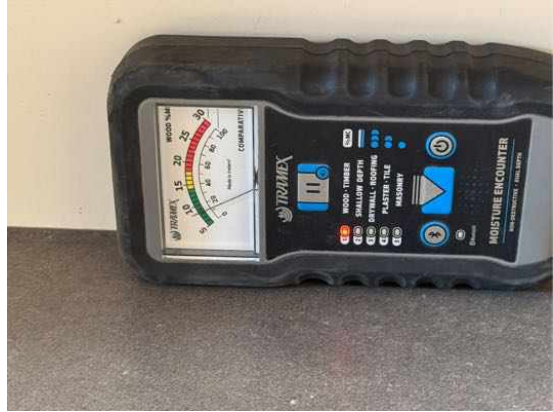
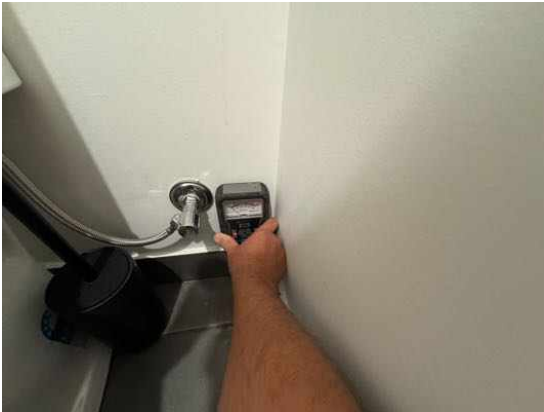
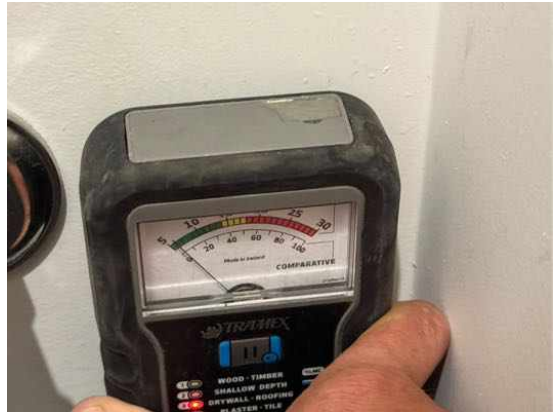
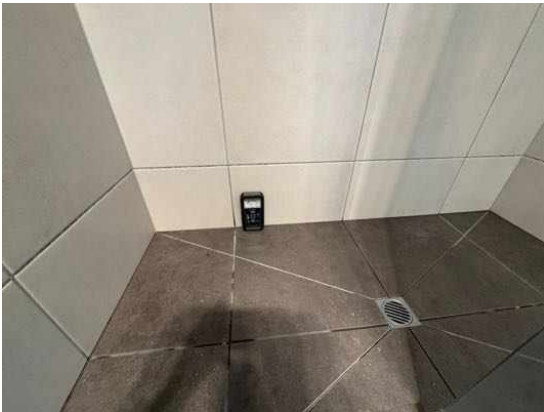
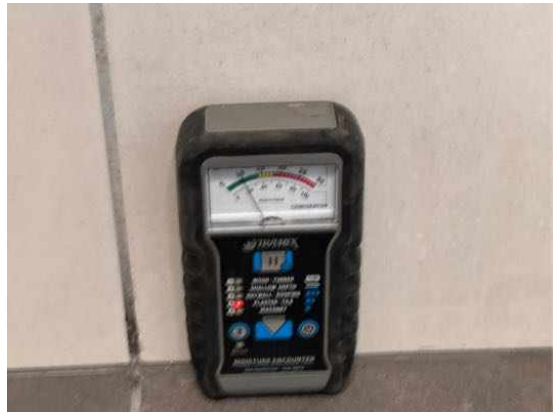
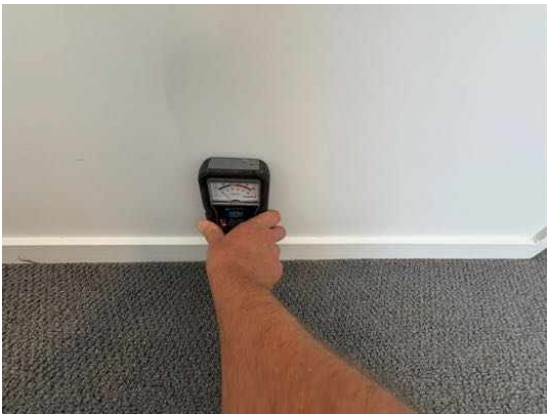
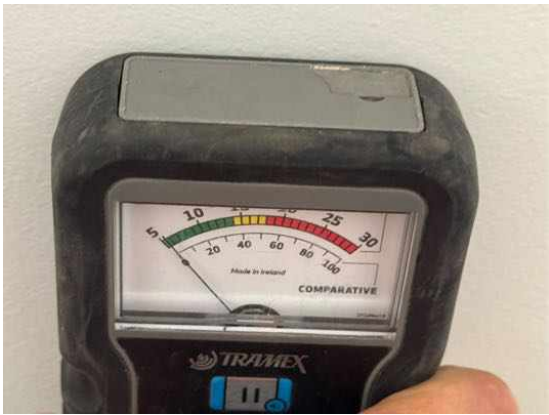
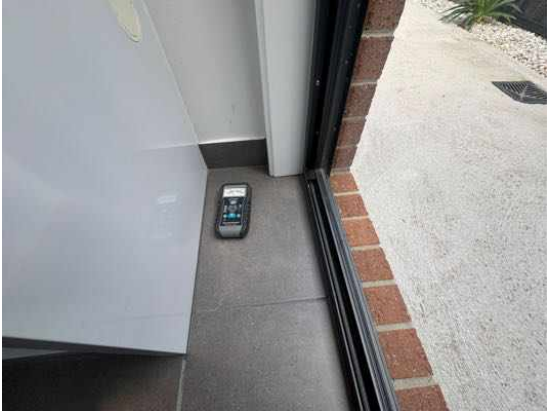
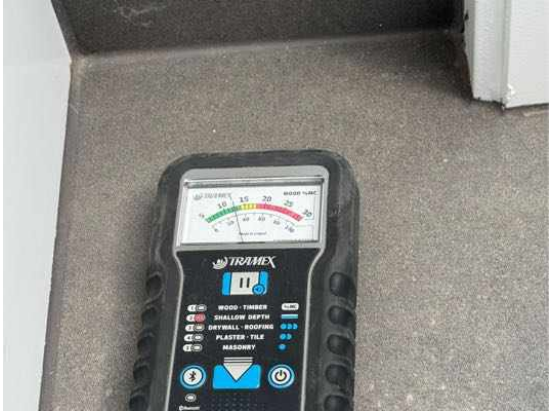
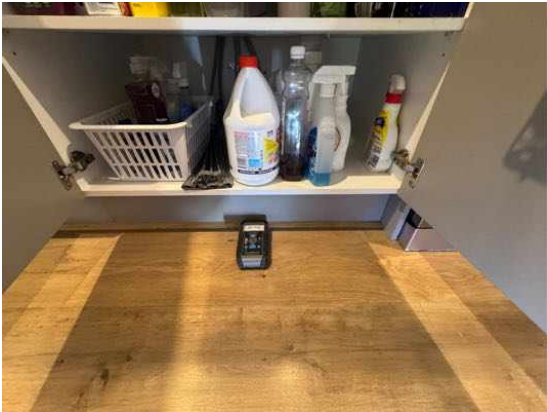
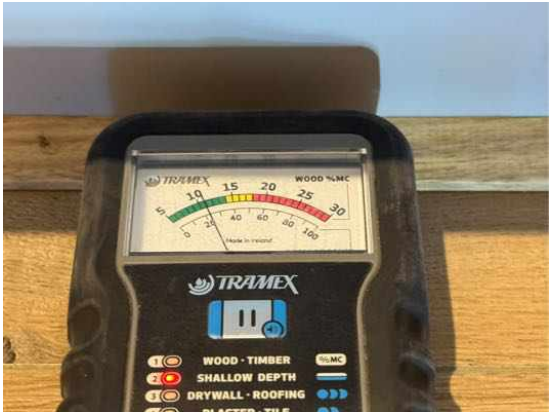
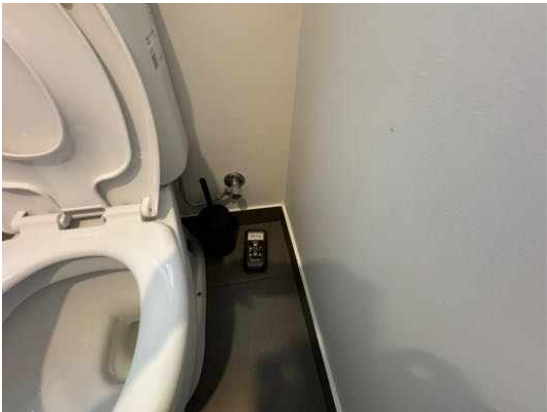
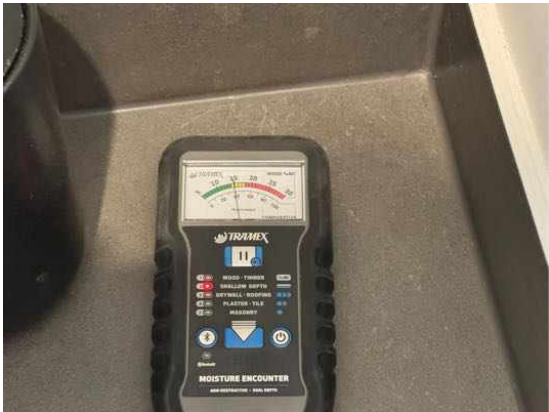
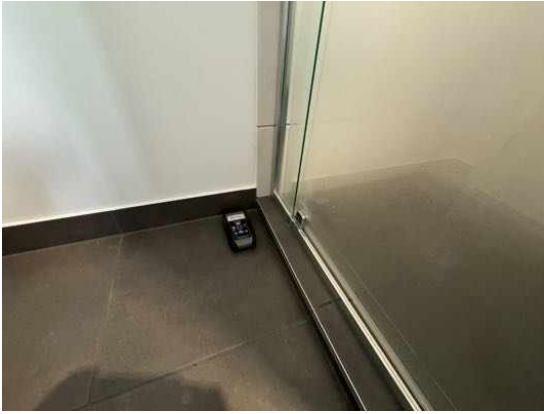
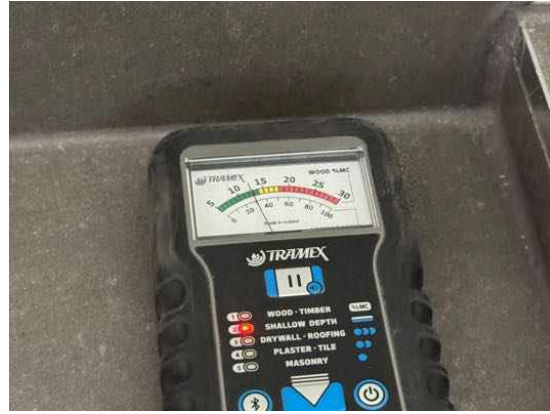
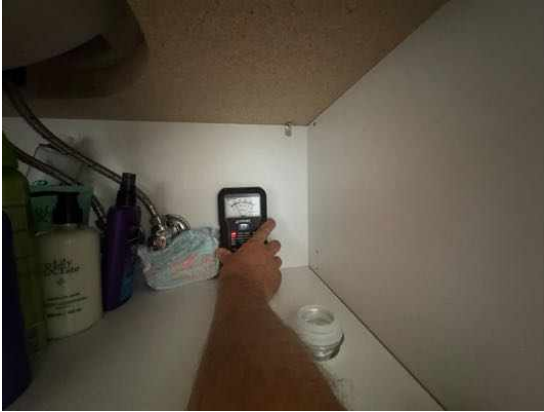
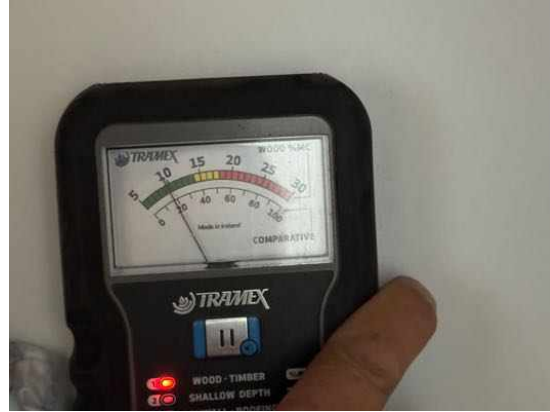
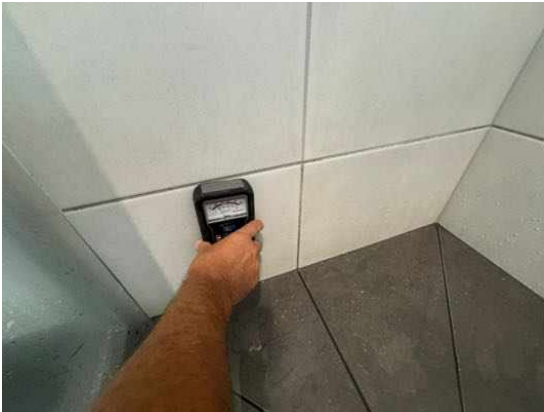
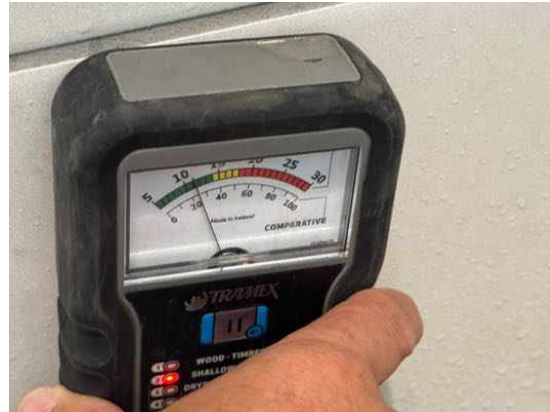
Building: Main Building
 Location: All Internal Areas
 Finding: Wet area - Inspection
 Information: There was no visible evidence of water escape from the accessible areas around the wet areas of the property at the time of inspection.

Plasterboard walls, ceilings, carpet, cabinetry or timber skirting adjoining the wet areas showed no evidence of water staining or damage.

Moisture readings taken did not indicate any areas of elevated dampness to the external areas and to the opposing walls.

The client should be aware that all wet areas should be inspected regularly. Deteriorated grout and sealants should be immediately addressed to prevent water from escaping. Even the smallest break in sealants or grout will allow water to escape into the adjoining structures.

If there are any signs of deterioration to sealants and grout, cracked tiles or bases, water damage or water escape a registered building practitioner should be immediately engaged.

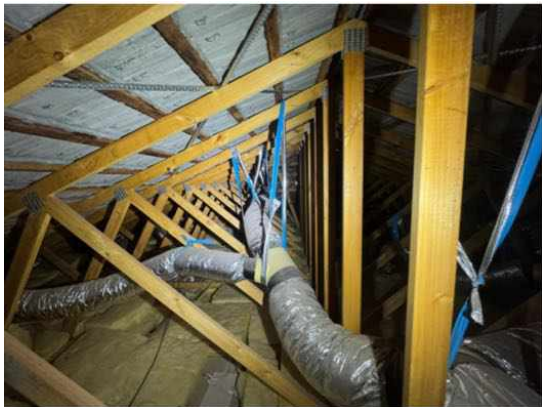
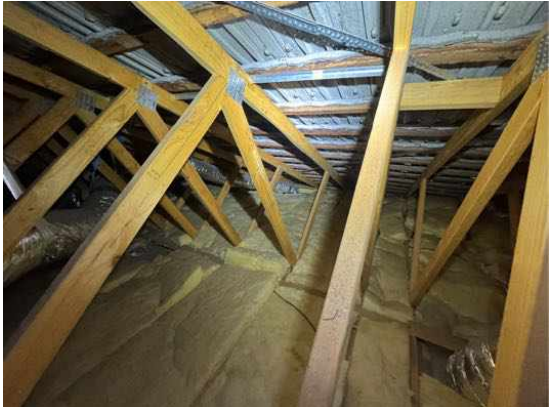
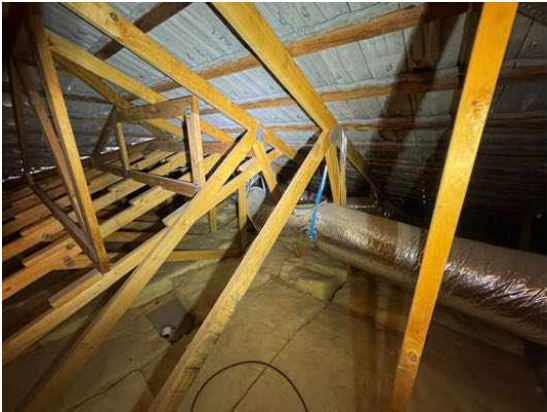
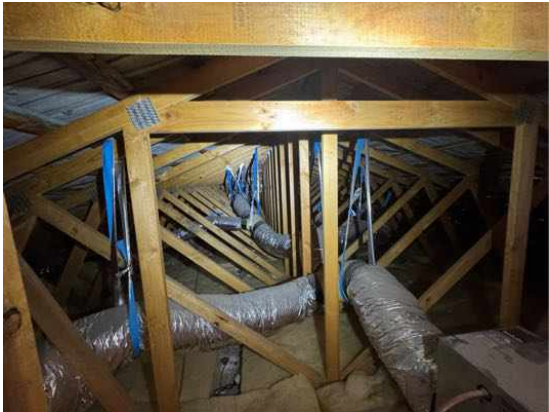
Building: Main Building
 Location: Roof Void
 Finding: Additional Photos - Obstructions and Limitations
 Information: These photographs are an indication of the obstructions and limitations which impeded full inspection of the property at the time of inspection. These obstructions can hide an array of defects and should be removed to allow full inspection to be carried out. A re-inspection is recommended once the areas are made accessible.

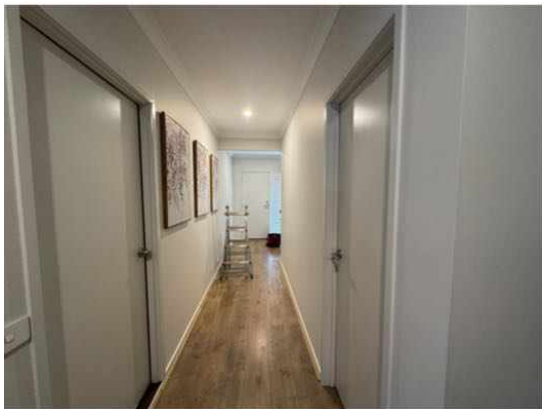
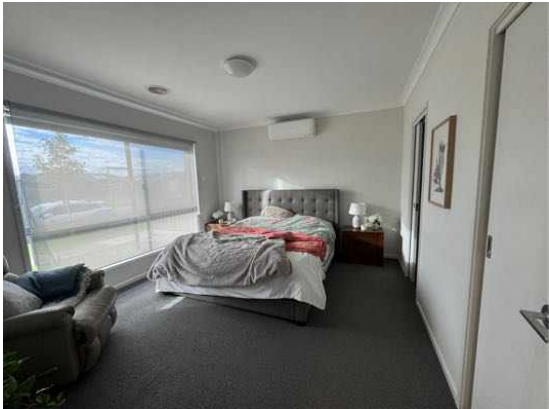
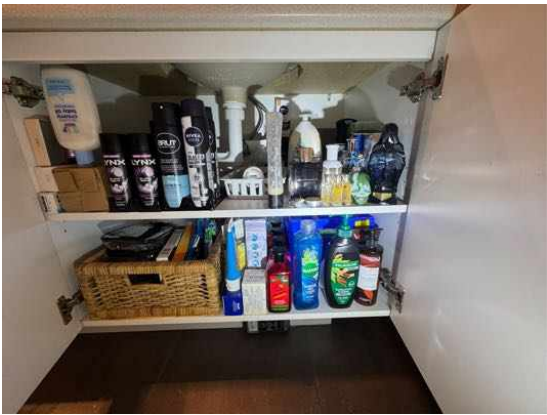
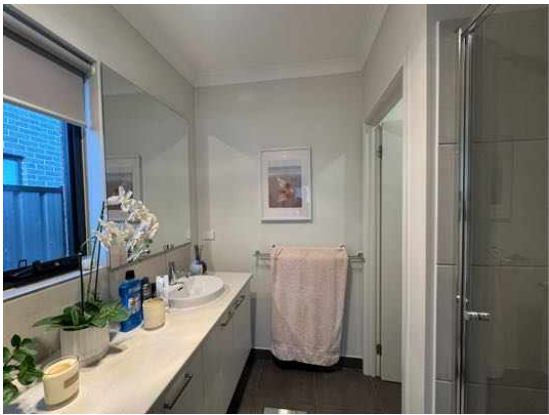
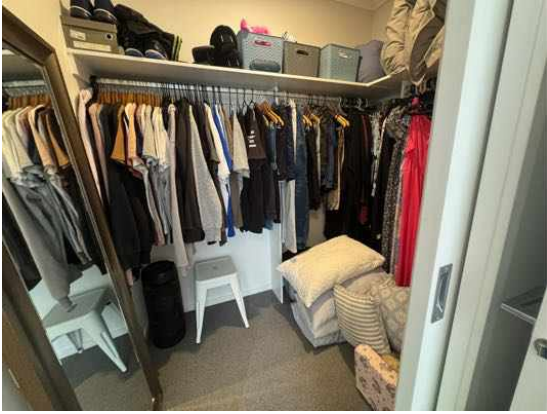
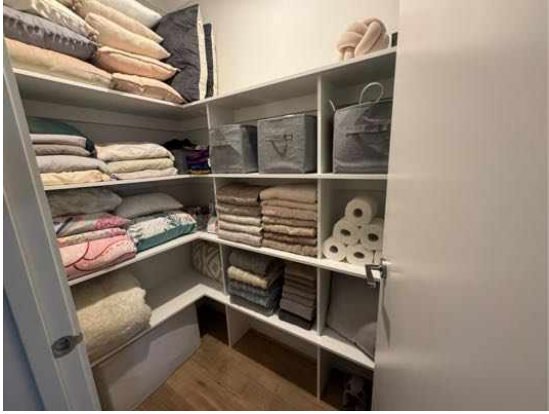
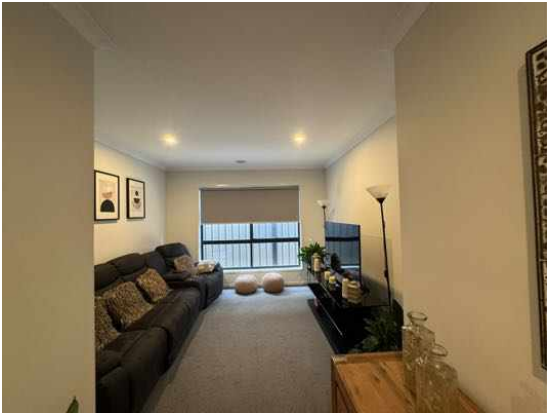
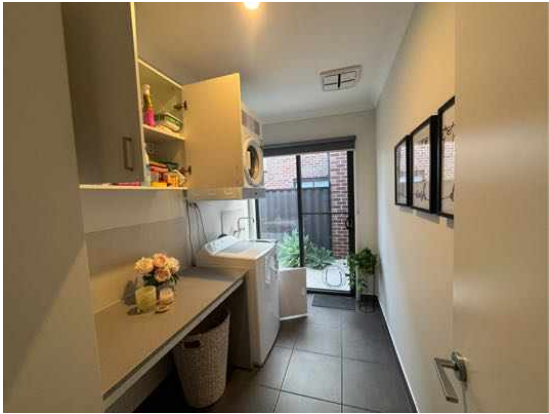
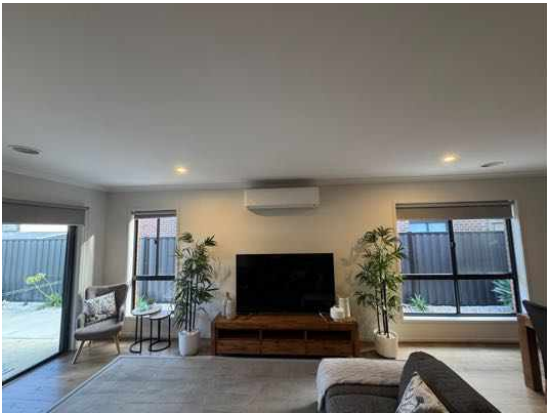
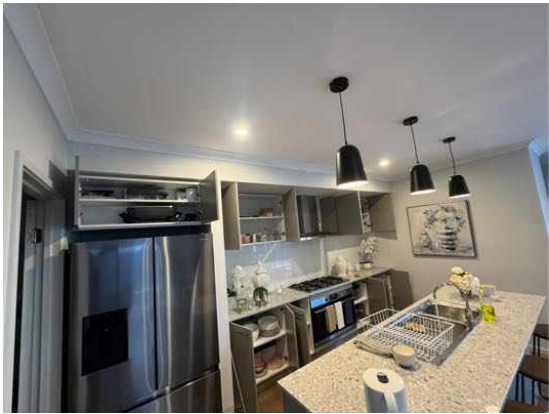
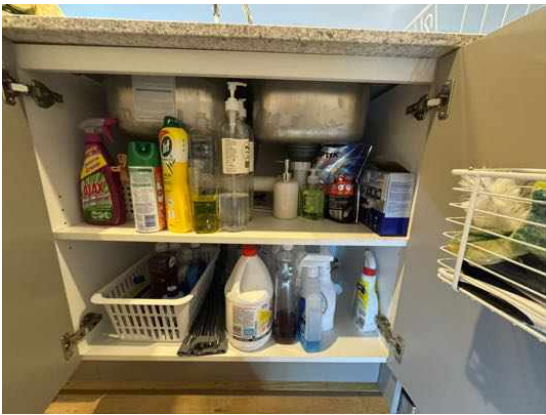
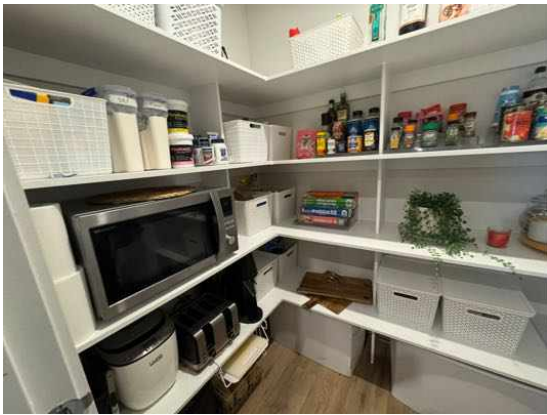
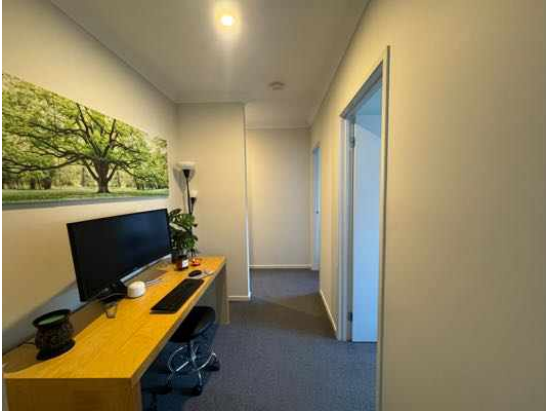
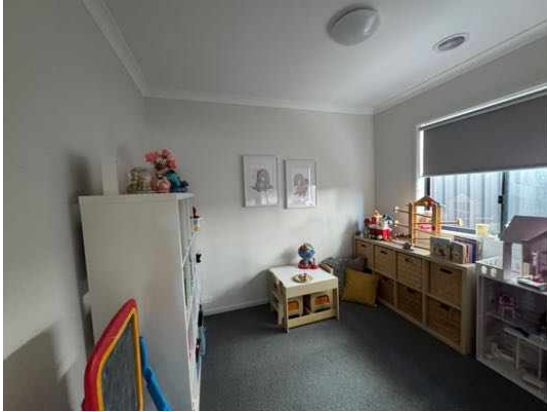
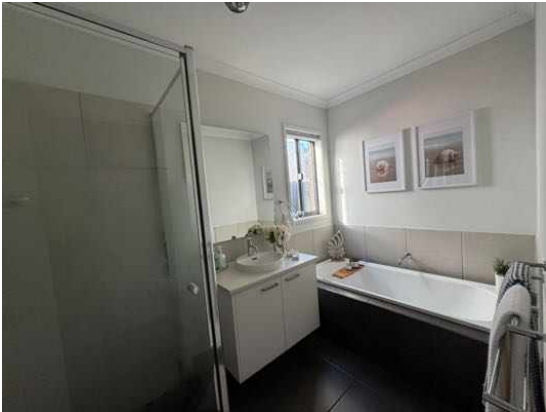
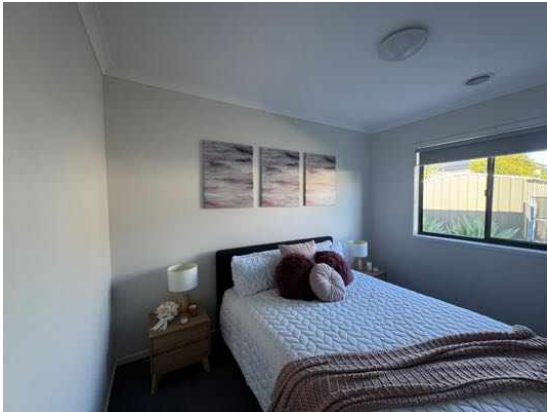
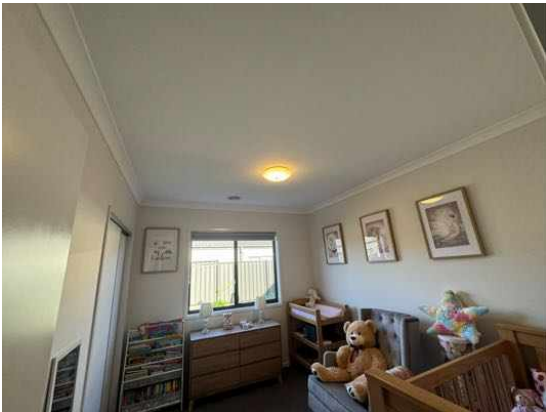
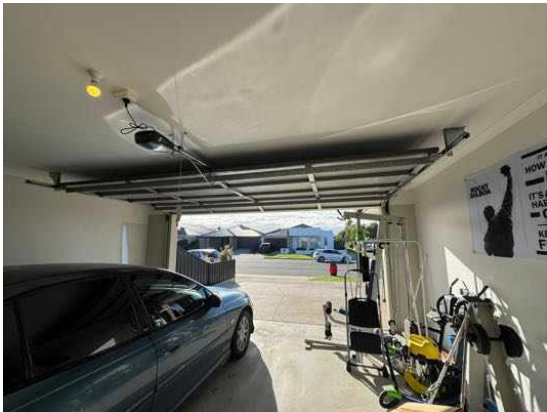
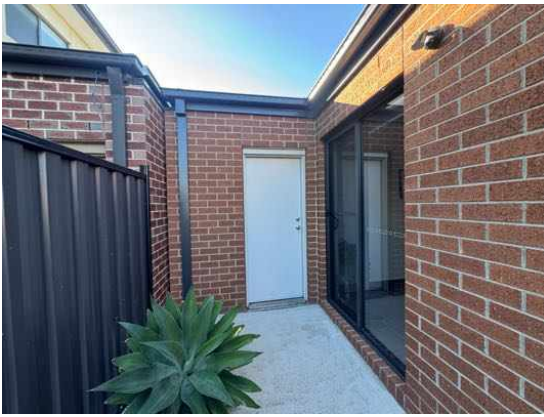
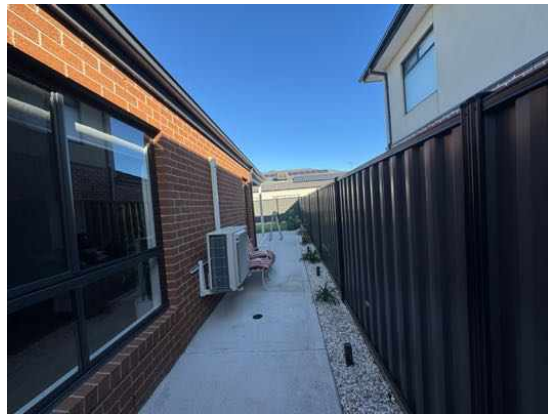
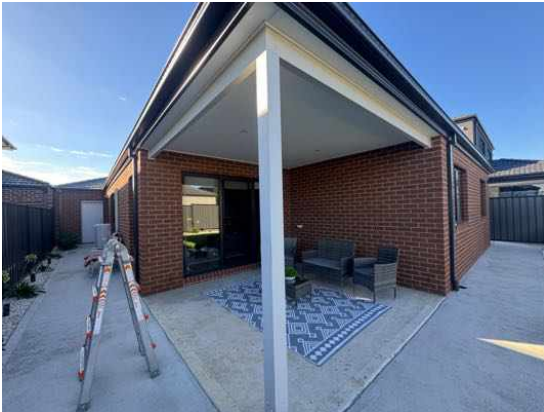
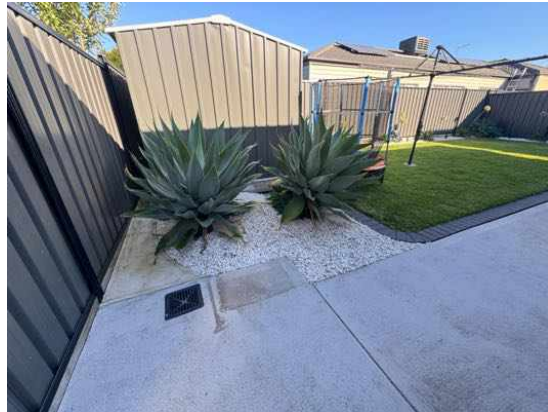
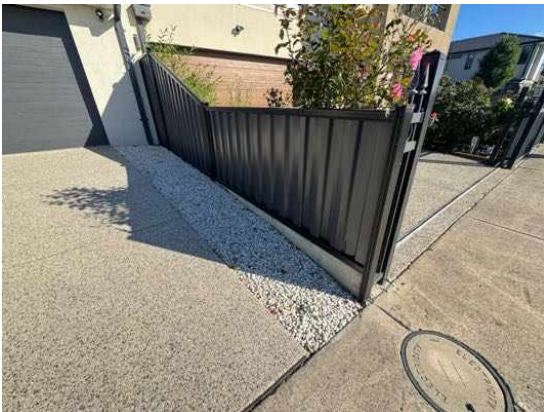
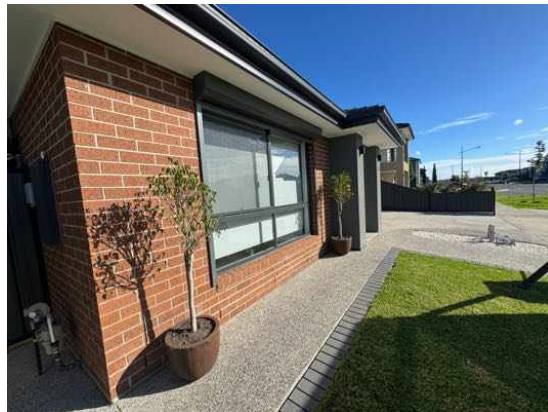
Building: Main Building
Location: All Areas
Finding: Additional Photos - Obstructions and Limitations
Information: These photographs are an indication of the obstructions and limitations which impeded full inspection of the property at the time of inspection. These obstructions can hide an array of defects and should be removed to allow full inspection to be carried out. A re-inspection is recommended once the areas are made accessible.
