Building and Timber Pest Inspection Report

Inspection Date: Tue, 27 Jan 2026

Property Address: 22 Tortola Pl, Parrearra QLD 4575, Australia

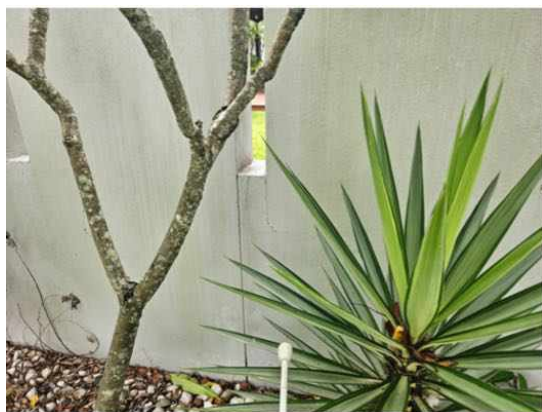
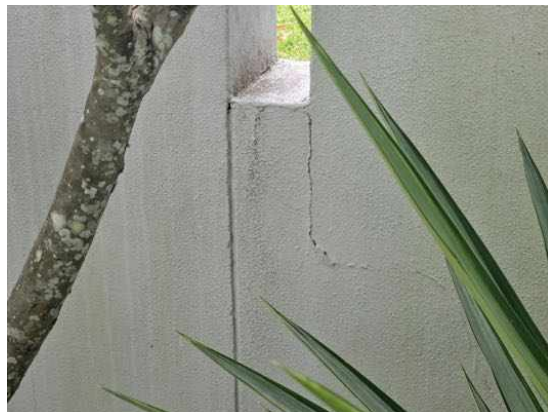
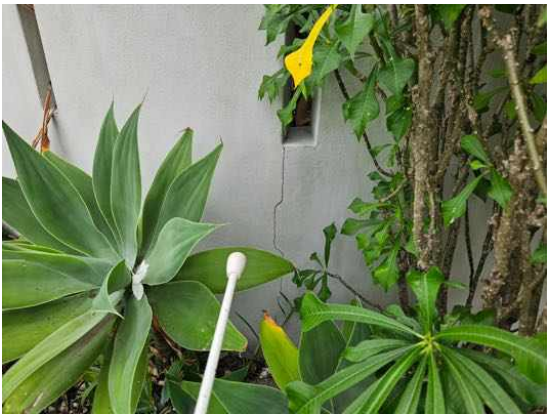
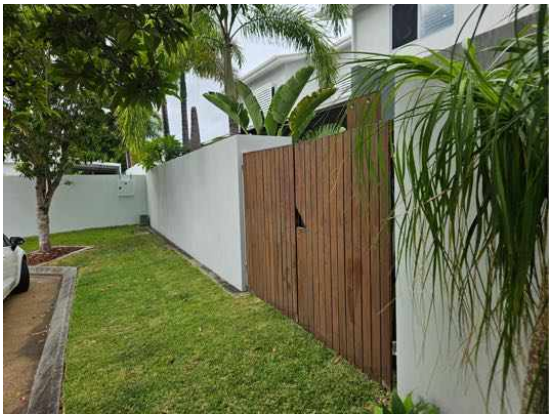
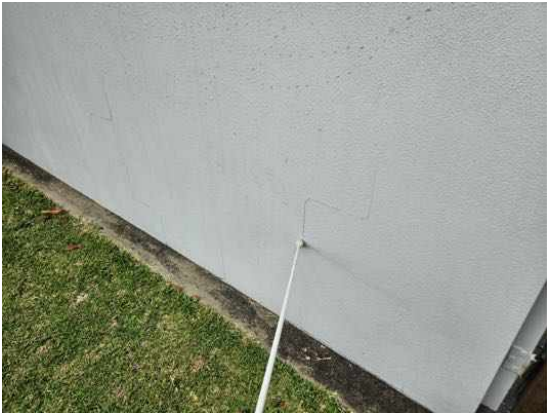
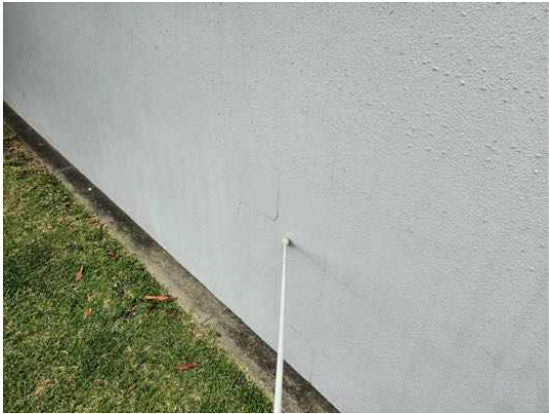
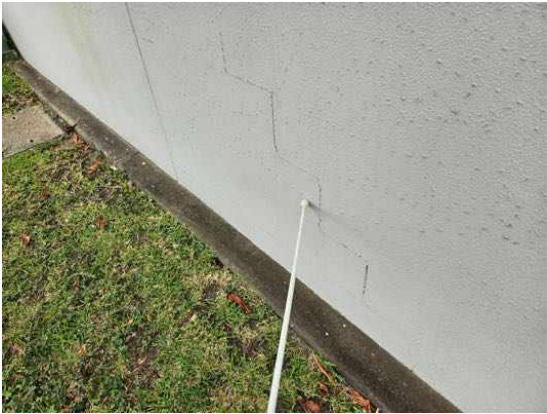
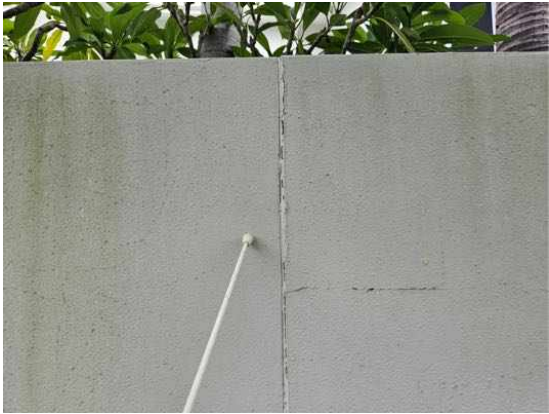
Finding 3.01

Building: Yard
Location: Front fence
Finding: Blockwork cracking - minor
Information: On the day of inspection the external fence block wall showed evidence of minor movement cracking.

These cracks appear to be minor and related to minor movement, they should be monitored over time. The minor cracks could be sealed and repainted by a licensed painter or suitably qualified handy person.

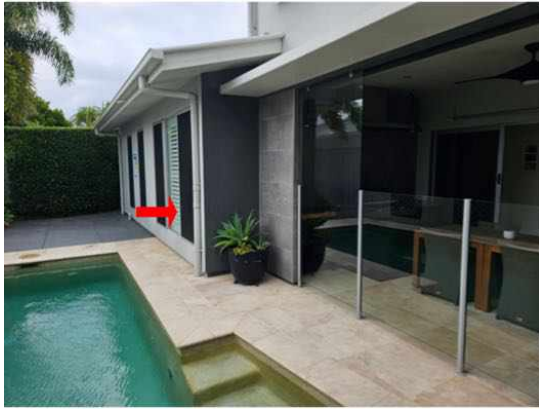
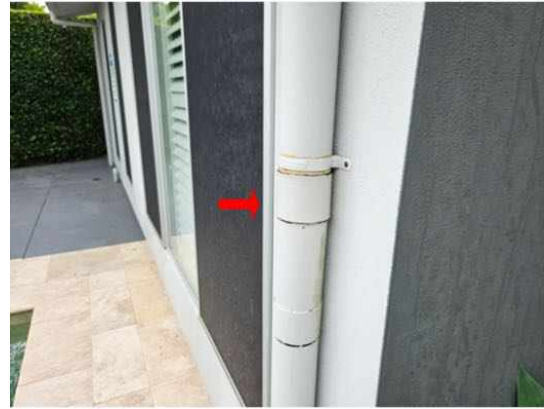
Finding 3.02

Building: Main Building
 Location: As shown
 Finding: Downpipe leaking
 Information: During the inspection of the perimeter of the building it was noted that there was a downpipe leaking.

Leaking downpipes can create excess moisture at the building perimeter, leading to conditions conducive attractive to timber pests.

The client could engage a plumber or handy person to seal the leak.

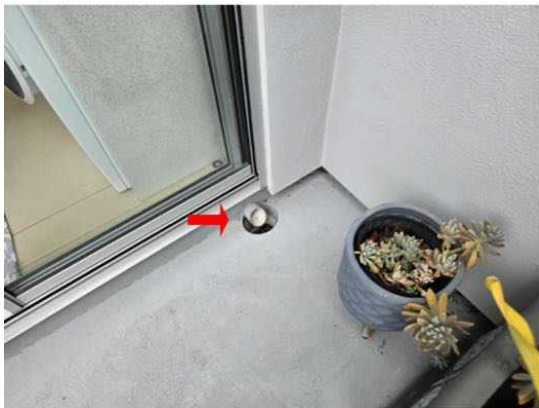
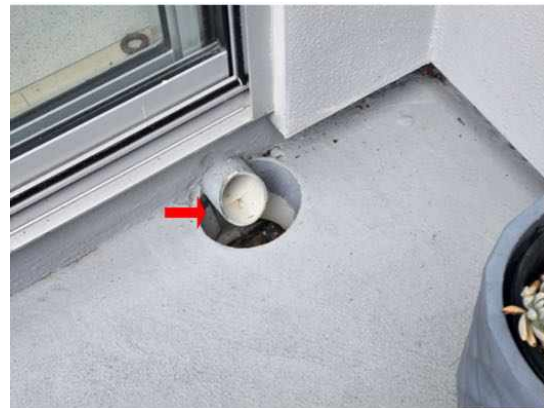
Finding 3.03

Building:	Main Building
Location:	Laundry
Finding:	Dry waste vermin flap - broken
Information:	The floor waste in the laundry is a dry waste and the exit point is adjacent to the sliding glass door of the laundry. These waste exit points have a vermin proof flap attached to the external opening.

The flap on the is waste is missing. A replacement should be fitted at the clients discretion to prevent vermin from entering the property.

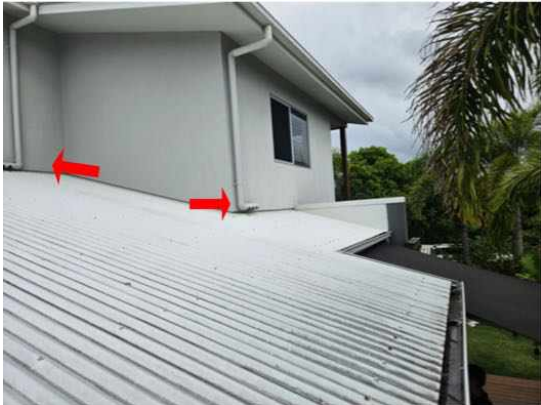
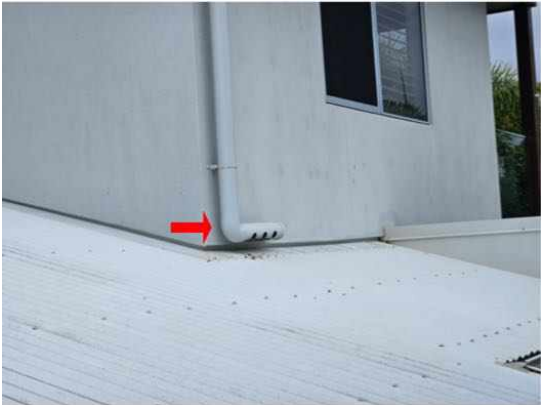
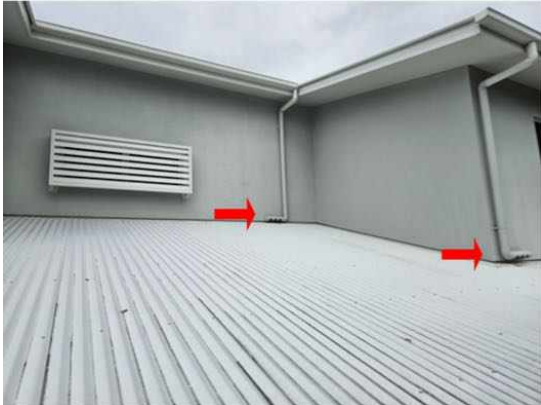
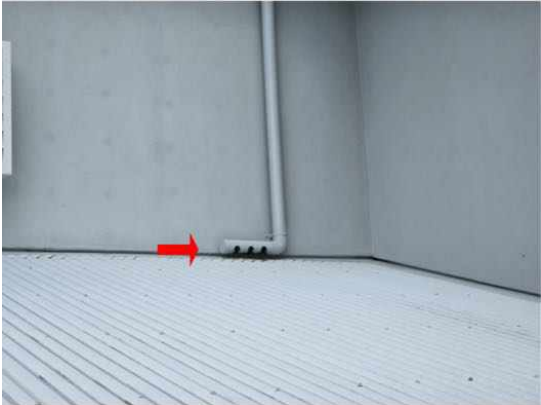
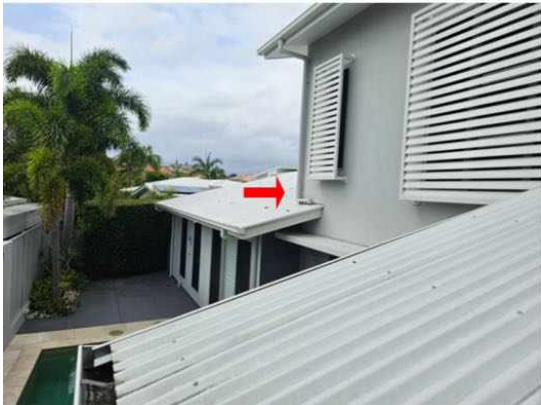
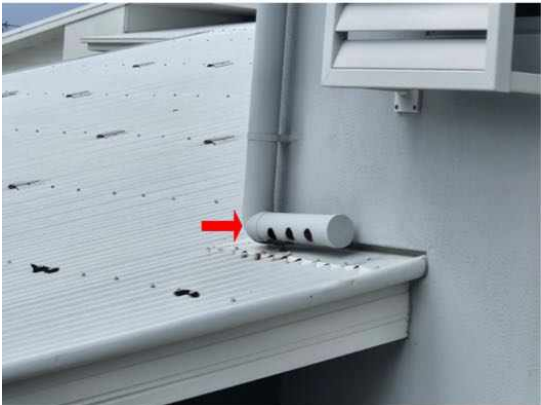
Finding 3.04

Building:	Main Building
Location:	As shown
Finding:	Downpipe - spreader discharge on flashings
Information:	On the day of inspection it was noted that the downpipe spreaders of the upper roof finish on the flashings of the lower roof.

In accordance with HB 39-2015, clause 5.7.7, Spreaders:

- not exceeding 15 m² provided the following conditions are satisfied (see Figure 5.7.7):
 - (a) When discharging onto a tiled roof, the lower section is sarked a minimum width of 1800 mm, either side of the point of discharge extending down to the eaves gutter.

It is the recommendation to have water eject from downpipes at a distance where the outflowing water cannot discharge onto flashings of the roof surface.

A licensed plumber could be engaged to make these alterations to the downpipes as necessary.

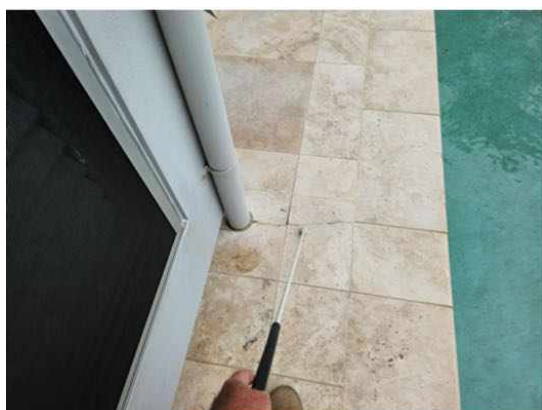
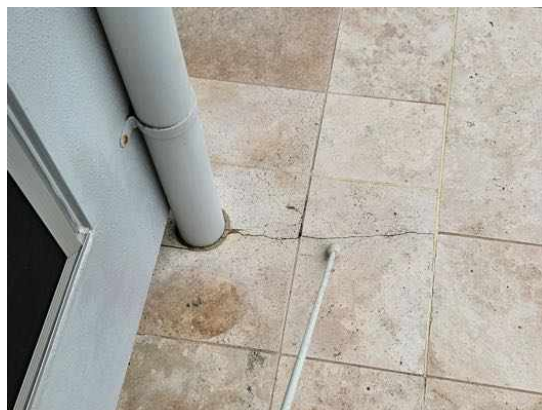
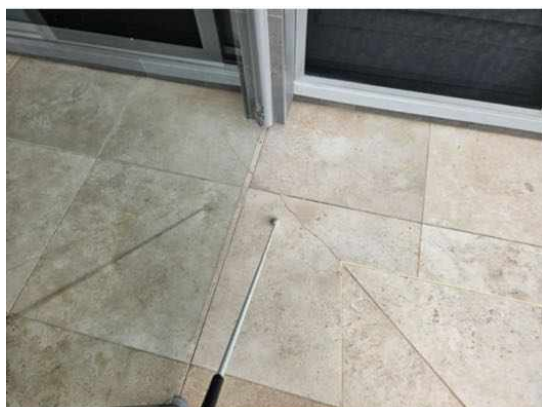
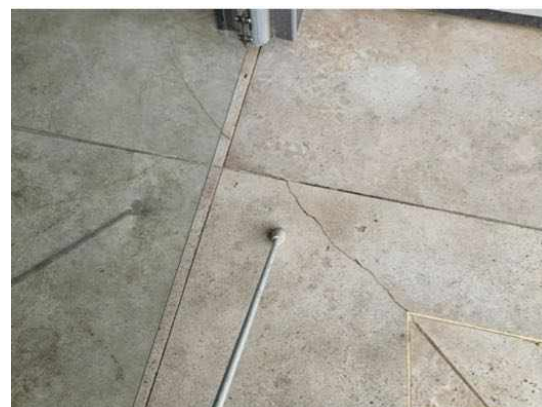
Finding 3.05

Building: Main Building
Location: Pool area
Finding: Tiles - Drummy and / or cracked
Information: Drummy and / or cracked tiled areas were identified at the time of inspection.

The term 'drummy' refers to tiles that have become detached from their fixing, despite otherwise being in relatively good condition. Such defects are generally caused by physical or moisture damage to the area. Drummy tiled areas may also be a direct result of poor workmanship during the construction process.

Tiled areas may swell and shrink with changes in air humidity if the area has sustained moisture damage. Any exposure to moisture is capable of causing tiled areas to become drummy and/or cracked over a prolonged period of time. Drummy tiled areas generally require removal and replacement of affected tiles.

Specialist trades are available for these types of services. A licensed builder may be required to undertake works if damage is extensive or if secondary building defects have resulted. Otherwise, it is advised that a tiling contractor be appointed to perform works as necessary.

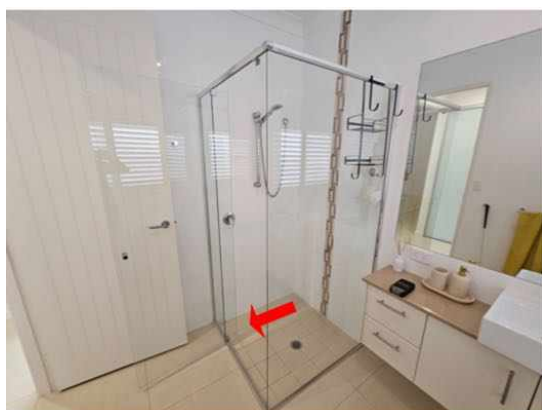
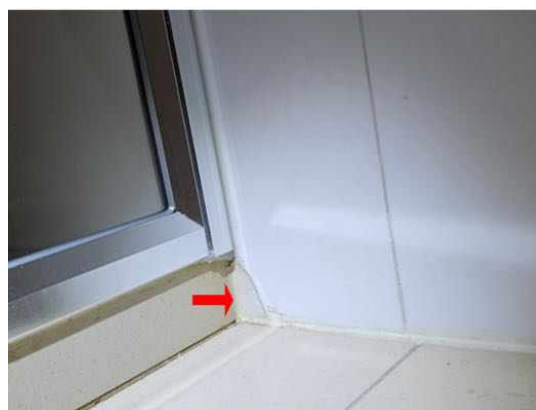
Finding 3.06

Location: Bathroom
Finding: Cracked ceramic tiles
Information: Cracking in the ceramic tile of the bathroom shower recess was evident in this area at the time of inspection. It is suspected that this cracking has occurred as a result of minor settlement or poor preparation of the substrate.

Cracked tiles detract from the overall appearance of the affected areas however, it is unlikely to create or lead to any secondary defects. While not considered a matter of urgency, replacement of cracked tiles is recommended at the client's discretion. A tiling contractor may be appointed to perform these works.

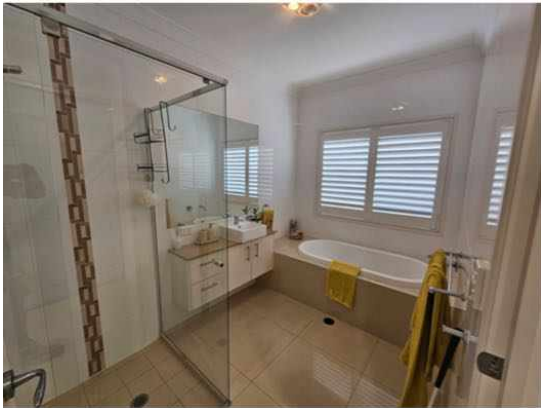
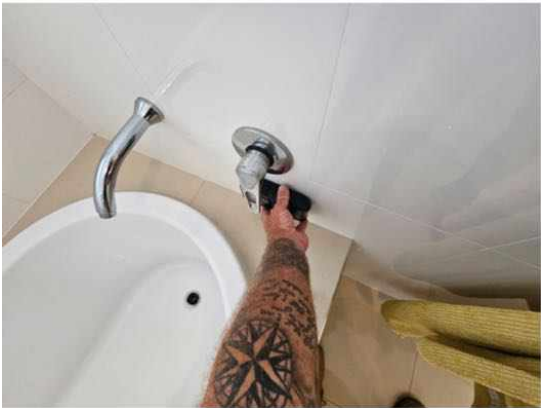
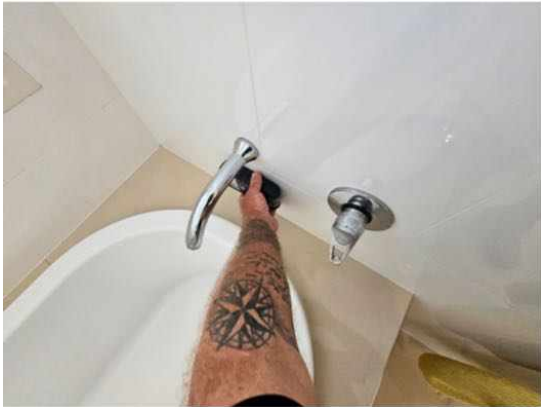
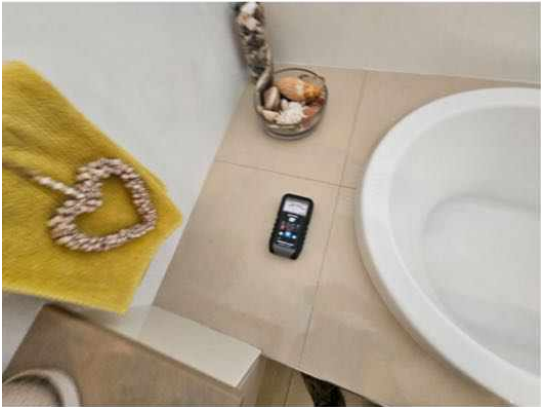
Building: Main Building
Location: Bathroom, ensuites
Finding: No moisture detected in bathroom / ensuites
Information: On the day of inspection the showers in the bathroom/s and ensuites are measure for moisture using a "Tramex" moisture meter. During this inspection no moisture was detected in these areas and the tiled / sheeted surfaces appear to be in good order.

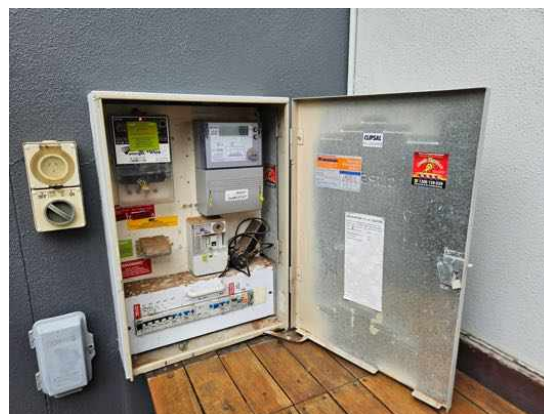
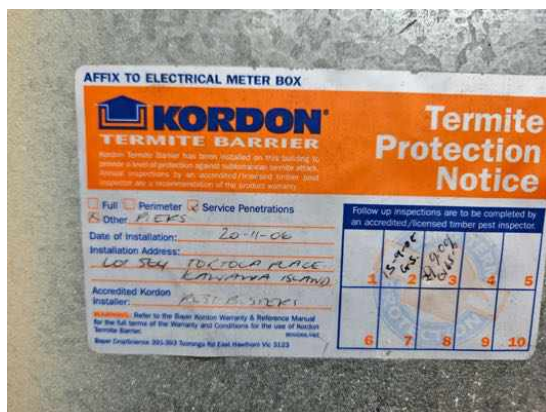
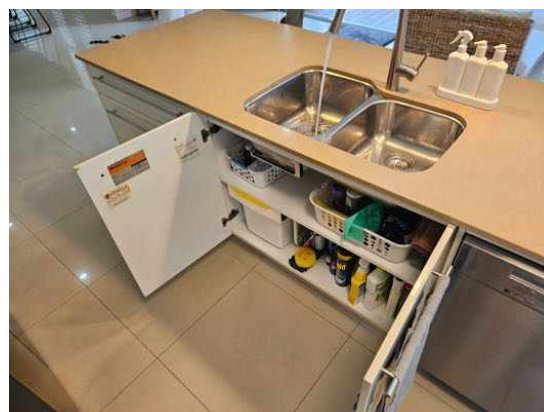
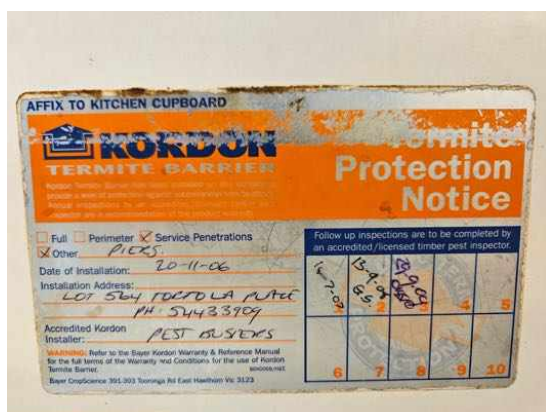
Building: Main Building
 Location: Meter box, kitchen cupboard
 Finding: Durable pest inspection notice - not assessable
 Information: On the day of inspection it was noted that the durable timber pest inspection / treatment notice was missing, not visible or out of date. These notices / stickers are to verify the timber pest inspection dates, the inspector, the currency and type of timber pest system / barrier in place or being used in and around the property.

It is recommended that a licensed timber pest controller be contacted to assess the properties needs and provide costings for an annual inspection programme.

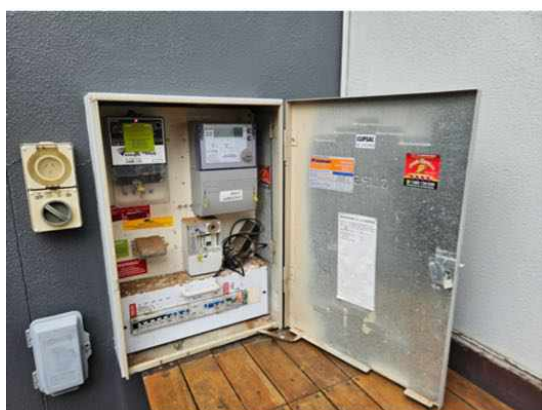
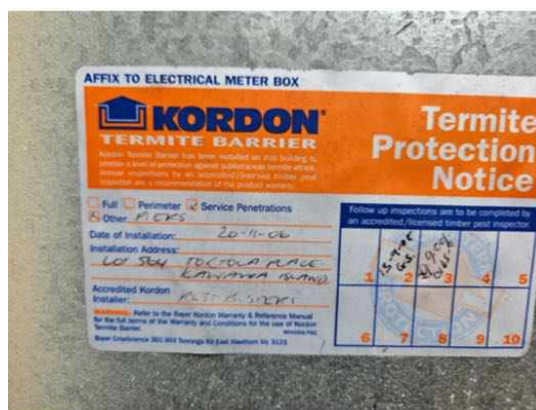
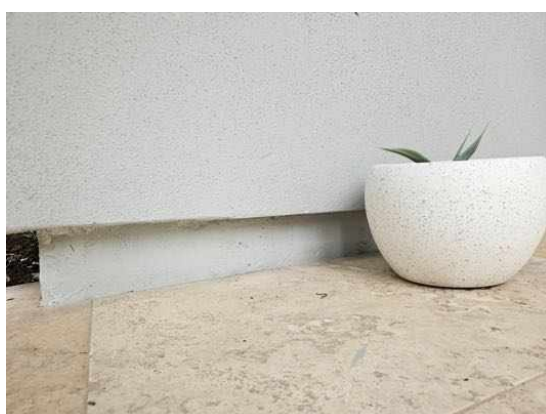
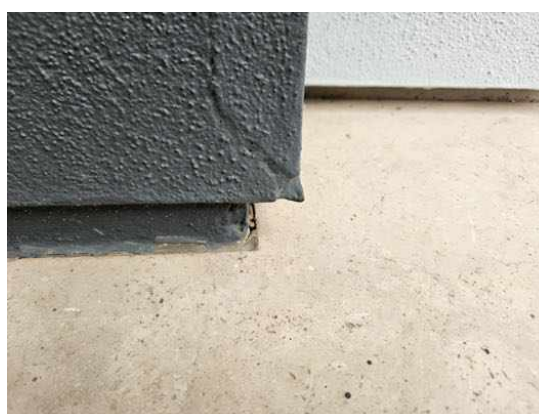
The building employs a physical barrier system to the slab penetrations, and a visual exposed slab edge to the perimeter. In order for a barrier system to be effective, the property must have regular inspections at intervals of not greater than 12 months. Depending on the risk profile attributed to the property, these inspections may be recommended at lesser time periods.
