# Building and Timber Pest Inspection Report

Inspection Date: Fri, 30 Jan 2026

Property Address: 9 Arakoon Avenue, Penrith, NSW 2750

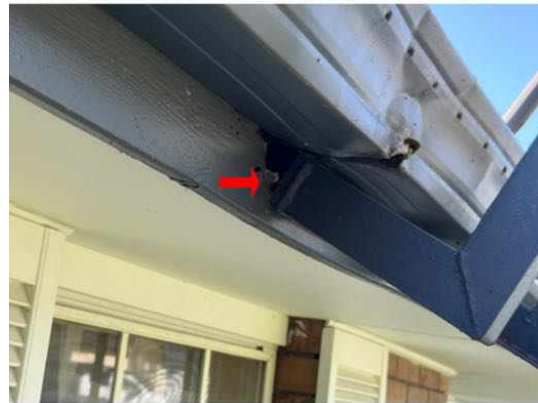
Building:	Main Building
Location:	Front Elevation
Finding:	Structure — Unstable
Information:	Movement was evident in the structure due to severe timber rot, indicating that it may not be structurally sound or compliant with current building regulations.

If left unmanaged, the structure is likely to deteriorate further, potentially collapsing.

A licensed electrician should be appointed for consultations and rectifications as a matter of urgency.

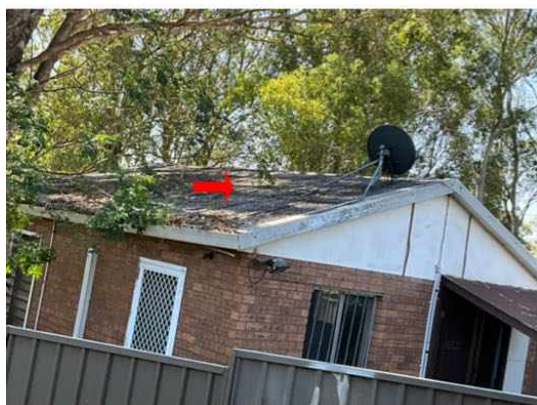
#### Finding 1.02

Building:	Main Building
Location:	Studio
Finding:	Asbestos - Suspected ACM Identified on Site
Information:	Reporting on Asbestos is outside the Scope of this Report. This suspected defect is highlighted as a caution only. We suspect, based on our experience in the building industry, that there is a higher risk of the identified building element containing asbestos.

As Asbestos Reporting is outside the scope of this report, we advise that you consider a separate Asbestos Inspection and Condition Audit, which can include the taking of samples for definitive confirmation of the presence of Asbestos.

In the interim, the client is advised to act with caution, especially when considering any damage to building materials general wear and tear renovations extensions demolition and general maintenance activities due to the suspected presence of Asbestos.

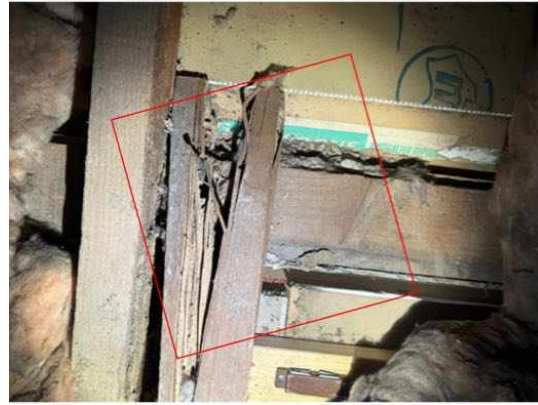
Building:	Main Building
Location:	Roof Void
Finding:	Evidence of termite damage
Information:	Despite no live termite or timber pest activity being indicated, previous termite damage was found to have affected this area or otherwise termite workings were identified at the time of inspection. This damage is considered to be inactive, however structural in nature. Due to safety concerns, further access and inspection of the roofvoid was not completed.

A licensed builder should then be appointed to replace or reinforce all structural damages.

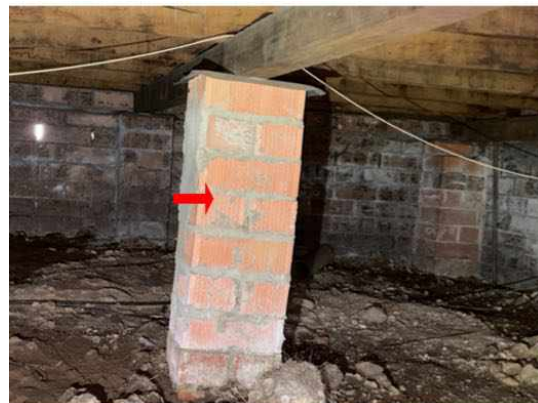
### Finding 3.01

Building:	Main Building
Location:	Subfloor
Finding:	Piers - Leaning
Information:	Pier to the subfloor structure is leaning, indicating that its structural integrity may have been affected. The cause of this instability is likely to be caused by movement / minor subsidence of the pier due to moisture.

Although only minor the pier should be monitored to avoid potential structural damage, which is likely to lead to a range of major and minor defects. Improving site drainage is recommended to avoid further movement / subsidence of the affected pier.

If further movement is evident appointment of a structural engineer is advised to assess the condition of the piers and provide advice on remedial works that may be required.

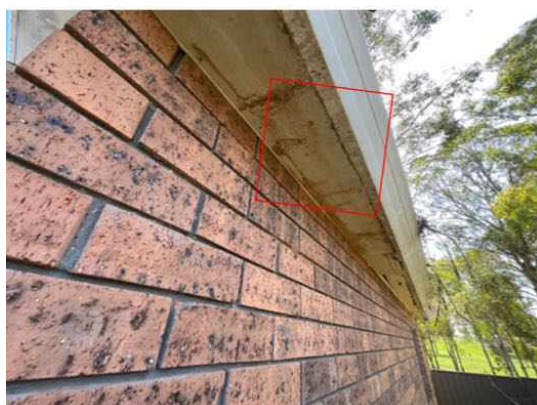
Building:	Main Building
Location:	Studio
Finding:	Eaves/Roof plumbing -- water damages
Information:	Water damage is generally an indication of excessive moisture being present, usually via a leak. It is suspected that gutter blockages causing stormwater to backflow into the eaves causing water damages. This is additionally conducive to termite activity due to the damp conditions.

Where water damage is evident, the primary requirement is to identify and rectify the source of the leak. Gutters must be kept clear of any blockages moving forward. A roofing plumber should be appointed for further assessment if the problem persists.

Once the leak is repaired, consultation with relevant tradespeople, including carpenters, plasterers and painters, is advised.

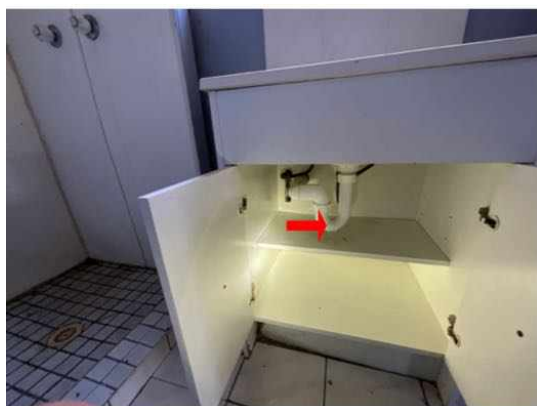
Building:	Main Building
Location:	Studio
Finding:	Damp or wet - leak
Information:	Damp or wet conditions are generally a direct result of poor drainage an active leak or poor ventilation (or a combination of the three). Dry conditions should be maintained to prevent secondary building defects from developing.

If left unattended damp or wet conditions may have many consequences including the development of fungal decay and/or wood rot as well as providing an environment that may be conducive to termite or timber pest attack.

A qualified plumber should be appointed immediately to identify the cause of the excessive moisture in order to prevent further damage. The water leak should be resolved prior to any repairs of the damaged area which may require localised replacement of building materials and refinishing..

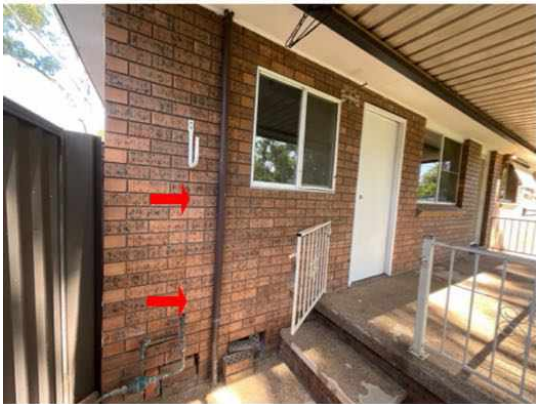
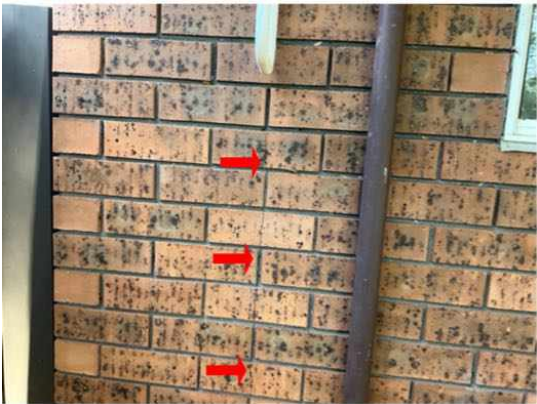
### Finding 3.11

Building:	Main Building
Location:	Multiple areas
Finding:	Damage to Masonry Walls (Cracks)- Category 2
Information:	It has been observed that damage to masonry walls caused by movement of slabs, footings, or other causes, has occurred. The degree of damage falls within Category 2, described as noticeable cracks which are easily filled. Such cracking may cause doors and/or windows to stick slightly, and are generally less than 5mm in width.

Damage of this category is not considered a defect for rectification. Always contact your building inspector should cracks widen, lengthen, or become more numerous.

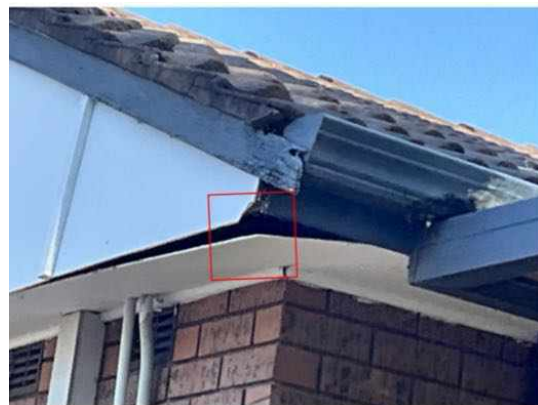
### Finding 3.13

Finding: Beads - Damaged

Repair or replacement of the beading is advised to ensure the protection and longevity of any associated building elements. Such works may be performed by a general handyman or qualified carpenter.

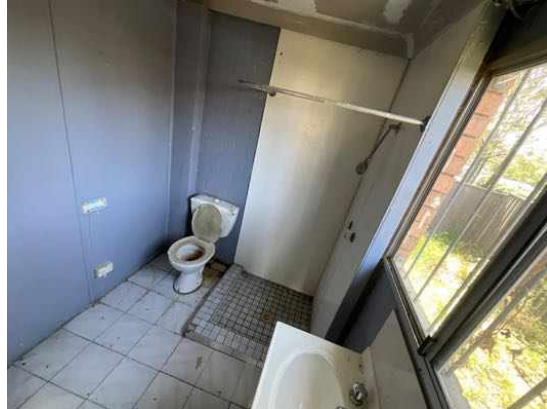
### Finding 3.17

Building:	Main Building
Location:	Studio
Finding:	Incomplete or substandard works
Information:	The works to this area appear to be incomplete or have been completed to a substandard level.

It is highly recommended that the relevant trades be appointed to complete these works and ensure the safety of the area and the longevity of all associated building elements.

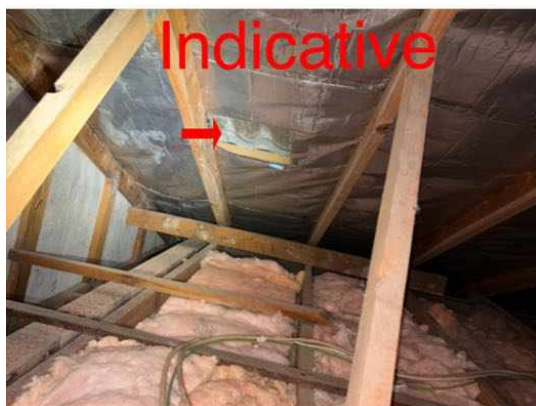
### Finding 3.20

Building:	Main Building
Location:	Roof Void
Finding:	Sarking - Damaged
Information:	Sarking, a laminated aluminium foil applied to the interior of the roof covering, assists in insulating the property and acting as a vapour-barrier to the roof void and, subsequently, to the household.

It is important to repair any holes or damaged sections of sarking to ensure that the building material is fully functional. A registered builder or qualified carpenter should be consulted to provide further advice on this defect and to perform rectification works at client discretion.

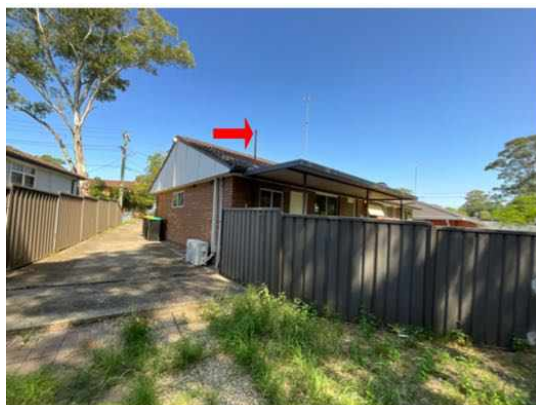
### Finding 3.21

Building:	Main Building
Location:	Roof Exterior
Finding:	Pipe vent cowl - Missing
Information:	The pipe vent cowl on the roof was found to be missing at the time of inspection.

A general handyman should be appointed to install the top flue ensuring further damages are prevented.

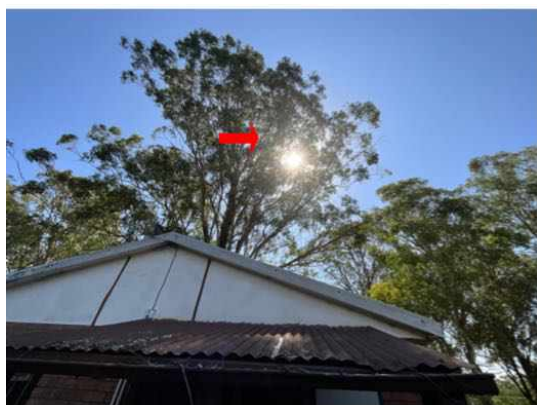
### Finding 3.22

Building:	Main Building
Location:	Roof Exterior
Finding:	Trees - Overhanging and filling gutters
Information:	Overhanging trees often result in excessive amounts of leaf debris accumulating in gutters.

Such works should be performed by the homeowner; however, appointment of a landscape contractor or an arborist may be required. Consultation with a licensed roof plumber is required where guttering has been damaged.

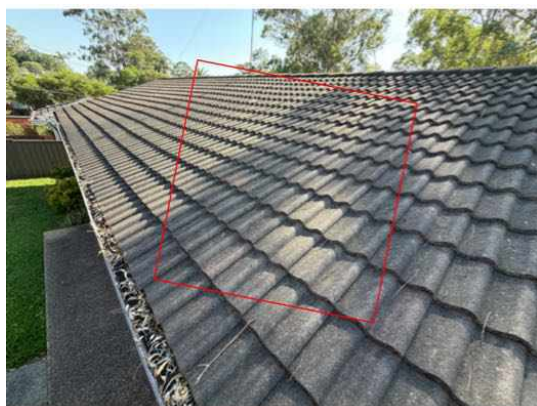
### Finding 3.23

Building:	Main Building
Location:	Roof Exterior
Finding:	Roof tiles - Weathered
Information:

Consultation with a licensed roofing contractor is highly advised to gain advice on cost of remedial works that may be required in the short to medium term. Remedial works are likely to increase the longevity of the exterior roofing structure.

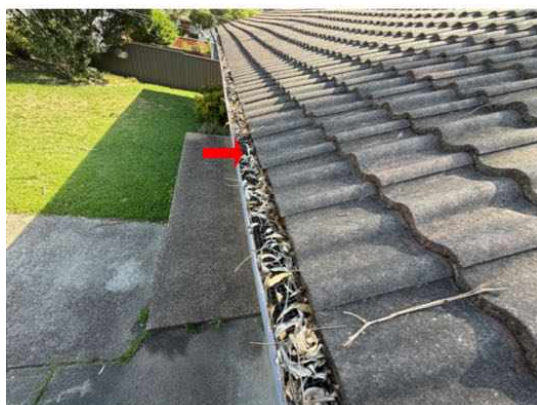
### Finding 3.24

Building:	Main Building
Location:	Gutters >
Finding:	Gutters - Debris
Information:	Roof plumbing structures, such as guttering and downpipes, should be free of all debris to prevent blockages. Blockages of the guttering and downpipes will lead to pooling and accumulated water overflows, which is likely to subsequently flood eaves and exterior walls.

Consult a Licensed Plumber for further specific advice on remedial works that may be required. In the interim, it is highly advised that blocked gutters be removed by the homeowner or a general handyperson as a matter of urgency.

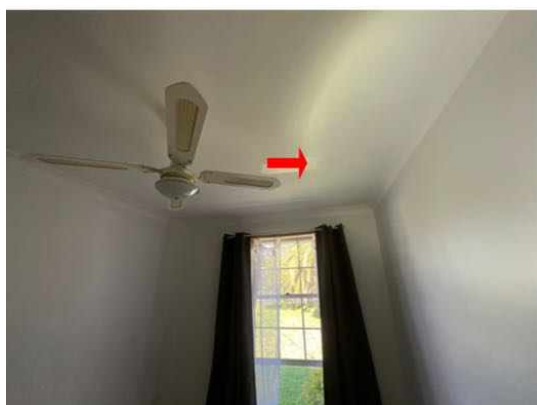
### Finding 3.25

Building:	Main Building
Location:	Bedroom 2
Finding:	Ceiling - Water stained
Information:	Water staining to ceiling linings in this area was evident at the time of inspection. Water staining indicates that surfaces have been exposed to excessive moisture over time. The minerals and other elements in the water lead to staining, which may graduate to corrosion and deterioration if left unmanaged.

Conversely, where water staining is old and inactive, affected building materials may be repaired or replaced at client discretion.

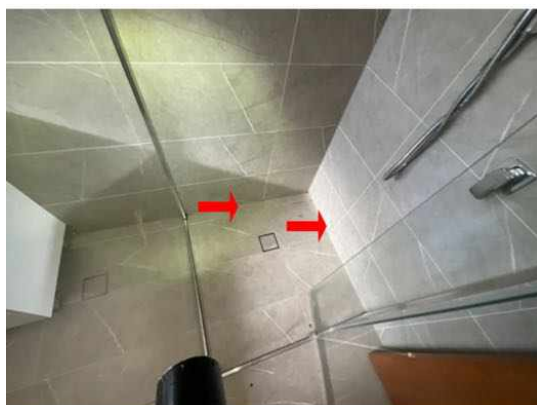
### Finding 3.26

Building:	Main Building
Location:	All Wet Areas
Finding:	Sealant and grouting - Missing or damaged
Information:

A sealant specialist should be appointed to complete these works as soon as possible.

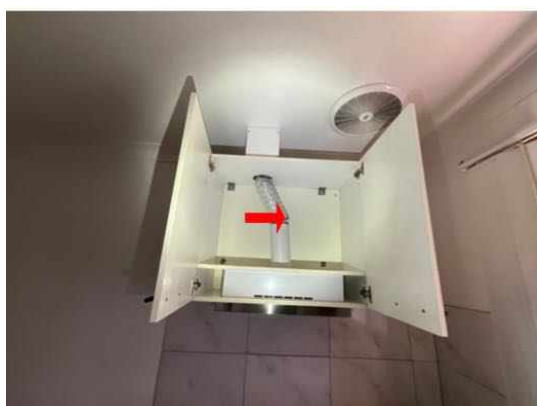
### Finding 3.27

Building:	Main Building
Location:	Linen cupboard
Finding:	Water leak - Inactive
Information:	Water leaks generally occur when a particular area of the property is not weather- or water-tight. While the damage in this area appears to be from an old inactive water leak, the area should be monitored frequently for the recurrence of any dampness.

A relevant tradesperson should be appointed to repair or replace the affected building element prior to any subsequent damage being caused.

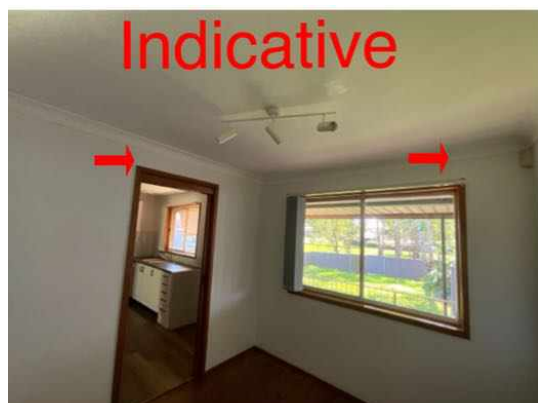
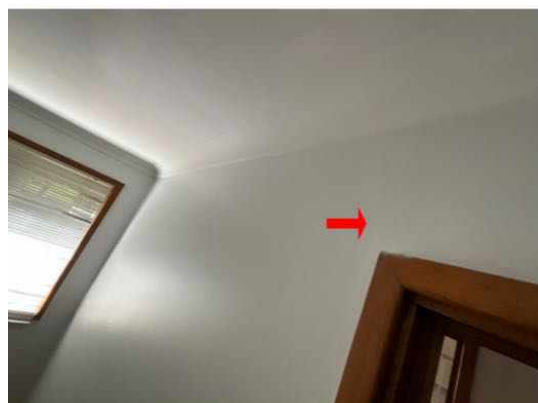
### Finding 3.29

Building:	Main Building
Location:	Multiple areas
Finding:	Cracking - Damage Category 1 - Fine (up to 1mm)
Information:	Although fine cracks are quite noticeable, they are often only considered to be an

Monitoring of all cracking should be conducted frequently. Always contact a building inspector should cracks widen, lengthen, or become more numerous.

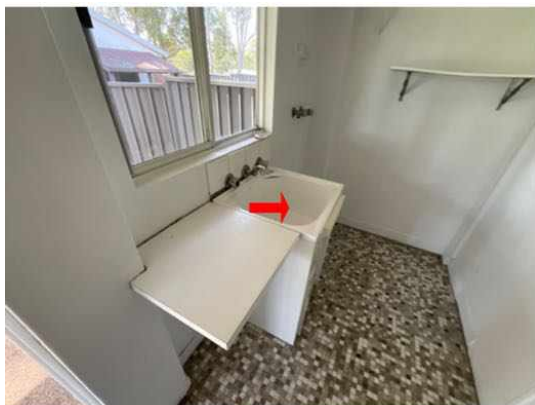
### Finding 3.30

Building: Main Building  
 Location: Bathroom  
 Finding: Sink/basin - slow draining  
 Information:

A licensed plumber should be appointed to perform these rectification works.

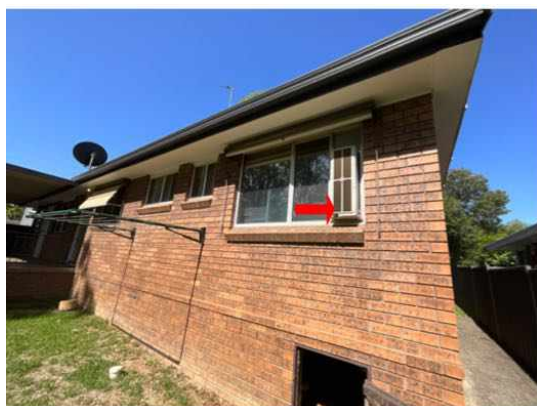
### Finding 6.02

Building:	Main Building
Location:	Multiple areas
Finding:	Stormwater drain - Not connected
Information:	The roof plumbing is not adequately connected to stormwater drainage on the site. This disconnection negatively impacts the functional capacity of the roof plumbing.

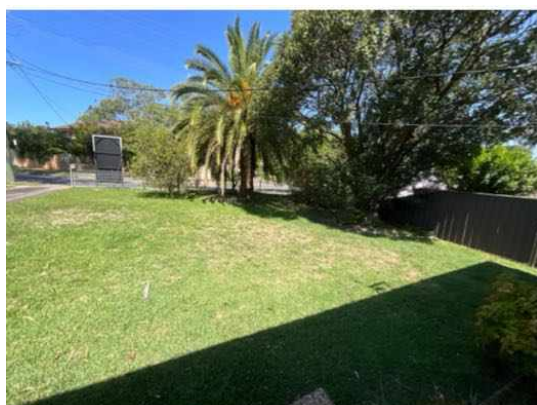
### Finding 6.04

Building:	Main Building
Location:	
Finding:	Surrounding bushland - Conductive
Information:	Home and or building is situated in a high risk area for termite activity, due to close proximity to surrounding bushland.

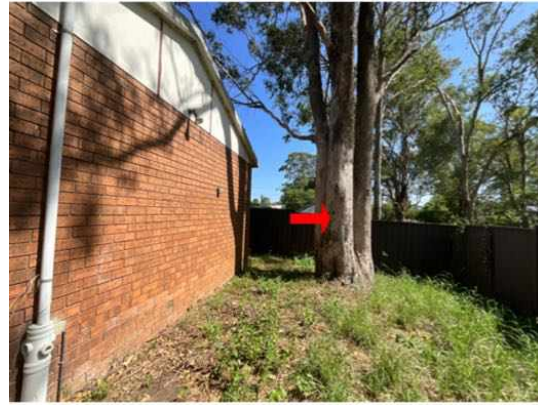
### Finding 6.05

Building:	Main Building
Location:	Vegetation
Finding:	Vegetation - Abutting property
Information:	Vegetation against external wall may have an invasive root system. If there are weak points in the brick work or concrete slab, it is possible for the roots to gain entry into these areas. Once the roots have gained entry, it is possible for termites to gain concealed entry via these roots. It is recommended to remove the vegetation and root system where possible.

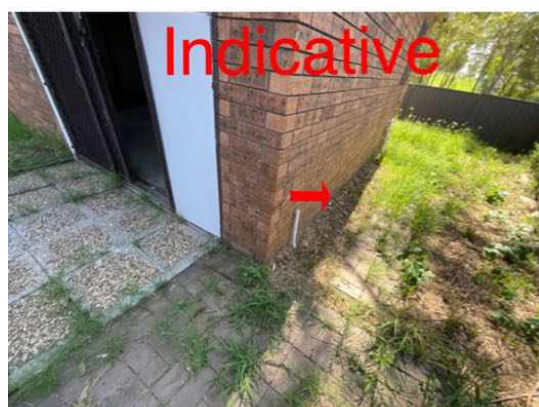
### Finding 6.06

Building: Main Building  
 Location: External tap  
 Finding: Tap - No drain  
 Information: The external tap in this area was noted to have no drain at the time of inspection.

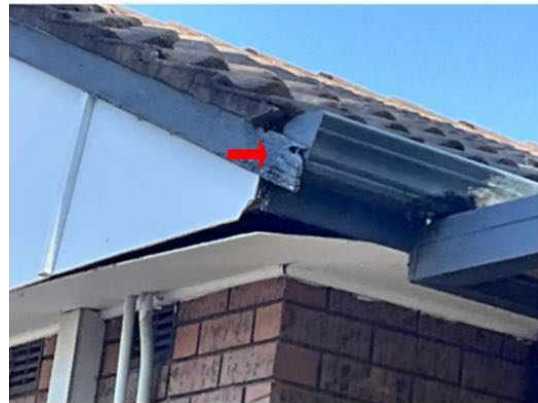
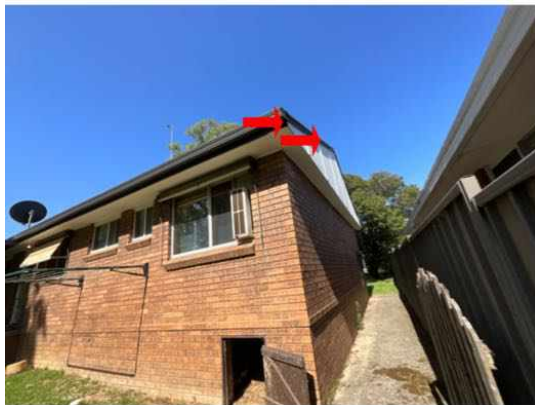
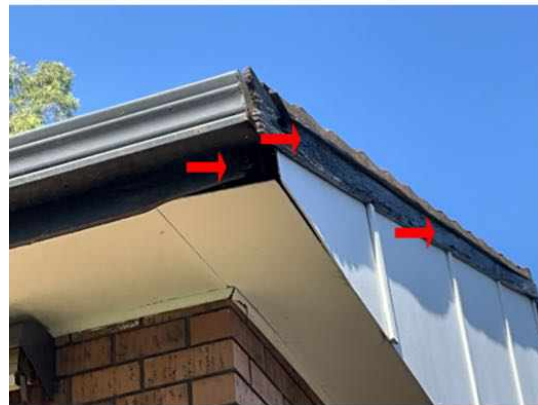
## Finding 7.02

**Building:** Main Building  
**Location:** Fascias  
**Finding:** Fascias - Wood rot/decay  
**Information:** Wood rot was found to be affecting fascias and barges in this area, evidenced by the presence of mould on the surface in some areas. Wood rot, also known as Fungal Decay, occurs when timbers and other cellulose building materials are exposed to damp conditions on an ongoing basis.

A licensed plumber may be appointed to assess the cause of excessive moisture and to provide advice on any remedial works as required. A licensed carpenter may also be required to replace affected building materials.

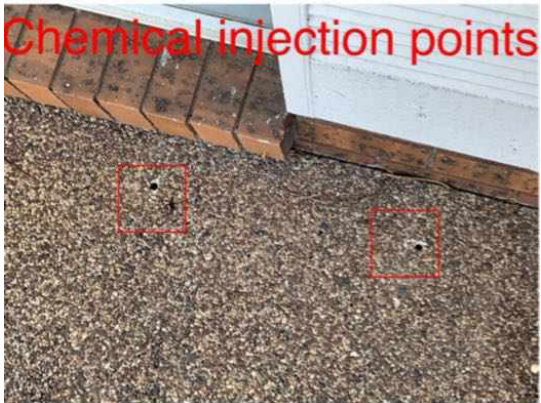
Chemical injection points
