Building and Timber Pest Inspection Report

Inspection Date: Thu, 9 Apr 2026

Property Address: 7/17-21 Brisbane Street, Oxley Park NSW
2760

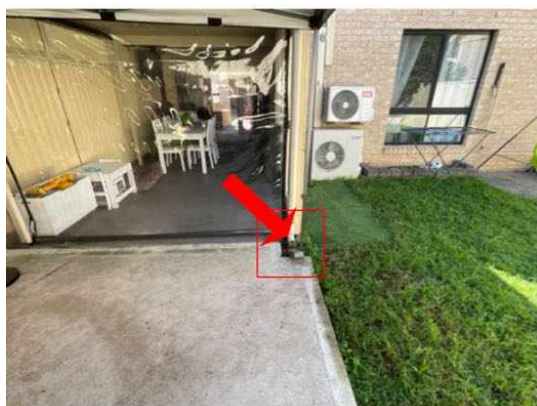
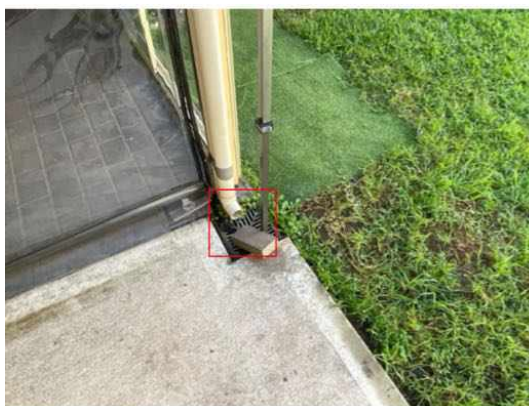
- Poorly sealed or disconnected downpipes can result in:
- Water pooling around the base of the building
- Excessively damp conditions at the foundation or subfloor level
- Increased risk of foundation movement

Recommendation:

- Rectification is strongly advised.
- A licensed plumber should be appointed to:
- Inspect the area thoroughly
- Assess the condition of the stormwater system
- Repair, replace or properly connect all downpipes to ensure compliant and effective drainage

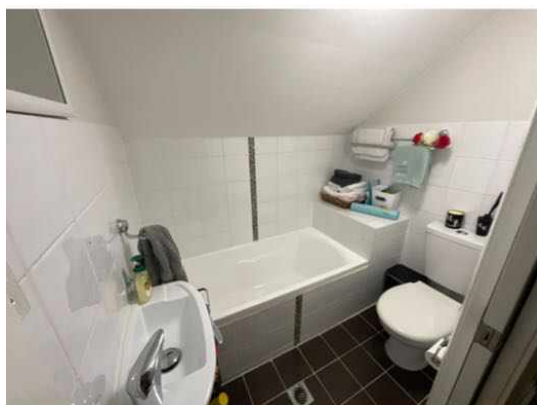
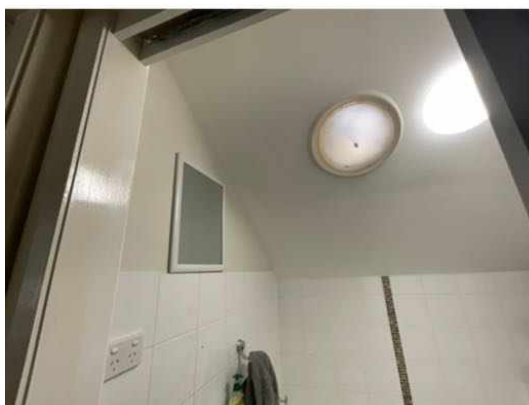
Finding 3.02

Building:	Main Building
Location:	Bathroom > Upstairs
Finding:	Defect – Inadequate Ventilation (No Exhaust Fan Installed).
Information:	Observation:

At the time of inspection, it was noted that no exhaust fan or alternative form of mechanical ventilation had been installed in this area.

- Odours
- Excessive moisture
- Mould growth

This can result in deterioration of building elements and may pose health risks over time if left unaddressed.

Recommendation:

- An electrician and/or ventilation specialist should be engaged immediately to:
- Assess the area
- Install a compliant exhaust fan or alternative ventilation system
- Rectification is recommended prior to occupancy to ensure compliance and reduce the risk of long-term moisture-related issues.

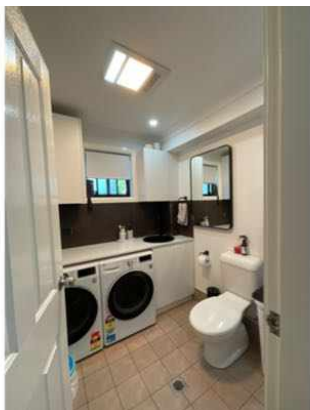
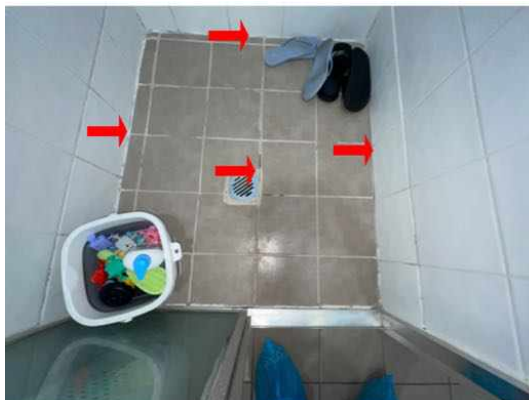
Finding 3.03

Building:	Main Building
Location:	Bathroom > Ground Level
Finding:	Minor Defect – Shower Floor Sealant/Grout Deterioration.
Information:	Observation:

At the time of inspection, sections of the shower floor were observed to have deteriorated, cracked, or missing grout and/or sealant at junctions and along tiled interfaces. These areas are subject to regular water exposure and form part of the waterproofing surface system.

Building materials expand and contract at differing rates, particularly at junctions between surfaces. Rigid grout in these locations is prone to cracking over time, while sealant can degrade due to age, moisture exposure, and lack of maintenance. Where sealant or grout is compromised, water ingress may occur, potentially leading to deterioration of underlying substrates, concealed moisture damage, and mould growth if left unaddressed.

Recommendation:

It is recommended that all affected areas be cleaned, assessed, and re-sealed using a flexible, mould-resistant sealant suitable for wet areas. Any defective grout should be repaired or replaced as required. Ongoing maintenance of sealant and grout in wet

areas is essential and should be undertaken periodically as part of routine property upkeep.

A suitably qualified sealant specialist or tiling contractor should be engaged to carry out these works in a timely manner.

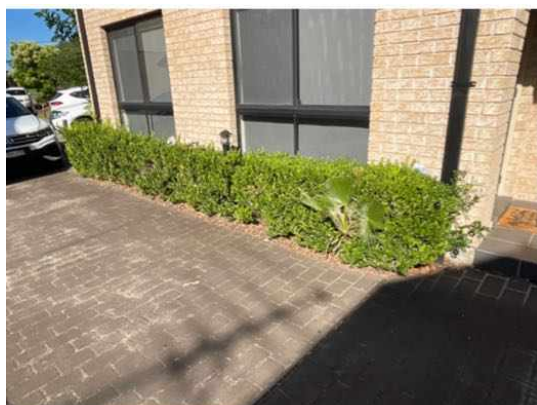
Garden beds were observed directly against the perimeter of the building. This condition can result in water pooling or retention during rainfall or from regular watering/hosing, which may lead to moisture ingress beneath the structure.

- Persistent moisture buildup around the base of the building creates an environment that is conducive to termite activity and timber decay.
- Plants and vegetation close to or in contact with external walls can provide shade and cover, further increasing the likelihood of termite infestation.

Recommendation:

It is strongly recommended that garden beds be removed or relocated away from the building perimeter. Maintaining a clear inspection zone around the structure helps reduce moisture retention and improves visibility during regular pest inspections. This preventative measure significantly lowers the risk of termite ingress and related structural damage.

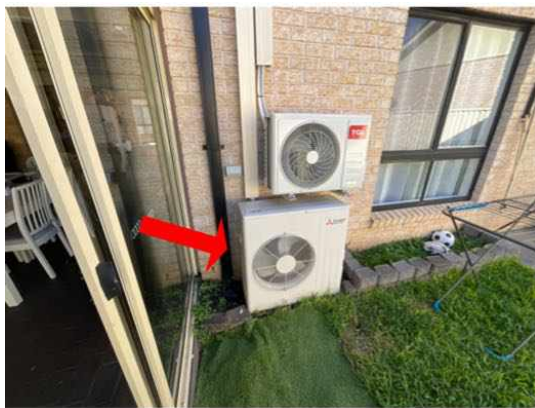
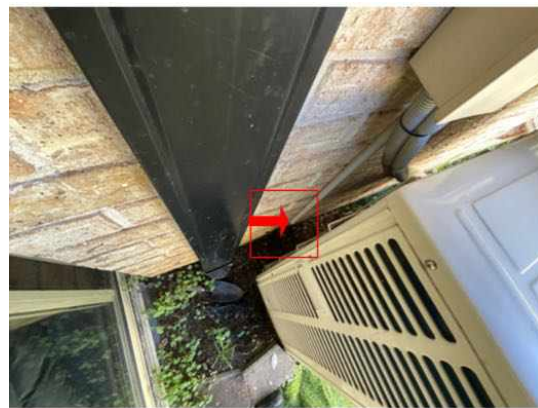
Finding 6.02

Building:	Main Building
Location:	Rear Elevation
Finding:	Overflow Management – Risk of Termite Activity..
Information:	Observation: Water Pooling from HWS and Air Conditioning Overflows

Water discharge from the Hot Water System (HWS) pressure relief valve and air conditioning unit overflows was observed discharging close to the base of the structure, contributing to water pooling around the building perimeter.

Persistent moisture near the foundation or subfloor area significantly increases the likelihood of termite activity. Termites are highly attracted to damp environments, and stagnant water near structural elements provides ideal conditions for foraging and infestation.

- **Moisture Conducive to Infestation:** Termites require moisture for survival, and pooled water can soften timber materials, making them more accessible.
- **Structural Risk:** Prolonged dampness may also contribute to timber decay, further

Recommendation:

It is highly recommended that all overflows from the HWS and air conditioning units be redirected away from the building, preferably via fixed drainage or extension piping, to prevent water accumulation near the structure.

These minor corrective works should be undertaken promptly to minimise the risk of both termite ingress and potential structural damage due to ongoing moisture exposure.

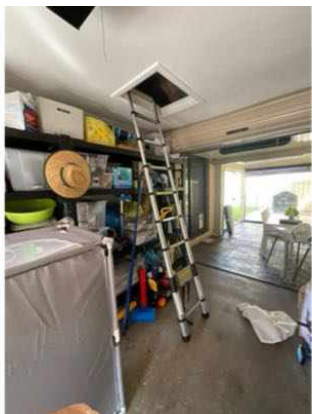
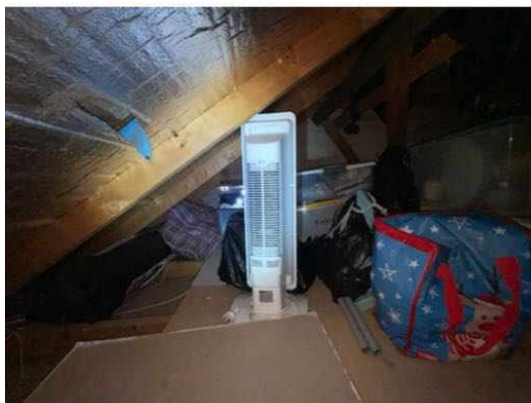
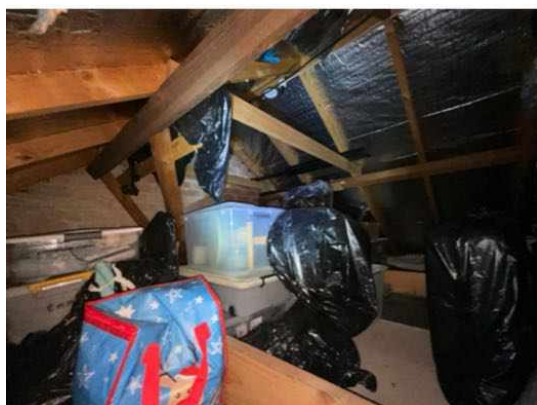
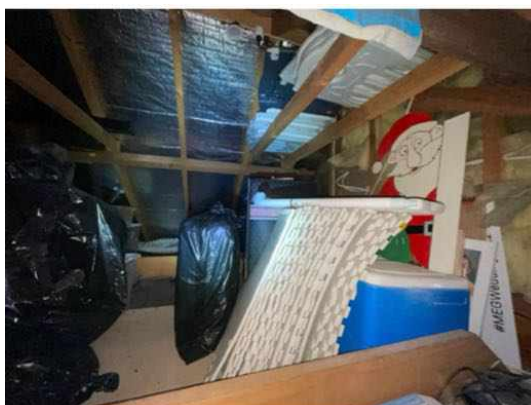
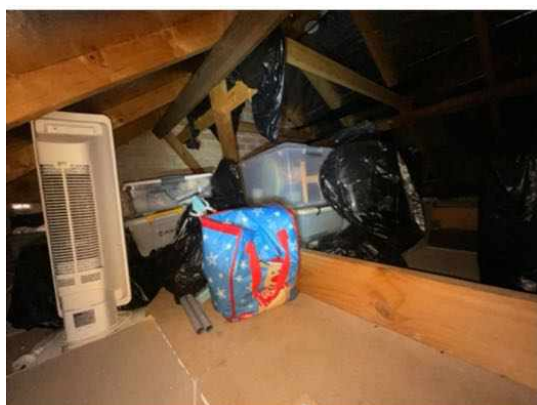
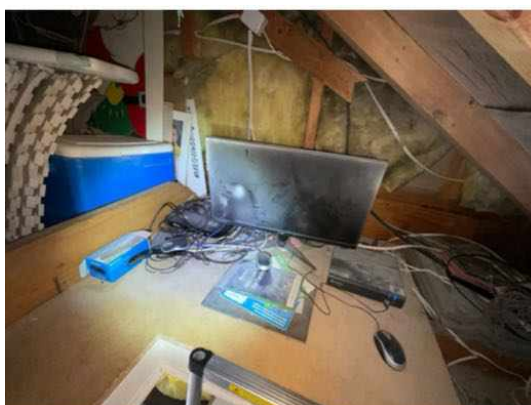
Building: Main Building
 Location: Roof Void
 Finding: Roof Void – Limited Accessibility..
 Information: Observation:

Recommendation:

Installation of an additional manhole is recommended to facilitate a re-inspection and enable a more thorough assessment of the roof void in the future. This will help ensure that all structural elements and concealed areas are properly evaluated.

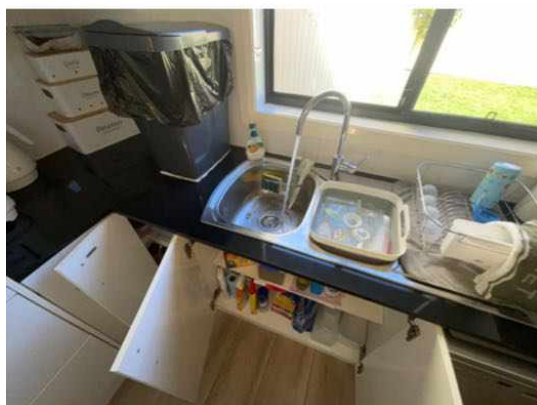
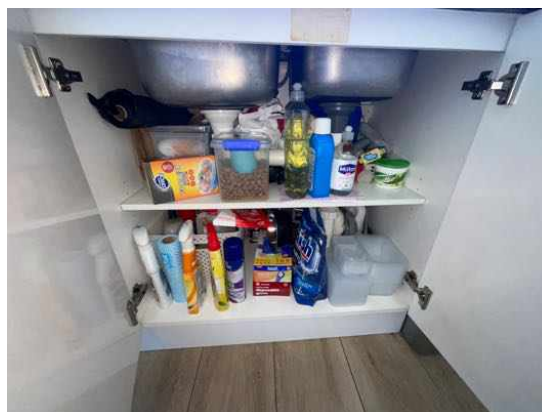
Building: Main Building
 Location: Kitchen
 Finding: Kitchen Sink – Overall Condition & Recommendations.
 Information: Observations:

Recommendations:

- Further monitoring and testing are recommended once the tap(s) are in constant use, to identify any drainage issues or signs of slow leaks not evident during the limited inspection.
- For long-term property care, it is advised that sealant and grouting in water-exposed areas be regularly inspected and maintained.
- It is recommended that the stored items beneath the sink be removed to allow for a full re-inspection of the plumbing and cabinetry, ensuring no concealed defects are present.

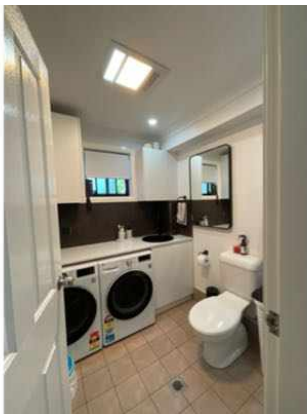
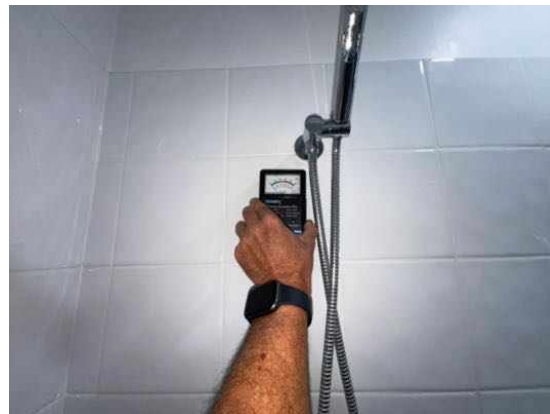
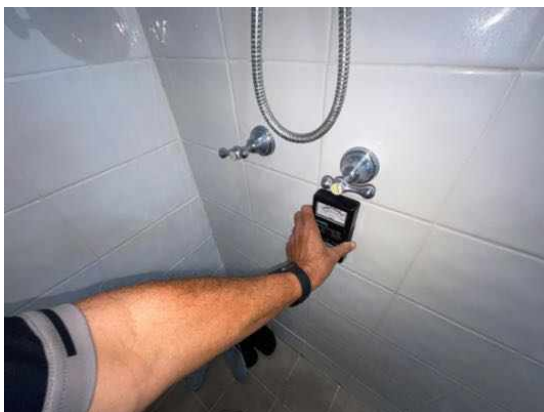
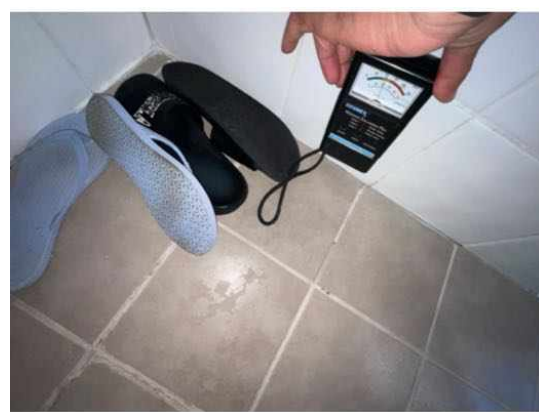
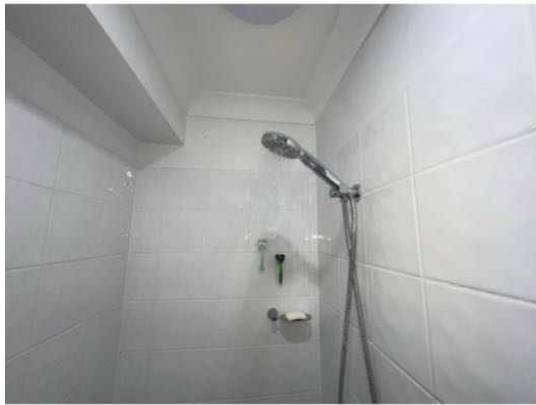
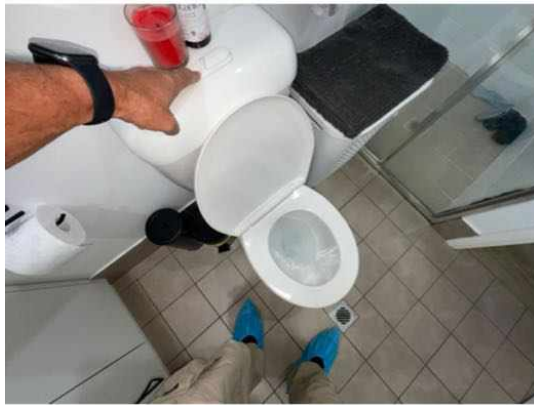
Building: Main Building
 Location: Bathroom > Ground Level
 Finding: Wet Areas - Bathroom(s) - Overall Condition & Recommendations.
 Information: Overall Condition & Recommendations

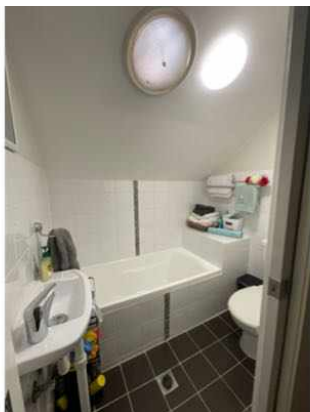
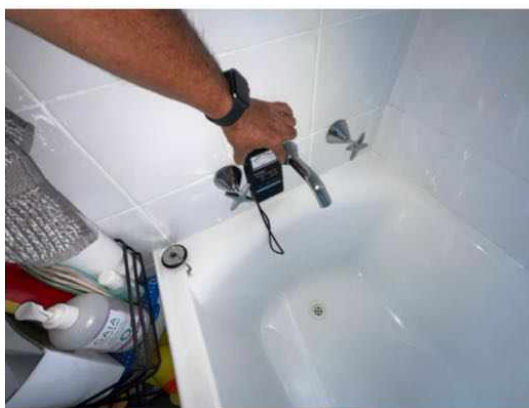
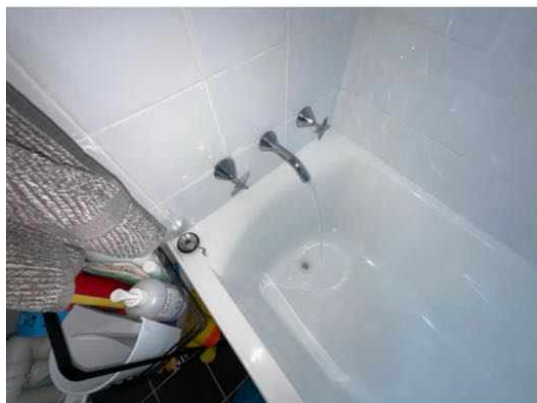
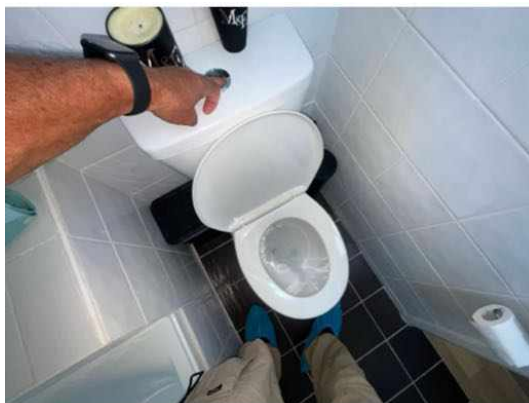
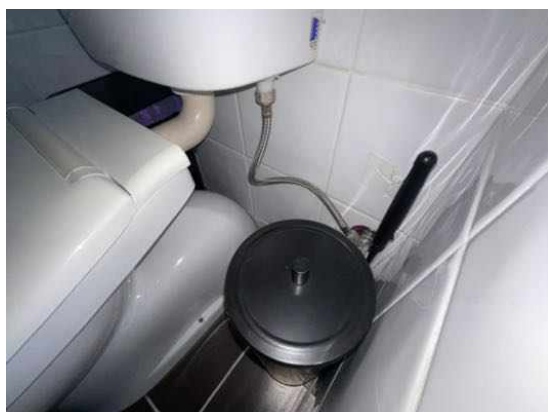
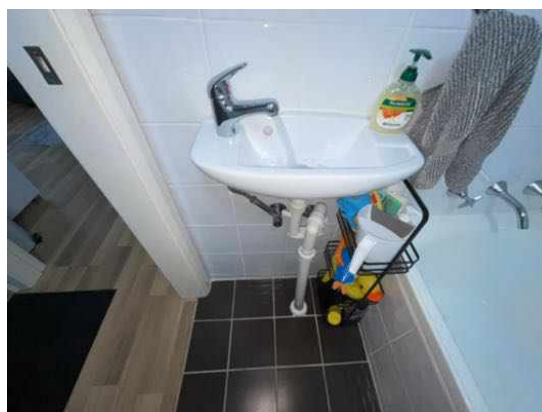
Building: Main Building
Location: Bathroom > Upstairs
Finding: Wet Areas - Bathroom(s) - Overall Condition & Recommendations.
Information: Overall Condition & Recommendations
