# Building and Timber Pest Inspection Report

Inspection Date: Wed, 4 Mar 2026

Property Address: 38 Hoyle St, Tocumwal NSW 2714, Australia

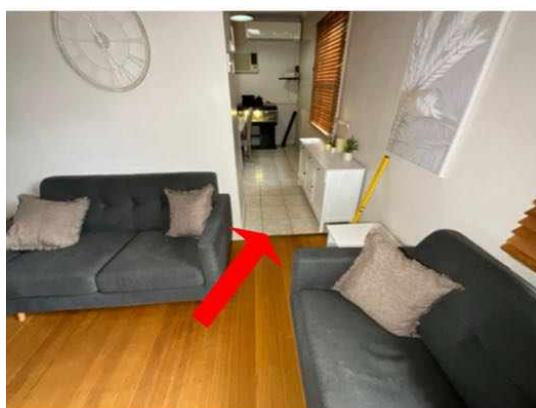
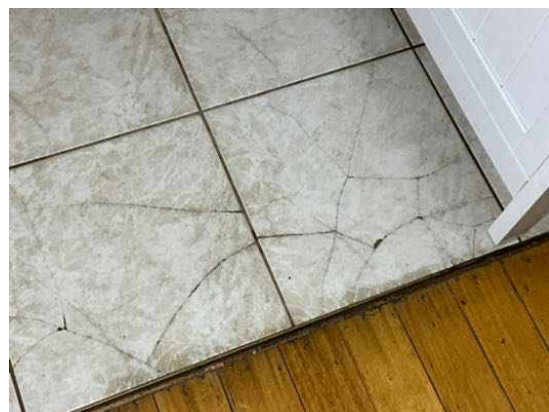
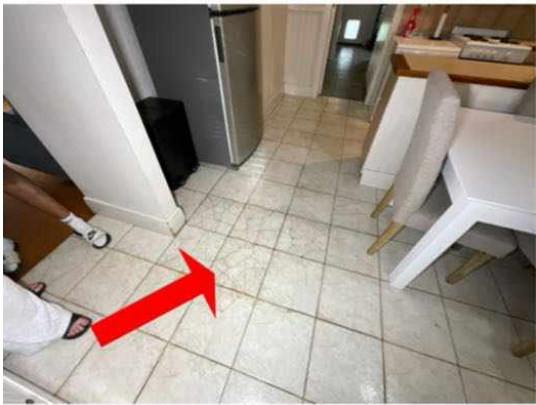
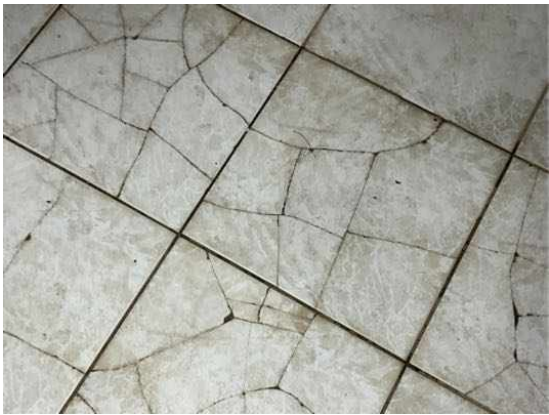
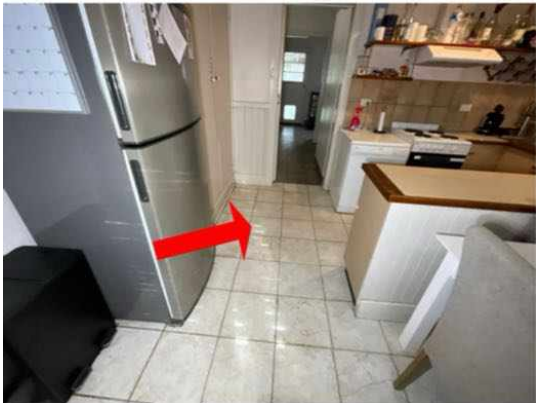
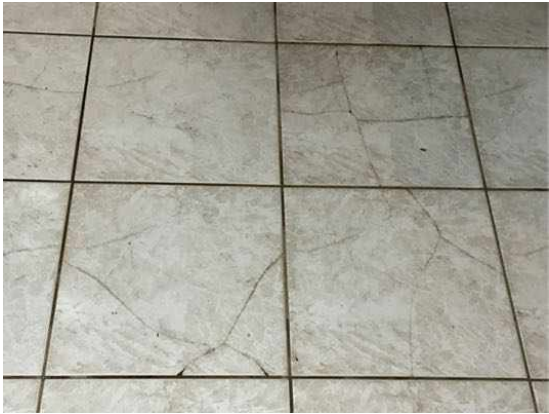
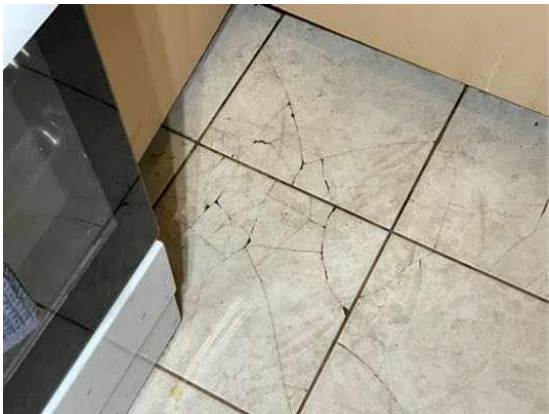
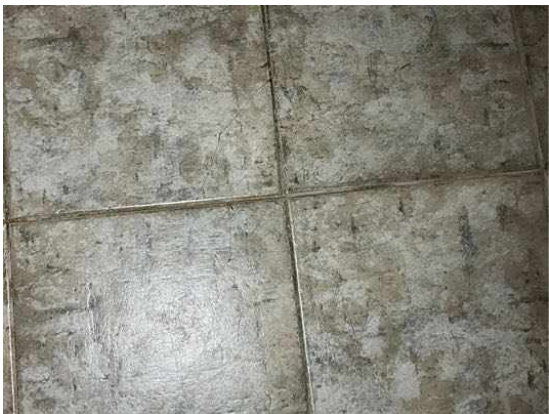
Building: Building 1  
Location: Kitchen, laundry  
Finding: Cracked floor tiles  
Information: Cracking in the floor tiles was evident in this area at the time of inspection. It is suspected that this cracking has occurred as a result of minor settlement or impact damage.

Cracked tiles throughout the household detract from the overall appearance of the affected areas however it is unlikely to create or lead to any secondary defects.

While not considered a matter of urgency, replacement of cracked floor tiles is recommended at the clients discretion. A tiling contractor may be appointed to perform these works. Where cracks become more numerous, contact a licensed building inspector for further investigation.

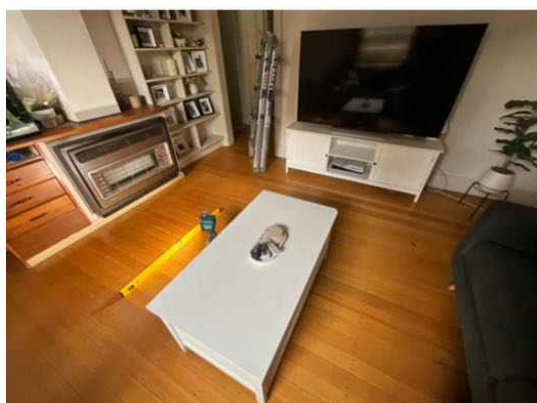
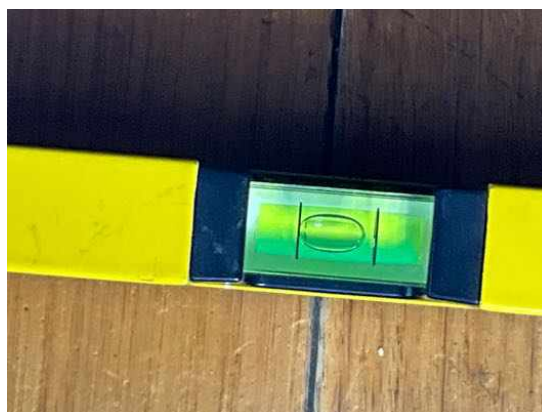
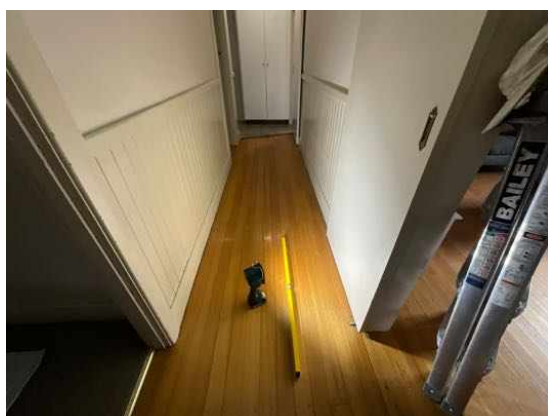
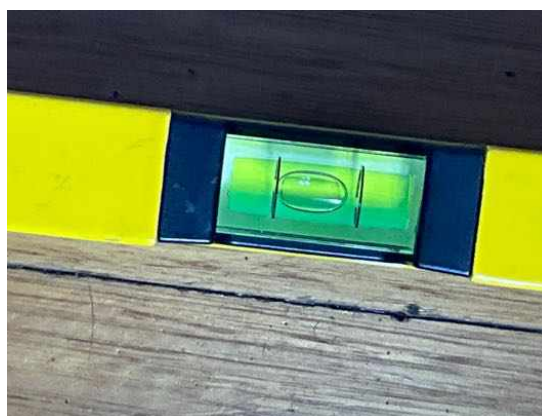
Finding 3.02

Building: Building 1  
 Location: All Internal Areas  
 Finding: Flooring - Uneven  
 Information: The internal flooring in this area is out of level and uneven. Uneven flooring is likely to indicate minor defects such as expected movement of the foundations of the property, but may also indicate subsidence of the associated subfloor stumps.

It is advised that the flooring be closely monitored to identify any further movement. Where flooring remains relatively unchanged for an extended period of time (i.e. several months), it is likely that this defect has been caused by expected movement of the foundations of the property.

However, where flooring is uneven further, potentially invasive inspection of the subfloor structures and stumps in this area is required. In this case, works to repair are likely to be required, and would be carried out by a registered builder specialising in re-stumping.

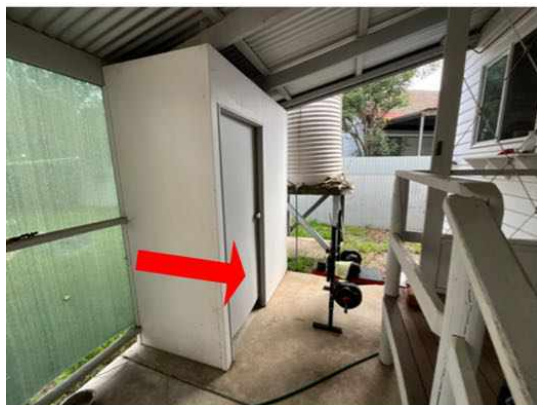
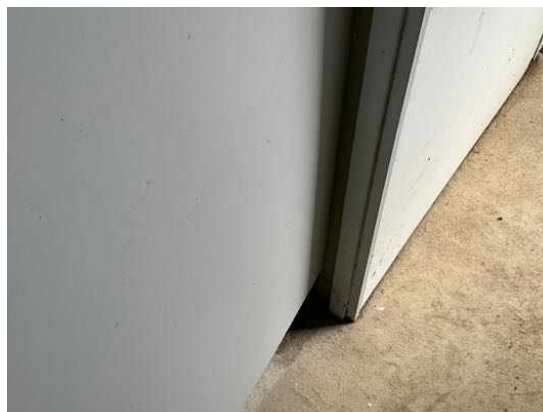
### Finding 3.03

Building: Building 1  
 Location: Toilet (WC) - 2  
 Finding: Door- Binding/jamming  
 Information: Binding and/or jamming of this door is evident during standard operation. This defect

inhibits the functionality of the affected door as well as creating potential for secondary defects to associated building elements, such as damage to the floor covering.

A door that binds to flooring or to the associated door frame may have several causes, ranging from minor defects, such as poor installation of the door or deteriorated hinges, through to major structural issues, such as damage to subfloor structures.

A qualified carpenter or general handyperson should be appointed to perform minor rectification works at client discretion.

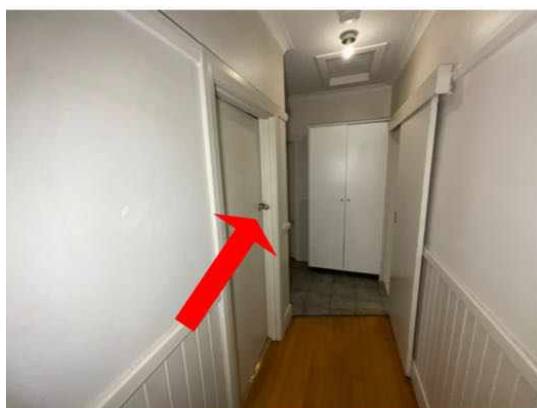
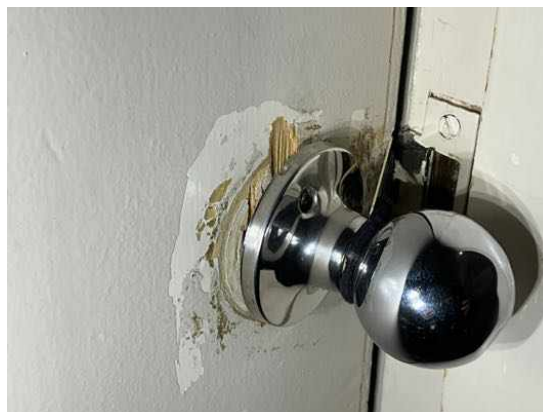
### Finding 3.04

Building: Building 1  
 Location: Bedroom 3  
 Finding: Door handle- Poor operation  
 Information: The door handle/ catch in this area was found to be faulty during the visual inspection. This is most probably because of a lack of maintenance or wear and tear over time.

A general Handy person or lock specialist should be contacted to make needed repairs at the discretion of the owner and restore full function.

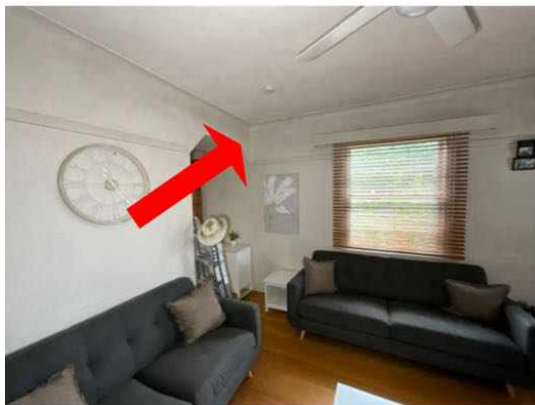
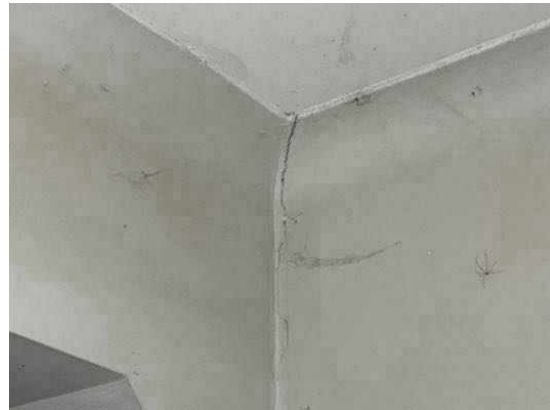
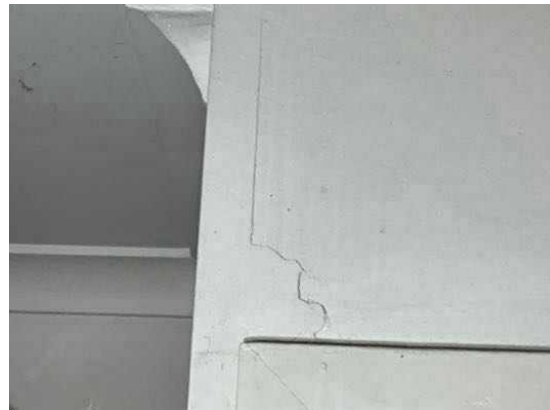
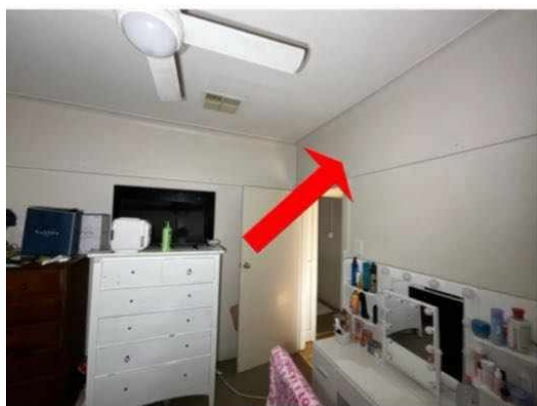
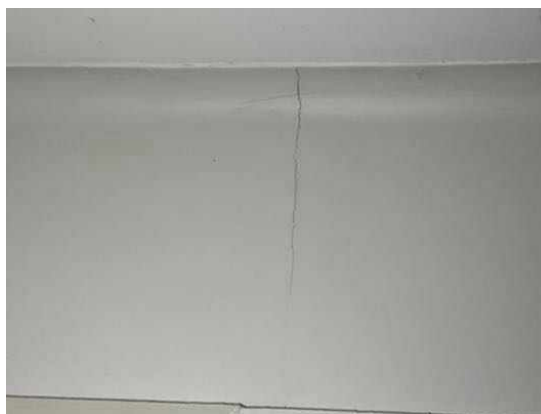
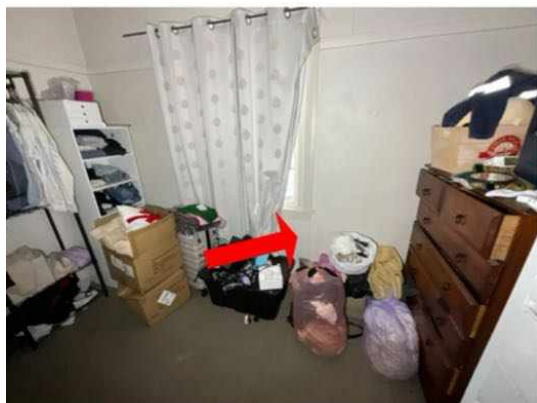
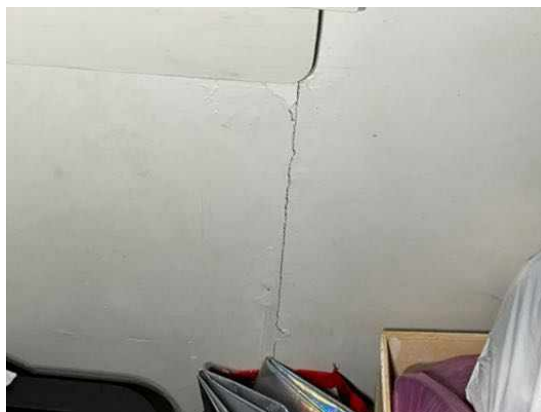
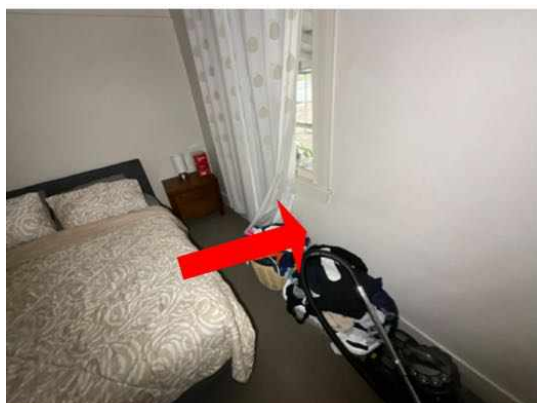
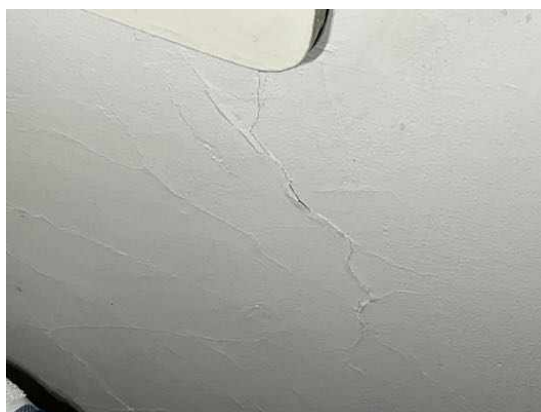
### Finding 3.05

Building: Building 1  
Location: Living Room, kitchen, bed 1,3  
Finding: Cracking - Damage Category 1 - Fine (up to 1mm)  
Information: Although fine cracks are quite noticeable, they are often only considered to be an appearance defect, and usually do not indicate any structural damage. Generally, the cause of a fine crack is indicative of a separation between building materials and finishes (e.g. paint, plaster, etc.) along joins.

Cracking of this nature can generally be repaired with minor sanding, filling and/or repainting. Such works should be performed by a qualified painter or a general handyman.

Monitoring of all cracking should be conducted frequently. Always contact a building inspector should cracks widen, lengthen, or become more numerous.

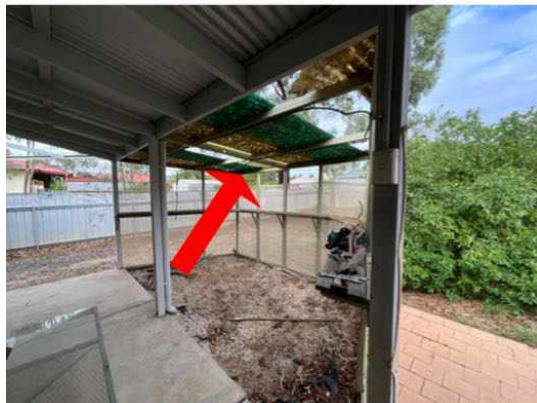
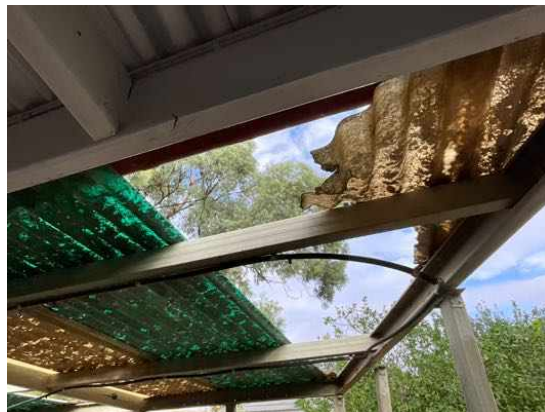
### Finding 3.06

Building:	Building 1
Location:	Verandah > Rear
Finding:	Polycarbonate sheeting - Damaged
Information:	The polycarbonate sheeting has deteriorated as a result of exposure to weather conditions over a prolonged period of time. Exposure to elements, such as heavy rain and hailstorms, is likely to damage polycarbonate sheeting, which is not as strong as other roof coverings.

Further deterioration of the polycarbonate sheeting is likely to occur if left unmanaged. Such deterioration creates potential for water penetration and secondary damage to the internal roofing structure, accelerating deterioration of all associated building

elements.

Repair and replacement of several sections of the sheeting is required. Appointment of a roofing restorer is required to perform these works as soon as possible to prevent any further damage being sustained.

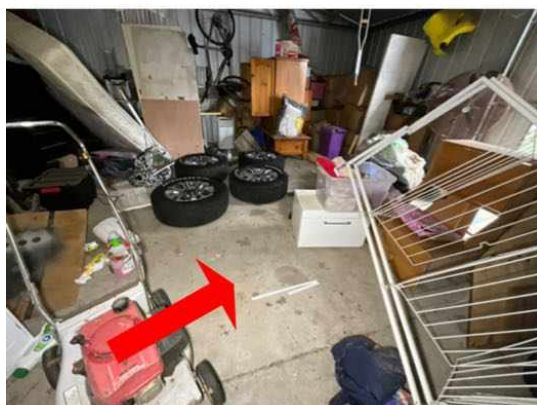
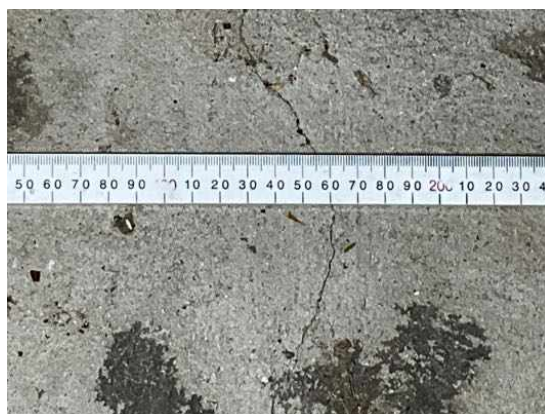
### Finding 3.07

Building: Building 1  
 Location: Garage  
 Finding: Crack in concrete slab - Category 1  
 Information: A crack coded as Category 1 was identified in the slab. A Category 1 crack is described as a fine but noticeable crack, with the slab at an otherwise reasonable level.

To be considered Category 1, the approximate width of the crack is less than 1.0mm, or a less than 10mm change in offset when a 3m straight edge is placed over the defect.

Category 1 cracks should be monitored for a period of 12 months. At the end of the monitoring period, identified cracks that are rated greater than Category 2 are considered defects, and require rectification.

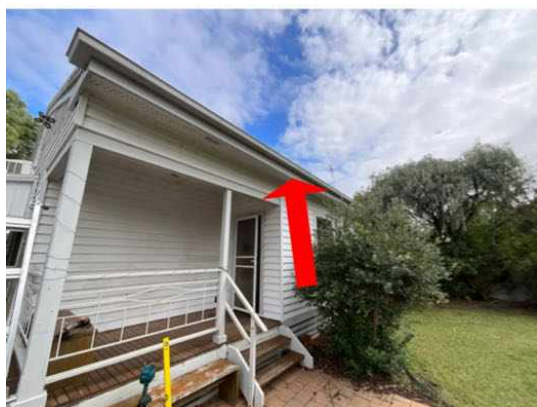
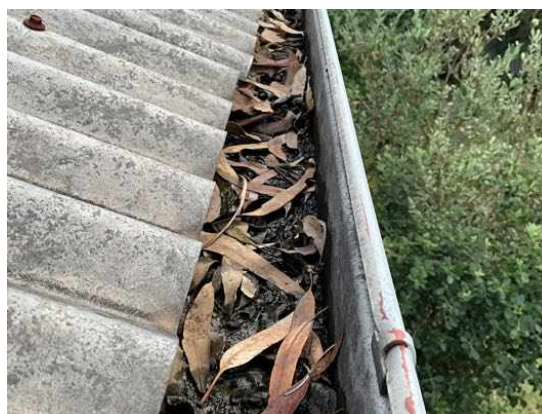
Blocked gutters are likely to lead to high levels of moisture in the affected areas. Such moisture will not only cause rust and decay of the associated building materials, but can also provide conditions that are conducive to termite and timber pest activity. Blockages in gutters should therefore be removed immediately to ensure dry conditions are maintained.

Consult a Licensed Plumber for further specific advice on remedial works that may be required. In the interim, it is highly advised that blocked gutters be removed by the homeowner or a general handyperson as a matter of urgency.

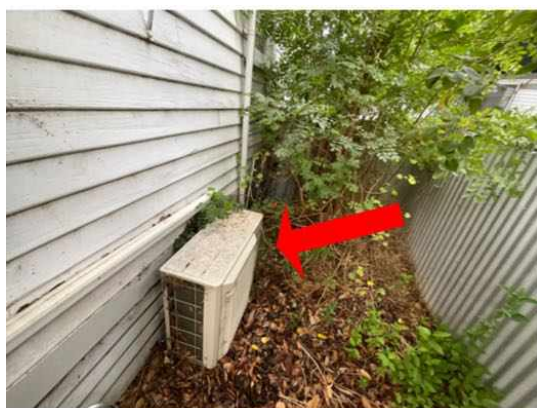
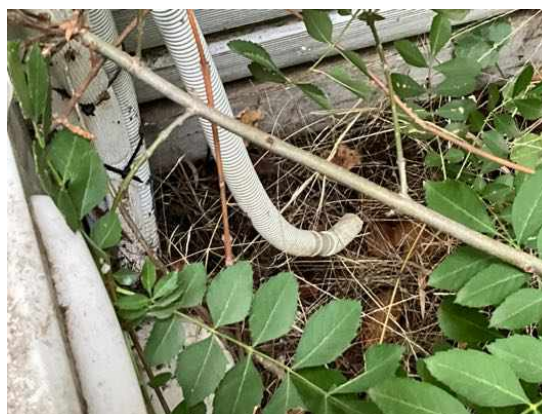
### Finding 6.02

Building: Building 1  
 Location: Yard - Side

- Finding: Air conditioner - Disconnected overflow
- Information: The Air Conditioner (A/C) overflow was found to be disconnected from storm water drainage and is creating excessive moisture in the surrounding area.
- Such leaking creates an environment which is conducive to an array of defects, including water damage to associated building elements and the attraction of termite or timber pest infestation.
- It is highly recommended that a licensed plumber be appointed to connect the A/C overflow in order to prevent such an environment from being created. These minor works should be carried out as soon as possible.

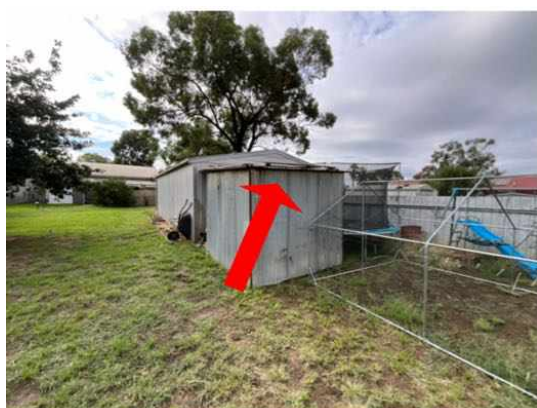
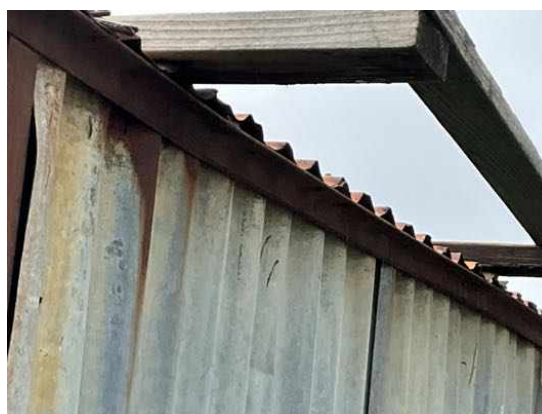
### Finding 6.03

- Building: Building 1
- Location: Shed
- Finding: Guttering Missing
- Information: The Guttering in this area was missing at the time of inspection. Guttering, Downpipes and Stormwater drainage are vital to protect the integrity of the structure and to prevent an environment conducive to Timber Pest attack.
- A Plumber should be contacted as soon as possible to replace and connect to drainage the missing Guttering.

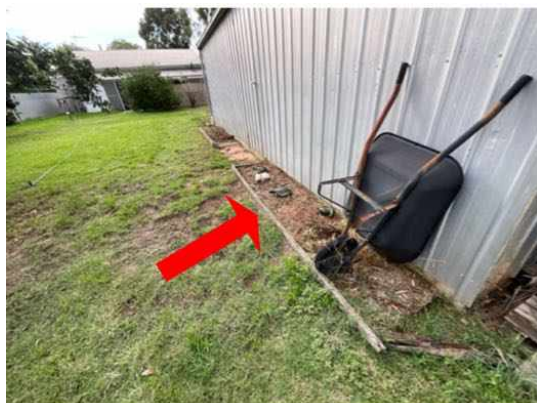
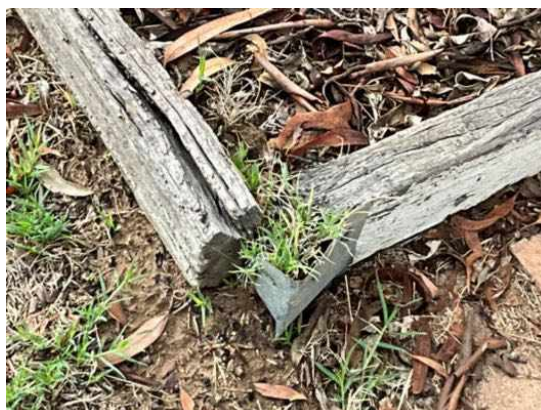
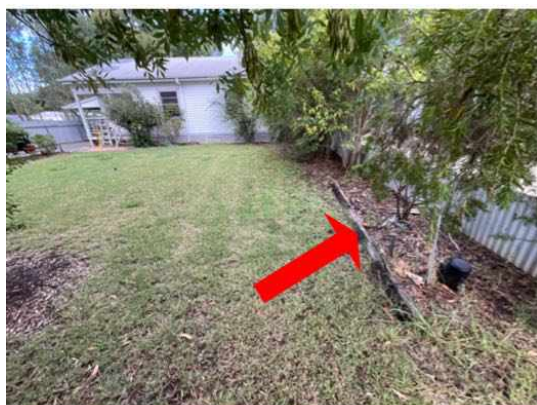
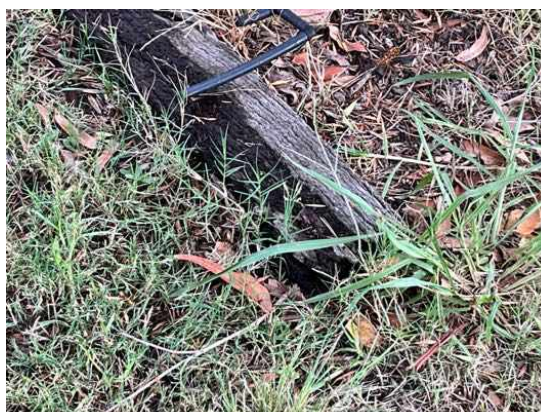
## Finding 6.04

Building:	Building 1
Location:	Yard - Back, front
Finding:	Untreated or non-durable timbers in a hazardous environment
Information:	To reduce the risk of timber pest attack it is essential that timber used in a hazardous environment (e.g. in direct contact with the ground or frequently exposed to damp conditions) is of sufficient durability and/or is adequately preservative treated.

Untreated timbers in direct contact with the ground are likely to develop severe wood rot and/or fungal decay if left unattended creating attraction for subterranean termites to infest the timbers from surrounding areas.

If untreated or non-durable timbers are found to be in a hazardous environment it is highly advised that replacement of these building elements be performed as soon as possible to aid the protection of the property against termite / timber pest attack.

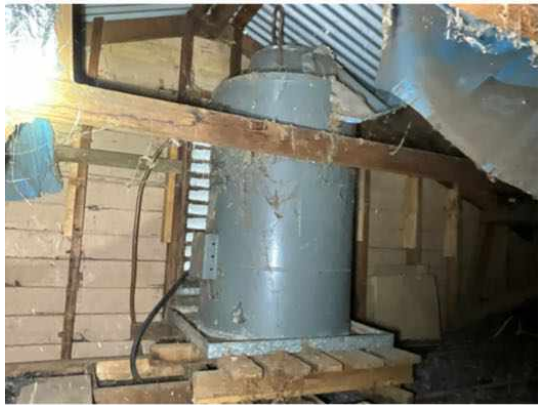
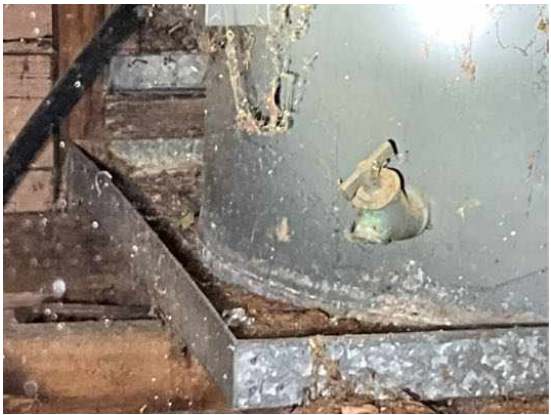
Building:	Building 1
Location:	Roof Void
Finding:	Gravity-Fed HWS - Disconnected
Information:	It was noted at the time of inspection that a disconnected gravity-fed hot water system (HWS) remains in this area.

Despite this plumbing structure being unused, it is likely to be storing residual water, and is therefore susceptible to rust and corrosion. If allowed to continue, rust and corrosion is likely to lead to damage to adjoining building elements, and may also make the area susceptible to termite or timber pest activity.

While it is a costly exercise to remove the disused gravity-fed HWS, it is advisable in the short-term future to prevent any further damage to the area. Further consultation with a licensed plumber is required to gain further advice on removal of the structure.

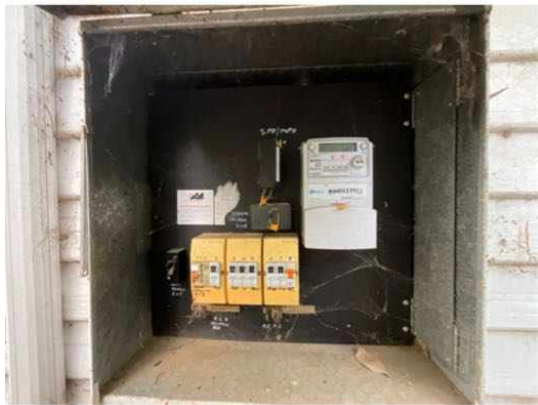
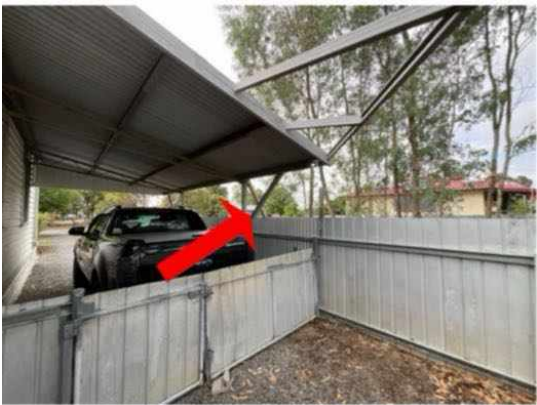
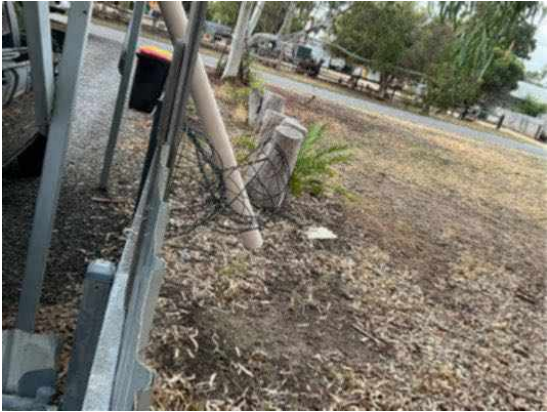
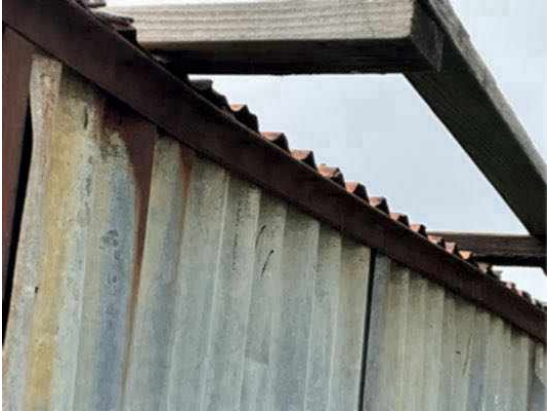
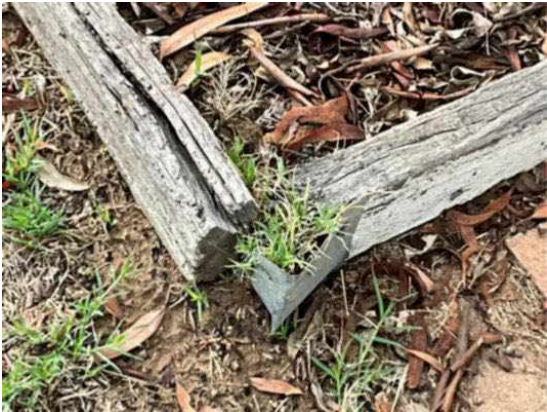
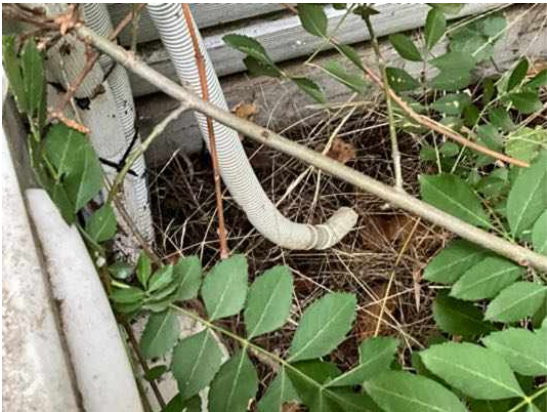
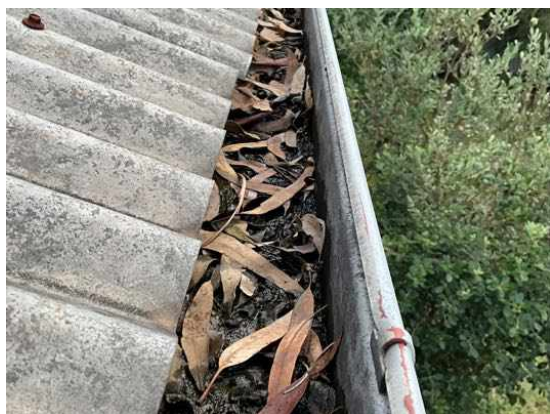
**Finding 6.07**

Building: Building 1  
Location: All External Areas  
Finding: Termite Management System - no evidence of a chemical installation  
Information: The application of a post-construction chemical termite barrier is highly recommended for all properties, particularly if live termite activity has been found on the site previously. Such barriers are highly effective in preventing termite attack on any timber building elements throughout the property.

A durable notice should be placed in the switchboard unit to indicate current termite barriers. At the time of inspection, it appeared as though no termite management system has been installed, with no evidence to suggest preventative works taking place.

The client may consider gaining further advice from a pest controller as to the costs and procedures involved with this application. It is recommended that obtaining such advice be a short-term priority.

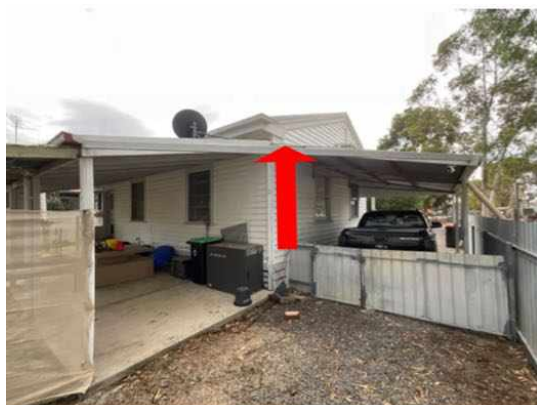
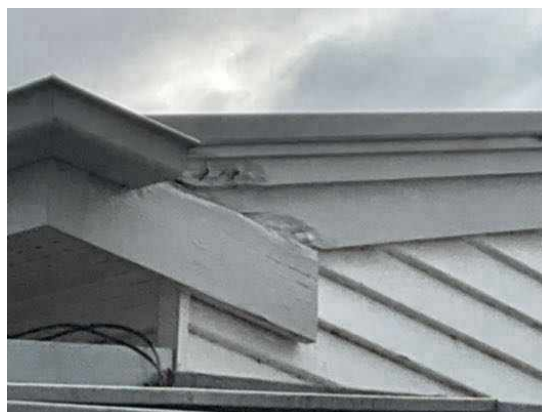
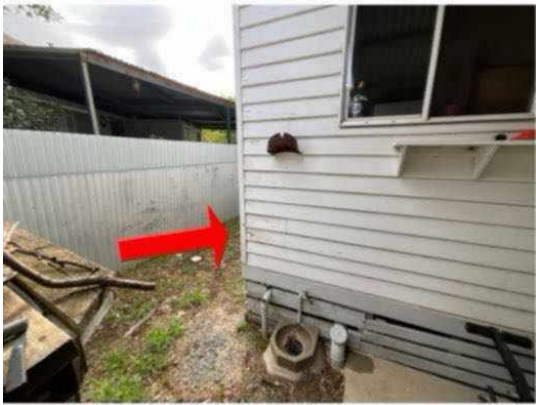
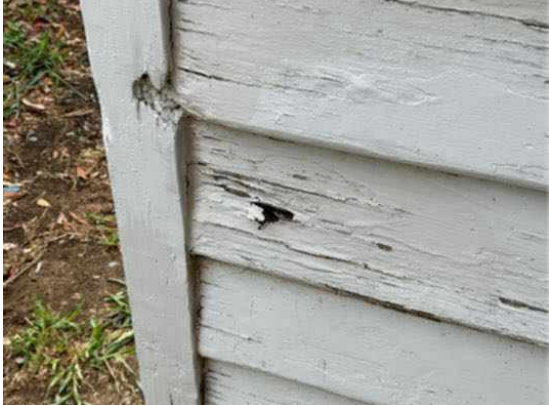
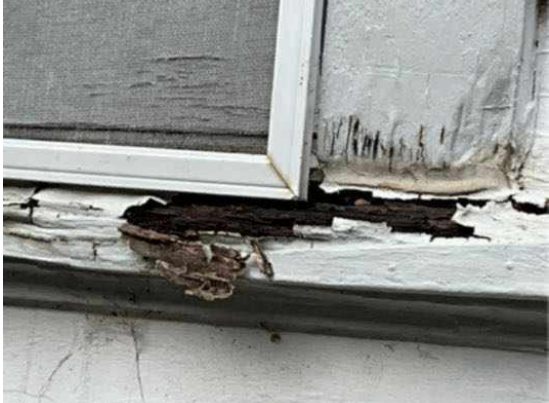
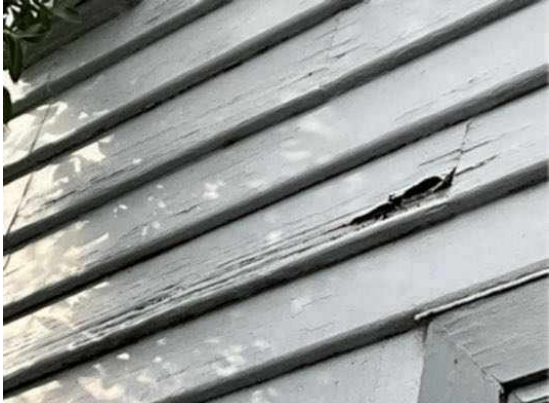
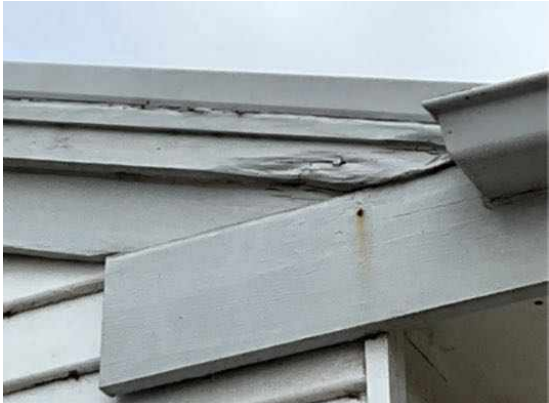
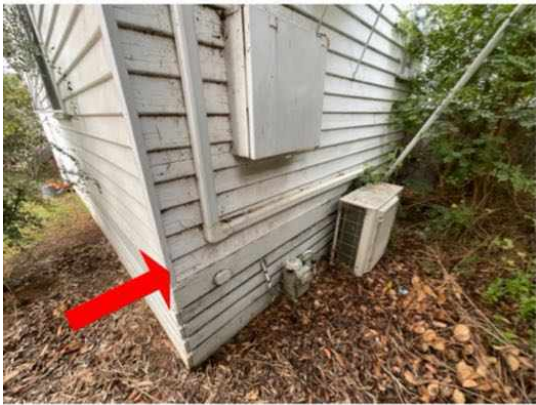
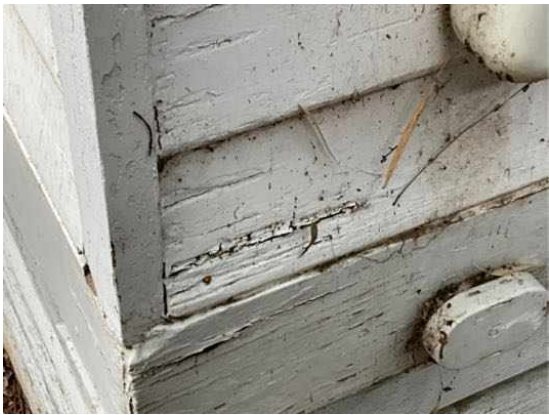
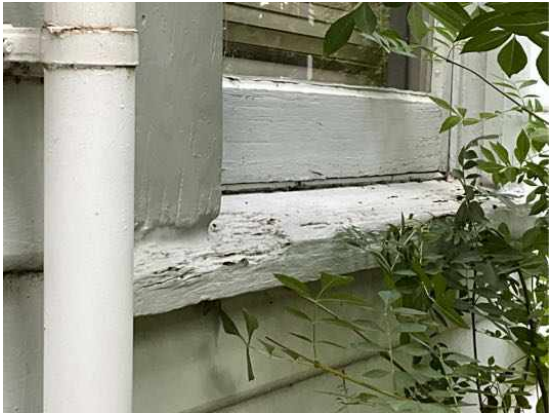
### Finding 7.01

Building:	Building 1
Location:	Eaves, walls
Finding:	Fungal decay - present (localised)
Information:	Fungal decay also known as wood decay or wood rot generally refers to the deterioration of timber elements when in contact with excessive levels of moisture for a prolonged period of time.

The development of fungal decay is accelerated by temperatures in the range of 5degreeC to 40degreeC as well as the presence of oxygen. Generally fungal decay develops on timber elements that are in use in an external environment which are exposed to rain penetration.

In this case although the affected timber element is in a decaying state the extent of any visible damage appears to be localised to a specific area and is yet to spread to other parts of the building element or affect adjoining structures. The fungal decay is therefore likely to be of a relatively superficial nature with minimal impact on the structural integrity or tensile strength of the timber element.

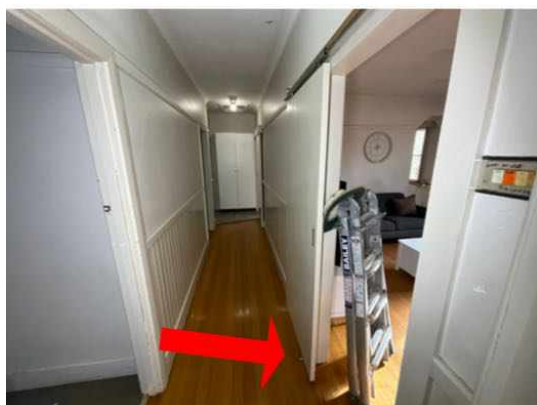
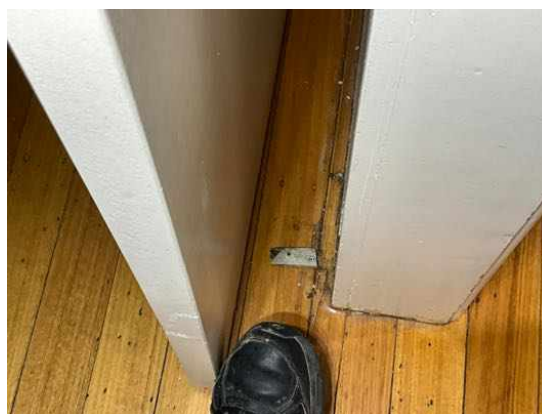
Building: Building 1  
 Location: Hall  
 Finding: Sliding Door- Guide missing  
 Information: The door in this area was difficult to slide along the associated tracks at the time of the inspection. Restricted function of the affected door may pose as a potential safety hazard if required for emergency egress from the building. The Door may come off the track during operation and fall. This may create a potential safety hazard.

Generally, factors such as general age of the building element and a lack of maintenance are the usual causes for this type of defect.

Replacement of door guide hardware or tracks may be required, as well as minor repairs and cleaning. A general handy person will be required to restore the affected door to full function.

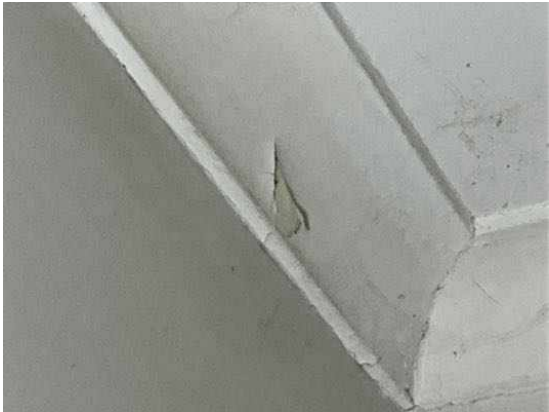
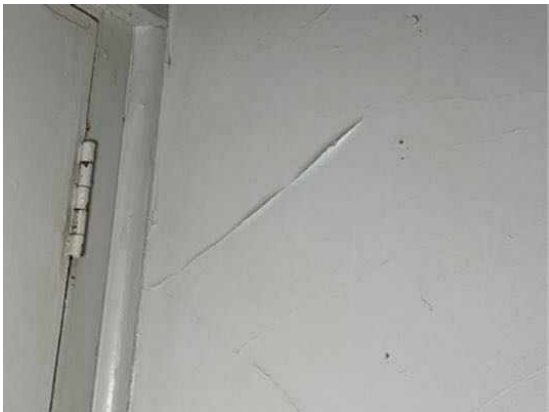
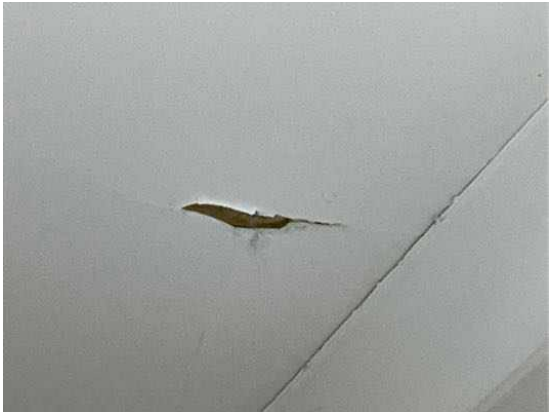
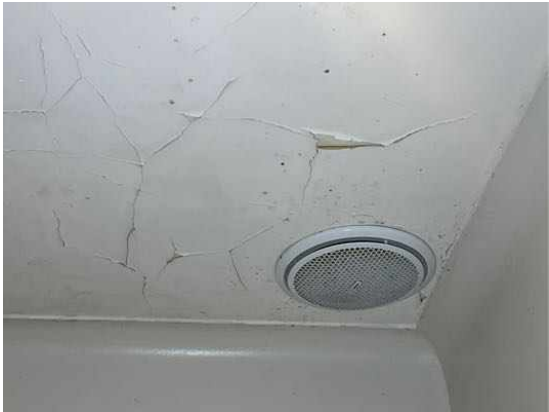
Building: Building 1  
 Location: Kitchen, hall, bathroom  
 Finding: Paint- Flaking  
 Information: Sections of paint in this area was found to have deteriorated. Paint flaking is generally an indication of excessive moisture in the area, that is currently hidden by the painted surface.

The presence of excessive moisture can have major implications on associated building elements if left unattended. While only seemingly minor at this stage, the damage cannot be determined due to the paint obstructing any further inspection of the damage.

A qualified Painter should be contacted at the Owner's discretion to re-paint the area.
