Building Inspection Report

Inspection Date: Wed, 28 Jan 2026

Property Address: 20 Princeton St, MOUNT DUNEED, VIC,
3217, Australia

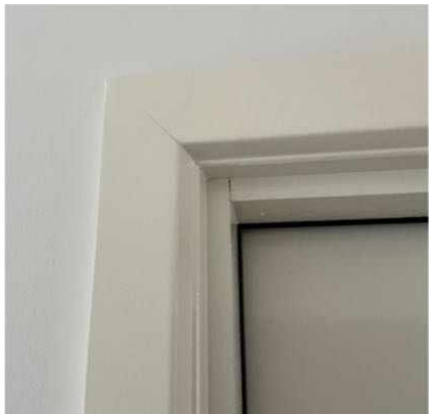
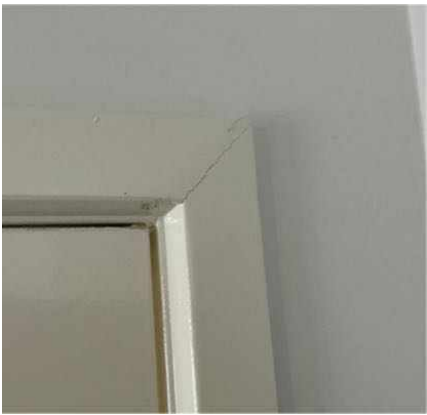
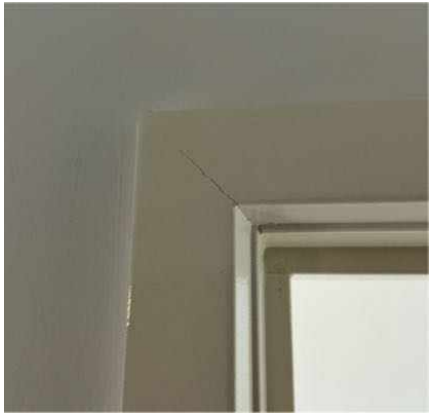
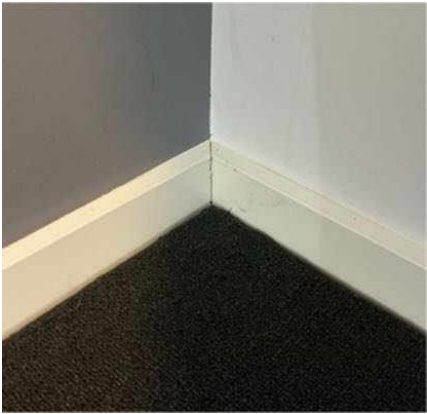
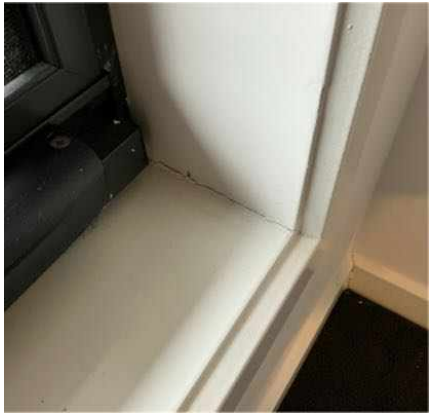
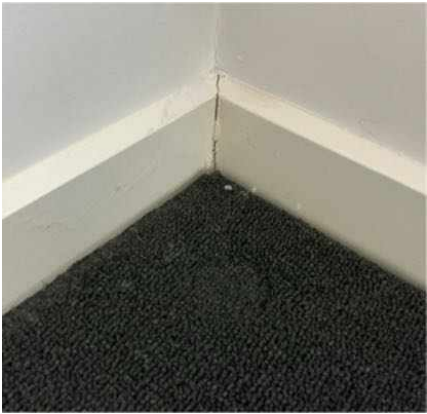
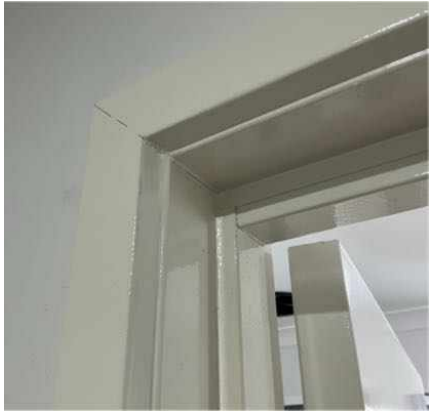
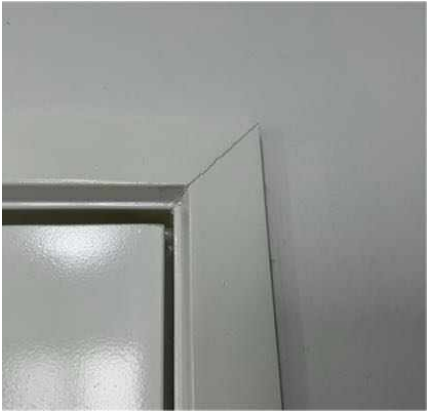
Defects 3.01

Building: Main Building
Location: All Internal Areas
Finding: Cracking to Painted Architraves and Skirting Boards
Information: Cracks were observed opening up in various sections of the painted architraves and skirting boards. These cracks may be associated with minor building movement, timber shrinkage, or inadequate surface preparation prior to painting.

- Aesthetic presentation is compromised by visible cracking.
- Potential ongoing movement may lead to further deterioration or require repeated maintenance.
- May indicate underlying workmanship or preparation issues.

This condition is not uncommon following recent painting, particularly in timber joinery, and is typically considered a maintenance item unless associated with significant structural movement.

- Engage a qualified painter or builder to assess the extent of cracking and undertake necessary repairs, which may include filling, sanding, and repainting affected areas.
- Monitor for any signs of worsening or recurring movement over time.

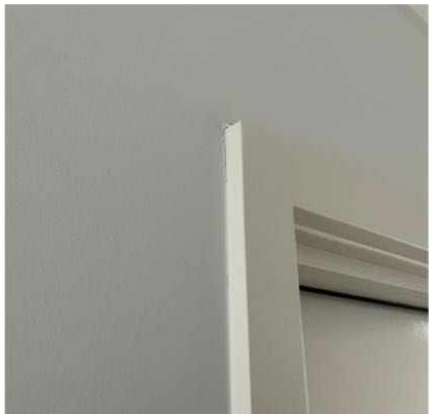
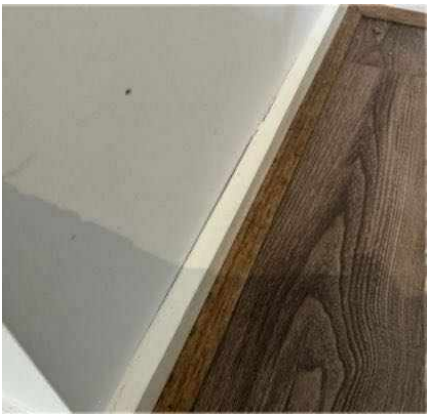
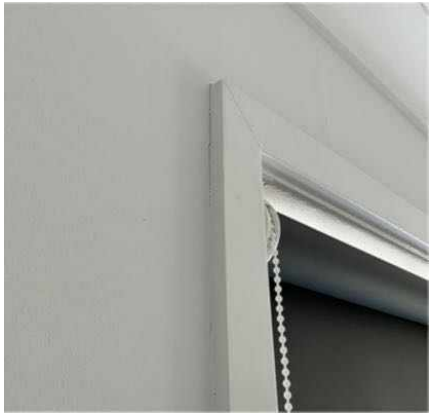
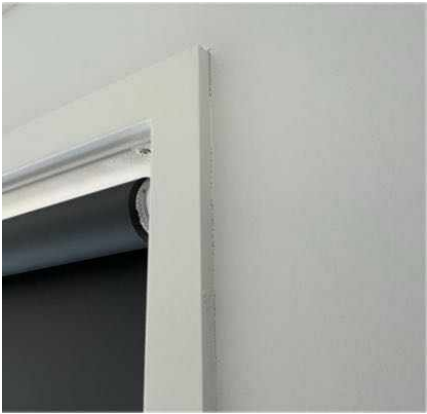
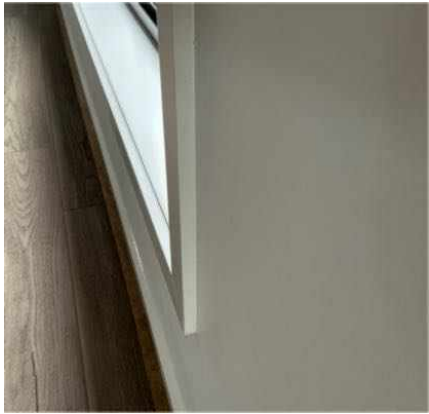
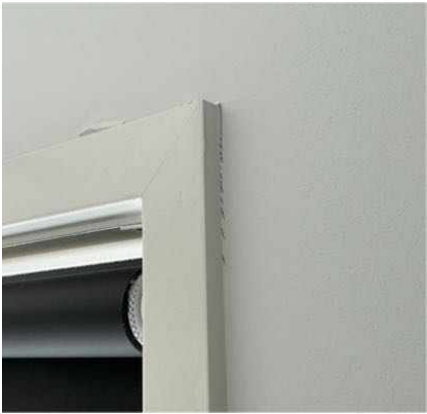
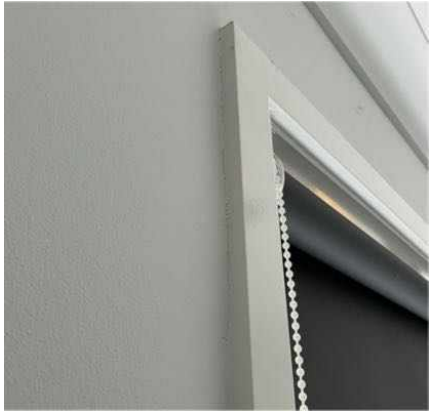
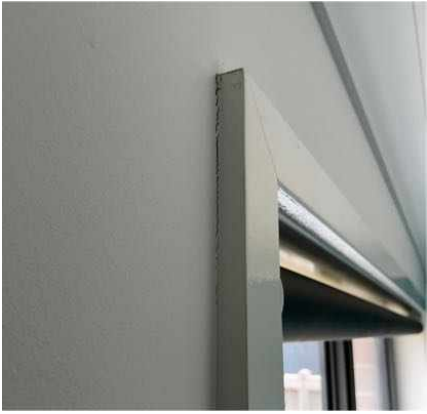
Defects 3.02

Building:	Main Building
Location:	All Internal Areas
Finding:	Cracking Between Architrave and Wall Junction
Information:	During the inspection, cracking and separation were observed between the architrave and the adjoining wall surface. This condition is commonly caused by normal building movement, minor frame shrinkage, or seasonal expansion and contraction of materials. In some cases, movement may also be influenced by additional loads from attached fittings such as blinds or curtain brackets.

- Cracking detracts from the appearance of internal finishes.
- Minor separation may continue with seasonal changes or building movement.
- Unsealed gaps can collect dust or allow minor moisture staining over time.

The condition appears cosmetic and is typical of normal building movement. It can be readily repaired through routine maintenance and repainting.

- Inspect the affected areas and refix or reinforce the architrave where movement is evident.
- Recaulk or fill the junction using a flexible sealant suitable for painted surfaces, then sand and repaint.
- Ensure that any attached fittings are adequately supported to reduce future stress on trim components.

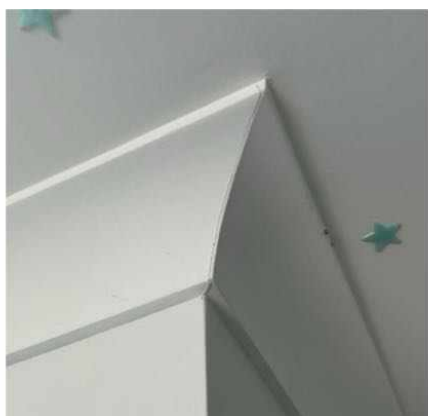
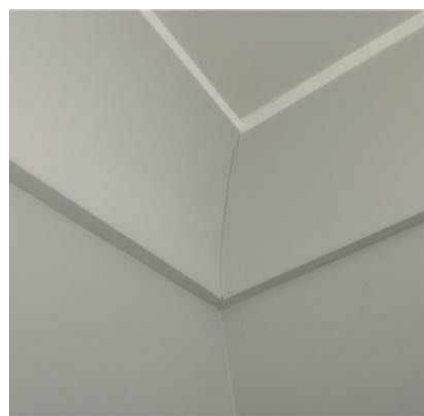
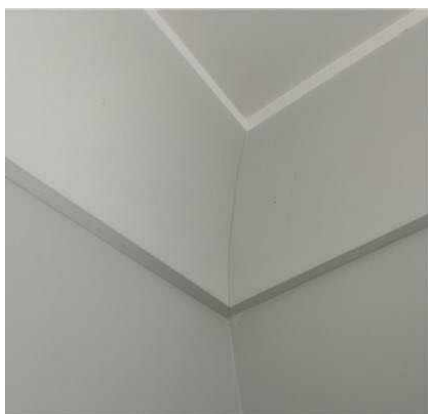
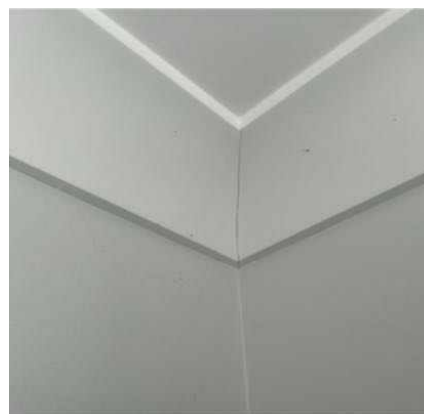
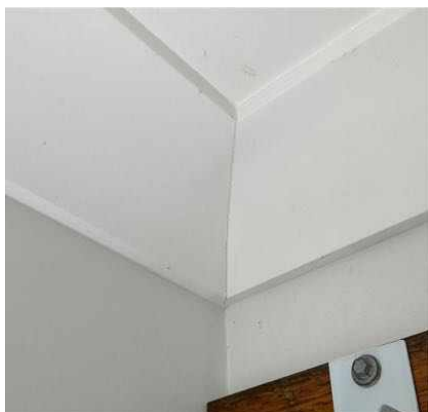
Defects 3.03

Building:	Main Building
Location:	All Internal Areas
Finding:	Cracking to Internal Wall Linings
Information:	Cracking was observed to internal wall linings during the inspection. These types of cracks are generally considered common and are typically the result of natural building movement, age-related wear, thermal expansion and contraction, or minor installation-related issues in plasterboard or supporting framing members.

The cracking noted is typical of minor building movement and does not currently present as structural. Regular monitoring and cosmetic repair will assist in preserving the internal presentation and allow early intervention if future issues arise.

- Engage a qualified plasterer to repair cracks and consider installing expansion joints if necessary to accommodate ongoing building movement.
- Arrange for repainting by a qualified painter following any plaster repairs.
- Monitor cracks over time for signs of progression (e.g. widening, lengthening, or new cracks forming).
- If deterioration continues or operational issues with doors/windows arise, seek further assessment from a building inspector or structural engineer.

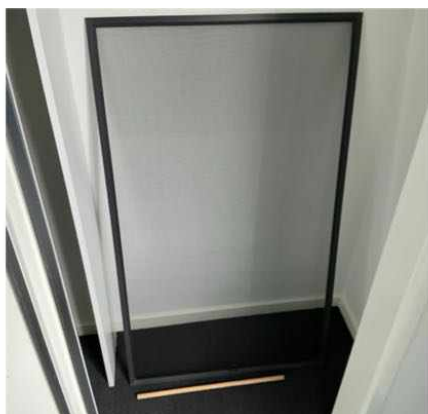
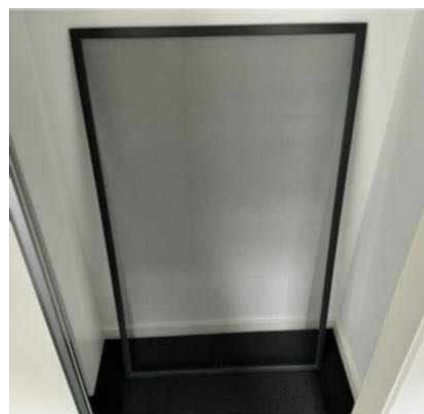
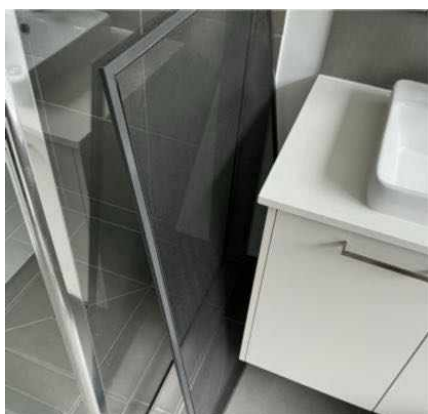
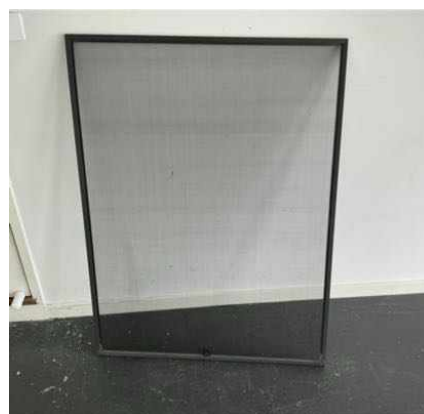
Defects 3.04

Building:	Main Building
Location:	All Internal Areas
Finding:	Missing Flyscreens to Windows
Information:	At the time of inspection, several windows were observed to be missing flyscreens. It is likely these were removed for window cleaning and have not been reinstated. The affected windows were otherwise intact, however the absence of flyscreens was noted.

- Windows cannot be left open without allowing insects or pests to enter the dwelling.
- The usability and amenity of the affected windows is reduced.
- Missing flyscreens represent an incomplete finish item.

In summary, several windows were observed without flyscreens installed. Reinstatement or replacement is recommended to restore normal window function and amenity.

- Confirm the missing flyscreens are available and reinstall them to the affected windows.
- If flyscreens are missing or damaged, replacements should be supplied and fitted to all applicable windows.

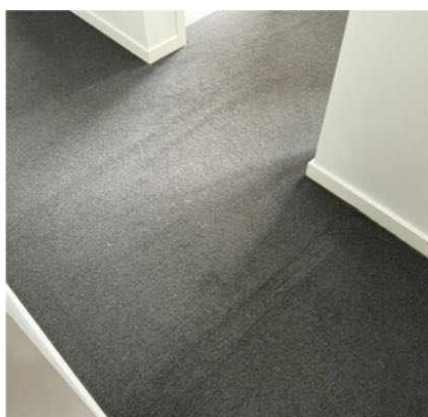
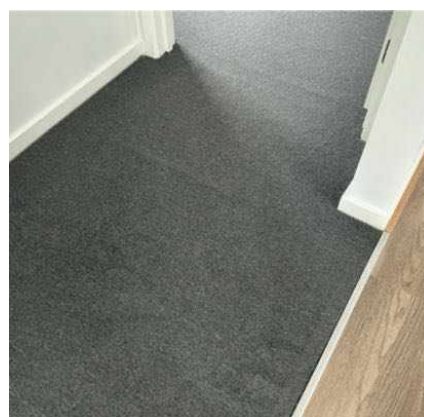
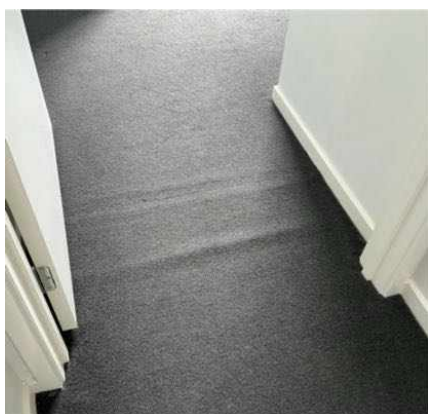
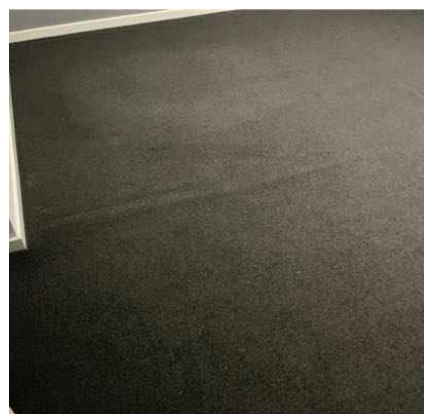
Defects 3.05

Building:	Main Building
Location:	All Internal Areas
Finding:	Worn and Loose Carpet
Information:	Several sections of the carpet exhibit visible signs of wear and tension loss. In high-traffic areas, the carpet appears uneven, rippled, and flattened, with fibres showing clear signs of deterioration. This condition is typically caused by prolonged foot traffic, furniture movement, or inadequate initial installation. The affected areas detract from the floor's presentation and may also present safety concerns.

- Uneven and untidy visual appearance that reduces room presentation
- Increased risk of trips or falls due to rippled or sagging carpet
- Progressive fibre degradation if left untreated

The condition of the carpet suggests general wear and reduced installation integrity. Remedial work is recommended to restore flooring presentation and safety.

- Engage a qualified carpet installer to assess and either re-stretch or replace affected carpet sections
- Implement ongoing carpet maintenance, including periodic cleaning and traffic control, to prolong lifespan and improve appearance

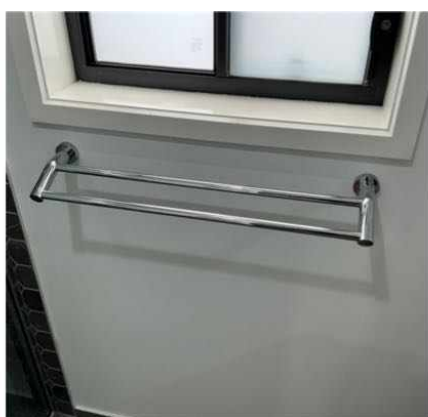
Defects 3.06

Building:	Main Building
Location:	Ensuite
Finding:	Loose Towel Rail
Information:	During the inspection, it was noted that the towel rail is loose and not securely affixed to the wall. This condition reduces its functional reliability and may result in further damage to the surrounding wall surface or the fixture itself if not rectified.

- Fixture failure – continued use may lead to detachment from the wall, potentially damaging the fixture or wall lining.
- Wall damage – repeated movement or strain on the fixings can cause

deterioration to tiled surfaces, plasterboard, or underlying wall materials.

- Reduced visual appeal – a visibly unstable fixture detracts from the presentation of the bathroom and may indicate general wear or poor maintenance.
- Safety risk – loose fixtures may pose a minor hazard if they detach unexpectedly, particularly in high-use bathrooms.

In summary, the towel rail is loose and requires repair or replacement to prevent further cosmetic or structural damage and to restore full functionality.

- Engage a qualified handyperson or contractor to re-secure the towel rail using appropriate fixings suited to the wall type.
- If fixings are stripped or damaged, reposition or replace the towel rail as required.
- Ensure appropriate wall plugs, anchors, or brackets are used to provide long-term stability.
- Periodically check the towel rail and surrounding wall for signs of movement, cracking, or deterioration and address issues promptly.

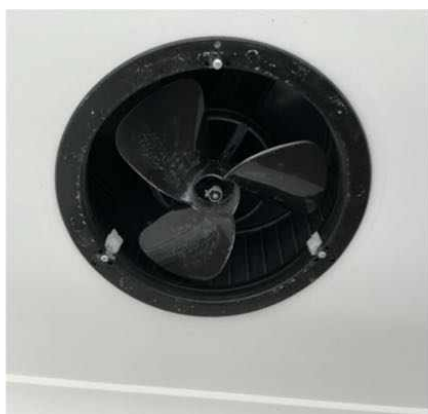
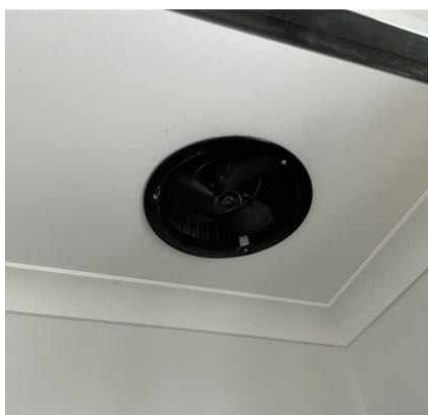
Defects 3.07

Building:	Main Building
Location:	Ensuite & Bathroom
Finding:	Exhaust Fan Covers Not Reinstalled
Information:	At the time of inspection, one or more bathroom exhaust fan covers were observed to be missing. The fan housings were visible within the ceiling, indicating the covers have not been reinstalled. Based on the condition and location, this is most likely the result of the covers being removed for cleaning and not refitted.

- The exhaust fans are unfinished in appearance and not operating as intended.
- Exposed fan housings may allow dust or debris to enter the fan unit.
- The missing covers reduce the effectiveness of ventilation and detract from presentation.

In summary, the missing exhaust fan covers represent a minor defect that requires reinstatement to restore proper function and finish.

- Reinstall the correct exhaust fan covers to all affected locations.
- Confirm fans operate correctly once covers are refitted.

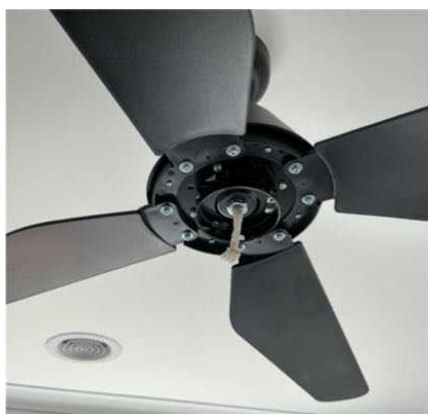
Defects 3.08

Building:	Main Building
Location:	Bedroom
Finding:	Ceiling Fan Missing Light Globe and Cover
Information:	At the time of inspection, the ceiling fan was observed to be missing the light globe and protective cover. The internal light fitting and wiring connection were exposed,

indicating the fixture is incomplete and not in a finished condition.

- Exposed electrical components may present a minor safety risk.
- The light function of the ceiling fan cannot be used in its current condition.
- Dust or insects may enter the fitting, potentially affecting performance over time.

In summary, the ceiling fan light fitting is incomplete due to the missing globe and cover. Completion of the fitting is recommended to ensure safe and proper operation.

- The correct globe and compatible light cover should be installed.
- The fitting should be checked to confirm it operates correctly once completed.
- Any electrical work should be carried out by a suitably qualified electrician if required.

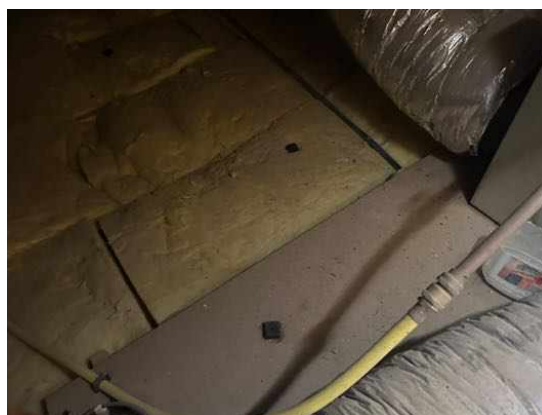
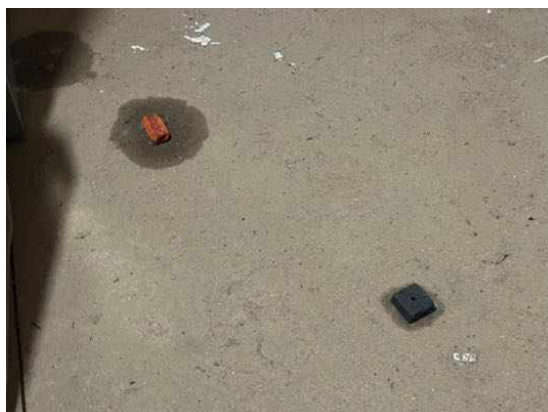
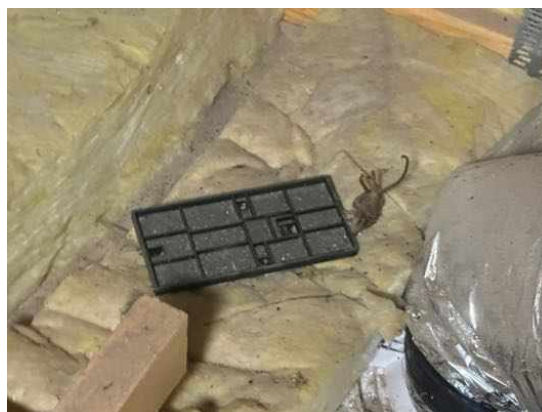
Defects 3.09

Building:	Main Building
Location:	Roof Void
Finding:	Evidence of Rodent Activity Within Roof Void
Information:	At the time of inspection, evidence consistent with rodent activity was observed within the roof void. This included the presence of rodent bait and a rodent carcass located on top of the ceiling insulation. While no live rodents were observed at the time of inspection, these findings indicate either prior or potentially ongoing rodent activity within the roof space.

- Rodent activity within roof voids can result in contamination of insulation and ceiling linings through urine and droppings.
- Rodents may damage electrical wiring, ductwork, and insulation materials, which can pose fire and safety risks.
- The presence of bait indicates that pest management measures have been required previously, suggesting the area may be attractive to rodents.

While no active infestation was confirmed at the time of inspection, further assessment and preventative measures are recommended to reduce the risk of future rodent activity within the roof space.

- A licensed pest control contractor should be engaged to assess the extent of rodent activity and confirm whether the issue is active or historical.
- Any contaminated insulation or materials should be removed and replaced as required following pest treatment.
- Entry points to the roof void should be identified and sealed where practicable to reduce the likelihood of recurrence.

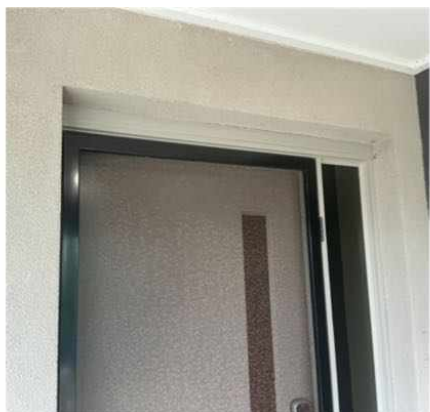
Defects 3.11

Building:	Main Building
Location:	Front Door
Finding:	Cracked Sealant to Infill Panel at Lintel Junction
Information:	At the time of inspection, cracking was observed to the sealant applied at the junction between the external infill panel and the lintel above the window opening. The sealant has separated along sections of the joint, reducing the effectiveness of the weather seal at this location.

- Cracked or failed sealant can allow water ingress into wall cavities during rainfall events.
- Moisture entry may contribute to concealed damage to internal wall linings, insulation, or framing materials.
- Continued movement or thermal expansion may cause further deterioration of the joint if not rectified.

In summary, cracking to the sealant at the infill panel and lintel junction presents a potential moisture ingress point and should be rectified to maintain weather tightness and reduce the risk of future internal damage.

- The junction should be monitored following rectification to ensure the seal remains intact.

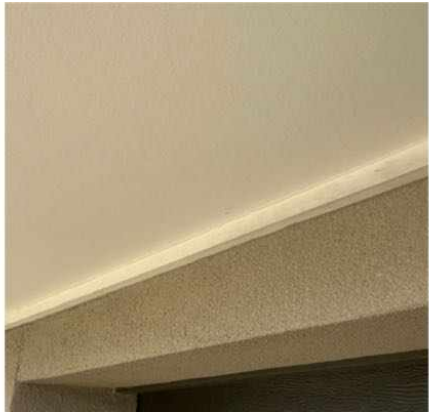
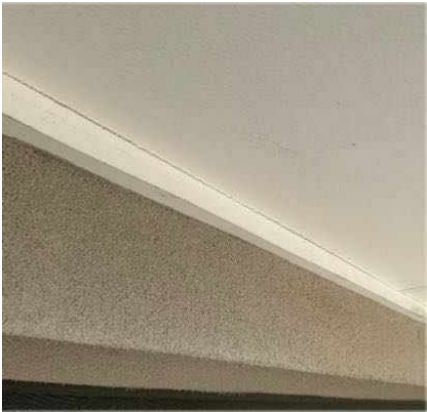
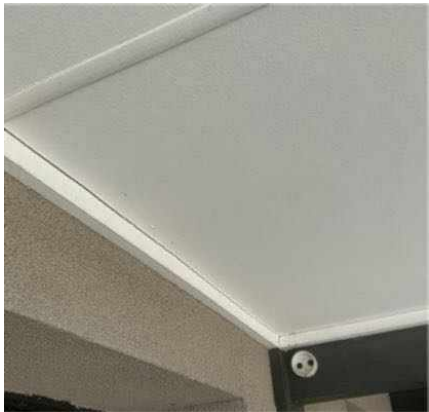
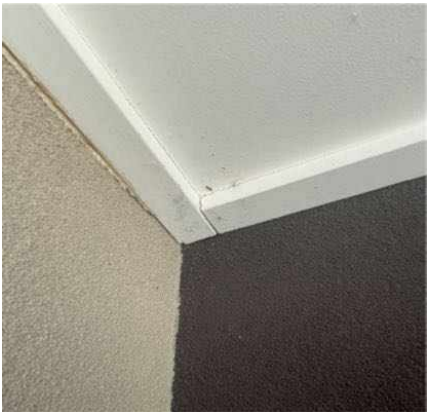
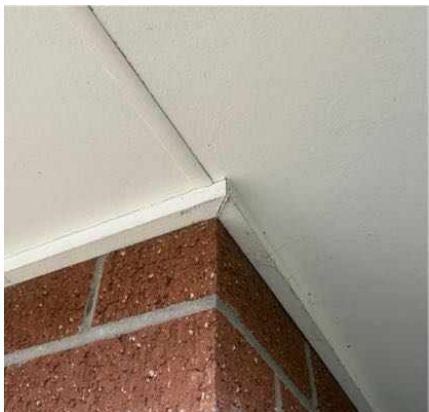
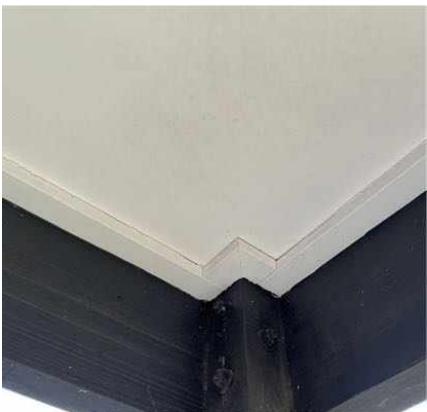
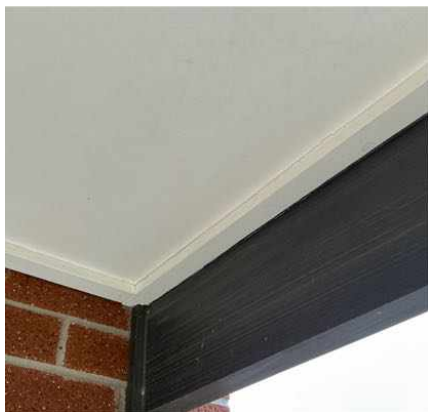
Defects 3.12

Building:	Main Building
Location:	Eaves
Finding:	Cracking and Separation of Timber Quad Moldings at Eaves
Information:	During the inspection, cracking and separation was noted at the mitre joints of timber quad moldings installed around the eaves in multiple locations. This condition is common in aging properties and is typically associated with natural movement and environmental exposure over time.

- Cosmetic deterioration of external timber finishes.
- Potential for moisture ingress if gaps are left untreated, leading to timber decay.
- May require ongoing monitoring as the building continues to age and move.

The separation observed is consistent with typical age-related wear and environmental exposure, and is considered a maintenance item rather than a structural concern. Prompt attention will help prevent moisture-related deterioration and preserve the external appearance of the property.

- Monitor repaired areas as part of routine exterior maintenance, particularly following seasonal changes or heavy rain events.

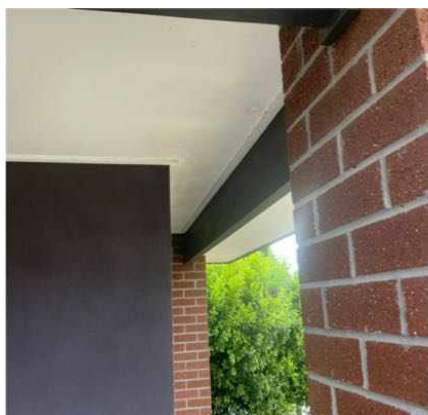
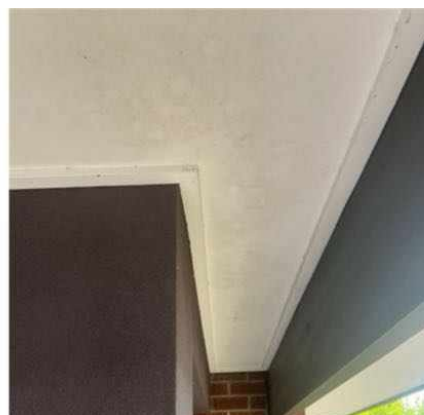
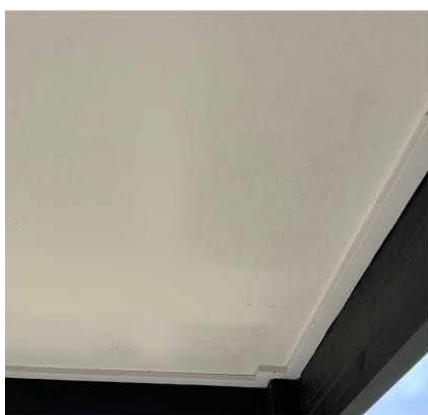
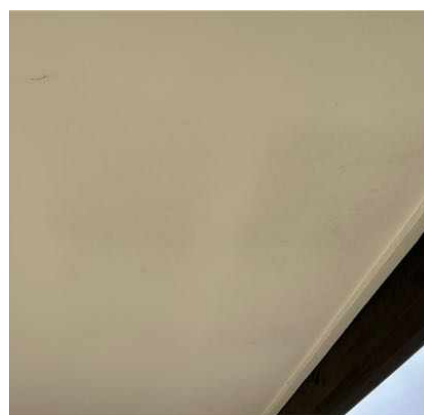
Defects 3.13

Building:	Main Building
Location:	Porch
Finding:	Mould Growth on Porch Ceiling
Information:	A substantial amount of dark discolouration and circular staining was observed across the porch ceiling lining, consistent with mould or mildew growth. This is likely the result of prolonged exposure to moisture and inadequate ventilation in the external covered area. Mould growth is a common issue in shaded outdoor ceilings where condensation and humidity are not effectively managed.

Although external ceilings are more vulnerable to environmental moisture, regular monitoring and maintenance will help ensure the area remains safe, functional, and

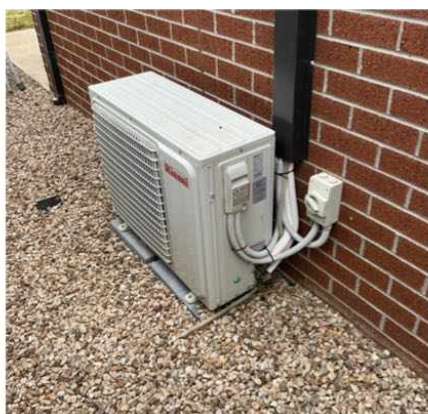
Defects 3.14

Building:	Main Building
Location:	Left-hand Side
Finding:	Uncontrolled Discharge from Air Conditioner Overflow Pipe
Information:	The air conditioning unit's overflow pipe discharges directly onto the adjacent surface, rather than being connected to a compliant stormwater or drainage system. This results in persistent dampness in the immediate area, particularly during extended periods of use.

Although this is a relatively minor plumbing oversight, it presents an ongoing risk to nearby building elements and termite management. Correction is typically straightforward and should be planned as part of post-settlement maintenance to preserve building durability and reduce pest-related risks.

- Engage a licensed plumber to assess and reroute the overflow pipe into a compliant drainage system, ensuring water is directed safely away from the property.
- Monitor adjacent building elements for signs of moisture damage, corrosion, or fungal growth.
- Ensure that landscaping, garden beds, or other features around the area do not trap moisture against the building.
- Incorporate this item into ongoing property maintenance schedules to reduce the risk of long-term damage or pest attraction.

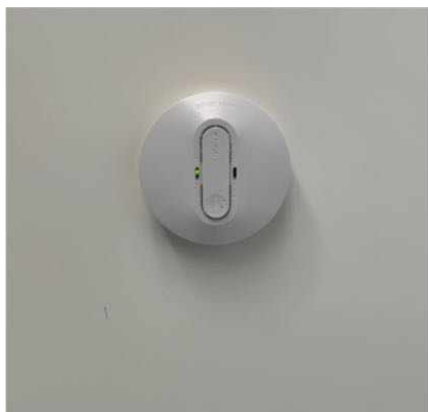
Noted Item

Building:	Main Building
Location:	All Areas
Finding:	Smoke Detector Compliance Not Assessed
Information:	The inspection and reporting on the presence, function, and compliance of smoke detectors—whether battery-operated or hard-wired—fall outside the formal scope of this pre-purchase building inspection. However, general observations regarding smoke alarm coverage or deficiencies are noted for the client's awareness.

This report does not verify the number, condition, location, or legal compliance of smoke detection systems. Clients are strongly advised to confirm fire safety measures prior to occupancy through a specialist inspection.

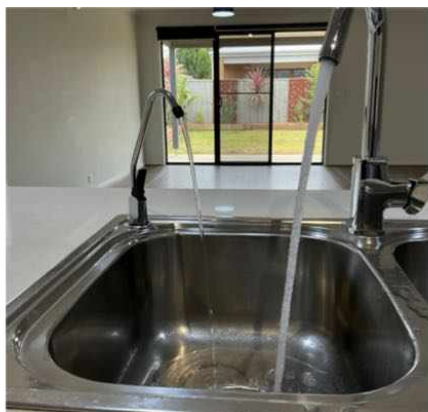
Noted Item

Building:	Main Building
Location:	Kitchen
Finding:	Water Filter Tap Installed to Kitchen Sink – Ongoing Maintenance Required
Information:	A separate water filter tap was installed at the kitchen sink at the time of inspection. The system appears to be a cartridge-based water filtration unit, which requires routine maintenance to operate effectively. Filter cartridges are consumable items and require periodic replacement in accordance with the manufacturer's recommendations.

In summary, a water filter tap is installed to the kitchen sink and requires routine maintenance. Confirmation of servicing and replacement of the filter cartridge is recommended to ensure the system operates as intended.

- The filter system should be checked to confirm the type and service interval required.
- The filter cartridge should be replaced if the service history is unknown.
- Ongoing maintenance should be carried out in accordance with the manufacturer's instructions.

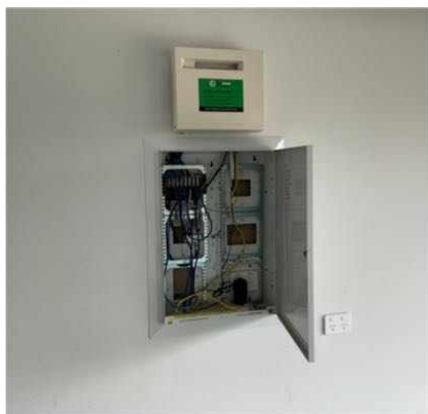
Noted Item

Building:	Main Building
Location:	Garage
Finding:	Fibre/NBN Connection Equipment Installed
Information:	At the time of inspection, a fibre internet connection enclosure was observed mounted to the internal wall. The unit appears to contain a fibre termination device and associated cabling, with power connected and indicator lights illuminated. Adjacent data outlets and a power point were also present. This indicates that fibre/NBN infrastructure is installed to the dwelling; however, confirmation of active service availability requires inquiry with the relevant service provider.

The fibre connection equipment was visually sighted, but functionality and connection

status were not tested as part of this inspection.

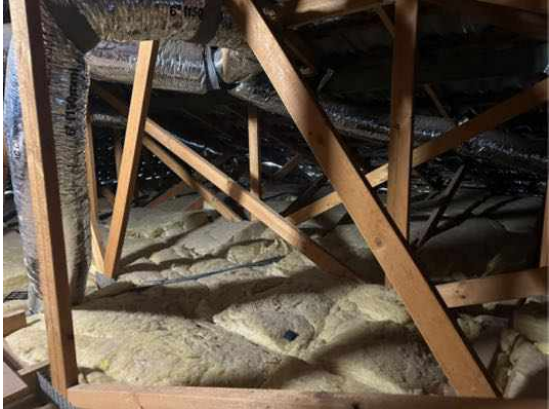
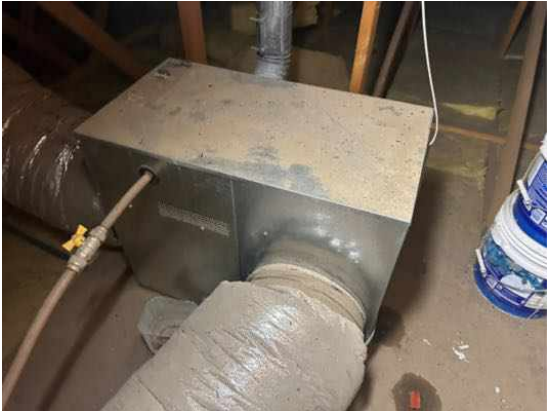
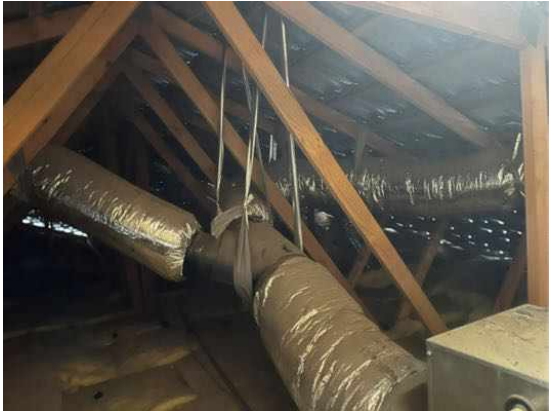
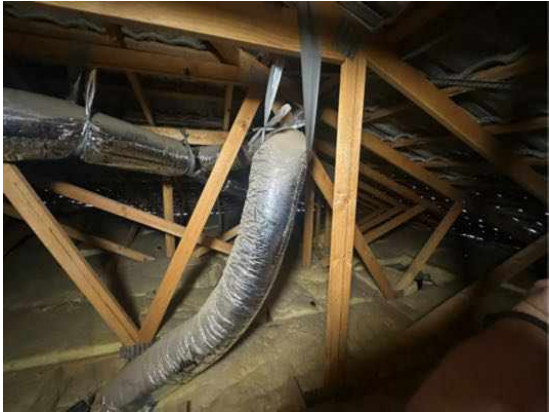
Noted Item

Overall, the insulation and ducted heating components observed within the roof void were found to be in satisfactory condition at the time of inspection.

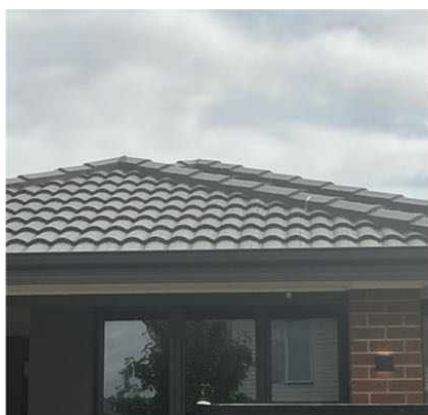
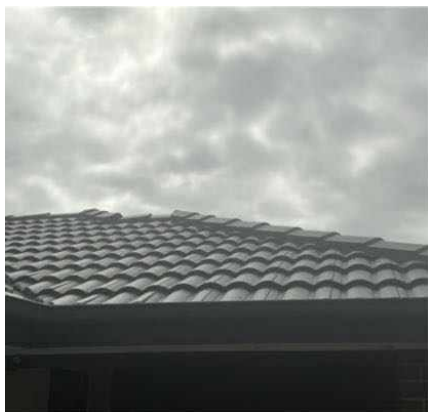
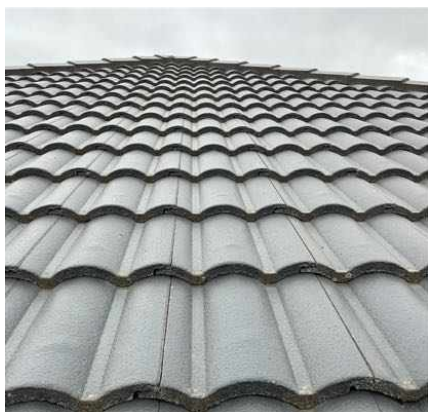
Noted Item

Building: Main Building
Location: Roof Exterior
Finding: General Weathering of Roof Tiles - Good

Overall, the observed condition is considered minor and consistent with normal wear and tear. The roof does not present as defective at the time of inspection, however routine maintenance will assist in preserving its long-term performance.

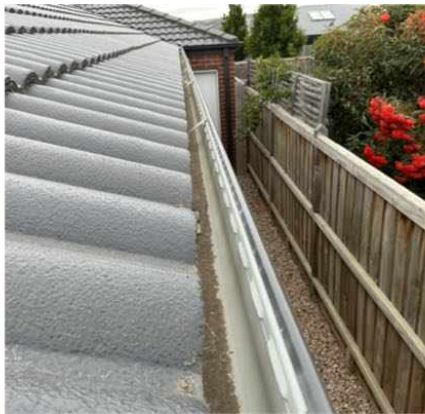
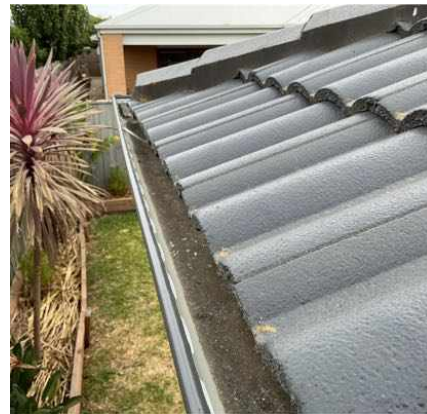
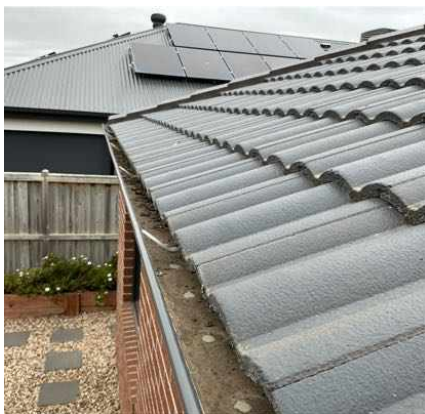
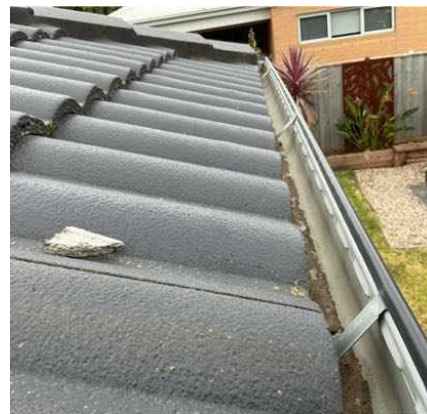
Noted Item

Building:	Main Building
Location:	Roof Exterior
Finding:	General Gutter Maintenance Requirements
Information:	Regular maintenance of the guttering system is essential to ensure effective roof drainage and to prevent avoidable damage to the building structure. Gutters naturally collect leaves, dirt, and other debris over time, which can reduce their ability to channel water away from the home.

Routine gutter maintenance is a simple but important measure to protect the home from water ingress, deterioration, and potential fire hazards.
