## Building and Timber Pest Inspection Report

Inspection Date: Wed, 4 Feb 2026

Property Address: 9/40 Francis Rd, Brahma Lodge SA 5109,  
Australia

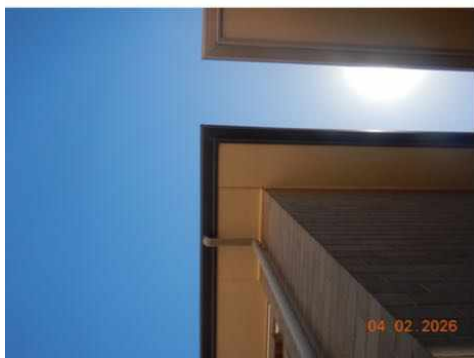
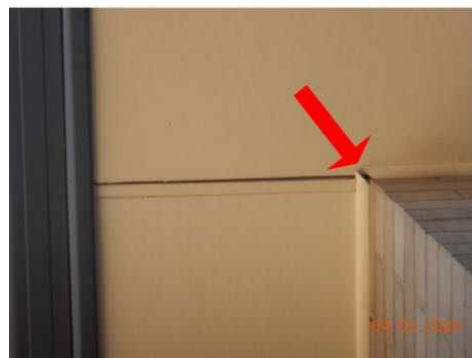
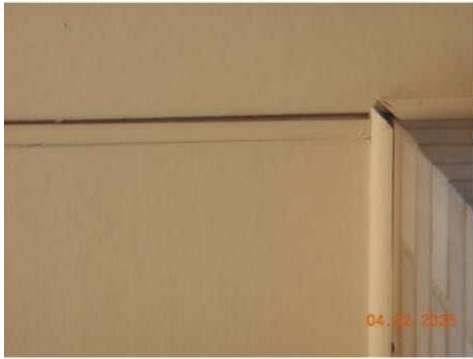
#### Finding 3.01

Building: Building 1  
Location: Exterior eave  
Finding: Eaves Gaps  
Information: Gaps/ movement was identified to the eaves linings to the rear left side of the dwelling at the time of inspection.

Minor gaps such as these two eaves linings usually indicate general and minor thermal expansion and contraction of building materials and do not indicate any major structural issues.

Defects like these should be monitored and should any excessive movement of this type be recorded, then further inspection by Jims Building Inspections would be recommended.

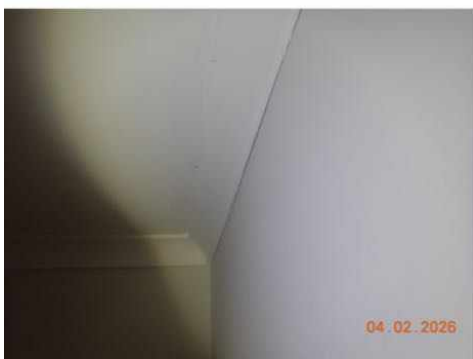
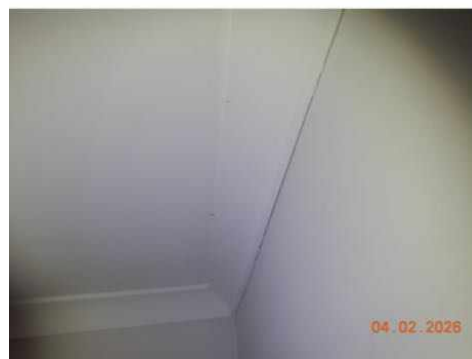
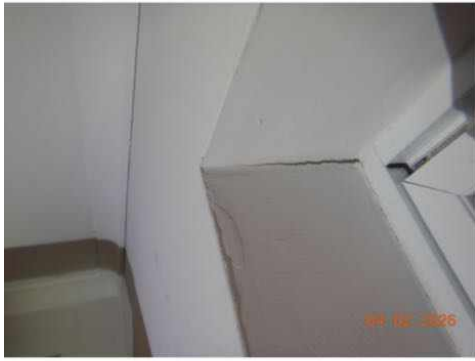
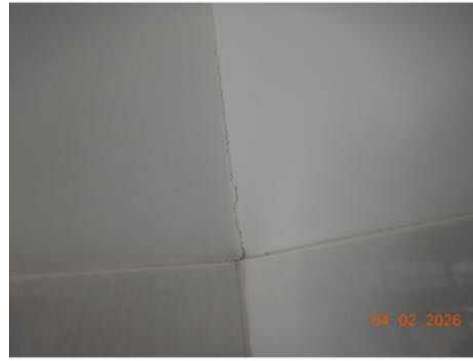
### Finding 3.02

| Finding: | Cracking - Damage Category 1 - Fine (up to 1mm) |
| Information: | There were fine cracks evident to the walls and ceilings throughout the dwelling at the time of inspection. |

Although fine cracks are quite noticeable, they are often only considered to be an appearance defect, and usually do not indicate any structural damage. Generally, the cause of a fine crack is indicative of a separation between building materials and finishes (e.g. paint, plaster, etc.) along joints.

Cracking of this nature can generally be repaired with minor sanding, filling and/or repainting. Such works should be performed by a qualified painter or a general handyman.

Monitoring of all cracking should be conducted frequently. Always contact a building inspector should cracks widen, lengthen, or become more numerous.

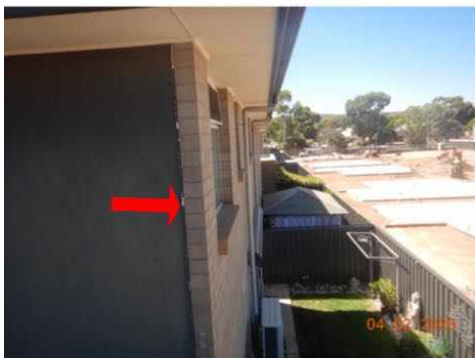
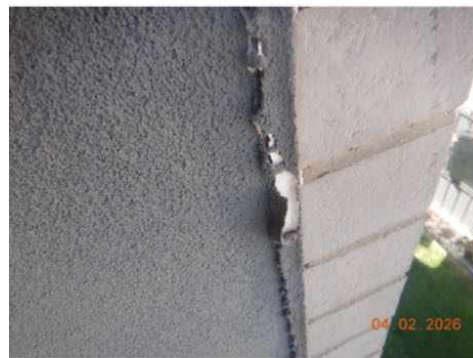
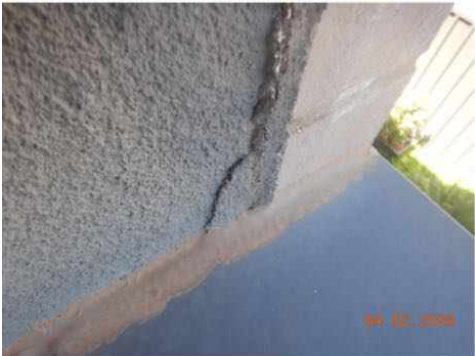
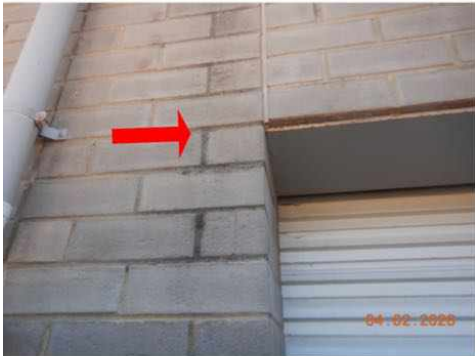
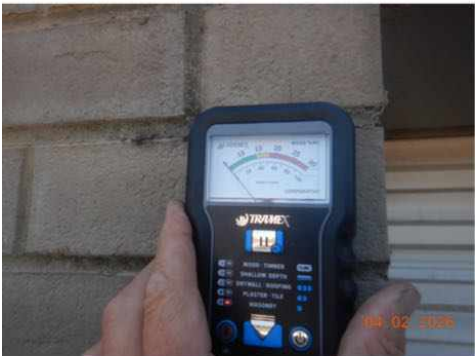
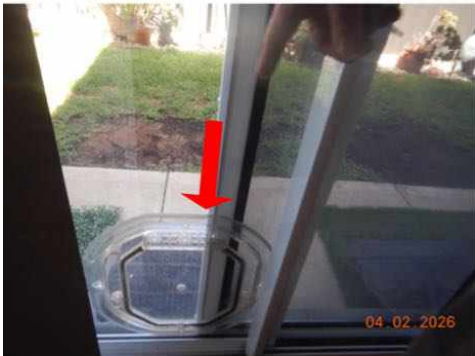
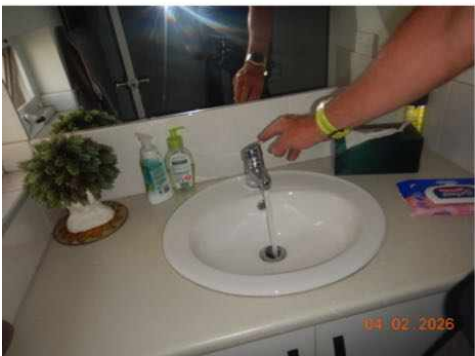
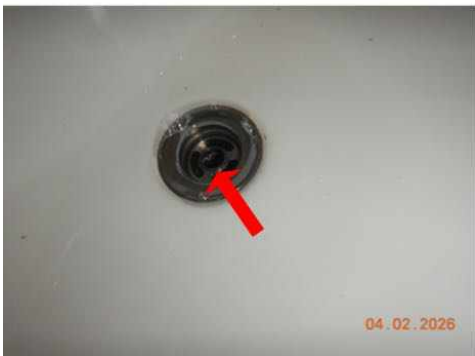
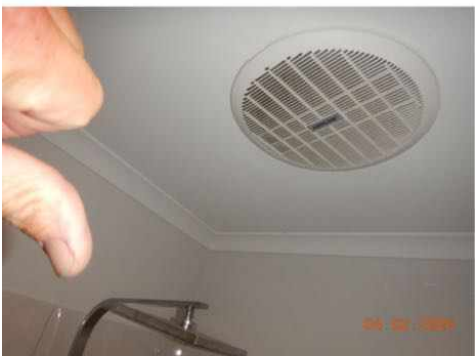
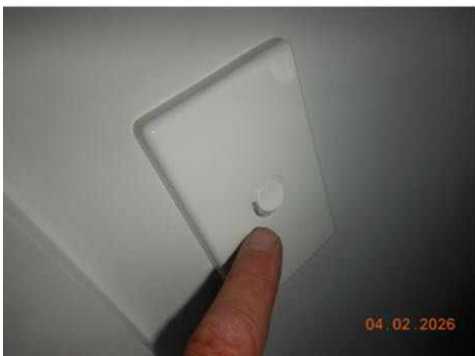
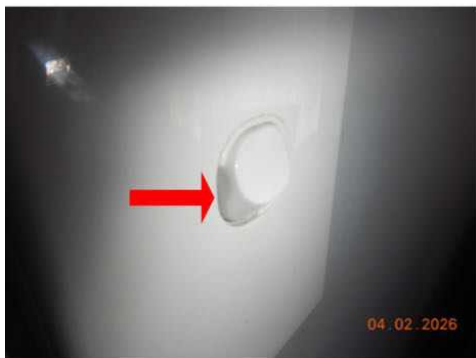
### Finding 3.03

Building: Building 1  
 Location: All Areas  
 Finding: Minor defects present  
 Information: There were several age and maintenance related defects evident to the dwelling at the time of inspection. These defects include but are not limited to

- Render peeling above garage
- Stain brickwork likely from rain dripping down wall. No high moisture readings
- Sliding door clashes on doggy door
- Vanity drain plug damaged
- Exhaust fan not operating
- Bathroom light switch mech damaged.

Appropriate licensed trades people could be appointed to make repairs at the discretion of the client.

Replace exhaust fan

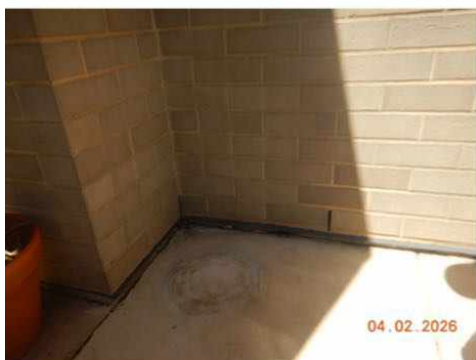
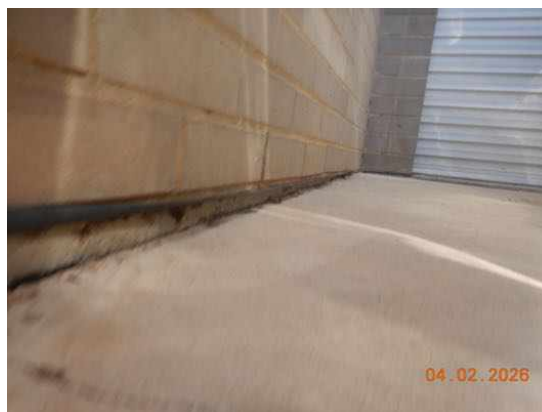
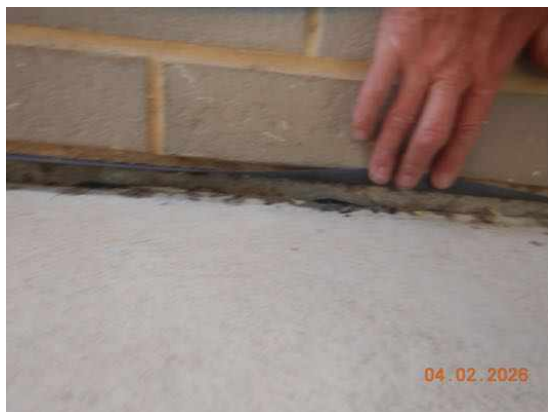
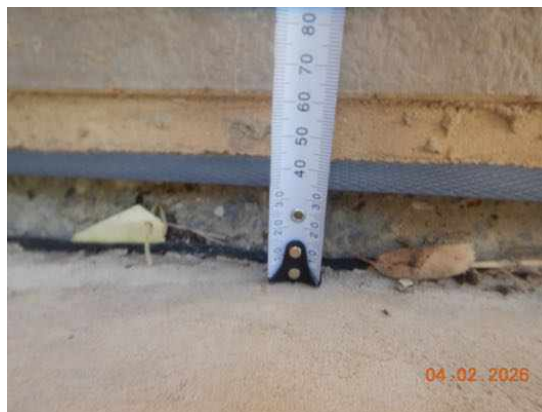
### Finding 6.01

| Finding: | Slab Edge - Exposure |
| Information: | An inspection zone of at least 75mm in relation to the exposed slab edge, between the bottom brick and the perimeter pavement, is required. This inspection zone should be maintained in order to force termites into the open where they can be detected more readily during regular inspections. The slab edge should not be concealed by anything that may prevent inspection of the area, including render, landscaping, soil, turf, paving, concrete cladding or other structures. |

If the slab edge is not properly exposed there is a high risk of concealed termite attack which your inspector will likely not be able to see. Sometimes, in order to determine the type of slab, a suitably qualified person such as an architect or builder may be required to consult construction plans.

Where the slab edge cannot be properly inspected, it is highly recommended that termite or timber pest inspections be carried out every 6-12 months to aid protection of the property against infestation and termite treatment advice is followed closely.

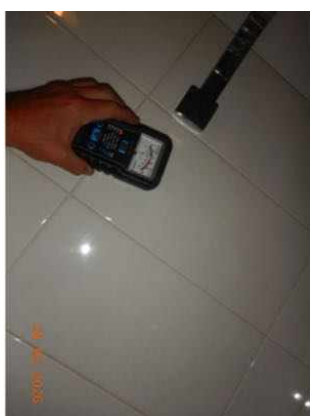
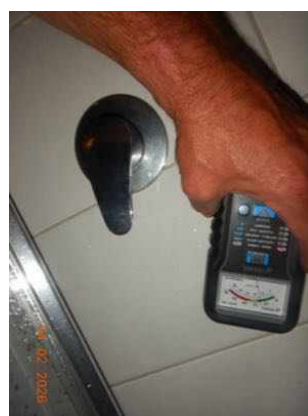
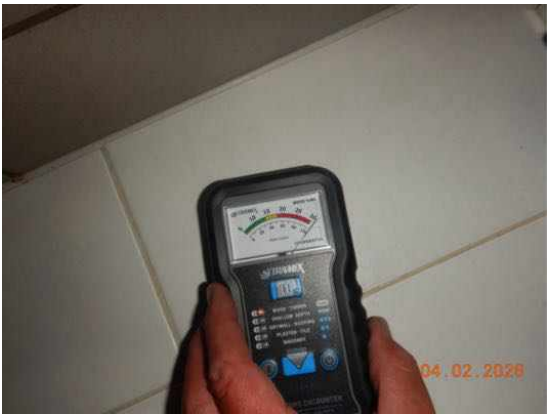
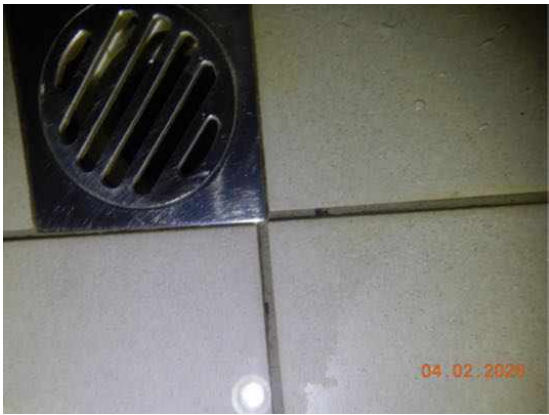
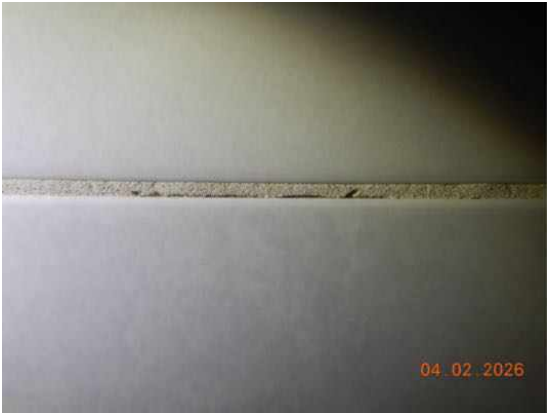
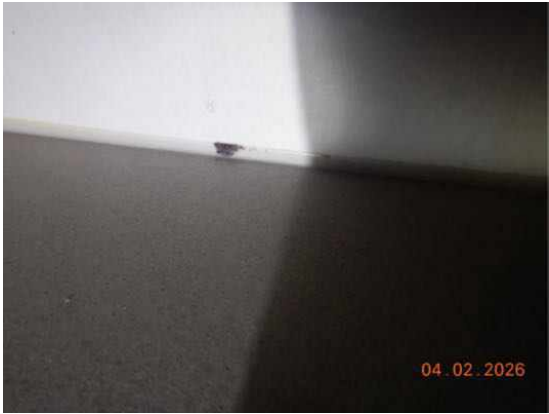
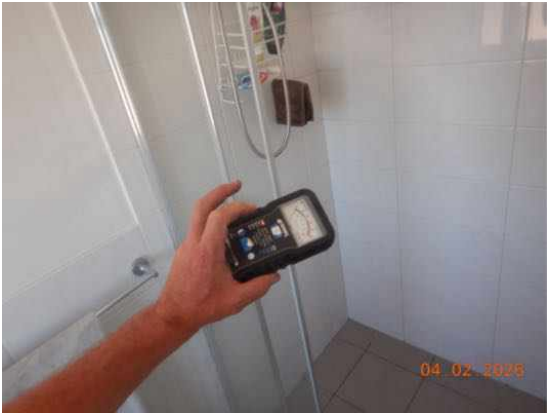
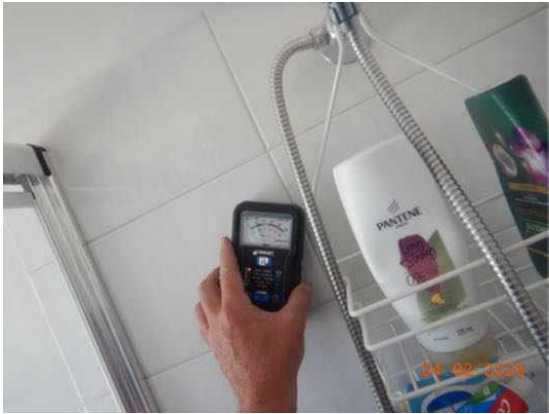
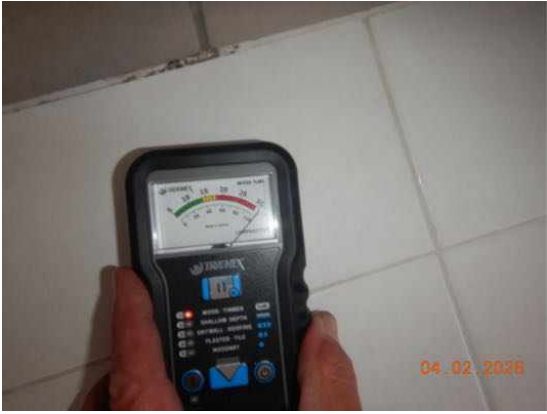
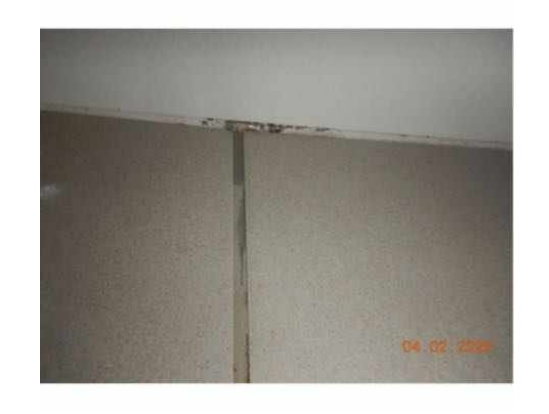
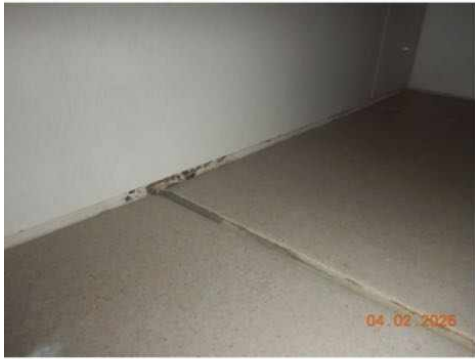
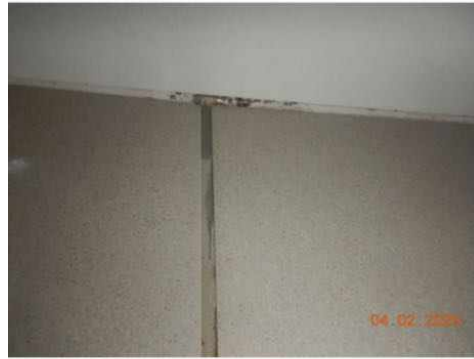
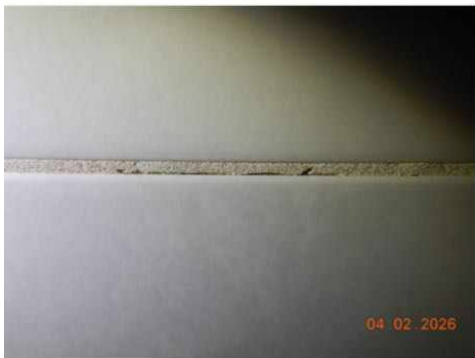
### Finding 6.03

Finding: Shower damp - Sealant and grout  
Information: Damp is evident to sections of the lower wall to the shower alcove of both bathrooms.

This defect is quite common, and is suspected to have been caused by moisture permeating or leaching through the tiling, grouting and sealant in this area, which shows evidence of deterioration.

There were no high moisture readings around the taps no were there high readings transferring to the other side of the wall.

Unmanaged damp in the shower recess is likely to facilitate the formation and development of mould and fungi growth, decaying associated building materials and compromising their structural integrity of associated elements.

Damp conditions also create a conducive environment for termite infestation.

Consultation with a bathroom sealant specialist is advised immediately to make repairs to the shower alcove.

Always ensure that sealant and grout is in good condition to prevent any moisture issues occurring in the future.

Maintain sealant and grout

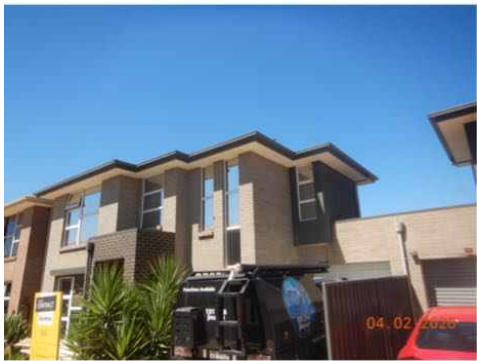
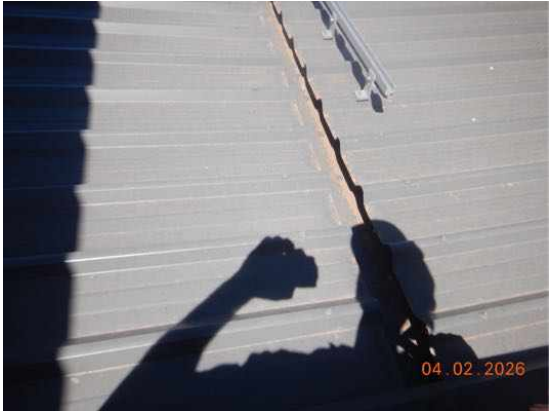
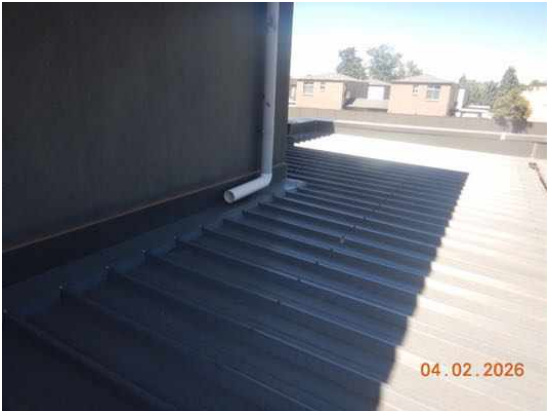
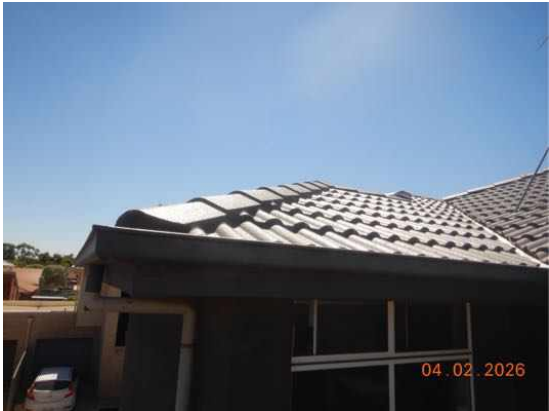
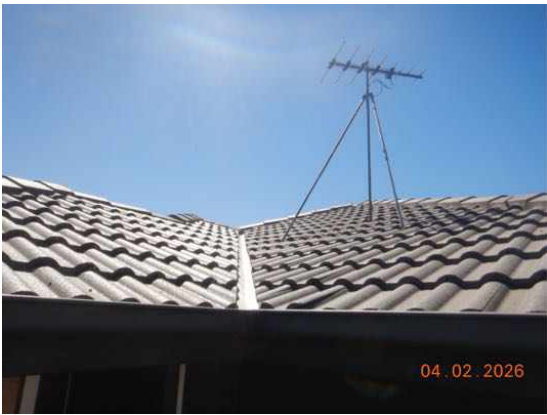
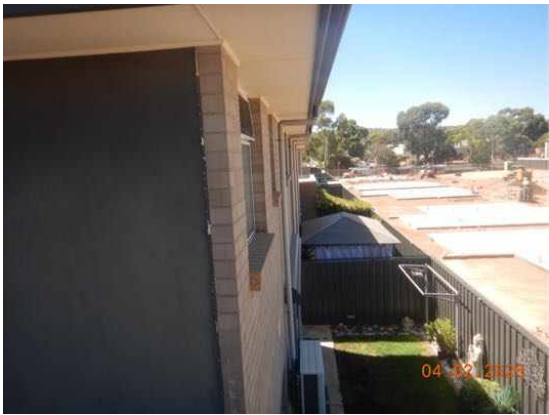
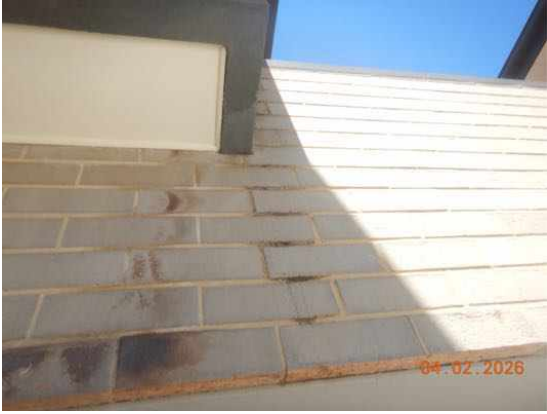
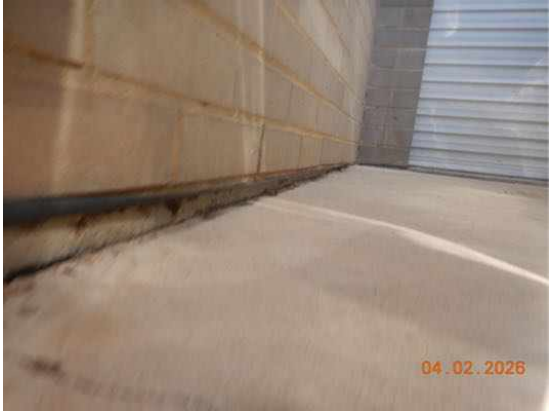
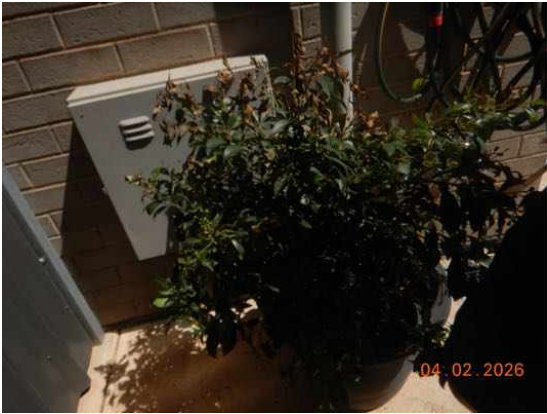
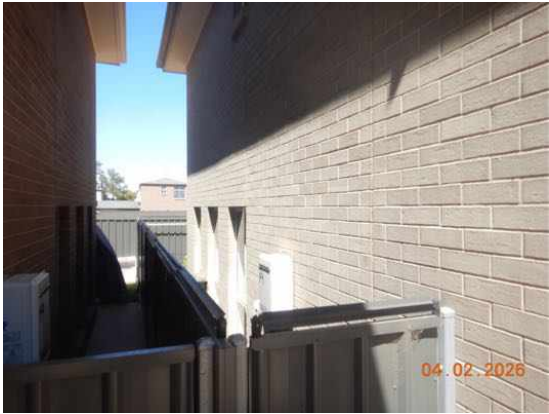
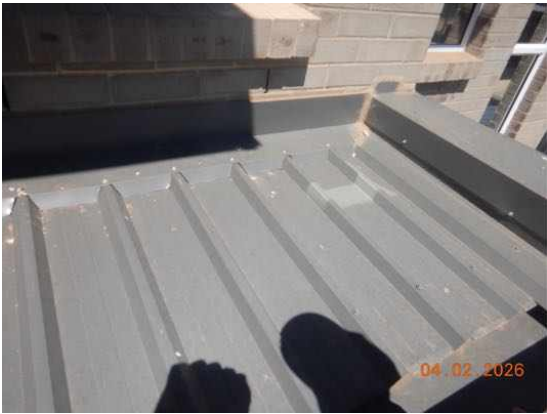
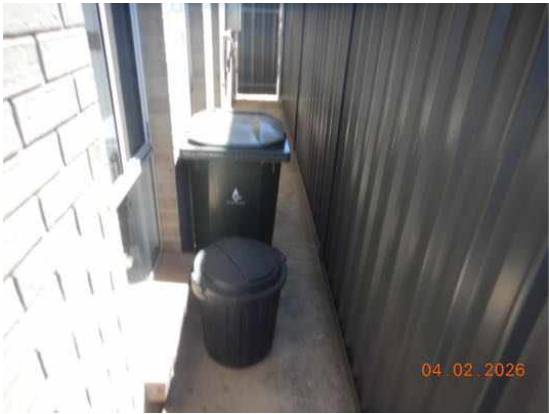
Building: Building 1  
 Location: All Areas  
 Finding: Additional Photos - Obstructions and Limitations  
 Information:

These photographs are an indication of the obstructions and limitations which impeded full inspection of the property at the time of inspection. These obstructions can hide an array of defects and should be removed to allow full inspection to be carried out.
