Building Inspection Report

Inspection Date: Tue, 24 Mar 2026

Property Address: 27a Streeters Rd, North Plympton SA 5037,
Australia

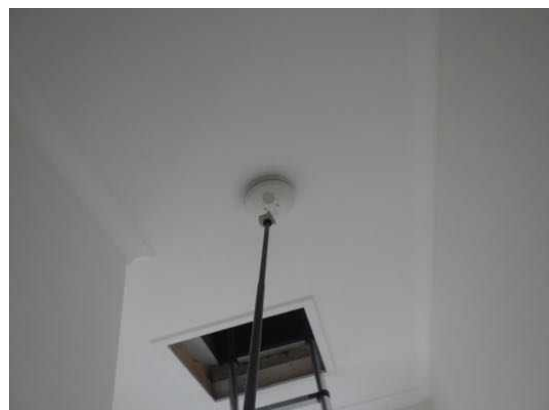
Defects 1.01

Building:	Building 1
Location:	All Internal Areas
Finding:	Smoke Detectors and Alarms - Missing
Information:	At the time of inspection it was noticed Smoke Detectors and Alarms - missing in this area and creating a potential safety hazard from the persons coming in contact in this area.

Please note that this defect is highlighted as a caution only. We suspect, based on our experience in the building industry, that the absence of smoke detectors, or their poor condition, should be addressed as a matter of urgency to improve occupant safety.

Always ensure sufficient working and suitable smoke detectors are installed prior to occupying any building. Additionally, it is advised that all smoke detectors be tested by the homeowner on a monthly basis.

Please refer to AS3786 and state based legislation, which may also apply.

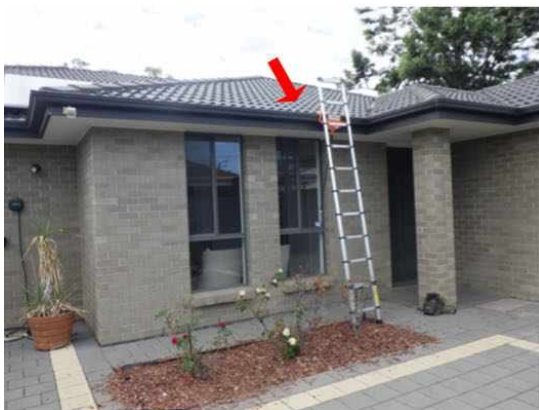
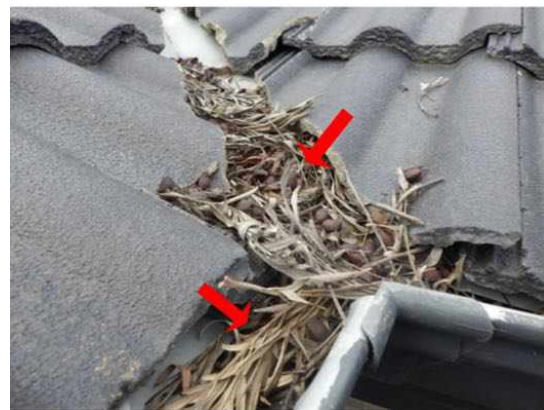
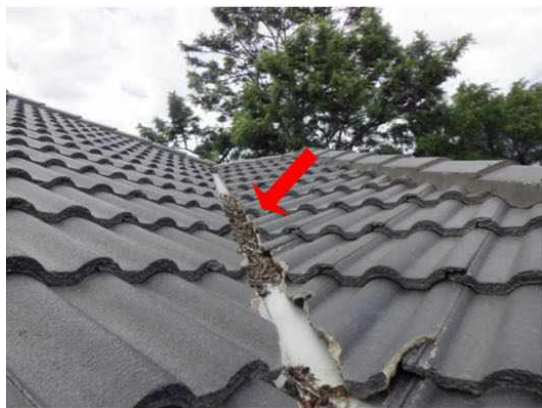
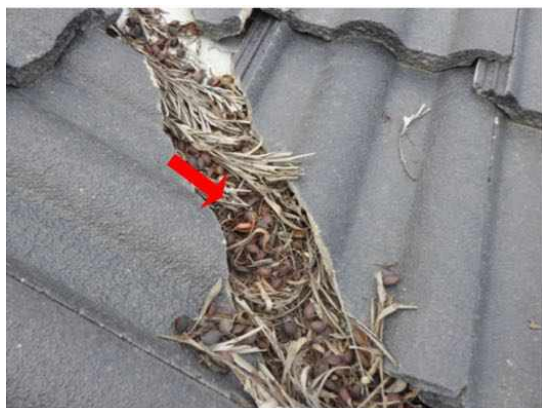
Defects 2.01

Blocked gutters are likely to lead to high levels of moisture in the affected areas. Such moisture will not only cause rust and decay of the associated building materials, but can also provide conditions that are conducive to termite and timber pest activity. Blockages in gutters should therefore be removed immediately to ensure dry conditions are maintained.

Consult a Licensed Plumber for further specific advice on remedial works that may be required. In the interim, it is highly advised that blocked gutters be removed by the homeowner or a general handyman as a matter of urgency.

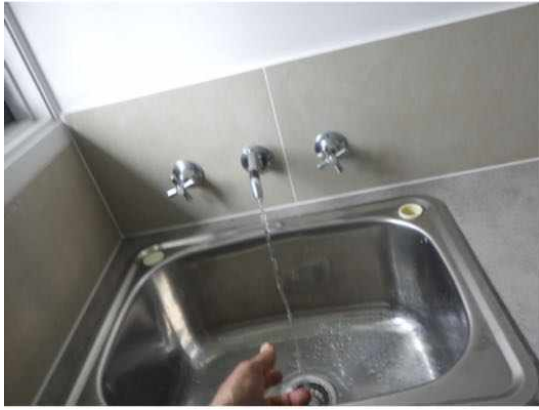
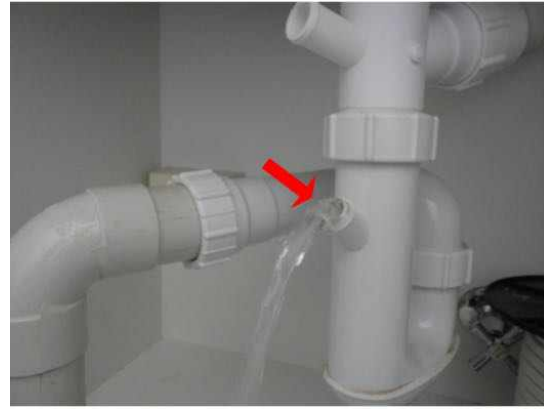
Defects 2.02

Building:	Building 1
Location:	Laundry
Finding:	Laundry Area – Washbasin Plumbing – Leaking
Information:	At the time of inspection it was noticed that plumbing associated with the washbasin in the laundry area was leaking during standard operation.

Leaks associated with plumbing fixtures should be addressed promptly, as prolonged leakage may contribute to moisture ingress, deterioration of surrounding building elements, and potential secondary defects.

Repair of the leaking plumbing component is recommended. It is highly recommended that an appropriately qualified plumber be engaged as soon as possible to assess and carry out any necessary remedial works.

Such works should be performed prior to the development of secondary defects to ensure adequate functionality of all associated building elements.

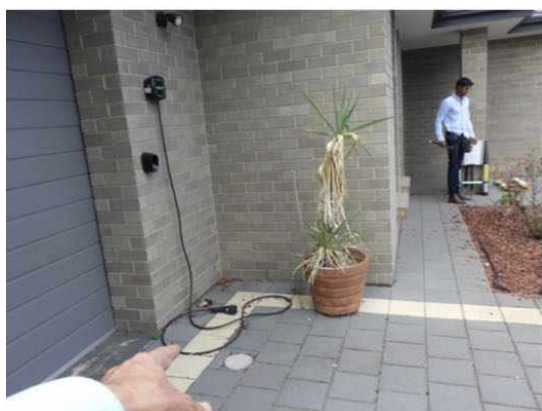
Defects 3.01

If the slab edge is not properly exposed there is a high risk of termite attack. Sometimes, in order to determine the type of slab, a suitably qualified person such as an architect or builder may be required to consult the construction plans.

Where the slab edge cannot be properly inspected, it is highly recommended that termite or timber pest inspections be carried out every 6-12 months to aid protection of the property against infestation.

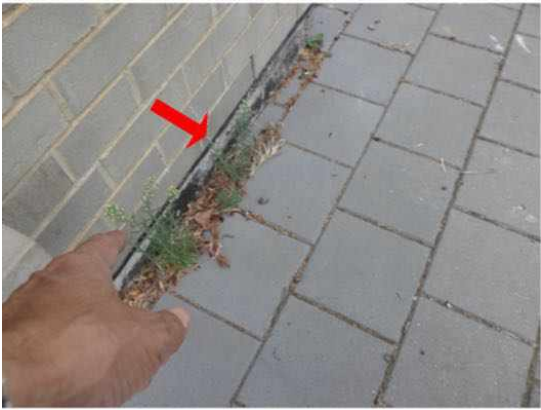
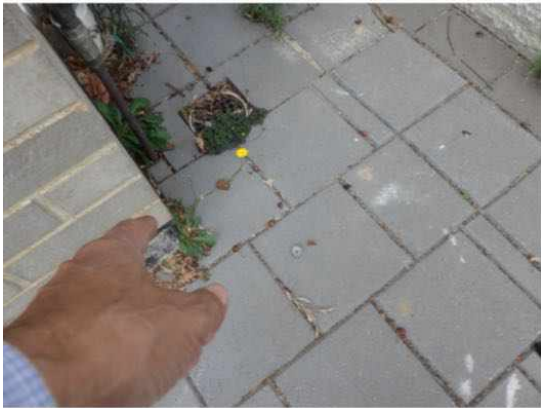
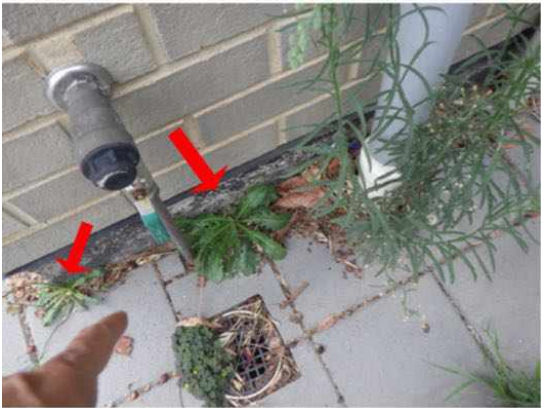
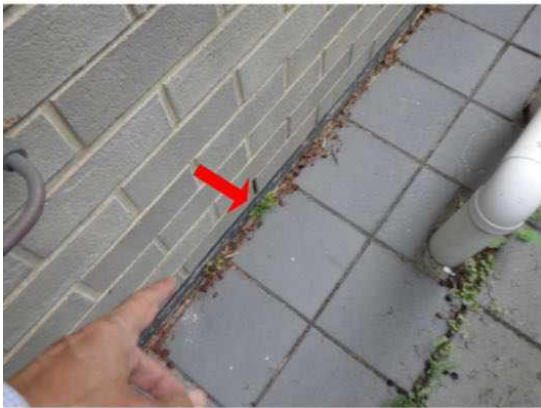
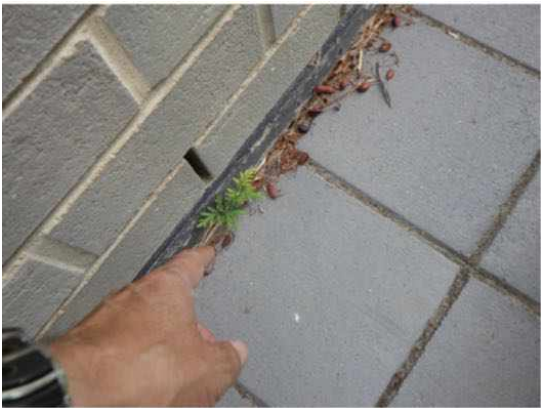
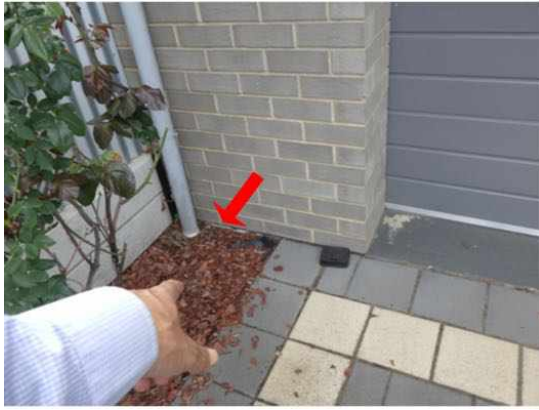
Defects 3.02

Building:	Building 1
Location:	All External Areas
Finding:	Bridging - Vegetation
Information:	Where vegetation obstructs inspection of building elements, also known as bridging as it provides a bridging point for the access of termites, full inspection can not be achieved. Consequently moisture or dampness may be present and the areas becomes conducive to termite activity. Plants against or very close to buildings provide cover, shade and can provide an environment that is attractive to termite infestation.

The removal and replanting of species that do not provide "cover" or cutting back of existing vegetation will assist greatly in preventing Bridging from occurring.

The removal of any such materials that may be conducive to termite activity should be carried out as soon as possible and arrange re inspection to minimize the risk of termite attack.

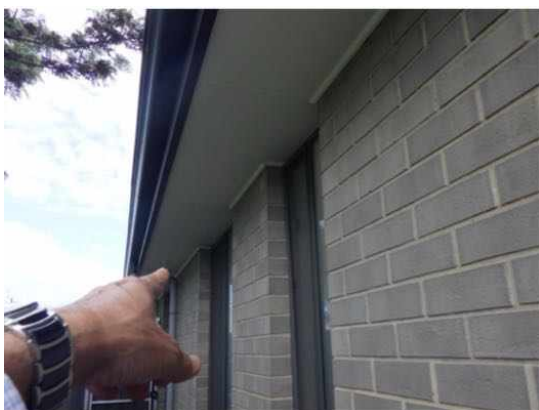
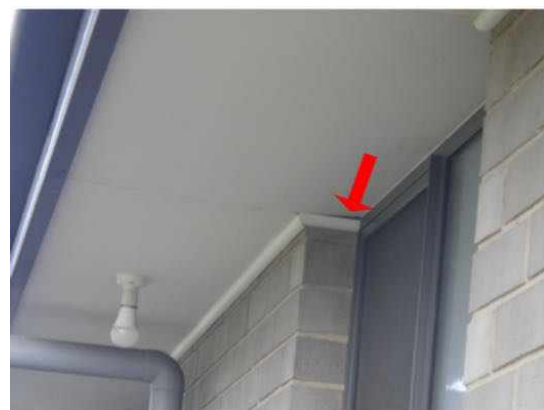
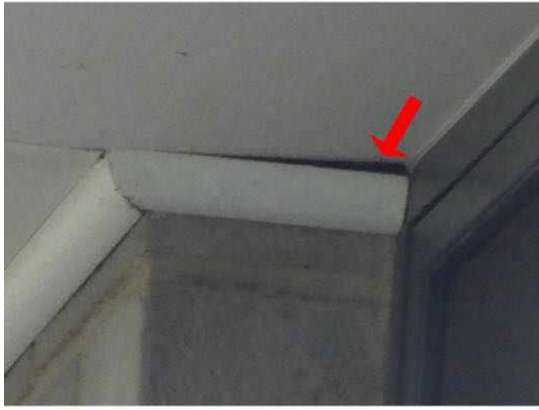
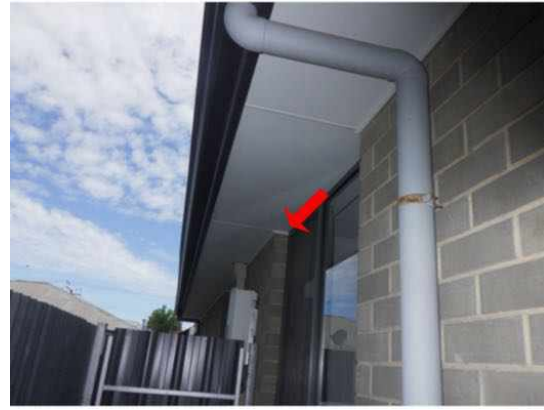
Defects 3.03

Building:	Building 1
Location:	All External Areas
Finding:	Building element - Damaged / Loose from its original fixing
Information:	At the time of inspection it was noticed that eaves guad lining was damaged / loose from its original fixing in few sections around the property.

Breakage occurs generally when the building materials have either aged and decayed, or as a result of damage (accidental or deliberate).

Repair and/or replacement of broken elements is advised to ensure that additional secondary defects do not arise as a consequence. Such works are necessary, as all building elements play a key role in the operation and function of the overall structure and its performance.

A relevant tradesperson should be appointed to repair or replace the affected building element prior to any subsequent damage being caused.

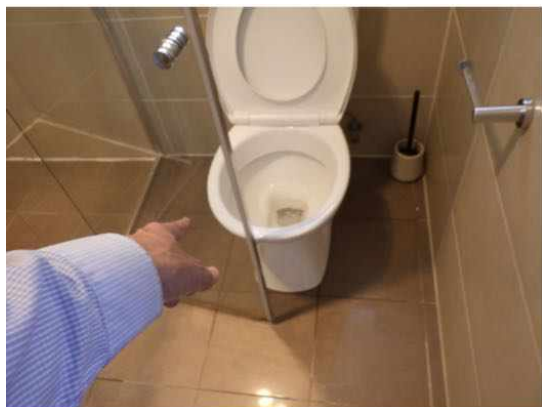
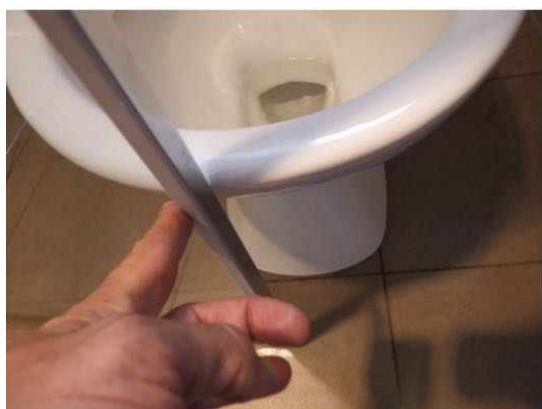
Defects 3.05

Building: Building 1
Location: Bathroom- Ensuite
Finding: Shower screen touching -Toilet assembly during standard operation
Information: At the time of inspection it was noticed that shower screen door is touching to the toilet assembly and creating a potential safety hazard in this area. It advised that

builder should take appropriate measures to avoid/ reduce the impact of shower screen hitting during door operations.

A qualified glazier is required to repair the shower screen as soon as possible. Please be advised that any persons coming into contact with the shower screen should do so with due caution to avoid any personal injury that may ensue.

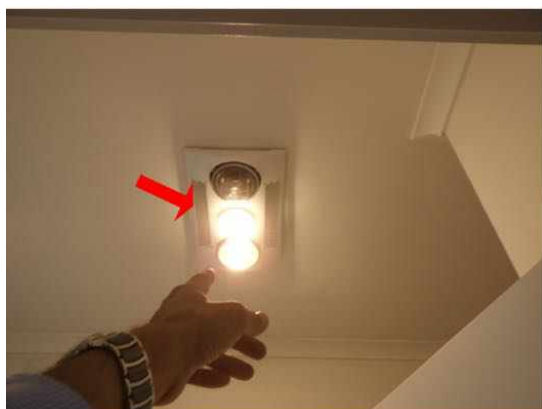
Defects 3.07

This may indicate wear, internal obstruction, loose components, or mechanical deterioration affecting normal performance.

It is advised that an appropriate qualified tradesperson be appointed to assess the exhaust fan and carry out repairs or replacement as required to ensure satisfactory operation.

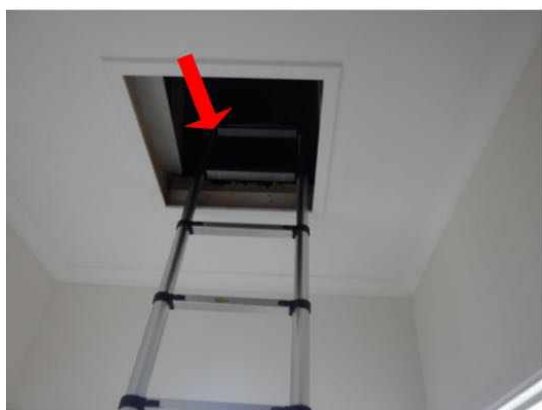
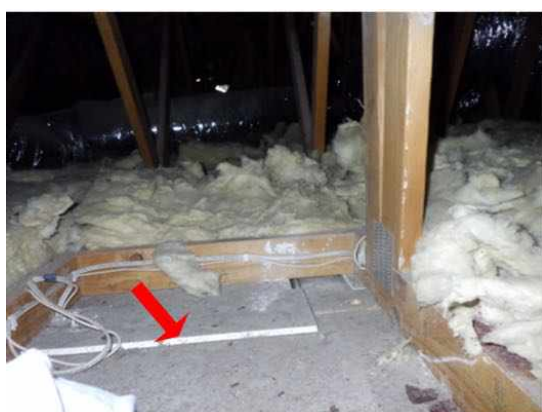
Defects 3.11

Building:	Building 1
Location:	All Internal Areas
Finding:	Insulation - Missing
Information:	Upon inspection of the roof void it was noted that insulation is not present in few sections of roof space area. Apart from that at the time of inspection it was also noticed that insulation is present in other sections of the roof space area.

Insufficient insulation will result in a comparatively higher cost to heat and cool a property as there is a lack of Insulation (or uneven coverage of insulation) which works as a barrier to heat transfer. This helps to keep out unwanted heat in summer and preserves warmth inside your home in winter. It can also help soundproof your home from unwanted airborne noise transfer.

Where insulation is absent, the area does not meet current Australian Standards. Installation of adequate insulation is required and should be conducted as soon as possible.

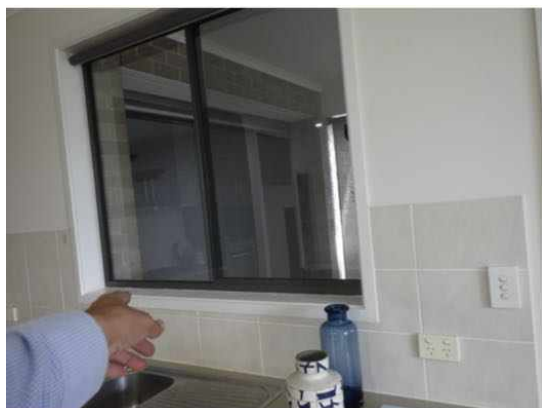
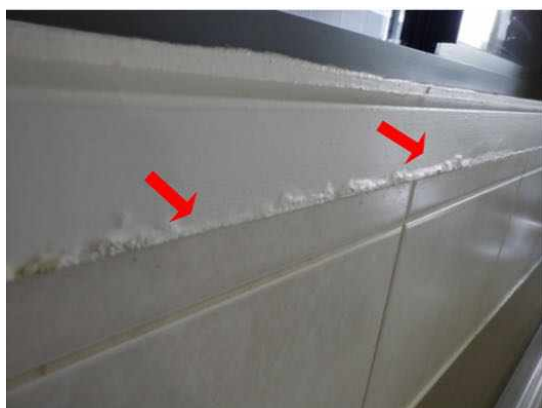
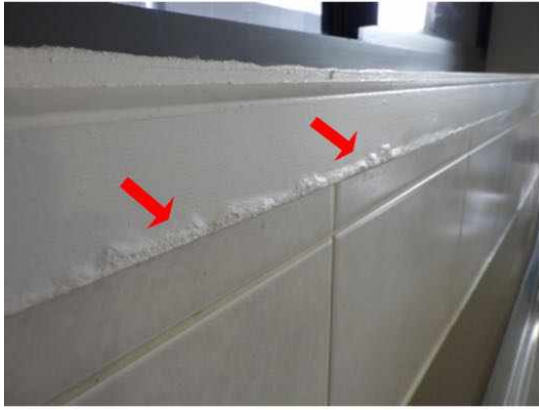
Defects 3.12

Finding: Building element - Swollen
Information: Swollen building elements generally indicate that the building materials have been affected by excessive moisture over a prolonged period of time, and have swollen as a result. The formation and development of mould/fungi or mildew is also a likely consequence of excessive moisture, which may pose major respiratory issues for occupants, particularly the elderly, the very young and those with existing illnesses and could be potential health safety hazards. In these cases an appropriately qualified inspector/tester should also be contacted for advice and/or technical assistance.

The structural integrity of swollen building elements can not be guaranteed, and further damage is likely to develop if left unmanaged. Excessive moisture is likely to lead to the development of secondary damage to any associated building elements, which may necessitate major reparation works if prolonged.

Rectification of the cause of the water leak should be addressed prior to any remedial works to the swollen building elements. A licensed plumber should be appointed immediately to identify the cause of the leak and provide advice on remedial works as necessary, Repair and/or replacement of swollen building elements should be conducted as a matter of urgency by a registered builder or qualified carpenter.

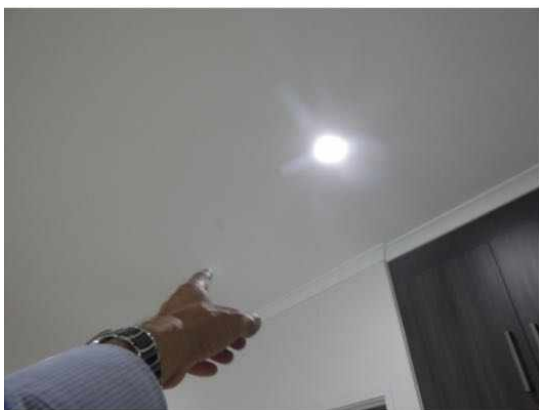
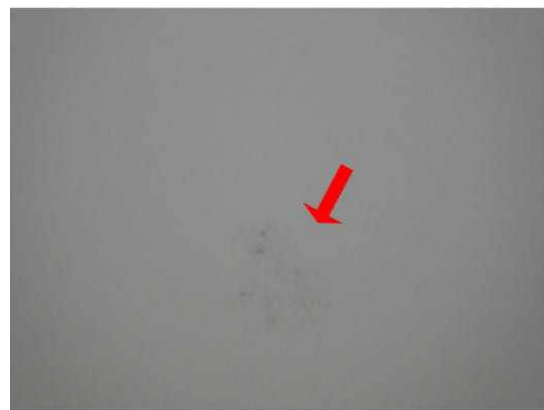
Defects 3.13

Information: At the time of inspection it was noticed that few sections of ceilings were scuffed in this bedroom area. Scuffed surfaces, while detracting from the overall appearance of the affected building element, do not indicate any operational or structural damage. This degree of surface damage is consistent with general wear and tear and minor impact damage, normally accumulated over a number of years.

Marked surfaces may be left as is at the discretion of the client; no repairs or replacement are necessarily required, as this is an appearance defect. However, the client may wish to seek quotations for the cost to refurbish or replace the identified building element.

A general handyman or plasterer may be appointed to rectify marked surfaces if considered necessary by the client.

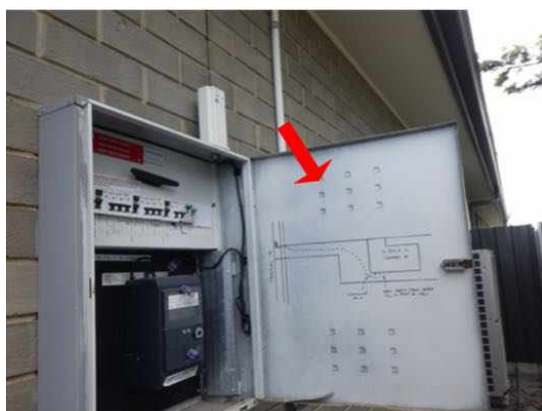
Building: Building 1
 Location: All External Areas >
 Finding: Termite Management System - No evidence of a chemical installation
 Information: The application of a post-construction chemical termite barrier is highly recommended for all properties, particularly if live termite activity has been found on the site previously. Such barriers are highly effective in preventing termite attack on any timber building elements throughout the property.

A durable notice should be placed in the switchboard unit to indicate current termite barriers. At the time of inspection, it appeared as though no termite management system has been installed, with no evidence to suggest preventative works taking place.

The client may consider gaining further advice from a pest controller as to the costs and procedures involved with this application. It is recommended that obtaining such advice be a short-term priority.
