# Building and Timber Pest Inspection Report

Inspection Date: Tue, 27 Jan 2026

Property Address: 5 James Ruse Cl Windsor, NSW, Australia

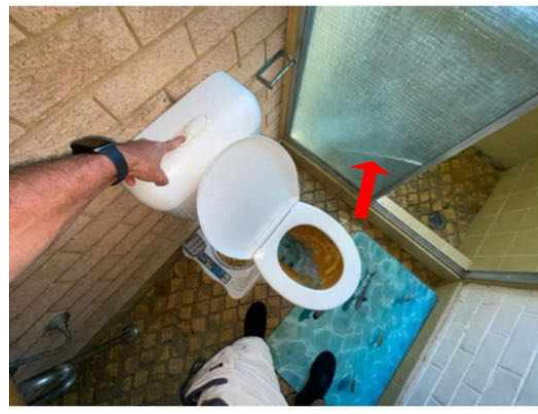
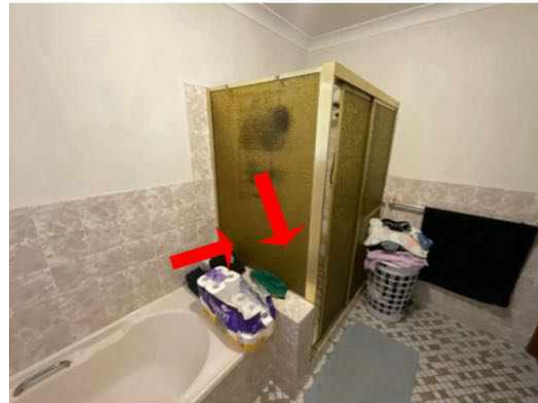
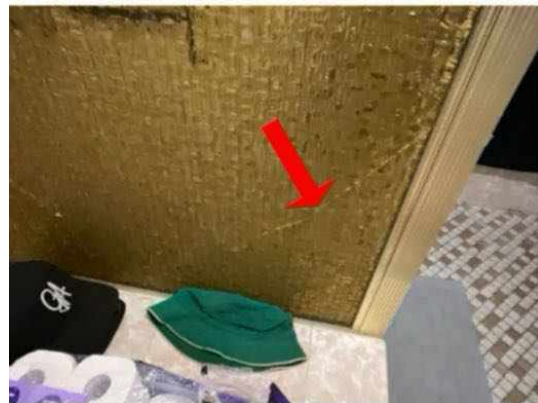
Building:	Main Building
Location:	Bathrooms
Finding:	Damaged Shower Screen Glass Panel.
Information:	Major Defect – Bathroom Shower Screen (Cracked Glass Panel)

During the inspection of the bathrooms, the shower screen glass panels were observed to have sustained visible and significant cracking. The cracking is clearly evident and extends through the glass panel, indicating that the integrity of the glass has been compromised. Based on the condition observed at the time of inspection, the damage is considered major. Any additional stress, vibration, or minor impact may cause the crack to propagate further or result in sudden and complete failure of the glass panel.

Cracked shower screen glass presents a serious safety hazard. Tempered or toughened glass, when compromised, can fail without warning and shatter into multiple fragments, creating a high risk of personal injury to occupants. Continued use of the shower in its current condition significantly increases the likelihood of glass failure. In addition, deterioration of the crack over time is likely, which will ultimately require full replacement of the shower screen assembly rather than minor repair.

It is strongly recommended that a qualified glazier be engaged as a matter of urgency to assess the extent of the damage. The cracked glass panel should be repaired or, more likely, fully replaced to restore the shower screen to a safe and compliant condition. Until appropriate remedial works are completed, occupants should exercise extreme caution and avoid using or coming into contact with the affected shower screen to minimise the risk of injury.

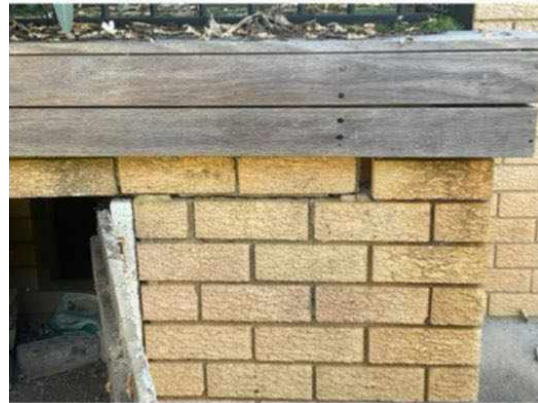
## Finding 2.02

Building:	Main Building
Location:	Exterior walls - rear
Finding:	Major Defect – Deteriorated Masonry Wall.
Information:	Observation:

At the time of inspection, the masonry retaining wall in this area was found to be defective and showing signs of deterioration. Cracking and visible movement were noted, which are consistent with long-term site and drainage-related issues. While only limited further deterioration may be occurring at present, the wall supports a small landing adjacent to the rear sliding door, and any ongoing movement is likely to adversely affect the stability of this structure.

The condition of the wall indicates it has been compromised and may continue to deteriorate if left unmanaged. Progressive movement or failure of the wall could affect the supported landing and present a potential safety risk to occupants. As the wall contributes to the support of an access area, this issue is considered a major defect.

It is recommended that a qualified bricklayer or suitably experienced building

contractor be engaged to assess the wall and carry out necessary remedial works. Prompt attention is advised to maintain structural stability, limit further movement, and reduce potential safety hazards.

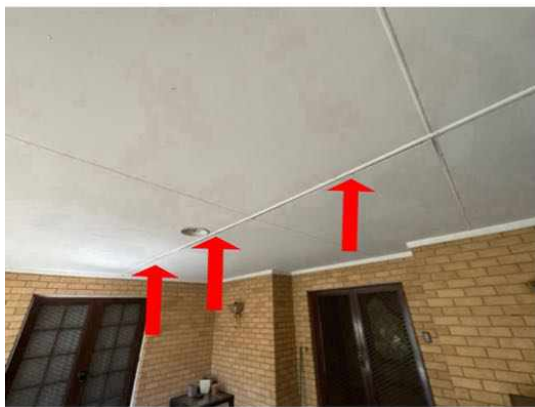
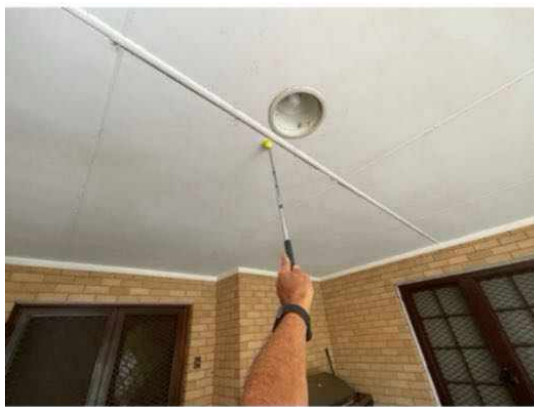
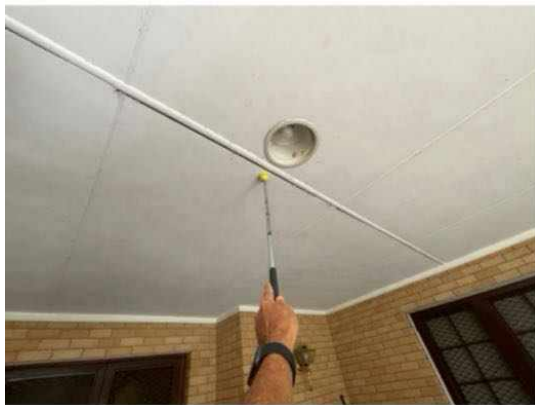
### Finding 3.01

Uneven sagging ceiling linings were observed in this location, the condition appeared to be minor and cosmetic in nature, however, repairs are recommended.

This is a common occurrence in homes of similar age and construction, often caused by the gradual deterioration or loosening of original fixings, such as nails, screws, or adhesives used to secure ceiling sheets.

- Remedial works may be recommended to improve appearance and prevent further sagging. These may include:

Further investigating Structural roofing elements

- Re-gluing or re-adhering the ceiling sheeting
- Re-securing sheets using appropriate modern fixings
- These works can be carried out by a qualified plasterer or painter,
- Ongoing monitoring is advised to detect any worsening of the condition or further movement over time.

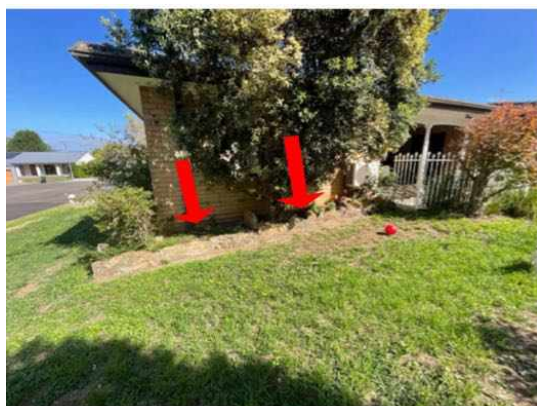
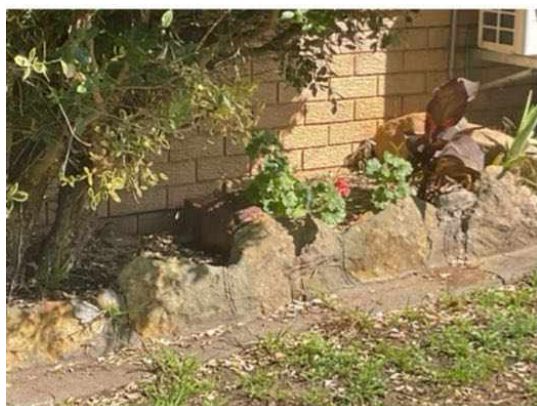
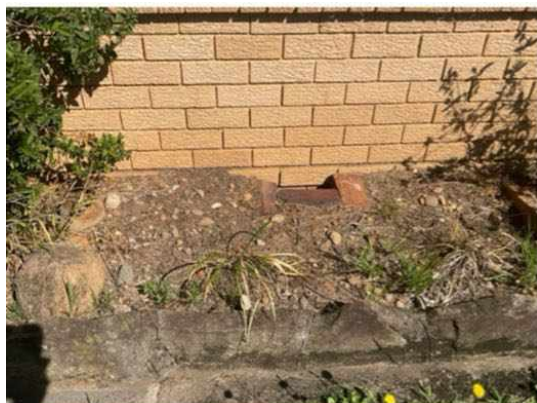
### Finding 3.02

Building: Main Building  
 Location: Exterior walls - front  
 Finding: Subfloor ventilation - Too low.  
 Information: Subfloor Ventilation and Ground Levels – Moisture Risk

Subfloor wall vents in the inspected locations were found to be positioned too low due

to substandard external landscaping and ground levels. The external ground raised adjacent to the building perimeter, increasing the likelihood that rainwater can enter the subfloor via the vents during wet conditions.

Ongoing moisture ingress into the subfloor can result in persistently elevated moisture levels. If left unrectified, these conditions may promote fungal growth, timber decay, deterioration of mortar and brickwork, and cracking or subsidence of supporting piers. Elevated moisture levels also increase the susceptibility of the property to termite and other timber pest activity. Secondary water damage is likely to occur over time if the issue remains unmanaged.

Perimeter landscaping and ground levels should be rectified to expose and ensure adequate airflow through vents and fall away from the building. As a general guide, paved surfaces should fall away from the structure by a minimum of 25 mm over the first metre, and bare ground should fall away by approximately 50 mm over the first metre. This will assist in preventing moisture from pooling against the building and entering the subfloor.

Where site drainage is inadequate or rectification is complex, a qualified plumber and landscaping contractor should be engaged to further assess the site and undertake appropriate remedial works to achieve and maintain a dry subfloor environment.

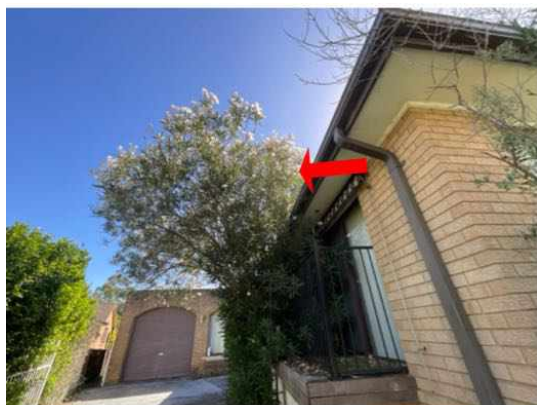
### Finding 3.03

Building: Main Building  
 Location: Exterior - Rear and Right side  
 Finding: Overhanging Trees and Gutter Maintenance – Observations & Recommendations.  
 Information: Overhanging tree branches were observed above the roofline, contributing to the accumulation of leaf litter and debris within the gutters. This condition can adversely affect the performance of the roof plumbing system, particularly during periods of heavy rainfall.

Blocked or restricted gutters impede the effective discharge of stormwater, increasing the likelihood of water pooling or overflow. This may result in accelerated rusting and corrosion of gutters and downpipes, as well as the creation of damp conditions that

To mitigate these risks and maintain effective stormwater management, the following actions are recommended:

- Prune or remove overhanging tree branches to minimise debris accumulation.
- Clean all gutters and downpipes to restore full drainage capacity.
- Consider the installation of gutter guards as a preventative measure, particularly in heavily treed areas.

General gutter cleaning may be undertaken by the homeowner; however, pruning of larger branches should be carried out by a suitably qualified arborist or landscape contractor. A licensed roof plumber should be engaged to assess the condition of the guttering system and undertake any necessary remedial works. Regular maintenance will assist in preserving roof plumbing components, protecting the building envelope, and reducing the risk of moisture-related damage or pest activity.

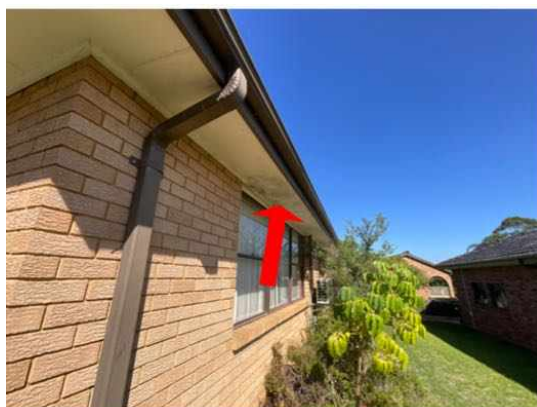
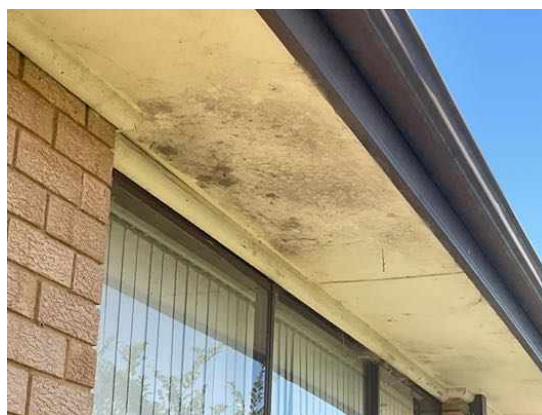
#### Finding 3.04

Building: Main Building  
 Location: Eaves - Right Side  
 Finding: Eaves - Mould present.  
 Information: Defect Type: Mould growth and staining

Condition: Unsightly, potential moisture ingress

Mould growth and associated staining were observed on the eave linings in this area. This is typically caused by elevated moisture levels, which may result from a roof or

gutter leak, or in some cases, excessive condensation within the roof space.

The source of moisture should be identified and rectified as necessary to prevent further mould development and potential damage. This may involve inspection of the roof covering, flashings, or guttering in the affected area.

Cleaning and/or repainting the eaves to restore appearance is at the client's discretion. A licensed painting contractor may be appointed to carry out such cosmetic works once the underlying cause has been addressed.

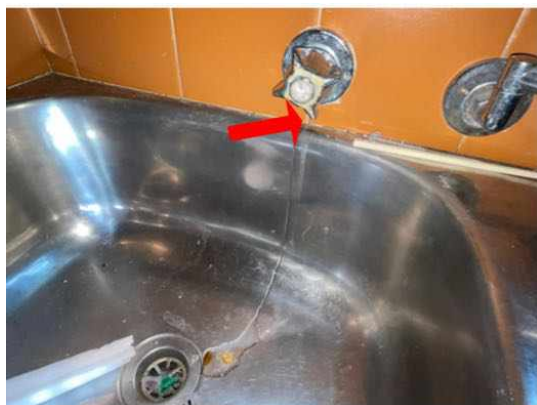
### Finding 3.05

Building: Main Building  
 Location: Laundry  
 Finding: Minor Defect – Leaking Tap  
 Information:

At the time of inspection, the tap in this area was found to be leaking. The leakage was evident during normal operation and indicates that the tap fitting or its internal components, such as washers, seals, or cartridges, are worn or defective. No leaks were observed to the associated drainage components at the time of inspection.

A leaking tap, while considered a minor defect, may result in ongoing water wastage and can contribute to deterioration of surrounding building elements if left unmanaged. Prolonged leakage may also indicate secondary issues within the plumbing system, including deteriorated fittings or connections, which may not be readily visible during a non-invasive inspection.

It is recommended that a licensed plumber be engaged to further assess the tap and

carry out necessary repairs or replacement of defective components. Prompt rectification is advised to prevent ongoing water loss and reduce the risk of moisture-related damage to adjacent building materials.

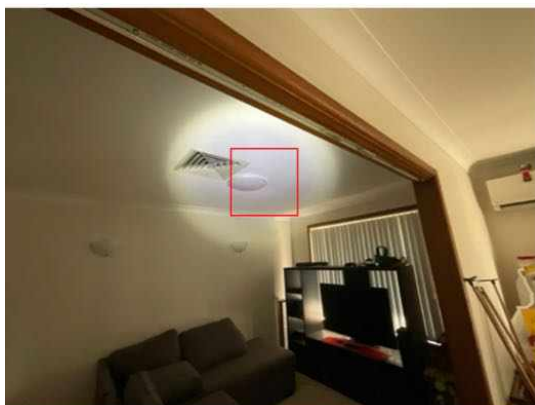
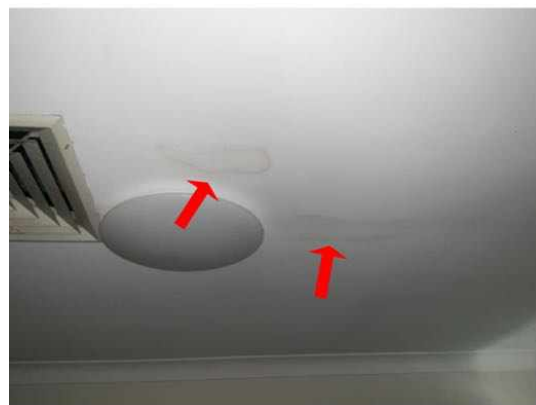
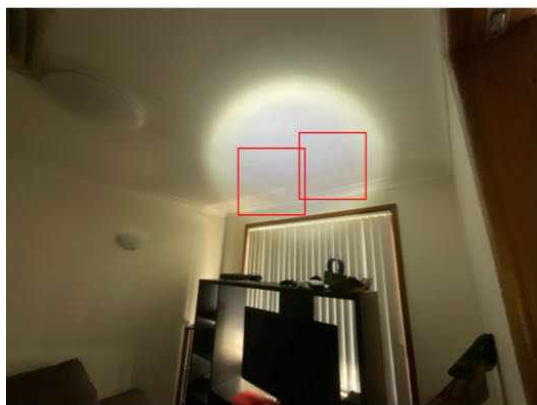
### Finding 3.06

Building:	Main Building
Location:	Living Room
Finding:	Ceiling - Water stained.
Information:	Observation:

Water staining was noted to ceiling linings in the inspected area(s) at the time of the inspection. These stains present as discoloured or patchy areas and may suggest a history of moisture ingress, most commonly associated with roof leaks or plumbing issues.

Water staining is typically the result of prolonged exposure to moisture, which allows minerals and other contaminants carried by the water to accumulate on surfaces, leaving visible marks. If ongoing or left untreated, moisture ingress can lead to more serious issues such as:

- Corrosion of structural elements

Due to the visual-only nature of this pre-purchase inspection, it is not possible to conclusively determine whether water staining is active or inactive at the time of inspection. Further assessment under a special-purpose inspection is recommended if a more detailed diagnosis is required.

Additionally, it is important to note that even minor damage to roofing materials—such as lifted flashings, cracked tiles, or poorly sealed penetrations—can allow water ingress that may lead to costly internal damage. Close-up inspection by a roofing contractor is advised to assess the condition of the roof coverings and associated fixtures more accurately.

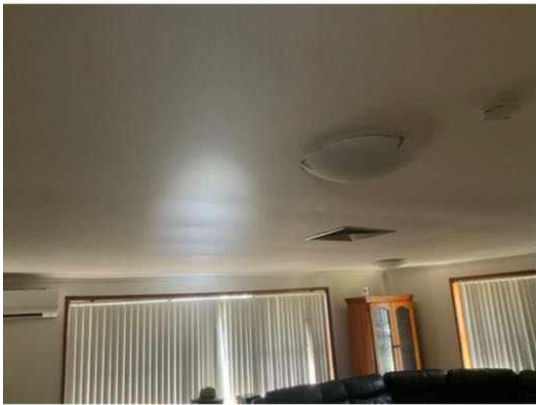
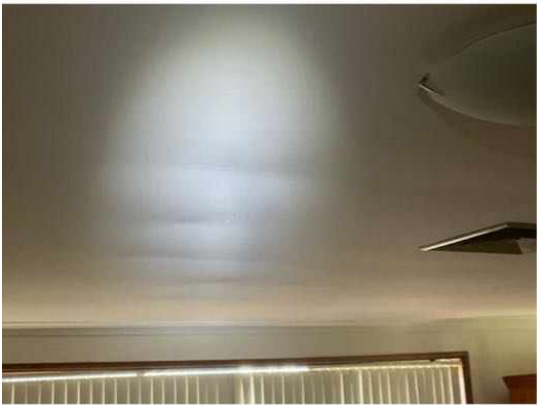
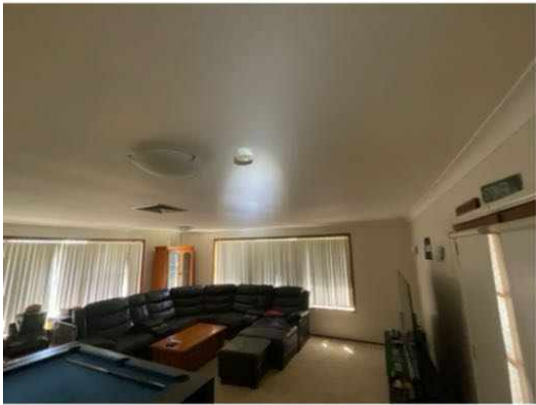
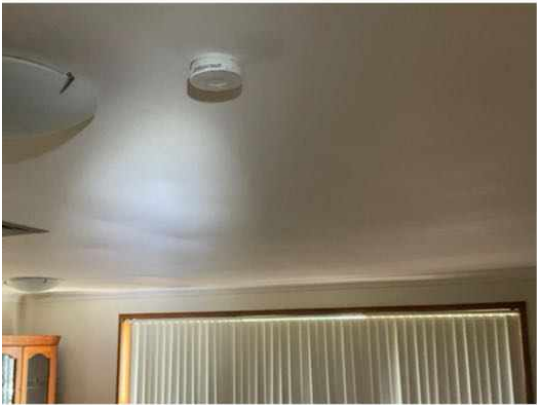
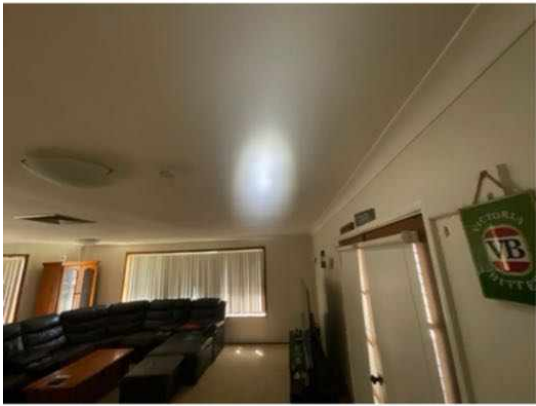
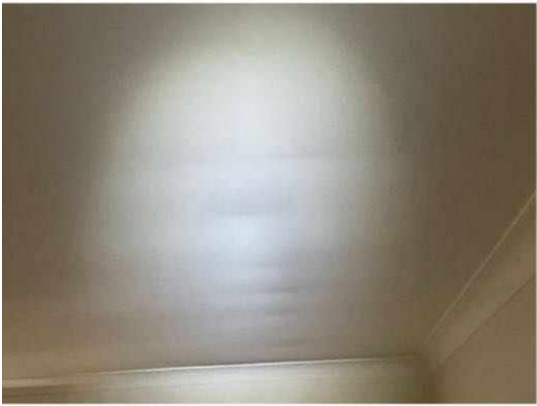
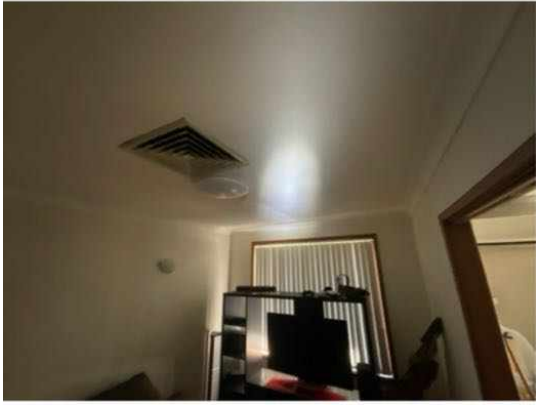
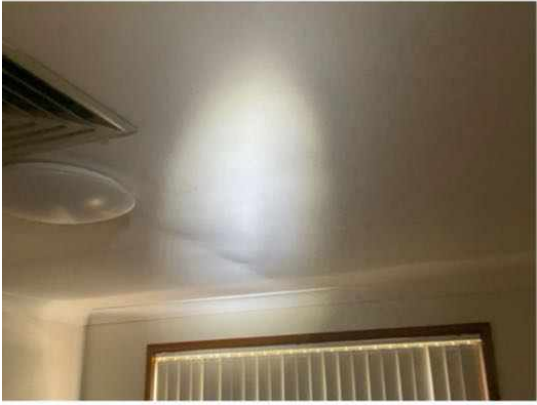
### Finding 3.07

Building: Main Building  
 Location: Living Room  
 Finding: Ceiling Linings – Uneven or Sagging Surfaces.  
 Information: Observation:

Further investigating Structural roofing elements

- Re-gluing or re-adhering the ceiling sheeting
- Re-securing sheets using appropriate modern fixings
- These works can be carried out by a qualified plasterer or painter,
- Ongoing monitoring is advised to detect any worsening of the condition or further movement over time.

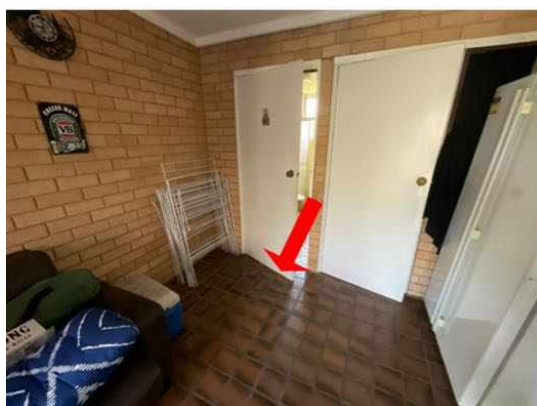
Finding 3.08

Building: Main Building  
Location: Bathroom 2  
Finding: Door - Binding on Floor Covering (insufficient clearance).  
Information: Observation:

The bottom edge of the door should be trimmed or planed to provide adequate clearance, and the edge sealed appropriately after adjustment.

Rectification can be carried out by a qualified carpenter or general handyperson, depending on the extent of adjustment required and at the client's discretion.

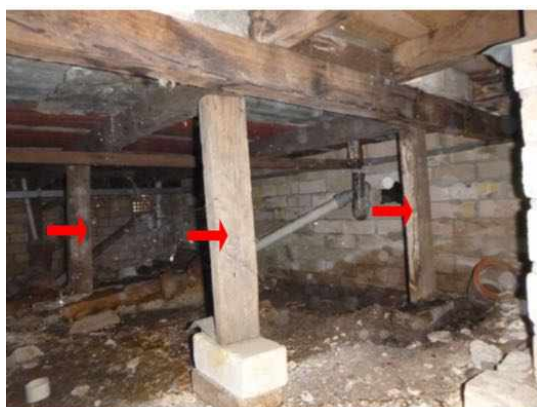
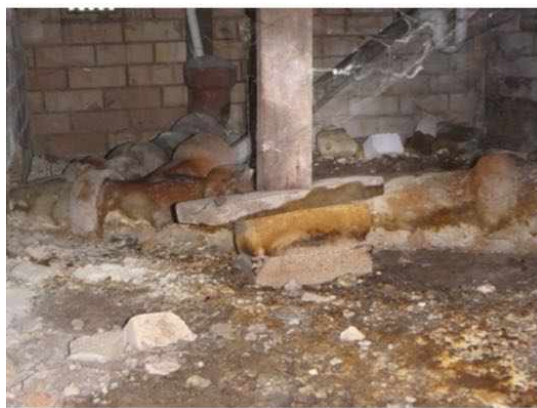
## Finding 6.02

Building:	Main Building
Location:	Exterior walls - front
Finding:	Subfloor Ventilation Issue: Wall vents adjacent ground.
Information:	Findings:

It is strongly recommended that all residual formwork timber and loose timber debris be immediately removed from the subfloor and surrounding areas of the property.

Preventative action—such as maintaining a clean, dry, and well-ventilated subfloor—is significantly more effective and less costly than dealing with active termite infestation or structural timber damage at a later stage.

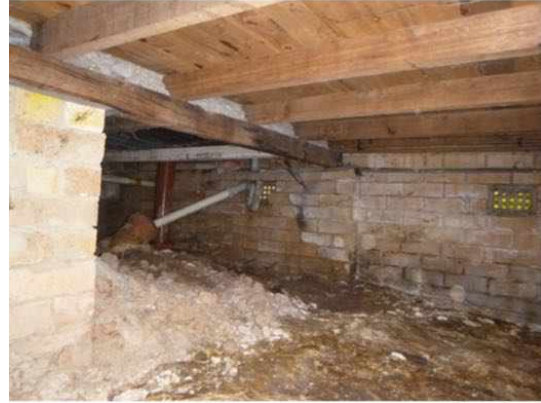
### Finding 6.04

Building:	Main Building
Location:	External Areas
Finding:	Subfloor - Excessive moisture conducive conditions..
Information:	Observation:

High – Conducive to concealed termite activity and fungal growth and should be rectified promptly.

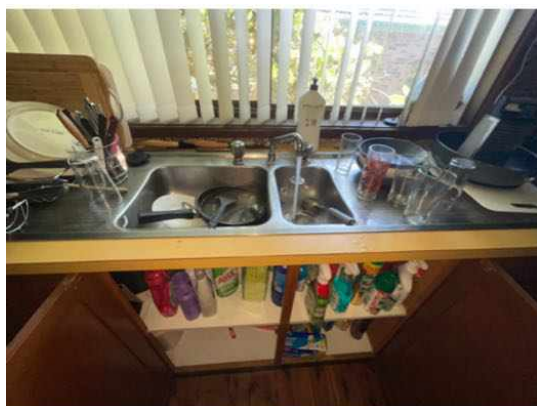
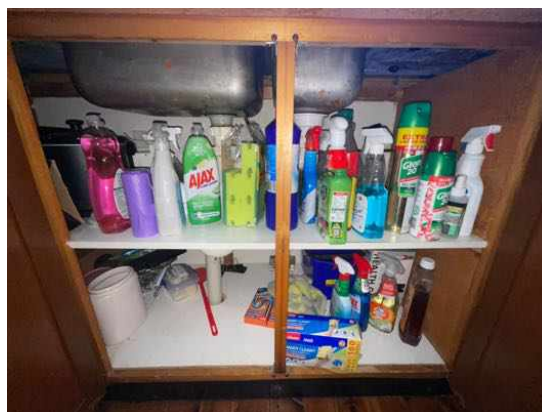
Building: Main Building  
 Location: Kitchen  
 Finding: Kitchen Sink – Overall Condition & Recommendations.  
 Information: Observations:

- Further monitoring and testing are recommended once the tap(s) are in constant use, to identify any drainage issues or signs of slow leaks not evident during the limited inspection.
- Flexible, mould-resistant sealant should be applied at wall junctions and other wet-area interfaces to prevent water ingress and potential damage. This is considered routine maintenance, and damaged or missing sealant should be replaced as needed.
- For long-term property care, it is advised that sealant and grouting in water-exposed areas be regularly inspected and maintained. A sealant specialist or tiling contractor may be engaged to carry out these works where necessary.
- It is recommended that the stored items beneath the sink be removed to allow for a full re-inspection of the plumbing and cabinetry, ensuring no concealed defects are present.

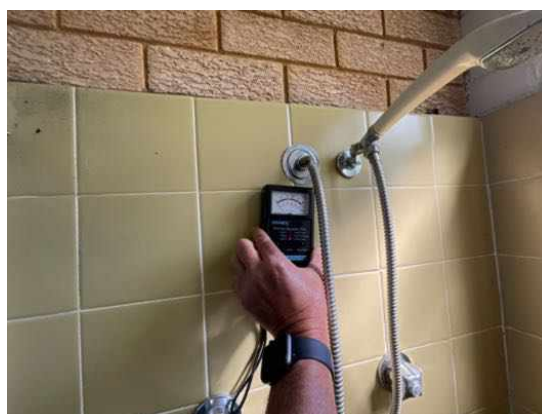
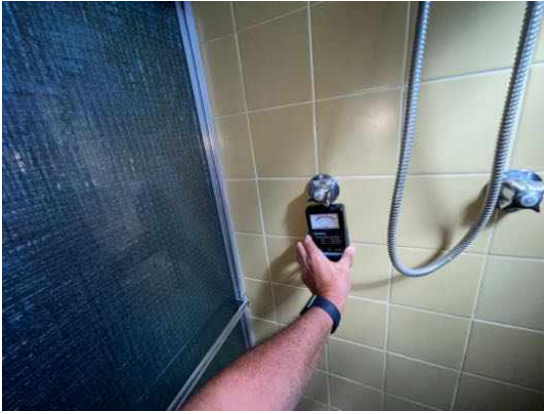
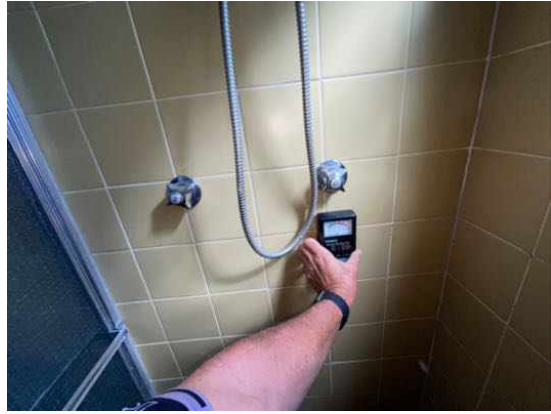
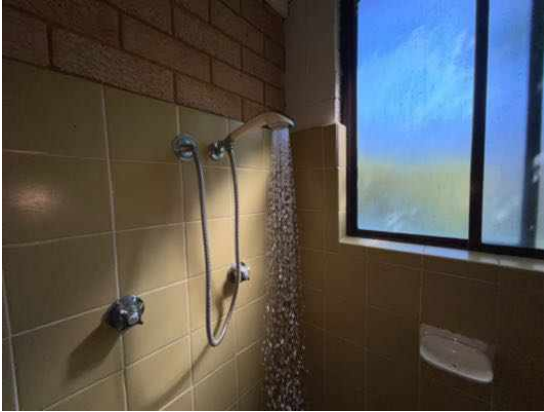
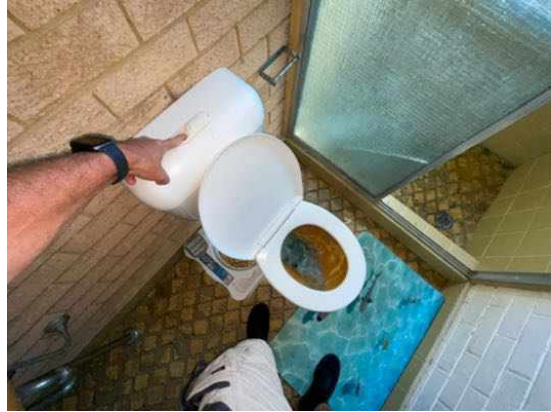
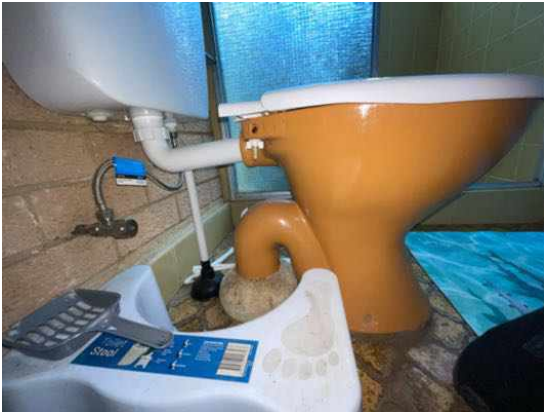
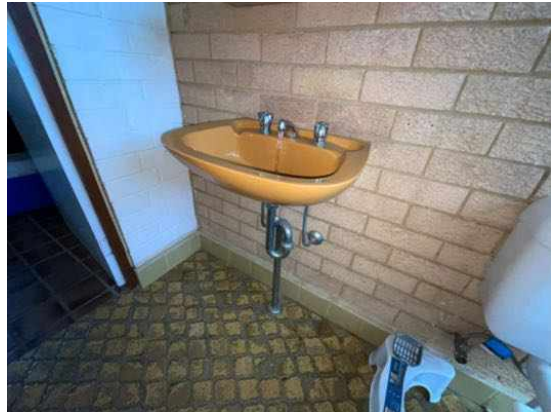
Building: Main Building  
 Location: Bathroom 2  
 Finding: Wet Areas - Bathroom(s) - Overall Condition & Recommendations.  
 Information: Overall Condition & Recommendations

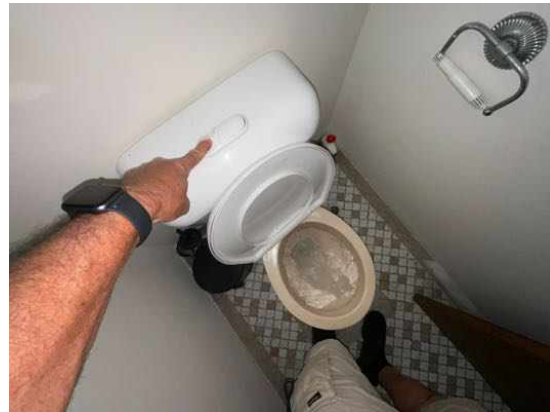
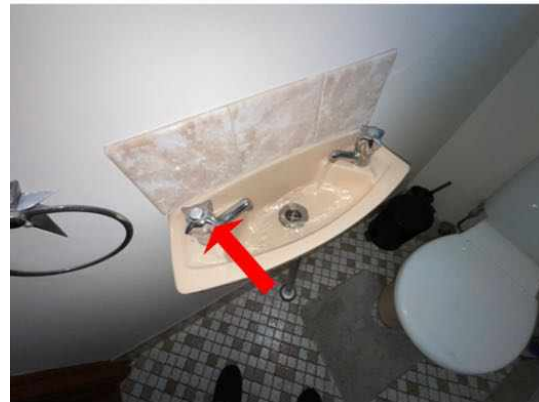
Building: Main Building  
Location: Toilet (WC)  
Finding: Overall Condition: Toilet & Basin.  
Information: TOILET & BASIN ASSESSMENT

- Basin(s) were water tested and inspected, the hot water tap did not operate, no evidence of leaks or blockages identified in the plumbing or drainage systems at the time of inspection.
- Water flow and drainage appeared satisfactory under limited-use testing conditions.
- Regular maintenance of sealant and grouting in wet areas is essential to prolong the life of surrounding materials and reduce the risk of water damage.

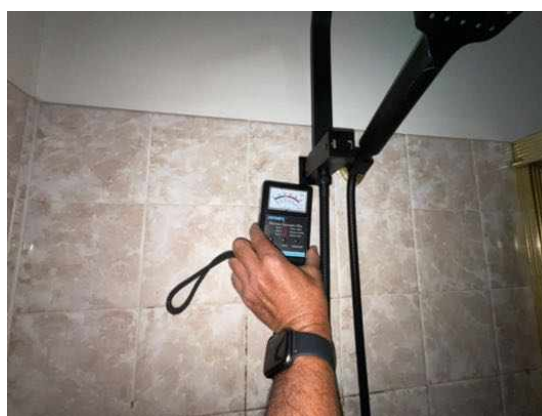
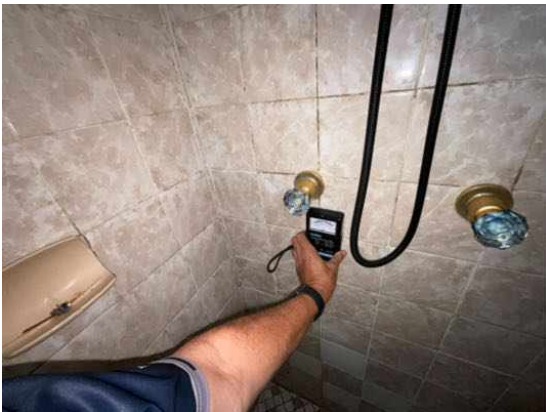
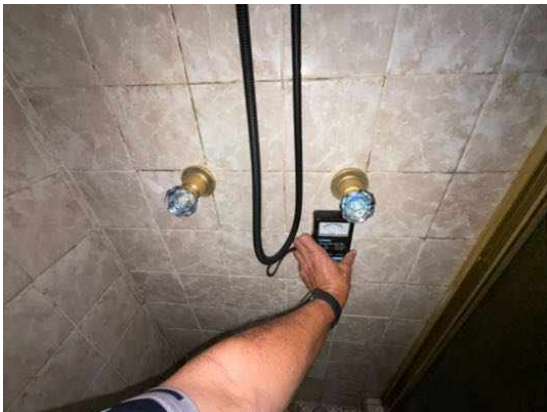
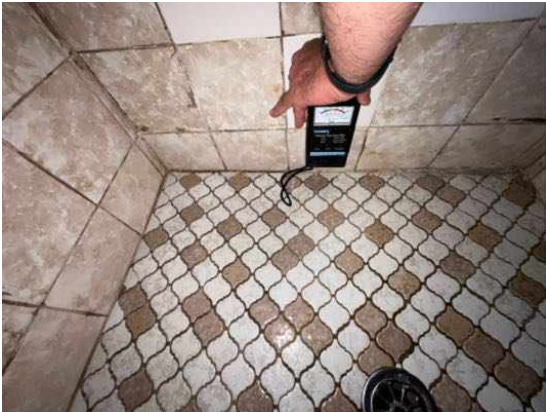
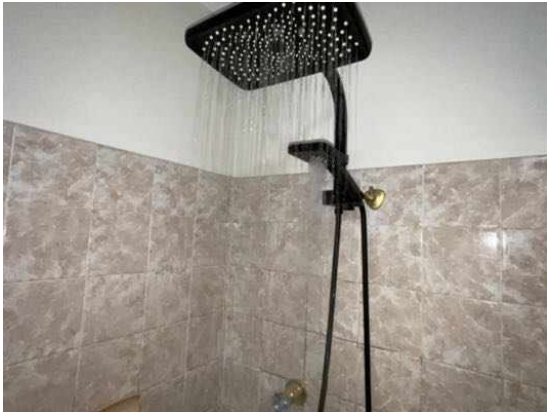
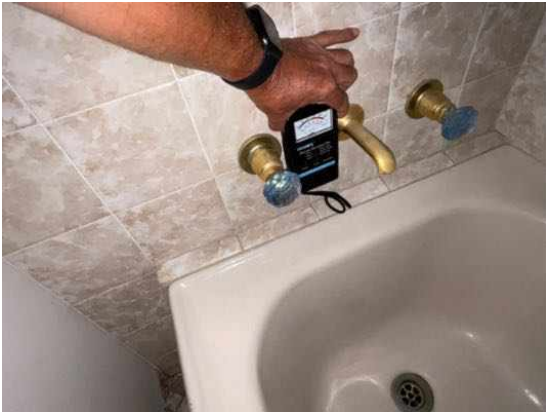
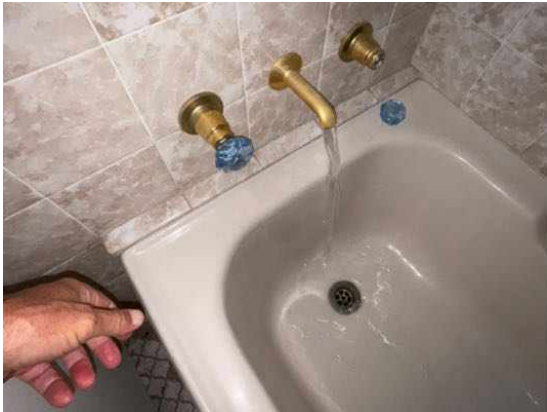
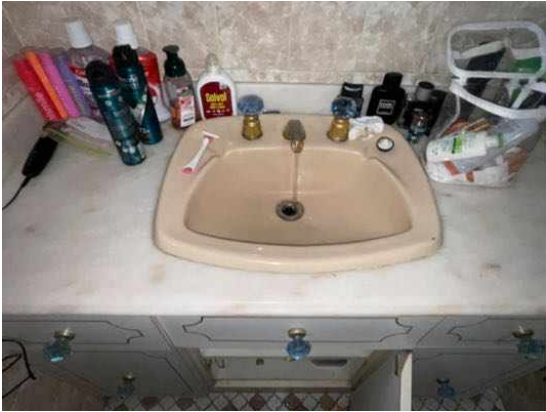
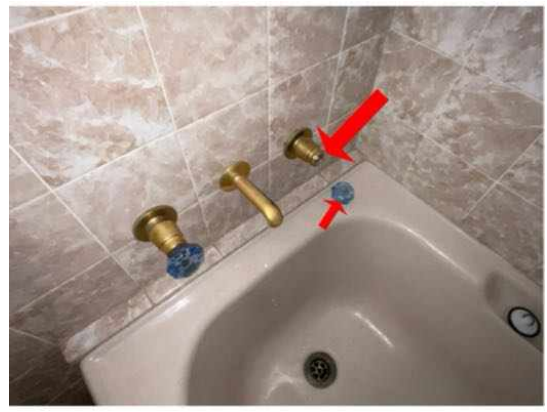
Building: Main Building  
 Location: Bathroom  
 Finding: Wet Areas - Bathroom(s) - Overall Condition & Recommendations.  
 Information: Overall Condition & Recommendations

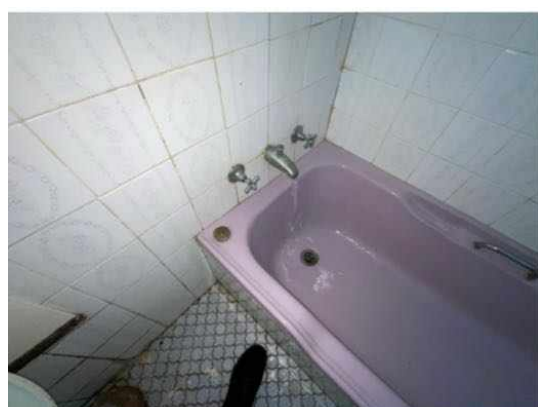
Building: Main Building  
Location: Ensuite  
Finding: Wet Areas - Bathroom(s) - Overall Condition & Recommendations.  
Information: Overall Condition & Recommendations
