Building and Timber Pest Inspection Report

Inspection Date: Fri, 23 Jan 2026

Property Address: 13 Marsanne Place Eschol Park NSW 2558

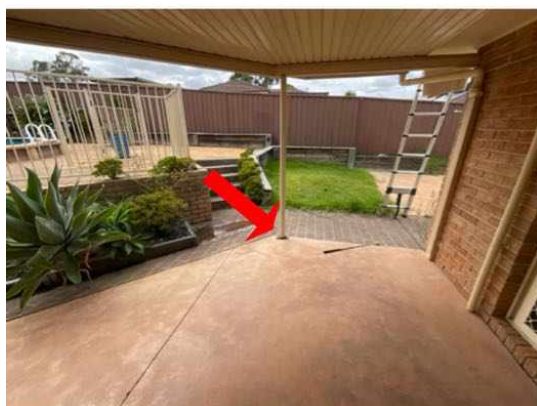
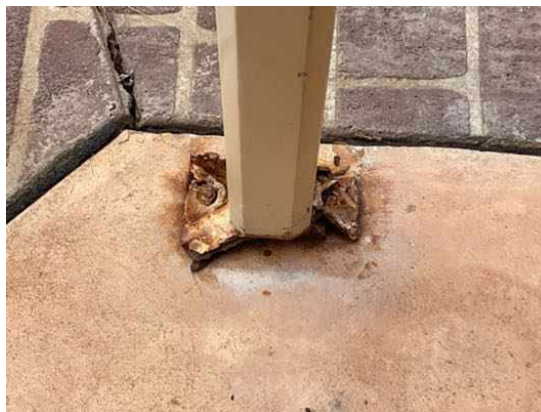
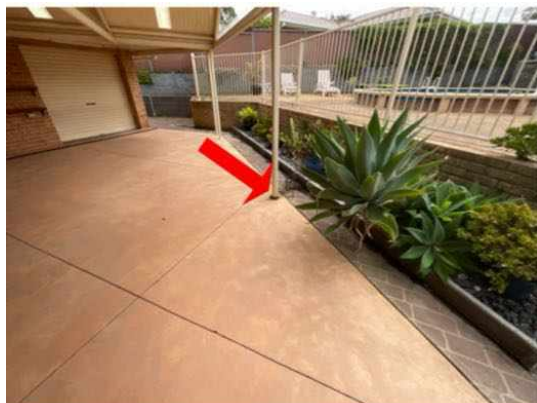
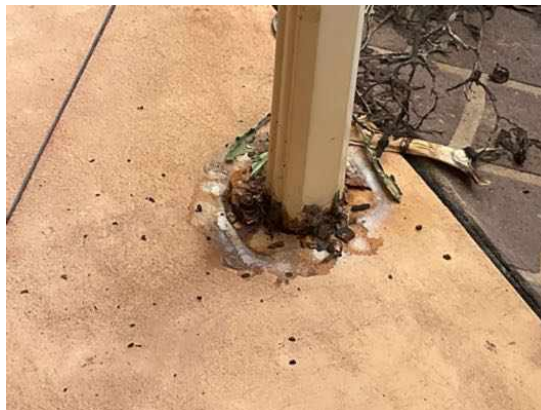
Building: Main Building
Location: Pergola
Finding: Major Defect – Pergola Structure (Corrosion to Lower Posts and Fixings)
Information:

The lower sections of the metal posts supporting the pergola exhibit advanced rusting and corrosion, most pronounced at the base plates and anchorage points. This deterioration is consistent with prolonged exposure to moisture and/or the absence or failure of appropriate protective coatings. The extent of corrosion suggests that the post bases and fixings have been compromised and may no longer be providing adequate structural support or restraint.

Corrosion at the post bases significantly reduces the structural capacity of the pergola, particularly its resistance to uplift and lateral loads. As a result, there is an increased risk of movement of the posts under minor impact or wind loading. In adverse weather conditions, this defect may lead to progressive instability and presents a risk of partial or total collapse of the pergola roof structure. This condition constitutes a major defect due to the potential safety hazard to occupants and visitors and the likelihood of further deterioration if left unaddressed.

It is strongly recommended that a registered builder or suitably qualified structural contractor be engaged as a matter of priority to assess the pergola structure. Remedial works are likely to include repair or replacement of the affected posts, base plates, and anchorage systems, together with appropriate corrosion protection measures. All works should be carried out in accordance with current building standards and manufacturer specifications to restore structural stability and reduce the risk of uplift or collapse.

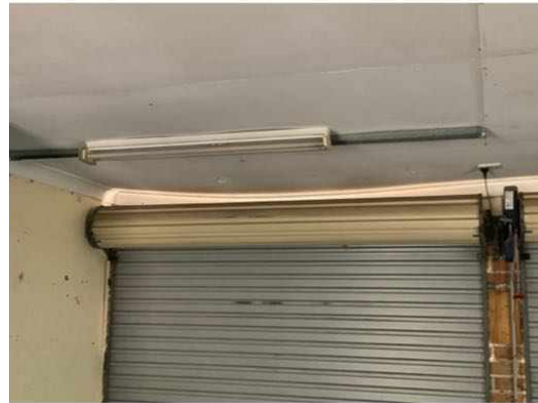
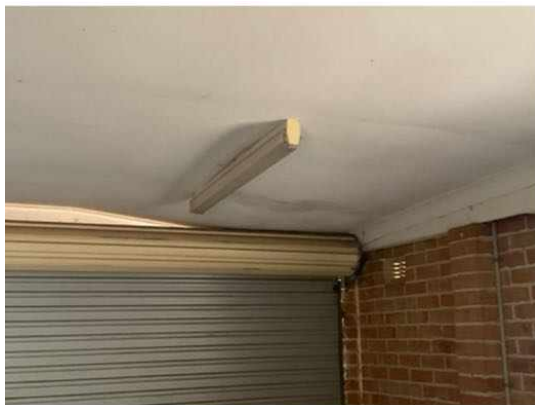
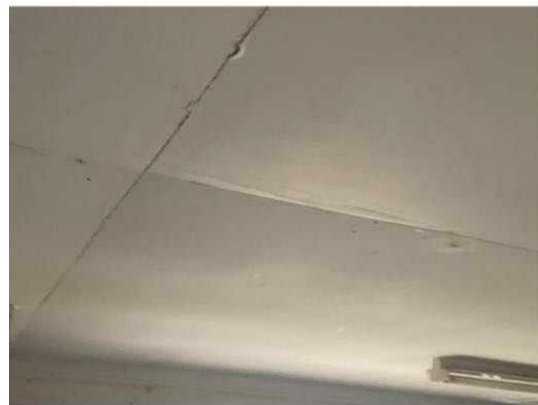
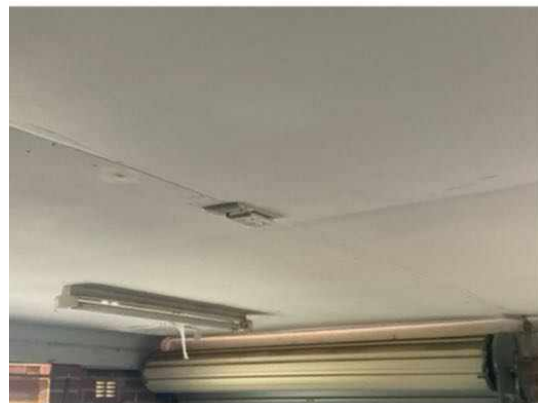
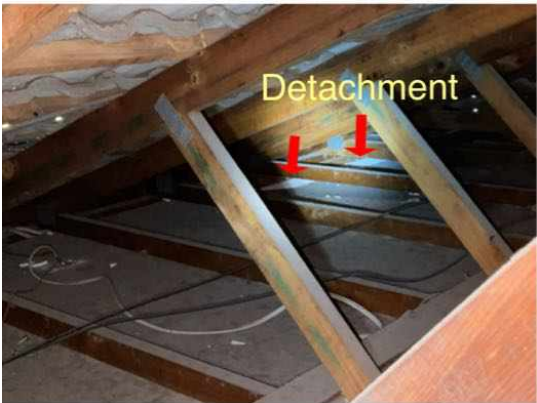
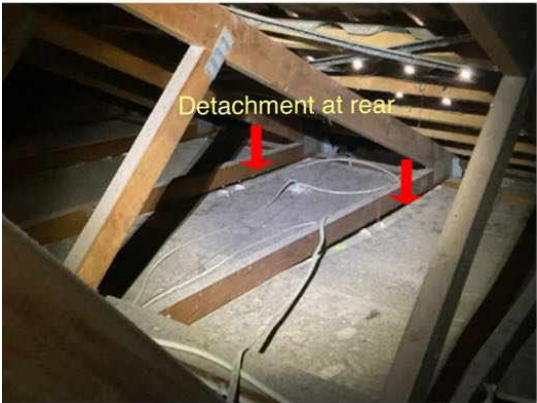
Finding 2.02

Building:	Main Building
Location:	Garage
Finding:	Ceiling lining - Localised Ceiling Sagging (Garage Area).
Information:	During the inspection, the ceiling lining were found to be uneven and sagging, detachment was noted particularly near the garage doorway and sections at the rear. This type of defect is commonly observed in garage areas and is typically attributed to general wear over time.

- Age-related deterioration of ceiling fixings (e.g. nails, screws, or adhesive/glue)
- Moisture exposure or humidity-related expansion, often exacerbated by incorrect or low-grade paint coatings that fail to protect the ceiling surface adequately

While the defect is currently considered minor and does not appear to compromise the structural integrity of the ceiling, it may worsen over time if left untreated. Early signs such as minor sagging may eventually lead to partial detachment of ceiling sheets or visible cracking along joints or edges.

Repairs may involve re-gluing and re-fixing the ceiling sheets to the joists, a task

generally undertaken by qualified plasterers or general interior trades. In some cases, repainting with moisture-resistant coatings may also be appropriate, particularly in garages where humidity levels can fluctuate.

It is recommended that buyers allow for maintenance or minor repair costs in the medium to long term and engage a relevant trade professional to assess and carry out works as needed. Timely intervention will help prevent further deterioration and maintain the visual and functional condition of the ceiling.

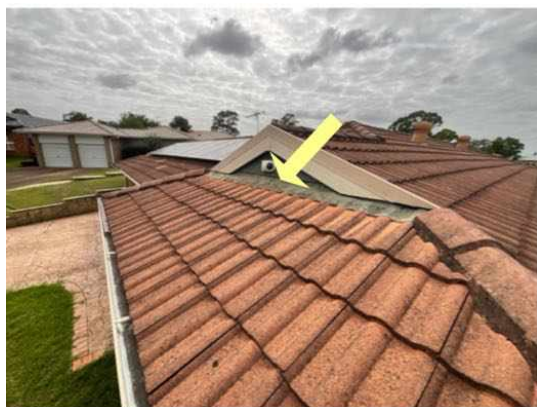
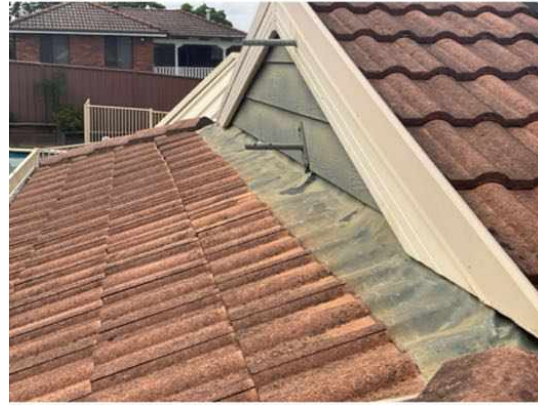
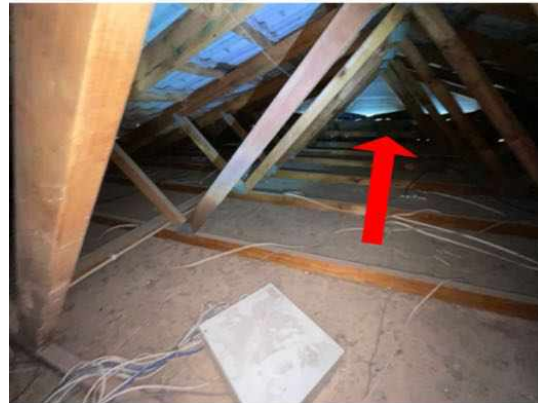
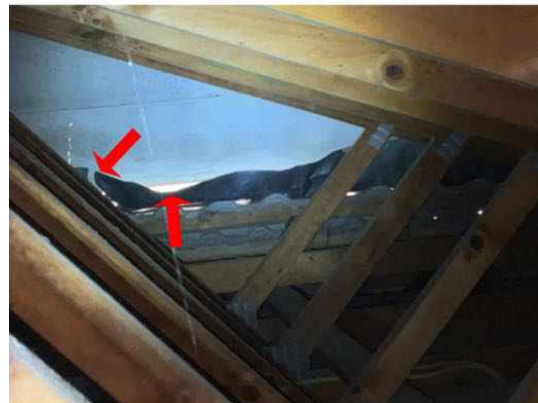
Finding 3.01

Building: Main Building
 Location: Roof Exterior
 Finding: Roof Flashing - Defect & Recommendation (cracked).
 Information: Observation:

Cracking and displacement was observed in sections of the roof flashings. These materials, typically composed of metal, lead, or similar weather-resistant components,

Damaged or deteriorated flashings significantly increase the risk of water penetration into the internal structure of the property. Over time, this can result in:

It is recommended that a licensed roofing plumber or qualified carpenter be engaged as soon as possible to assess and repair the affected flashings. Prompt remediation will help prevent further water damage and ensure the roof plumbing system remains functional and weatherproof.

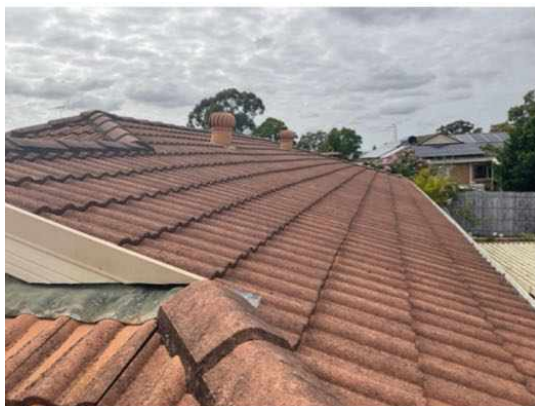
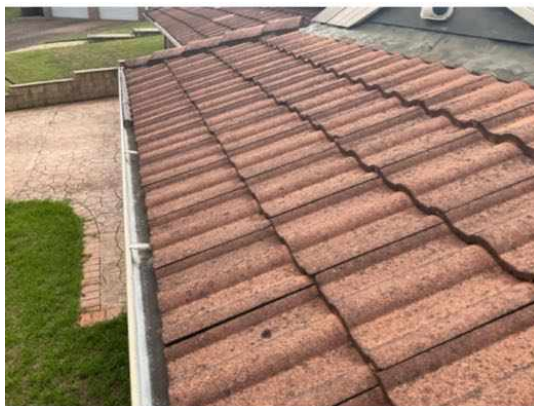
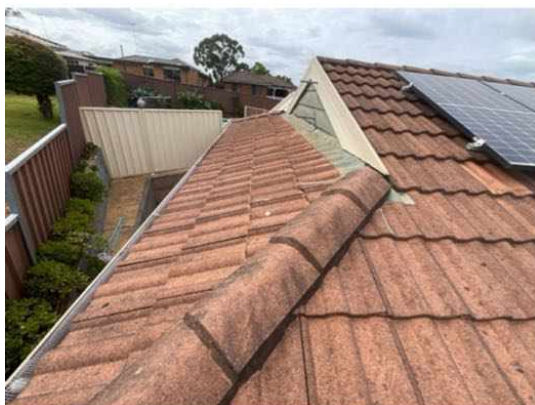
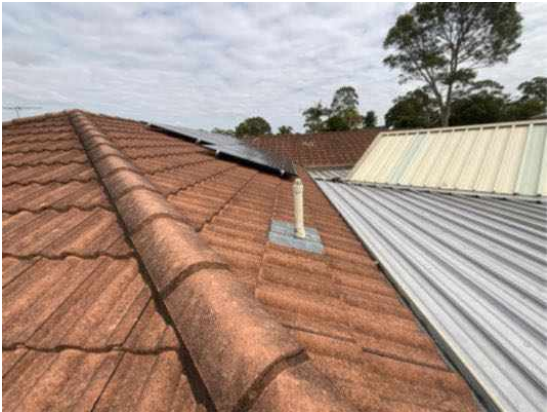
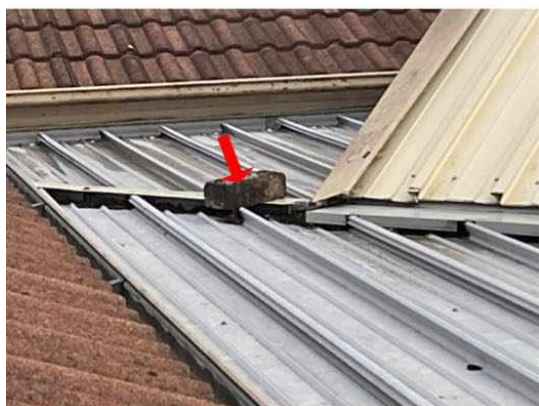
Finding 3.02

The roof tiles were generally in sound condition. Tiles appeared well seated overall; however, evidence of prior silicone repairs to cracked or dislodged tiles was noted. The tiles show general weathering consistent with age and exposure.

Tile alignment was generally uniform across the roof. Minor movement was noted to some tiles at the rear sections.

Ridge and hip cappings were generally intact, with bedding and pointing appearing sound overall. Minor cracking and deterioration were noted to the bedding/pointing at the front right corner.

Flashings around visible roof penetrations (vents, flues, etc.) appeared serviceable at the time of inspection. Flashings to both Dutch gables were observed to require maintenance and minor repairs.

A loose brick was observed placed on the metal pergola roof, positioned over a capping section.

At the time of inspection, the tiled roof covering was generally sound, with no evidence of active leaks observed. Minor maintenance is recommended to flashings, ridge pointing, and select roof tiles to ensure continued weather resistance. Access limitations due to the pergola restricted inspection to safely accessible areas only. Regular roof and gutter maintenance is advised to maximise the remaining service life of the roof system.

Monitor repaired areas and undertake replacement of damaged tiles as required to maintain weatherproofing.

Secure any loose or mobile tiles as part of routine roof maintenance.

Re-pointing is recommended as a non-urgent maintenance item to maintain long-term weather resistance.

Further investigation is recommended, with repairs carried out as necessary to properly secure the pergola roofing.

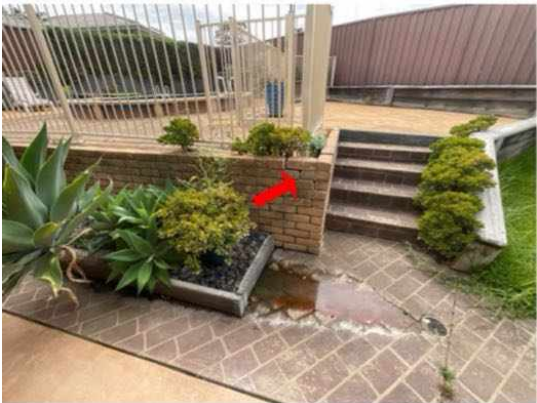
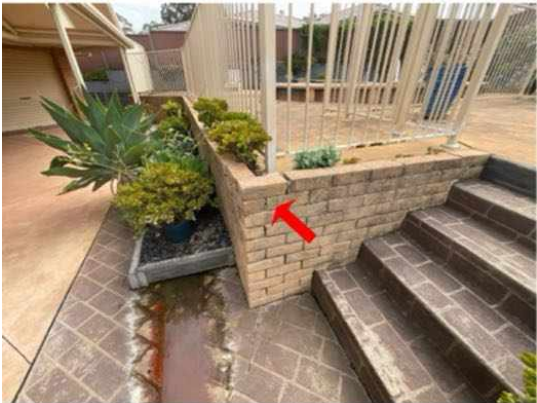
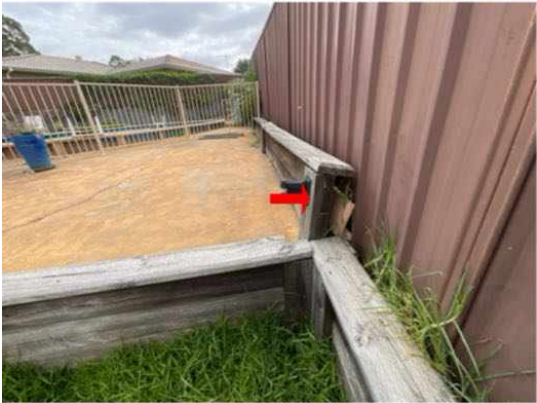
Finding 3.03

Building: Yard
 Location: Pool Area
 Finding: Minor Defect – Masonry Retaining Wall.
 Information:

At the time of inspection, movement and step cracking were observed to sections of the masonry retaining walls. Minor displacement was evident, with visible gapping noted where the concrete paved area abuts the retaining wall. Cracking was also observed within the raised concrete paved area, consistent with minor subsidence and ground movement. Excessive moisture was present in the vicinity of the retaining walls, and the mortar joints to the brickwork appeared darkened with mould growth, suggesting an ongoing moisture-related issue. Minor movement was additionally noted to the rear retaining wall. It is suspected that a nearby swimming pool may be contributing to elevated moisture levels, potentially due to leakage.

Defects of this nature are commonly associated with factors such as age, inadequate drainage, soil movement, or original construction methods. While the observed movement and cracking were assessed as minor at the time of inspection and no immediate safety hazard was identified, continued moisture exposure and ground movement may result in progressive deterioration if left unmanaged.

Ongoing monitoring of the retaining walls and adjoining paved areas is advised. Should movement, cracking, or moisture-related deterioration increase, further investigation and remedial action may be required. Consider engaging a suitably qualified landscaper or retaining wall contractor to assess and carry out repairs as necessary. Where the retaining wall is deemed to be structural, consultation with a qualified structural engineer or building surveyor is recommended to provide advice on appropriate remediation. A dedicated pool inspection is also recommended to confirm whether leakage is contributing to the elevated moisture levels.

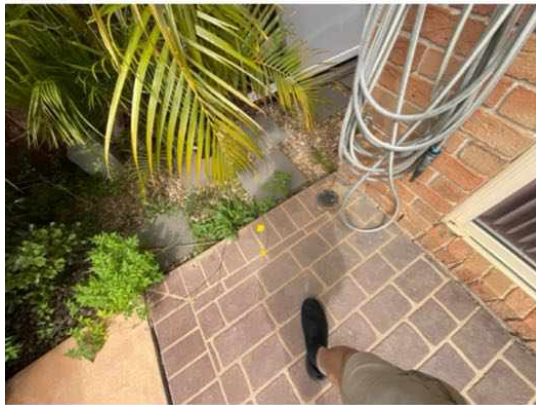
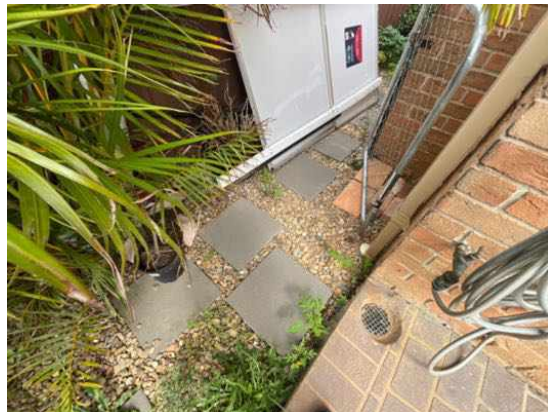
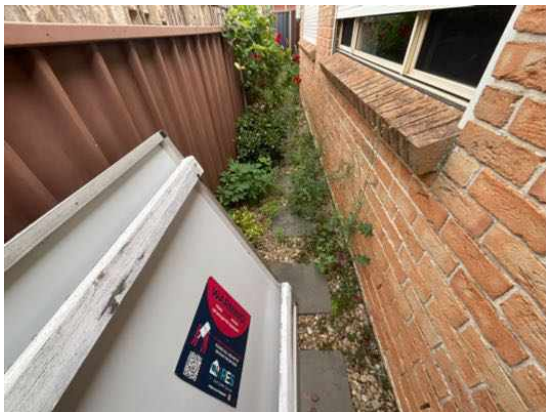
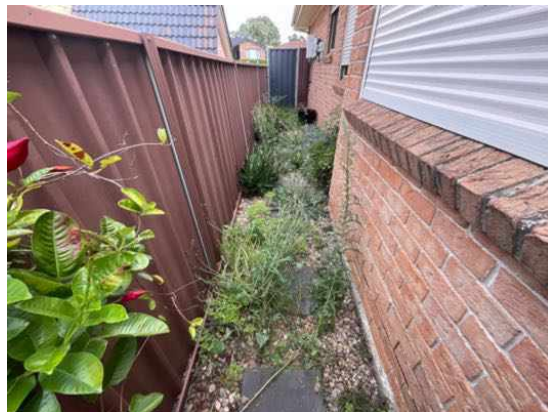
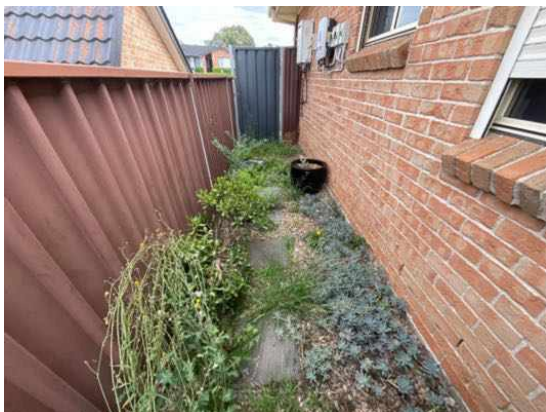
Finding 3.04

Building: Yard
Location: Exterior yard - right side
Finding: Site/Yard Drainage – Below Average.
Information: Defect – Below Average Site Drainage

Site drainage in the inspected areas appears to be below average, with no surface drains observed at the time of inspection. Ground surfaces and paved areas adjacent to the building do not appear to be adequately graded to facilitate effective surface water runoff.

Failure to meet these minimum drainage falls increases the risk of water ingress, foundation issues, and secondary building defects.

- A licensed plumber and/or landscaping contractor should be engaged to:
 - Evaluate the current site grading and surface runoff conditions
 - Install or upgrade surface water drainage (e.g. strip drains, spoon drains, grated channels) as required
 - Improve grading around the building to ensure water flows away from the structure

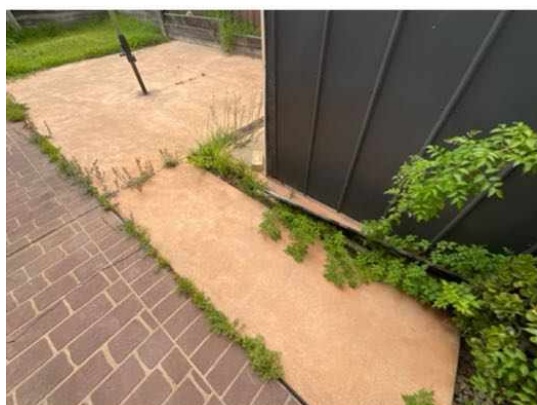
Finding 3.05

Building: Yard
Location: Exterior yard - right side
Finding: Minor Defect – Surface Strip Drainage (Rear Shed)
Information: Observation:

Blocked strip drains are typically the result of inadequate routine maintenance. When drainage systems are unable to operate as intended, surface water may pond or overflow, increasing the risk of moisture retention against adjoining structures. If left unaddressed, this condition may contribute to the deterioration of surrounding building materials and may lead to more significant moisture-related defects over time.

It is recommended that the strip drain be cleaned and cleared of all debris to restore proper drainage function and prevent water pooling. Ongoing periodic maintenance should be undertaken to ensure continued performance. Where remedial works or modifications to the drainage system are required, a licensed plumber should be engaged to carry out the works in accordance with relevant standards.

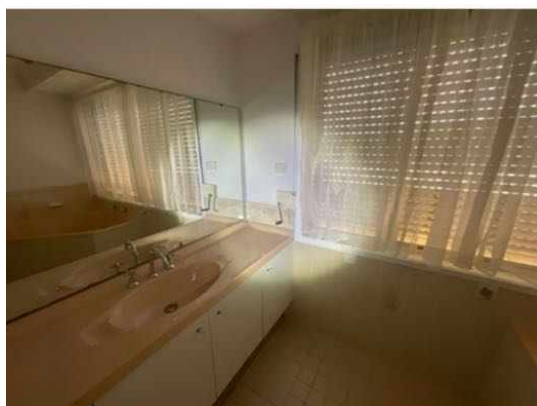
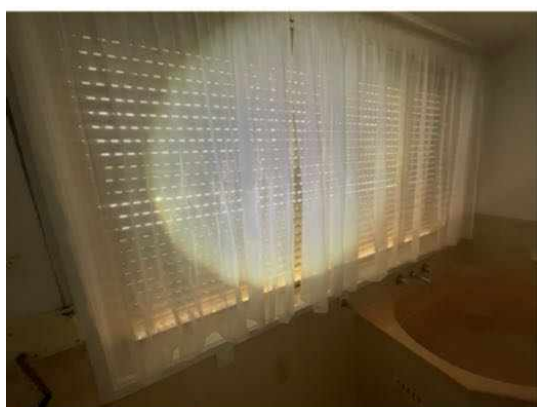
Finding 3.06

Building: Main Building
Location: Bathroom

Repairs or replacement of the roller shutter and associated operating mechanisms are recommended at the client's discretion to restore full functionality. Engagement of a suitably qualified tradesperson or roller shutter specialist is advised to assess the defect and carry out appropriate remedial works.

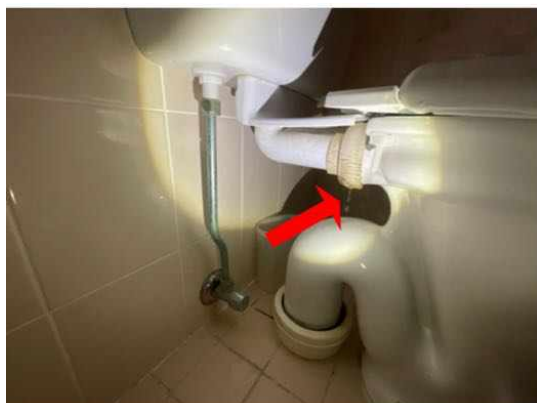
Finding 3.07

Building: Main Building
Location: Bathroom
Finding: Evidence of Internal Water Leak – Toilet.
Information: Defect Type: Plumbing – Internal Leak

It is strongly advised that the internal water leak is investigated and rectified by a licensed plumber at the earliest opportunity.

Use of the leaking toilet should be minimised until repairs are completed to avoid further damage.

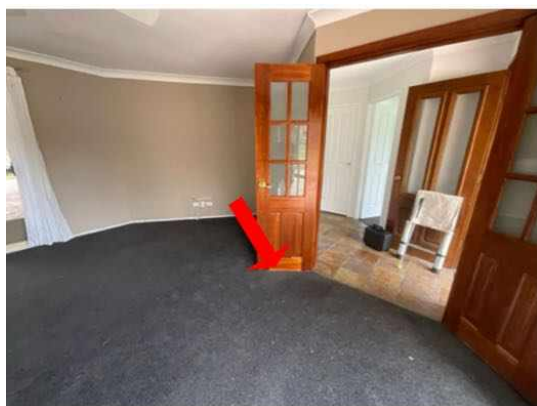
Finding 3.08

Building: Main Building
Location: Lounge Room
Finding: Door - Binding on Floor Covering (insufficient clearance).
Information: Observation:

The bottom edge of the door should be trimmed or planed to provide adequate clearance, and the edge sealed appropriately after adjustment.

Rectification can be carried out by a qualified carpenter or general tradesperson, depending on the extent of adjustment required and at the client's discretion.

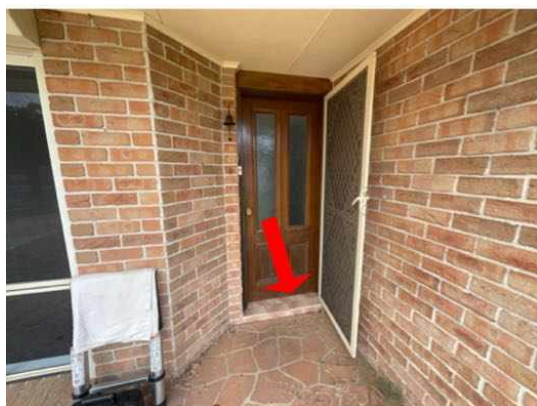
Finding 3.09

Building:	Main Building
Location:	Entry
Finding:	Minor Defect – External Doors (Missing Weather Seals).
Information:	Observation:

It is recommended that compliant weather seals be installed to all applicable edges of the external door(s), including a draft protection device to the bottom edge. These works will assist in improving weather resistance, reducing air leakage, and minimising the risk of moisture affecting internal flooring and finishes. A suitably qualified tradesperson should be engaged to carry out the installation in accordance with NCC requirements.
