Building Inspection Report

Inspection Date: Mon, 16 Mar 2026

Property Address: 207 Beach Rd, Black Rock VIC 3193,
Australia

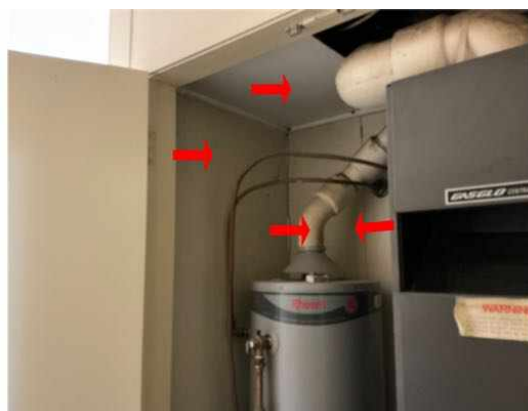
Defects 1.01

Building:	Main Building
Location:	Laundry
Finding:	Asbestos - Suspected ACM Identified on Site
Information:	Reporting on Asbestos is outside the Scope of this Report. This suspected defect is highlighted as a caution only. We suspect, based on our experience in the building industry, that there is a higher risk of the identified building element containing asbestos.

As Asbestos Reporting is outside the scope of this report, we advise that you consider a separate Asbestos Inspection and Condition Audit, which can include the taking of samples for definitive confirmation of the presence of Asbestos.

In the interim, the client is advised to act with caution, especially when considering any damage to building materials general wear and tear renovations extensions demolition and general maintenance activities due to the suspected presence of Asbestos.

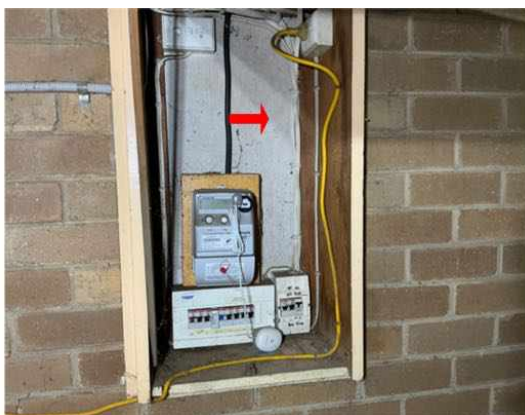
Defects 1.03

Building:	Main Building
Location:	Electrical Switchboard
Finding:	Asbestos - Suspected ACM Identified on Site
Information:	Reporting on Asbestos is outside the Scope of this Report. This suspected defect is highlighted as a caution only. We suspect, based on our experience in the building industry, that there is a higher risk of the identified building element containing asbestos.

As Asbestos Reporting is outside the scope of this report, we advise that you consider a separate Asbestos Inspection and Condition Audit, which can include the taking of samples for definitive confirmation of the presence of Asbestos.

In the interim, the client is advised to act with caution, especially when considering any damage to building materials general wear and tear renovations extensions demolition and general maintenance activities due to the suspected presence of Asbestos.

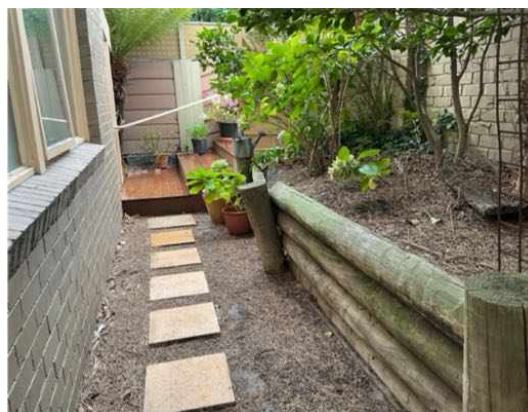
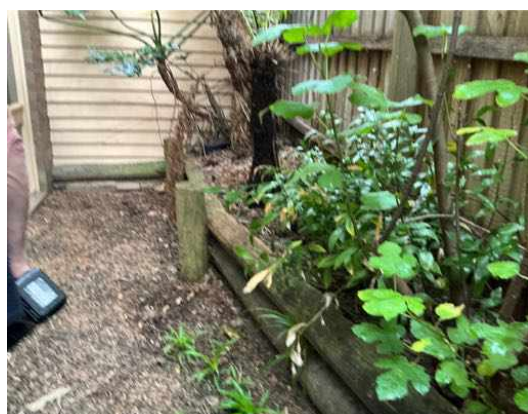
Defects 1.04

Building: Main Building
Location: All Areas
Finding: Retaining wall - Defective
Information: The retaining wall in this area was found to be defective at the time of inspection. Generally, defective retaining walls are caused by poor original design or material use. However, deteriorated retaining walls may also be a result of substandard construction, poor site drainage or unmanaged stormwater flows.

If left unmanaged, the retaining wall may become a safety hazard if it continues to destabilise. Where retaining walls further rot and decay, an environment is created that is conducive to termite and pest infestation.

Significant repair and replacement should be expected. Where retaining walls are considered structural walls, a structural engineer / surveyor should be consulted regarding required remedial works. Otherwise, a landscaper or retaining wall installer may be appointed to repair or replace the wall, at the discretion of the client.

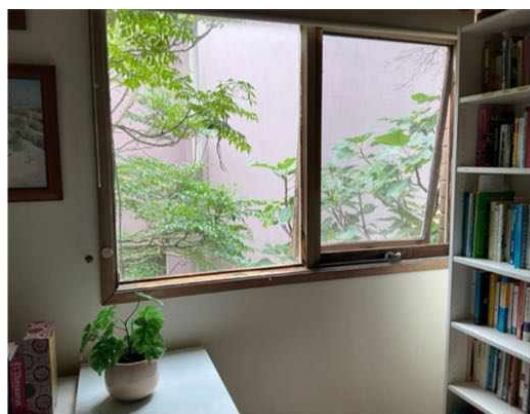
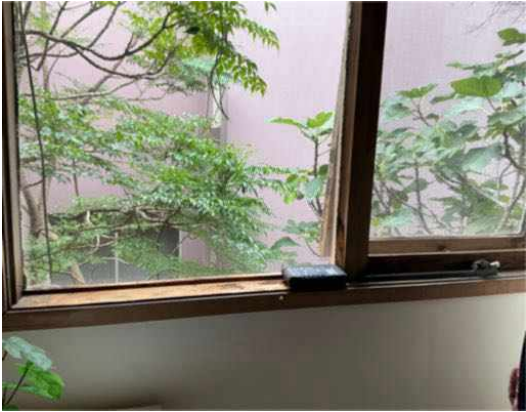
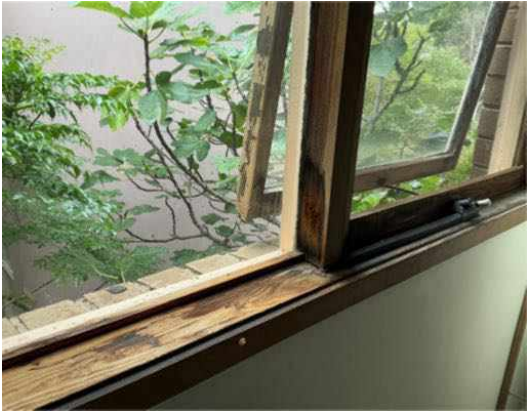
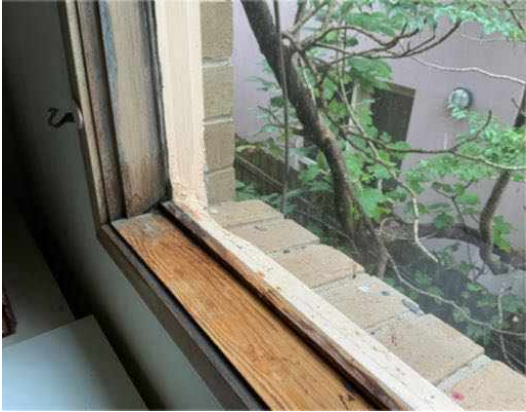
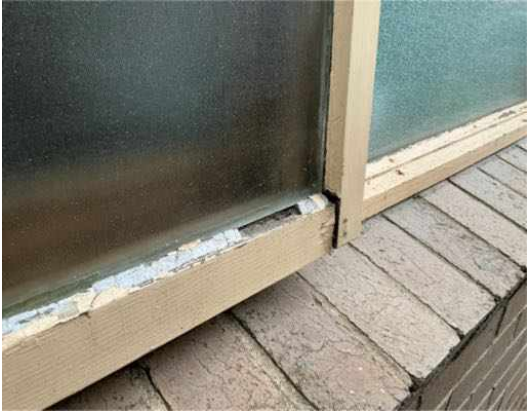
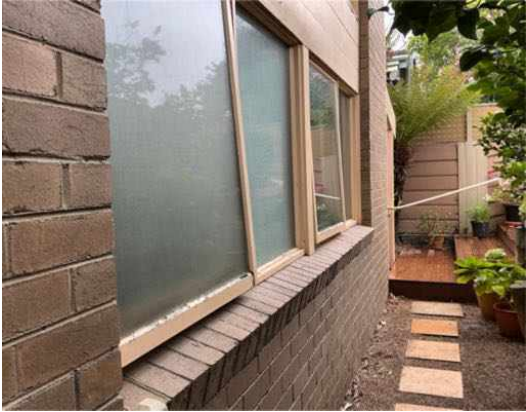
Defects 3.01

Building:	Main Building
Location:	All Areas
Finding:	Windows - Wood rot
Information:	Wood rot was found to be affecting external windows. Wood rot, also known as Fungal Decay, occurs when timbers and other cellulose building materials are exposed to damp conditions on an ongoing basis.

It is likely that this wood rot has developed as a result of frequent exposure to rain and other weather conditions. It is suspected that failure to maintain the window frames over a prolonged period has resulted in them deteriorating at an accelerated rate, increasing their susceptibility to the development of wood rot. Leaks in roof plumbing or associated pipework may have also contributed to the formation of the wood rot in this area.

Early intervention and regular maintenance will prolong the useful life of these building elements. Prior to any works being performed, any associated pipework or roof plumbing should be inspected by a licensed plumber for faults or leaks.

Repair and/or replacement of affected window frames may be a necessary step in protecting surrounding building elements from such deterioration. Remedial works should be performed by a qualified carpenter or registered builder as soon as possible to prevent any further damage.

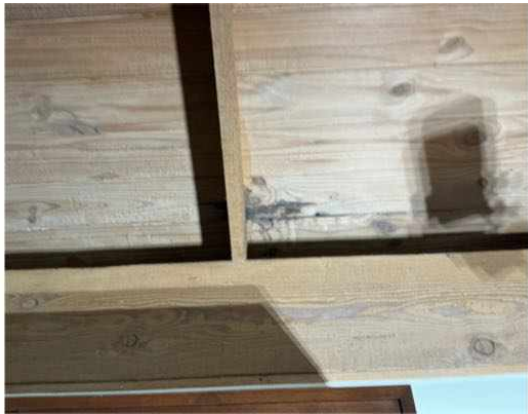
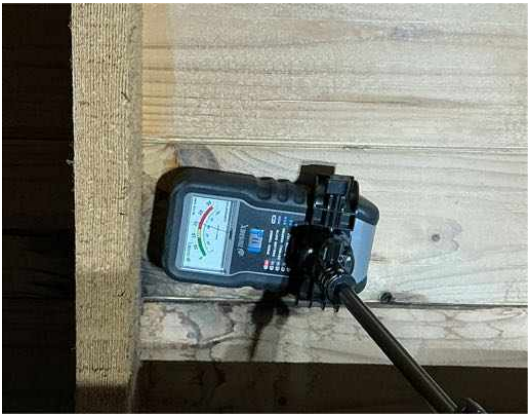
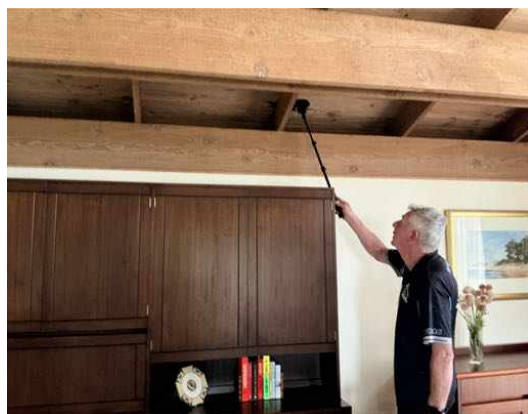
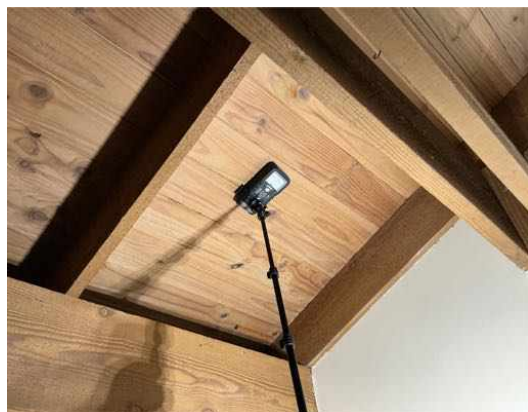
Defects 3.02

Building: Main Building
Location: Dining Room
Finding: Ceiling - Water stained
Information: Water staining to ceiling linings in this area was evident at the time of inspection. Water staining indicates that surfaces have been exposed to excessive moisture over time. The minerals and other elements in the water lead to staining, which may graduate to corrosion and deterioration if left unmanaged.

While mostly an appearance defect, water staining can be indicative of more serious defects, which may be currently concealed by interior ceilings.

Where water staining is active, a licensed plumber must be consulted to identify the cause of the staining and to provide advice on any reparation works that may be required. Replacement of any damaged structures is advised.

Conversely, where water staining is old and inactive, affected building materials may be repaired or replaced at client discretion.

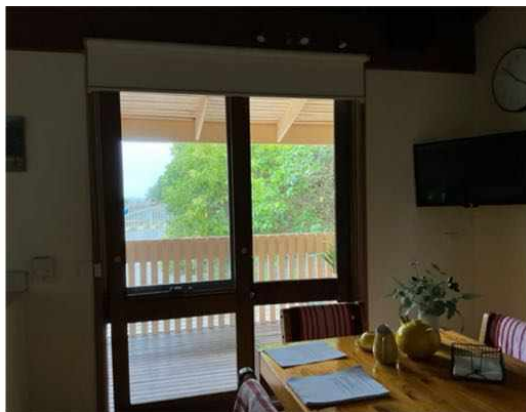
Defects 3.03

Building:	Main Building
Location:	Kitchen
Finding:	Sticking or jamming
Information:	Building elements which are sticking or jamming are difficult to operate and don't function as intended. There are a variety of causes for sticking and jamming.

The most usual causes are swelling of timbers due to moisture, bulging or bowing of metal frames, or general material deterioration. Generally, sticking and jamming building elements indicate that their frames are uneven or out of level, generally as result of movement to surrounding walls and floors.

Easement will be required, which usually depends on the building materials used. This may involve some sanding and/or application of a lubricant. It will almost always include ensuring the areas are cleaned and free of any debris that may be detrimental to their operational state.

Appointment of a carpenter or general handyman is recommended to rectify any sticking/jamming building elements.

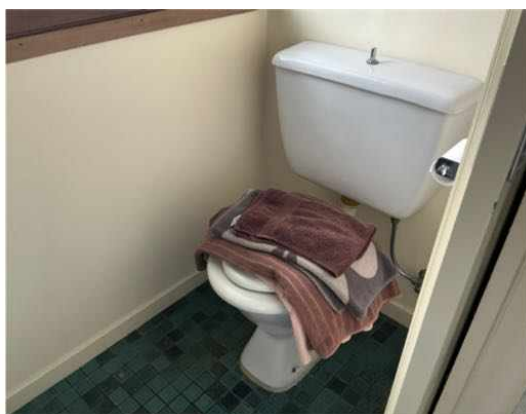
Defects 3.04

Building: Main Building
 Location: Ensuite - Master
 Finding: Toilet - Continually running
 Information: At the time of inspection, the toilet showed evidence of continually running.

It is highly advised that this be addressed by a licensed plumber as soon as possible.

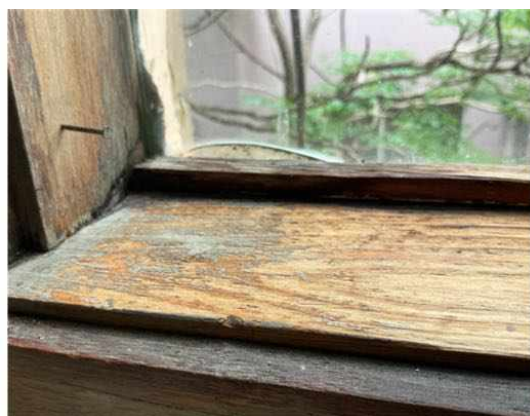
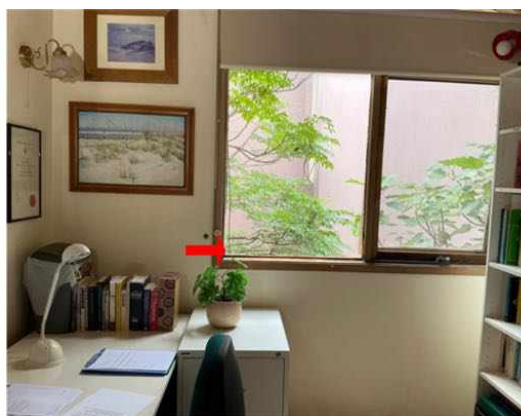
Defects 3.05

Building: Main Building
 Location: Study
 Finding: Window - Cracked
 Information: Cracks were identified in the window in this area. Cracking in windows is generally the result of impact damage, and is likely to develop further when left unmanaged.

The likelihood of this windowpane further cracking and shattering is increased exponentially, providing a safety hazard in the area. The cracked window also impairs the weather tightness of the building, creating potential for minor water leaks.

A qualified glazier is required to repair the window as soon as possible. Depending on the extent of the cracking, replacement of the window may be required. Please be advised that any persons coming into contact with the cracked window should do so

with due caution to avoid any personal injury that may ensue.

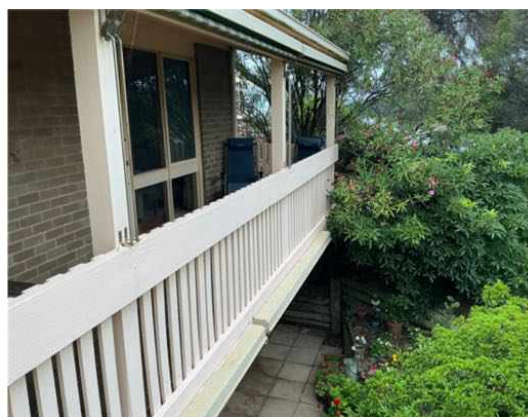
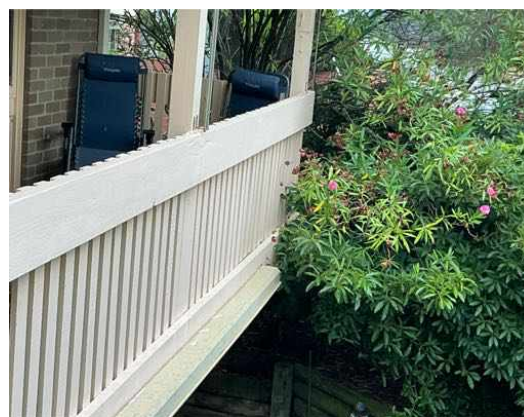
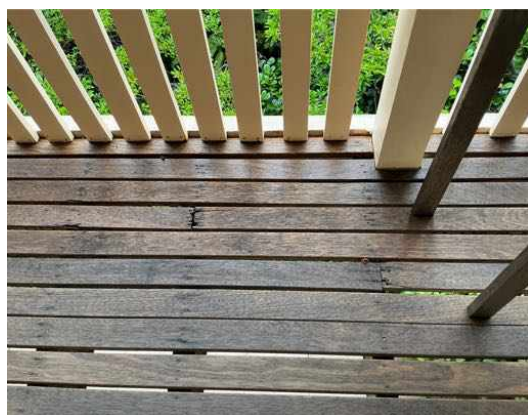
Defects 3.07

Building:	Main Building
Location:	Deck and balustrade
Finding:	Wood rot
Information:	This building element shows evidence of wood rot. Wood rot, also known as Fungal Decay, occurs when timbers and other cellulose building materials are exposed to damp conditions on an ongoing basis. This could be the result of exposure to weathering over a prolonged period of time, or the attraction of excessive moisture from other abutting building materials. Contributing factors also include poor air ventilation in the area.

Wood rot is often associated with general damp problems and is evidenced by a 'musty' smell or mould and mildew occurring on surfaces. If left unmanaged, damp conditions can lead to further health problems and the decay of timbers will continue.

Early intervention and regular maintenance, particularly of exterior timbers, will prolong the useful life of these building elements. Prior to any works being performed, the cause of the moisture that has created the visible wood rot should be identified and addressed in a suitable manner. Replacement of affected timbers may then be a necessary step in protecting surrounding building elements from such deterioration.

A qualified plumber may be appointed to assess the cause of excessive moisture and to provide advice on any remedial works as required. A qualified carpenter or registered builder may also be required to replace affected building materials.

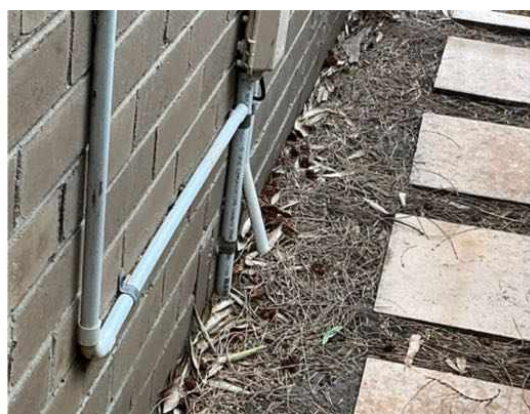
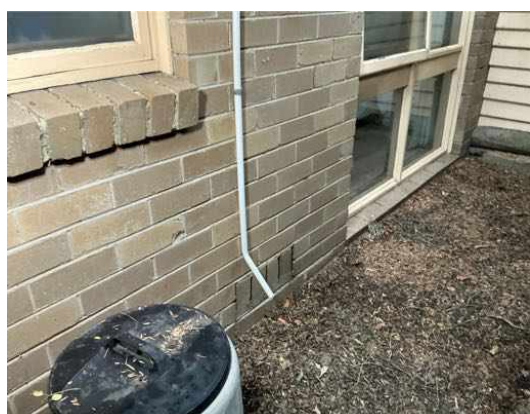
Defects 3.08

Building:	Main Building
Location:	All Areas
Finding:	Air conditioner - Disconnected overflow
Information:	The Air Conditioner (A/C) overflow was found to be disconnected from storm water drainage and is creating excessive moisture in the surrounding area.

Such leaking creates an environment which is conducive to an array of defects, including water damage to associated building elements and the attraction of termite or timber pest infestation.

It is highly recommended that a licensed plumber be appointed to connect the A/C overflow in order to prevent such an environment from being created. These minor works should be carried out as soon as possible.

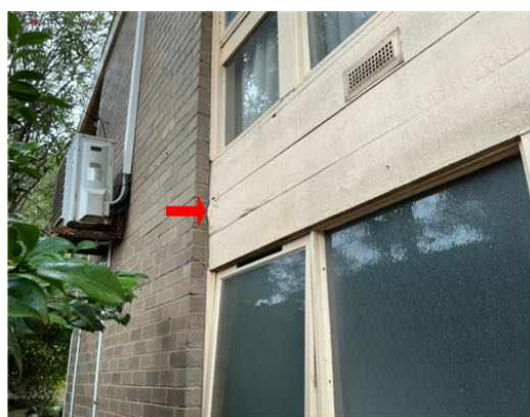
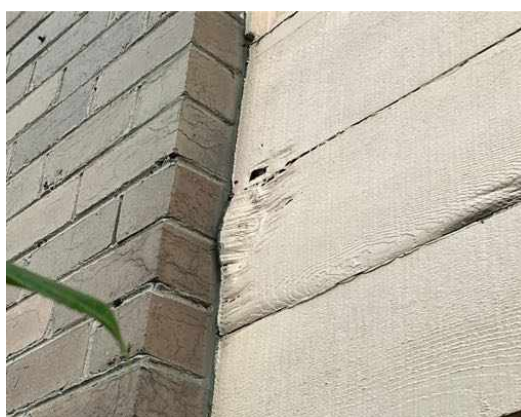
Defects 3.09

Building:	Main Building
Location:	Timber Cladding
Finding:	Weatherboards - Rotting
Information:	The external weatherboards show signs of fungal decay (wood rot) in several sections. This wood rot is suspected to have developed over a prolonged period of time due to

frequent weather exposure, which is expected in a property of this age and condition

Weatherboards are sealed and protected by paint and other sealants. When these sealants deteriorate over time, they allow water penetration to the weatherboards, causing wood rot. If left unmanaged, the wood rot is likely to develop further, possibly necessitating major repair or replacement works in the long-term future.

To maintain the condition of the external wall cladding, any severely affected weatherboards should be substituted as soon as possible with pre-treated replacements. Where weatherboards have rotted due to excessive moisture other than rain penetration, the cause of the moisture should be identified immediately by a licensed plumber. A qualified carpenter should be appointed to repair and replace rotting weatherboards.

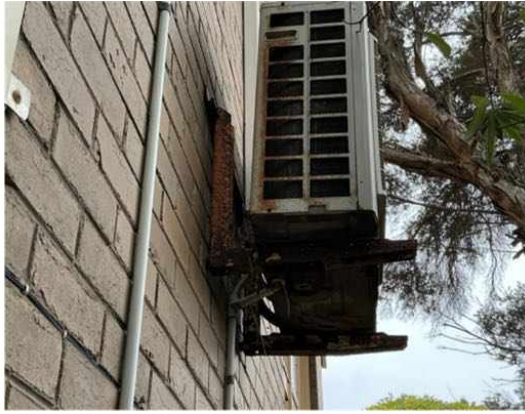
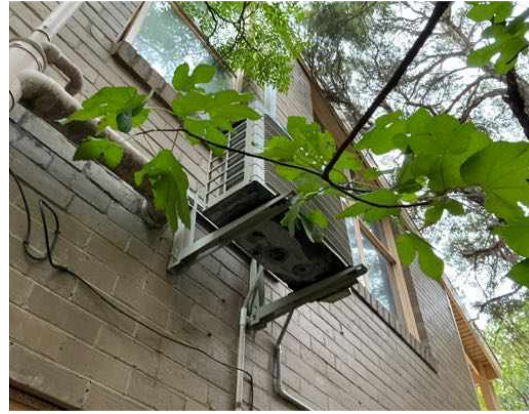
Defects 3.10

Building:	Main Building
Location:	Air conditioner, condenser
Finding:	Building element - Rusted or corroded
Information:	This building element shows evidence of rusting and corrosion, which is likely to have developed as a result of excessive exposure to moisture and or inadequate coatings.

As surface rust provides no protection to the underlying iron, the deteriorating condition is likely to worsen if not addressed in the short-term future.

Where possible, the use of galvanized (treated) metals or aluminium coated metals aid in rust prevention, as does regular general maintenance. Rust formation can be controlled with coatings, such as paint, that isolate the iron from the environment.

Rusting and corrosion should be managed by ideally removing or limiting the affected surface from exposure to moisture. A registered builder may be appointed to replace any building elements that have been severely affected by rust or water damage.

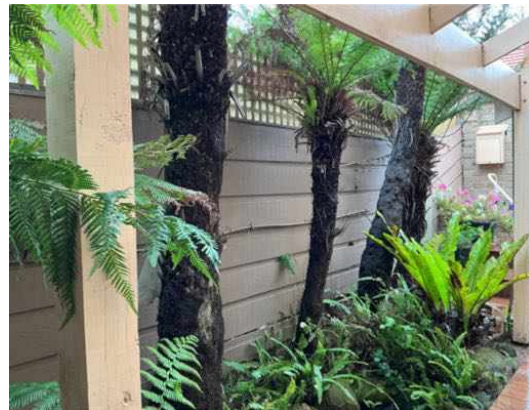
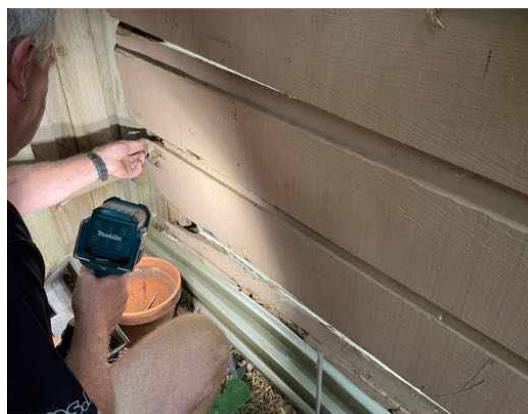
Defects 3.11

Building:	Main Building
Location:	Rear Elevation
Finding:	Fencing - Deteriorated with large sections of wood rot
Information:	It was noted at the time of inspection that sections of the fencing throughout the property have deteriorated. Typically fencing deteriorates due to age and or wear, rot and or rust which is generally expected for a structure of this age, due to prolonged exposure to weather conditions. Sometimes inadequate installation or maintenance can be to blame.

If left unattended, it is likely that further damage will occur. It is suspected that repair of several elements of the fencing may be required however replacement may be a consideration of the client also.

A licensed fencing contractor should be appointed to provide further advice and perform rectification works as necessary.

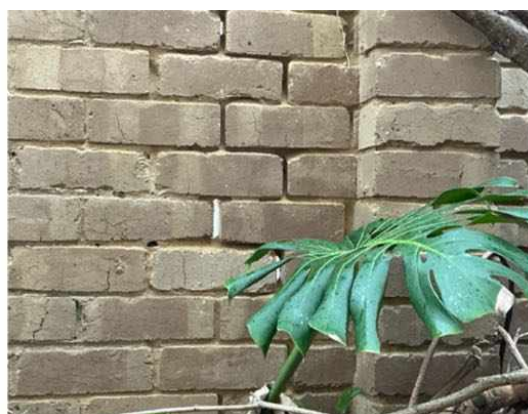
Defects 3.12

Building:	Main Building
Location:	Brick fence
Finding:	Brickwork - Deteriorated mortar
Information:	Mortar, or 'bedding', is the material which fills joints and intersections between bricks in masonry walls and structures. Sections of mortar in this brickwork were identified as having deteriorated, which is generally expected for a property of this age and condition.

Mortar may deteriorate as a result of age of building materials, minor movement of bricks, or frequent exposure to weathering. Mortar should be replaced to ensure that bricks remain in their intended location and to prevent gaps, which would allow water or moisture ingress and secondary damage as a result.

Mortar deterioration can be addressed by a bricklayer where areas of deterioration are localised and easily accessible. Alternatively, appointment of a registered builder is advised, to repoint large areas of decaying mortar. Where secondary structural defects have become evident, consultation with a structural engineer may be required.

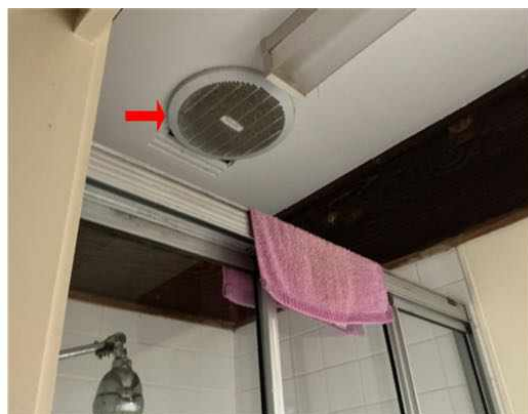
Building: Main Building
 Location: Ensuite - Master
 Finding: Unconventional handyman work
 Information: This handyman work appears to have been completed to a substandard level and does not comply with regular building practices. Where handyman work is not completed satisfactorily, accelerated deterioration of the associated building elements is likely to occur and secondary defects to surrounding structures may develop.

It is highly recommended that the substandard work be rectified by professional services. Works to improve this area are likely to increase the safety and the operation of the associated building elements.

The client should exercise care when coming into the immediate vicinity of the substandard works. Rectification works are advised as soon as possible by the appropriate trades.

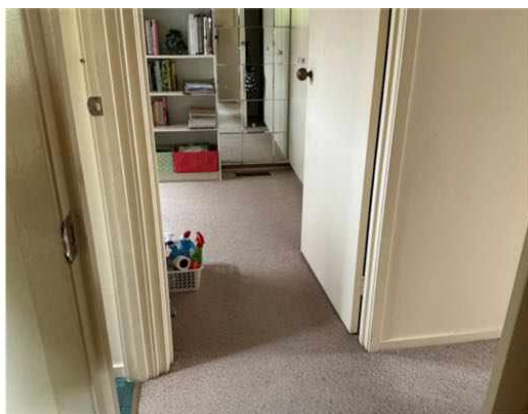
Building: Main Building
 Location: Study
 Finding: Floors squeaky
 Information: Floor in this area were found to be squeaky at the time of inspection, specialists in squeaky Floors may be able to rectify this issue.

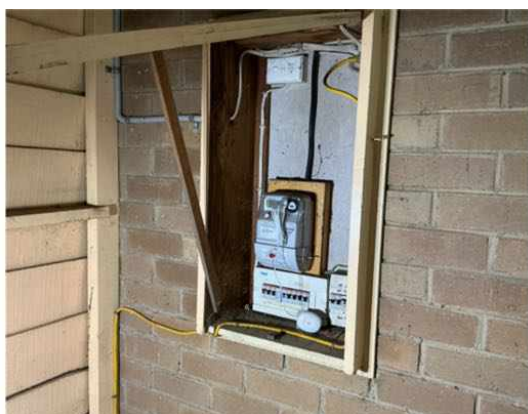
Building: Main Building
 Location: Electrical Switchboard
 Finding: Termite Management System - no evidence of a chemical installation
 Information: The application of a post-construction chemical termite barrier is highly recommended for all properties, particularly if live termite activity has been found on the site previously. Such barriers are highly effective in preventing termite attack on any timber building elements throughout the property.

The client may consider gaining further advice from a pest controller as to the costs and procedures involved with this application. It is recommended that obtaining such advice be a short-term priority.
