Building Inspection Report

Inspection Date: Wed, 4 Mar 2026

Property Address: 10/3-17 Taylor St, Parkdale VIC 3195,
Australia

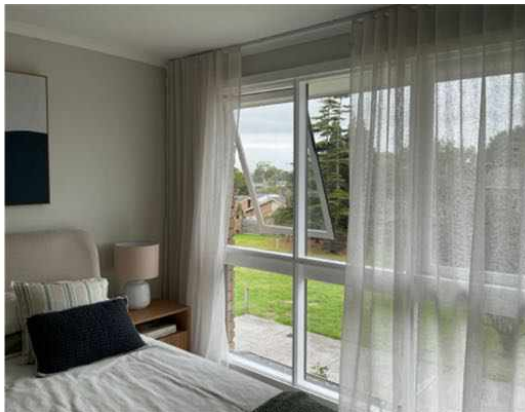
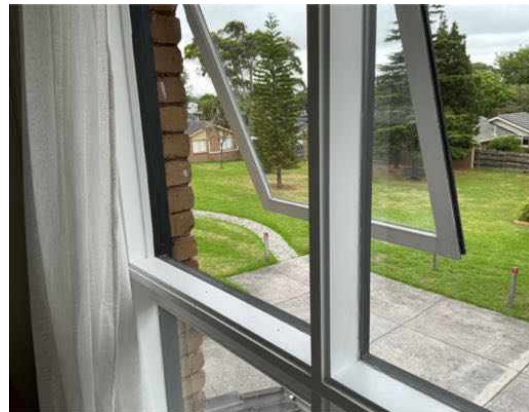
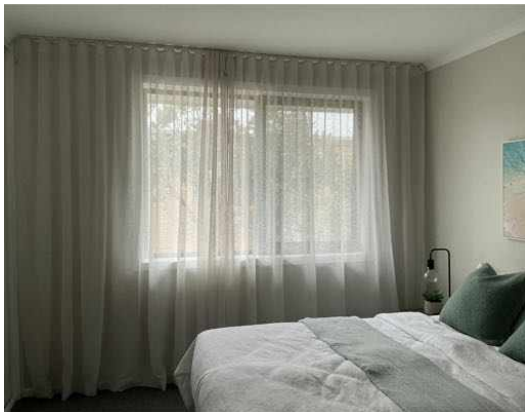
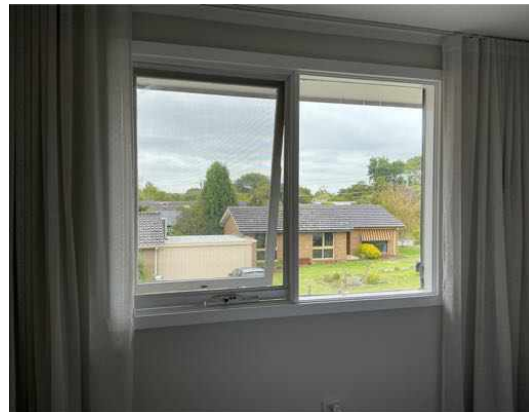
Defects 1.01

Building:	Main Building
Location:	Upstairs
Finding:	Windows not restricted opening
Information:	Second story windows in buildings constructed after 2013 must be fitted with devices to restrict the window opening more than 12.5cm to prevent falls. Even if this property was constructed prior to this date it is a safety hazard not to have restricting devices installed.

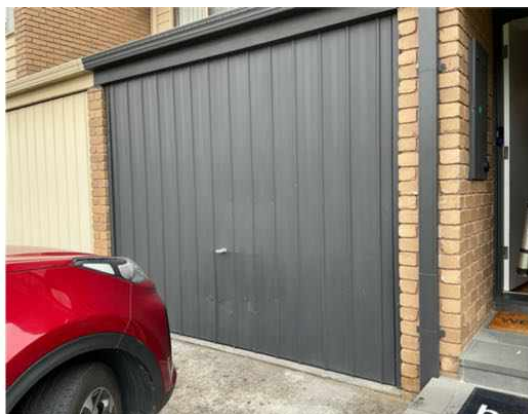
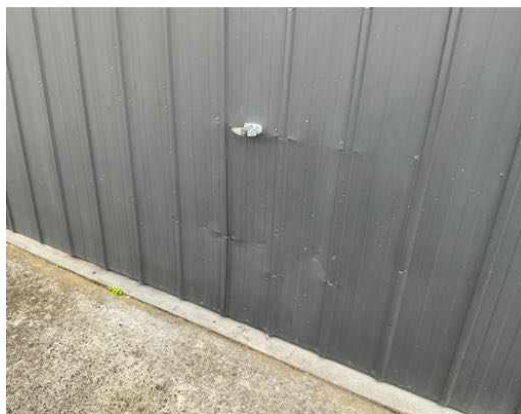
Defects 3.01

Building:	Main Building
Location:	Garage
Finding:	Garage door - Superficial markings
Information:	The garage roller door has a number of marks and dents likely to have resulted from impact damage be it accidental or deliberate impact at sometime.

Garage roller doors can fail when the building materials have aged but may be indicative of impact damage (accidental or deliberate). While superficial markings detract from the aesthetics of the building element, the functionality has not been hindered in any way.

Repair and/or replacement of the two garage doors would improve the condition of the garage but certainly not an urgent item

A qualified roller door installer or supplier should be engaged to check out the operation and overall condition of the doors to determine if repair is an option otherwise replacement may need to be considered.

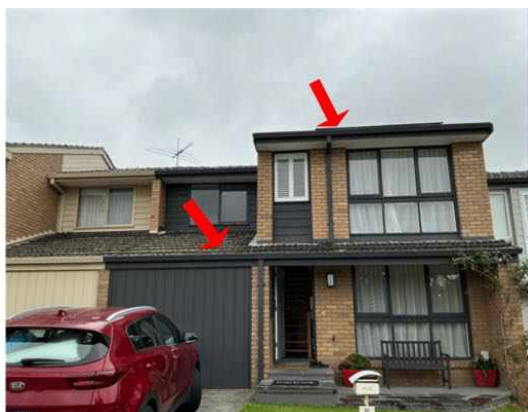
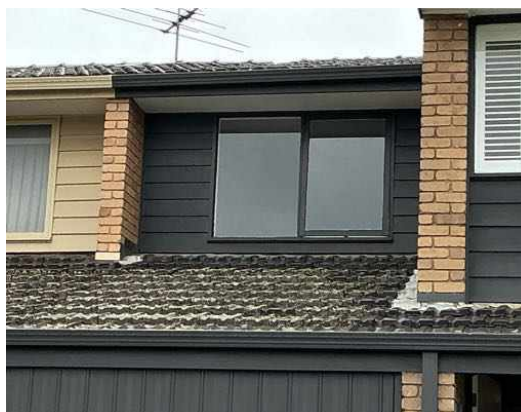
Defects 3.02

Building:	Main Building
Location:	Roof Exterior
Finding:	Roof tiles - Weathered
Information:	Upon inspection of the exterior roofing, the majority of roof tiles were considered to be in a fair condition. While weathering of the tiles is consistent with the age of the property, maintenance works are required.

Isolated areas of mortar have come loose in the valleys and minor cracking is also present. Re-pointing and re-sealing the may be considered as an interim solution by the client to help preserve and extend the life span of the tiles.

Where left unmanaged, deteriorating roof tiles are likely to lead to a number of secondary defects, including minor water leaks and weather exposure to internal roofing structures.

Consultation with a roofing contractor is highly advised to gain advice on cost of remedial works that may be required in the short to medium term. Remedial works are likely to increase the longevity of the exterior roofing structure.

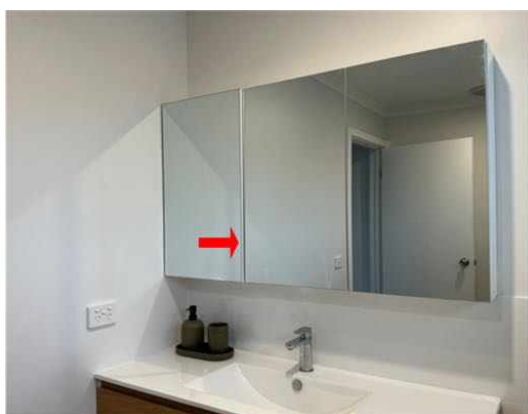
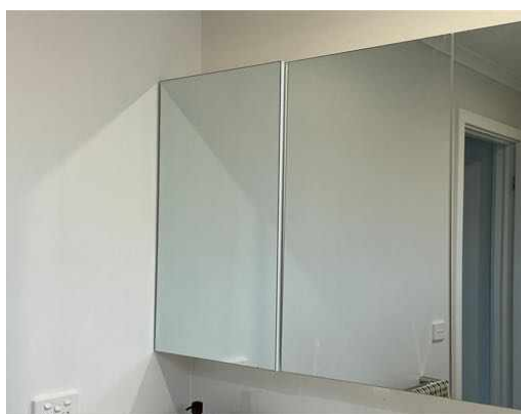
Defects 3.03

Building: Main Building
 Location: Bathroom
 Finding: Cabinetry - Loose hinges
 Information: Several cupboard doors are not level and detract from the operational state of the cabinetry. Upon further inspection, it was noted that the hinges to the cupboard doors have deteriorated over time and, as a result, have come loose from their original fixing. To improve operation of the affected cupboard doors, a general handyman may be appointed to replace the faulty hinges. Such works should be completed at discretion of the client.

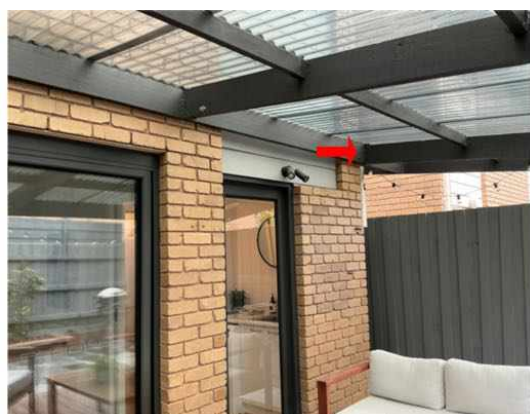
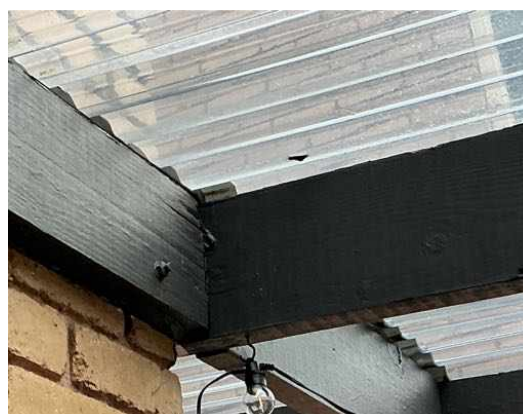
Defects 3.04

Building: Main Building
 Location: Alfresco
 Finding: Wood rot
 Information: This building element shows evidence of wood rot. Wood rot, also known as Fungal

Decay, occurs when timbers and other cellulose building materials are exposed to damp conditions on an ongoing basis. This could be the result of exposure to weathering over a prolonged period of time, or the attraction of excessive moisture from other abutting building materials. Contributing factors also include poor air ventilation in the area.

Wood rot is often associated with general damp problems and is evidenced by a 'musty' smell or mould and mildew occurring on surfaces. If left unmanaged, damp conditions can lead to further health problems and the decay of timbers will continue.

Early intervention and regular maintenance, particularly of exterior timbers, will prolong the useful life of these building elements. Prior to any works being performed, the cause of the moisture that has created the visible wood rot should be identified and addressed in a suitable manner. Replacement of affected timbers may then be a necessary step in protecting surrounding building elements from such deterioration.

A qualified plumber may be appointed to assess the cause of excessive moisture and to provide advice on any remedial works as required. A qualified carpenter or registered builder may also be required to replace affected building materials.

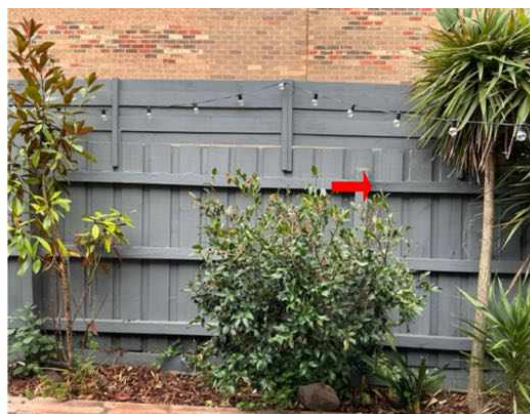
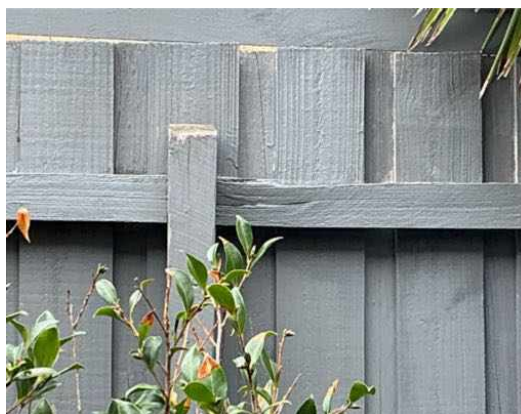
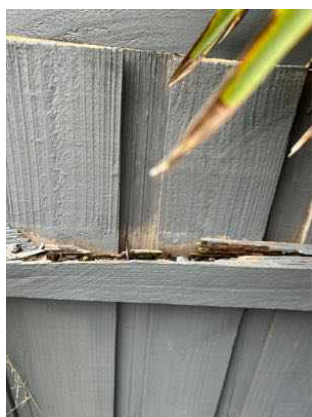
Defects 3.05

Building:	Main Building
Location:	Fencing
Finding:	Wood rot
Information:	This building element shows evidence of wood rot. Wood rot, also known as Fungal Decay, occurs when timbers and other cellulose building materials are exposed to damp conditions on an ongoing basis. This could be the result of exposure to weathering over a prolonged period of time, or the attraction of excessive moisture from other abutting building materials. Contributing factors also include poor air ventilation in the area.

Wood rot is often associated with general damp problems and is evidenced by a 'musty' smell or mould and mildew occurring on surfaces. If left unmanaged, damp conditions can lead to further health problems and the decay of timbers will continue.

Early intervention and regular maintenance, particularly of exterior timbers, will prolong the useful life of these building elements. Prior to any works being performed, the cause of the moisture that has created the visible wood rot should be identified and addressed in a suitable manner. Replacement of affected timbers may then be a necessary step in protecting surrounding building elements from such deterioration.

A qualified plumber may be appointed to assess the cause of excessive moisture and to provide advice on any remedial works as required. A qualified carpenter or registered builder may also be required to replace affected building materials.

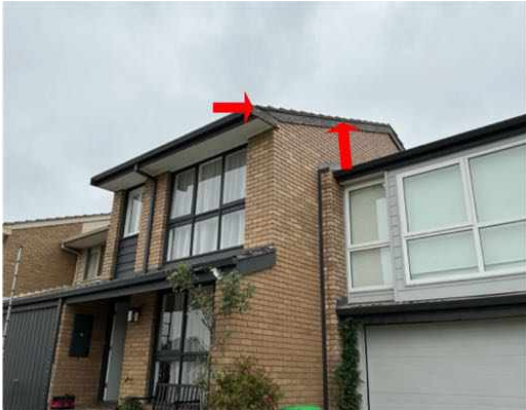
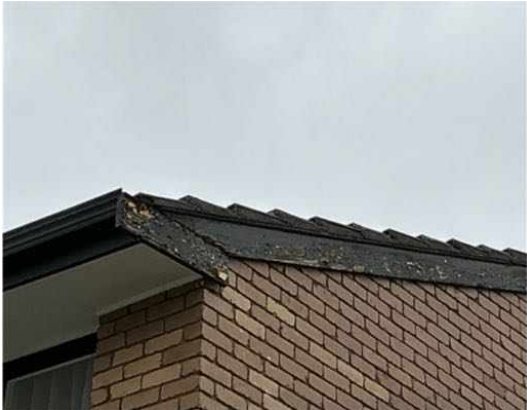
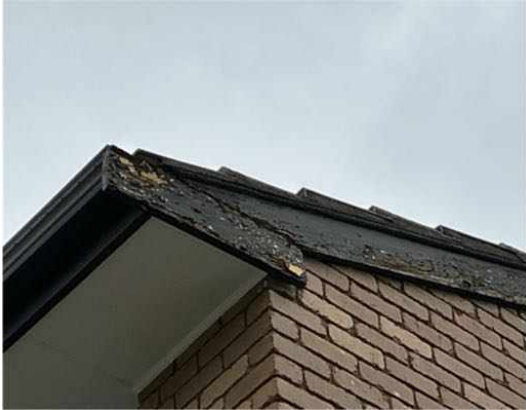
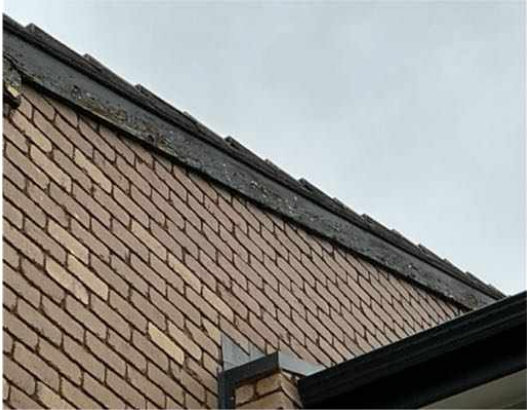
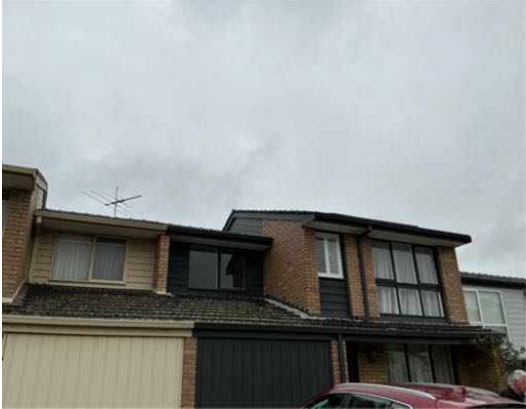
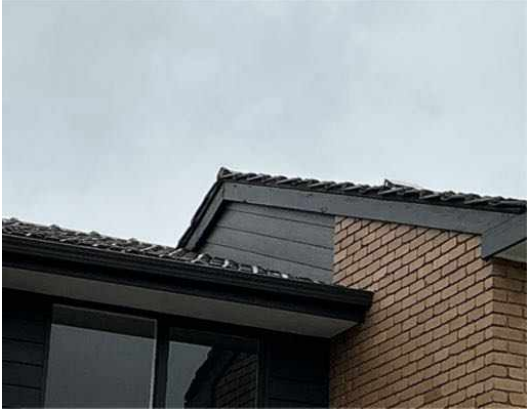
Defects 3.06

Building:	Main Building
Location:	Fascias
Finding:	Fascias - Wood rot
Information:	Wood rot was found to be affecting fascias and barges in this area, evidenced by the presence of mould on the surface in some areas. Wood rot, also known as Fungal Decay, occurs when timbers and other cellulose building materials are exposed to damp conditions on an ongoing basis.

It is likely that this wood rot has developed as a result of faults in the roof plumbing, creating excessive moisture in this areas. Frequent exposure to rain and other weather conditions also make fascias and barges susceptible to accelerated deterioration.

Early intervention and regular maintenance will prolong the useful life of these building elements. Prior to any works being performed, the cause of the moisture that has created the visible wood rot should be identified and addressed in a suitable manner.

It is advised that a roof plumber be appointed to inspect all roof plumbing and subsequently identify the cause of the wood rot. Replacement of affected fascias and barges may then be a necessary step in protecting surrounding building elements from such deterioration.

A qualified plumber may be appointed to assess the cause of excessive moisture and to provide advice on any remedial works as required. A qualified carpenter or registered builder may also be required to replace affected building materials.

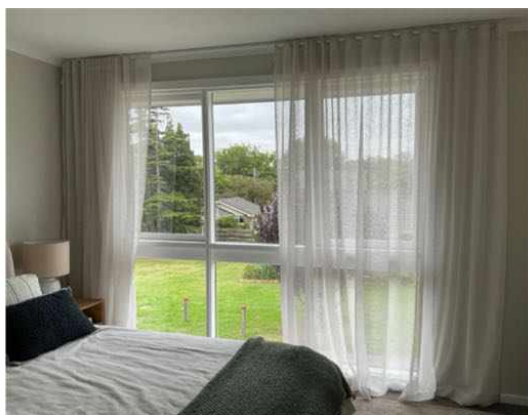
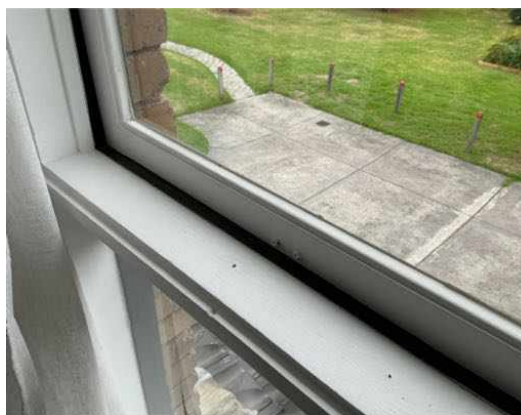
Defects 3.07

Building:	Main Building
Location:	Upstairs bedroom
Finding:	Building element - Missing window handles
Information:	Although some building elements may seem irrelevant or unnecessary, all building elements play a key role in the operation and function of the overall structure and its performance.

Replacement of any missing building element should be conducted as soon as possible to ensure that no damage or functional issues occur to associated building materials.

The appropriate tradesperson should be appointed as soon as possible to replace the missing building element.

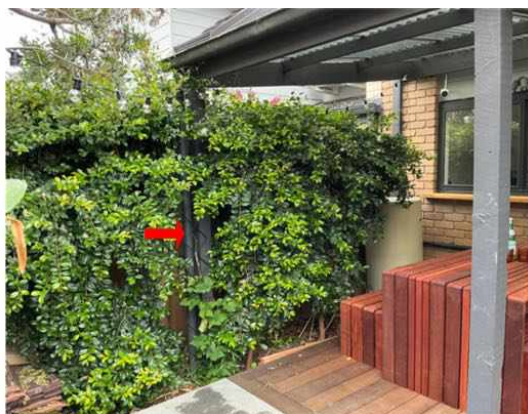
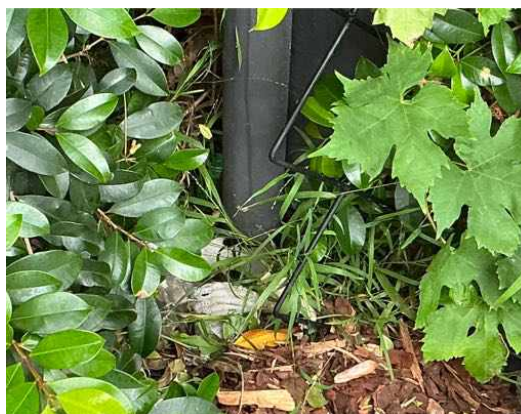
Defects 3.08

Building:	Main Building
Location:	Alfresco
Finding:	Stormwater drain - Not connected
Information:	The roof plumbing is not adequately connected to stormwater drainage on the site. This disconnection negatively impacts the functional capacity of the roof plumbing.

Where roof plumbing doesn't drain adequately, the area at the base perimeter can become excessively damp, potentially creating an environment that is susceptible to rust and corrosion of surrounding building elements, as well as attracting termites and other pests.

It is highly recommended that a plumber be appointed to further inspect the area and to install adequate drainage equipment where necessary.

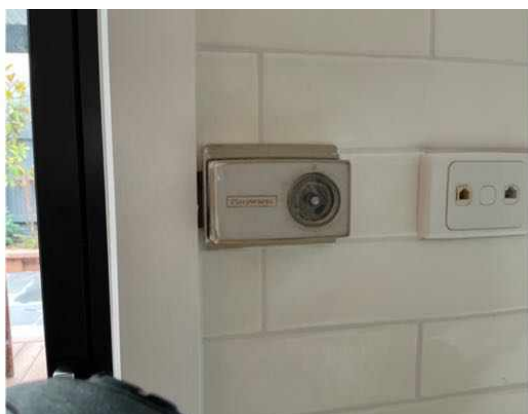
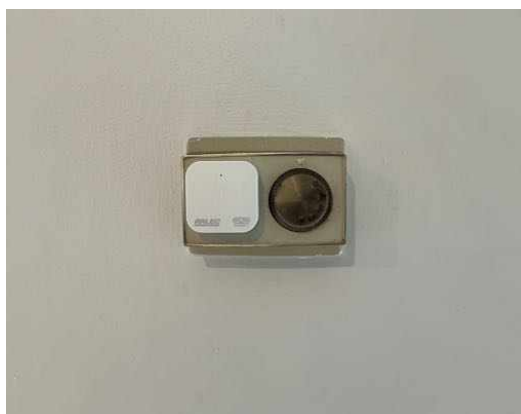
Defects 3.09

Building:	Main Building
Location:	All Areas
Finding:	Warranty - Expired (floor heating)
Information:	Where appliances are beyond their warranty period, the owner should be prepared to meet the cost of replacement or repair of the item at any time. The operation of the appliance can not be guaranteed and further inspection by an appropriately qualified tradesperson may be required.

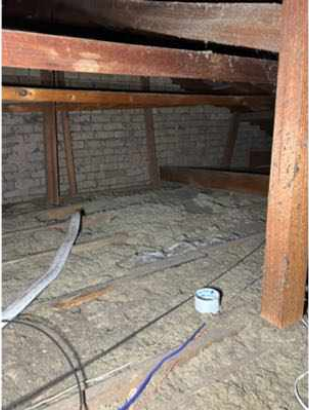
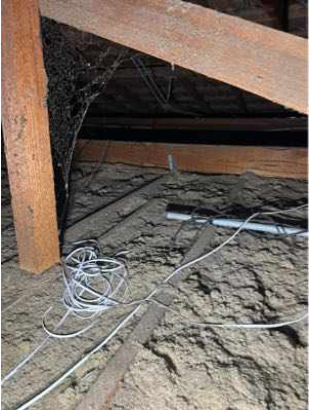
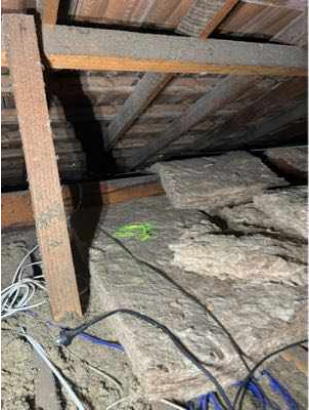
Defects 3.10

Building:	Main Building
Location:	All Areas
Finding:	Insulation - Reduced in volume
Information:	<p>Insul-fluff is common in many older homes and is a loose form of insulation that is 'blown' into roof voids. While this type of insulation was considered effective at the time of installation, modern materials have surpassed it as the preferred insulator.</p> <p>This type of insulation is susceptible to settling and reducing in volume, detracting from its effectiveness and resulting in an overall loss of energy within the household. Additionally, the reduction in volume has led to an uneven distribution of insulation within the ceiling void, further detracting from its effectiveness.</p>

It is highly advised that this insulation be removed and replaced with a more appropriate material. This will ensure that the property is adequately insulated and will promote an increase in energy efficiency within the property. An insulation contractor should be appointed to provide further advice on replacement options and to perform works as necessary.

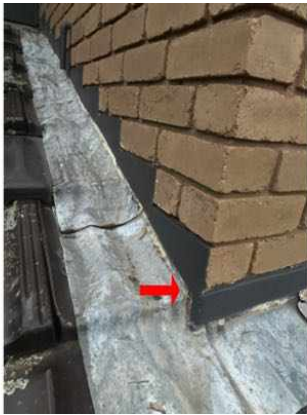
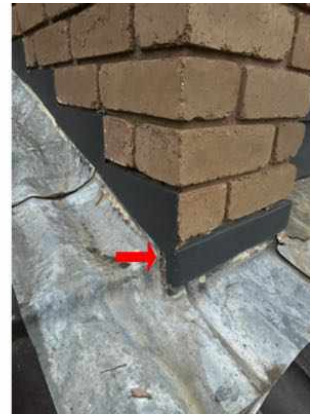
Defects 3.11

Building: Main Building
Location: Flashings
Finding: Caulking/sealant to junctions - Missing
Information: Areas where waterproof sealant to is missing to junctions were identified.

All Sealant/ Caulking works should be completed by a caulking contractor.

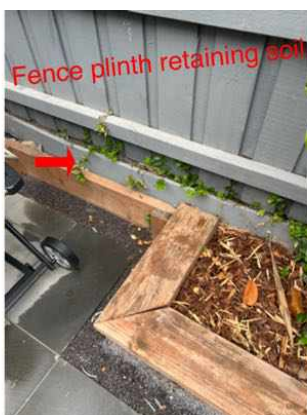
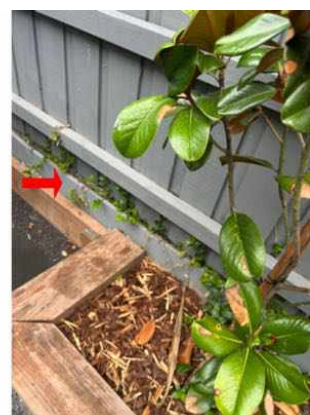
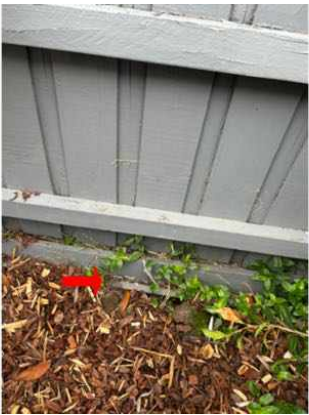
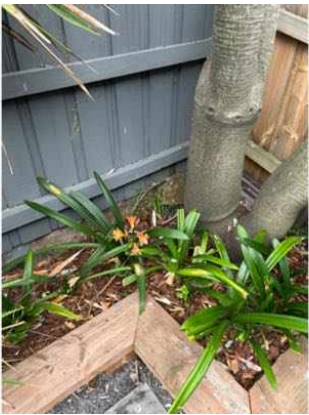
Defects 3.12

Building: Main Building

Location: Fencing

Finding: Retaining wall - Defective

Information: The retaining wall in this area was found to be defective at the time of inspection. Generally, defective retaining walls are caused by poor original design or material use. However, deteriorated retaining walls may also be a result of substandard construction, poor site drainage or unmanaged stormwater flows.

If left unmanaged, the retaining wall may become a safety hazard if it continues to destabilise. Where retaining walls further rot and decay, an environment is created that is conducive to termite and pest infestation.

Significant repair and replacement should be expected. Where retaining walls are considered structural walls, a structural engineer / surveyor should be consulted regarding required remedial works. Otherwise, a landscaper or retaining wall installer may be appointed to repair or replace the wall, at the discretion of the client.

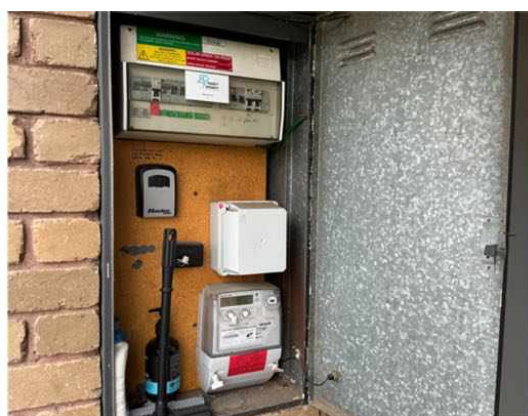
Building:	Main Building
Location:	Electrical Switchboard
Finding:	Termite Management System - no evidence of a chemical installation
Information:	The application of a post-construction chemical termite barrier is highly recommended for all properties, particularly if live termite activity has been found on the site previously. Such barriers are highly effective in preventing termite attack on any timber building elements throughout the property.

A durable notice should be placed in the switchboard unit to indicate current termite barriers. At the time of inspection, it appeared as though no termite management system has been installed, with no evidence to suggest preventative works taking place.

The client may consider gaining further advice from a pest controller as to the costs and procedures involved with this application. It is recommended that obtaining such advice be a short-term priority.

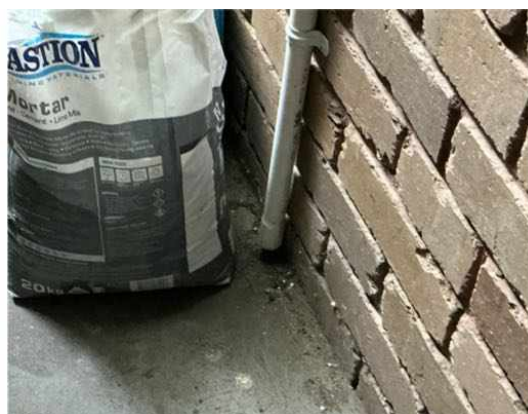
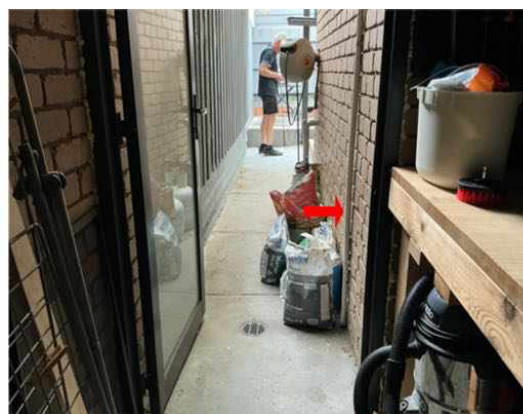
Building:	Main Building
Location:	Exterior walls - left side

Finding: Air conditioner - Disconnected overflow

Information: The Air Conditioner (A/C) overflow was found to be disconnected from storm water drainage and is creating excessive moisture in the surrounding area.

Such leaking creates an environment which is conducive to an array of defects, including water damage to associated building elements and the attraction of termite or timber pest infestation.

It is highly recommended that a licensed plumber be appointed to connect the A/C overflow in order to prevent such an environment from being created. These minor works should be carried out as soon as possible.

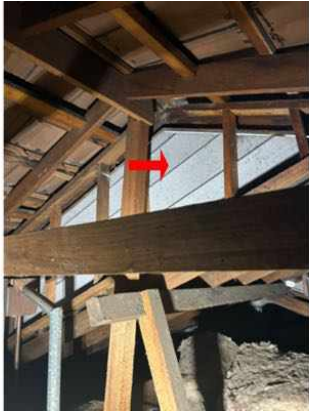
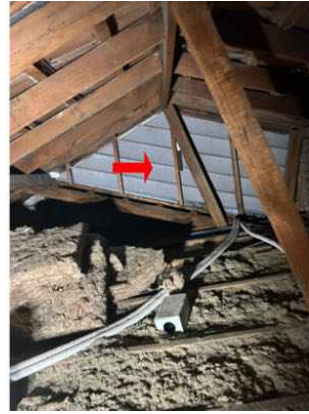
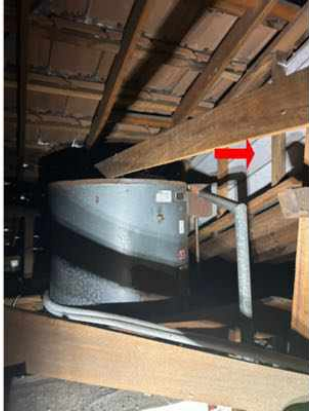
Information: Reporting on Asbestos is outside the Scope of this Report. This suspected defect is highlighted as a caution only. We suspect, based on our experience in the building industry, that there is a higher risk of the identified building element containing asbestos.

As Asbestos Reporting is outside the scope of this report, we advise that you consider a separate Asbestos Inspection and Condition Audit, which can include the taking of samples for definitive confirmation of the presence of Asbestos.

In the interim, the client is advised to act with caution, especially when considering any damage to building materials general wear and tear renovations extensions demolition and general maintenance activities due to the suspected presence of Asbestos.

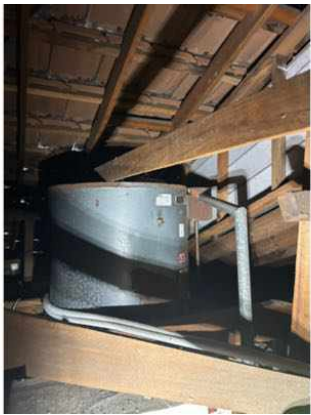
Building:	Main Building
Location:	Roof Void
Finding:	Gravity-Fed HWS - Disconnected
Information:	It was noted at the time of inspection that a disconnected gravity-fed hot water system (HWS) remains in this area.

Despite this plumbing structure being unused, it is likely to be storing residual water, and is therefore susceptible to rust and corrosion. If allowed to continue, rust and corrosion is likely to lead to damage to adjoining building elements, and may also make the area susceptible to termite or timber pest activity.

While it is a costly exercise to remove the disused gravity-fed HWS, it is advisable in the short-term future to prevent any further damage to the area. Further consultation with a licensed plumber is required to gain further advice on removal of the structure.
