# Building and Timber Pest Inspection Report

Inspection Date: Fri, 13 Mar 2026

Property Address: 12 Birkdale Cl, Wantirna VIC 3152, Australia

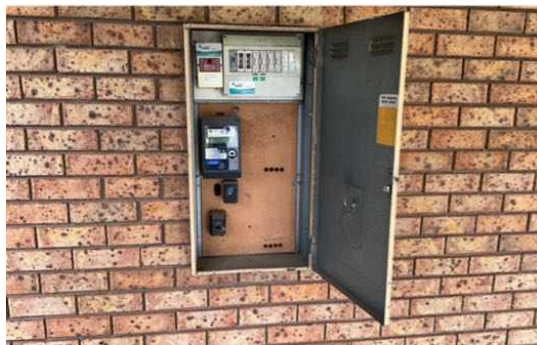
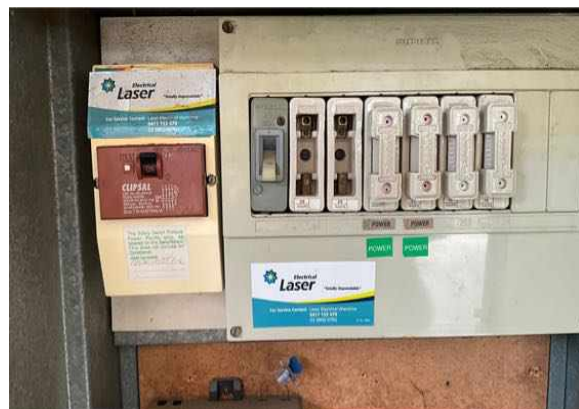
It is noted for the clients consideration that a switchboard upgrade will be required in the short to mid term to improve the functionality and safety of the electrical system.

A licensed electrician should be appointed to provide quotation for the works at the client's discretion which may in turn expose other required works to bring the system up to a compliant state.

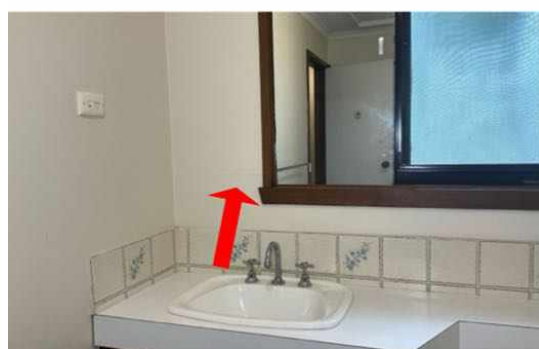
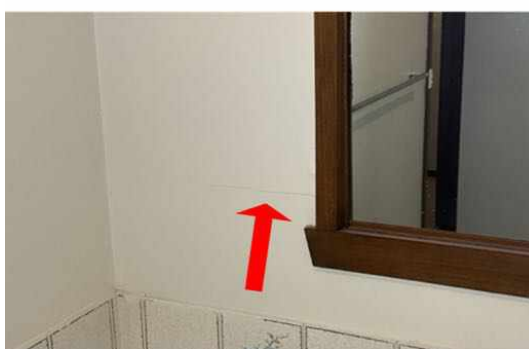
Finding: Cracking - fine

Information: Some fine cracking was noted throughout the property.

appearance defect, and usually do not indicate any structural damage. Generally, the cause of a fine crack is indicative of a separation between building materials and finishes (e.g. paint, plaster, etc.) along joins.

Note: photos included are indicative of fine cracking noted at the the time of inspection. Other fine cracks may be present but not recorded here.

Cracking of this nature can generally be repaired with minor sanding, filling and/or repainting. Such works should be performed by a qualified painter or a general handyman.

Monitoring of all cracking should be conducted frequently. Always contact a building inspector should cracks widen, lengthen, or become more numerous.

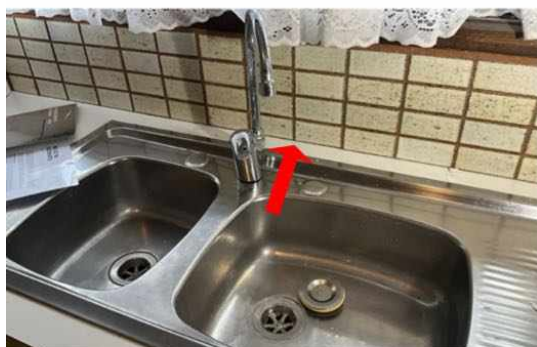
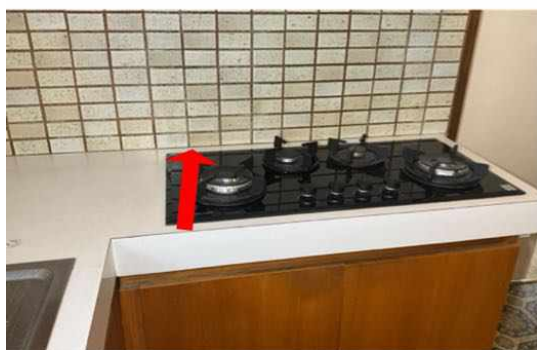
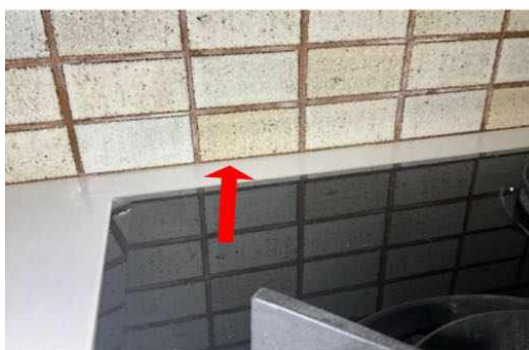
### Finding 3.02

Sealant - Missing or degraded

Sealant is missing or degraded in this area. Sealant is used to protect gaps and crevices in building materials to ensure that they are water-tight and prevent water penetration to the associated structures.

Where sealant is missing or degraded , a tiling contractor should be appointed immediately to re-apply any silicone where necessary. Failure to do so may lead to water damage to the surrounding area.

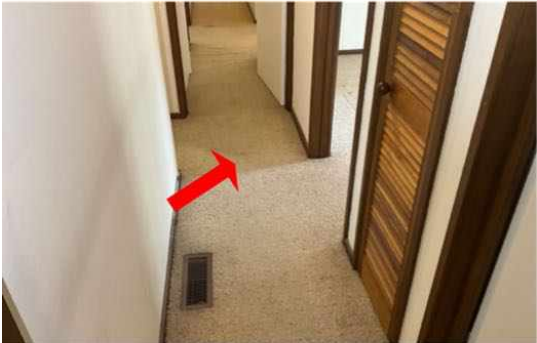
### Finding 3.03

Creaking floors generally indicate that the floorboards or the subfloor structures are coming loose from the supporting structure that they are installed on.

The areas should be monitored for any changes or unevenness. Should this occur, consultation with a registered builder should be undertaken to determine the cause. The potential resolution may involve regluing and screwing the floor down through to replacement of subfloor support structures.

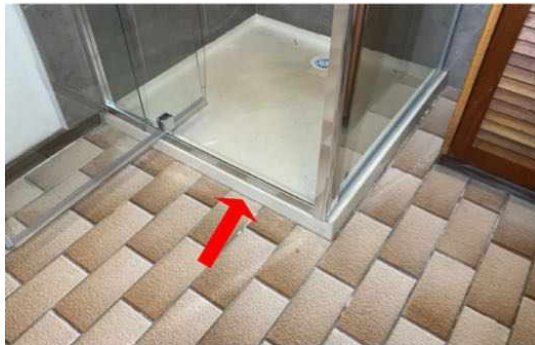
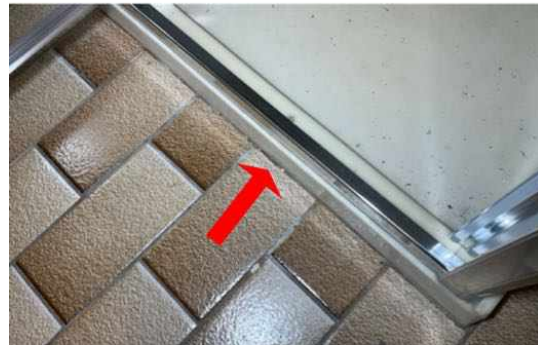
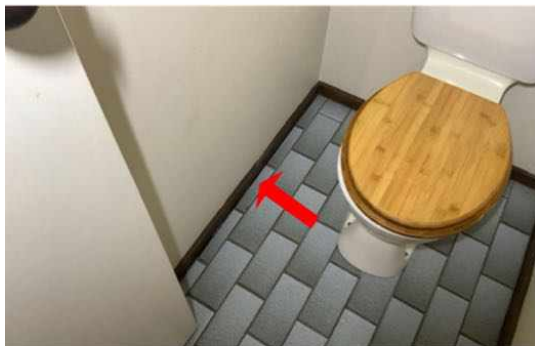
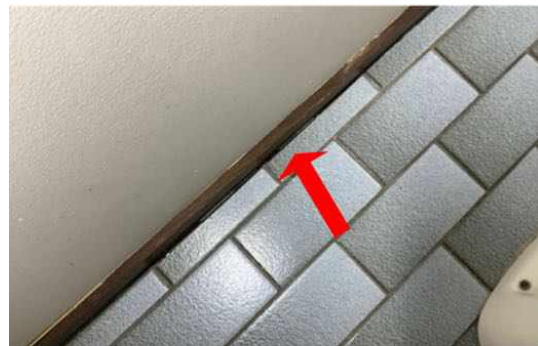
Finding 3.04

Building:  
Location: Bathroom  
Finding: Grout and sealant - Missing or degraded within the bathroom area  
Information: It was noted on inspection that grout or sealant is degraded to areas within the bathroom.

Different materials move at different rates, generally causing cracking to grout at this point. Build up of moisture in the bathroom can also cause grout and sealants to degrade and become mouldy.

Any damaged or degraded materials should be scraped out and flexible and mould resistant materials should be applied to affected areas to prevent any subsequent water damage that may occur. Regular maintenance and replacement of damaged or missing grout/ sealant is highly recommended to the wet areas, as this is a regular wear and tear defect. Both grout and sealant in areas that come into regular contact with water should be maintained for the long term care of your property.

A bathroom specialist or tiling contractor should be appointed to complete these works as soon as possible.

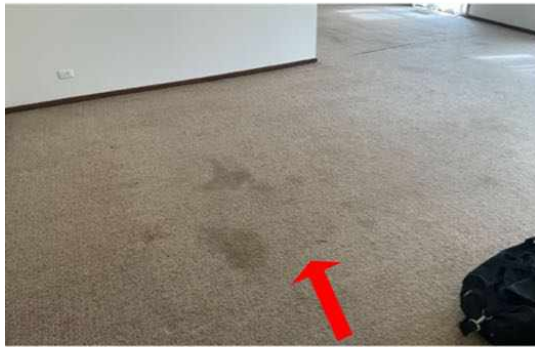
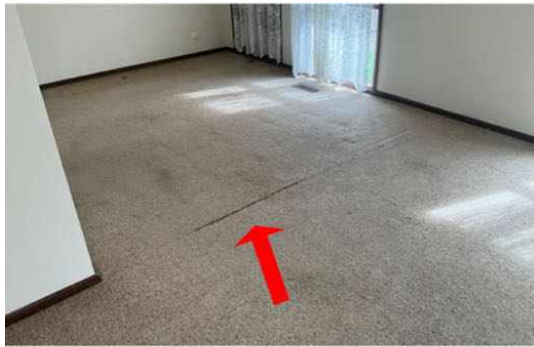
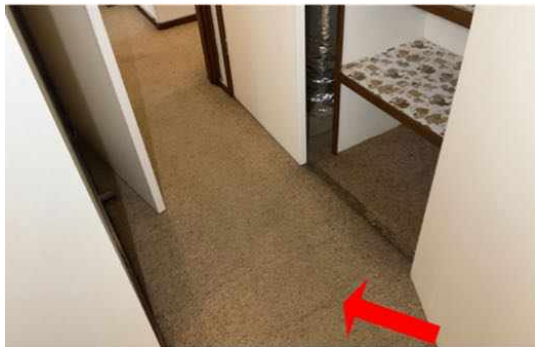
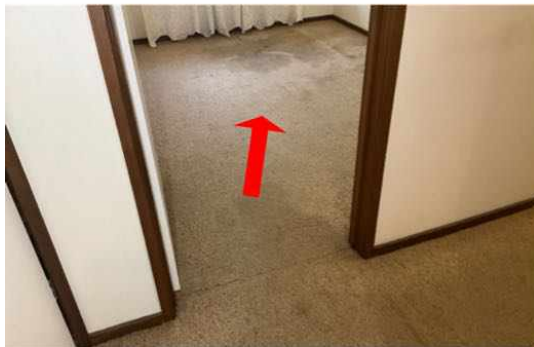
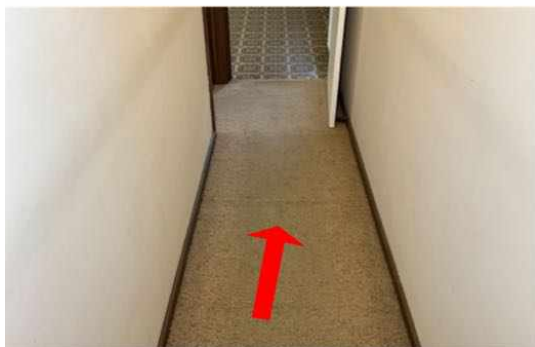
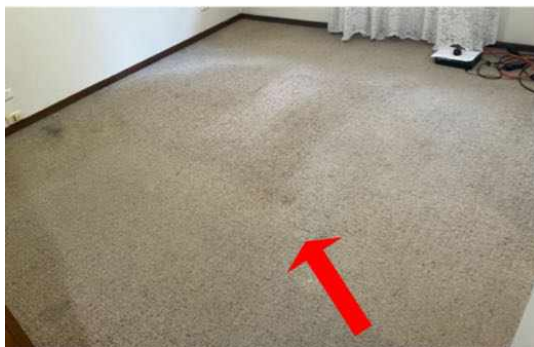
Location: All Areas  
Finding: Carpet stained and deteriorated in some areas  
Information: At the time of inspection, the carpet throughout the property was stained and deteriorated. It was observed that several areas were loose and raised. This is consistent with properties of this age.

The carpet may be replaced at the discretion of the homeowner.

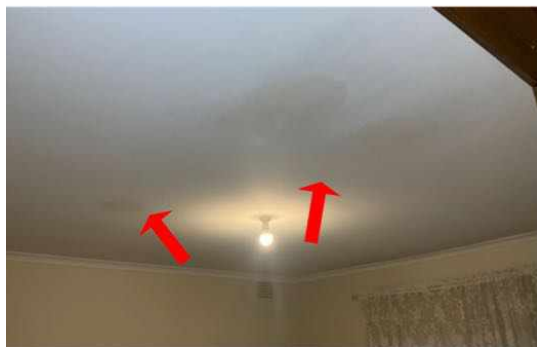
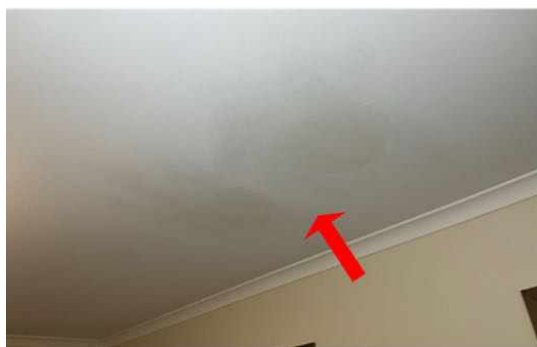
### Finding 3.07

Building:  
Location: Bedroom 2

Finding: Ceiling marked - no current moisture noted  
 Information: At the time of inspection, there appeared to be some marks to the ceiling in this area. It is unclear how the marks have occurred. It is suspected that there may have been some patching and repainting carried out to the ceiling.

At the time of the inspection, there was no moisture within the marked area of the ceiling when tested with a moisture meter.

It is recommended that the area be monitored for any changes or increase in marks. Should this occur, consultation with a roofing plumber should be undertaken to determine the source of the leak and make necessary repairs.

Should no changes occur, the area may be repainted at the discretion of the homeowner.

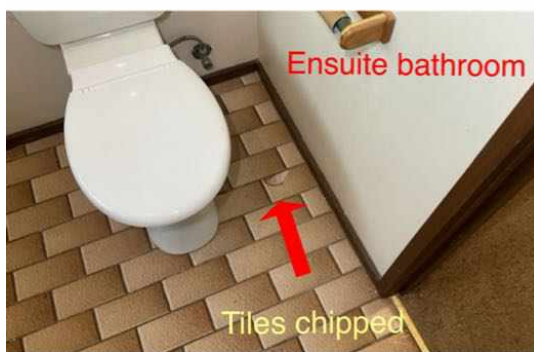
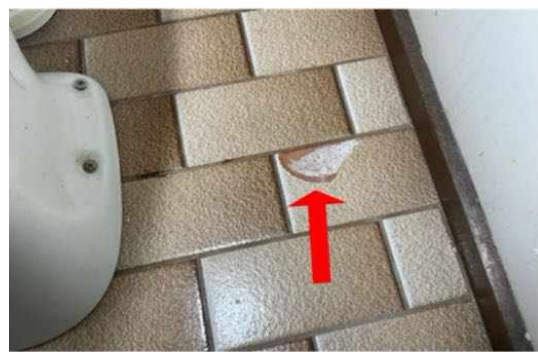
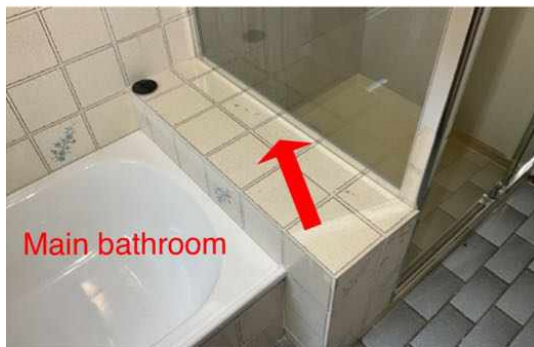
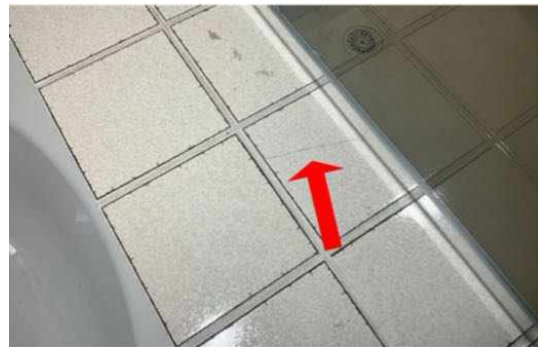
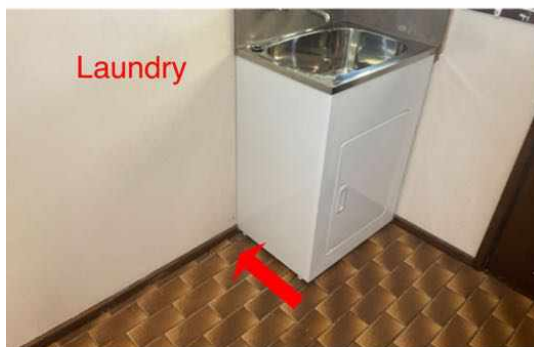
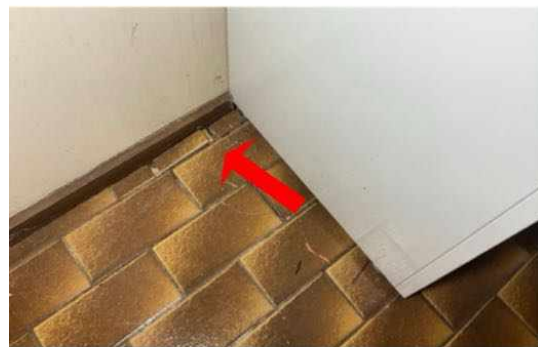
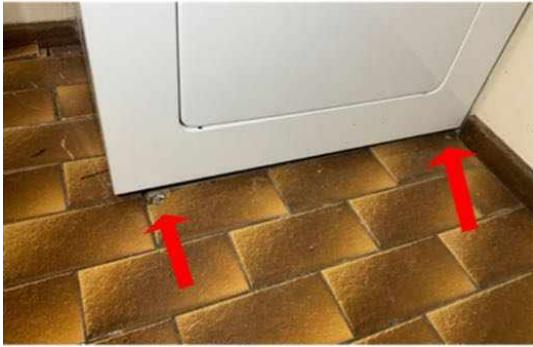
### Finding 3.08

Building: All Areas  
 Location: All Areas  
 Finding: Floor tiles - Cracked/ chipped  
 Information: Cracking and chipping in the floor tiles was evident in this area at the time of inspection. It is suspected that this cracking has occurred as a result of the floor being uneven and lacking a solid or suitable foundation for the tiles to be laid on. Settlement

in the floor foundations may also have caused movement and resulted in the cracking of tiles in this area. Impact damage to the area may also be a cause.

Cracked / chipped tiles throughout the household detract from the overall appearance of the affected areas, as well as creating potential for water penetration to adjoining building elements. If left unmanaged, water damage may occur as a result of constant water penetration over a prolonged period of time.

While not considered a matter of urgency, replacement of cracked/ chipped floor tiles is advised as a solution. A tiling contractor or general handyperson may be appointed to perform these works at client discretion. Where cracks become more numerous, consultation with a registered builder specialising in re-stumping may be required.

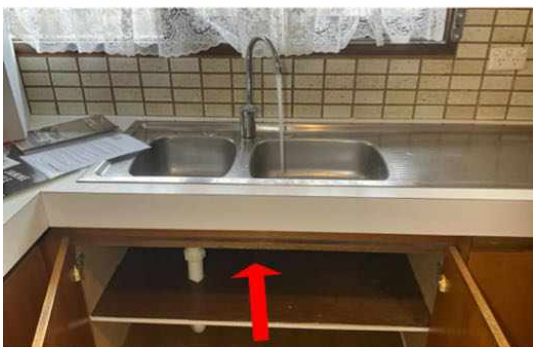
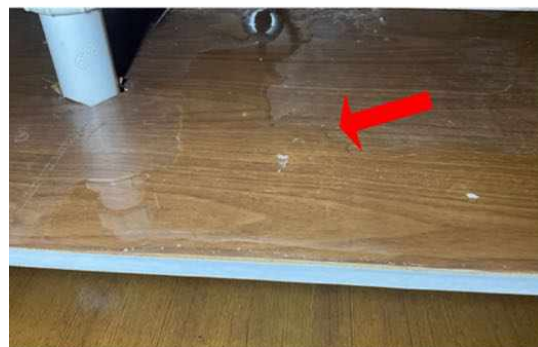
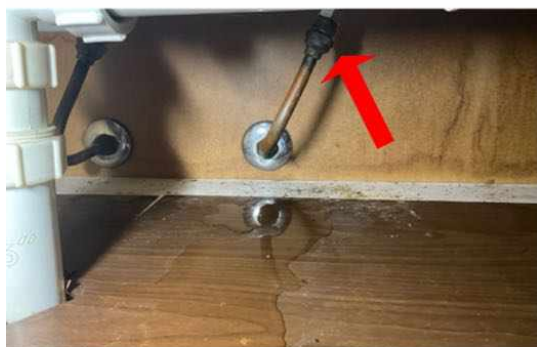
### Finding 3.09

Finding: Tap - Leaking

Information: The tap in the kitchen was found to be leaking at the time of inspection. This is a common defect that is consistent with general ageing of the tapwear.

While this defect only seems minor, if left unmanaged, it is likely to result in the development of rust, water damage and/or extensive water usage.

It is advised that a licensed plumber be appointed to perform remedial works on the affected tap. Such works should be performed prior to the development of secondary defects to ensure adequate functionality of all associated building elements.

Please note this defect should not be left unattended. Failure to repair this leaking tap may result in further deterioration of the property.

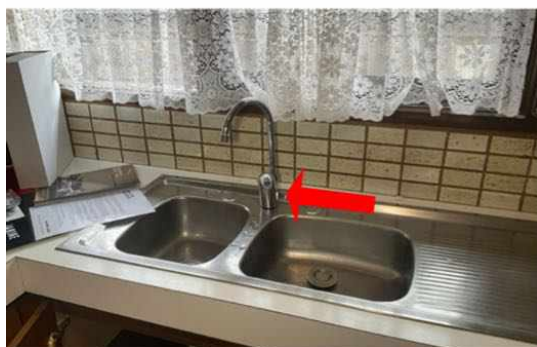
### Finding 3.10

Finding: Tap - Loose

Information: The tap in this area has not been installed correctly, or has deteriorated with age, and is consequently loose. This tap being loose creates potential for water leaks and subsequent water damage to the surrounding area.

Failure to act on this defect may cause the the tap to further deteriorate and cause leaking.

Where taps or spouts are loose, a qualified plumber should be appointed to re-fix the plumbing fitting as a matter of urgency.

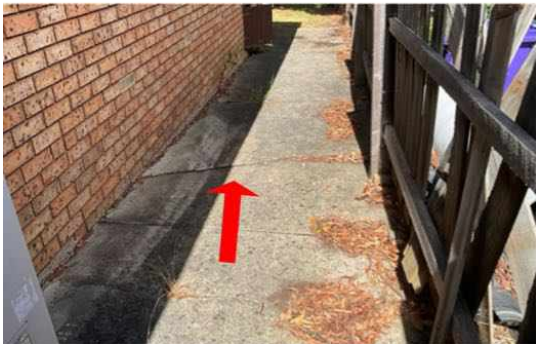
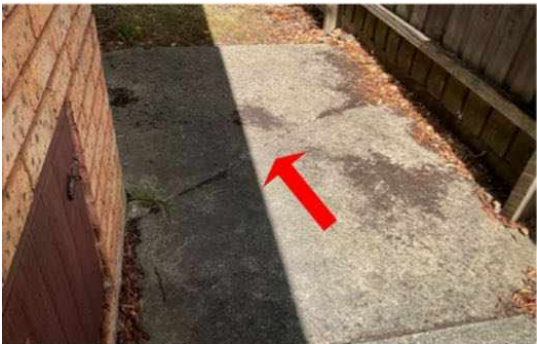
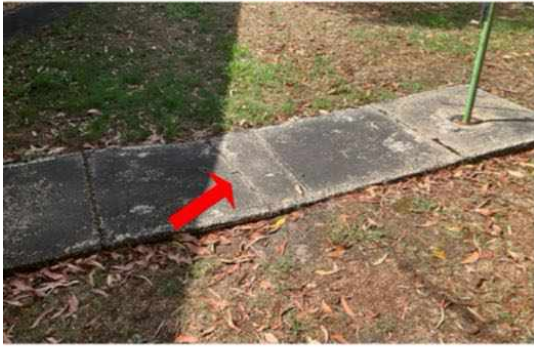
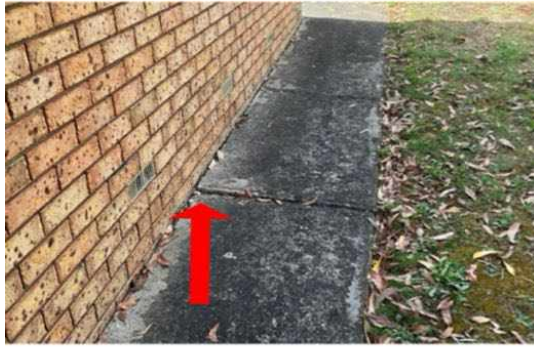
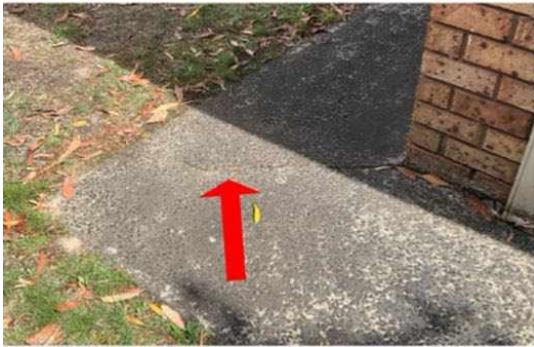
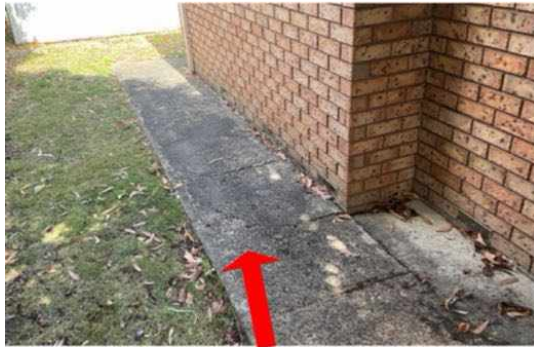
Building:  
Location: All External Areas  
Finding: Noticeable Cracking - External Concrete Paving  
Information: Noticeable cracks were identified in the concrete paving at the rear of the property.

General age and expected deterioration of the paved areas is a common cause of this type of cracking. However, expansion and contraction of the concrete may also have occurred due to environmental factors. Such factors include variable moisture and weather conditions, the presence of trees and their roots having a settling or lifting affect on the soil, or the effect of load bearing over a sustained period of time.

Cracking to this degree may also be due to poor original installation of the concrete. Factors such as poor compaction of the sub surface and/or inadequate reinforcing of the slab may create cracking and other secondary defects. Noticeable cracks may also be due to subsidence of soils.

The area should be monitored for any changes that may occur and potentially cause tripping hazards. Should this occur, repair and likely replacement of the concrete paving may be necessary.

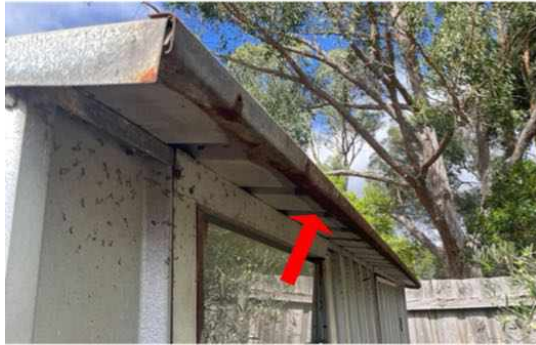
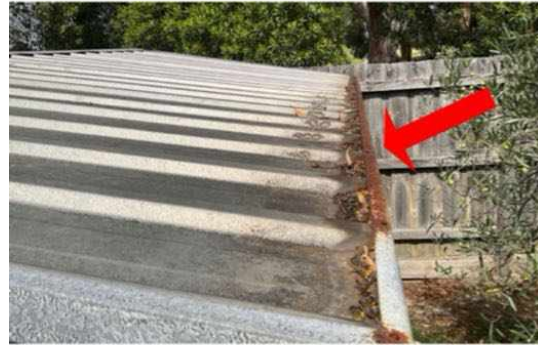
### Finding 3.14

Finding: Shed Roof - Rusted

Information: This building element shows evidence of rusting and corrosion, which is likely to have developed as a result of excessive exposure to moisture and or inadequate coatings.

As surface rust provides no protection to the underlying iron, the deteriorating condition is likely to worsen if not addressed in the short-term future.

Where possible, the use of galvanized (treated) metals or aluminium coated metals aid in rust prevention, as does regular general maintenance. Rust formation can be controlled with coatings, such as paint, that isolate the iron from the environment.

Rusting and corrosion should be managed by ideally removing or limiting the affected surface from exposure to moisture.

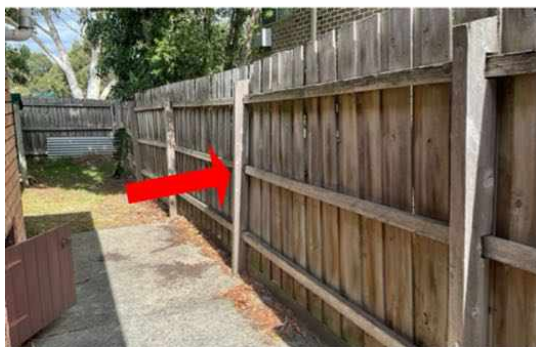
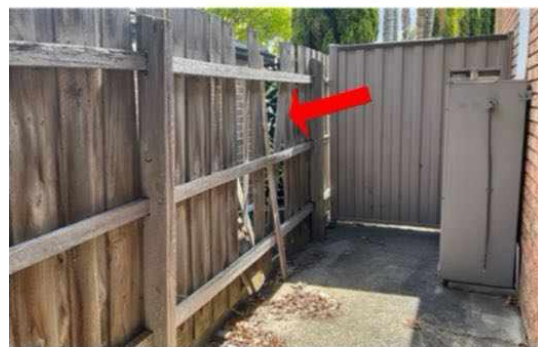
### Finding 3.15

Finding: Fencing - Deteriorated

Information: It was noted at the time of inspection that sections of the fencing throughout the property have deteriorated. Typically fencing deteriorates due to age and or wear, rot and or rust which is generally expected for a structure of this age, due to prolonged exposure to weather conditions. Sometimes inadequate installation or maintenance can be to blame. Significant wood rot was noted in sections of the fencing.

If left unattended, it is likely that further damage will occur. It is suspected that repair and replacement of several elements of the fencing will be required.

A licensed fencing contractor should be appointed to provide further advice and perform rectification works as necessary.

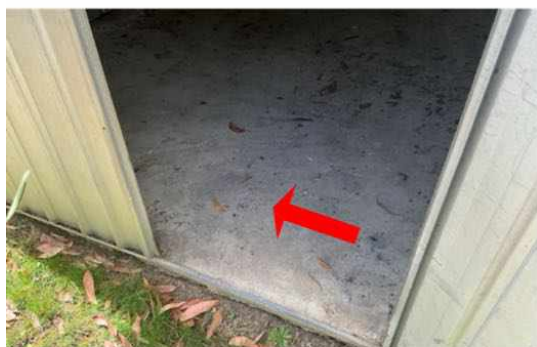
### Finding 3.16

Finding: Fine Cracking - concrete floor within shed

Information: Fine cracks were identified in the concrete flooring of the shed . Although fine cracks are quite noticeable, they are often only considered to be an appearance defect, and usually do not indicate any structural damage.

Generally the cause of a fine crack in existing concrete paving is indicative of the expansion and contraction of the concrete. Such causes are generally due to environmental factors, such as moisture levels, weather conditions, root systems of nearby trees or the soil types on which they are laid.

Fine cracks may also be due to poor original installation of the concrete. Factors such as poor compaction of the sub surface and/or inadequate reinforcing of the slab may create cracking and other secondary defects.

Monitoring of all cracking should be conducted frequently. Always contact a building inspector should cracks widen, lengthen, or become more numerous.

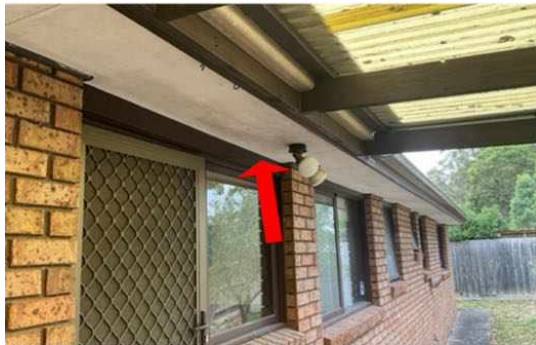
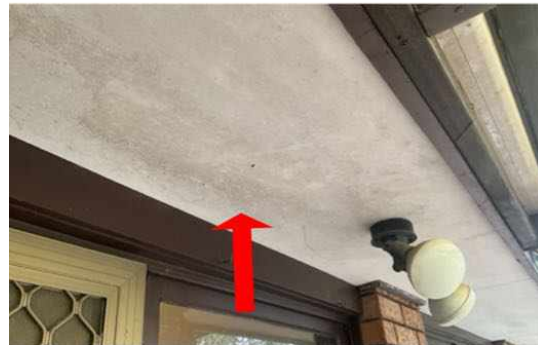
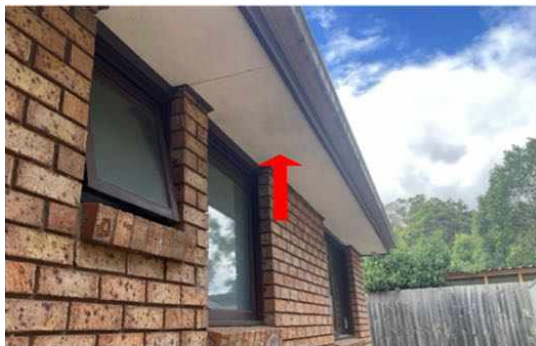
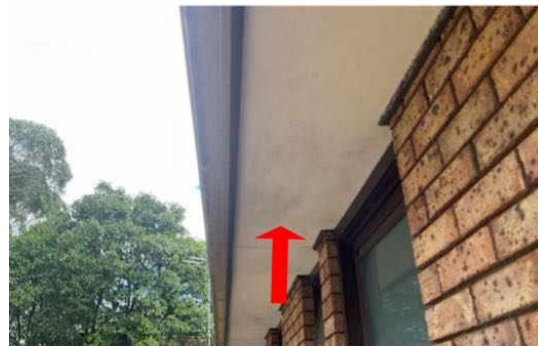
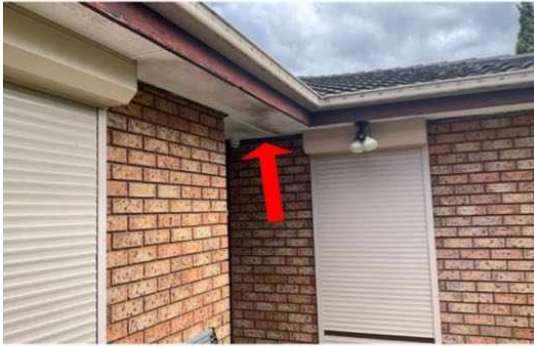
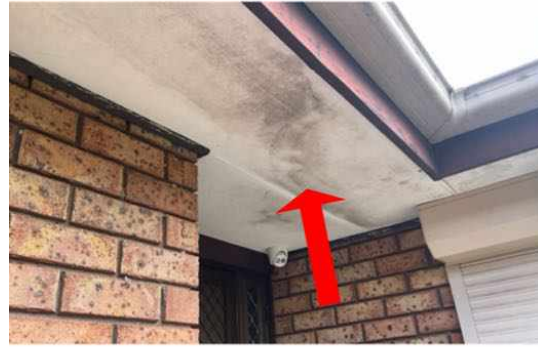
Finding: Eave linings - Water stained

Information: At the time of inspection, there appeared to be some water staining to various areas of the eaves linings around the property .

Water staining indicates that surfaces have been exposed to excessive moisture over time. The minerals and other elements in the water lead to staining, which may graduate to corrosion and deterioration if left unmanaged.

While mostly an appearance defect, water staining can be indicative of more serious defects, which may be currently concealed. It is suspected that the staining in this instance may be from overflowing gutters due to being blocked with leaves and other vegetation.

Where water staining is active, a licensed plumber must be consulted to identify the cause of the staining and to provide advice on any reparation works that may be required. Replacement of any damaged structures is advised.

Conversely, where water staining is old and inactive, affected building materials may be repaired or replaced at client discretion. All gutters should be cleared to allow for correct operation.

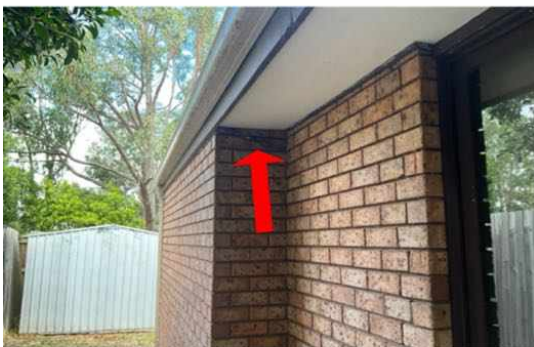
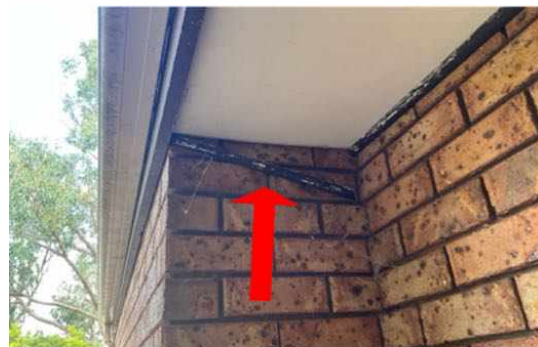
### Finding 3.19

Finding: Beads - Damaged

Information: Beading acts (like cornice or skirtings) to cover the intersection or joins of building materials. It was noted at the time of inspection that beading in this area has come loose. This deterioration is suspected to have been caused by general ageing and frequent exposure to weather, which is expected in a building of this age and condition.

Beading is important in weatherproofing the surrounding building elements and preventing termite or pest ingress. Furthermore, beading works to protect the joins of building materials, which are more susceptible to deterioration and decay.

Repair or replacement of the beading is advised to ensure the protection and longevity of any associated building elements. Such works may be performed by a general handyperson or qualified carpenter.

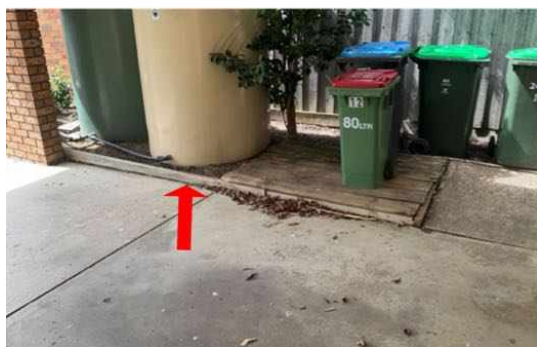
When met with excessive moisture, timber begins to decay and develop wood rot. Any timbers that are in direct contact with external grounds especially if left untreated or non-durable also provide ingress for subterranean termites into that particular element.

Where possible, the removal of any such materials that may be conducive to termite activity should be carried out as soon as possible to minimise the risk of termite attack. Where not possible or practical, regular monitoring of timber elements is recommended. Replacement of any damaged materials should be carried out where necessary.

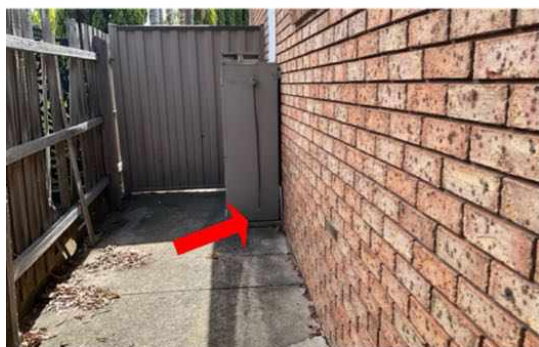
### Finding 6.03

Building: Exterior walls - right side  
 Location: Exterior walls - right side  
 Finding: Hot Water System Overflow - Not plumbed for drainage  
 Information: The overflow from the hot water system is not plumbed or connected to suitable drainage, which may result in the surrounding area becoming excessively damp.

These damp conditions can lead to secondary defects such as rot, rust or corrosion of associated building elements or the formation of fungal decay. When coupled with poor site drainage, pooling of water may also attract termite activity to this area.

It is recommended that a qualified plumber be appointed to install adequate drainage to the overflow or that it be diverted away from the edge of the building. These works will ensure that the area remains dry and free of any secondary defects.

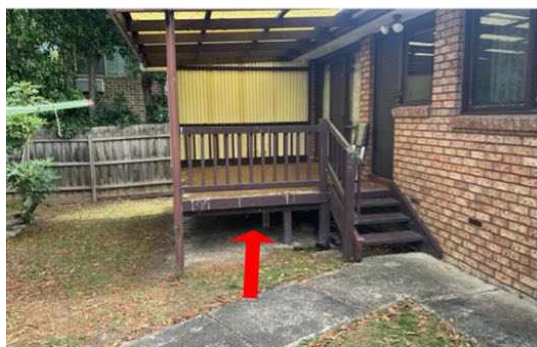
Building:  
 Location: Balcony  
 Finding: Elevated structure inspections - load capacity  
 Information: It was observed that the property had elevated timber decking areas. External timber structures are constantly exposed to weather elements and can deteriorate in an accelerated manner. As a result, ongoing assessments are required.

You should also arrange annual inspections of the structure by an engineer or other suitably qualified person to ensure any maintenance, that may become necessary, is identified. Care must be taken not to overload the structure.
